Damage Assessment of Historic Earthen Buildings After the August 15, 2007 Pisco, Peru Earthquake

Research Report

Claudia Cancino

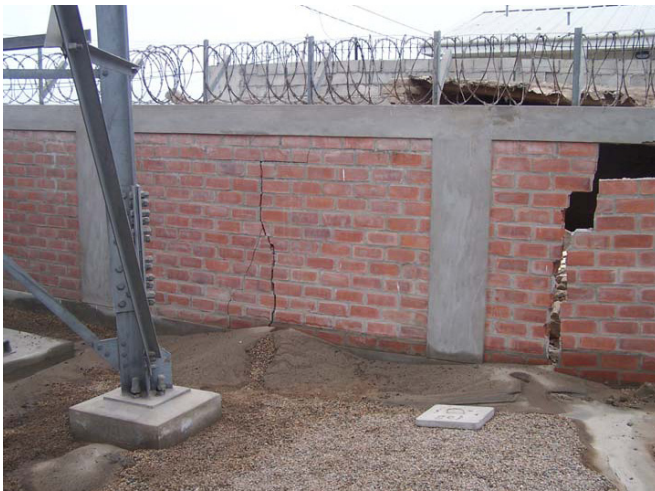
Liquefaction is the process by which saturated, unconsolidated soil or sand is converted into a suspension during an earthquake. The town of Tambo de Mora—due to its location above marine deposits and sand—was severely affected by liquefaction. This was recorded in several reports where liquefied sand was observed inside houses and on the sides of the streets.¹⁷ Most of the buildings affected were one- or two-story confined concrete masonry structures that suffered settlement between 0.2 to 1.0 m relative to street level (Figure 2.18). According to the Tambo de Mora citizens, the area had experienced liquefaction during the 1970 and 1974 earthquakes but no preventive action was taken.

FIGURE 2.18
Liquefaction at a site in Tambo de Mora.
Image: Courtesy Jorge Alva Hurtado.

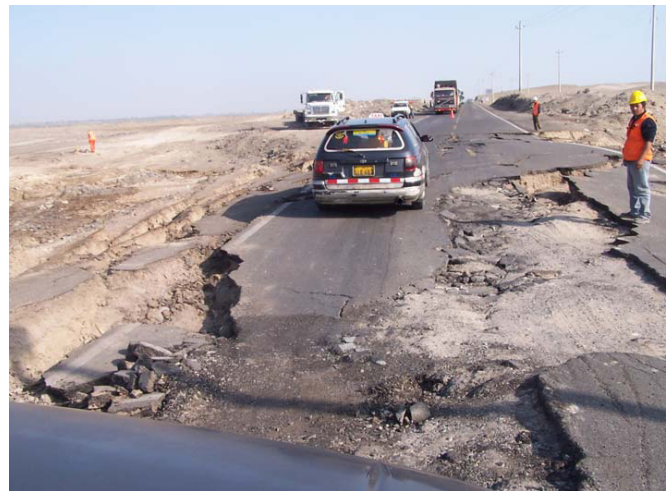
FIGURE 2.19
Landslide effects at the Pan-American Highway.

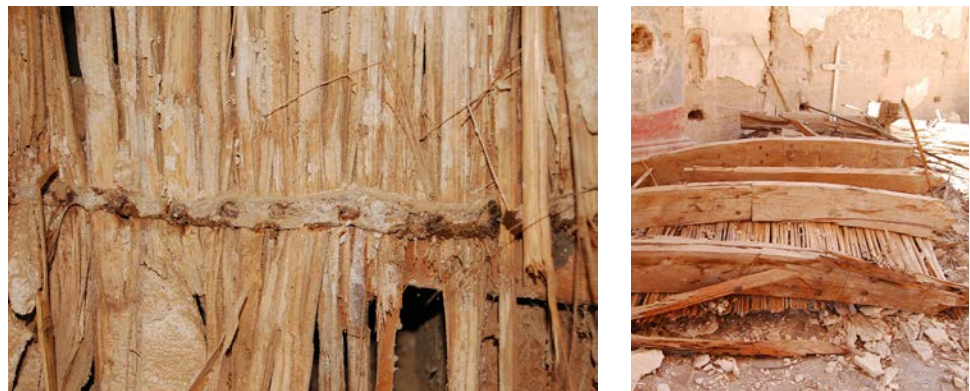
Quincha detail showing deteriorated wooden arches at the Church of San José de Nazca, in October 2007.

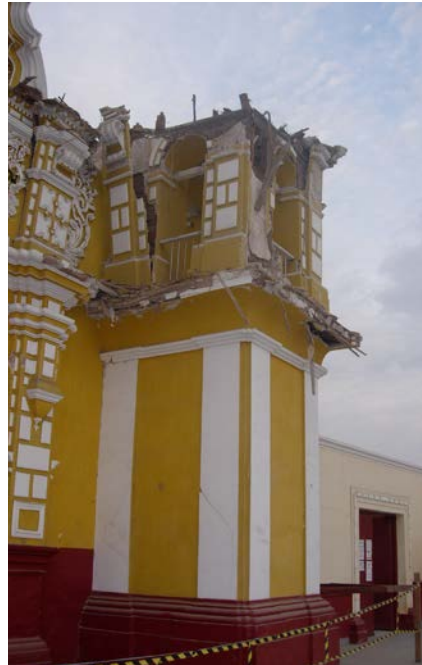
FIGURE 4.7
Detail showing total collapse of church tower dome at the Church of El Carmen in Chincha, as it appeared in October 2007.

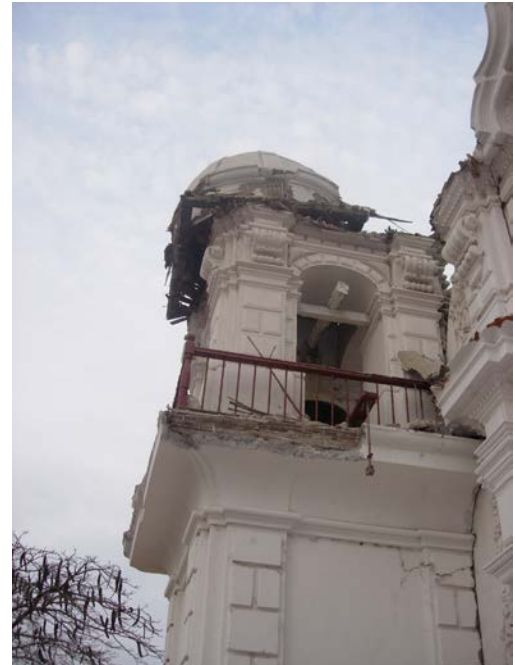
FIGURE 4.8
Detail showing shift of church tower dome at the Estate Church of San José, Cañete, as it appeared in October 2007.

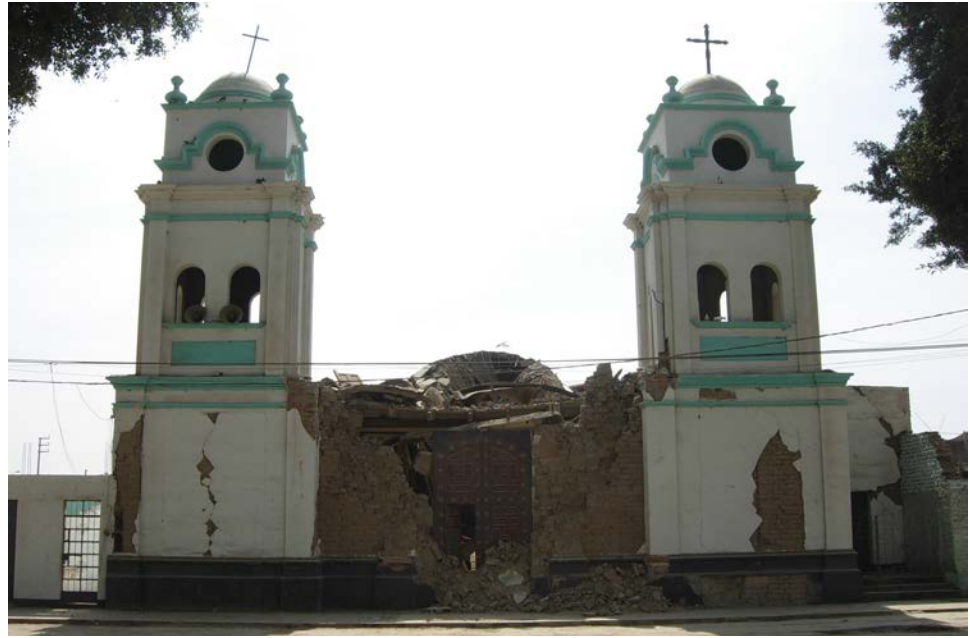
Earthquake damage to the Church of Guadalupe in Ica, as seen in October 2007.

connection between the adobe walls and the facade, particularly at the Church of Guadalupe (Figure 4.9), which occurred either before the earthquake or at the moment of the earthquake. Another pre-earthquake condition contributing to collapse is the presence of a heavy layer of dirt or cement mortar over the vault, probably due to lack of or inappropriate maintenance.

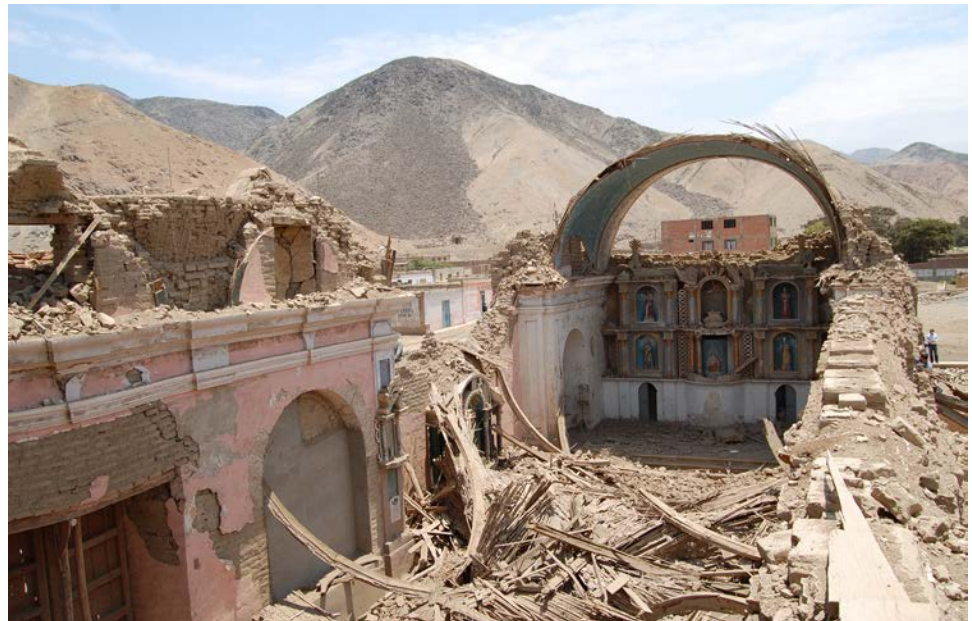
**Figure 4.12**

View of the total collapse of the vault at the Church of Coayllo, Cañete, as seen in October 2007.

the vaults stiffened the structure at both ends, which, in conjunction with the deteriorated arches, created transversal tension and induced the quincha vault to fail (Figures 4.11 and 4.12).

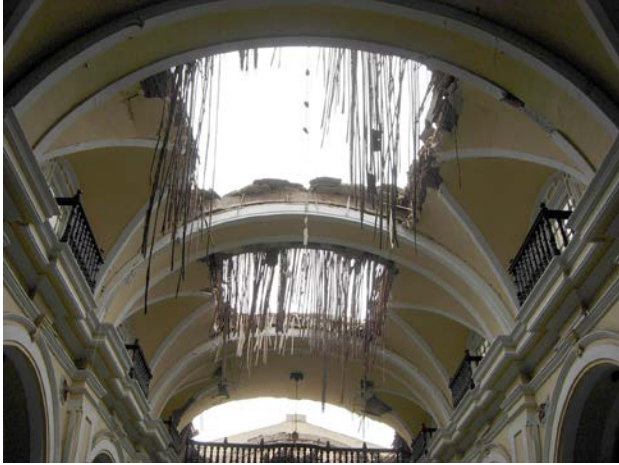
FIGURE 4.13
Detail of vault failure in the main nave of Cathedral of Ica following the Pisco earthquake, as seen in October 2007.

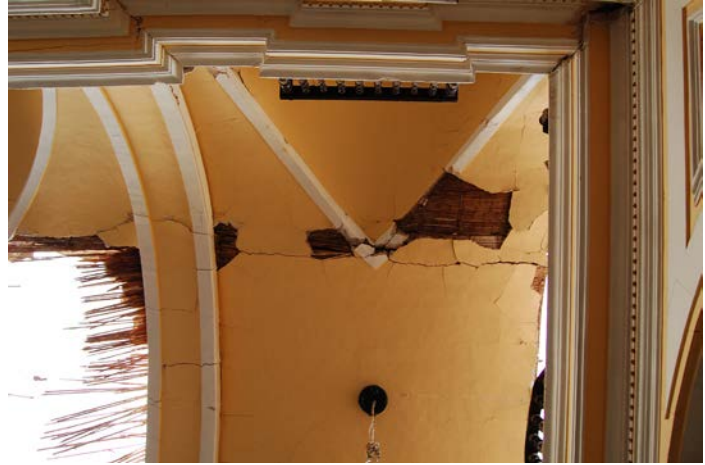
FIGURE 4.14
View of crack where partial collapse of the vault occurred at the Cathedral of Ica, as seen in October 2007.

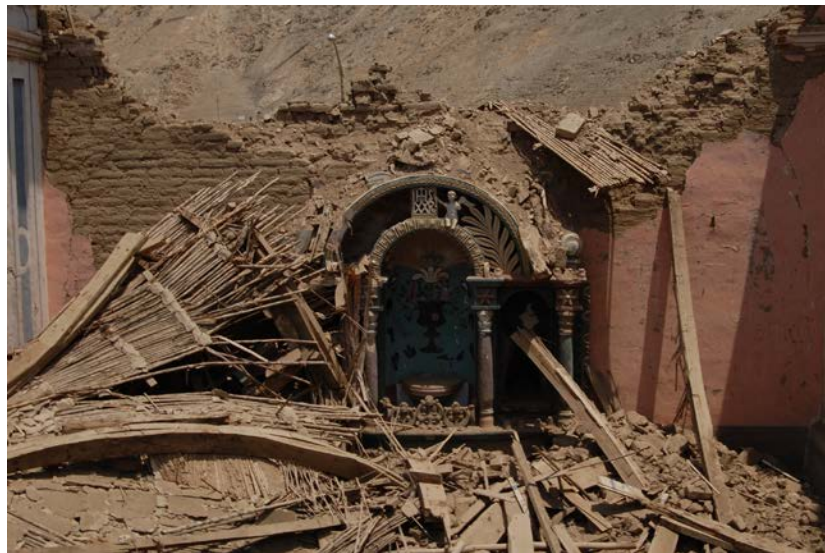
Partial out-of-plane failure of adobe lateral wall at the Church of Coayllo, Cañete, as seen in October 2007.

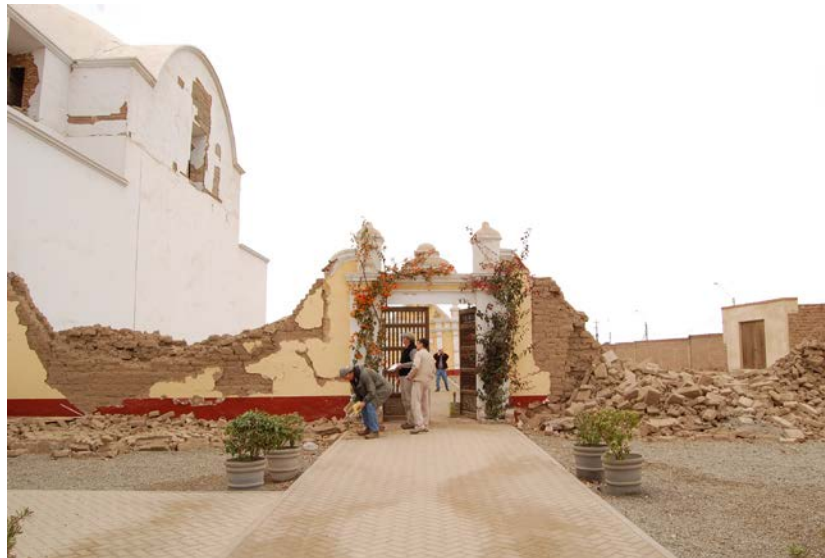
A stand-alone adobe wall at the Church of Chilca showing out-of-plane failure in October 2007.

A much more obvious example of this type of failure, however, was observed at stand alone walls at the Church of Chilca (Figure 4.19) and at the main house and worker residences of the San José and Arona y Montalván Estate respectively (Figure 4.20), where wall sections collapsed. In both cases, the slenderness ratio of the walls didn't withstand the rocking during the earthquake. The process for this type of failure is very well explained by Tolles et al. who write, "Flexural cracks begin as vertical cracks at transverse walls, extend downward vertically or diagonally to the base of the wall, and extend horizontally to the next perpendicular wall . . . after cracks have developed, the out-of-plane stability of a wall is dependent on the slenderness ratio, connection to the structure, vertical loads, and the condition of the wall at its base."⁴

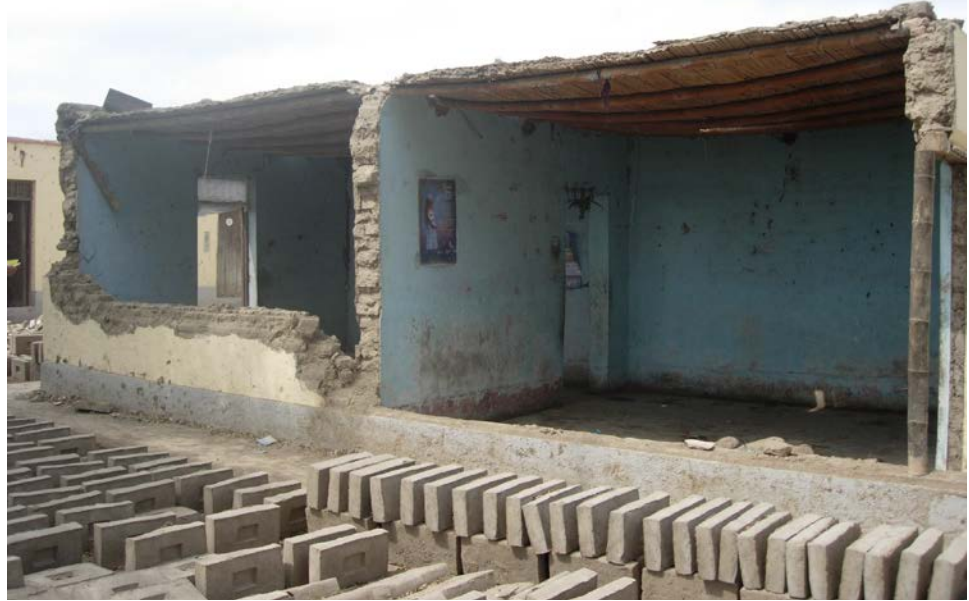
Arona y Montalván estate workers residences showing out-of-plane collapse, October 2007.

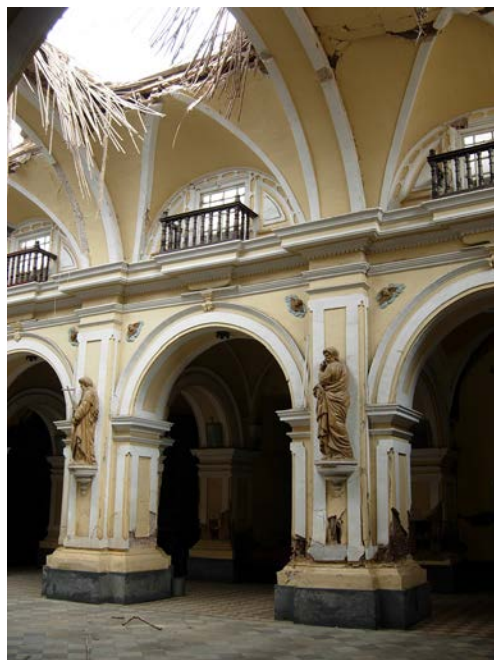
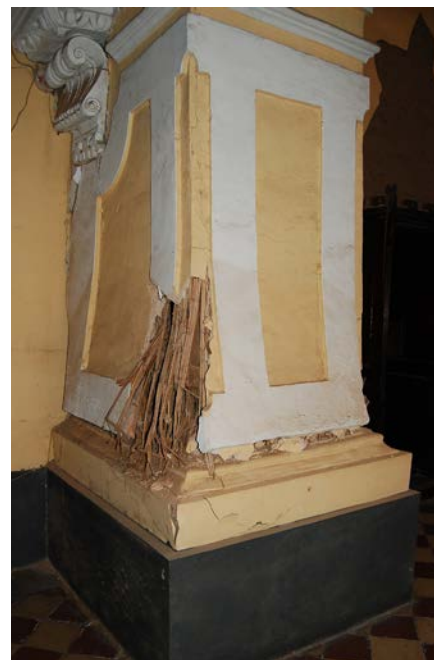
Detail of plaster detachments at quincha pillars of the Cathedral of Ica, October 2007.

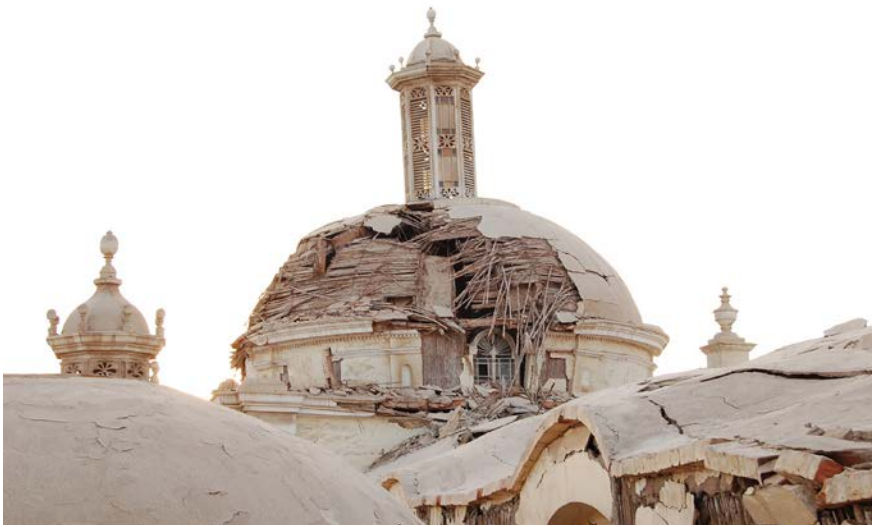
Many plaster detachments were observed on vaults, domes, walls, columns, and pillars of the visited sites (Figures 4.28 and 4.29). Furthermore, and most importantly, previous unrepaired plaster detachments left the wooden elements of the quincha roofing systems, as well as columns and pillars, exposed to the environment which generated termite damage, as observed at the Churches of San José and San Javier de Ingenio in Nazca.

FIGURE 4.28
Plaster detachment on the dome of the Cathedral of Ica, as seen in October 2007.

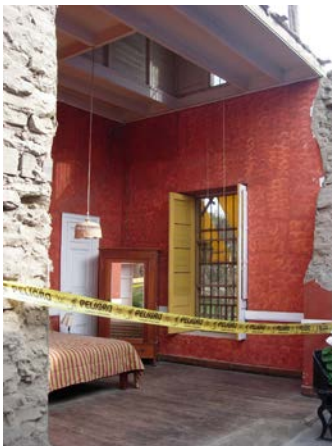
FIGURE 4.30
Out-of-plane of adobe wall failure due to lack of proper wall-roof connections. Main estate house, Hacienda San José, Cañete, as seen in October 2007.

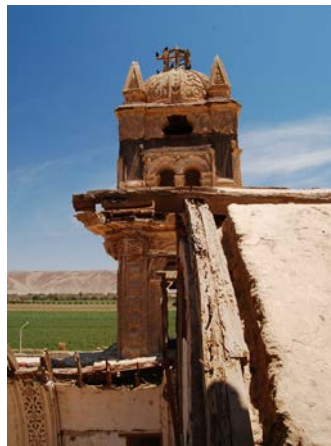
FIGURE 4.31
Separation of main façade from vault at the Church of Hacienda San José de Nazca, as seen in October 2007.

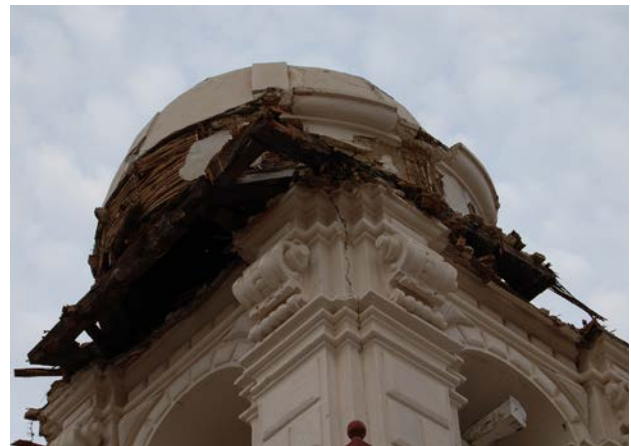
FIGURE 4.32
Displacement of upper dome due to failure of connections with tower pillars, Church, Hacienda San José, Cañete, as seen in October 2007.
