总体状况概述 Overall Condition Summary

会乘殿，室内 - 塑像：

Huicheng Hall, Interior - Sculpture:

Avalokitesvara (*Guanyin*) on a *chaotianhou*

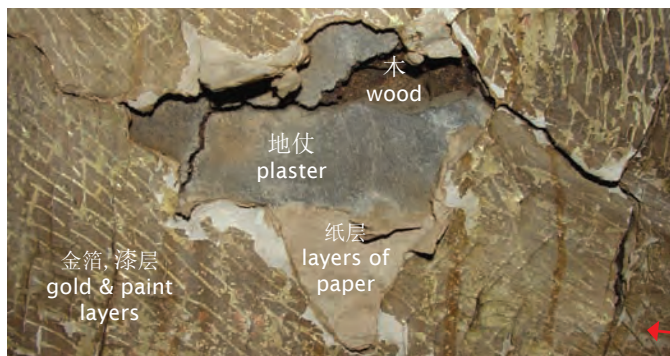
白象塑像上的深层脱落显现出组成塑像的各层次木骨架、地仗、纸层、金箔、漆层。

Area of deep loss on the elephant sculpture showing the layers which make up the sculpture, including the wooden armature, plaster, layers of paper followed by gold and paint layers.

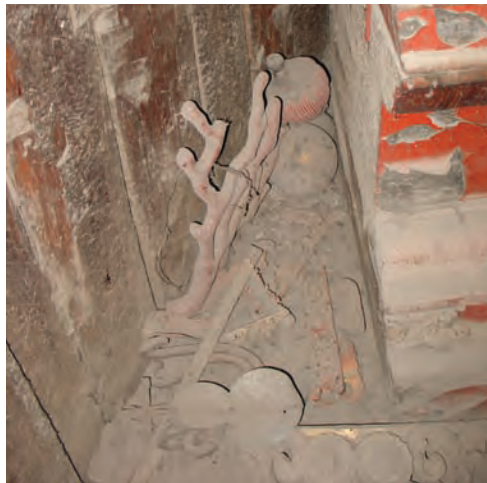
莲花瓣表面和地仗层起甲和脱落。

Flaking and loss of painted plaster on lotus petals.

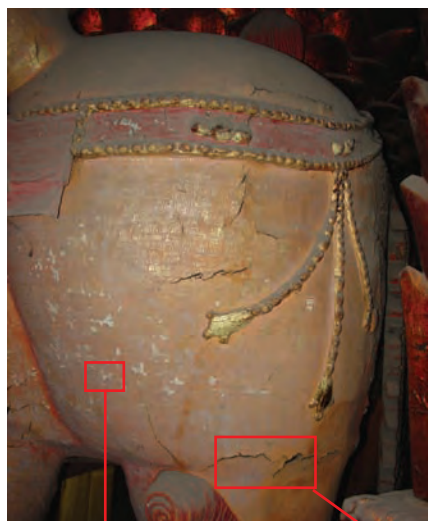
朝天吼背面，可见油漆层的起甲及开裂。
Rear end of the *chaotianhou* showing flaking of the paint layer and cracks.

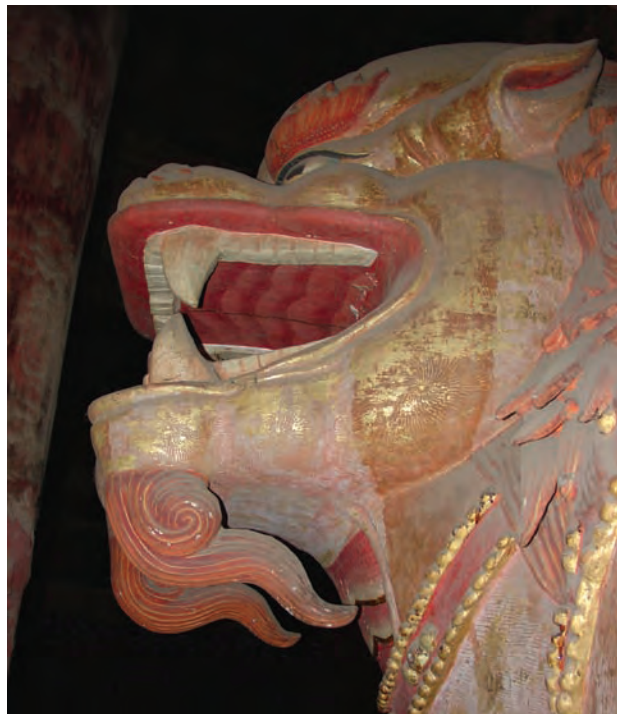
朝天吼头部及其口腔上颚的开裂的详图。

Head of *chaotianhou* and detail of crack on upper roof of the mouth.

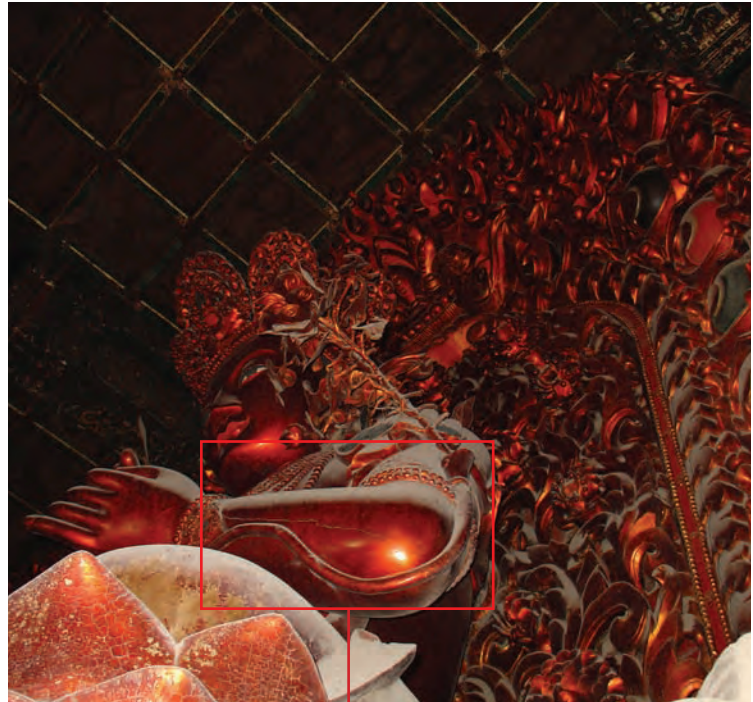
文殊像左臂上的裂缝。

Crack on the left arm of Manjusri.

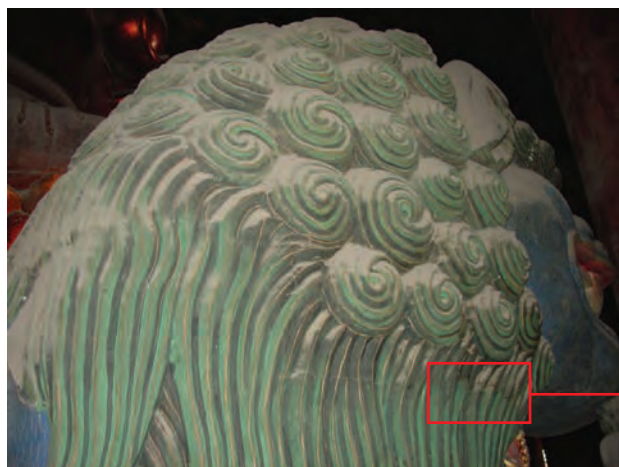
狮后部的裂缝。

Cracks on backside of lion.

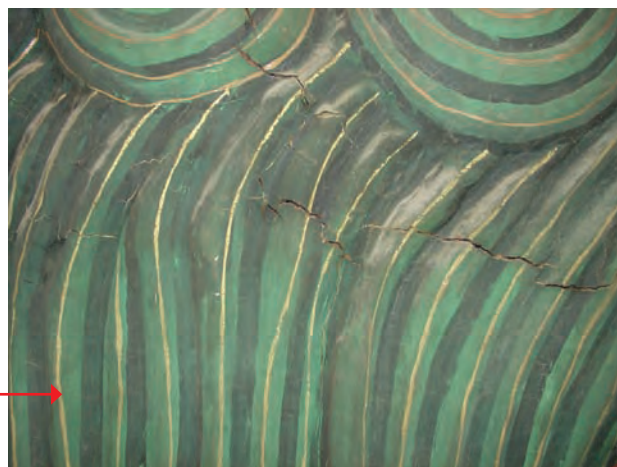
狮鬃毛上的裂缝。

Cracks on lion's mane.

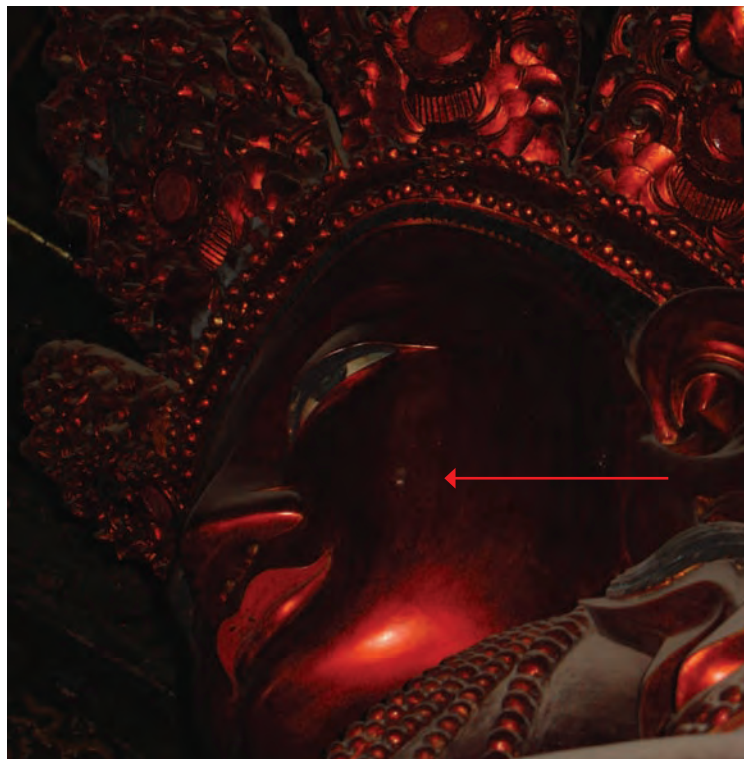
普贤右臂上的裂缝。

Cracking on right arm of Samantabhadra.

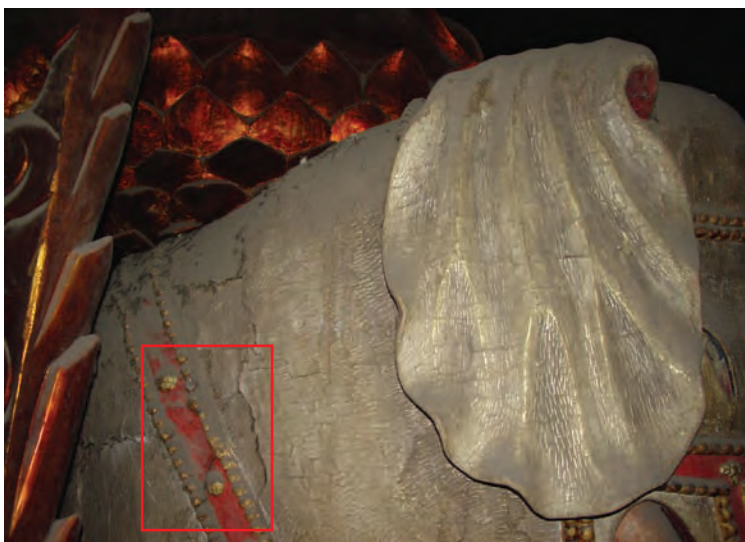
象头右侧有裂缝。

Right side of elephant head showing cracks.

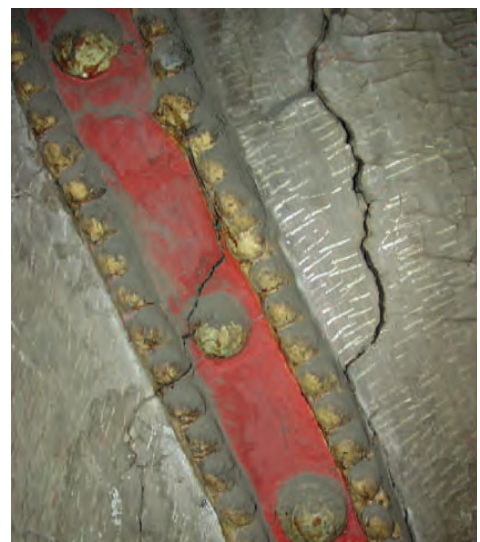
裂缝详图。

Detail of cracks.

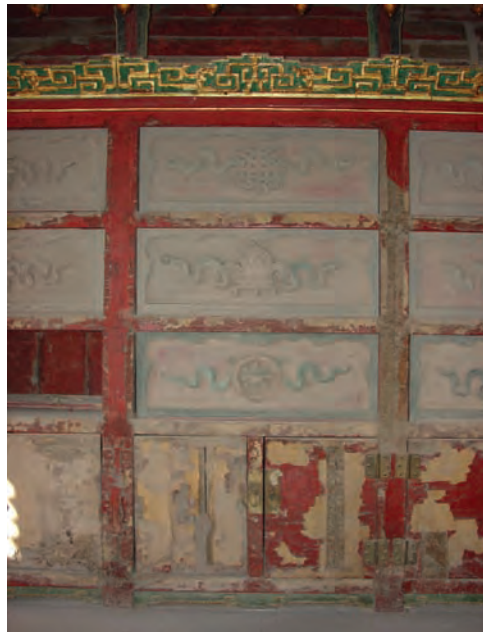
很多的经格门都已缺失。虽然有一些后来补换的门，但并没有被装上。

Many of the sutra shelf doors are now missing. However, later replacement doors exist but have not yet been attached.

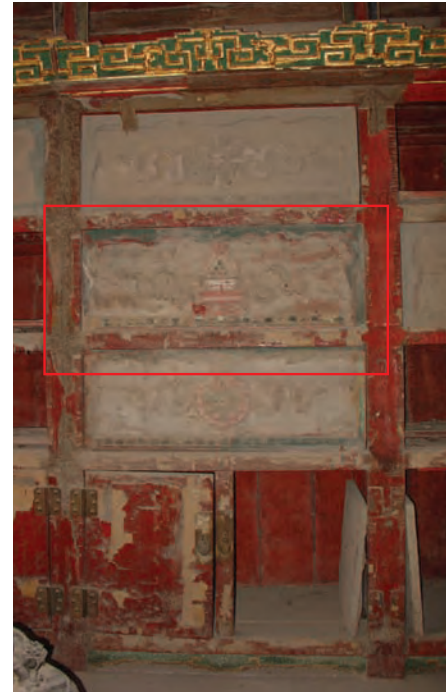
原经格门，但有补换的部分，如上沿和左沿的绿框。

Original sutra shelf door with replaced elements such as the green frame on the top and left edges.

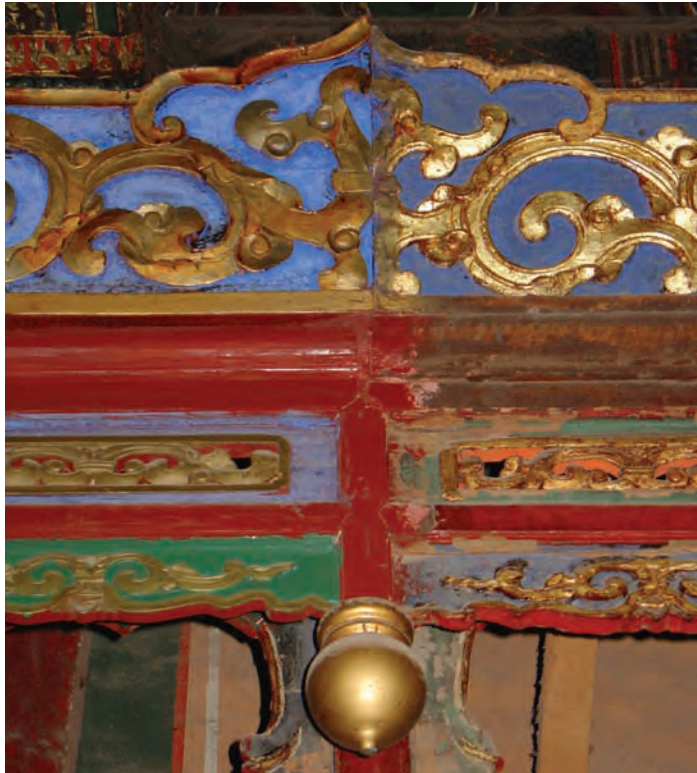
东西两侧经格顶部的部分装饰也被修复过。一些构件有进行补换、重绘和重上罩面清漆。修复的部位与原来的部位看起来不同。有些地方使用了不同的颜色。新的金色部位涂了很多的罩面清漆但没有原来的那么亮。

The upper tier decoration on both the west and east sides above the sutra shelves have also been partially restored. Note that some elements have been replaced, repainted and reglazed. The restored areas are noticeably different from the original, in some cases different color paint is used from the original and the new gold areas are heavily glazed and are do not appear as shiny as the original areas.

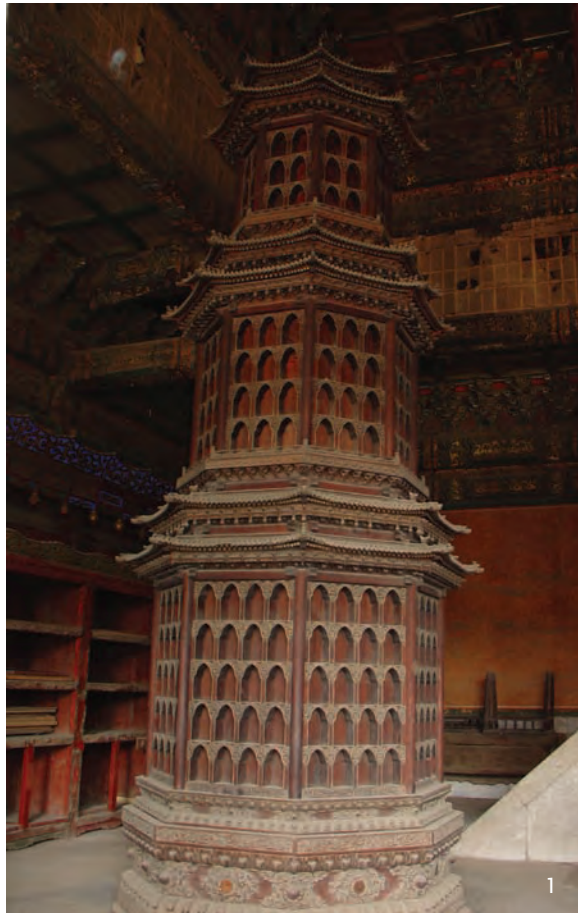
西侧的木塔除了少量装饰性构件缺失，如底部球形物、屋顶上的走兽、屋檐上的钟和栏杆等以外，基本状况良好。在塔的最底层有一个洞。

The western pagoda is in good condition with only minor missing decorative elements such as some of the ball decorations along the base, animal pieces from the roofs, hanging bells from the roof eaves and balustrades. A small hole exists in the lowest level of the pagoda.

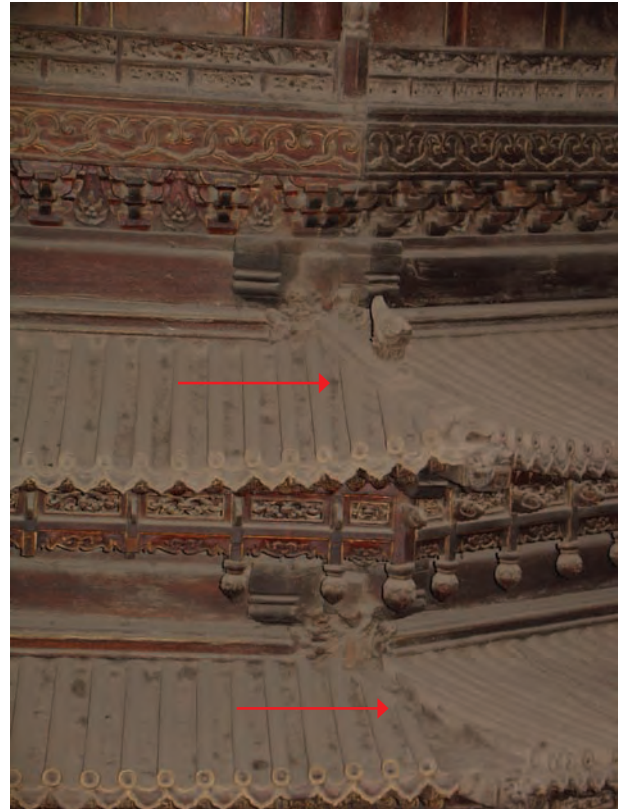
屋顶上走兽像缺失。

Missing animal sculptures on roofs.

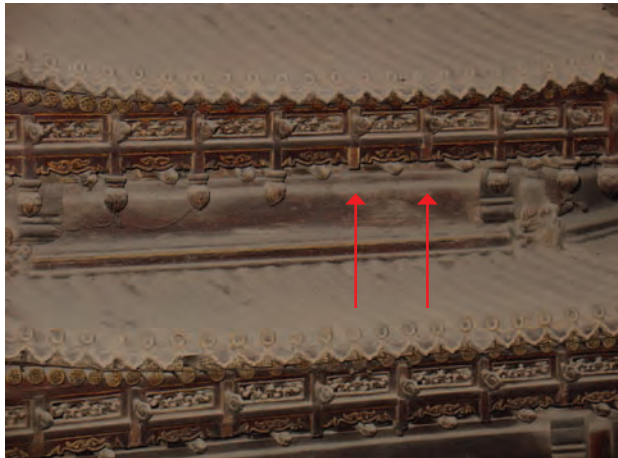
球形装饰缺失。

Missing ball ornaments.

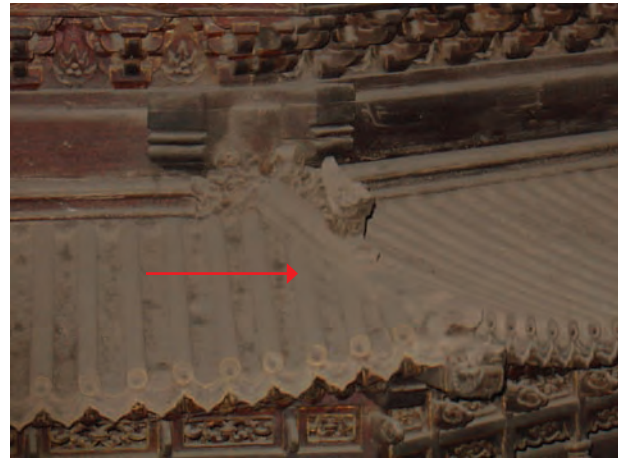
屋顶上走兽像缺失详图。

Detail of missing animal sculptures on roof.

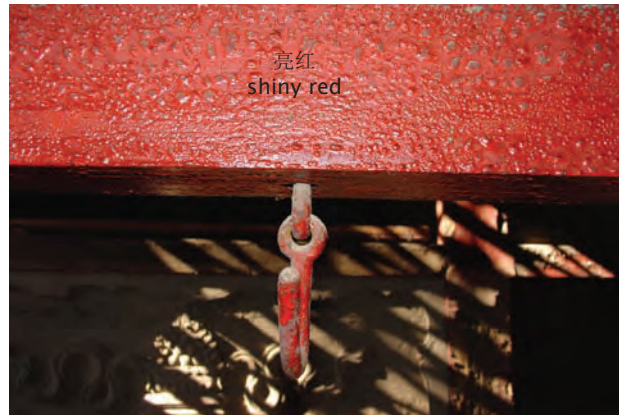
中间铁钩的详图。注意光亮红漆上的凹凸不平，这是鼓架表面主要的状况。这层漆应该是后期干预所致。

Detail of the center painted metal hook. Note also the bumpy and blistering condition of the shiny red paint. This is the predominant surface condition on the drum stand and is thought to be related to a later application of red paint.

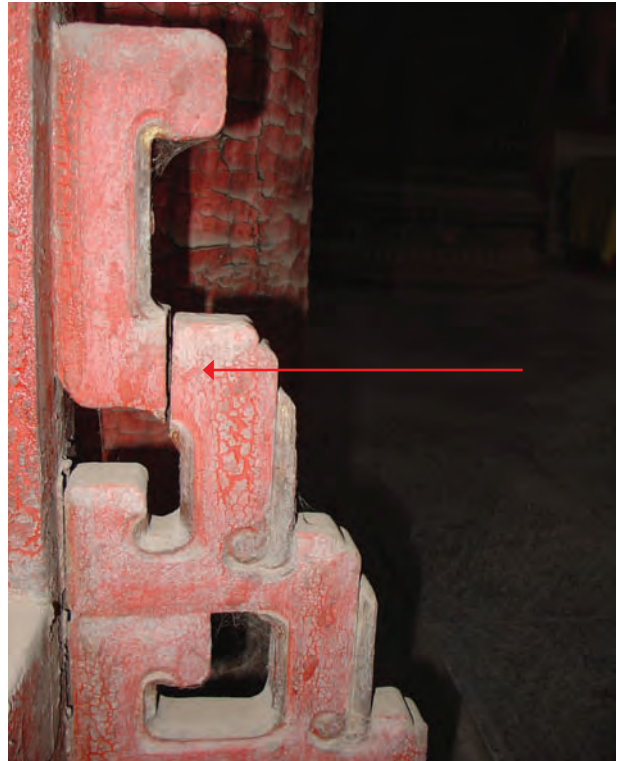
装饰构件的侧面显示断裂的部分。

Side view showing the break in the decorative element.

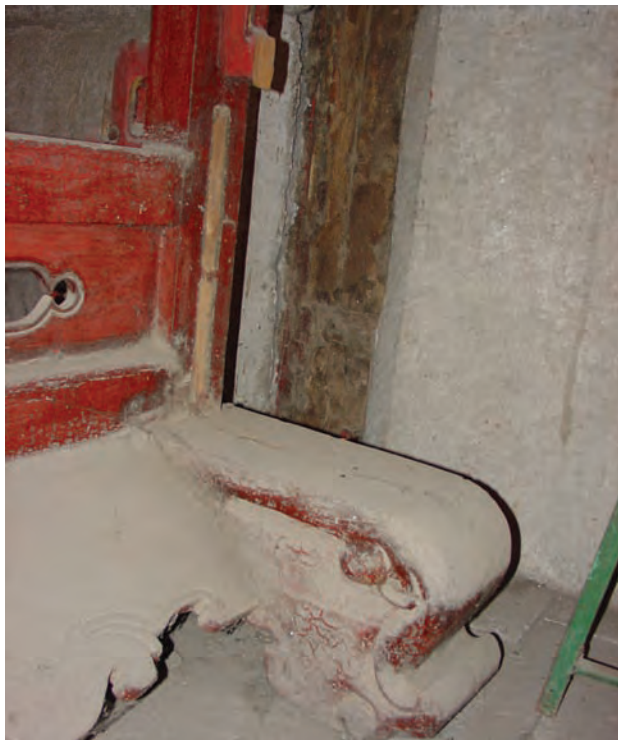
底座的装饰构件已缺失和厚重的灰尘。

Missing decoration at base and heavy layer of dust.

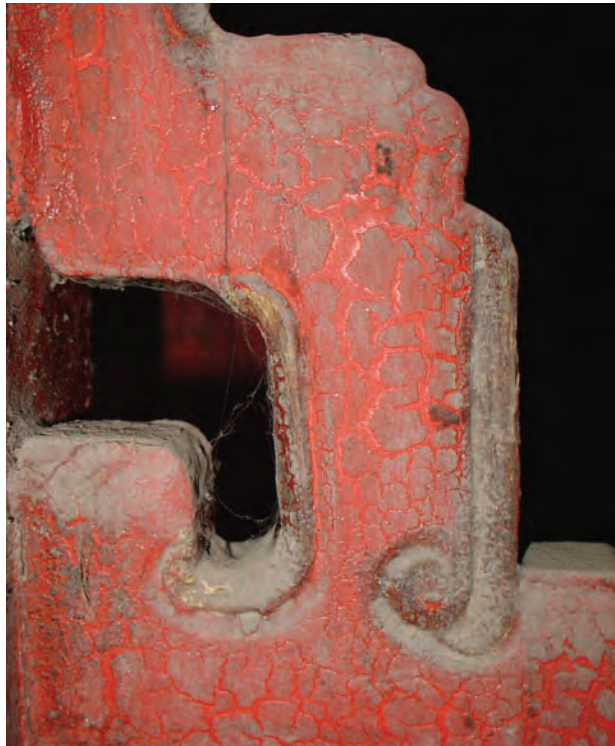
钟架底座木构件细部的详图。可看到油漆的状况。

Detail of the wooden detailing at the base of the bell stand. Note the condition of the paint.

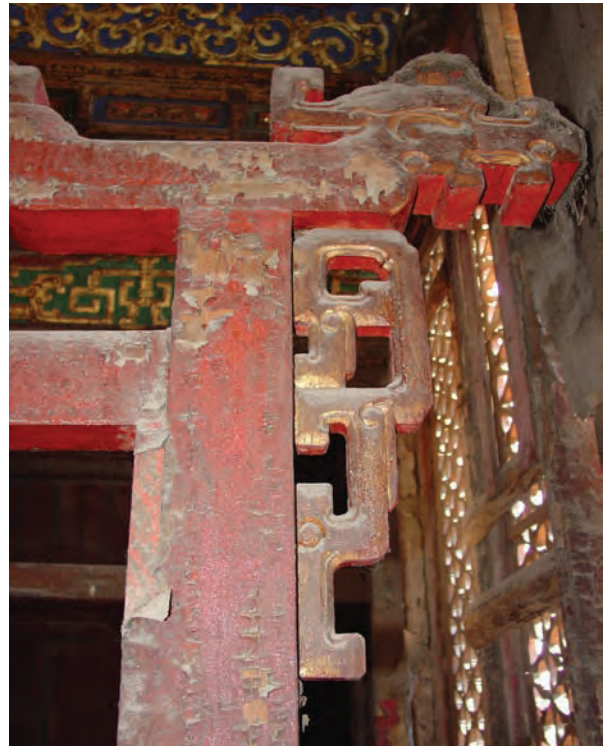
钟架顶部的雕刻装饰构件与漆层起甲脱落的部分。

Carved decorative elements on the top of the bell stand and areas of flaking and loss of the paint layer.

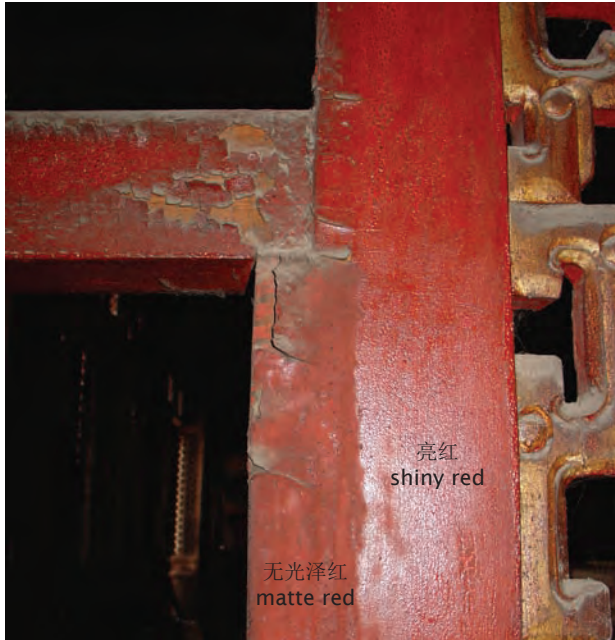
在钟架上可明显看到两种不同的红漆。一种认为是原来的无光泽红漆而另外一种则是后来使用有光泽的红漆。亮红漆涂在有脱落的部分（直接涂在木材上），有时也涂在原来无光泽的红漆上。不同的漆层有不同的残损。

Two different types of red paint are visible on the bell stand. The matte red paint (thought to be original) and a later application of a shiny red paint. The shiny red paint was applied in areas of loss (directly onto the wood) and in other areas over an existing layer of the matte red paint. The deterioration is different depending on the type of paint layer.

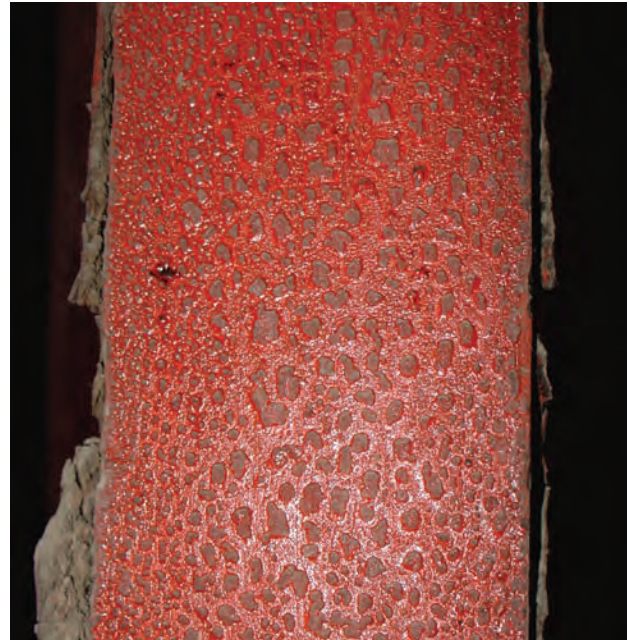
后加的亮红漆表面凹凸不平的详细情形。造成这种状况的成因不明，但可能是漆中胶结物量的问题。

疱疹状主要出现在钟架的内侧。

Detail of the bumpy and blistering appearance of the later shiny red paint. It is unknown what caused this surface condition but it may be related to the amount of binding media in the paint.

The blistering is found primarily on the inner sides of the bell stand.

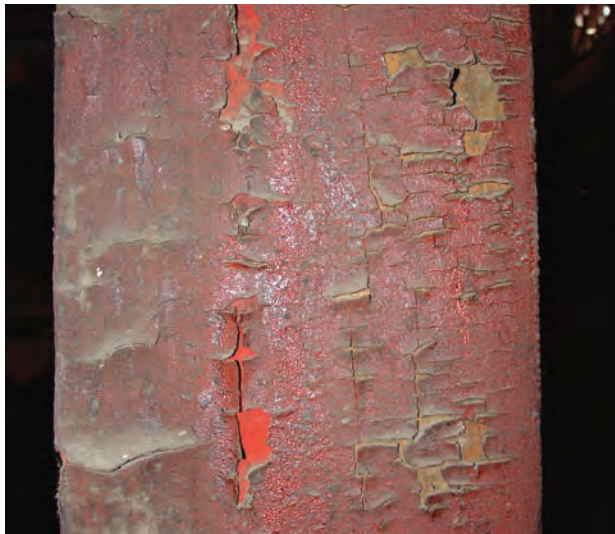
无光泽红漆出现起甲的详图。钟架上有许多这种起甲现象。

在本照片中可以看到亮红漆主要涂在已脱落的部位。

Detail of the type of flaking associated with the matte red paint. There is a lot of this type of flaking found on the bell stand.

A bright red paint layer is visible in this image preferentially applied in areas of loss.

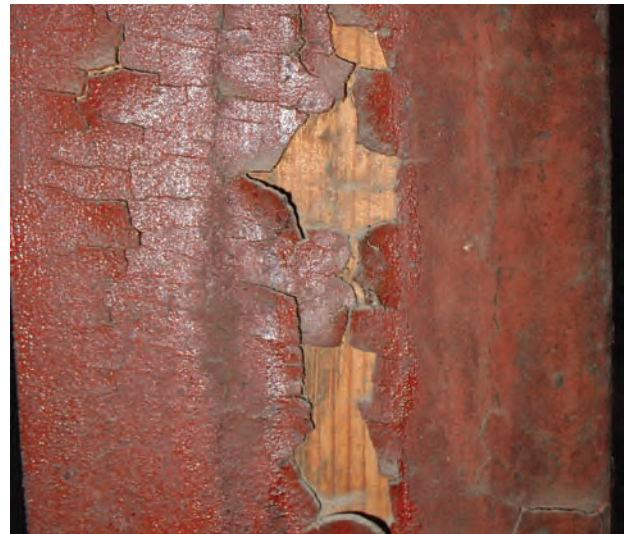
油漆地仗脱落后显示底下的木结构。从这里也可以看到两层漆底层是无光泽红漆和后加的亮红漆。这一种例子未涂漆的木材表示亮红漆一定是在漆脱落之前所涂的。

Losses in the painted plaster show the underlying wood structure. Note again, two layers of red paint, an underlying matte red and a shiny red paint. In this case the losses must have occurred after the application of the shiny red paint as they are unpainted.

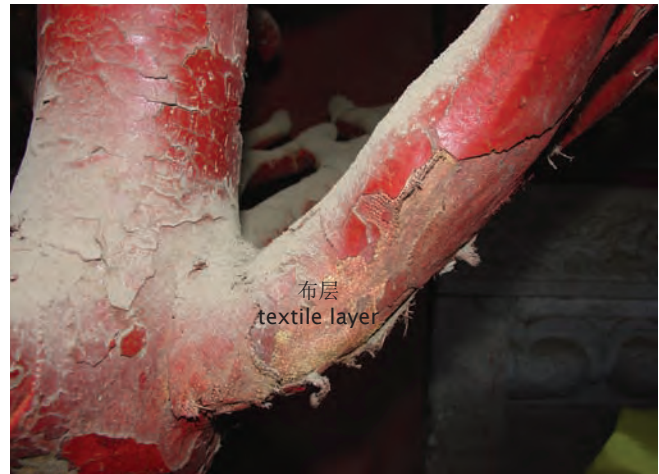
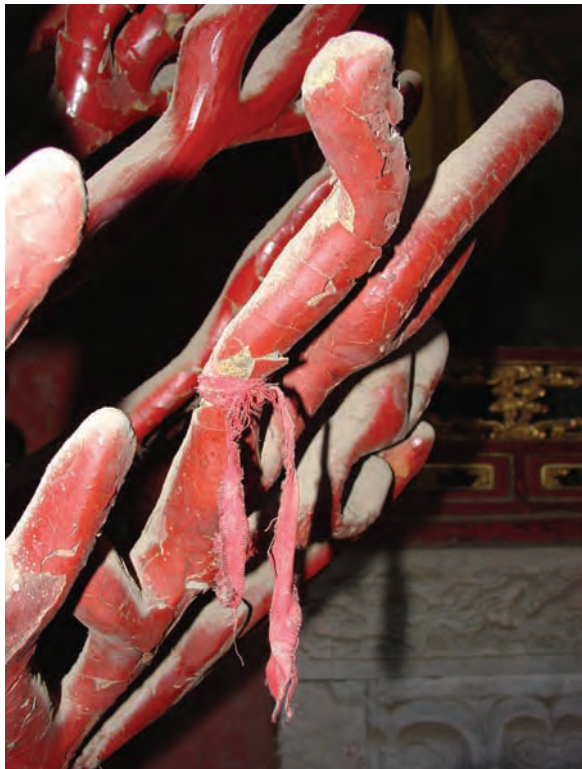
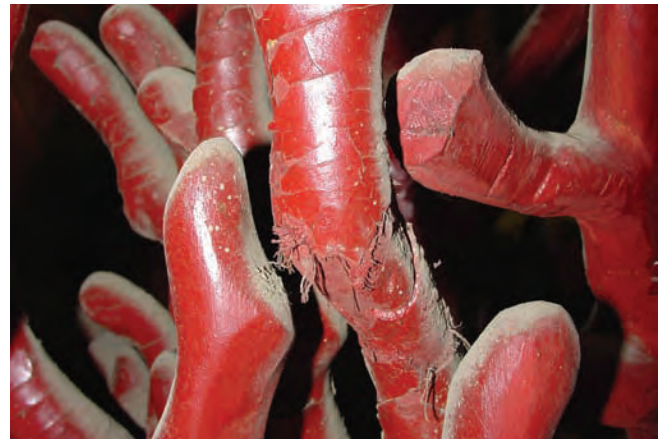
红漆地仗层的脱落露出底下的布层。许多的脱落部分被漆上红色表示曾进行过修复。图片的右边显示一段用来牢固珊瑚树断片的红布条。

Losses in the red painted plaster reveal the textile preparation layer below. Many of the losses are painted red indicating past restoration. Broken pieces have in some cases been crudely reattached back to the tree. The image on right shows a red cloth strip used to tie back on the piece of coral tree.

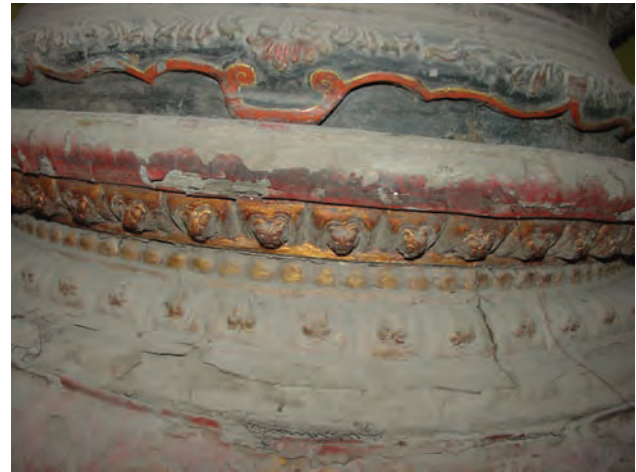
珊瑚树底座侧面图显示浮雕装饰上的裂缝和小面积脱落。
Side view of coral tree base showing showing cracks and small losses in the painted relief decoration.

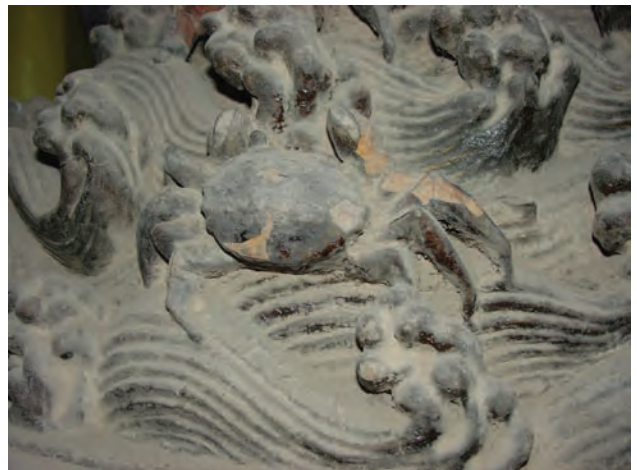
底座上一只螃蟹的详图，显示地仗装饰上轻微的脱落。
Detail of a crab on the stand showing minor losses in the plaster decoration.

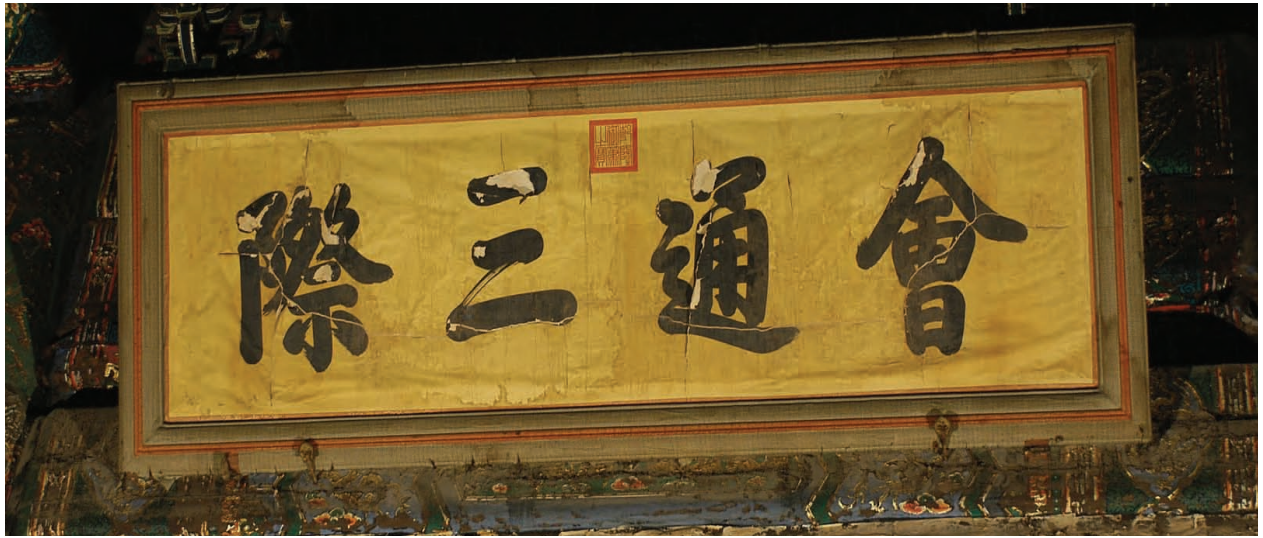
写在纸上的黑墨字。字体上有少量的脱落，并且纸上可以看到撕裂的痕迹。

Black ink calligraphy on paper. Small losses are visible in the characters and there is evidence of tears in the paper.

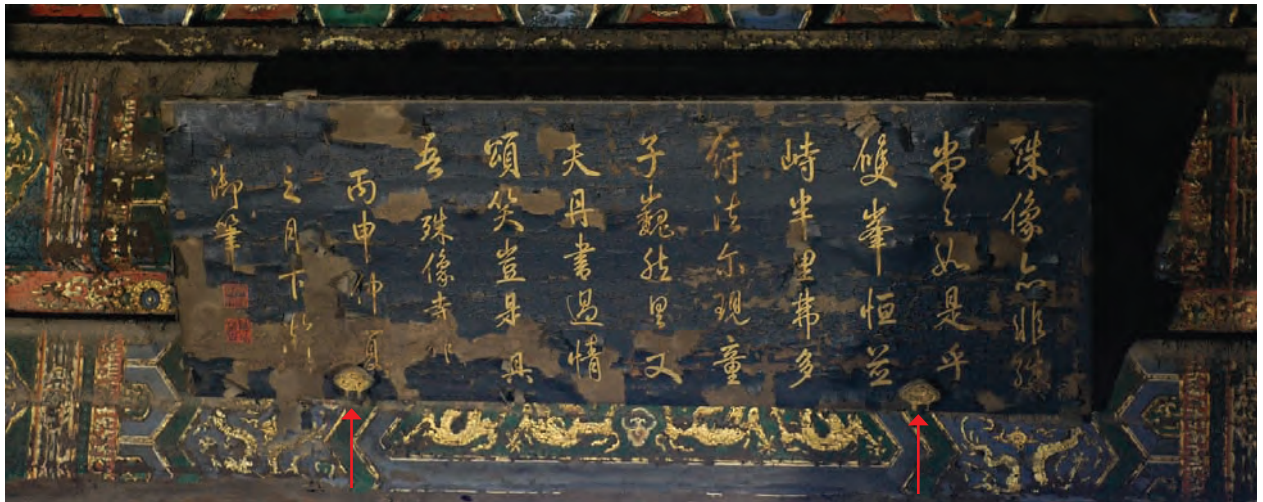
木质匾额是黑木底色上刻金色书法。黑漆上有很多脱落的部分。两个金色夹子将匾额固定在位置上。

Wooden tablet is painted black with calligraphy in gold paint. There are many losses in the black paint. Two gold-colored decorative clamps hold the tablet in place.

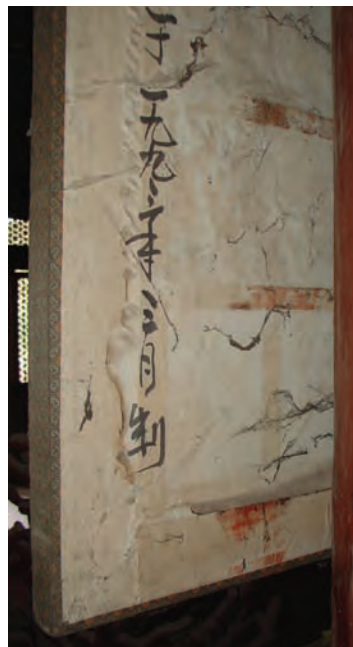
东侧楹联背面下方显示内部木质骨架的粘接剂污垢和1993年进行重新裱画的工匠名字。
Lower back of east couplet showing adhesive staining on interior wooden frame and the names of the craftsmen who carried out the reframing in 1993.

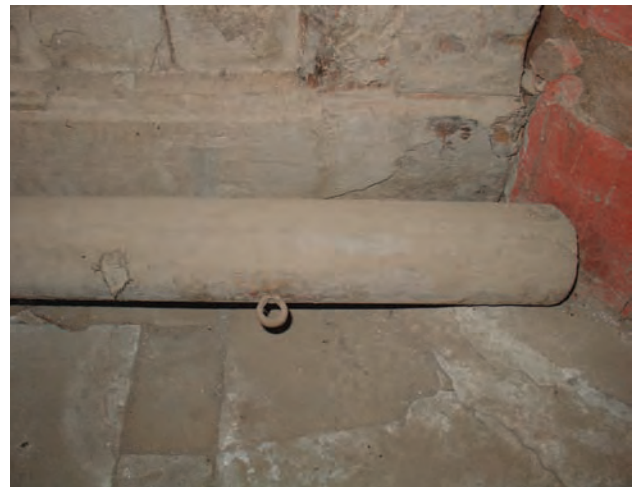
东次间挂杆细节，可见其中一个铁环。挂杆上堆积了厚重的尘土。

Detail of next east bay curtain rod showing one of the metal rings. Note the heavy layer of dust on this curtain rod.

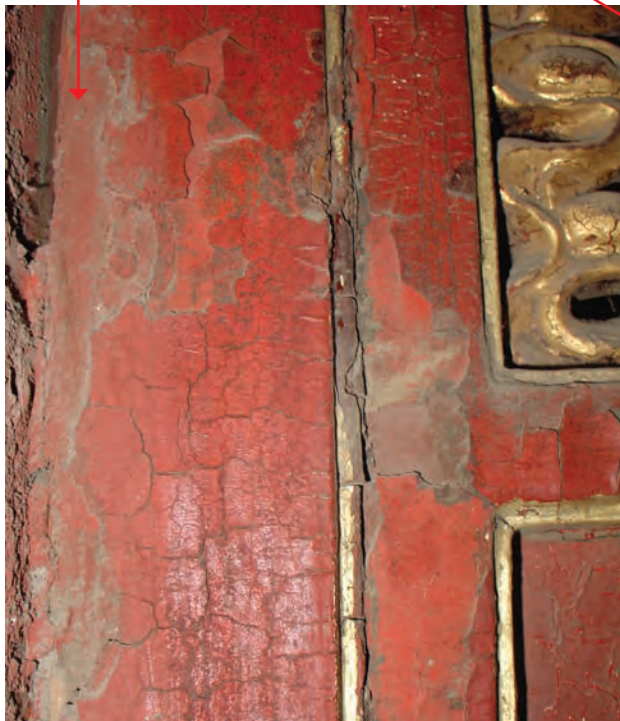
栏杆的状况。有两层红漆，底色是无光泽红漆，上层是光亮的红漆。
Condition of the balustrades. Note two layers of red paint including a lower matte red and an upper shiny red paint.
