CHAPTER 4

Cathedral of Ica

4.1 Summary

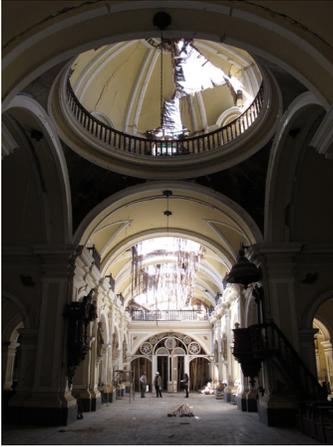
FIGURE 4.3
View of damages to the dome and vault resulting from the 2007 earthquake.

1813 and 1942 earthquakes, which led to the rebuilding of its façade, including the two bell towers, in fired brick masonry. The structure has been at risk since the 2007 earthquake, which led to the collapse of sections of the barrel vault near the façade, partial collapse of the central dome, total collapse the roof over one bay of the south side aisle, and loss of plaster at the pillar and pilaster bases (Fig 4.3).

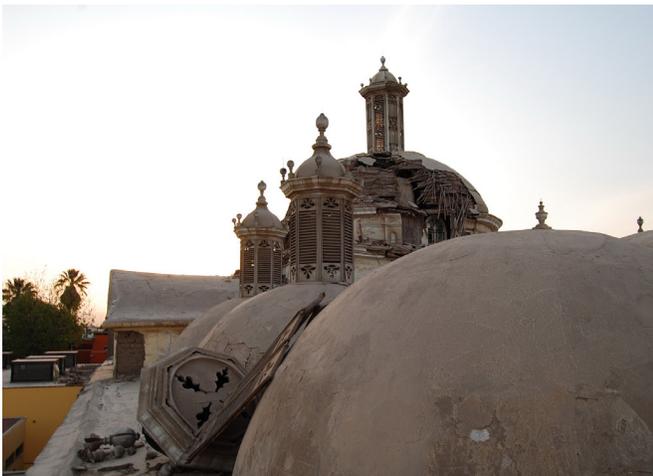
FIGURE 4.13
View of domes over south lateral aisle, with damaged main dome in the distance, 2007.
Image: Instituto Nacional de Cultura del Perú.
