CHAPTER 5

Church of Kuño Tambo

5.1 Summary

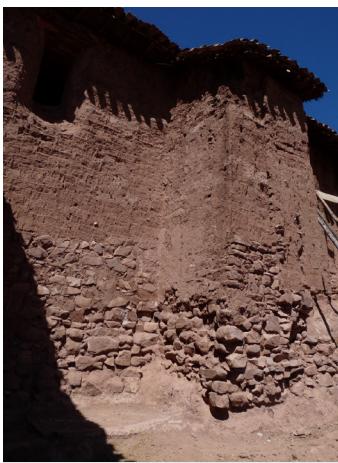
**FIGURE 5.12**

View of erosion at east side of church.

The church (lat 13°39'38" S; long 71°51'26" W) is built on a natural rock outcropping, with some compacted clay fill used to level the site. Thus, depending on the topography, the foundation either bears directly on the rocky soil or the compacted clay fill. As a result of the steep topography and use of clay fill, some portions of the interior finish floor are significantly higher than the adjacent exterior grade level. The most extreme differential is at the east side of the church, where the interior floor elevation is approximately 2 m higher than the adjacent grade and large portions of the natural rock outcropping are visible below the base course. The visible outcropping in this area shows signs of sedimentary rock erosion (Fig. 5.12). This erosion may be the result of improper site drainage, which is made worse by the natural slope of the site; however, the water source(s) contributing to the erosion were not immediately clear, as the construction assessment survey was carried out during the dry season. Possible drainage sources include surface water runoff from the upper village, falling water from the roof eaves, or a combination of those two factors. Alternatively, this erosion may be the result of excavations carried out in the past.

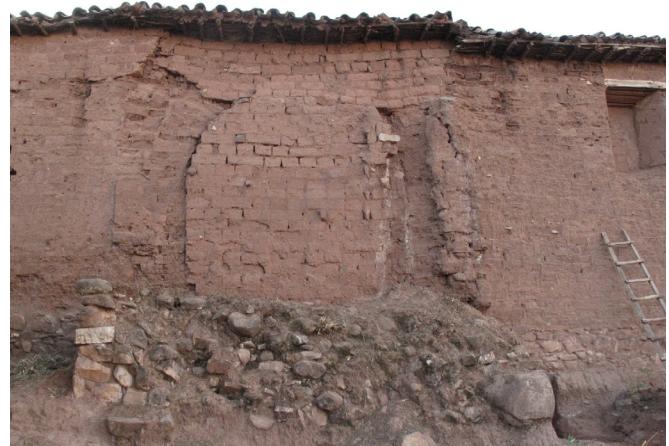
**FIGURE 5.21**

West lateral wall of main church, showing the infilled opening and collapsed buttresses.

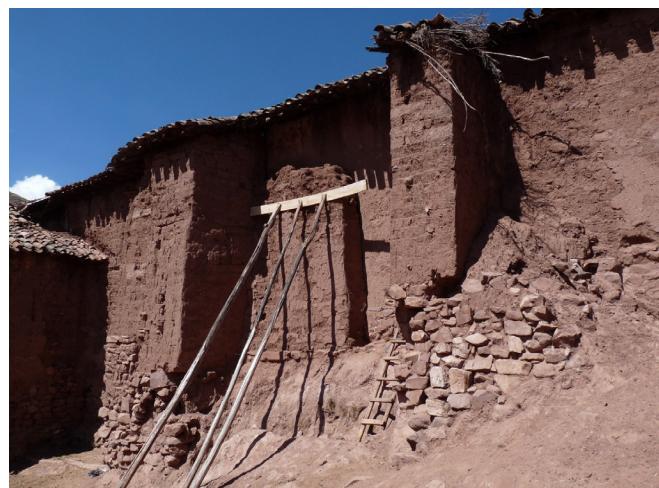
In those sections of the base course that are visible from the exterior or through projections carried out as part of the survey, the base course was observed to be in fair to good condition. The mortar is generally cohesive; however, in some locations, the stones have become loose. There has been some loss of face stones and mortar at the exterior side of the base course. This deterioration is greatest at the east wall of the church and baptistery. The base course of the north buttress at the east wall has been severely compromised by loss of material at its southeast corner. Improper site drainage, erosion, and/or excavation of the rock outcropping in this area may be contributing to the damage (Figs. 5.33, 5.34).

Deterioration of base course at east lateral wall and buttresses. Also note the modifications and shoring at the former arched opening between the buttresses.

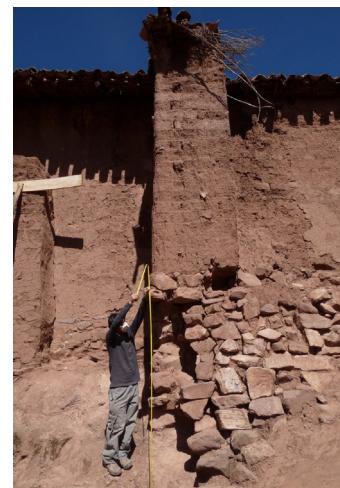
FIGURE 5.34 (RIGHT)

Detail view of deteriorated base course at north buttress, east lateral wall.

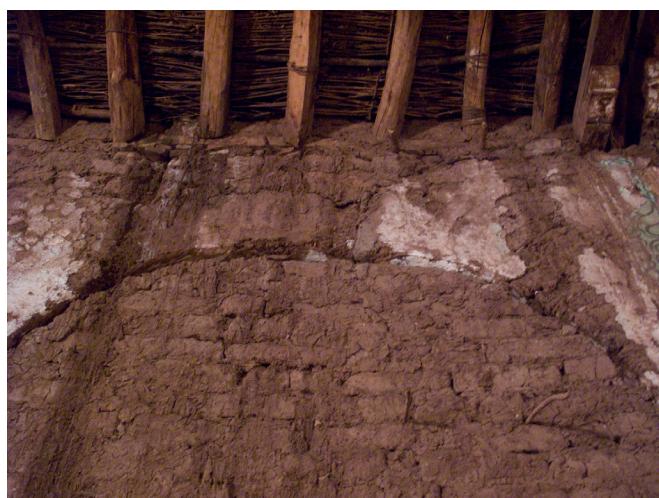
FIGURE 5.35

- The large arched door opening at the west lateral wall has been infilled with mud bricks, which are not structurally connected to the adjacent walls. These mud bricks have not been plastered or painted and thus are visible from the interior (Fig. 5.35).

Infill construction at former arched opening in west lateral wall. Note that infill is not connected to adjacent wall construction.

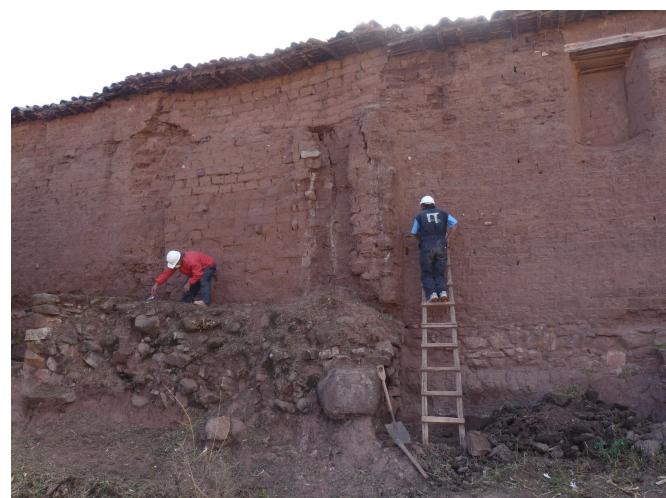
FIGURE 5.36

View of collapsed or dismantled buttresses at west lateral wall.
Image: Wilfredo Carazas, for the GCI.

- The west lateral wall exhibits outward displacement. The loss of the western exterior buttresses may be a cause or result of this displacement. This

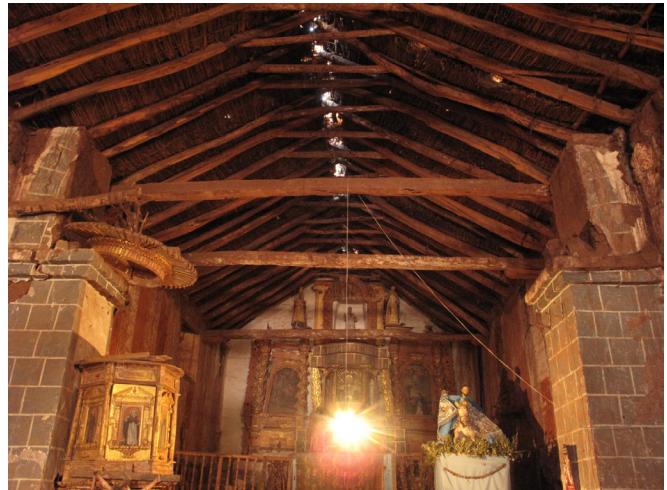
FIGURE 5.38

It is assumed that the church originally had a quincha arch separating the nave from the presbytery, based upon the extant damage at the top of the remaining earthen piers and the existence of an arch in the nearby Church of Rondocán, which is of a similar overall design to the church of Kuño Tambo (Figs. 5.37, 5.38). The arch has since collapsed or been dismantled, and the remaining west pier exhibits cracking (Figs. 5.39, 5.40).

View of remaining mud brick piers at the Church of Kuño Tambo. It is likely that the piers originally supported an arch above.

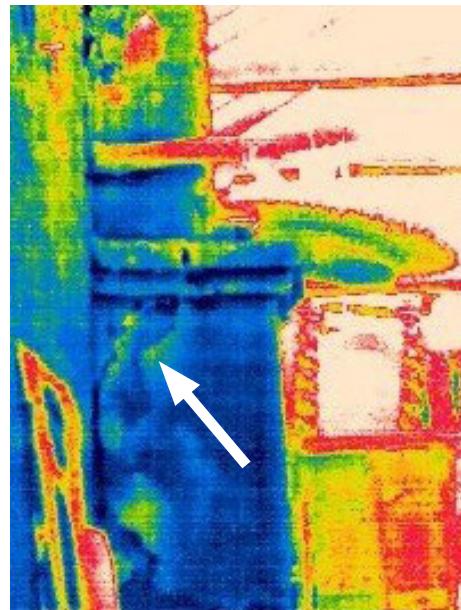
FIGURE 5.39 (LEFT)

Thermal image, showing crack in west mud brick pier of the Church of Kuño Tambo, as viewed from the nave.

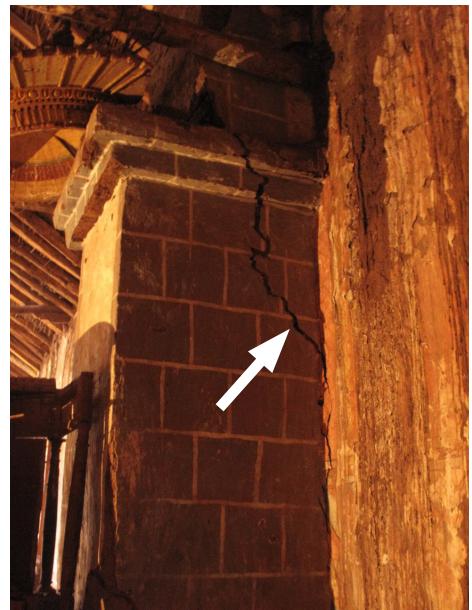
FIGURE 5.40 (RIGHT)

Crack in west mud brick pier of the Church of Kuño Tambo, as viewed from the presbytery.

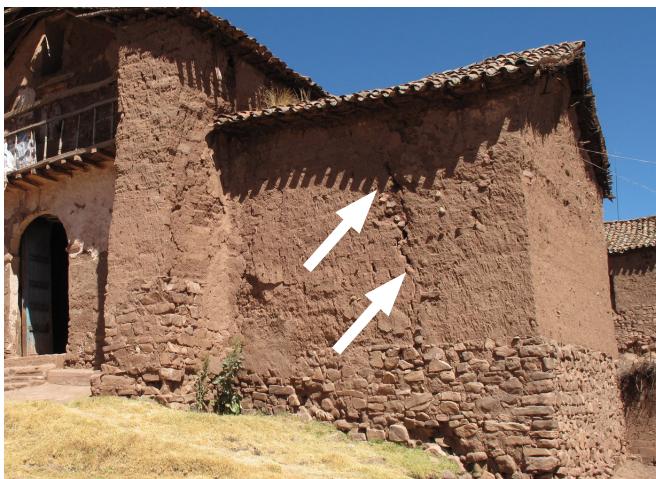
- Several other walls exhibit cracking and displacement:
 - At the baptistery wing, there are several vertical cracks, averaging 50 mm in width, in both the south and east façades, near the southeast corner. These cracks appear to be related to settlement of the base course, either due to rising damp and loss of mortar or erosion of the rock soil. These cracks may also be, in part, caused by differences in the thickness of the baptistery walls. The choir loft staircase is set into the south wall of the baptistery, reducing its thickness and causing it to behave differently during seismic events (Fig. 5.41).

FIGURE 5.41
Crack in the south façade of the baptistery wing.
Image: Wilfredo Carazas, for the GCI.

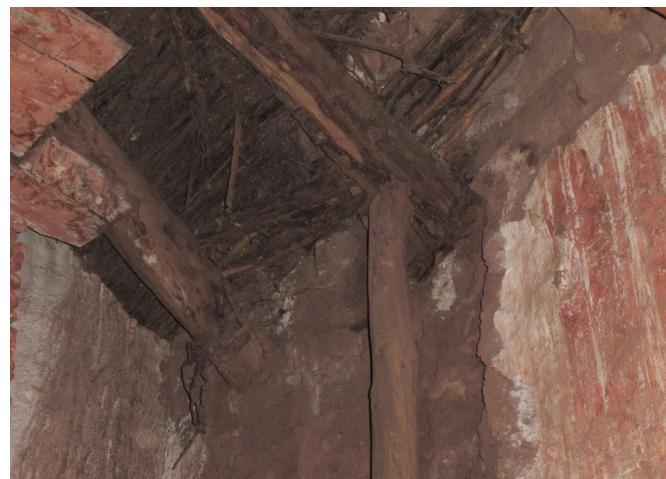
- As previously mentioned, the interior piers exhibit diagonal cracking.
- At both the base and tops of the east, south, and west walls, the mud bricks are water-damaged and partially eroded, with an average depth of loss of 50 mm. A leaking roof and rising damp are the presumed sources of this damage. The walls do not appear to be unstable as a result of the water damage; however, the erosion at the top of the wall has led to failure of some roof-wall connections. This water infiltration has also led to biological growth in the tops of the mud brick walls, as well as detachment and loss of interior plaster at the base and top of walls (Fig. 5.42).

FIGURE 5.42
Erosion at the top of the mud brick wall in the northeast corner of the altar has led to failure of the roof rafter. A wood post has been installed to temporarily support the rafter end.
Image: Sara Lardinois.

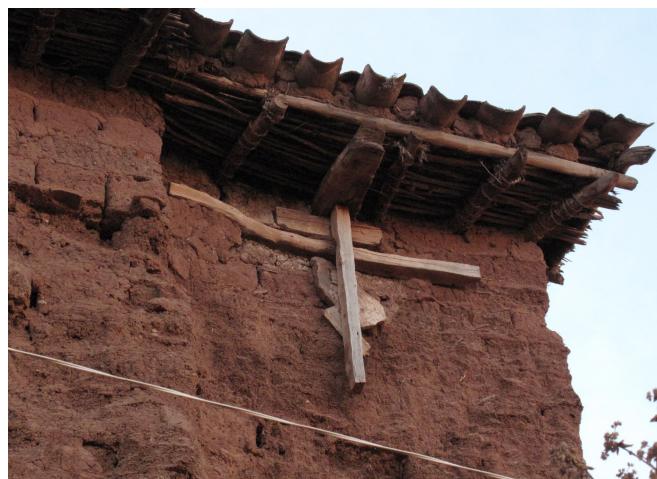
The choir loft floor framing is in fair to good condition; but, it is separating from the adjacent west lateral wall of the church. The area of separation corresponds to the location where wood keys have been installed to prevent outward displacement of the wall (see section 5.6.4 below for additional discussion).

Wood key at south end of west lateral wall.
