Seismic Retrofitting Project: Assessment of Prototype Buildings

Volume 1

Research Report

Seismic Retrofitting Project: Assessment of Prototype Buildings Volume 1

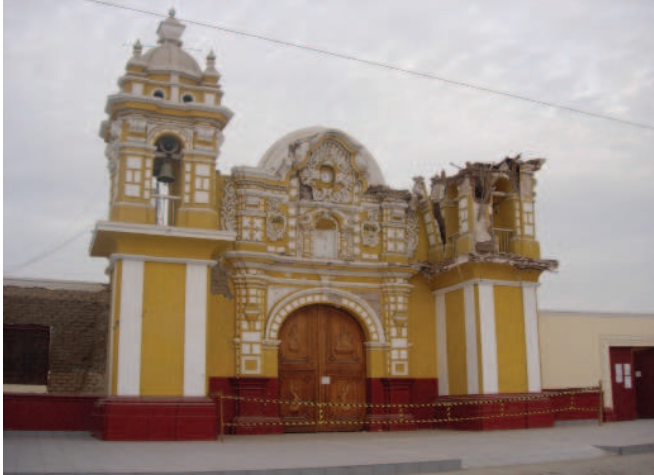
FIGURE 1.3
The earthen Church of El Carmen, Chinchipe, Peru. The bell tower collapsed during the 2007 Pisco earthquake.
Image: Philippe Garnier, for the GCI.

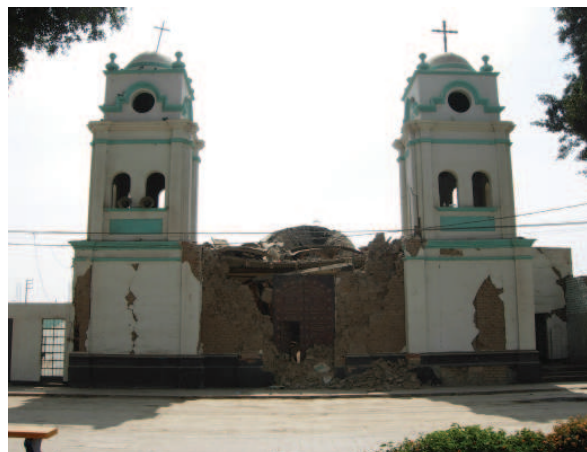
Church of Guadalupe, damaged by the 2007 Pisco earthquake, 2007.
Image: Claudia Cancino.

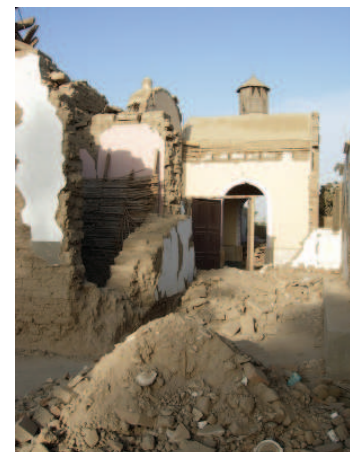
FIGURE 2.2 (RIGHT)

Church of Humay, damaged by the 2007 Pisco earthquake, 2007.
Image: Claudia Cancino.

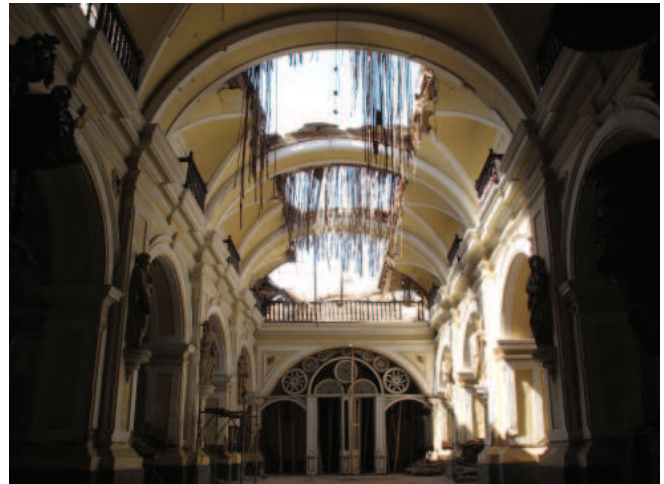
FIGURE 2.7

Interior view of the Cathedral of Ica, showing damage to the vault after the 2007 earthquake.

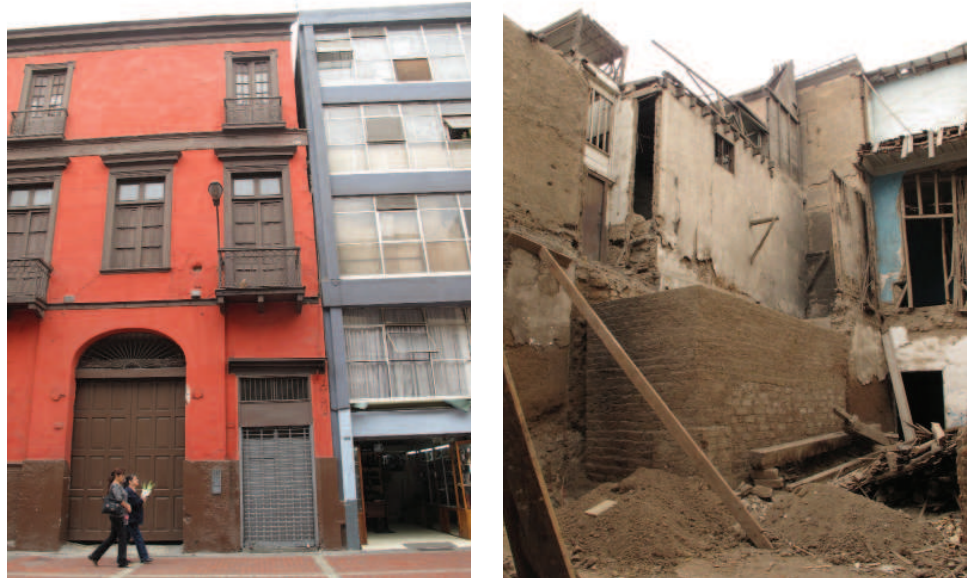
FIGURE 3.11 (RIGHT)
Collapsed bay between the two patios.
Image: Sara Lardinois.

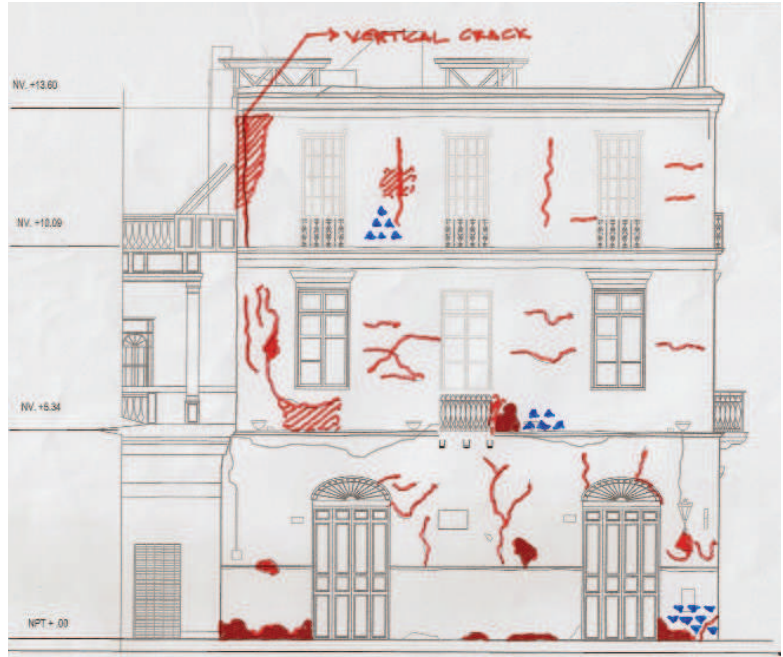
FIGURE 3.45
Northeast façade, graphic condition survey indicating observed cracks and areas of plaster loss in red and humidity in blue.
Drawing: Claudia Cancino.

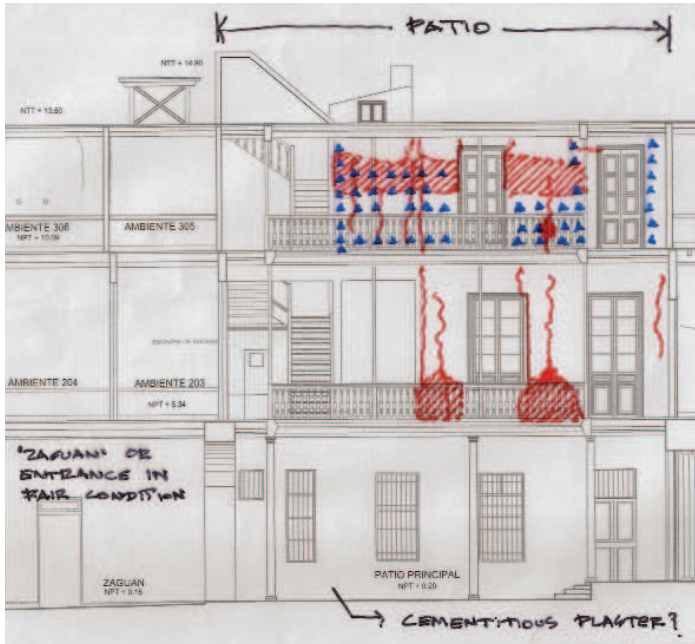
FIGURE 3.46
Northeast patio façade, graphic condition survey indicating observed cracks and areas of plaster loss in red and humidity in blue.
Drawing: Claudia Cancino.

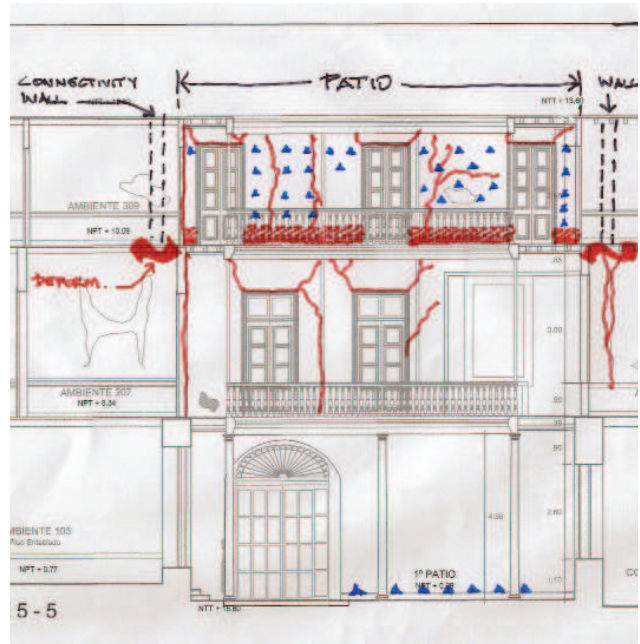
FIGURE 3.47
Northwest patio façade, graphic condition survey indicating observed cracks and areas of plaster loss in red and humidity in blue.
Drawing: Claudia Cancino.

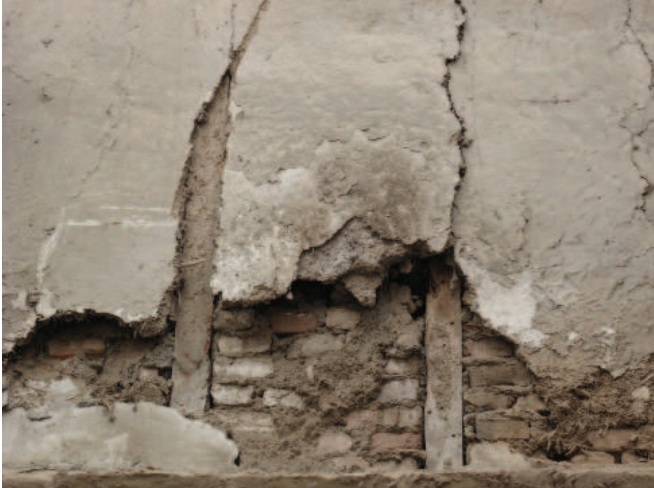
FIGURE 3.48
Typical plaster detachment at quincha wall bases and posts.
Image: Claudia Cancino.

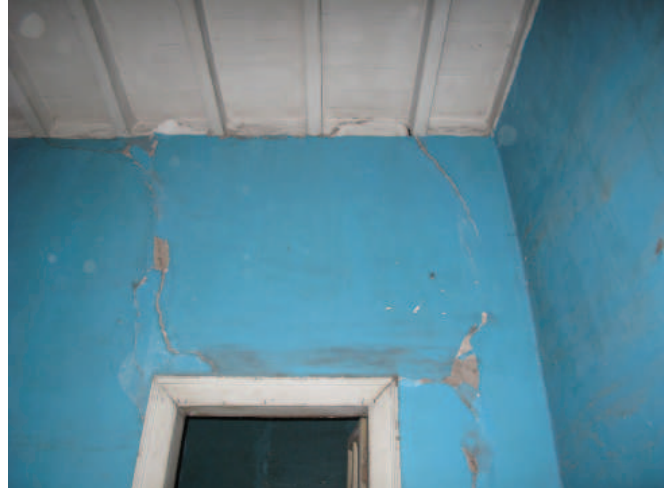
FIGURE 3.49
Typical crack pattern at openings in quincha walls.
Image: Claudia Cancino.

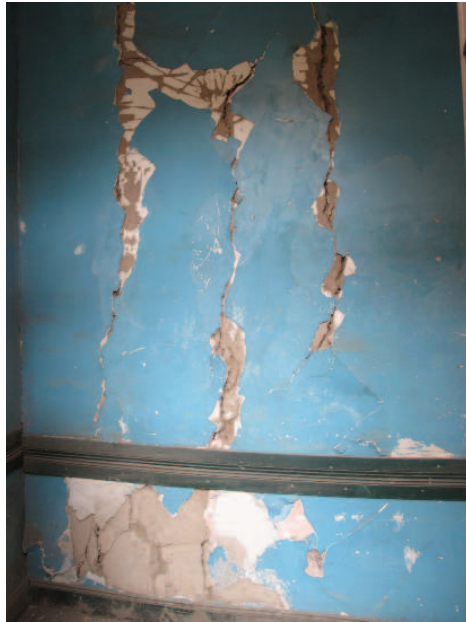
FIGURE 3.50
Typical crack pattern, corresponding to the
quincha post locations.
Image: Claudia Cancino.

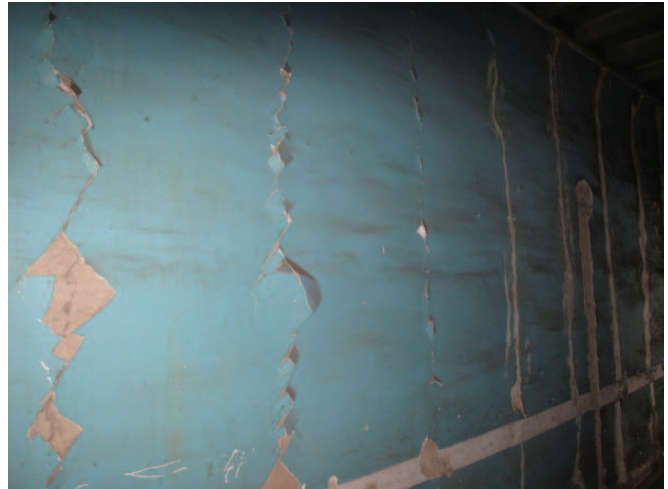
FIGURE 3.51
Vertical cracks corresponding to quincha post locations, southeast
wall of corridor 246, sector C.
Image: Amila Ferron.
