Assessment of Current Conditions

Condition Survey

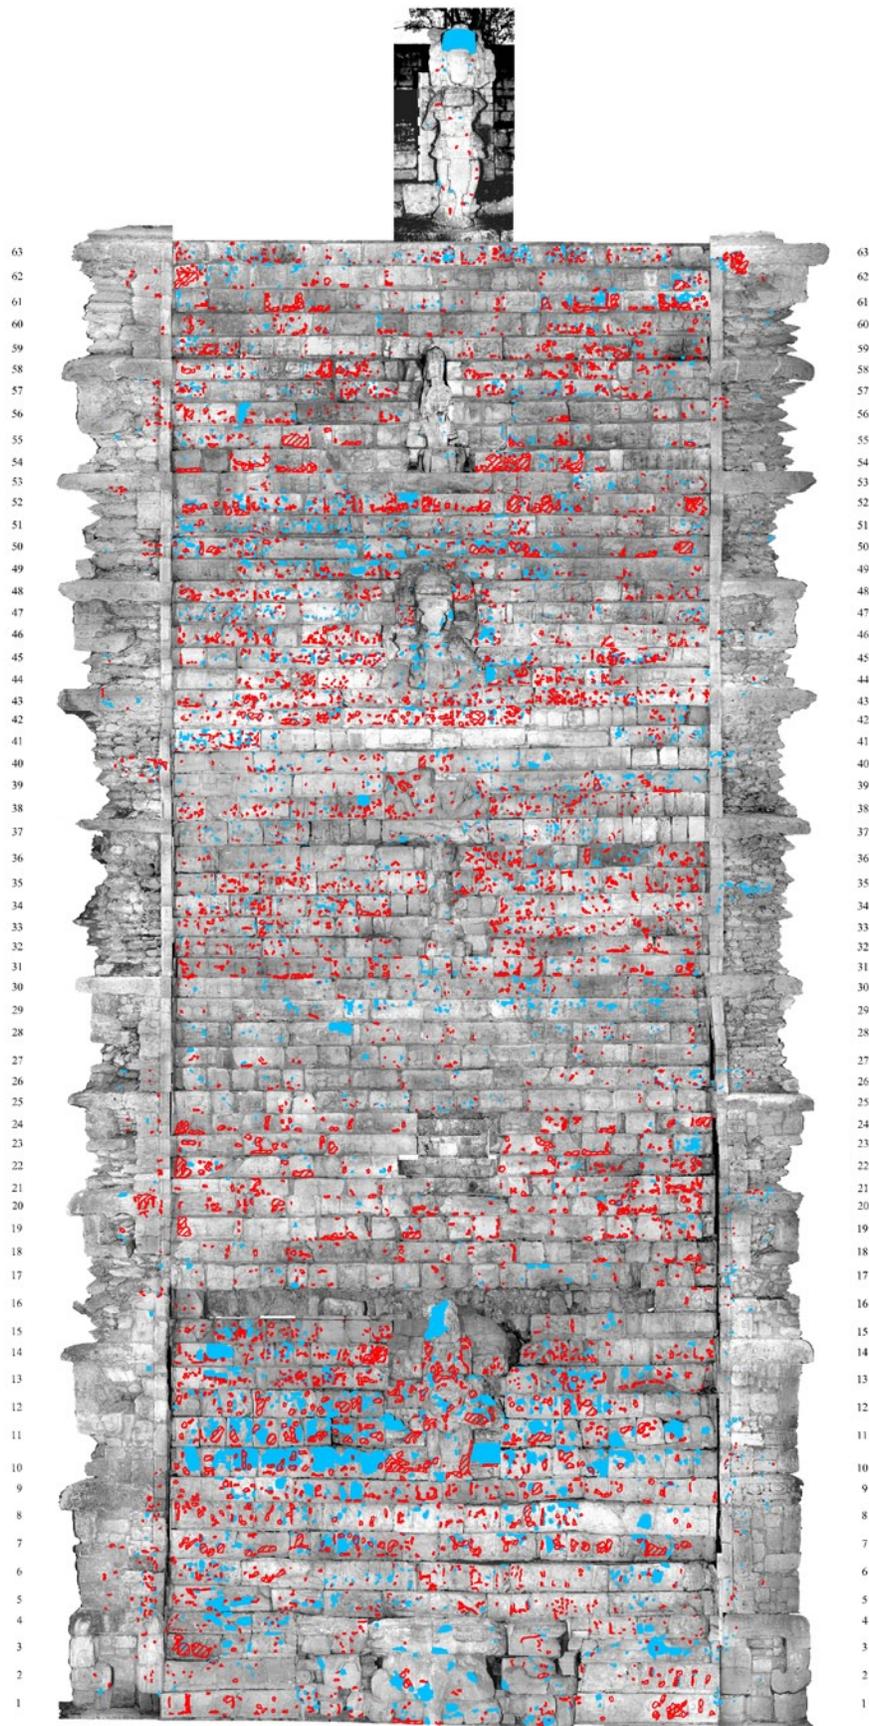
The condition survey revealed that the most widespread and main types of deterioration found throughout the Stairway are millimeter-scale flaking and small-scale detachment (**Fig. 55**), often accompanied by thin, short, surface fissures. These types of deterioration occur often, but not always, on the relief parts of the glyphs. In general, the lower halves of the blocks tend to be more deteriorated than the upper parts, a fact that is evidenced

Figure 55 The extent and locations of deterioration by flaking (red) and detachment (blue) on the Hieroglyphic Stairway.

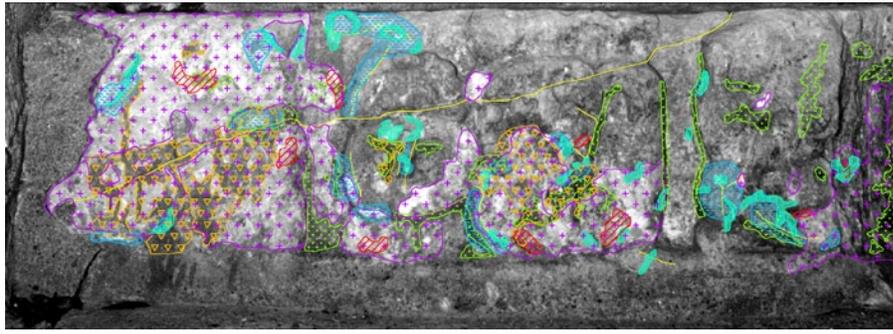
Figure 56 Condition survey of block 531, step 59, showing the extent of flaking and detached surfaces.

by superficial microflaking in the lower part, while intact but detached surfaces are often found in the top halves of the blocks (**Fig. 56**). Disaggregation of the stone, a condition that is not widespread, was not mapped separately from flaking. However, it actually constitutes a type of deterioration that would require a different conservation treatment in the future. There was no discernible relationship between geological veins and any condition. Areas of surface whiteness corresponded to areas of surface disaggregation, or to areas behind fallen flakes. There do not appear to be any areas of surface whiteness due to the presence of salt efflorescence.

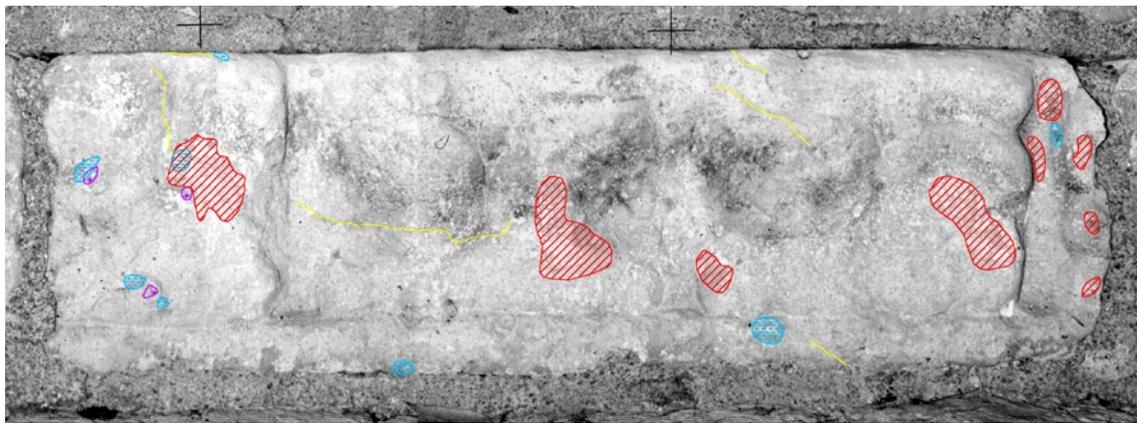
Figure 57 Condition survey of block 197, step 23, showing an overall lack of deterioration.

A significant number of blocks also present an eroded but stable surface, but erosion was not a condition that was surveyed (**Fig. 57**).

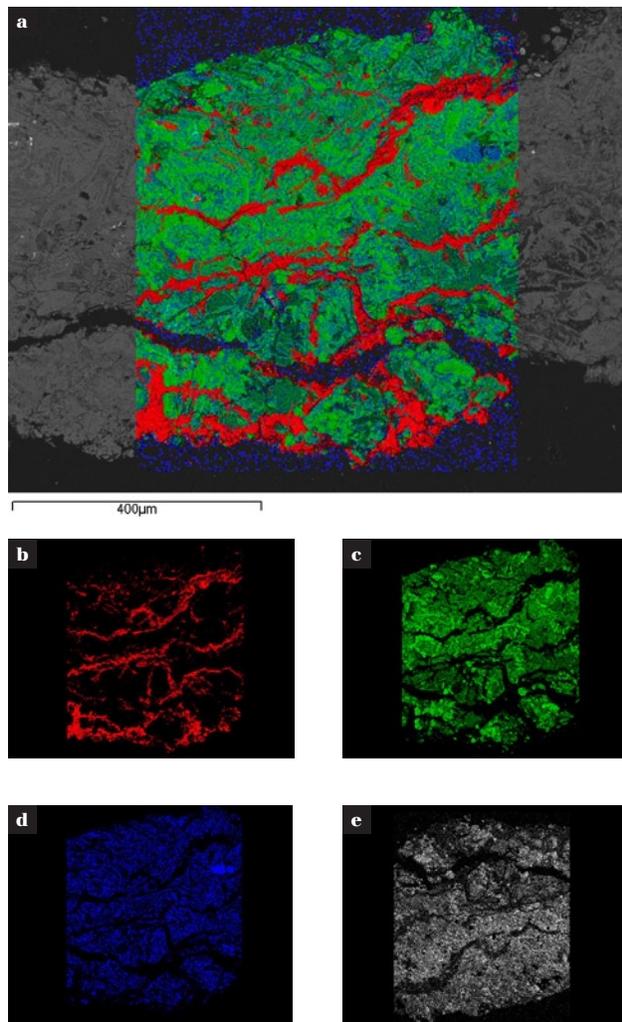
On the Hieroglyphic Stairway, whitish efflorescences have often been observed behind detaching flakes of surface stone. An examination by polarized light microscopy of cross sections of six typical stone flakes shows surface-parallel cracks filled partly with white crystals. Under uv light, the filling material is more fluorescent than the stone, suggesting incorporation of organic material (Druffel 1997). The analysis by environmental scanning electron microscopy/energy dispersive spectroscopy (ESEM/EDS) reveals a precipitation of calcite along those cracks (Figs. 64a–e). The same analysis shows that the inner surface of the flakes, which is the plane of detachment, is depleted in silicon and oxygen, suggesting a selective dissolution of these components in the course of weathering.

Figures 64a–e ESEM/EDS images of Copán stone flake c1 in BSE mode, with X-ray overlays of four elements showing distribution of calcite in fractures (false color–red) (a), calcium X-ray overlay (b), silicon X-ray overlay (c), aluminum X-ray overlay (d), and oxygen X-ray overlay (e). Scale bar is 400 μm.

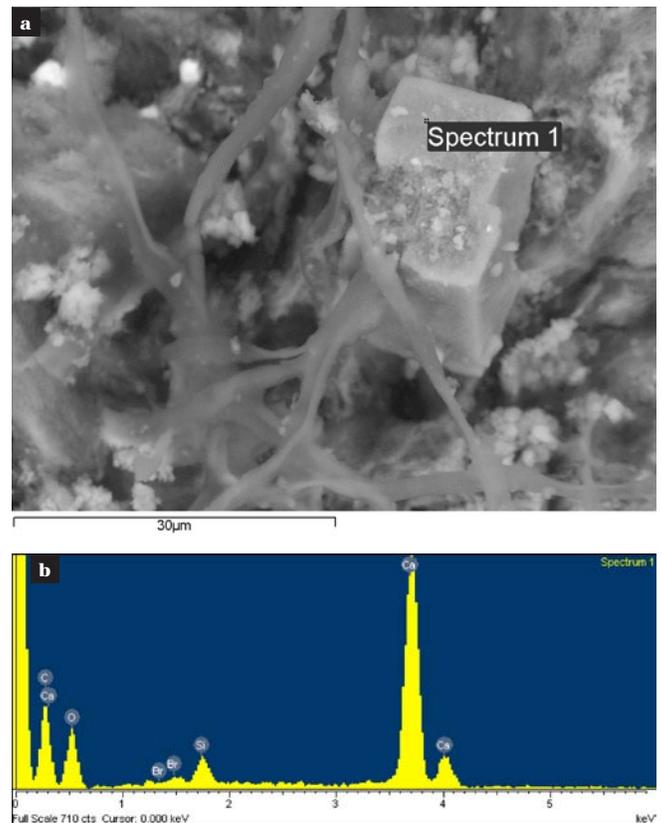
Additionally, the cracks in the flakes are often filled with organic material, including remnant fungal hyphae (Figs. 65a, b), which can sometimes be associated with calcite formation (Chen, Blume, and Beyer 2000).

Figures 65a and b ESEM/EDS image of Copán stone flake c5, showing calcite crystals and fungi on flake surface (a); EDS X-ray “spectrum 1,” showing calcium and oxygen peaks identifying the crystals as calcite (b).

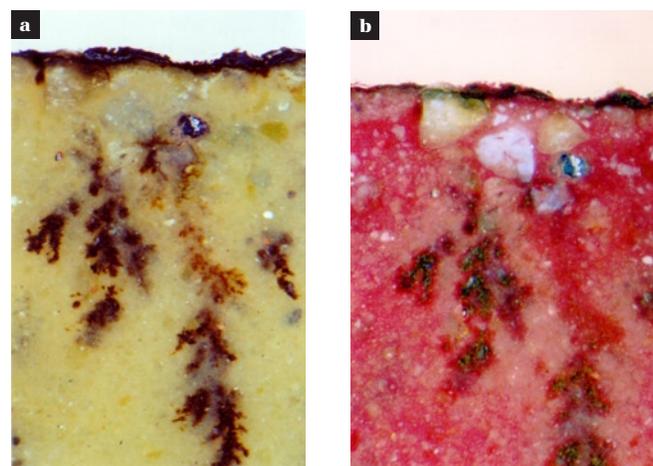
Figures 80a and b Cross section (a) and cross section stained with PAS (b) (x114), showing the deep fungal penetration in the quarry samples.

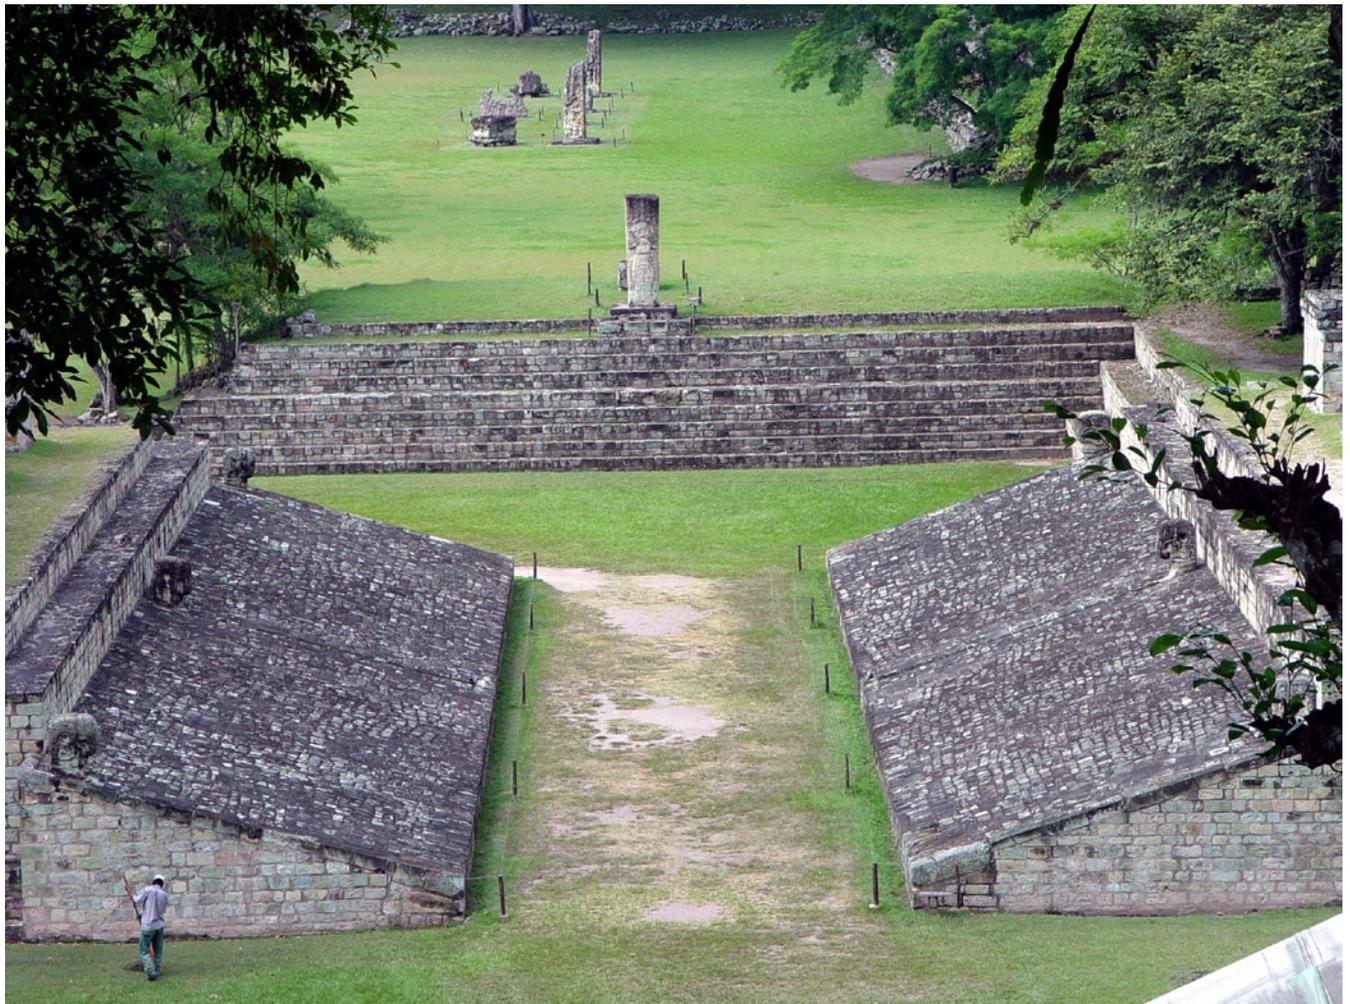
Figure 81 The present condition of the Ballcourt, showing a black patina on the horizontal surfaces and its absence on vertical surfaces.

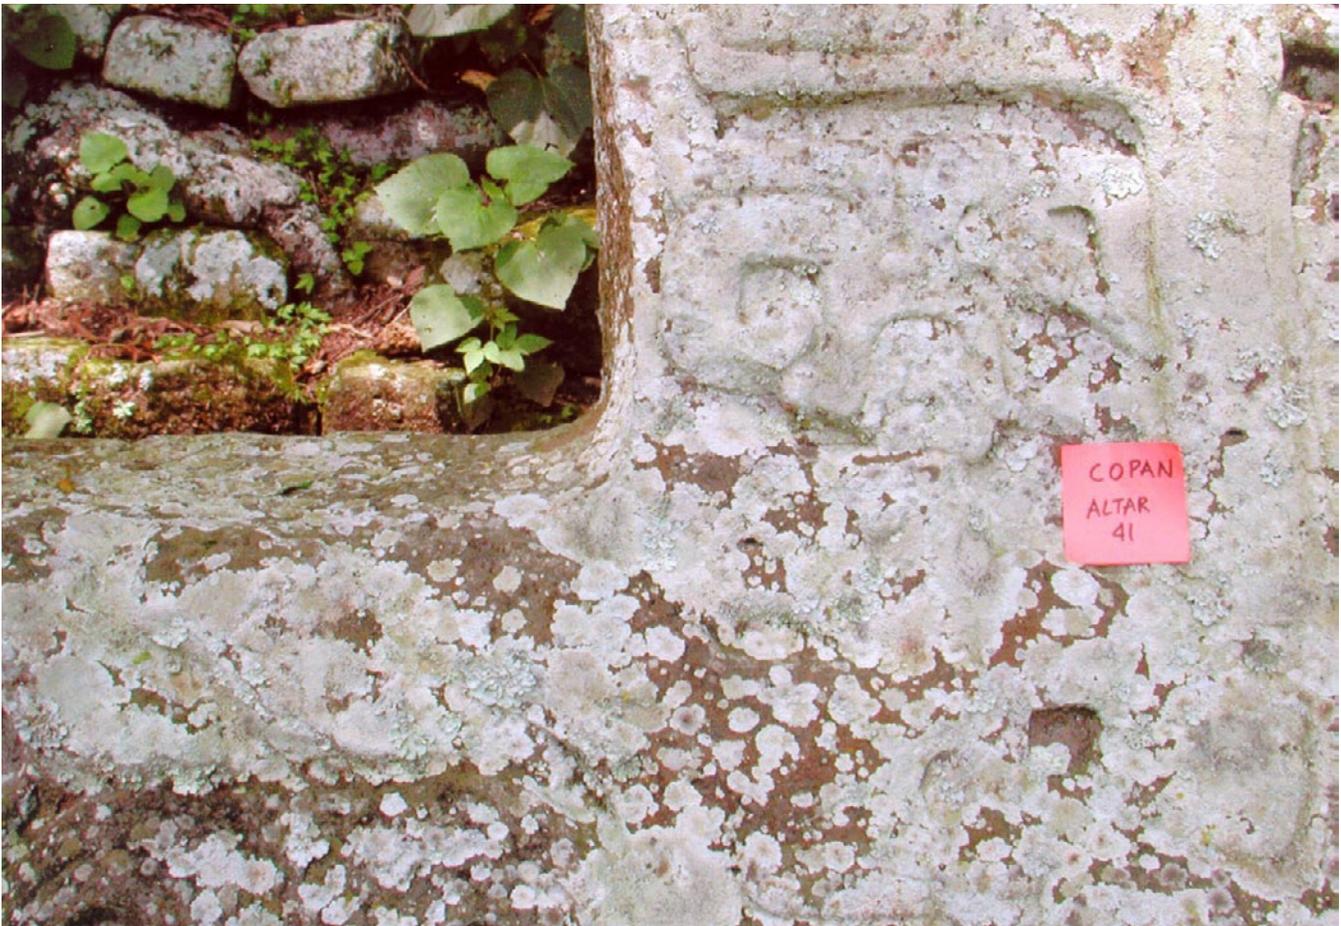
Figure 83 Condition of Altar 41 in 2000, revealing rapid recolonization of lichens (*Candelaria concolor*, *Parmotrema tinctorum*, *Dirinaria picta*).

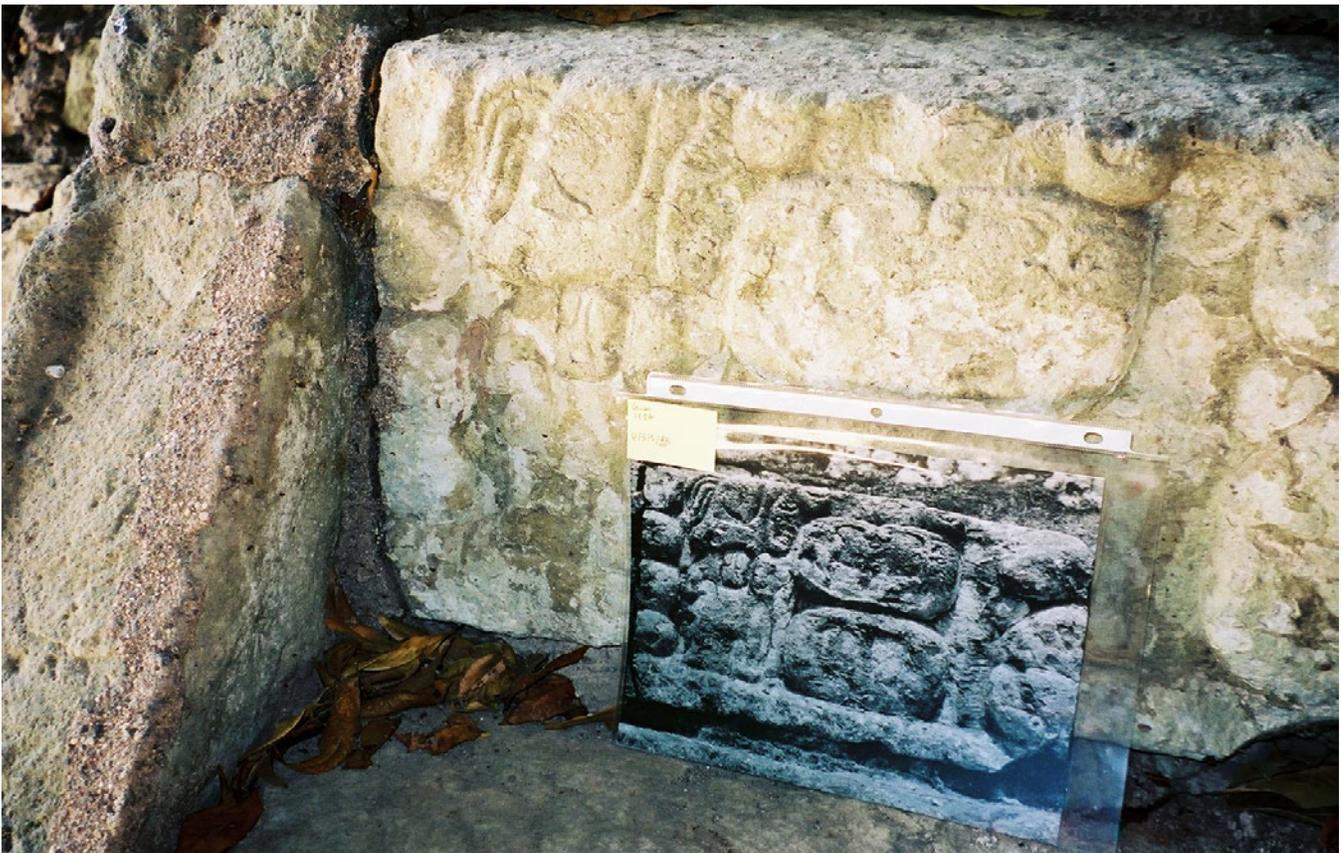
This survey was repeated five times between April 2002 and August 2004. It was observed that all control blocks had suffered some limited loss since 1987, and that the amount of loss varied greatly from one block to another, with blocks 375–376 exhibiting the greatest amount of loss and most active deterioration from disaggregation and flaking. The surface loss on control blocks is generally located in already deteriorated areas where detachment, flaking, and previous treatments were present in 1987. However, a few control blocks have been observed to exhibit surface loss in previously untreated areas between April 2002 and August 2004. Most of these losses appeared to be due to impact, resulting from people accessing the Stairway to repair or change the tarpaulin shelter; these tasks were performed four times between January and July 2005. In conclusion, active deterioration of block surfaces by disaggregation and flaking is not limited to certain blocks of the top step. There are, in fact, a very few blocks located in other areas of the Stairway that continue to lose surface in this manner, despite the protection of the shelter. Loss of surface due to impact related to human access to the Stairway is, nonetheless, the more significant ongoing cause of surface deterioration of all Stairway blocks.

Figure 86 The north end of block 375, step 41, next to the balustrade, seen in April 2002 with a photograph of the same location taken in 1987. The same space between the balustrade and the stair can be seen in both photographs.

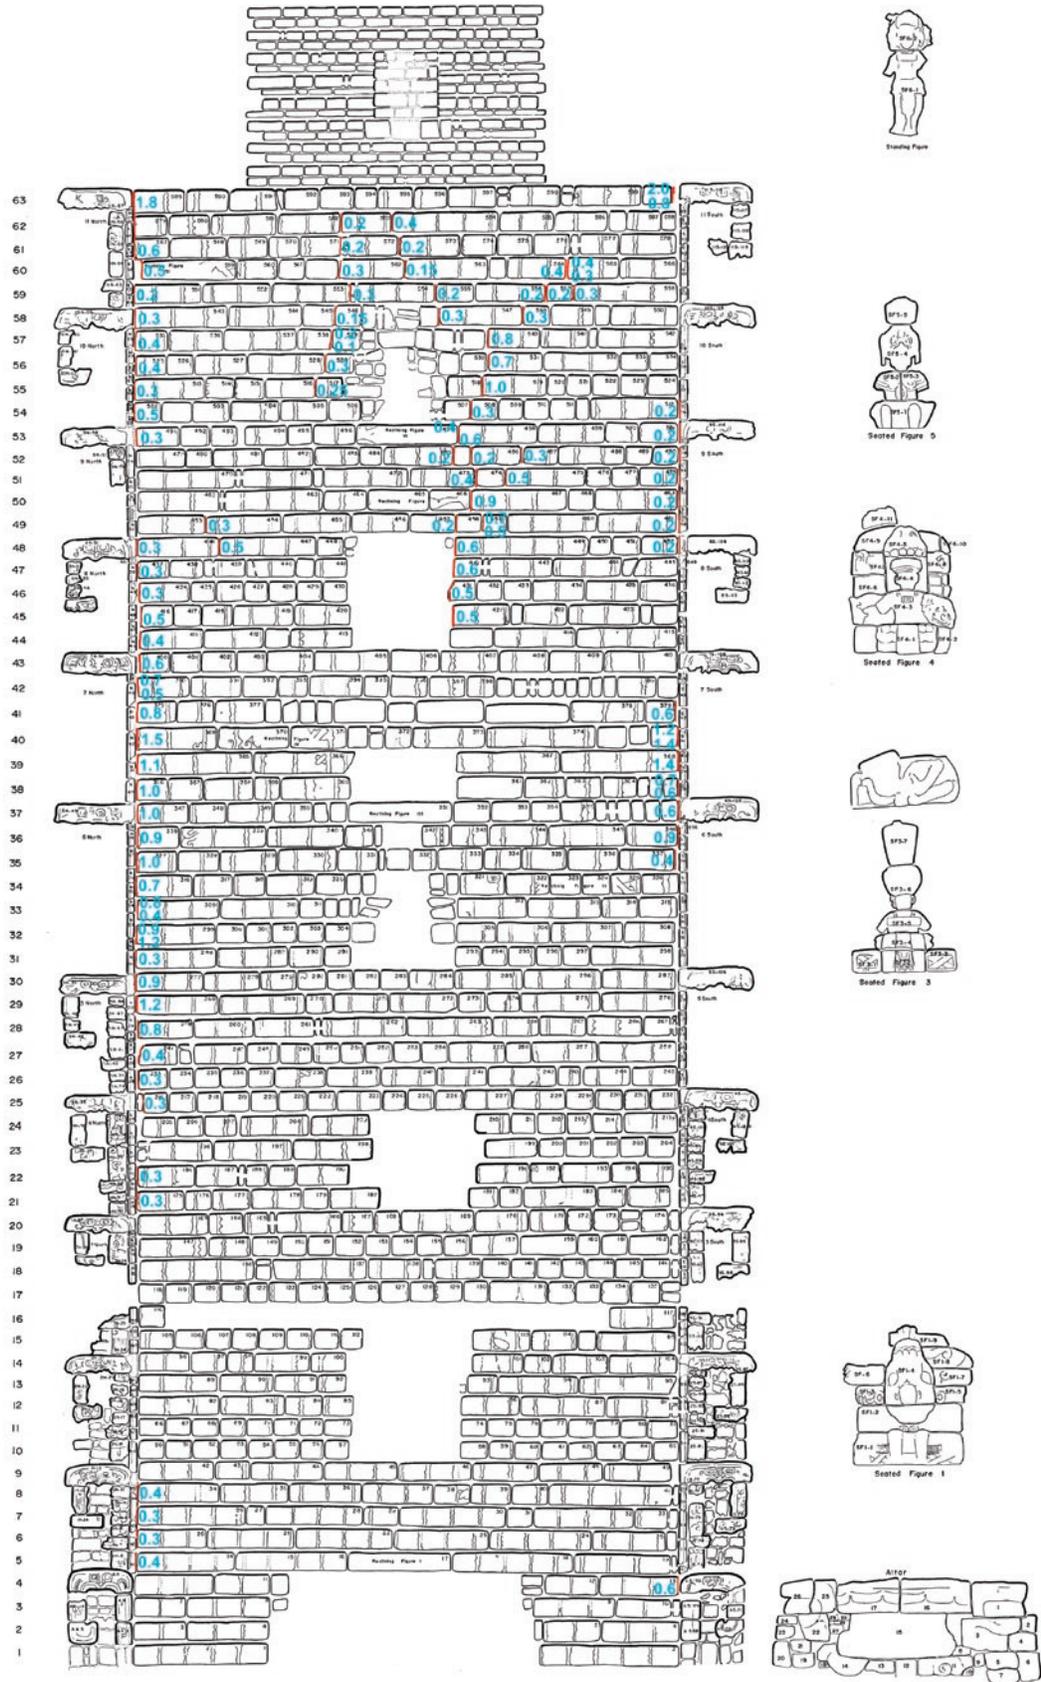
Figure 87 Map of the main cracks on the Hieroglyphic Stairway, with their widths in centimeters.

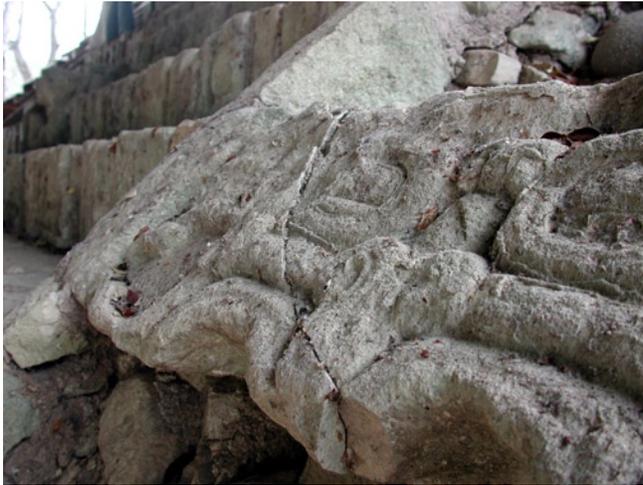
Figure 88 A crack in a large horizontal stone (6S-107) of the south balustrade, near step 37.

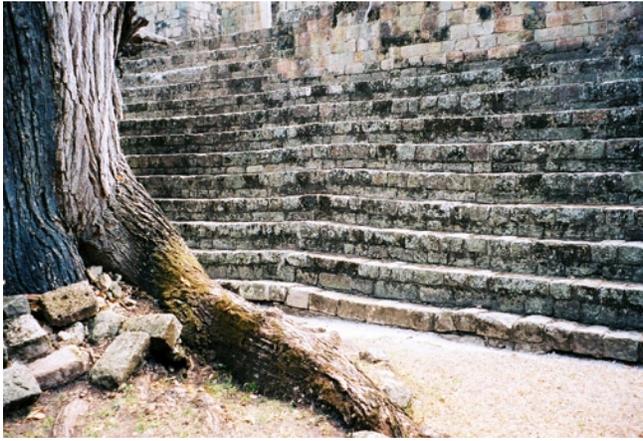
Figure 91 View of the stone steps of Structure 9, showing deformation from tree roots.

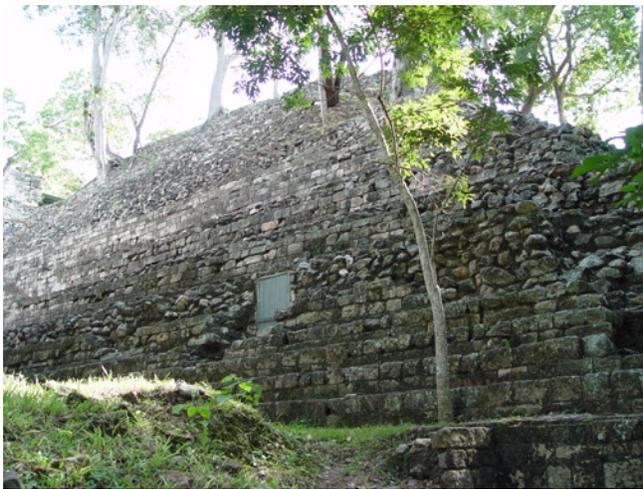
Figure 92 A small tree growing on the north end of the east face of Structure 26; it could easily be removed before it grows to a damaging size.
