LAETOLI

HOMINID TRACKWAY, SITE G

CONDITION RECORDS

G1 AND G2/3 FOOTPRINTS

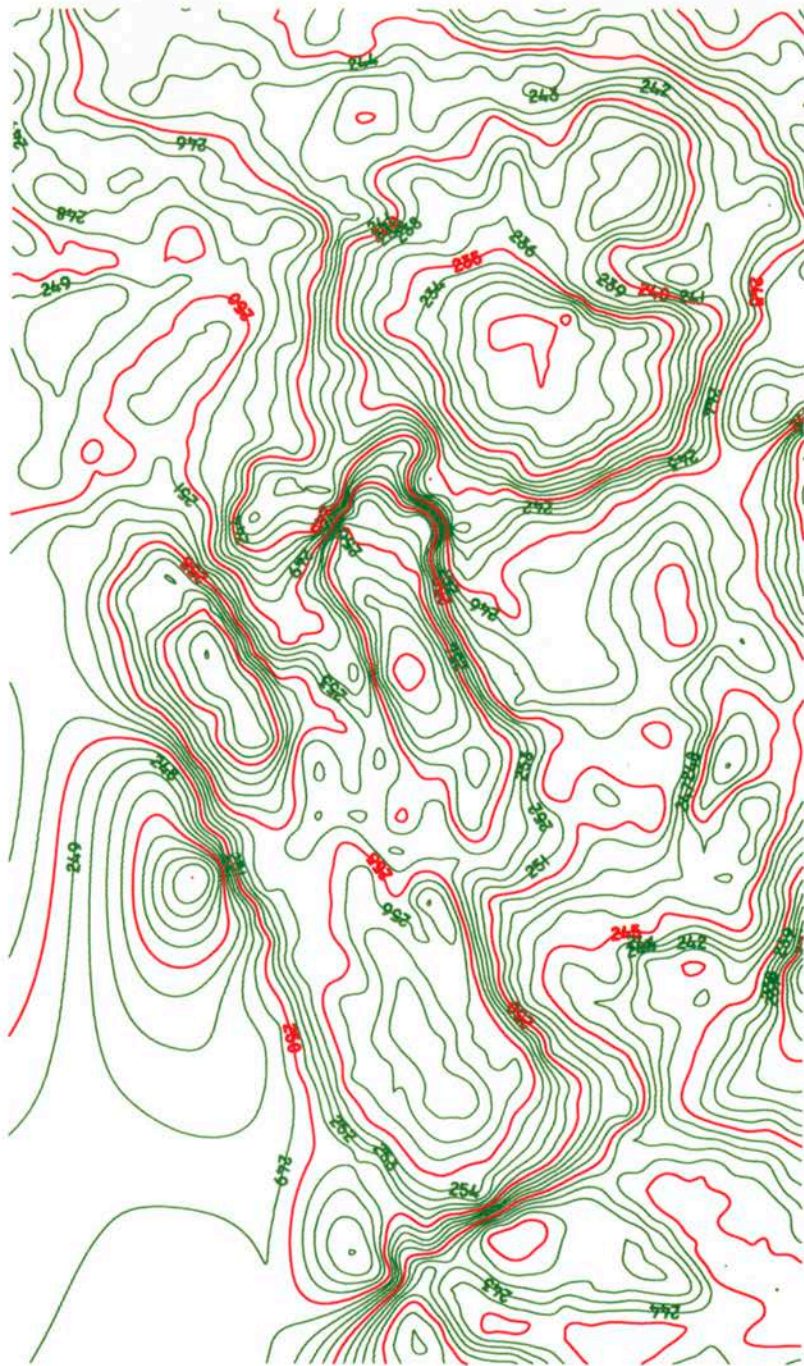
<p><u>Location</u> Northern sector of trackway, trench 7</p>
<p><u>Excavation and Reburial History</u> Excavated and reburied in 1978; re-excavated and reburied in 1996.</p>
<p><u>1978-1979 Description</u> G1-7 to 11. Depressions in the lower part of the tuff, G1-9 left, G1-10 right, G1-11 left.</p>
<p><u>1996 Condition</u> <u>General condition:</u> Moderate alteration: Fair</p> <p><u>Tuff conditions:</u> <u>Weathering:</u> Moderate weathering of tuff in and around print. <u>Cracking:</u> none <u>Losses:</u> Abraded tuff surface, associated with 3mm deep hole, noted outside west margin of print. Cause of phenomenon was not ascertained, but may be result of insect activity or from loss of tuff fragment since 1978 photos. <u>Detached/loose tuff:</u> Small area of loose tuff near center of print, and near east margin extending beyond the margin of G1-7 to G2/3-5. <u>Powdering:</u> none <u>Other:</u> none</p> <p><u>Conditions related to 1978-79 interventions:</u> <u>Bedacryl:</u> none <u>Embedding:</u> Embedding of fine particles in weathered areas. <u>Silicone:</u> none <u>Excavation tool marks:</u> none <u>Inventory number on tuff:</u> none <u>Other:</u> none</p> <p><u>Root damage:</u> none</p> <p><u>Insect activity:</u> <u>Non-specific:</u> Possible insect activity; see <u>Tuff conditions: Losses</u>.</p>

<p><u>1996 Interventions</u> <u>Consolidation/stabilization:</u> Loose areas of tuff inside and outside margins of print stabilized with WS-24 @ 25%. <u>Fills:</u> none <u>Reattachment:</u> none <u>Root treatment:</u> none <u>Other:</u> none</p>
<p><u>Comparison with 1978-79 Cast/Photograph</u> No cast. Comparison with 1978 photos showed slight loss of resolution of features and an increase in weathering of the tuff.</p>
<p><u>Notes</u> Graphic condition record includes prints G1-6, 7, 8 & G2/3-5 (see graphic record under G1-6), and is printed at a different scale than the other Polaroids with single prints. See other condition records for description of conditions in or around those prints. Print G1-7 is identified as G2/3-5 on the plan of the trackway published in Michael Day, Guide to Fossil Man, 1986, 184, Fig. 63 (see <i>1996-1998 Report on the Laetoli Project</i>, p. 13).</p>

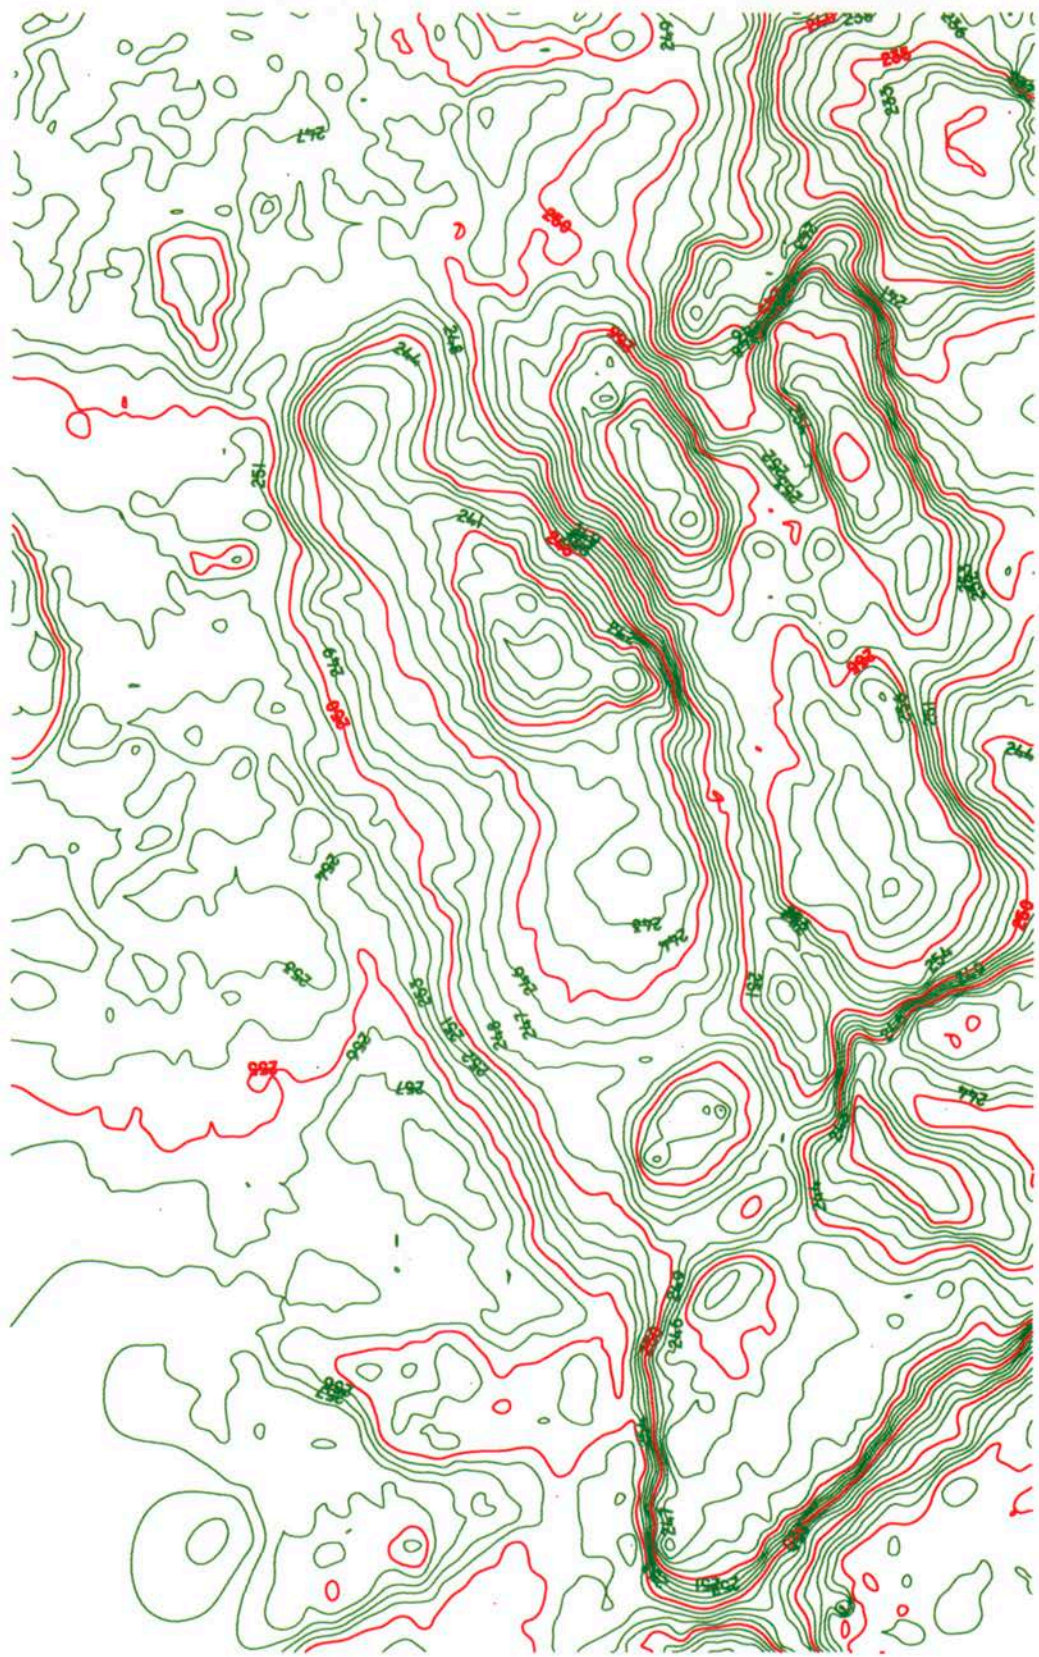
<p><u>Location</u> Northern sector of trackway, trench 7</p>
<p><u>Excavation History</u> Excavated and reburied in 1978; re-excavated and reburied in 1996.</p>
<p><u>1978-1979 Description</u> G1-7 to 11. Depressions in the lower part of the tuff, G1-9 left, G1-10 right, G1-11 left.</p>
<p><u>1996 Condition</u> <u>General condition:</u> Moderate alteration: Fair</p> <p><u>Tuff conditions:</u> <u>Weathering:</u> Moderate weathering in all areas within print margins. <u>Cracking:</u> Crack traverses print. <u>Losses:</u> see G1-7 for loss of tuff between G1-7 and 8. <u>Detached/loose tuff:</u> Dislodged and loose tuff outside anterior east margin and posterior margin. <u>Powdering:</u> none <u>Other:</u> none</p> <p><u>Conditions related to 1978-79 interventions:</u> <u>Bedacryl:</u> none <u>Embedding:</u> Embedding in weathered areas, especially posterior area. <u>Silicone:</u> none <u>Excavation tool marks:</u> none <u>Inventory number on tuff:</u> none <u>Other:</u> Yellow staining of tuff outside west margin</p> <p><u>Root damage:</u> none</p> <p><u>Insect activity:</u> see G1-7 for possible insect activity on tuff between G1-7 and 8.</p>

<p><u>1996 Interventions</u> <u>Consolidation/stabilization:</u> Minor stabilization of loose tuff outside margins of print with WS-24 @ 25% <u>Fills:</u> none <u>Reattachment:</u> none <u>Root treatment:</u> none <u>Other:</u> none</p>
<p><u>Comparison with 1978-79 Cast/Photograph</u> No cast. Comparison with 1978 photos showed slight loss of resolution and additional weathering of tuff.</p>
<p><u>Notes</u> Graphic condition record includes prints G1-6, 7, 8 & G2/3-5 (see graphic record under G1-6) and is printed at a different scale than the other Polaroids with single prints. See other condition records for description of conditions in and around those prints.</p>

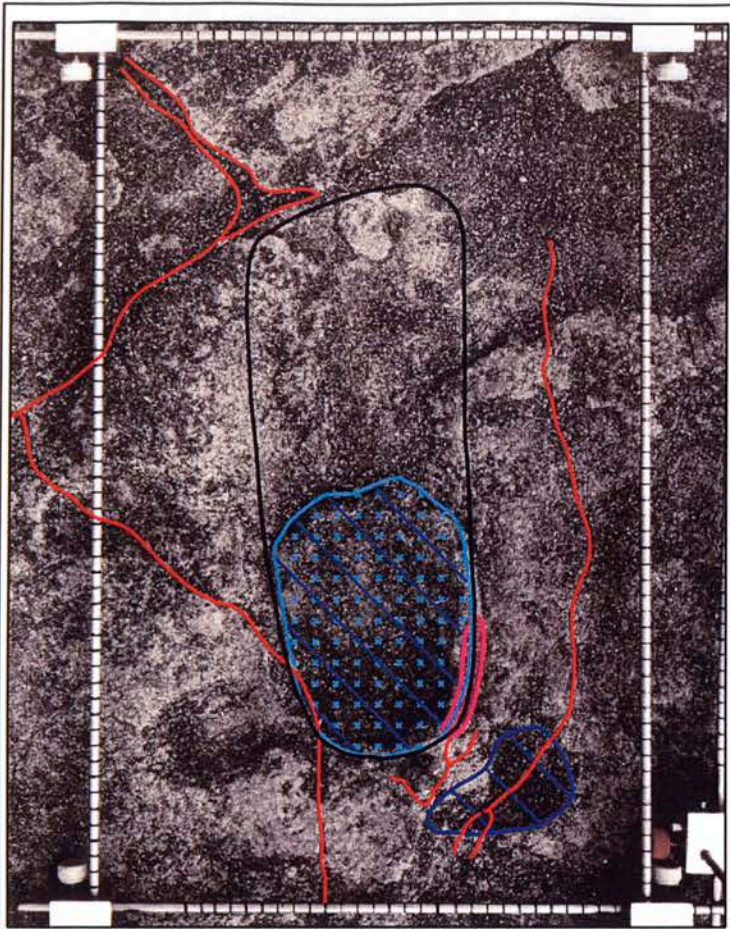
<p><u>Location</u> Northern sector of trackway, trench 7</p>
<p><u>Excavation History</u> Excavated and reburied in 1978; re-excavated and reburied in 1996.</p>
<p><u>1978-1979 Description</u> G1-7 to 11. Depressions in the lower part of the tuff, G1-9 left, G1-10 right, G1-11 left.</p>
<p><u>1996 Condition</u> <u>General condition:</u> Moderate alteration: Fair</p> <p><u>Tuff conditions:</u> <u>Weathering:</u> Weathering of tuff in heel portion. Anterior portion of tuff was well-calcified. <u>Cracking:</u> Cracks in tuff outside margins of print only. <u>Losses:</u> Surface abrasion of tuff on posteromedial margin of heel. <u>Detached/loose tuff:</u> Tuff associated with weathered area in posterior portion of print was loose; one small fragment in center of heel portion was detached. <u>Powdering:</u> none <u>Other:</u> none</p> <p><u>Conditions related to 1978-79 interventions:</u> <u>Bedacryl:</u> none (see <u>Other:</u> yellow staining) <u>Embedding:</u> Minor embedding in weathered tuff. <u>Silicone:</u> none <u>Excavation tool marks:</u> none <u>Inventory number on tuff:</u> none <u>Other:</u> Faint yellow staining on surface of hominid print and on lagomorph print lateral to the heel.</p> <p><u>Root damage:</u> Rootlets adhered to surface in and around print.</p> <p><u>Insect activity:</u> none</p>

<p><u>1996 Treatments</u> <u>Consolidation/stabilization:</u> none <u>Fills:</u> none <u>Reattachment:</u> Reattachment of dislodged tuff fragment in the heel. <u>Root treatment:</u> Surface roots removed leaving slight impressions in tuff. <u>Other:</u> none</p>
<p><u>Comparison with 1978-79 Cast/Photograph</u> No cast. Comparison with 1978 photos showed slight loss of resolution of details, an increase in weathering in heel portion, and embedding of particles in tuff.</p>
<p><u>Notes</u> Three lagomorph prints outside posterior and lateral margins.</p>

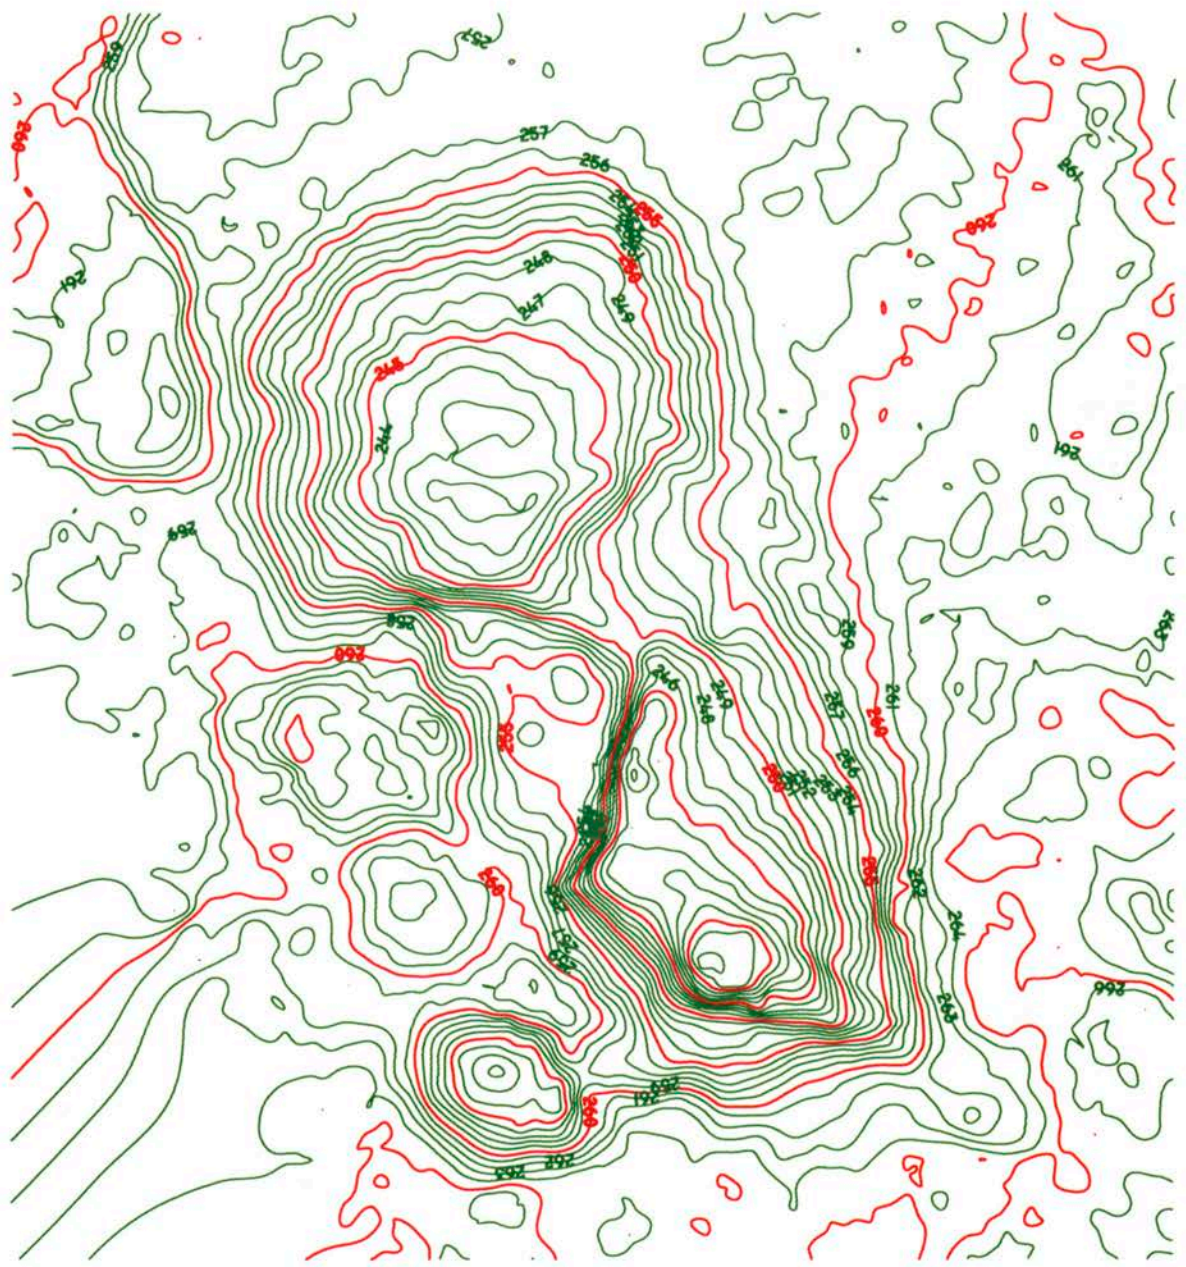
<p><u>Location</u> Northern sector of trackway, trench 7</p>
<p><u>Excavation and Reburial History</u> Excavated and reburied in 1978; re-excavated and reburied in 1996.</p>
<p><u>1978-1979 Description</u> Eroded right footprint retaining some morphology of the sole of the foot.</p>
<p><u>1996 Condition</u> <u>General condition:</u> Minor alteration: Good</p> <p><u>Tuff conditions:</u> <u>Weathering:</u> Moderate weathering of tuff in heel portion; and in lagomorph print outside medial margin. <u>Cracking:</u> Crack with calcite vein (fragments of calcite missing) runs parallel to axis of print outside lateral margin; a second large crack runs perpendicular to the first outside posterior margin. <u>Losses:</u> none <u>Detached/loose tuff:</u> none <u>Powdering:</u> none <u>Other:</u> none</p> <p><u>Conditions related to 1978-79 interventions:</u> <u>Bedacryl:</u> none <u>Embedding:</u> Severe embedding of fine particles in weathered areas. <u>Silicone:</u> none <u>Excavation tool marks:</u> none <u>Inventory number on tuff:</u> none <u>Other:</u> none</p> <p><u>Root damage:</u> A few surface rootlets in heel portion and beyond print margin (not shown in graphic).</p> <p><u>Insect activity:</u> none</p>

<p><u>1996 Interventions</u> <u>Consolidation/stabilization:</u> none <u>Fills:</u> none <u>Reattachment:</u> none <u>Root treatment:</u> Surface roots removed. <u>Other:</u> none</p>
<p><u>Comparison with 1978-79 Cast/Photograph</u> No cast. Comparison with 1978 photos showed slight loss of resolution where tuff was weathered; an increase in weathering in the heel; and embedding of particles in weathered tuff. Loss of calcite in crack outside print was also visible in 1978 photos. Some 1978 photos show fragments of tuff in center of anterior portion of print that is missing from later 1978 photos and was not seen <i>in situ</i> in 1996.</p>
<p><u>Notes</u> Five possible lagomorph prints were noted outside margins of print.</p>

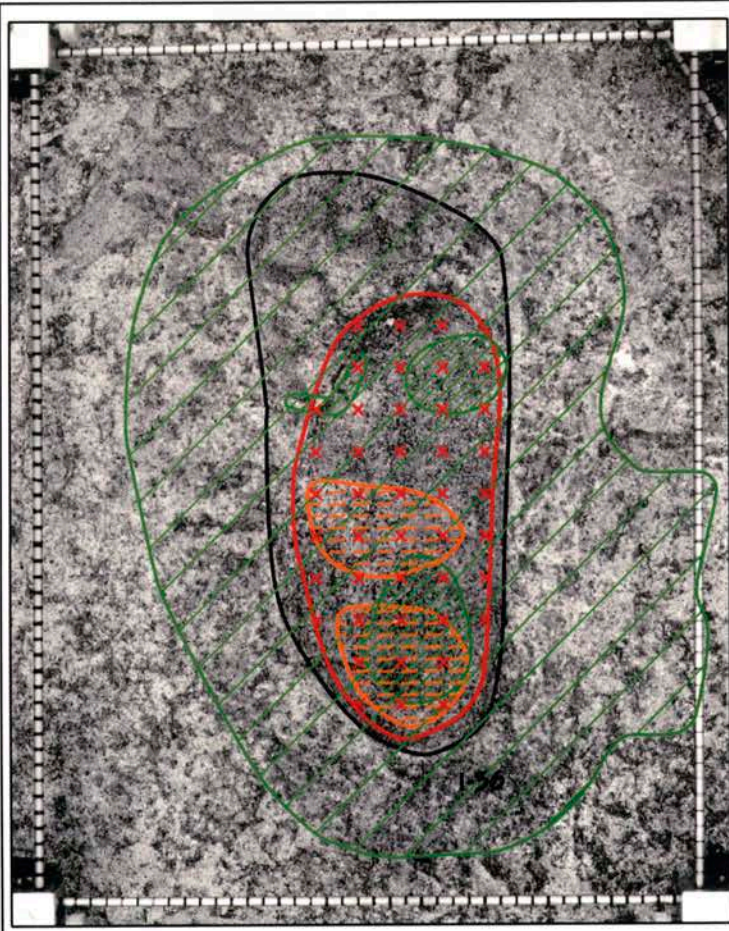
G1-36
TUFF CONDITIONS

Comparison with the 1979 cast and photos showed loss of resolution of features on the floor of the print due to Bedacryl coating. Tool marks clearly visible in the arch and heel portions of the cast and photos were muted in the print *in situ*; tool marks in the anterior portion of the print were not visible *in situ*. The transverse crack in the heel was visible in both the cast and the footprint *in situ*.

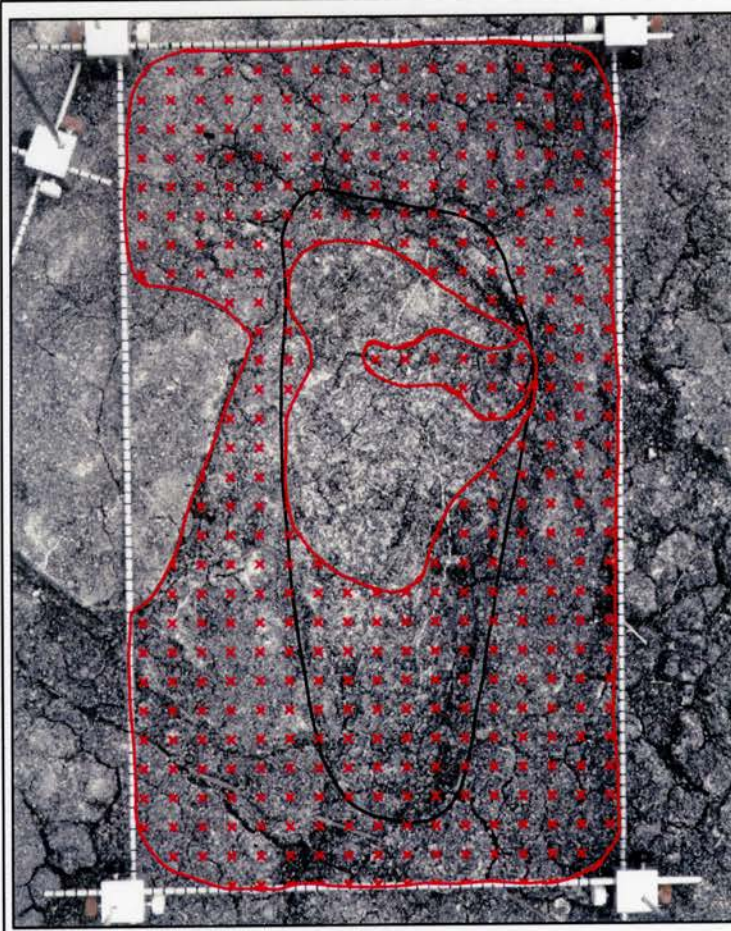
G2/3-2
TUFF CONDITIONS

Fill excavated in 1996 ranged from highly consolidated in the posterior region to loose fill in the anterior portion. The consolidated fill tended to detach in clumps. In the posterior portion, at the tuff interface, fine particles of the overburden were deeply embedded.

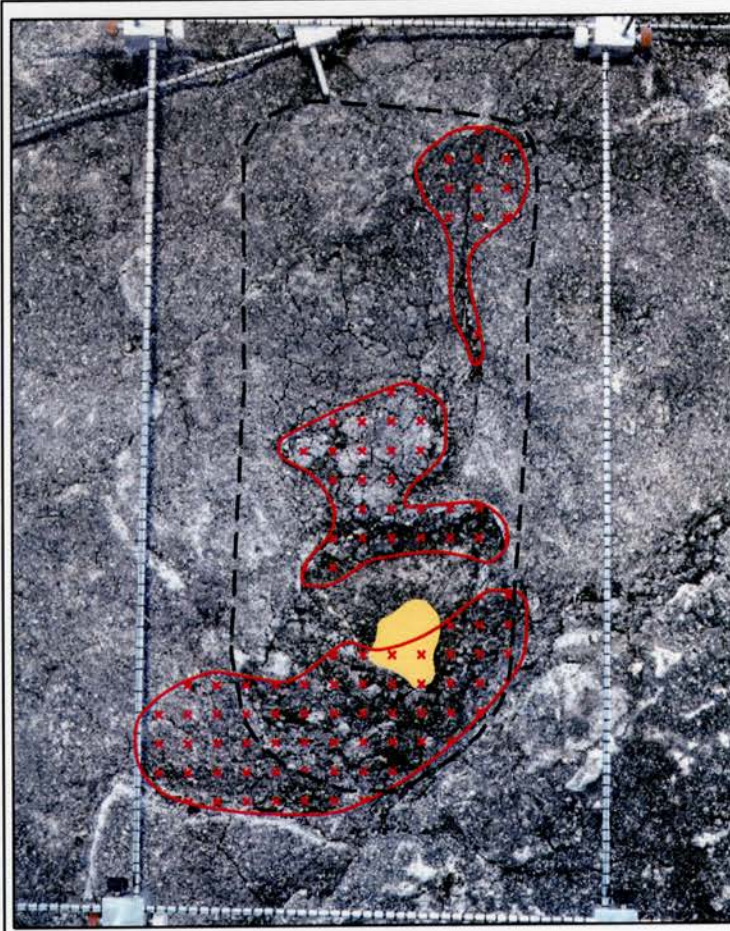
G2/3-16
TUFF CONDITIONS

1995 Condition**General Condition:** Moderate alteration: Fair**Tuff conditions:****Weathering:** Moderate to severe weathering of tuff in central and posterior portions of the prints.**Cracking:** Two 1-2mm wide cracks in anterior portion.**Losses:** Slight loss of surface grains in powdering areas of tuff.**Detached/loose tuff:** Tuff fragments were loose and easily dislodged throughout the weathered area and in the heel as a result of root penetration.**Powdering:** Tuff was powdering in the central portion of the prints.**Other:** none**Conditions related to 1978-79 interventions:****Bedacryl:** none**Embedding:** Deeply embedded particles within the weathered area and in the anterior region in a possible lagomorph print.**Silicone:** none**Excavation tool marks:** none**Inventory number on tuff:** none**Other:** Small fragment of plastic found on the heel surface.**Root damage:** 5mm root penetrated heel margin and caused disruption and dislodging of small tuff fragments. Rootlets present throughout the cracks and weathered tuff.**Insect activity:** none**1996 Interventions****Consolidation/stabilization:** Weathered and loose tuff in central and posterior regions was stabilized with Acrysol WS-24 at 25%.**Fills:** none**Reattachment:** none**Root treatment:** Surface rootlets and exposed portion of 5mm root were removed; subterranean root left *in situ*.**Other:** none**Comparison with 1978-79 Cast/Photograph**

No cast. Comparison with the 1978 photos showed increased weathering of the tuff and particle embedding, especially in the central and posterior regions of the prints. "Rainprints" visible in 1978 photo to the west of the print could not be seen *in situ* due to embedding of overburden in tuff. It was clear from the 1978 photo that G2/3-16 was in poor condition when first excavated. Print margins are not visible in 1978 photographs; identification of location based on tuff features.
