LAETOLI

HOMINID TRACKWAY, SITE G

CONDITION RECORDS

G1 AND G2/3 FOOTPRINTS

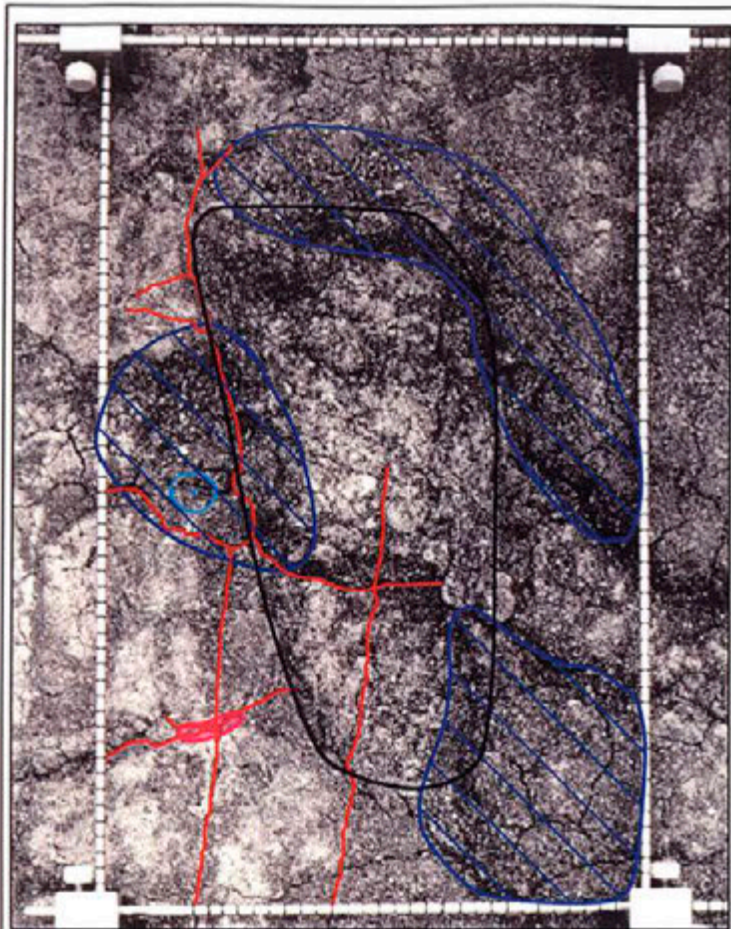
G1-2
TUFF CONDITIONS

On excavation in 1996, the 1978 reburial fill was extremely hard and compact. Calcified surface yellowish-cream in color, which may suggest application of a consolidant in 1978; however this was not so obvious as to warrant describing it as yellow staining, nor were any signs of Bedacryl stringers found. Within its margins, the print showed only minor alteration; however, the surrounding tuff exhibited moderate alteration as a result of more extensive weathering of the tuff since 1978.

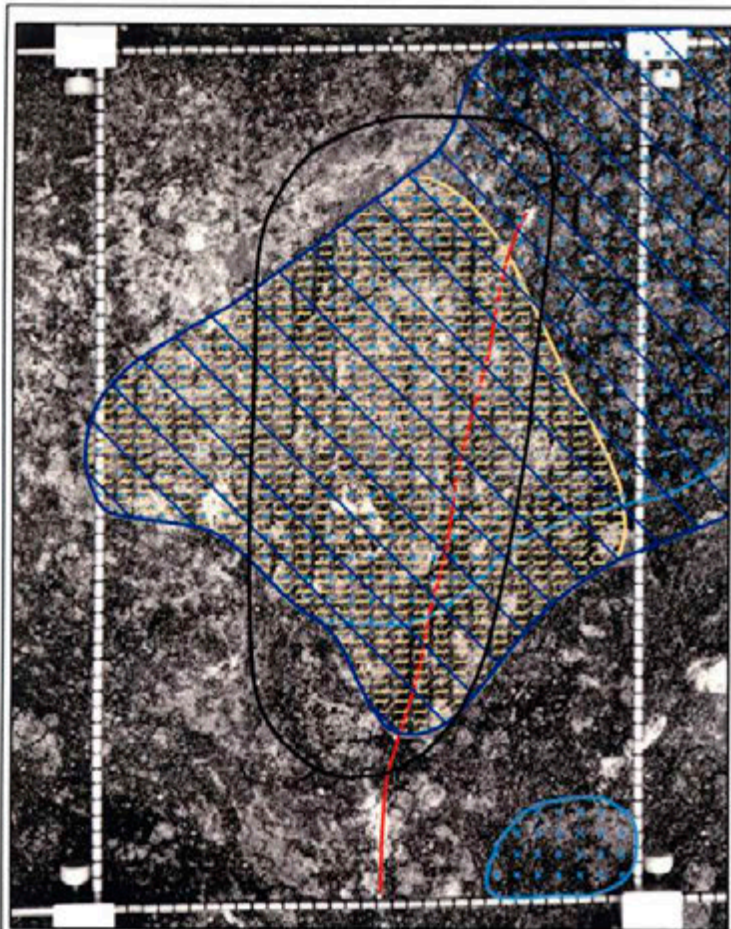
G1-21
TUFF CONDITIONS

Heel and anterior margin of print were well defined in 1978, leaving remainder of print with grey infill matrix. The calcite skin lining the print was visible in the heel and anterior margins. Assessment of condition based on examination of the unexcavated matrix.

The 1978 fill in graben was very wet when excavated in 1996.

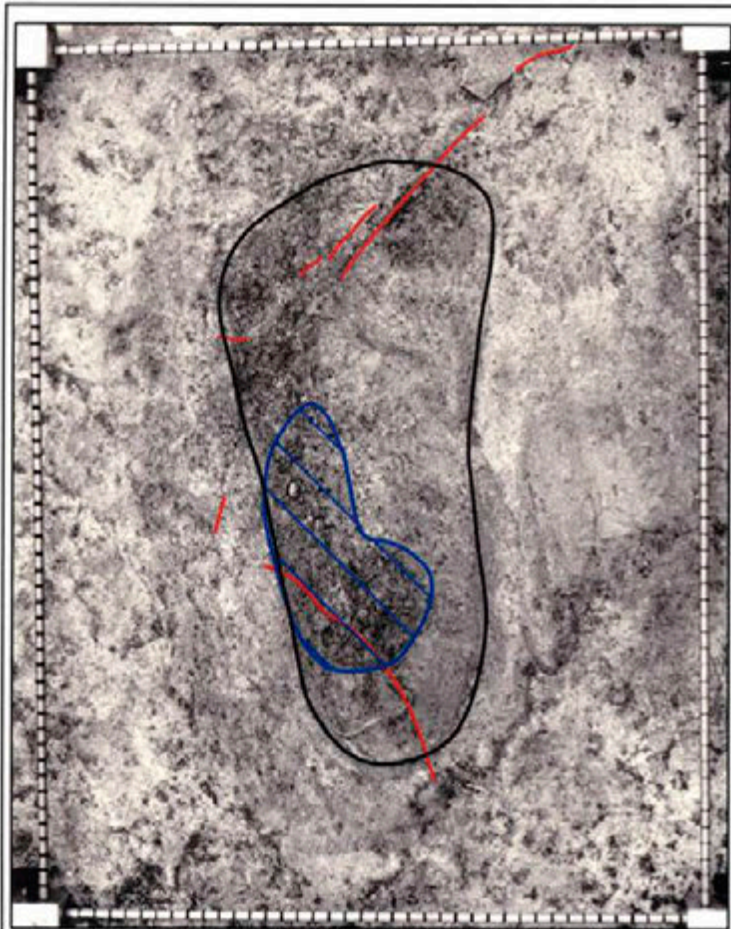
LAETOLI PROJECT AUGUST 1995 G1-35
TUFF CONDITIONS

Comparison with the 1979 cast and photos showed slight loss of resolution of features, such as cracks and excavation tool marks, due to Bedacryl coating the print surface. Slight weathering of tuff along lateral margin was not apparent in 1979 photos.

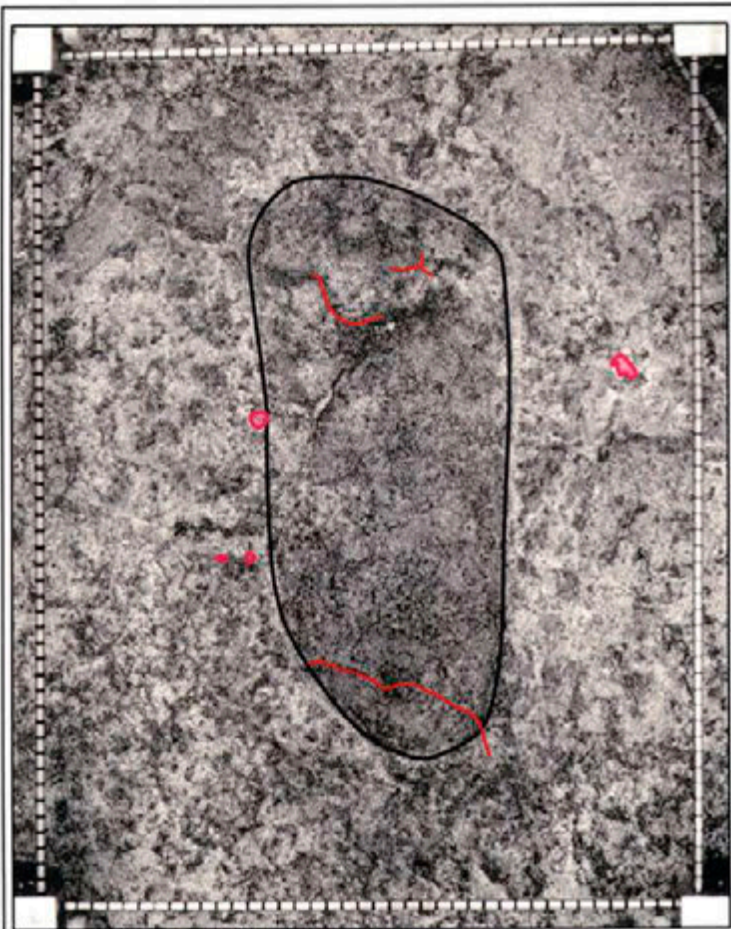
G1-36
TUFF CONDITIONS

Comparison with the 1979 cast and photos showed loss of resolution of features on the floor of the print due to Bedacryl coating. Tool marks clearly visible in the arch and heel portions of the cast and photos were muted in the print *in situ*; tool marks in the anterior portion of the print were not visible *in situ*. The transverse crack in the heel was visible in both the cast and the footprint *in situ*.

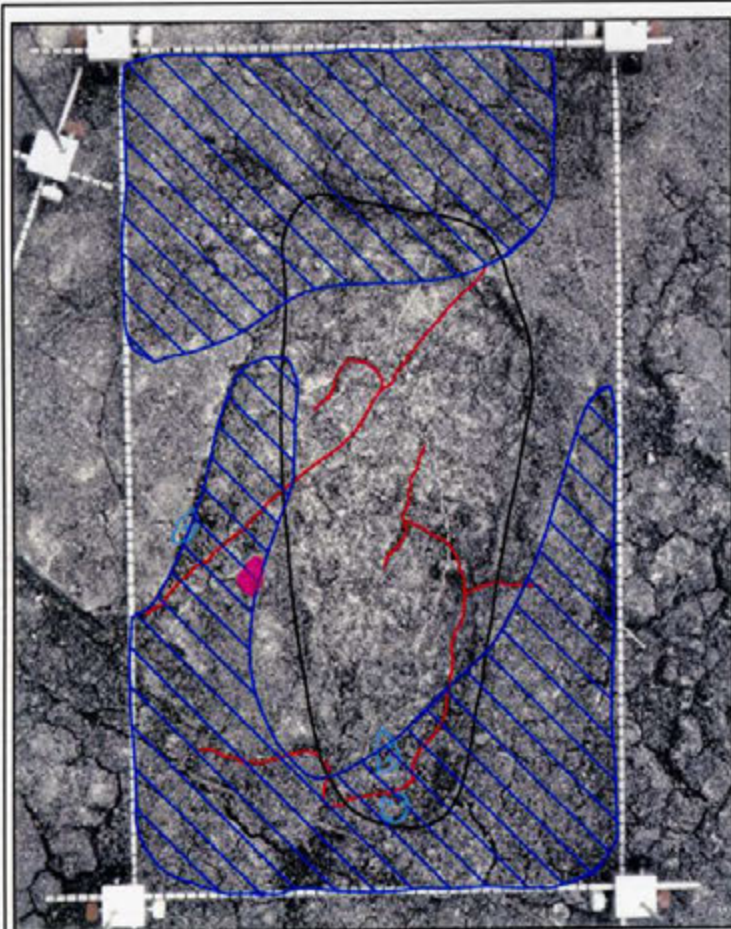
G2/3-2
TUFF CONDITIONS

Fill excavated in 1996 ranged from highly consolidated in the posterior region to loose fill in the anterior portion. The consolidated fill tended to detach in clumps. In the posterior portion, at the tuff interface, fine particles of the overburden were deeply embedded.

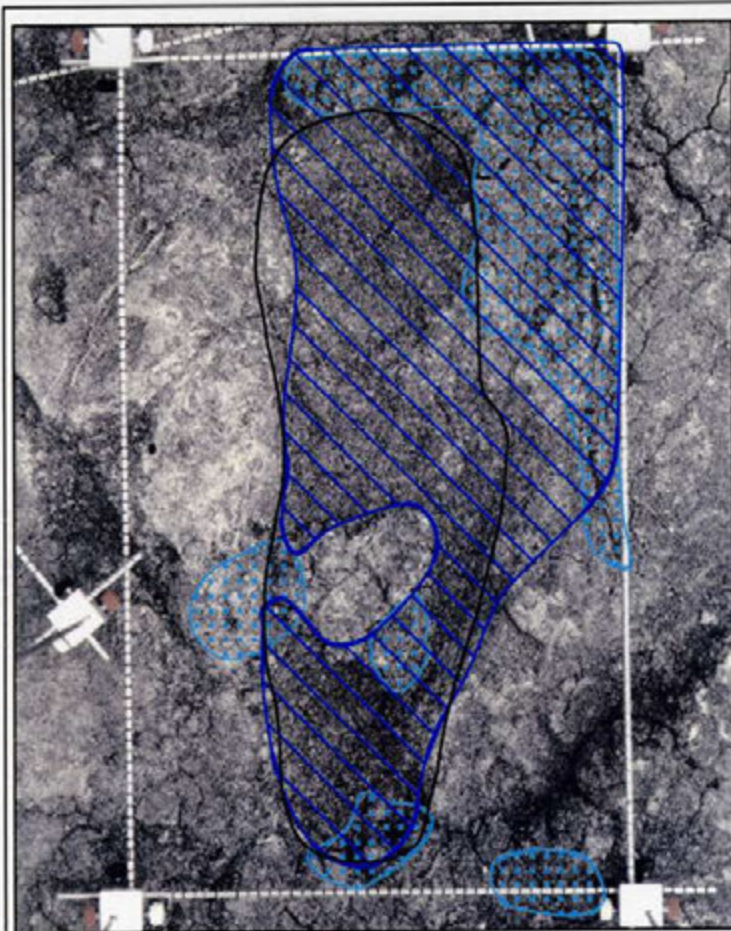
G2/3-6
TUFF CONDITIONS

1995 Condition**General Condition:** Moderate alteration: Fair**Tuff conditions:****Weathering:** Severely weathered on interior of the prints, except on an island of tuff (with remnants of L14) in the center, and outside anterior and lateral margins.**Cracking:** none**Losses:** none**Detached/loose tuff:** Discrete patches of loose tuff associated with weathering in posterior portion, and outside anterolateral margin. Two small fragments in posterior half, each averaging 0.50cm², were detached.**Powdering:** none**Other:** none**Conditions related to 1978-79 interventions:****Bedacryl:** Bedacryl stringers observed in raised central portion (anterior to island of L14 tuff).**Embedding:** Deeply embedded particles at bottom of the prints and in weathered areas.**Silicone:** none**Excavation tool marks:** none**Inventory number on tuff:** none**Other:** Yellow resinous material (identified as cellulose nitrate; see **Interventions: Other**) in raised central portion (island of L14 tuff).**Root damage:** Numerous surface rootlets but no significant root penetration on interior of prints. Single root, 3-4mm diameter, penetrated the tuff beyond the lateral margin. Root had nearly disintegrated, leaving a distinct impression in the surface.**Insect activity:****Cut-worm pupal cases:** Six small cut-worm casings, all located outside medial and posterolateral margins.**1996 Interventions****Consolidation/stabilization:** Loose fragments of weathered tuff stabilized with Acrysol WS-24 at 25%.**Fills:** none**Reattachment:** Two detached fragments in posterior half were reattached with Paraloid B-72.**Root treatment:** Surface rootlets removed.**Other:** Sample of yellow resinous material taken for analysis (identified as cellulose nitrate; location not shown on graphic); see *1996-1998 Report on the Laetoli Project*, p. 39 for discussion of analysis.**Comparison with 1978-79 Cast/Photograph**

No cast. Comparison with the 1978 photos showed a slight loss of resolution of features on the prints' surface, particularly in the anterior portion; increased weathering of the tuff; and embedding of fine particles.

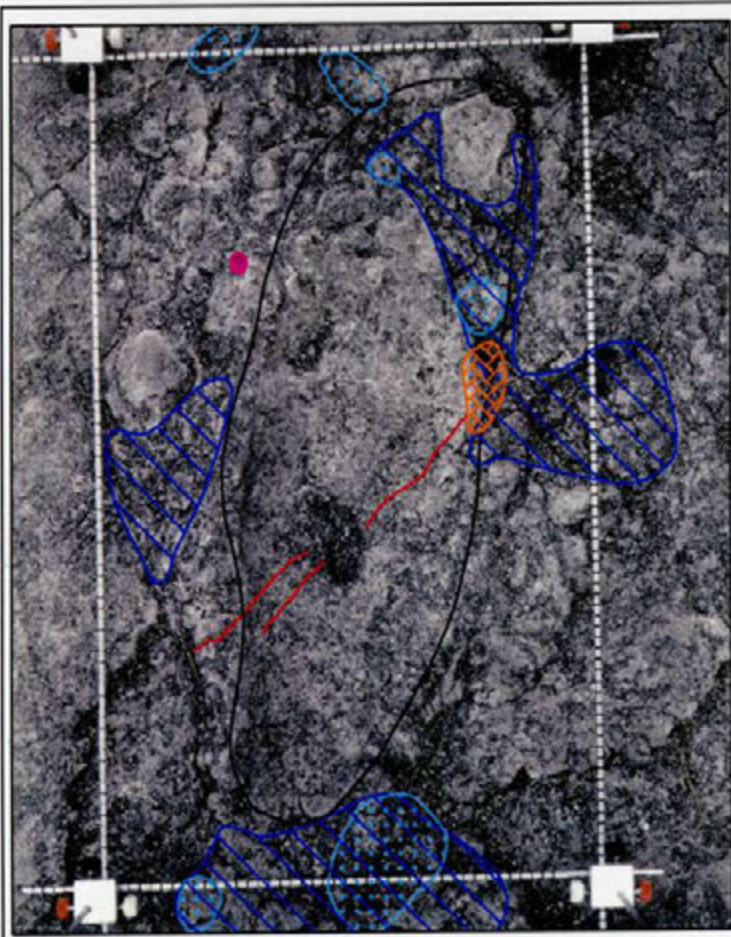
LAETOLI PROJECT AUGUST 1996 0mm 25mm G2/3-7 TUFF CONDITIONS

Comparison with the 1978 cast and photos showed only a slight loss of resolution of features on the prints' surface; and slight increase in weathering of tuff outside margin of prints. One of the least altered (best preserved) prints in the northern sector.

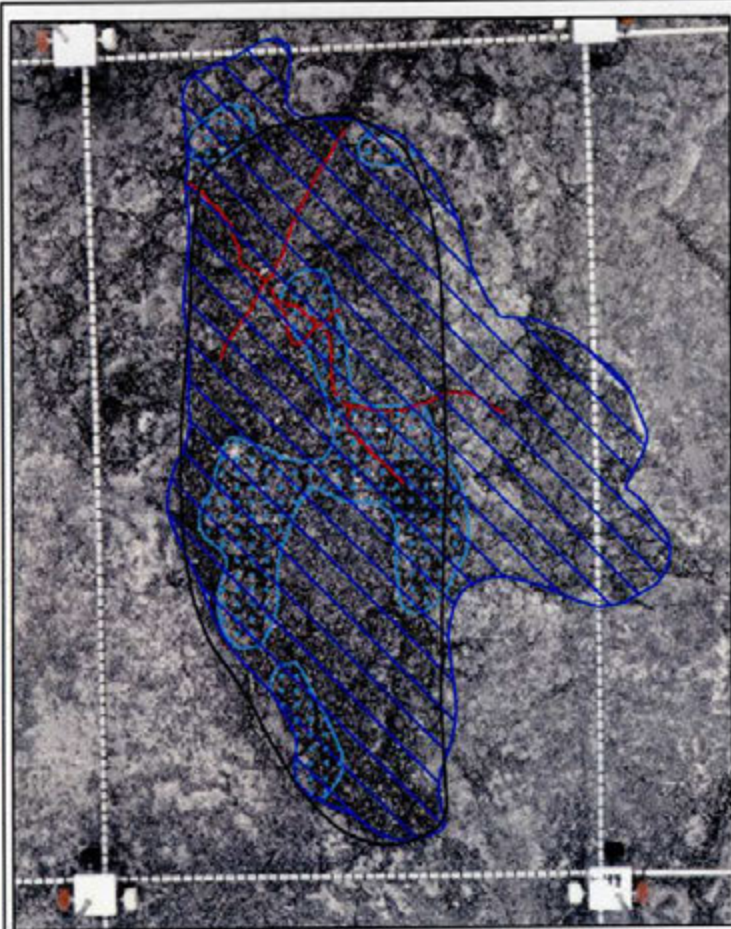
G2/3-8
TUFF CONDITIONS

1995 Condition**General Condition:** Moderate alteration: Fair**Tuff conditions:****Weathering:** Patchy weathering throughout the interior of the prints and outside lateral margin.**Cracking:** Two cracks traversed the prints in the anterior portion; one was associated with missing calcite vein.**Losses:** none**Detached/loose tuff:** Areas of loose tuff associated with weathered tuff.**Powdering:** none**Other:** none**Conditions related to 1978-79 interventions:****Bedacryl:** none (see **Other**)**Embedding:** Embedded fine particles throughout weathered areas, concentrated in low areas on the uneven surface of the prints.**Silicone:** none**Excavation tool marks:** none**Inventory number on tuff:** none**Other:** Remnant of plastic found just outside medial margin. Faint yellow staining in posterior portion and in one patch on the anterior margin; may be from cellulose nitrate, though it did not appear as resinous as other examples found on the northern sector of the trackway.**Root damage:** Rootlets on the anterior of the prints penetrated the tuff, but did not significantly disrupt the surface. One 6mm root penetrated the heel.**Insect activity:** none**1996 Interventions****Consolidation/stabilization:** Loose tuff in weathered areas was stabilized with Acrysol WS-24 at 25%.**Fills:** none**Reattachment:** Fragment of tuff (~4cm²) outside the lateral margin was reattached with Paraloid B-72.**Root treatment:** Surface rootlets were removed. 6mm diameter root in heel was cut and reduced to a level just below the tuff surface.**Other:** none**Comparison with 1978-79 Cast/Photograph**

No cast. Comparison with the 1978 photos showed a distinct increase in cracking of weathered tuff; cracks enlarged by 1-2mm after excavation. Slight loss of resolution of features on the prints' surface, but print margins retained similar level of definition.

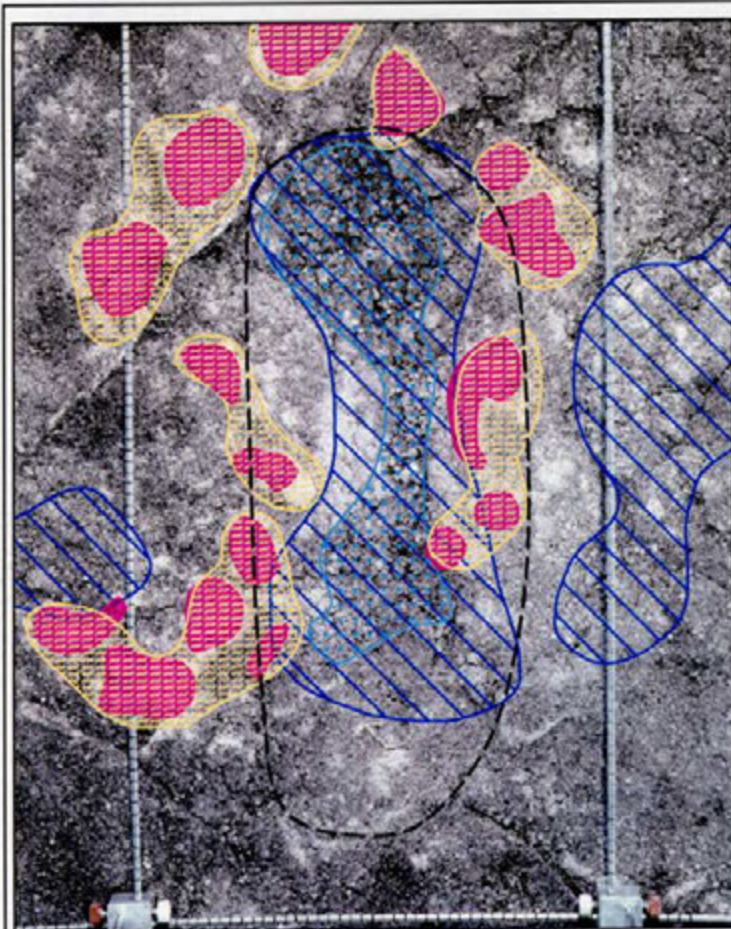
G2/3-15
TUFF CONDITIONS

1995 Condition**General Condition:** Significant alteration: Poor**Tuff conditions:****Weathering:** Severe weathering of tuff along the axis of the prints and in patches outside margins.**Cracking:** none**Losses:** Surface of powdering tuff slightly abraded as a result of brushing this weakly consolidated tuff.**Detached/loose tuff:** Tuff was loose within weathered area inside margins of prints.**Powdering:** Areas of tuff along and outside margins of prints were powdery.**Other:** none.**Conditions related to 1978-79 interventions:****Bedacryl:** none**Embedding:** Deeply embedded particles up to 3mm in diameter in the weathered areas, especially in the center of the prints.**Silicone:** none**Excavation tool marks:** none**Inventory number on tuff:** none**Other:** none**Root damage:** Root penetrated tuff outside the posterior margins, and left a distinct root impression when surface root removed. Small rootlets on the surface and within cracks.**Insect activity:** none**1996 Interventions****Consolidation/stabilization:** Weathered and loose tuff was stabilized with Acrysol WS-24 at 25%.**Fills:** none**Reattachment:** none**Root treatment:** Surface rootlets were removed.**Other:** none**Comparison with 1978-79 Cast/Photograph**

No cast. Comparison with the 1978 photos showed increased weathering of tuff, especially along axis of prints, and particle embedding. It is clear from the 1978 photos and notes that the tuff was in poor condition (weathered, fractured and powdering) in 1978. Print margins are not visible in 1978 photographs; identification of location based on tuff features.

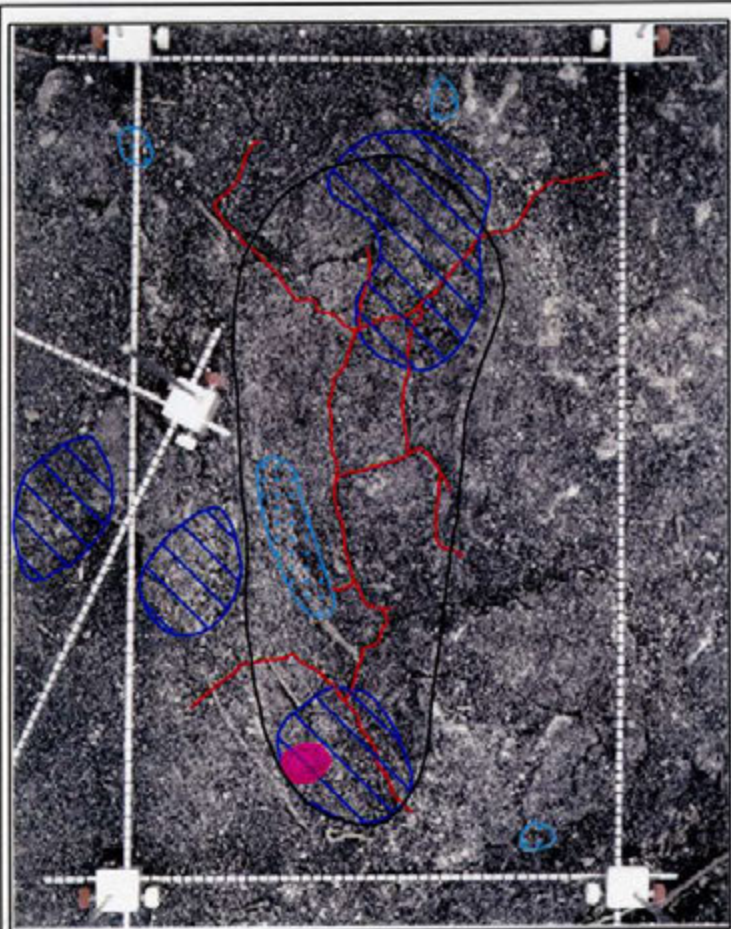
G2/3-17
TUFF CONDITIONS

The 1978 reburial fill excavated in 1996 was moderately consolidated and was removed relatively easily from the prints' surface. Tuff surface inside margins noted as being dark in comparison with surrounding tuff, suggesting application of Bedacryl, although its presence could not be confirmed.

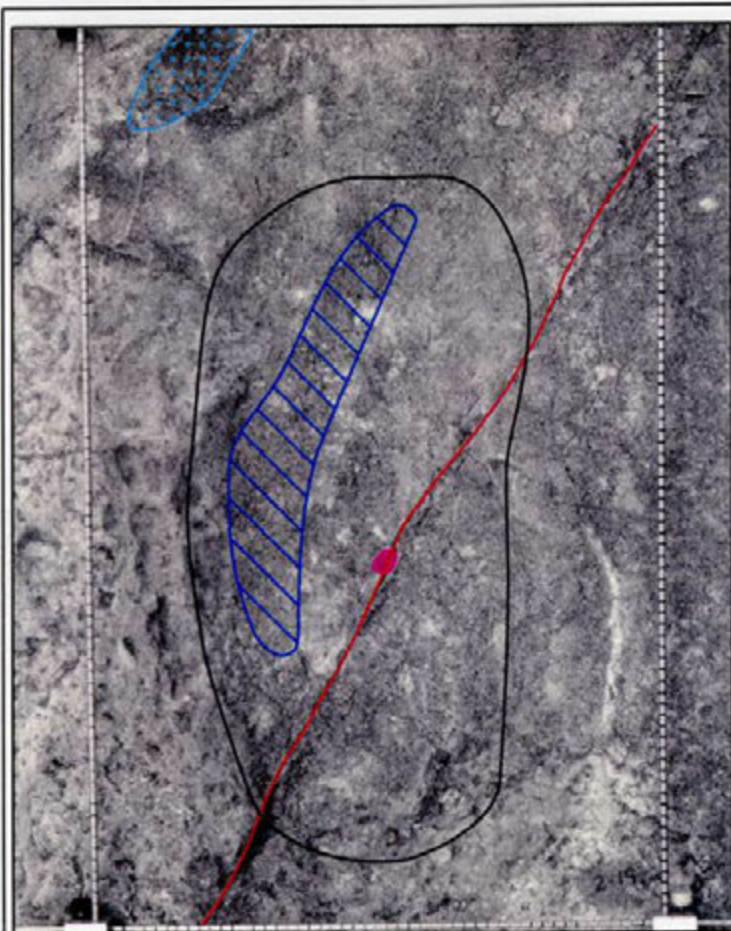
G2/3-19
TUFF CONDITIONS

1995 Condition**General Condition:** Minor alteration: Good**Tuff conditions:****Weathering:** Slight weathering near lateral margin.**Cracking:** Large crack with a maximum width of 2mm traversed the prints; associated with calcite vein.**Losses:** 1cm² loss along crack.**Detached/loose tuff:** Localized area of tuff was loose outside the anterior margin of the prints.**Powdering:** none**Other:** none**Conditions related to 1978-79 interventions:****Bedacryl:** Bedacryl found throughout the prints and just beyond the margins. It had deteriorated slightly and was impacted by rootlet penetration on the floor of the prints and extending beyond the anterior margin, and was lost in small discrete areas within the prints. The Bedacryl layer was more thickly applied in the deteriorated areas.**Embedding:** Minor embedding of very fine particles in the Bedacryl (not shown on graphic).**Silicone:** none**Excavation tool marks:** none visible (see Comparison below)**Inventory number on tuff:** 1979 label ("2-19") located just beyond the medial heel margin.**Other:** none**Root damage:** Extensive network of rootlets (indicated as root mat on graphic) penetrated the Bedacryl layer, but did not appear to penetrate the footprint tuff; most are not visible in photo.**Insect activity:** none**1996 Interventions****Consolidation/stabilization:** Loose tuff beyond the anterior print margin was stabilized with Acrysol WS-24.**Fills:** none**Reattachment:** none**Root treatment:** Surface rootlets were removed. Since removal of the rootlets penetrating Bedacryl layer would have caused disruption to the layer, most were not removed.**Other:** none**Comparison with 1978-79 Cast/Photograph**Comparison with the 1979 cast and photos showed slight loss of resolution of some of the finer details on the prints' surface, particularly at the bottom, and darkening of the surface, both due to the coating of Bedacryl. Tool marks were visible in the cast that were obscured by the Bedacryl coating *in situ* and calcite ridge in crack was more prominent in cast than *in situ*.
