*Report on the partial re-excavation
of the Laetoli hominid trackway, Site G*

The Getty Conservation Institute

Partial re-excavation of the Laetoli hominid trackway, February 2011

Condition record of Laetoli hominid prints re-excavated in February 2011

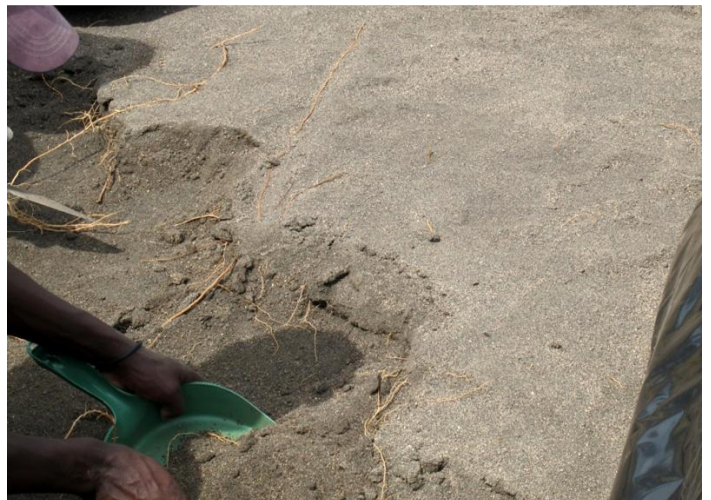
Roots entering trench laterally were found in Layer 2, which abuts the 1979 trench wall.

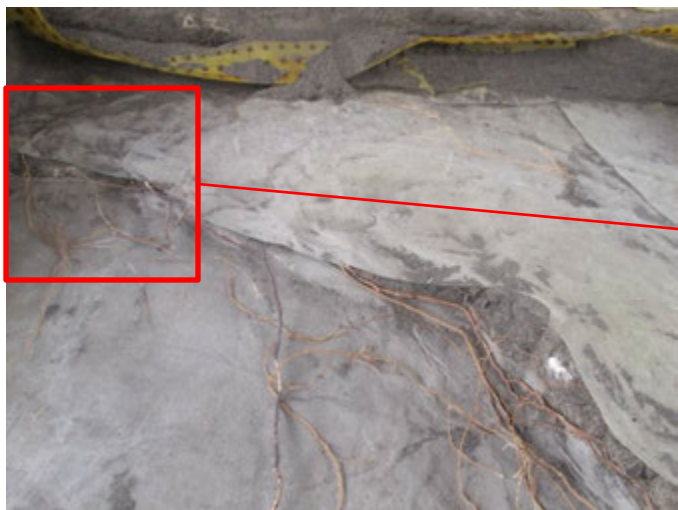
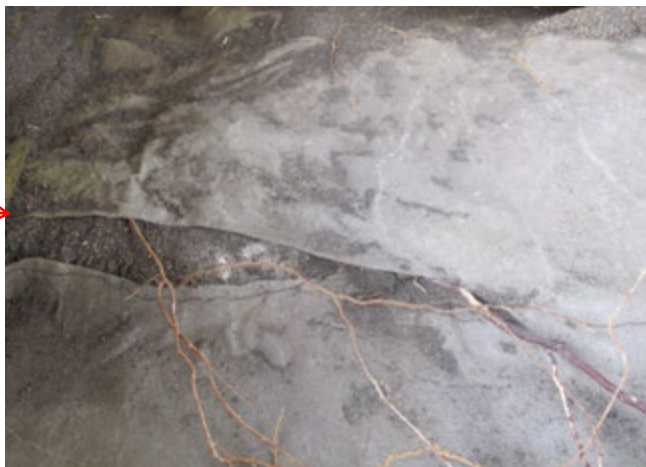
Roots running above geotextile along the Augite Biotite scarp. Roots found easy access below geotextile where 2 pieces of geotextile met at the top of the Augite Biotite scarp.

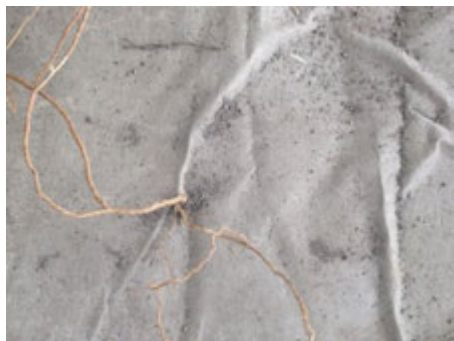
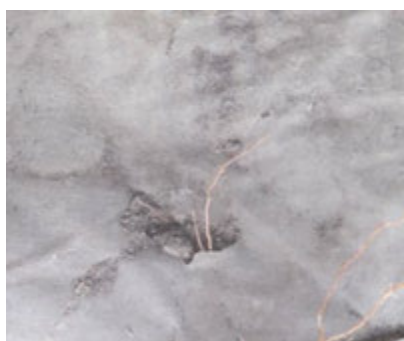
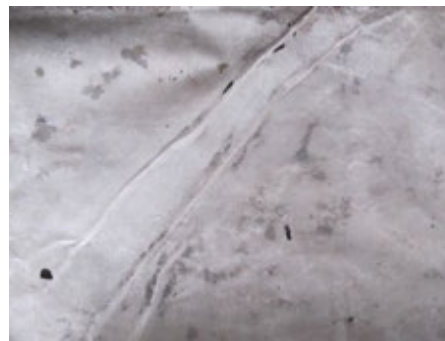
Roots penetrated geotextile in 2 places (left and center); holes may have been created by termites, allowing root access. Small holes created by termites in geotextile (right).

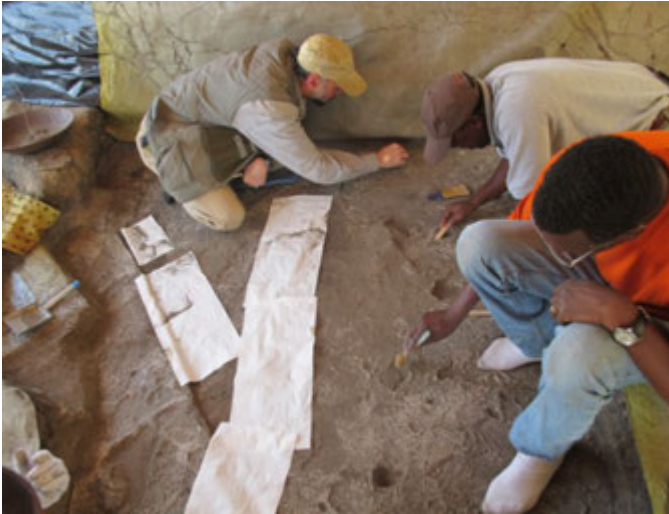
Removing Layer 1 from surface of tuff. Absorbent paper on prints and tuff that were subject to water infiltration from rain.

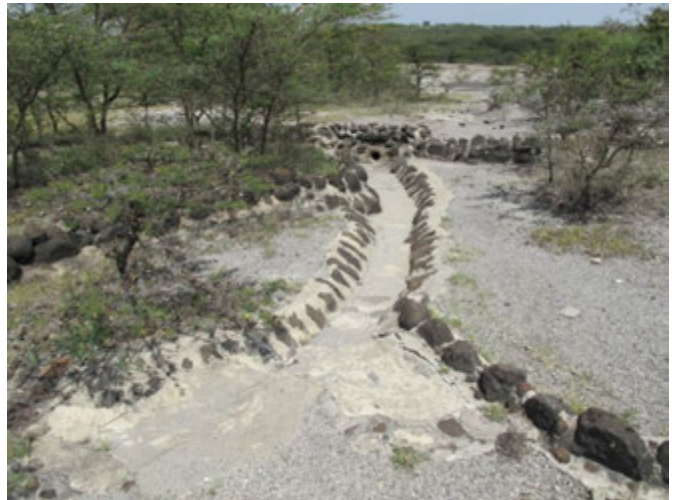
Inlet channel leading to main catchment sump; cement apron is cracking.

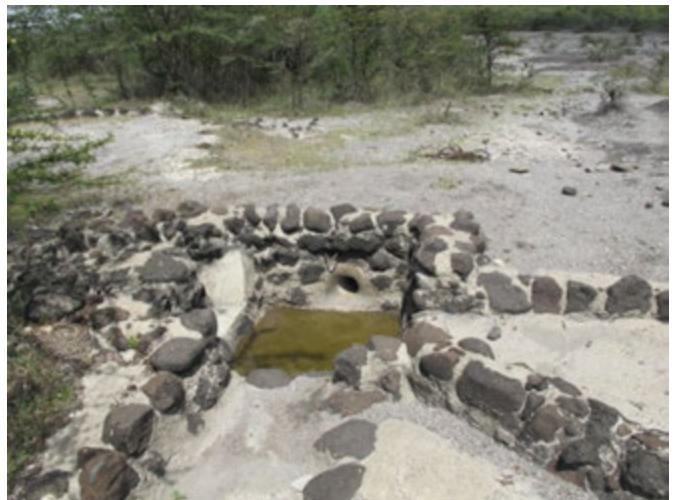
Catchment sump. Steel grill to prevent outflow pipe from clogging with vegetation is missing.

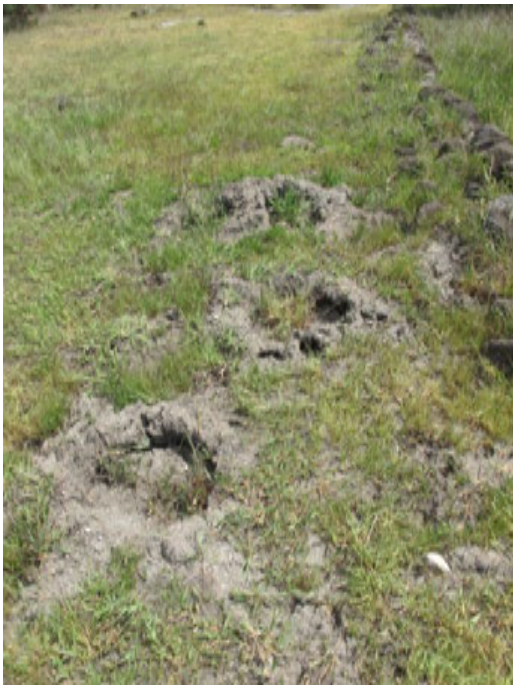
Elephant (and cattle) tracks in mud adjacent to berm where water accumulates. Thorn fence around Site G established in 1996 to deter animals from entering has been removed.

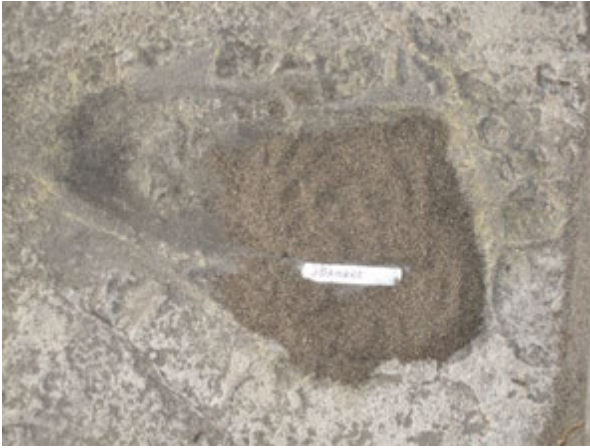
Damaged margin of print G2/3-27 protected with a piece of geotextile and labeled, with Layer 1 sand holding geotextile in place.

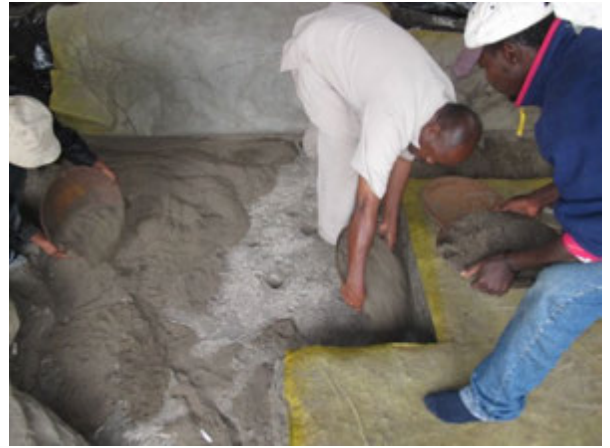
Placing Layer 1 on trackway surface. Detached piece of tuff on fault with damage label in foreground

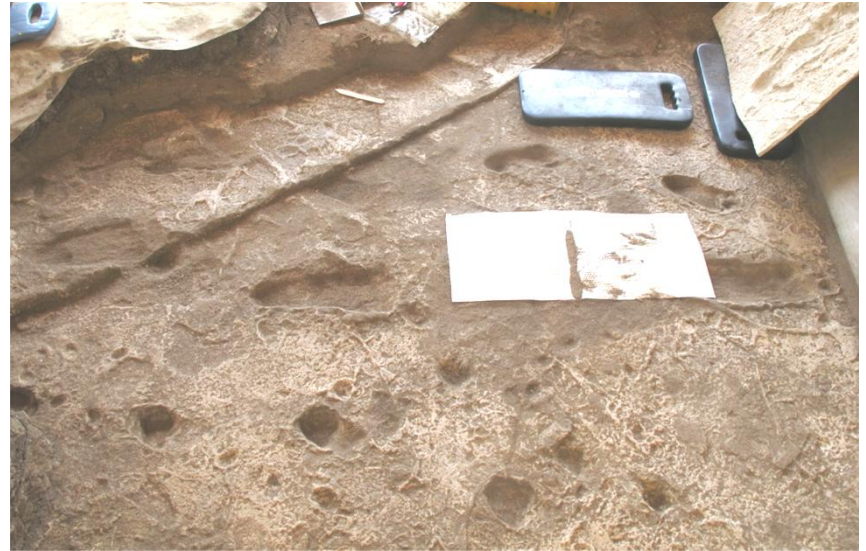
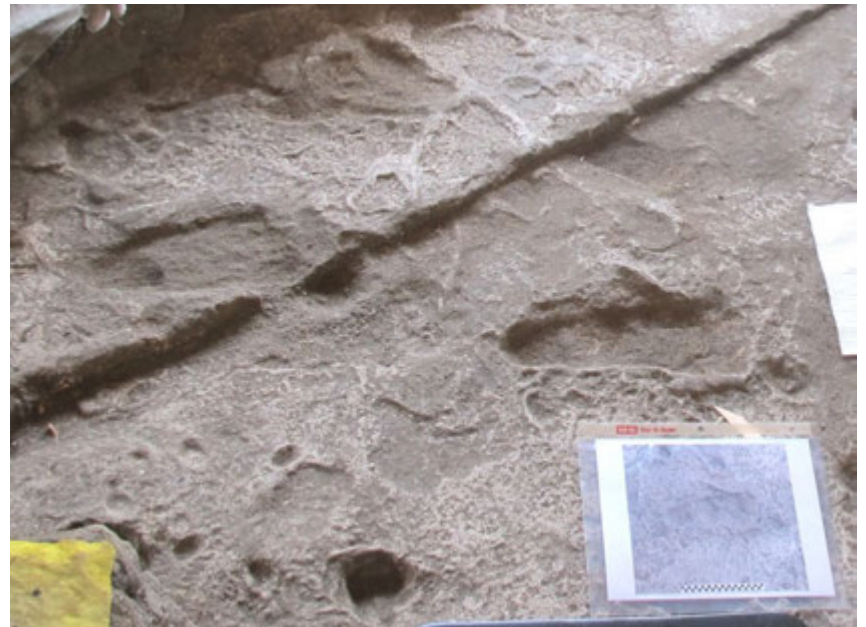
Trackway before final cleaning of tuff surface and with fill still in prints. Roots growing in Layer 1 are visible on the surface and penetrating tuff at the edge of Fault 1.

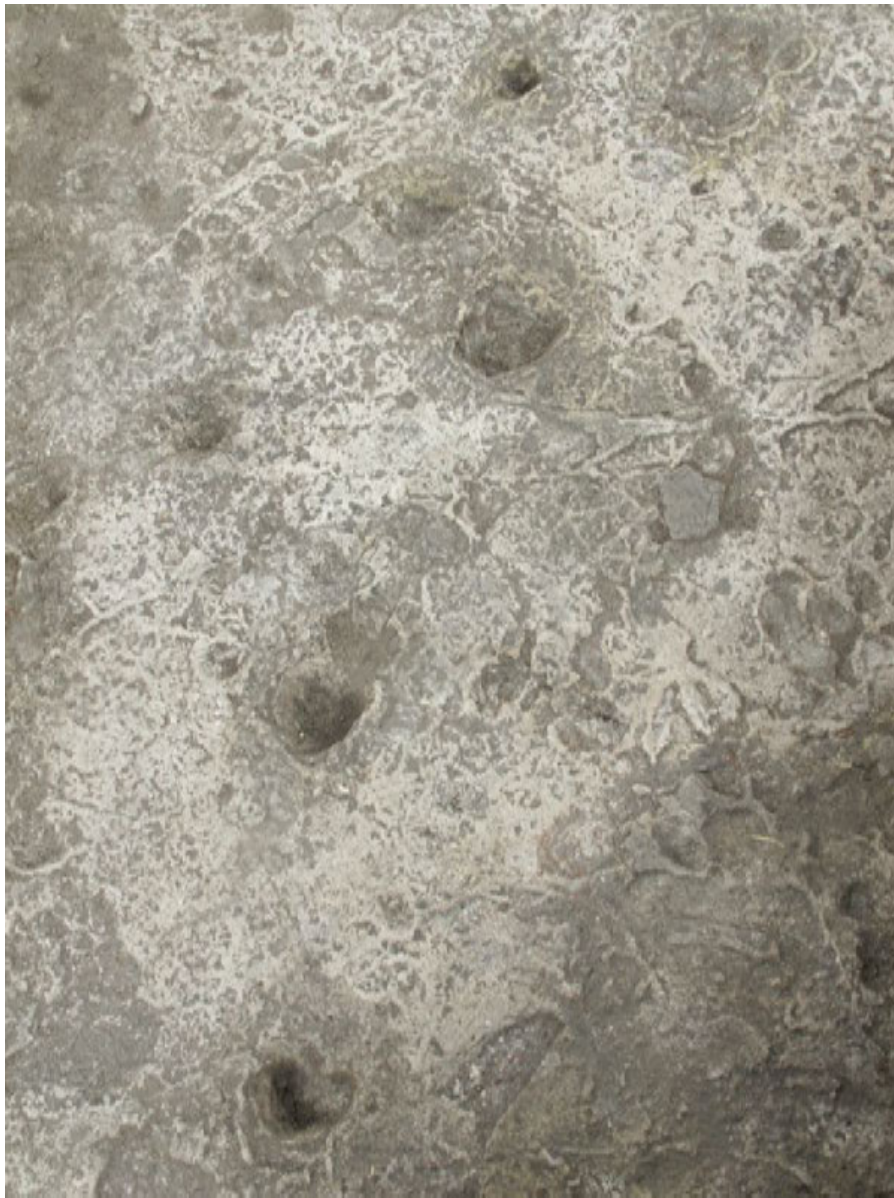
Footprint Tuff with hipparion prints, east of hominid trail.
Bedacryl darkening and halo around hipparion prints is visible.

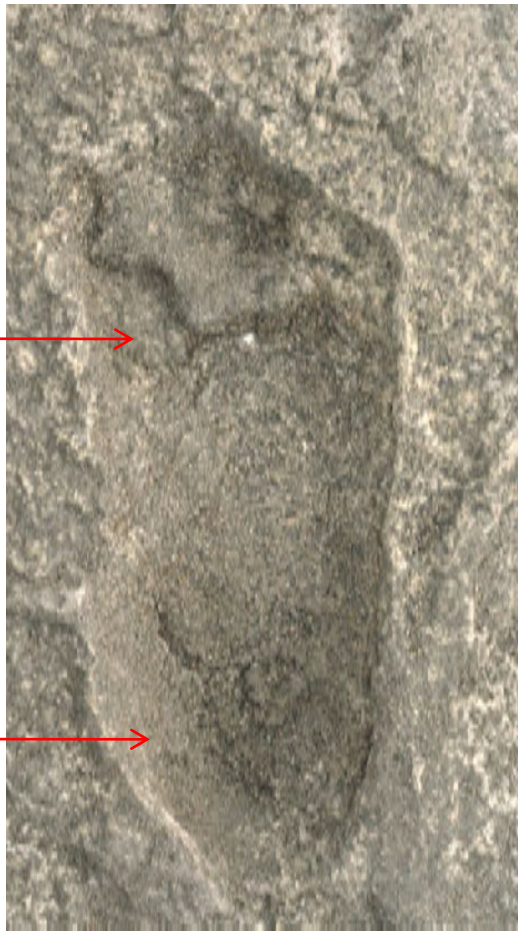
G1- 36: Right print 1995 recorded conditions [2011 recorded conditions]

Cracking along fossil burrows

Cracking in heel of print

1995 Condition General condition: Minor alteration/good. [Moderate alteration/Fair]
Tuff Conditions: Weathering: none Cracking: Hairline cracks transect heel and are evident on the burrows in anterior portion. [Incipient cracks noted in 1995 in heel and along the fossil termite burrows in the anterior portion have propagated] Losses: Minor loss of tuff surface noted outside medial and lateral margins of print. Detached/loose tuff: none Powdering: none Other: none
Conditions Related to 1978-79 [1995] Interventions: Bedacryl: Bedacryl found throughout the print and surrounding it; deterioration of Bedacryl in heel area and anterior to arch. [Bedacryl visible as darkening on floor of print and yellow halo around print] Embedding: Slight embedding of fine particles in Bedacryl layer on the floor of the print. [Moderate embedding and adherence of sand grains] Silicone: none Excavation tool marks: Tool marks visible in the arch and heel portions of print. Inventory number on tuff: 1979 label ("1-36") visible on tuff surface. Barely visible; largely obscured by adherent sand] Other: none

Root damage: A few rootlets on the surface, which did not penetrate the Bedacryl layer. [Hair roots primarily penetrating in cracks of tuff or Bedacryl layer]
Insect activity: none
1995 Interventions Consolidation/stabilization: none Fills: none Reattachment: none Root treatment: Surface roots removed. [Penetrating hair roots were not removed] Other: none
Comparison with 1978-79 Cast/Photograph Comparison with the 1979 cast and photos showed loss of resolution of features on the floor of the print due to Bedacryl coating. Tool marks clearly visible in the arch and heel portions of the cast and photos were muted in the print <i>in situ</i> ; tool marks in the anterior portion of the print were not visible <i>in situ</i> . The transverse crack in the heel was visible in both the cast and the footprint <i>in situ</i> . [see Cracking above]
Notes [Print was not cleaned to the same level as in 1995]

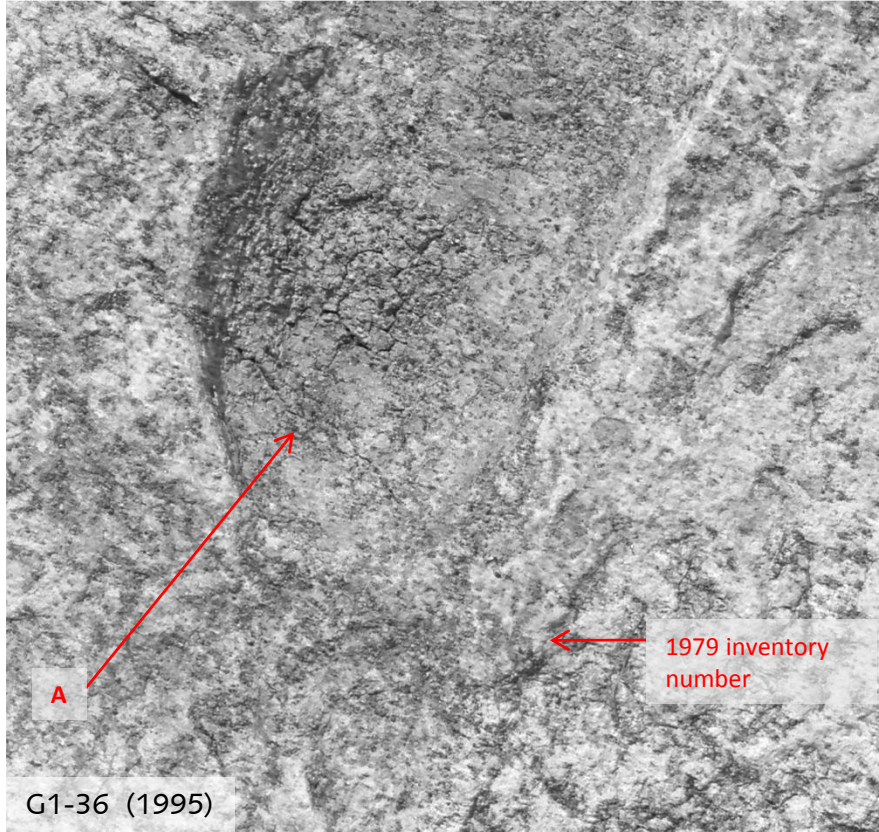
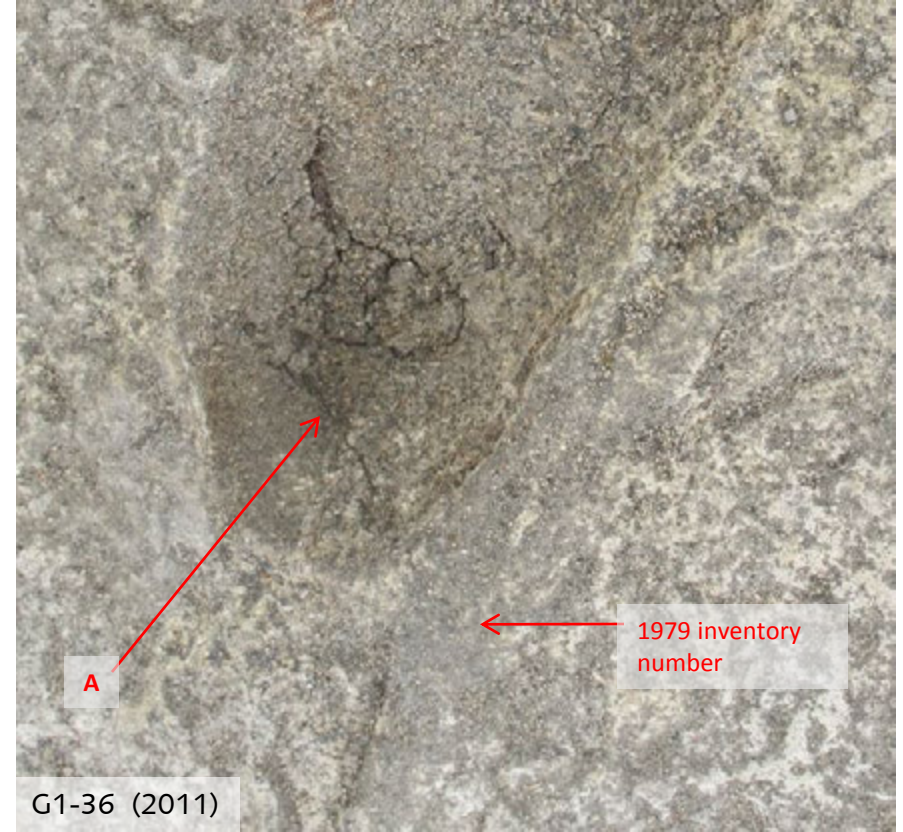
Close-up of the heel of G1-36 in 1995 and 2011. Transverse crack in heel (A) was visible in 1995 and was noted on photos and cast from 1979. Incipient cracking (possibly weathering) in heel recorded in 1995 has increased.

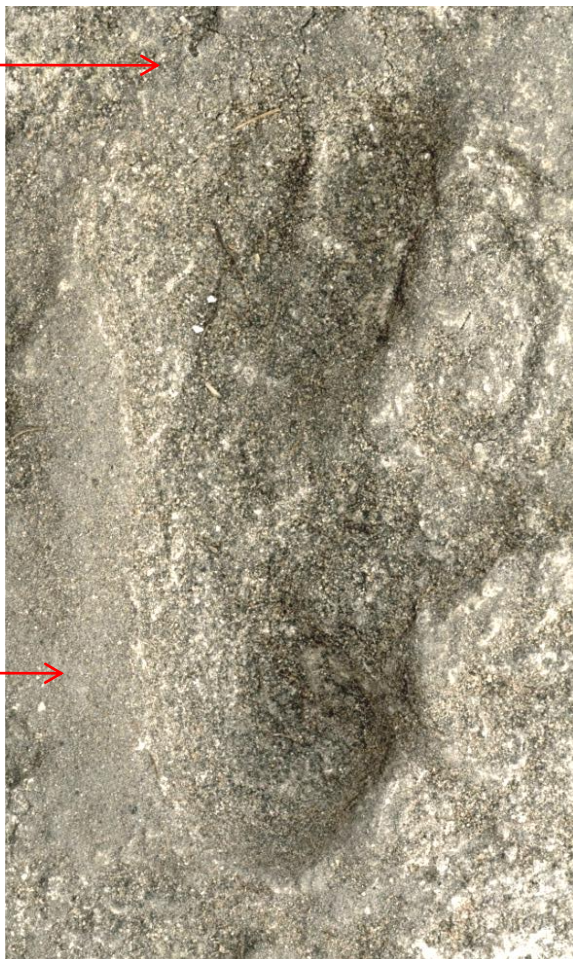
G1- 37: Left print **1995 recorded conditions** [2011 recorded conditions]

Cracking
outside lateral
margin

Adhered fines
outside
posterior
margin

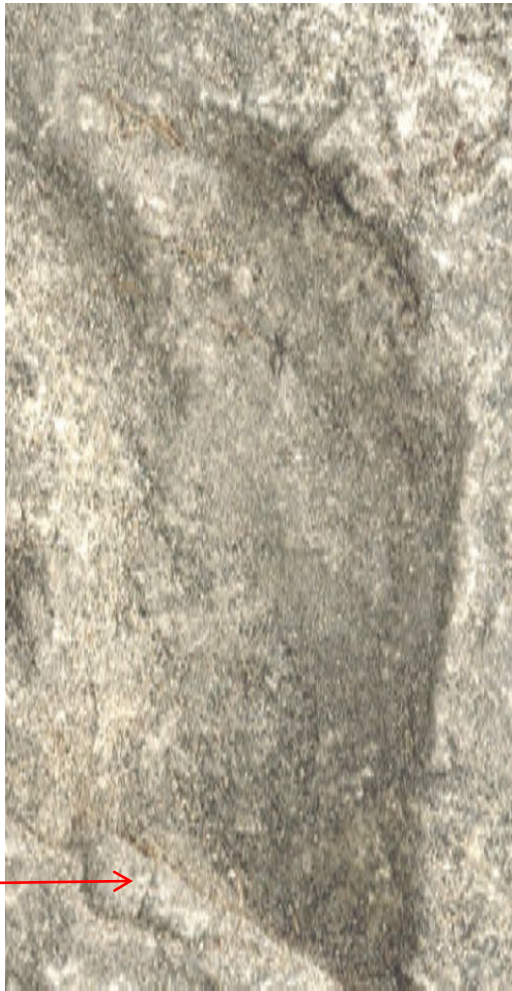
Crack on fault

1995 Condition**General condition:** Minor alteration/Good. [Minor alteration/Good]**Tuff Conditions:****Weathering:** Slight weathering of tuff at the point where the fault intersected the print.**Cracking:** Fine surficial cracks at the fault intersection (not visible in photograph). [Slightly raised tuff at fault line has a new crack perpendicular to the fault line]**Losses:** Minor abrasion of tuff surface outside posterior print margin; appears to be an old loss.**Detached/loose tuff:** none**Powdering:** none**Other:** none**Conditions related to 1978-79 [1995] Interventions:****Bedacryl:** Bedacryl covered the print and surrounding tuff surface. Patches of deteriorated Bedacryl on floor of print. [Bedacryl visible as darkening on floor of print and yellow halo around print.]**Embedding:** Severe embedding of fine particles in the area of weathered tuff and along medial margin; slight embedding on the remainder of the print surface. [Minor embedding and adherence of sand grains on floor of print and outside lateral margin]**Silicone:** Traces of silicone outside print margin.**Excavation tool marks:** Tool marks visible outside medial margin near fault line.**Inventory number on tuff:** 1979 label ("1-38") visible on tuff surface. [Number visible]**Other:** none**Root damage:** Root penetrated the wall of the fault where it intersected the print, but did not go directly into the floor of print. Rootlets on surface of print. [A few rootlets in anterior part penetrating tuff and cracks]**Insect activity:** none**1995 [2011] Interventions****Consolidation/stabilization:** none**Fills:** none**Reattachment:** none**Root treatment:** Surface roots removed. [Fine rootlets and hair roots penetrating Bedacryl layer or tuff not removed]**Other:** none**Comparison with 1978-79 Cast/Photograph**Comparison with the 1979 cast and photos showed distinct loss of resolution of features on the print surface due to Bedacryl and embedding of fine particles covering the surface of the print. Tool marks visible in the cast on the floor of the print were obscured *in situ*.**Notes**

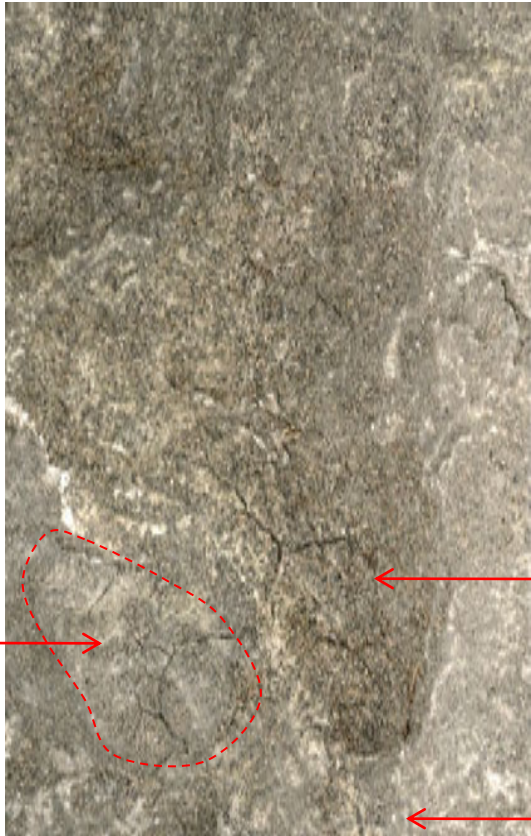
G1-39: Left **1995 recorded conditions [2011 recorded conditions]**

<p>1995 Condition General condition: Minor alteration/Good. [Moderate alteration/Fair]</p> <p>Tuff Conditions: Weathering: Slight weathering of the tuff along the lateral margin of print. Cracking: none. [Incipient cracking visible on the island of tuff west of the heel in 1995 has widened and cracks have propagated. Cracking in the heel and lateral margin of the print occur principally in the same area where weathering and cracking of Bedacryl layer were noted in 1995. Cracks were free of sand grains indicating opening occurred as a result of drying from re-excavation.] Losses: Minor loss of tuff outside margin of great toe and lateral margin of print. Detached/loose: none Powdering: none Other:</p> <p>Condition Related to 1978-79 [1995] Interventions: Bedacryl: Bedacryl covered the surface of the print and surrounding tuff. It was slightly deteriorated along the lateral print margin with numerous hairline cracks in Bedacryl layer, and outside the anterior margin. [Bedacryl visible as darkening on floor of print and distinct yellow halo around print] Embedding: Slight embedding noted in Bedacryl layer (not shown on graphic). [Moderate embedding and adhered sand grains] Silicone: Minor traces of silicone outside print margins. Excavation tool marks: none Inventory number on tuff: 1979 label ("1-39") visible on tuff surface. [Number partially visible] Other:</p> <p>Root damage: Rootlets, less than 1mm diameter, weaved in and out of the Bedacryl layer and a few penetrated the tuff along the lateral side, forming a root mat in the lateral heel portion. [Rootlets and hair roots penetrated tuff and cracks in heel and arch area]</p> <p>Insect activity: none</p>

<p>1995 Interventions Consolidation/stabilization: none Fills: none Reattachment: none Root treatment: Roots removed. [Penetrating rootlets or hair roots were not removed] Other: none</p>
<p>Comparison with 1978-79 Cast/Photograph Comparison with the 1979 cast and photos showed slight loss of resolution of surface features. Slight weathering already visible in 1979 photos.</p>
<p>Notes [Print was not cleaned to the same level as in 1995]</p>

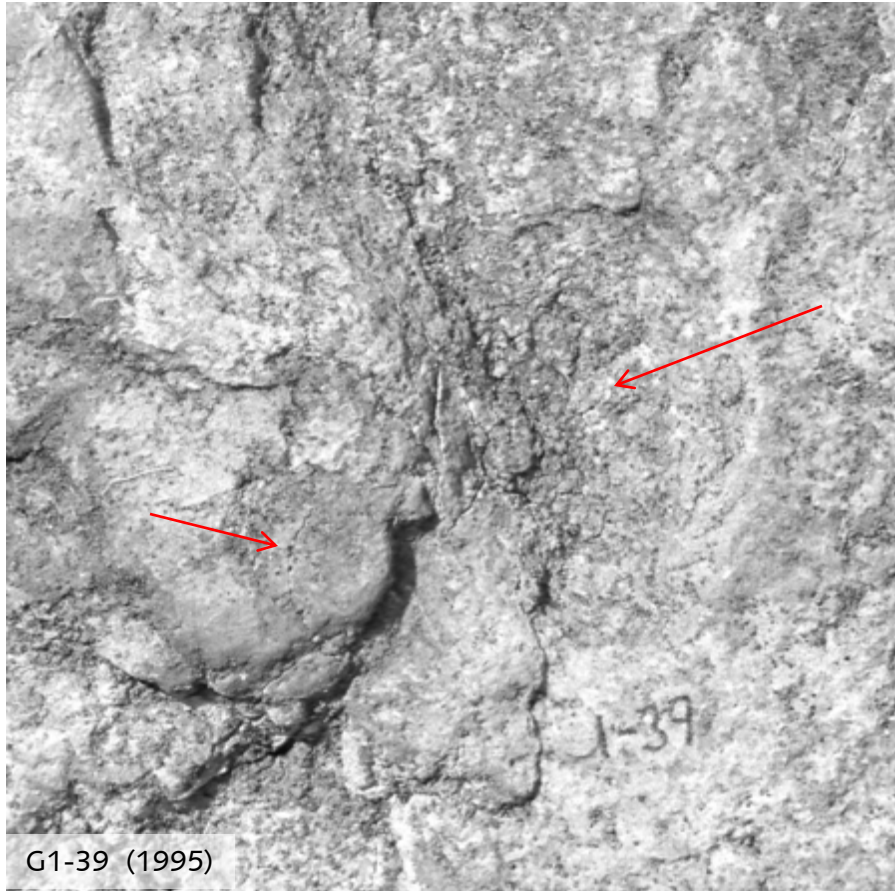
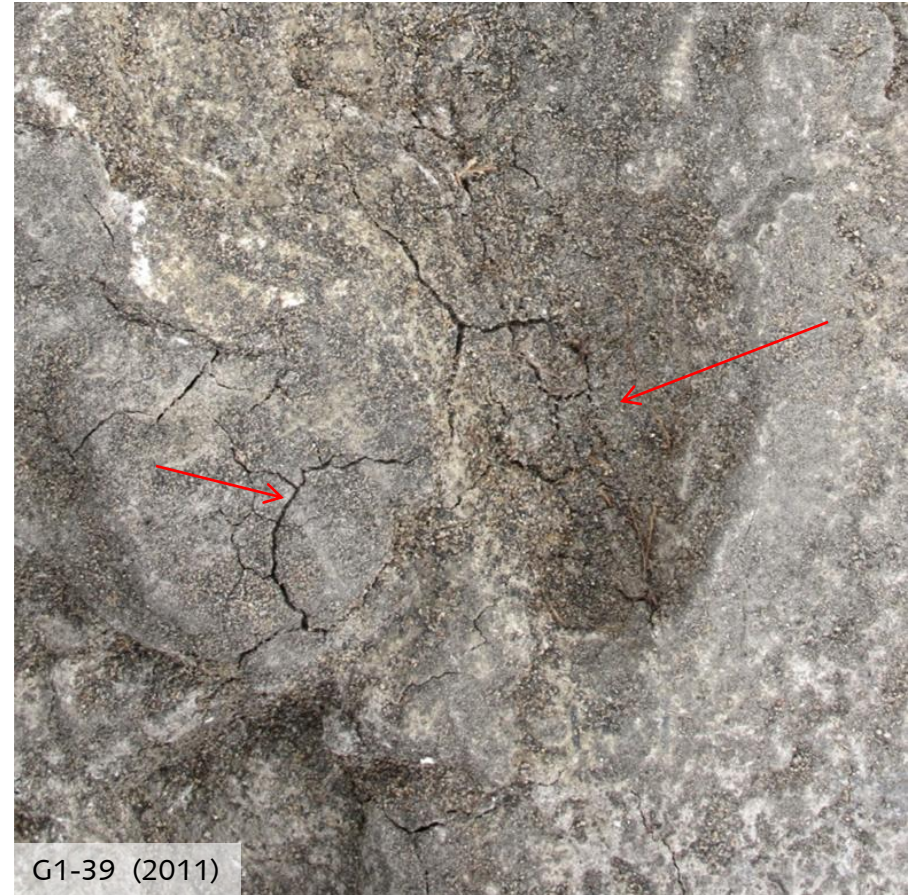
Close-up of the heel of G1-39 in 1995 and 2011. Incipient cracking on raised island of tuff and weathering along lateral margin and floor of heel, visible in 1995 and 1979 photos, increased and propagated on re-excavation and drying in 2011.

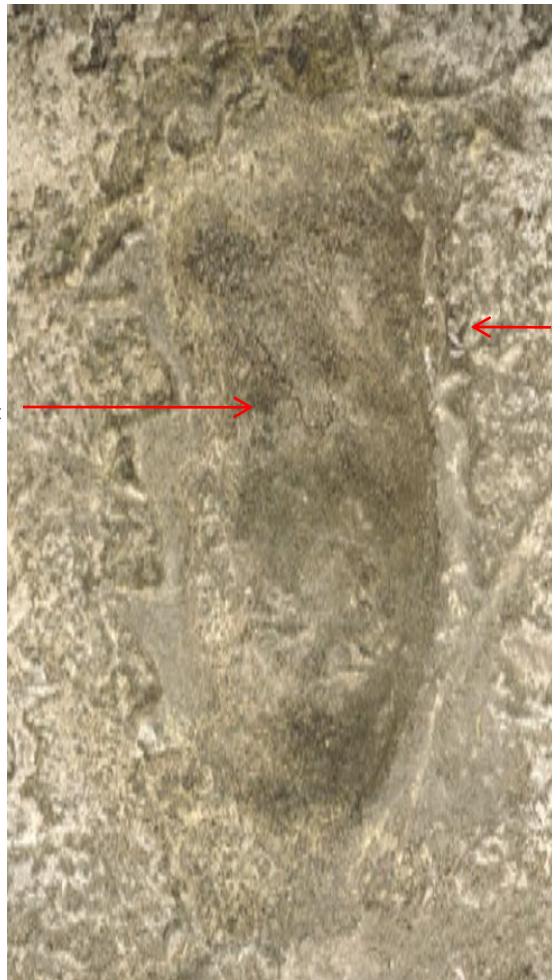
Cracking in anterior part of print

Mechanical damage

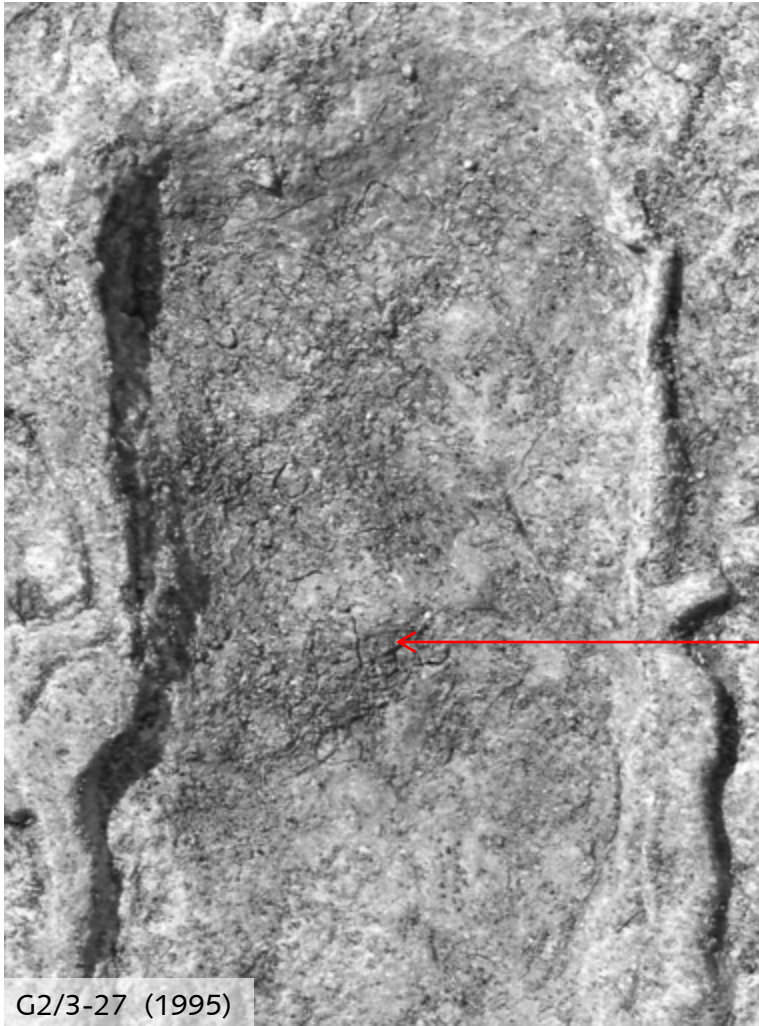
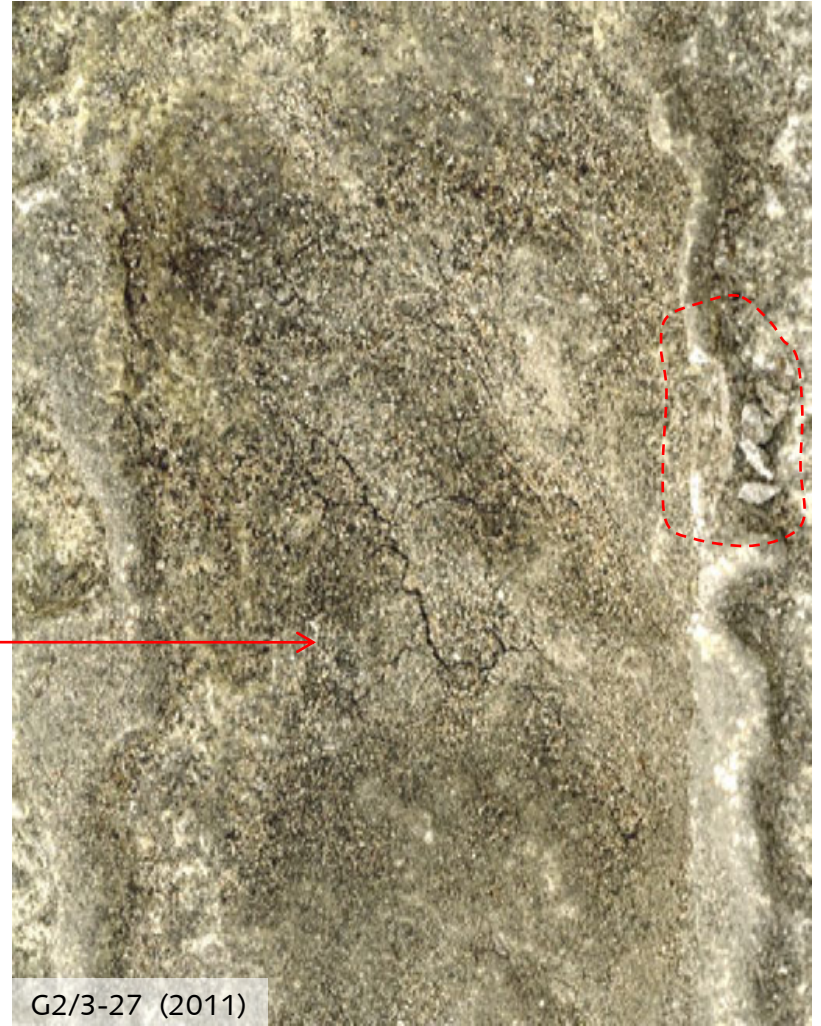
Mechanical damage: The 2011 re-excavation resulted in mechanical damage from excavation to the fossil termite burrow on print G2/3-27.

Close-up of the anterior portion of G2/3-27 in 1995 and 2011. Incipient cracking and weathering recorded in 1995 has enlarged and propagated on re-excavation and drying in 2011. Dashed line marks the area of mechanical damage to fossil termite tunnels; fragments are adjacent to broken area.

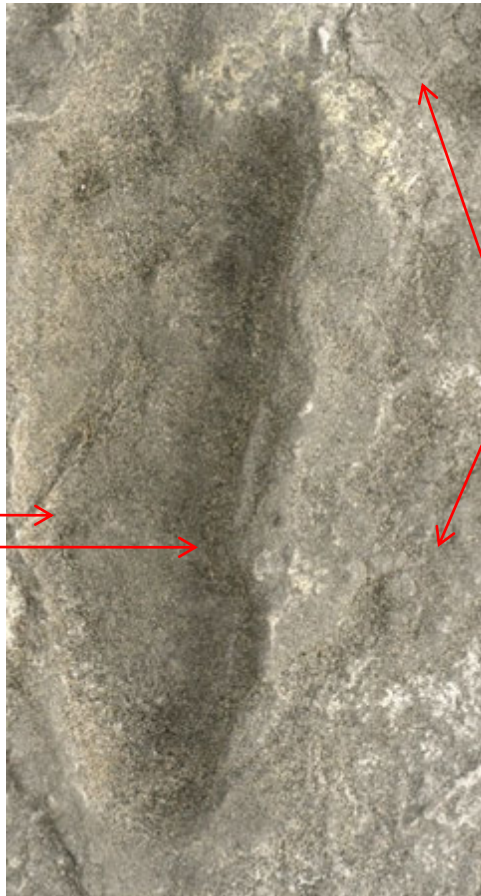
G/3-28: Left 1995 recorded conditions [2011 recorded conditions]

Incipient cracking on margins

Cracking on tuff surface

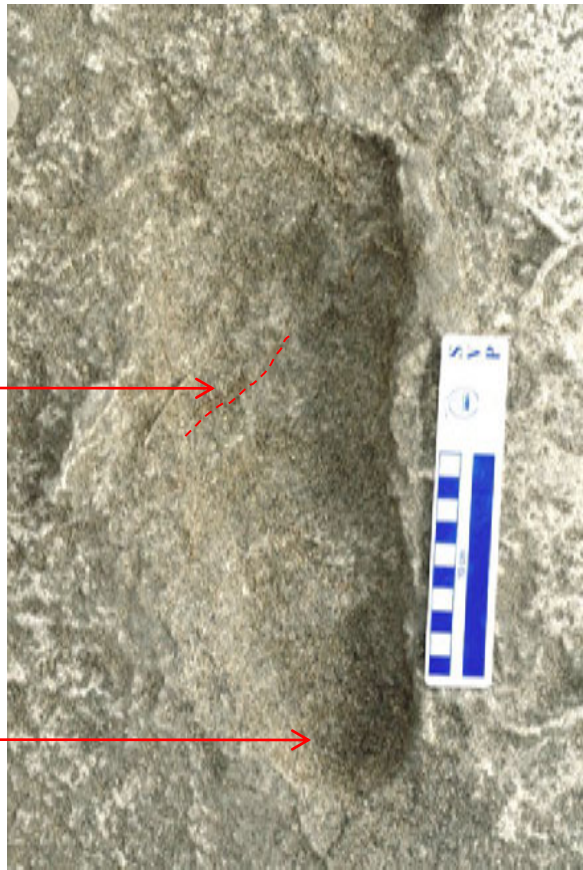
G2/3-29: Right 1995 recorded conditions [2011 recorded conditions]

Rootlet penetrating tuff (larger root to the left is windblown fragment)

Incipient cracking

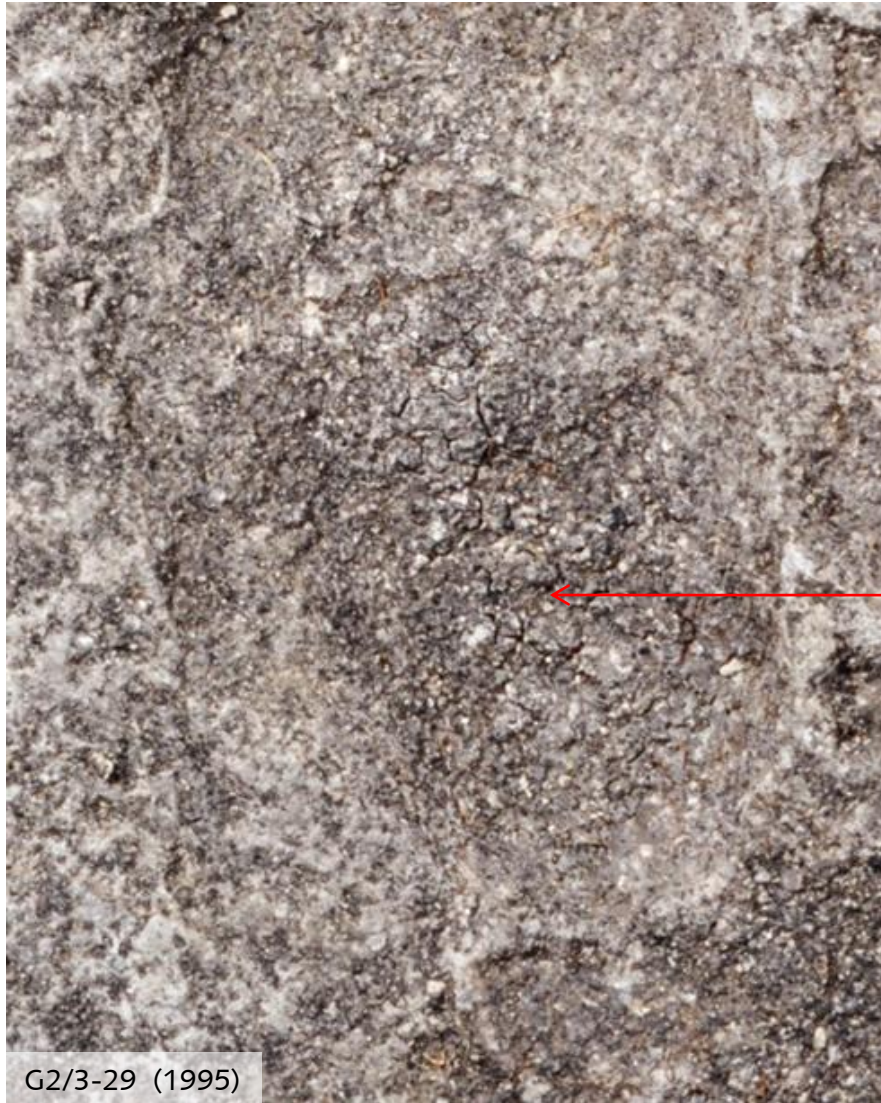
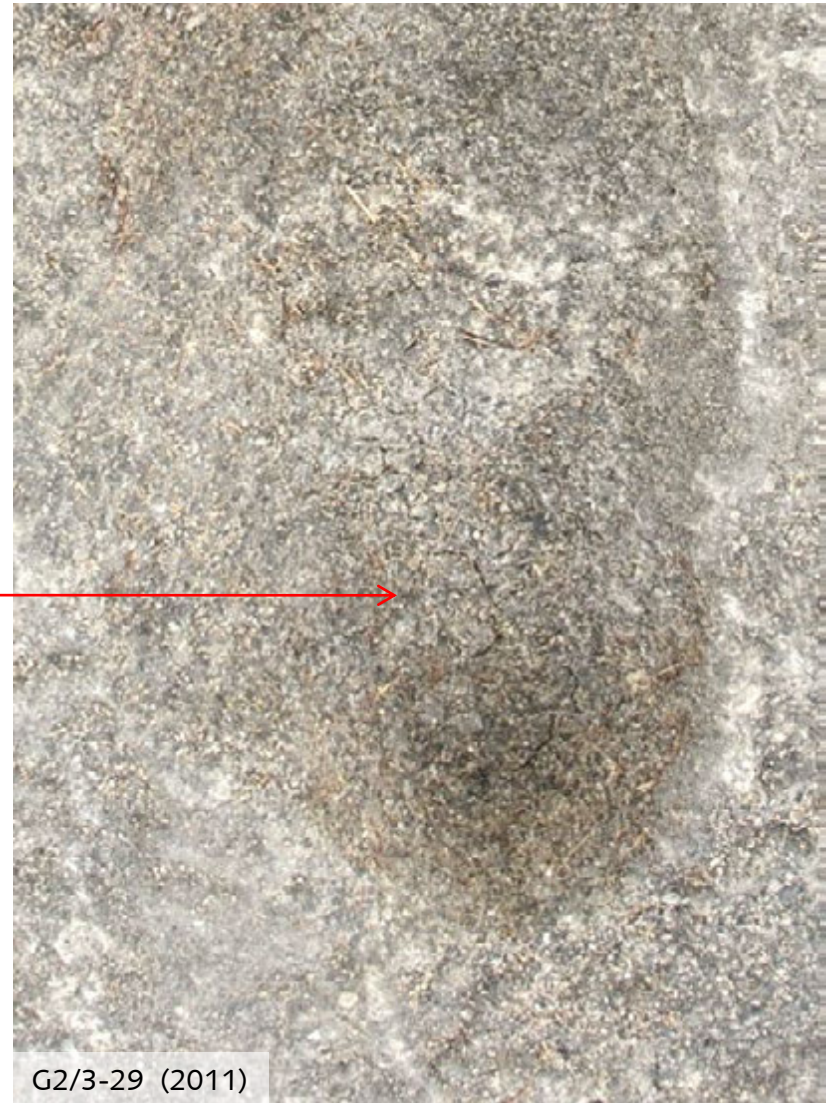
Close-up of heel of G2/3-29 in 1995 and 2011 showing incipient cracking in heel in 1995 slightly enlarged in 2011

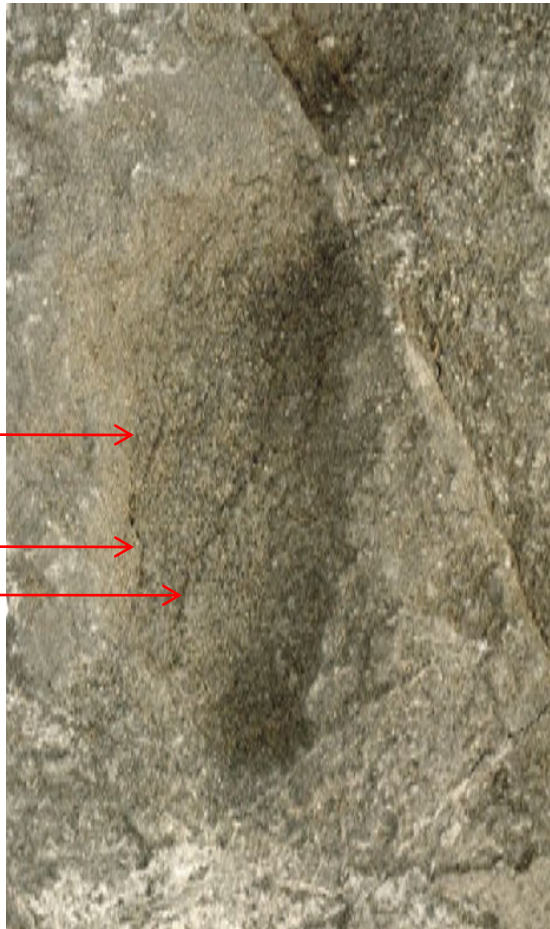
Rootlet in crack →

Cracking on lateral margin and floor →

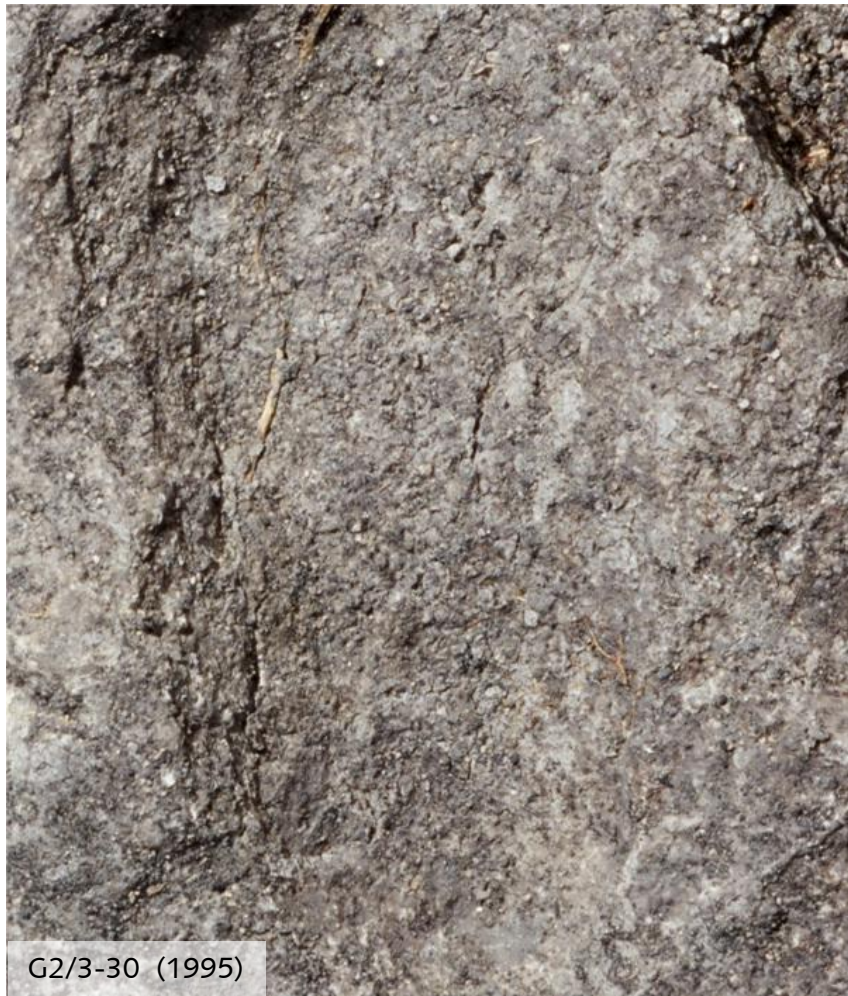
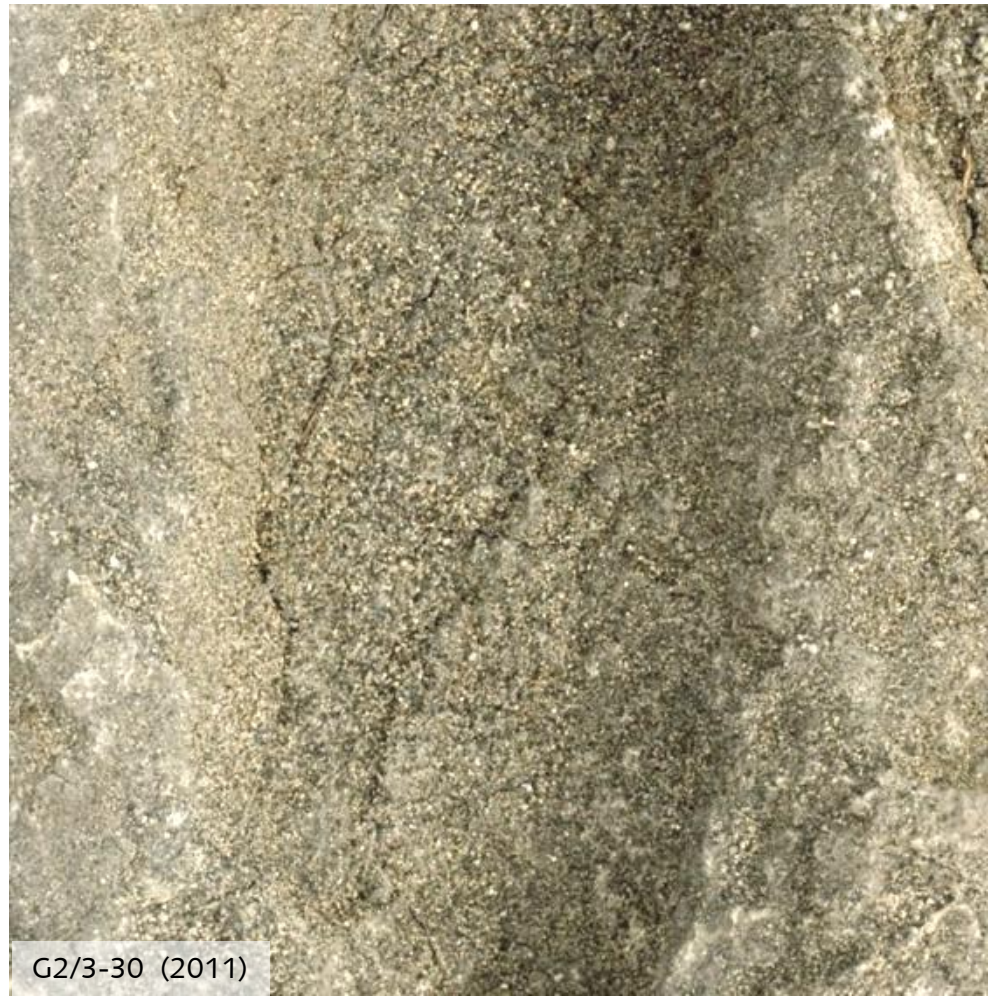
Close-up of G2/3-30 in 1995 and 2011 showing incipient weathering and hairline cracks in 1995 enlarged in 2011

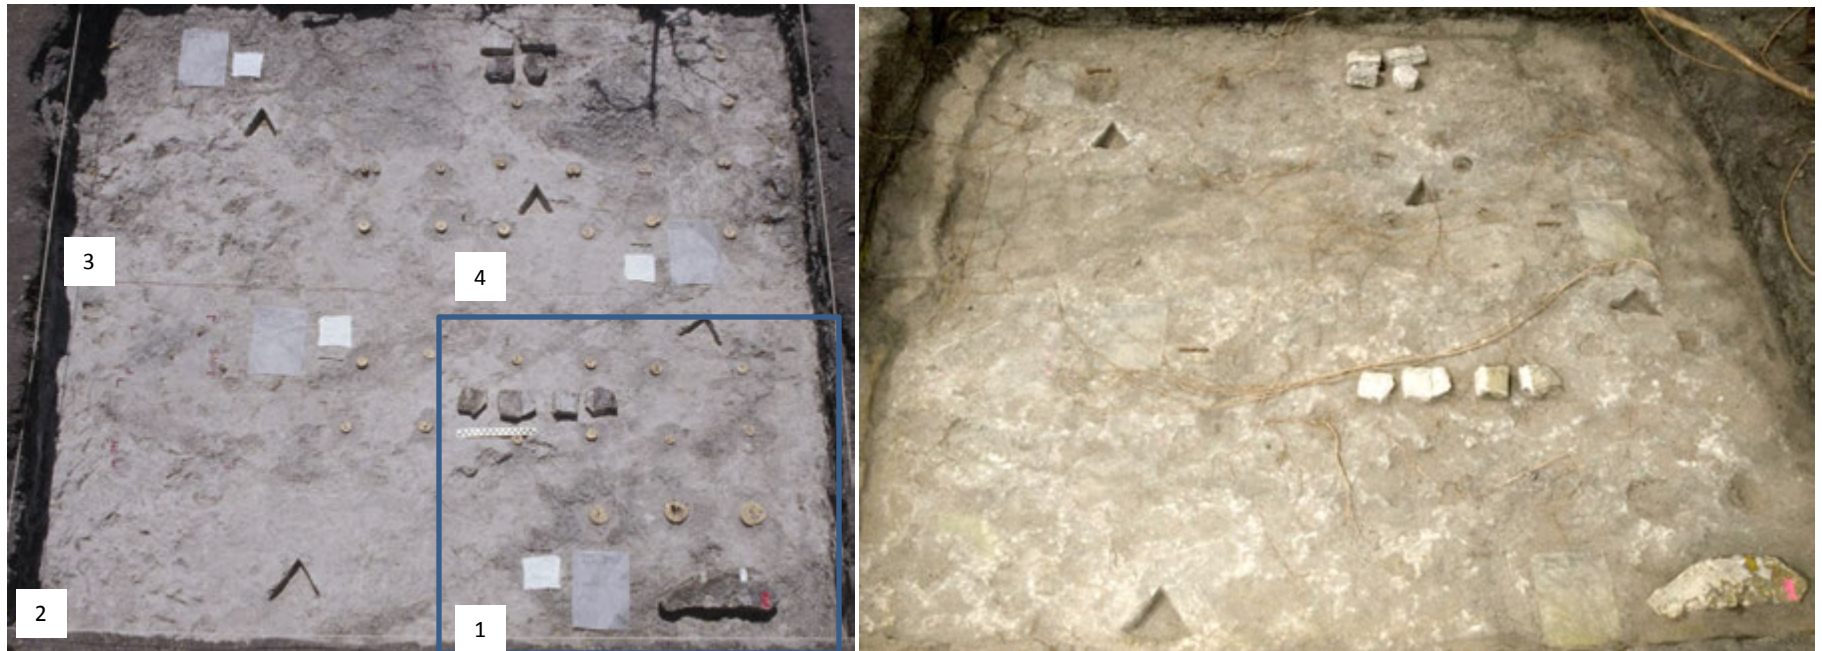
Monitoring trench floor with objects as laid out in 1995 (left) and as re-excavated in 2011 (right). Quadrant 1 (in box left) was excavated in 1997.

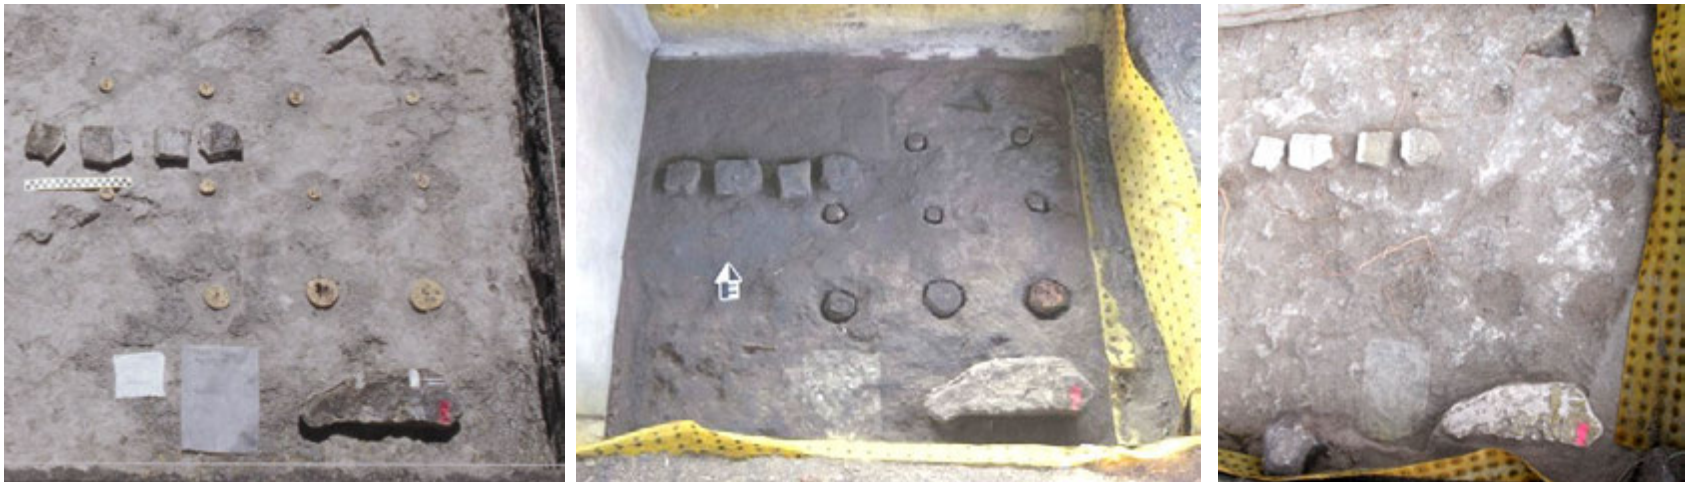
Quadrant 1 as established in 1995 (left), excavated in 1997 (center) and re-excavated in 2011 (right). Weathering and cracking of tuff floor can be seen in the 1995 photo around the geotextile and treated block.
