*Report on the partial re-excavation
of the Laetoli hominid trackway, Site G*

The Getty Conservation Institute

Partial re-excavation of the Laetoli hominid trackway, February 2011

Condition record of Laetoli hominid prints re-excavated in February 2011

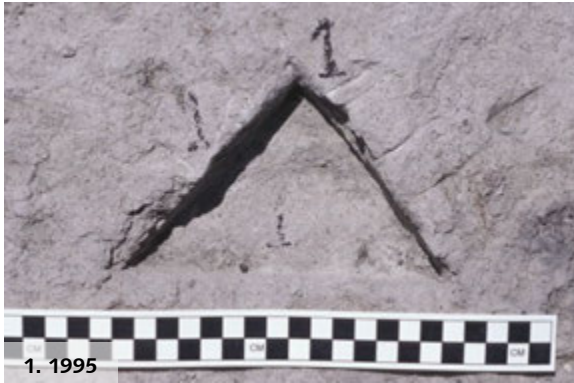
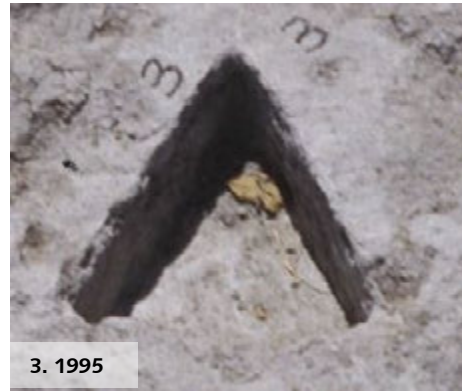
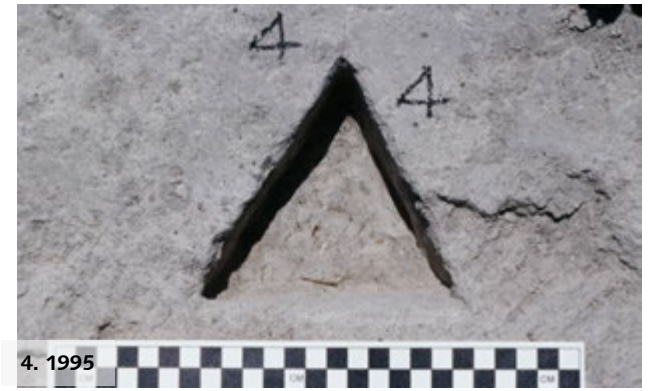
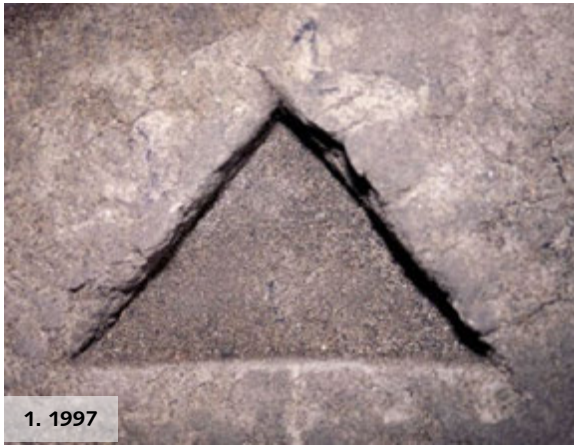
Monitoring triangles 1,3 and 4. Cracking of tuff has increased since 1995. The form, edges and score marks are little changed but obscured by embedding.
