Valley of the Queens Assessment Report

Volume 2

Assessment of 18th, 19th, and 20th Dynasty Tombs

A collaborative project of the Getty Conservation Institute
and the Supreme Council of Antiquities, Egypt

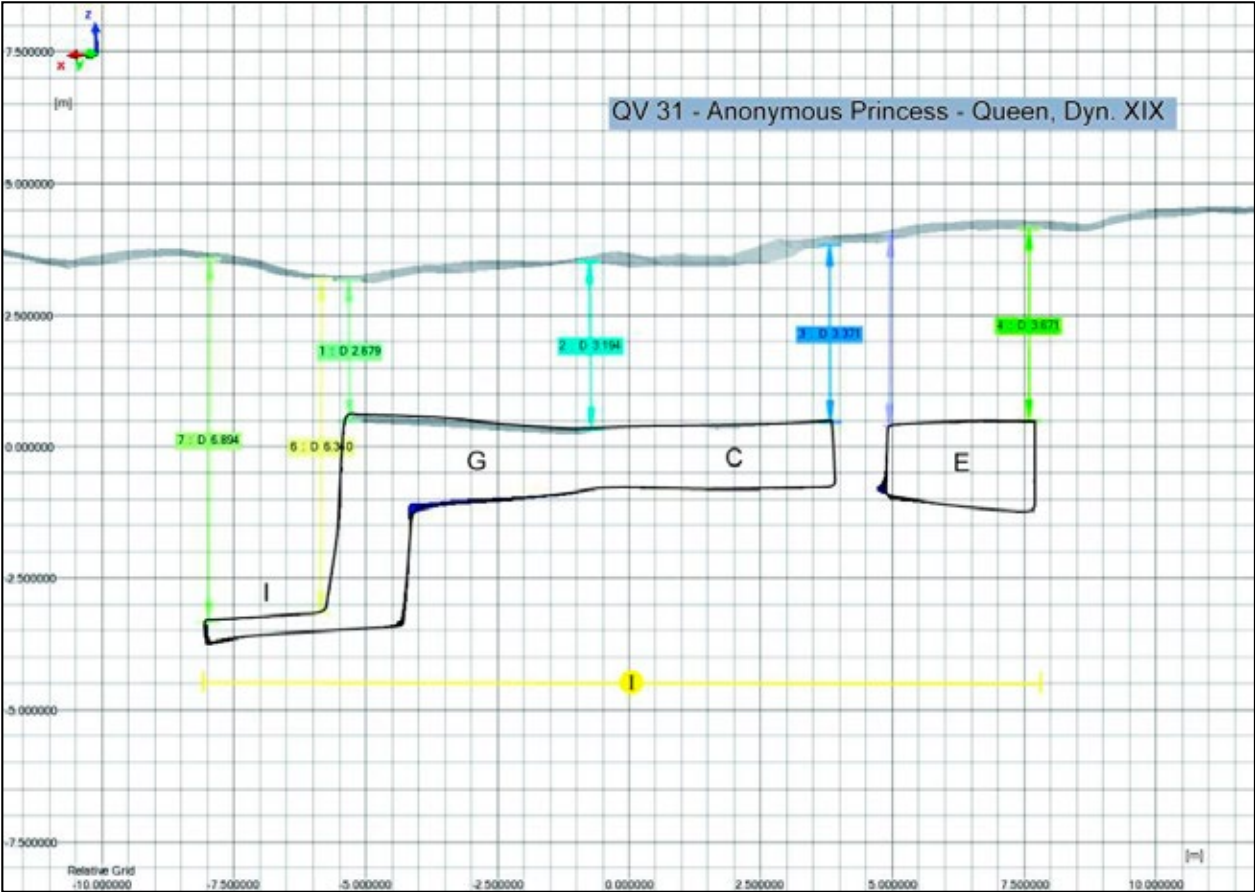
Overburden analysis of tomb reveals no less than 1m of rock thickness between chamber ceilings and exterior rock surface.

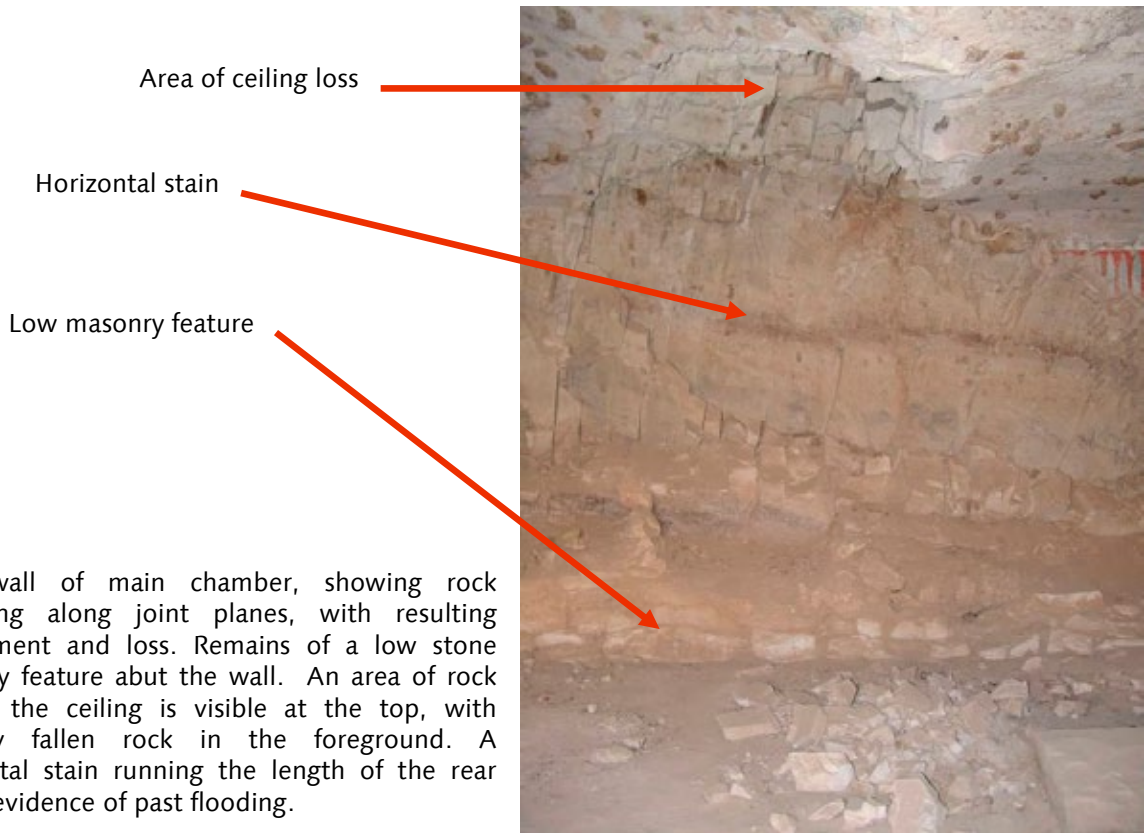
Main chamber (C), view towards doorway (D). Fractures with resulting loss along rear wall of tomb; painting only survives in this chamber along upper portion of wall; a large area of ceiling plaster is also extant (photo 2007).

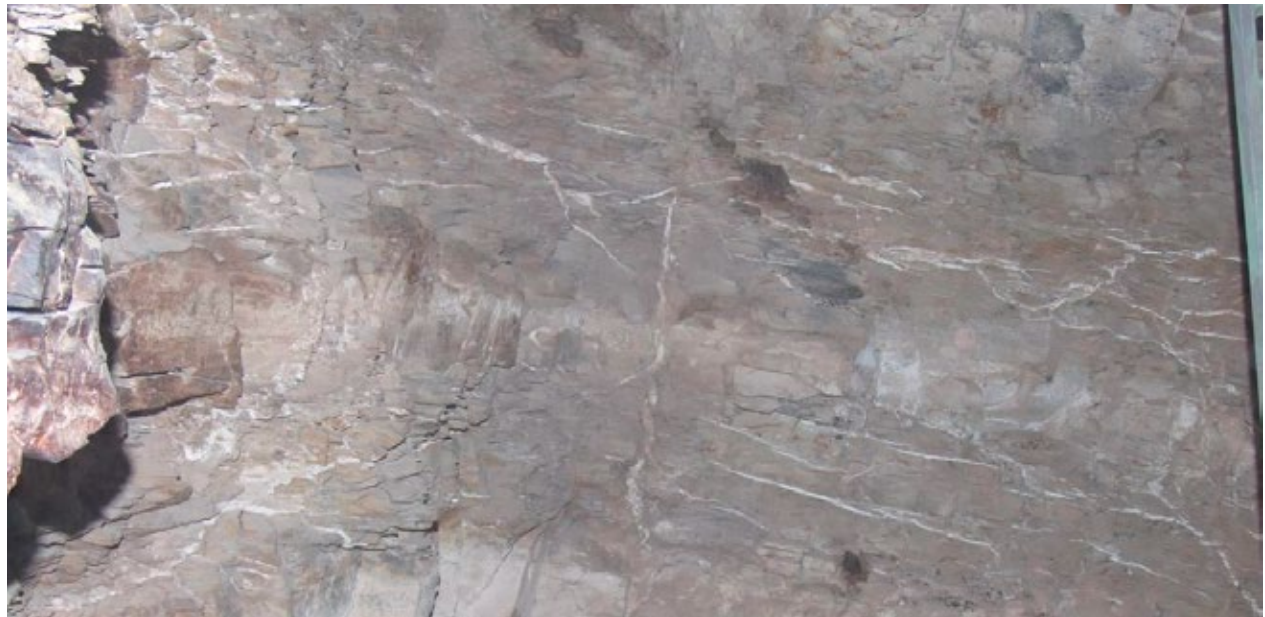
Main chamber ceiling with ongoing rock loss in 2008. Localized efforts to stabilize falling rock are evident to the left of the photo. The original ceiling level lies behind the pictured hand and has extant plaster with possible dung inclusions.

Lower chamber (I) is excavated into a shale bed, characterized by the rock color, its many salt veins, and fractured nature.

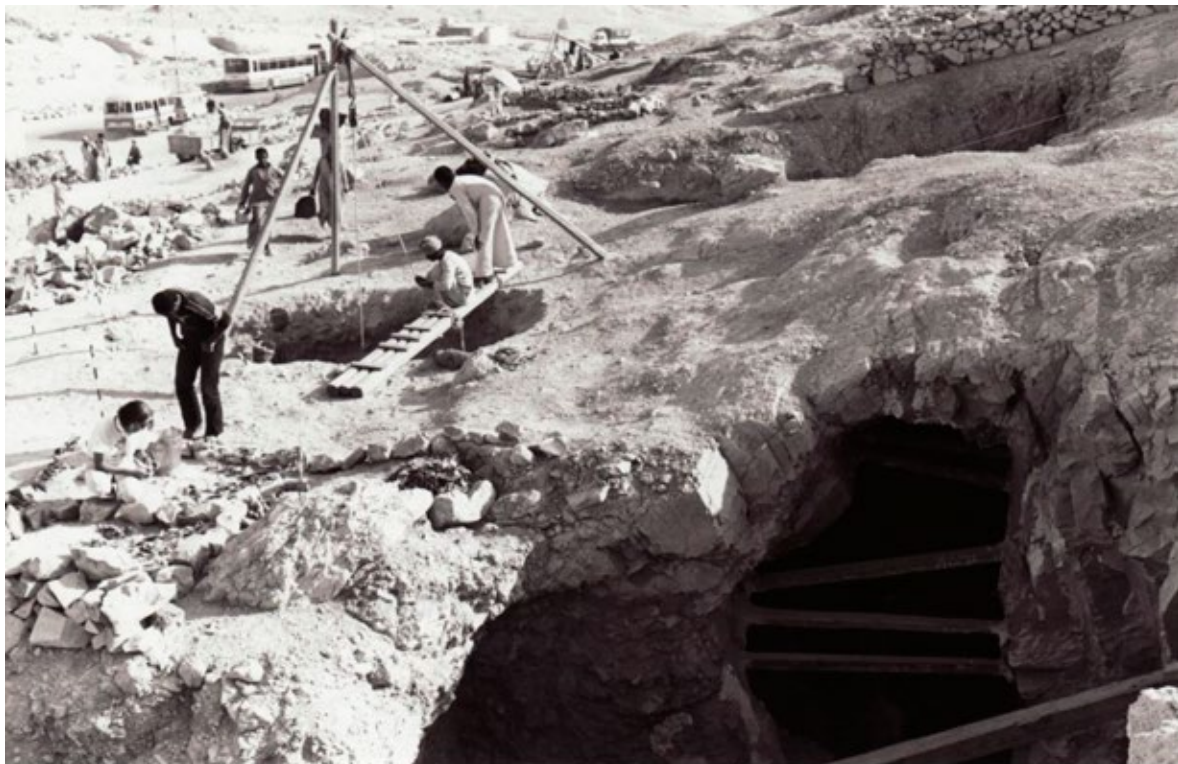
Excavations around QV 34 in 1987. QV 34 is in foreground with shoring visible and very shallow overburden that has collapsed over much of the tomb (Image: CNRS).

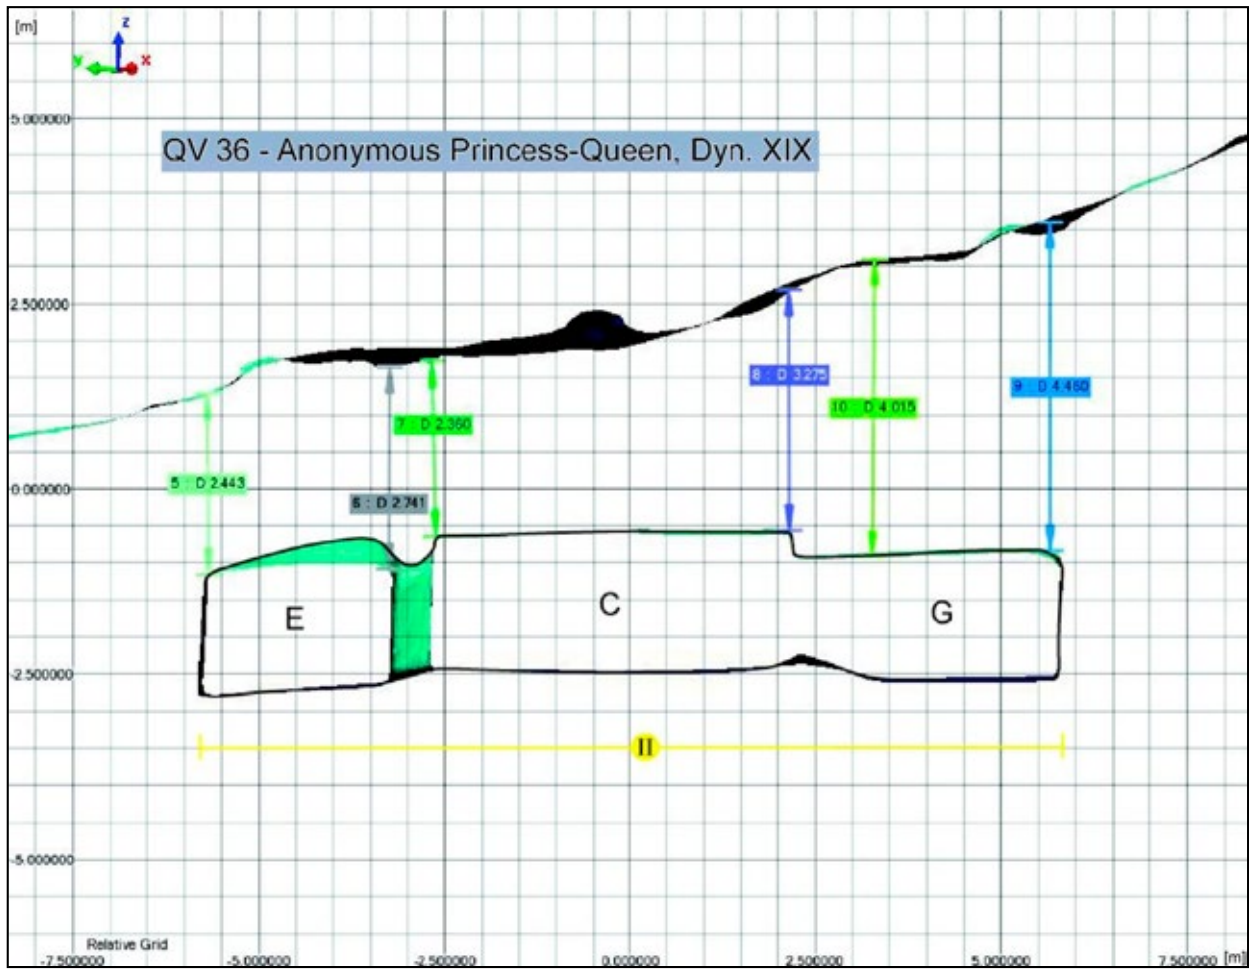
Overburden analysis showing cross-section through tomb. Note that this schematic does not include the large open fracture with substantial wedge-shaped rock loss in the ceiling of chamber (C), which is only about one meter from the surface.

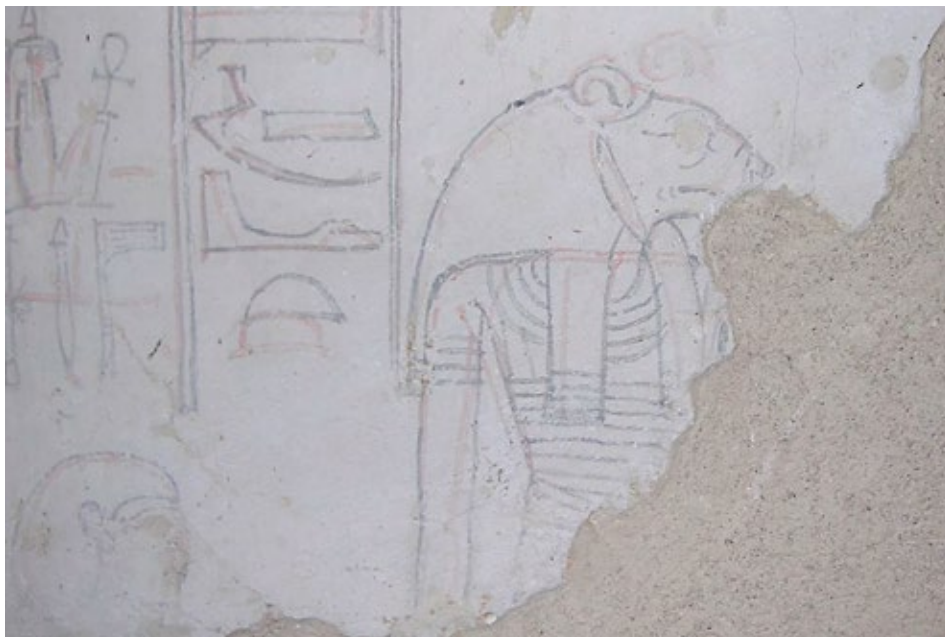
Same area on the north wall, west side of chamber (C) taken in 2006 indicating that the repaired areas have remained stable.

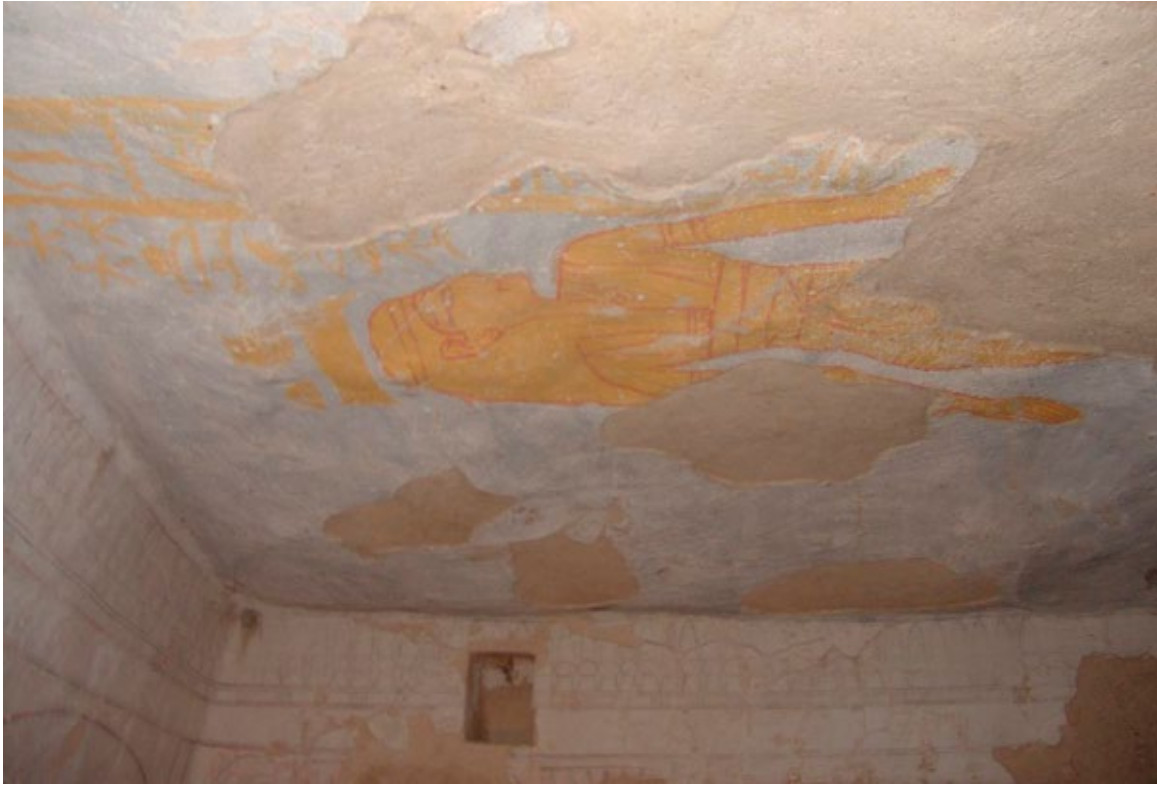
Crack has reopened where a previous plaster repair existed.

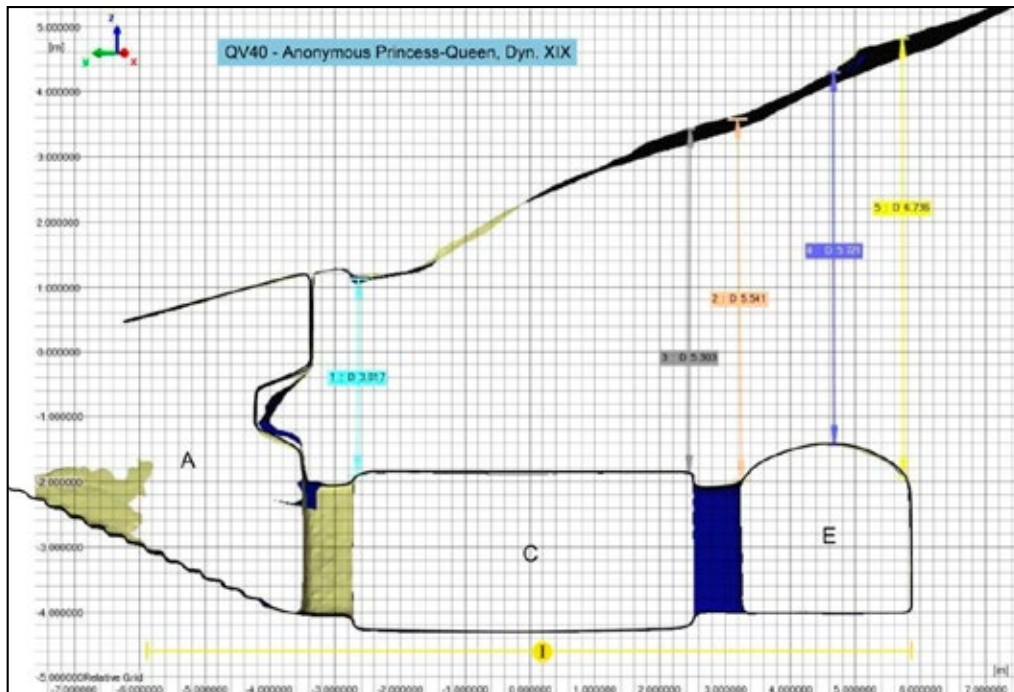
Overburden section of QV 40 shows the thickness ranging from 3m above the antechamber (C) to 5.7m above the burial chamber (E).

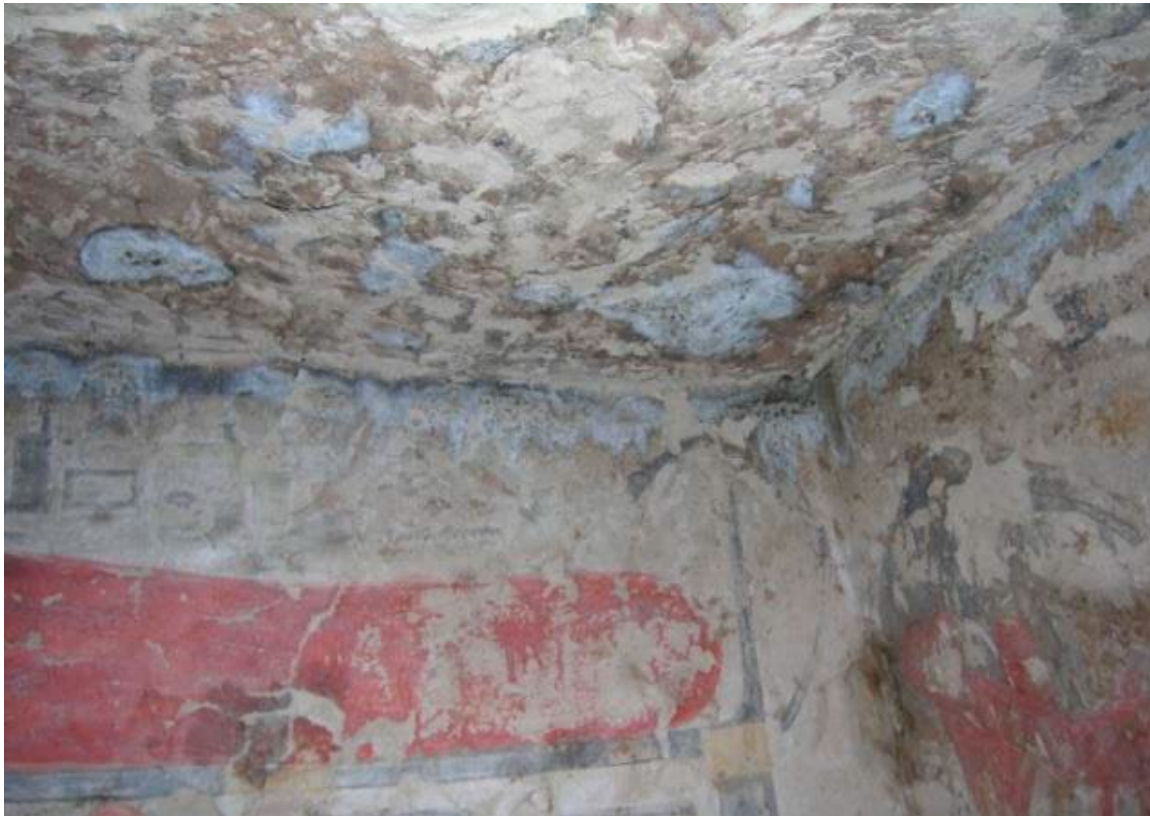
Evidence of bats on the upper part of walls and ceilings in the side chamber (G), in the form of crystalline deposits (salt residues) and staining. The problem is already evident in the 1973 CEDAE photographs (right).

White crystalline deposits on ceiling of Chamber (G) indicate considerable past bat activity in this tomb.

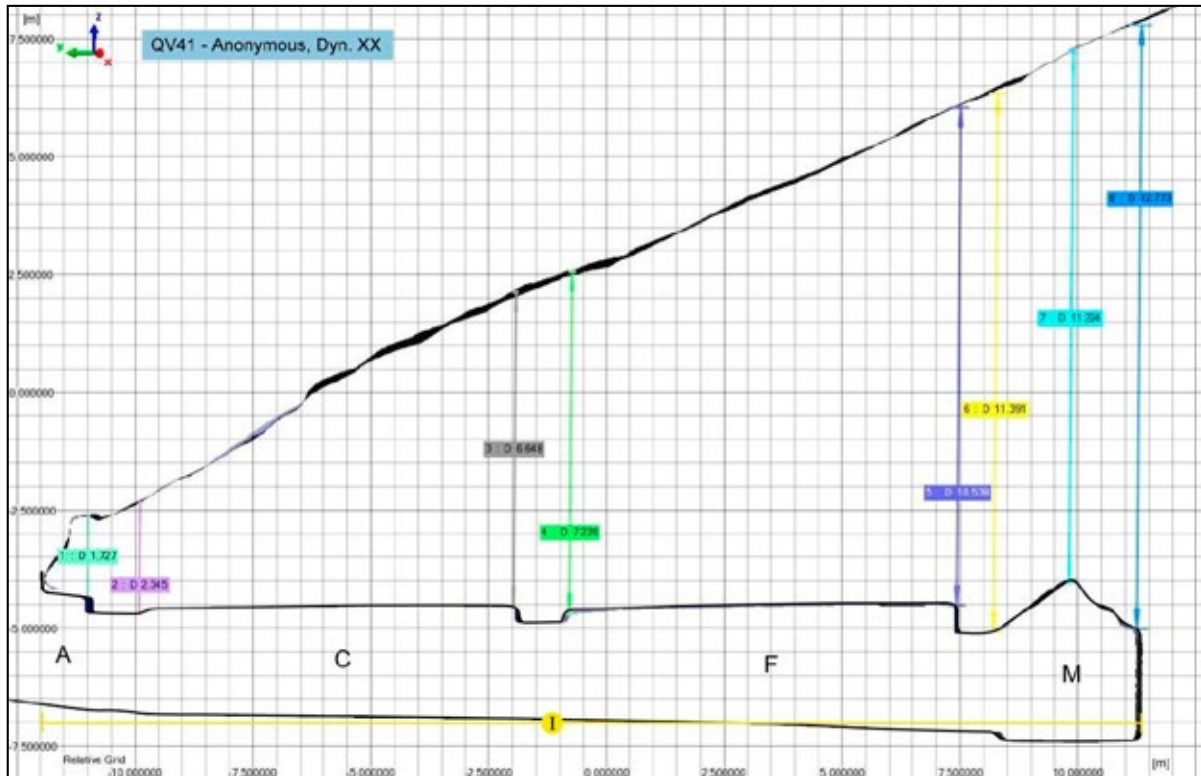
Overburden analysis of QV 41 showing the tomb is cut through at 2.3m at entrance (B) to 12.7m at the chamber (M) and below the bedrock.

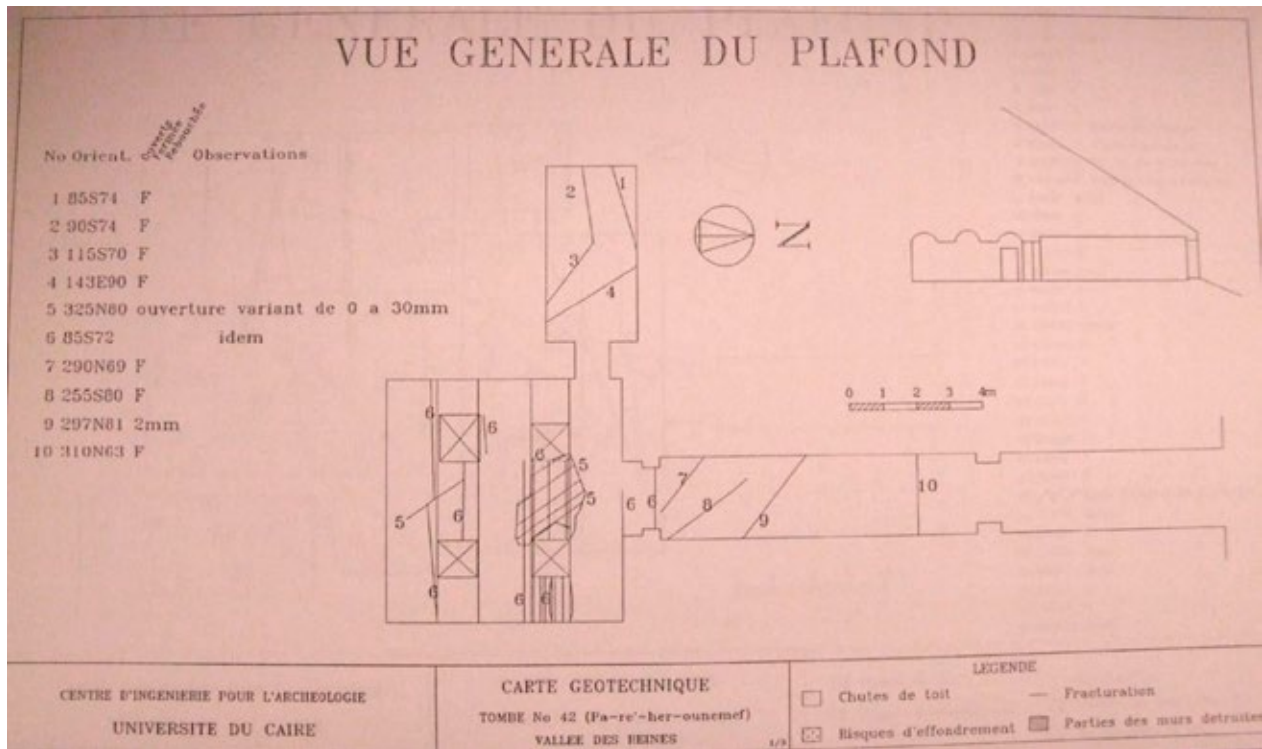
Geotechnical analysis conducted in 1993 by University of Cairo. The principal area of concern is indicated as the ceiling rock between pillars I and III (CNRS).

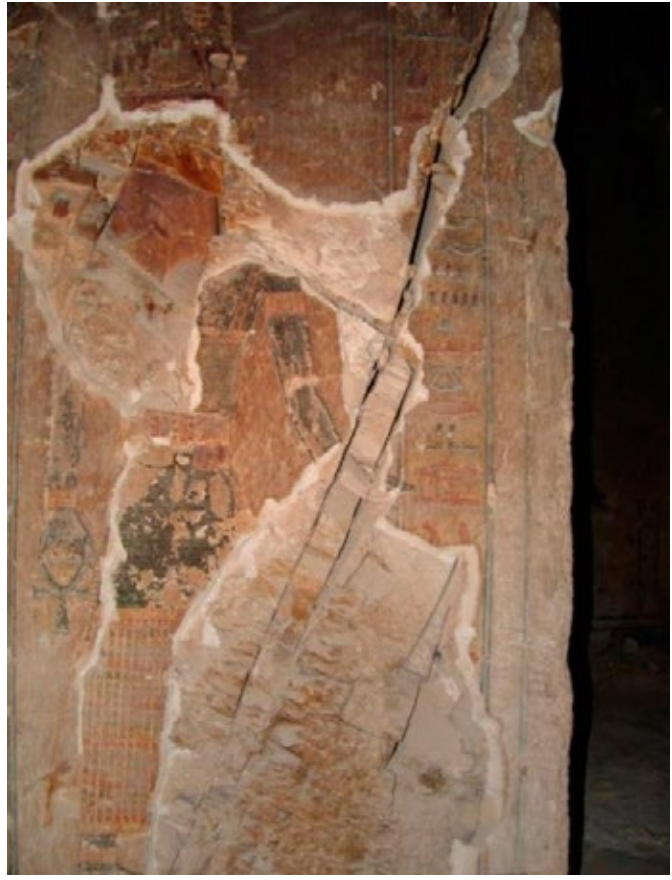
West face of pillar IV showing recent (likely 1989-91) edging repairs of wall paintings, but no change in rock fracture since 1977.

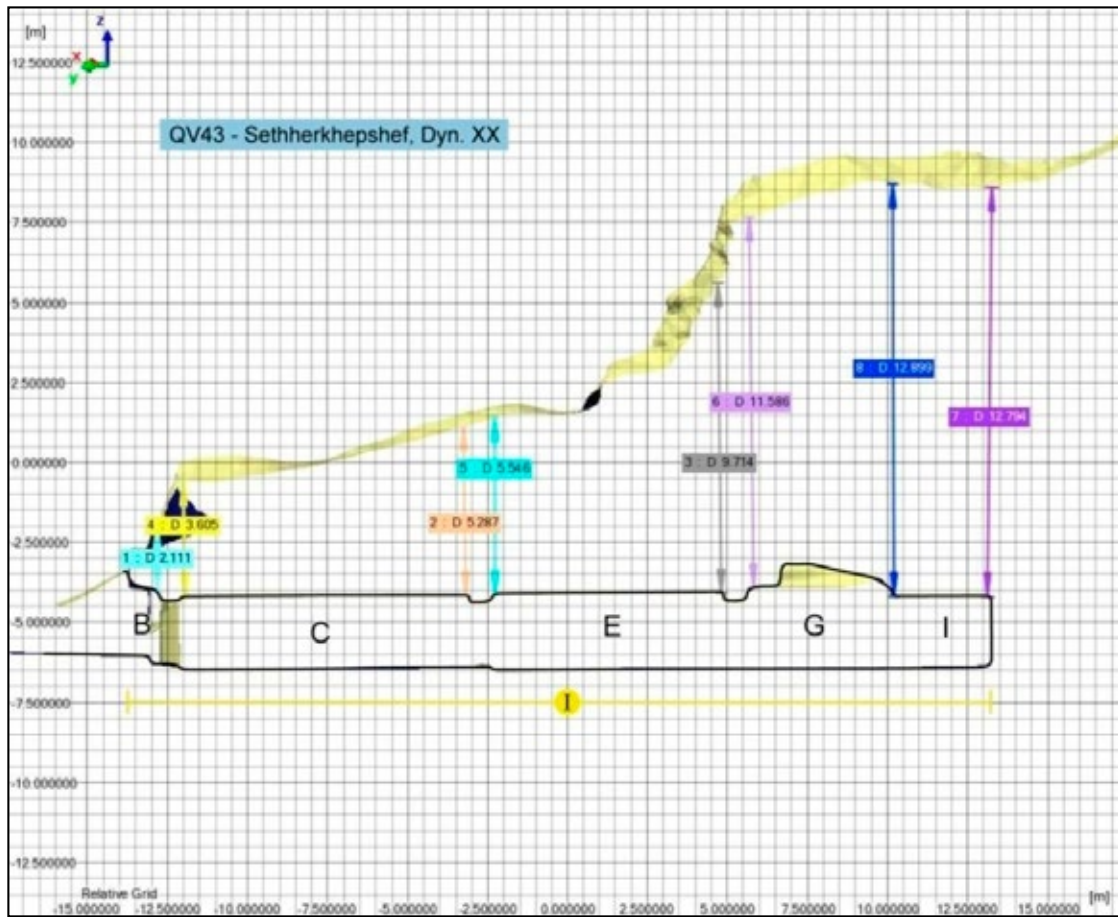
Overburden section of QV 43 showing rock thickness ranges from 2.1m at entrance (B) to 12.8m at rear chamber (I). Tomb has little inclination as is typical in 20th Dynasty tombs.

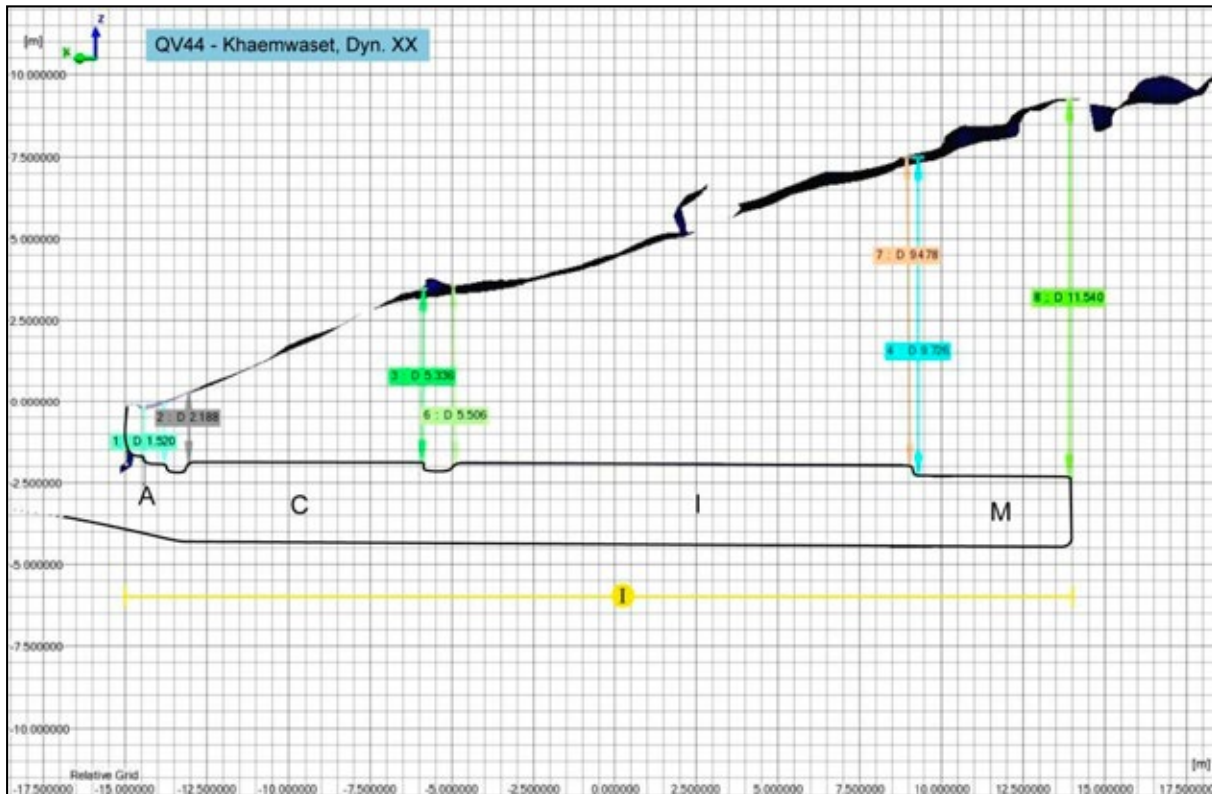
Overburden analysis of QV 44 showing the tomb lies between 2.1m at entrance (B) and 11.5m at rear chamber (M).

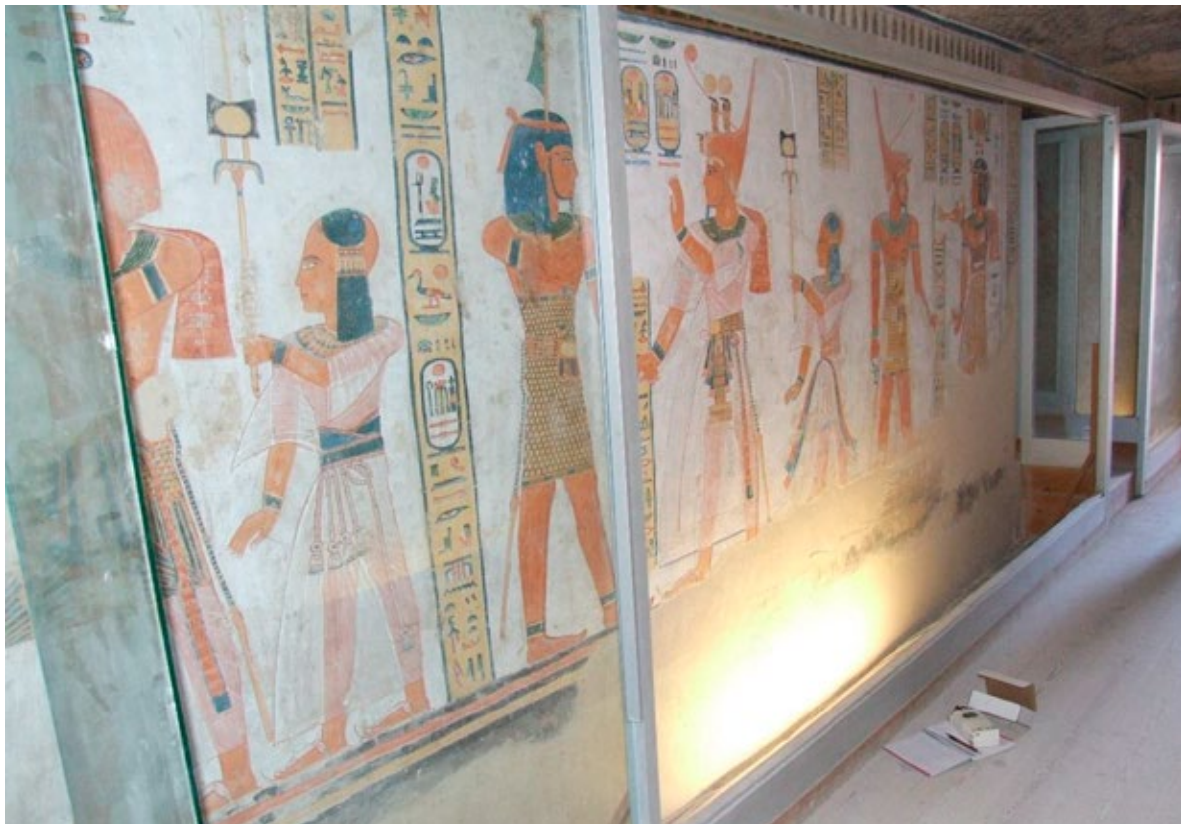
Panel of glass missing in first chamber corridor (C) (above and right), leaving the paintings unprotected.

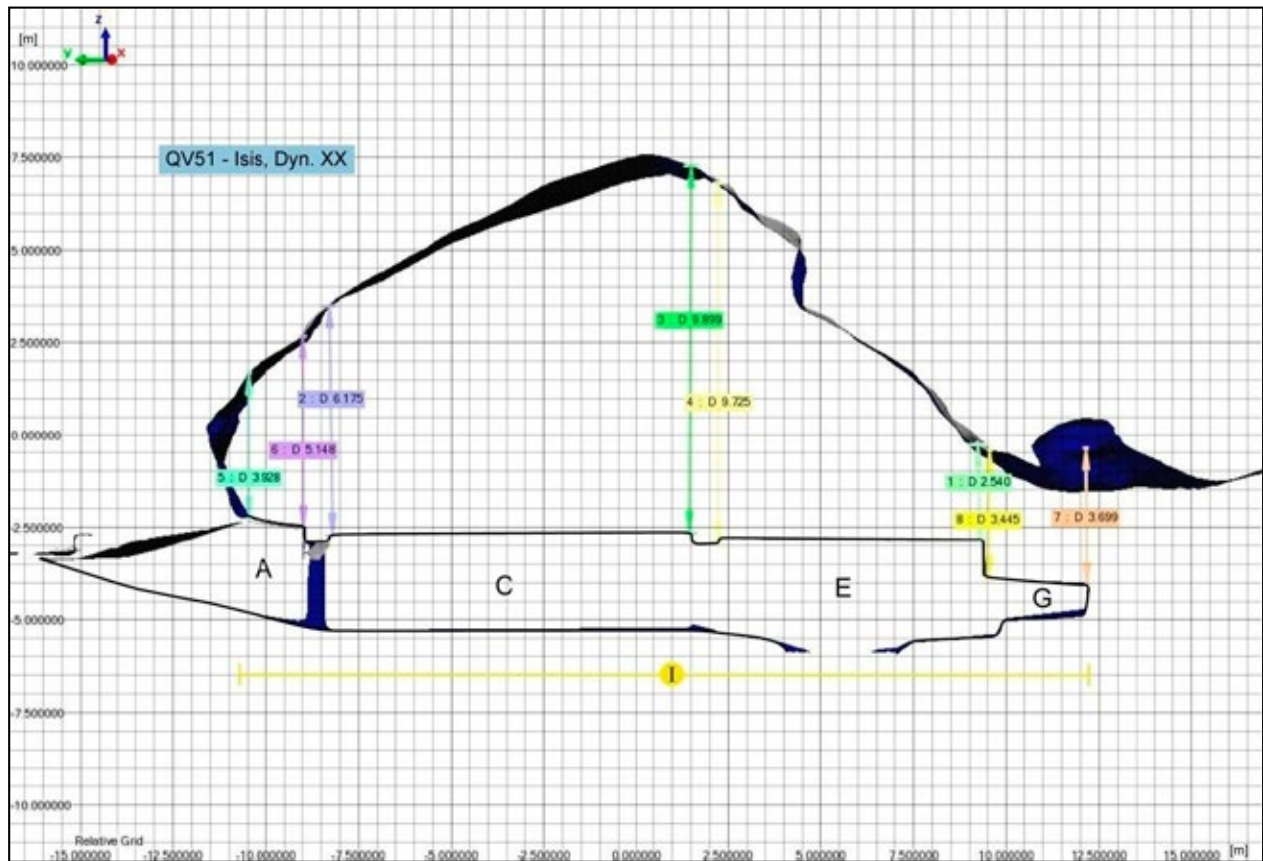
Overburden analysis of QV 51, showing that the thickness of rock ranges between 2.5m at the end of chamber (E) and 9.8m at doorway (D).

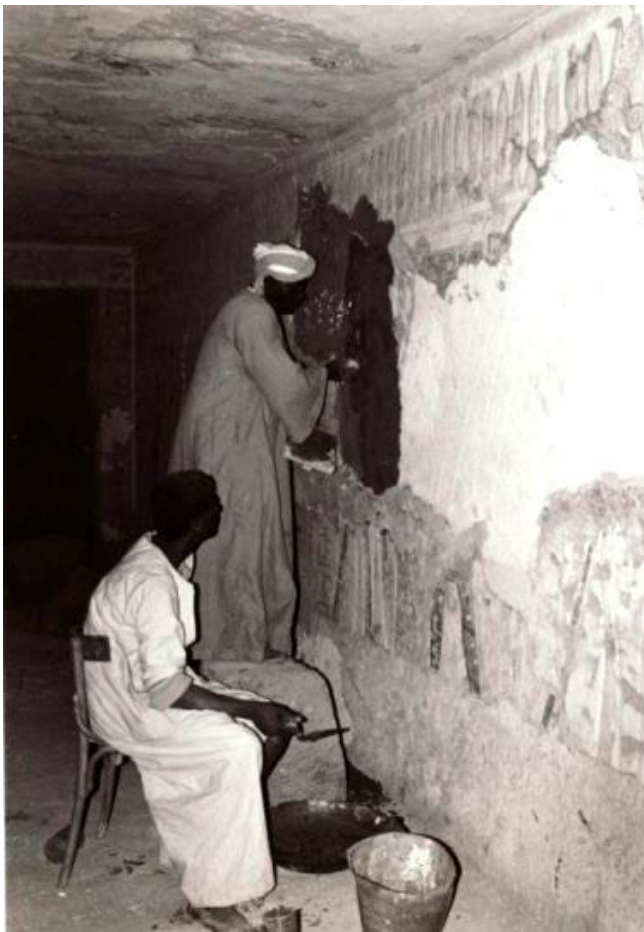
A large repair plaster being undertaken in corridor (C) in 1988 by the EAO (Image: CNRS); right, same area in 2006.

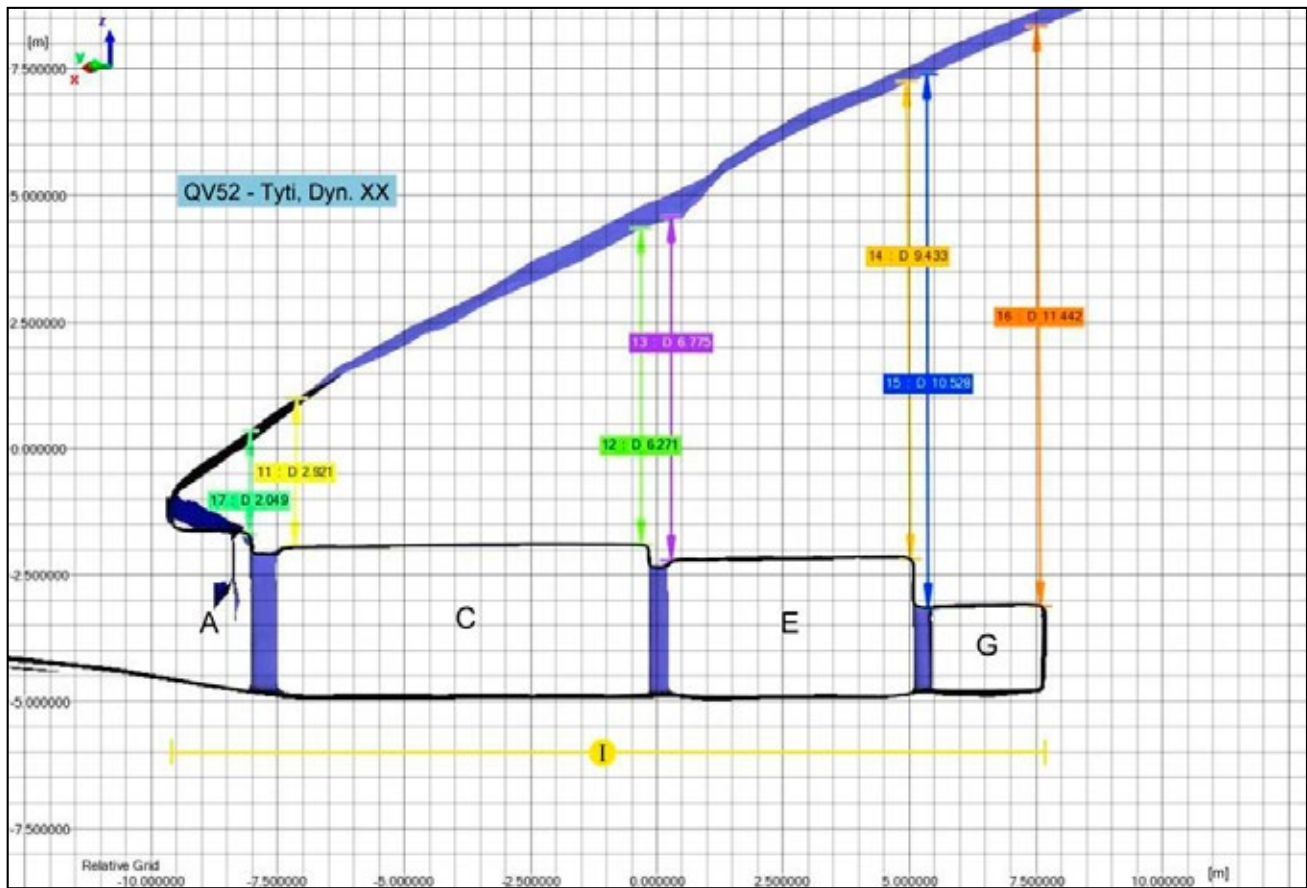
Overburden analysis of QV 52 showing that the rock thickness varies from 2.0m at doorway (B) to 11.4m at rear chamber (G).

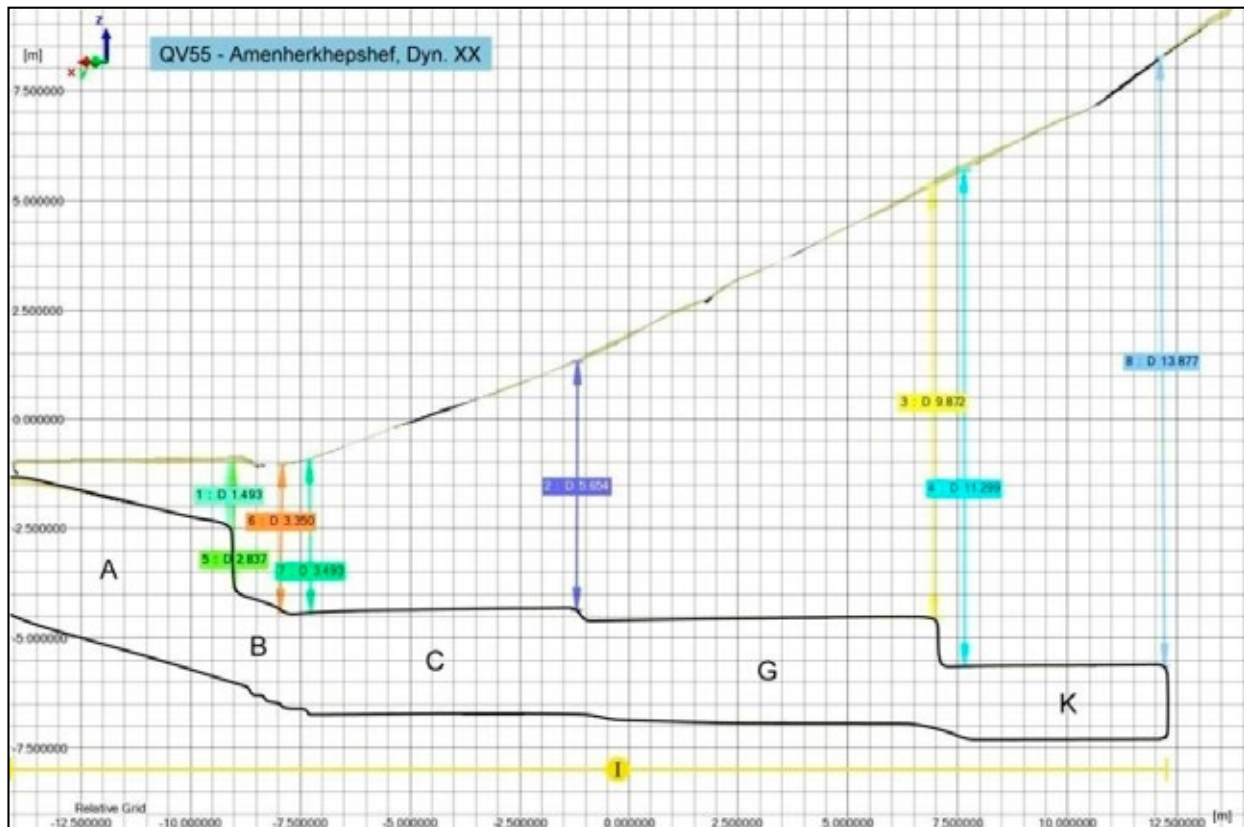
Overburden analysis of QV 55 illustrates the thickness ranges from 1.5m at entrance (A) to 13.9m at rear chamber (K)

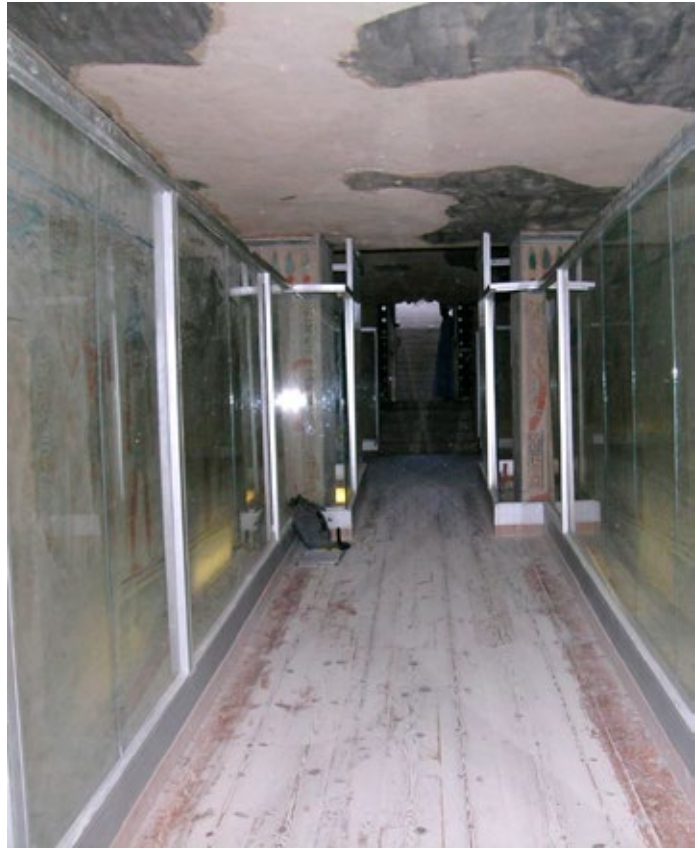
The ceiling losses have been filled with a modern repair plaster.

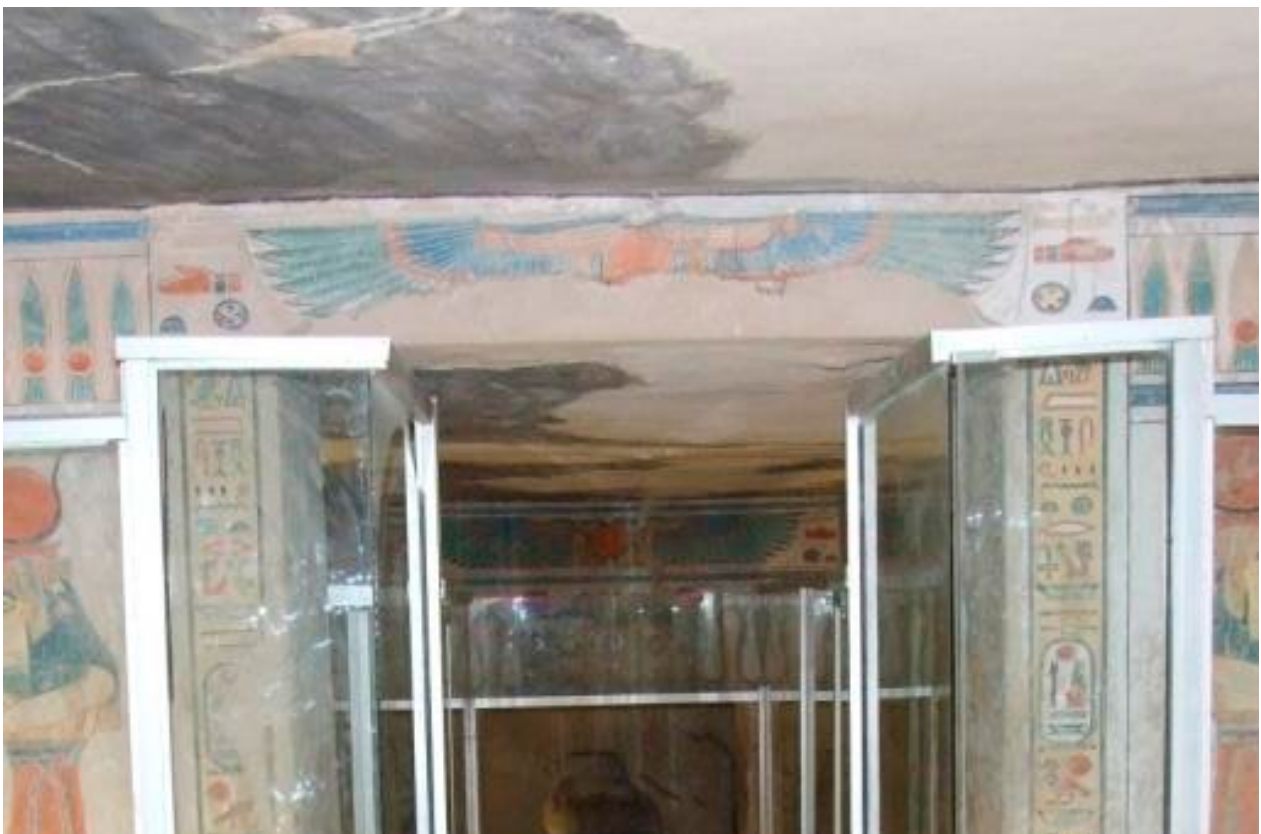
Lintel at doorway (F) is unprotected.

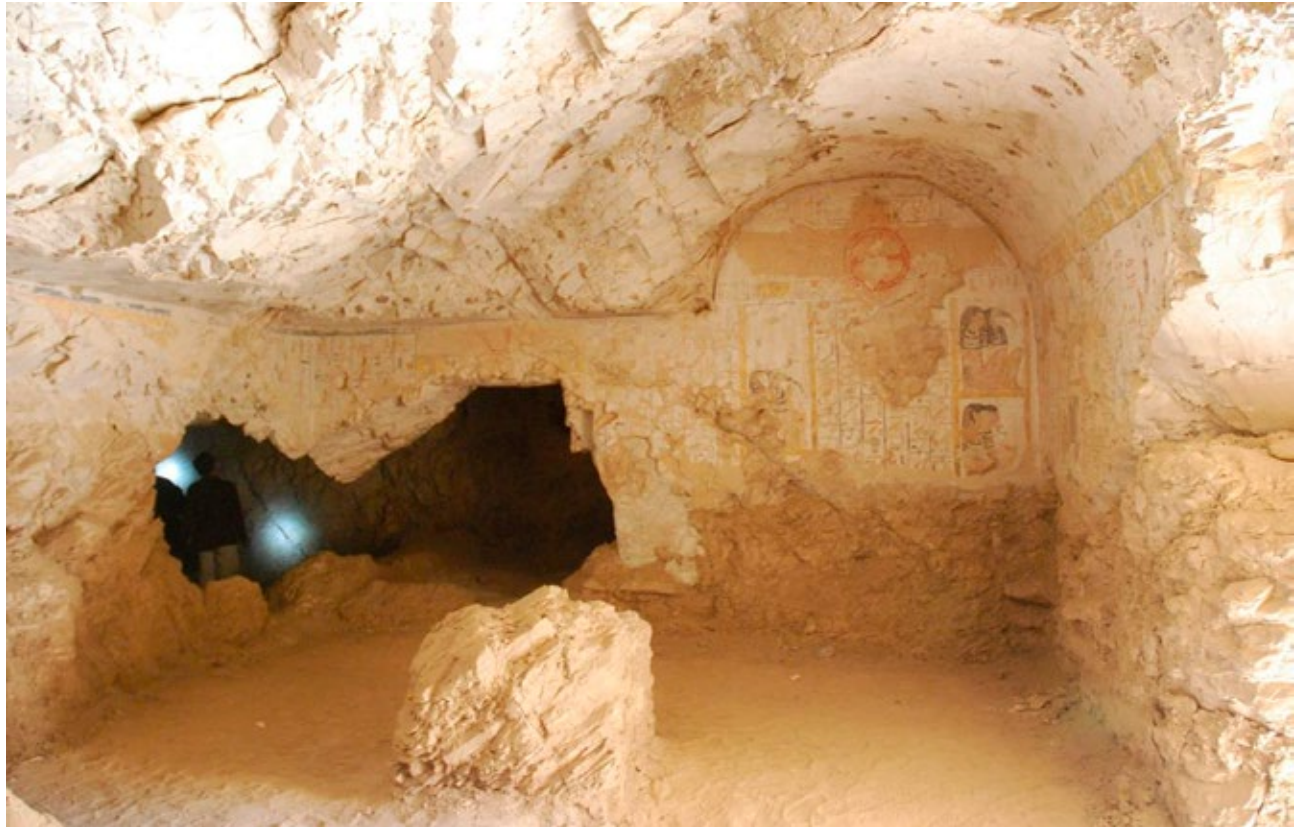
View of main chamber (C), east wall, with partial pillar, basal wall deterioration, ceiling loss, and rock fracturing.

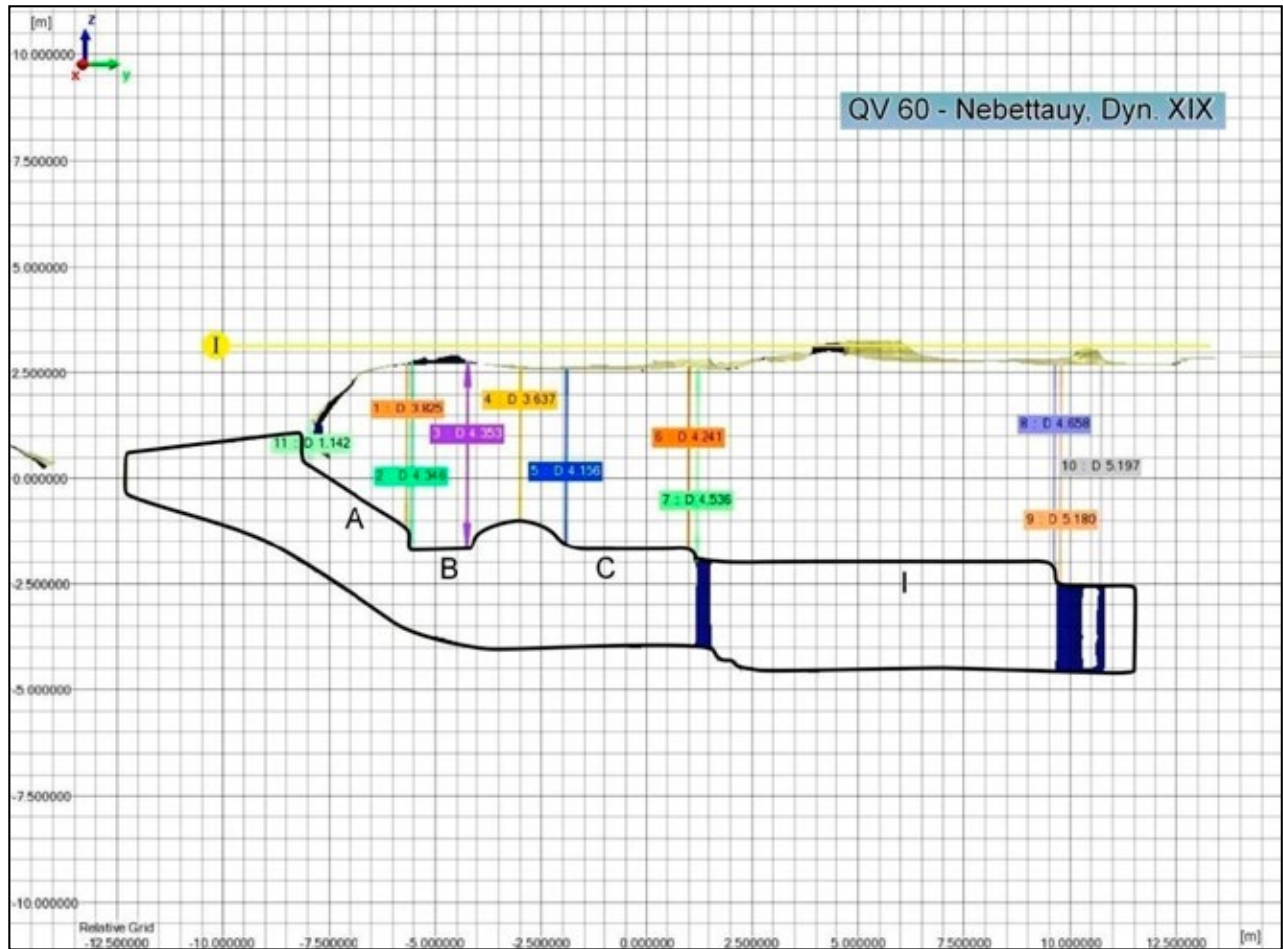
Overburden analysis reveals a rock thickness of over 3m throughout tomb.
