Valley of the Queens Assessment Report

Volume 2

Assessment of 18th, 19th, and 20th Dynasty Tombs

A collaborative project of the Getty Conservation Institute
and the Supreme Council of Antiquities, Egypt

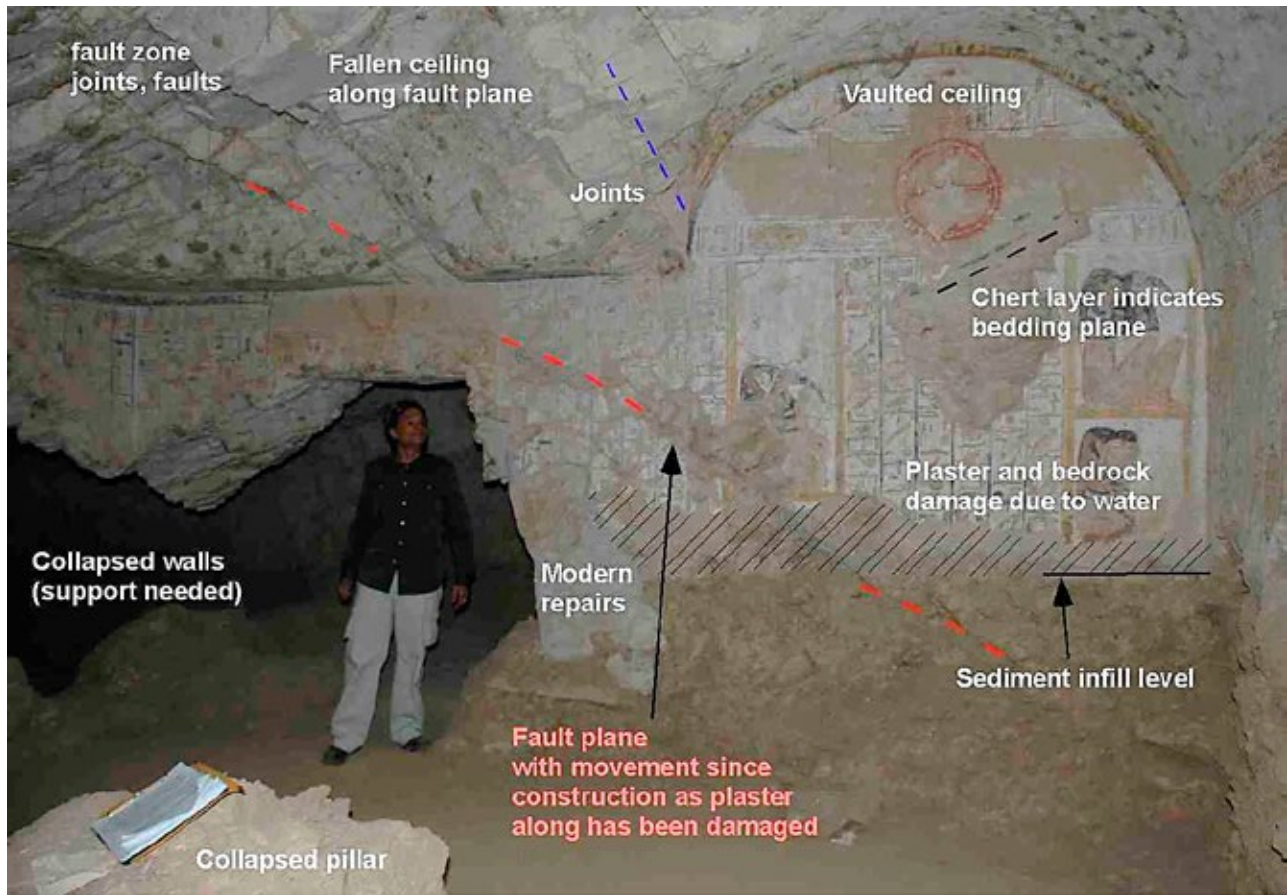
East wall of chamber (C) shows major structural and sedimentary damages, such as plaster deterioration due to sediment infill, floodwater and fault zones. Fault zones and open joint plane contribute to ceiling and wall collapse.

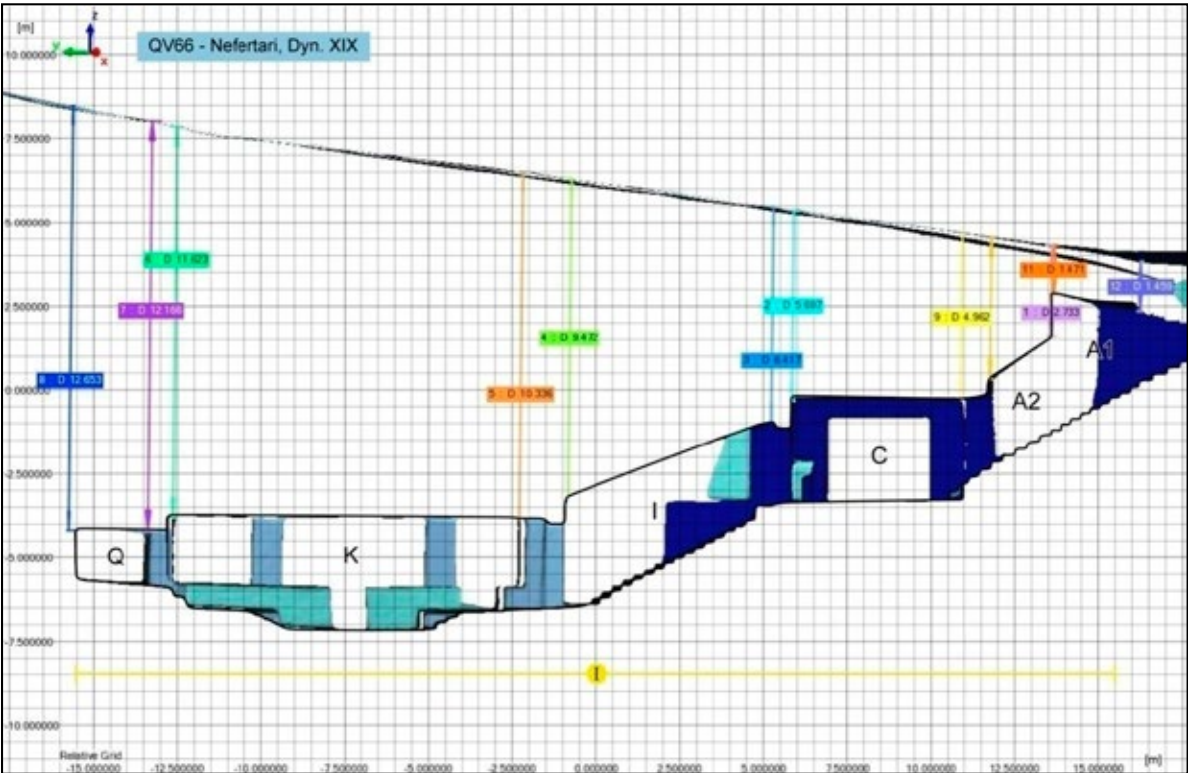
Overburden analysis shows the thickness ranges from 4.96m above chamber (C) to 11.6 meter above burial chamber (K)

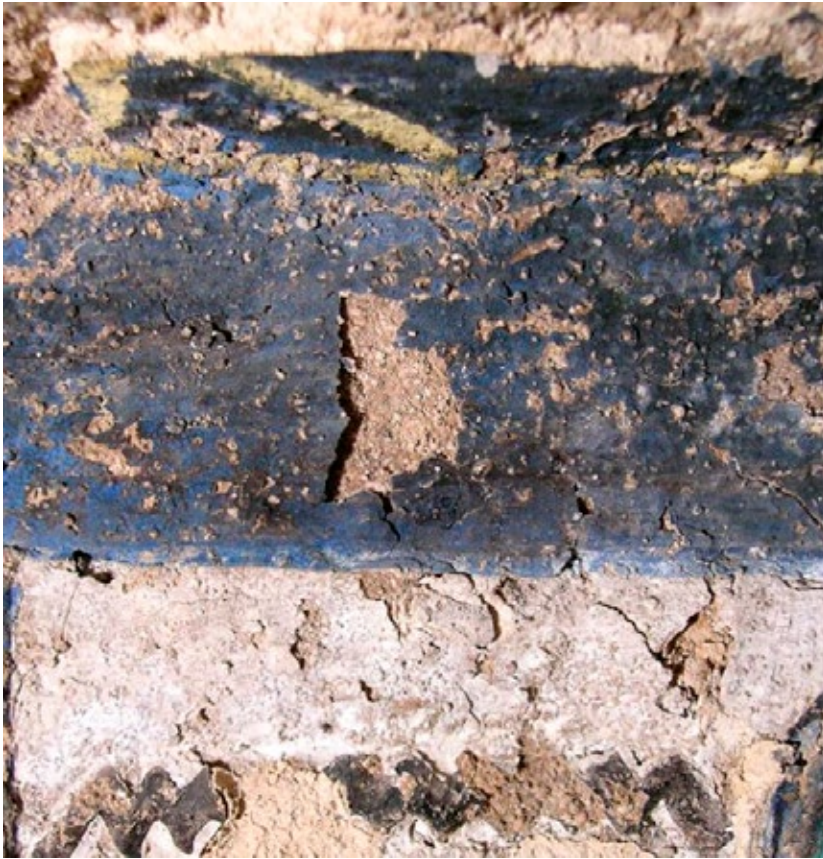
Detail of severe salt-related deterioration on the south wall of chamber (O). Although in a fragile condition, monitoring of such areas has indicated little or no change since 1997.

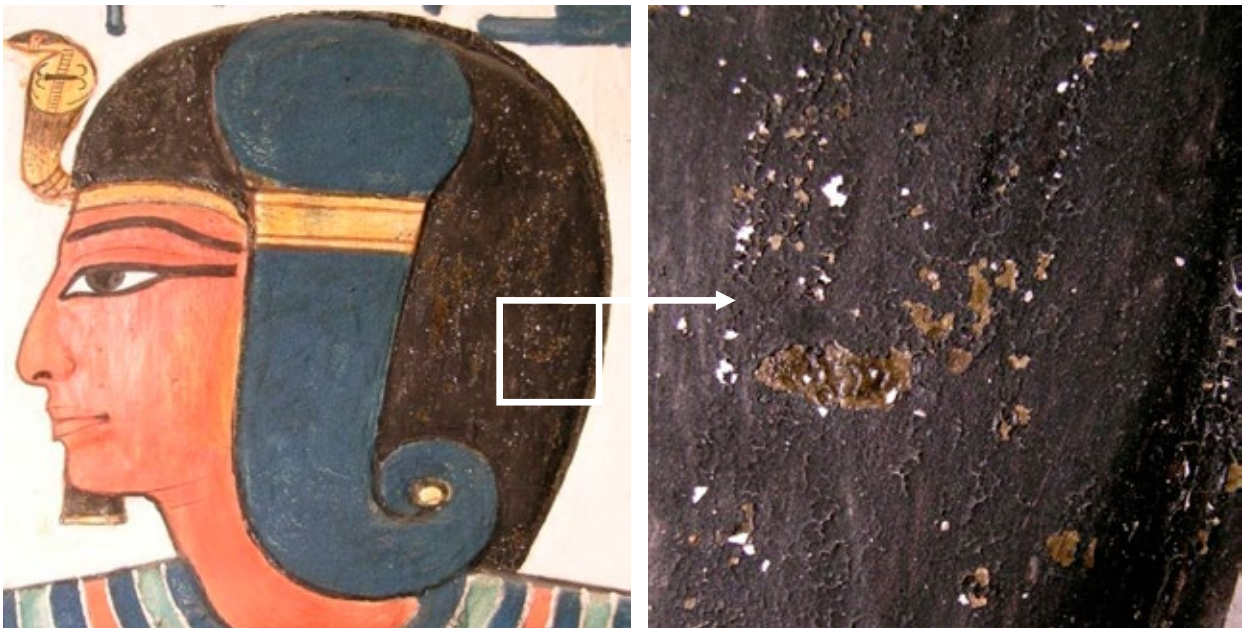
Paint flaking related to the inherent susceptibility of the original painting technique, such as the black on the wig of the figure on the south face of pillar II in chamber (K), does not present a serious risk but should be monitored.

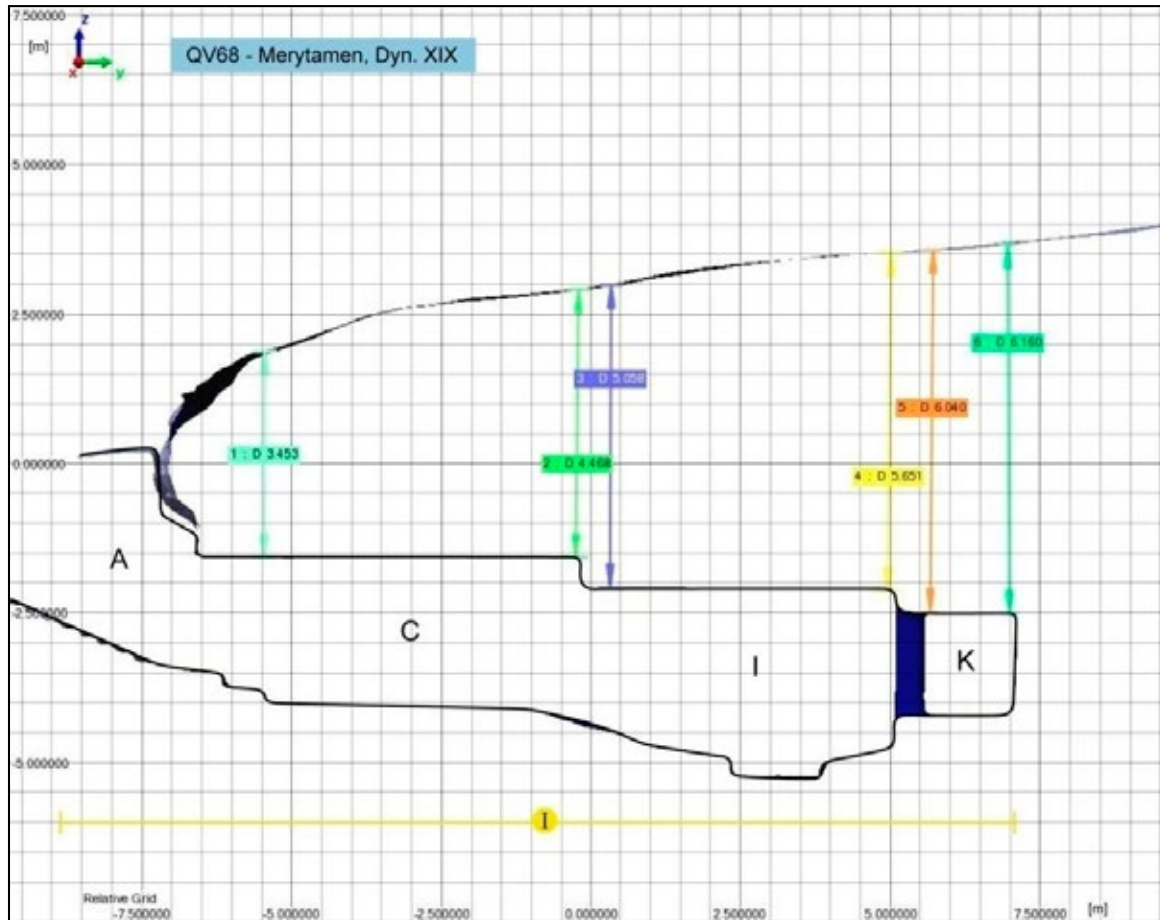
Schematic of overburden analysis of QV 68. The thickness ranges from 3.4m to 6.1m.

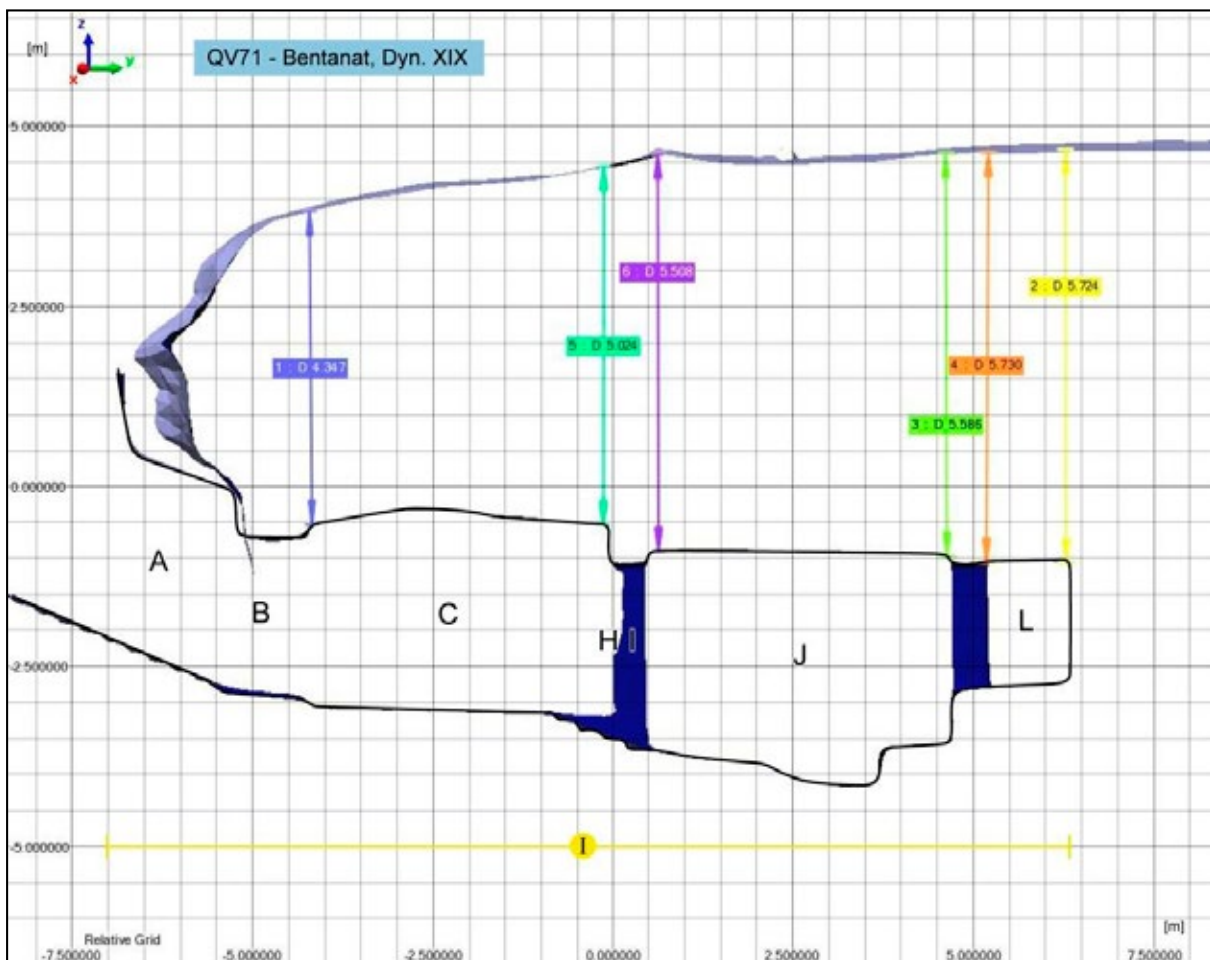
Schematic section shows overburden of QV 71. Rock thickness ranges from 4.3m at entrance (B) to 5.7m at niche (L).

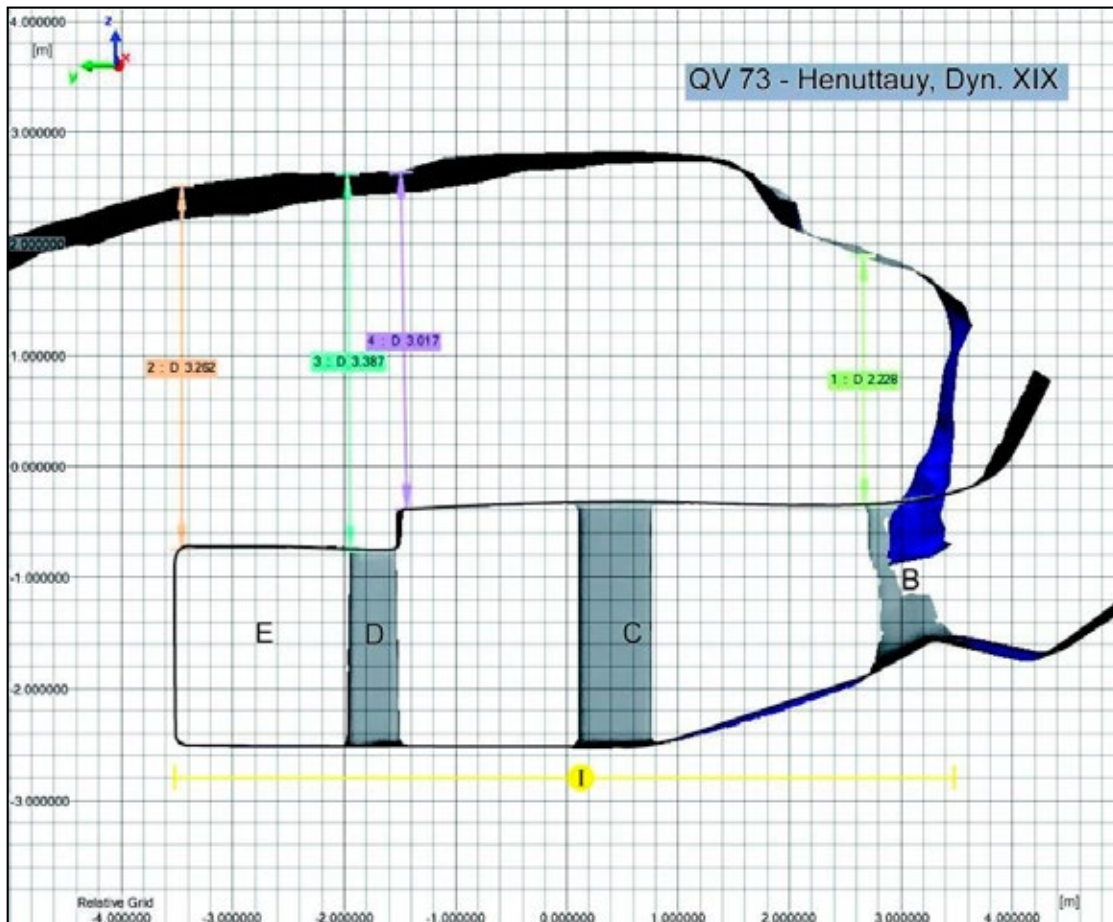
Overburden analysis reveals only about 2m of heavily weathered marl and partially cemented debris fan overlying major ceiling fracture.

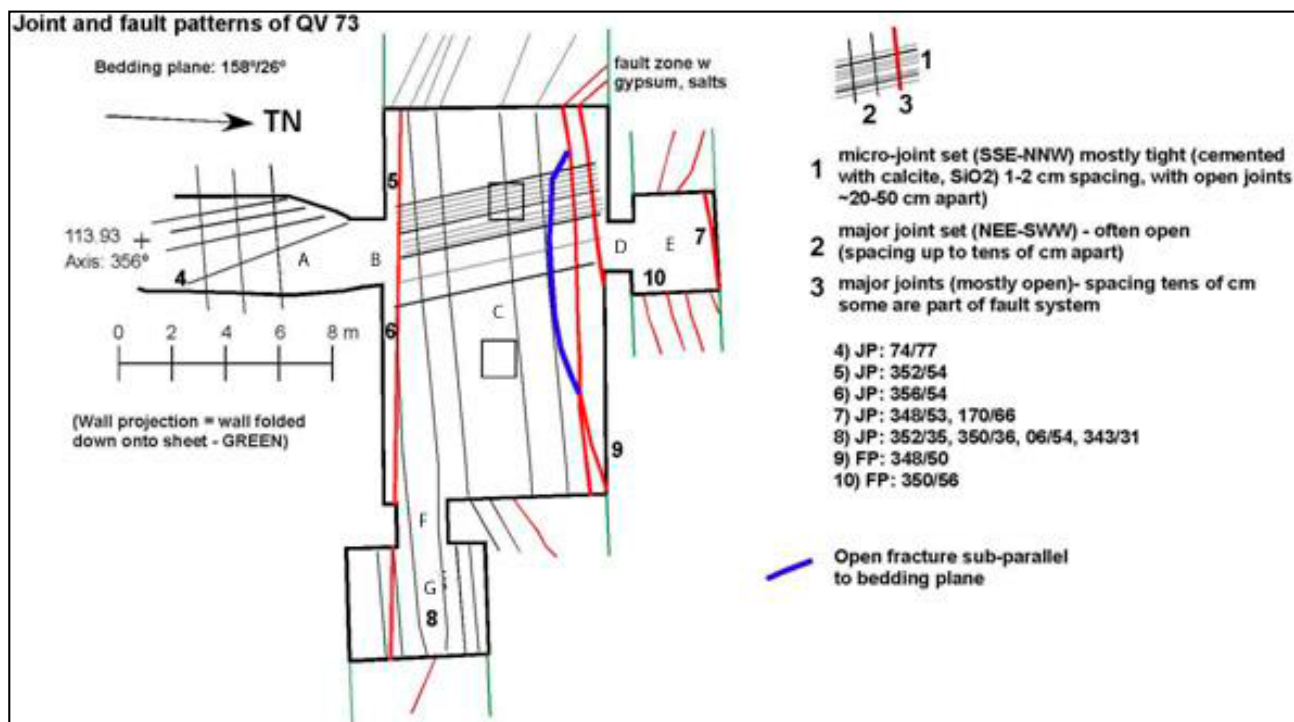
Geological and geotechnical analysis showing joint and fault patterns of the tomb. The diagonal open fracture (blue line) threatens the collapse of the ceiling rock in chamber (C) as it may be closely connected to the vertical fracture/fault that laterally crosses the entire tomb.

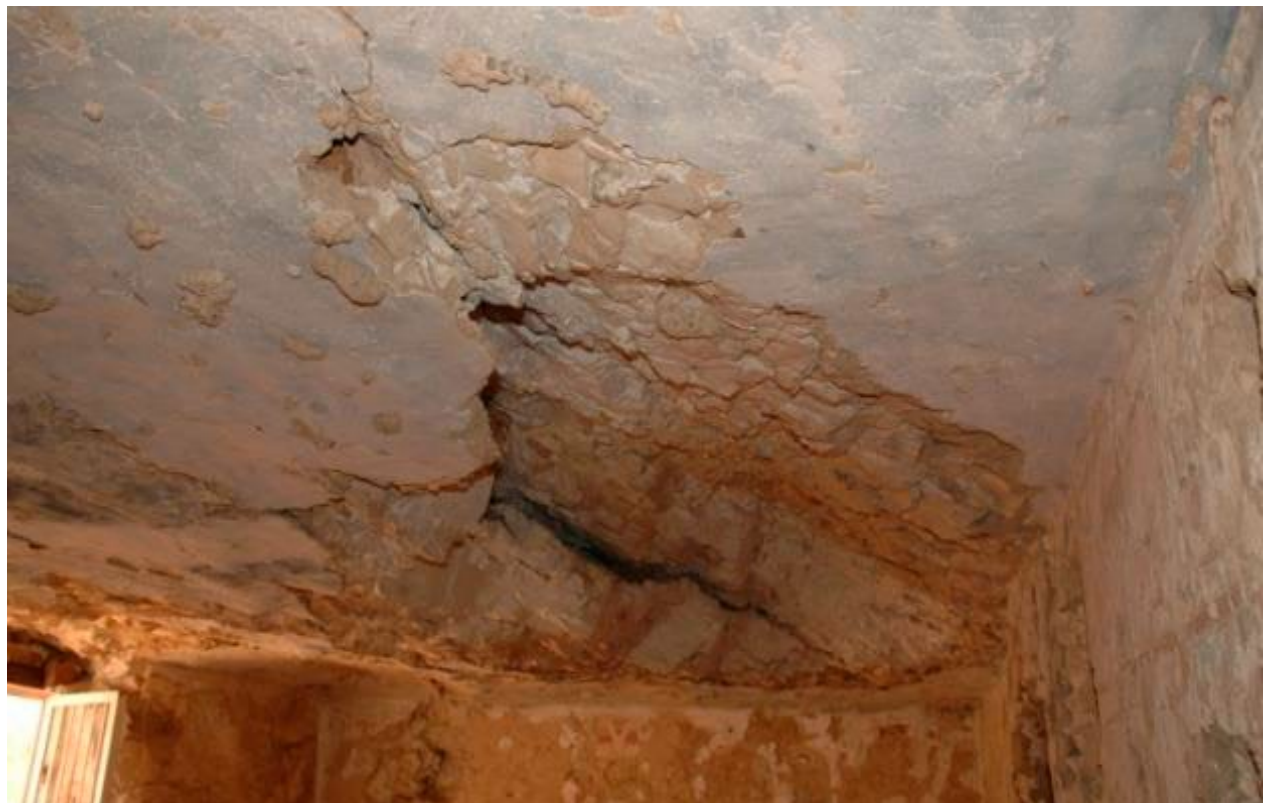
Open diagonal ceiling fracture with adjacent areas of unstained rock, indicating loss in the past.

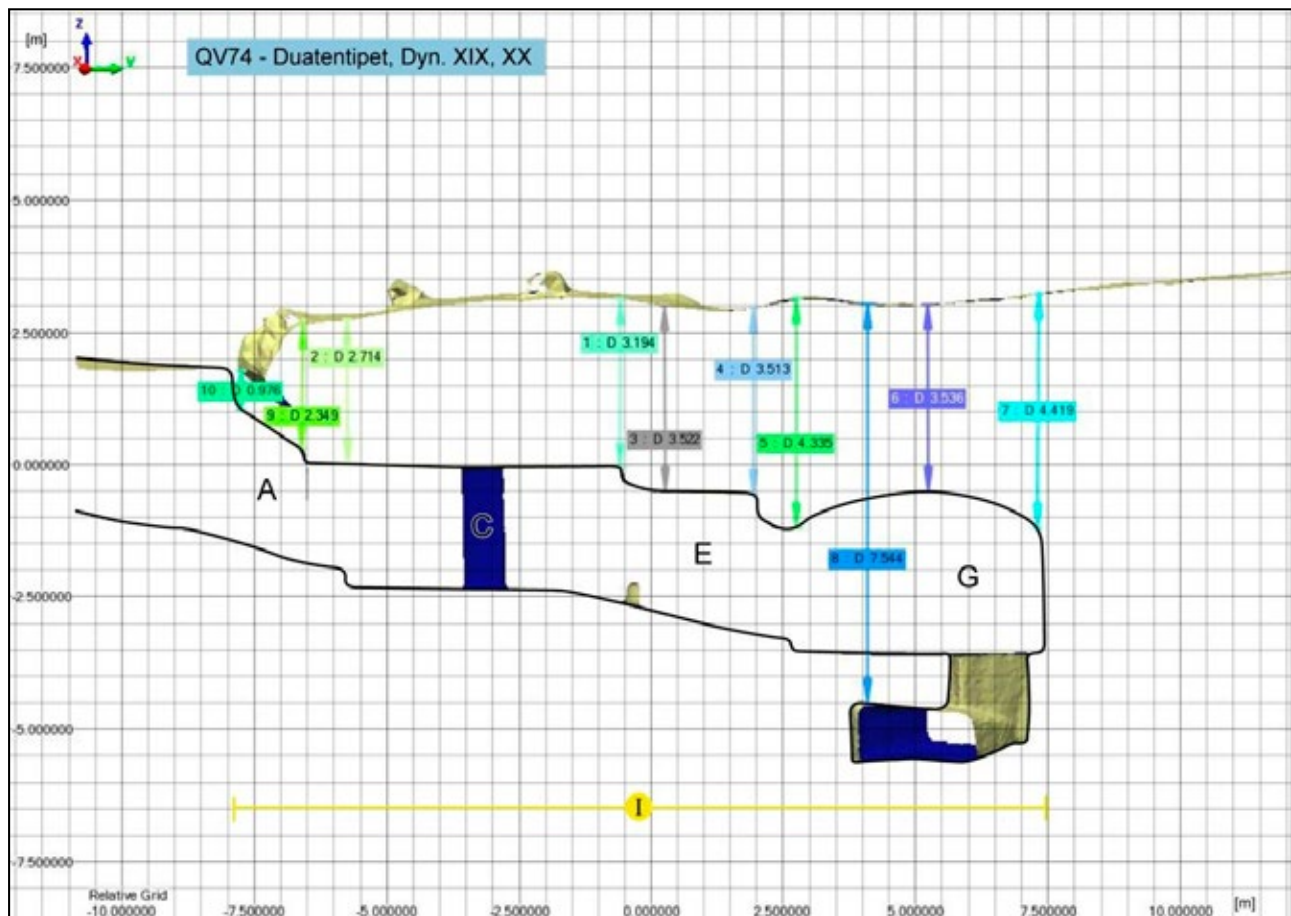
Overburden analysis shows the thickness of rock and the palaeofan conglomerate is between 2.3m at doorway (B) and 3.5m at chamber (G).

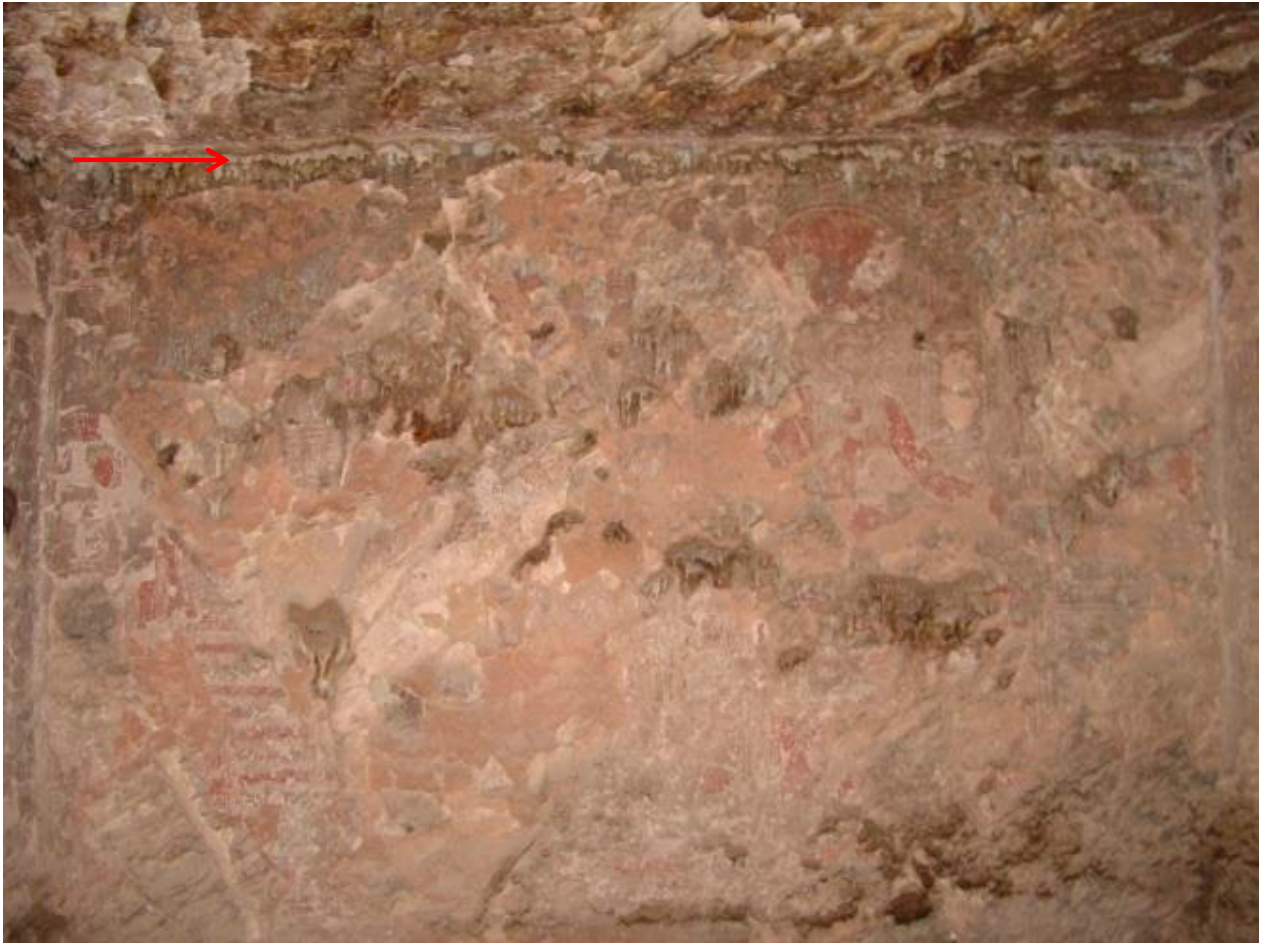
Fragmentary survival of painting in chamber (E). Though the lower plaster survives, the upper painted layer has suffered much loss. Bats also appear to roost on the edges of surviving plaster on this wall leaving staining and a line of white crystalline material at the tops of walls (indicated by red arrow).
