Conservation Management Plan

GROPIUS HOUSE

68 Baker Bridge Road
Lincoln, Massachusetts

Historic New England
Baseline Report: 2016

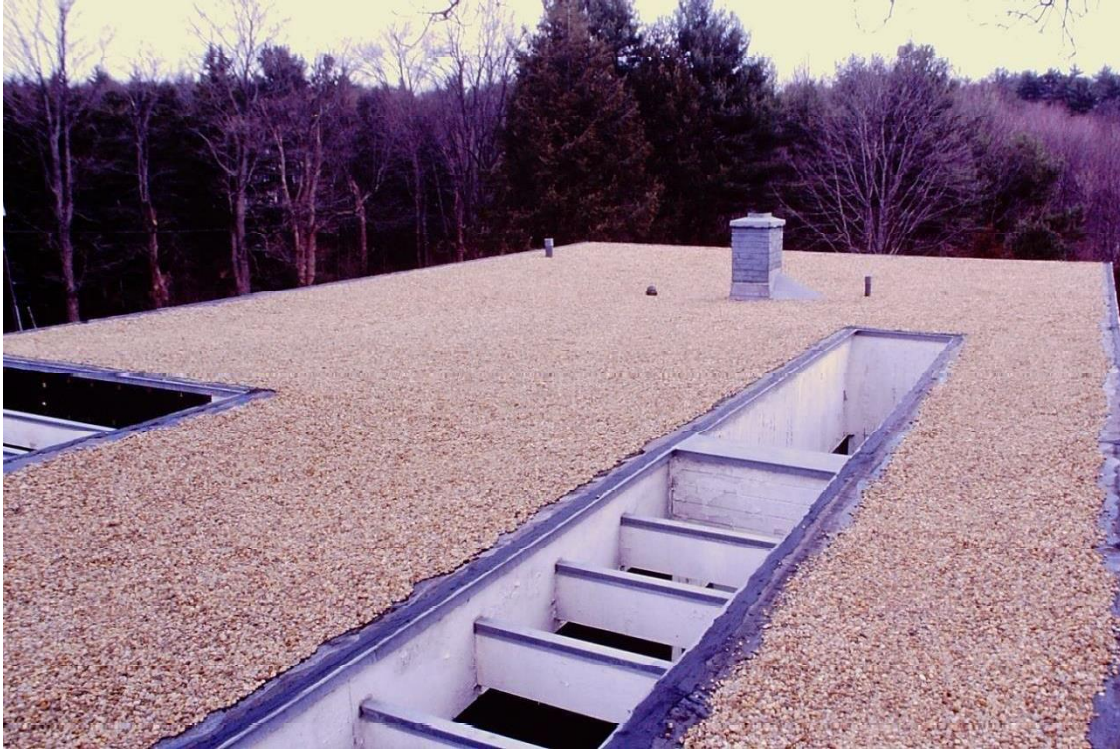
of new flashing.⁶¹ Replacement of the roof, flashings, and gravel stop was completed in 1998, and a rain leader near the front door was power snaked around the same time along with two drains (Figure 7).⁶²

Figure 7: New roof from west, 1999
Historic New England, Property Care Files

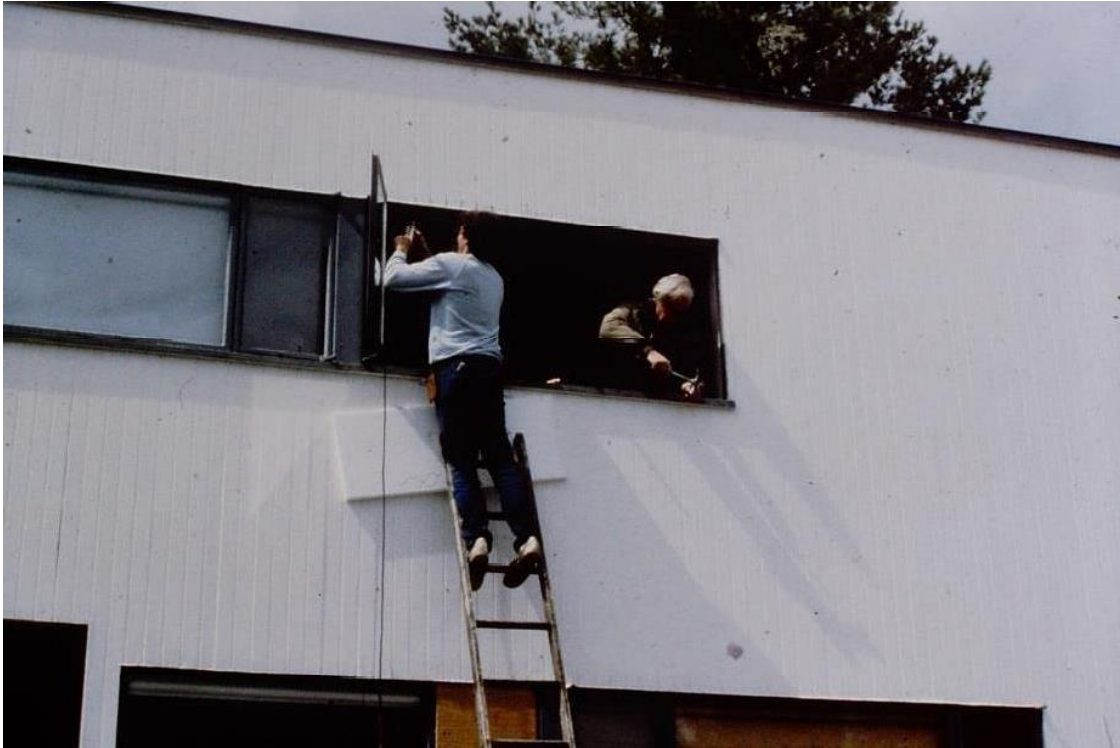
evidence or details to confirm that this happened.²⁸ It was in 1986 that restoration work was certainly completed (*Figure 4*). Four windows on the first floor were removed for refurbishment along with one upstairs window.²⁹ Window vents and two doors were weather-stripped, all vents were adjusted for operation, defective caulking and glazing was removed and replaced, exterior glass was needle-caulked where necessary with Tremco Small Joint Sealant, all abrasions were primed and repainted after mechanical repairs and rust removal, and UV film was installed.³⁰ The replacement of a cracked pantry window was included on a list of necessary maintenance work, but it is unclear whether the replacement was ever carried out.³¹

Figure 4: Repairs to east elevation windows, 1985
Historic New England Archives, Binder of Slides

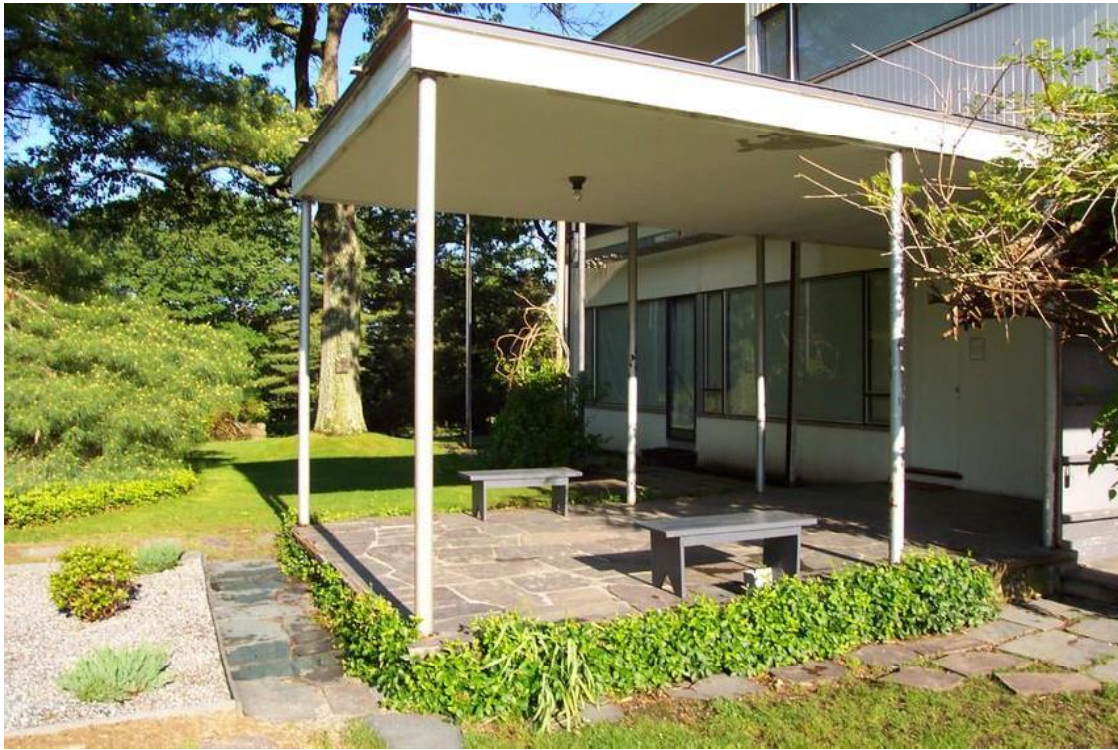
removed and patched before they were fully coated with zinc primer and urethane gloss.⁴⁰ Finally, the deteriorating flagstones in the porch were repaired and leveled.⁴¹

Figure 7: Screen porch during 2001 repairs
RS ID #57137

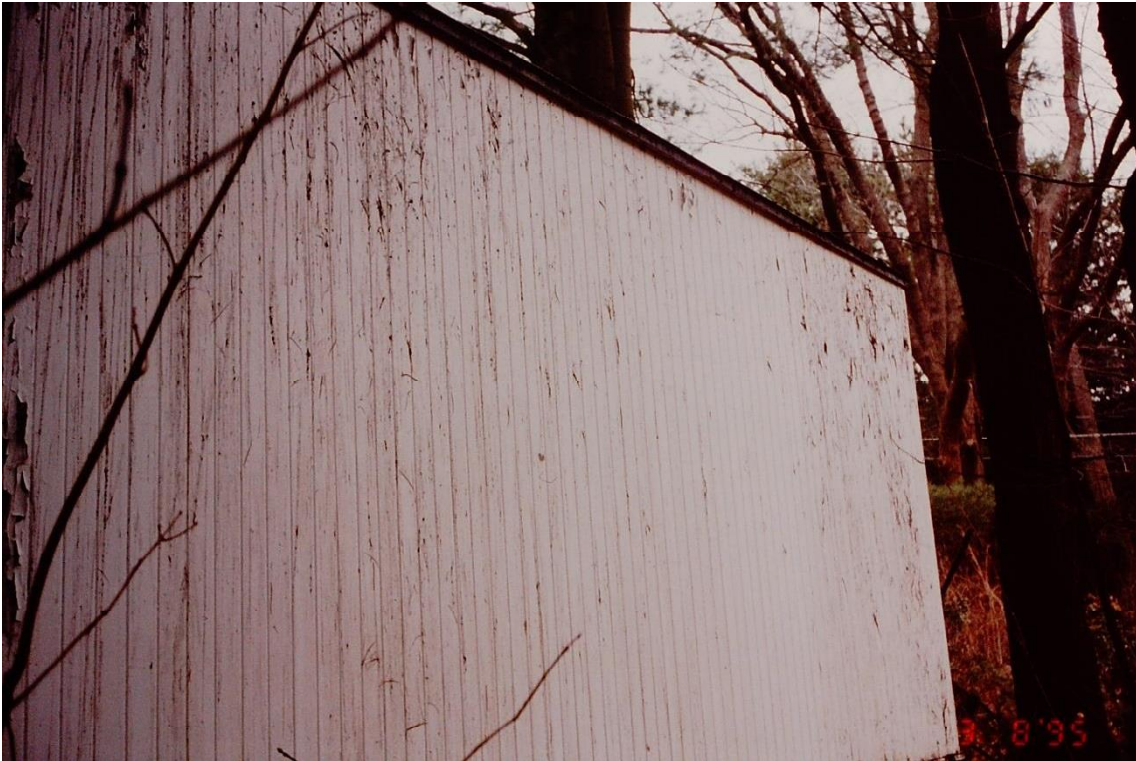
Figure 4: Damage to garage façade due to roof damage, 1995
Historic New England, Property Care Binders

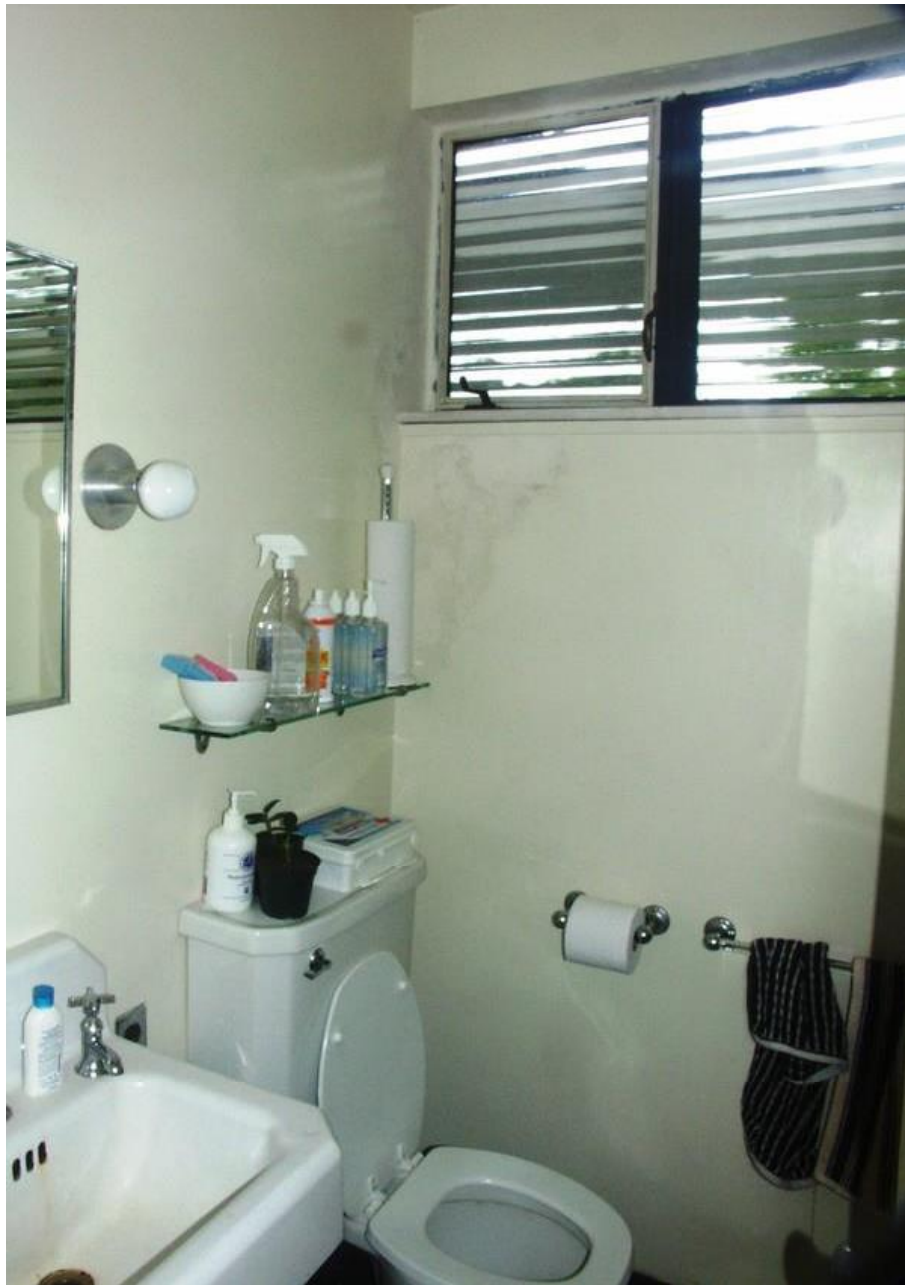
Figure 4: Stained bathroom walls, 2009
RS ID #56596

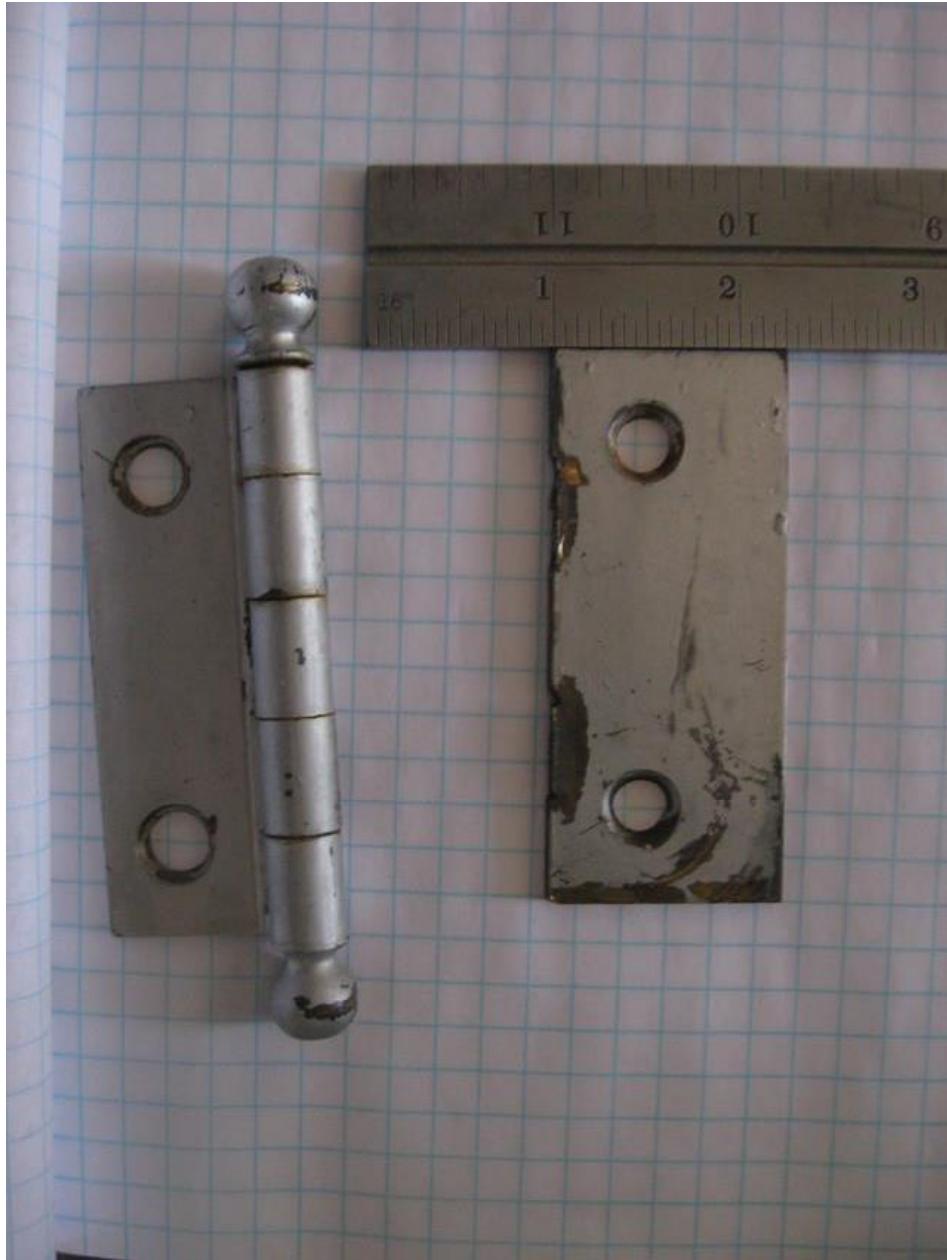
Figure 4: Living room screen door hinge, 2012 ó D1-03
RS ID #142167

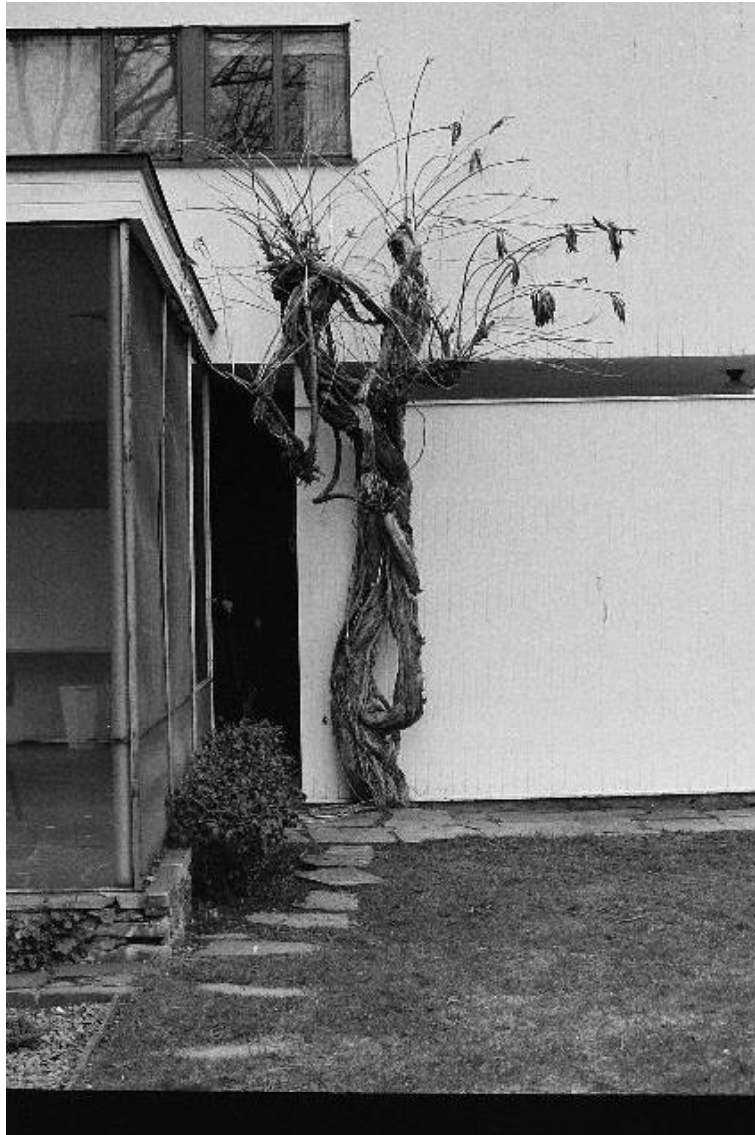
Figure 8: Flagstones along the porch and south façade, 1994
Historic New England Property Care Binders

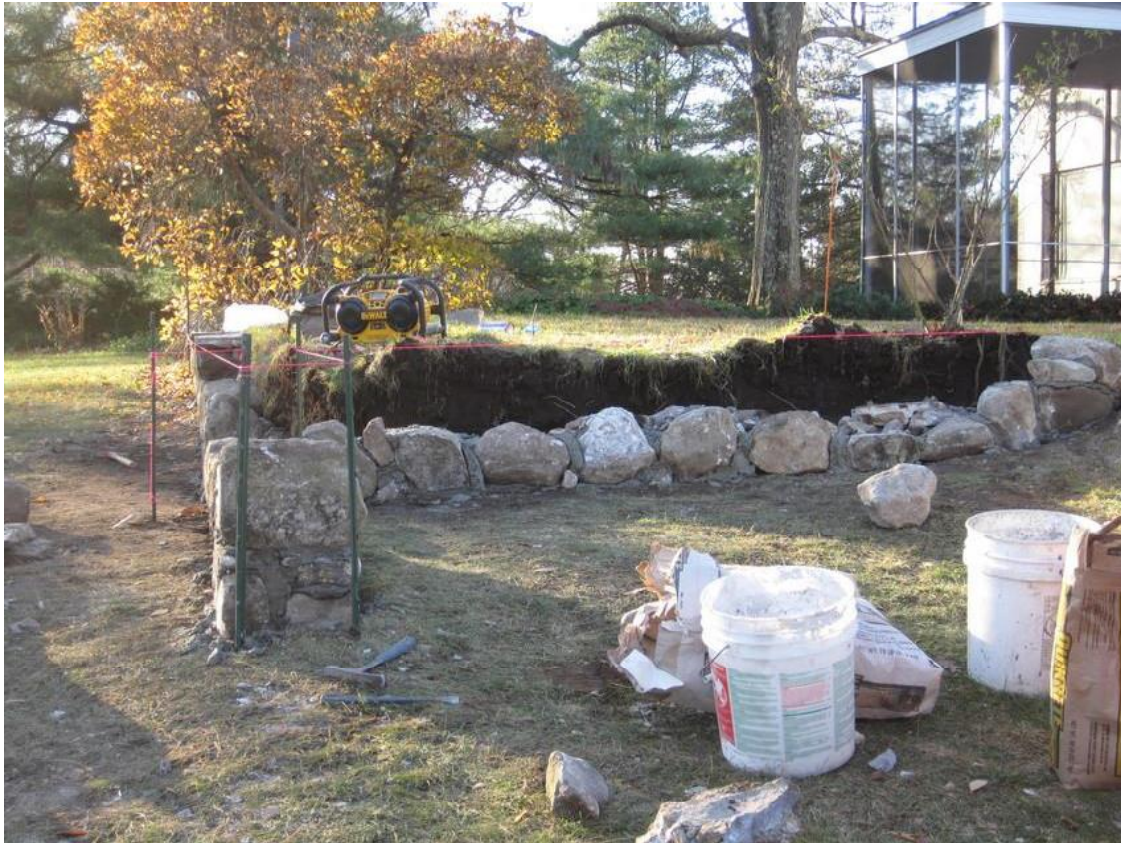
Figure 6: Stone wall repair, 2009
RS ID #46978

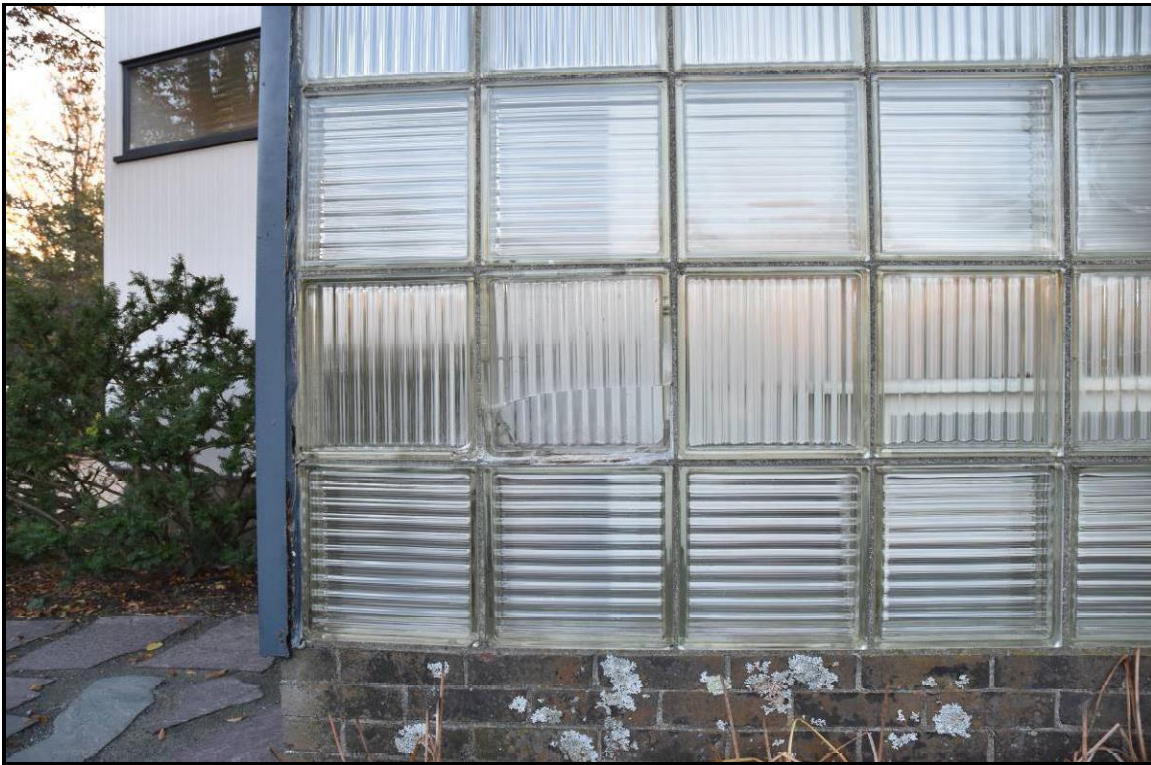
Figure 15. The lower portion of a Block H2 (second course from bottom, 2nd block from left) has broken away as a result of stress cracking exacerbated by freezing moisture. Note the displacement of the metal channel (left of glass block) caused by corrosion.

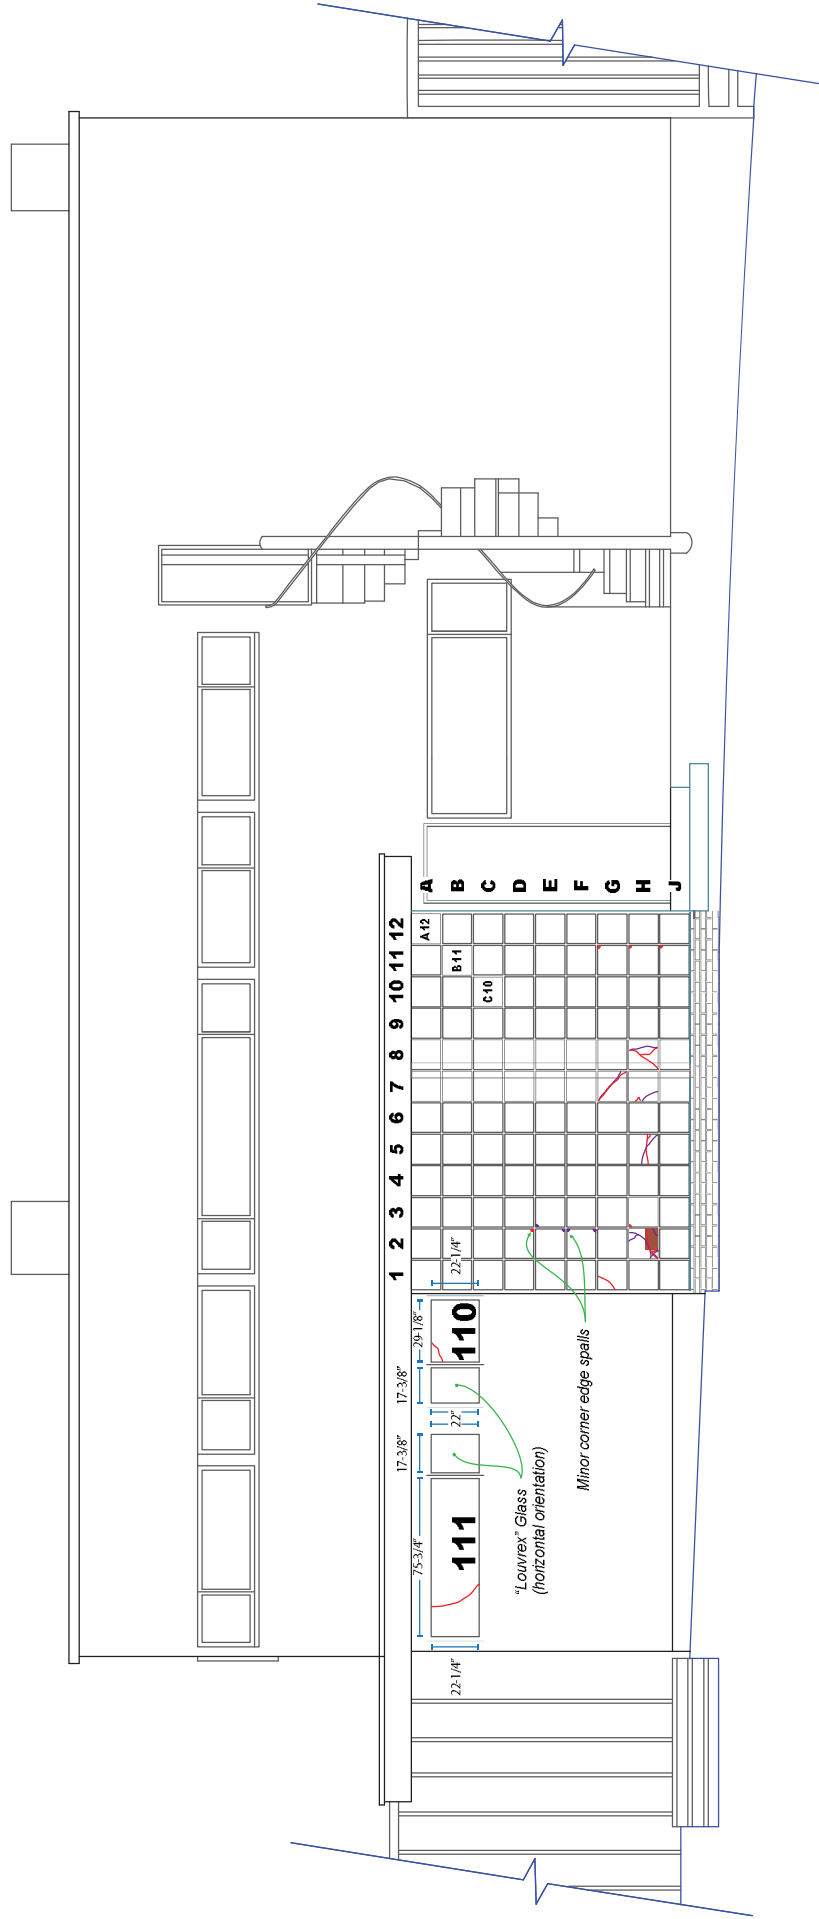
GLASS CONDITIONS
 CRACK
 CRACK ON REVERSE (INTERIOR-FACING SIDE) (GLASS BLOCK)
 MISSING

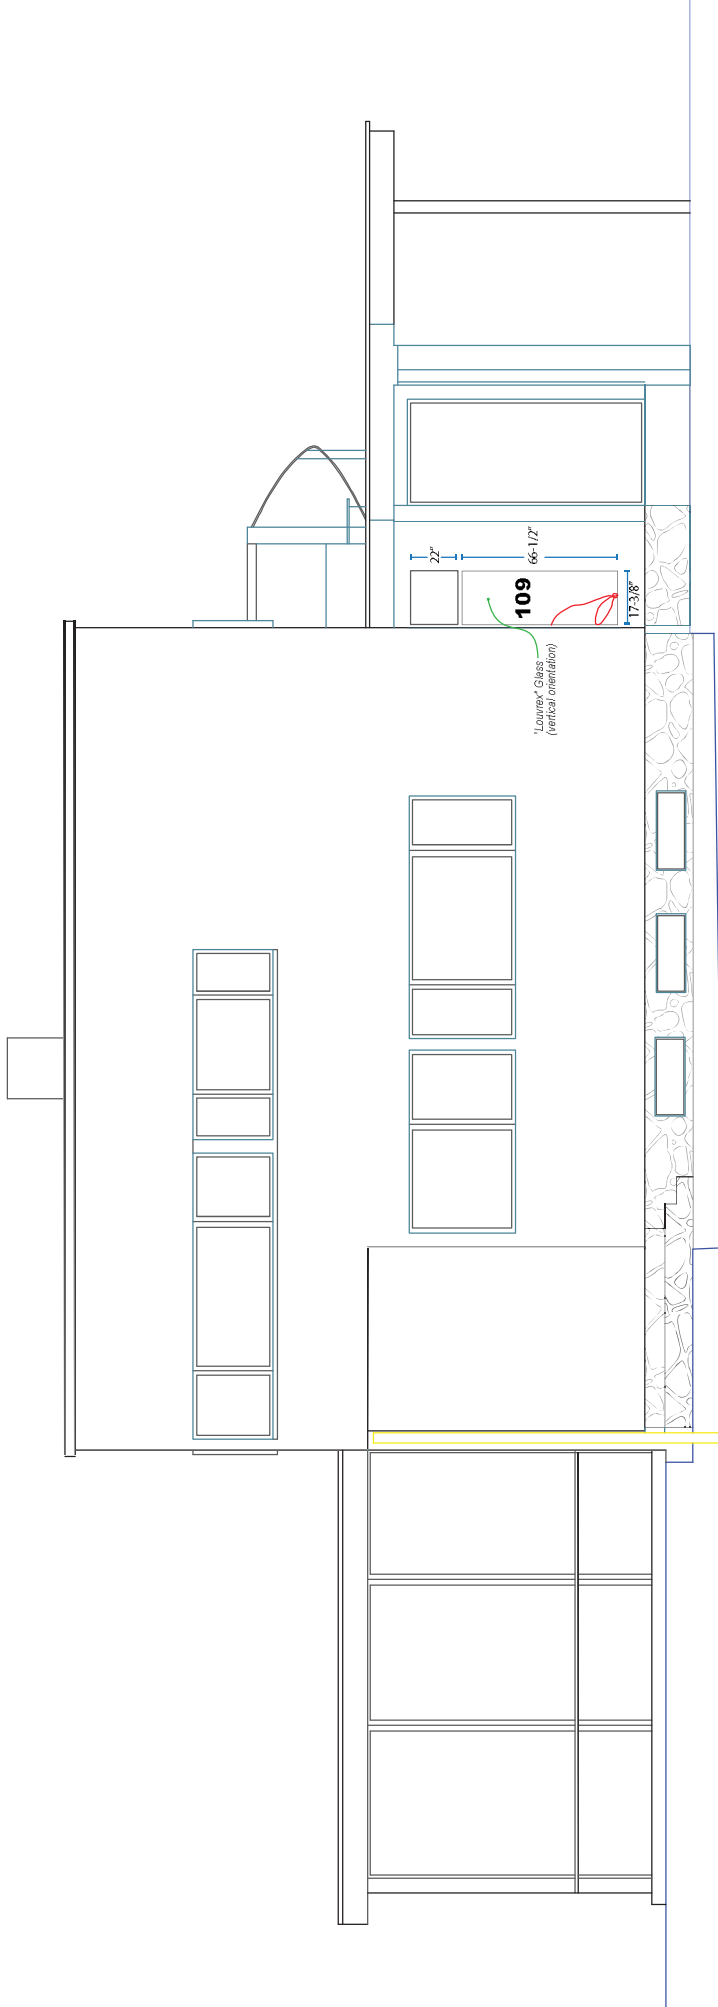
GLASS CONDITIONS
 CRACK
 MISSING

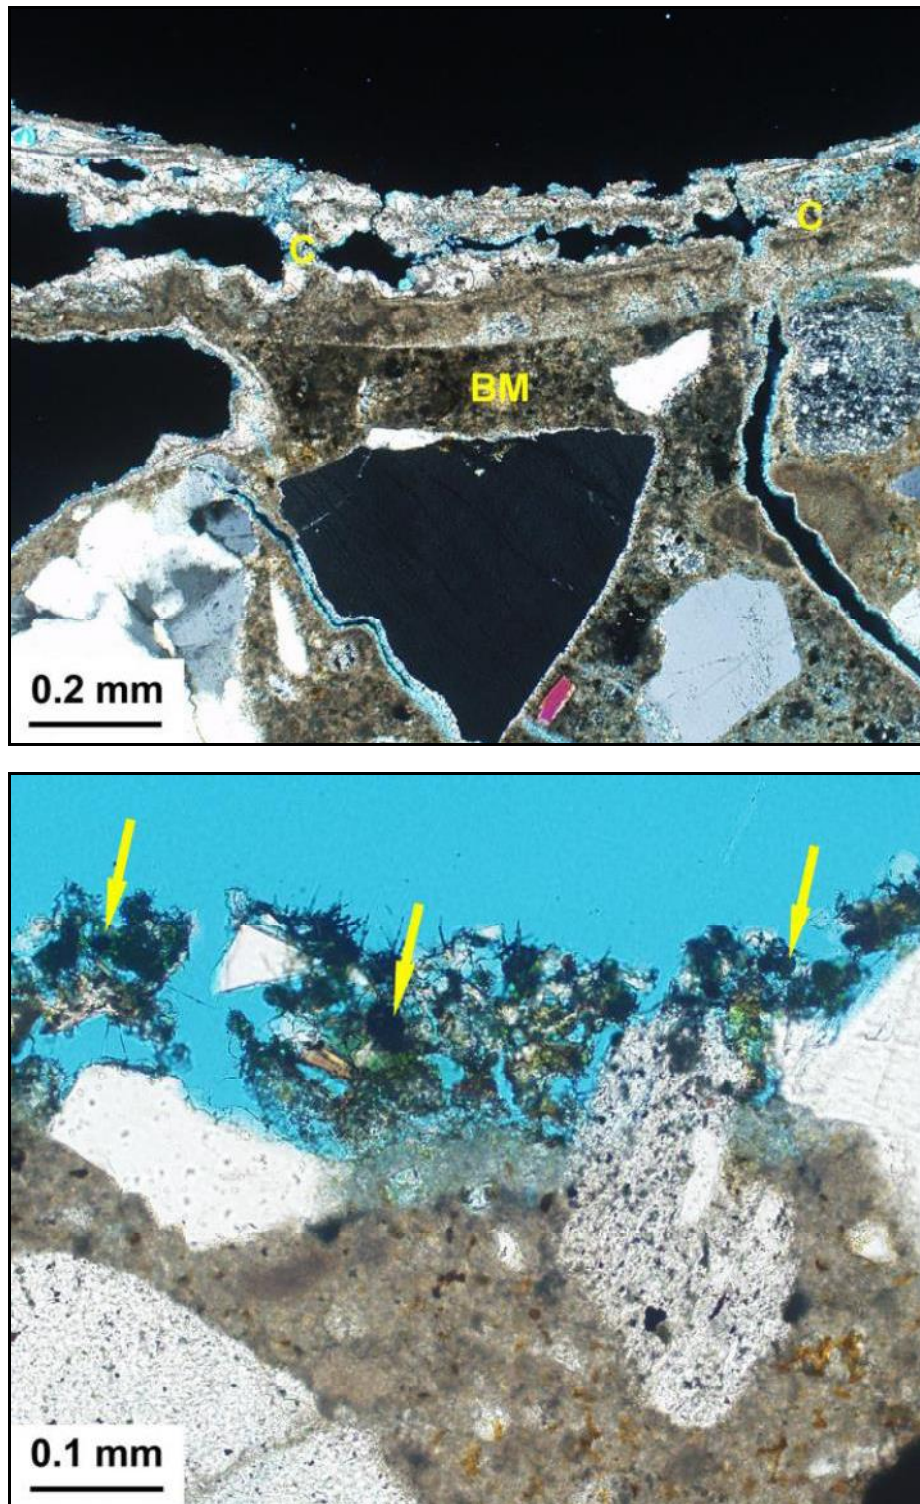
Figure 5: Photomicrographs illustrating secondary effects observed in the mortar sample. (Upper XPL image) One bed surface is covered with thin calcite scale (C). This is differentiated from the carbonated binder matrix (BM) by the coarser texture of the recrystallized carbonate. No other secondary mineralizations are observed in the examined mortar sample. (Lower PPL image) Other bed surfaces are covered with a thin layer of soiling and biological growth (arrows). These features are only observed on the surfaces of the mortar, and the bulk of the sample is considered to be in generally sound condition.

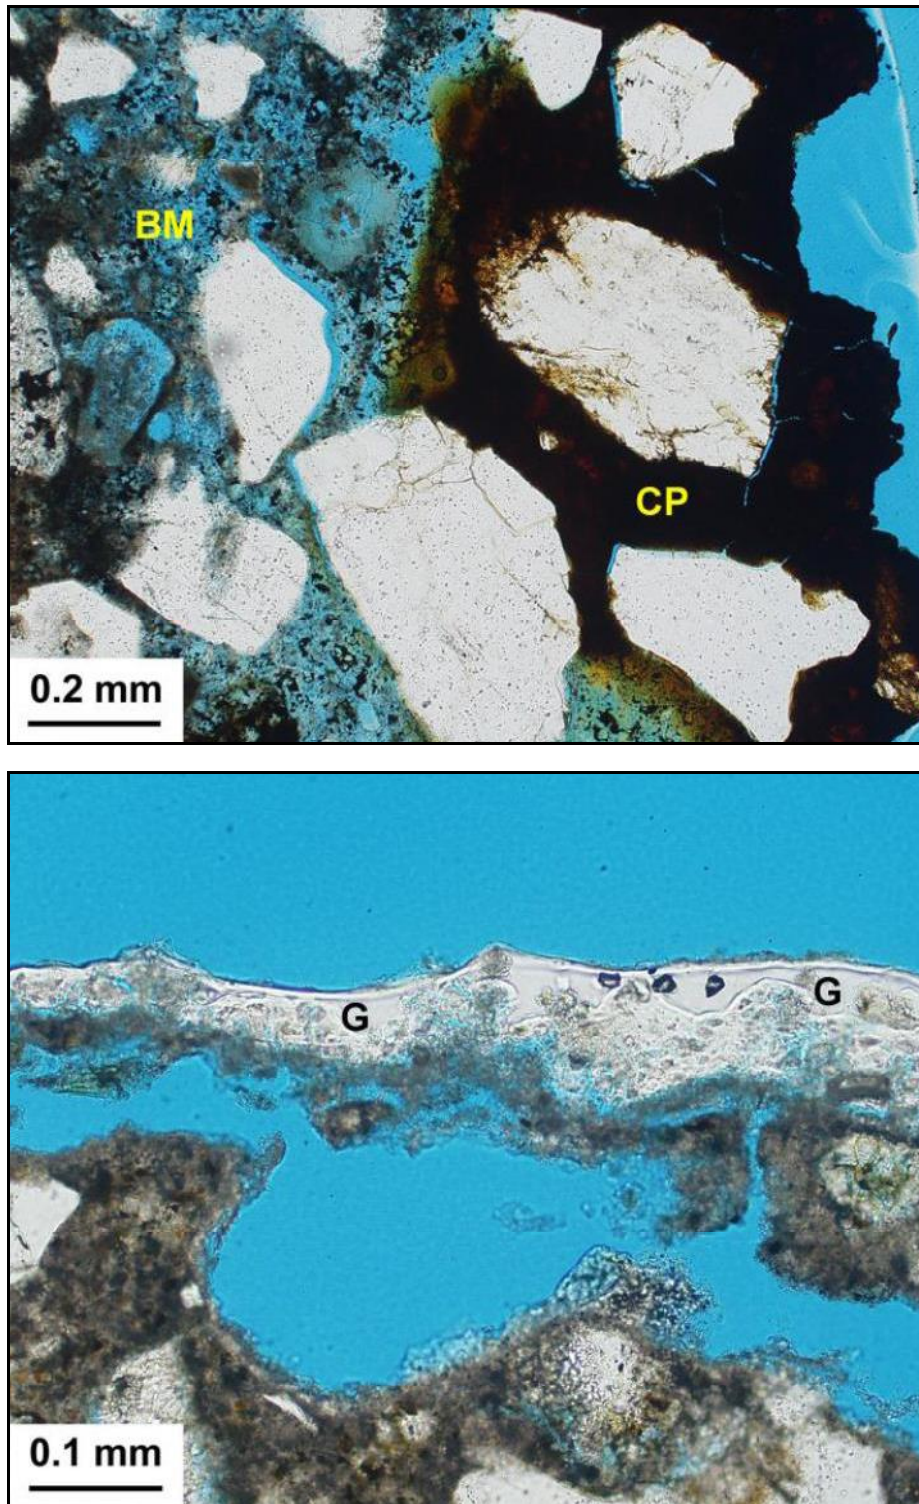
Figure 6: PPL photomicrographs illustrating secondary effects observed in the mortar sample that are potentially related to other materials in the masonry assembly. (Upper image) There is a thin layer of corrosion product (CP) opposite from the tooled joint surface. It is shown here directly adjacent to the binder matrix (BM) and enveloping sand grains. The laboratory is not aware of the construction details but it is possible that this is due to corrosion of some encased steel in the carbonated mortar. (Lower image) There is also one surface with a thin deposit of what could be a silica or alkali-silica reaction gel (G). This identification of the material is not confirmed but is likely due to the association of the bed surface with the glass block masonry units.

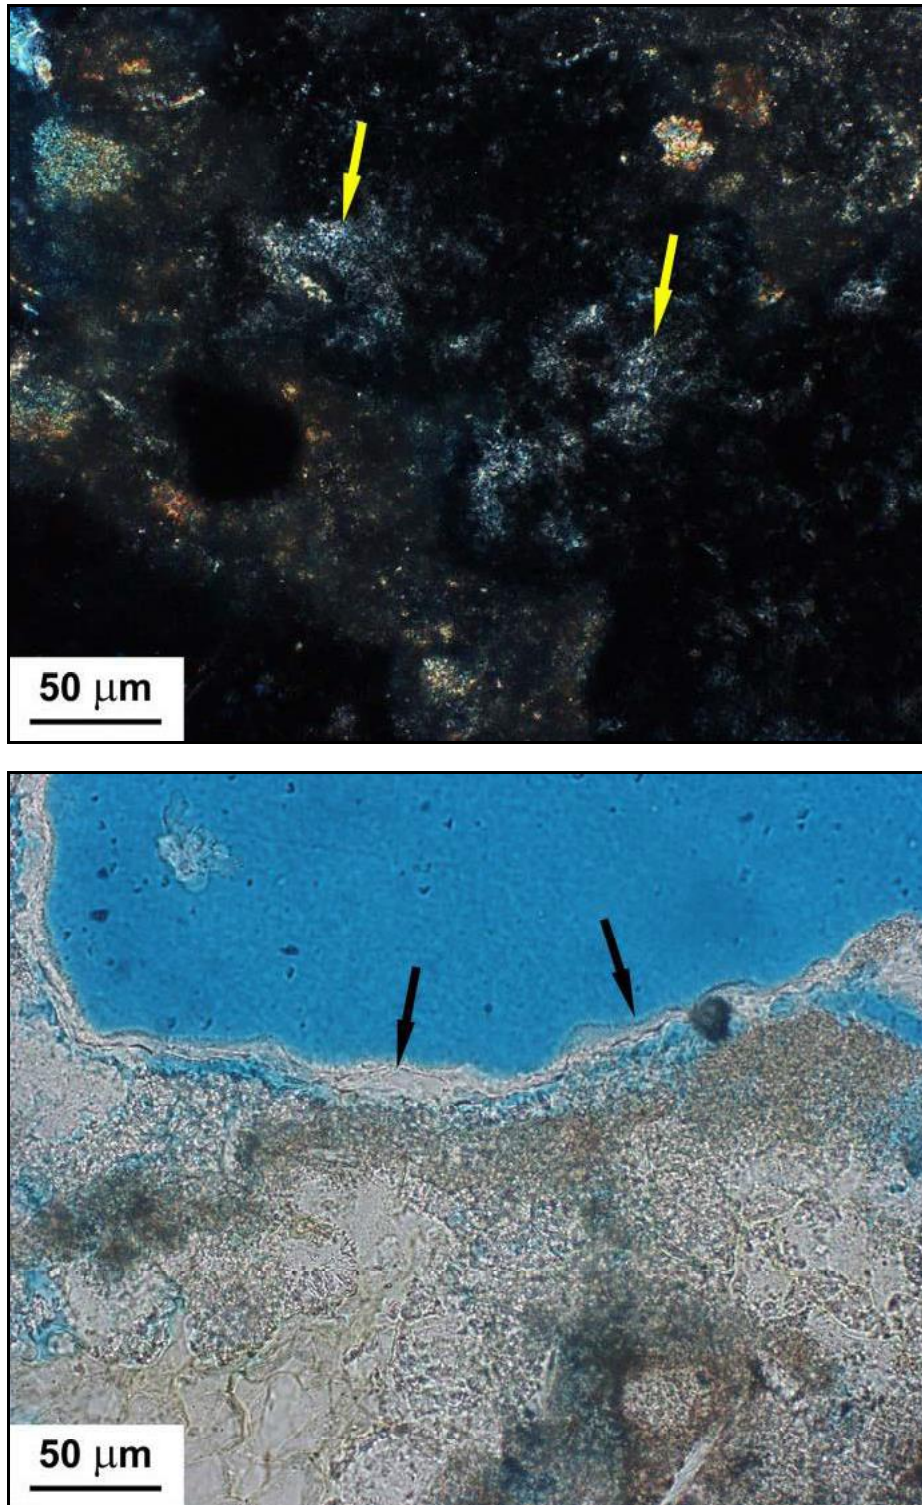
Figure 9: Photomicrographs illustrating secondary mineralizations. (Upper XPL image) The arrows indicate diffuse patches of birefringent material within the micropores of the lime binder. These are consistent in optical character with sulfate deposits. (Lower PPL image) The arrows indicate a fine mineral lining along an air-void surface. The optical properties are consistent with chloride salts.

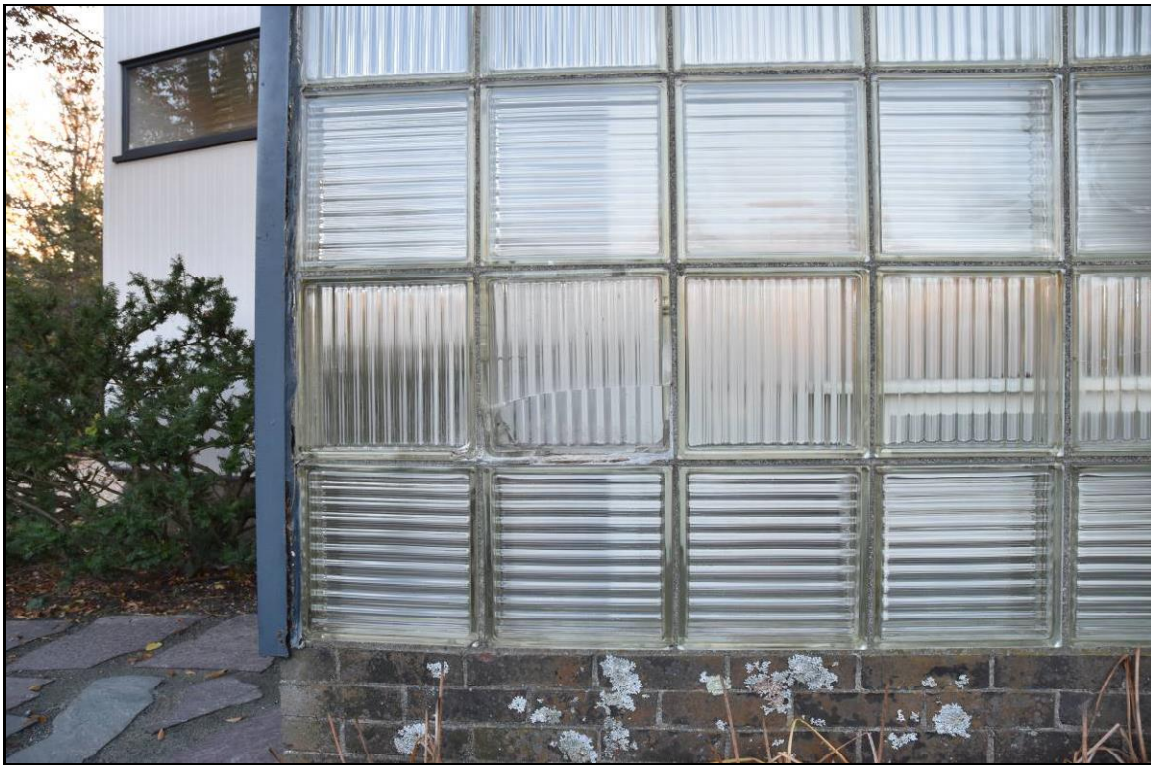
Figure 15. The lower portion of a Block H2 (second course from bottom, 2nd block from left) has broken away as a result of stress cracking exacerbated by freezing moisture. Note the displacement of the metal channel (left of glass block) caused by corrosion.

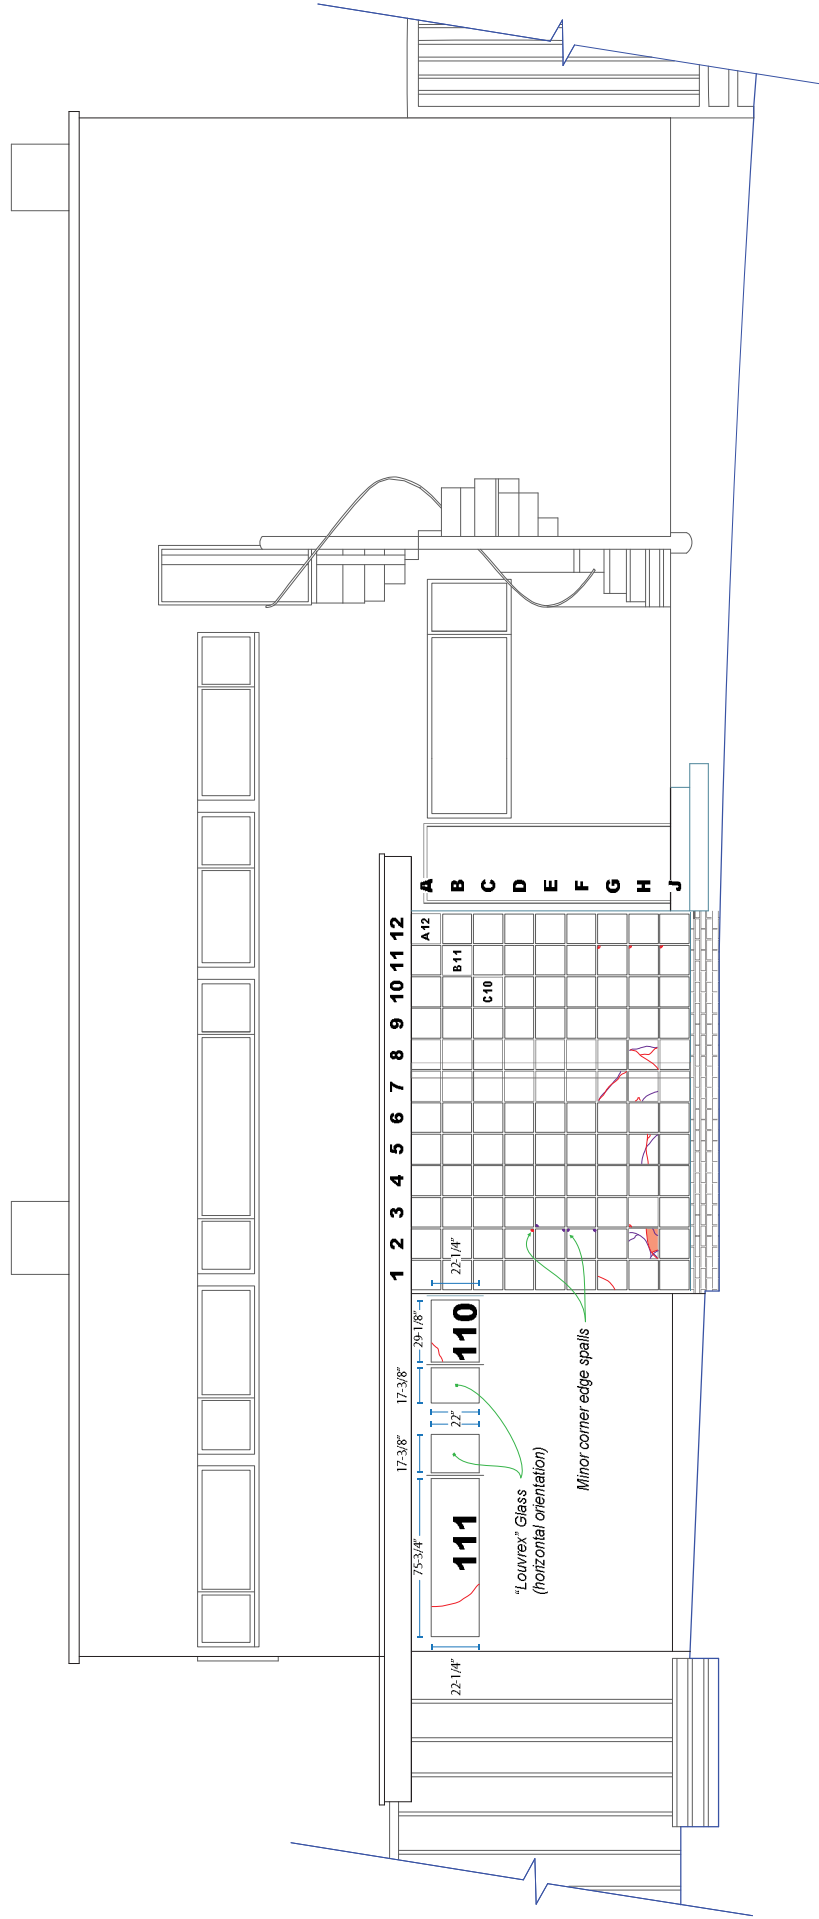
GLASS CONDITIONS
 CRACK ON REVERSE (INTERIOR-FACING) SIDE (GLASS BLOCK)
 CRACK
 MISSING

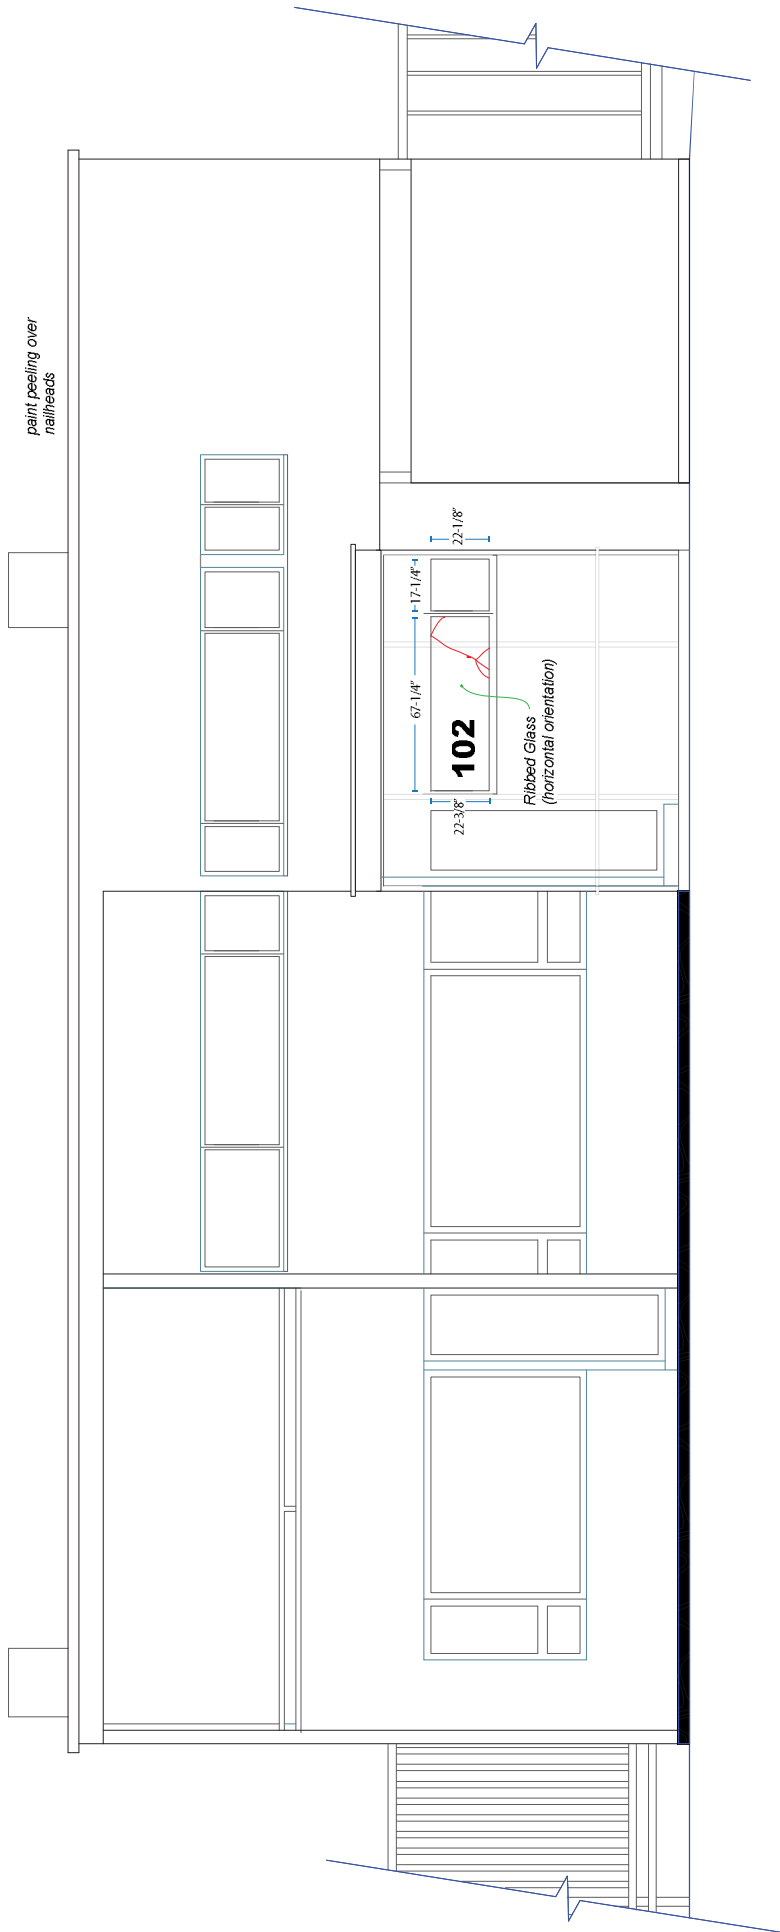
GLASS CONDITIONS
 CRACK
 MISSING

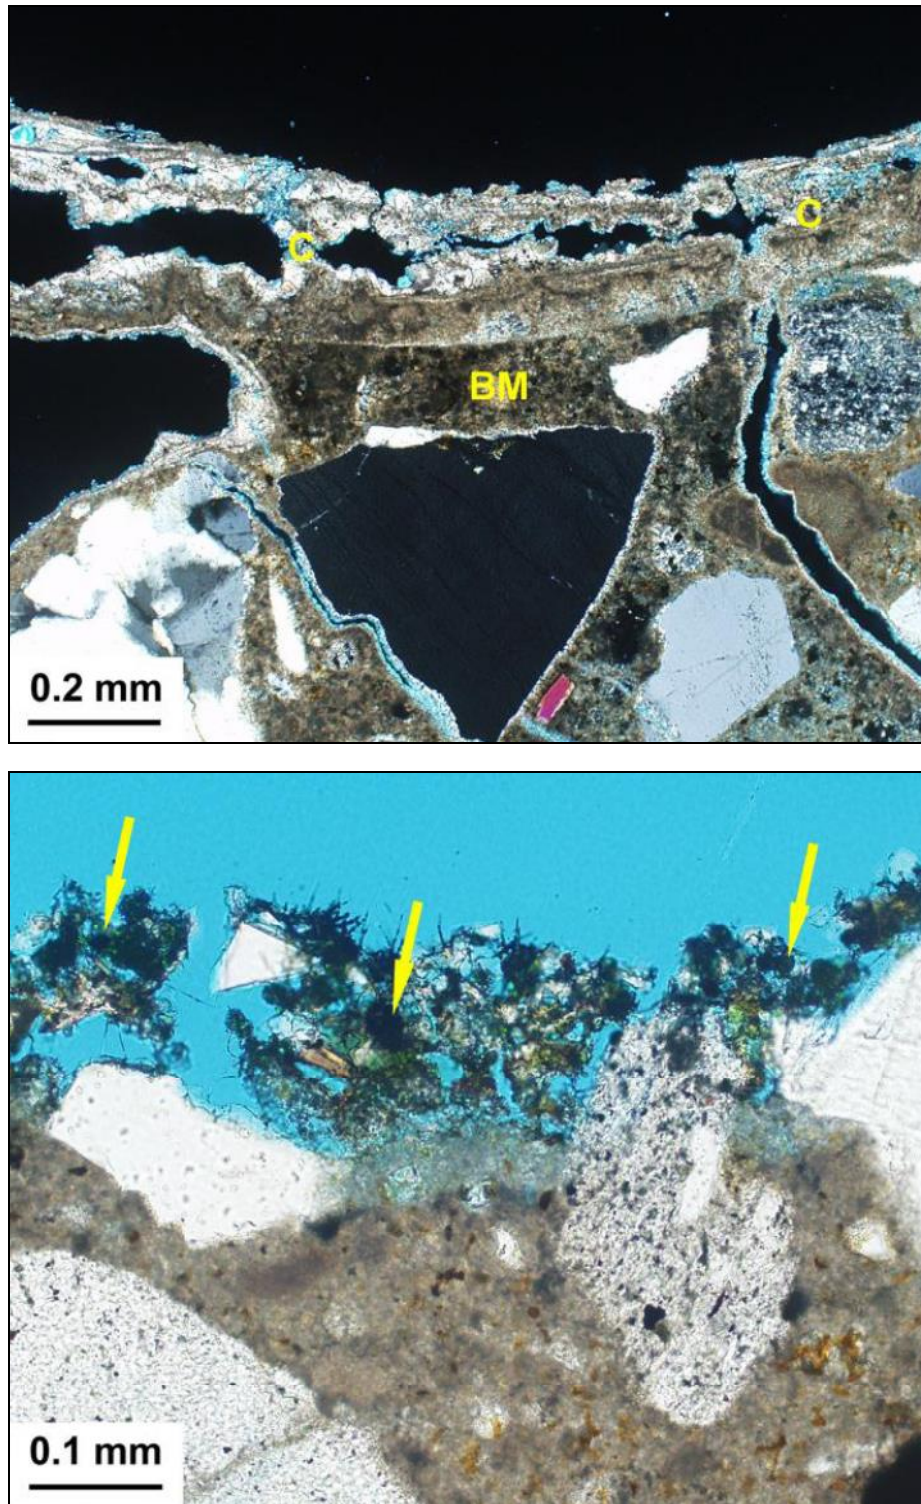
Figure 5: Photomicrographs illustrating secondary effects observed in the mortar sample. (Upper XPL image) One bed surface is covered with thin calcite scale (C). This is differentiated from the carbonated binder matrix (BM) by the coarser texture of the recrystallized carbonate. No other secondary mineralizations are observed in the examined mortar sample. (Lower PPL image) Other bed surfaces are covered with a thin layer of soiling and biological growth (arrows). These features are only observed on the surfaces of the mortar, and the bulk of the sample is considered to be in generally sound condition.
