Conservation Management Plan

GROPIUS HOUSE

68 Baker Bridge Road
Lincoln, Massachusetts

Historic New England
Baseline Report: 2016

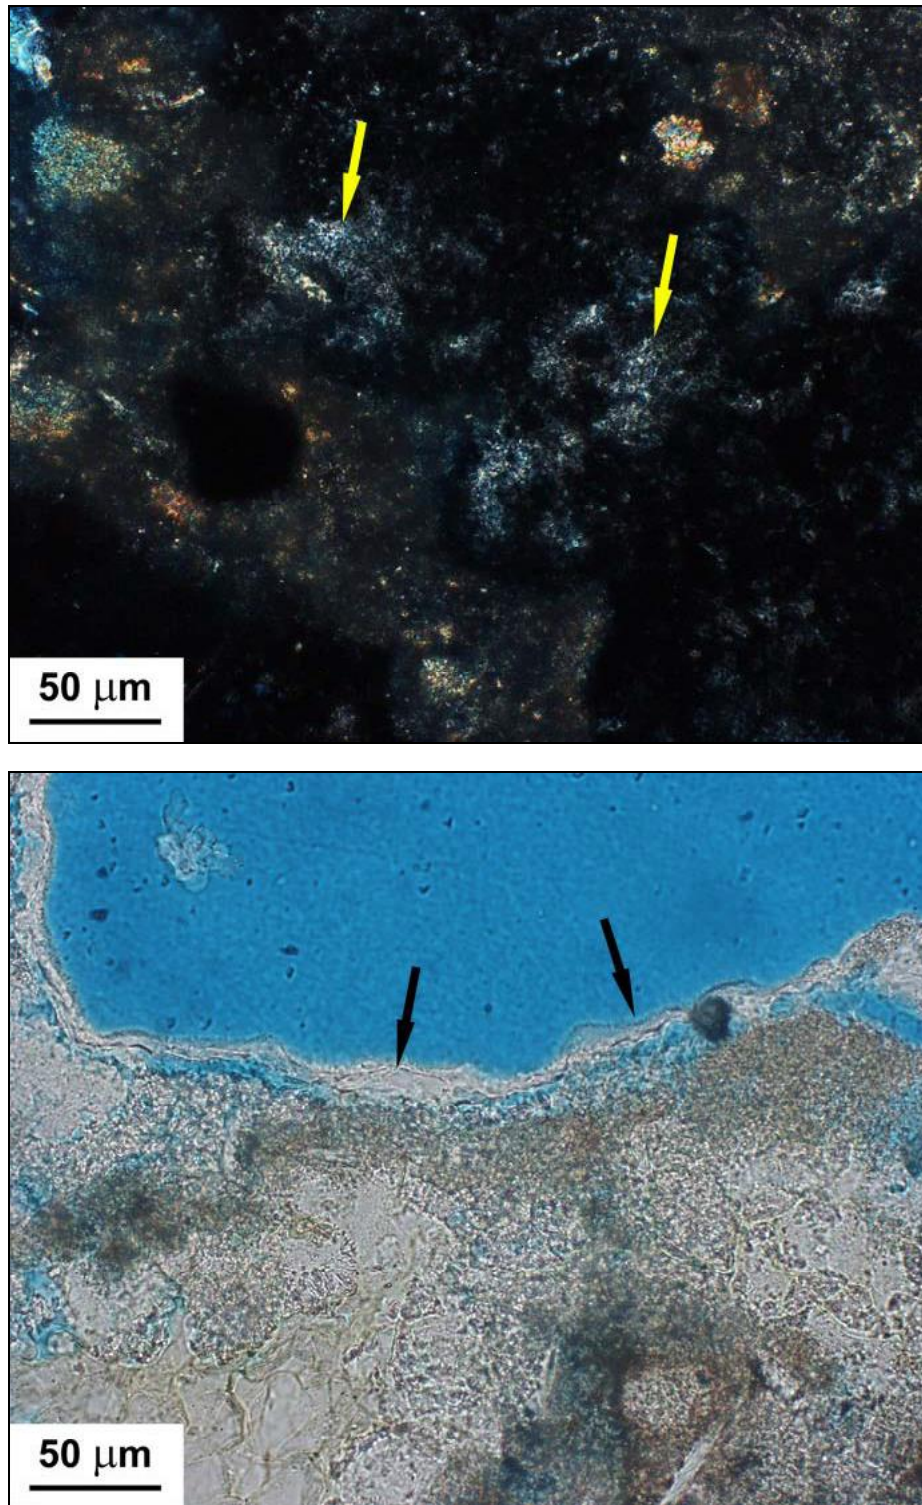
Figure 9: Photomicrographs illustrating secondary mineralizations. (Upper XPL image) The arrows indicate diffuse patches of birefringent material within the micropores of the lime binder. These are consistent in optical character with sulfate deposits. (Lower PPL image) The arrows indicate a fine mineral lining along an air-void surface. The optical properties are consistent with chloride salts.

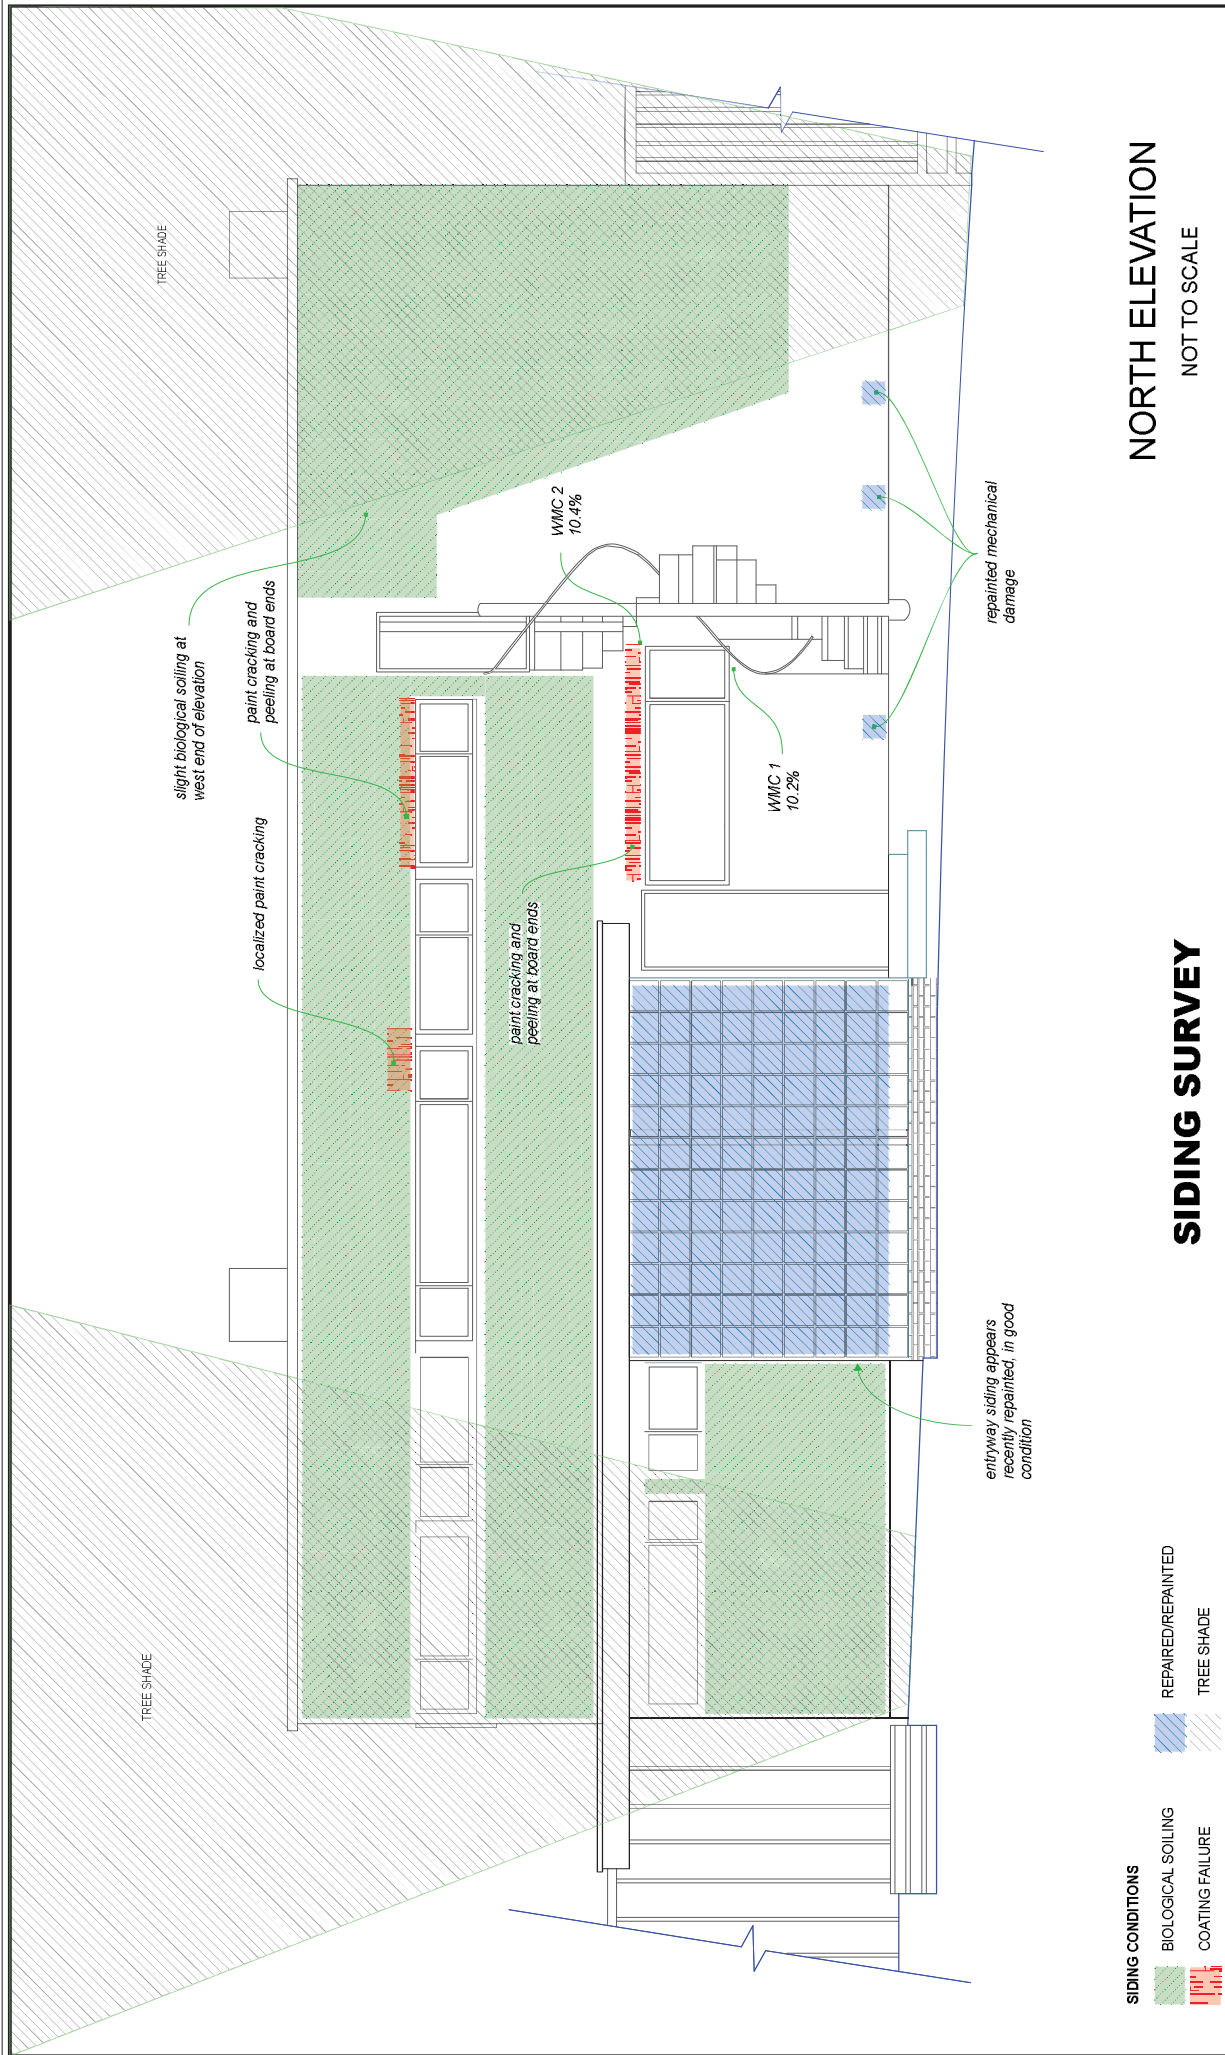
SIDING CONDITIONS
 BIOLOGICAL SOILING
 COATING FAILURE
 REPAIRED/REPAINTED
 TREE SHADE
