HERITAGE & ARCHITECTURE

5 November 2018

Keeping it Modern Grant,
The Getty Foundation

Conclusions and recommendations from the research Colour, Form and Space: Rietveld Schröder House challenging the Future.

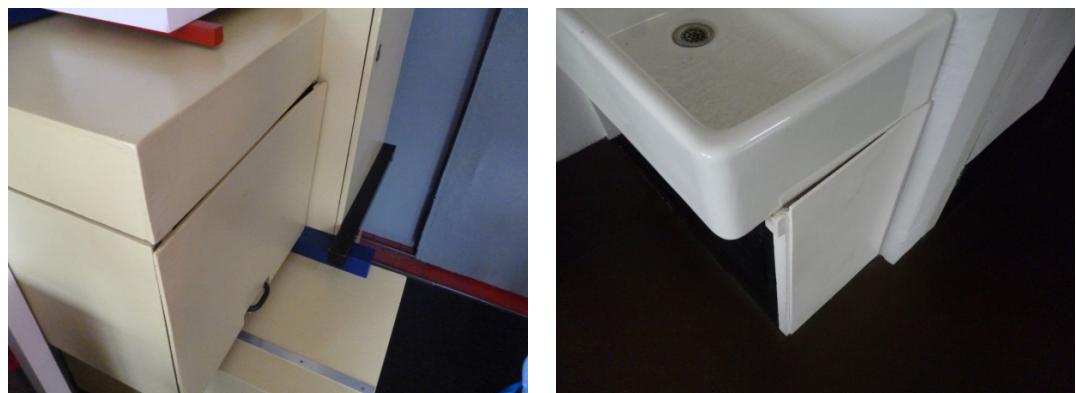
Figure 5: Deformation of thin timber elements of furniture

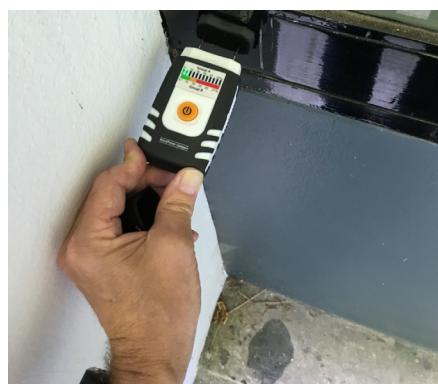
- The state of conservation of the building, as far as it could be assessed visually, is good. No moisture spots have been observed on the walls of the buildings, indicating the presence of moisture due to e.g. leakages or surface condensation. Only exception was the study at the ground floor where parts of the plaster layer detached in 2017. Separate inspection has been carried out and reported [^{4 5 6 7}]. It should be mentioned that problems might have been masked by the frequent maintenance (e.g. painting of the walls) of the building.
- The state of conservation of the furniture is generally good. However, some pieces of furniture, mainly thinner parts, are visibly deformed (figure 5). Floor finishes (carpet and linoleum) are regularly replaced, as they get worn due to the use.
- The moisture content measured in the timber window frames is low (figure 6).

Figure 6: Indicative measurement of moisture content in timber window frames

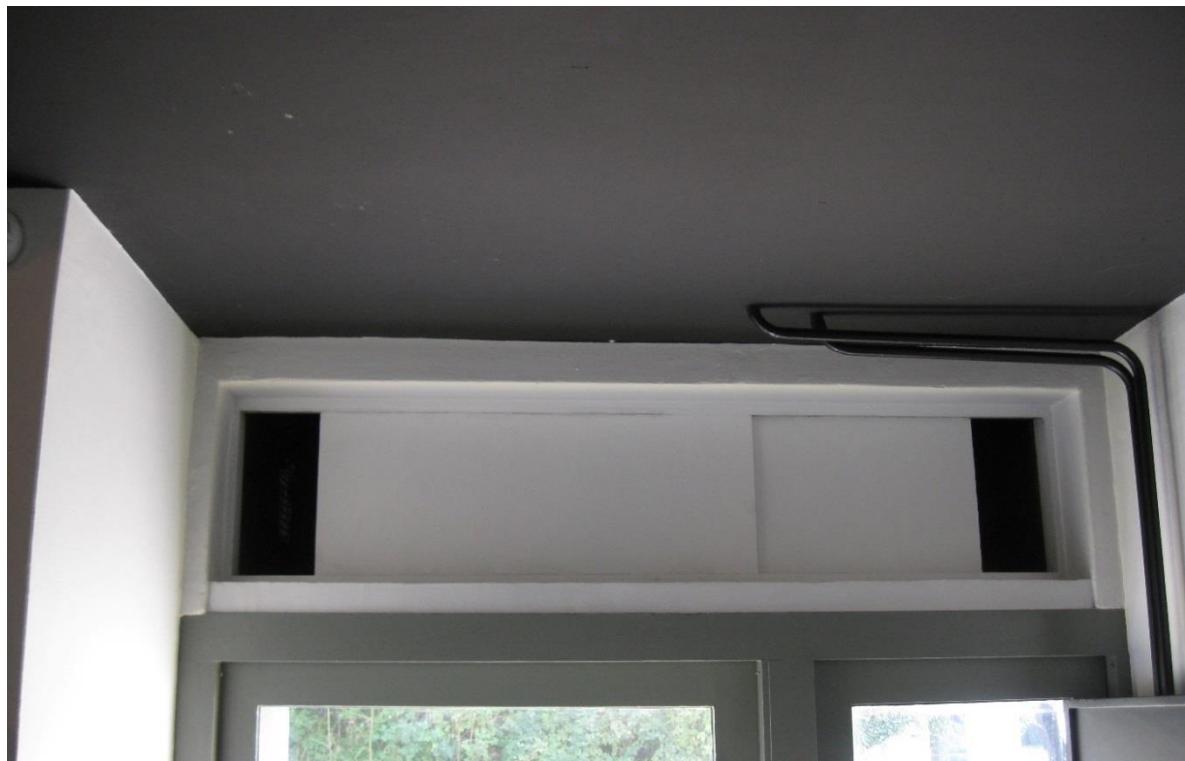
Het gebouw bevat veel koudebruggen en is niet geïsoleerd. Dit levert een groot risico op condensvorming op. Bij de inspectie zijn echter geen vochtplekken waargenomen.

Foto 4 Dragende vloerbalken zijn door het plafond niet zichtbaar

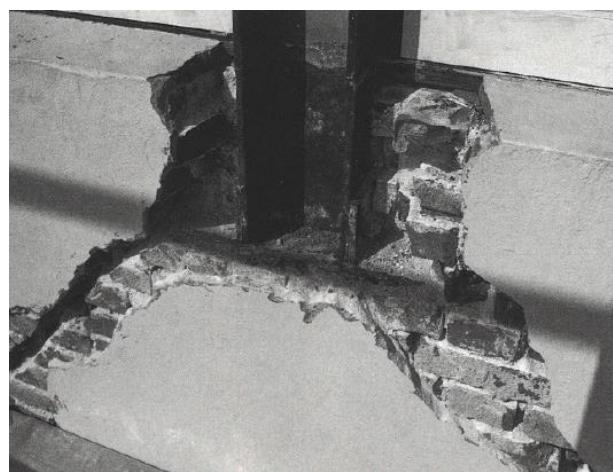
Foto 11 Stalen kolom boven het keukenraam gedragen door metselwerk. De doorbuiging van de ondergelegen stalen latei veroorzaakte diagonale scheuren.

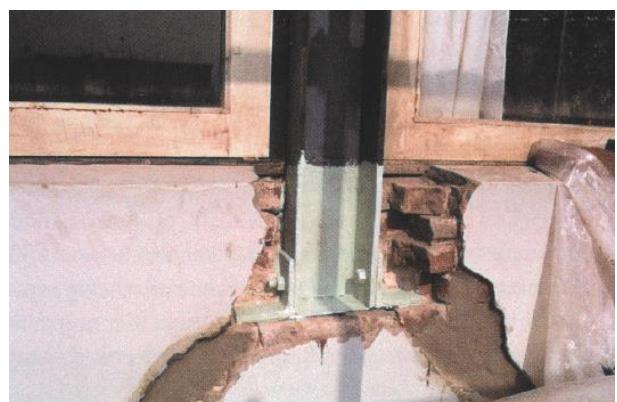
Foto 12 De stalen kolom is in 1974 voorzien van corrosieverende verf en ingepakt in kunststofmortel.

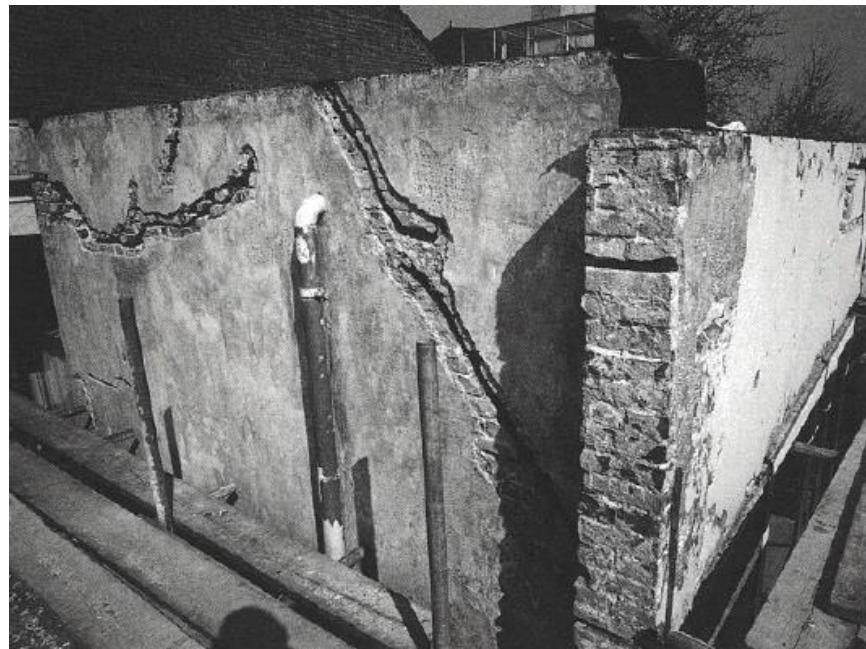
Foto 13 Diagonale scheur in de zuidgevel, ontstaan door het ontploffen van een munitieauto tijdens WWII. De scheur is gerepareerd met 1 m lange ingeboorde en gelijmde fiberstaven (Zijl and Mulder 2009).

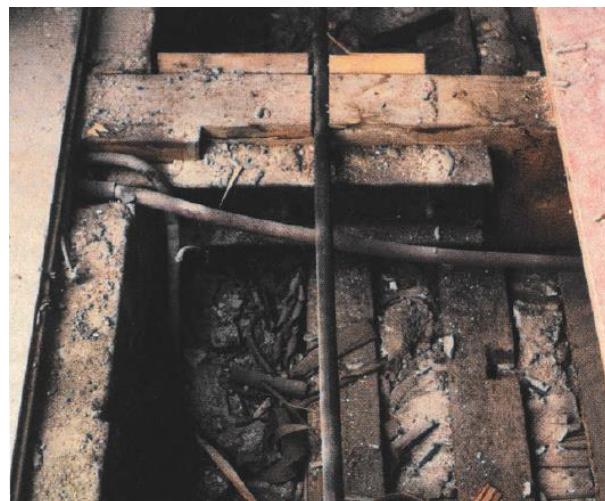
Foto 14 Verbinding van de staalconstructie van het balkon aan de oostgevel met de houten balklaag (Zijl and Mulder 2009)

- The balconies are a risk for use by visitors, both in terms of load and because of the insufficiently strong balustrades. They should be immediately closed to visitors.
- The roof and rainwater drains must be checked and maintained regularly to prevent leakages.

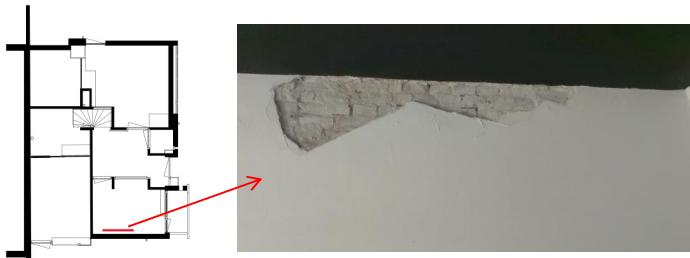
In October 2016, a piece of plaster from the top of the south wall of the study on the ground floor of the Rietveld Schröder House partially came loose. TU Delft carried out research into the causes for the release of the plasterwork and, in collaboration with TNO, the composition and properties of the plaster were investigated. The results are presented in *Petrografisch onderzoek pleisterwerk Rietveld-Schröderhuis Utrecht* (Nijland 2017; see appendix 3) and *Onderzoek naar het pleisterwerk van het Rietveld Schröder Huis* (Lubelli & Van Hees 2017; see appendix 4).

Figuur 1. Schade in de vorm van loslaten van het pleisterwerk in de studeerkamer van het Rietveld Schroder Huis.

The repair in the study room can be done in two ways:

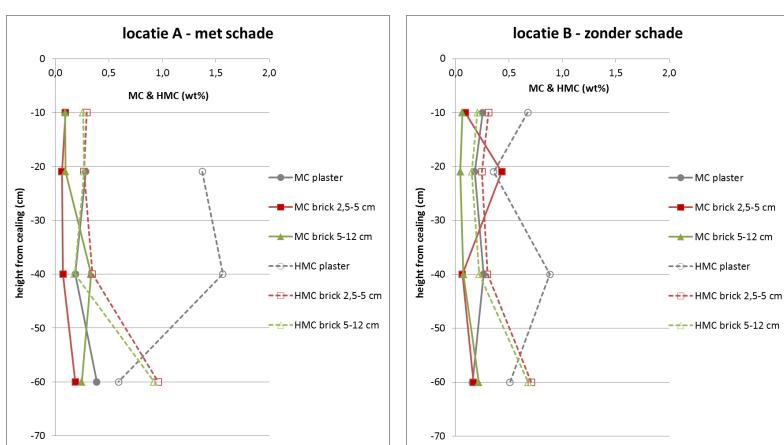
Het hygroscopische vochtgehalte (HMC) is ook laag (voor deze materialen kunnen waarden onder 2 gewicht % als laag beschouwd worden); dit betekent dat geen significante hoeveelheden hygroscopische zouten aanwezig zijn.

Figuur 6. MC en HMC in het pleisterwerk en achterliggende muur op beschadigde (A, links) en niet beschadigde (B, rechts) locaties

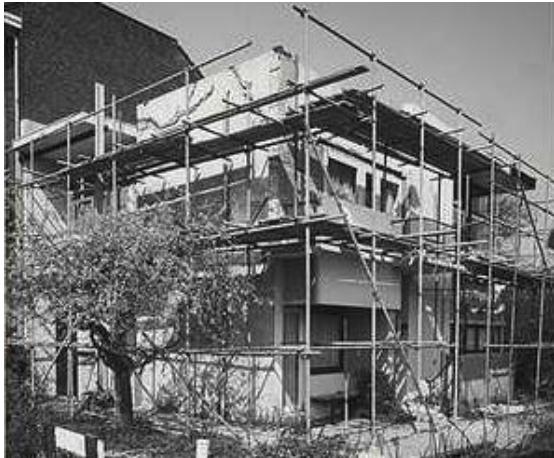
Tijdens de restauratie exterieur 1974; hierbij werden al veel nog aanwezige verflagen verwijderd, scheuren geopend, roestende en daardoor uitzettende dragers behandeld en met kunstharsmortel worden de scheuren weer gesloten.

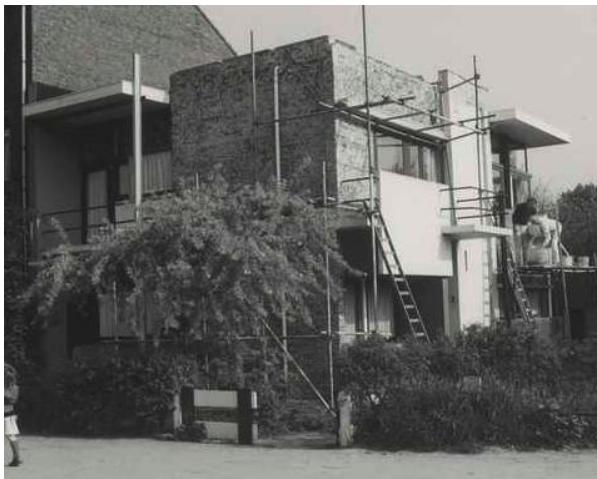
2^e ingreep aan het exterieur 1979: de scheuren in de gevelvlakken kwamen relatief snel weer terug. Men heeft het oude pleister van sommige vlakken helemaal verwijderd en vervangen.
