**CONSERVATION MANAGEMENT
PLAN FOR GOVERNMENT
MUSEUM AND ART GALLERY,
CHANDIGARH**

*This report is made possible through a grant from the Getty
Foundation through its 'Keeping It Modern' initiative.*

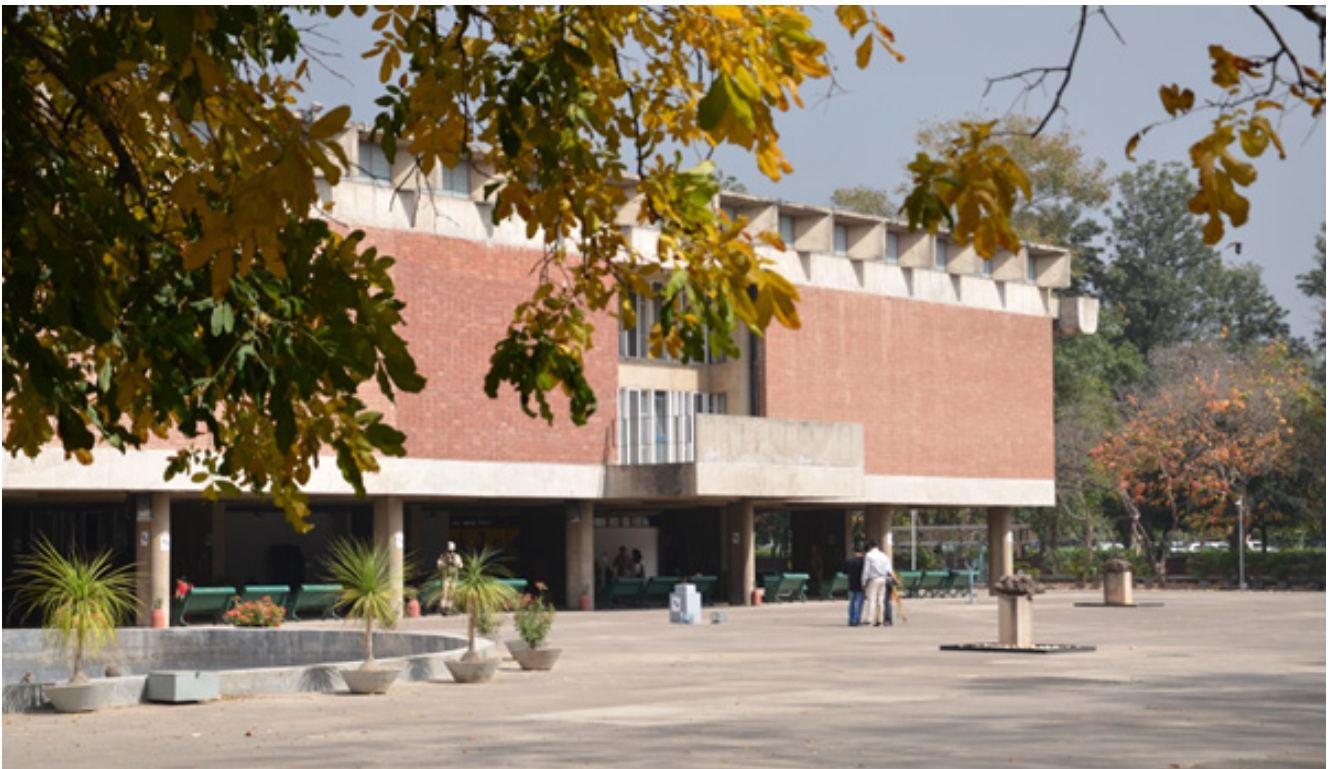
Fig. 1: Government Museum and Art Gallery, Chandigarh. Source: DRONAH

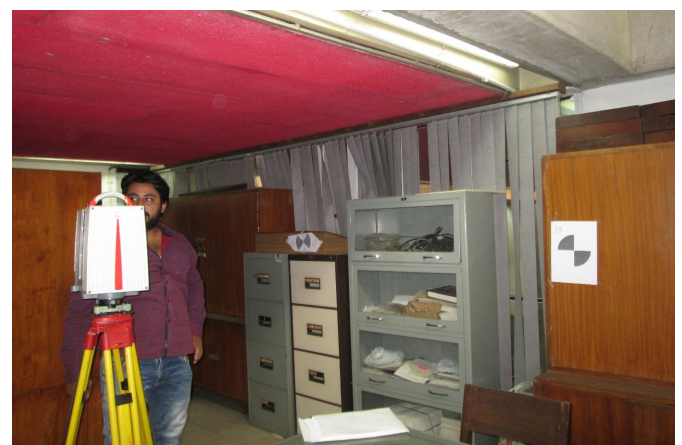
Fig. 3: Laser scanning team on site. Source: PEGS

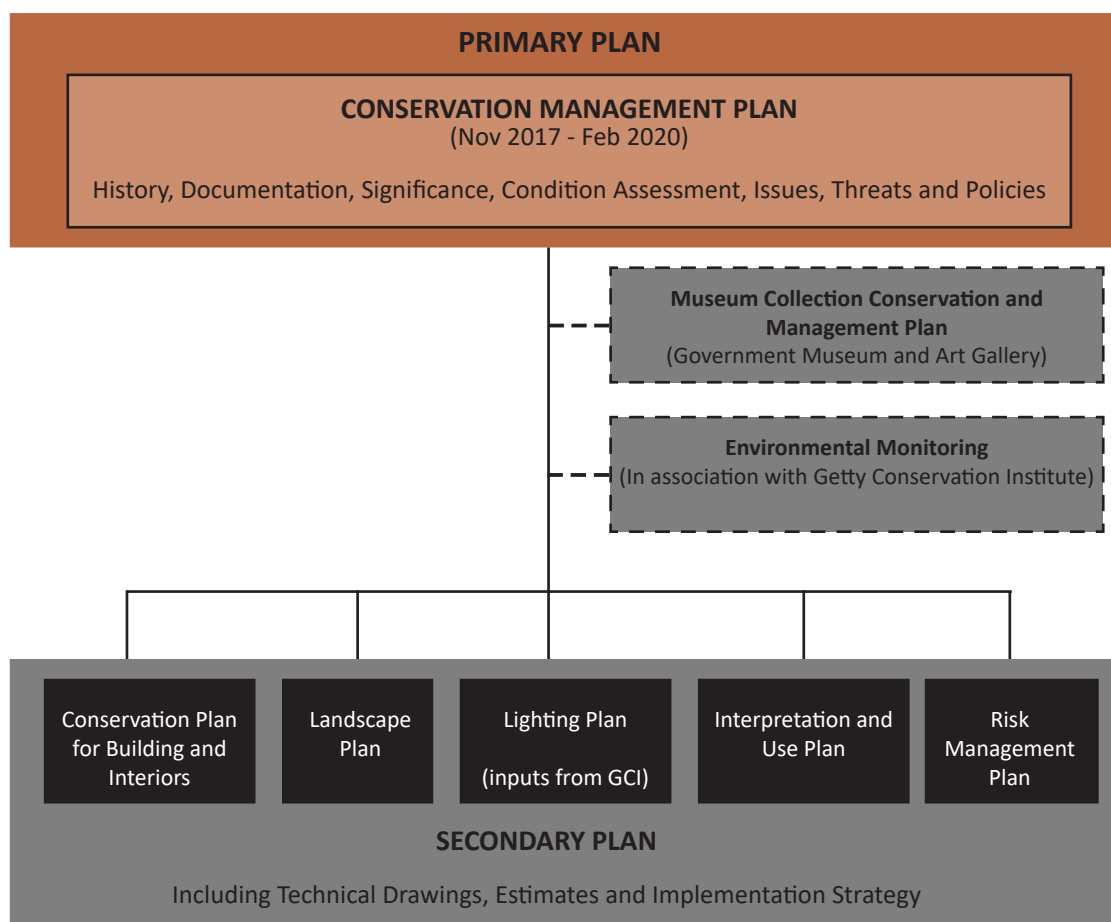
Fig. 4: Components of the Conservation Management Plan for Government Museum and Art Gallery

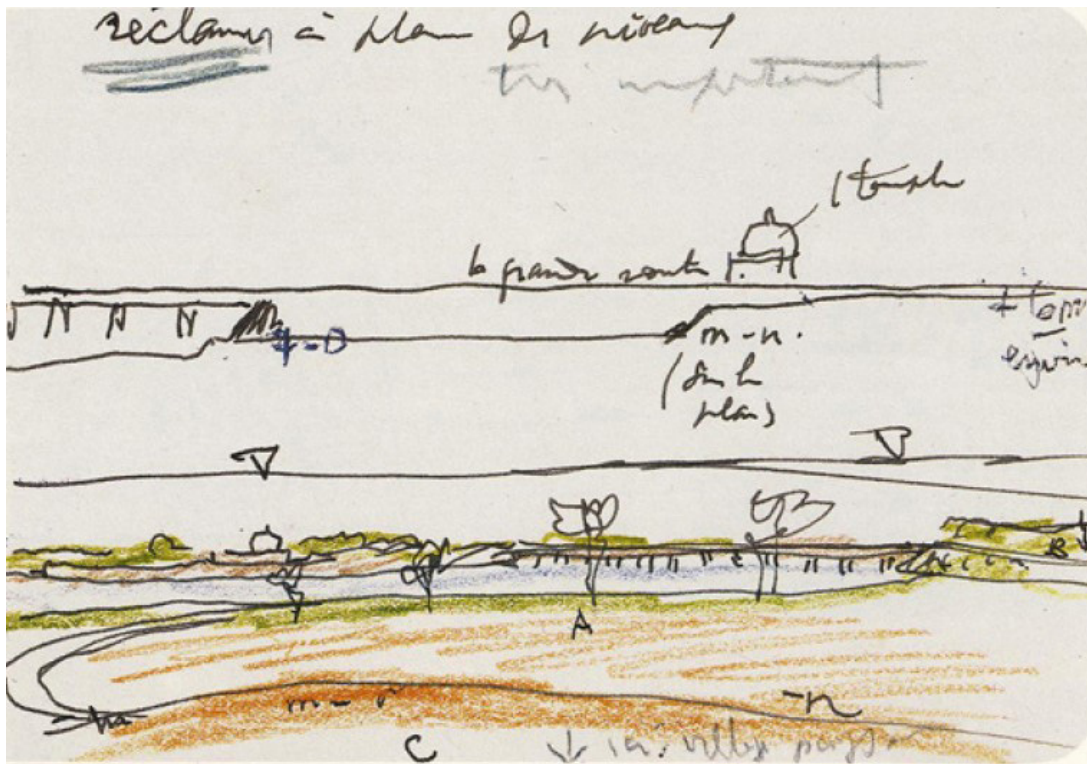
Fig. 18: Sketch by Le Corbusier on site of Ahmedabad Museum. Source: Le Corbusier (1981-82) *Le Corbusier Carnets. Vol. 2*

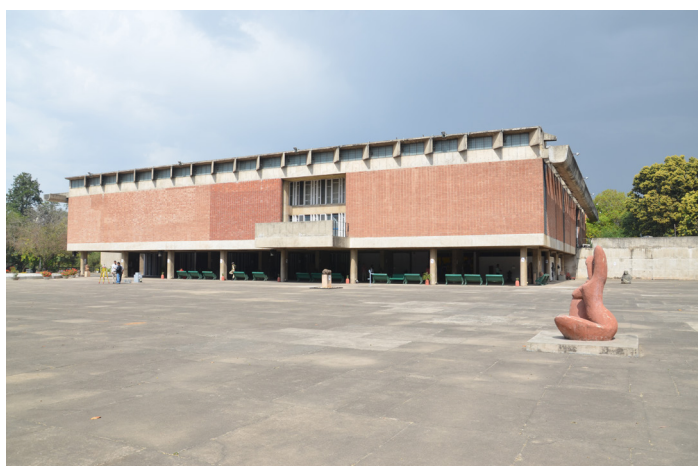
Fig. 40: South-west façade of the museum photographed around 12 noon in January. Source: DRONAH

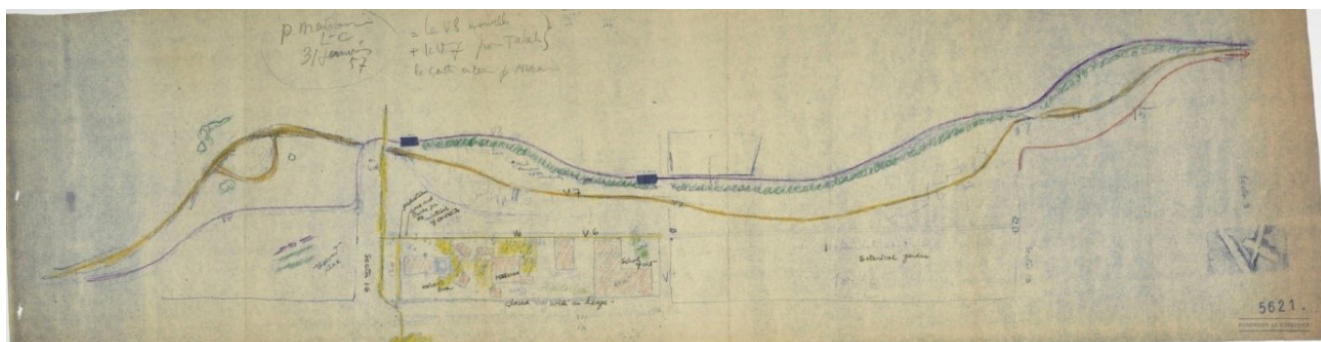
Fig. 41: Sketch showing pedestrian path mirroring the curve of the stream. Source: FLC Archive

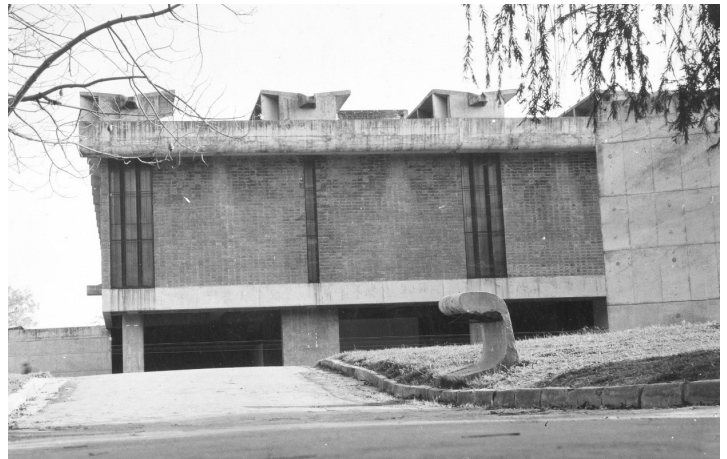
Fig. 49: Concrete bollard light. Source: Museum Archive

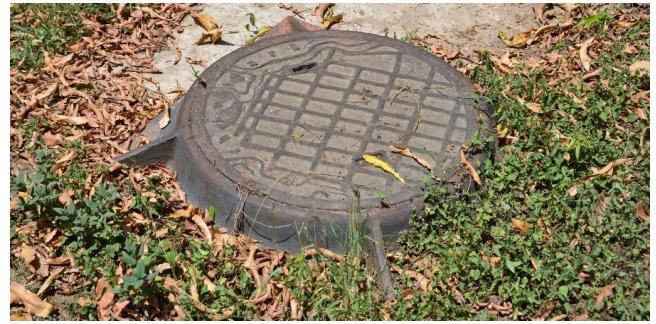
Fig. 51: Manhole cover with sectoral grid of Chandigarh city. Source: DRONAH

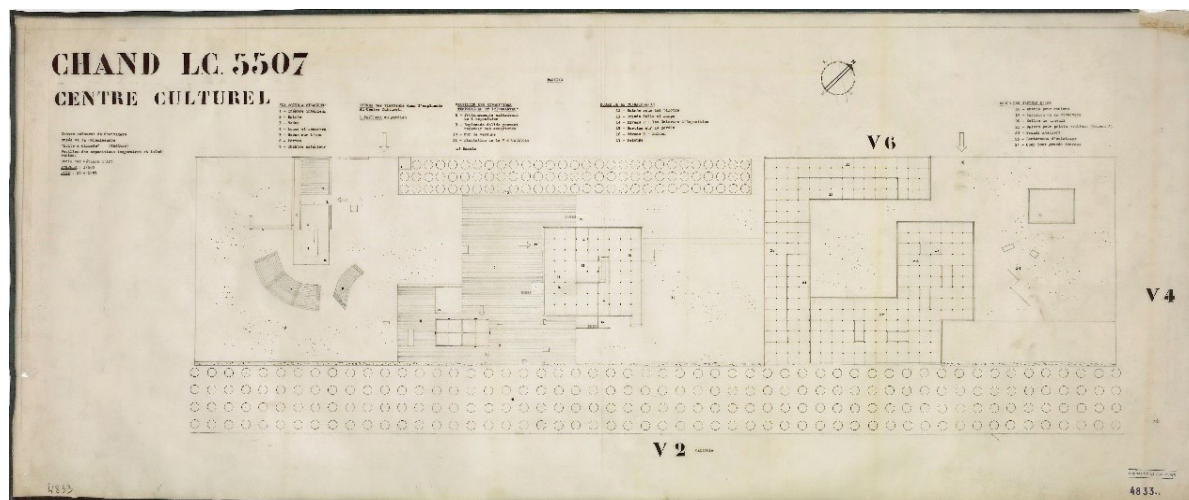
Fig. 52: Archival drawing showing layout of Cultural Centre, 1957. Source: FLC Archive

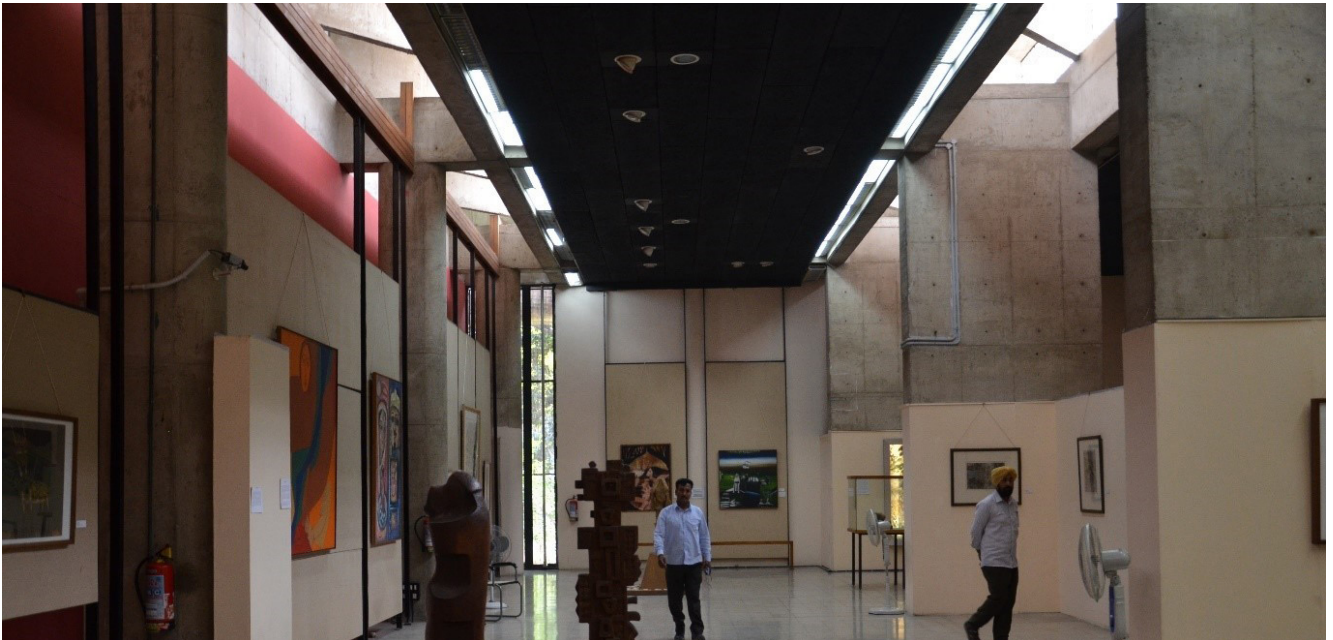
Fig. 71: Gallery space lit by skylight above. Source: DRONAH

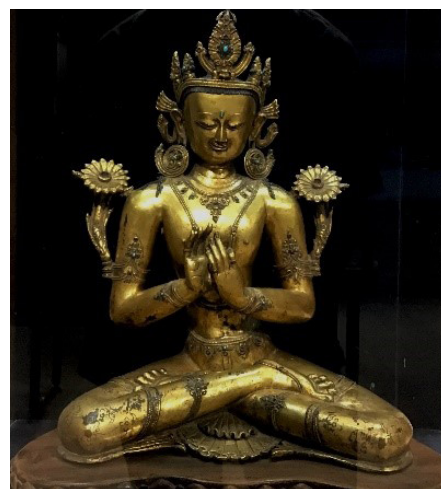
Fig. 91: Bronze sculpture of Bodhisattva Maitreya (L); Source: DRONAH

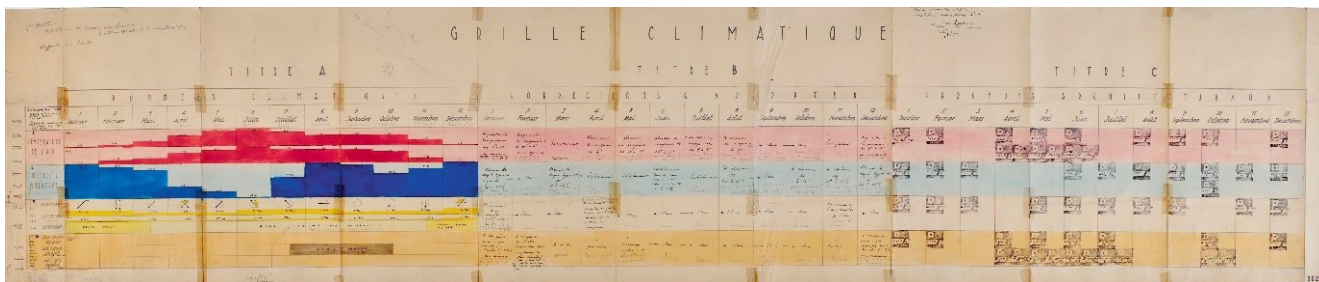
Fig. 97: Grille Climatique or Climatic grid formulated by Le Corbusier. Source: FLC

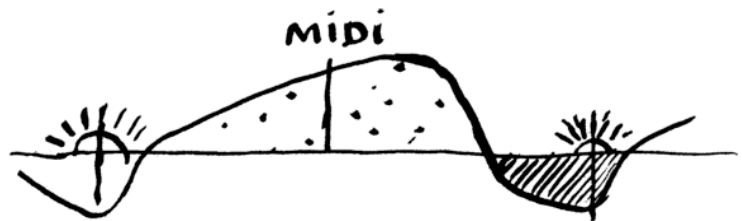
Fig. 100: Sketch by Le Corbusier showing cumulative experience of solar heat. Source: <http://solarhousehistory.com/blog/2013/10/28/le-corbusier-and-the-sun>

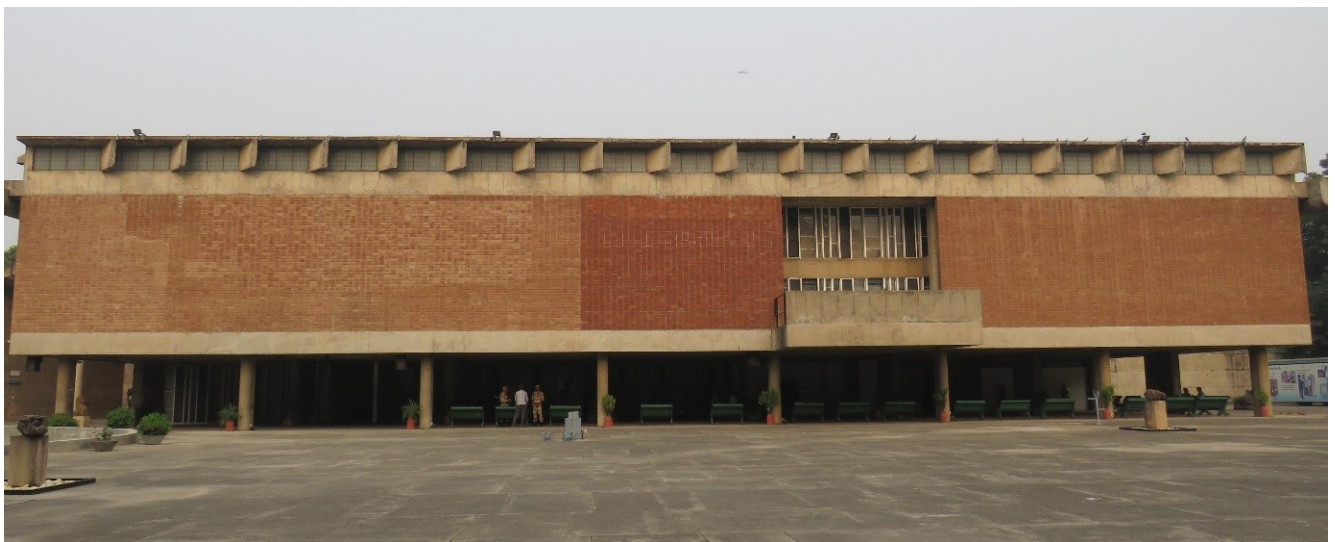
Fig. 101: South-west façade of the building with sun protection system. Source: DRONAH

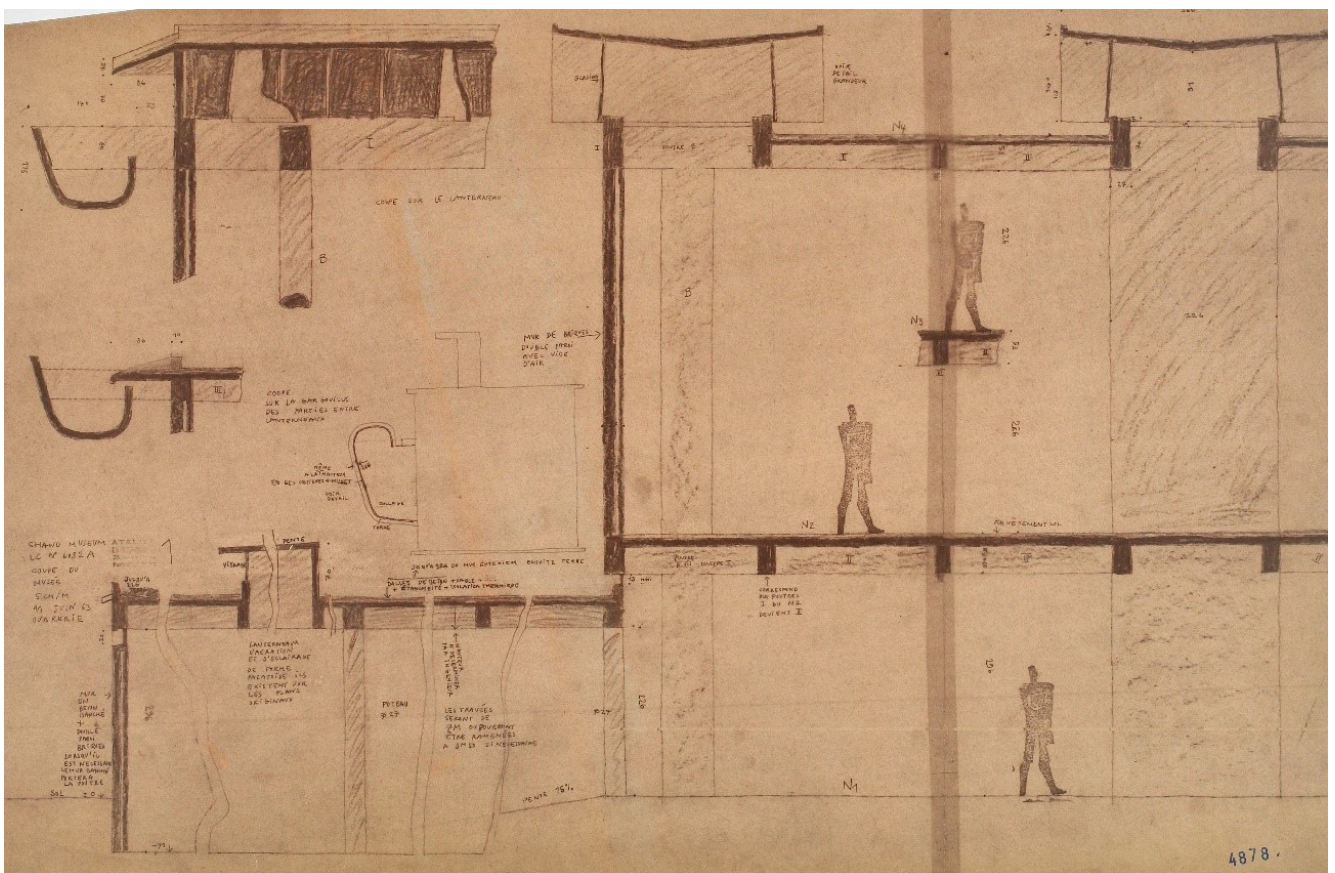
Fig. 102: Archival drawing showing section through double brick wall with cavity. Source: FLC Archive

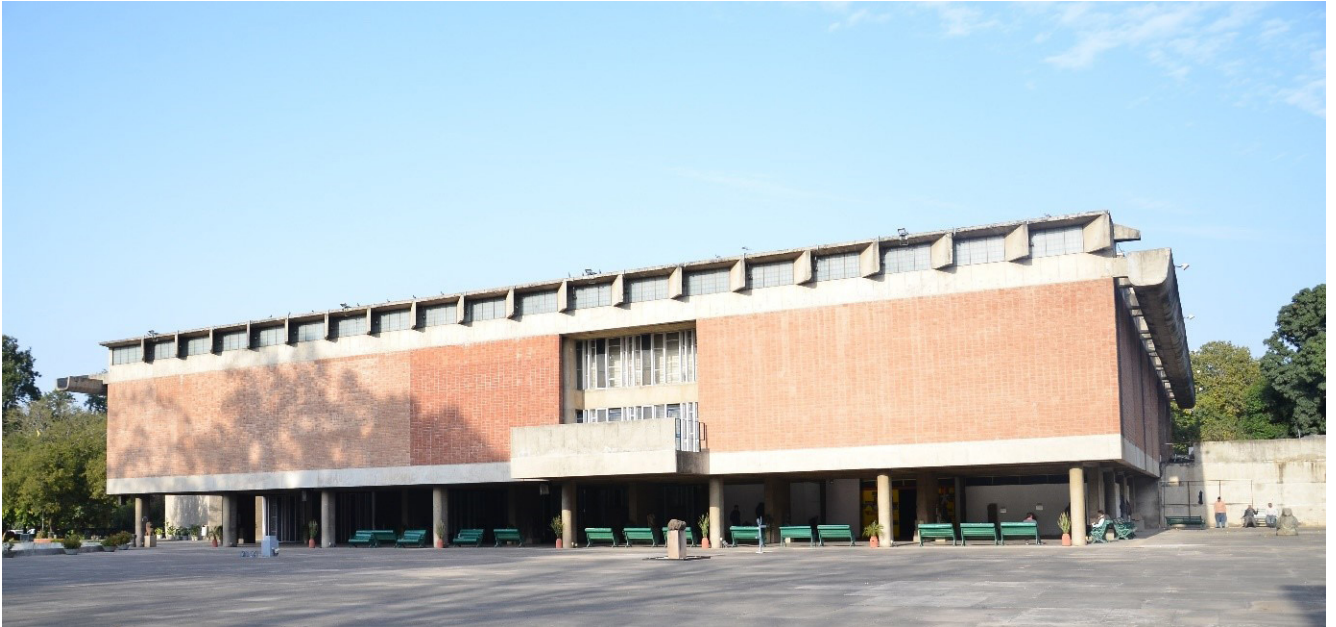
Fig. 108: Replacement of brick tiles on exterior façade shows incompatibility in terms of specification and colour.

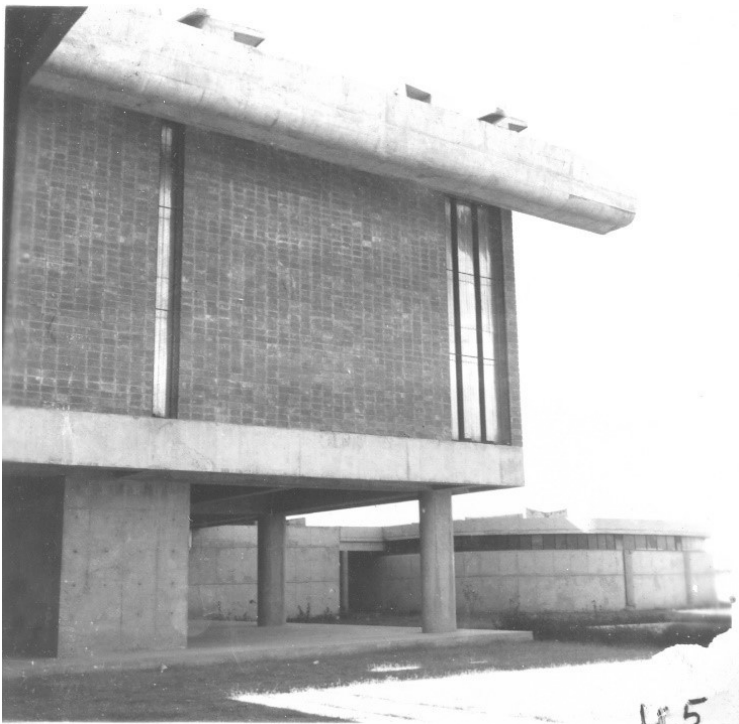
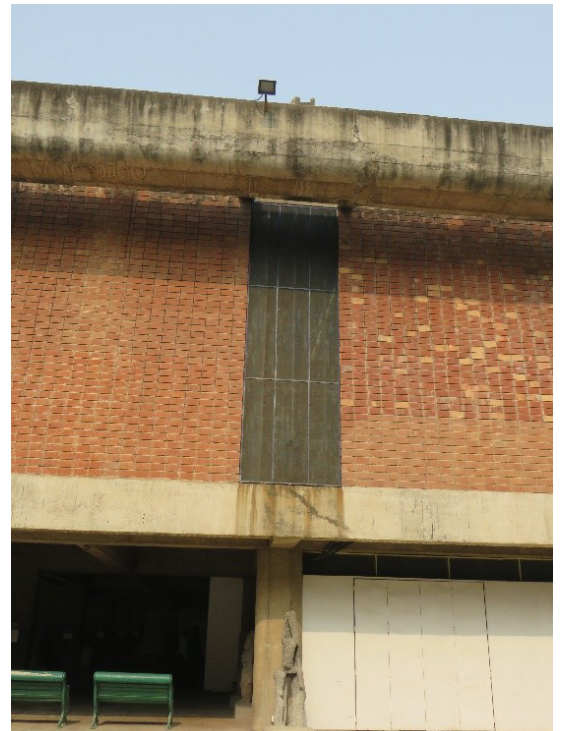
Fig. 109: Painted mesh over vertical fenestrations as later addition.

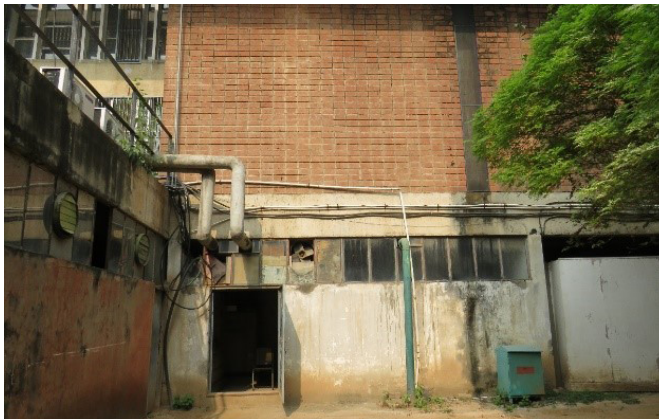
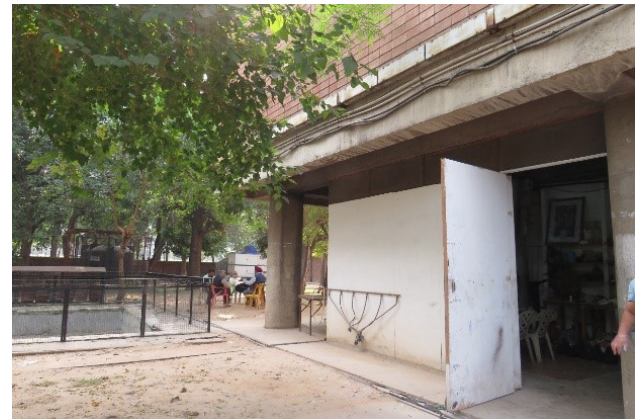
Fig. 110: Additions using permanent and temporary materials to accommodate utility spaces at the rear side of the building.

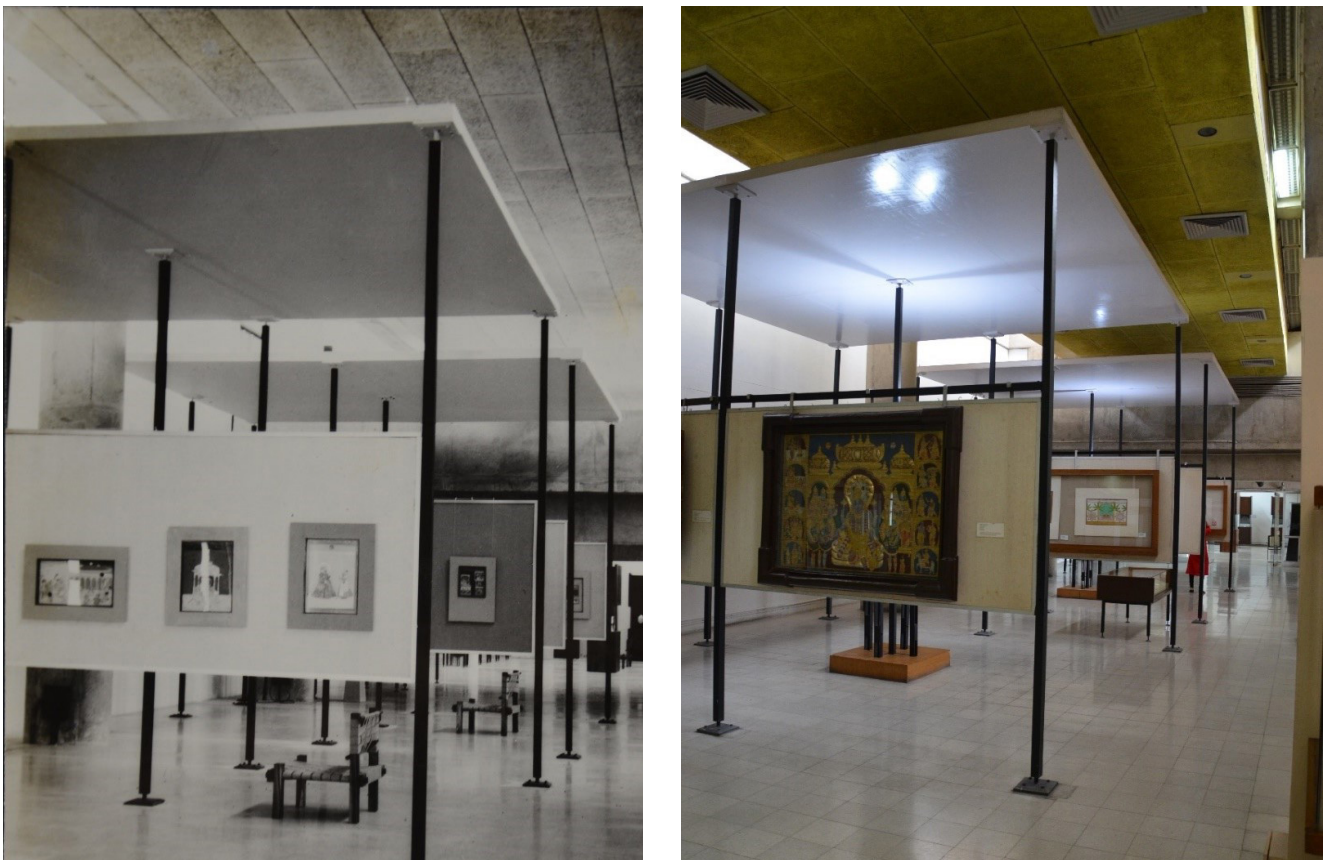
Fig. 113: Addition of air conditioning units has brought down the ceiling level in the gallery dampening the spatial quality.

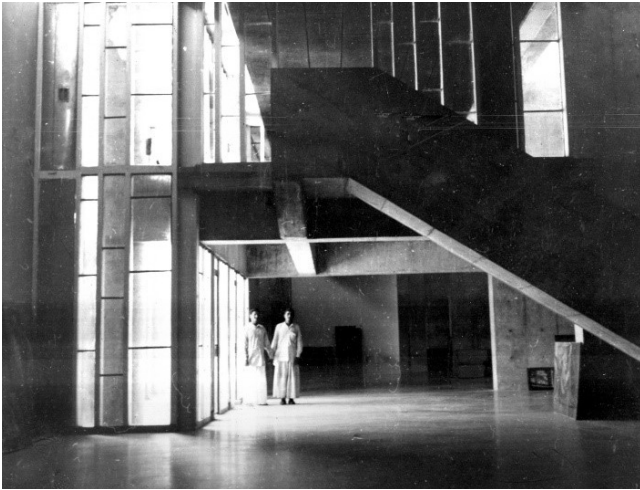
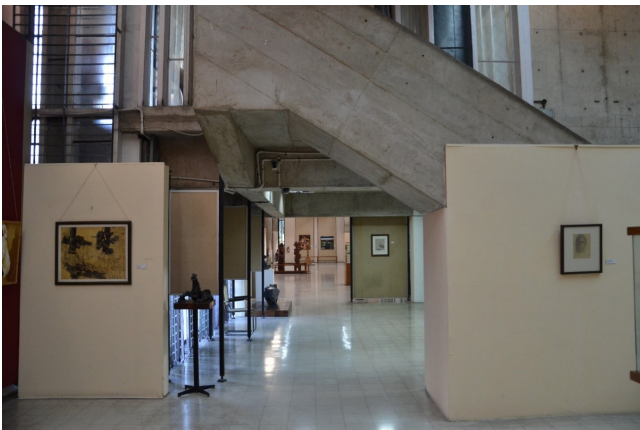
Fig. 114: Partitions that serve as display panels block the window opening.

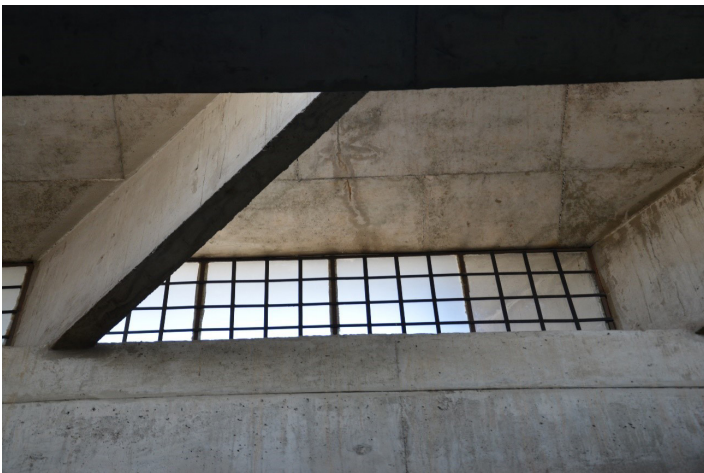
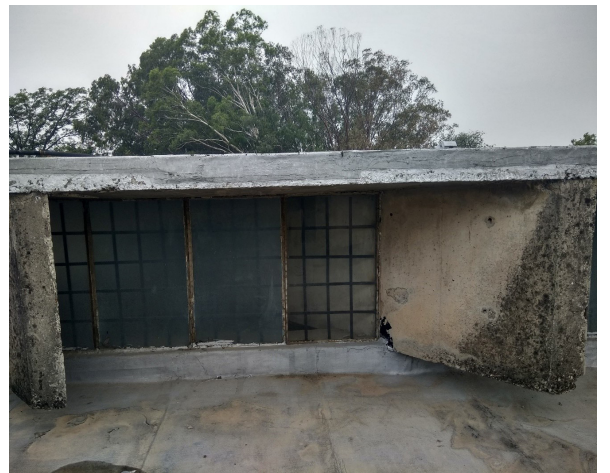
Fig. 123: Protective Addition of protective grills to clerestory windows. The window pane is replaced with glass that do not match the original tinted glass.

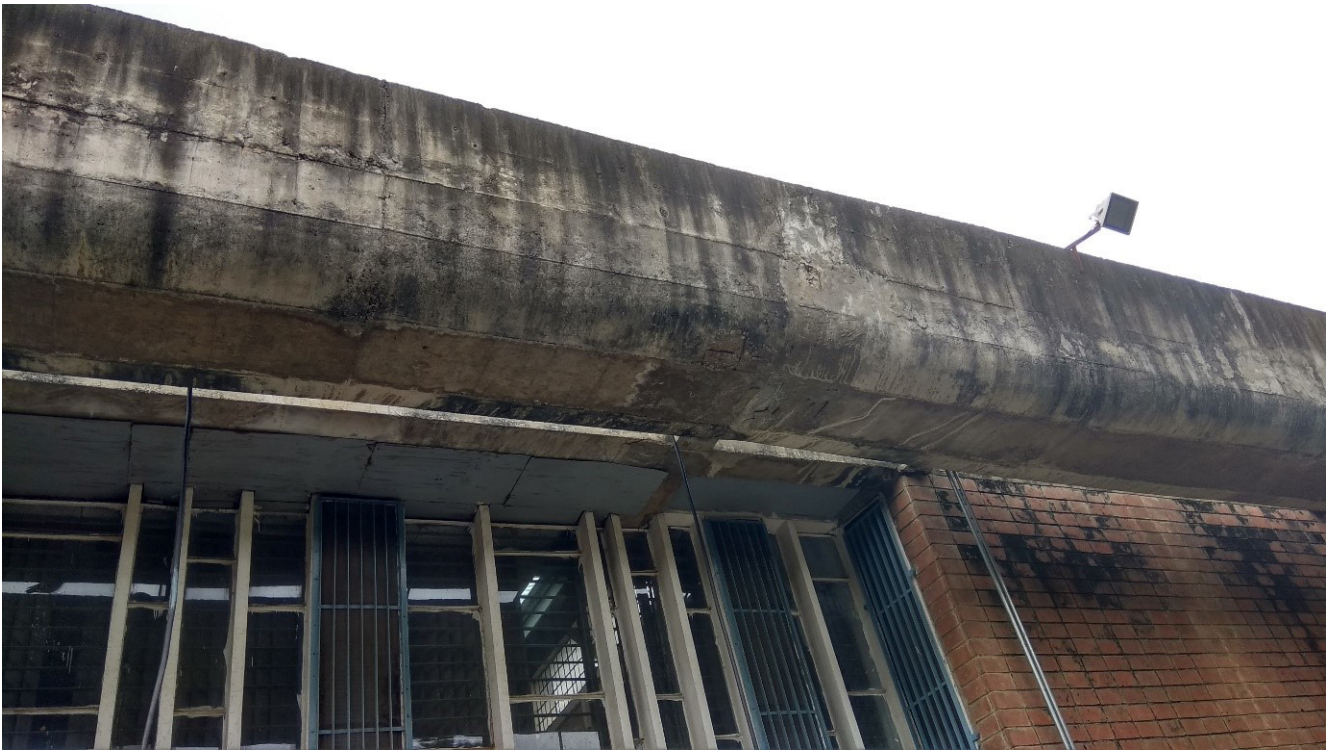
Fig. 124: Patch repair of concrete drains

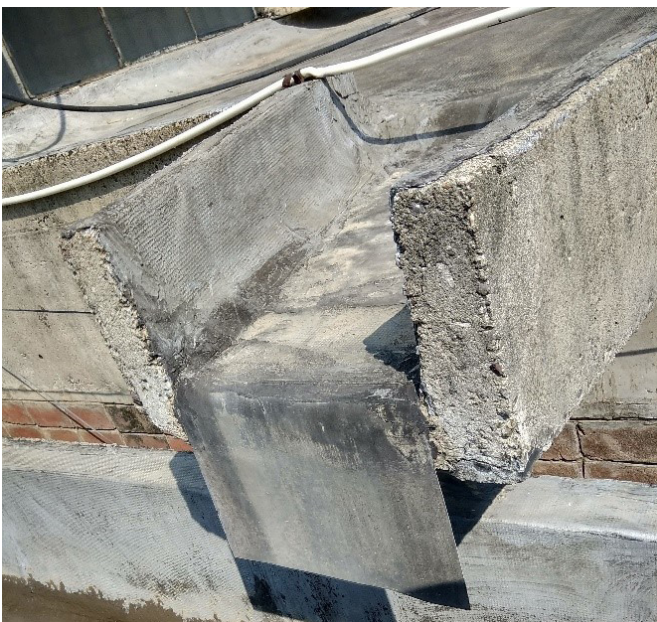
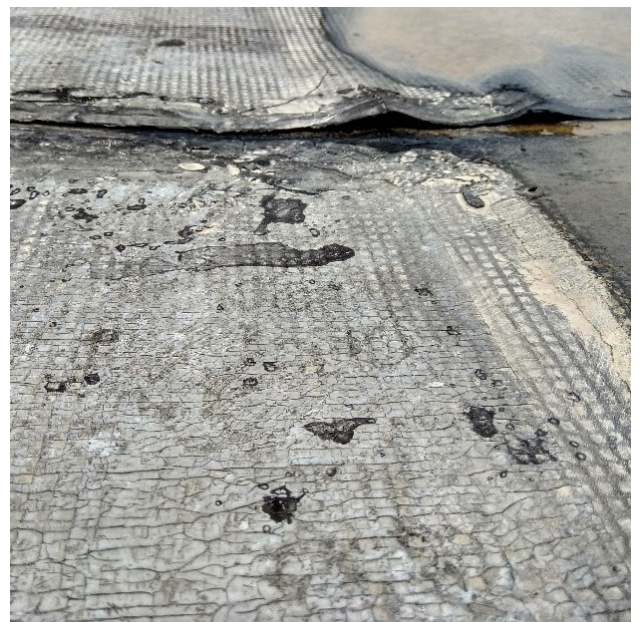
Fig. 125: Inefficient patch repair of terrace waterproofing

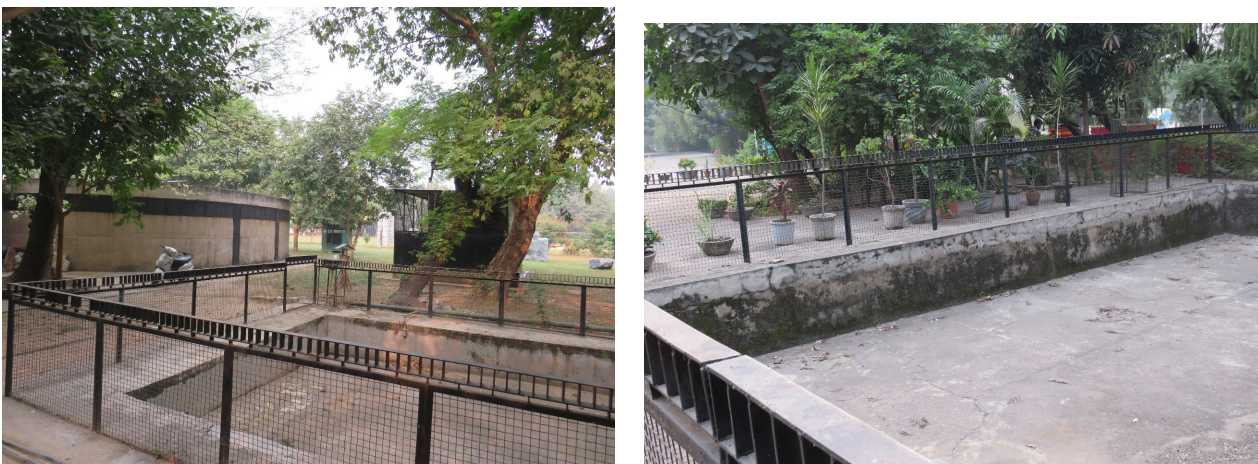
Fig. 127: Addition of metal railing around - Rear pool (L); Auditorium pool (R)

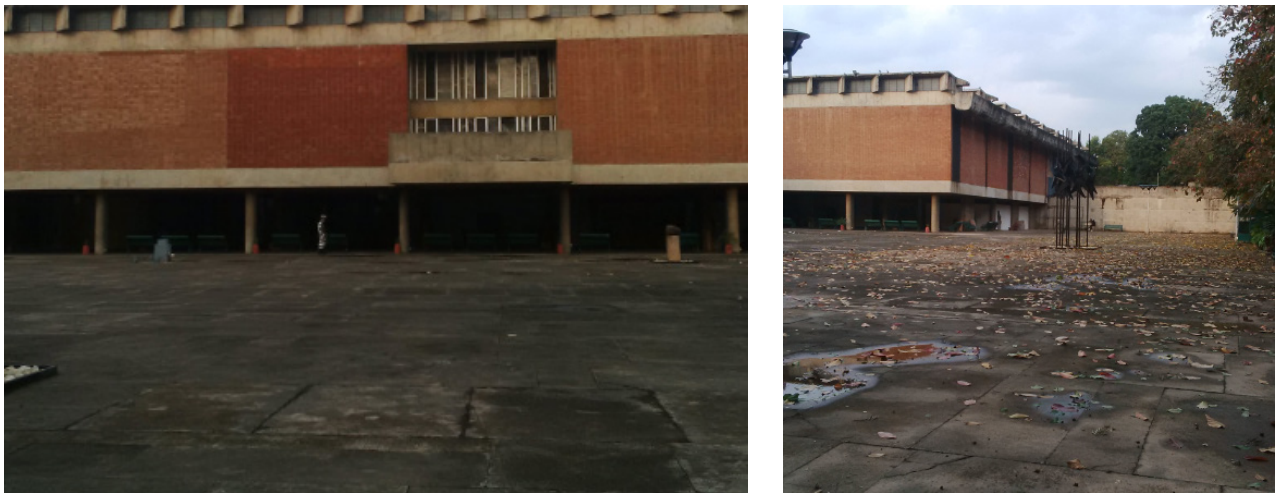
Fig. 128: Condition of piazza flooring- water-logging at places, discoloration of concrete surface

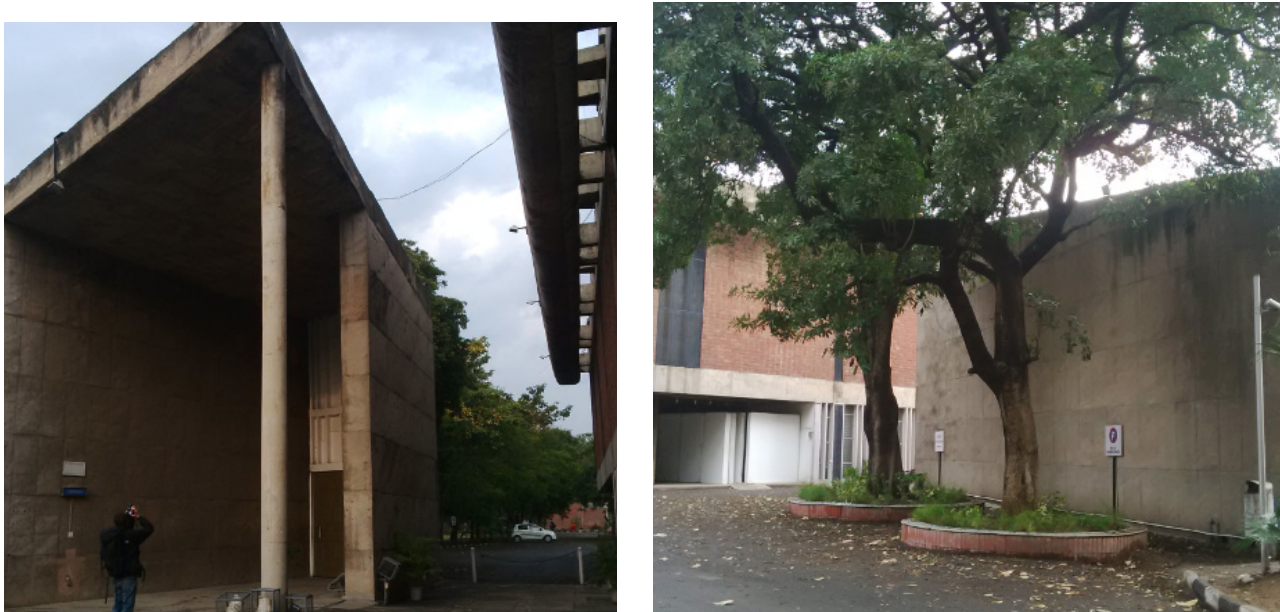
Fig. 129: Damaged litterbin and cluster of uplighters near auditorium (L); Inefficient signage and other utilities

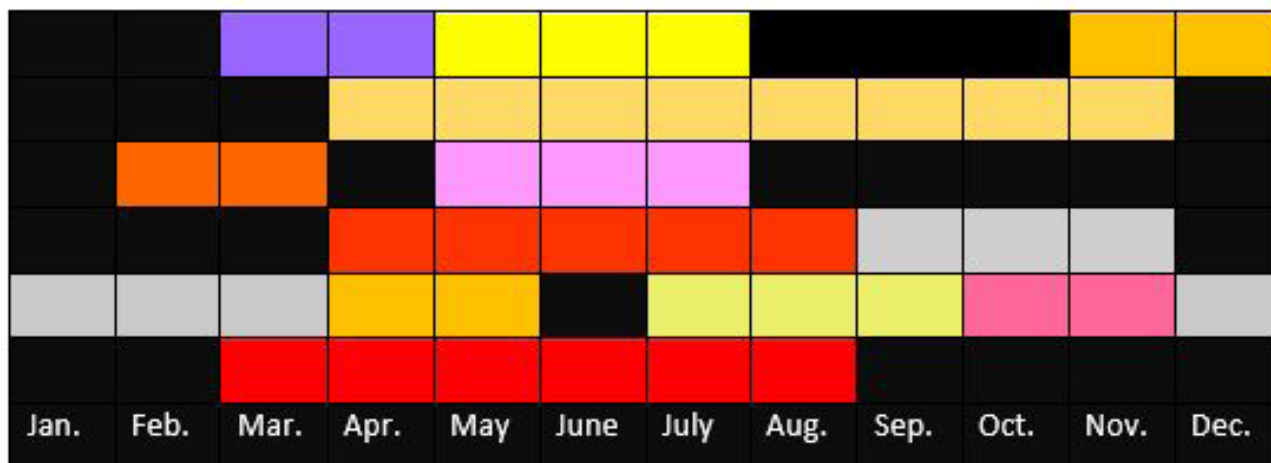
As evident from the above Table 9, it is seen that three to four tree species in the landscape are always in flowering state during most part of the year, with the spring and summer months contributing to the most colourful sight, when six to seven trees flower simultaneously. Thus the planting palette reveals a well-thought out concept and strong rationale in selection and positioning of the trees in the museum landscape, further corroborated through the Figure 131(L), where it is seen that 56% of the trees present in the Museum site are flowering trees, of which 51% are of bright colours. The percentage distribution of different colours of this tree category is given in Figure 131(R), that indicates a high preference towards red and allied colours, which constitutes nearly 50% of the flowering trees, distantly followed by those with purple hues and further with the yellow ones.

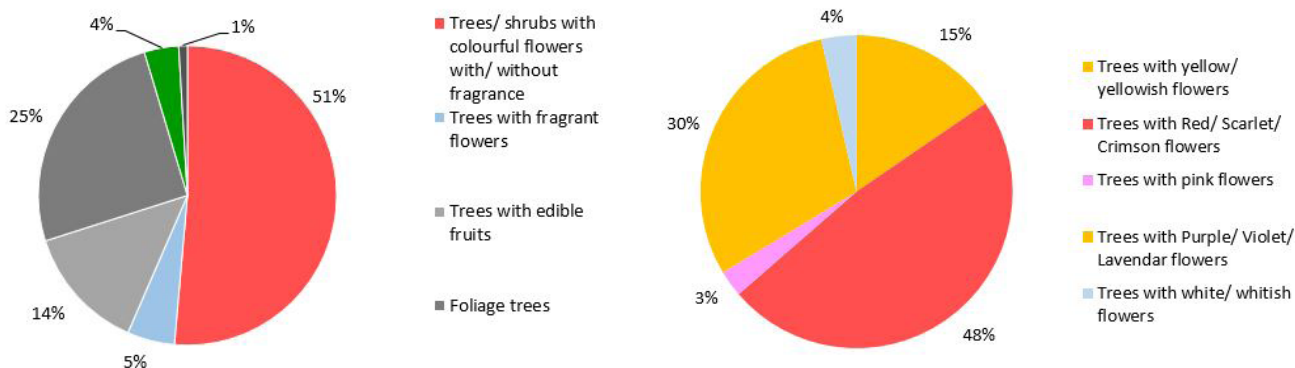
Fig. 131: Tree composition and categorization of Museum site (L); Percentage colour distribution of flowering trees in the site (R)

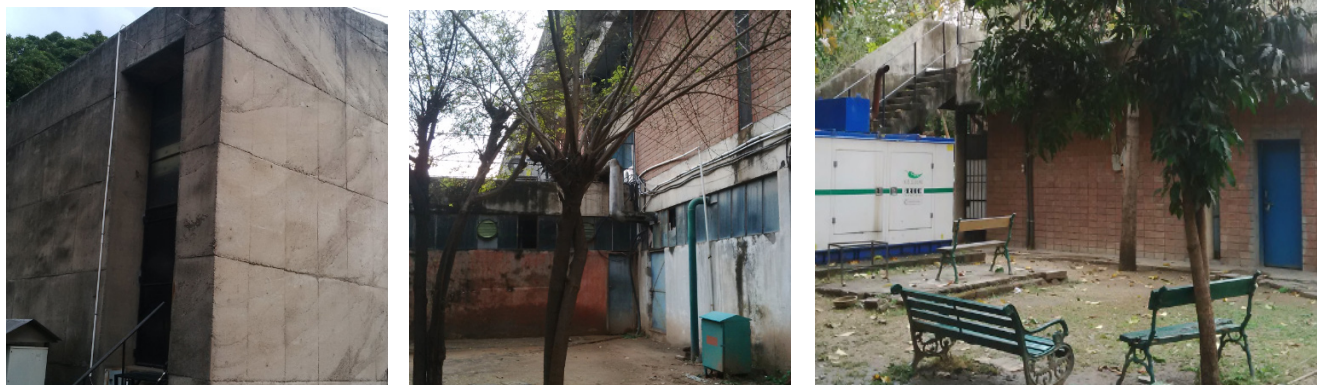
Fig. 134: Air Conditioning outdoor units at the rear side of the auditorium (L); Trees have been heavily pruned in the utility areas (C); The DG set within a rather unkempt landscape, hidden from the public view, but with garden benches (R)

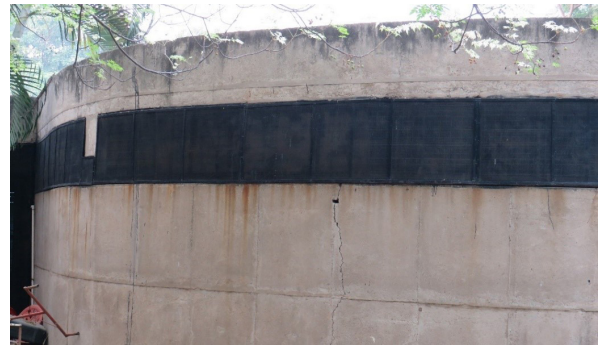
Fig. 135: Cracks due to repairs made in the interior of the temporary exhibition gallery

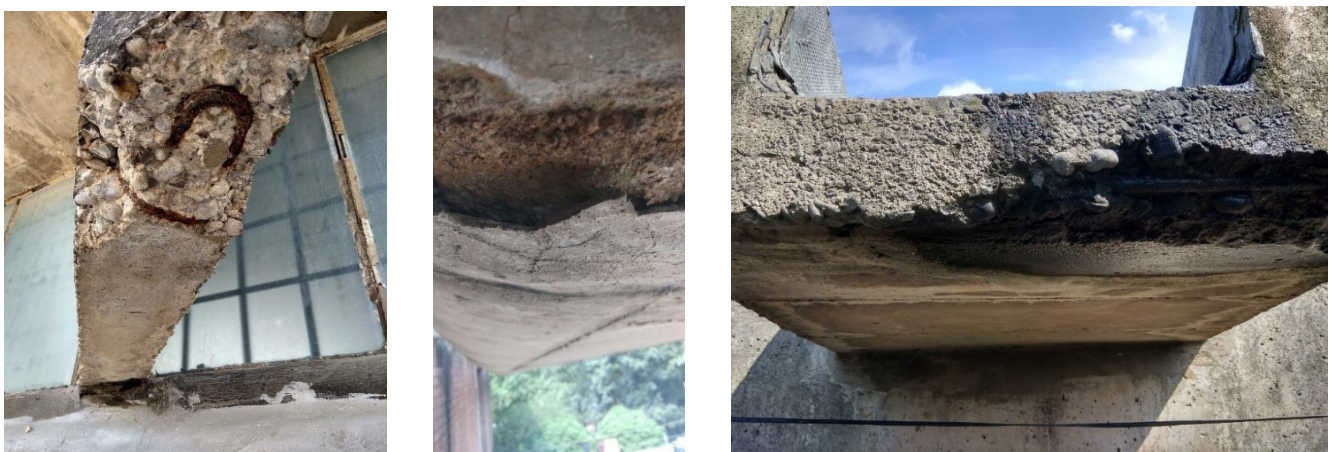
Fig. 136: Spalling leading to loss of material and exposed rebars along the outer edges of fins(L); Concrete spall at the underside of concrete drains (C)

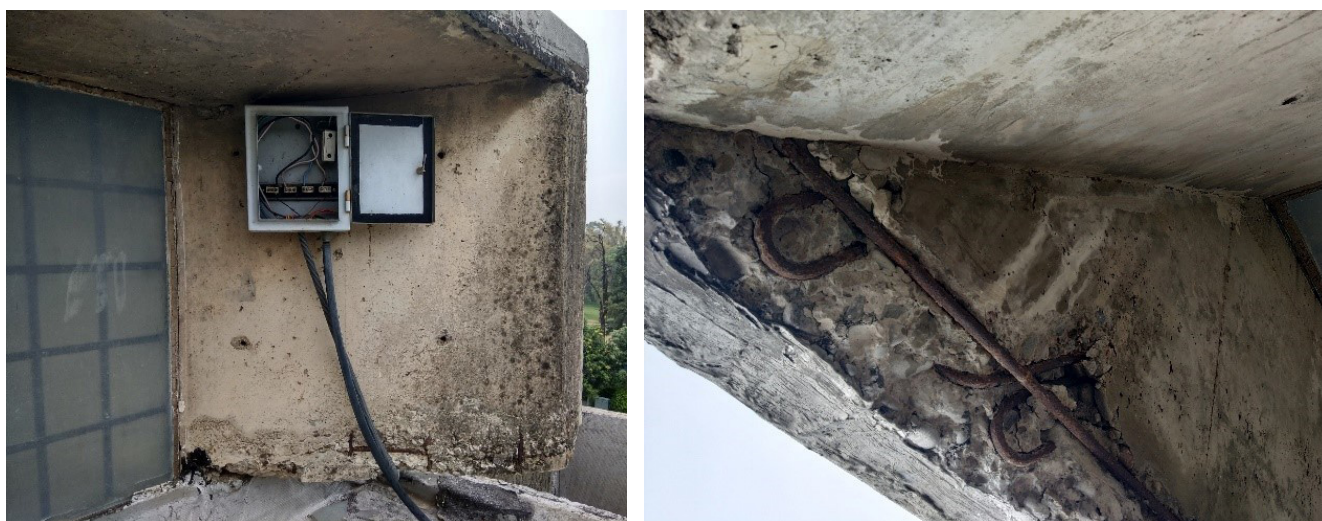
Fig. 137: Exposed rebars of terrace elements

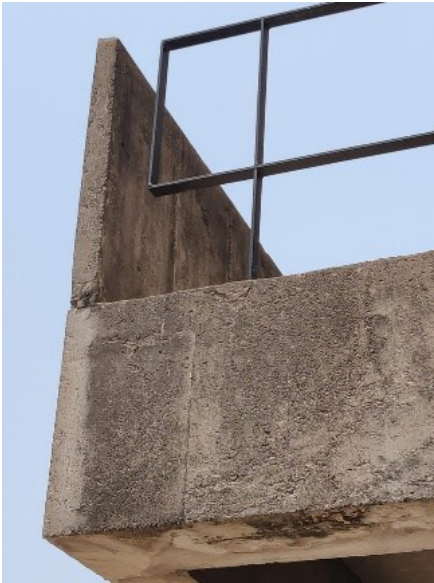
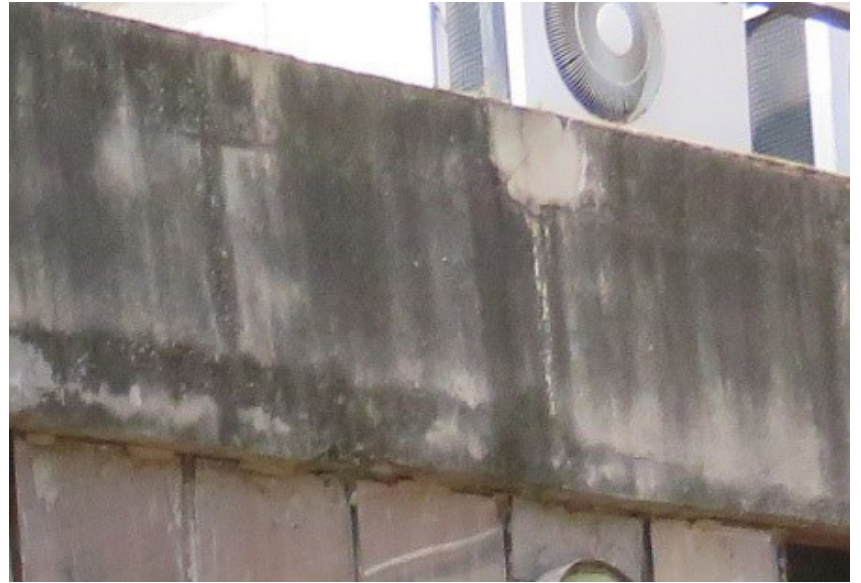
Fig. 138: Surface deterioration and soiling on concrete surface.

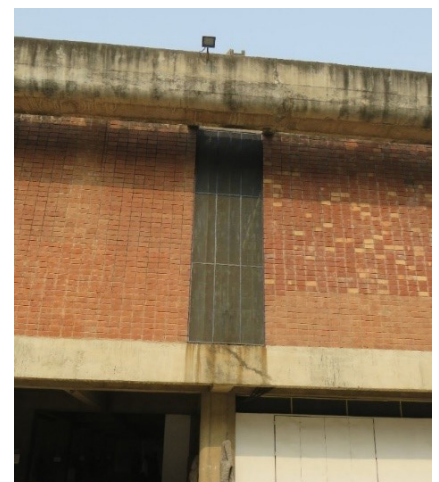
Fig. 139: Rust stains on concrete beam due to water washing over rusted metal mesh at the window openings

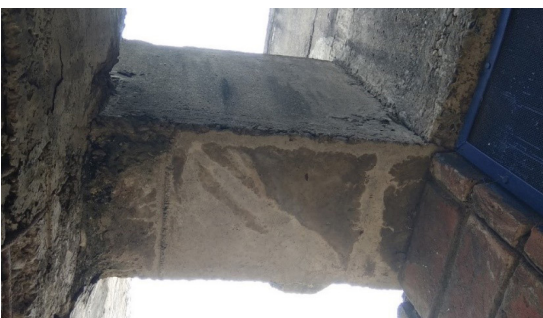
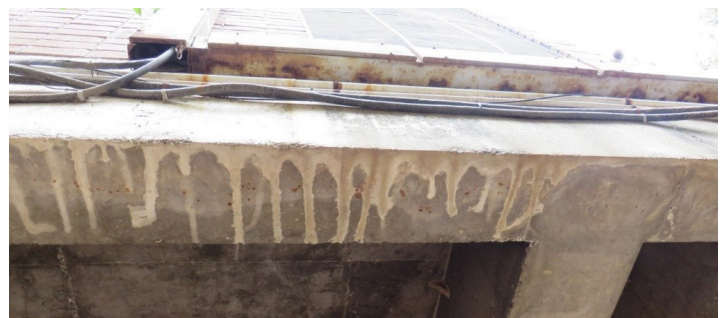
Fig. 140: Water stains at the bottom surface of connectors (L); Staining under beams (R)

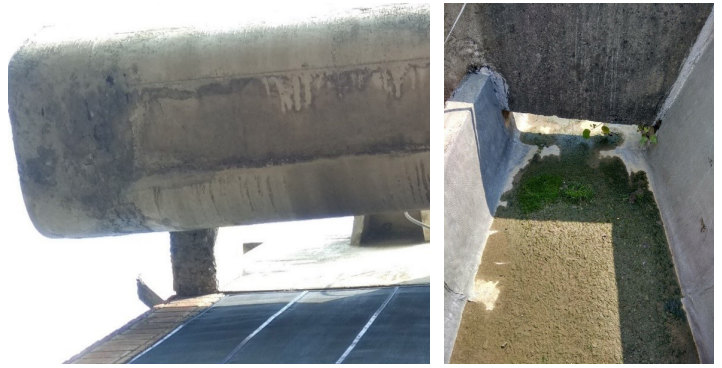
Fig. 141: Failing patch repairs (L); Water stagnation inducing vegetation growth within concrete drain (R)
