**CONSERVATION MANAGEMENT
PLAN FOR GOVERNMENT
MUSEUM AND ART GALLERY,
CHANDIGARH**

*This report is made possible through a grant from the Getty
Foundation through its 'Keeping It Modern' initiative.*

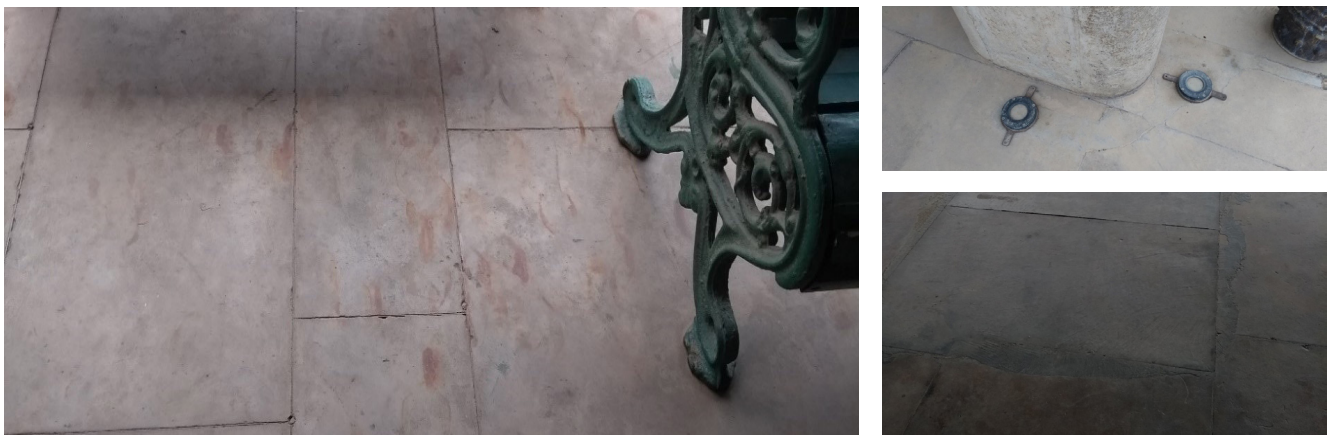
Fig. 142: Surface abrasions and rust stains (L); Alterations and repairs made on concrete flooring in pilotis (R)

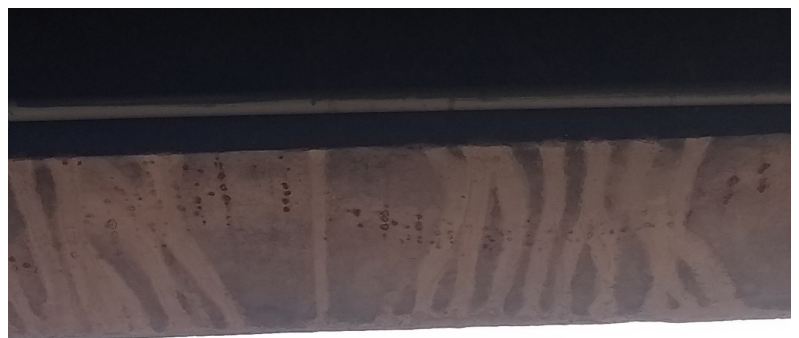
Fig. 143: Rust staining and exposed rebars due to loss of concrete cover

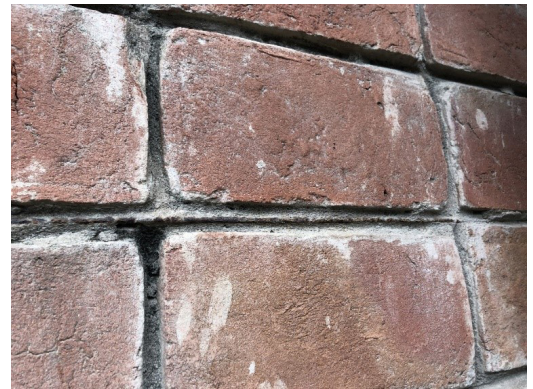
Fig. 144: Metal strips between brick tile cladding

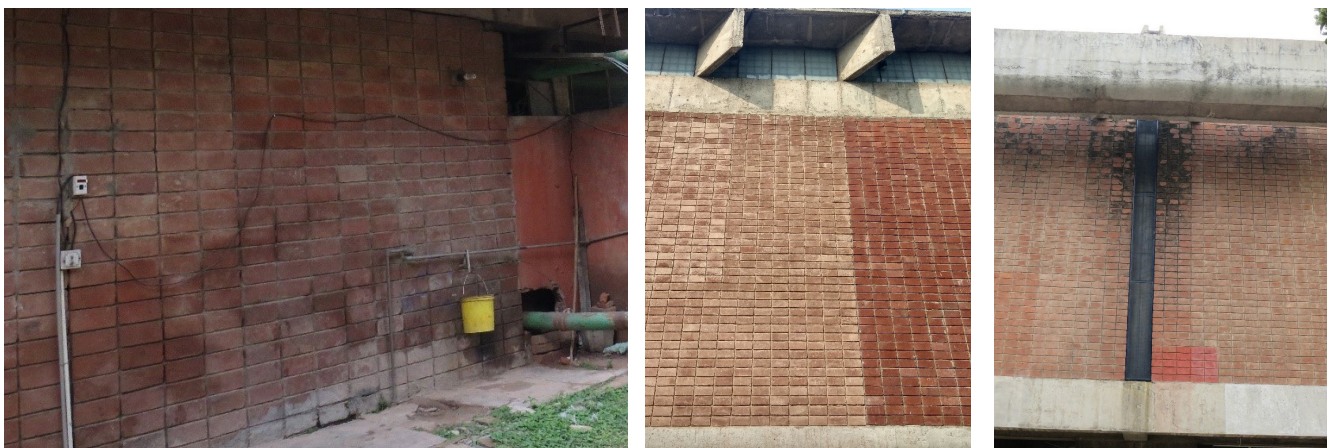
Fig. 145: Brickwork damaged due to water seepage (L); Discoloration of replaced bricks (C); Algal growth on brick tile surface under gargoyle (R)

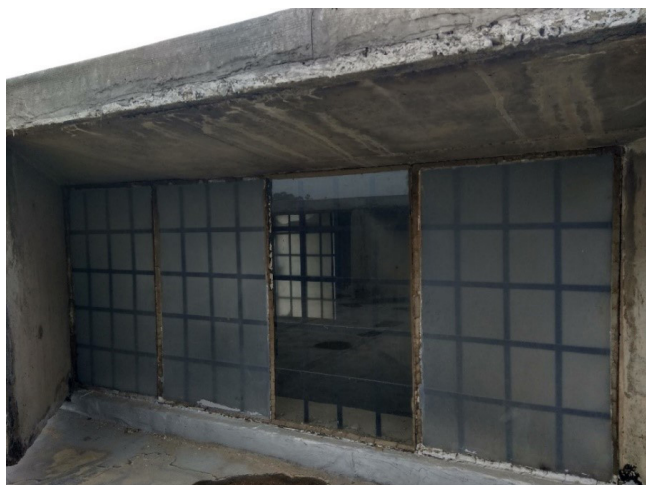
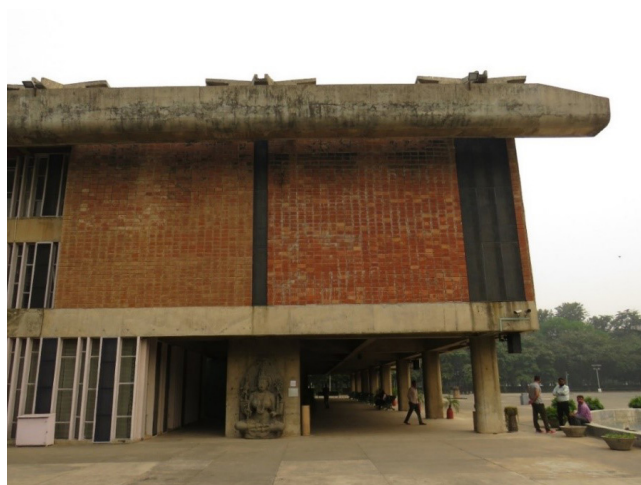
Fig. 146: Glass panes replaced with un-tinted glass (L); Painted metal mesh over the external windows allows water into the galleries during the rain (R)

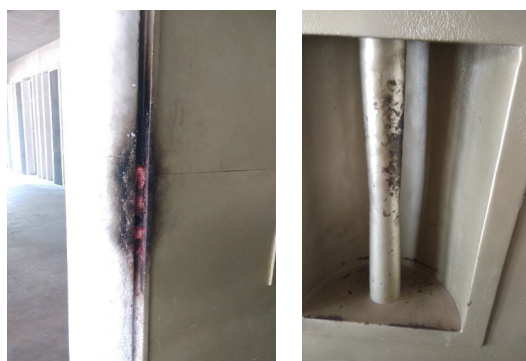
Fig. 147: Wearing of entrance door and handle

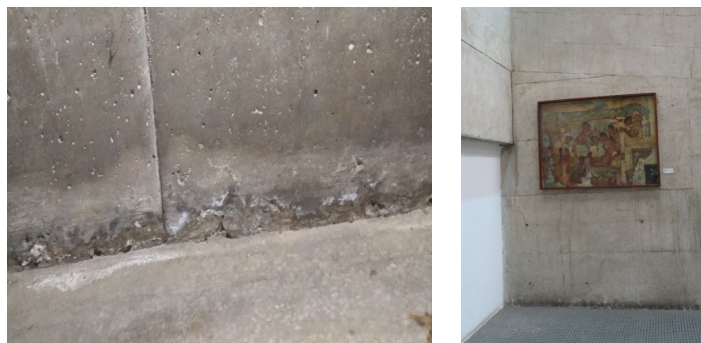
Fig. 148: Discoloration due to daily swabbing

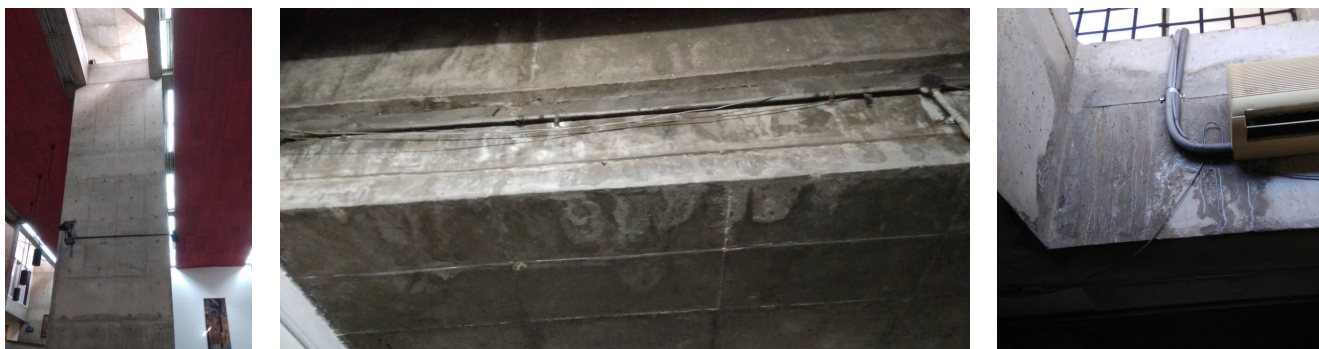
Fig. 149: Water seepage from clerestory windows (L); Failing air conditioning pipes (C)(R)

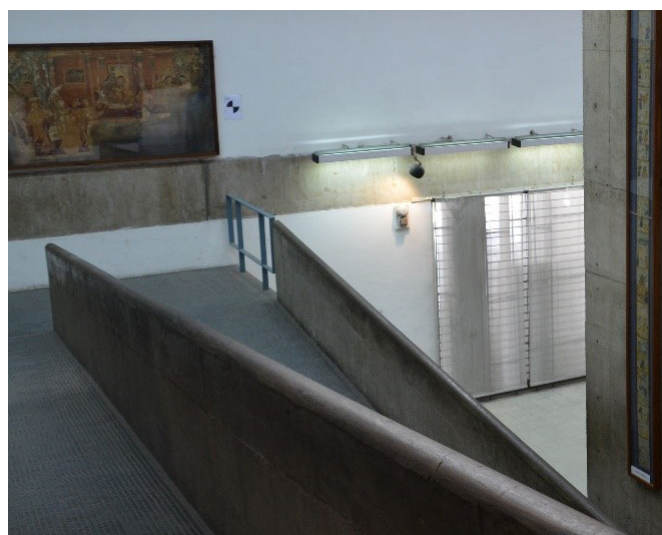
Fig. 150: Stratigraphy of paint sourced from metal railing on ramp (L); Staining on concrete handrail due to weathering (R)

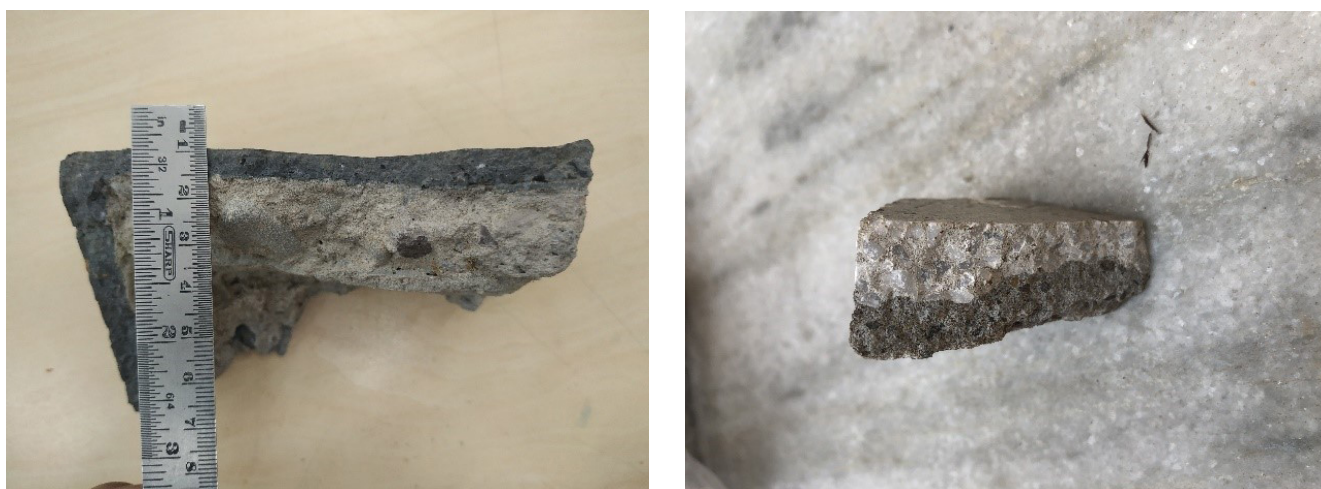
Fig. 151: Terrazzo sample taken for analysis. Black terrazzo (L); White terrazzo (R)

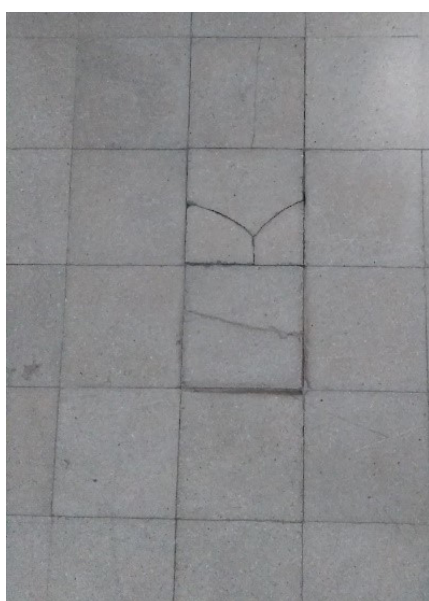
The terrazzo flooring of the museum interior shows general weathering of the surface. A few cracked tiles in the first floor galleries have also been observed.

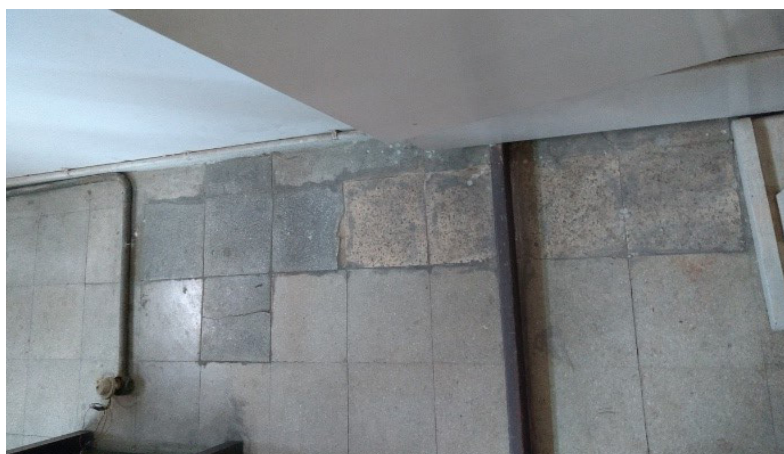
Fig. 152: Broken terrazzo tiles in gallery (L); The replaced and repaired tiles seem to be different from the original terrazzo tiles in colour and composition

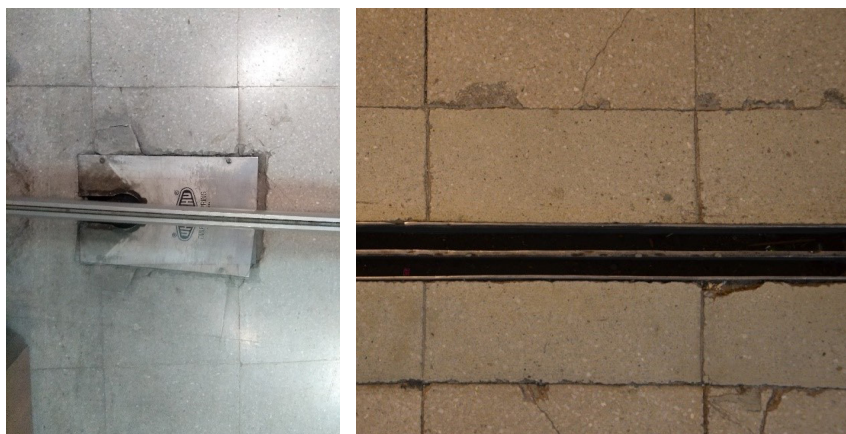
Fig. 153: Modern alterations damaging original terrazzo floor tiles

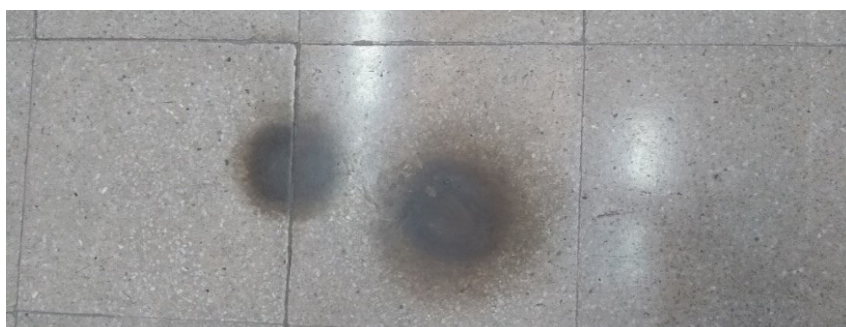
Fig. 154: Tile damage due to water dripping from roof

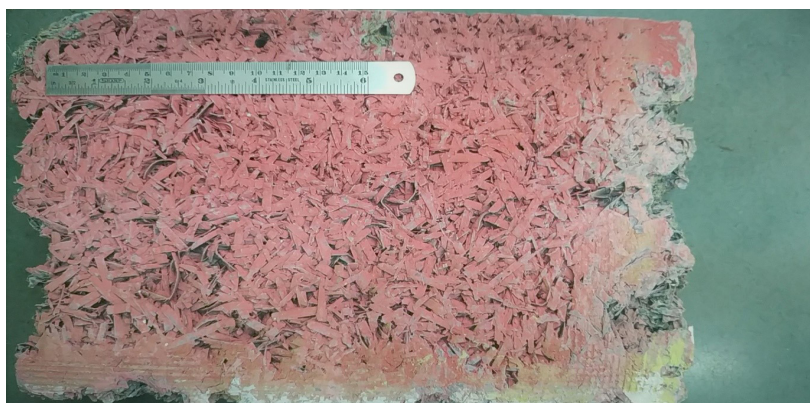
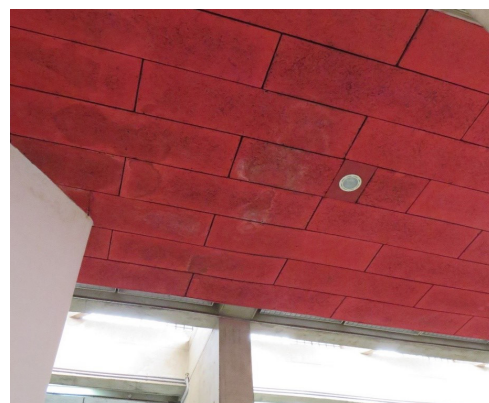
Fig. 155: Fibreboard sample taken for analysis (L); Water damage of fibreboard ceiling panels is also seen.

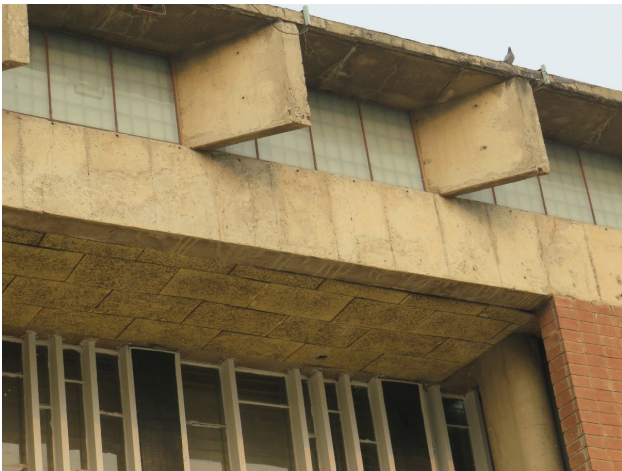
The fibreboard ceiling panels on the exterior of the building show deterioration due to exposure to weather. Several panels have come loose and show displacement. The replaced panels do not match the original material.

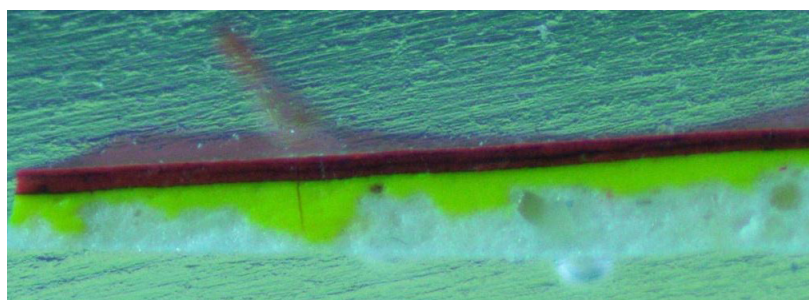
Fig. 158: Stratigraphy of paint sourced from gallery door at interior stairwell

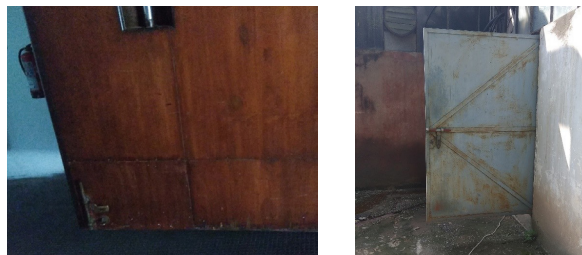
Fig. 159: Worn door corners (L); Ad hoc additions (R)

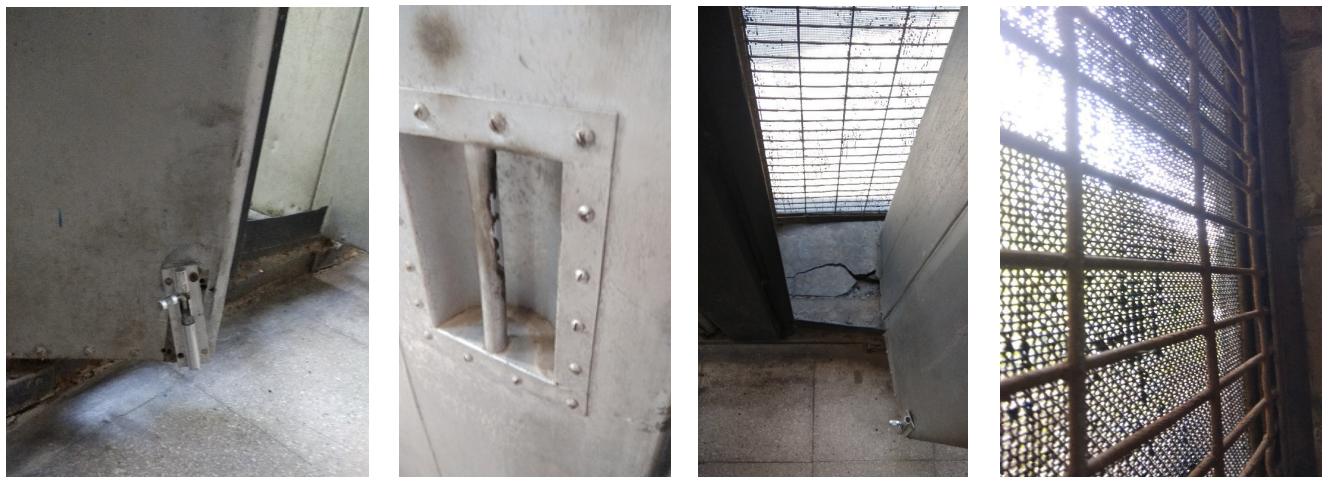
Fig. 160: Damaged door fixtures, concrete sill and rusting grills.

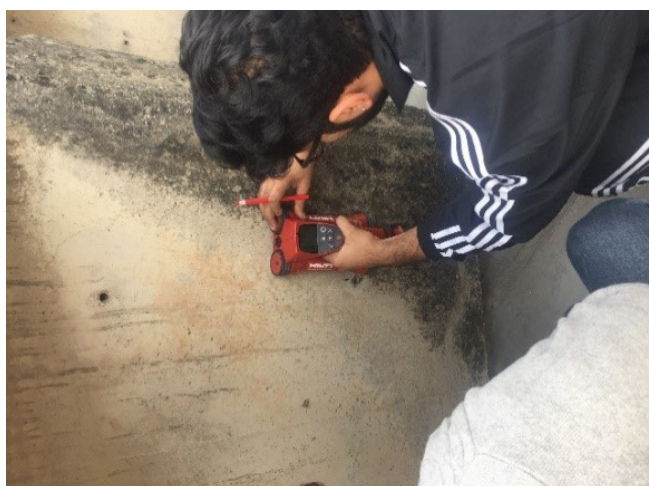
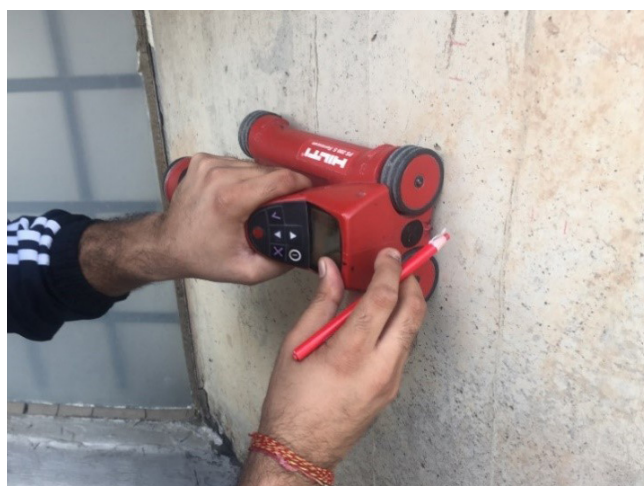
Fig. 161: Ferrosscanner to locate rebars before locating sites for core cutting

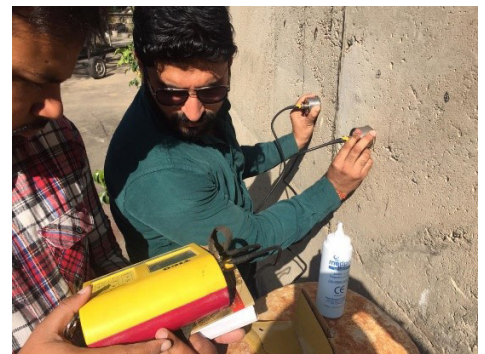
Fig. 164: Ultra sonic pulse test

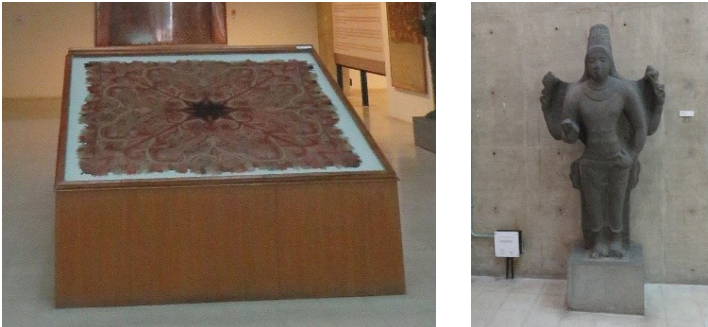
Fig. 167: The bottom surface of the display shows discoloration due to daily floor swabbing.

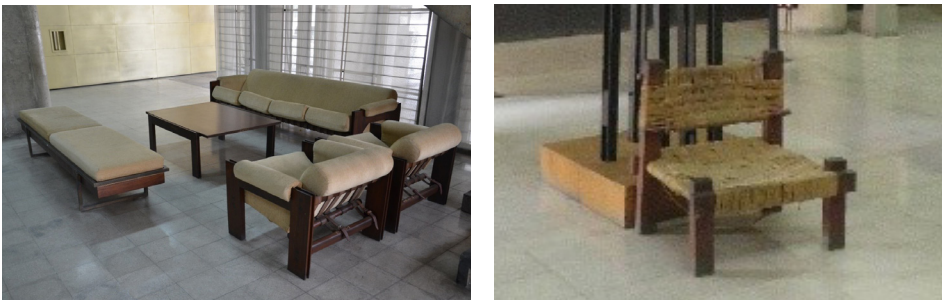
Fig. 168: Reception sofas have been repaired with leather straps that do not match the colour of the original straps.(L): Jute strings of the low stool hanging loose (R)

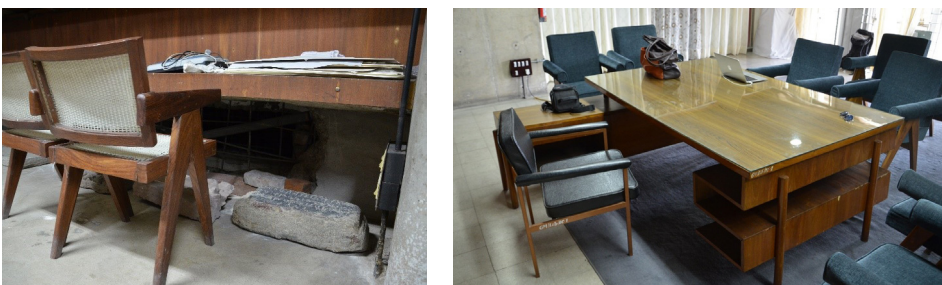
Fig. 169: Loss of polish and dust accumulation at bottom of the table and chair legs

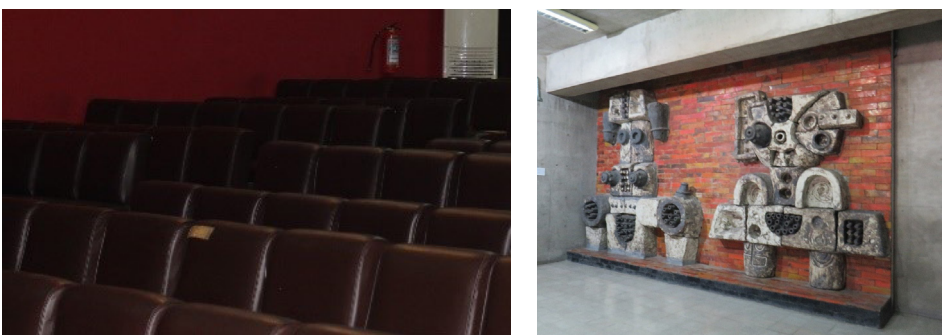
Fig. 170: Patch repair of Auditorium chair upholstery (L); Mural at the reception by the artist Satish Gujral show accumulation of dust

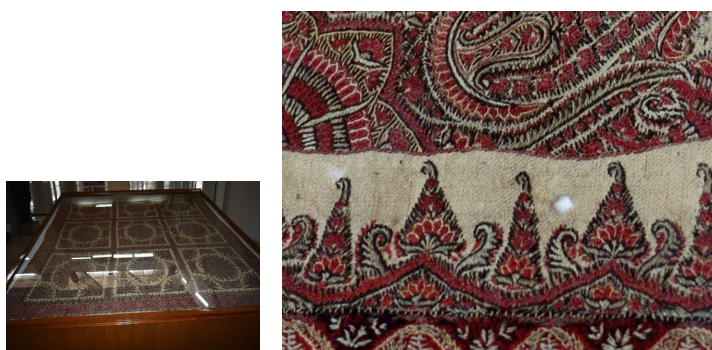
Fig. 171: Loss of material observed on textile

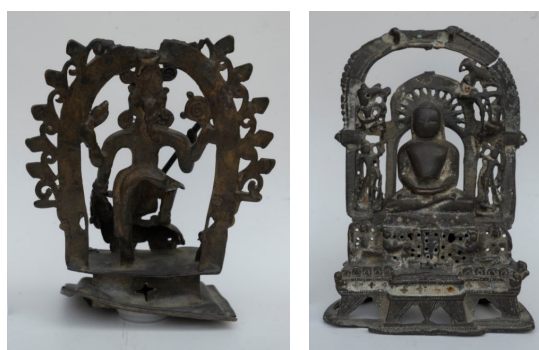
Fig. 172: Corrosion and calcareous deposits on metal artefacts

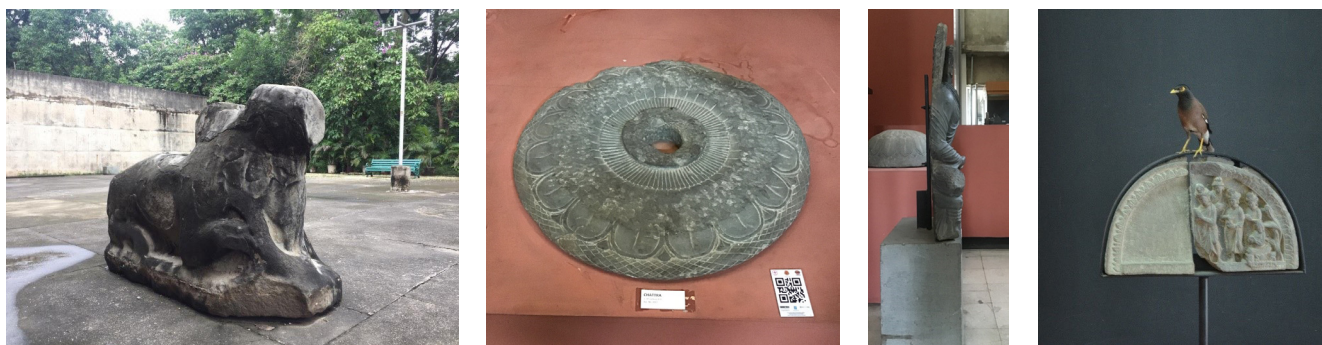
Fig. 173: (L-R) Deteriorations including deformation, detachment and discoloration observed on the sculpture; Display pedestal with visible evidences of water stains; Sculpture mounted on a pedestal towards the edge; Bird activity observed in galleries

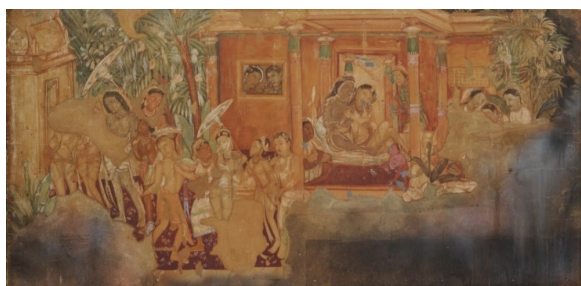
Fig. 174: Flaking of paint layers observed on artworks

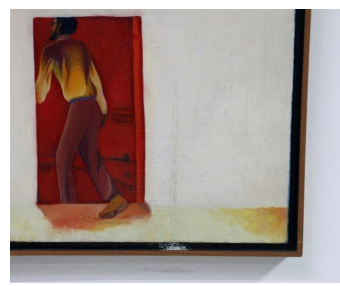
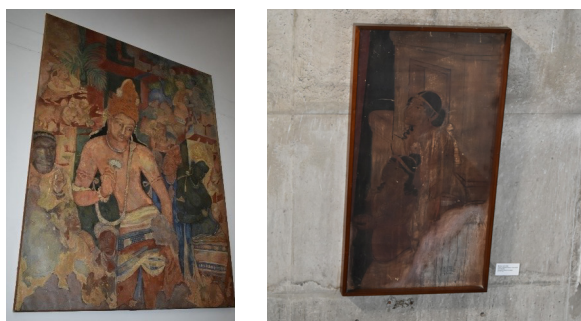
Fig. 176: Waviness observed on the tempera paintings

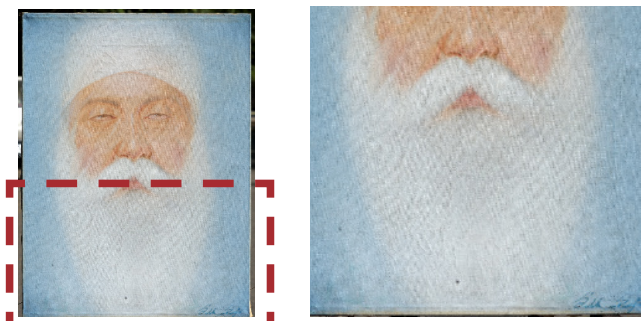
Fig. 177: Craquelure observed on paint layers in painting

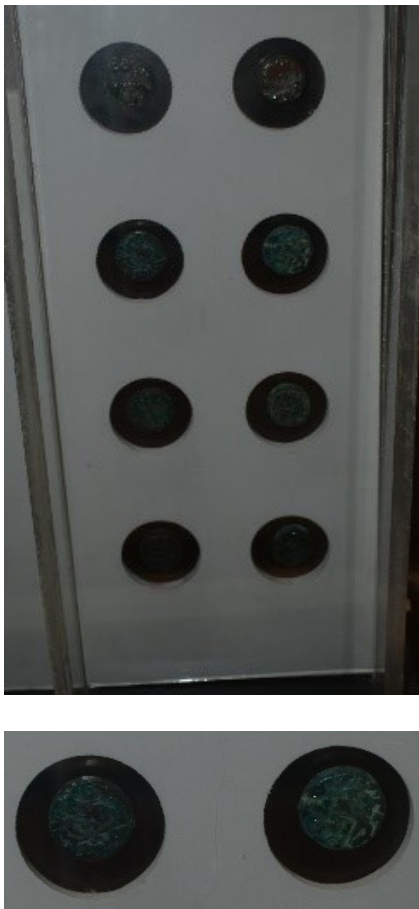
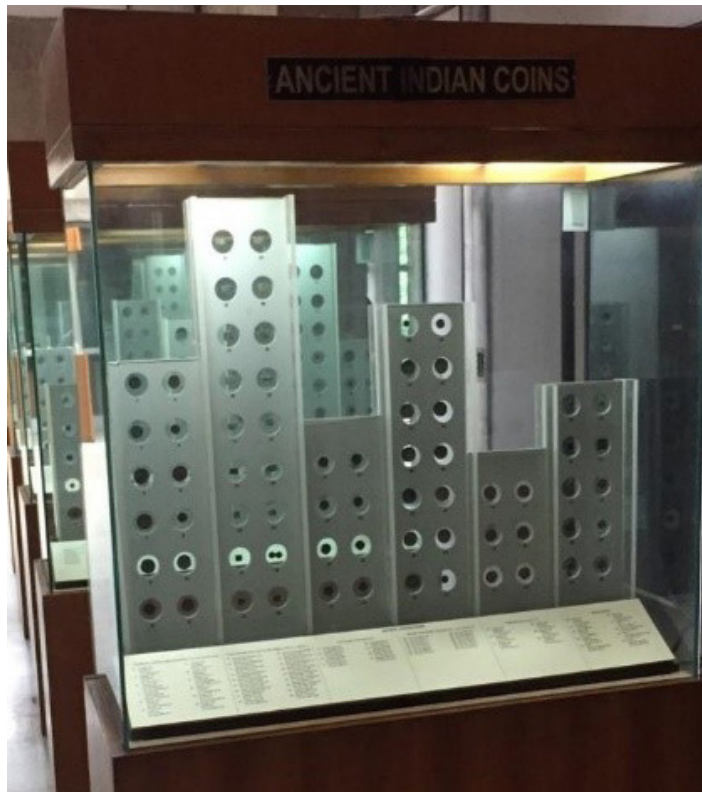
Fig. 178: Patination and bronze disease observed on bronze coins (L); Vertical display of coins with lighting from the top. This reduces the visibility of the coins displayed towards the lower parts of the display unit (R)

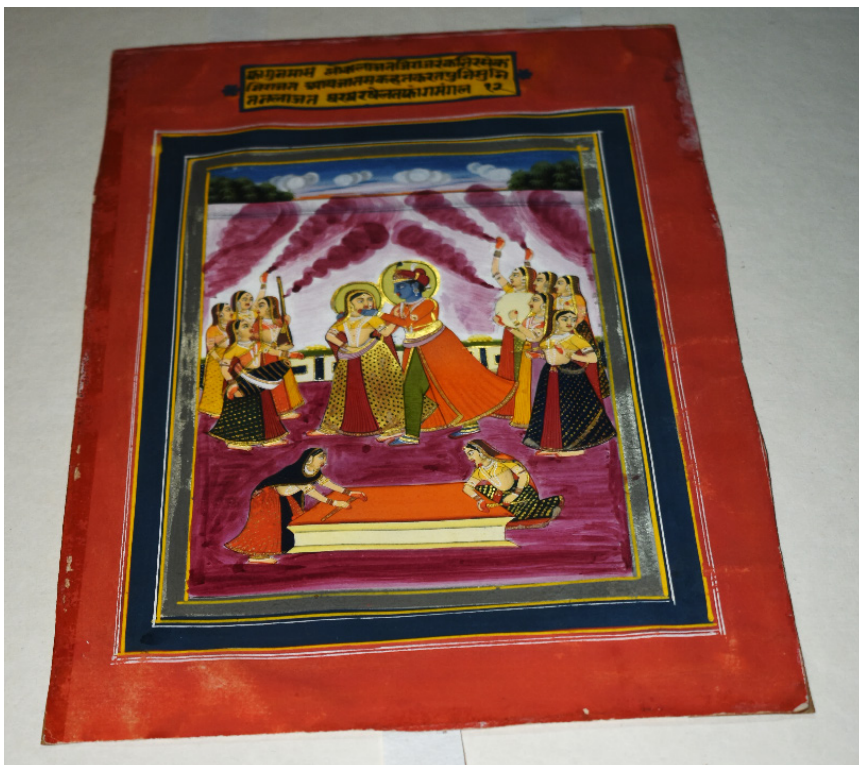
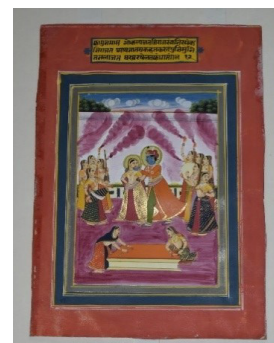
Fig. 179: Stains, fold marks, fading and loss of material observed on miniature paintings

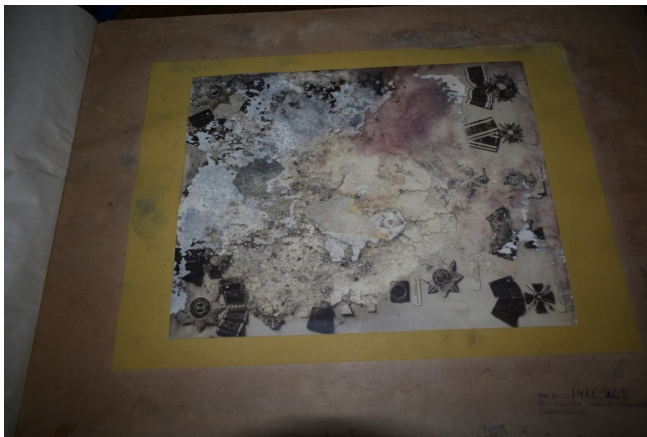
Fig. 180: Blooming and stains observed on photographs

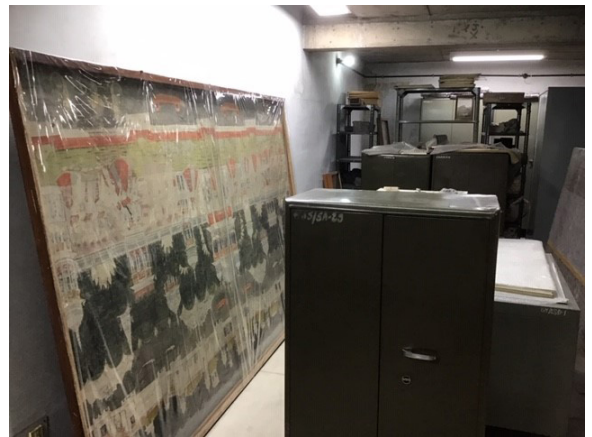
Fig. 181: Objects placed on the floor within the storage

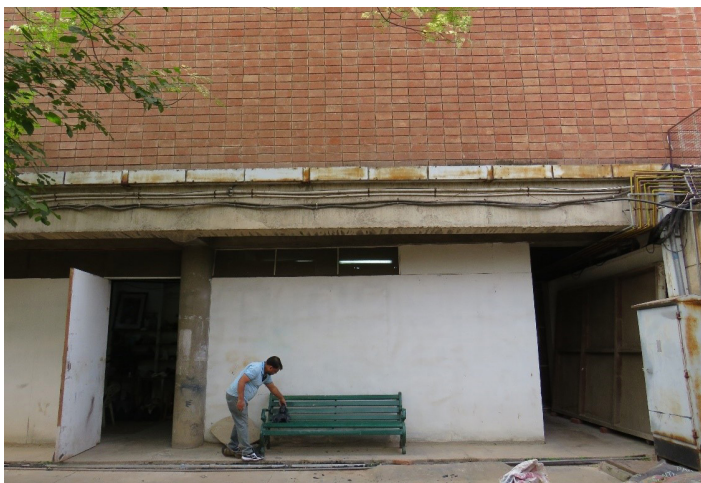
Fig. 182: Objects Exposed electrical wiring and conduit casing disfiguring the building façade

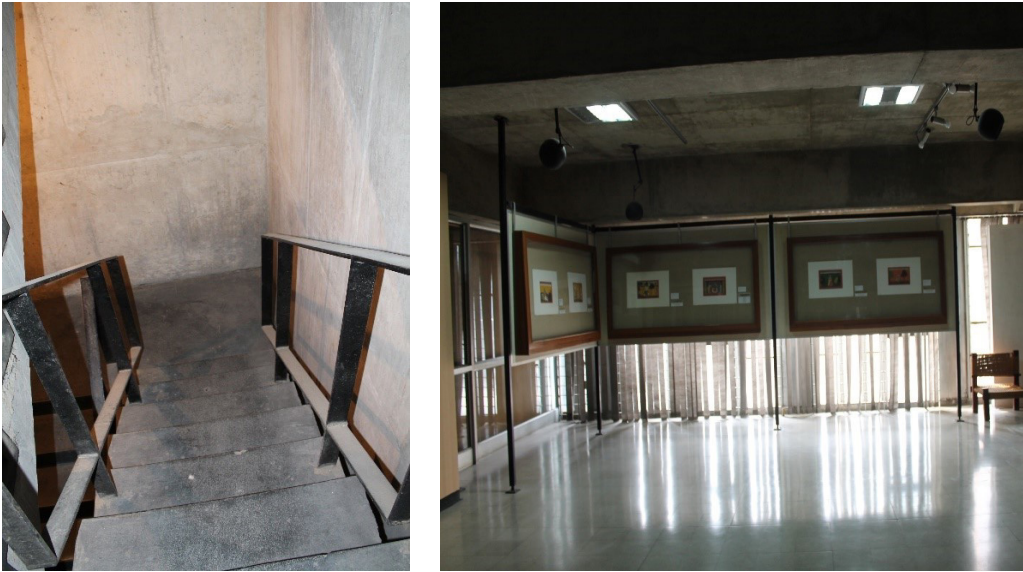
Fig. 184: Inadequately and inappropriately lit spaces – Staircase to terrace (L), Miniature gallery (R)

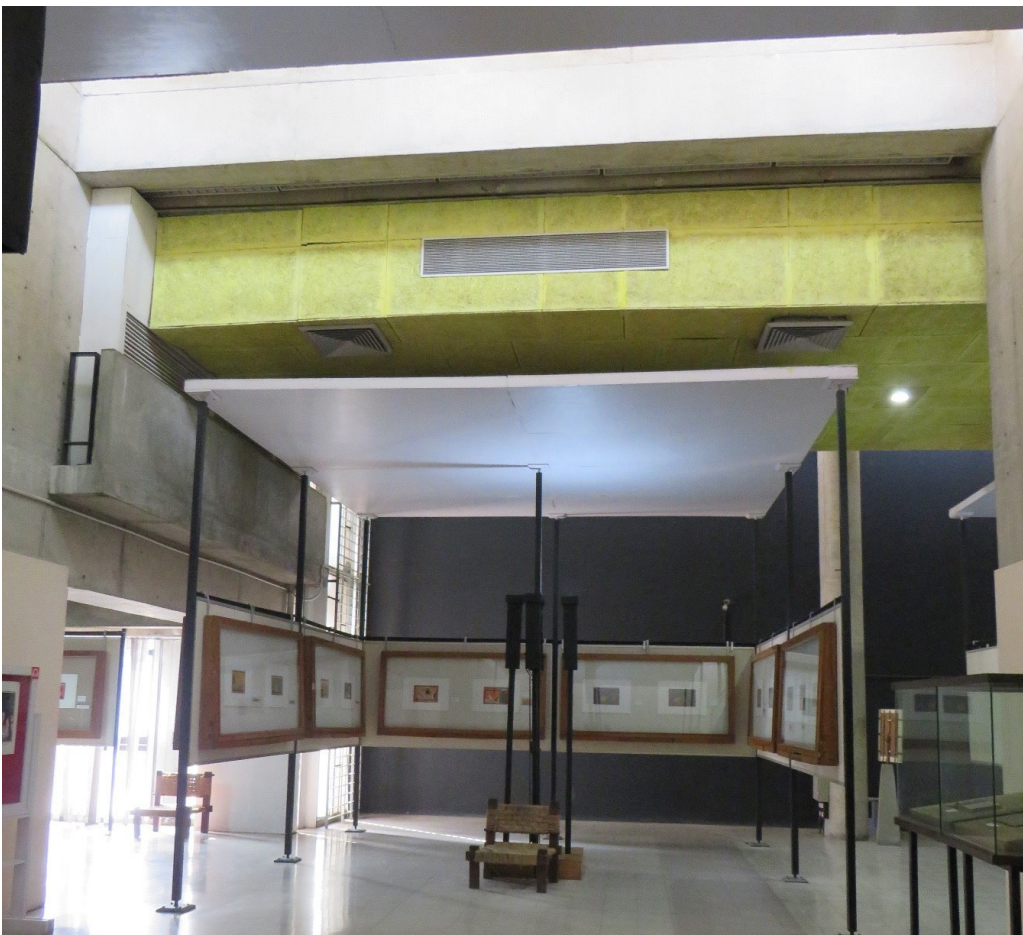
Fig. 185: Air conditioning units alters the gallery height

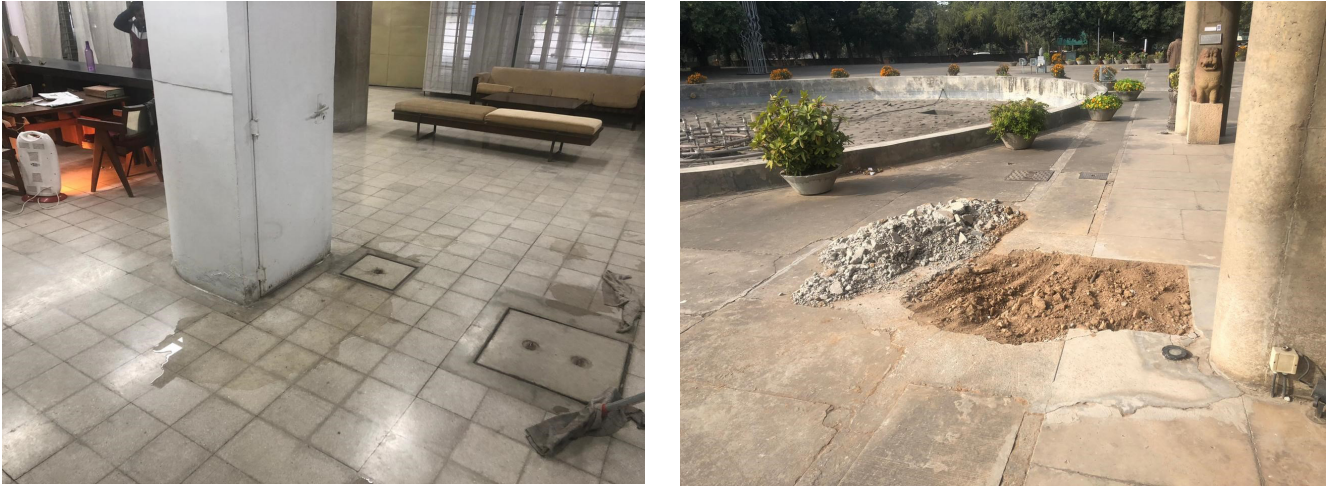
Fig. 186: Water leakage due to damaged pipework under floor of entrance lobby (L); Main water supply has been temporarily blocked to check the leakage (R)

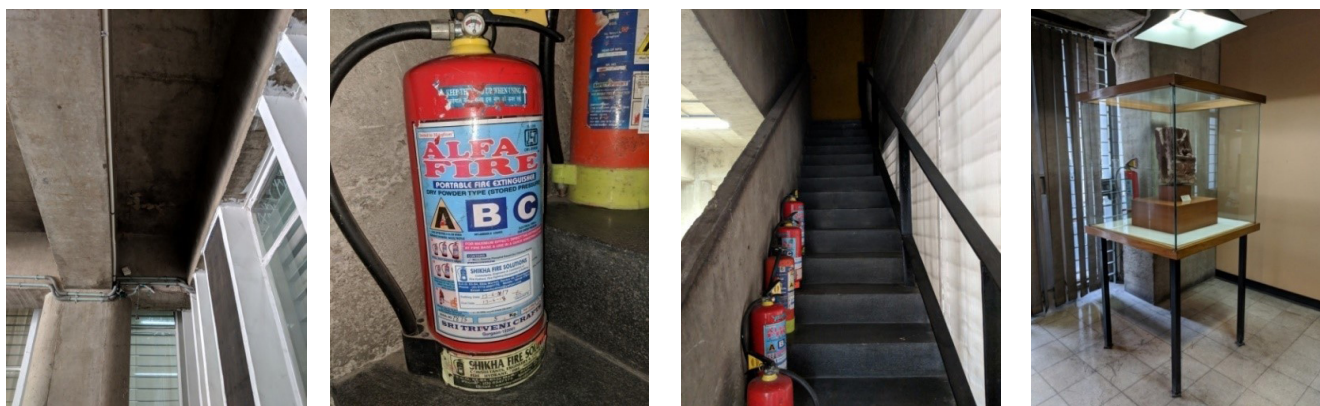
Fig. 187: (L-R) Area of past incident; Type B extinguisher; Units stored on the staircase; Fire extinguishers hidden away behind exhibits

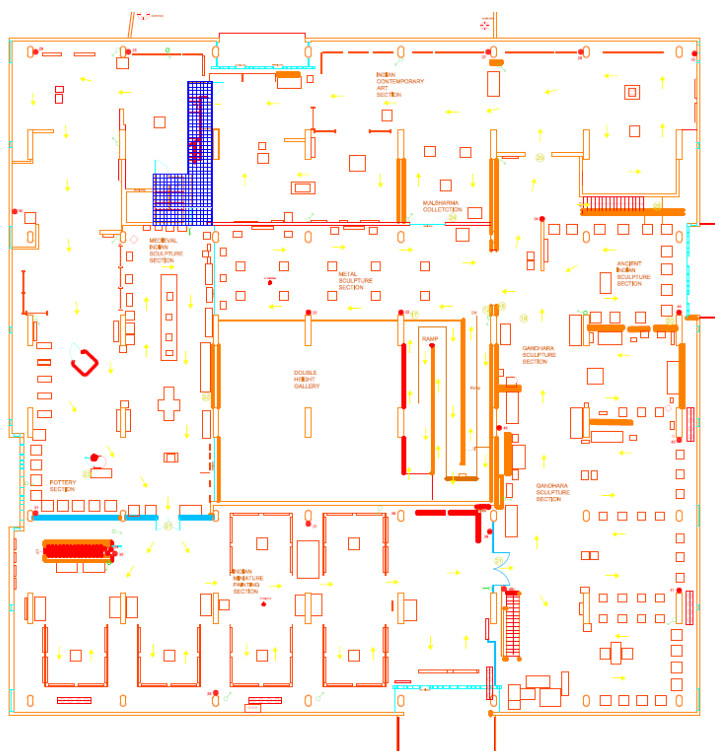
Fig. 188: Blue highlights the location of collapsible gates restricting the exit

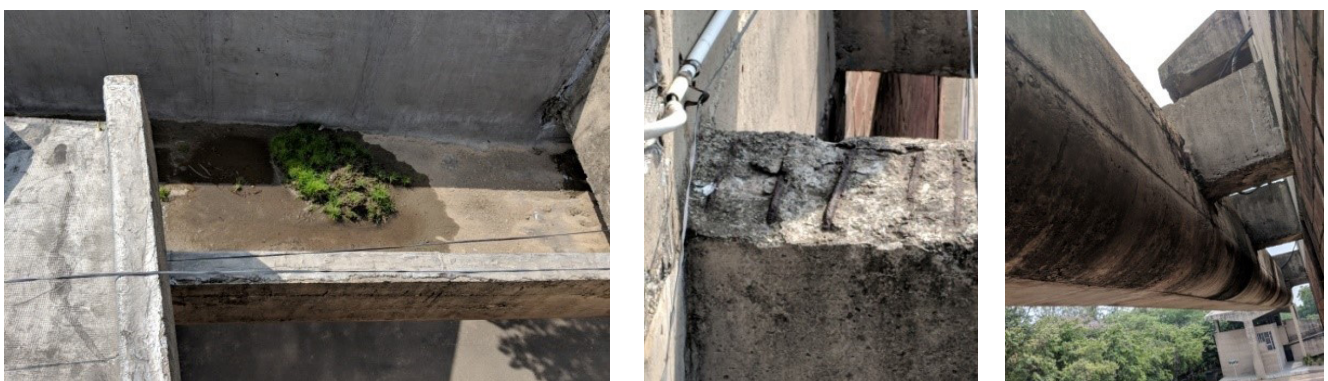
Fig. 190: Vegetation growth in concrete duct (L); Exposed reinforcement bars and major cracks seen on beams connecting the concrete drains to the building (C)(R)

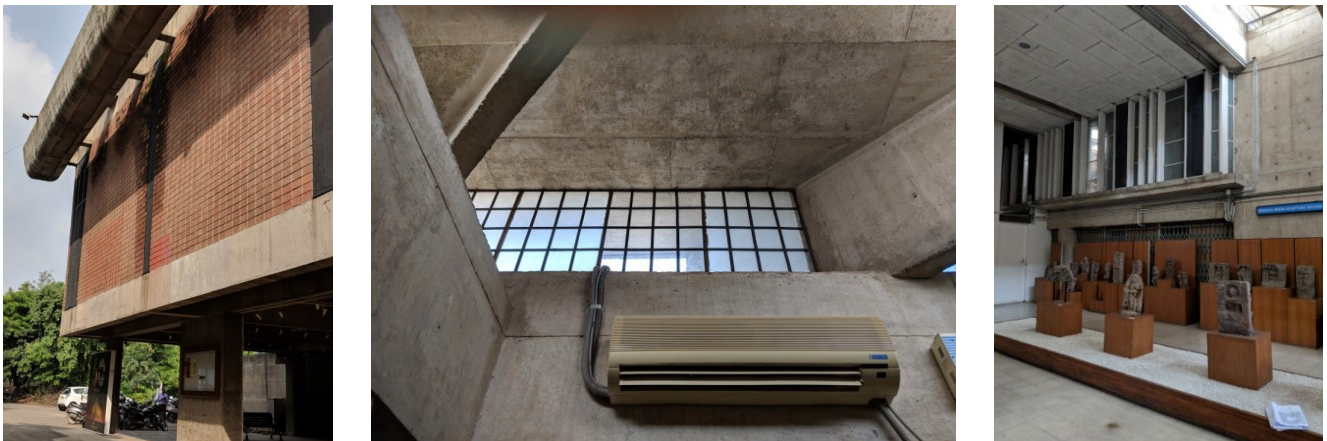
Fig. 191: Dampness seen on external wall (L); Discoloration of ceiling due to water seepage (C); Marks on interior floor tiles due to water dripping from the roof in the past (R)

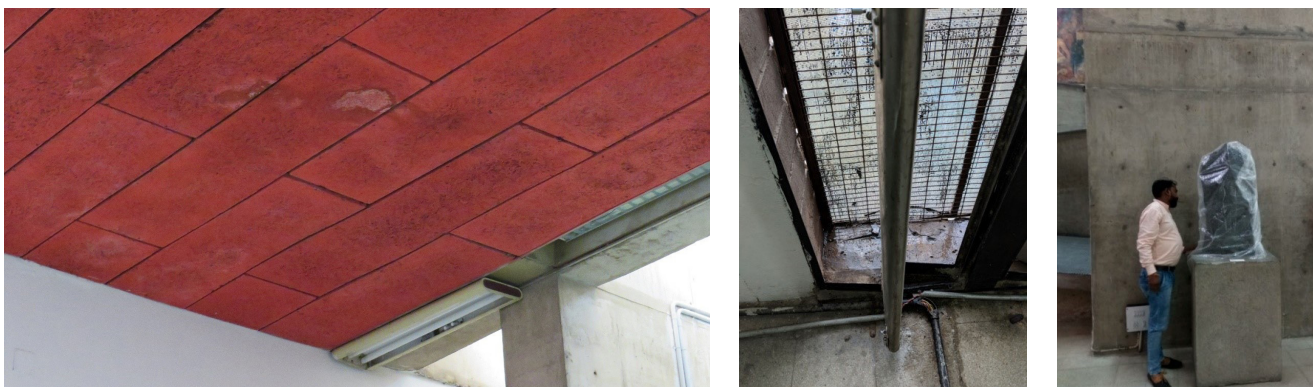
Fig. 192: Damp stains on false ceiling (L); Water seepage through aerators (C); Sculpture wrapped to protect from seepage (R)

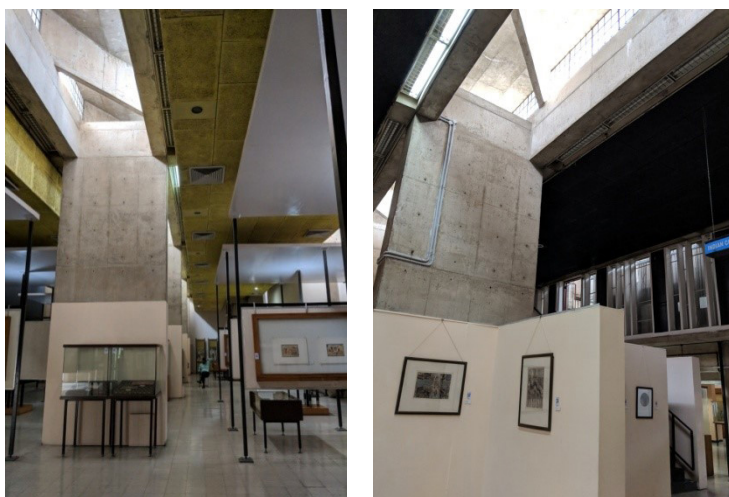
Fig. 193: Paintings in Miniature gallery (L) and Contemporary gallery (R) exposed to light from skylight

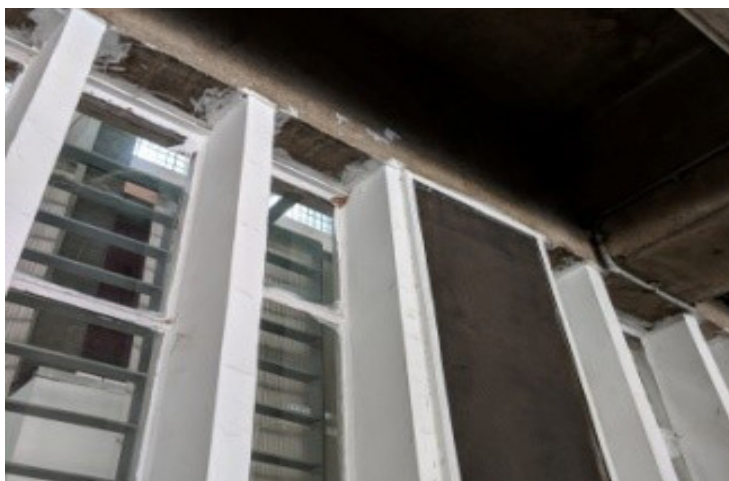
Fig. 194: Termite growth seen on window frames in the pilotis area

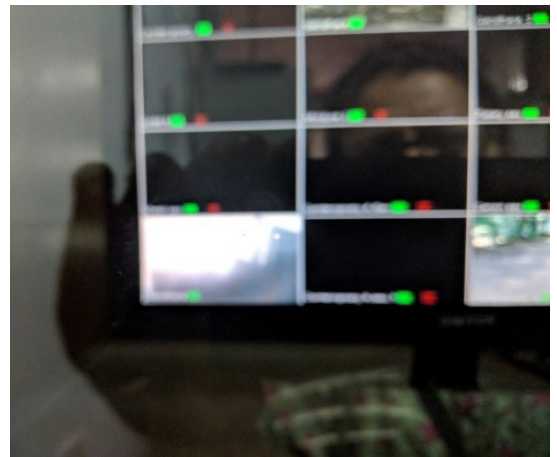
Fig. 195: Blurred vision of the camera outside the storage area

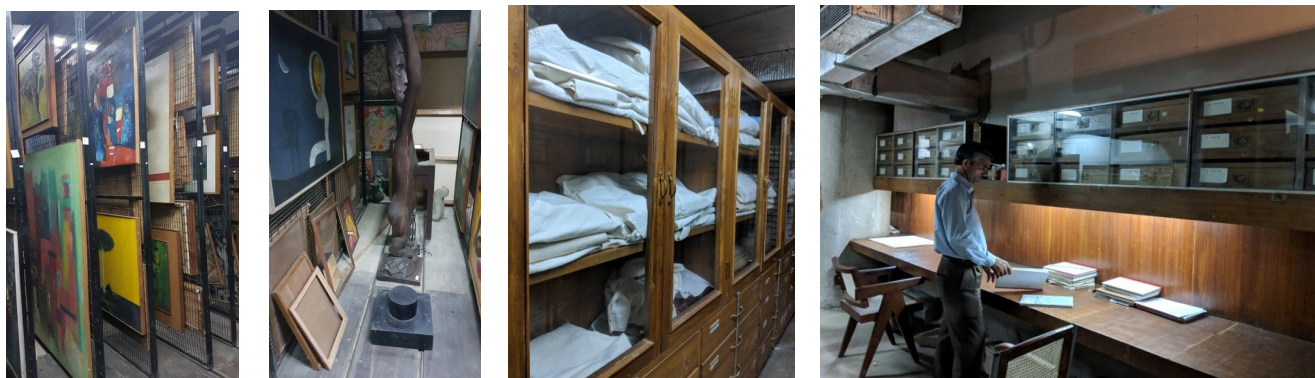
Fig. 196: (L-R) Overcrowded racks for storage of Contemporary paintings; Paintings on the floor due to lack of space; Large size objects rolled up in wooden cupboards; Miniature paintings stored in wooden boxes

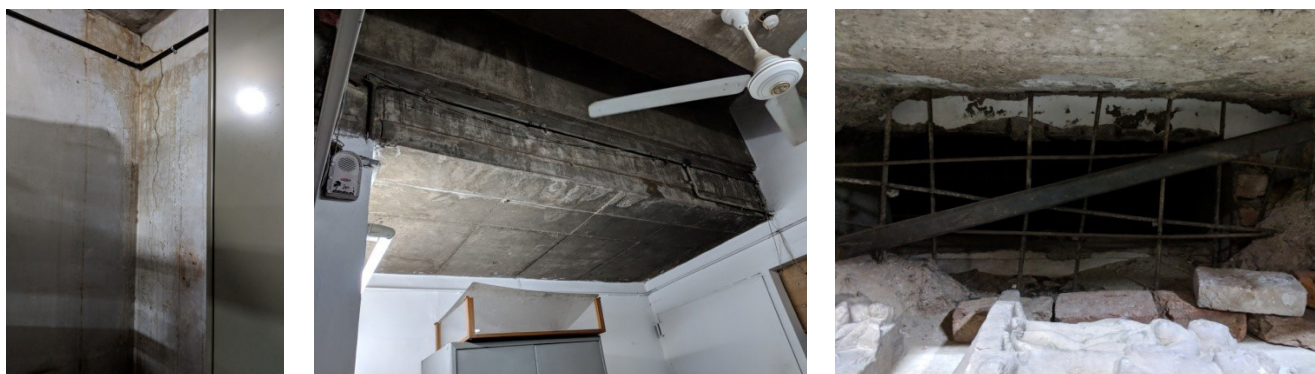
Fig. 197: Damp walls and ceiling in storage areas (L)(C); Unfinished construction between two storage areas (R)

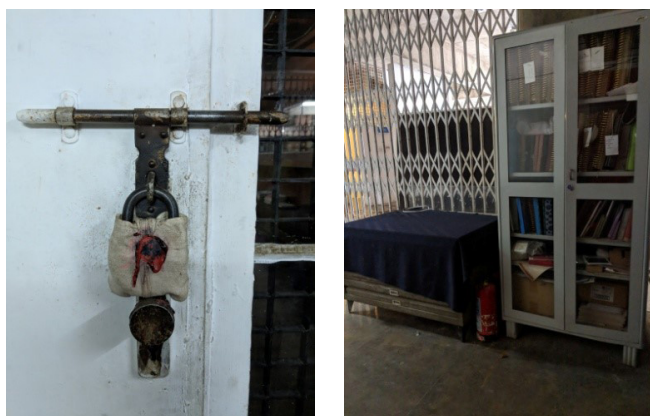
Fig. 198: Lock sealed with wax (L); Fire extinguishers hidden between cabinets (R)

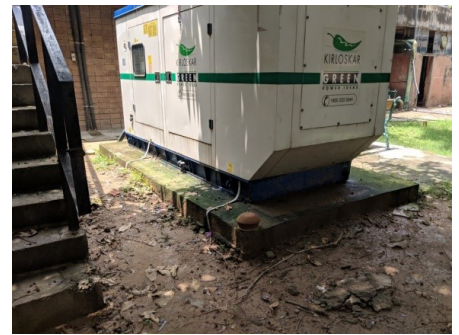
Fig. 199: Water logging at the base of electrical transformer

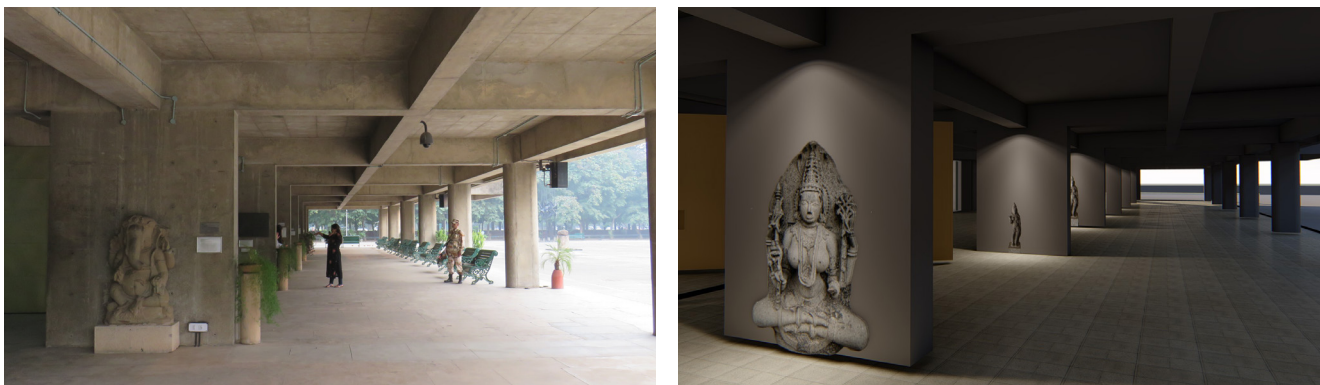
Fig. 204: Sculpture display in pilotis. Existing (L), Proposed (R)

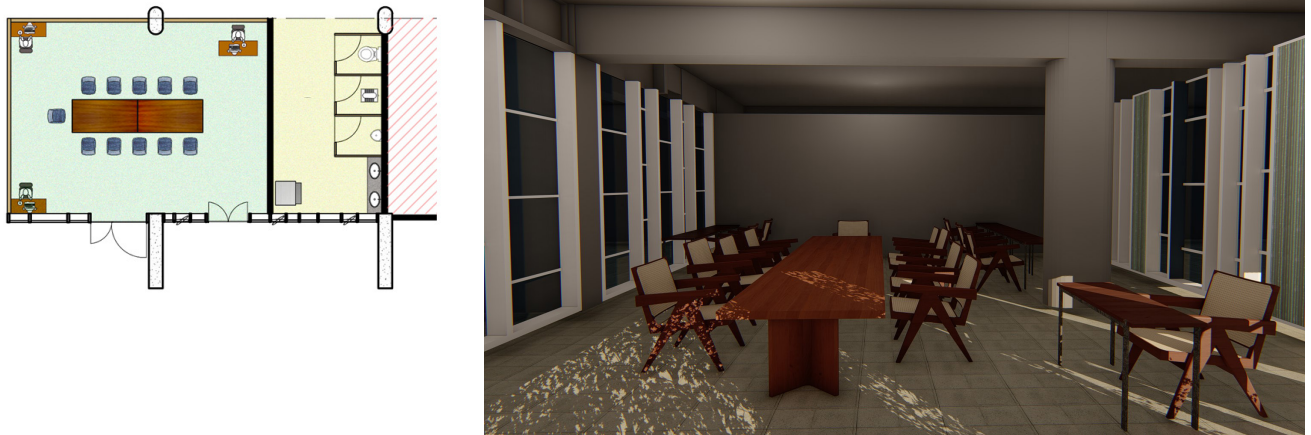
Fig. 207: Proposed layout (L) and view (R) of Conference Room on the ground floor of the Museum
