**CONSERVATION MANAGEMENT
PLAN FOR GOVERNMENT
MUSEUM AND ART GALLERY,
CHANDIGARH**

*This report is made possible through a grant from the Getty
Foundation through its 'Keeping It Modern' initiative.*

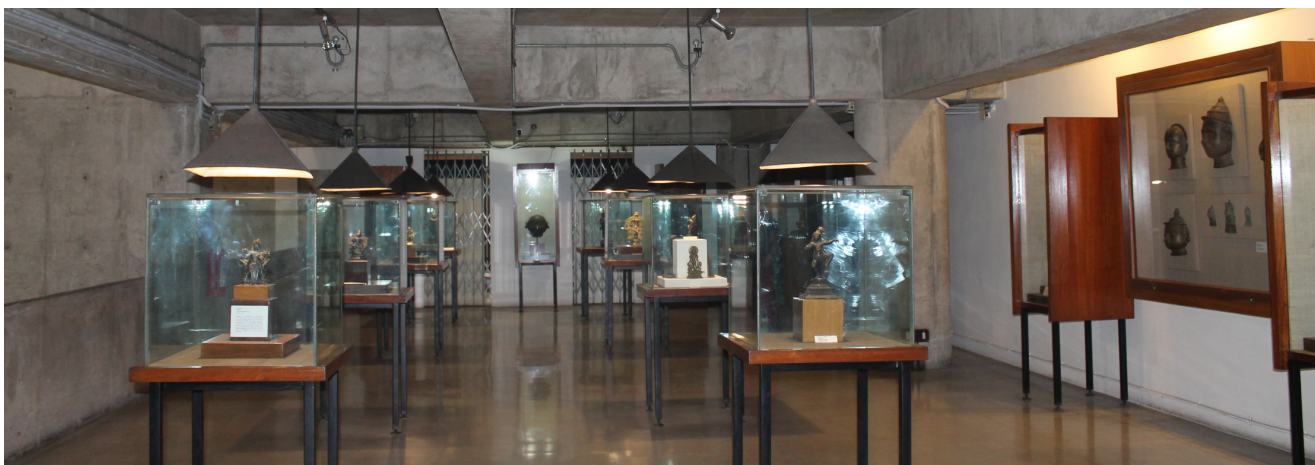
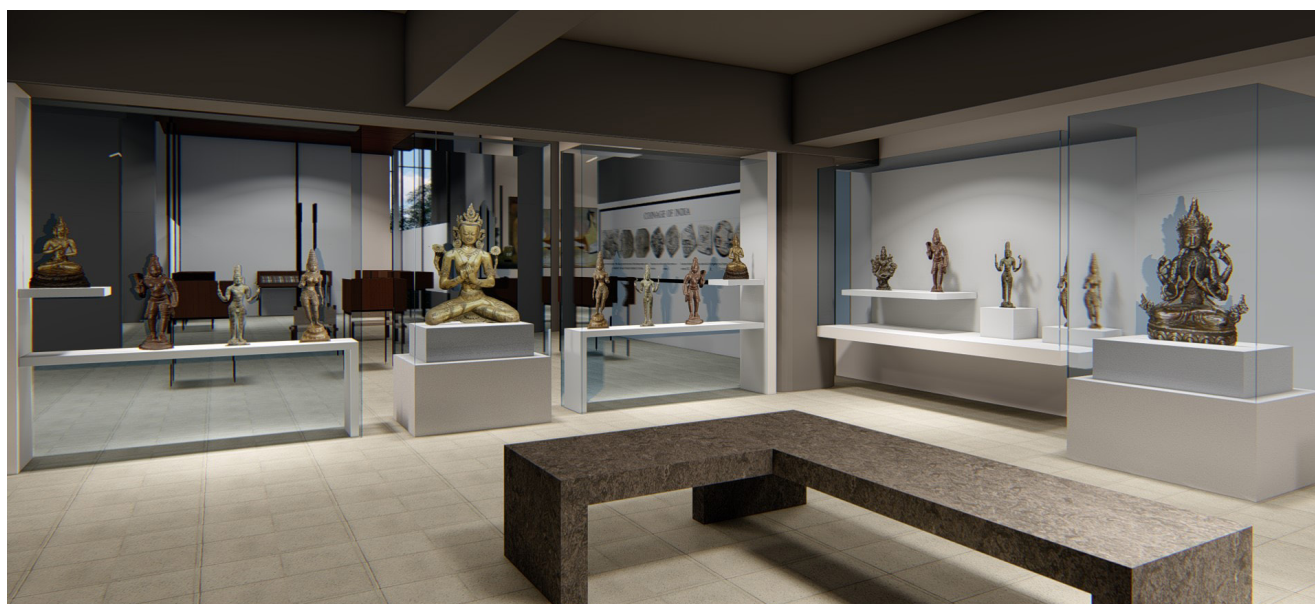
Fig. 210: Proposed views of Metal Sculpture Gallery. Existing (T), Proposed (B)

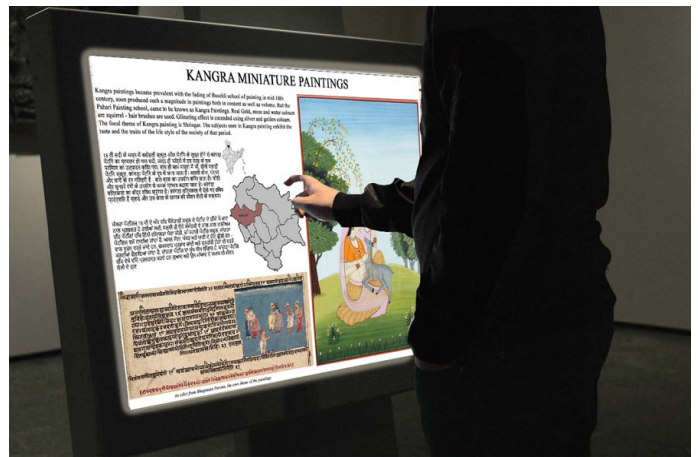
Fig. 217: Proposed view of interactive display in Miniature Gallery

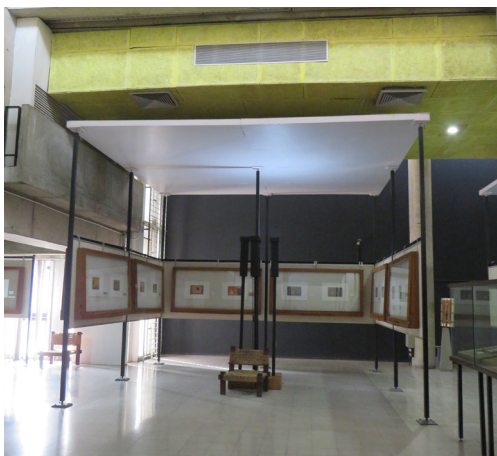
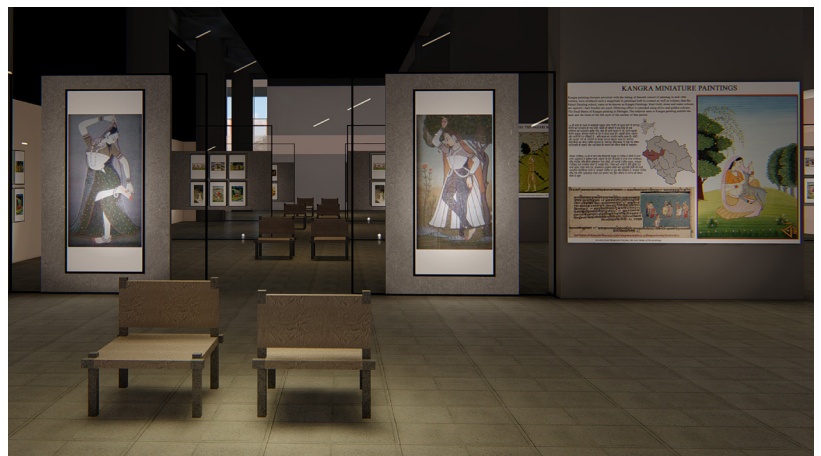
Fig. 218: Proposed view of Miniature Paintings Gallery. Existing (T), Proposed (B)

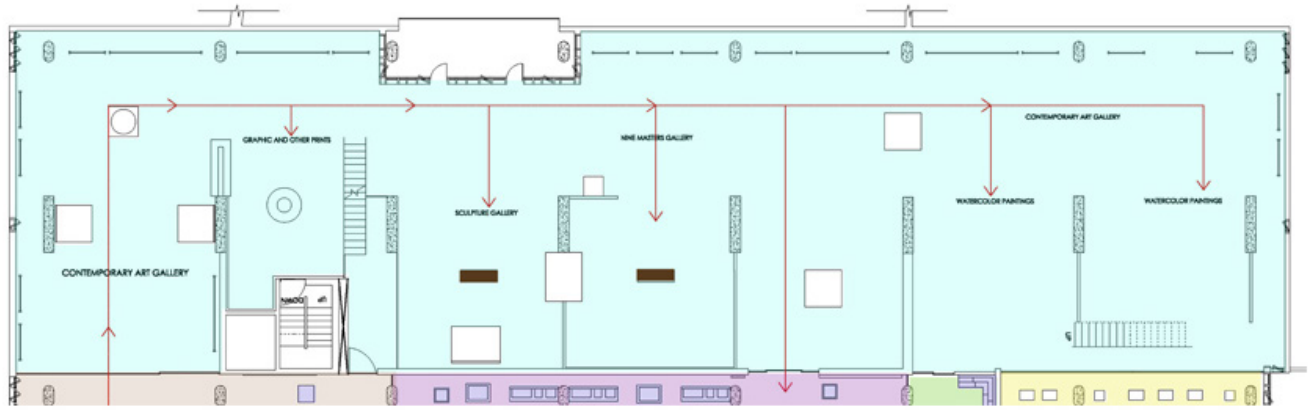
Fig. 222: Proposed plan of Contemporary Art Gallery on the First floor

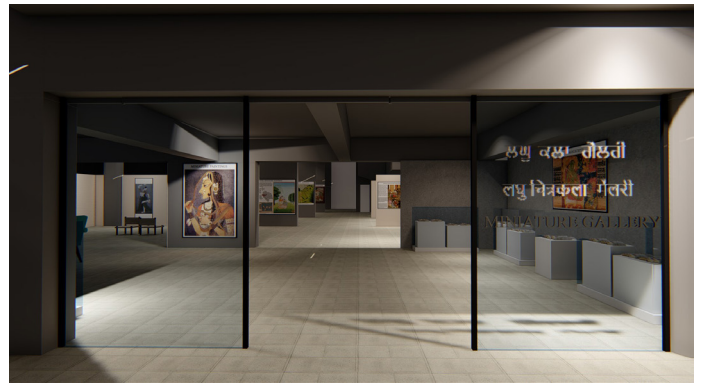
Fig. 229: Proposed signage for gallery name etched on glass partition

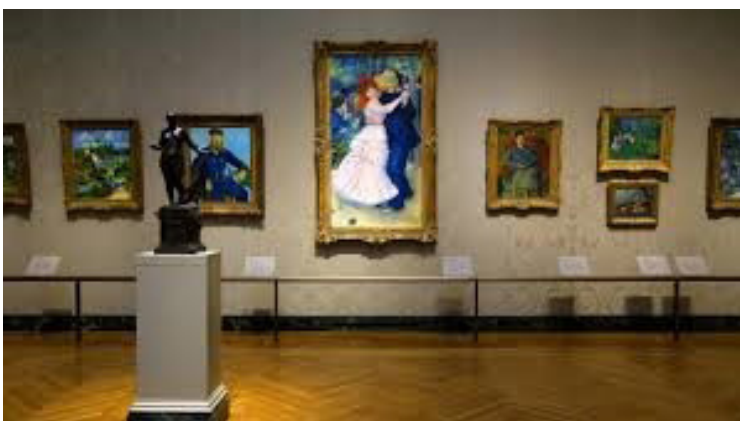
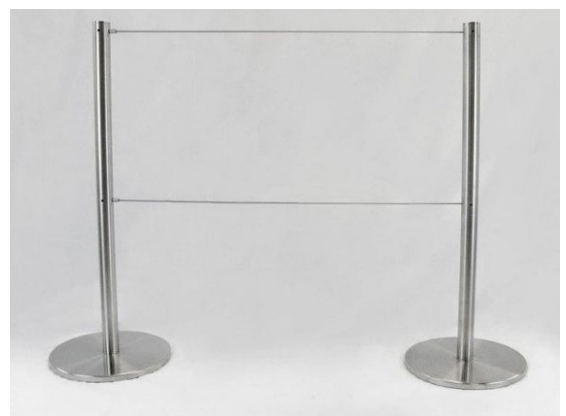
Fig. 232: Reference image for railing options to keep visitors at a distance from the exhibits. Railing option for painting (left); Free standing flexible system (right). Source: Google

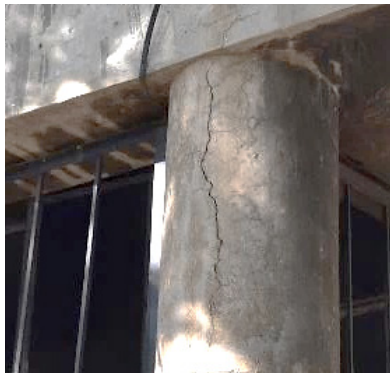
Condition resulting from separation of one part from another, more than 4 mm wide.

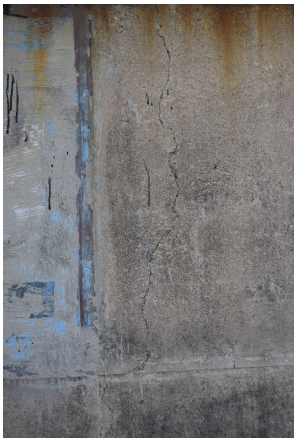
Surface cracks / prominent cracks which may become severe in the future

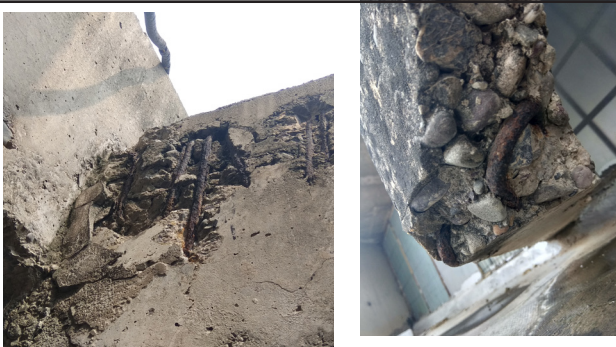
Reinforcement bars visible due to loss of cover, possibly due to deterioration of surface.

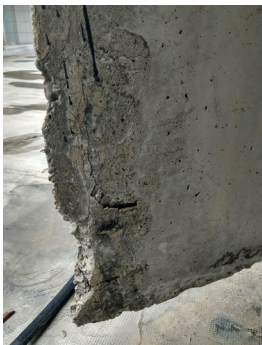
Loss of concrete material creating a void, either by erosion, water or mechanical damage

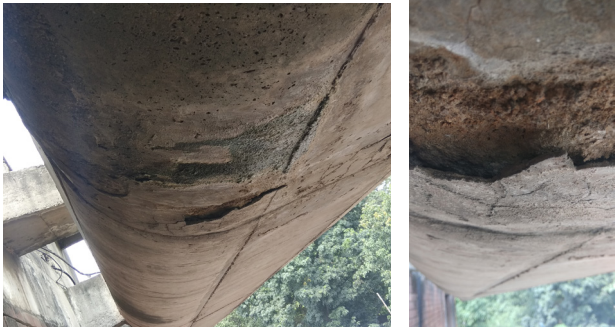
Loss of cohesion resulting in separation from the base.

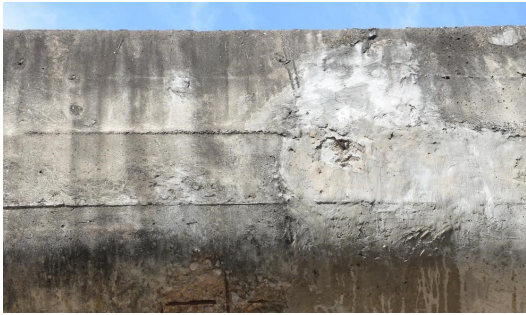
Interventions undertaken in the past to repair or modify that have altered original character and are sometimes carried out with incompatible materials <i>(Patch filling due to loss of material or filling of cracks or pointing)</i>

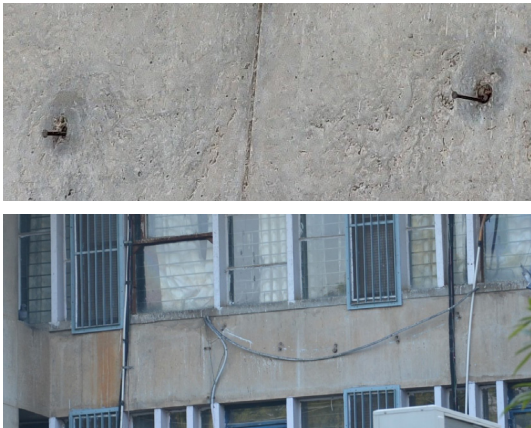
Presence of screws, nails, rods or metal anchors on concrete wall surface

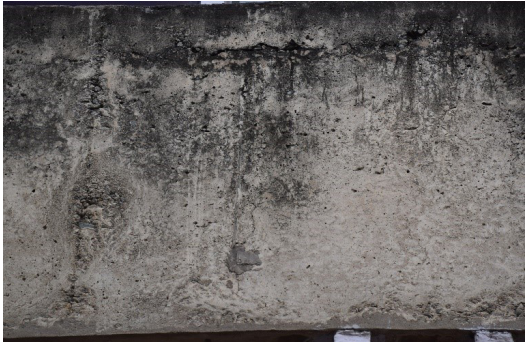
Surface erosion or loss of original finished surface. Areas with exposed coarse aggregate missing binding material

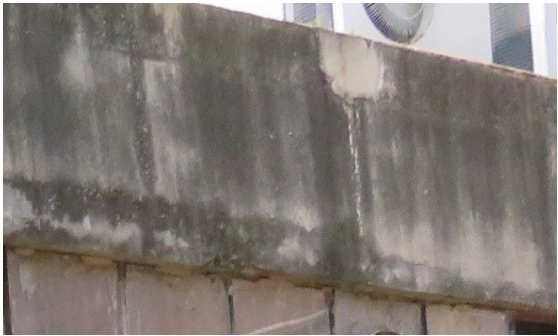
<p>Accumulation of materials including dirt on the surface due to action of water, pollution or any other external factors. Dry/ inactive algae leaving black stains.</p>

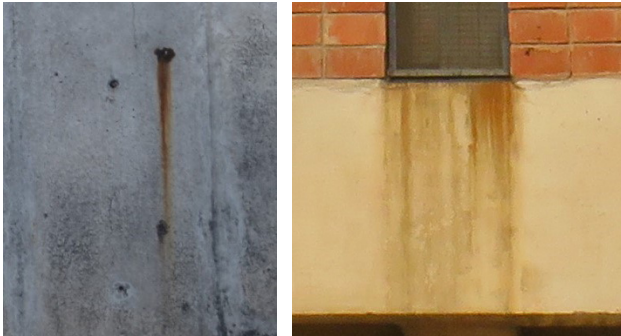
<p>Reddish brown stains due to presence of iron oxides</p>

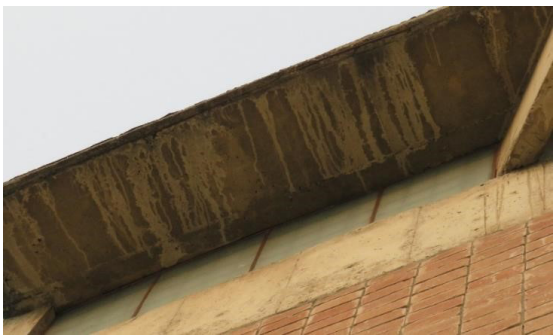
<p>Active ingress of water in the form of stains (dry / active)</p>

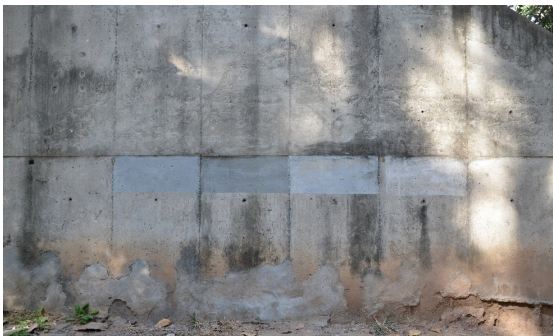
<p>Accumulation of extrinsic material on concrete surface, like paint, cement splashes, residues from repairs, graffiti</p>

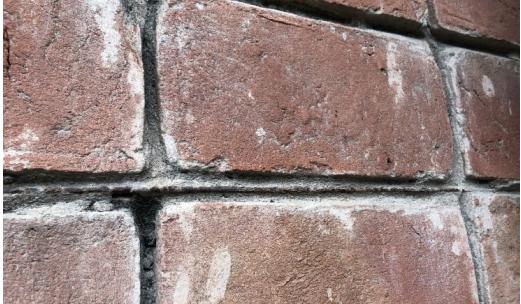
Reinforcement bars visible due to loss of cover, possibly due to deterioration of surface.

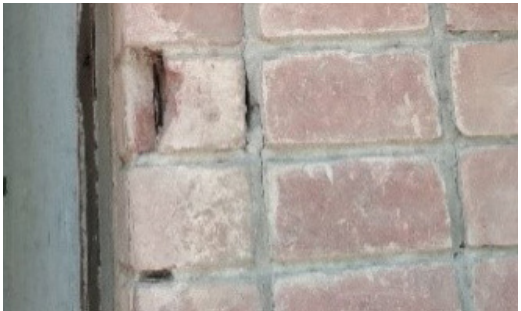
Damage due to mechanical action or impact

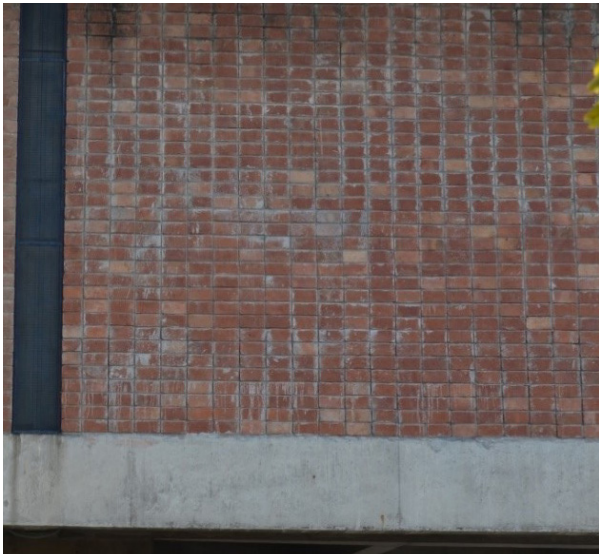
<p>Interventions undertaken in the past to repair or modify that have altered original character and are sometimes carried out with incompatible materials</p> <p><i>(Patch filling due to loss of material or filling of cracks or pointing)</i></p>

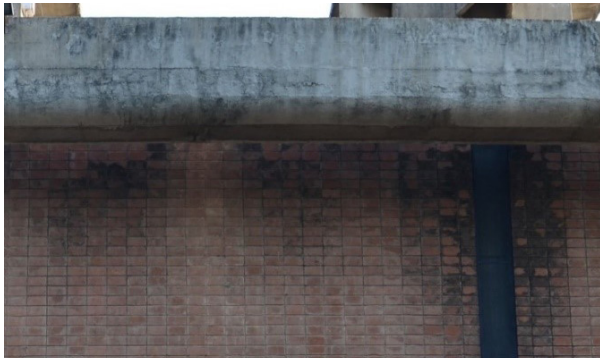
<p>Accumulation of materials including dirt on the surface due to action of water, pollution or any other external factors. Dry/ inactive algae leaving black stains.</p>

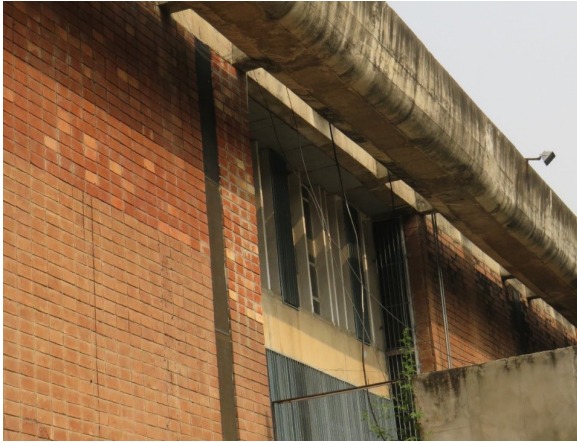
<p>Change in original color of material due to weathering or change in composition of material</p>

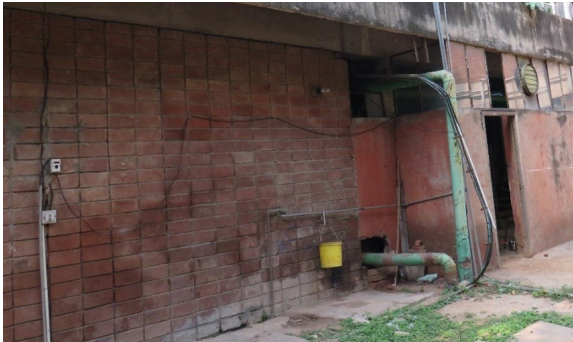
<p>Active ingress of water in form of stains (dry / active)</p>

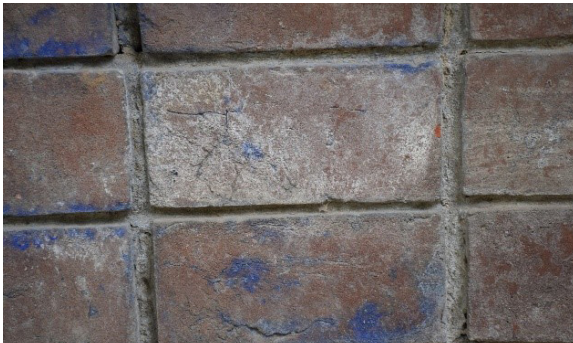
<p>Accumulation of extrinsic material like paint & cement splashes, residues from repairs</p>

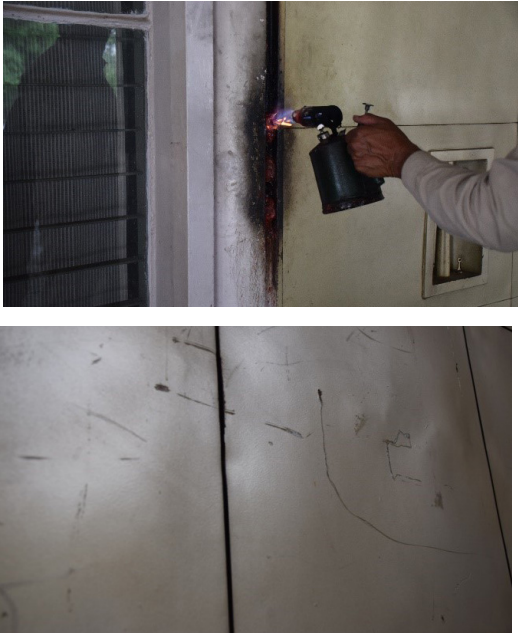
<p>Damaged due to mechanical action or impact. Dents and bulges on metal surface.</p>

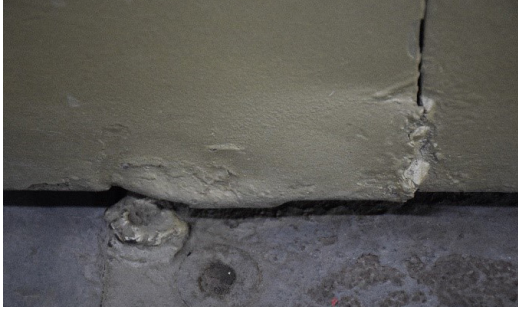
<p>Interventions undertaken in the past to repair or modify that have altered original character and are sometimes carried out with incompatible materials</p> <p><i>[Welded joints between metal door panels]</i></p>

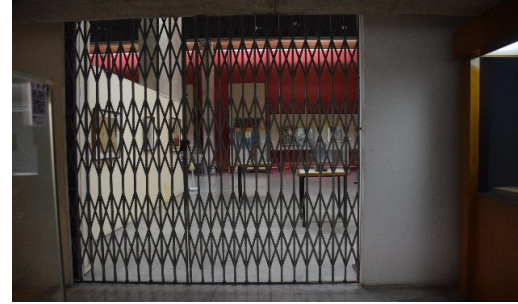
<p>Addition of new material to replace original. May include demolition/ removal of original to incorporate new additions. Addition of grills, wire mesh on doors and windows and addition of collapsible door to create partition.</p>

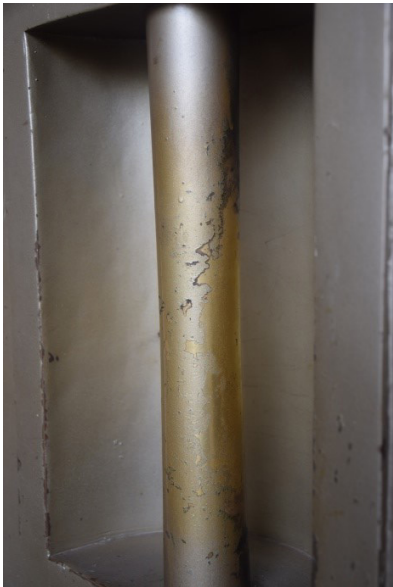
Loss of paint, polish and exposing the inner layer due to mechanical damage, scratches, wear and weathering

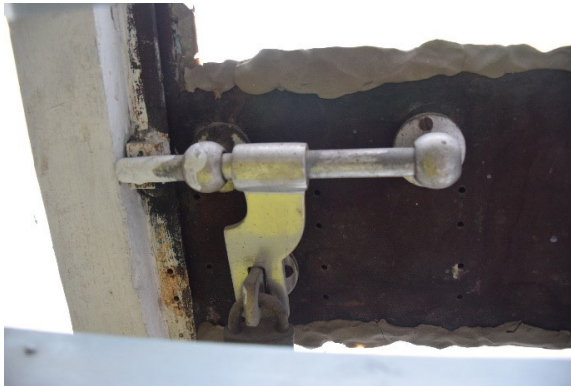
Reddish brown stains due presence of iron oxides

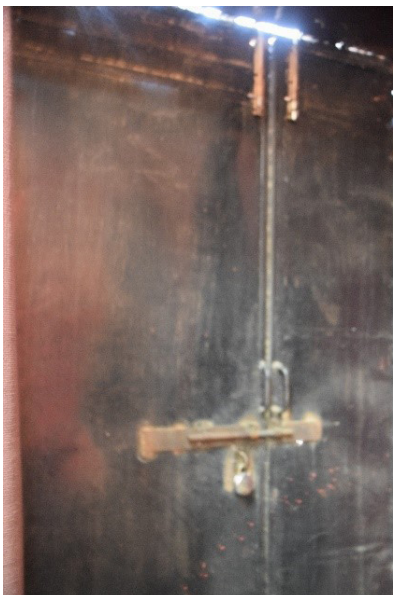
Accumulation of extrinsic material like paint, seal wax and cement splashes, residues from repairs, graffiti

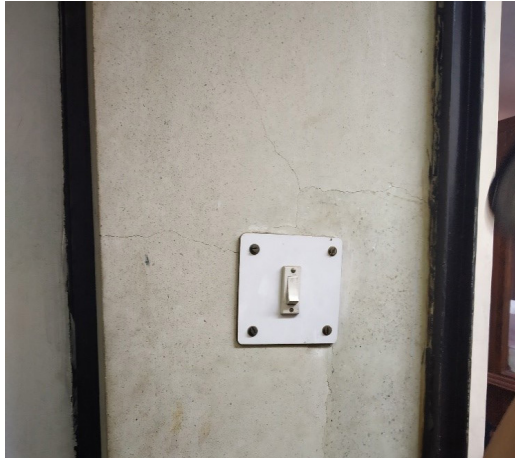
<p>Surface cracks / prominent cracks which may become severe in the future</p>	
<p>LOSS OF MATERIAL</p>

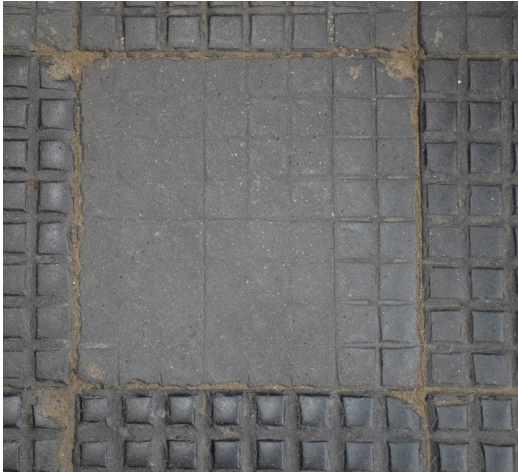
<p>Loss of compositional material creating a void, either by erosion, water or mechanical damage</p> <p><i>[Loss of grid pattern in terrazzo tile on ramp making its surface flat]</i></p>

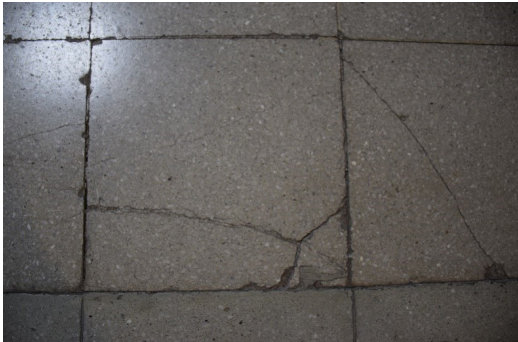
<p>Damaged due to mechanical action or impact</p>

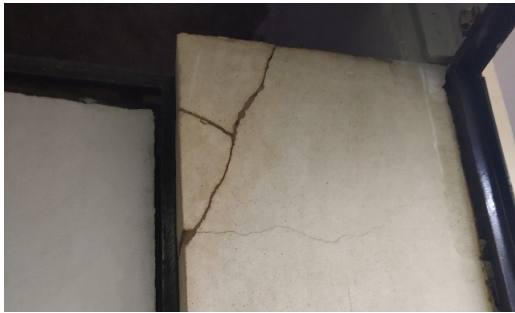
<p>Loss of cohesion resulting in separation of material from its base.</p>

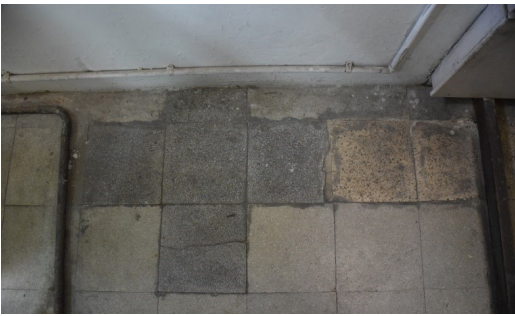
<p>Interventions undertaken in the past to repair or modify that have altered original character and are sometimes carried out with incompatible materials</p> <p><i>(Addition of similar tiles with different composition of material)</i></p>

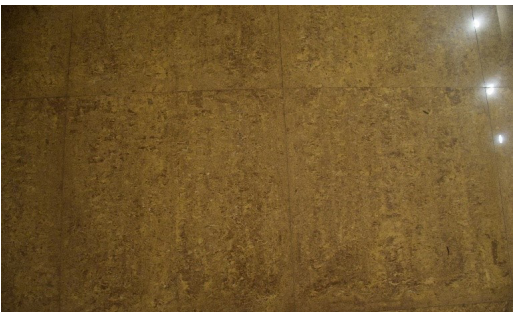
<p>Addition of new material to replace original. May include demolition/ removal of original to incorporate new additions</p> <p><i>[Addition of new tiles in child art gallery]</i></p>

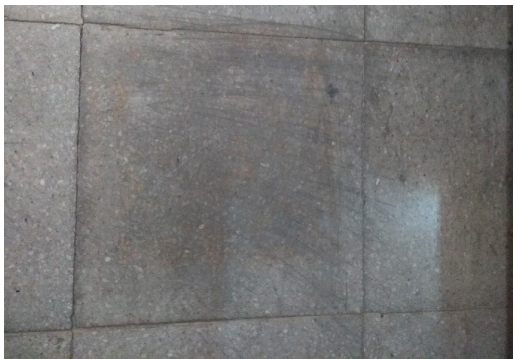
<p>Surface erosion or loss of original finished surface.</p>

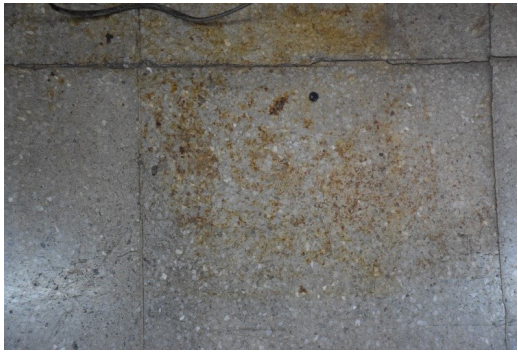
Reddish brown stains due to presence of iron oxides	
SEEPAGE/ DAMP PATCHES/ WATER STAINS

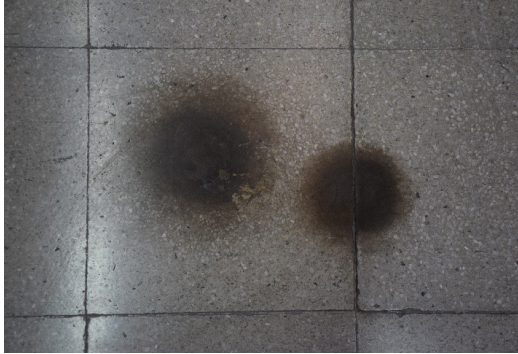
Active ingress of water in form of stains (dry / active)

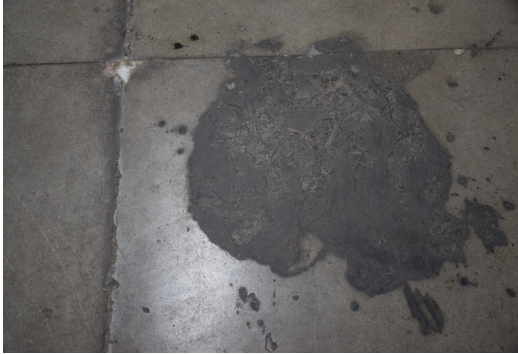
Accumulation of extrinsic material like paint, seal wax and cement splashes, residues from repairs, graffiti

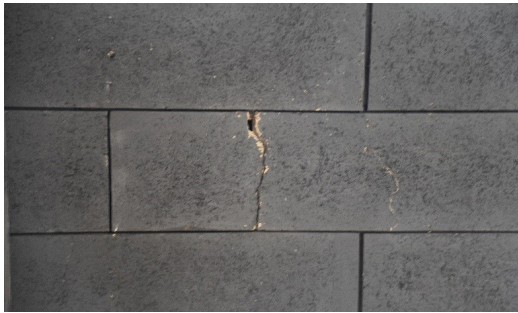
Damaged due to mechanical action or impact

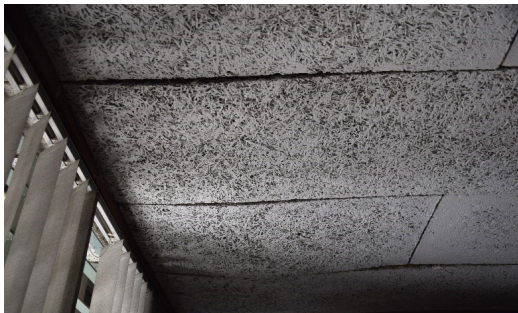
Slight shift or change of fiberboard panel from its original location <i>[Sagging fiberboard panels]</i>	+ -
PAST REPAIRS AND MAINTENANCE

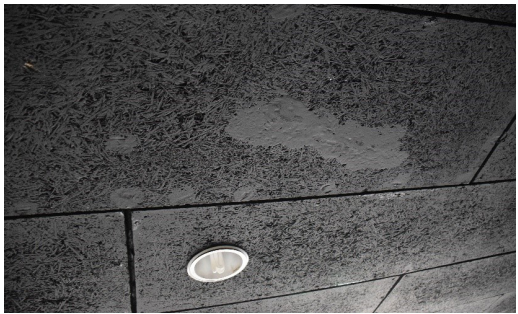
Interventions undertaken in the past to repair or modify that have altered original character and are sometimes carried out with incompatible materials <i>(Addition of ply board instead of fibreboard panel)</i>

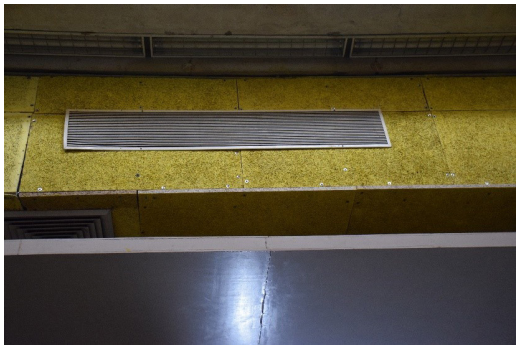
Addition of new material to replace original. May include demolition/ removal of original to incorporate new additions <i>[Addition of new fibreboard for installation of air conditioners]</i>

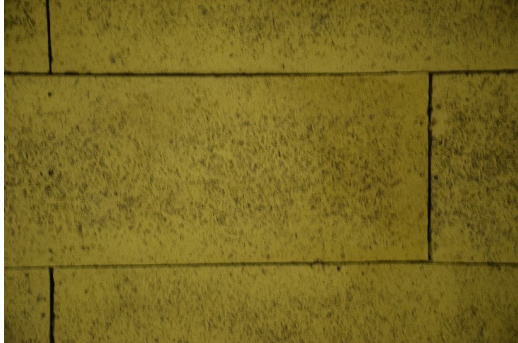
Active ingress of water in form of stains (dry/ active)

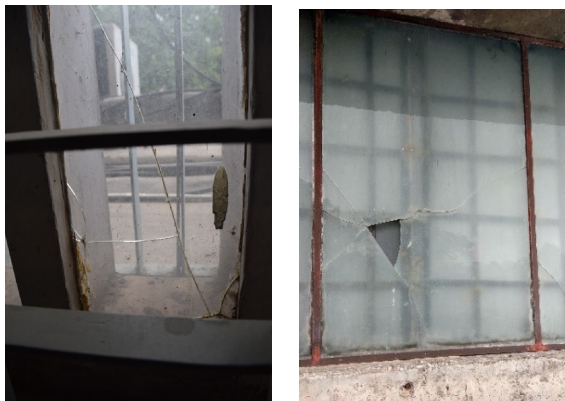
Damaged due to mechanical action or impact <i>[Cracked or broken glass]</i>

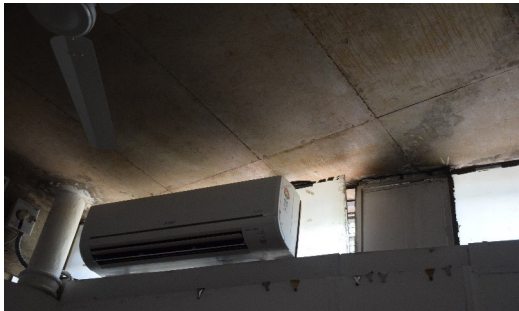
Slight shift or change of brick tile from its original location	+ -
PAST REPAIRS AND MAINTENANCE

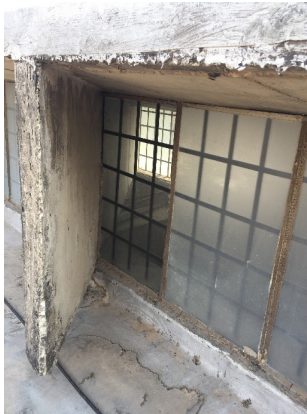
Interventions undertaken in the past to repair or modify that have altered original character and are sometimes carried out with incompatible materials <i>(Addition of clear glass instead of tinted glass)</i>

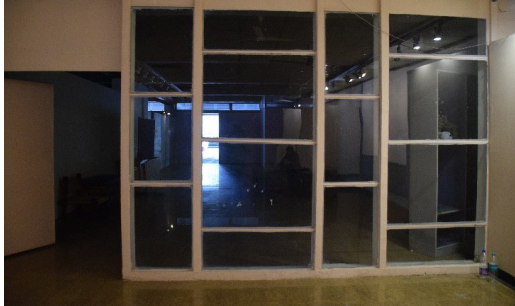
Addition of new material to replace original. May include demolition/ removal of original to incorporate new additions <i>[Addition of new glass in undulatory windows]</i>

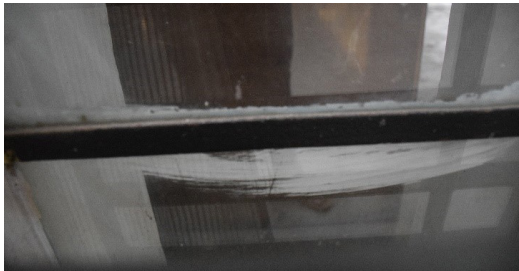
Accumulation of extrinsic material like paint and cement splashes, residues from repairs, graffiti

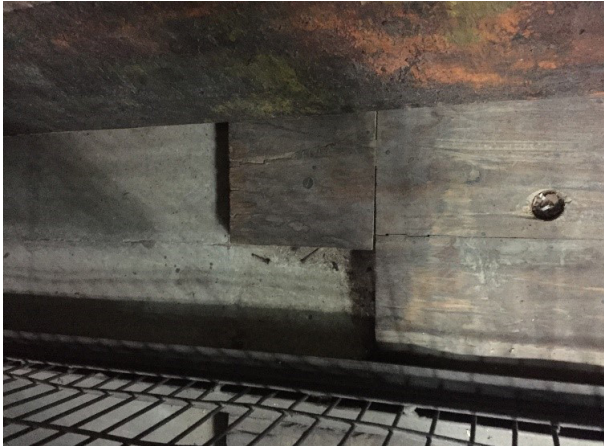
<p>Loss of compositional material creating a void, either by erosion, water or mechanical damage</p>

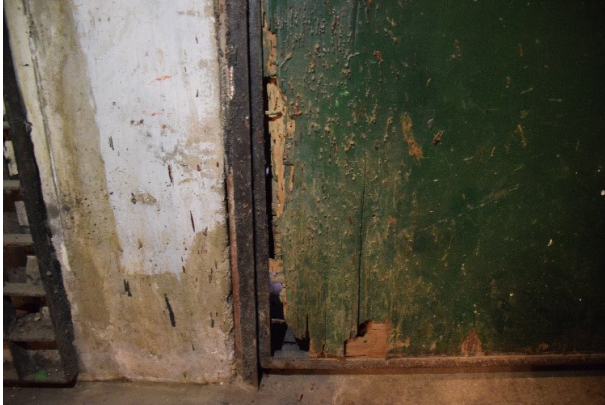
<p>Damaged due to mechanical action or impact</p> <p><i>[cracked or broken wooden door shutters]</i></p>

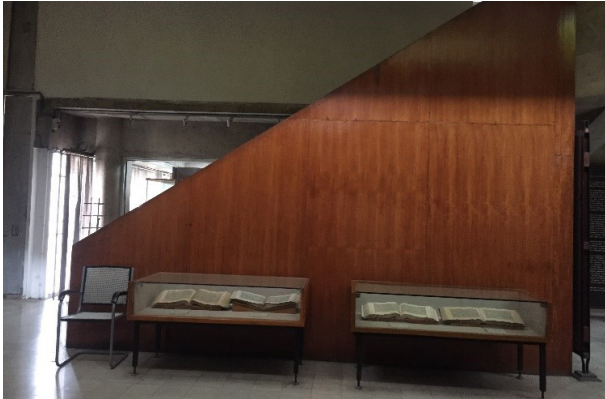
<p>Addition of new material to replace original. May include demolition/ removal of original to incorporate new additions</p> <p><i>[Addition of new wooden casing around staircase railing]</i></p>

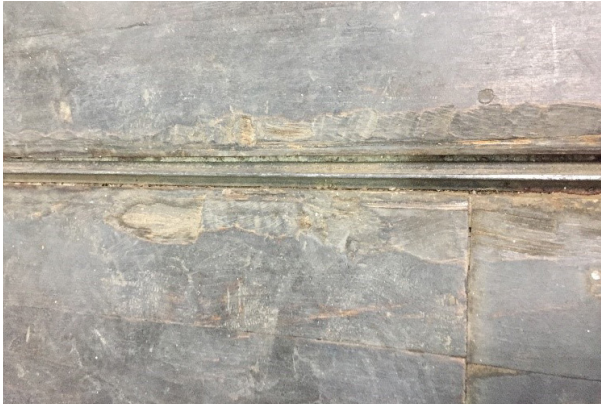
<p>Surface erosion or loss of original finished surface</p>

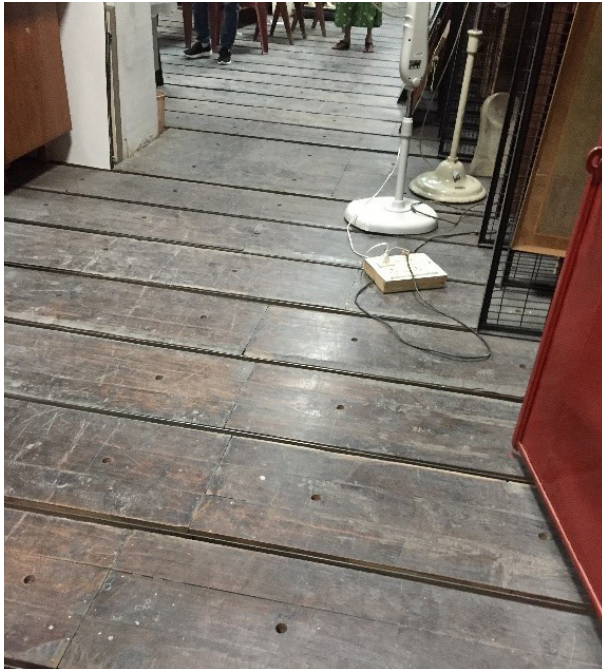
Loss of paint, polish and exposing the inner layer

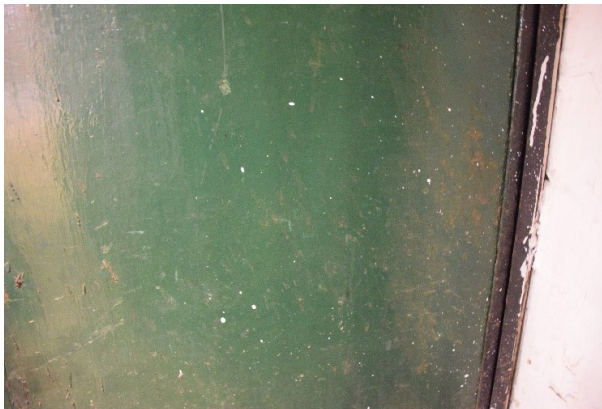
Accumulation of extrinsic material like paint and cement splashes, residues from repairs, graffiti

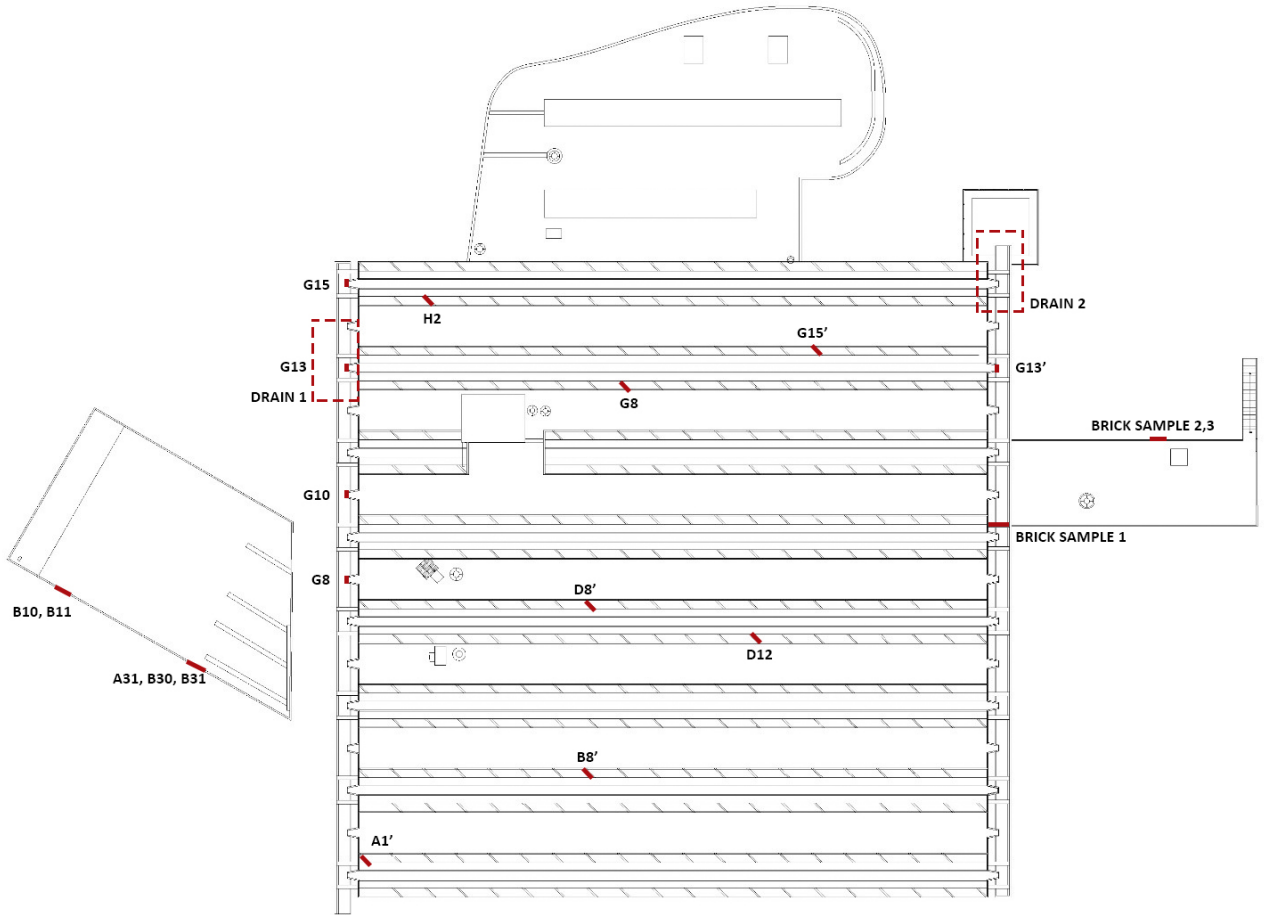
Fig. 231: Sample location for material testing of Concrete and Brick - Terrace level

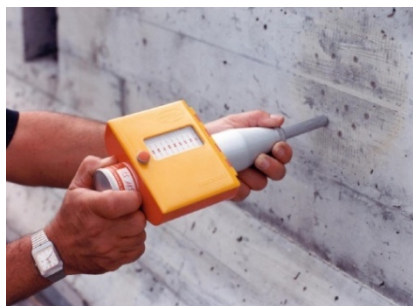
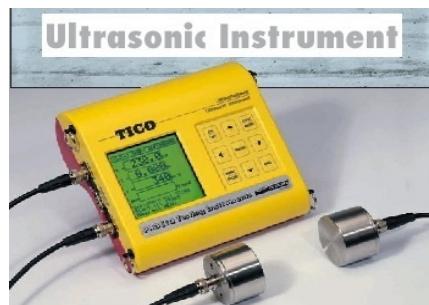
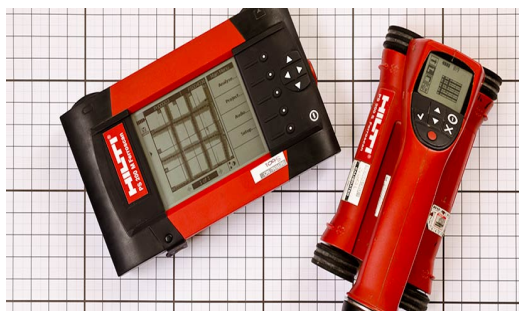
REBOUND HAMMER, ULTRASONIC PULSE VELOCITY TESTS, FERROSCANNING, CARBONATION AND CHEMICAL ANALYSIS FOR

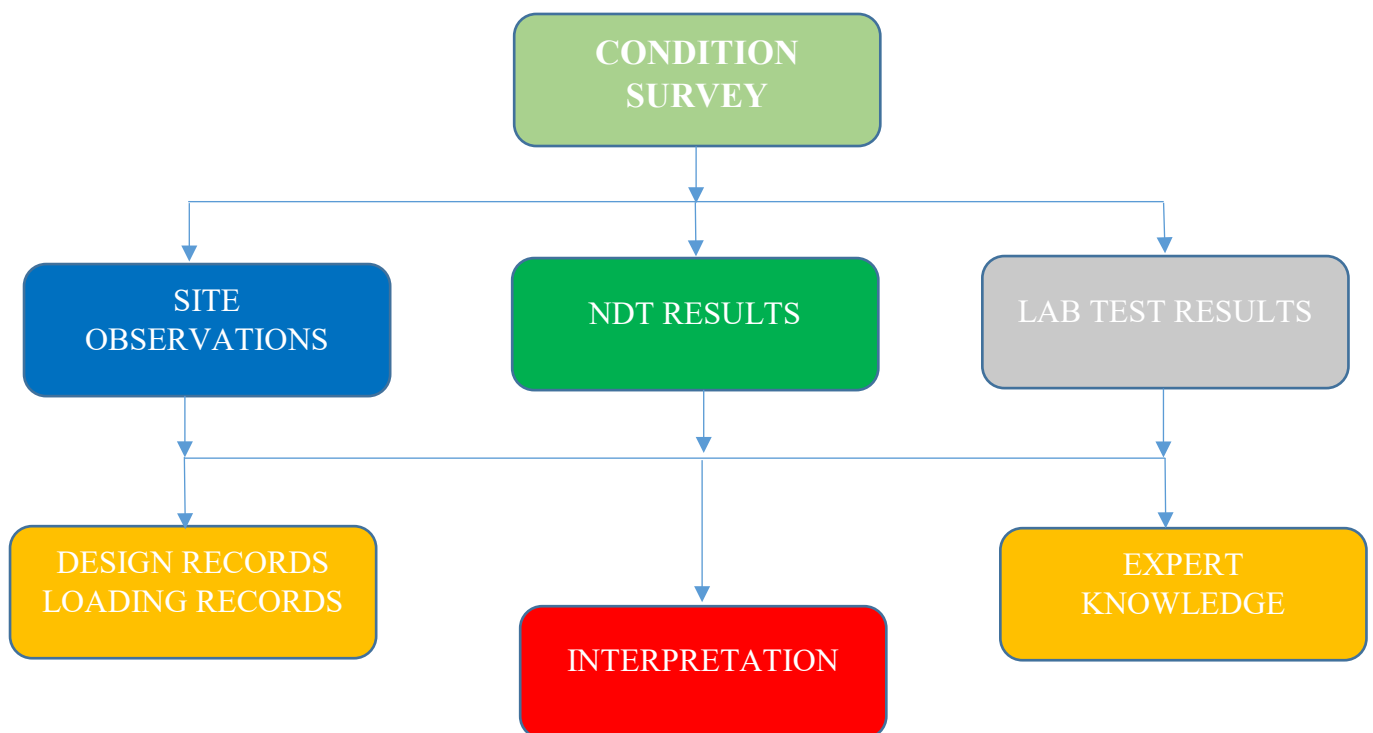
2.3 Physical and Mechanical Inspection

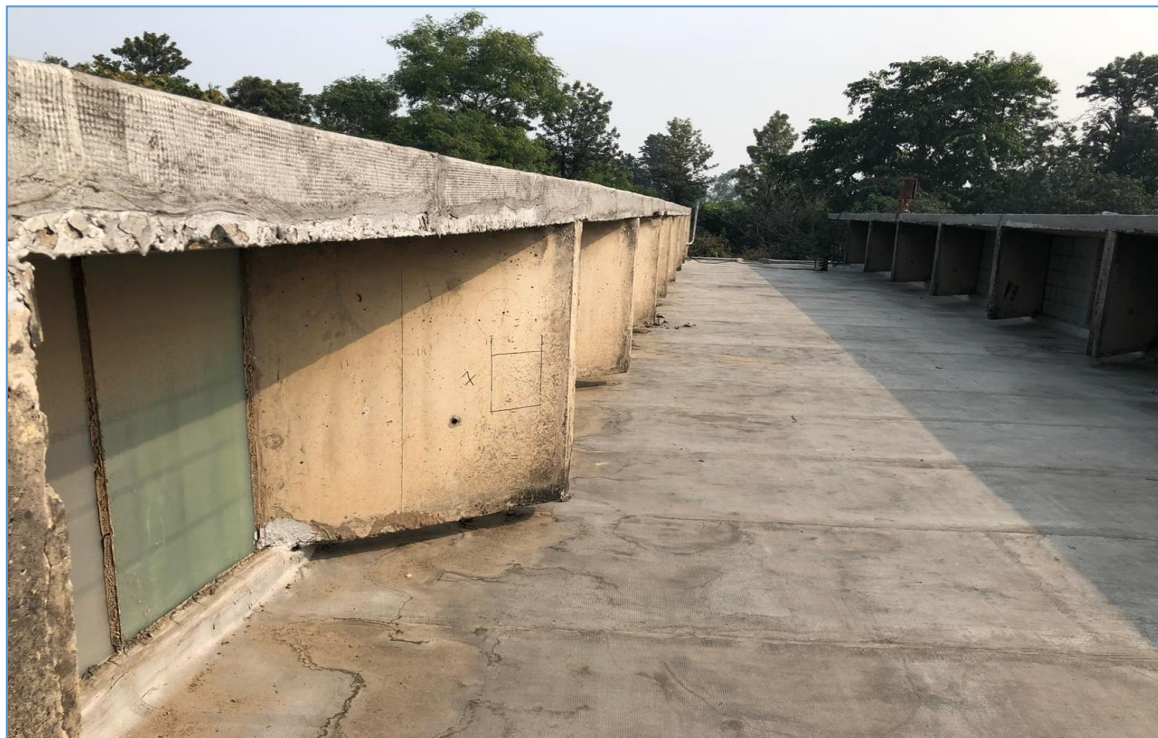
Figure 2 Extended fins at roof top of the building.

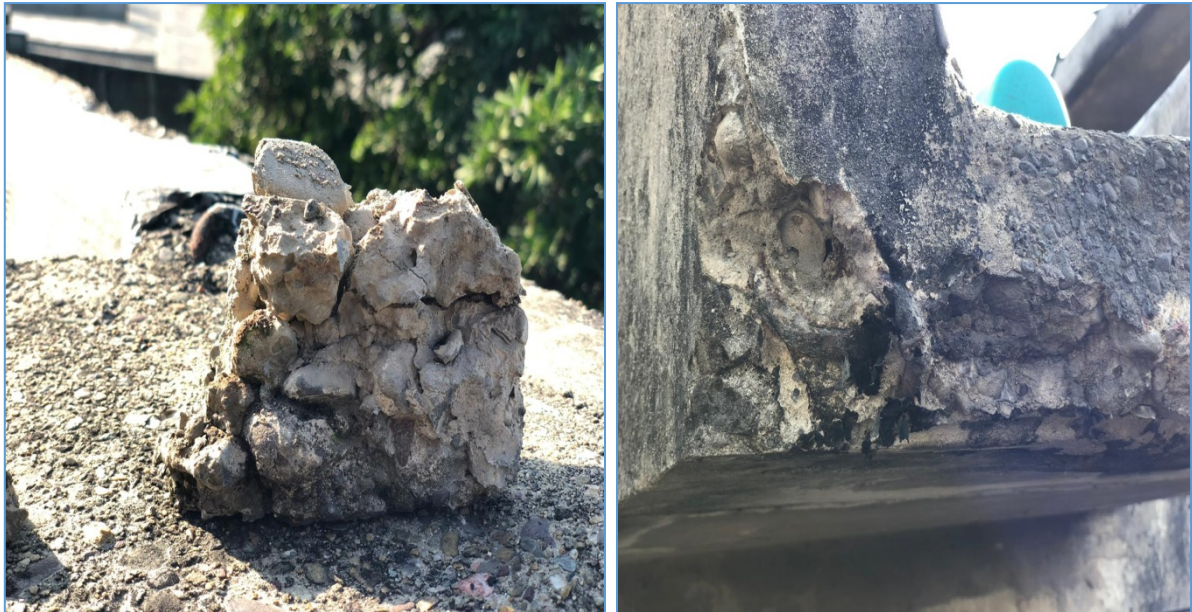
Figure 7 loose concrete fallen down just by light tamping with hammer

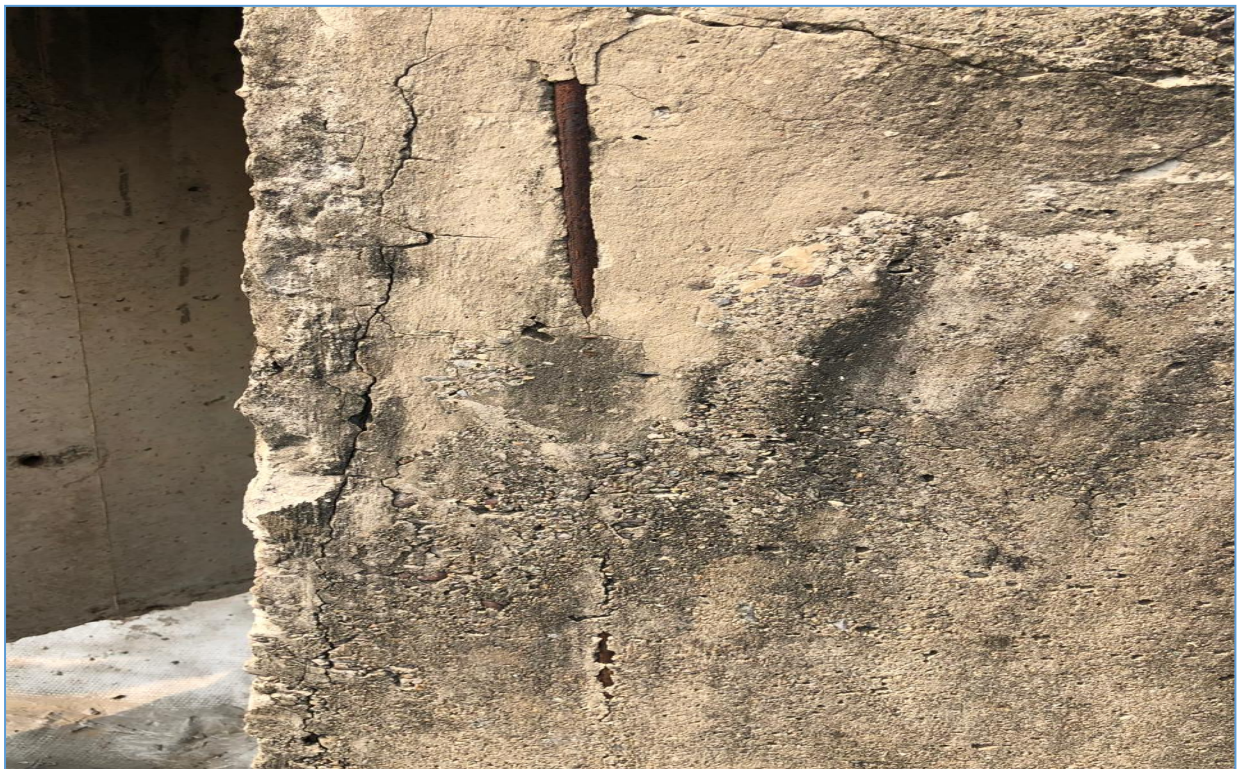
Figure 8 Exposed reinforcement bar leads to corrosion of reinforcement, resulting in cracks & spalling of concrete.

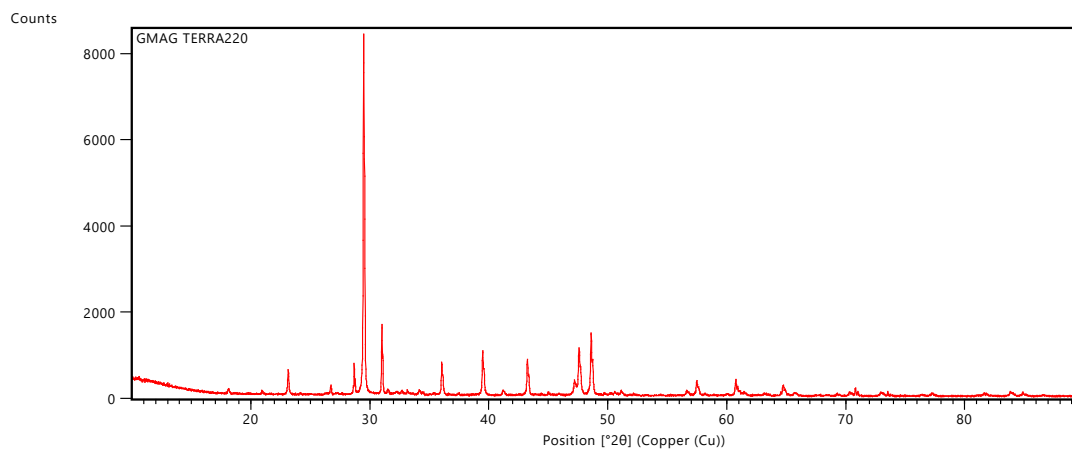
Measurement Conditions: [\(Bookmark 1\)](#)

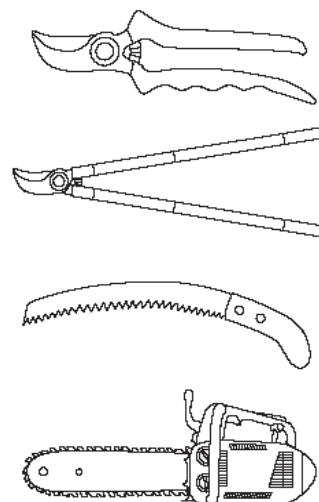
- Hand pruning for small branches, up to about ½ -inch diameter.
- Loppers or a saw for larger branches or for species with hardwood.
- Long-handled loppers to remove larger-diameter branches, but precise cuts are more difficult to make.
- Newer blade designs are able to cut large and small diameter branches quickly and cleanly. Pruning saws are available with fixed or folding blades, or mounted on a pole. Larger pruning saws are sometimes used by professionals.
- Chainsaws are not recommended for general pruning, except by professionals as a time saver.

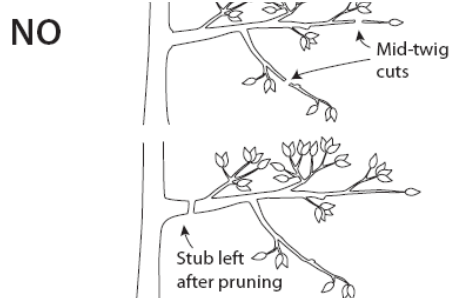
Do not leave a stub. Do not cut in the middle of a branch or twig. Pruning in this manner creates entry points for decay and pests.

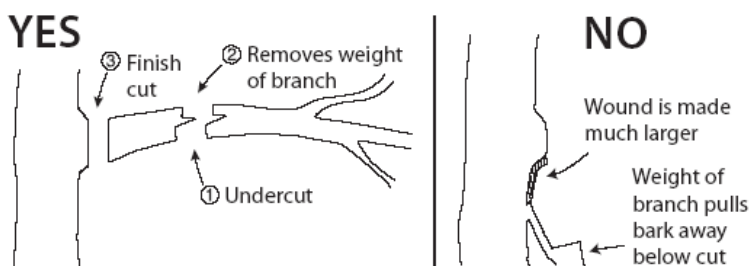
C.1.5 Saving branch collars

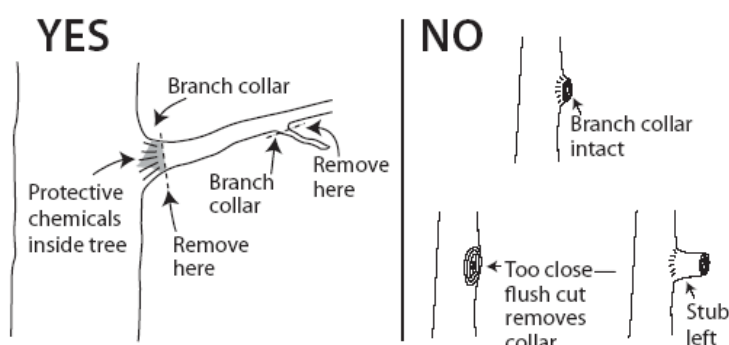
C.1.6 Degree of pruning

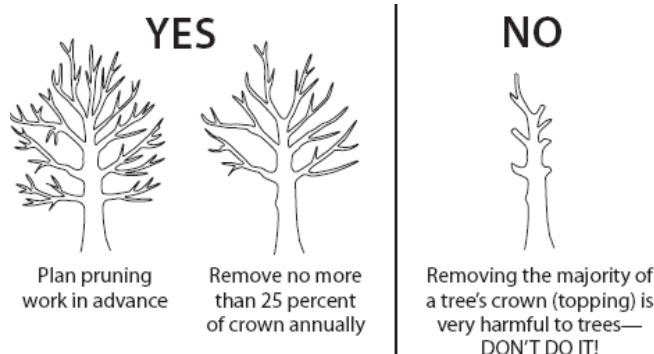
- The older and larger a tree becomes, the less energy it has in reserve to close wounds and defend against decay or insect attack. The pruning of large mature trees should be limited to removal of dead or potentially hazardous limbs.
- Weak or declining trees should be pruned still lesser.
- Severe pruning is absolutely undesirable as it may stimulate undesirable sprouting from the stem or roots.
- Pruning more than 25 percent of the live crown annually of any tree two years in succession should be strictly avoided.
