# The Conservation of Decorated Surfaces on Earthen Architecture

Proceedings from the International Colloquium  
Organized by the Getty Conservation Institute and  
the National Park Service

Mesa Verde National Park, Colorado, USA  
September 22–25, 2004

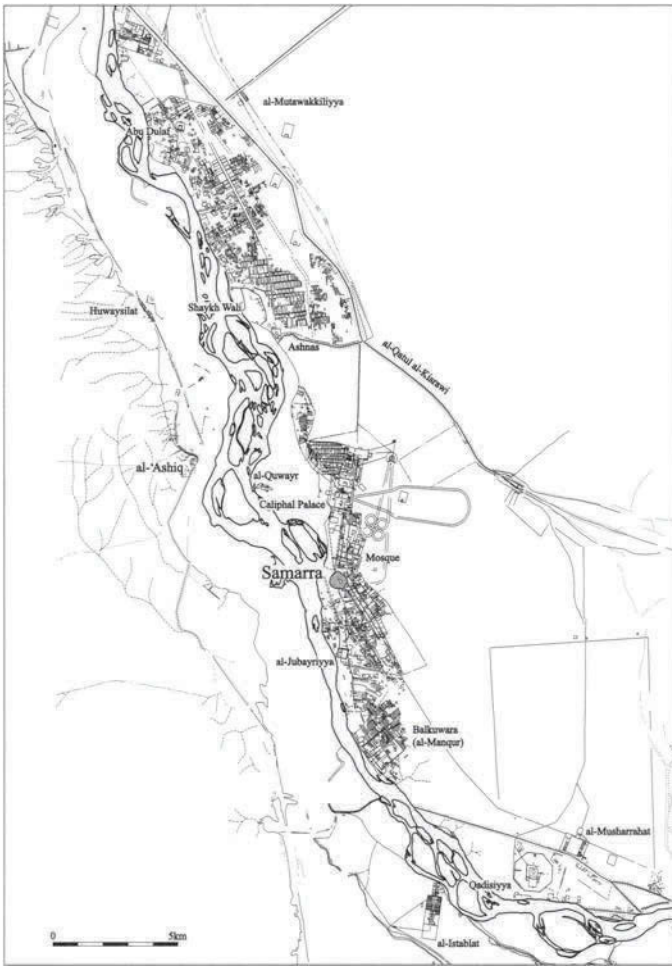
FIGURE 2 Overall plan of the archaeological site of Samarra.

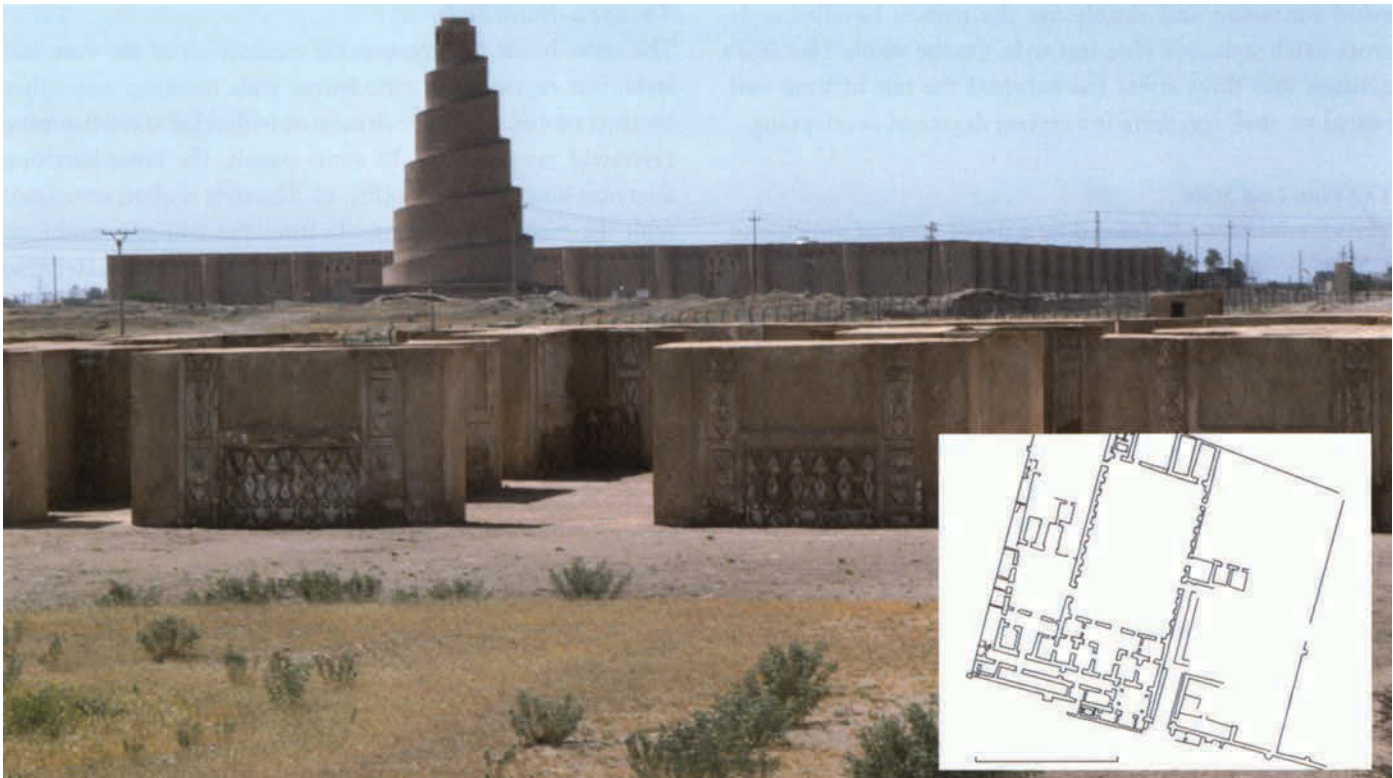
FIGURE 4 Plan and photo of House no. 5 (1983).

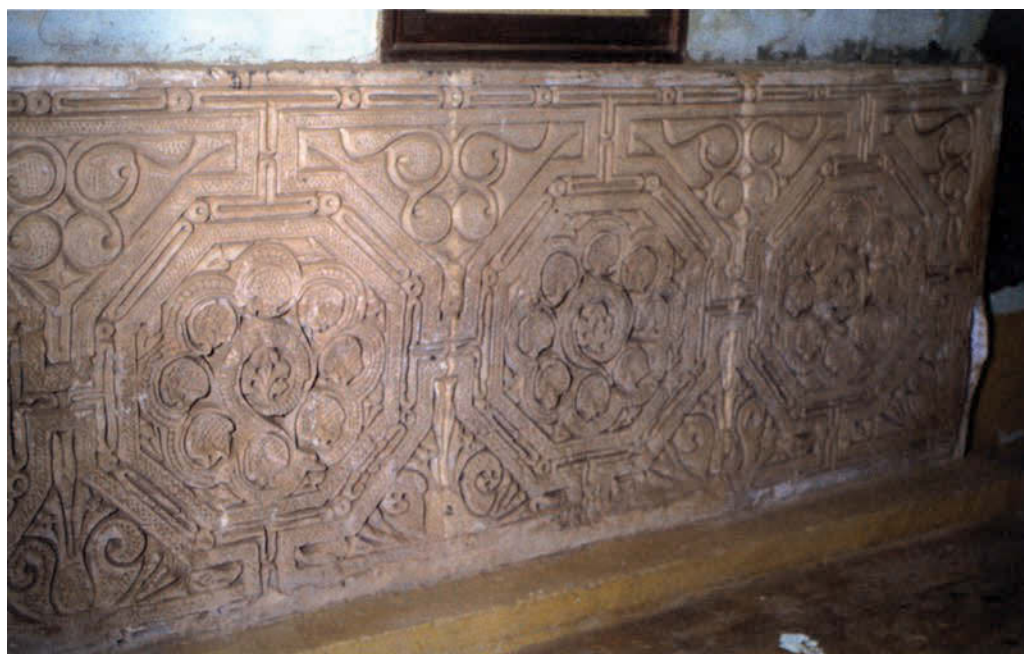
**FIGURE 6** Stucco panel of the cross-hatch style in the Samarra Museum.

The cross-hatch style retains the medallions of the vine-leaf style, but replaces the vine leaves with teardrop and other abstract motifs, which are decorated with relief cross-hatching (Herzfeld 1923: 117–82). In some panels, the cross-hatching degrades into simple dots (Fig. 6). The style is often associated with the vine-leaf style; motifs from the two are combined together in the Bab al-'Amma of the Caliphal Palace (Herzfeld 1923: 257–59). By contrast, it is not known before Samarra. Whereas vine leaves can be described as originating in classical or Middle Eastern art, the cross-hatch style has no known origin in the region. The only idea so far put forward is Dimand's, who proposed sources in Indian temple art, which can only be described as quite distant (Dimand 1952). More work is required on this subject.

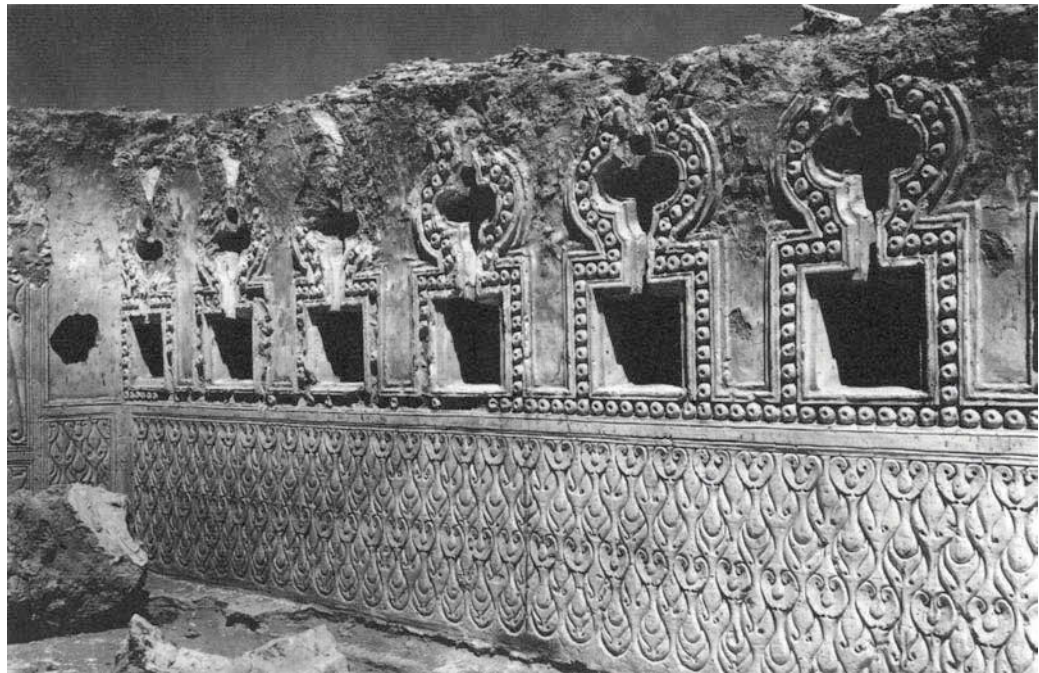
**FIGURE 7** Bevelled-style façade as excavated in the Balkuwara Palace. Courtesy of Staatliche Museen zu Berlin – Museum für Islamische Kunst, Photo no. Sam 249. Photo: Ernst Herzfeld, 1911/12.

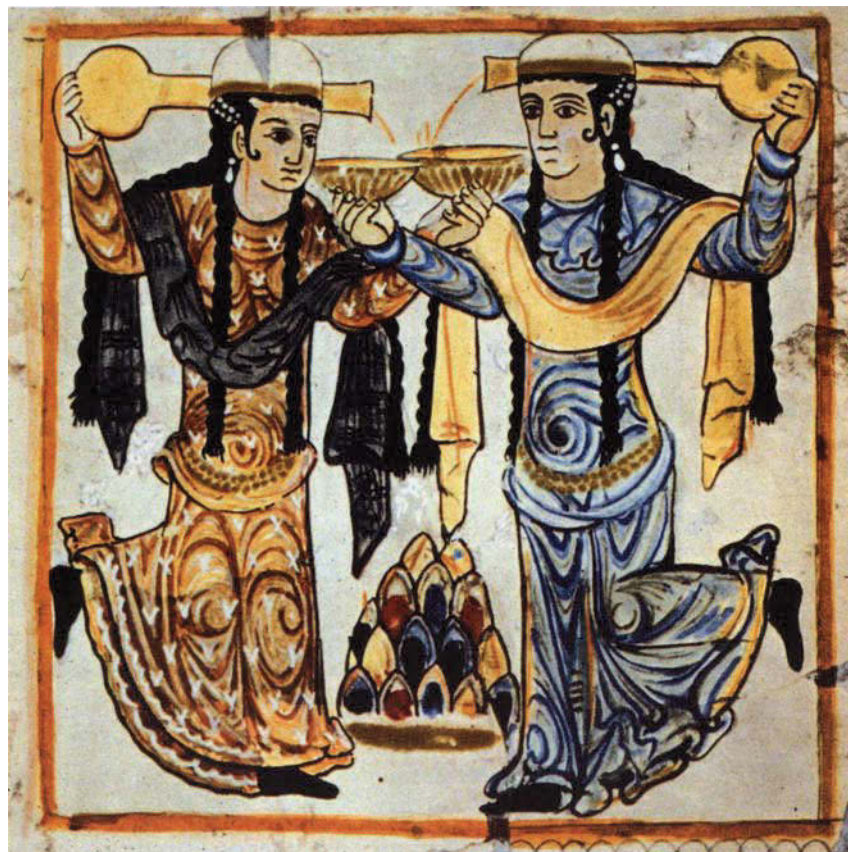
**FIGURE 8** Watercolor reconstruction of the painting of two wine-pourers from the “Harim” of the Caliphal Palace. (Source: E. Herzfeld, 1927, *Die Ausgrabungen von Samarra* 3, *Die Malereien von Samarra* [taf. ii] Berlin.)

Wall painting is relatively rare at Samarra, being found only in parts of the Caliphal Palace, notably the so-called Harim, and in five houses (Herzfeld 1927; DGA 1940: figs. 46–53). The paintings have all been found as fragments in the rubble, through collapse of walls and, often, later robbing of the bricks. Only one panel was partially preserved in situ, in House no. XIII of 1911 (Herzfeld 1927: taf. lix). There is one case of nonfigural painting, in House no. 4 of 1936 (DGA 1940:

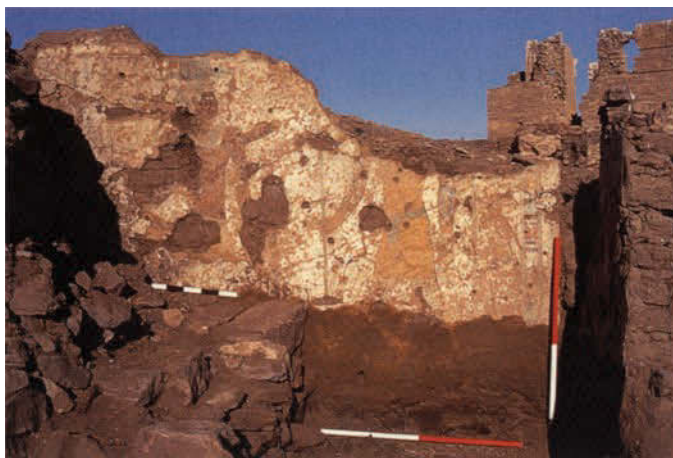
**FIGURE 1** The Taharqo temple during excavation work in 2000. Note the waterline and mud deposit on the lower portion of the painting. The remains of the east wall are on the right of the photo, and the apse of the church is still in situ in front of Taharqo's legs. Courtesy of the Egypt Exploration Society.

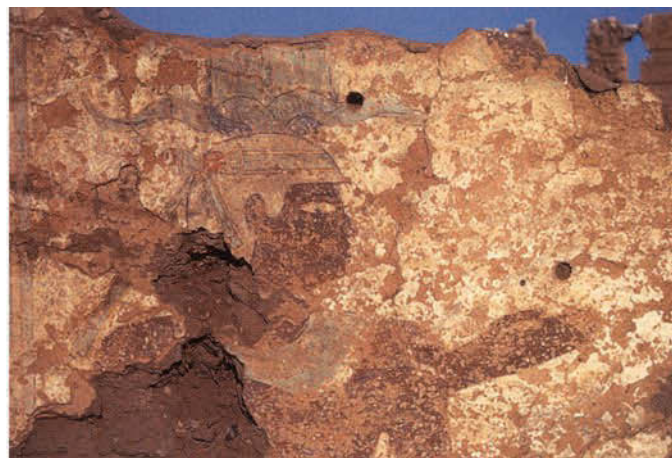
**FIGURE 2** The upper portion of the image of Taharqo (2000). The stratigraphy of the preparation can be seen in the damaged portions of the painting. Part of the eighth-century cathedral is visible over the top of the wall, at the top-right corner of the photo. Courtesy of the Egypt Exploration Society.

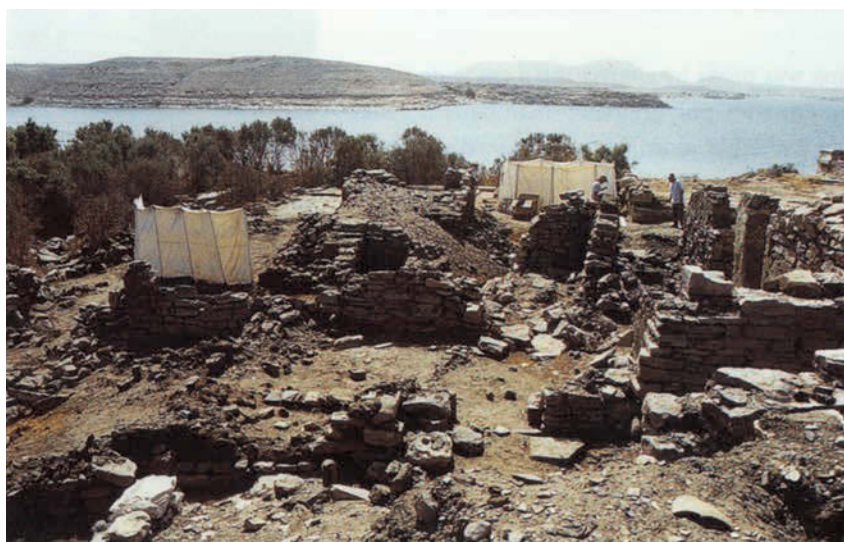
**FIGURE 3** The site of the Taharqo temple is located between the two windbreaks (February 2003). Note the vegetation encroaching where water covered the site in 1998. Courtesy of the Egypt Exploration Society.

The dampness of the soil as a result of the earlier high level had encouraged vegetation, especially acacia bushes, to become established on the site, particularly in the area around the Taharqo temple. There the thick layer of mud from the dissolution of the walls has proved an exceptionally fertile base. These plants' root systems continue to draw up moisture into the soil.

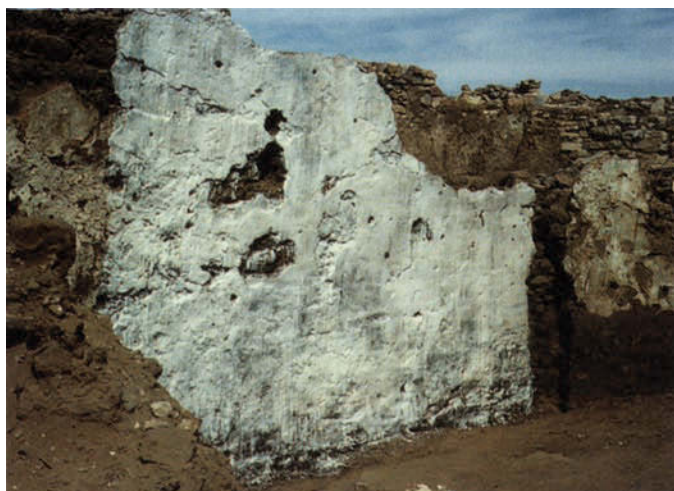
**FIGURE 4** The section of wall painting to be removed has been consolidated and received its first coat of cyclododecane (February 2003). Gauze bandage was incorporated into the second, facing layer of CDD to fill in or cover the missing areas. Courtesy of the Egypt Exploration Society.

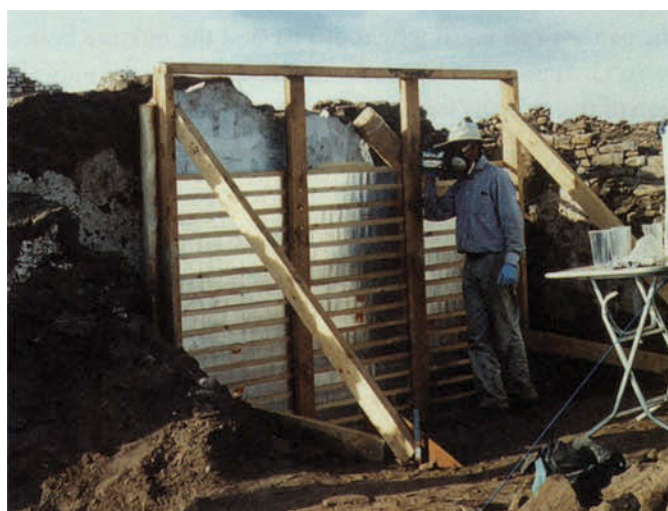
**FIGURE 5** The rectangular timber frame in place, supported by an A-frame at each end (February 2003). The process of building up the shuttering and pouring in the polyurethane foam is two-thirds complete. Courtesy of the Egypt Exploration Society.

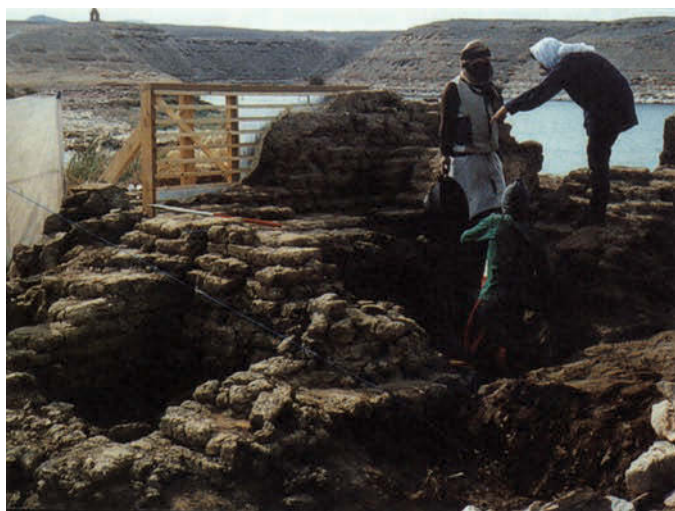
**FIGURE 6** Dr. Rose supervises the partial dismantling of the north wall, which supported the wall painting (February 2003). A corner of the support frame can be seen behind the wall. Note the thick mud-brick walls and multiple phases of building. Courtesy of the Egypt Exploration Society.

Recording and dismantling the mud-brick structure directly behind the framed section of wall painting now commenced (Fig. 6). The bricks were laid in alternating layers of headers and stretchers, with layers of woven *halfa* grass “matting” between every four courses. The matting consisted of

*halfa* grass culm bases that were connected by a single line of palm fiber string woven around them.

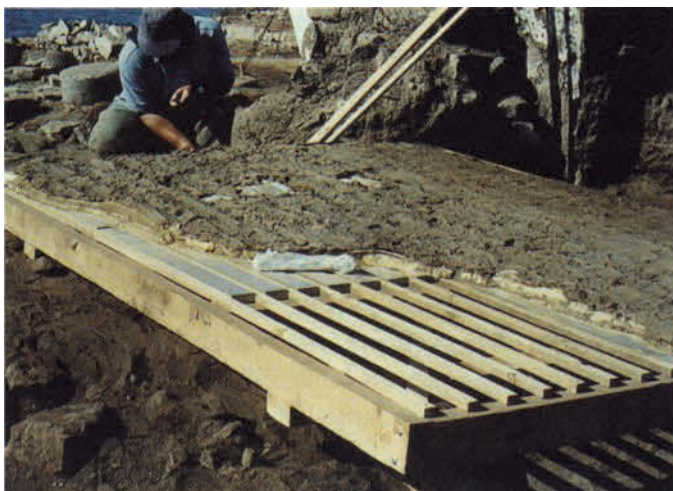
**FIGURE 7** The frame and wall painting having been lowered facedown onto the ground (February 2003). Courtesy of the Egypt Exploration Society.

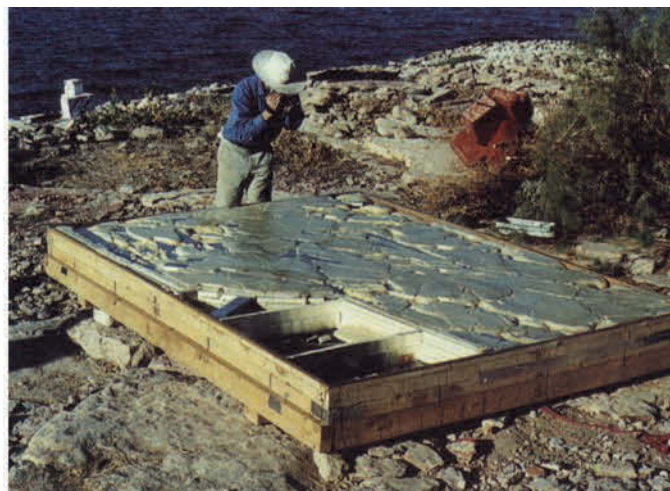
**FIGURE 8** The frame and wall painting with its temporary backing, designed to sandwich the wall painting while in transit (February 2003). The timber mold constructed around the edges of the plaster can be seen. A foil barrier was created on the plaster, and several pours of polyurethane foam cast into the back. The plywood lid, which had been used to contain the foam during casting, was then screwed on to complete the packing process. Courtesy of the Egypt Exploration Society.

Once in position and leveled, the mold was adjusted to the actual (nonrectangular) shape of the painting, and then sealed. To perform the casting, we used polyurethane foam in 1.5 L batches (Fig. 8). A polyethylene sheet separator and plywood lid were screwed into position as each batch of resin foamed and cured. The offcuts from the polyurethane foam battens were included in the void to ensure there was sufficient foam to complete the backing. On completion of

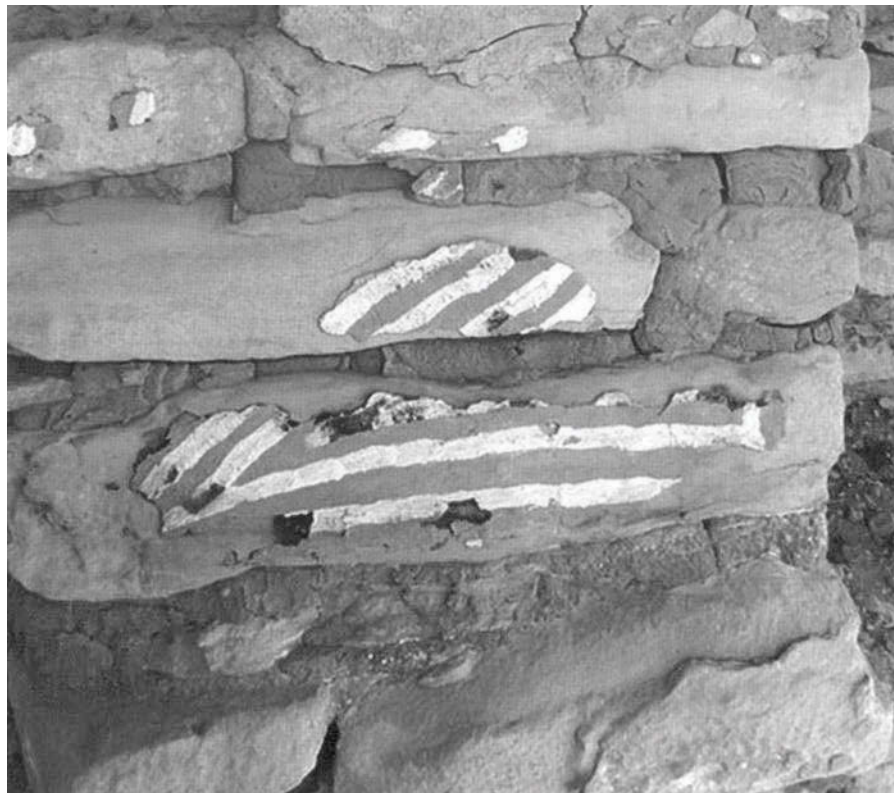
**FIGURE 1** The advanced deterioration of a kiva pilaster in Kodak House is attributed to its exposure to an outside environment. The surface finishes on this interior architectural feature were exposed to weathering after the roof of this kiva collapsed. Courtesy of ASCP Digital Archives, Mesa Verde National Park. Photo: Laurel Casjens.

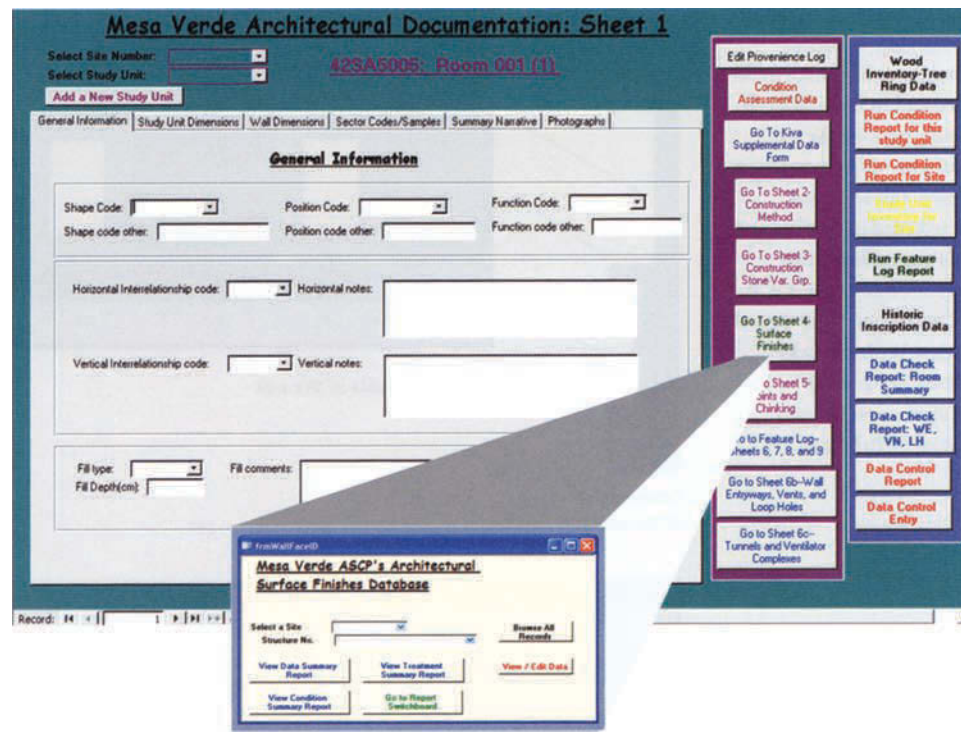
**FIGURE 2** The introductory data entry screen for the ASCP database. A link to the surface finish preservation module is highlighted. Courtesy of ASCP Digital Archives, Mesa Verde National Park. Database designed by Cynthia Williams and Rebecca Carr. Graphics by Rebecca Carr.

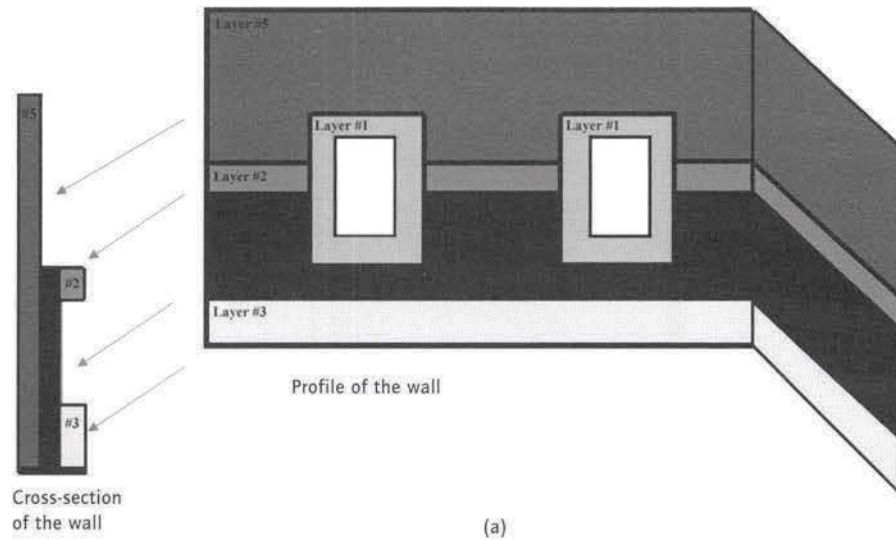
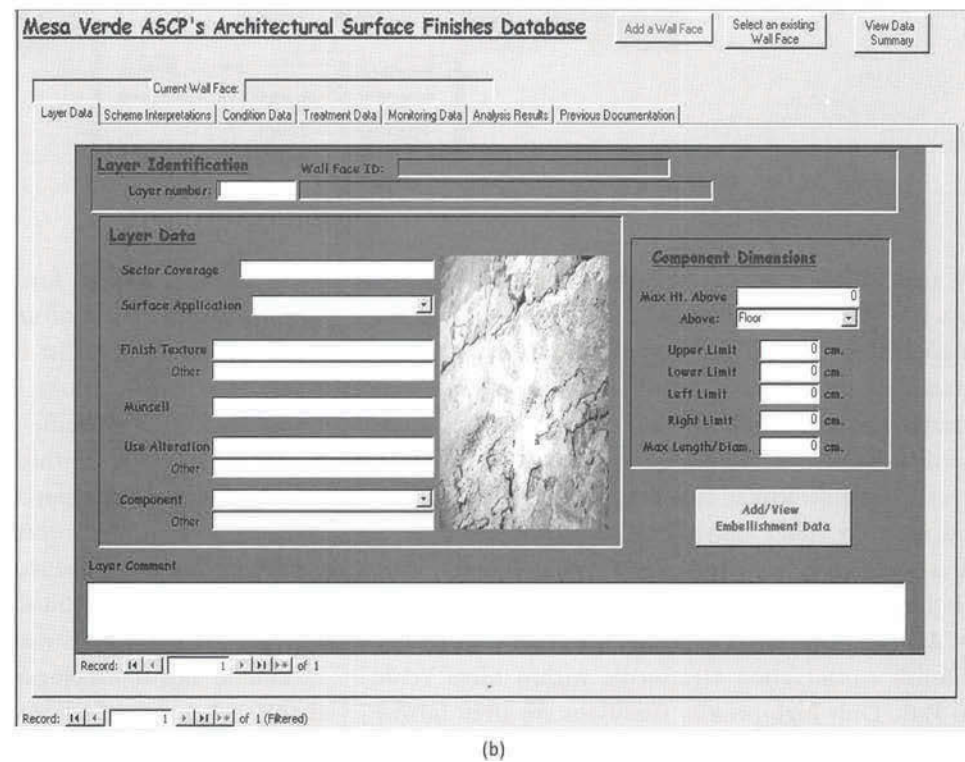
**FIGURE 3** (a) Numbering sequence for the stratigraphy of surface finishes. Each layer of surface finish is numbered and recorded according to its placement on the wall. (b) Data relating to the application method, color, and schematic design are recorded in the field and entered into the surface finish preservation module of the ASCP database. Courtesy of ASCP Digital Archives, Mesa Verde National Park. Database designed by Cynthia Williams and Rebecca Carr. Graphics by Rebecca Carr.

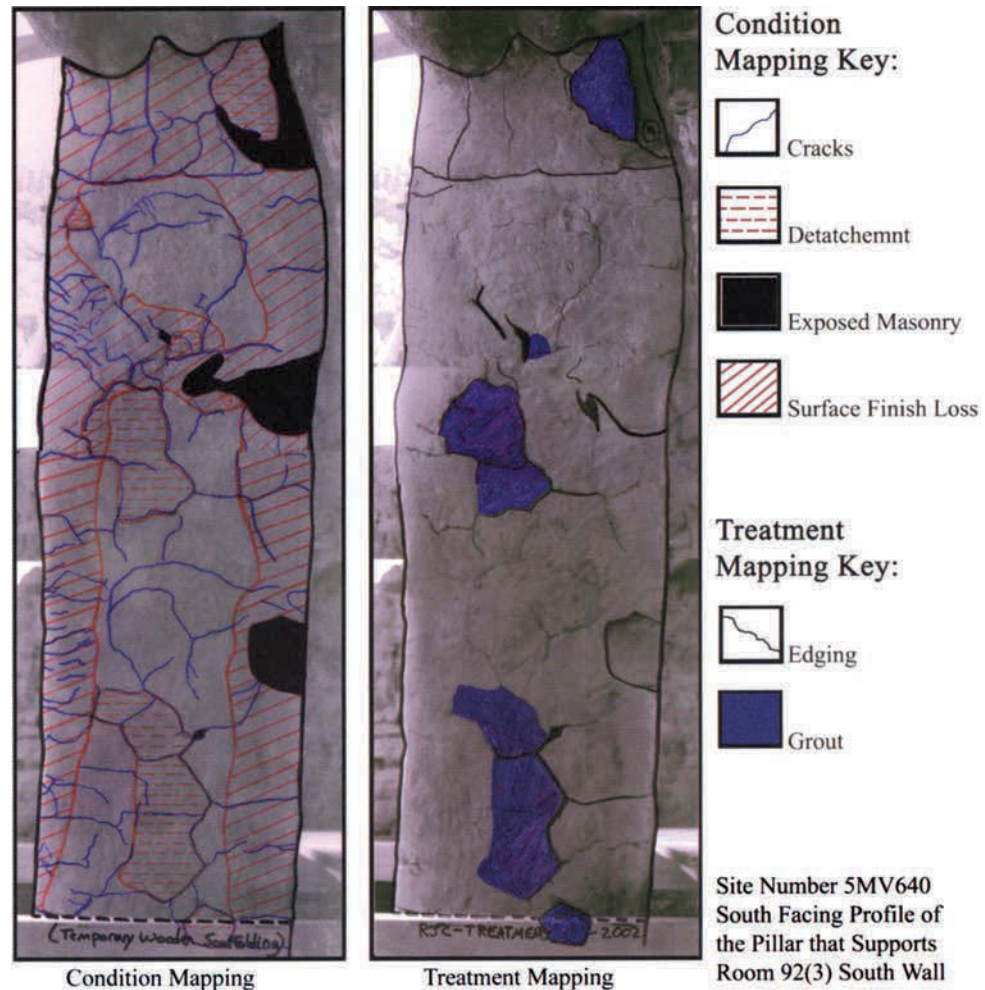
**FIGURE 4** Documentation for a stabilization treatment conducted at Spruce Tree House in 2002. Before treatments are administered, architectural conservators conduct a graphic assessment of architectural condition. This example of a photographic montage is overlaid with condition and conservation treatment documentation. Courtesy of ASCP Digital Archives, Mesa Verde National Park. Documentation and graphics by Rebecca Carr.

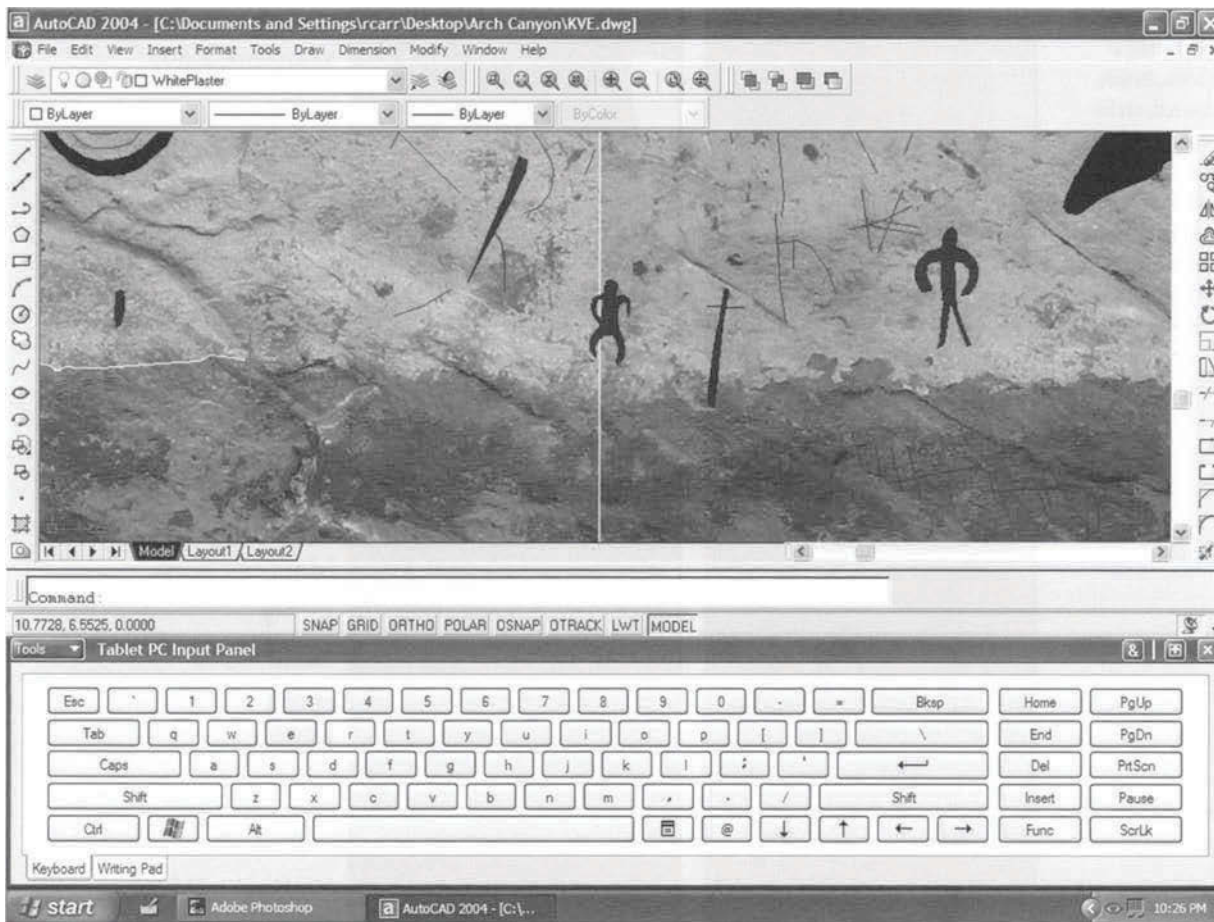
**FIGURE 5** Graphics tablet PC screen from the laptop computer used to digitize documentation of surface finishes while working in the field. Graffiti and historic iconography are outlined using AutoCAD 2004. Courtesy of ASCP Digital Archives, Mesa Verde National Park. Documentation and graphics by Rebecca Carr.

architecture. It also becomes a monitoring tool to quantify the factors that lead to surface finish deterioration. As a graphic supplement to the more traditional forms of photographic documentation, this method also enables researchers to document painted iconography at a higher level of detail (Fig. 5).

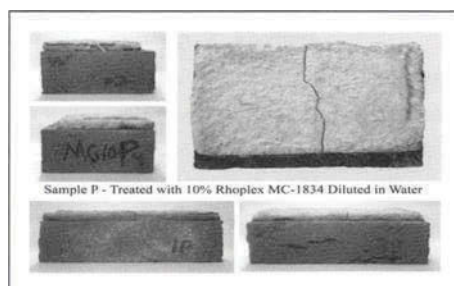
**FIGURE 6** Materials testing such as this accelerated weathering experiment can aid architectural conservators in their understanding of surface-finish-deterioration phenomena and potential treatment methods. Courtesy of University of Pennsylvania Department of Historic Preservation. Documentation from the master's thesis of Rebecca Carr.

within the ASCP surface finishes module is to compile data collected through prior surveys and to supplement this data with materials testing. Analysis of original building materials contributes to the assessment, documentation, and treatment recommendations for this resource. Examples of materials analysis include scanning electron microscopy (SEM), petrographic analysis, X-ray diffraction (XRD), X-ray fluorescence (XRF), particle size distribution, pH, soluble salt content, electrical conductivity, water vapor transmission rate, porosity, permeability, and accelerated weathering of facsimile surface finishes (Fig. 6; Carr 2002).

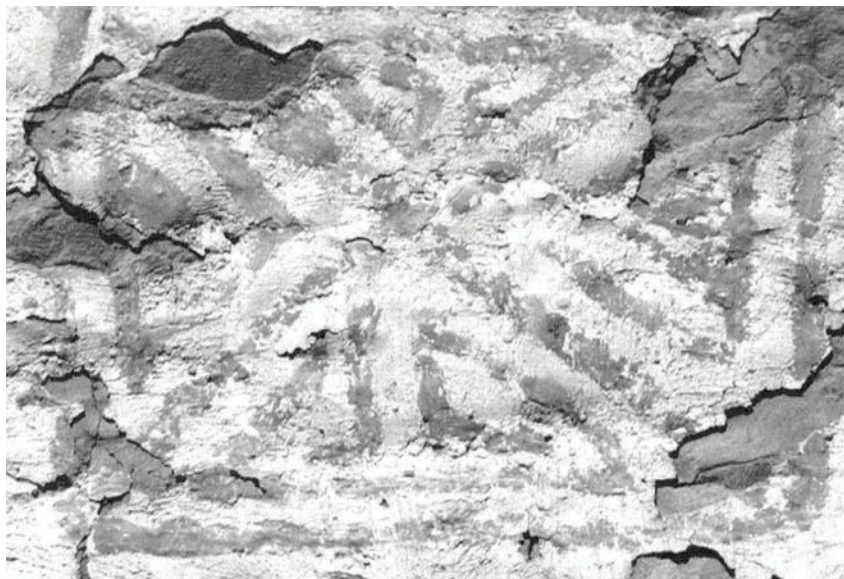
**FIGURE 8** This iconographic design adorns the north wall of Room 116 of Spruce Tree House. Courtesy of ASCP Digital Archives, Mesa Verde National Park. Photo: Valerie Gomez and Kristin Kent.

To monitor the impacts of site visitation and assess the general condition of this site, student interns produced scaled photographic images and documented this resource in its current condition. Room 116 was selected as a priority space for documentation and treatment due to the iconography displayed on its plastered surfaces. Close examination of the interior walls and archival descriptions of Room 116 reveals a complex design consisting of a tan floor band and red dado, both embellished with sets of triangles and dots. A red geometric design adorns the east-facing wall, and archival descriptions reveal the locations where bighorn sheep and other animals once decorated the north wall (Fig. 8). Conservation treatments have been recommended to preserve the paintings in this culturally significant room. The documentation

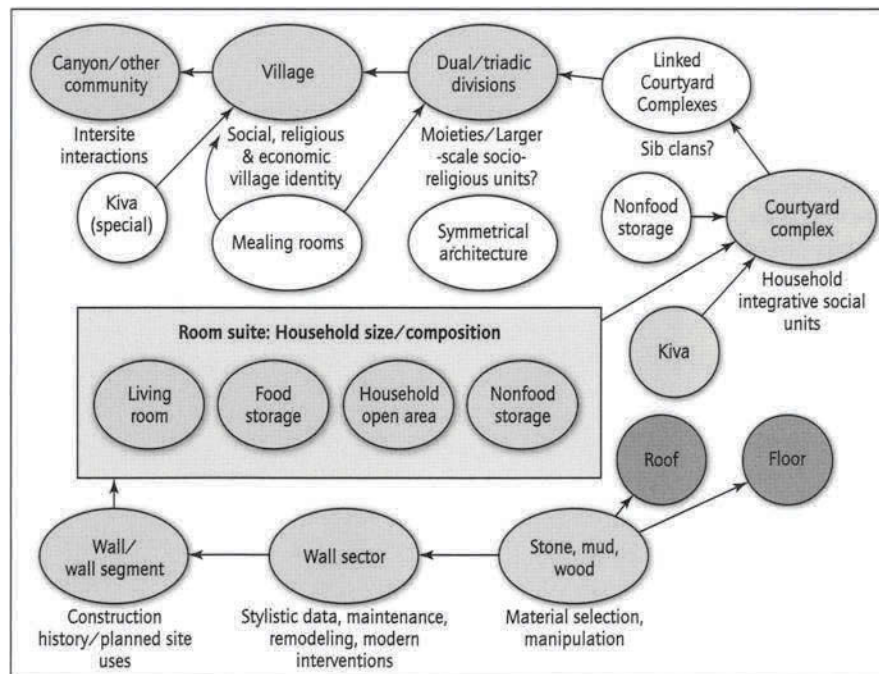
**FIGURE 2** The Hierarchical Social Interaction Model (HSIM) developed during the work at Cliff Palace is applied to explain architectural relationships at other sites at Mesa Verde National Park.

nization of its past residents (Fig. 2). The model is currently being applied at Spruce Tree House (Brisbin 2003) and Spring House (Nordby 2002), as well as at smaller sites in the park. For the purposes of this paper, I will focus on the courtyard complex to facilitate the study of Cliff Palace's (1) architectural units and the social organization that used these various

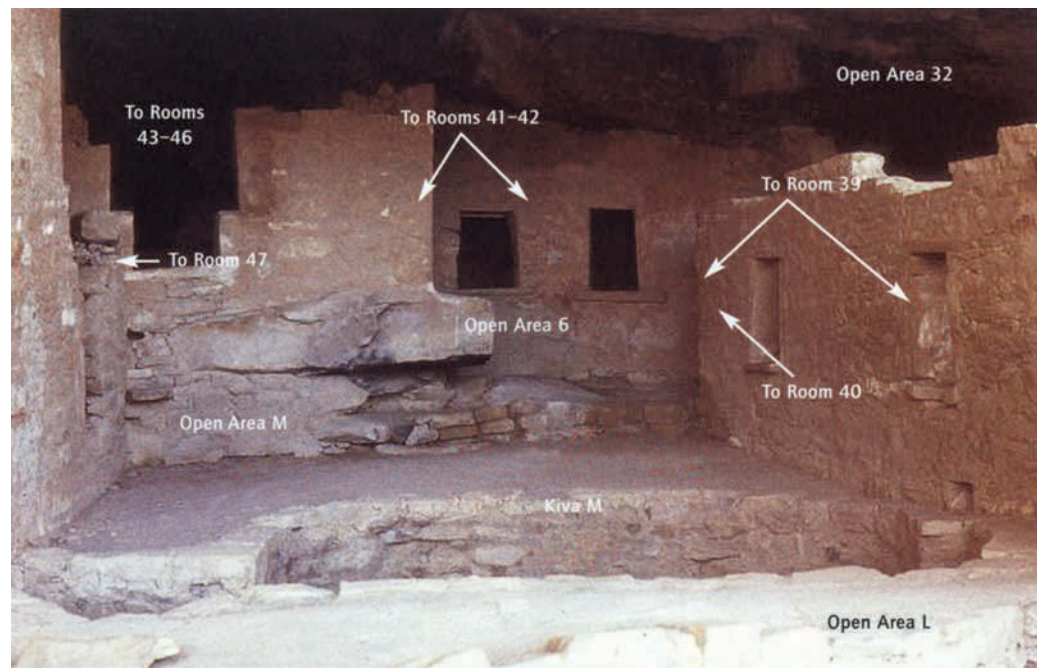
**FIGURE 3** This photograph of Courtyard Complex M shows a kiva and its surrounding rooms. When Kiva M was roofed, the rooms would have opened onto a courtyard or plaza that was used as a gathering space for the clan. The walls of the courtyard would have been plastered white, and the exterior walls of Rooms 39 and 40 were then decorated with a panel of stamped handprints.

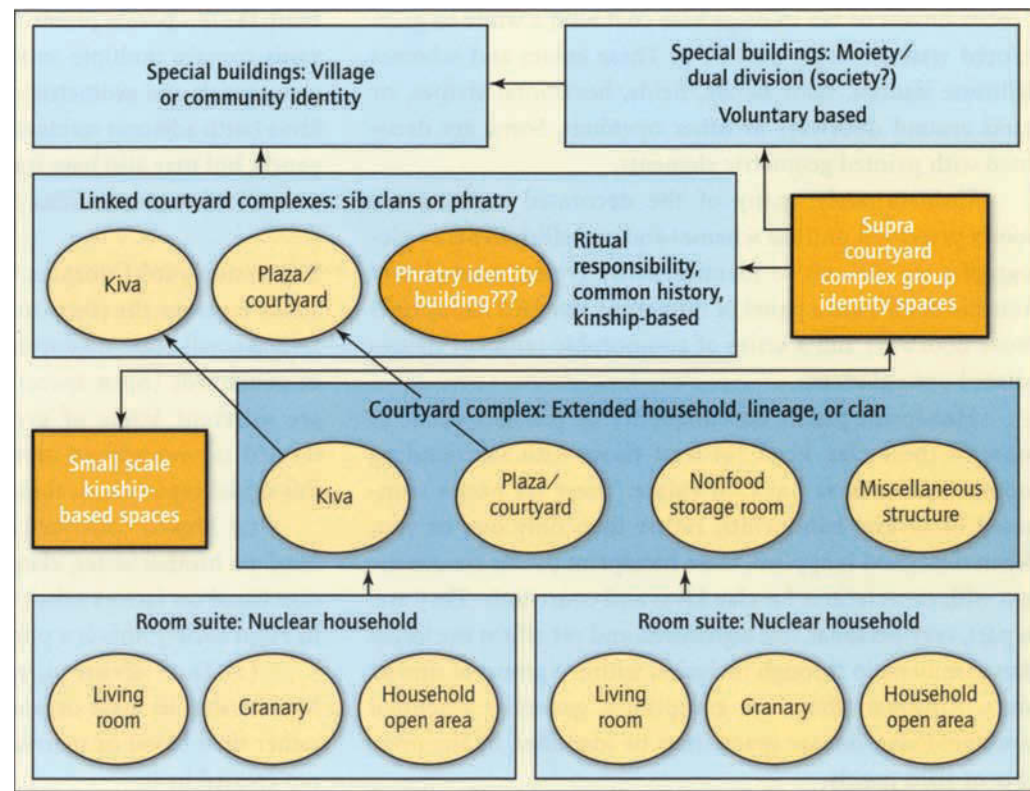
**FIGURE 4** This model depicts a derivation of the HSIM showing the complexity of social structure and architectural units of each. The concept of borrowed buildings is shown by the arrows.

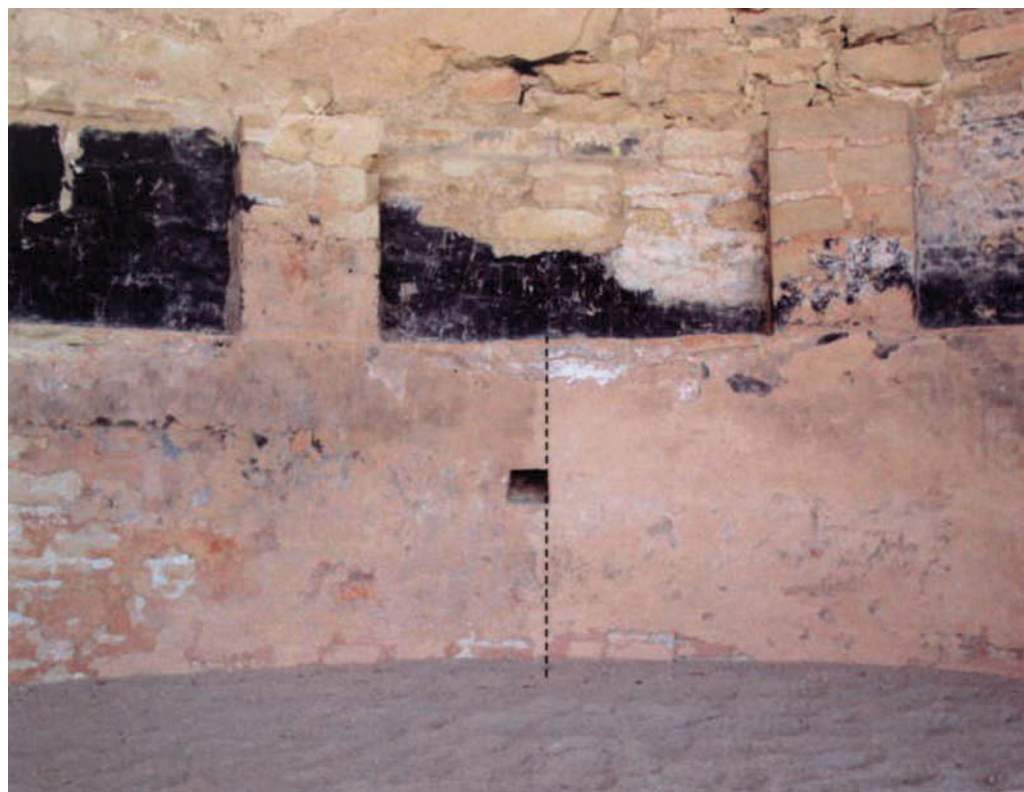
**FIGURE 6** Coupled with the placement of Kiva Q, the symmetrical bichromatic application of plasters (indicated by the dotted black line) probably shows the integration of two social units becoming one. This building may have been the gathering space for dual societies.

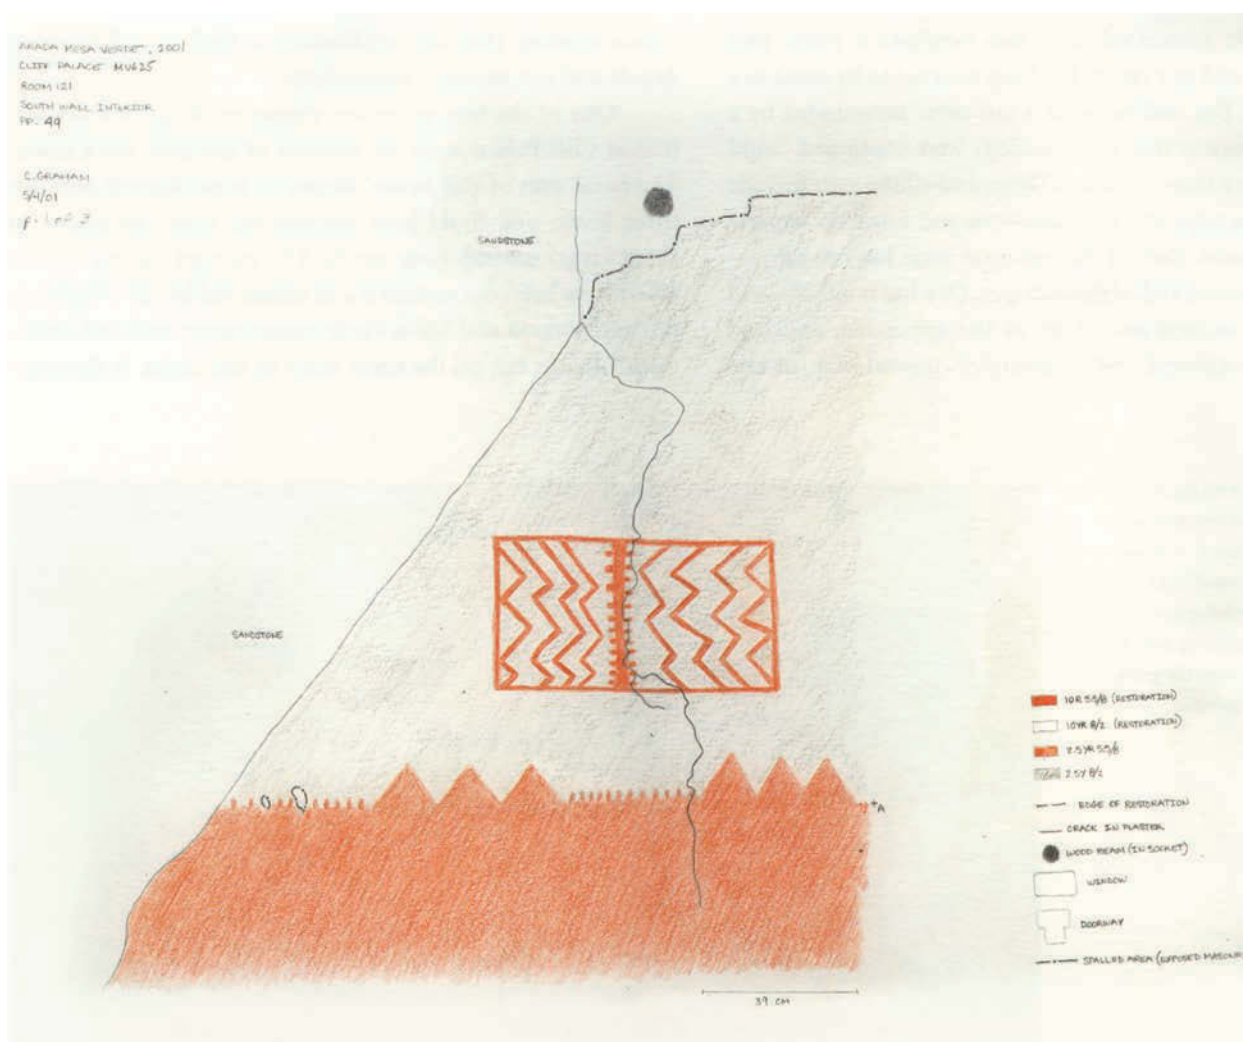
**FIGURE 7** Located in Room 121, this painting resembles a mended blanket and suggests that this building may have served as an integrative space where two societies within the village merged. The dark red dado below, with its multiple contiguous triangle design, is believed to be a signature motif for Mesa Verde culture, even when it occurs in other parts of the Southwest.

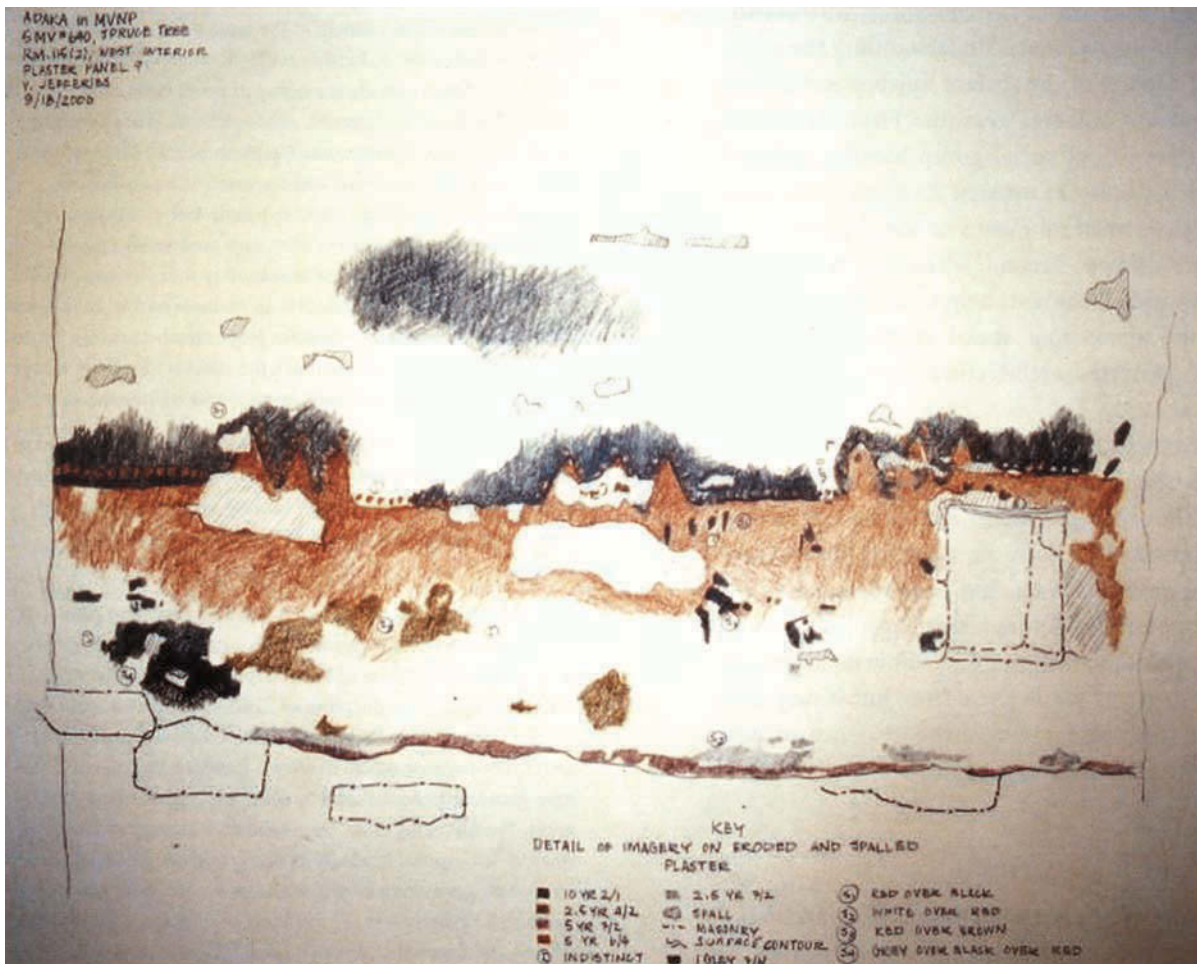
**FIGURE 8** This field drawing of one of the walls in an integrative building in Spruce Tree House shows the dark red dado with sets of three contiguous triangles, adding as well a row of dots above the dado. The wall above the dado has been painted or plastered black. Although the meaning of the multiple contiguous triangles is unknown, some believe that it is a group of mountains, such that the dado represents a skyline with landscape features.

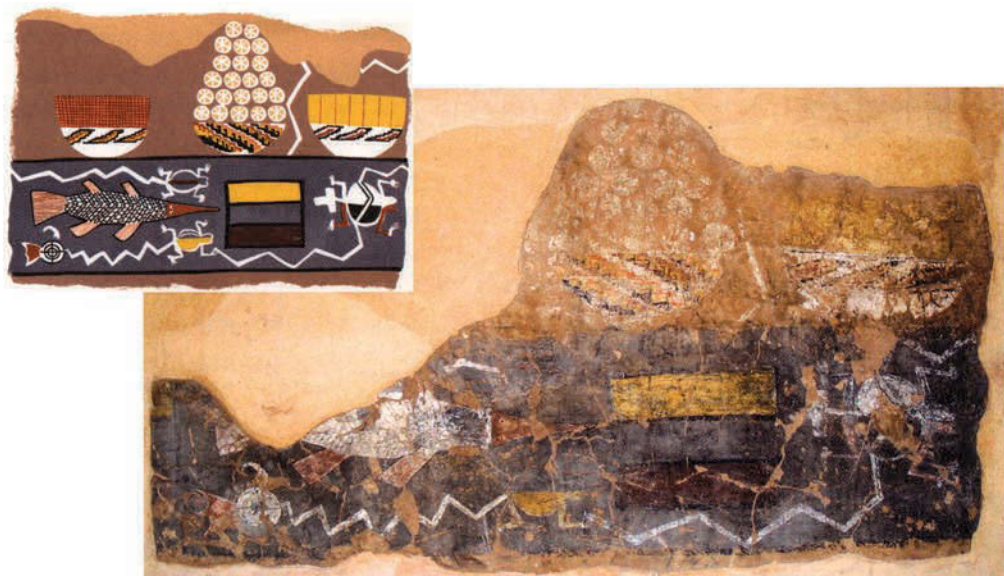
**FIGURE 3** Mural fragment from Kawaika-a (Room 4) after conservation treatment in 2004. This fragment depicts frogs or lizards in various shapes and colors, a fish resembling a pike or gar, lightning, ears of corn, and ceremonial bowls. Inset shows the painted reproduction made from the field notes (2630 NA 1001.R.4.20, Museum of Northern Arizona). Photo: Angelyn Bass Rivera. (Inset reproduced from Watson Smith, *Kiva Mural Decorations at Awatovi and Kawaika-a: With a Survey of Other Wall Paintings in the Pueblo Southwest*, Papers of the Peabody Museum of American Archaeology and Ethnology, vol. 37, 1952. Reprinted courtesy of the Peabody Museum of Archaeology and Ethnology, Harvard University.)

information on animals and plants of that time, as well as clothing and textiles<sup>6</sup> (Fig. 3). They emphasize the intimately dependent associations between man and nature, reality and mythology, and represent a depth of emotion, belief, and extraordinary artistry that inspires us today.

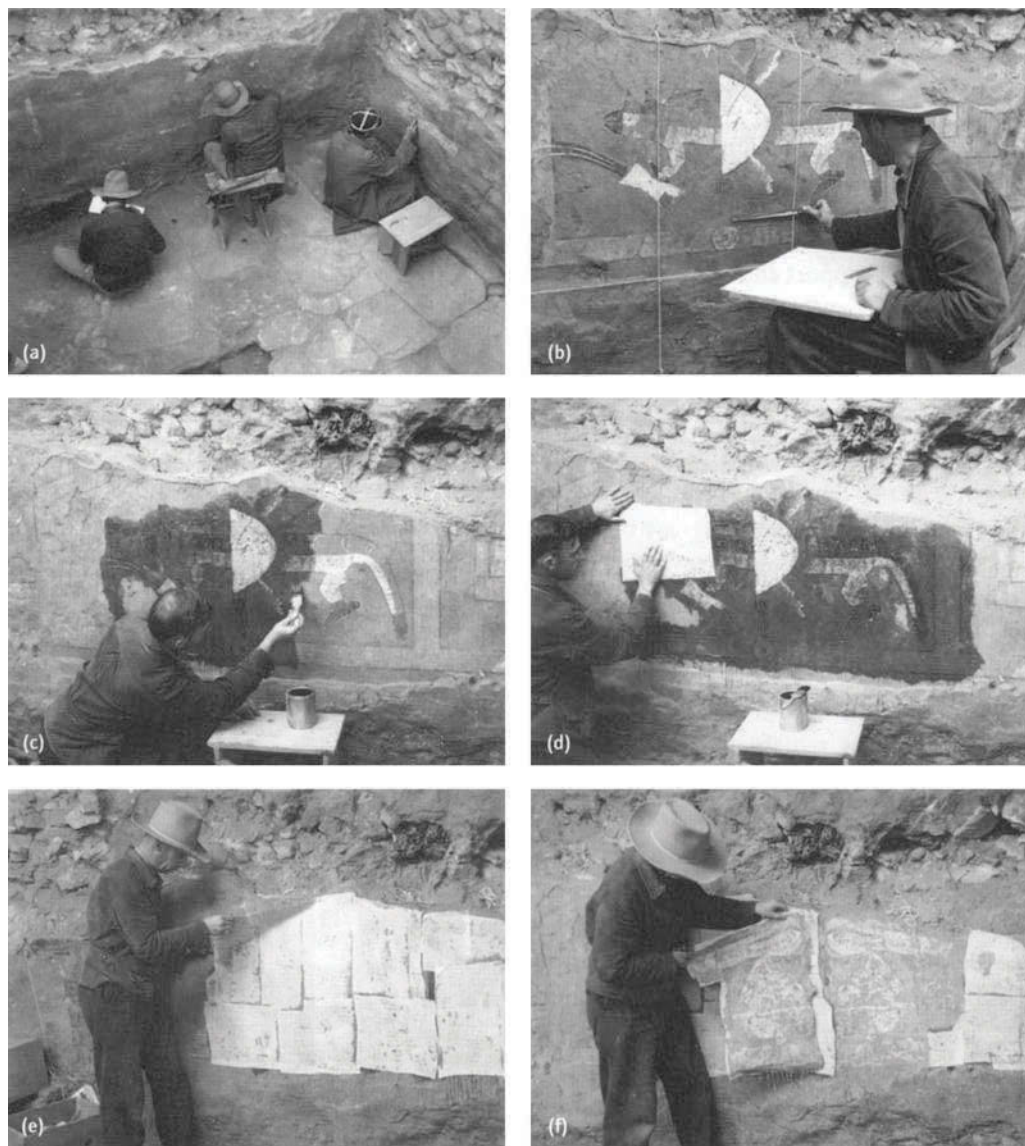
**FIGURE 4** Series of historic photographs showing (a) exposure of the murals, (b) field recording, (c, d) preparation of the mural surface with PVAc and muslin sheets, and (e, f) stripping of the paint layer from the wall. (Reproduced from Watson Smith, *Kiva Mural Decorations at Awatovi and Kawaika-a: With a Survey of Other Wall Paintings in the Pueblo Southwest*, Papers of the Peabody Museum of American Archaeology and Ethnology, vol. 37, 1952. Reprinted courtesy of the Peabody Museum of Archaeology and Ethnology, Harvard University.)

After detachment from the wall, the muslin-faced mural fragments were rolled or packed flat, and protected on both sides by newspaper to prevent the panels from sticking together.<sup>13</sup> The wall was then scraped again until the next mural was exposed, and the stripping process was repeated. Only sections from fifteen of the best-preserved murals were
