# The Conservation of Decorated Surfaces on Earthen Architecture

Proceedings from the International Colloquium  
Organized by the Getty Conservation Institute and  
the National Park Service

Mesa Verde National Park, Colorado, USA  
September 22–25, 2004

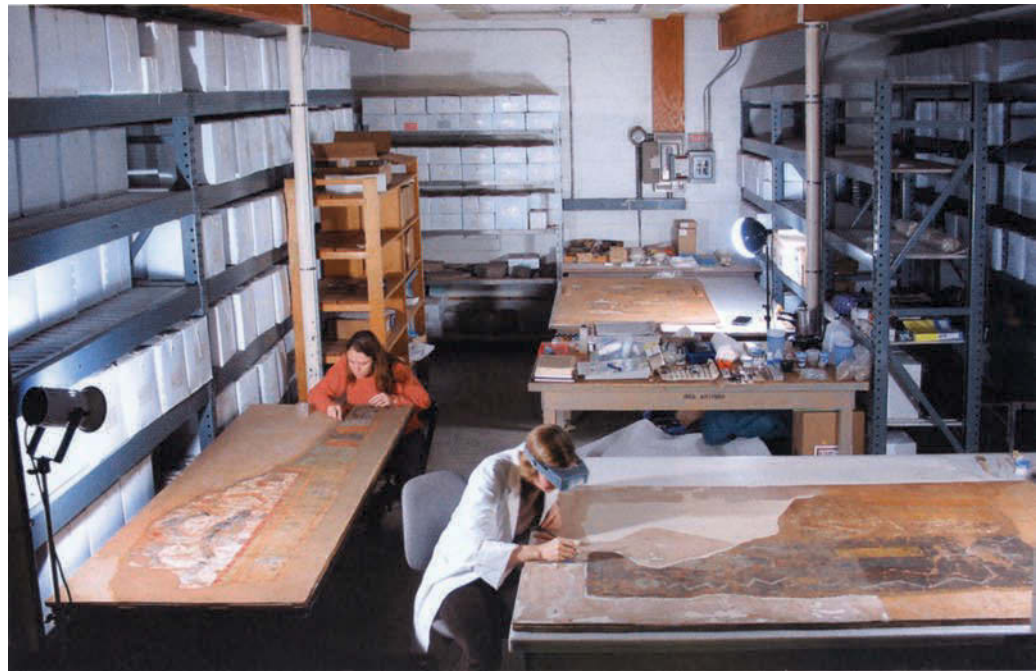
**FIGURE 8** Angelyn Bass Rivera and Leslie Rainer conserving fragments at the Museum of Northern Arizona. Note that the fragment at lower right is partially cleaned and the whitewash background has been partially removed. Photo: Angelyn Bass Rivera.

Modern whitewash borders on three of the Museum of Northern Arizona fragments were removed to expose the Masonite support. The whitewash, determined to be kaolin based, had been applied for a past exhibition and was no longer aesthetically appropriate. It was easily removed with a scalpel, after which the Masonite surface was cleaned first with gum erasers and then a damp cosmetic sponge.

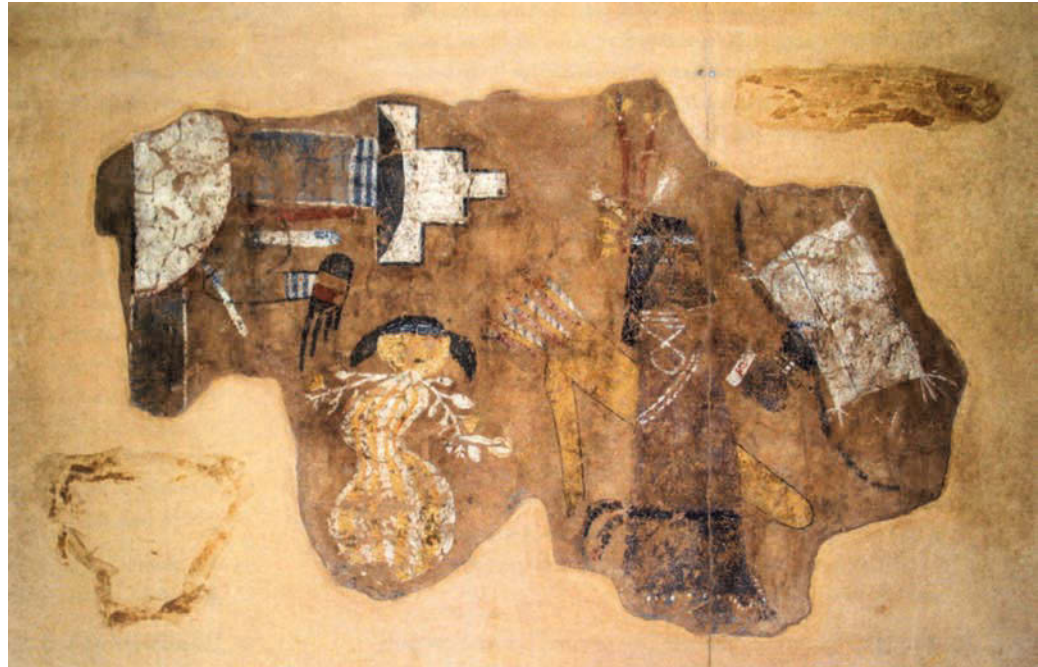
**FIGURE 9** Fragment from Awatovi (Room 529) after treatment in 2004 (2630 NA 820.R.529.20, Museum of Northern Arizona). The two principal figures depicted in this fragment are an anthropomorphized squash maiden with leafy arms (center) and a warrior figure wearing a headdress, kilt, and quiver with arrows and holding a banner or shield (right). It was not possible to completely remove from the Masonite the glue stains (at bottom left and upper right) from exhibition labels. Photo: Angelyn Bass Rivera.

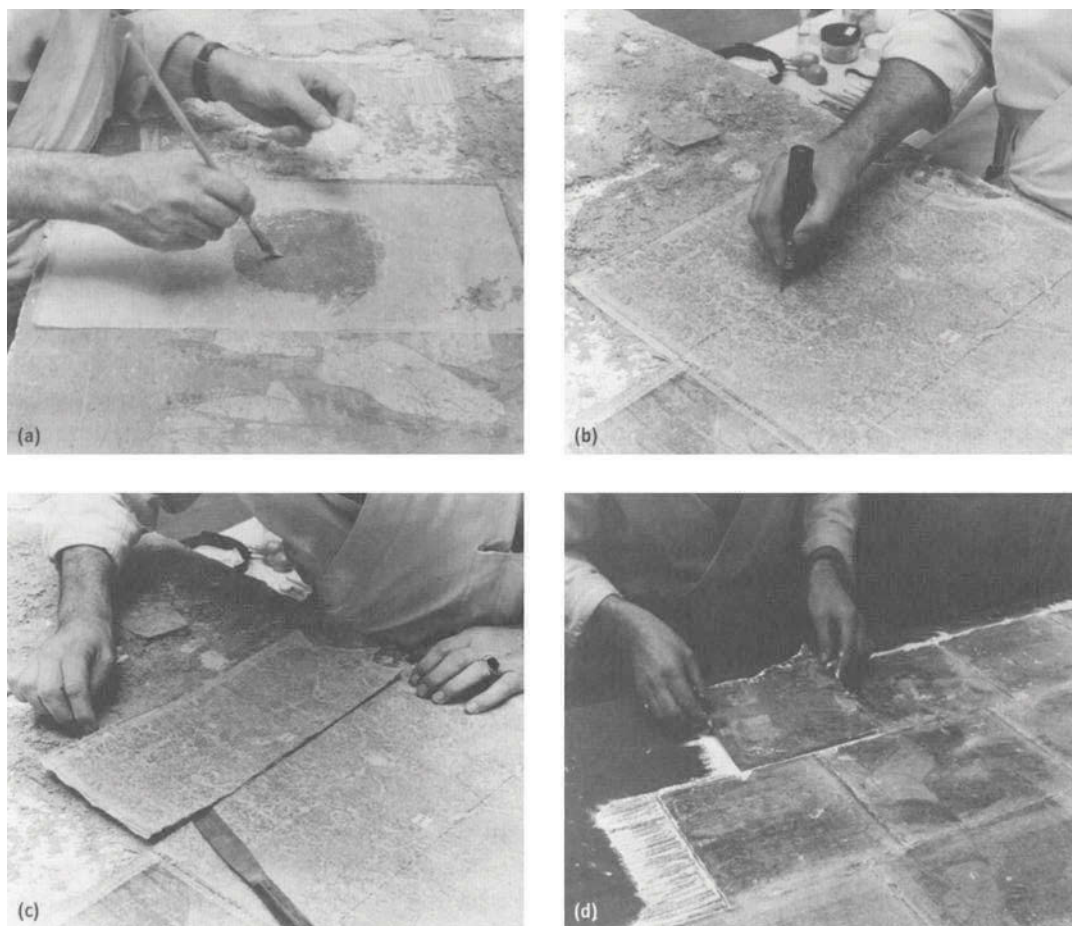
**FIGURE 4** James Roth, the Nelson-Atkins Museum’s paintings conservator, in 1952, separating *Two Bodhisattvas Preparing Incense* from the underlying painting: (a) applying a facing; (b) cutting through the paper, paint, and clay layers; (c) separating the two paintings at the clay interface; (d) attaching a section of the painting and facing to the Masonite board using gesso. Photos courtesy of the Conservation Department, the Nelson-Atkins Museum of Art.

The cut lines are still quite visible on the top painting, especially in raking light. Other than this inevitable damage, the 1952 treatment was generally a success. The painted surfaces on both paintings are still stable and visually well integrated. The Vinylite coating is perhaps not what conservators would apply now, but the appearance is pleasing, and the resin does not seem to have yellowed to any great degree.

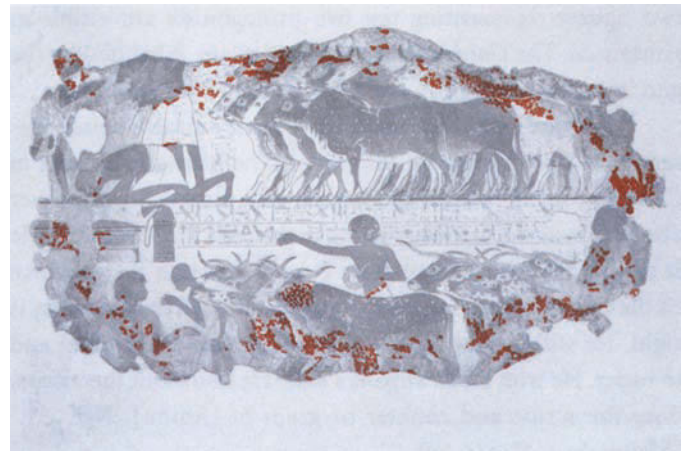
FIGURE 1 *Census of Cattle* (EA37976): Instances of flaking paint were recorded on a gray image. Photo: Compass.

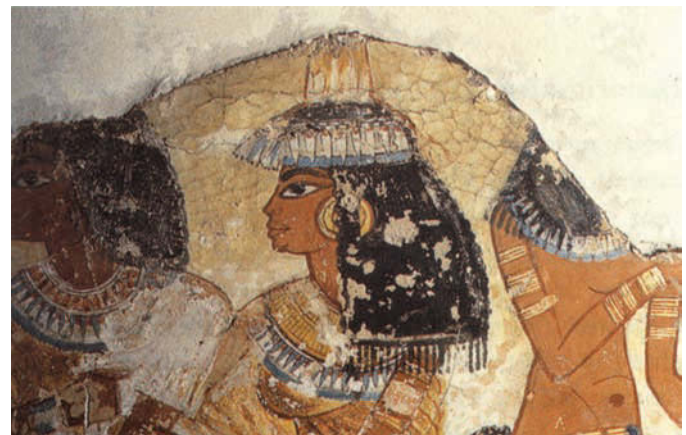
FIGURE 2 *Banqueting Scene with Dancers* (EA37984): Detail of paint losses in the perimeter zone. Photo: Corinna Kenyon.

As stated earlier, the wet plaster cast directly onto ancient mud plasters in the nineteenth century to form mounts was the single most important cause of impaired condition. Water was released into the mud, and it permeated the ancient *intonaco* to a distance of about 10 cm from the edges before evaporating. The most serious consequence of this was that a great deal of paint was loosened in these outer zones, and much of this loosened paint has since fallen away (Fig. 2).

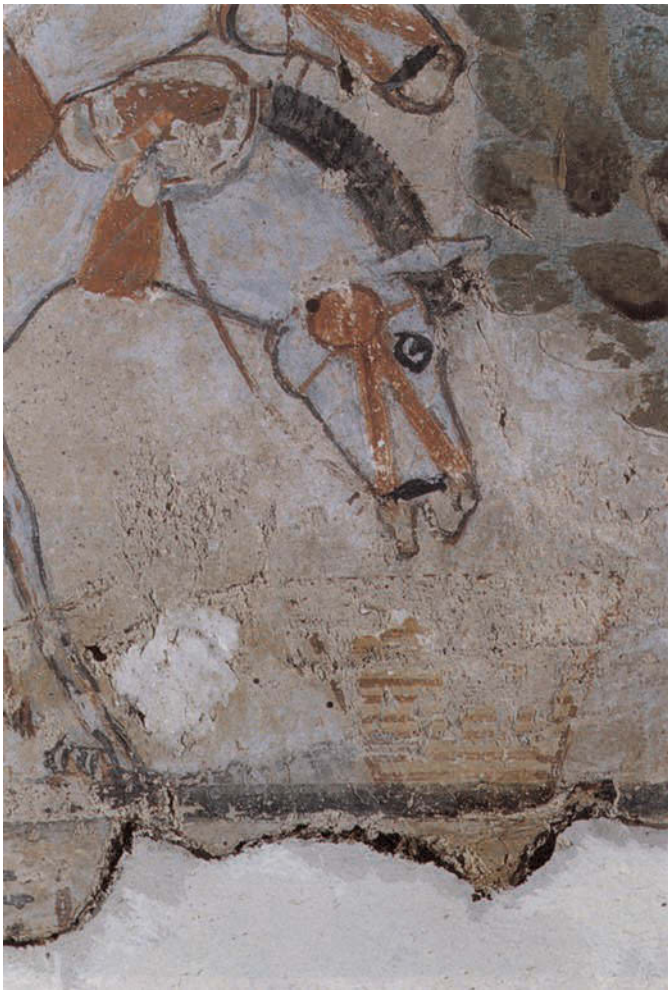
**FIGURE 3** *Harvest Scene* (EA37982): Detail showing friable *intonaco* caused by crystals of gypsum forming in the layer from calcium hemihydrate solution from the mount. Photo: Trevor Springett.

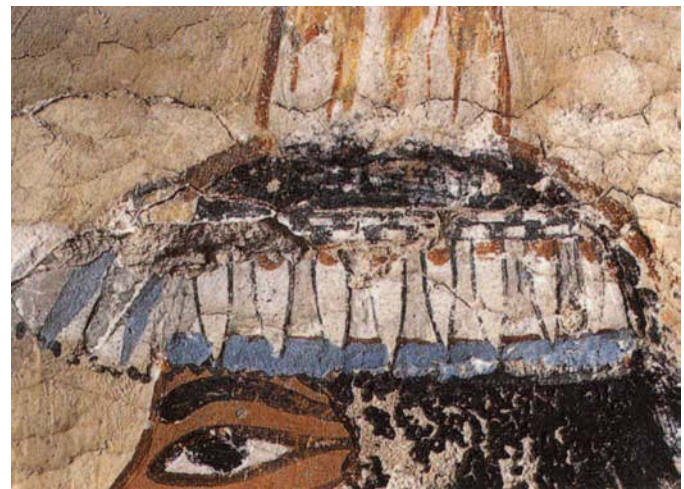
**FIGURE 4** *Banqueting Scene with Dancers* (EA37984): Detail from Figure 2 of bulging and cracking of the *intonaco* caused by compression. Photo: Corinna Kenyon.

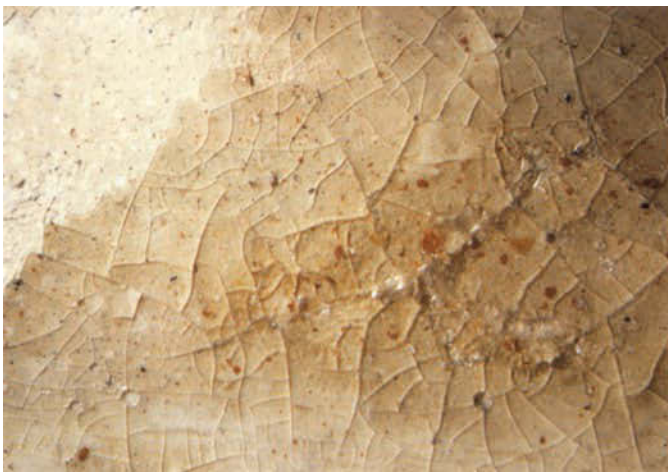
**FIGURE 5** *Census of Geese* (EA37978): 1.75x magnification of rabbit skin glue treatment layer fragmented by shrinkage cracks and partial loss. Photo: Jennifer Dinsmore.

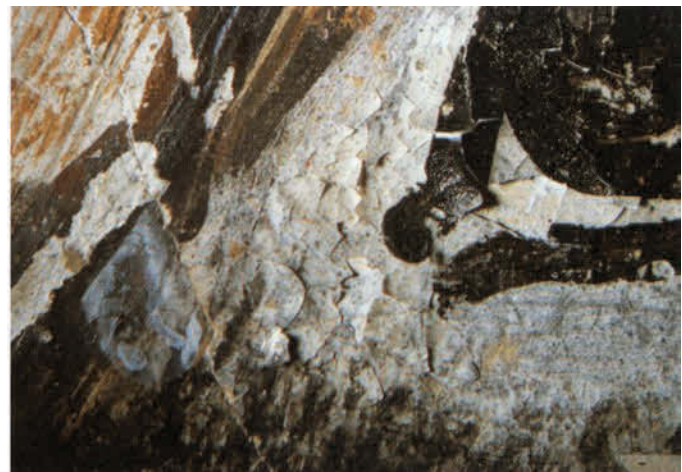
**FIGURE 6** *Census of Cattle* (EA37976): 1.75x magnification of paint lifted by carnauba wax. Photo: Eric Miller.

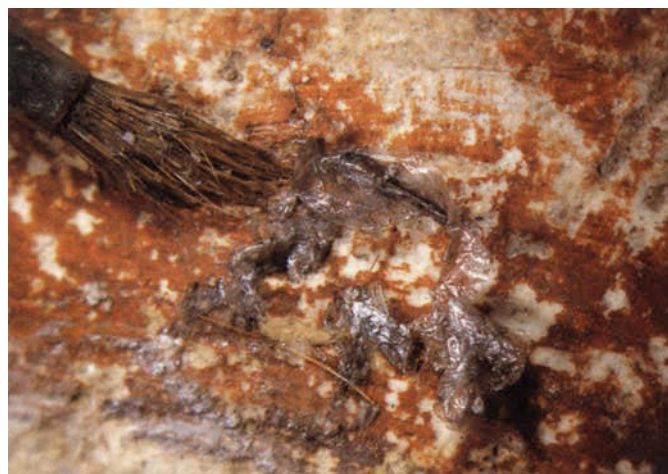
FIGURE 7 *Census of Cattle* (EA37976): 1.75x magnification of soluble nylon layer during removal. Photo: Eric Miller.

The cellulose acetate used on *Owner* and *Cattle* remains soluble in acetone, but the only mechanical action the paint could withstand was brushing with sable-hair brushes. The adhesive and dirt can be picked up by this action and discharged from the brush onto absorbent tissue. On the other hand, soluble nylon is virtually insoluble (Hanna and Lee 1988), but films formed by this material are permeable to water. Therefore, where it had been applied over cellulose acetate, water could be introduced through it to assist in the separation of the two layers. Once separated, the soluble nylon layer could be lifted with a sable-hair brush (Fig. 7). Soluble nylon applied directly on paint, however, is impossible to

remove without also removing paint. Since the nylon is not harming the paint, leaving it alone is the least-damaging option, and its glossy effect must be accepted.

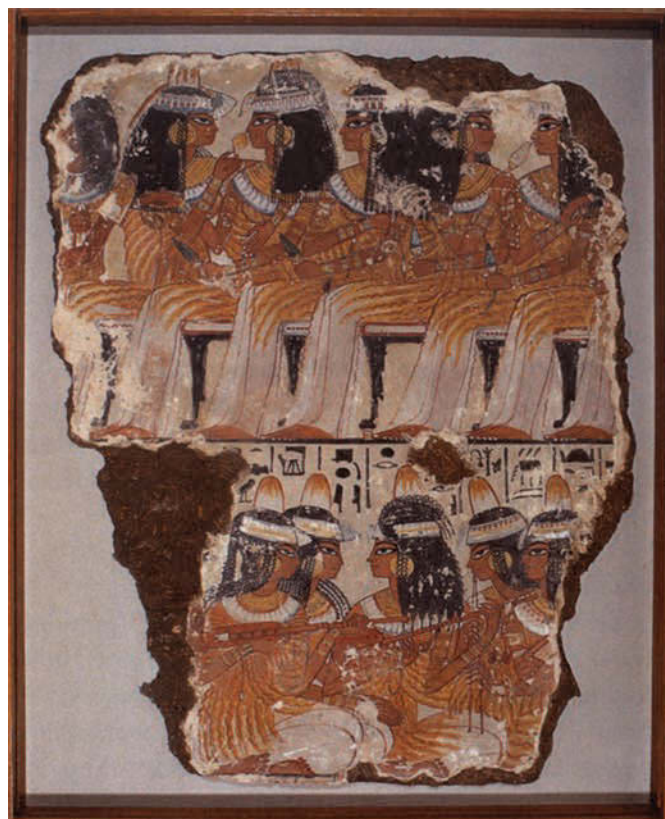
**FIGURE 8** *Banqueting Scene with Musicians* (EA37981): This painting was remounted in 1987; the surface of the mount is recessed to allow the mud plaster to be seen. Photo: Trevor Springett.

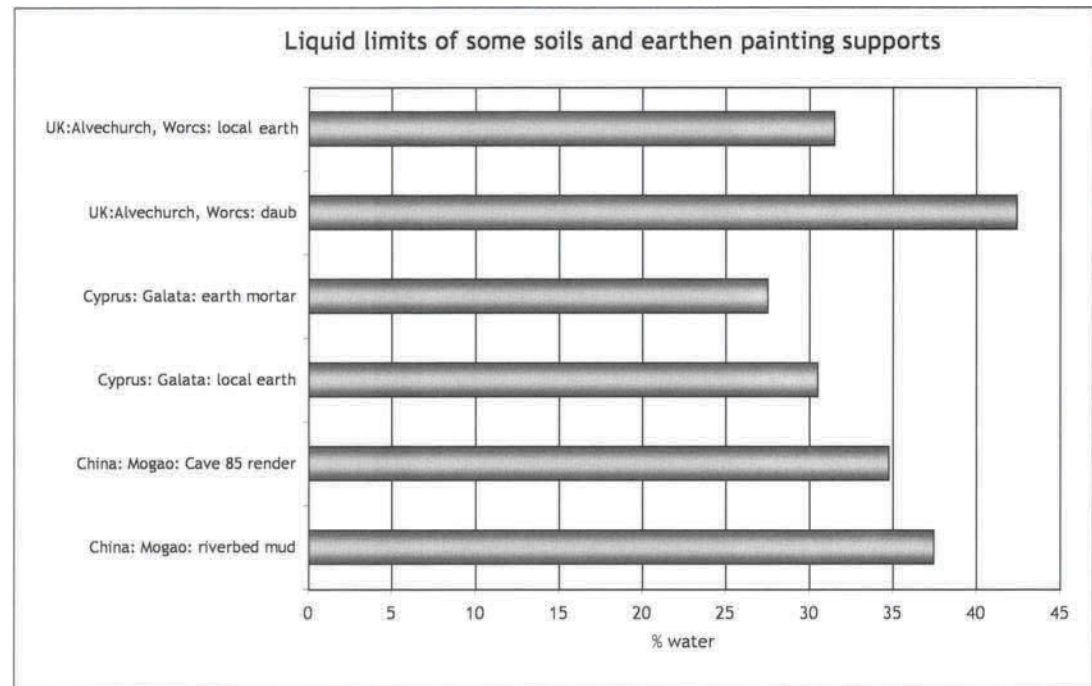
**FIGURE 3** Liquid limits of some soils and earthen painting supports. (Sources: Alvechurch and Galata data obtained from unpublished reports by Shekede and Rickerby, 2002. Mogao data obtained from unpublished data produced for the Getty Conservation Institute by G. S. Austin, New Mexico Bureau of Mines and Mineral Resources, 2000.)

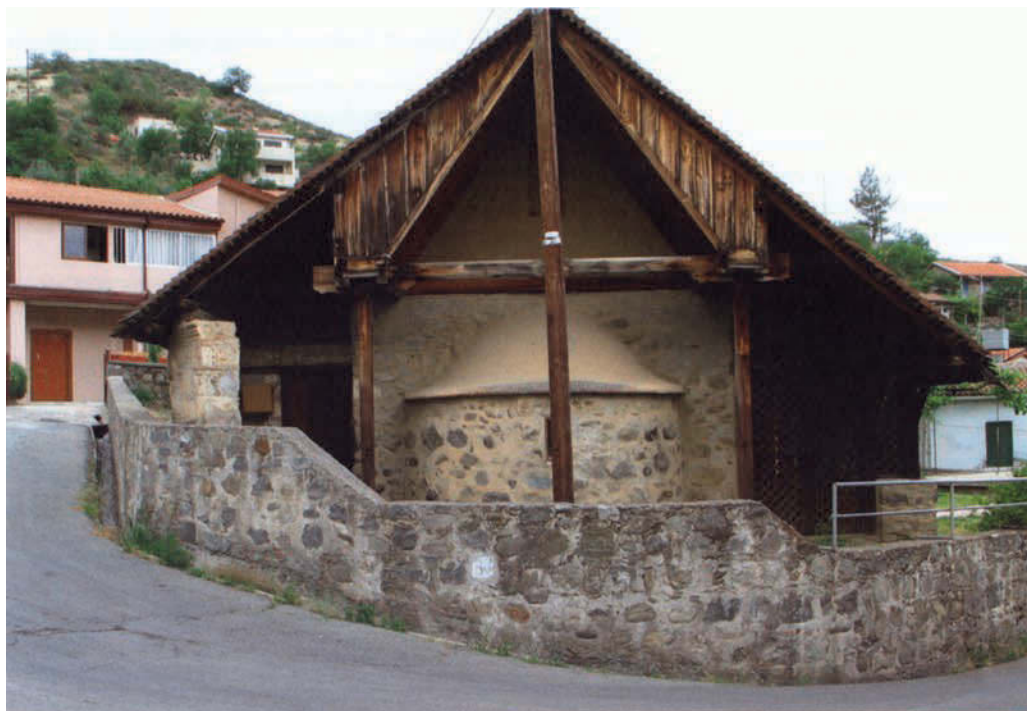
**FIGURE 4** The church of Agios Sozomenos, Galata, Cyprus, view from the east end. Photo courtesy of the Courtauld Institute of Art, Conservation of Wall Painting Department, 2002.

The church is a composite structure of earth, timber, and stone, whose vernacular features include a high stone plinth and the steep-pitched, wide-eaved, double roofing system typical of churches in the Troodos mountains (Myriantefs 2002: 75; Fig. 4). This architectural form is uniquely adapted to the seasonal heavy rain and snowfalls of the region—the double roof providing an effective barrier against infiltration, and the wide eaves and stone plinth offering protection against basal erosion. The church is built on a steep hillside, however, with its south wall partly buried by the incline, and is therefore vulnerable both to dispersed groundwater and to snow banking in the winter.

Earth is a major construction material at Agios Sozomenos, and it has been used in a variety of ways. The deep plinth constituting the wall bases is constructed of large, rounded boulders, of a type traditionally obtained from riverbeds. These are interspersed and stabilized with fired brick and tile pieces, and bedded in a thick, reddish earth mortar containing a large quantity of vegetable fibers. Wooden beams running the length of each wall and tied at each corner form a stable support structure above the high plinth. These also provide lintels for each of the three door openings and a level surface for the mud-brick construction of parts of the upper walls and the gable ends. These mud bricks are made from the local greenish brown soil, which is still frequently used in their manufacture today. Particularly uneven surfaces of the primary support—typically within doorjambs and cupboards and around the walls of the apse—were leveled using a plaster constituted from the same reddish

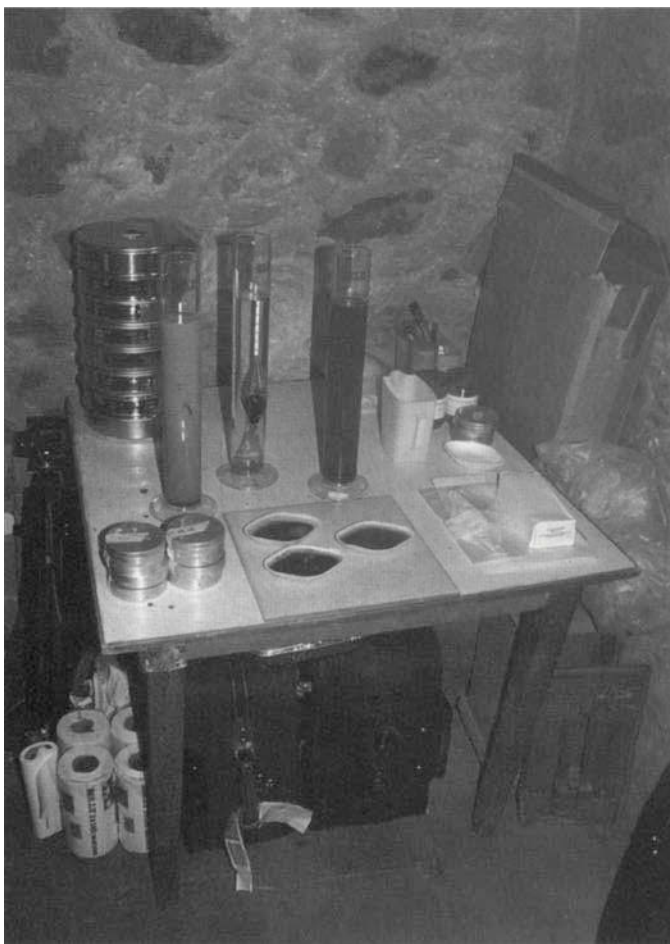
**FIGURE 5** Temporary earthen-materials analysis laboratory set up in the narthex of the church. Photo courtesy of the Courtauld Institute of Art, Conservation of Wall Painting Department, 2002.

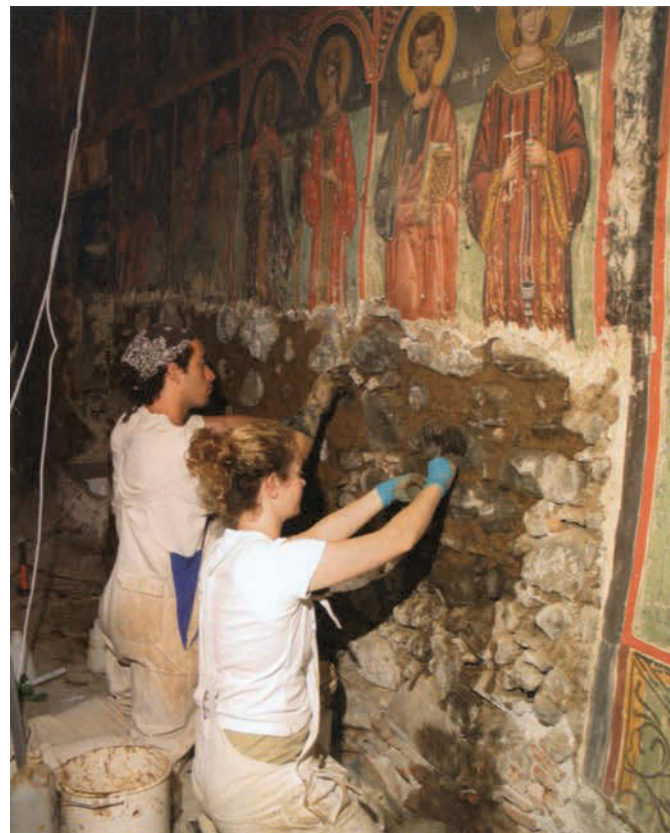
**FIGURE 6** Repointing of the stone plinth using the tested repair mortar. Photo courtesy of the Courtauld Institute of Art, Conservation of Wall Painting Department, 2002.

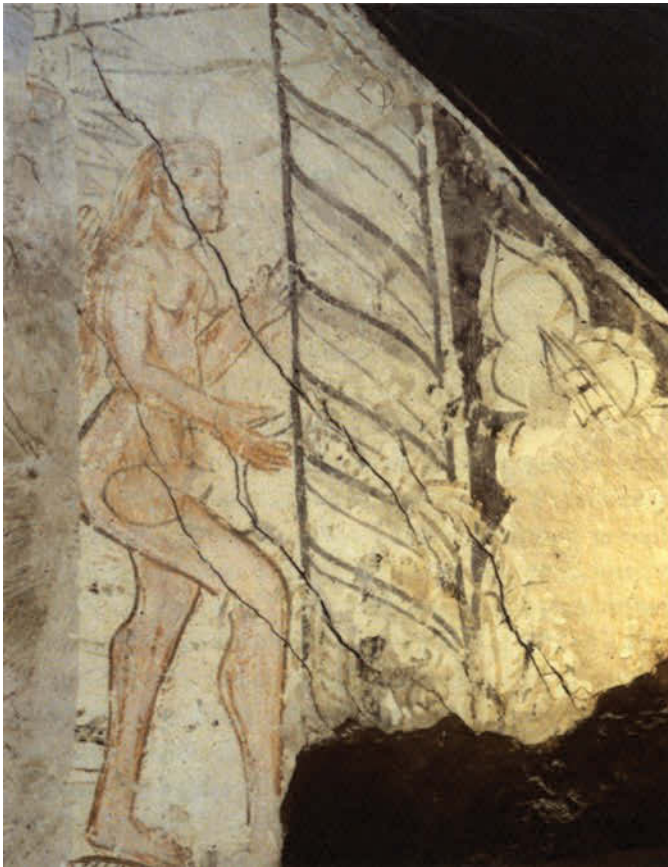
**FIGURE 7** Knightstone Manor, Ottery St. Mary, Devon, England: detail of *The Expulsion from the Garden of Eden* during uncovering and conservation. (Source: Shekede and Rickerby 1998.)

The painting is located within the roof space above the great hall, where it had been hidden for years, first by layers of limewash and subsequently behind a partition wall. Originally, it probably decorated the wall behind a gallery at the service end of the great hall, being visible from the dais end. It dates to the late sixteenth century and depicts the temptation of Adam and Eve, and the expulsion from the garden of Eden, executed in a crude and primitive, but undeniably vigorous style (Figs. 7–8).

The painting was rediscovered—and inadvertently severely damaged—during major building work in 1996, which included the insertion of piping and a water tank (Shekede and Rickerby 1998). During subsequent conservation treatment—which involved revealing the painting by removing the limewash covering—the earthen support was repaired and stabilized based on the investigation and analysis of original construction materials.

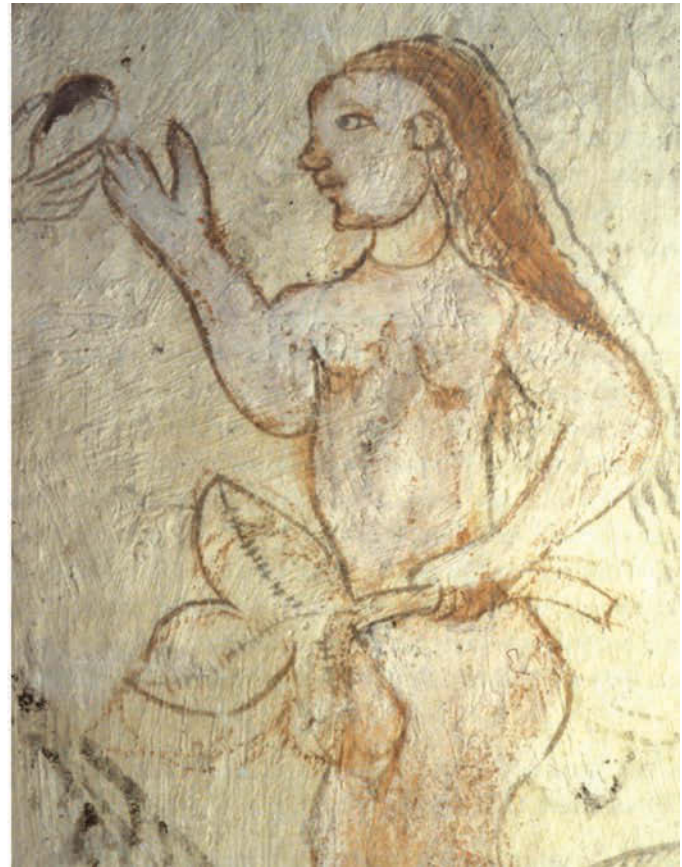
**FIGURE 8** Detail of Eve from *The Temptation in the Garden of Eden*, after conservation. (Source: Shekede and Rickerby 1998.)

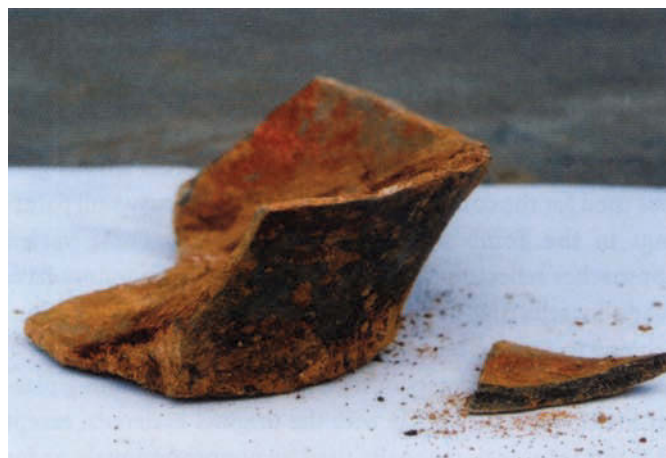
**FIGURE 2** Tomb of General Xu Xianxiu. Remains of pigment container found in the entranceway. Photo: Jun Zheng, 2001.

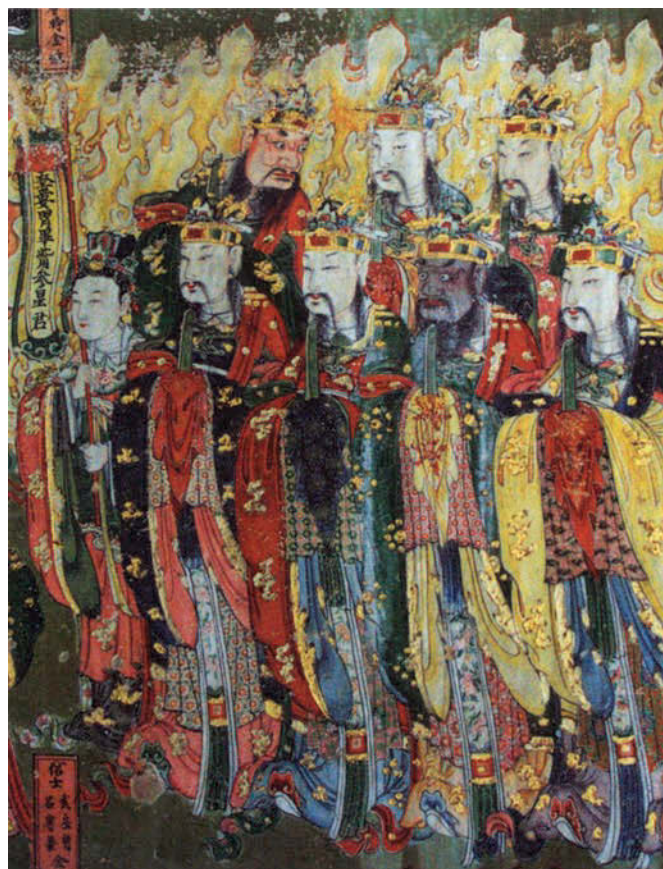
**FIGURE 4** Yong'an Temple, Hunyuan (Shanxi Province), seventeenth century. Detail of the wall paintings in the Chuan Fa Zheng Zong Temple Hall. A group of Taoist figures are depicted, with their names on the banner and the donor's name at bottom left. Photo: Jun Zheng, 2000.

Hall preserves 275 square meters of seventeenth-century Taoist wall painting, including over four hundred figures from heaven, earth, and hell shown approaching the sculpted figures of gods for blessing (Fig. 4). It is one of the most important examples of this subject in China (Chai 1997: 114).

The support is an adobe wall with the exterior protected by a layer of fired gray bricks. The interior is finished with two earthen-based plasters on which a ground was applied. The drawing was then made, and the colors filled in.

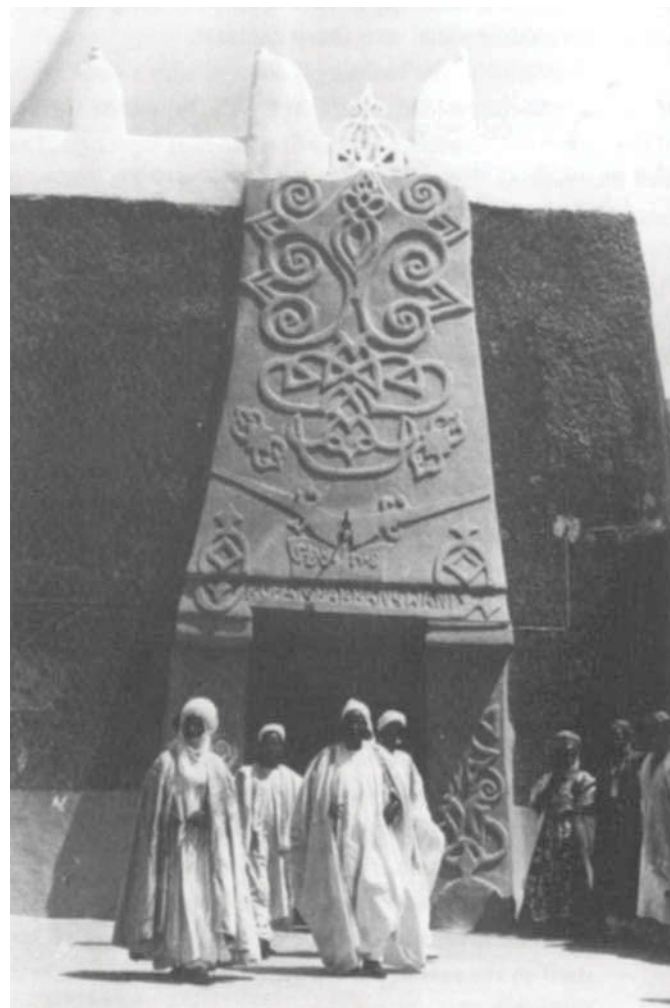
**FIGURE 2** The *Babban Gwani* in 1960. The decorations on the central panel are more intricate than the present day's. The decorated lintel shown is no longer in existence. Photo courtesy of Nigeria Ministries of Education (Source: Susan Denyer, *African Traditional Architecture*, 1978. London: Heinemann).

Each time the *Babban Gwani* undergoes conservation work, the detailing of the decorations on the central panel changes,

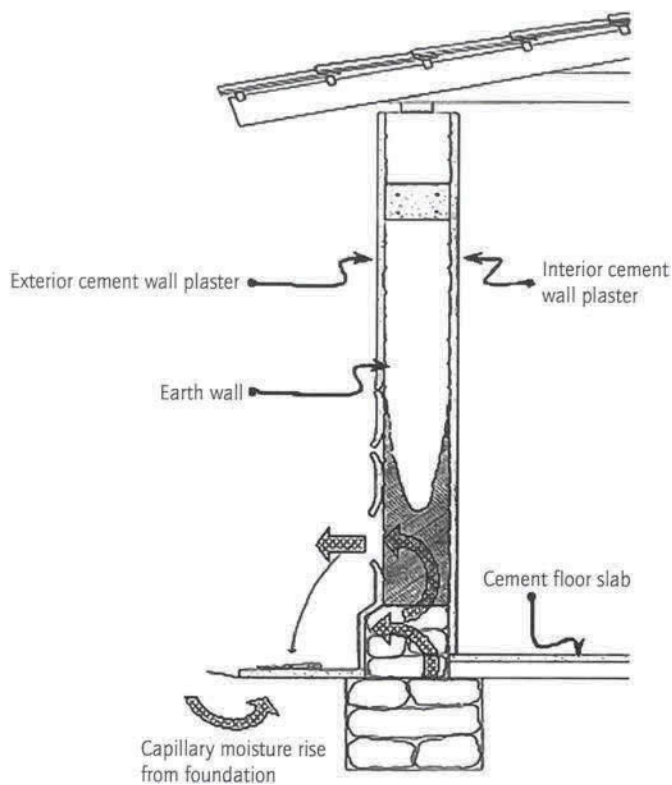
**FIGURE 3** The effect of cement plaster on earth walls. The buildup of moisture at the interface between the cement plaster and the earth wall eventually leads to a weakening of the bond, and the cement falls off. (Source: CRATerre-EAG.)

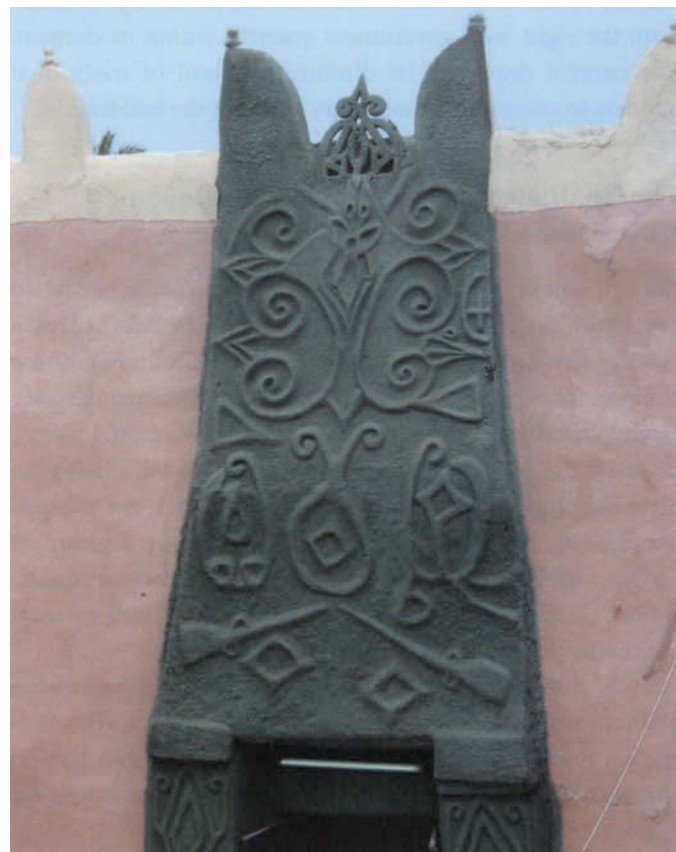
**FIGURE 4** External view of central panel in 2004. The decorative motifs have been changed from those of 1960 and the decorated lintel has disappeared, but the general concept remains the same. Photo: Ishanlosen Odiaua.

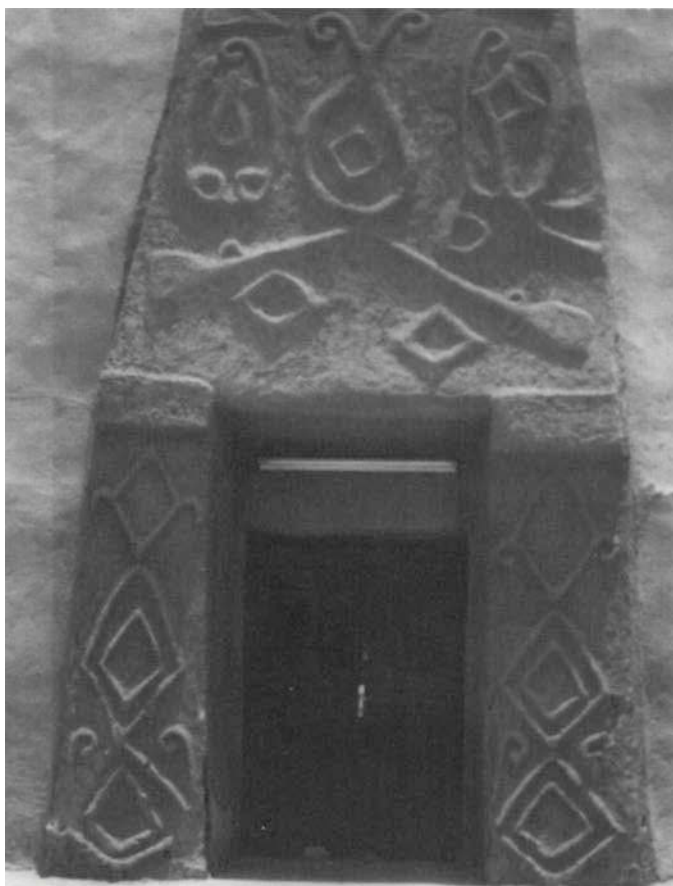
**FIGURE 5** *Babban Gwani* in 2002. Note the detached cement plaster at the base of the left pillar. Photo: Ishanlosen Odiaua.

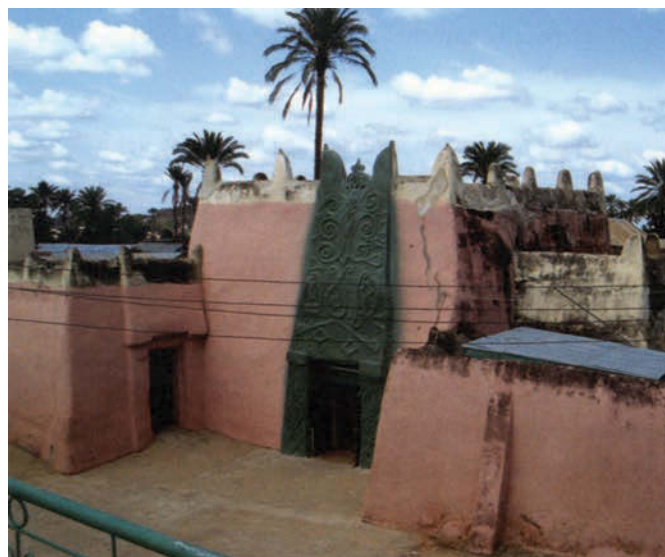
**FIGURE 6** View of the *Babban Gwani* in 2003. Note the cracked plaster to the right of the decorated panel. Photo: Ishanlosen Odiaua.

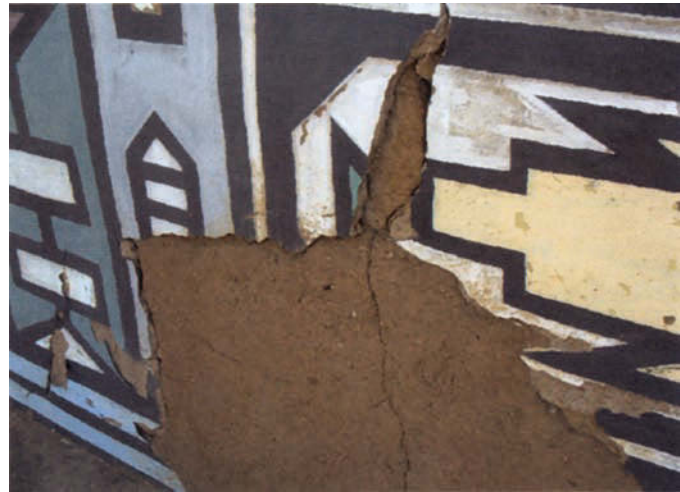
**FIGURE 7** Damage resulting from the use of cement additives. Here typical delamination and structural failures can be seen where the cement plaster layer has become detached from the original mud plasterwork of a Klipgat home. Photo: K. A. Bakker, 2004.

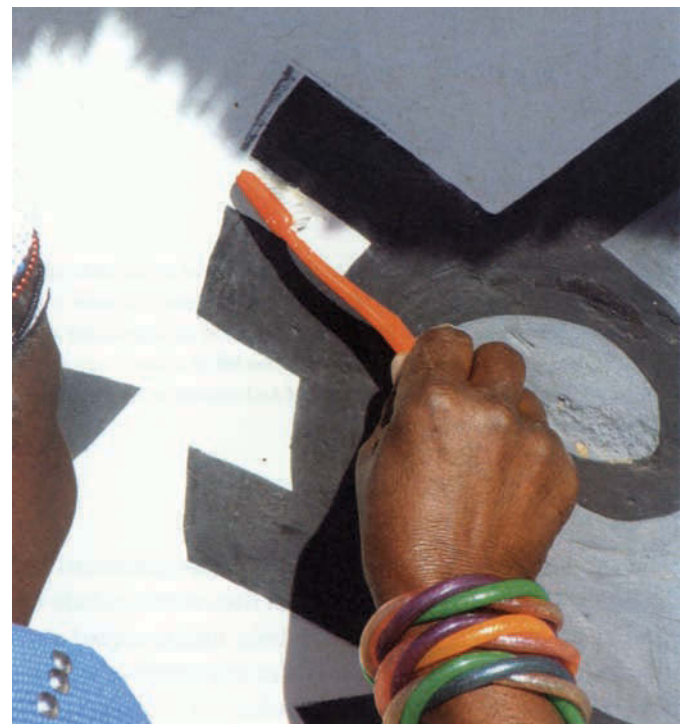
**FIGURE 8** Leah Msiza demonstrating the application of commercial acrylic paint with a toothbrush on the wall surface of a house. Photo: K. A. Bakker, 2004.

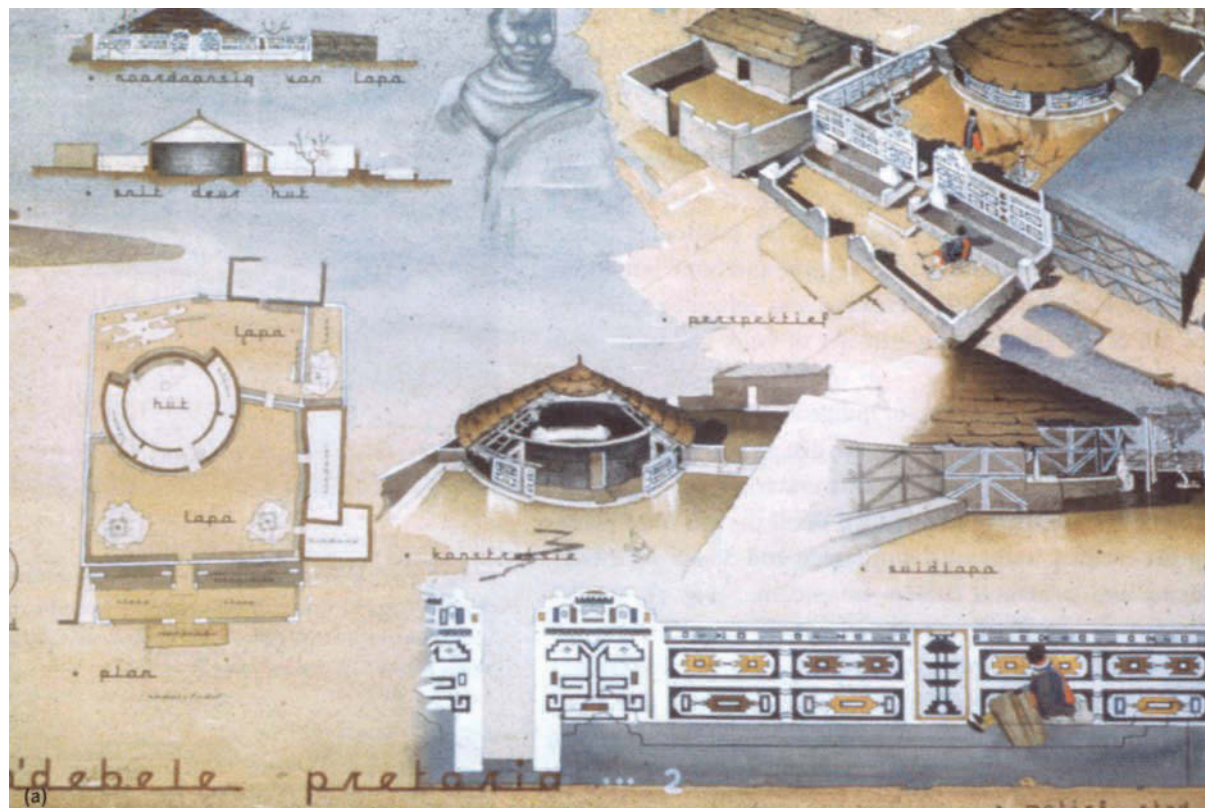
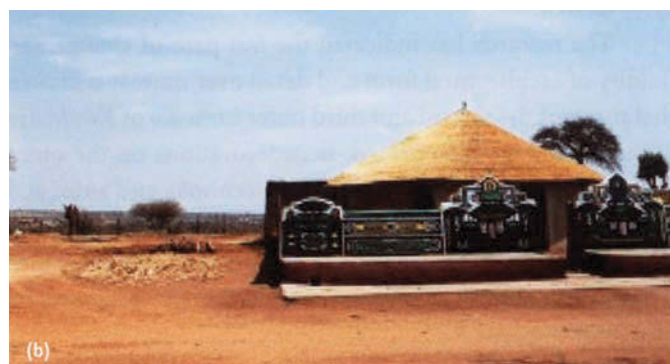
**FIGURE 9** Change and fluidity captured in the evolution of the *isirhodlo* of one woman from the Msiza family: (a) 'NaTshabangu Msiza's *isirhodlo* at Hartebeestfontein in 1953 before its destruction and (b) the open space at Klipgat in 2001, after her death, when the wall was left to decay. (Sources: [a] Meiring 1953b, courtesy of the Department of Architecture at the University of Pretoria; [b] K. A. Bakker, 2001.)

The research has indicated the fast pace of change and fluidity of architectural form and detail over time. It is known that many of the second and third outer *isirhodlo* of KwaMsiza homesteads have disappeared, that decorations on the outer walls of homesteads were altered between 1983 and 2001, and that there is no precise continuation in pattern making on any one single wall (Fig. 9). Regular documentation of successive changes is a requisite tool for the conservation-management process.

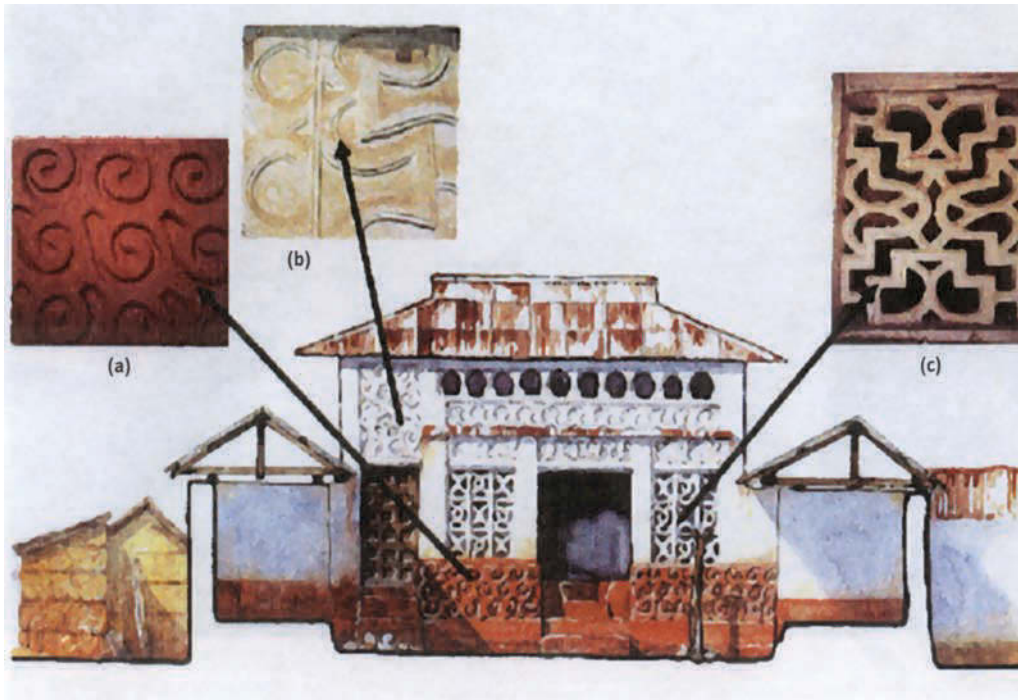
**FIGURE 1** Various decoration categories (Abirim shrine): (a) red decorations on the lower section of a wall (Besease shrine); (b) white decoration (Besease shrine); (c) screen wall (Adarko Jachi shrine). Drawing by Arnaud Misse, CRATerre-EAG; Photos: (a) and (b) Sébastien Moriset, CRATerre-EAG; (c) Thierry Joffroy, CRATerre-EAG.

This architectural ornamentation can be divided into two main categories: the white designs on the upper walls and the red ones on the lower sections of the walls (Fig. 1). The lower sections of the walls and columns show a variety of decorations modeled in bas-relief. Shapes commonly found on these red plinth walls include spiral and arabesque designs, as well as representations of animals and plants having symbolic meanings. The lower walls are only modeled with earth and are regularly painted with a red clay slurry.

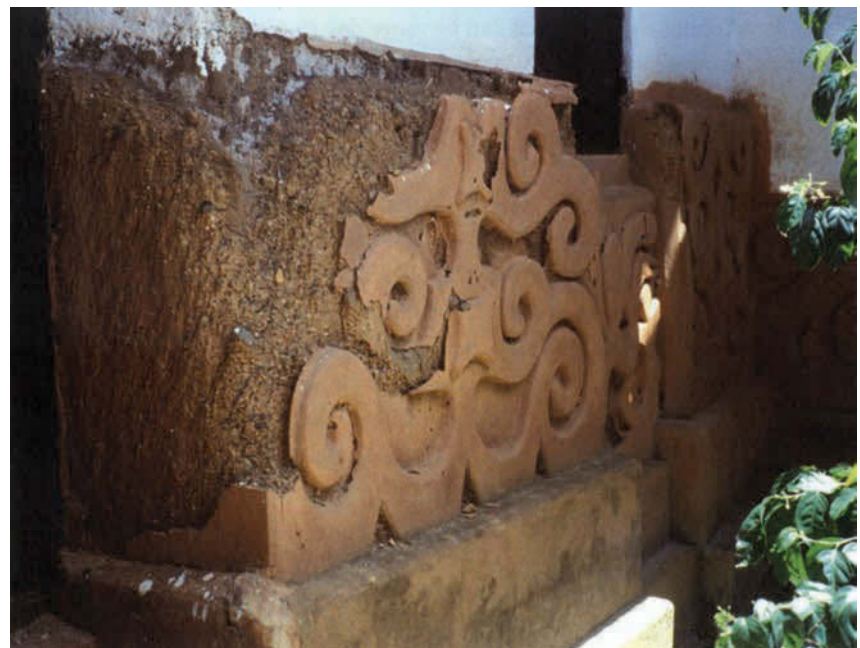
**FIGURE 2** Eroded decoration (Saaman shrine). Photo: Sébastien Moriset, CRATerre-EAG.

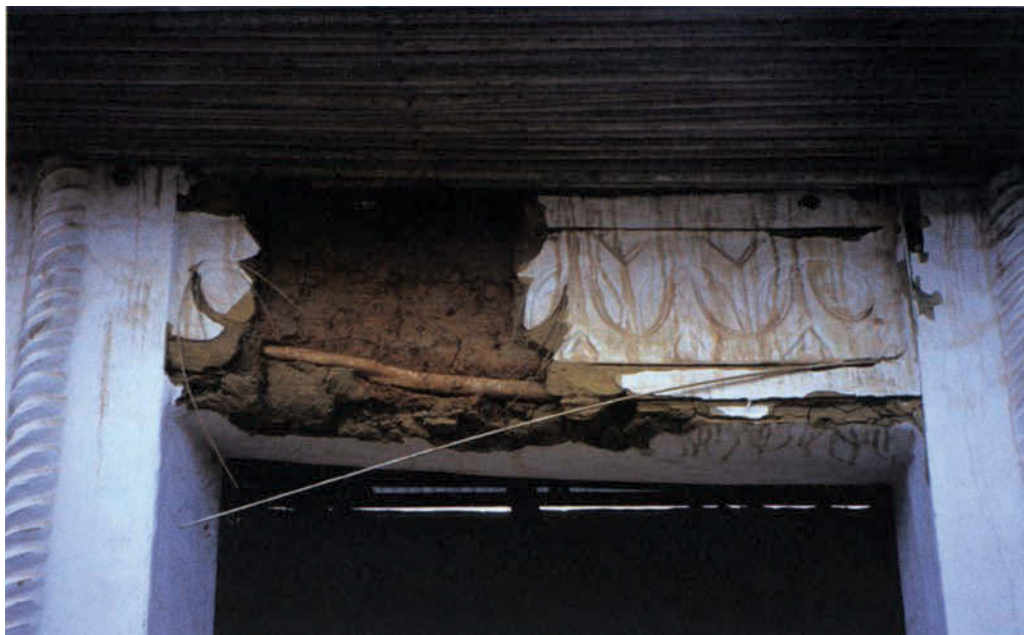
**FIGURE 3** Decorated beam, damaged after the displacement of a roofing sheet during a rainstorm (Patakro shrine). Photo: Sébastien Moriset, CRATerre-EAG.

Erosion of the exposed wall surfaces is continuous (Fig. 2). The decorations are rather fragile and can vanish quite quickly if the roof leaks or when heavy rainstorms occur (Fig. 3). Most of the Asante bas-reliefs have survived thanks to past traditions of monitoring and regular daily maintenance, but many of them have also been lost forever.

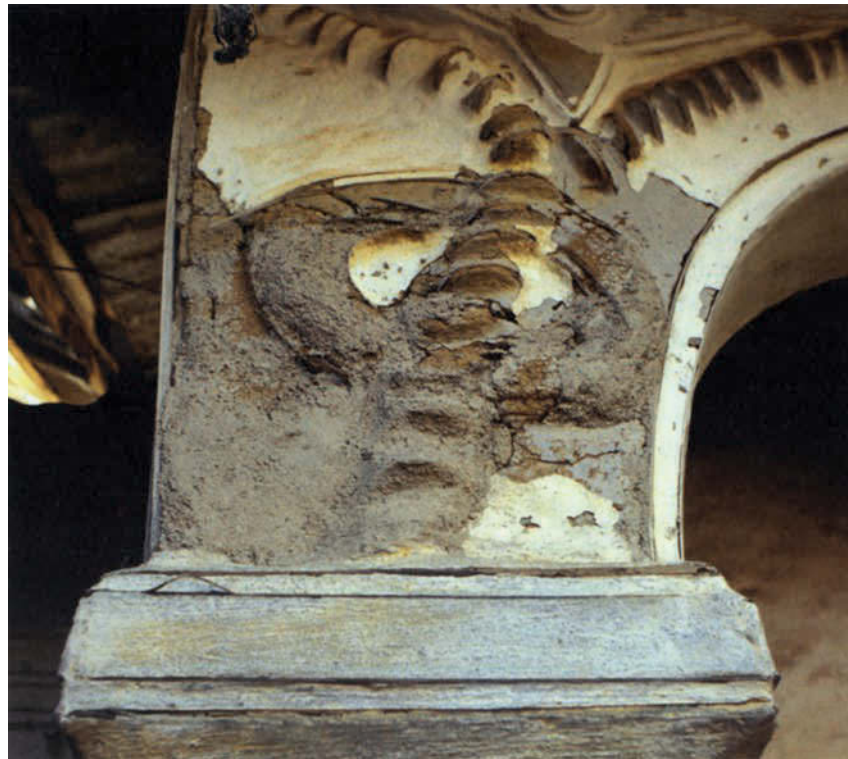
**FIGURE 4** White decoration patched with cement (Asawase shrine).  
Photo: Sébastien Moriset, CRATerre-EAG.

Past efforts to conserve the decorated walls have also produced bad results. In the 1990s, some experimentation using cement plasters to patch the broken spots increased the rate of deterioration of these unique decorations (Fig. 4). The cementitious waterproof coating accelerated the decay process of the decorated remains by trapping humidity and attracting termites. This cement patching was also done using trowels, resulting in a hard, smooth surface that looked completely different from the original decoration.

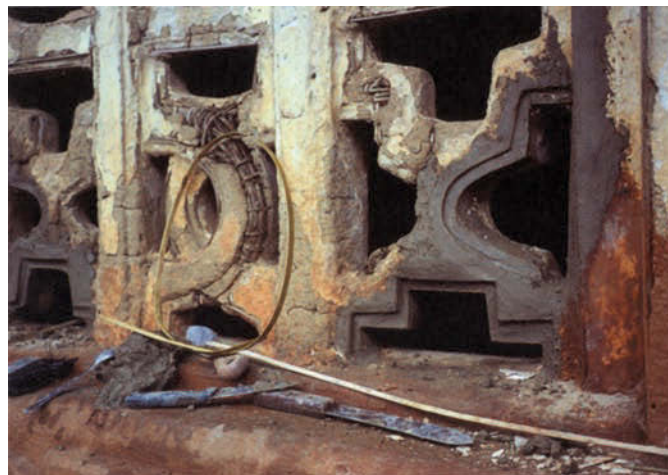
**FIGURE 5** Screen wall during a restoration campaign (Abirim shrine). Photo: Sébastien Moriset, CRATerre-EAG.

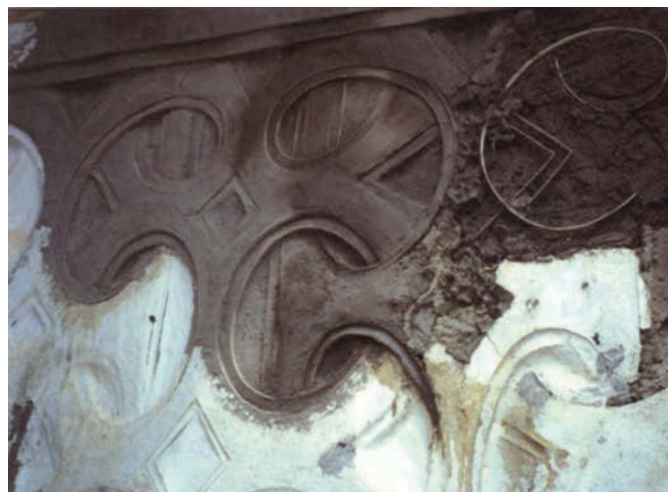
**FIGURE 6** White wall during restoration, showing the palm stick reinforcements inserted in the clay (Edwenase shrine). Photo: Sébastien Moriset, CRATerre-EAG.

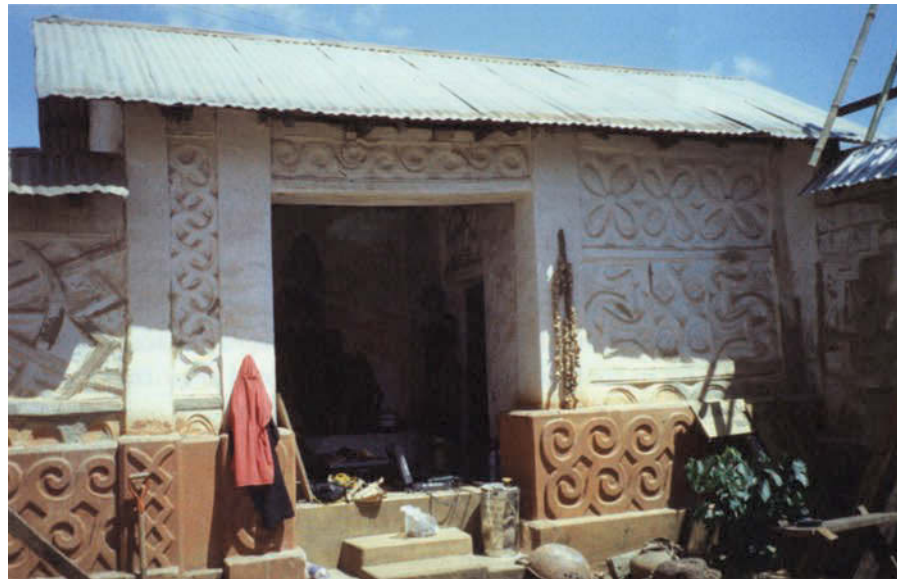
**FIGURE 8** Construction of a new roof with a steep slope that restores the traditional roof shape (Besease shrine). Photo: Sébastien Moriset, CRATerre-EAG.
