# The Conservation of Decorated Surfaces on Earthen Architecture

Proceedings from the International Colloquium  
Organized by the Getty Conservation Institute and  
the National Park Service

Mesa Verde National Park, Colorado, USA  
September 22–25, 2004

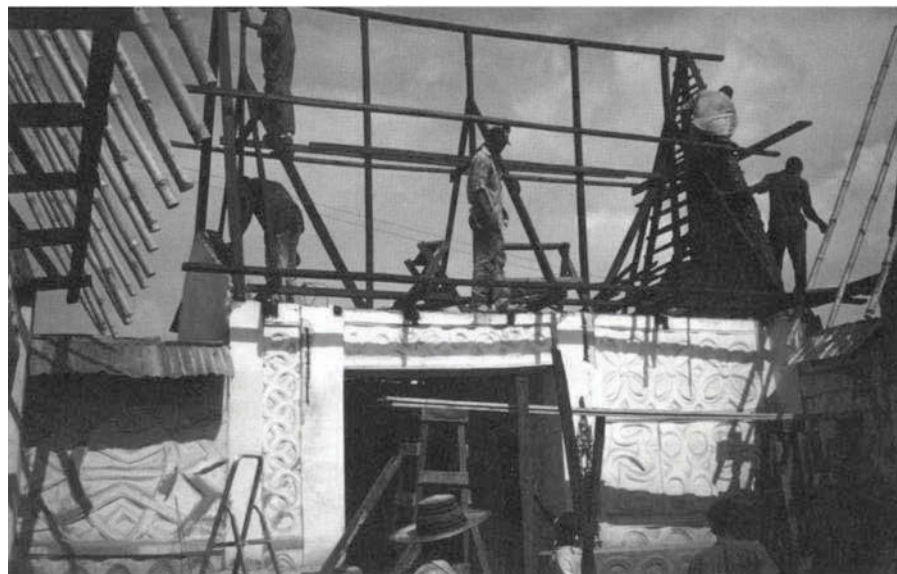
**FIGURE 9** Besease shrine after the replacement of the corrugated iron sheet roof with a steep traditional roof, made of wood, bamboo, and raffia thatch. Photo: Thierry Joffroy, CRATerre-EAG.

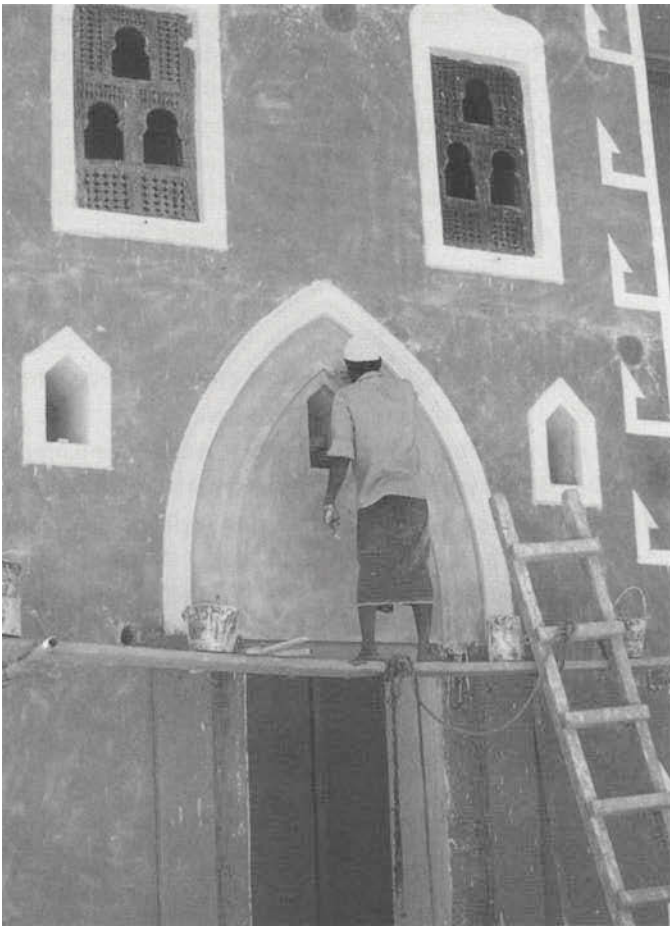
**FIGURE 2** Lime-plaster decorations are sometimes applied directly to mud-plastered surfaces, as in this example of the water tower from the al-Hawta Palace Hotel, Wadi Hadhramaut.

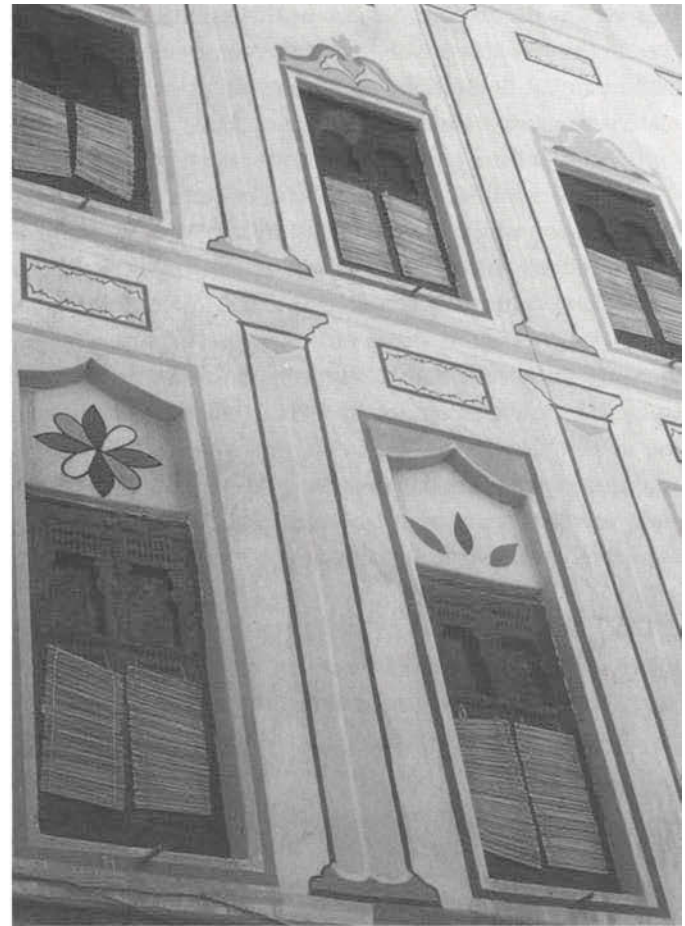
**FIGURE 3** Lime plaster is used for waterproofing and as a substrate for oil-based decorations. In Wadi Do'an, geometric designs tend to be favored. This example is from Sif, a sizable Do'ani town.

On the exterior, lime plaster can be applied directly as decorations to mud plaster (Fig. 2). In addition, it is often used to waterproof the most vulnerable areas of the building: the foundation, parapets, and roofs. If the owners are wealthy, the entire exterior is lime plastered. The mud-plastered surface is first wetted down and skim coated with a layer of mud; then it is lime plastered. The lime plaster mix is typically 1:2 (lime putty to sand). When sand is broadcast into the wet lime plaster, it acts as a mechanical key, thus providing an excellent substrate for limewash and oil-based painted decorations (Jerome, Chiari, and Borelli 1999: 43). These can be fanciful and of geometric design, as is typical of Wadi Do'an (Fig. 3), or subtle, like many of the historic examples in the Wadi Hadhramaut

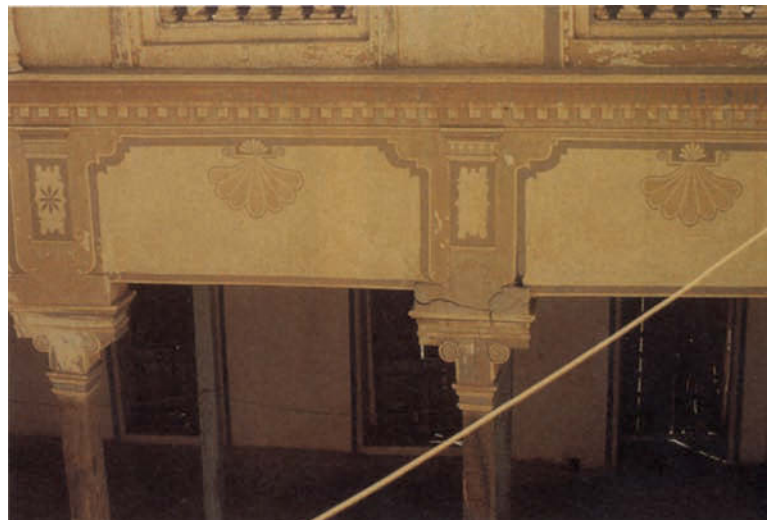
**FIGURE 4** Al-Munaysurah, one of the historic Tarimi mansions, has a subtle exterior polychrome decorative scheme.

(Fig. 4). The decorations can also be three-dimensional. However, in the ceaseless sun and periodic monsoons, exterior oil-based painted decorations are ephemeral at best, and these materials require frequent maintenance (Fig. 5).

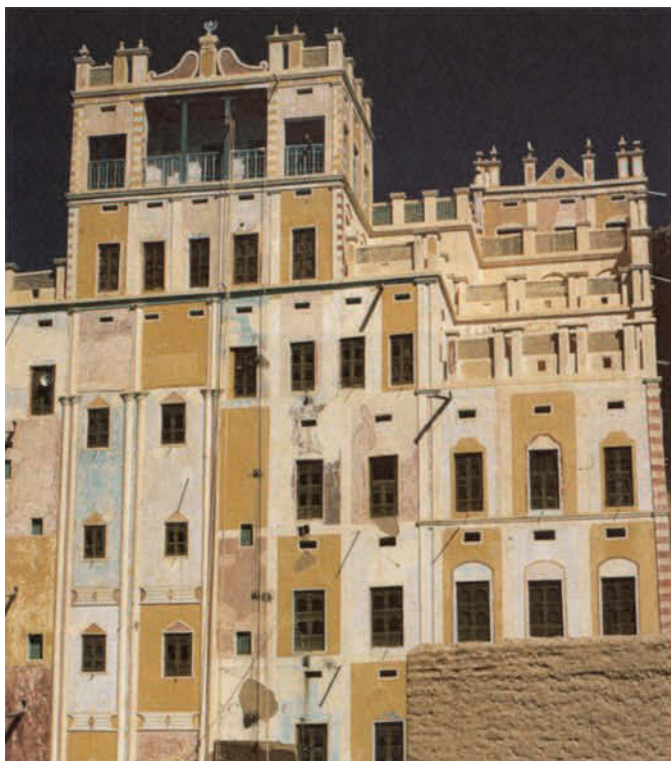
**FIGURE 5** Exterior lime plaster and painted decorations require frequent renewal, as in this example of a Bugshan family palace in Khailah, in the left branch of Wadi Do’an.

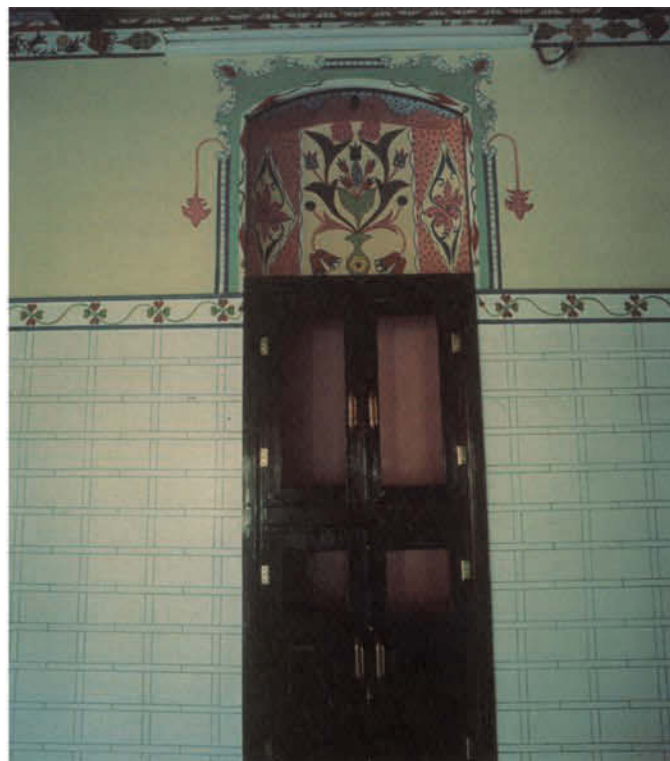
**FIGURE 6** *Malas*, a form of highly burnished lime plaster, is a labor-intensive interior finish. In this contemporary example from the ba-Zaraah house in Khoreiba, Wadi Do’an, the *malas* has been scored to resemble ceramic tiles.

form of burnished lime plaster reserved for sitting rooms, corridors, and bathrooms. *Malas* is made in the following manner: Lime plaster is applied to the mud-plastered surface to create a wainscot, using a metal rule to strike a dado at the appropriate height. Lime cream is then applied neat to the lime plaster. Lime cream is produced by adding water to lime putty and straining the lime putty through a muslin cloth. The resulting lime cream is hung in a sack so that all of the lime water drains out.

Layer upon layer of lime cream is applied. Because it is applied neat, it crazes, and more lime cream is used to heal the cracks. Lime wash (*rashah*) is also used; it typically consists of one part lime putty to two parts water. The *malas* is burnished with a trowel, stone, or the rim of a glass between applications of lime wash. The resulting high-gloss, ceramic tile–like finish repels both water and soiling (Jerome, Chiari, and Borelli 1999: 43). *Malas* is, in fact, sometimes scored to resemble tiles (Fig. 6). Some of the finest examples of historic *malas* are found in the ‘Ishshah mansion, and many are three-dimensional (Fig. 7).

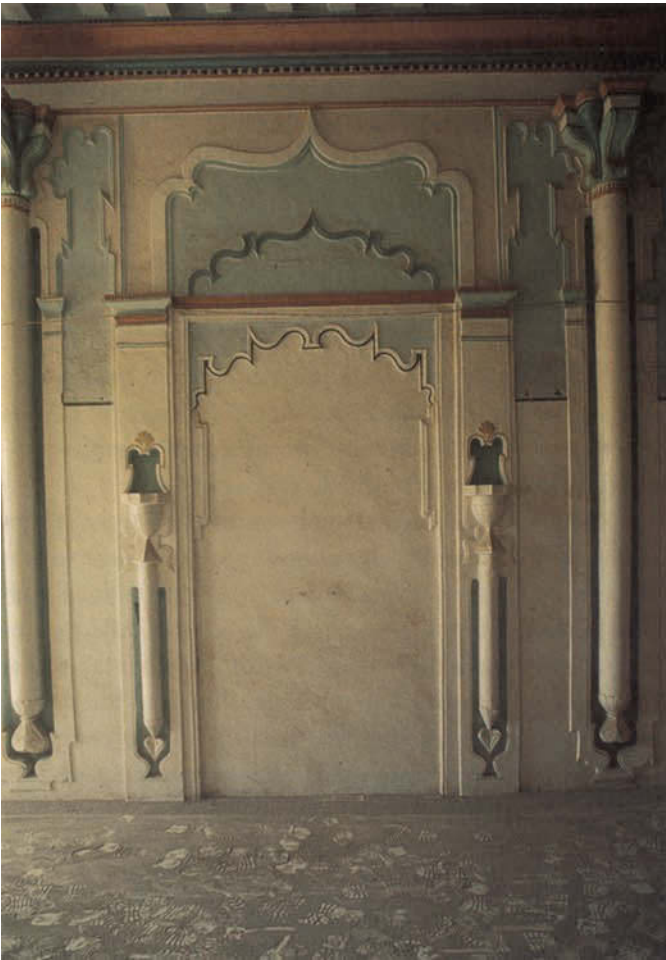
**FIGURE 7** The 'Ishshah palace of Tarim contains some of the finest examples of historic *malas*.

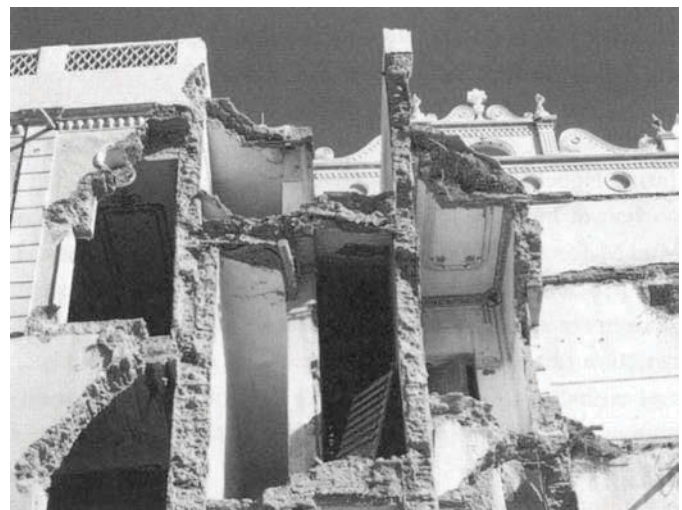
**FIGURE 8** The 'Ishshah palace exemplifies the hybrid of imported colonial styles executed in the local construction technology of mud-brick and lime plaster. A large section of the west elevation collapsed in 2000 and was reconstructed in 2003 through the efforts of the Tarimi Mansions Preservation Project.

The 'Ishshah palace, the most significant of the mansions, has exterior decorations that are three-dimensional and polychrome. The complex, a group of buildings and additions dating from the 1890s through the 1930s, was the seat of the al-Kaf family patriarch, 'Umar bin Shaikh al-Kaf, who made his fortune in Singapore around the turn of the twentieth century (Conlon, Jerome, and Al-Radi 2003: 13). The main part of the palace and later additions were designed by 'Umar's cousin Sayid Alawi Abu Bakr al-Kaf, a gentleman architect. Although it has suffered considerable structural damage (Fig. 8), the 'Ishshah is presented to the public as a house museum, the only one in the valley. The palace was recorded during the 2002–3 season.

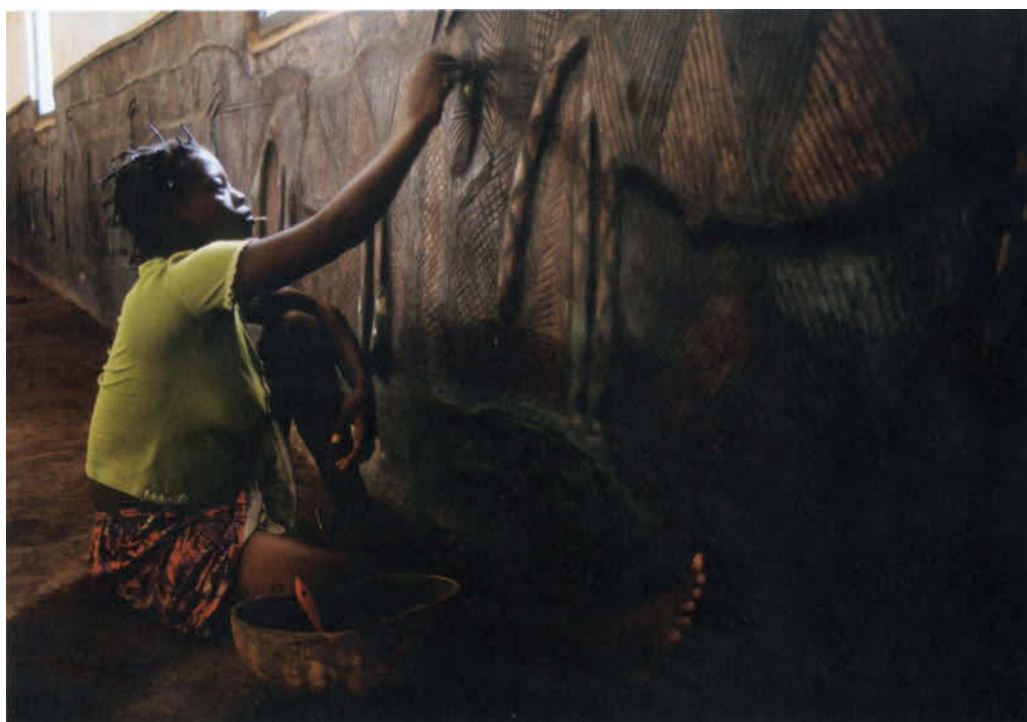
**FIGURE 3** View of the existing decorated side walls inside the cathedral. Photo: Nicolas Lecorre, 2003.

depicts various animals, such as cows, serpents, and crocodiles, and geometric patterns (Fig. 3). These designs are similar to those found on the traditional compounds. The overall chromatic scheme is composed of three colors: black, deep red, and white. The application of a local organic varnish, *dawa-dawa*, creates their deep, rich, shiny patina.

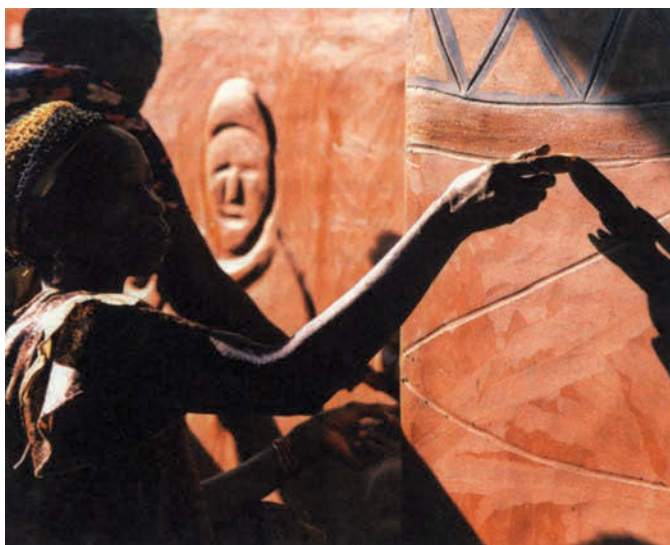
**FIGURE 4** New scene designed at the entrance of the cathedral. Designs are incised on the still-wet surface with the edge of a flat stone. Photo: Gisèle Taxil, CRA Terre-EAG, 2002.

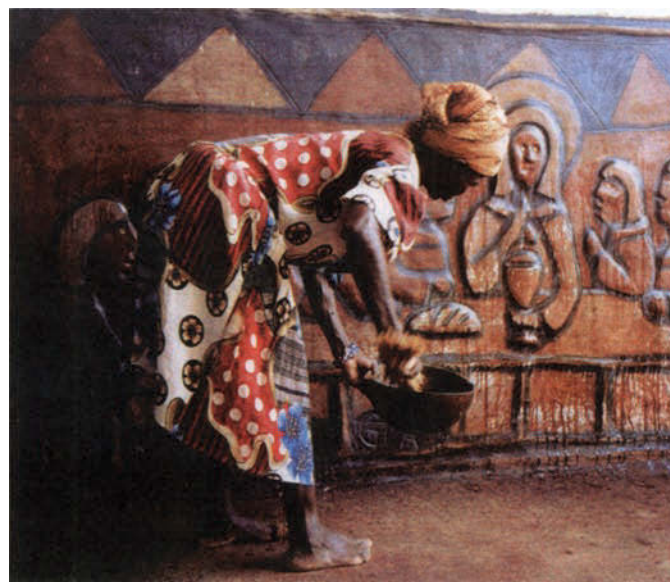
**FIGURE 5** New scene at the entrance of the cathedral. This woman is using a vegetal broom to apply *dawa-dawa*, a local varnish. Photo: Gisèle Taxil, CRA Terre-EAG, 2002.

The wall is left to dry for two or three days before the *dawa-dawa* varnish is prepared. It is spattered warm on the decorated surface, and gives the surface a shiny reddish patina and a waterproof quality (Fig. 5). It is important to let the plaster dry completely first, otherwise the thin polychrome layer cracks and then peels off.

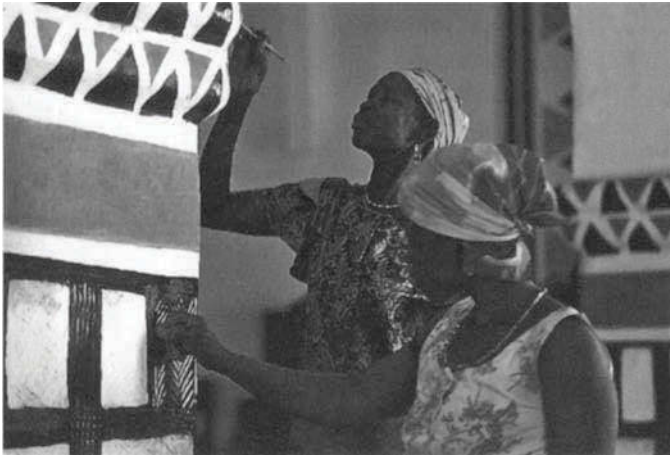
**FIGURE 6** Sirigu women restoring the columns. Photo: Gisèle Taxil, CRA Terre-EAG, 2003.

Since the tradition of decorating walls is still alive and the technical skills were still viable in the community, the decision was made to use traditional materials and techniques in the conservation work and to match existing decoration as closely as possible. Conservation treatments (Fig. 6) included surface cleaning; removal of inappropriate fills; filling of losses, cracks, and scratches; removal of paint and water drips as well as other surface accumulation; treatment against insects; reintegration of fills and superficial losses; and application of the traditional colors and the protective varnish. These treatments were adapted to the living tradition. The Sirigu women used the same materials and techniques as in the original decorations.

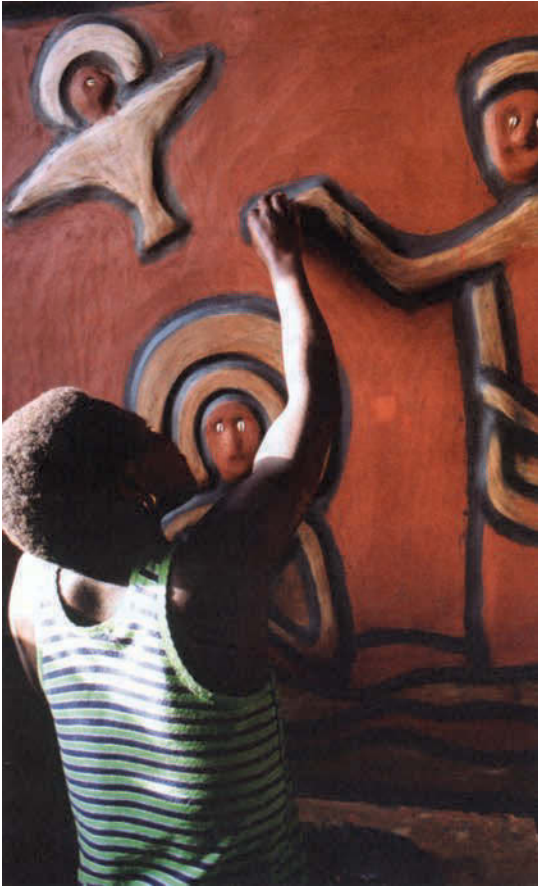
**FIGURE 7** Sirigu woman creating new decoration at the baptistery. Photo: Nicolas Lecorre, 2003.

The plan to add new decorations to the existing scheme was welcomed by the cathedral committee as a way to train younger women in the decorative traditions and to the new practice of maintenance and repair. The new decorations were completed in stages, starting in March 1999 with the sacristy. In November 2001 designs were added inside the Navrongo Museum; in November 2002, in the cathedral entrance porch; and finally in November 2003, inside the baptistery (Fig. 7) and back altars.

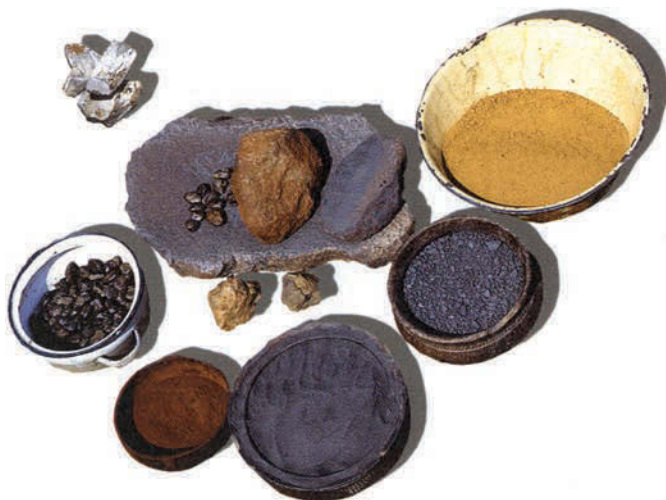
**FIGURE 1** Traditional materials used for the decorated surfaces. Counterclockwise from upper left: white stones called *kug peela* (white pigment), cracked pebbles to give the red color *gare*, the red pigment coming from these pebbles, black earth called *kug sabla* (black pigment), and red laterite earth called *zigi molego* in the large bowl (the preparation layer below the decoration). Photo: Leslie Rainer, 1999.

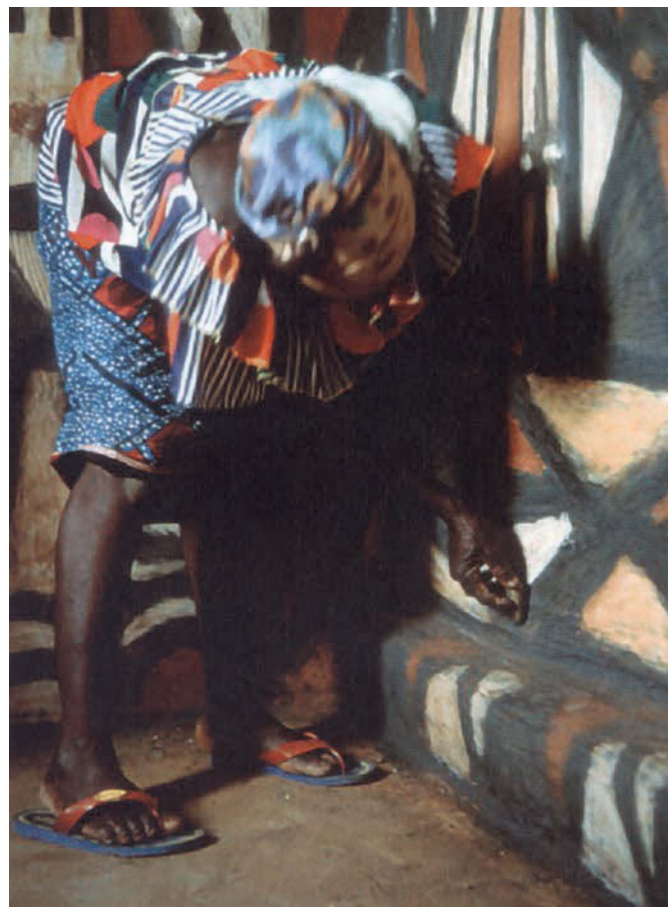
**FIGURE 2** A Sirigu woman polishing the surface of a painting. Photo: CRATerre-EAG, 1999.

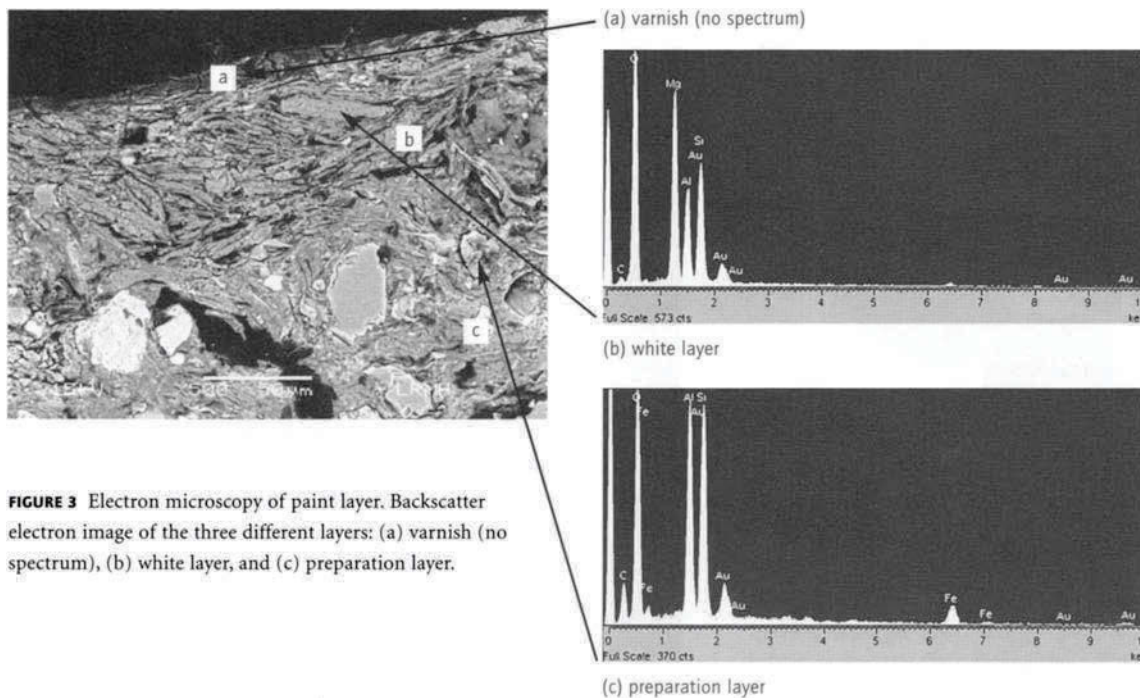
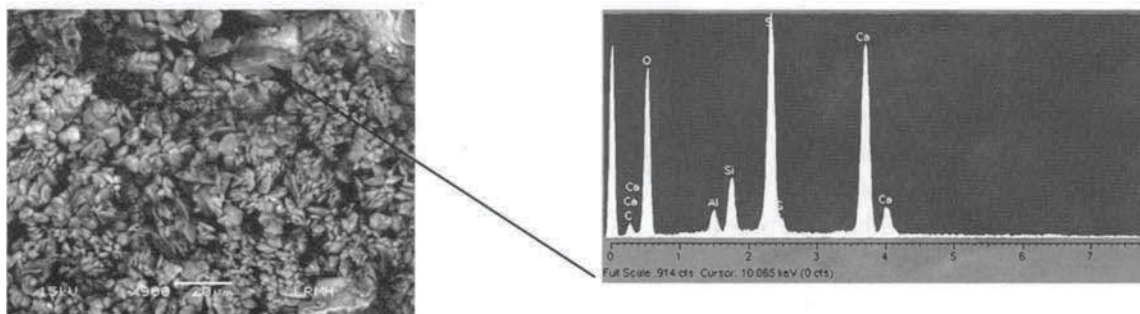
In the south corner of the cathedral, gypsum crystallization (calcium sulfate) was identified in the adobe wall and under the decorated surfaces (Fig. 4). The crystallization of this sol-

uble salt caused disintegration of the paint layer and the substrate. Generally, salts are transported from the soil to the inside of the wall by capillary action, and the water then evaporates on or beneath the surfaces. Although the soil was not analyzed for soluble salts in this case, it is assumed that the origin of the calcium sulfate is from a concrete plate (tomb plate) that abuts the inside wall of the cathedral. The concrete plate inhibits the evaporation of moisture through the ground, and instead pushes the moisture up through the adobe wall. Additional scientific investigation should be conducted to identify the source of the calcium sulfates and to prevent further decay of the decorated surfaces.

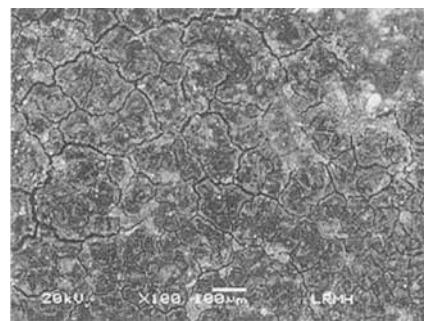
A second alteration pattern was also identified, this time in the varnish layer. Under changing temperature and relative humidity levels, the varnish expands and contracts. These movements cause the varnish layer to crack and flake, often

taking with it some of the paint layer (Fig. 5). This type of damage may be normal, since it is common practice to reapply the varnish to the decorated surfaces every one to two years. Fluctuations in the temperature and humidity inside the cathedral can be partially controlled by adjusting the shutters on the east and the west walls according to the sun exposure, which will reduce the incident ultraviolet light on the decorated surfaces.

FIGURE 5 SEM backscatter electron image showing micro-cracking of varnish.
