Conservation of the  
**Last Judgment**  
Mosaic

ST. VITUS CATHEDRAL, PRAGUE

Edited by Francesca Piqué and Dusan C. Stulik

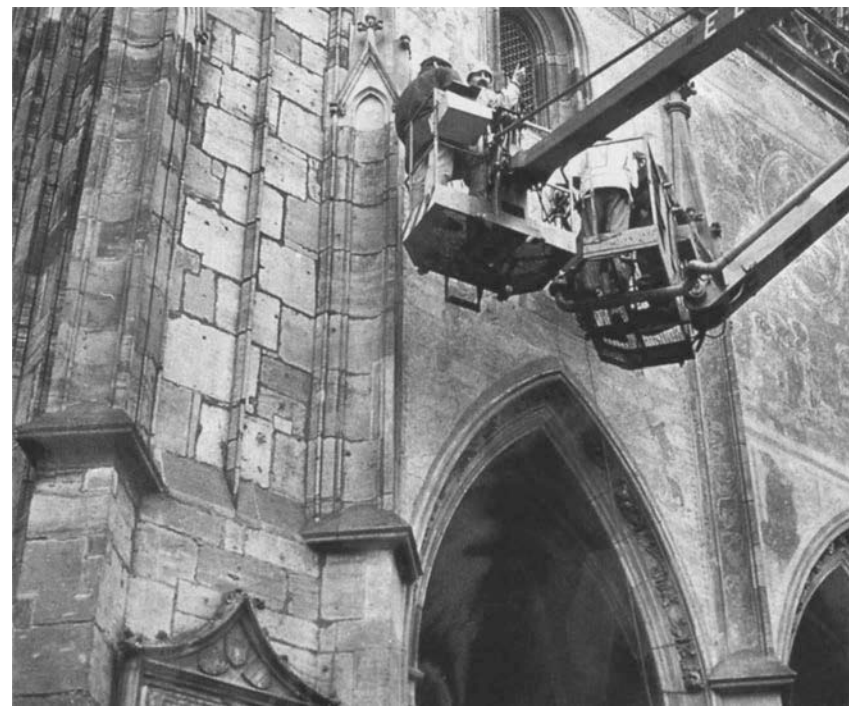
**FIGURE 1** Inspection of the condition of the Last Judgment mosaic in 1958.

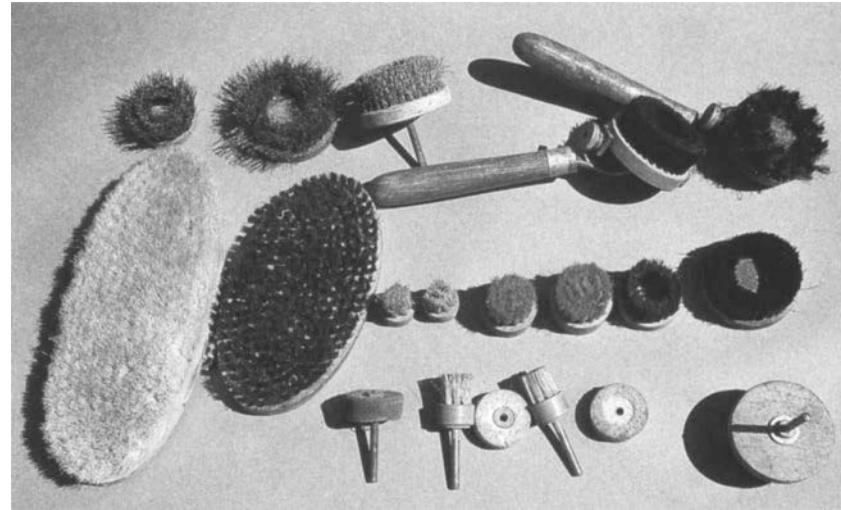
FIGURE 2 (ABOVE) Set of wire brushes used to remove corrosion.

*Removal of Corrosion* Using small brushes of various types and sizes (specially manufactured for this task), the corrosion removal was done manually and with an electric motor with a rotating shaft (figs. 2, 3). Brushes measuring 2.5 to 13 centimeters in diameter (2 cm of nylon, horsehair, brass, wire threads inserted in a wooden handle) were used in combinations for each tessera, depending on the thickness of the corrosion layer and the condition of the glass layer. On severely damaged tesserae, the corrosion was removed manually using similar brushes. In some cases, fine pumice on a felt disk 4 to 6 centimeters in diameter was used for the final cleaning (fig. 4). Because the corrosion was very hard and could only be removed mechanically, this work was

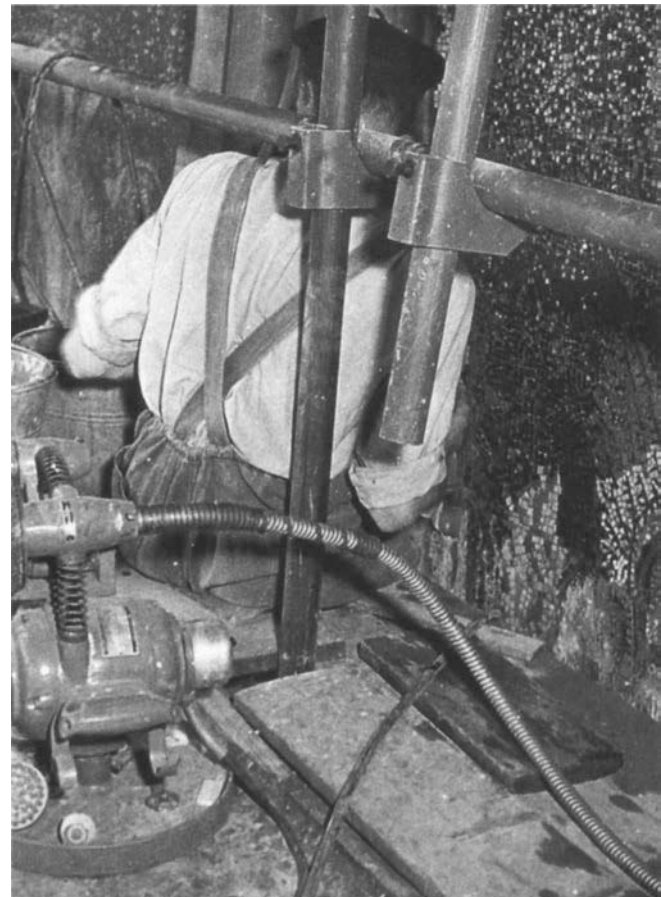
FIGURE 3 (BELOW) The corrosion was removed using wire brushes mounted on an electric motor-driven flexible shaft.

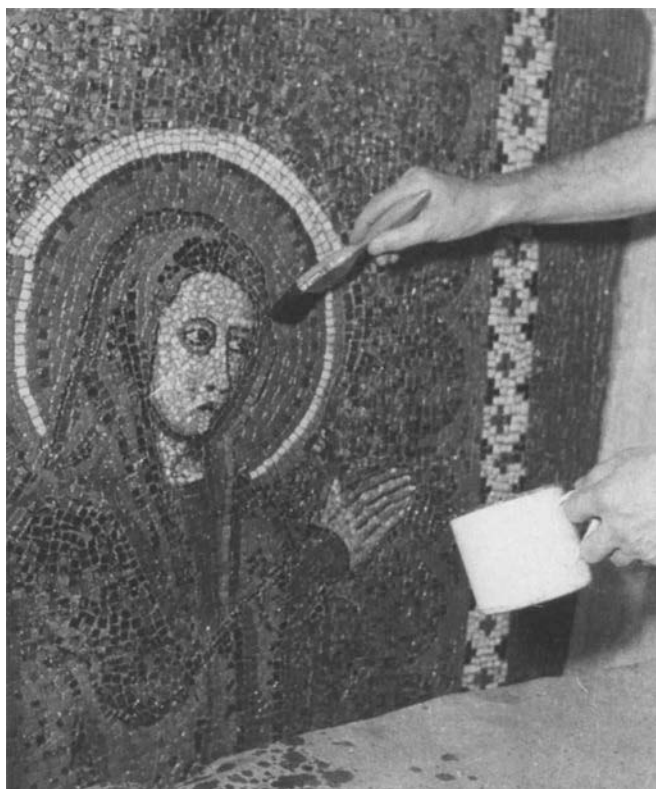
**FIGURE 7** Application of protective coating. Photo: A. Martan.

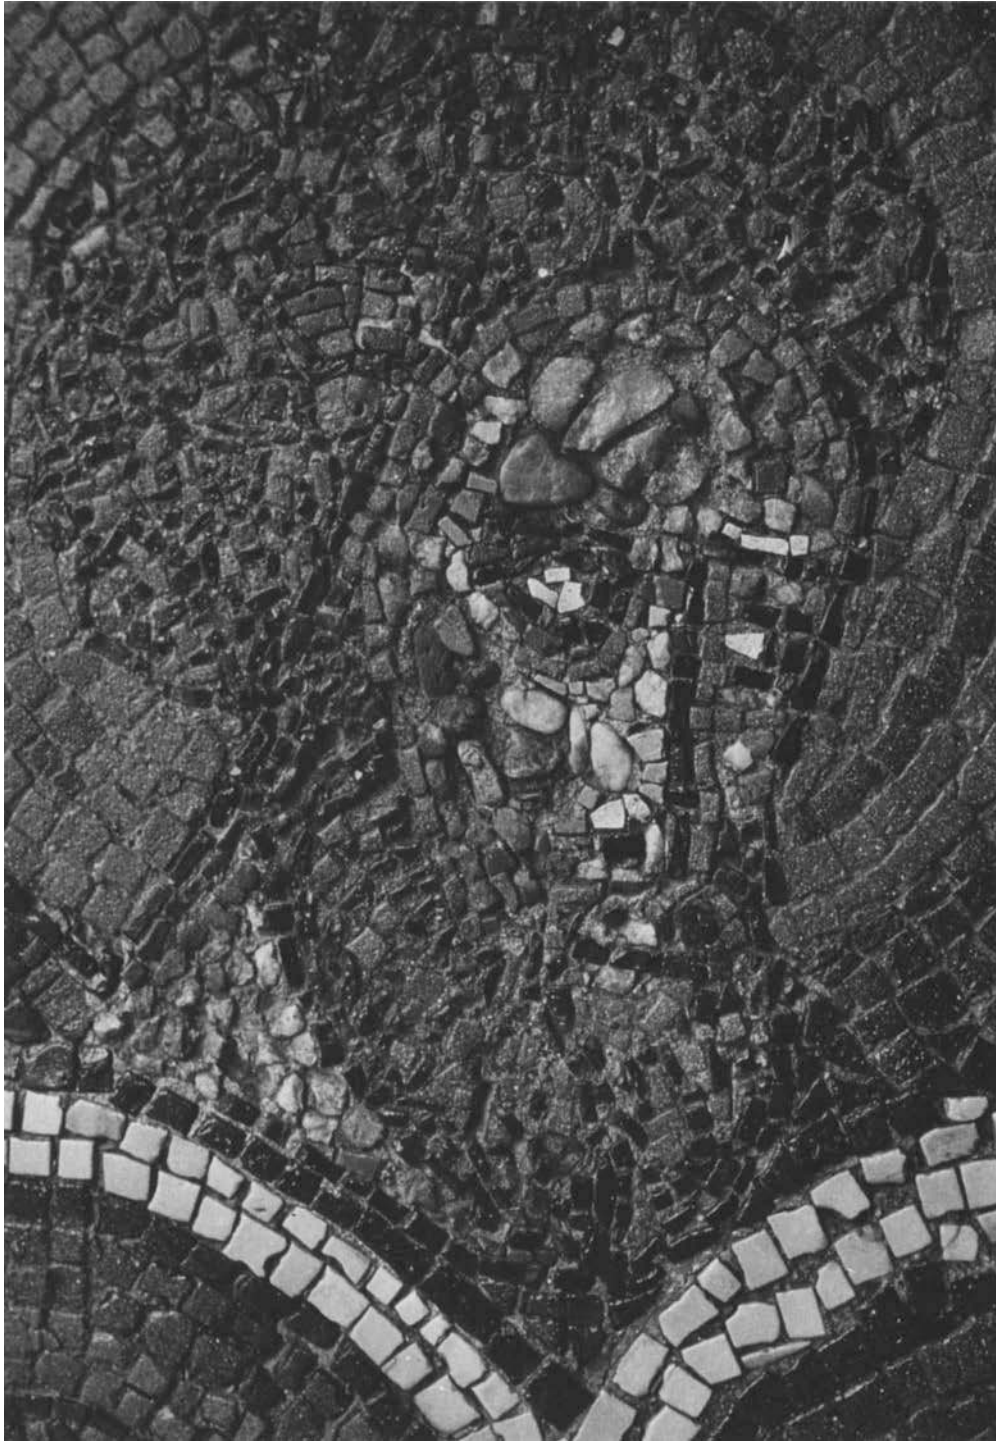
**FIGURE 10** Head of an apostle, left panel, after restoration. Previous repairs were left intact. Photo: A. Martan.

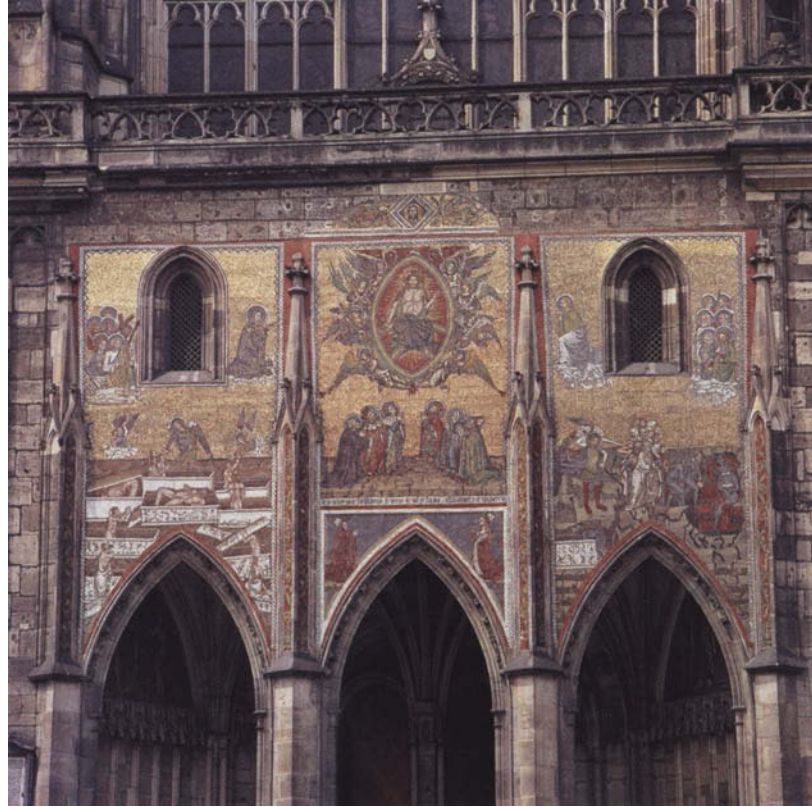
**FIGURE 3** The mosaic in 1992, covered with a corrosion layer, at the beginning of the project. Photo: D. Stulik.

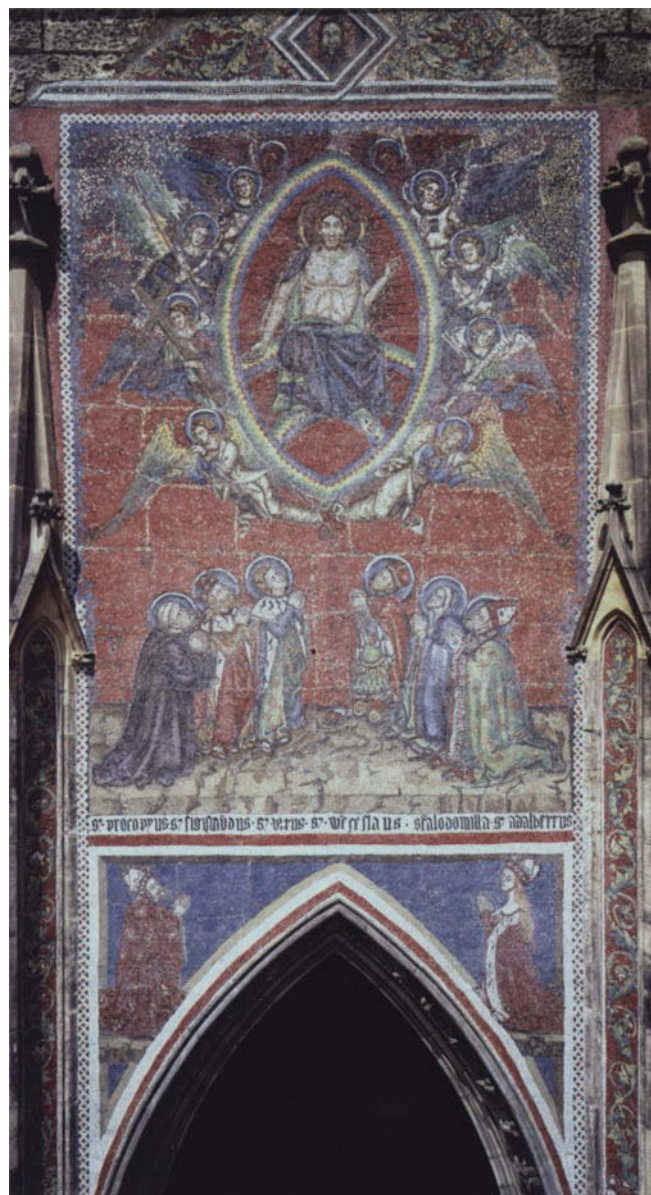
**FIGURE 6** Central panel of the mosaic in July 1998, after cleaning and before regilding. Photo: J. Zastoupil, 1998.

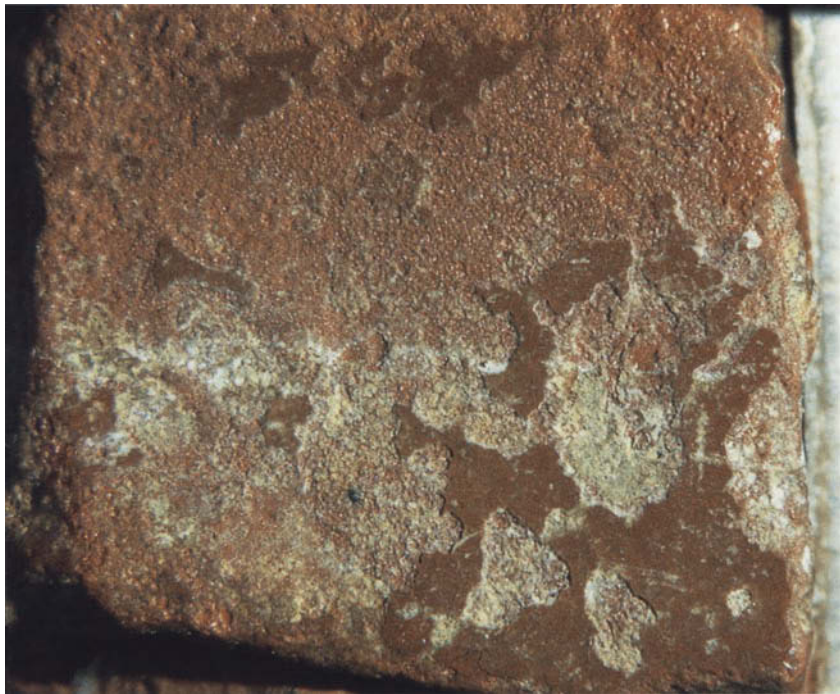
**FIGURE 2** Red tessera partially cleaned using the micro-jet abrasive method. Photo: M. Nečásková.

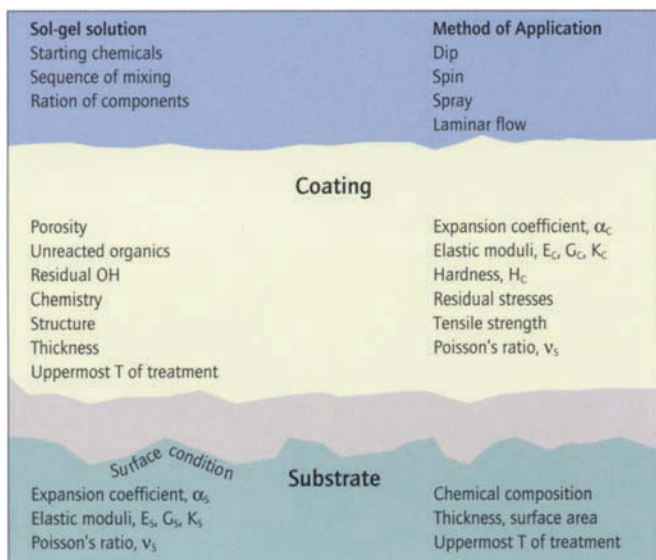
**FIGURE 3** A number of the parameters that affect the performance of a coating.

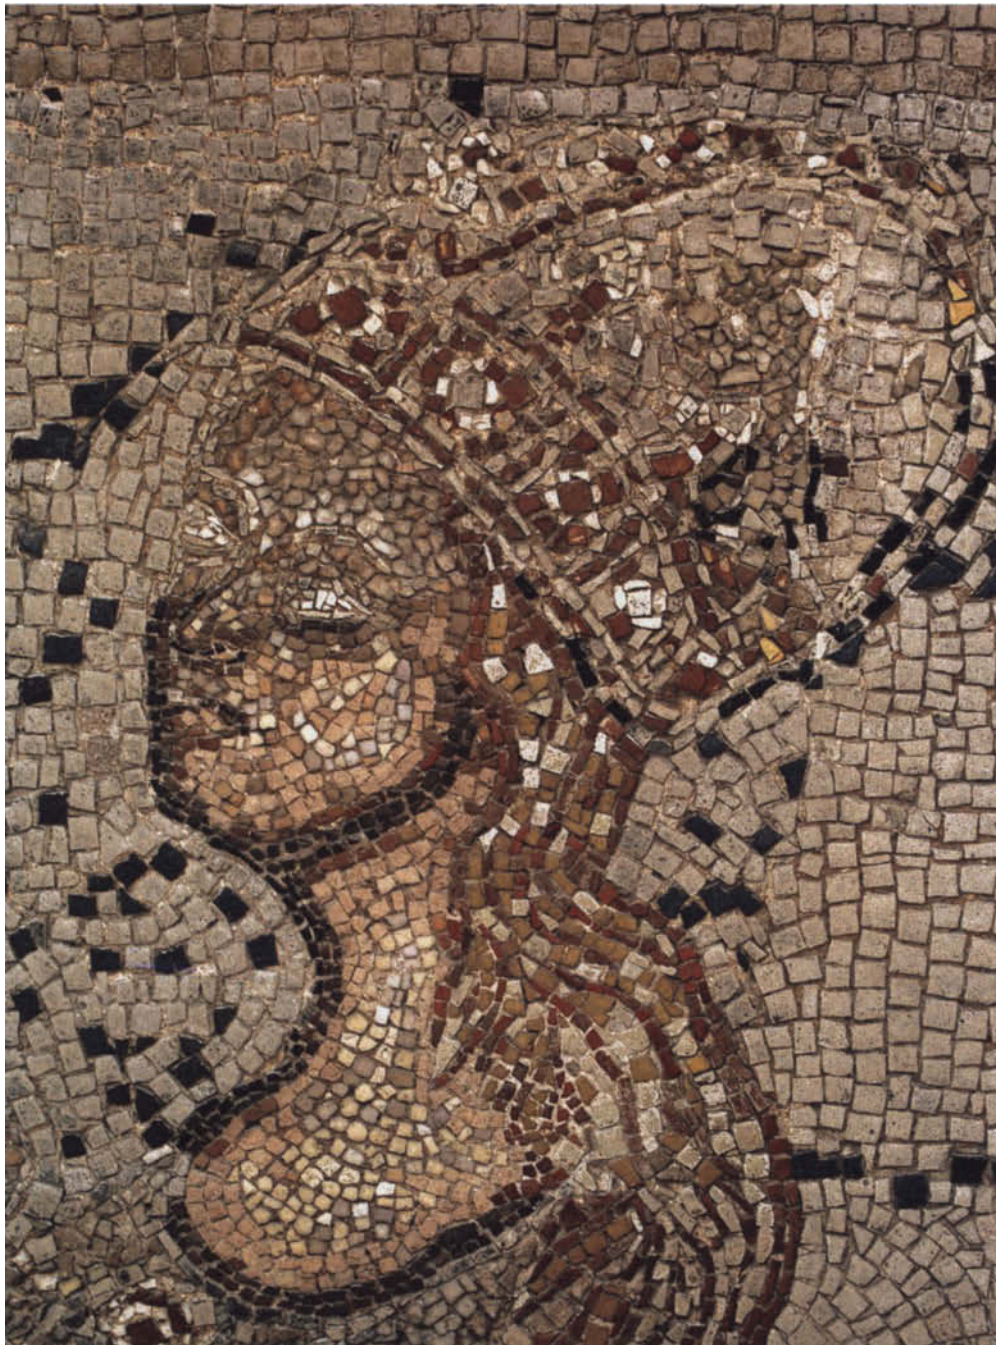
**FIGURE 14** Portrait of Queen Elizabeth before restoration. The damaged lower part of her face, hair, and chest was replaced with modern glass tesserae in 1910.

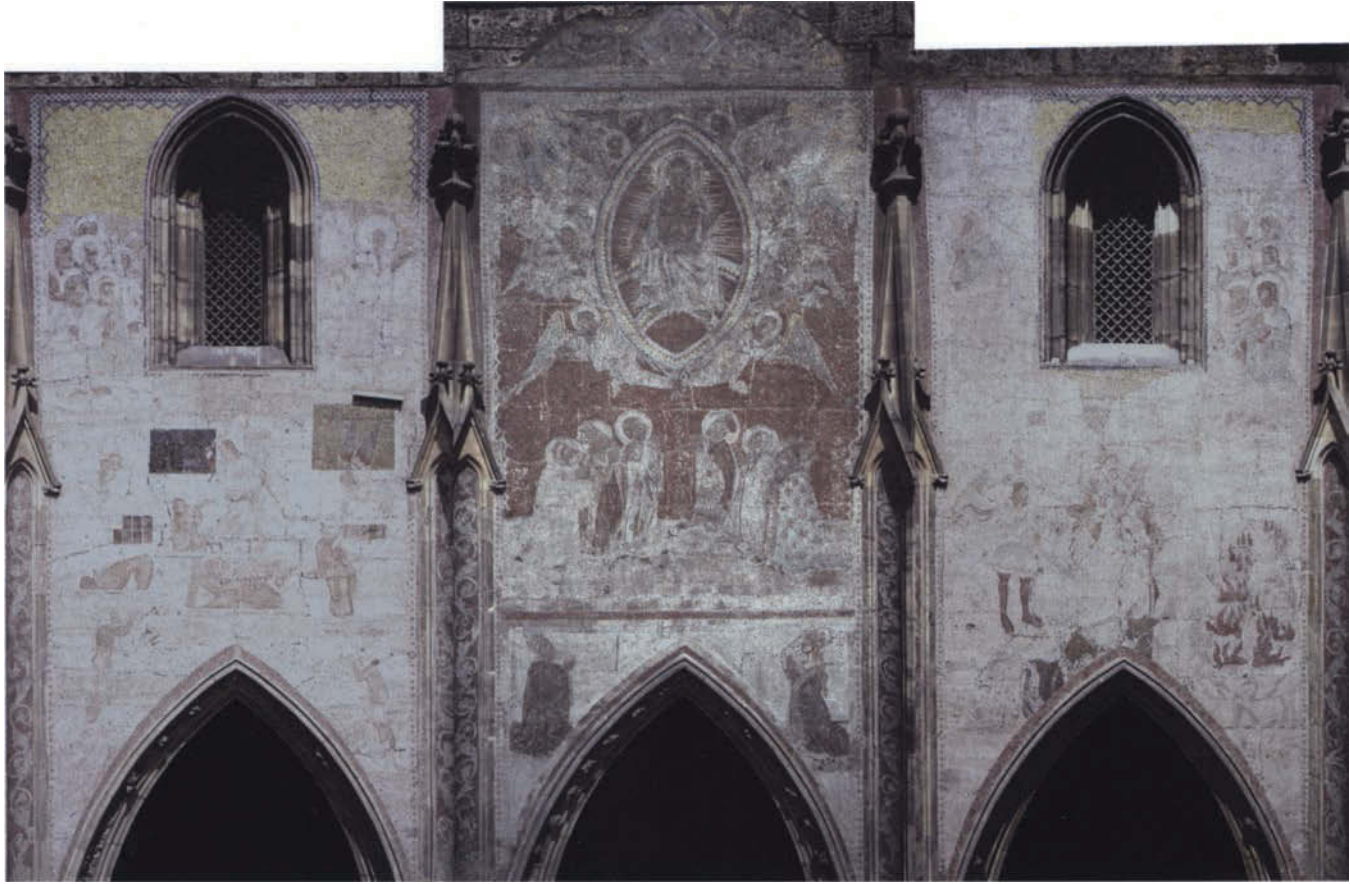
**FIGURE 1** Mosaic before treatment.

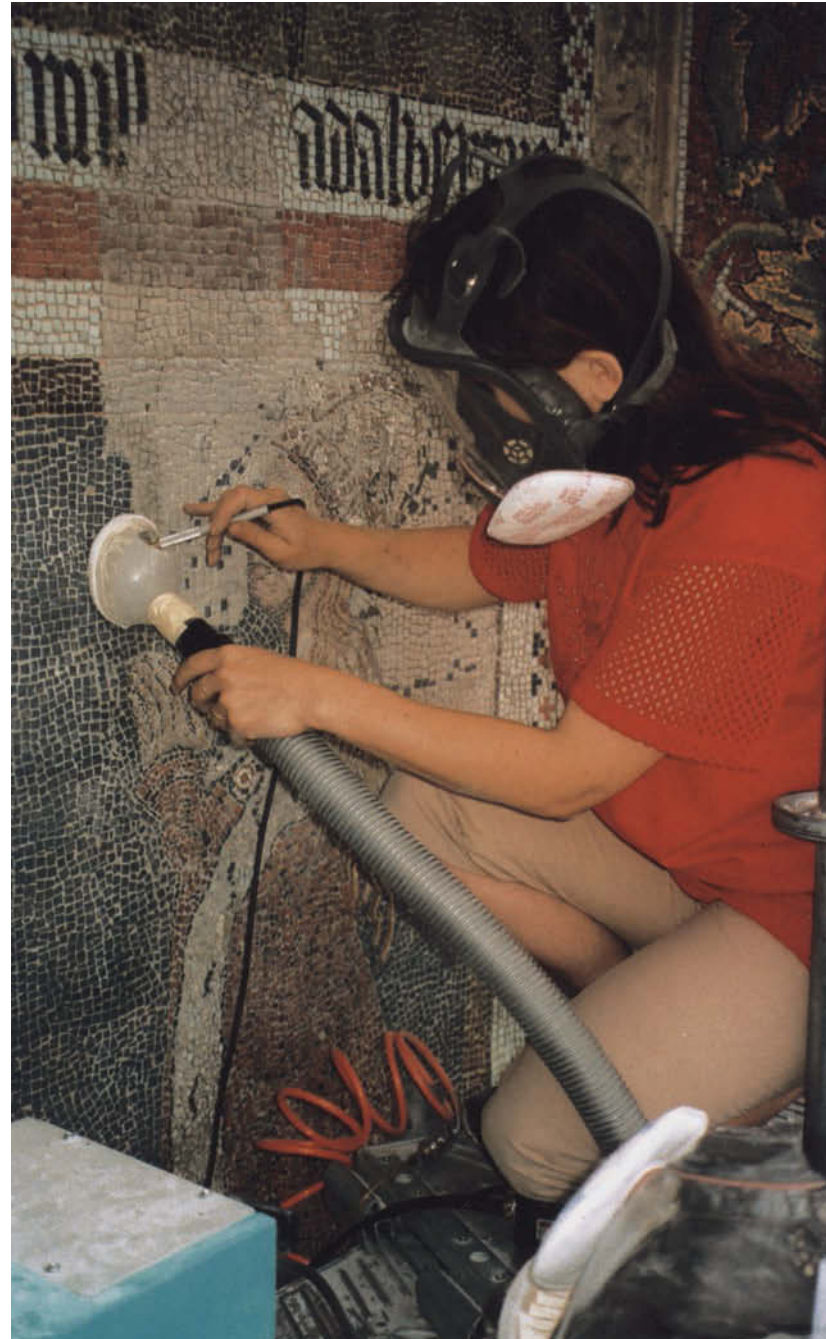
**FIGURE 2** Removal of corrosion using a micro-abrasive device with crushed glass particles. Photo: D. Stulik.

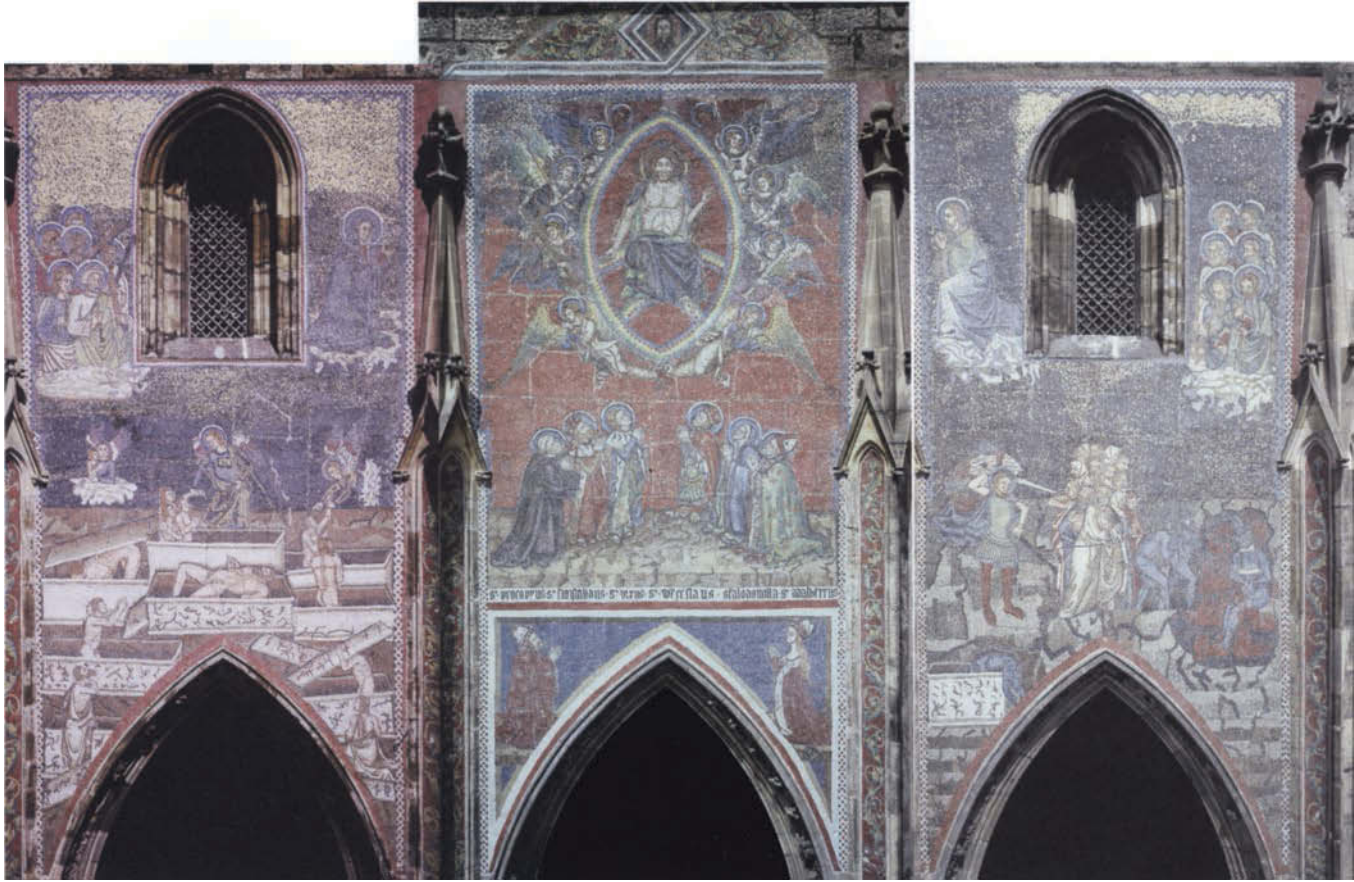
**FIGURE 3** Photomontage of mosaic after removal of corrosion, before regilding. Photos: J. Zastoupil.

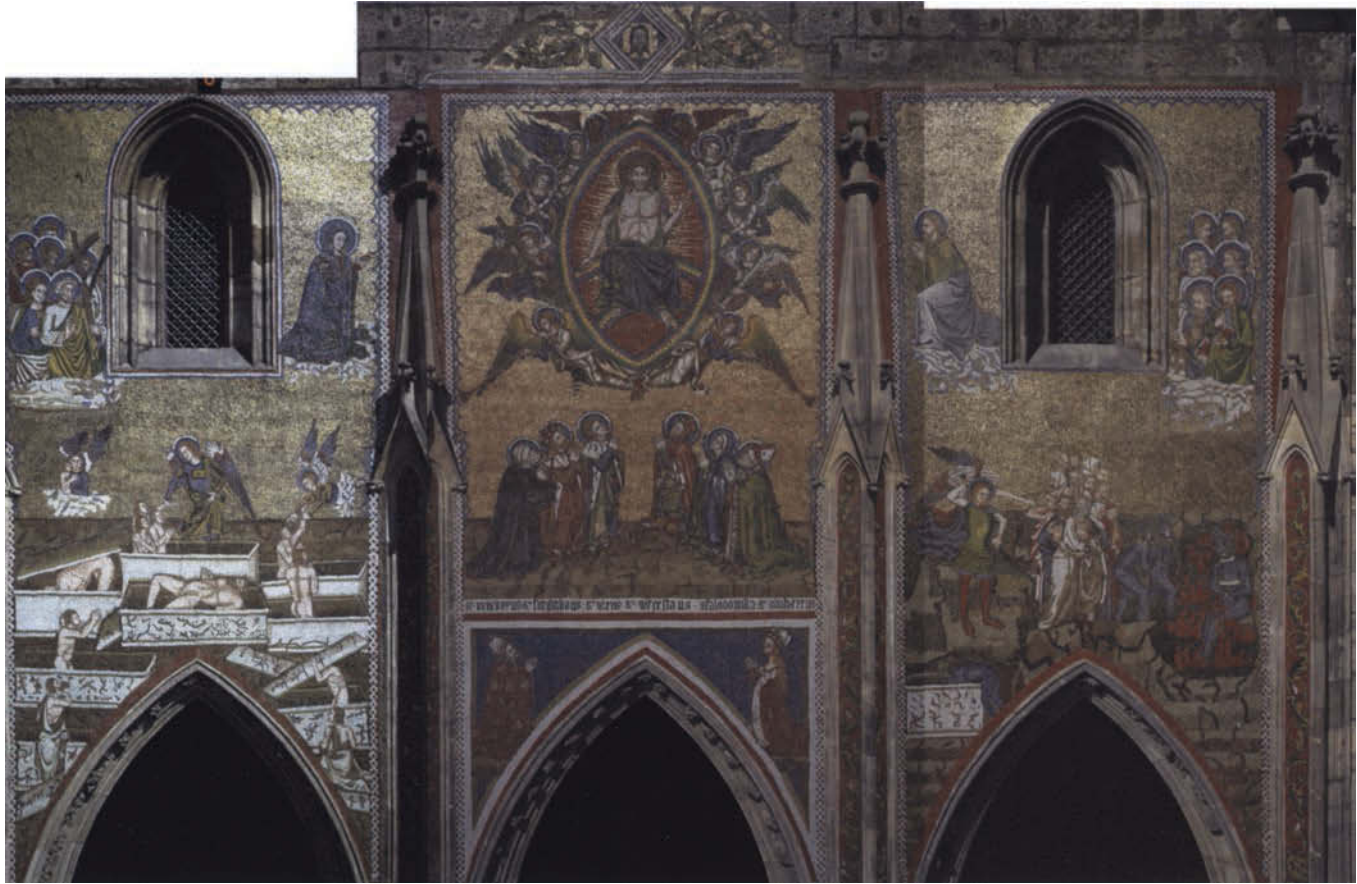
**FIGURE 8** The mosaic after regilding.

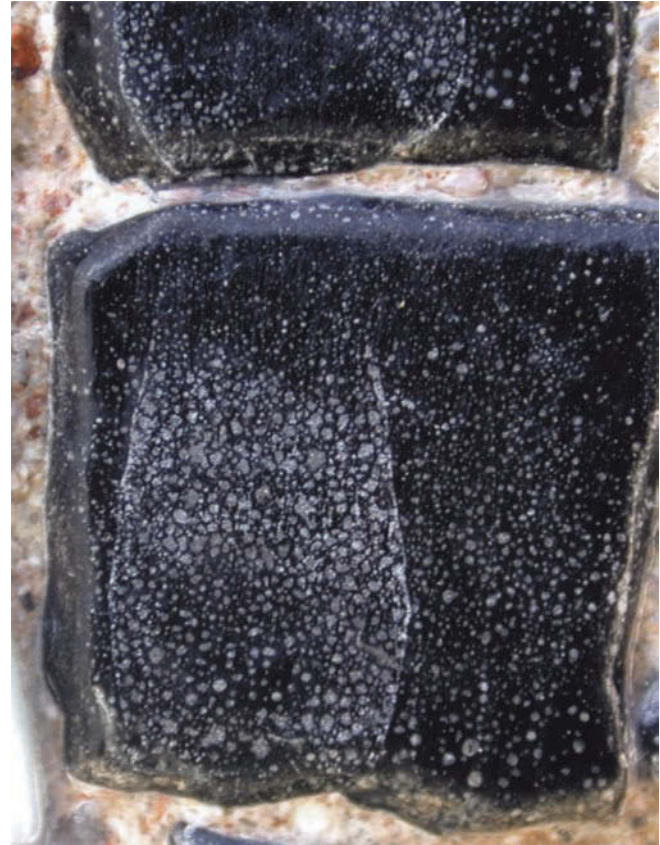
**FIGURE 3** Coating problems: close-up view of blue tesserae with bubbles that formed underneath one of the tested (and rejected) coating systems.

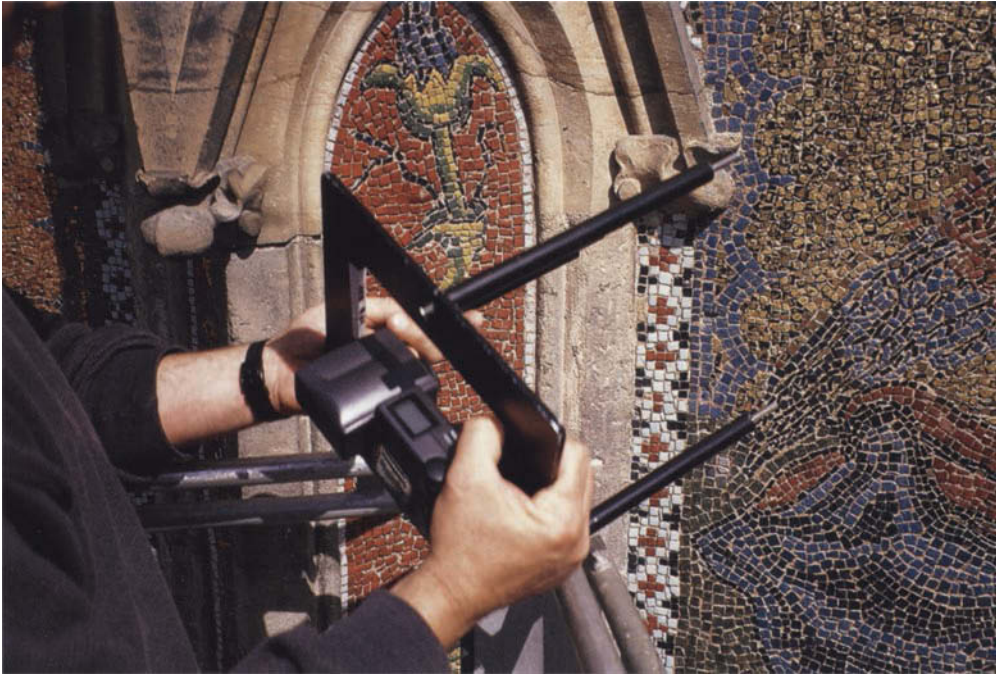
**FIGURE 5** Conservator positioning the camera for photo documentation.

it possible to perfectly overlap them, the camera was attached to a lightweight tripod that could be fixed to the mosaic surface (fig. 5). In each of the three sectors, the tripod's legs are positioned in the space between the glass tesserae where stainless casings were permanently inserted (fig. 6). These casings measure 35 mm long by 8 mm wide. They form an isosceles triangle with sides measuring 21 cm in length. (See triangular areas A, B, and C in fig. 4.) The camera's lens is therefore always positioned 20 cm from the mosaic. The photographs were taken at maximum close-up but without using the digital zoom to avoid lowering the final quality. The final result is an enlargement of the glass tesserae in a close-up 5 by 7 cm photograph.
