TECHNICIAN TRAINING FOR THE CONSERVATION OF MOSAICS

PART 2
THE CONSERVATION OF DETACHED MOSAICS

Mosaics detached and relaid in situ on
reinforced concrete:
their reinstallation in situ and documentation

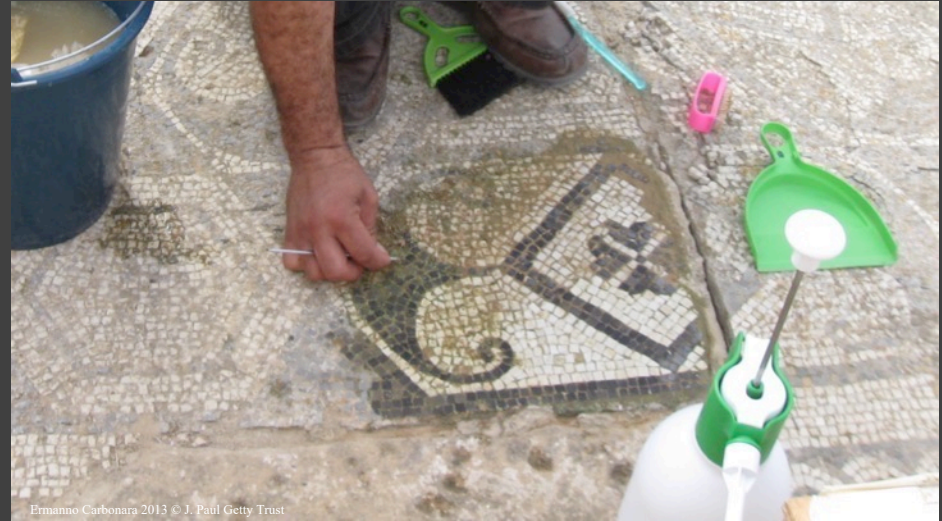
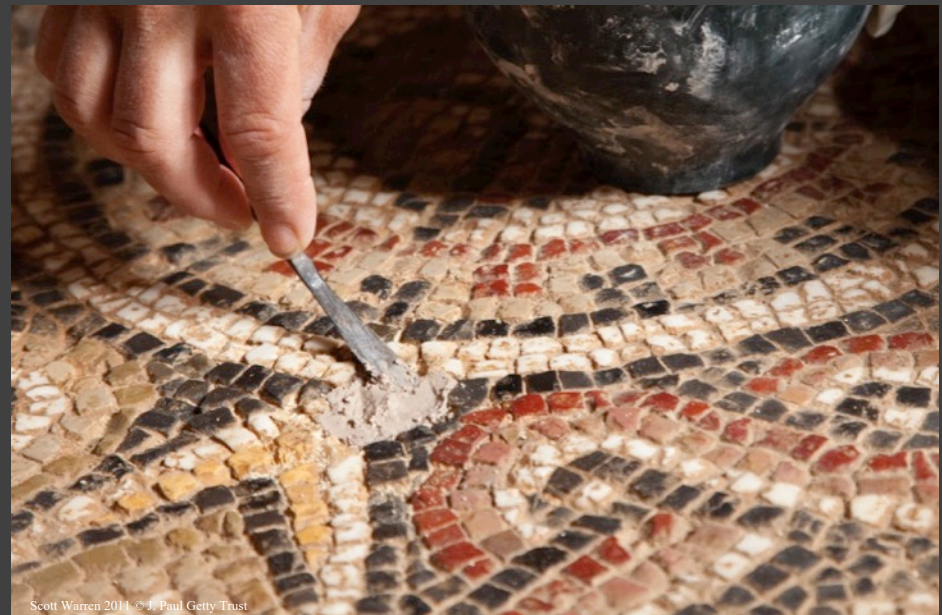
Cleaning of deposits of dirt and debris without water.

Cleaning of micro-organisms with water.

Resetting of detached tesserae using a weak mortar.

Filling lacunae with a weak mortar.

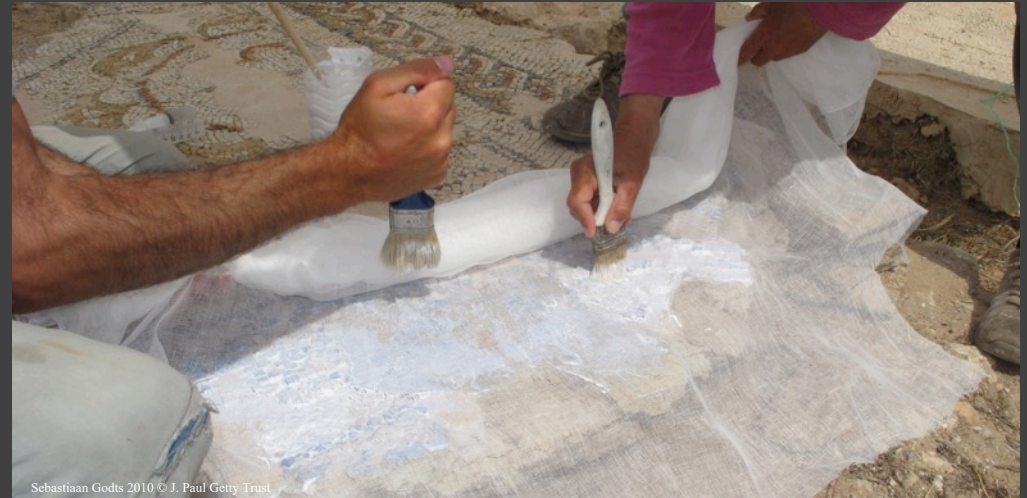
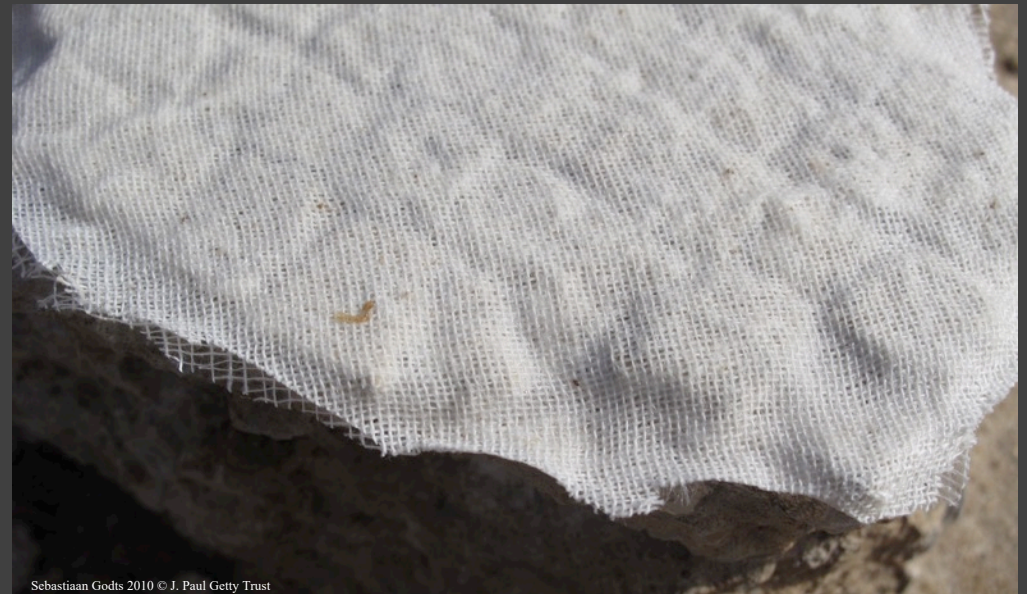
Apply one or more layers of fabric to the surface of the mosaic using an adhesive.

Characteristics of the adhesive to be used:

Characteristics of the fabric to be used:

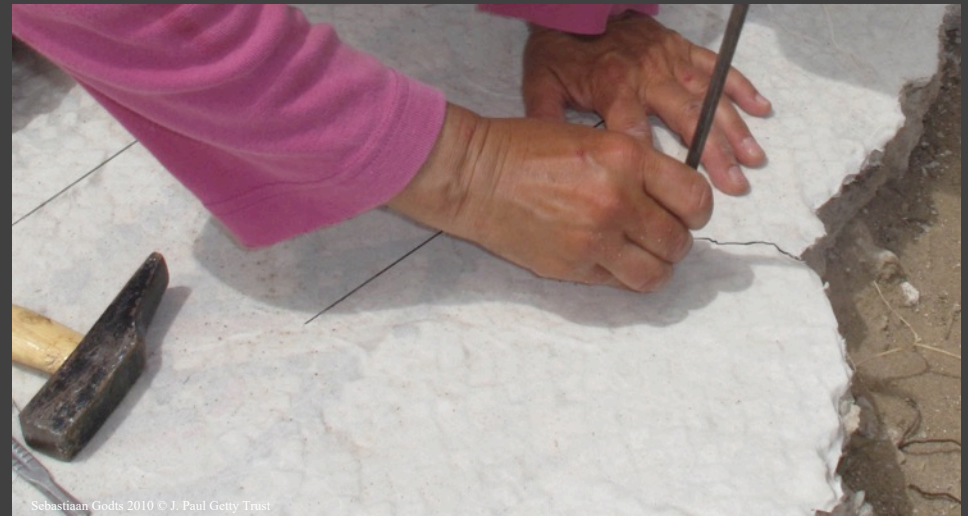
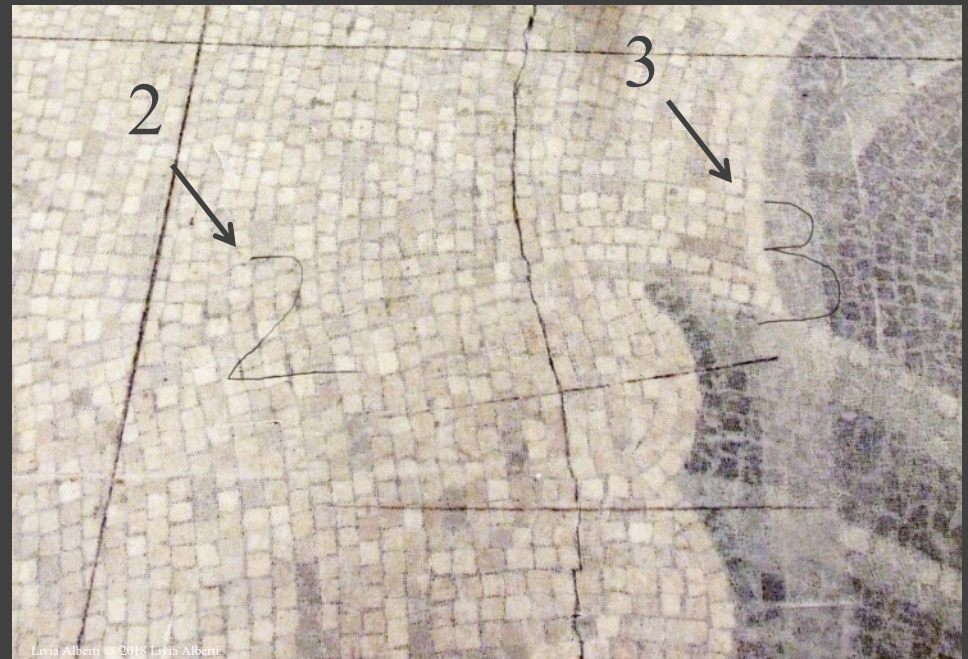
Mark and number the profiles of each section on a map and on each of the sections themselves.

Mark the reference lines between each of the sections.

Create a reference system separate from the mosaic.

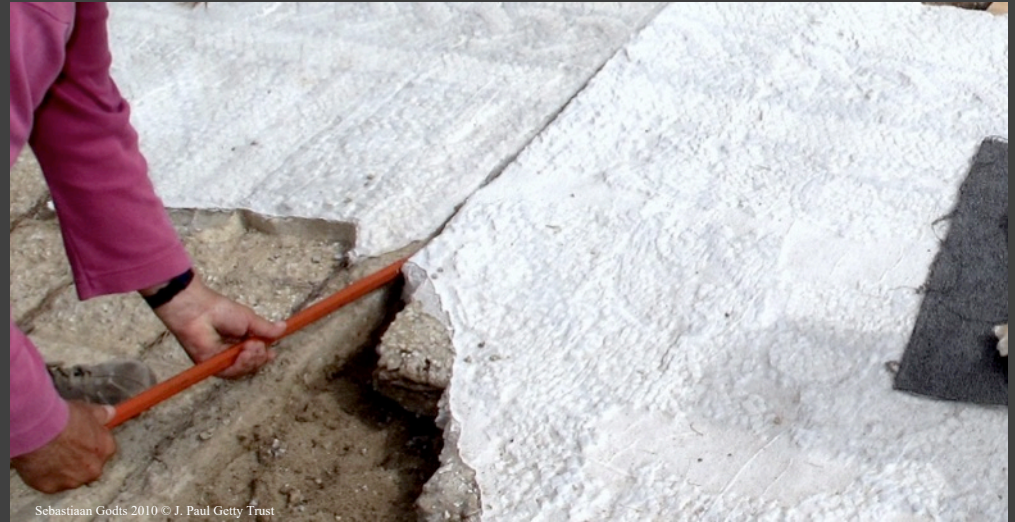
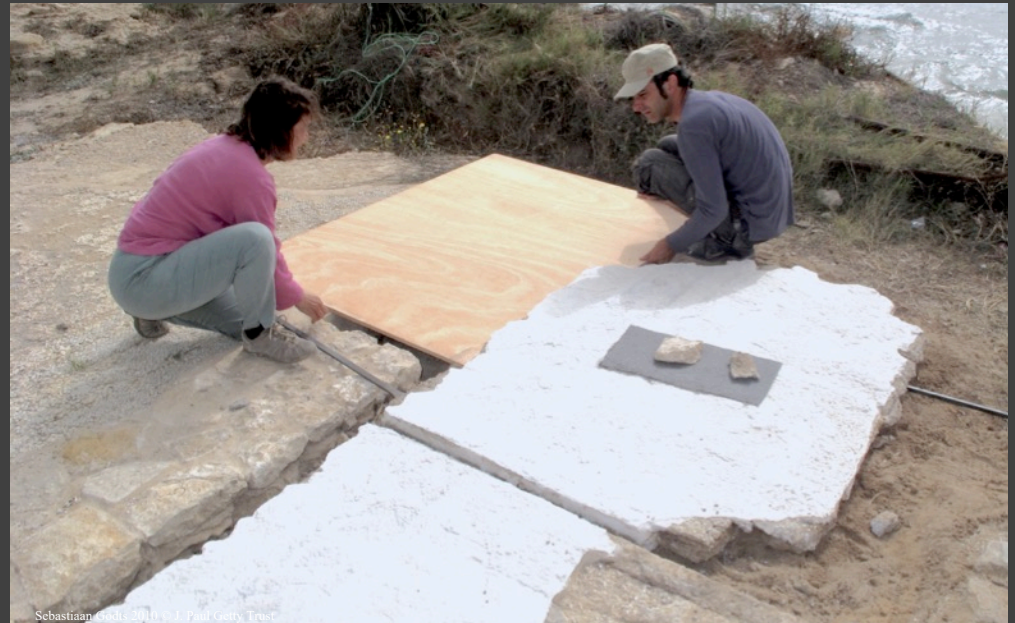
Detach and lift the sections using long, flat bars and/or a lever.

Slide the sections onto rigid plywood panels.

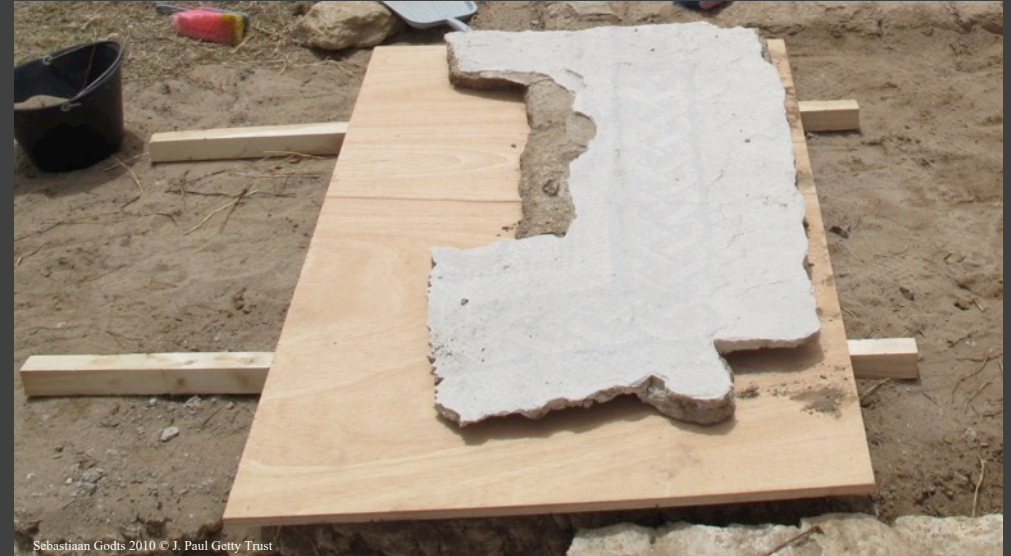
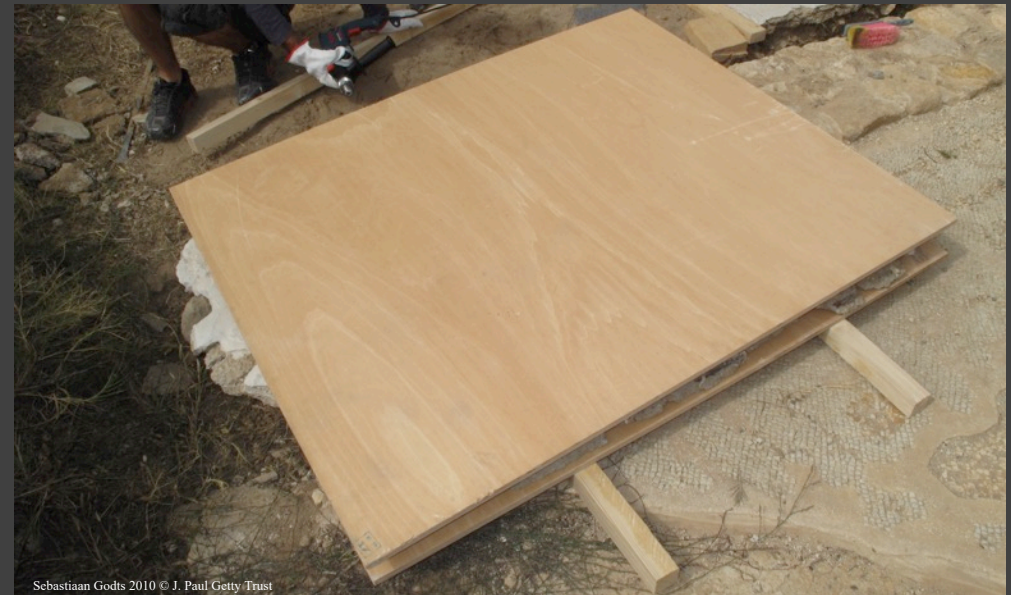
Place a plywood panel on the surface of the section.

Hold the two panels together using rigid braces.

Invert the mosaic section.

Secure the panels with the mosaic section, if necessary.

Transport the panels manually or by other means, depending on the weight.

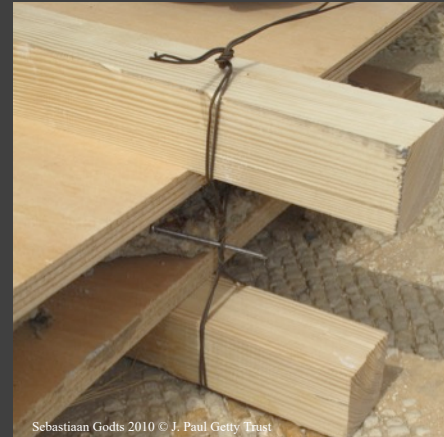
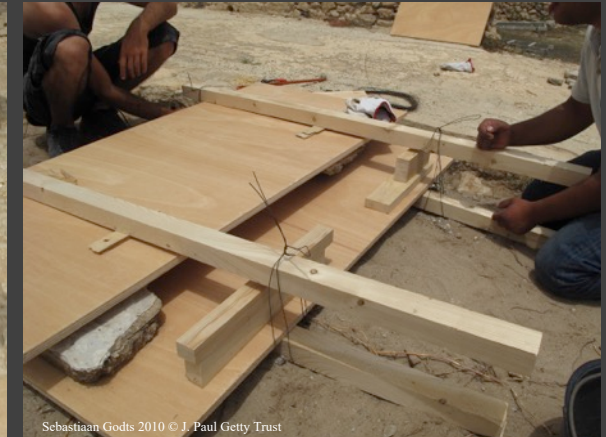
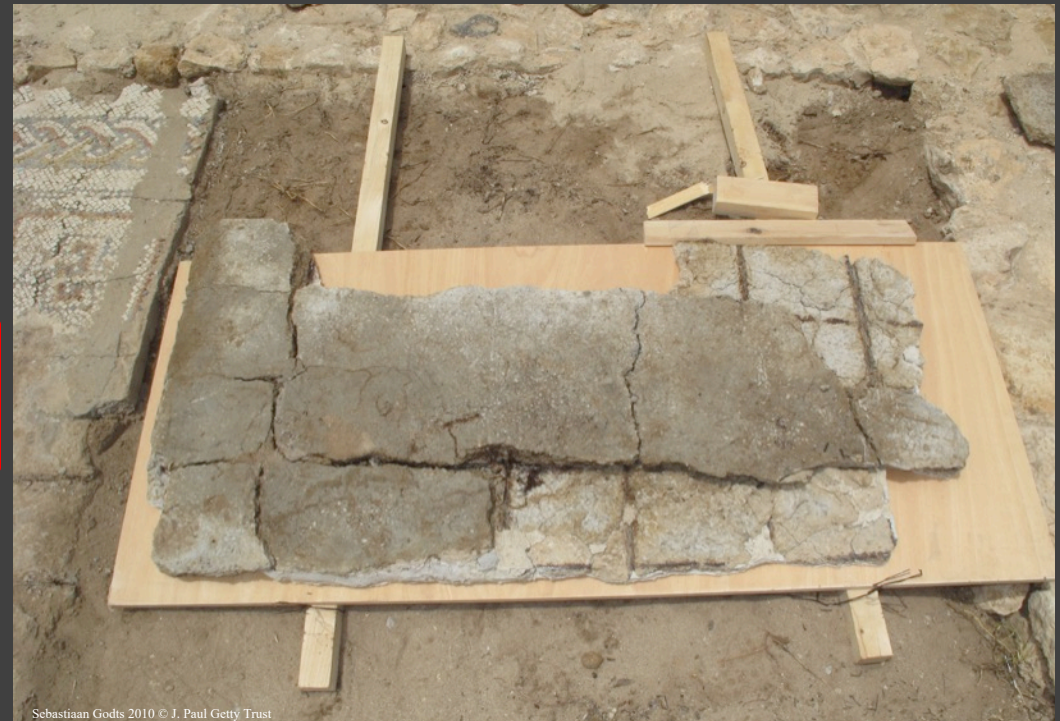
- Cleaning and Stabilization
- Facing of the surface with one or more layers of fabric and adhesive
- Numbering of sections to be removed and reference placement for reinstalling sections
- Separation and detachment of panels
- Inversion of panels and transport to the laboratory

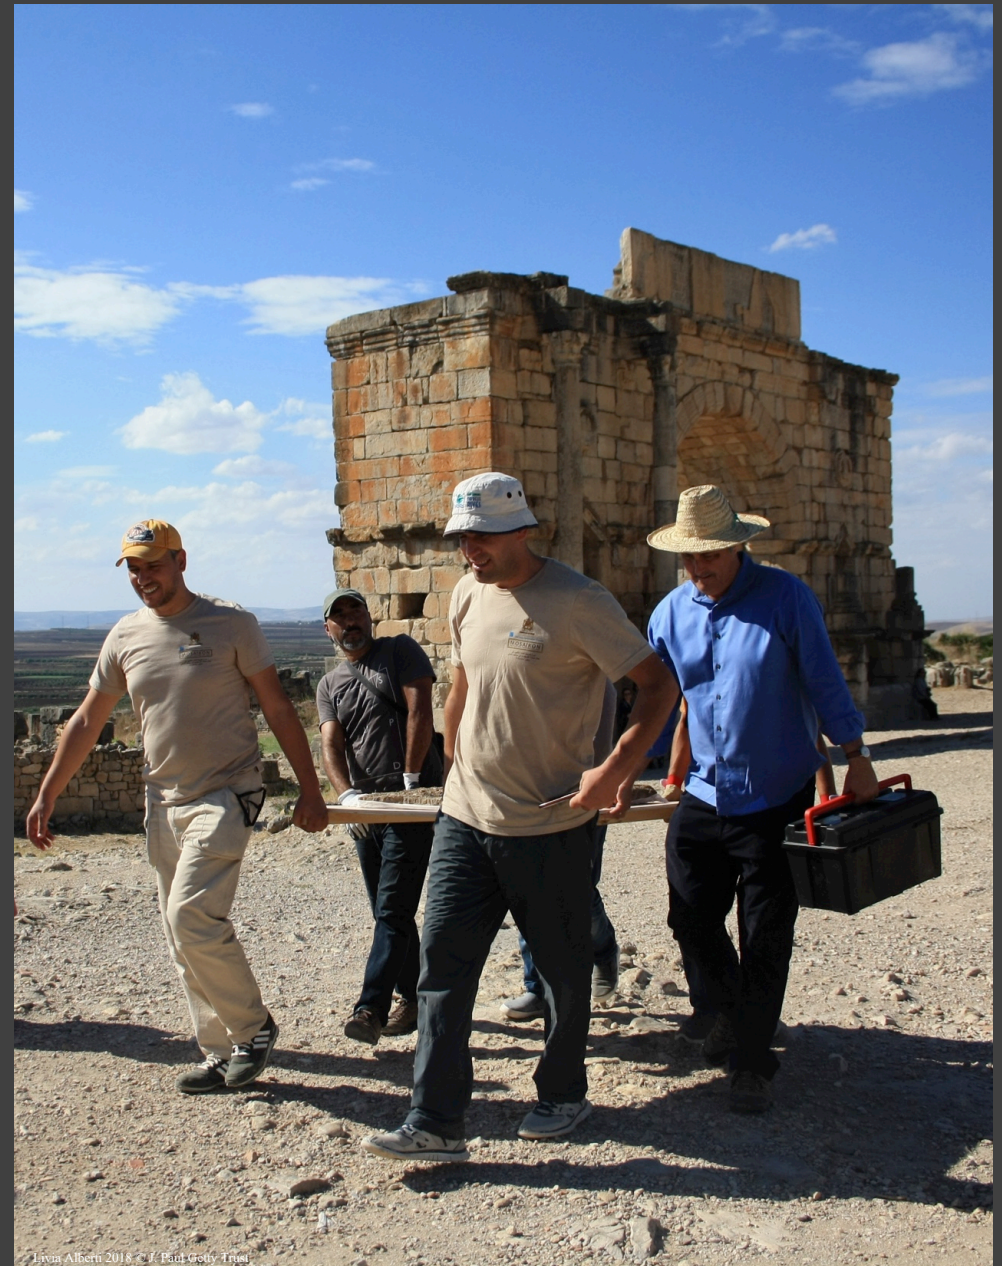
- Cleaning and Stabilization
- Facing of the surface with one or more layers of fabric and adhesive
- Numbering of sections to be removed and reference placement for reinstalling sections
- Separation and detachment of panels
- Inversion of panels and transport to the laboratory

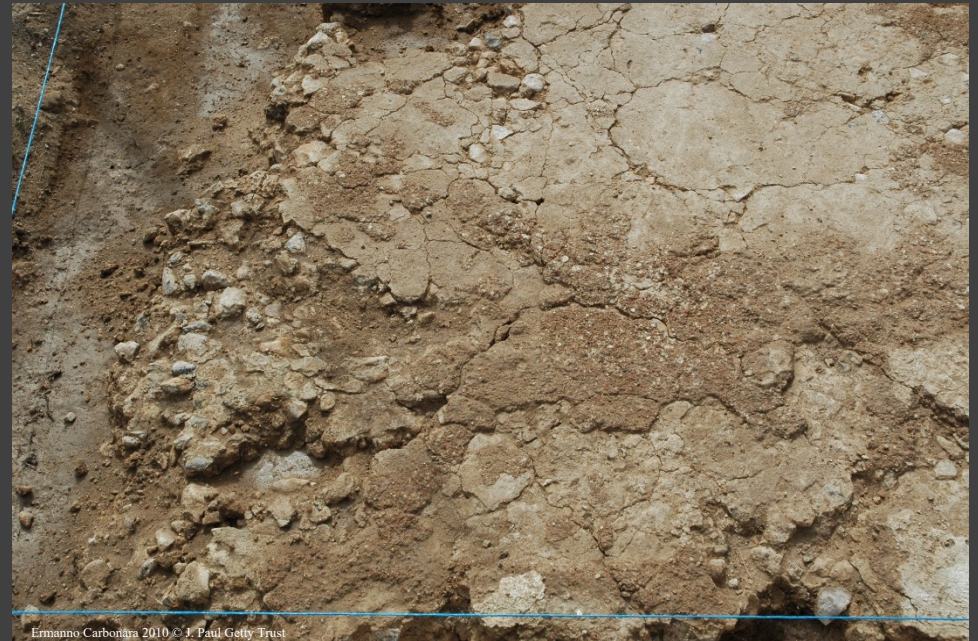
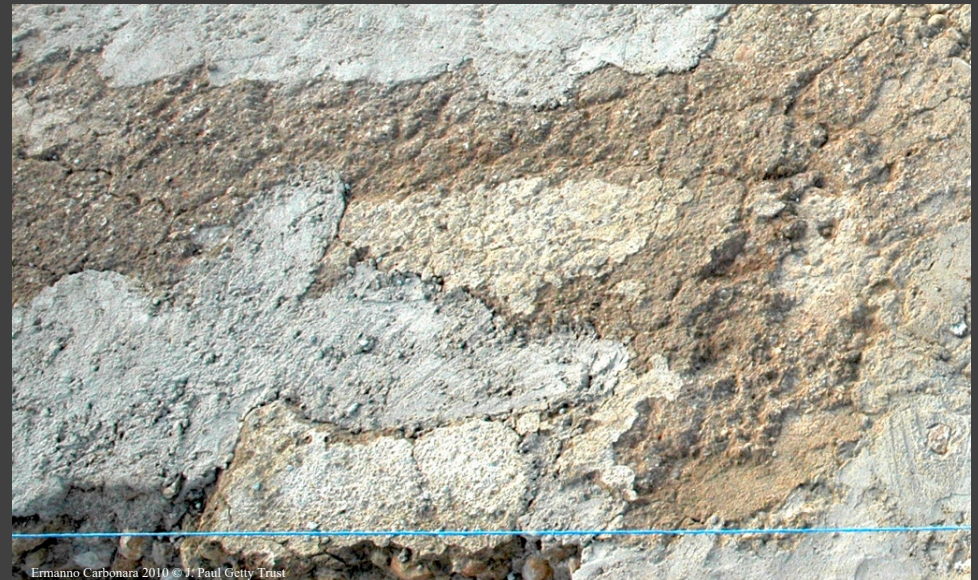
Cleaning loose dirt and debris without water.

Cleaning compact dirt with water, if necessary.

Fill lacunae and cracks with lime putty or hydraulic lime-based mortar similar to the original layer to be stabilized.

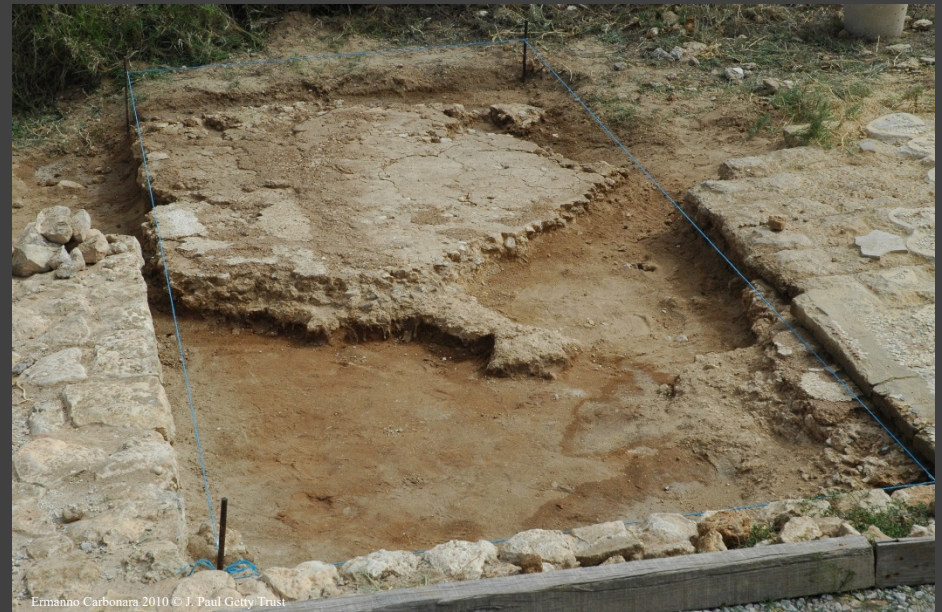
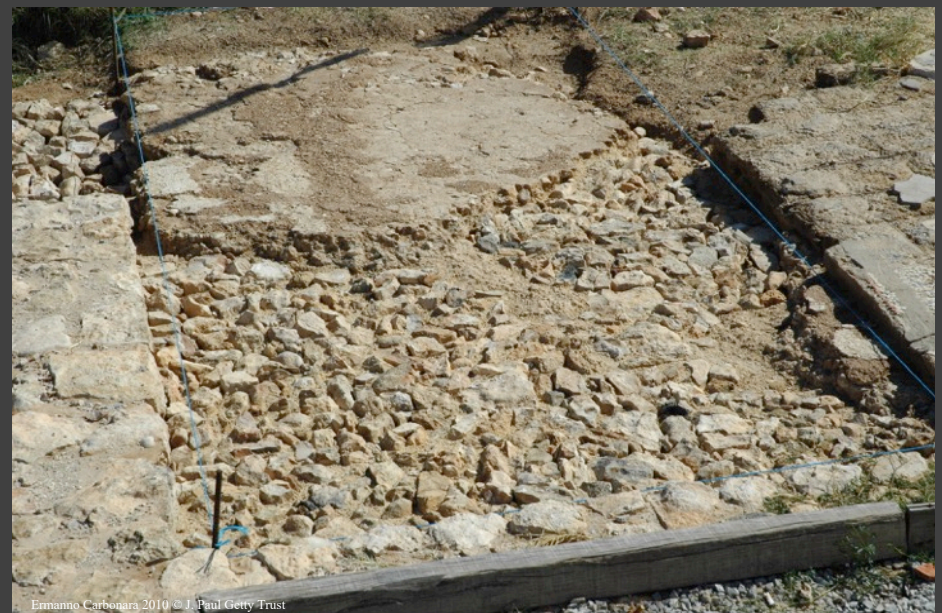
Create mortar samples for the various preparatory layers to be integrated.

At the correct level, reconstruct the missing parts of each original preparatory layer, excluding the bedding layer for the tesserae.

Consider the slope for draining rain water from the room and determine the placement of a water drainage opening, if necessary.

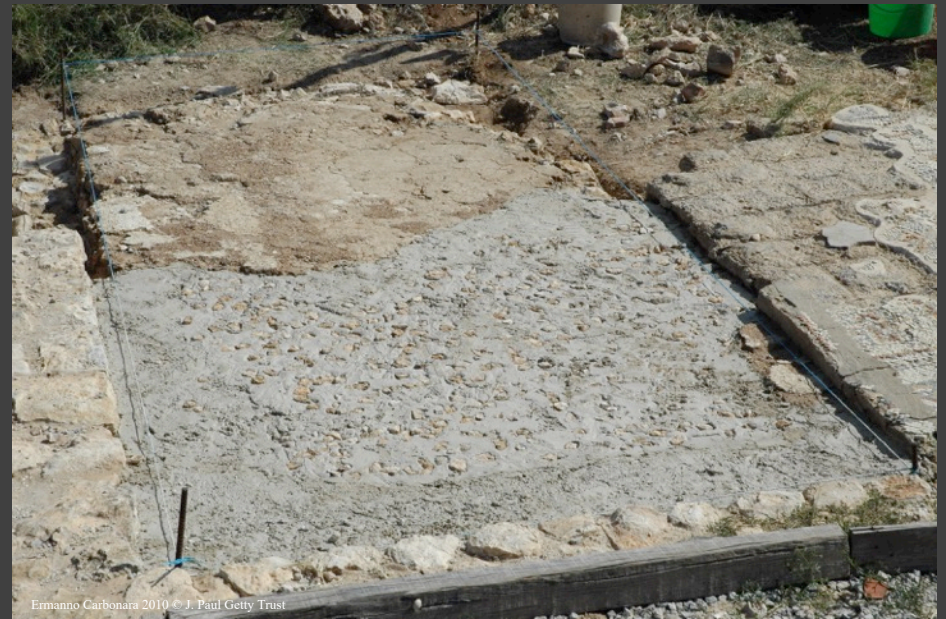
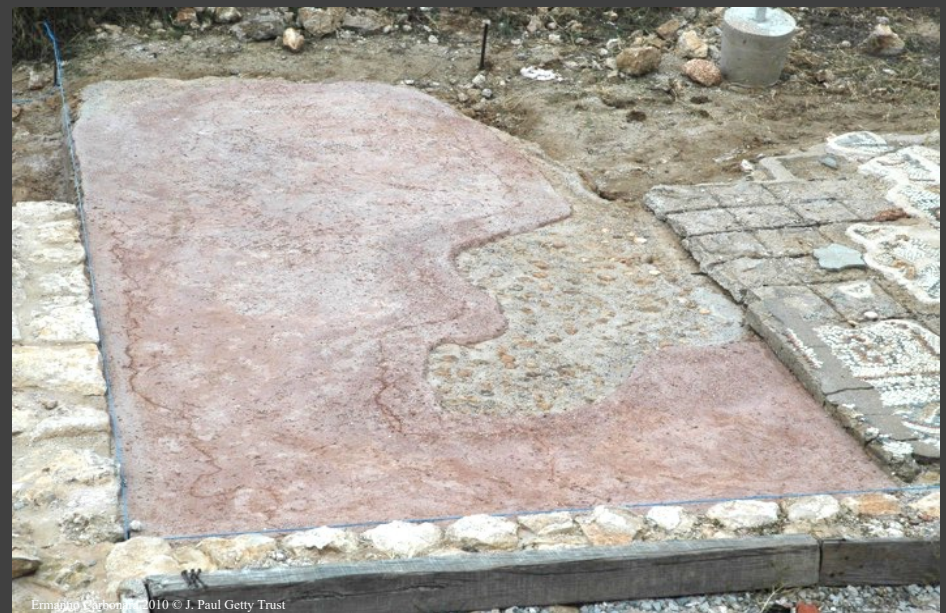
2. Preparation of reinstatement area for sections

- Cleaning and stabilization of each original preparation layer
- Reconstruction of each preparation layer

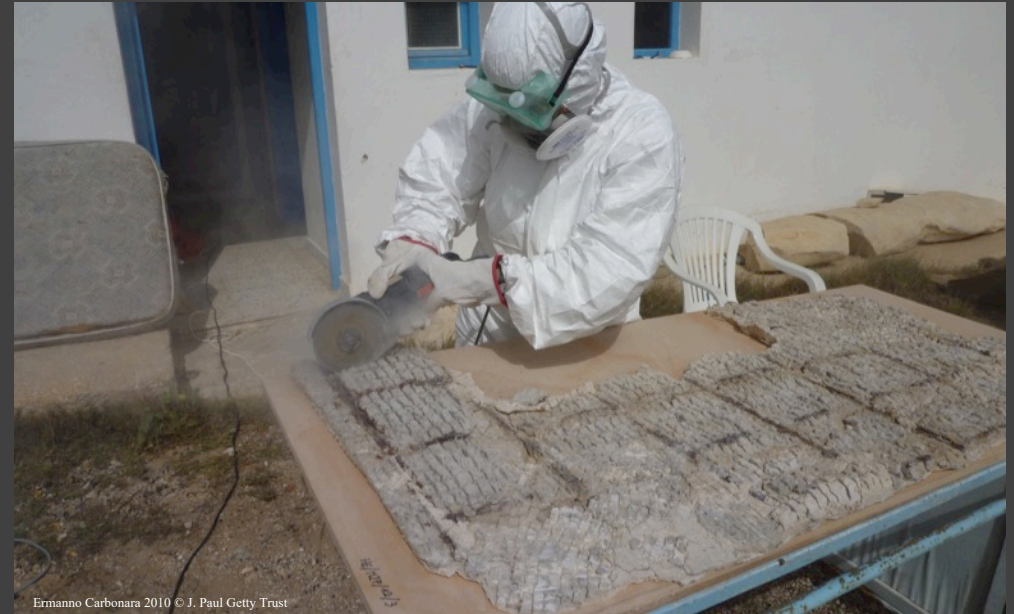
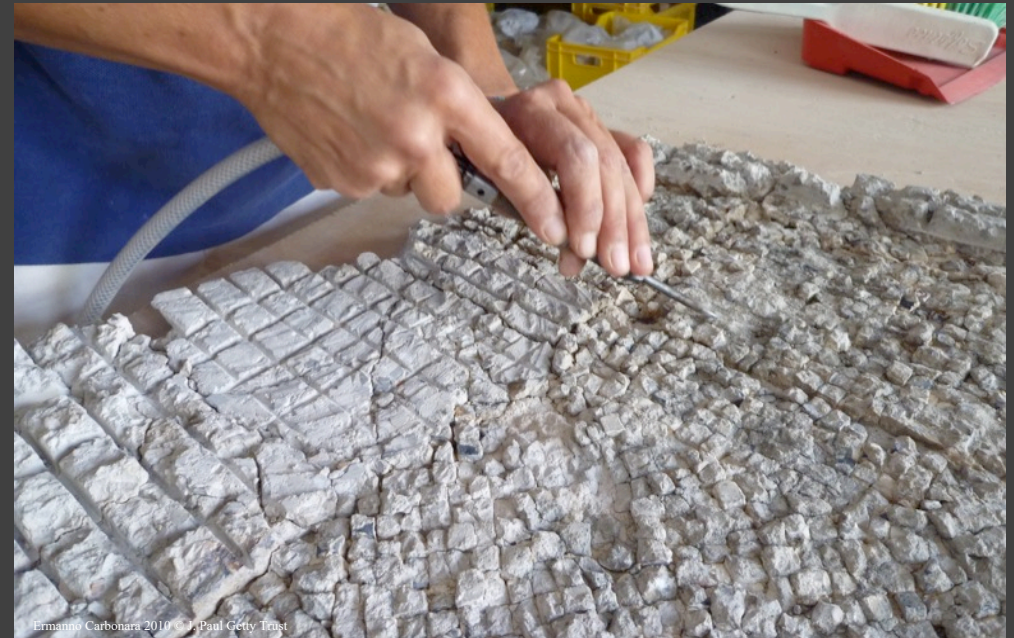
Make close parallel cuts in the panel using a disc grinder.

Remove the concrete ridges left behind by the cuts, using a hammer and chisel.

Clean the back of the tesserae with micro-chisels, micro-engravers, scalpel, etc.

Attach again with an adhesive any detached tesserae to the fabric, if necessary.

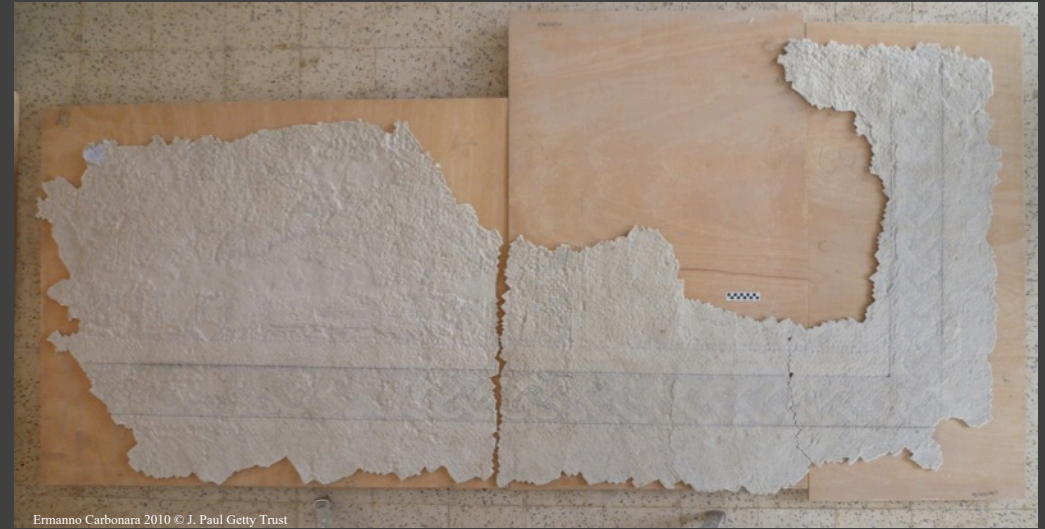
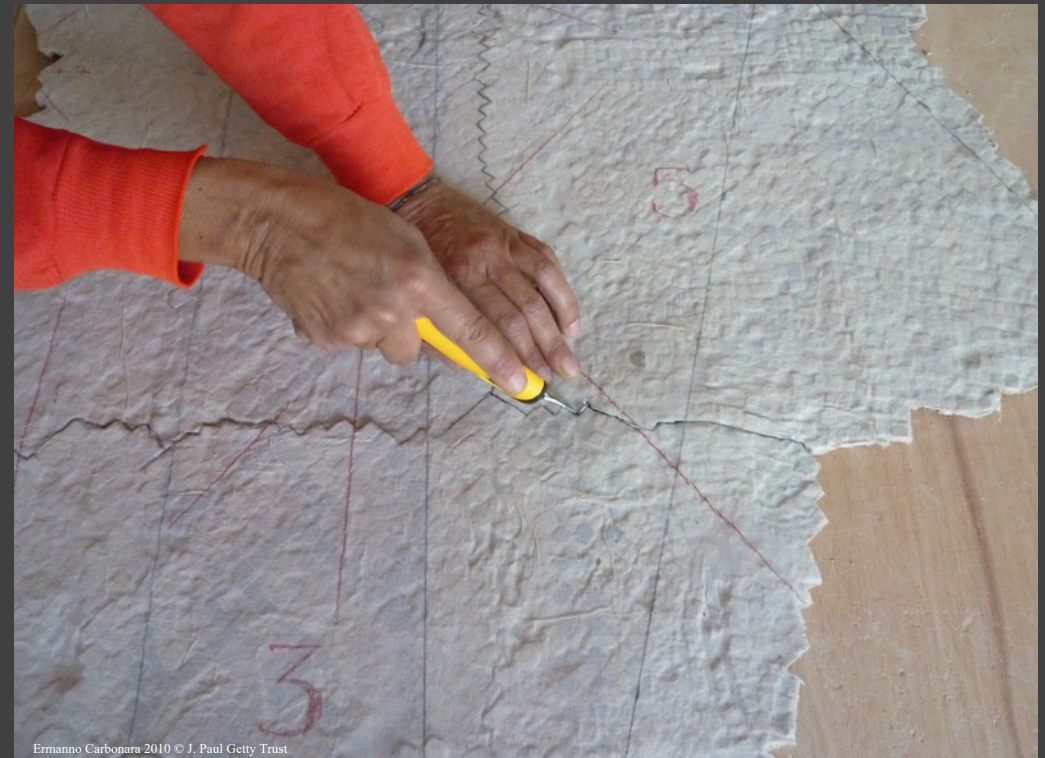
Procedure to follow in the event of minimal panel deformation:

Verify the connection between the sections, correct their position and mark the new reference lines if errors are detected in the alignment from the previous positioning.

Create new section cuts in the mosaic, if necessary.

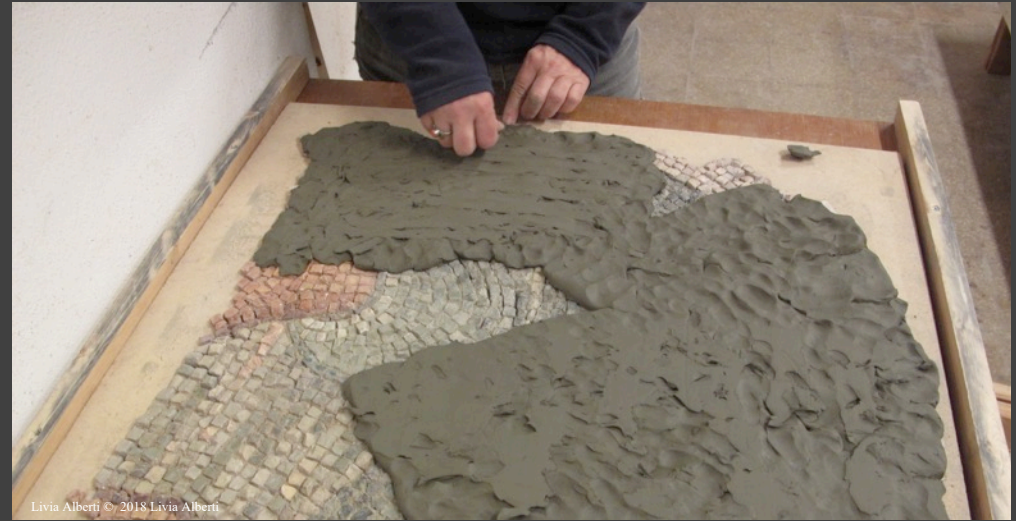
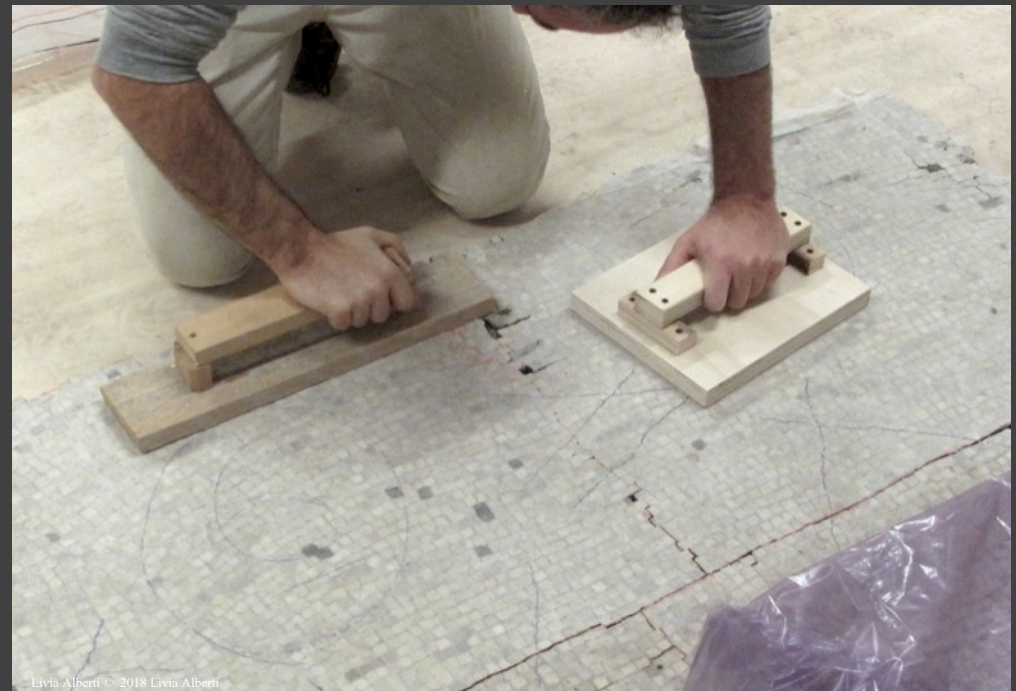
Procedure to follow in the event of significant panel deformation:

Apply a layer of clay to the back of the sections and invert them.

Tap the surface of the mosaic while the layer of clay is fresh to bring the sections together and correct the deformation of the mosaic, referring to the lines and motifs of the mosaic decoration itself.

Dissolve the facing adhesive with an appropriate solvent, depending on the type of adhesive used, and remove the fabric, verifying that the tesserae do not detach from the clay bedding layer.

Apply a new fabric layer (one or more) to the surface of the mosaic using an appropriate adhesive.

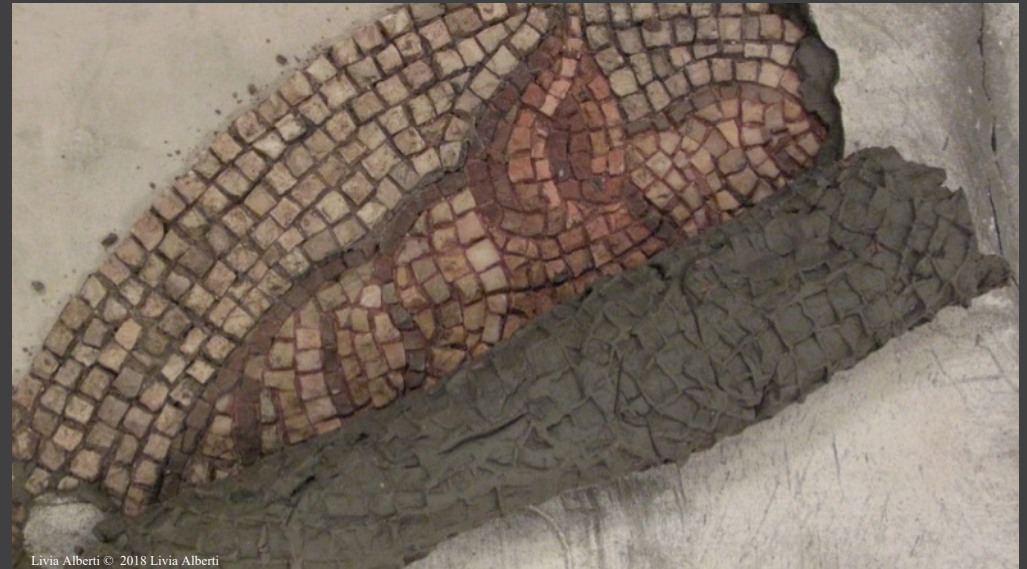
3. Removal of old panel supports

- Removal of reinforced concrete
- Temporary assembly of mosaic sections
- On-site transport of sections

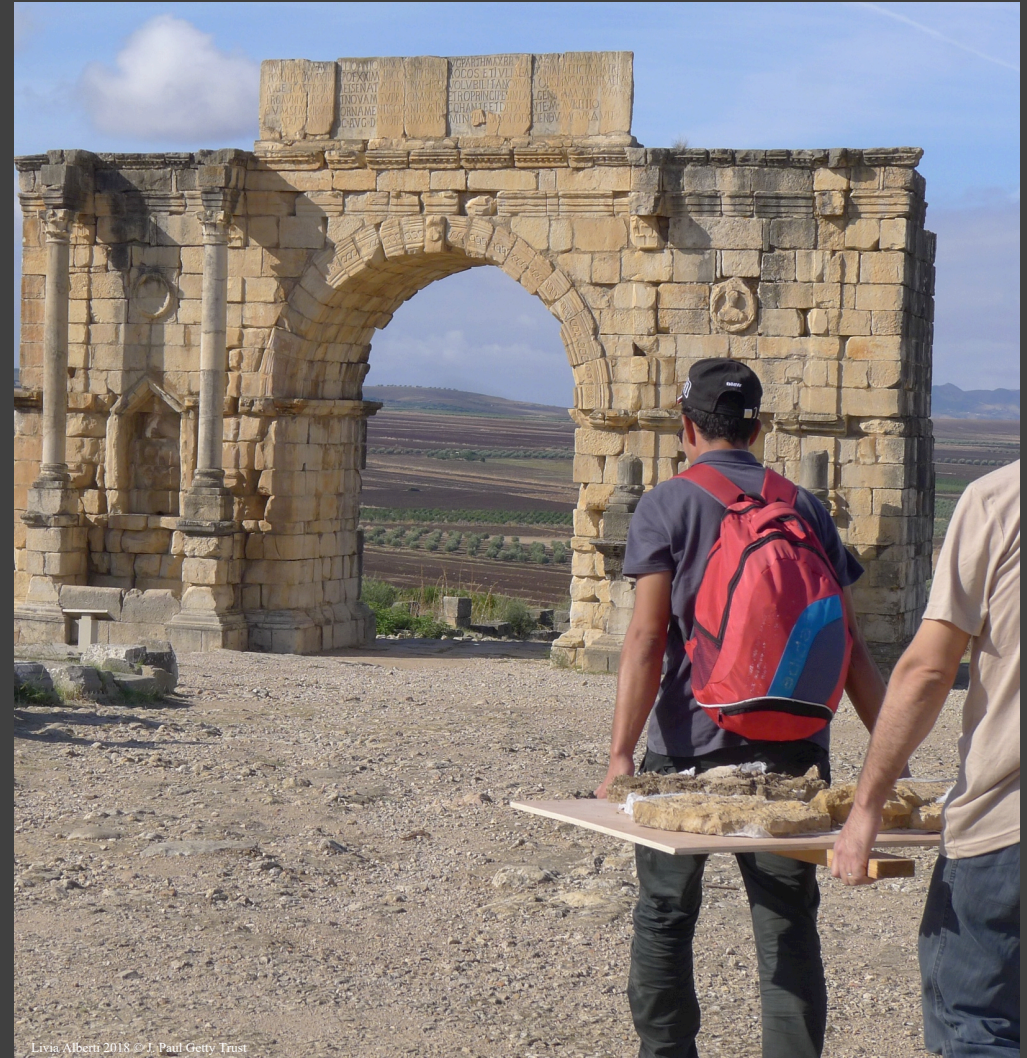
3. Removal of old panel supports

- Removal of reinforced concrete
- Temporary assembly of mosaic sections
- On-site transport of sections

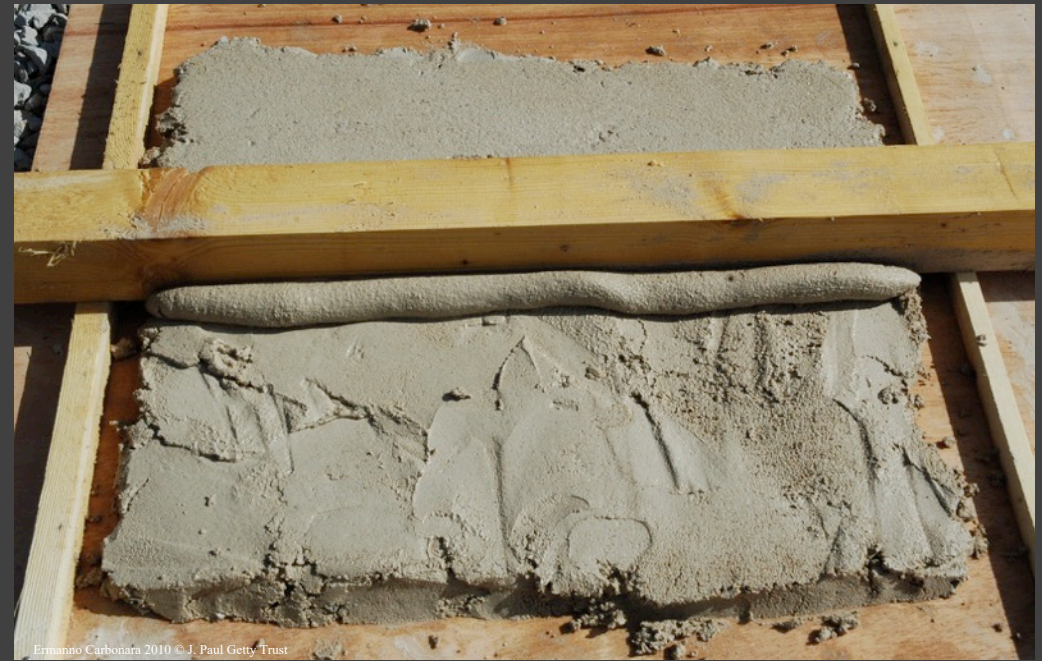
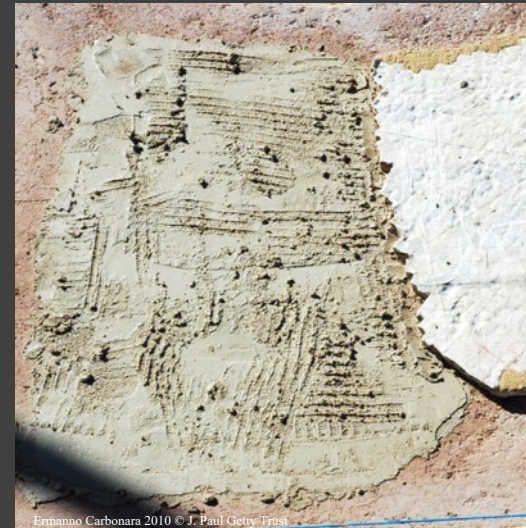
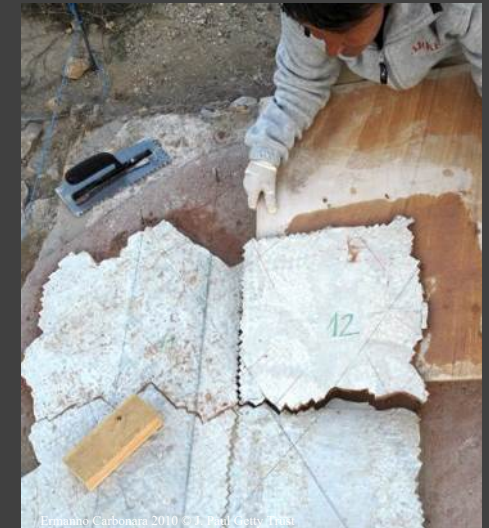
Apply the lime-based mortar on the tesserae and the section reinstallation area.

Reposition the sections one at a time by sliding them onto the mortar beds that are still freshly applied to the section reinstallation area.

Verify the position of the sections using the reference lines between the various sections and the reference systems previously set up around the mosaic.

Tap the surface of the mosaic while the mortar is still soft to bring the sections together and correct deformations, if necessary.

Apply weight to the surface of the mosaic while the mortar is setting.

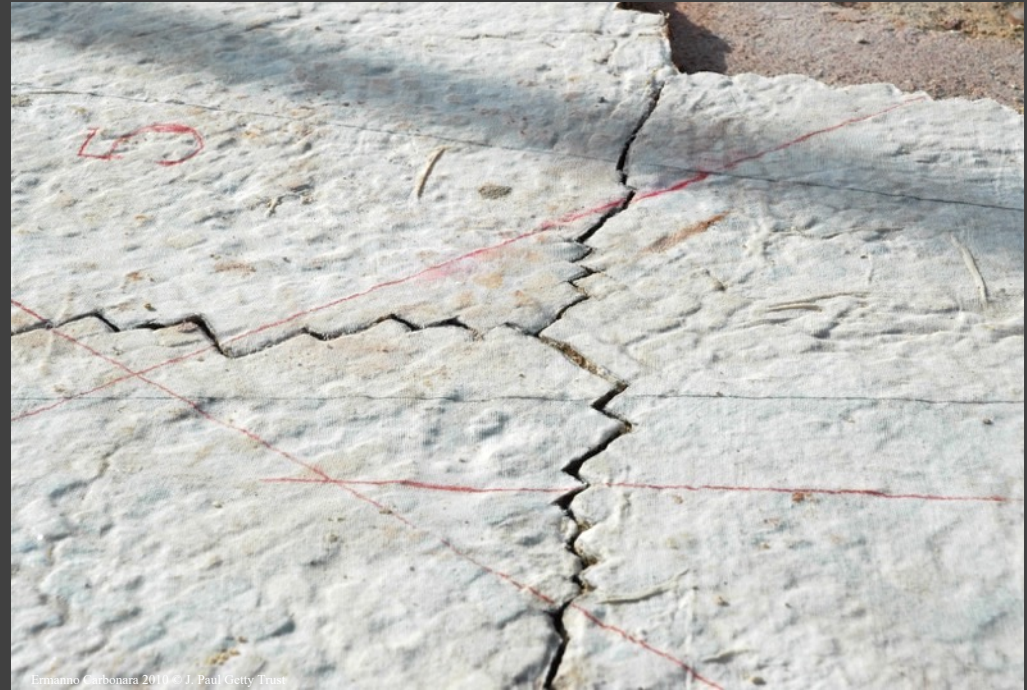
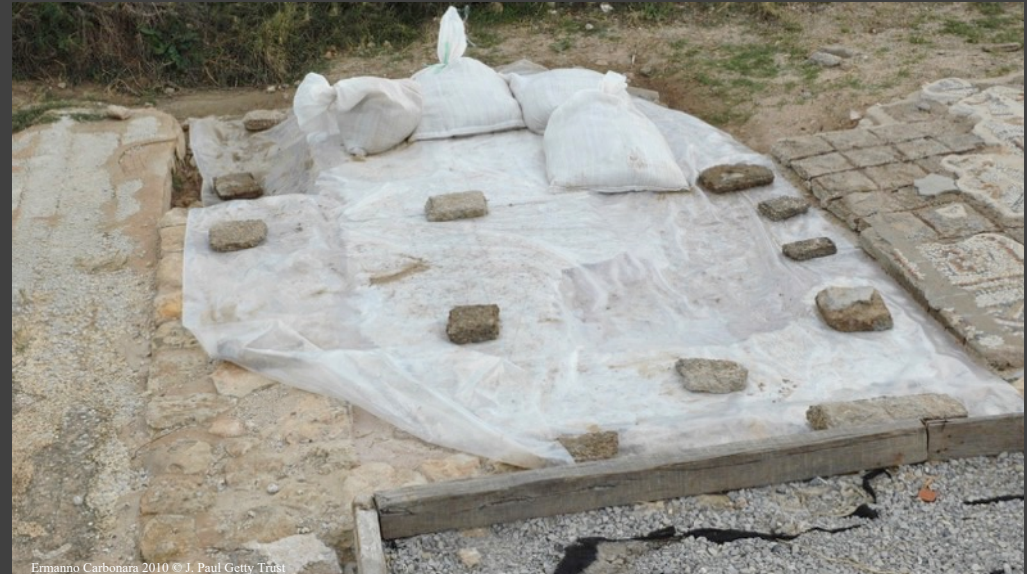
4. Reinstallation and presentation of the mosaic

- On-site reinstallation of mosaic sections
- Removing the fabric and cleaning the adhesive
- Stabilization of the tessellatum

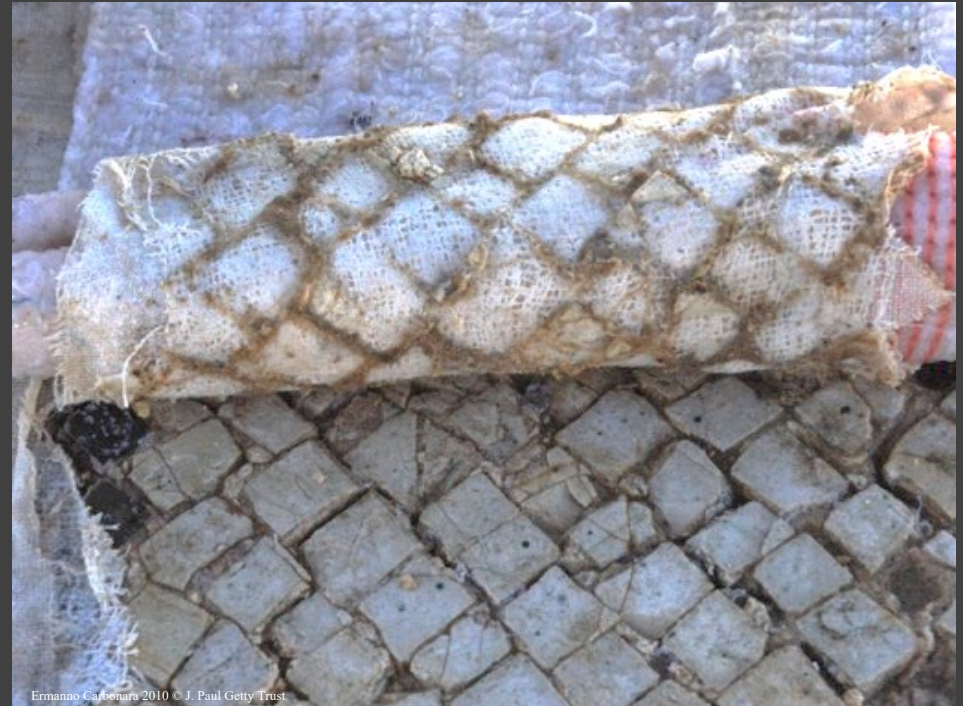
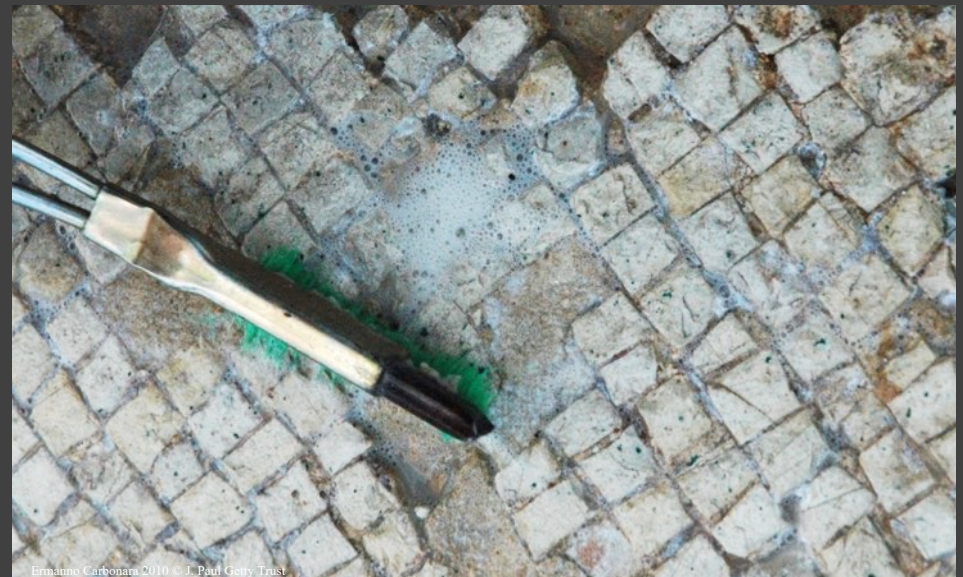
Dissolve the adhesive with an appropriate solvent, depending on the type of adhesive used.

Remove the fabric one small area at a time, verifying that the tesserae do not detach from the bedding layer.
