TECHNICIAN TRAINING FOR THE CONSERVATION OF MOSAICS

PART 2
THE CONSERVATION OF DETACHED MOSAICS

Mosaics detached and relaid in situ on
reinforced concrete:
their reinstallation in situ and documentation

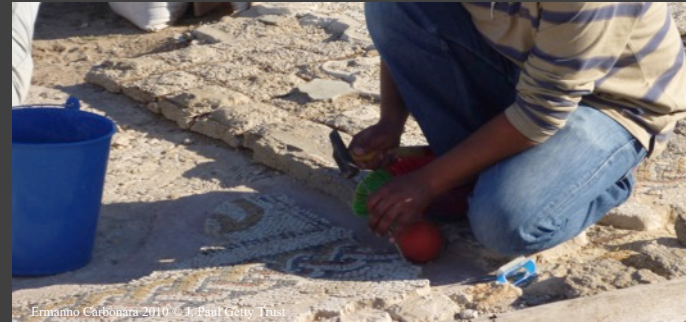
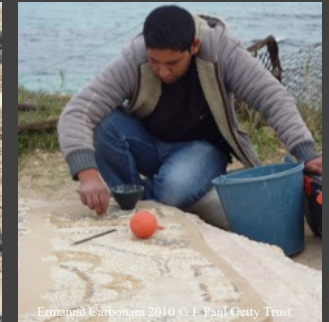
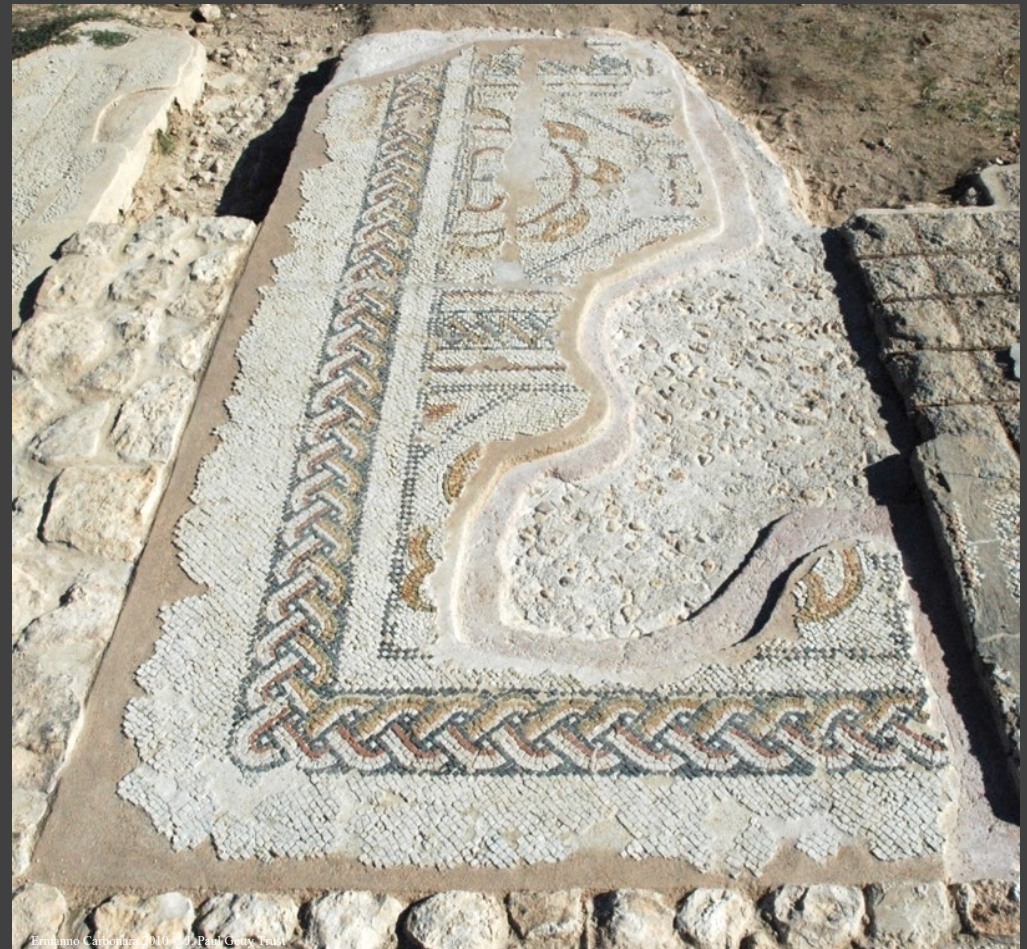
4. Reinstallation and presentation of the mosaic

- On-site reinstallation of mosaic sections
- Removing the fabric and cleaning the adhesive
- Stabilization of the tessellatum

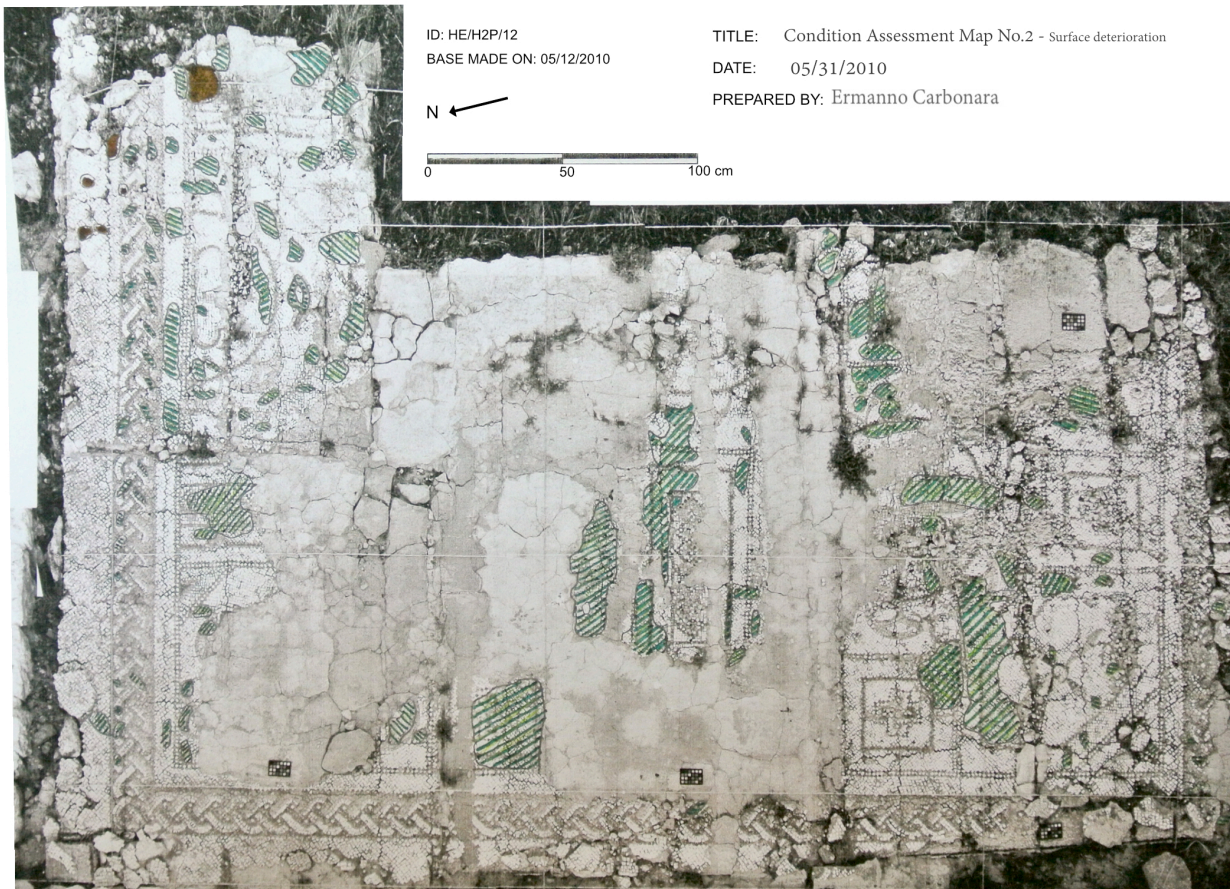
LEGEND - CONDITION ASSESSMENT MAP NO. 2

Deteriorated tesserae
-

Deteriorated mortar between tesserae
-

Stains
-

TITLE: Condition Assessment Map No.2 - Surface deterioration
