TECHNICIAN TRAINING FOR THE CONSERVATION OF MOSAICS

PART 1
THE CONSERVATION OF IN SITU MOSAICS

Deterioration of mosaics

Livia Alberti, Ermanno Carbonara, Thomas Roby

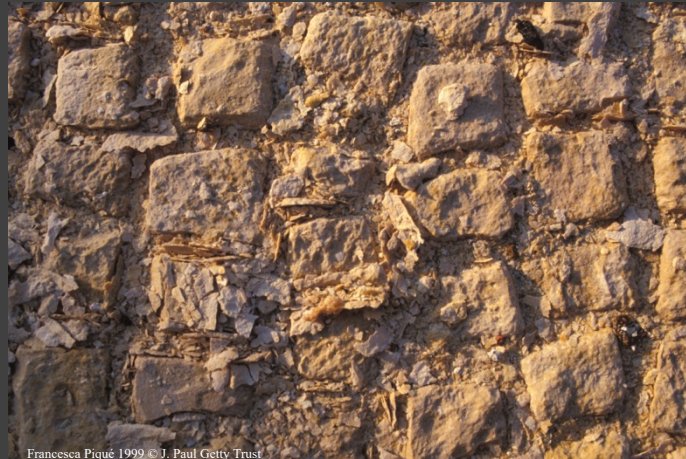
Damaged Tesserae

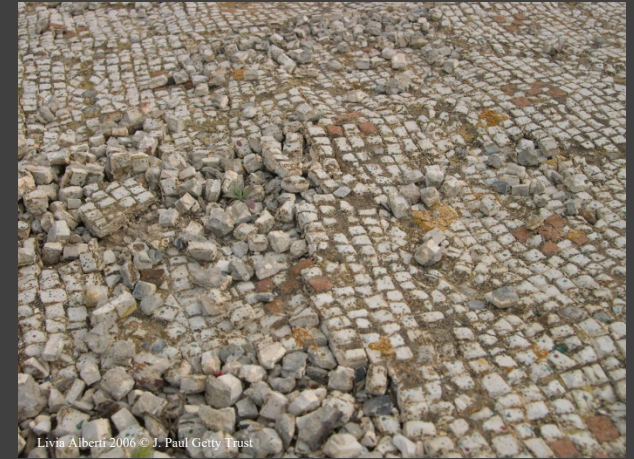
Bulges, Detachments, Cracks, Lacunae, Detached Tesserae

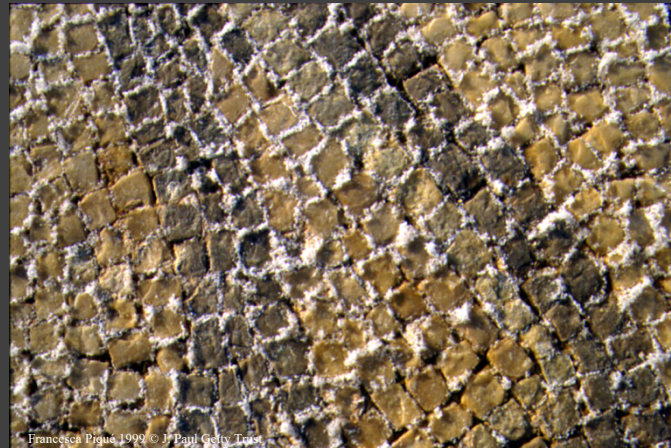
Efflorescence

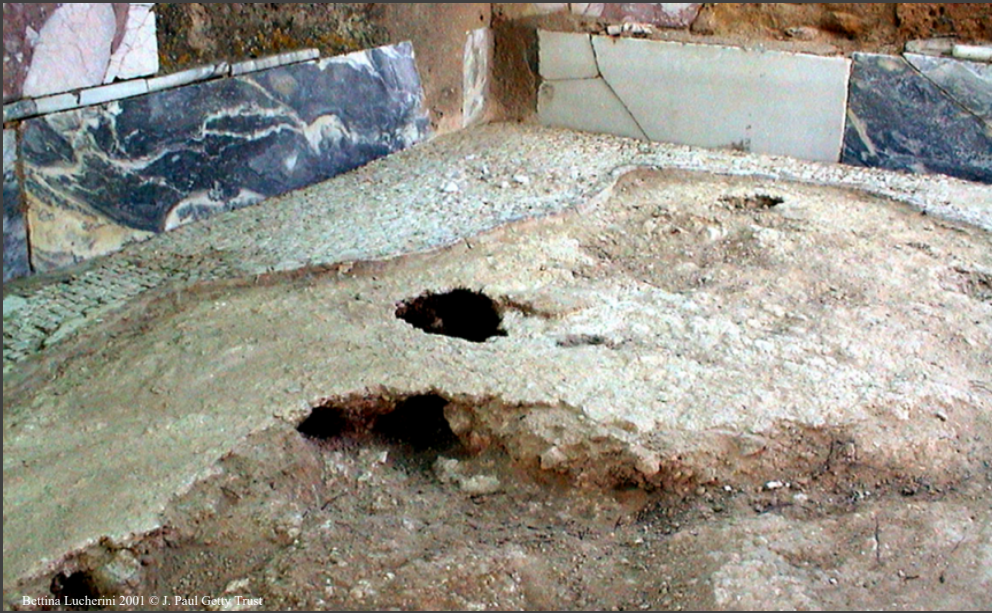
Bird excrement

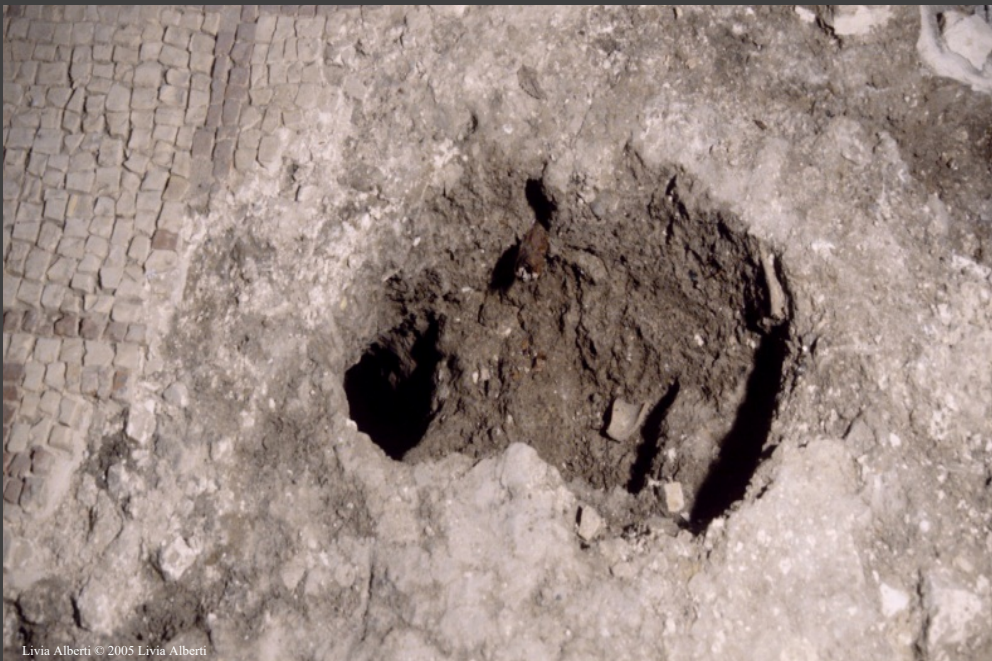
Tunnels and entrance holes made by animals

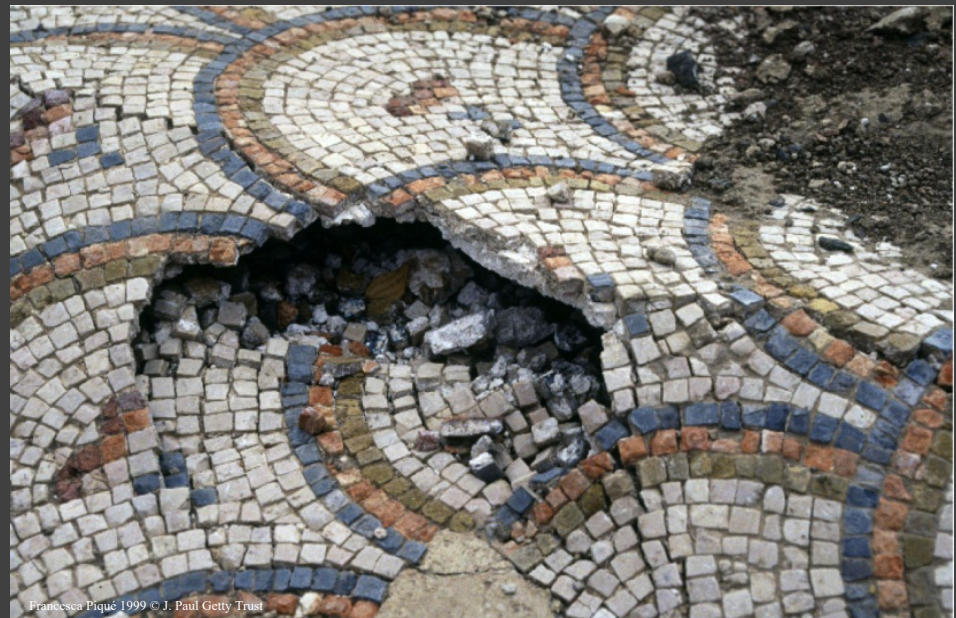
Bulges, Detachments, Cracks, Lacunae, Detached Tesserae

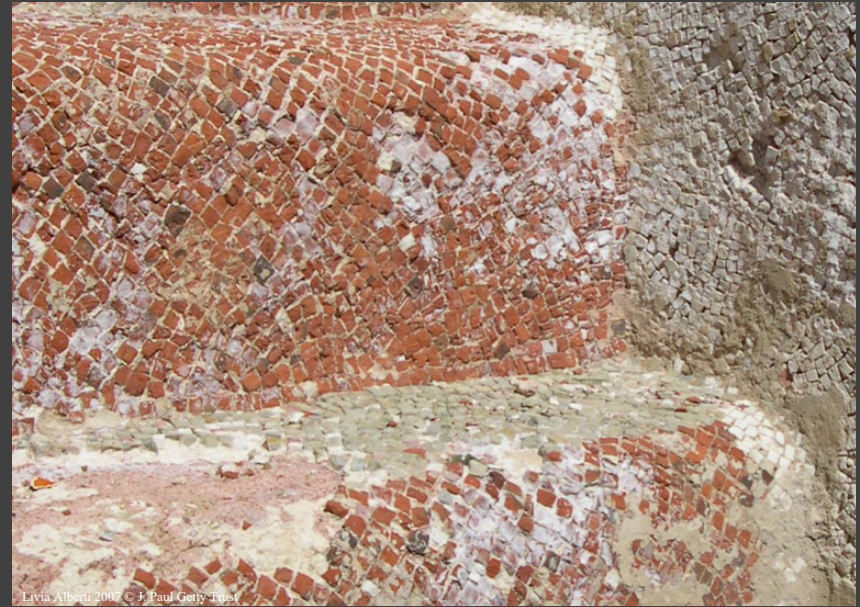
Efflorescence, Damaged tesserae

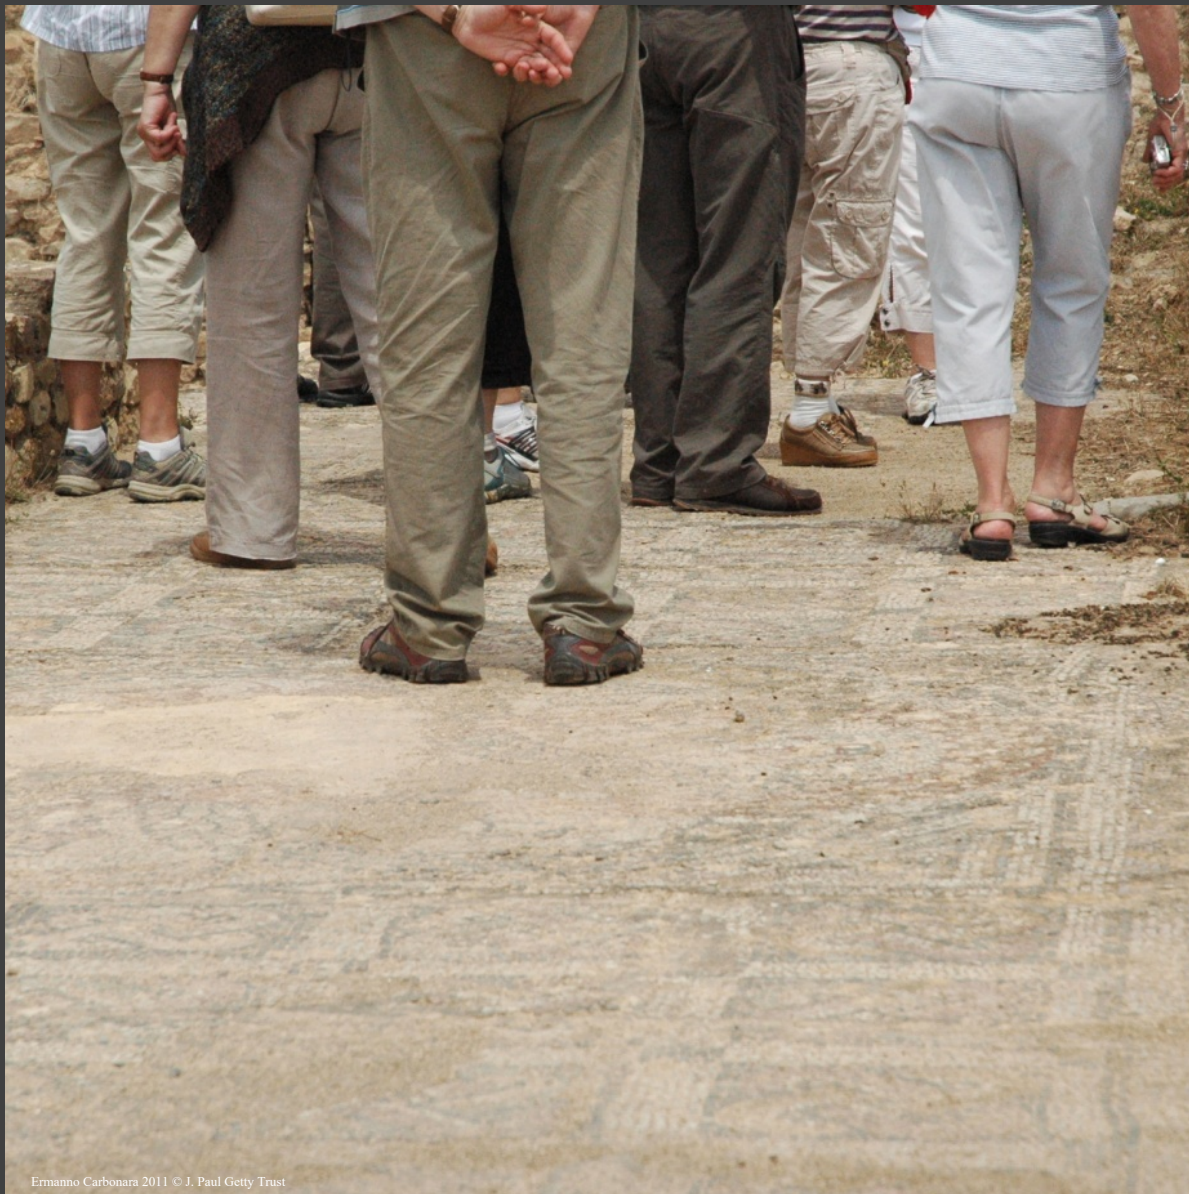
Foot traffic

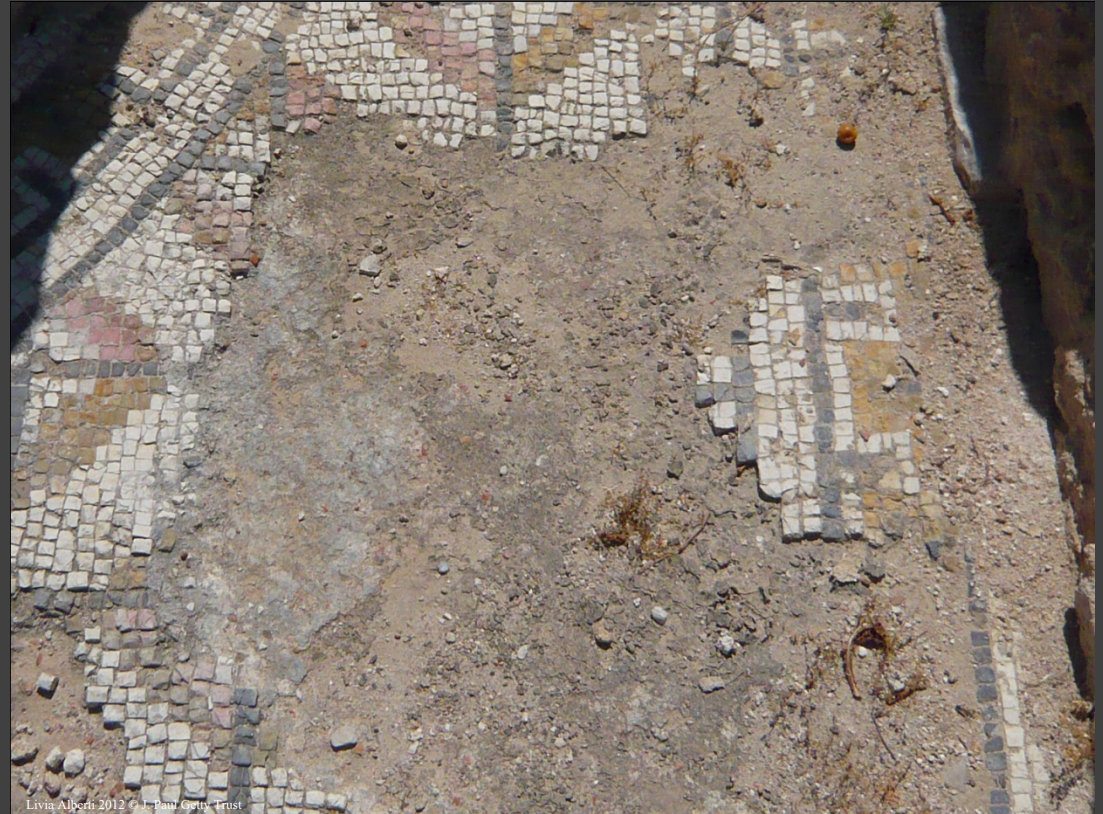
Tessellatum lacunae

Part of a mosaic where the tesserae layer has been lost.

Different levels of lacunae in a mosaic

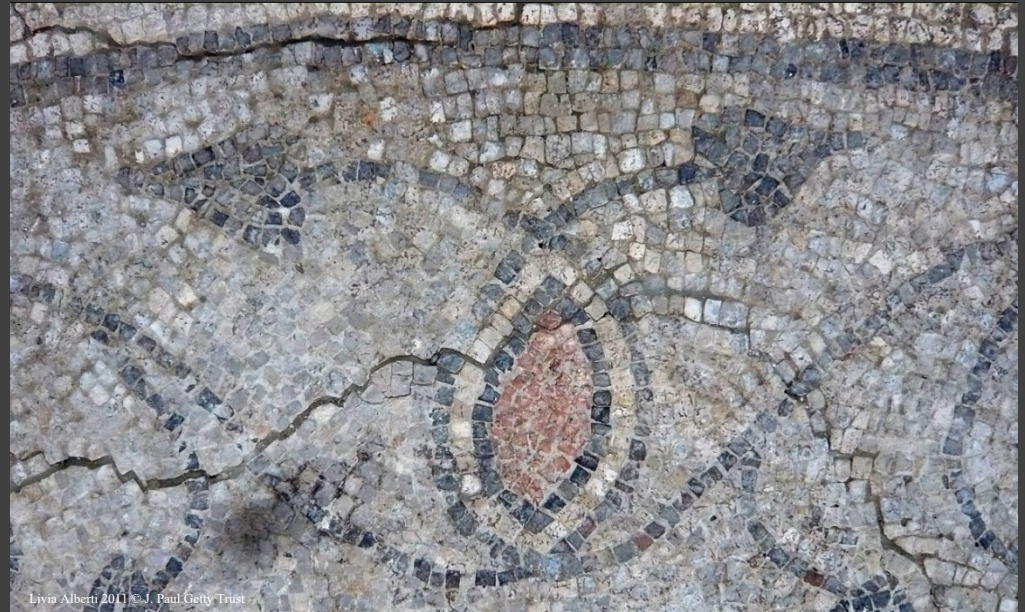
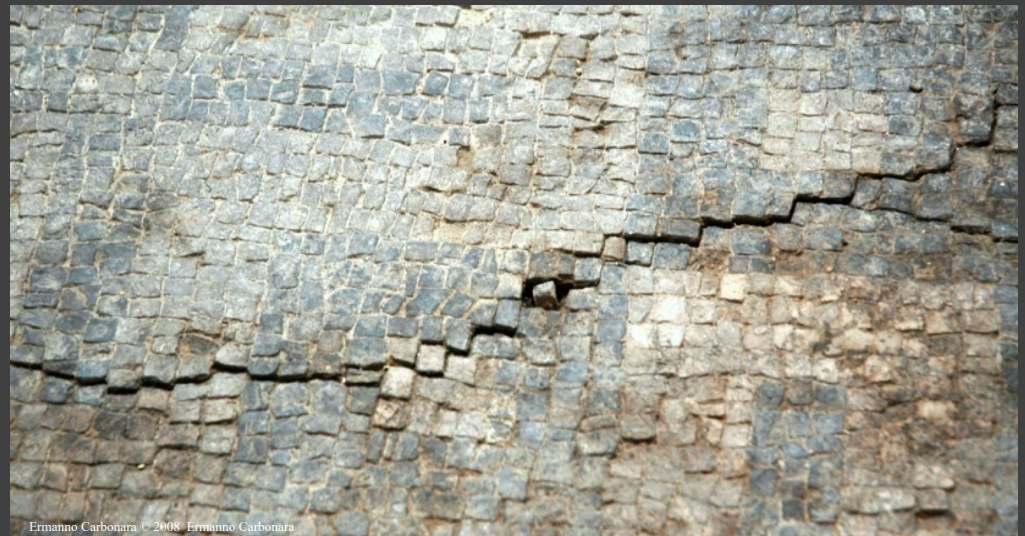
Cracks

Linear fissure visible on the surface of the mosaic that could also continue into the bedding layers.

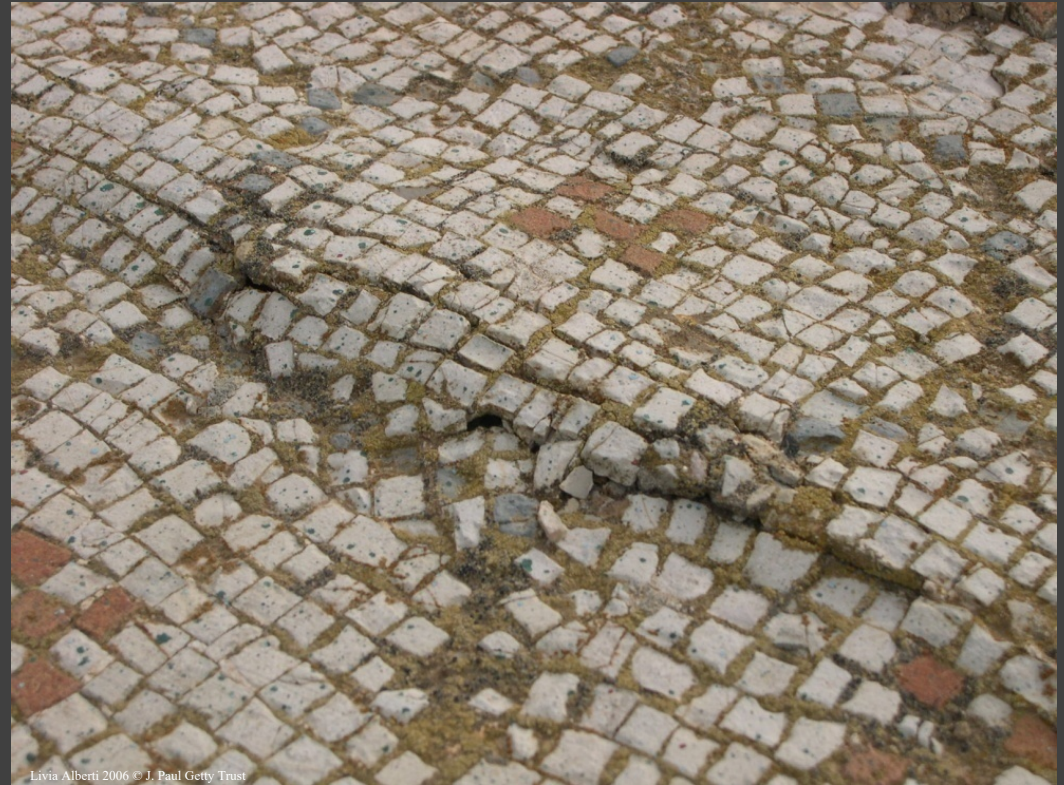
Bulges

An upward deformation of the mosaic above its original surface level.

Bulge with detachment

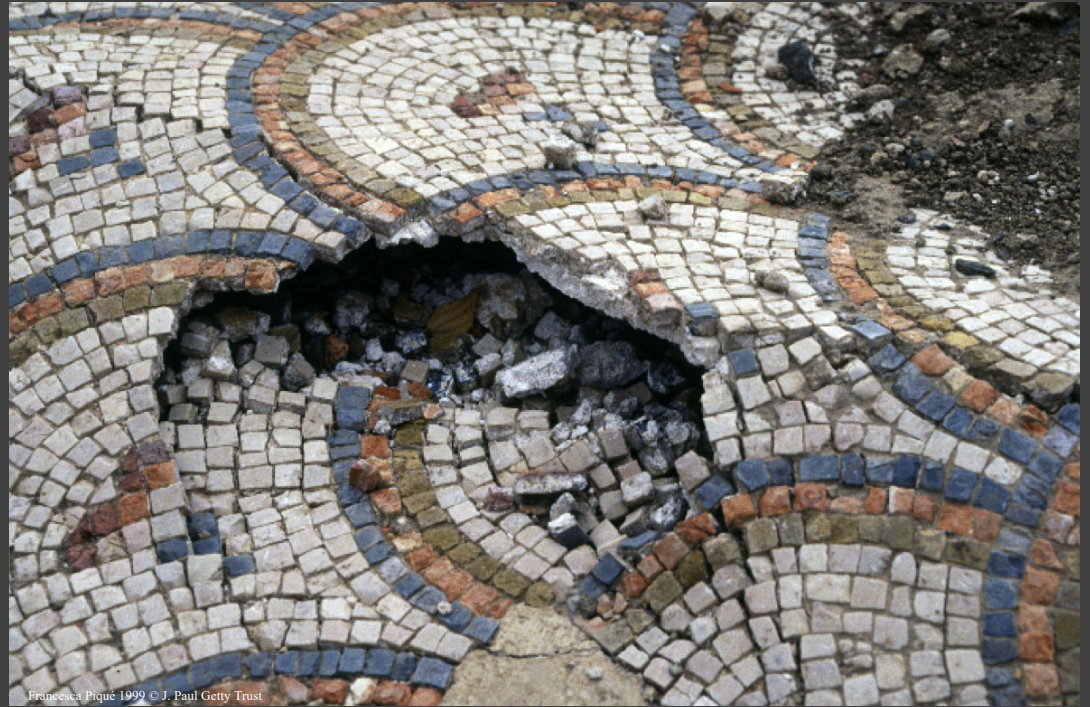
Detachments between mosaic layers

Separation or void between two layers of the mosaic. A detachment is generally not visible and can be detected by the corresponding hollow sound produced when it is tapped.

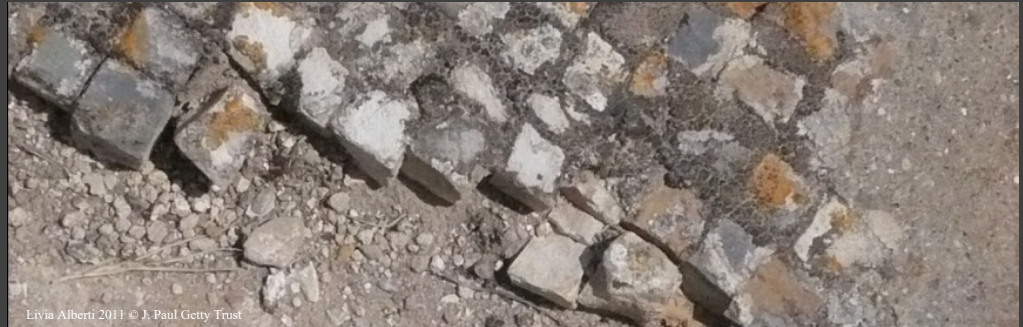
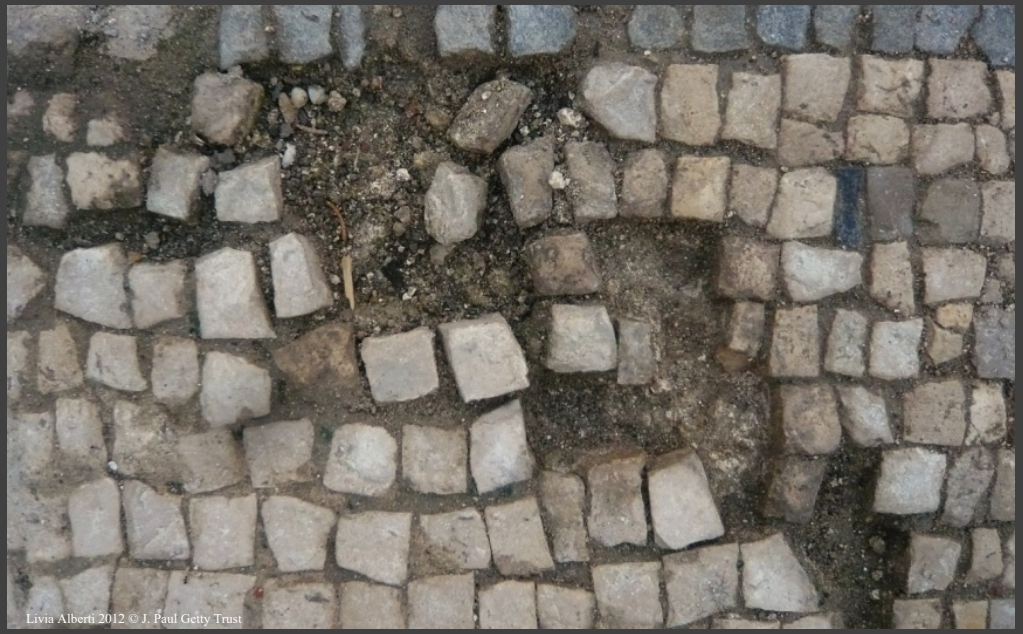
Detached tesserae

Tessera that is still in its original place but no longer adheres to the bedding layer and therefore moves when lightly touched.

Tesserae detached from bedding layer with change of position (center)

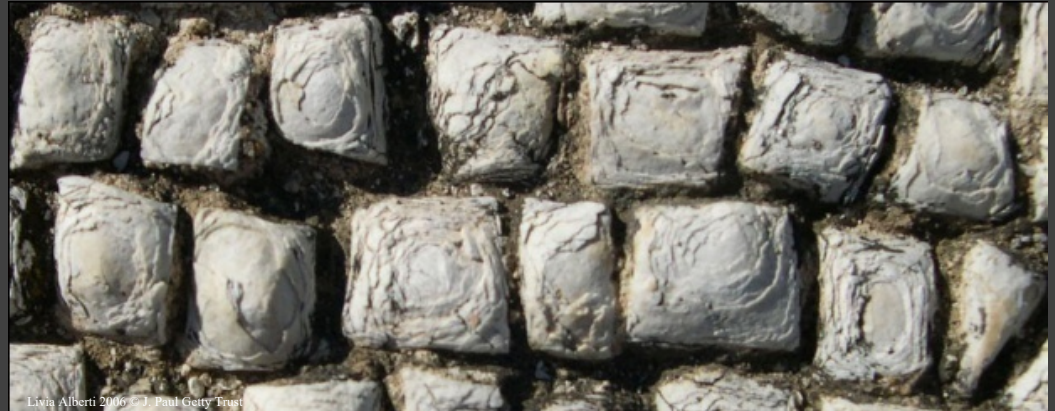
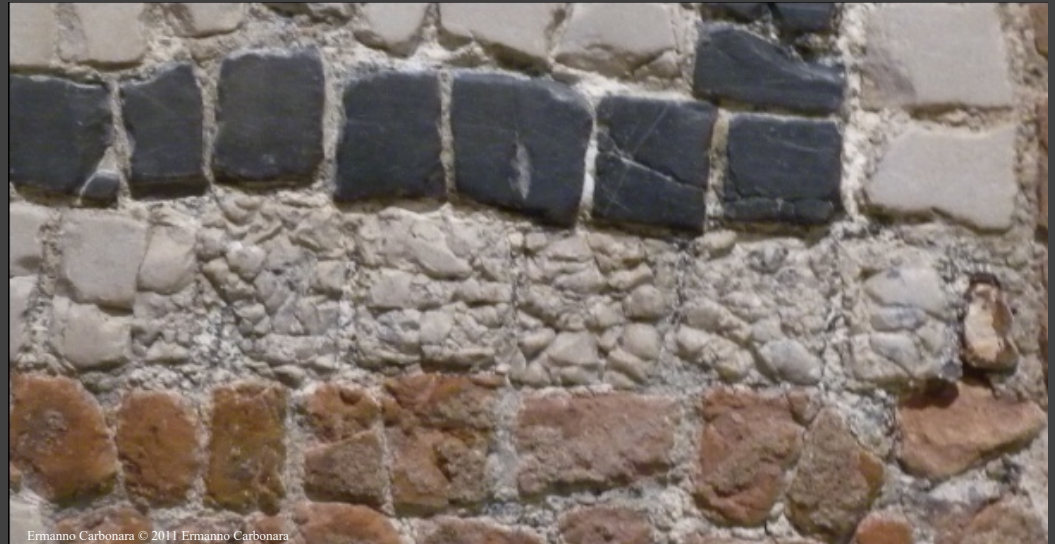
Deteriorated tesserae

Tesserae that are no longer in good condition. Damaged tesserae can be cracked, eroded, delaminated or show other types of damage or loss.

Disaggregation of tesserae

Delamination of tesserae

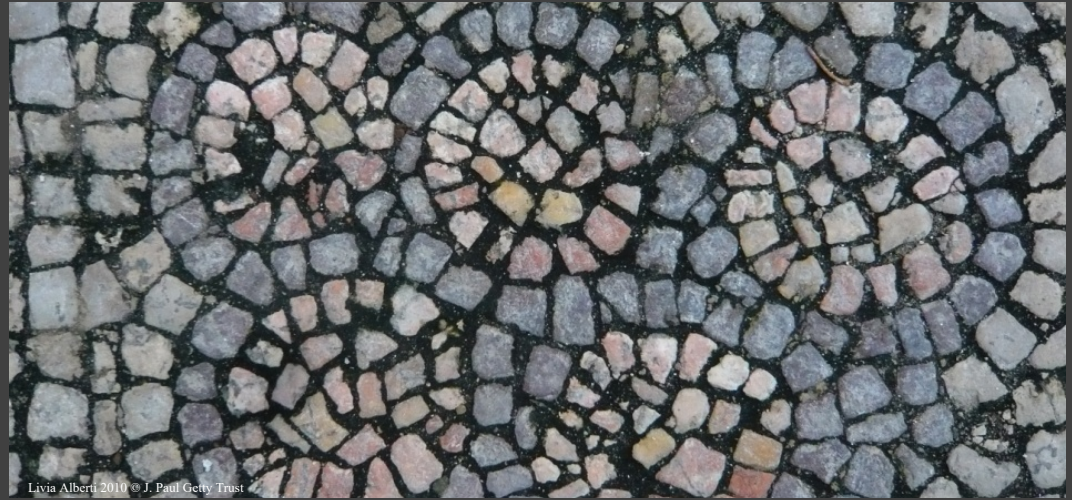
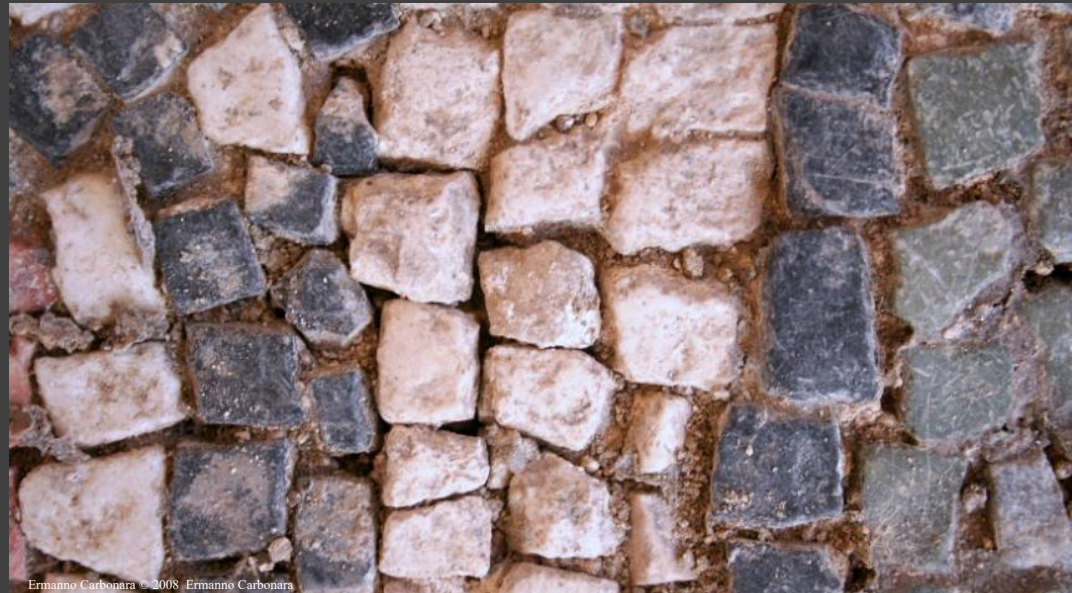
Deteriorated mortar between tesserae

Mortar located in the interstices between the tesserae that is lost or no longer in good condition.

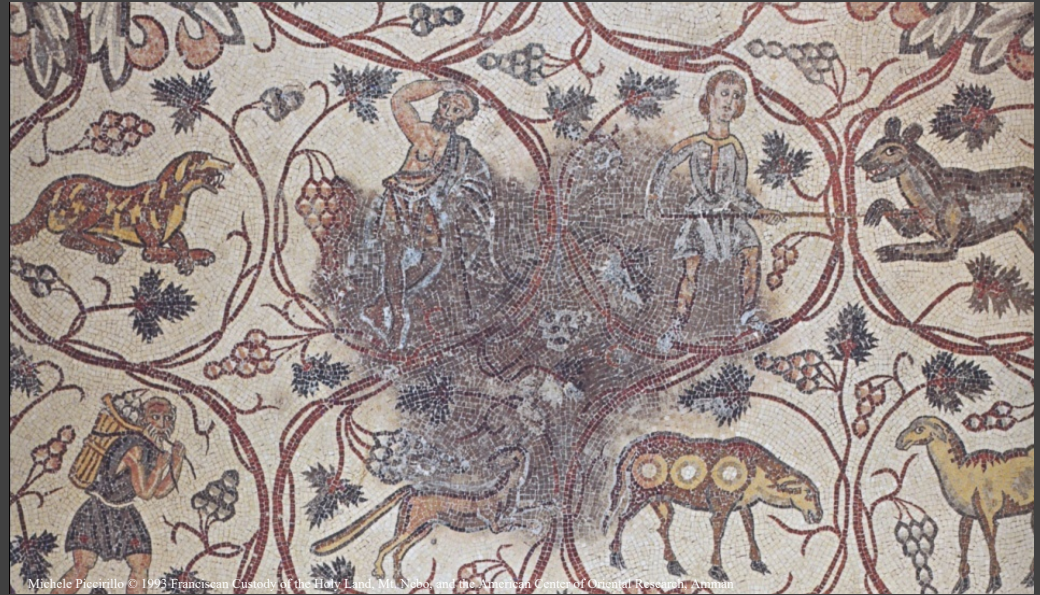
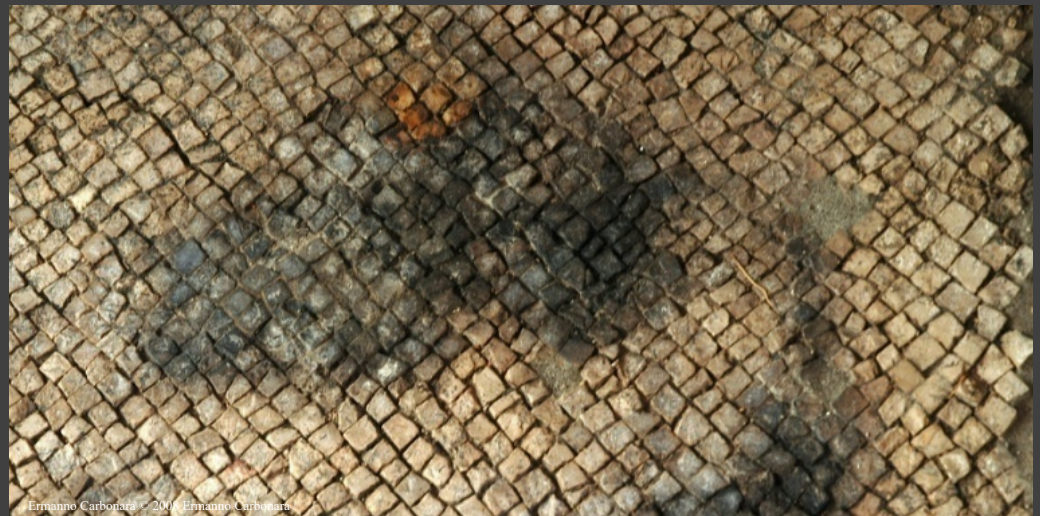
Stains

Localized changes in color of the mosaic surface.

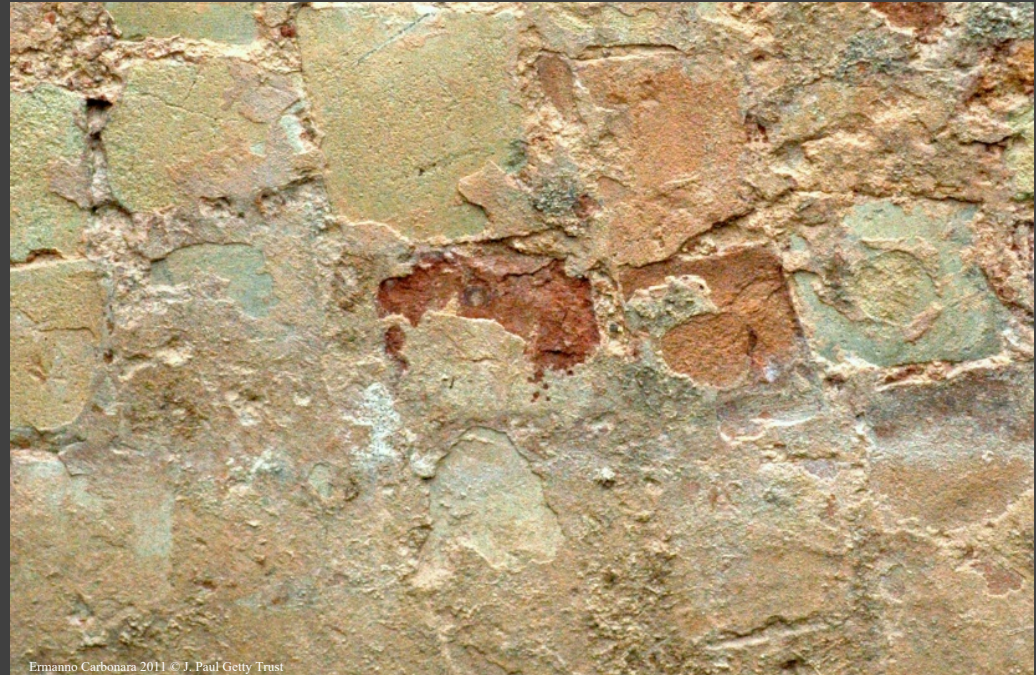
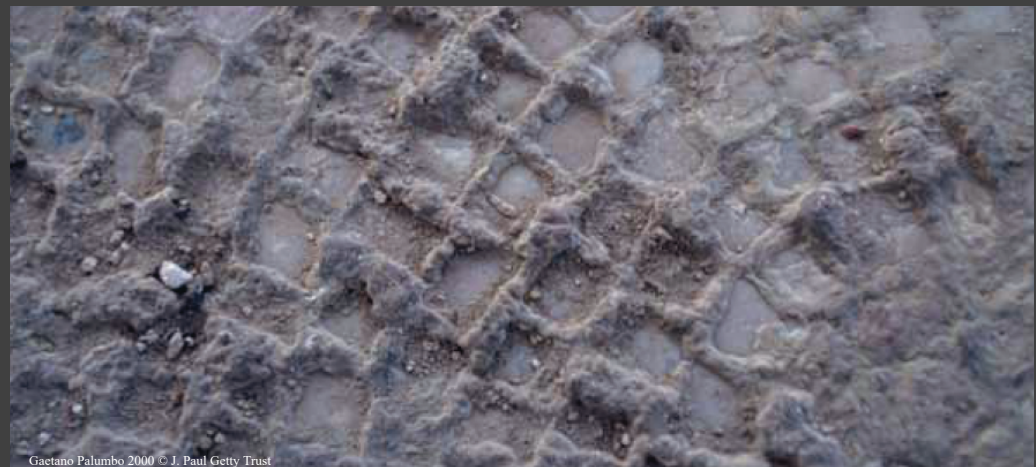
Incrustations

Mineral crust of variable thickness and area that is often hard and compact, located on the surface of the mosaic.

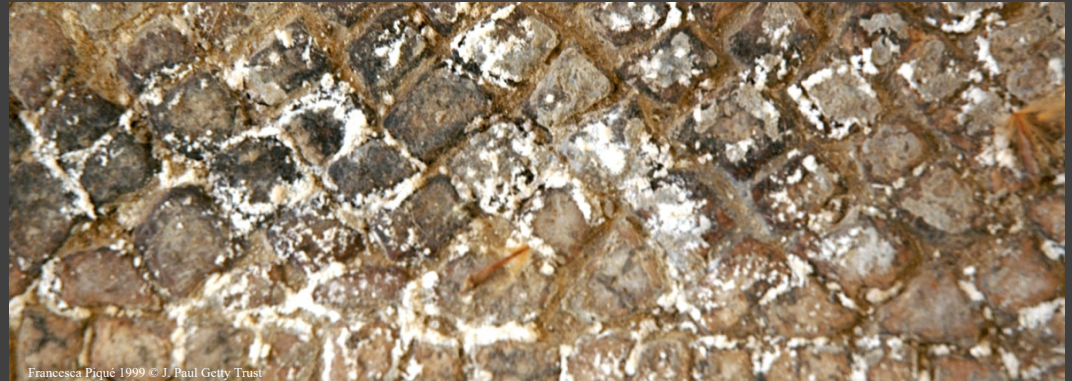
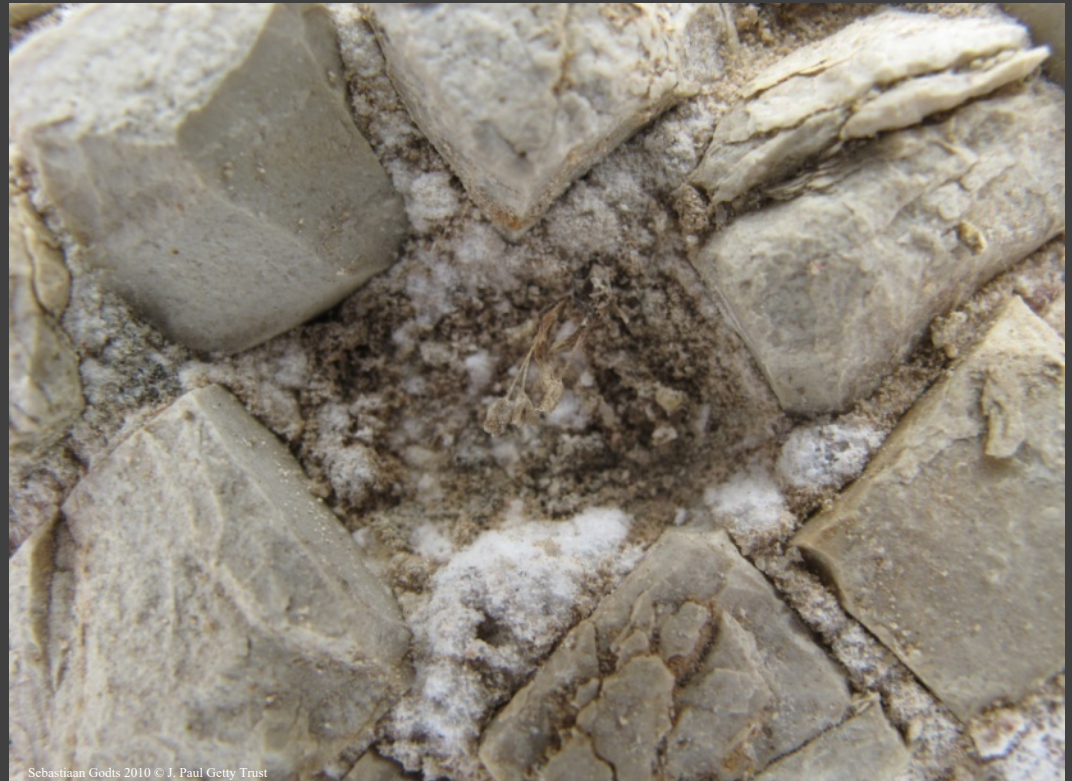
Efflorescence

Generally a white and crystalline substance, which adheres loosely to the mosaic surface, and is powder-like in appearance.

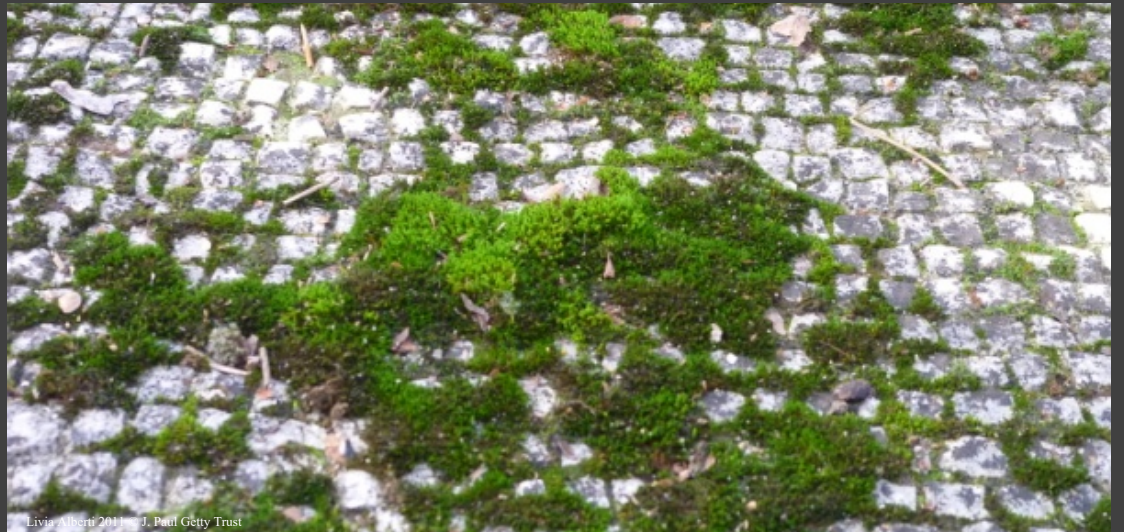
Lichens

Mosses

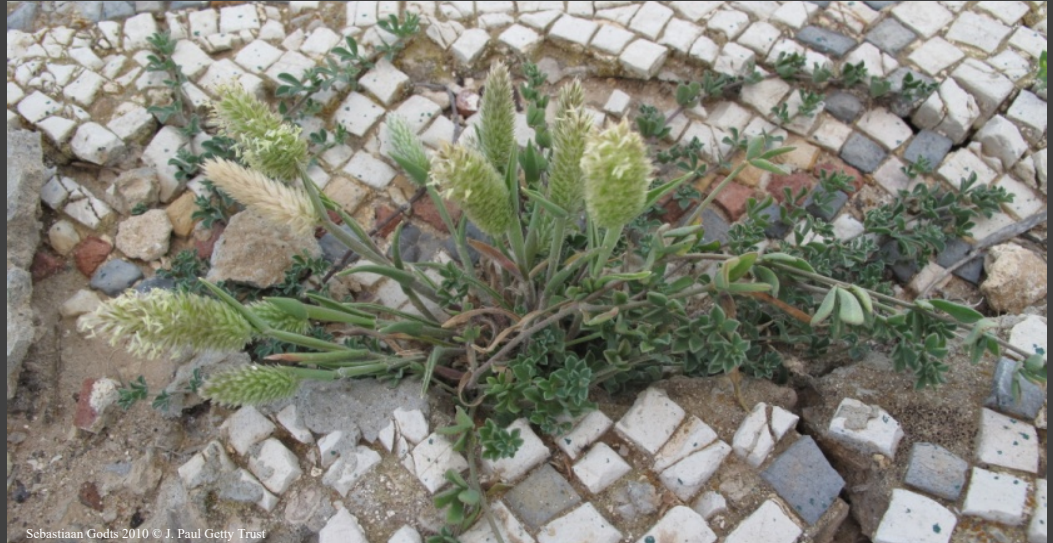
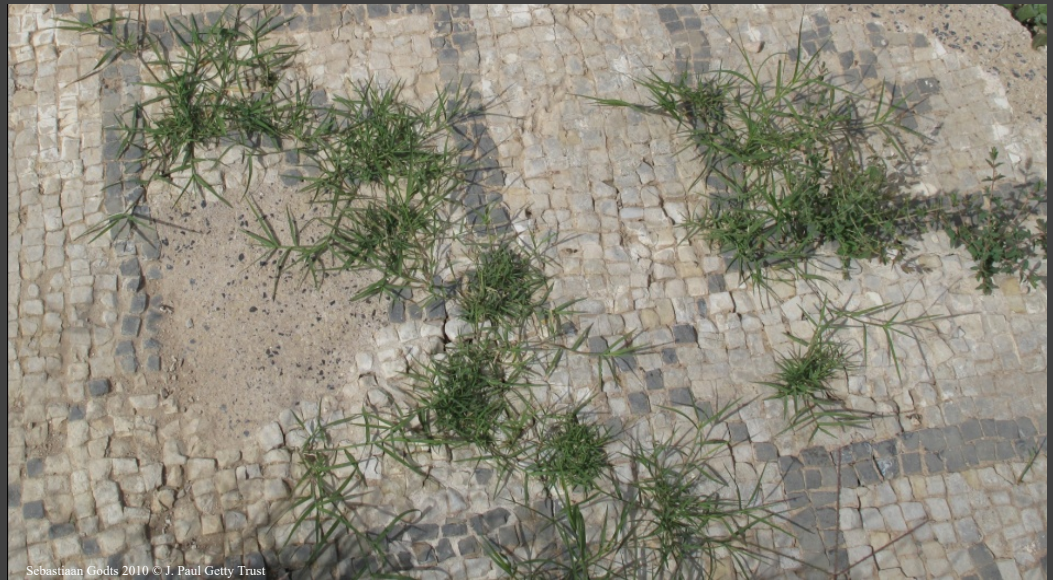
Vegetation

Plants such as grasses, weeds, bushes, as well as trees and their associated roots growing under, inside, or on top of the mosaic.

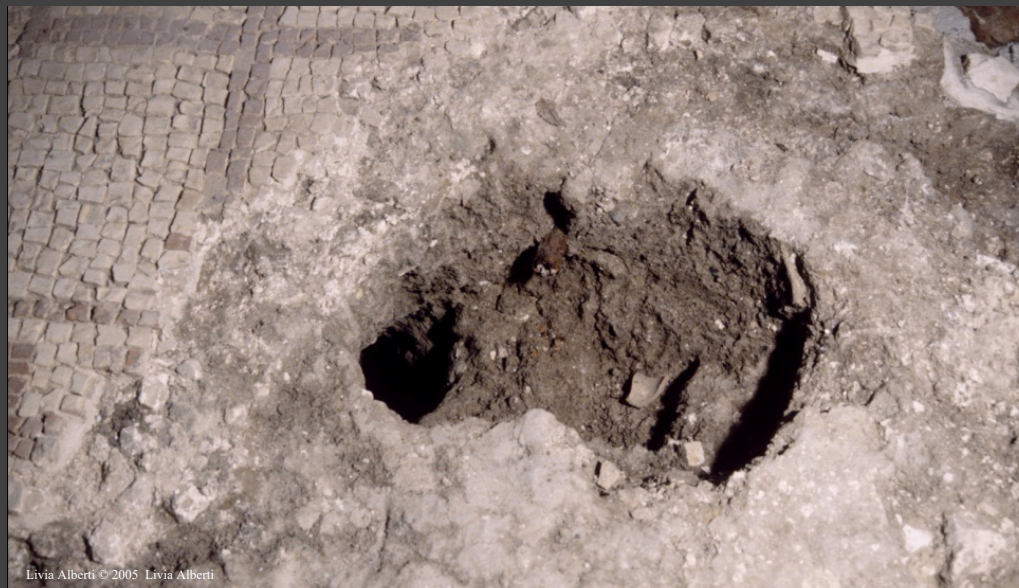
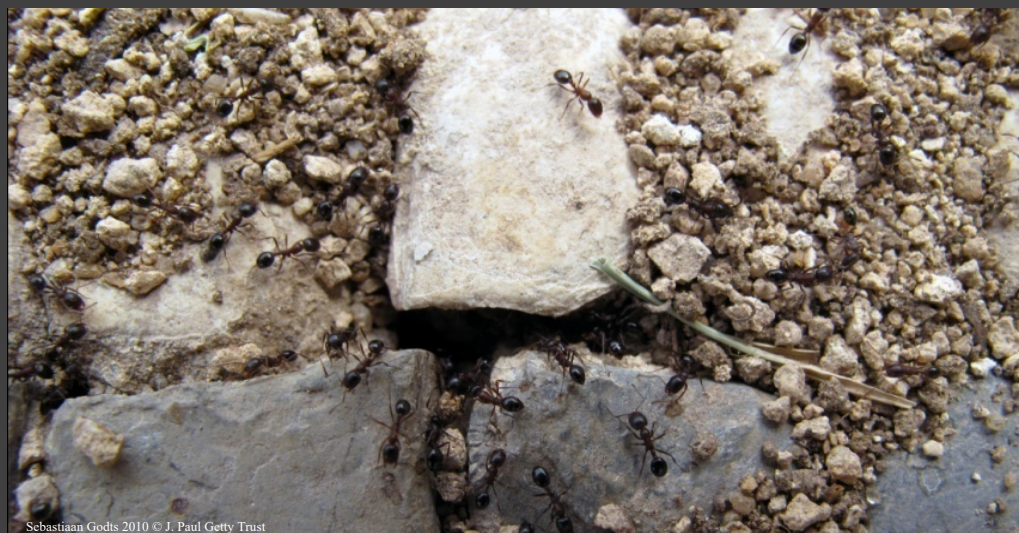
Tunnels or entrance holes made by insects or other animals

An area of the mosaic where insects or other animals have burrowed.

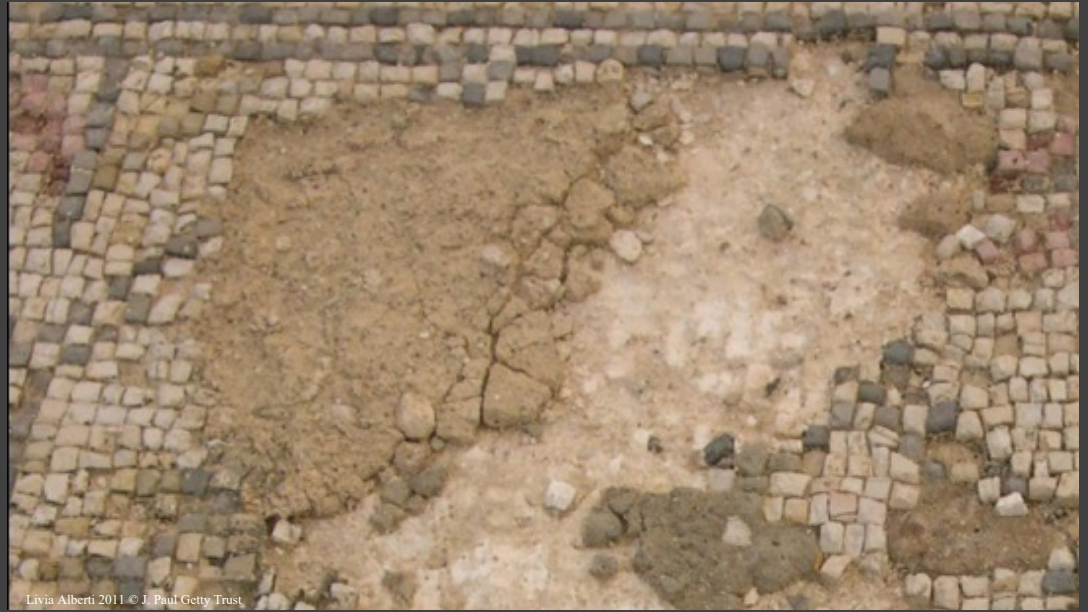
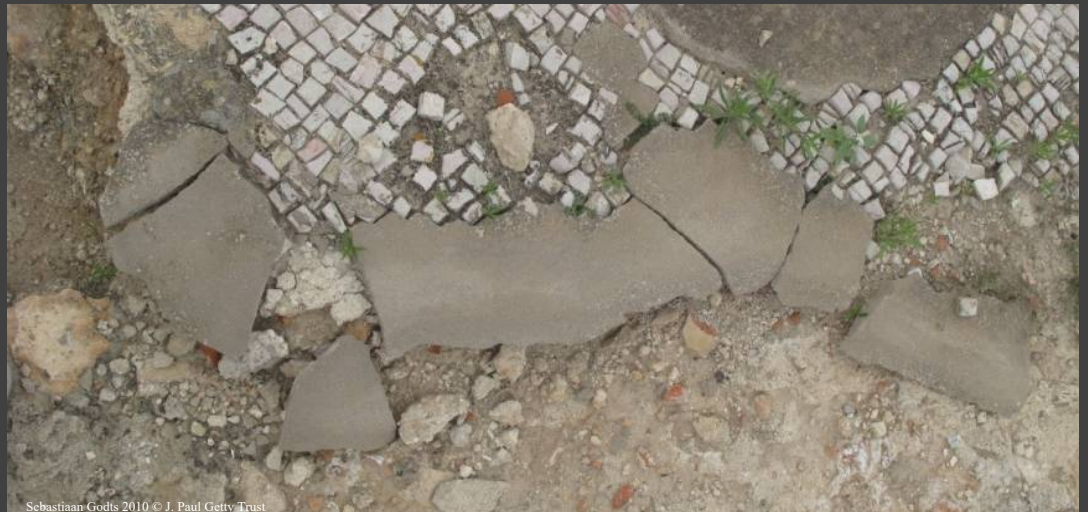
Deteriorated lacunae fills or edging repairs

Lacuna fill or edging repair between tesserae in poor condition, presenting cracks, erosion or other types of damage.

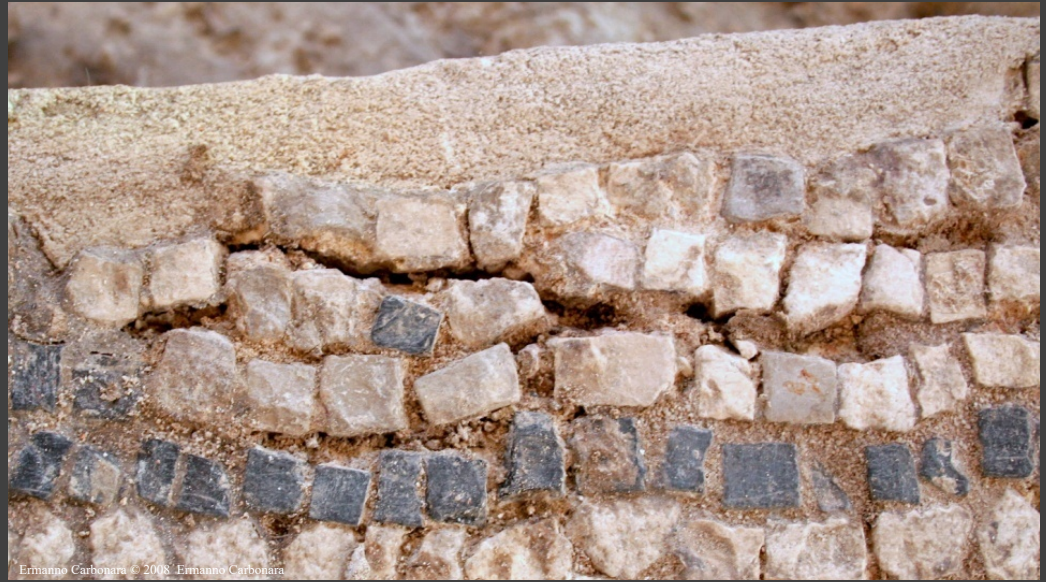
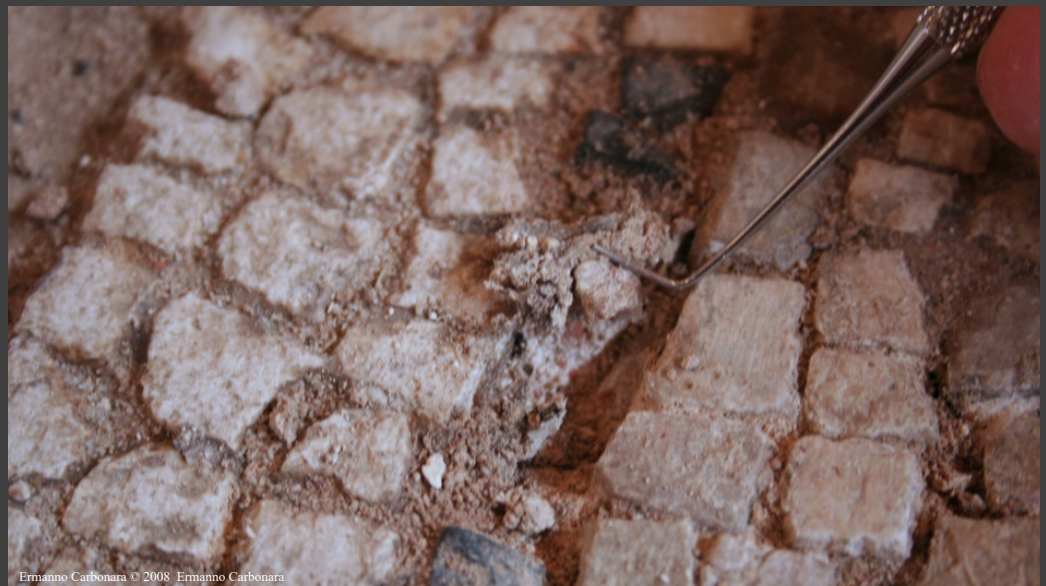
Deteriorated mortar between tesserae

Mortar fill between tesserae in poor condition, presenting cracks, erosion, or other types of damage.

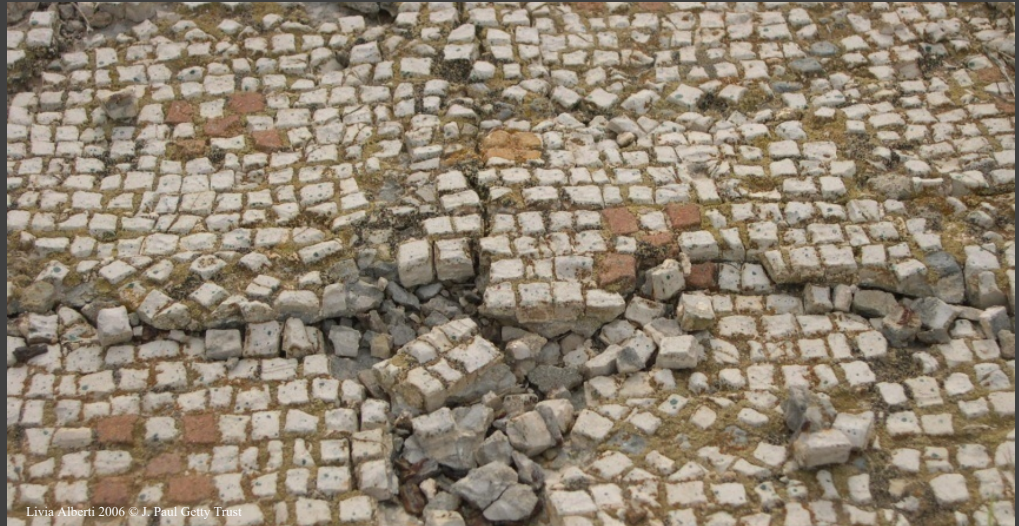
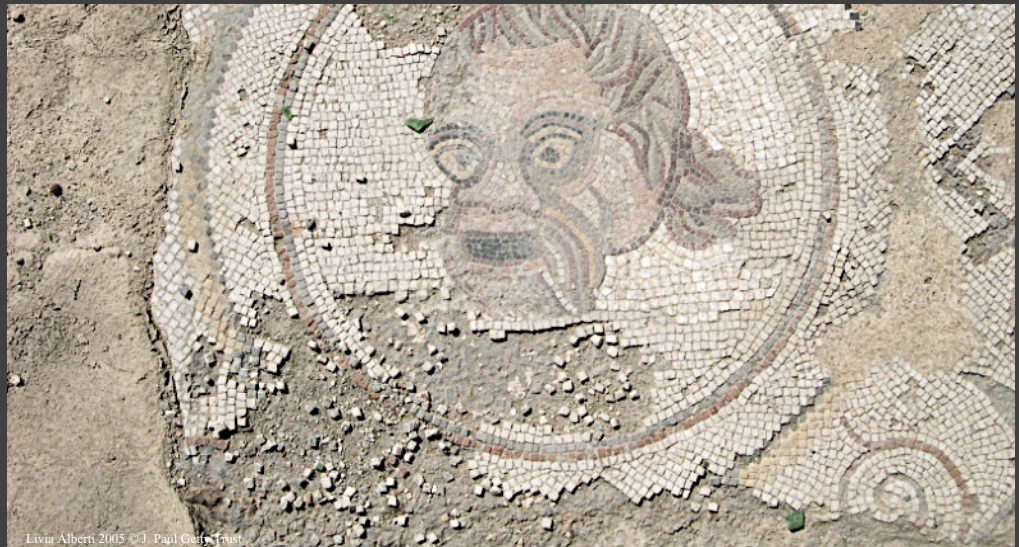
Re-detached tesserae or detached tesserae of a lifted and re-laid mosaic

Tesserae already reset during a previous intervention that are no longer adhered, or detached tesserae from a section of the mosaic that has been lifted and re-laid on a new support.
