TECHNICIAN TRAINING FOR THE CONSERVATION OF MOSAICS

PART 1
THE CONSERVATION OF IN SITU MOSAICS

Deterioration of mosaics

Livia Alberti, Ermanno Carbonara, Thomas Roby

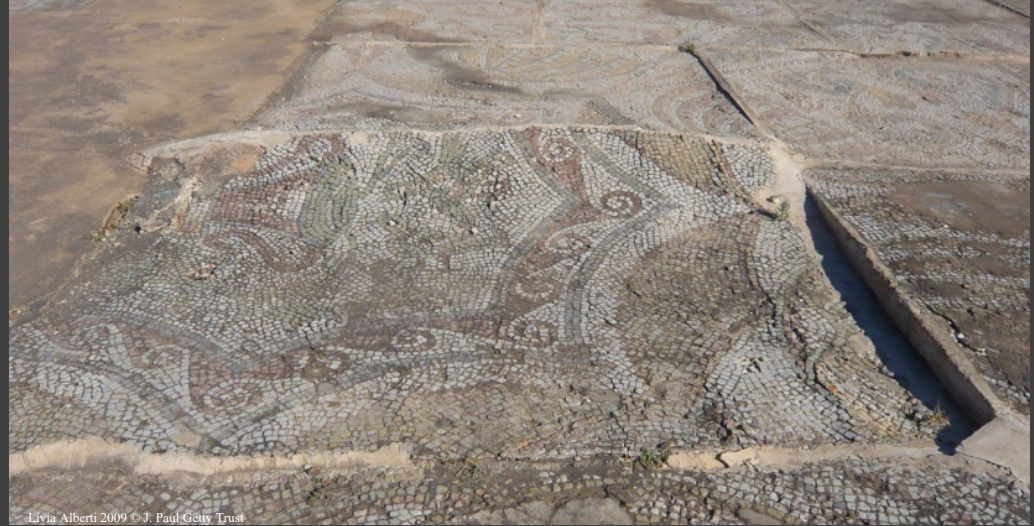
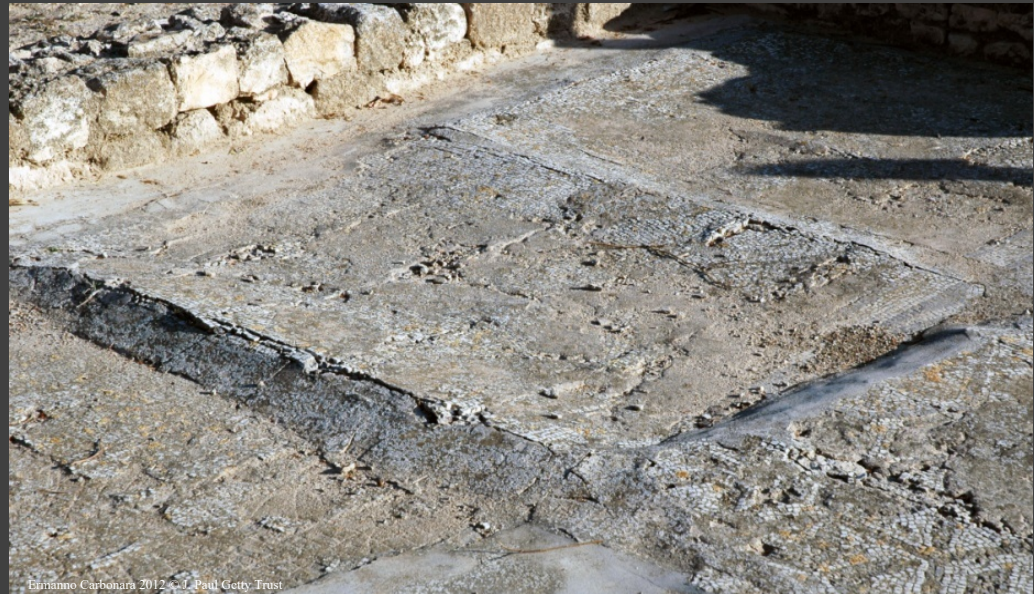
Deteriorated support panels

Deformed support panel: Modern support panel of a re-laid mosaic whose shape has changed, part of its surface being located above or below its original level.

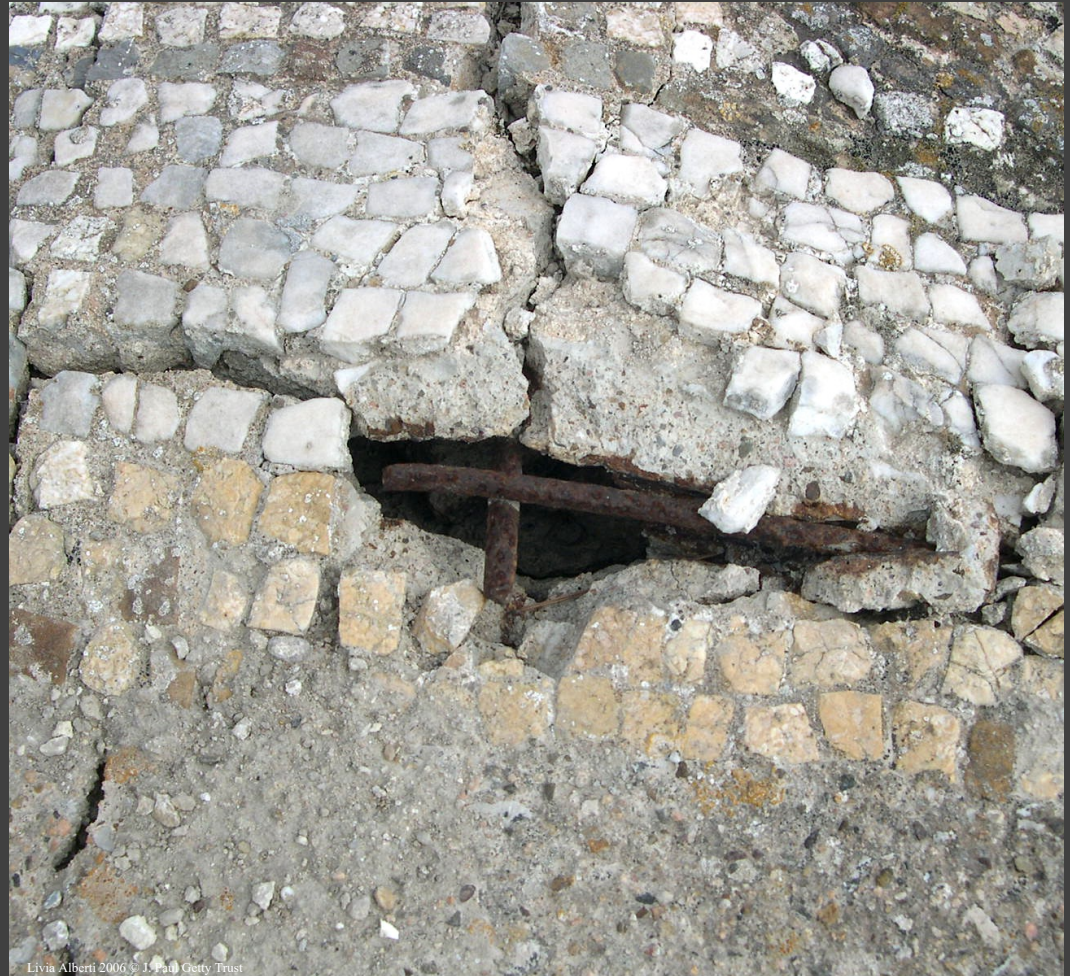
Deteriorated support metal reinforcements

Structural reinforcement of a support of a re-laid mosaic that is in poor condition.

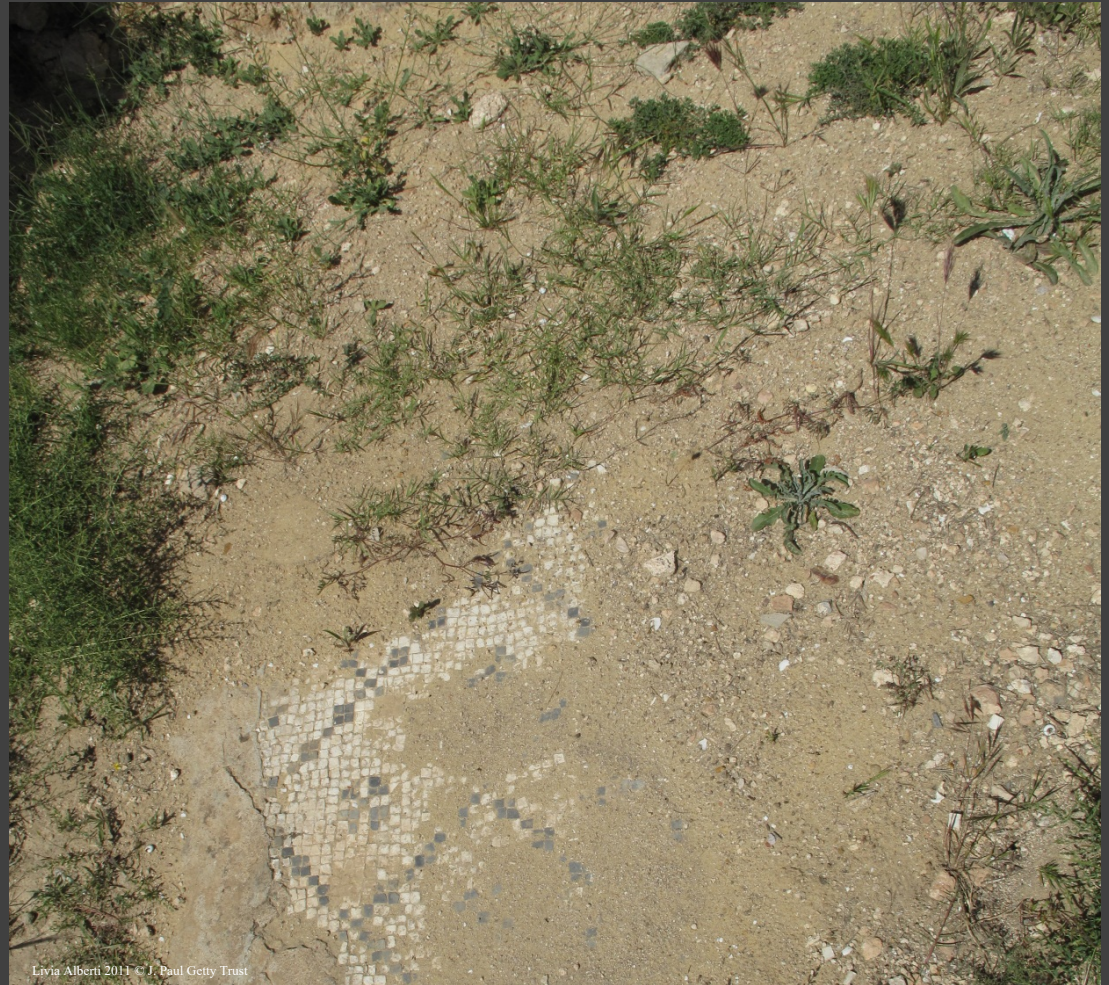
Presence of vegetation and loss of fill materials

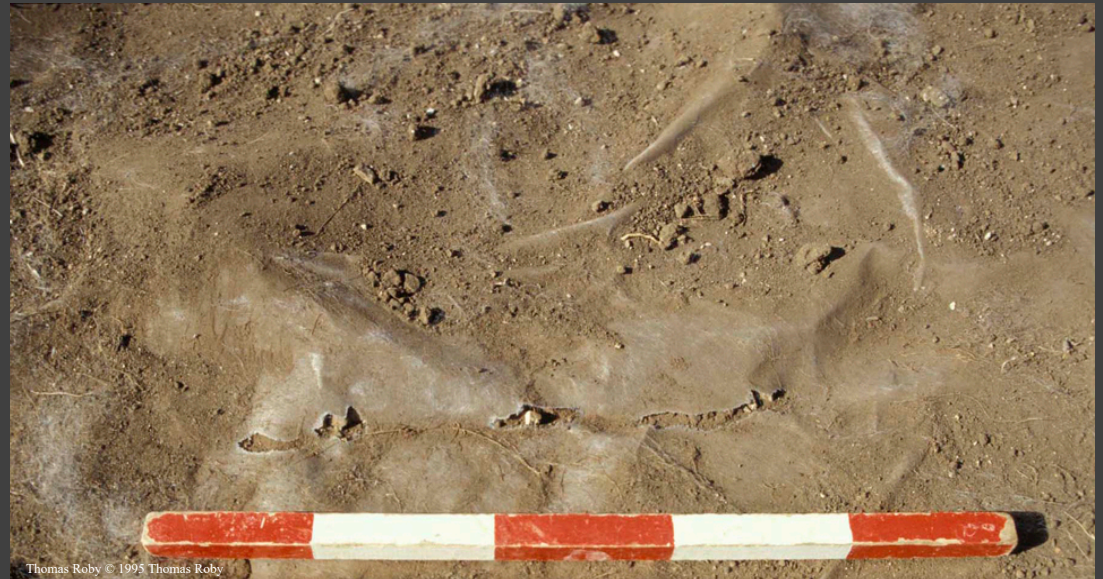
Deteriorated separation membranes

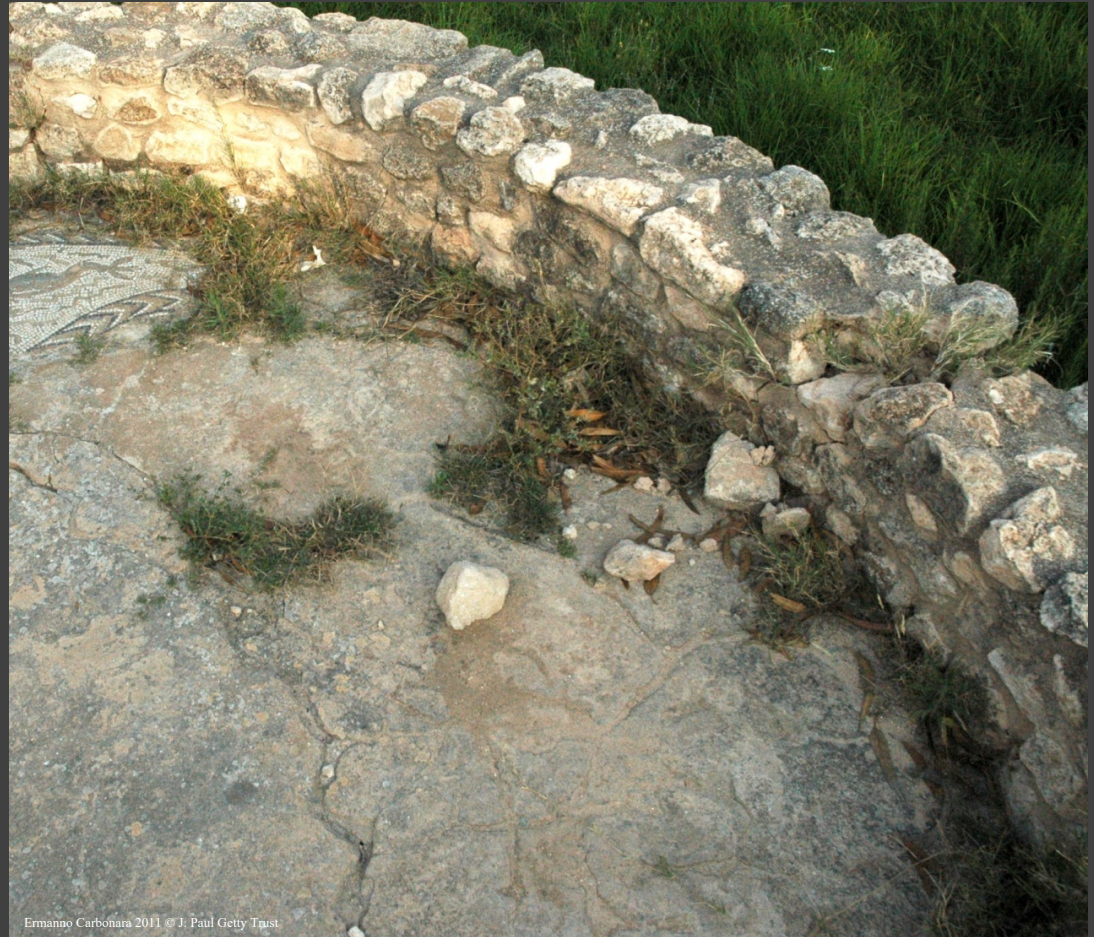
Stabilized walls with new deterioration

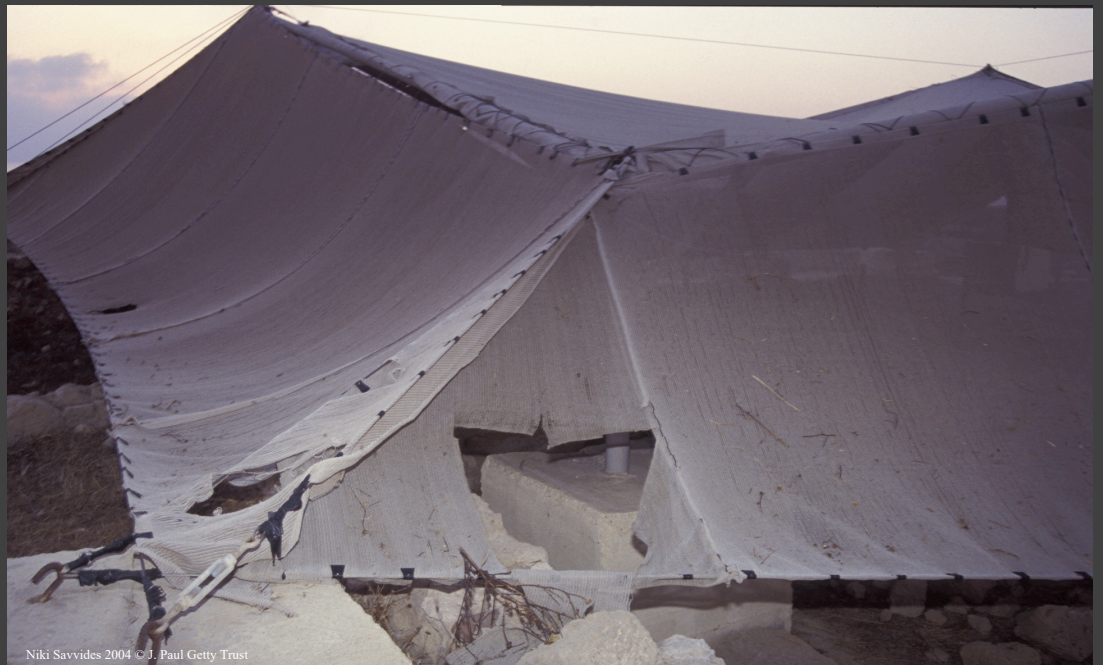
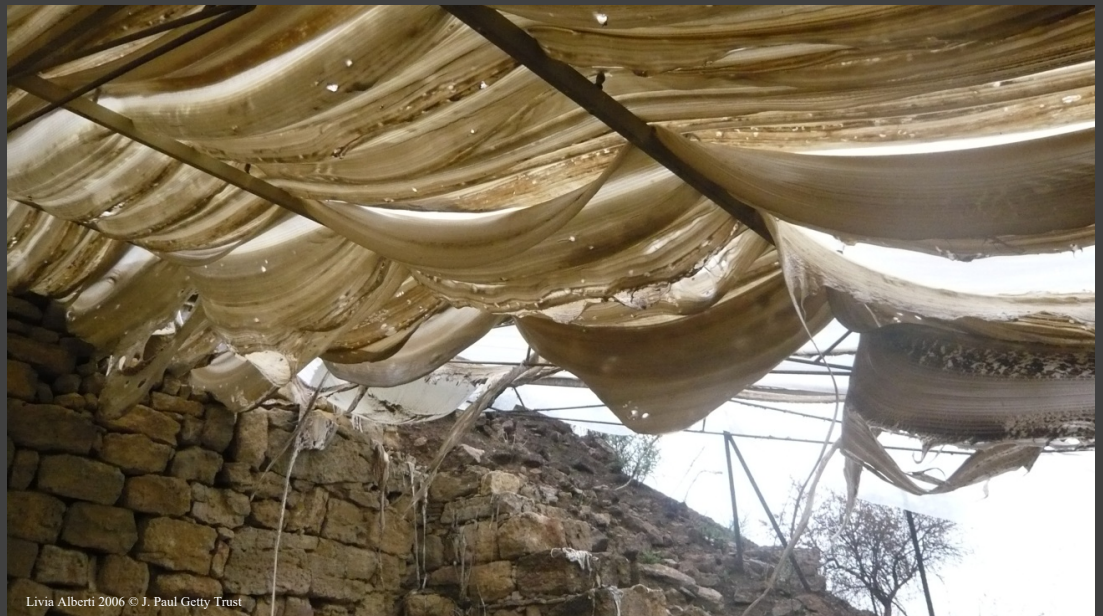
Deteriorated cover or shelter

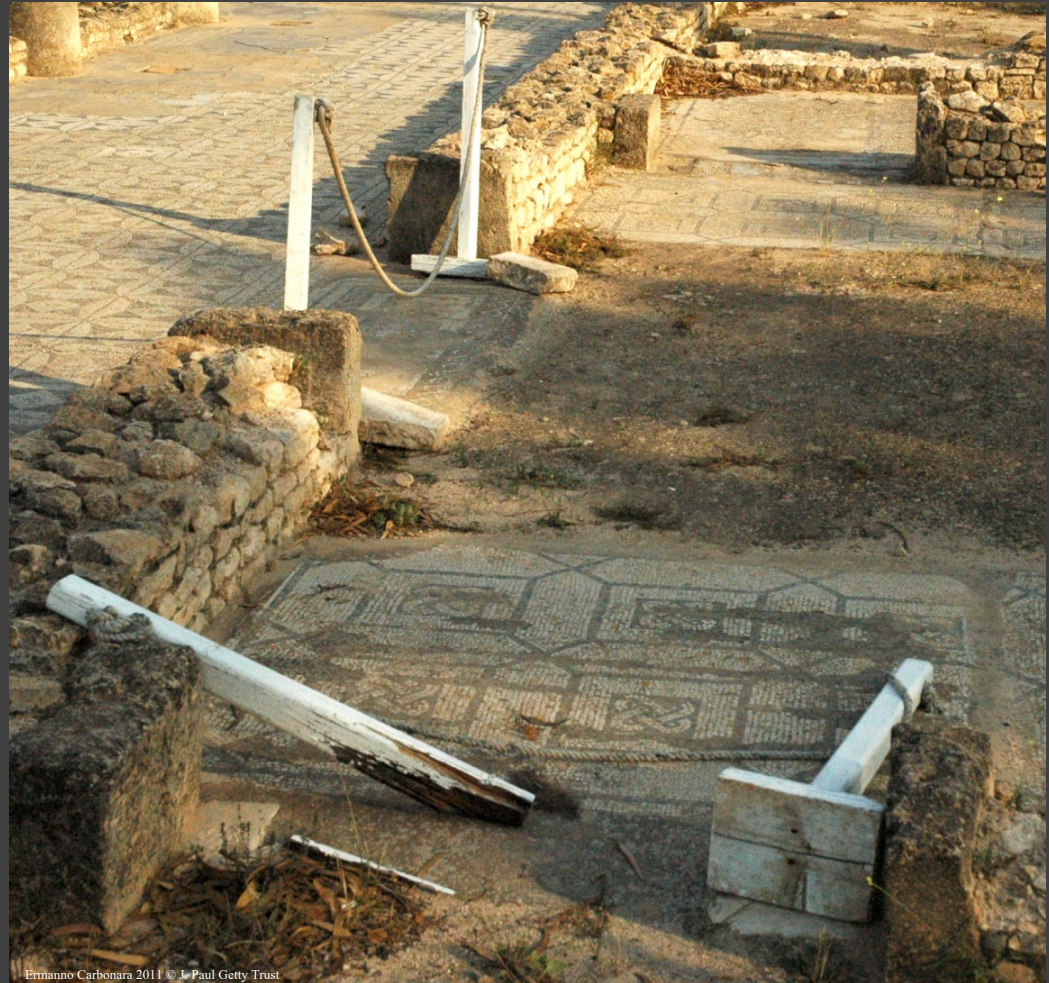
Damaged access barrier

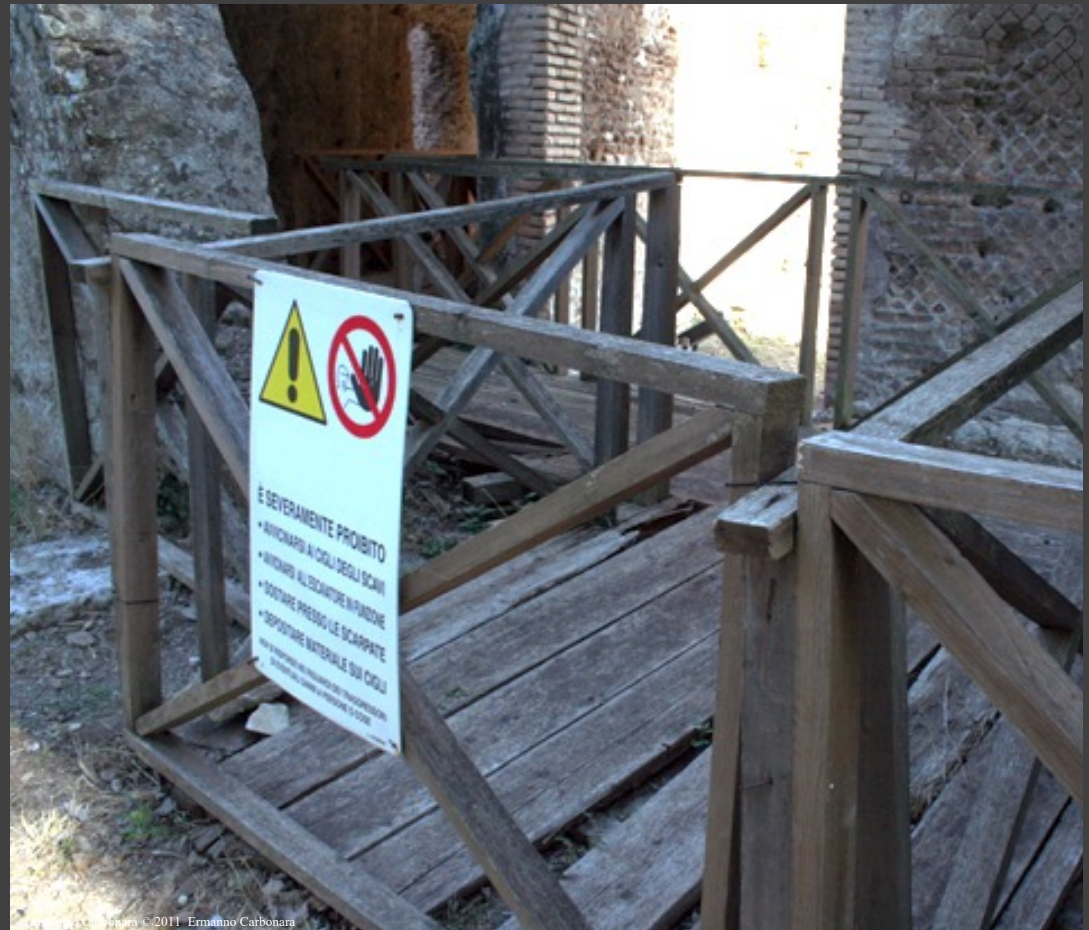
Damaged footbridge
