Problems of Moisture

METHODOLOGIE D'ETUDE AU LABORATOIRE DE LA TENUE A L'EAU DU MATERIAU TERRE

Gérard Didier et Fouad Ghomari

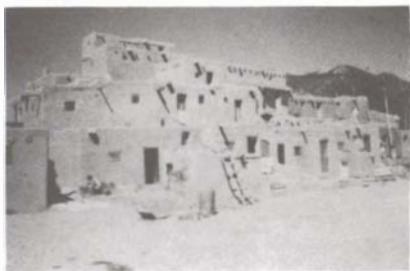
Figure 1. Five-story Taos Pueblo originally built of puddled adobe (made by patting mud into a wall-shape) before the introduction of Spanish adobe forms. Note mud plastering that is carried out each year to maintain the structure.

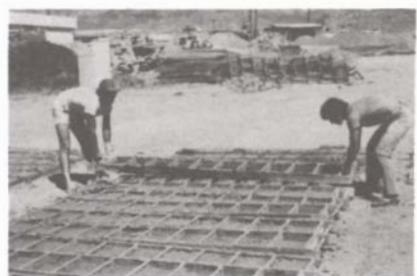
Figure 2. Adobe mud placed in 10-brick ladder forms at the commercial adobe yard of New Mexico Earth in Alameda, New Mexico.

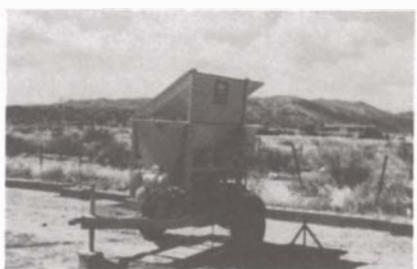
Figure 3. Earth Press III pressed-earth-block machine manufactured near Grants, New Mexico, and set up near a wall under construction in Velarde, New Mexico.

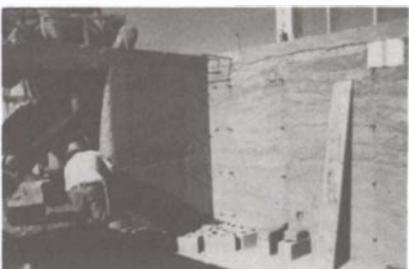
Figure 4. Exterior 60-cm-thick rammed-earth wall of home under construction by Soledad Canyon Earth Builders, Mesilla, New Mexico.

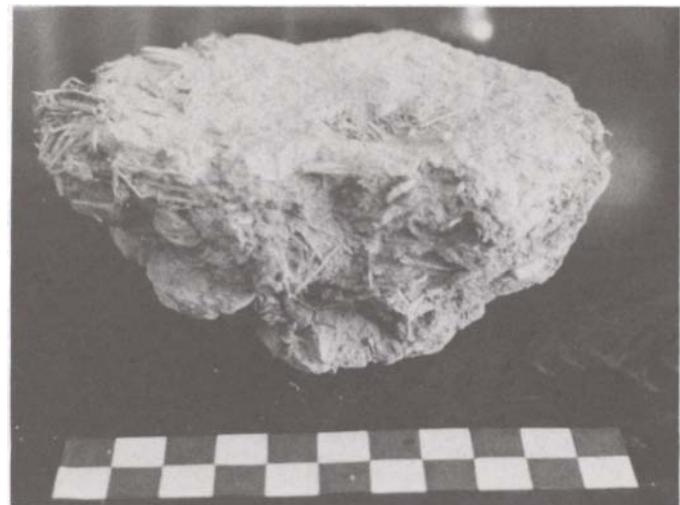
Figure 2: SC1A1 Partial Brick Exposing Straw Binder

The four whole and half brick samples donated to the study illustrate the mason's understanding of the importance of fibers in reducing unwanted shrinkage: in the larger samples whole pieces of straw intertwine to form a complete organic armature for the clay/silt/sand body to rest upon (see fig. 2). The two clay daubin homes located in Penfield include layers of whole straw in nearly equal volumetric proportions to the layers of soil.

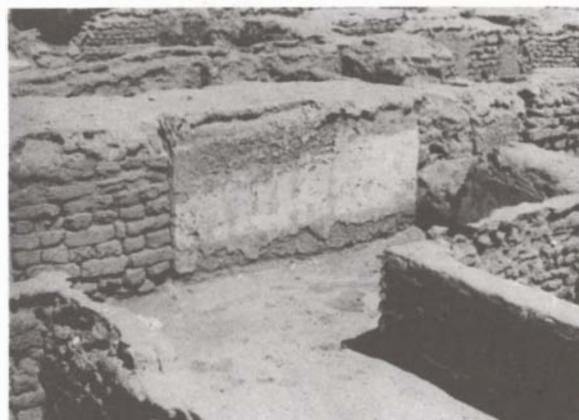
Fig. 4 Raneferef's complex, a part of slaughterhouse with remnants of plaster.
