The Hieroglyphic Stairway of Copán, Honduras

Study Results and Conservation Proposals

A PROJECT REPORT

The Getty Conservation Institute, Los Angeles

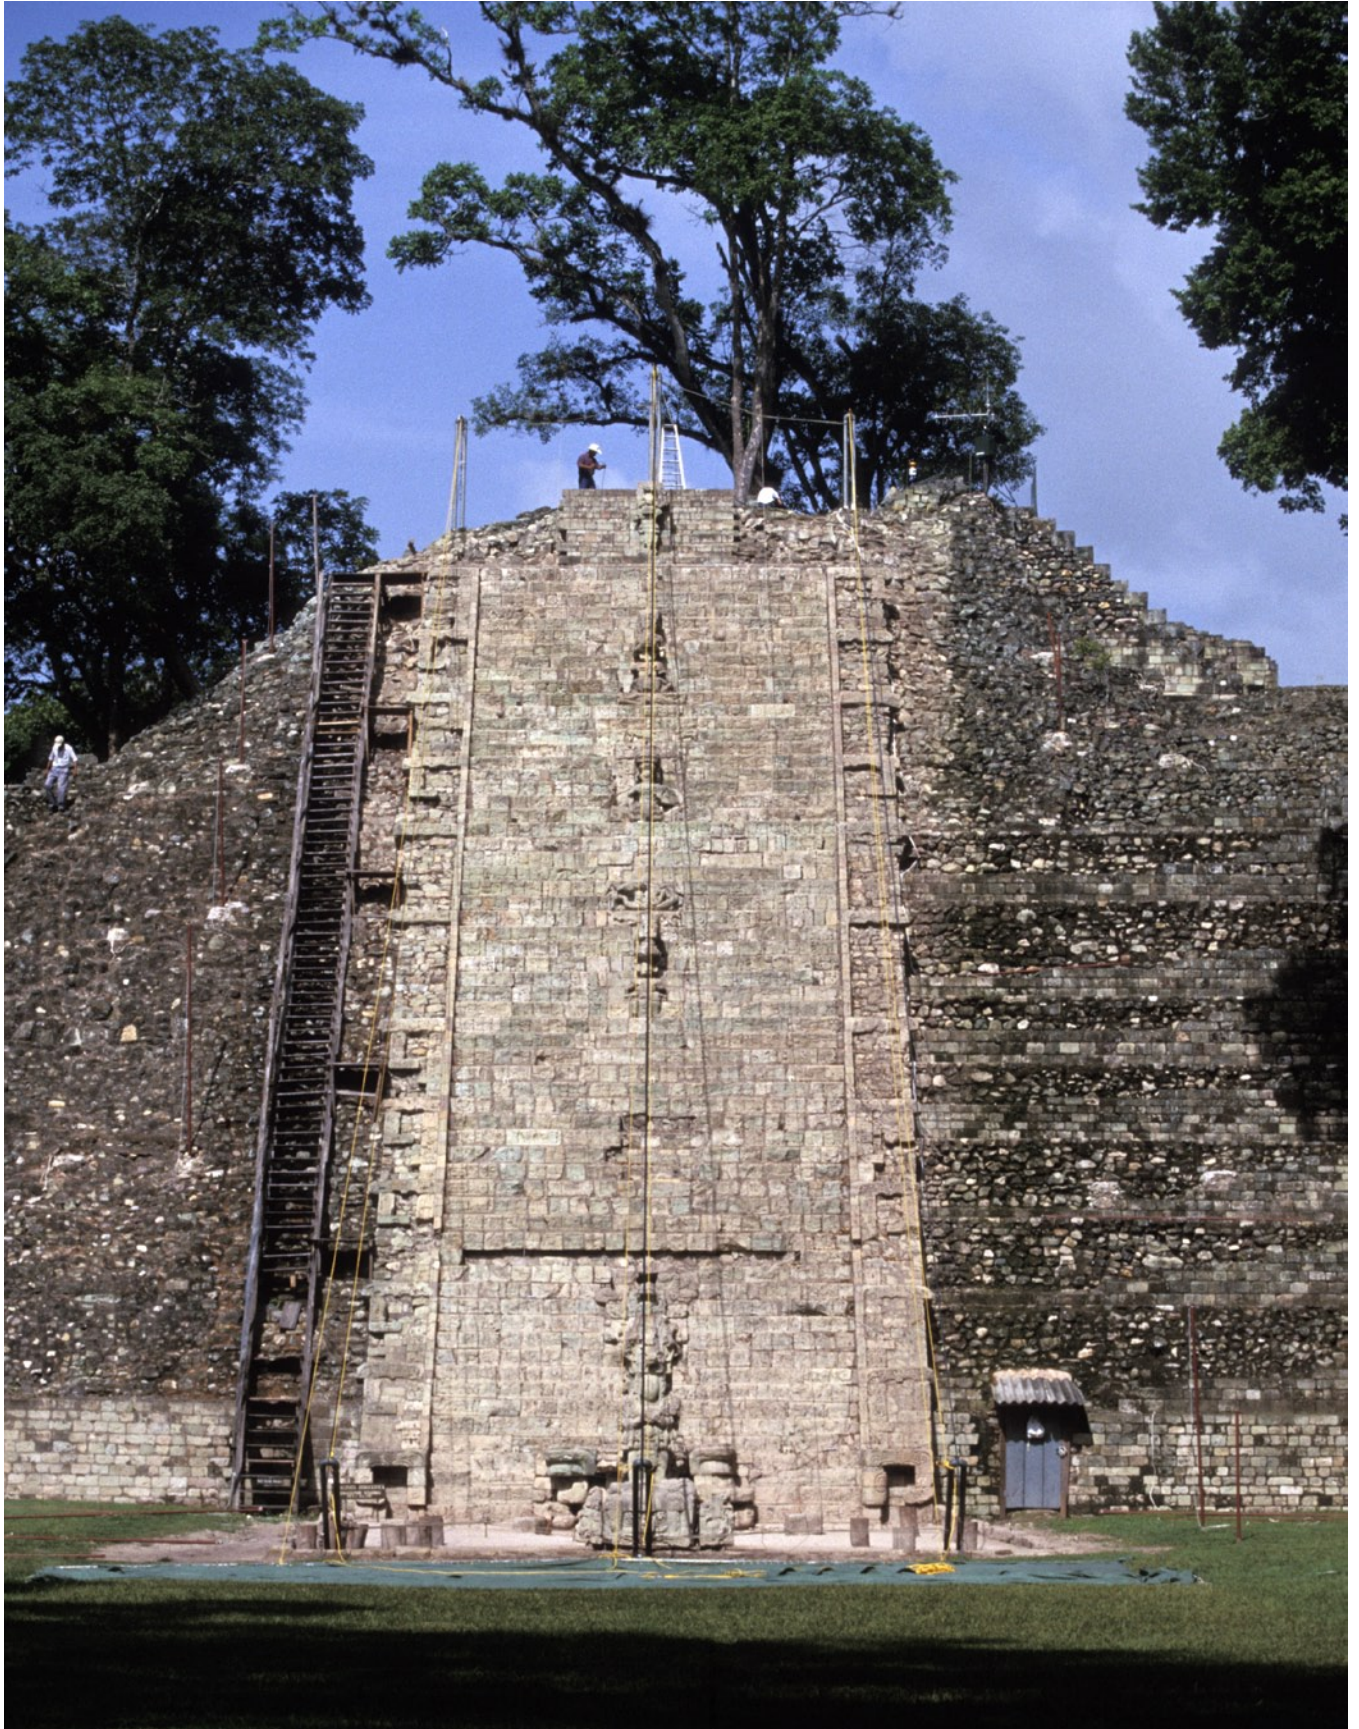
Figure 10 The Hieroglyphic Stairway during the temporary removal of its shelter. July 2003.

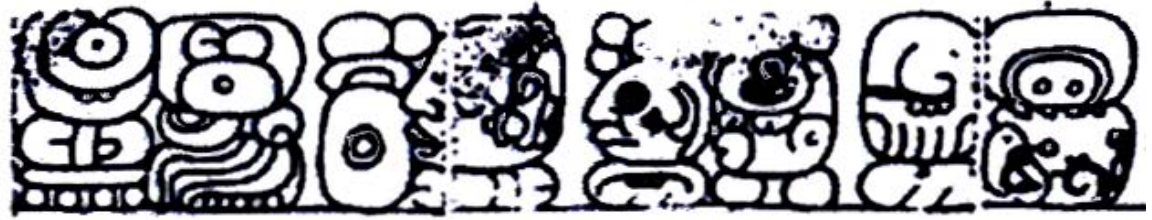
Figure 11 Drawing of glyphs of blocks 406 to 410, step 45.

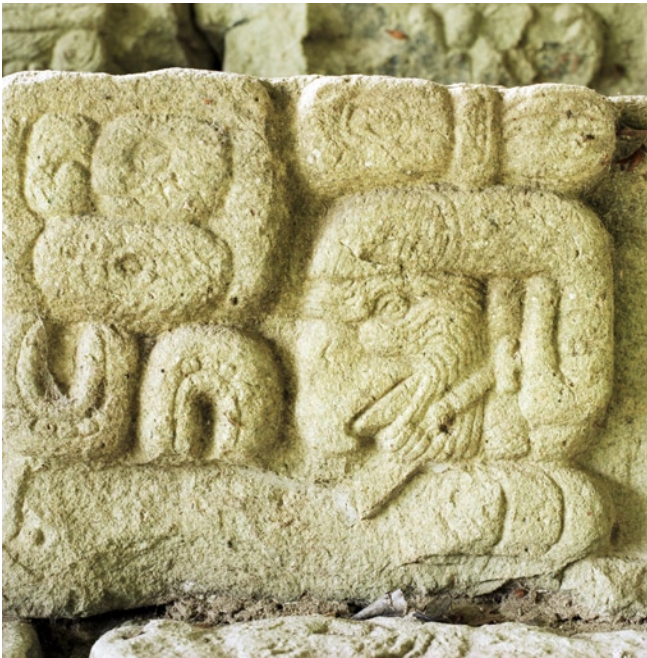
Figure 12 Detail of the Hieroglyphic Stairway showing block 565 (glyph B), step 39.

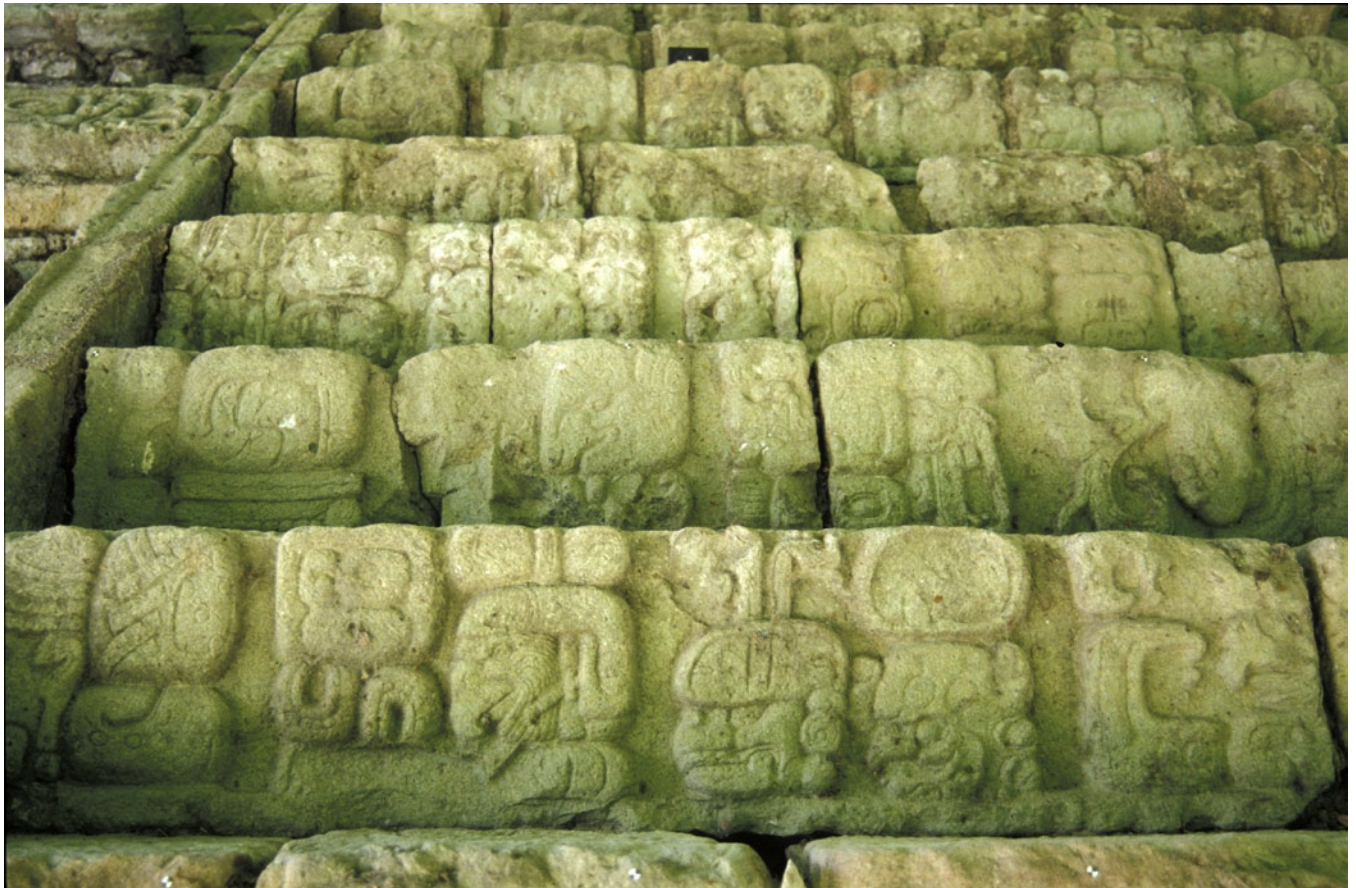
Figure 13 Steps 39 to 44 on the north side of the Hieroglyphic Stairway.
