Proceedings of the Getty Seismic Adobe Project 2006 Colloquium

Getty Center
Los Angeles
April 11-13, 2006

Editors
Mary Hardy
Claudia Cancino
Gail Ostergren

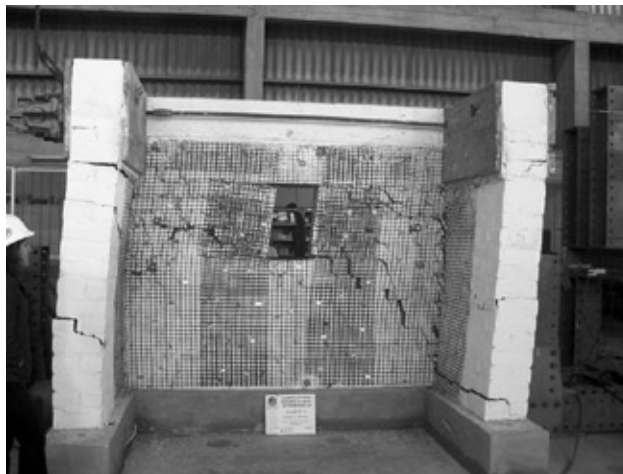
FIGURE 1 Cyclic static test results.

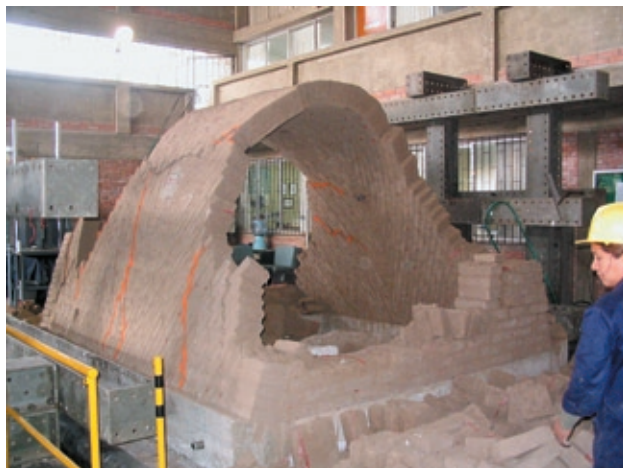
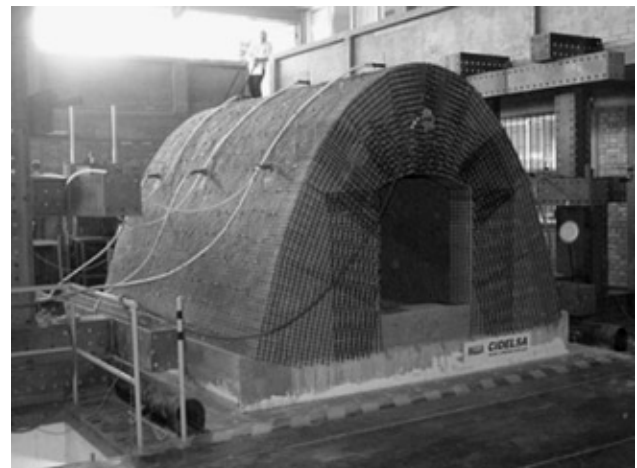
FIGURES 6A AND 6B Test results showing the collapse of unreinforced model URV (a); the fully reinforced vault RV-PM100 (b) fared better.

For the purpose of comparison, a range of table-induced damage was established: ND means no damage; LD means light damage, with small cracks; HD stands for heavy damage, with large cracks and some structural instability; and C signifies total or partial collapse. The seismic performance of all these models is depicted in table 2.

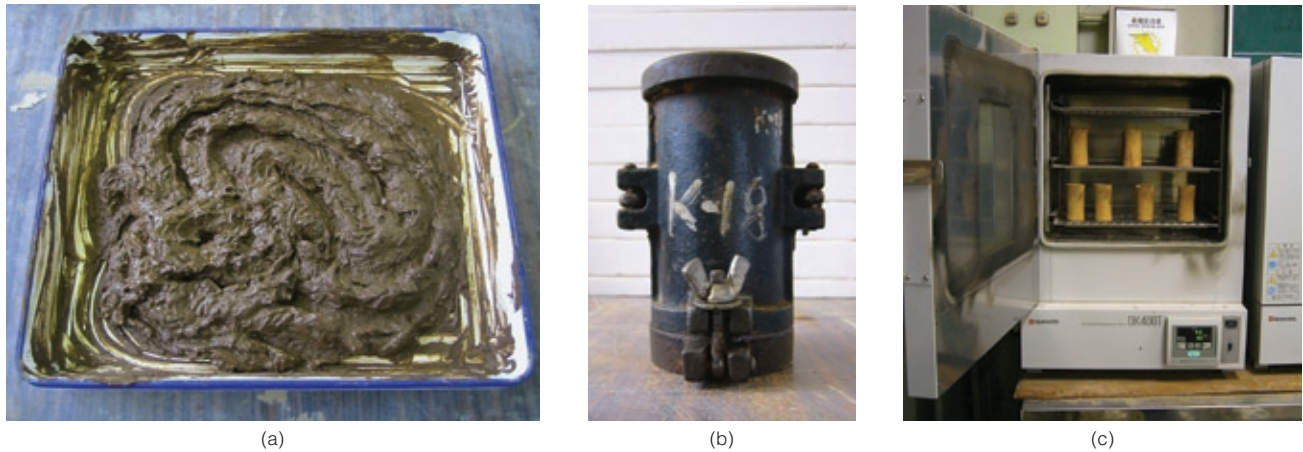
FIGURES 2A-C Preparation of adobe specimens: soil-sand slurry (a); steel mold for specimen preparation (b); and oven used for drying specimens (c).

The effect of three different fibers—hemp, jute, and straw—on the seismic resistance of adobe material was investigated. In all cases, specimens were prepared by mixing the soil-sand mixture with 1.0% fiber (by weight) of 1.0 cm (0.4 in.) in length. Final water content and dry

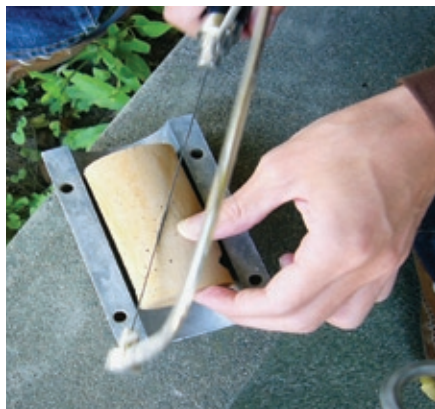
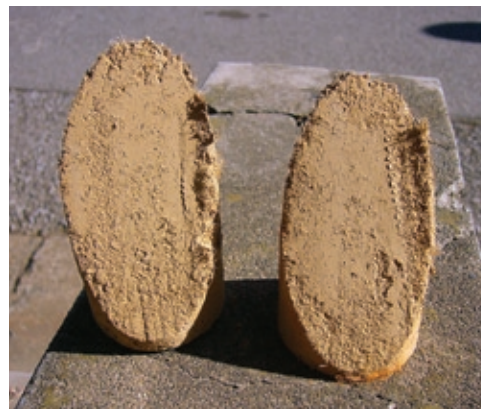
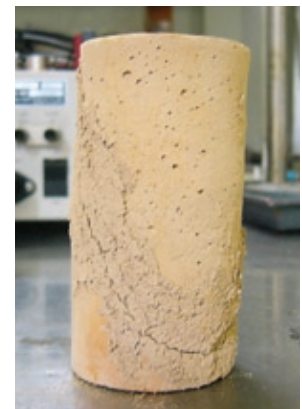
FIGURES 7A–C Making of sandwich specimens: cutting of cylindrical specimens at 60° to horizontal (a); two parts of specimen after cutting (b); and a sandwich specimen (c).

Past earthquakes showed that mortar is the weakest part of adobe structures. Cylindrical sandwich specimens were prepared to investigate the effectiveness of selected reinforcing material in improving mortar characteristics. Sandwich specimens were prepared cutting cylindrical specimens into two pieces at 60° to horizontal, since failure of specimens under uniaxial compression showed that specimens failed at 60°–70° to horizontal. Mortar of about 0.5 cm (0.2 in.) thickness was inserted between the two parts. The sandwich specimens were then kept in an oven at 60°C for three to four days for drying. Figures 7a–c show the details of the sandwich specimen preparation.

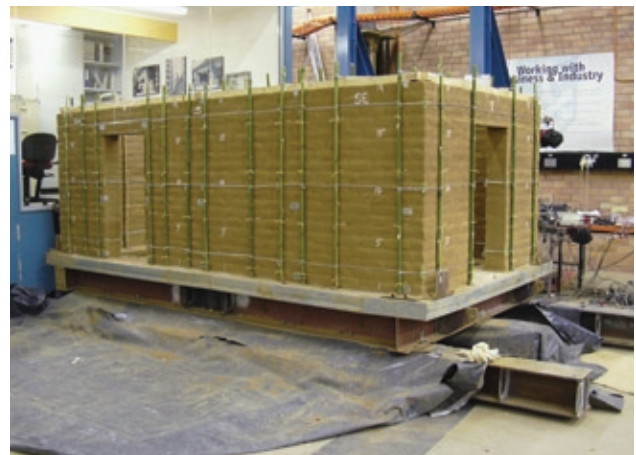
FIGURE 2 Model house 4A prior to testing; south and east walls are visible.

The sequence of construction and retrofitting of the model house was: (1) construct unreinforced house and allow to dry; (2) mark and drill holes in rows at top, middle, and bottom of each wall; (3) insert polypropylene string loops through holes; (4) fill holes with mud, allow to dry; (5) place timber ring/crown beam on top of wall and connect with bamboo dowels

and wire; (6) place external vertical bamboo (inside and outside house), tied with through-wall polypropylene string ties; (7) place and tension galvanized fencing wire horizontally between bamboo poles (top, middle, and bottom); and (8) connect bamboo poles and ring beam with wire loops.

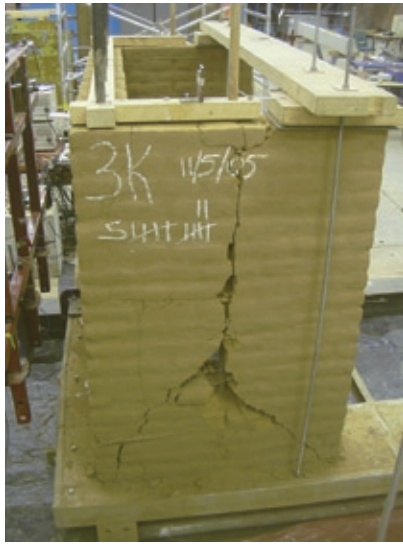
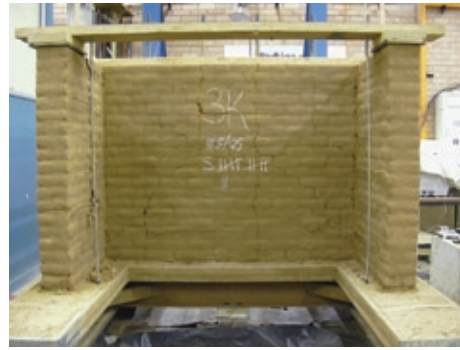
FIGURES 5A AND 5B Specimen 3K after simulation S12 (100% repeated). The in-plane wall and corner connection (a) and the out-of-plane wall (b) are shown.

Specimen 3K included internal vertical reinforcement (25 mm [1 in.] diameter timber broom poles), plus internal horizontal chicken wire mesh reinforcement. This method and derivations thereof have been widely promoted as an effective earthquake strengthening

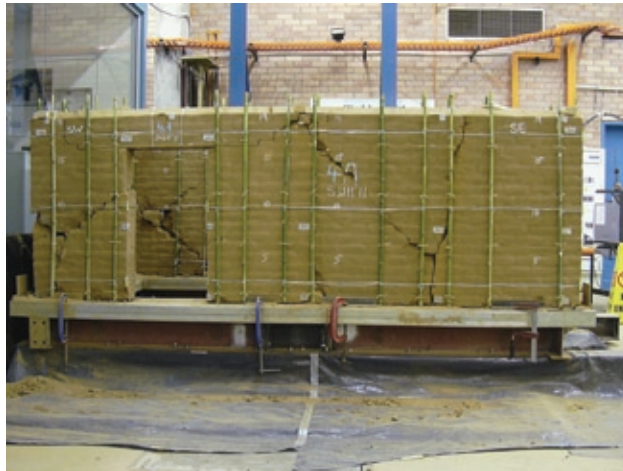
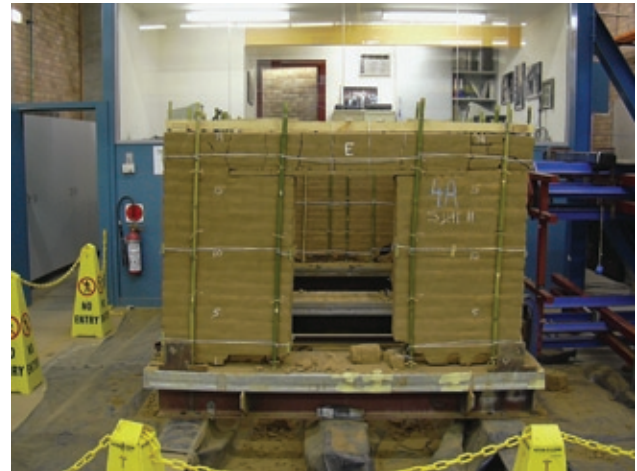
FIGURES 11A AND 11B Model house 4A: damage after simulation S8 (shakedown). The south wall (a) and the east wall (b) are shown.

Initial, minor cracking occurred during simulation S4 (75% intensity), with hairline cracking evident above the lintel in the east shear wall. (Recall that the unreinforced U-shaped wall panel 3A was severely damaged during a 75% intensity simulation—see fig. 3.) Damage of model

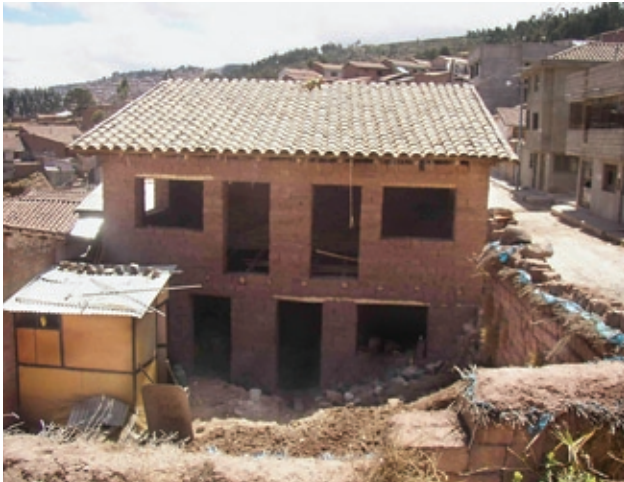
FIGURE 1 Seismically vulnerable adobe house in Peru.

because they are built in imitation of the architectural features of clay brick masonry houses that have large openings, long and slender walls, and very heavy roofs (fig.1).

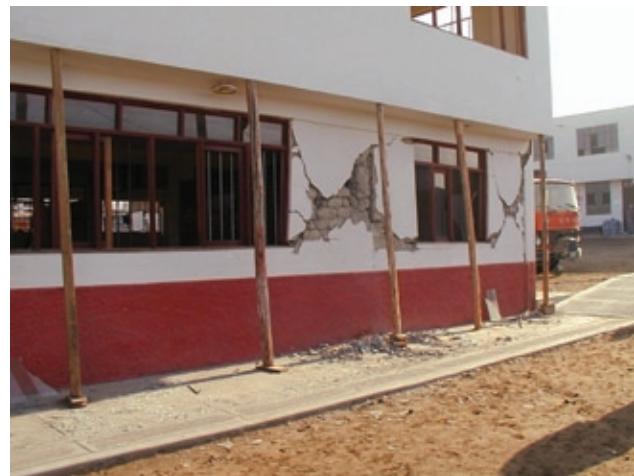
FIGURE 2 Seismic cracks of unreinforced adobe house.

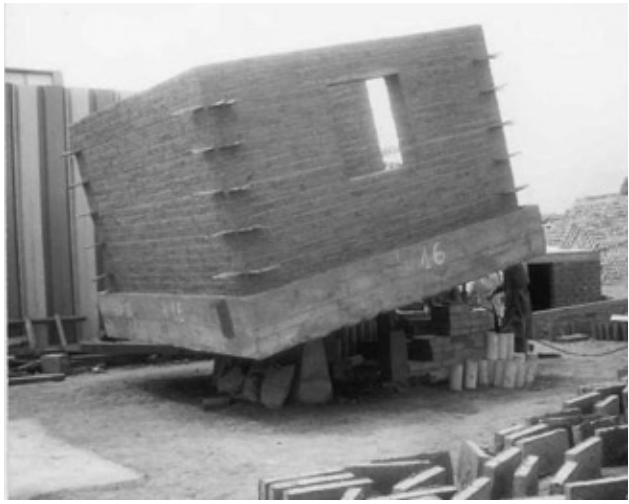
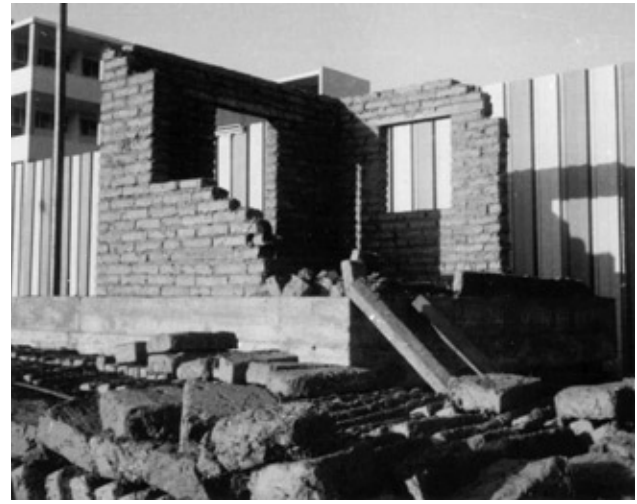
FIGURES 3A AND 3B Full-scale adobe models over tilting platform: reinforced adobe model with horizontal crushed cane strips showing at the corners (a), and unreinforced adobe model after the seismic simulation test (b).

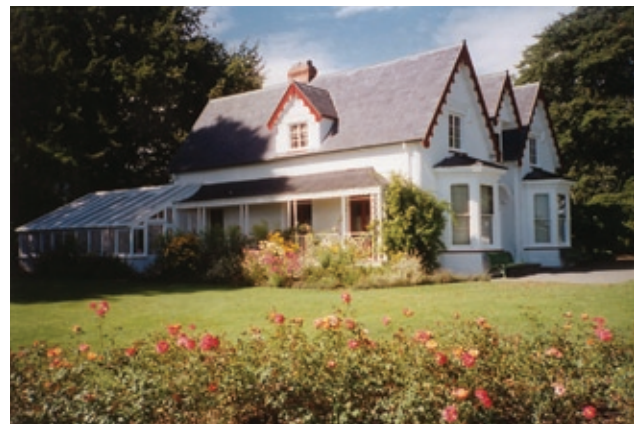
FIGURE 4 Broadgreen House, with lower-story cob walls. Photo: Richard Walker.

Another notable example of an 1850s earth building that has survived three major earthquakes (MMI VII or greater) is Broadgreen House, near Nelson in the upper South Island (fig. 4). The apparent factors that account for the good performance of this large two-story cob building are the low height-to-thickness ratio of the earth walls, the relatively few openings, sufficient earth bracing walls in each direction, the first floor acting as a structural diaphragm, and relatively good-quality earth wall construction. The 50 cm (19.5 in.) thick earth walls of the ground floor reach 2.7 m (8.9 ft.) to the first floor, giving a height-to-thickness ratio of 5.4, which complies with present design criteria for unreinforced earth walls in New Zealand.

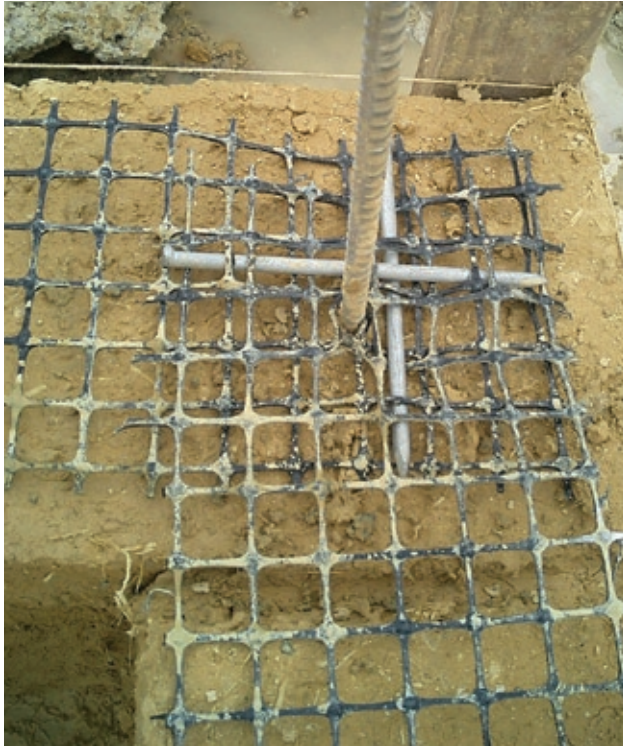
FIGURE 9 Geogrid reinforcement at corner joint. Photo: Richard Walker.

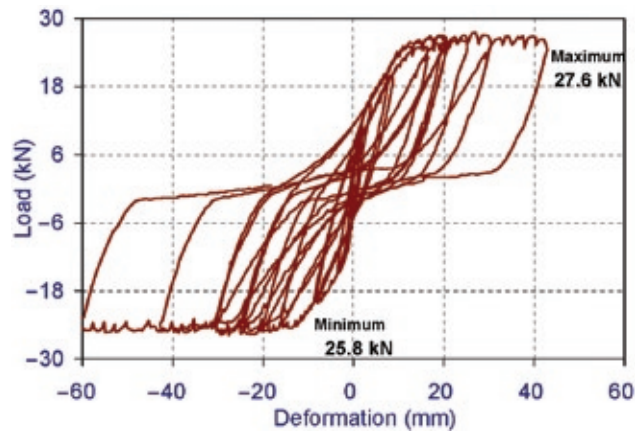
A near full-scale 1.8×1.8 m (5.9×5.9 ft.) adobe wall panel was quasi-statically earthquake tested, with horizontal slowly reversing in-plane loads applied to the top edge of the wall. Subsequent to this, a 1.2×1.8 m (3.9×5.9 ft.) wall panel was similarly tested by student Bernard Jacobson. Figure 10 is a plot of the load deformation performance of the top of the

FIGURE 10 Cyclic load performance of a 1.2×1.8 m (3.9×5.9 ft.) adobe wall.

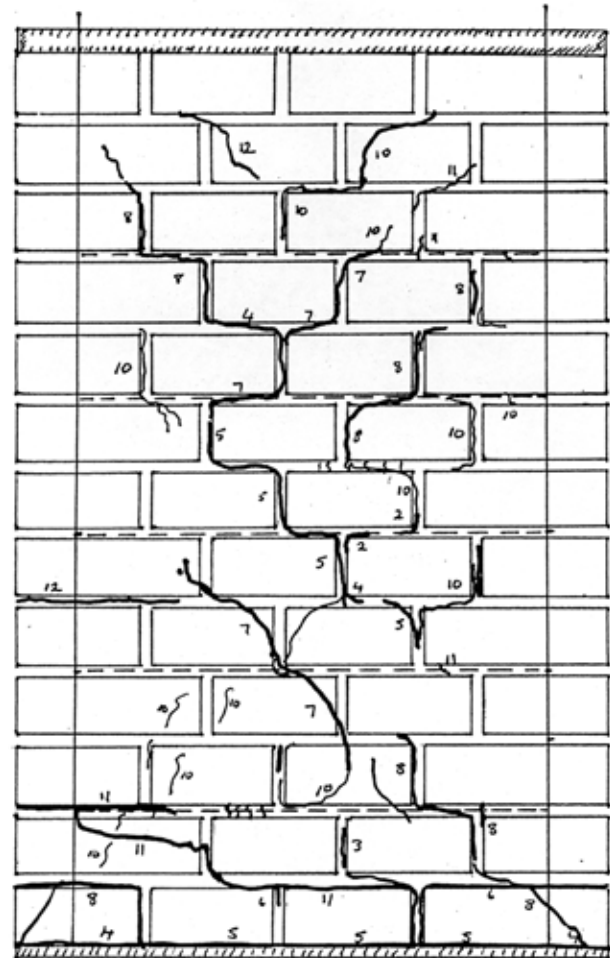
FIGURE 11 Crack pattern of an adobe wall, showing the load progression.

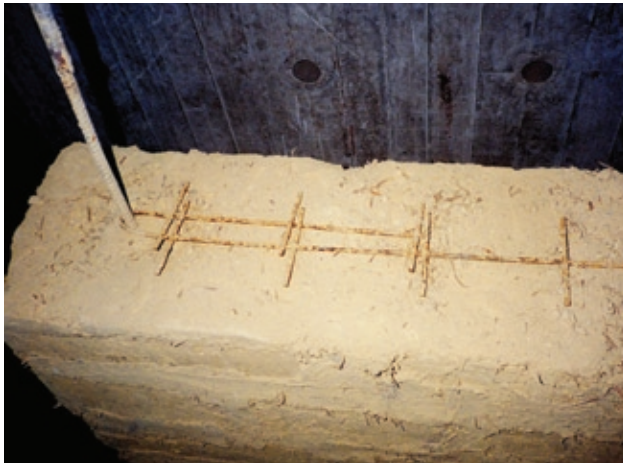
FIGURE 12 Detail of reinforcement, with vertical rods in holes through the adobes and horizontal reinforcement wrapped around the vertical rods. Now geogrid is more typically used for horizontal reinforcement.

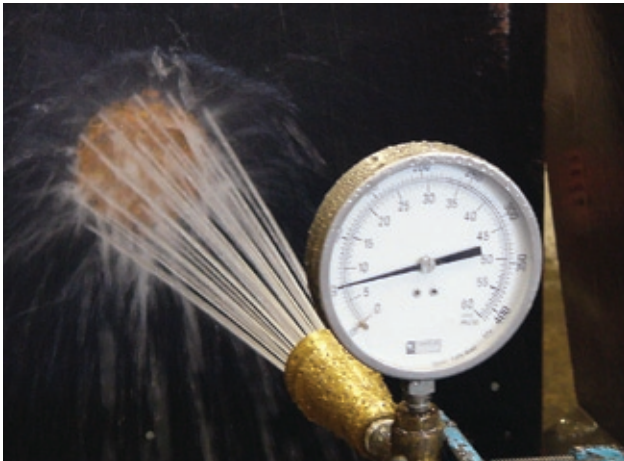
FIGURE 13 Accelerated degradation water spray test.

The durability of earth walls is of concern in both temperate and tropical climates. A need exists for a test approach that is simple and low in cost. The New Zealand standards have two tests modified from those developed in Australia. The accelerated spray test uses an expensive standard nozzle and sprays a very severe jet, as shown in figure 13. This can cause the failure of otherwise satisfactory adobe materials. This severe test is complemented by a very simple drip test, where water drops 40 cm (15.6 in.) onto the surface. This technique was checked by some simple laboratory experiments that considered raindrop energies, but the test needs field verification.

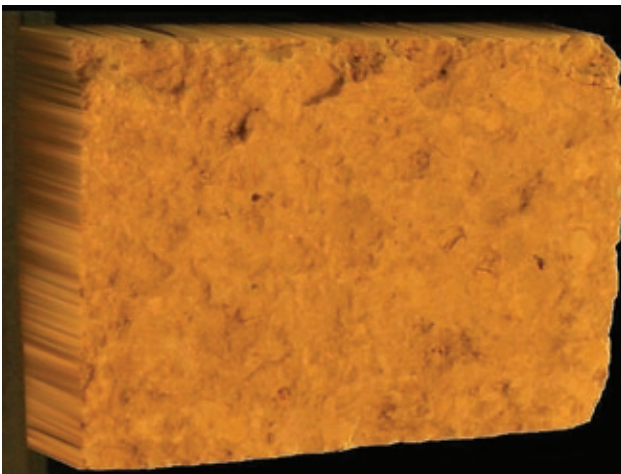
FIGURE 17 Three-dimensional extrusion of photograph of adobe block.

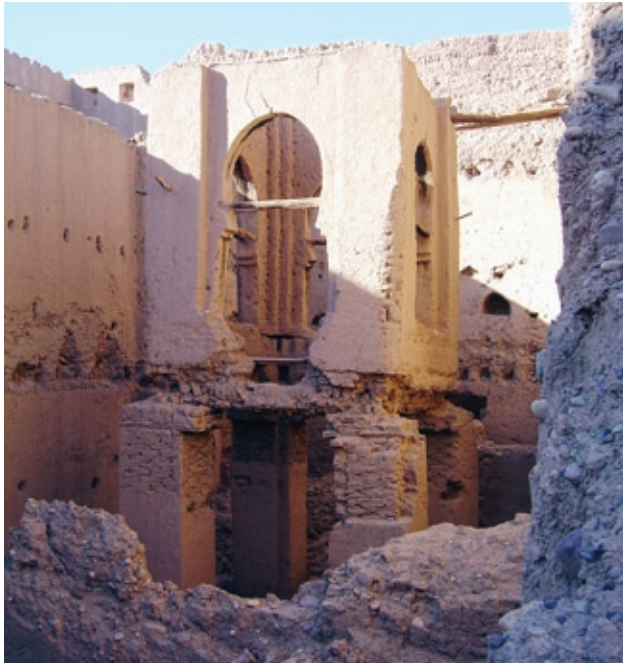
FIGURE 6 Remains of a four-column structure.

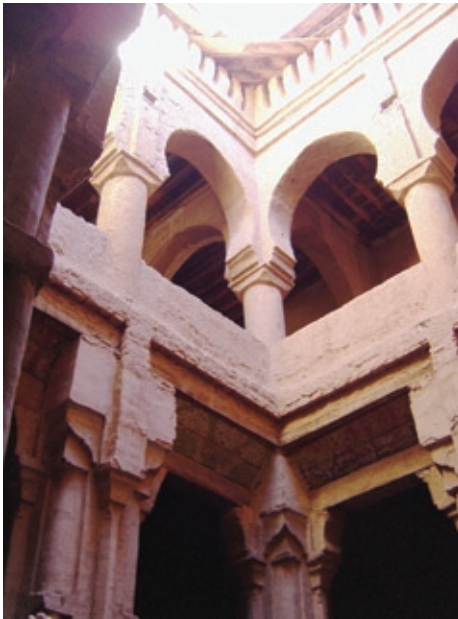
FIGURE 7 Interior of a house, Tanmougalt.

creates “breathing” (*ruh*), a dynamic articulation and a “soul.” It also exemplifies the “movement” of the house itself, growing away from the ground and developing in a standing position. The main difference from the *riyads* in Marrakech is that these are conceived as structures surrounding a garden, whereas the house we are describing in the *qsar* is conceived and built as a structure springing from the bearing columns, which literally generate the space (fig. 7).

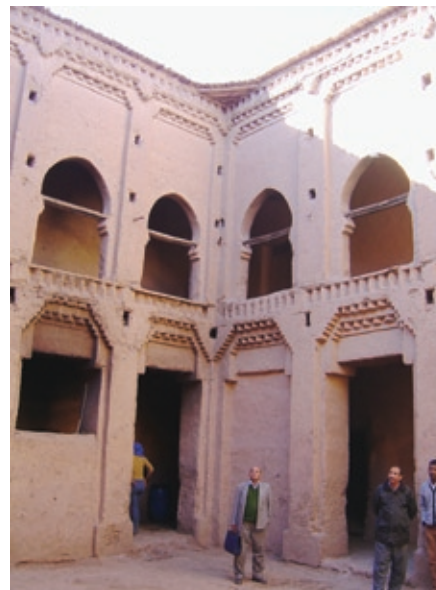
FIGURE 8 Interior of a house, Tanmougalt.

bearing columns (*sariya*, plural *swari*), with structural components that are interconnected, *mshebbek* (fig. 8).

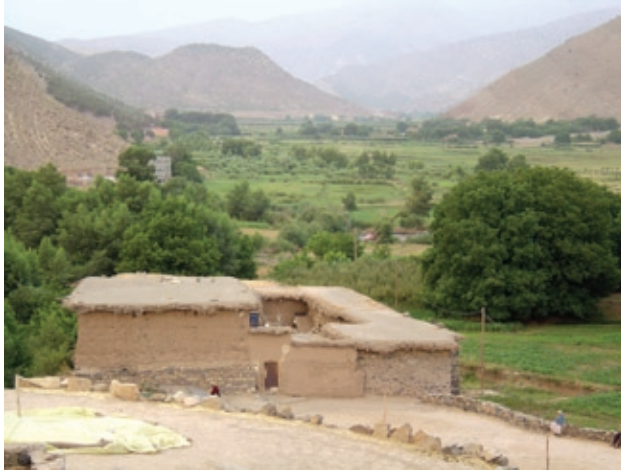
FIGURE 9 New house, Ait Bouguemmaz.

2. The new structural typology with traditional local materials. This is the model described as horizontal structures where components are no longer attached and interconnected (fig. 9).
3. A mixed typology that is structurally similar to the new typology but makes use of new conventional materials, in particular reinforced concrete (fig. 10).

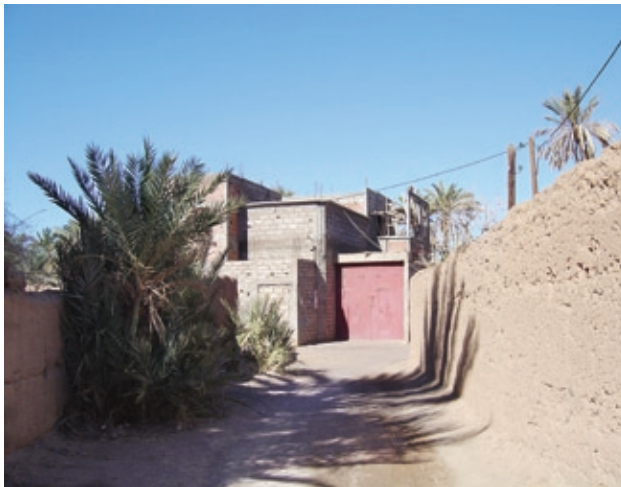
FIGURE 10 House in Zagora.

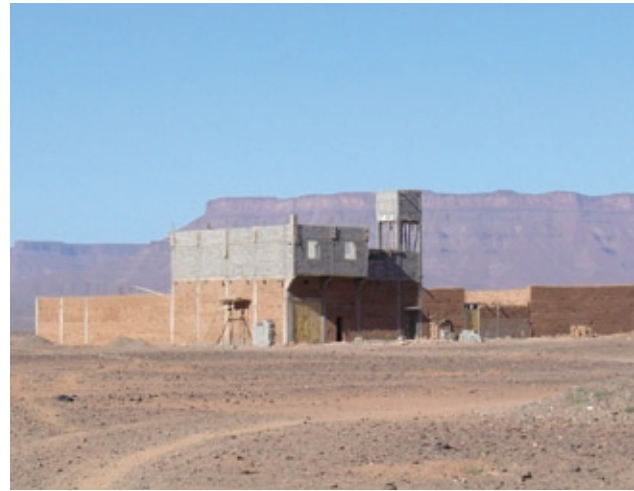
FIGURE 11 Structure exhibiting a mix of materials that reveals ignorance of rules of good practice.

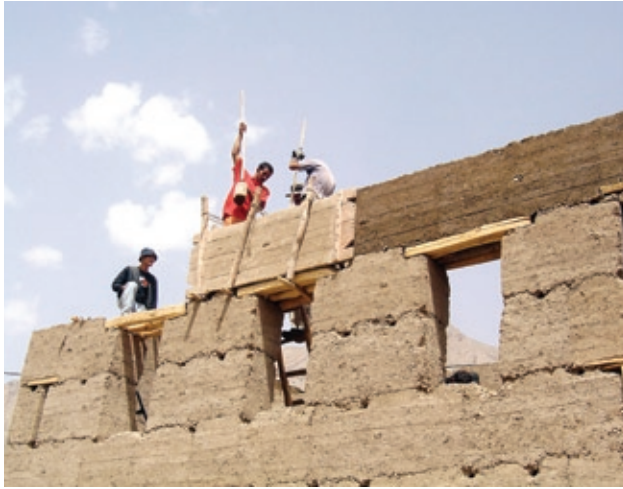
FIGURE 12 Building a rammed earth wall today, Ait Bouguemmaz (notice joint defects).

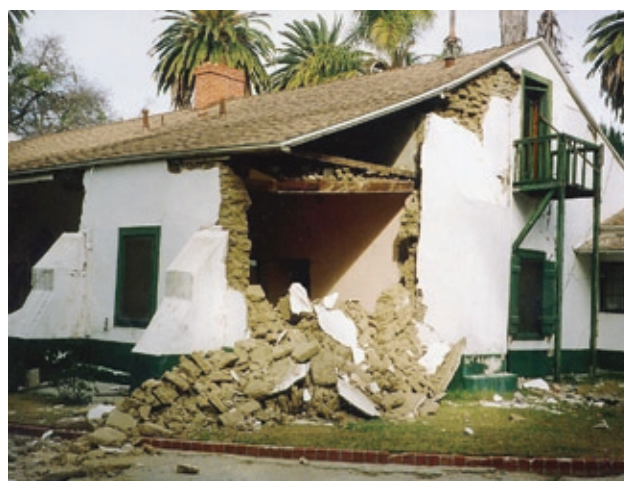
FIGURE 1 Main House, Rancho Camulos, damaged during the 1994 Northridge earthquake. Photo: E. Leroy Tolles, ELT and Associates.

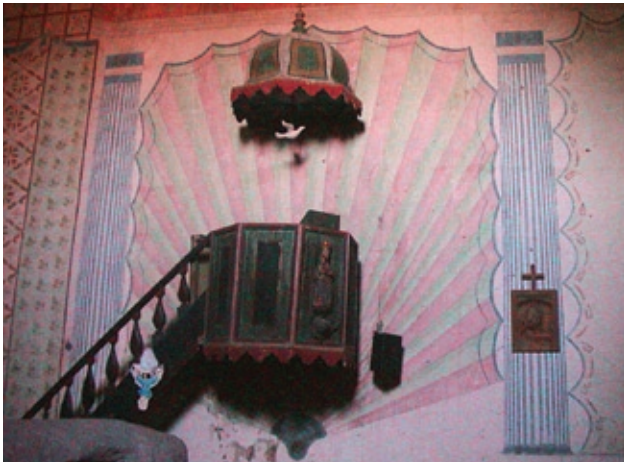
FIGURE 3 Interior of Mission San Miguel Chapel after the 2004 San Simeon earthquake. The decorative interior wall finishes were badly damaged. Photo: E. Leroy Tolles, ELT and Associates.

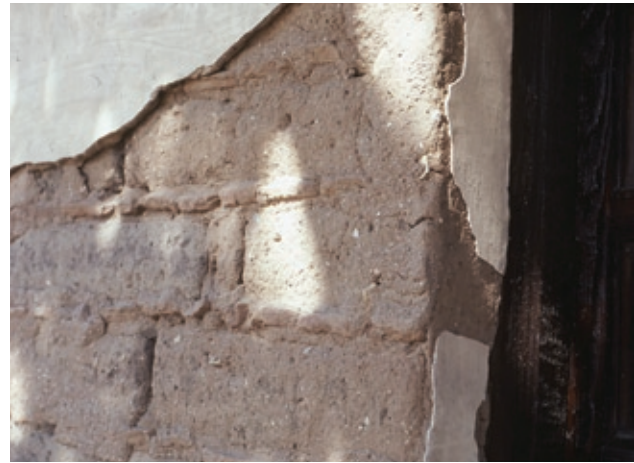
FIGURE 4 Adobe garden wall at Cooper-Molera State Historic Park, Monterey, California. Freestanding adobe structures are difficult to maintain and retrofit seismically.

In the United States, the term *conservation* is more narrowly defined. As the narrative at the Colonial Williamsburg Research Division Web site (no longer available) stated, “the field of architectural conservation emerged out of the historic preservation movement as a new and distinct discipline in the late 1960s.” Considered a subset of the field of historic preservation, conservation is closely allied with object or art conservation, with a focus on material science and preservation theory. Architectural or material conservation is considered to be treatment of building fabric and elements, including the stone foundations, clay roof tiles, adobe walls, and earthen coatings of historic adobes (figs. 3 and 4).

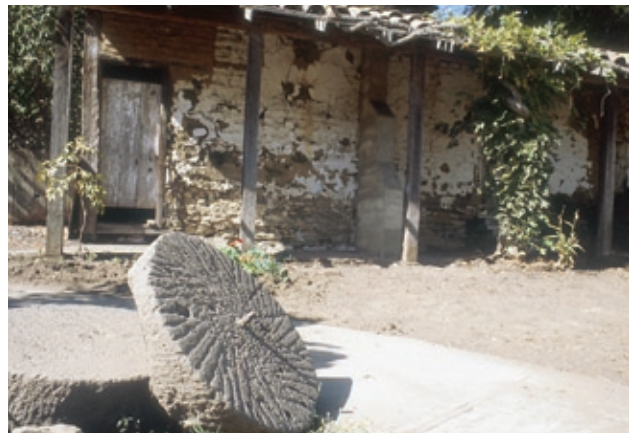
FIGURE 5 Don Jose Antonio Bolcoff Adobe, ca. 1840, Wilder Ranch State Park, near Santa Cruz, California. The Bolcoff Adobe's deteriorated condition is the result of deferred maintenance. Photo: California State Parks, © 1988.

ance clearly reveals some physical deterioration (fig. 5). The current historic appearance would be challenging, if not impossible, to retain if the building materials were properly conserved.

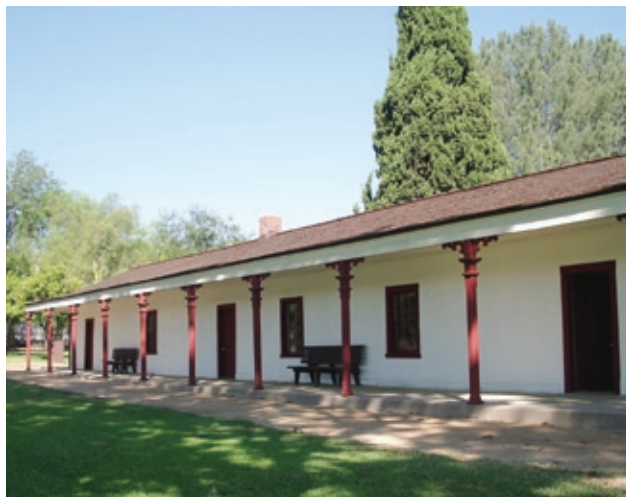
FIGURE 6 Exterior of de la Ossa Adobe, Los Encinos State Historic Park, Encino, Los Angeles. The adobe was damaged by the 1994 Northridge earthquake. Photo: Courtesy of Karen Hildebrand, California State Parks.

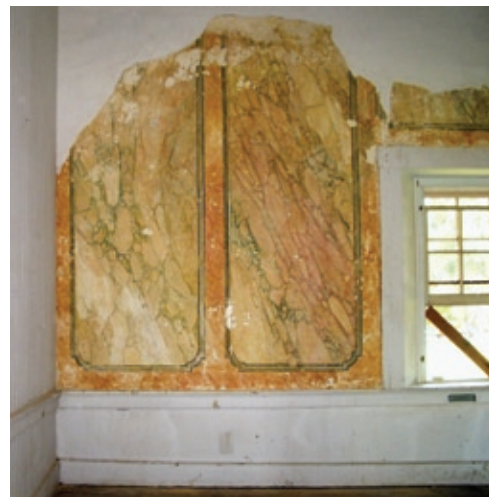
FIGURE 7 Conserved *sala* wall, de la Ossa Adobe, Los Encinos State Historic Park. This decorated surface was discovered beneath later paint layers. Photo: Courtesy of Karen Hildebrand, California State Parks.

Northridge earthquake. An interior faux stone wall treatment was discovered during the planning process for the adobe’s repair and seismic retrofit work (fig. 7). While inspecting the earthquake-damaged interior wall surfaces, State Archaeologist Karen Hildebrand and the project architect, Senior Architect Maria Baranowski, both of California State Parks, noticed varying colors in a deep crack that had exposed wall layers in Room 4B, the former *sala*. Conservation scientist Frank Preusser examined the room and found that the walls of the entire *sala* had been decorated in this manner during the ownership of the Garnier brothers. Conservator Molly Lambert performed the conservation work.

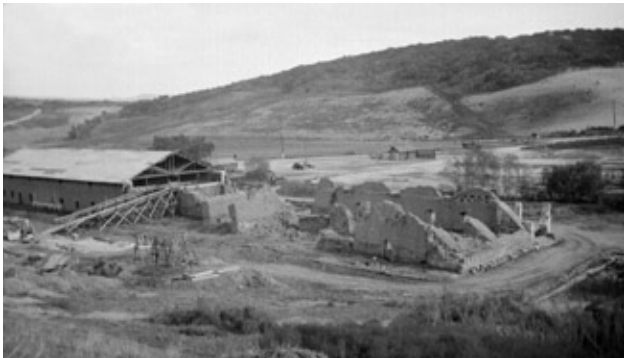
FIGURE 8 The Convento of La Purisima Mission, Lompoc, California, in 1935. The structure was in ruins prior to reconstruction by the Civilian Conservation Corps. Photo: Courtesy of California State Parks, 2007.

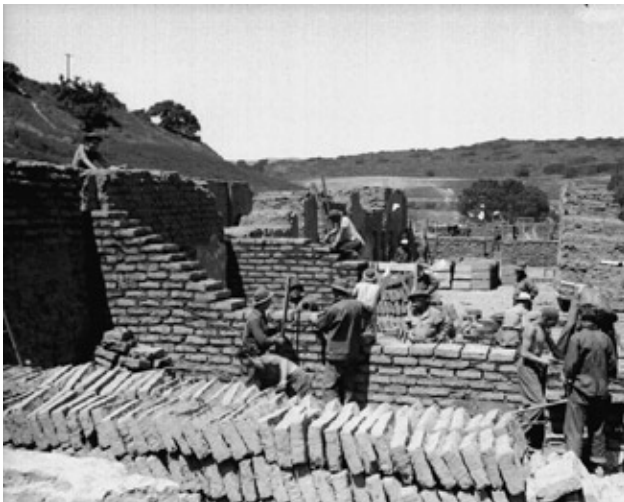
FIGURE 9 The Convento of La Purisima Mission, under reconstruction in 1935. The Civilian Conservation Corps documented building materials and structural work photographically. Photo: Courtesy of California State Parks, 2007.

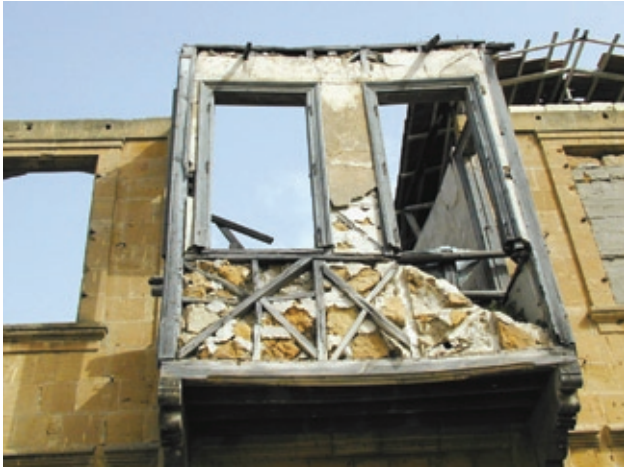
FIGURE 1 Detail of a hımiş building with stone infill.

material such as stone, wood, and brick or earthen block can be used as infill (figs. 1 and 2).

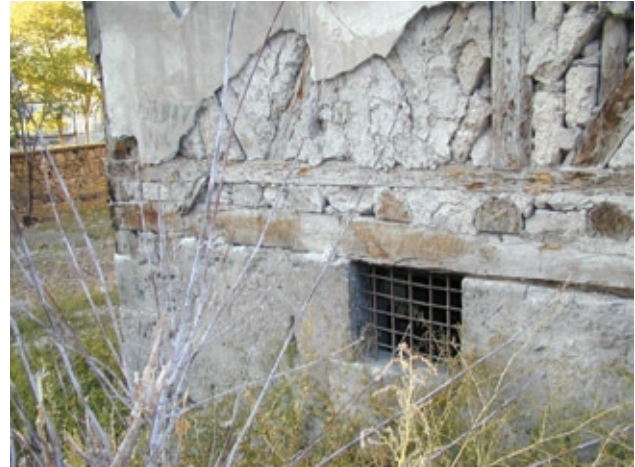
FIGURE 2 Detail of a hımiş building with earthen block construction.

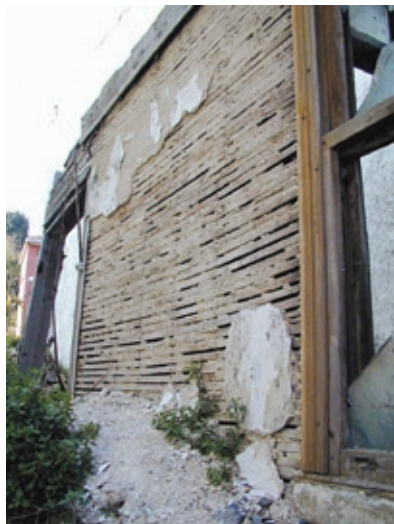
FIGURE 3 Wall constructed using the *Baghdadi* method: wood frame with lath and plaster siding.

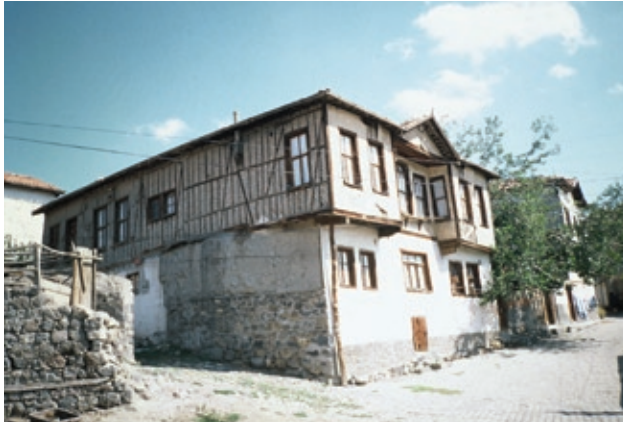
FIGURE 5 Himiř structure in Ayas, Turkey. The ground floor is constructed of stone and used for utility or domestic animals rather than for human habitation.

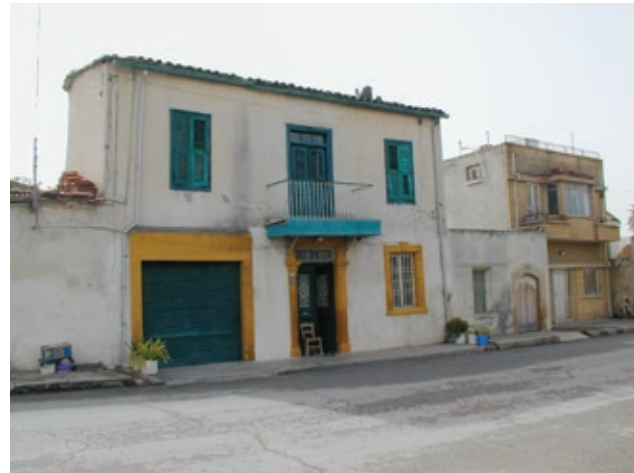
FIGURE 9 Earthen bearing-wall system in Cyprus.

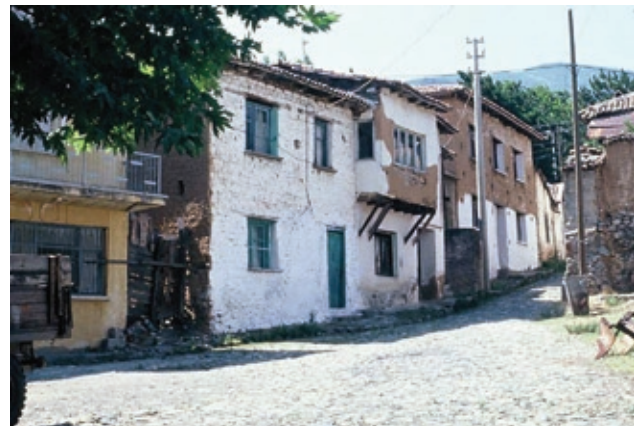
FIGURE 10 Earthen bearing-wall system in Güre, on the Aegean coast of Turkey.

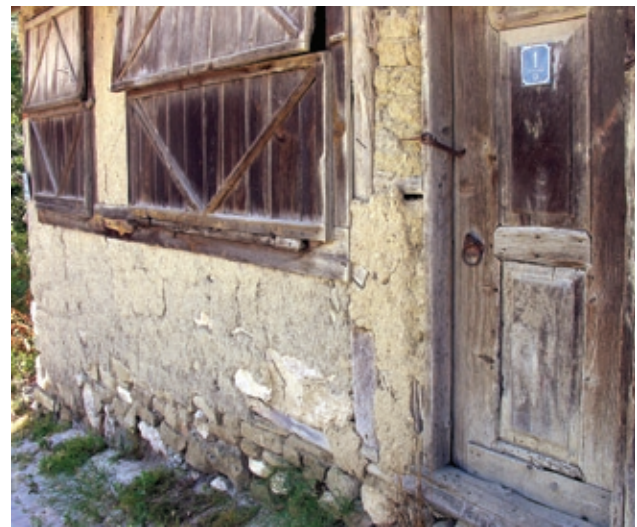
FIGURE 12 Traditional wood-frame building with stone foundation.

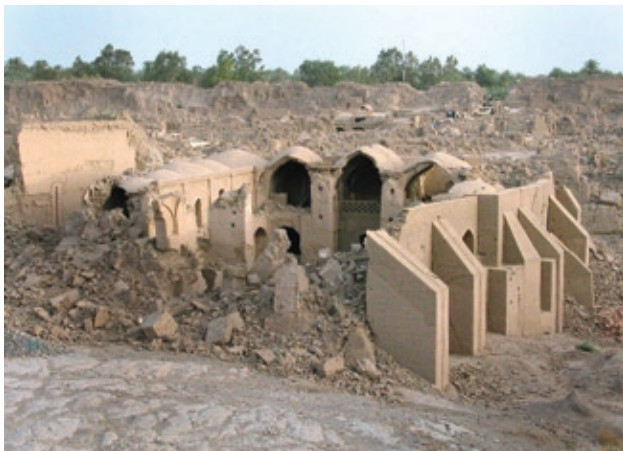
FIGURE 14 Building collapse due to earthquake, Bam, Iran, 2003. Photo: © Randolph Langenbach, 2004.

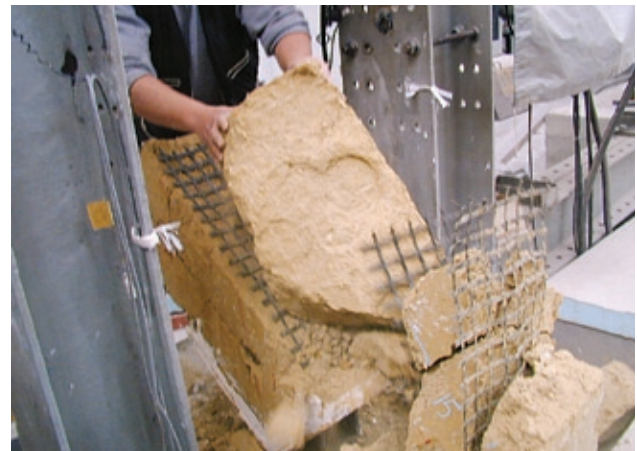
FIGURE 15 Horizontal joints in an earthen wall sample and their response to lateral forces.

joints created by the geomesh layer, while the wall parts between the joints were undamaged (fig. 15). Geomesh was applied horizontally, in 17 cm (6.6 in.) intervals during the ramming process, and it is expected to take the tensile forces in the wall during an earthquake. Tests showed that the mesh layer performed as a friction surface.

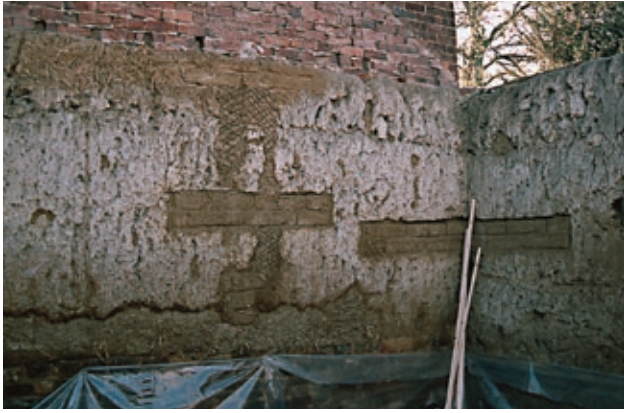
FIGURE 1 Stainless steel and adobe soft-stitch repairs to a corner and central end wall in Leicestershire, UK. The structure is an example of cob construction.

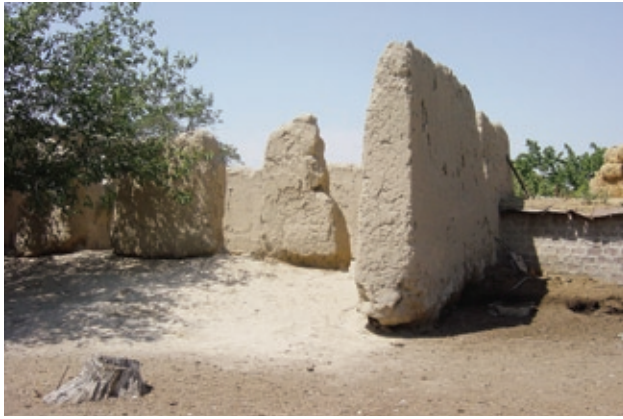
FIGURE 2 Pisé mosque with horizontal bark and twig ring beams in regular lifts, Armenia.

A selection of photographs and archaeological drawings demonstrate their use from the fourth to the nineteenth centuries (figs. 2–12). Locations include Turkey, where Ottoman stonework has continual and frequent lifts of brick tiles, and Armenia, where pisé structures have regular lifts of wood, bark, and other vegetation and also bear evidence of adobe repairs using the same protocols.

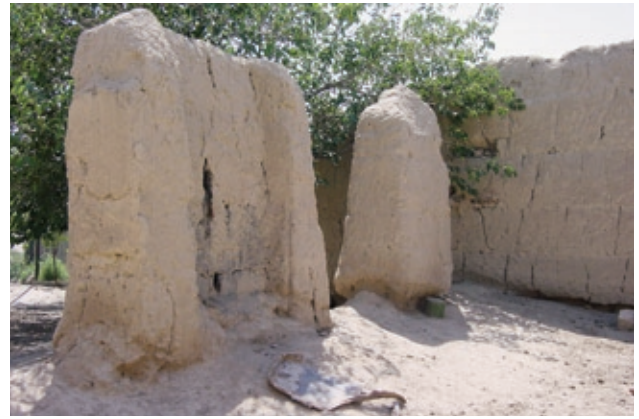
FIGURE 3 Mihrab of a pisé mosque in Armenia.

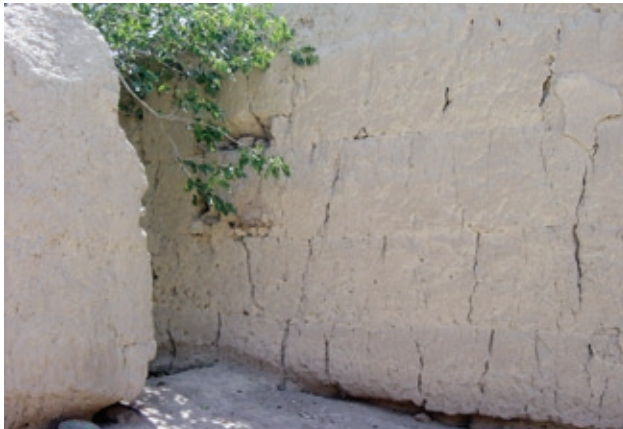
FIGURE 4 Pisé lifts in a mosque in Armenia. The visible lifts include organic fiber.

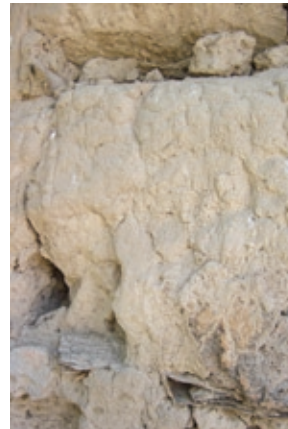
FIGURE 5 Bark ring beam, Armenia.

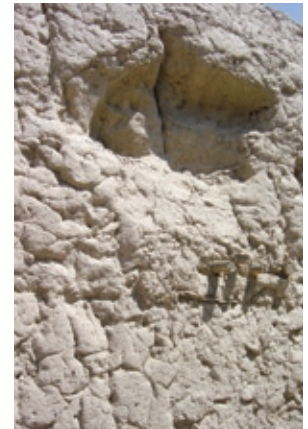
FIGURE 6 Timber-edged stitch with additional twig reinforcement, Armenia.

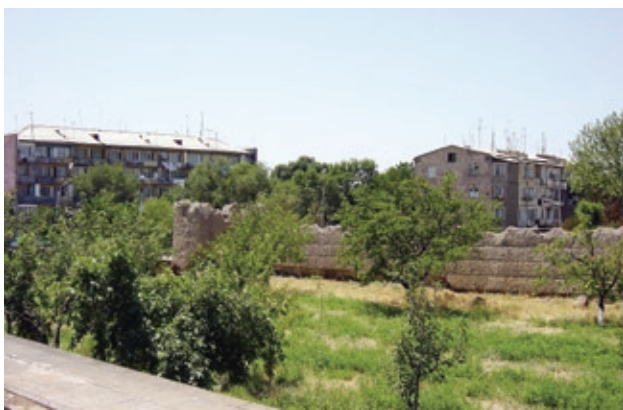
FIGURE 7 Pisé city wall, Yerevan, Armenia. There are regular horizontal lifts, each lift line concealing a turf lift.

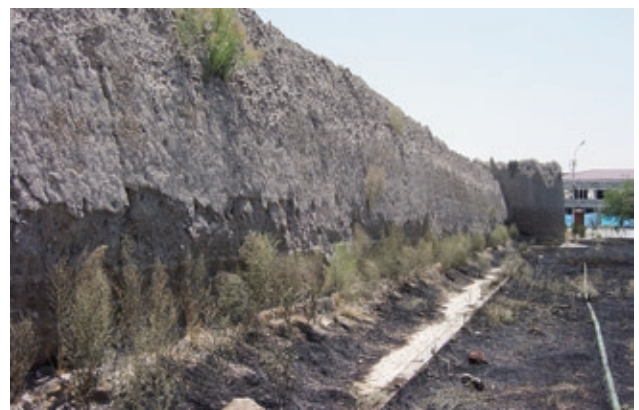
FIGURE 8 City wall with pisé lifts, Armenia. A horizontal turf lift is revealed behind plasters on the lower wall.

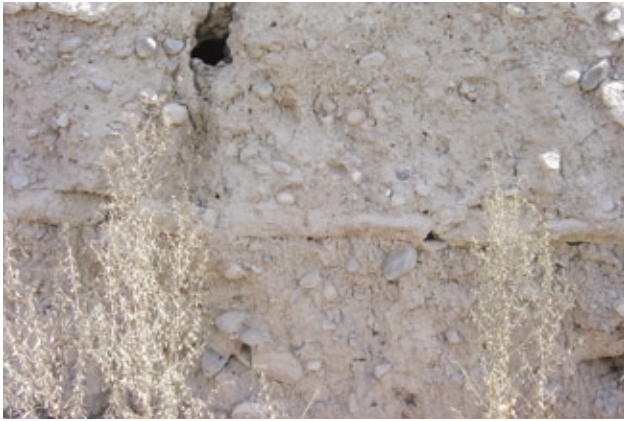
FIGURE 9 City wall with horizontal turf ring beam, Armenia.

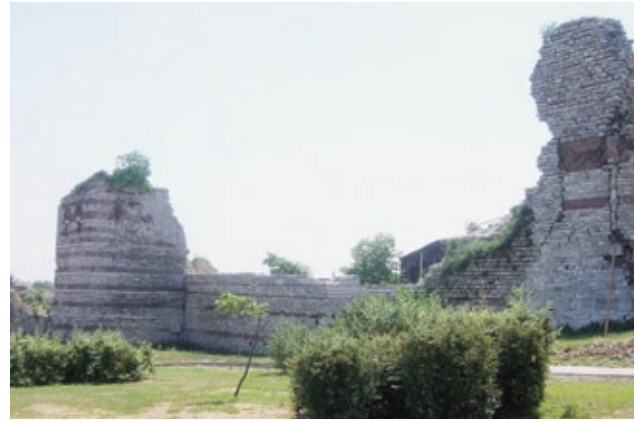
FIGURE 10 Byzantine city wall with brick ring beams, Istanbul.

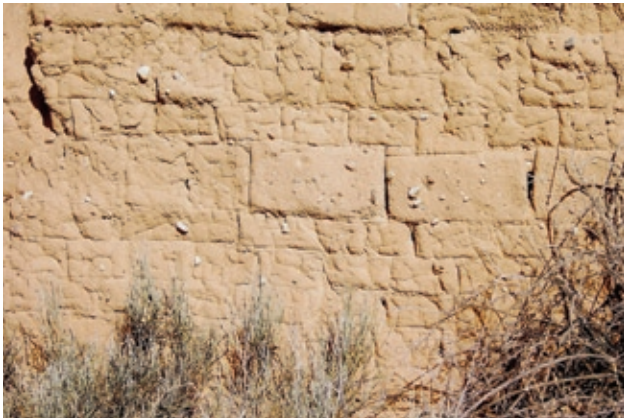
FIGURE 11 Nineteenth-century wall with large-block ring beam, Kyrgyzia. These modern remnants show horizontal changes in block size.

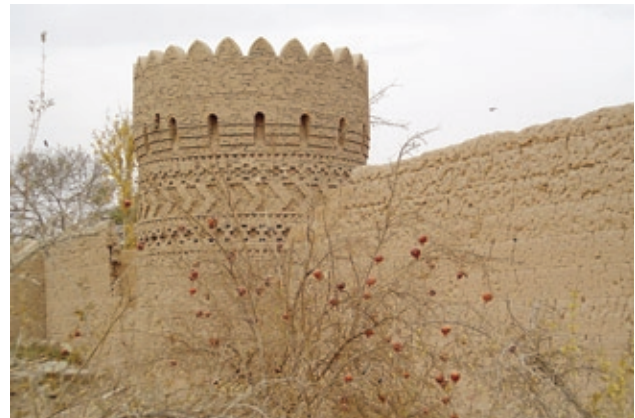
FIGURE 12 Adobe wall with horizontal vegetation mattresses in Yazd, Iran. The tower, which has been rebuilt, has no ring beam.

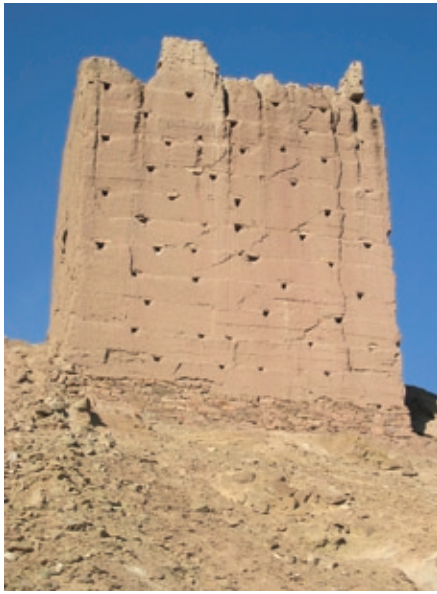
FIGURE 14 Pisé lookout tower in Ladakh, exhibiting typical tremor damage.

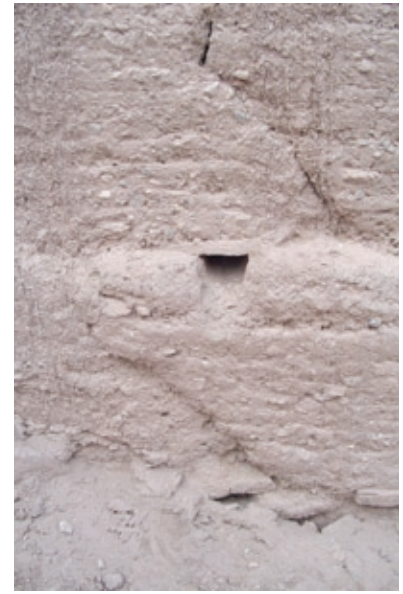
FIGURE 16 Detail of pisé, Ladakh.

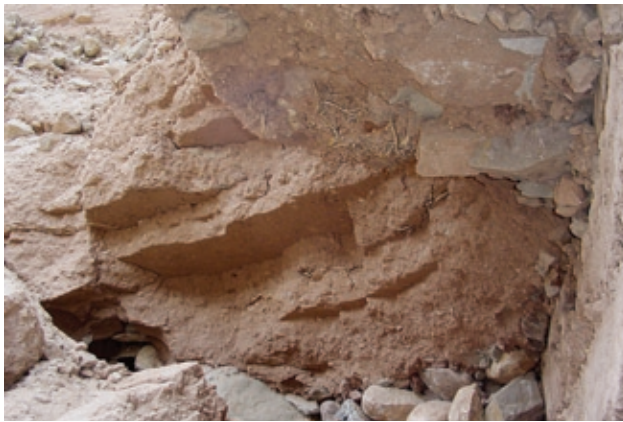
FIGURE 17 Detail of horizontal vegetation (*yagtsa*) mattresses at every third lift. Ladakh.

At a recent summer school in Ladakh, on the western Tibetan plateau, the author had the opportunity to demonstrate repairs to pisé structures from the fifteenth century. Here the pisé was constructed in short lifts of approximately 15 cm (about 6 in.) each. In every third lift, a vegetable “mattress” was rammed into the construction (fig. 17). Here cracks were stitched in the same techniques examined by the author across Asia, and

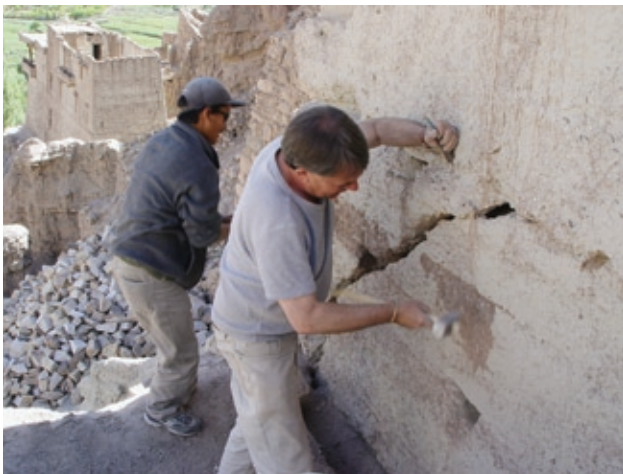
FIGURE 19 Cutting the chase in the shape of a staple.

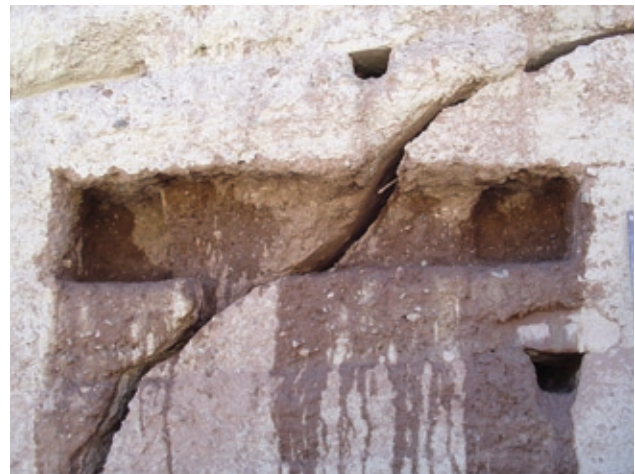
FIGURE 20 Wetting the finished chase.

eliminate suction leading to hairline cracks around the repair (fig. 20). The chase is then filled with alternative lifts of wet vegetation or woven matting with lifts of adobe bricks (figs. 21 and 22). The top course of the stitch some 10–15 cm (about 4–6 in.) deep is then wetted down and strongly but carefully mallet-dry-packed with loose material identical to that of the blocks (fig. 23). The dry packing presses down the whole stitch into a dense and strongly rammed fill (fig. 24). Alternate lifts are achieved at approximately 0.5 m (about 20 in.) intervals, internally and externally. The stitches are of varying length to allow for stitching of subsidiary cracks and to prevent the formation of new cleavage planes that may develop from stitches of regular length (figs. 25 and 26).

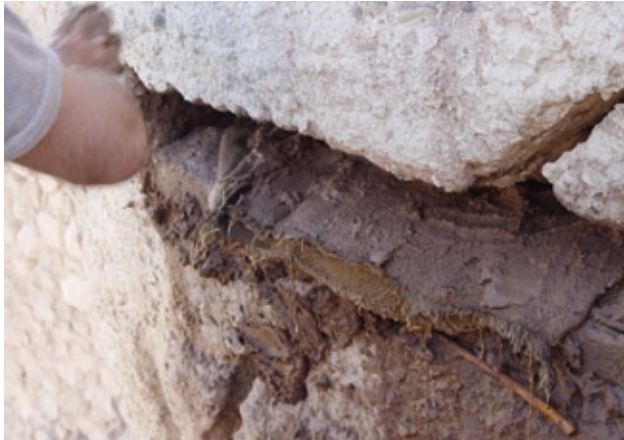
FIGURE 21 Filling the chase with *yagtsa* and hemp matting.
