Proceedings of the Getty Seismic Adobe Project 2006 Colloquium

Getty Center
Los Angeles
April 11-13, 2006

Editors
Mary Hardy
Claudia Cancino
Gail Ostergren

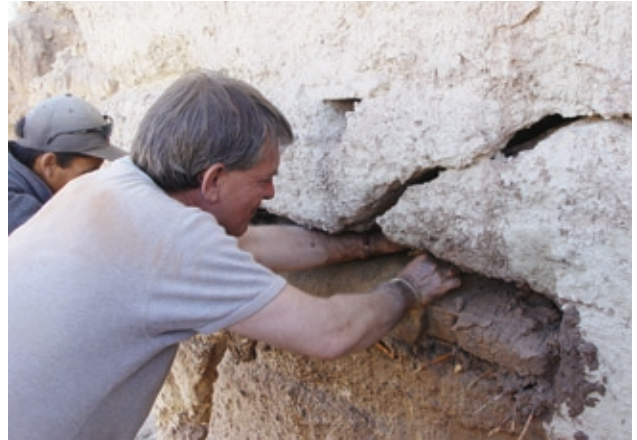
FIGURE 22 Filling the chase.

eliminate suction leading to hairline cracks around the repair (fig. 20). The chase is then filled with alternative lifts of wet vegetation or woven matting with lifts of adobe bricks (figs. 21 and 22). The top course of the stitch some 10–15 cm (about 4–6 in.) deep is then wetted down and strongly but carefully mallet-dry-packed with loose material identical to that of the blocks (fig. 23). The dry packing presses down the whole stitch into a dense and strongly rammed fill (fig. 24). Alternate lifts are achieved at approximately 0.5 m (about 20 in.) intervals, internally and externally. The stitches are of varying length to allow for stitching of subsidiary cracks and to prevent the formation of new cleavage planes that may develop from stitches of regular length (figs. 25 and 26).

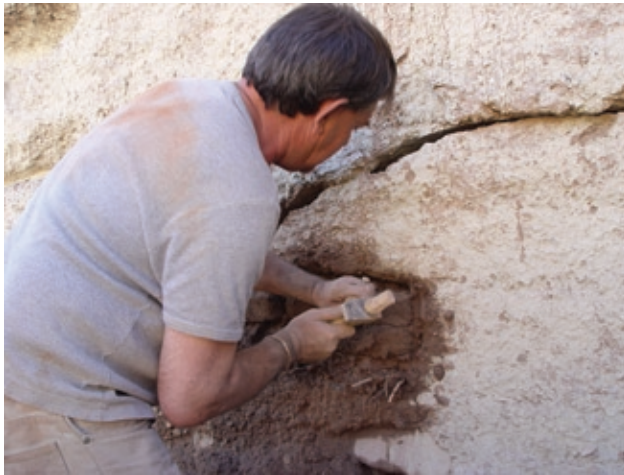
FIGURE 23 Dry packing the top of the stitch.

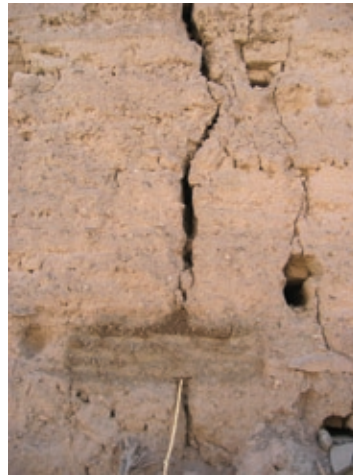
FIGURE 24 A completed stitch.

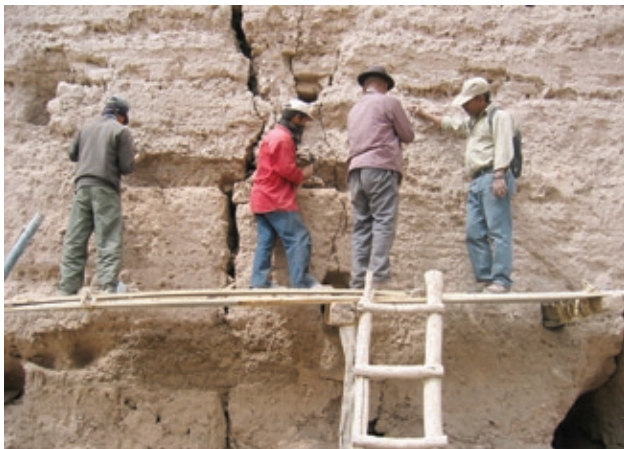
FIGURE 25 A second stitch above the preceding one.

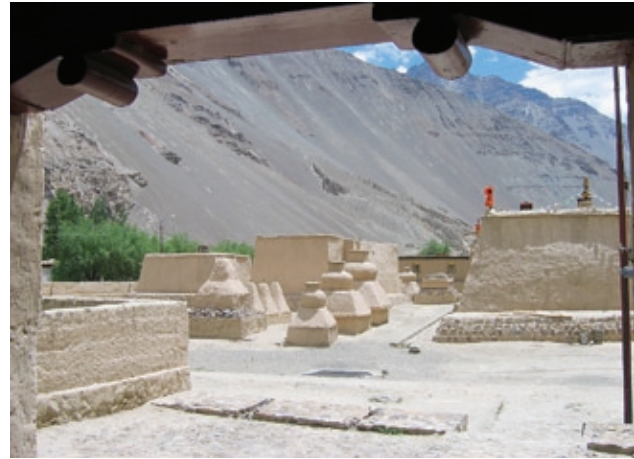
FIGURE 1 The tapered load-bearing adobe walls at a temple in Spiti provide extra stability to the building during seismic vibration.

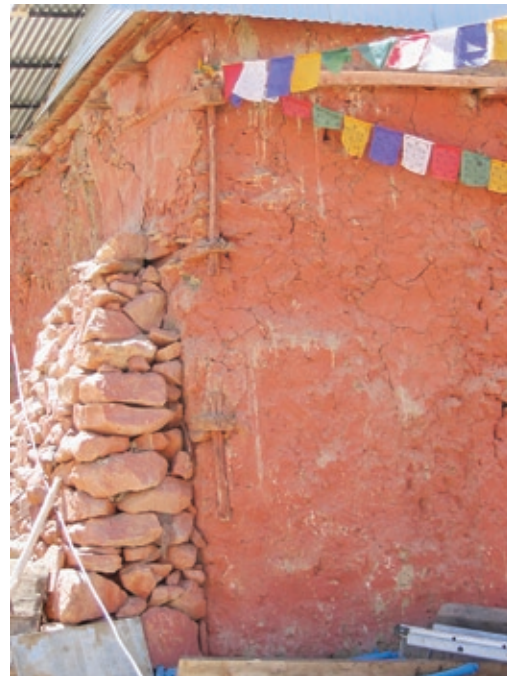
FIGURE 2 The external surface of the temple at Nako village in upper Kinnaur (AD 1025) is fitted with horizontal wooden wall ties and supporting rubble stone buttresses at the corners.

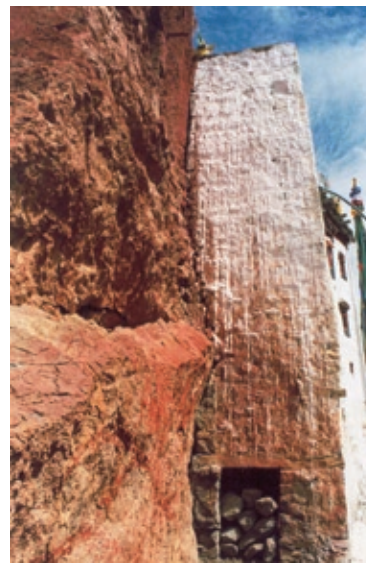
FIGURE 4 Vertical structural crack between buildings and the adjacent hill. This significant detachment was caused by the earthquake.

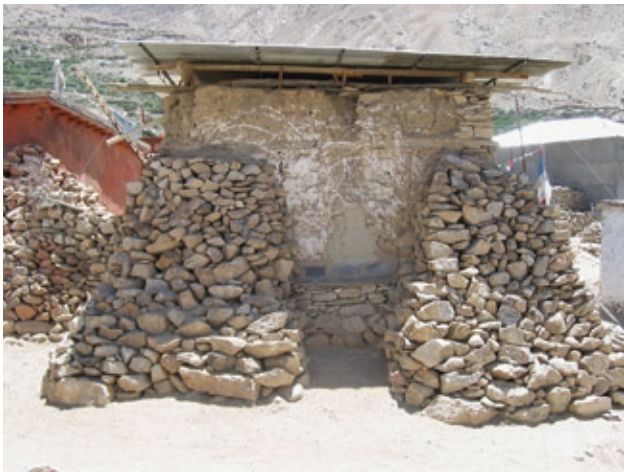
FIGURE 5 Piles of rubble stones stacked against the corners of the buildings after an earthquake in Nako village, to serve as buttresses to halt further outward movement of the masonry walls.

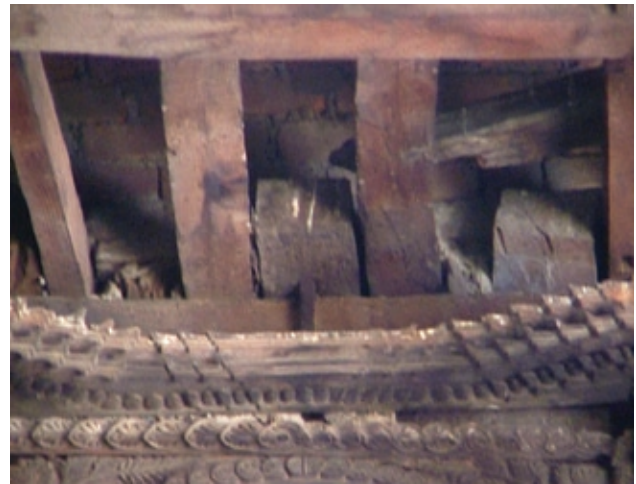
FIGURE 1 Timber pegs, or *chokus*.

A rather common feature of Nepalese traditional construction is the insertion of pegs, called *chokus*, to restrain floor joists from sliding over walls. Two vertical pegs are usually inserted through a joist on each side of the wall. Typically this will occur every two or three joists (fig. 1). From an external visual inspection, the *chokus* are easily identified at roof level, due to the presence of the overhang; however, they are also present at intermediate stories on joists passing over the internal wall. For the intermediate stories, the common practice is for the joists to be anchored with pegs on the internal face of the external wall and in between the two masonry leaves or wythes. This practice is very effective in preventing relative sliding of the floor structure on the walls in the presence of lateral forces and hence creates a box effect, while at the same time, given the flexibility of the pegs and their position, it does not prevent other movements associated with temperature and other environmental effects. The presence of the pegs is also

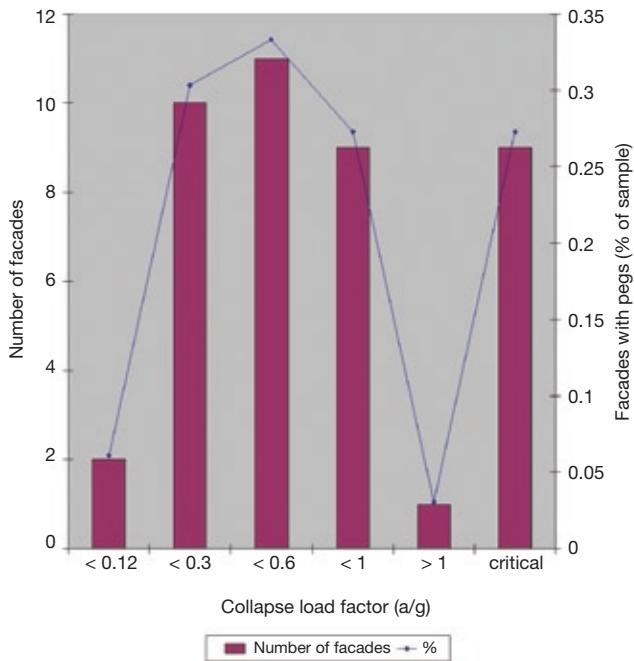
FIGURE 3 Occurrence of timber pegs (*chokus*) in the sample, and associated collapse load factor.

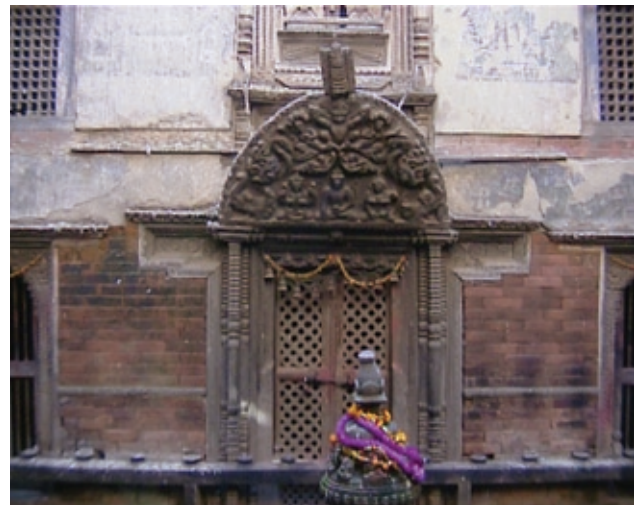
FIGURE 4 Structure with timber bands at mid-height of the wall.

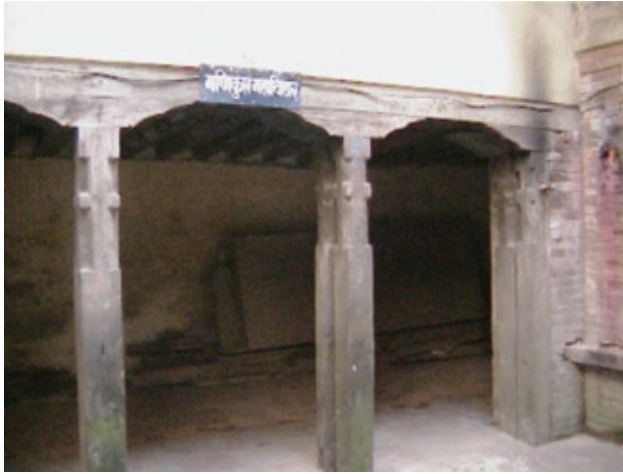
FIGURE 5 *Dalan* structure at the ground floor of a courtyard.

In seismic terms, the *dalan* construction can be compared to a modern, concrete, soft-story structure and its associated failure mechanism, as all connections are simply pinned. The only lateral restraint, when present, is provided by the shear strength of the masonry piers at the edge of the facade. Figure 5 shows a well-preserved

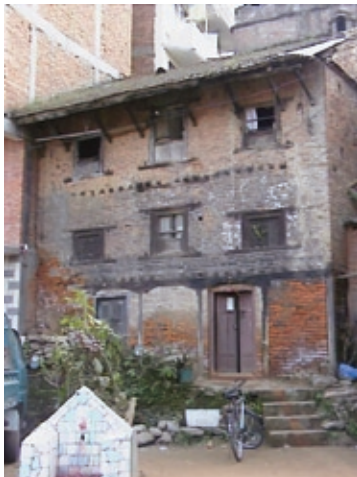
FIGURE 6 Original *dalan* structure walled in at a later time. Note that there is no external masonry pier adjacent to the external *dalan* column.

example of *dalan* in the internal courtyard of a *math* house, while figure 6 is an example of *dalan* walled in at a later stage to create more residential accommodation on the ground floor.

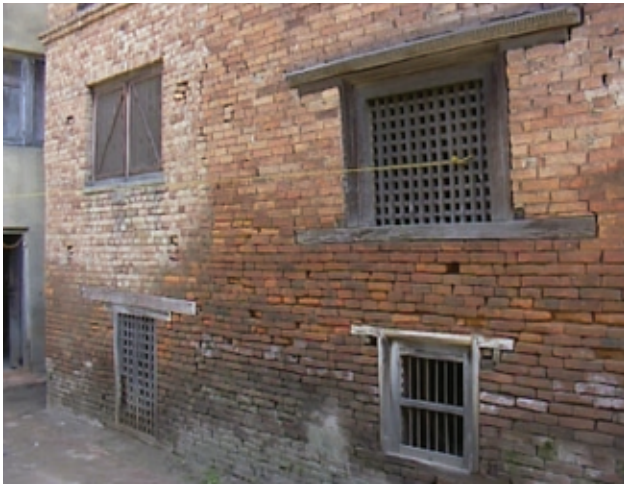
FIGURE 8 Malla period (ca. 1200–1767) window.

frame, one within the external masonry leaf or wythe and a slightly larger one within the internal masonry leaf or wythe. The two frames are connected by timber elements embedded in the masonry (fig. 8). The size of the windows within a story may vary, depending on the use of the room.

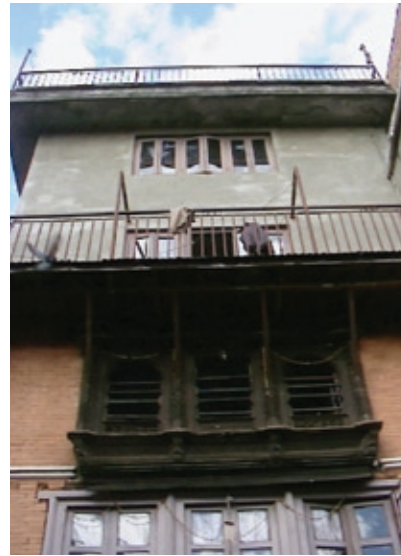
FIGURE 9 *San Jhya* window.

A feature of older buildings is the *San Jhya* window (fig. 9), a richly decorated window that spans most of the facade at the third-story level with seating framed within it. Later buildings have more homogeneous openings;

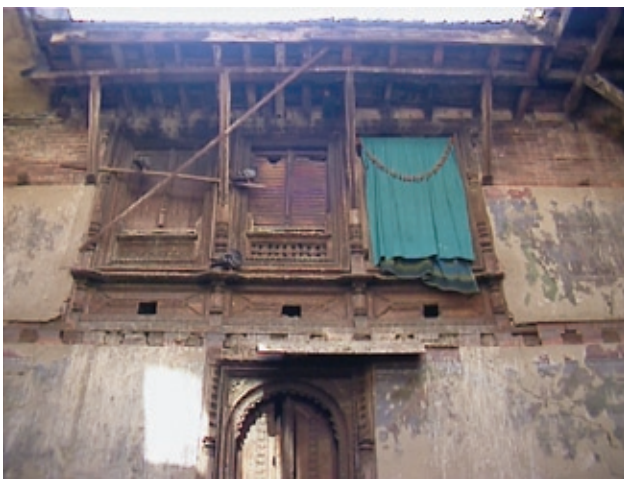
FIGURE 10 Full-height windows based on the *San Jhya* model.

they are usually taller and narrower, of about 800 mm (31.2 in.) in width and extending almost from floor to floor (fig. 10). In this typology, spandrels above windows are very narrow. In more recent construction or alterations, the concept of the *San Jhya* has been extended to each floor, so that there is very little masonry left on the front facade of the house.

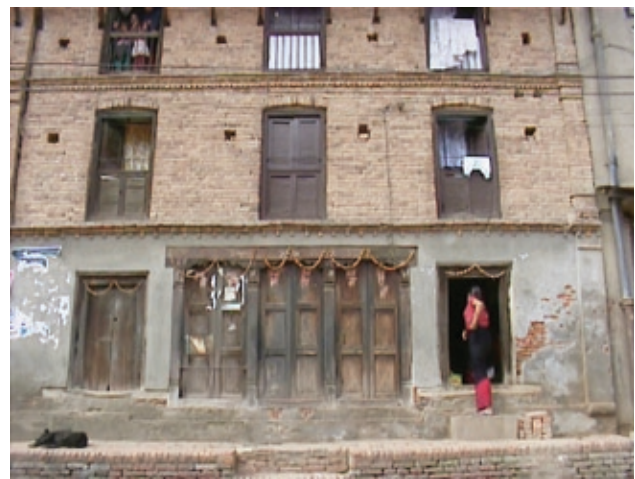
FIGURE 11 Full-height windows with flat brickwork arches.

In more modern construction, window lintels are made of flat brickwork arches and, in a minority of cases, by stone frames (fig. 11). Traditionally the openings are

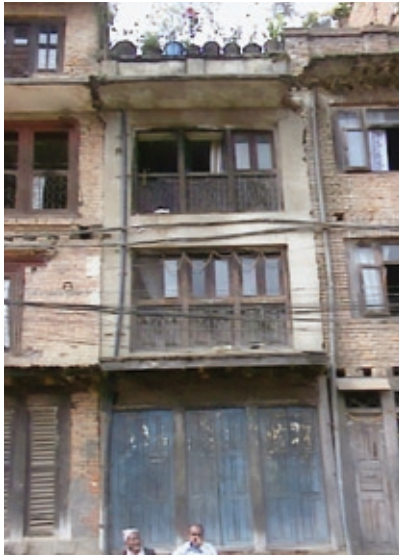
FIGURE 12 Full-width windows that do not leave sufficient width for the lateral pier.

The increasing alteration of the openings, due to population overcrowding and internal subdivision of units, has led, as mentioned above, to a reduction in the width of lateral piers (fig. 12). The lateral capacity of the facade is hence reduced to the piers' flexural capacity, which is modest because of the poor tensile strength of the masonry.

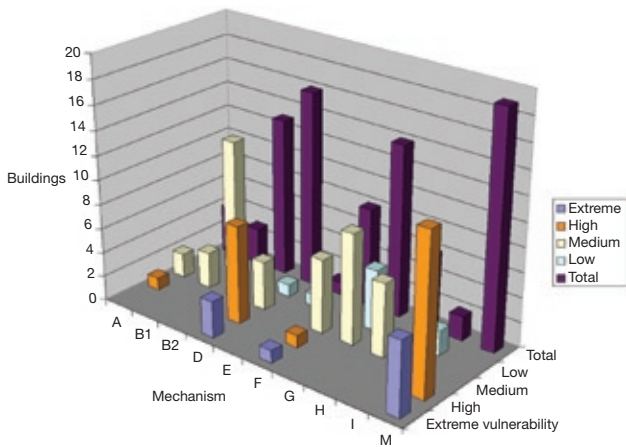
FIGURE 14 Distribution of failure mechanisms by class of vulnerability (see fig. 2 for mechanisms of failure).

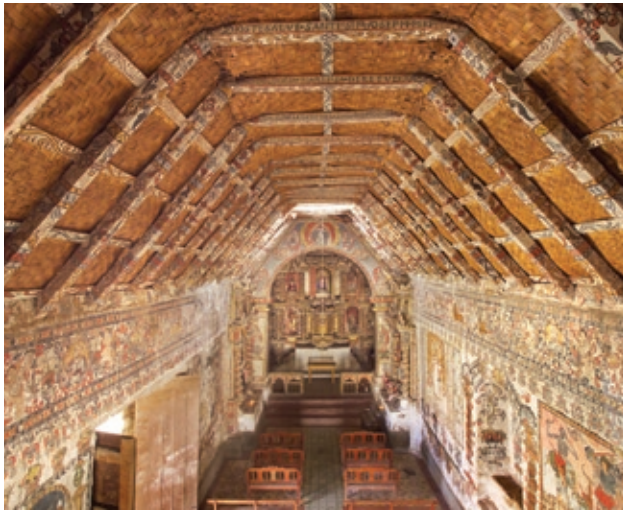
FIGURE 2 Interior of the Rapaz Missionary Chapel showing roof construction. Photo: Daniel Giannoni.

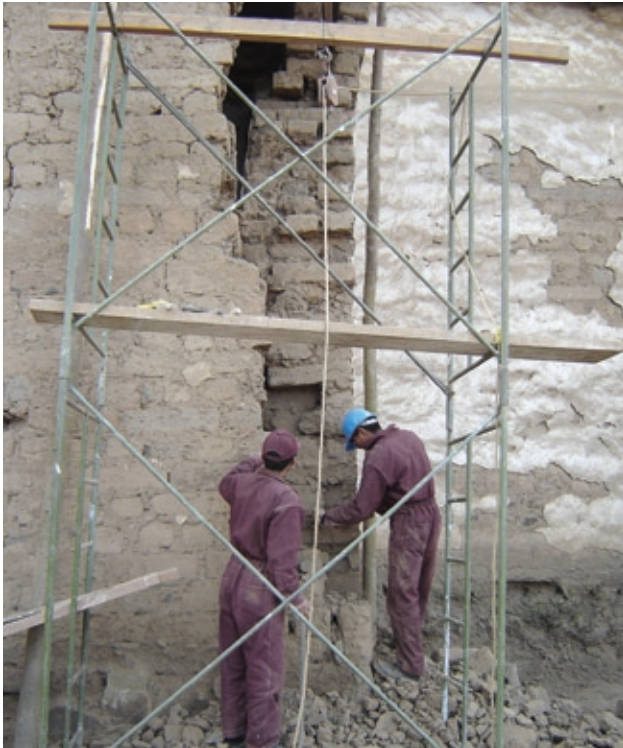
FIGURE 10 Damaged corner in the process of being demolished and rebuilt, San Pedro de Navan.

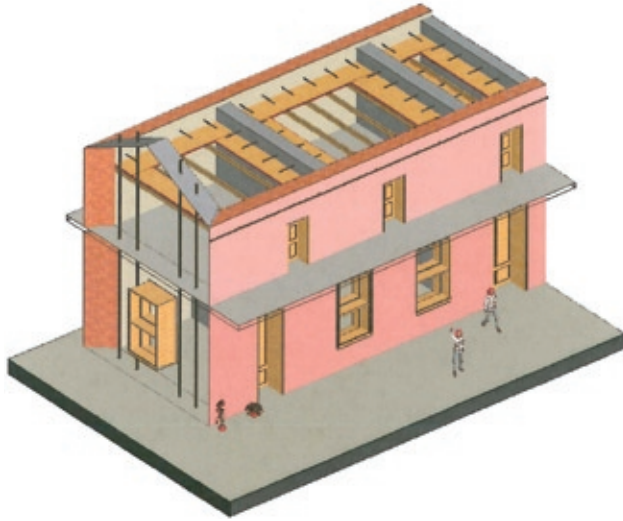
FIGURE 2 Selective use of full-height center core rods shown at the near gable-end wall, in the retrofit of the Castro-Breen Adobe. A partial plywood diaphragm with a horizontal exterior rod is used just below the roofline.

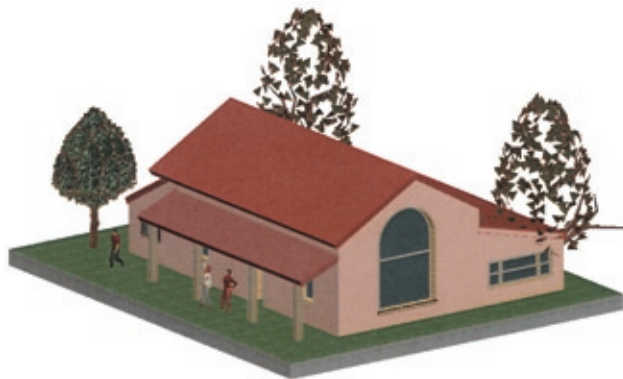
FIGURE 3 Casa de la Torre seen from the northeast corner. The retrofit included anchoring the adobe walls into the upper roof on all sides of the building; center core rods were also placed in the two walls that are visible.

Center core rods were installed into the north and east walls and anchored to the plywood roof diaphragm. The 0.75 in. (0.02 m) diameter center core rods were epoxy-coated steel reinforcing bars that were threaded on one end. The rods were placed in 2 in. (0.05 m) diameter holes that were then filled with a nonshrink cementitious grout. The north gable-end wall was already susceptible to collapse during strong ground motions, and the addition of the large window in this wall made it even more susceptible to severe damage or collapse. The long east wall is attached to the porch roof, but there are no transverse walls to provide additional lateral support. Therefore, full-height center core rods were also installed in the east wall.

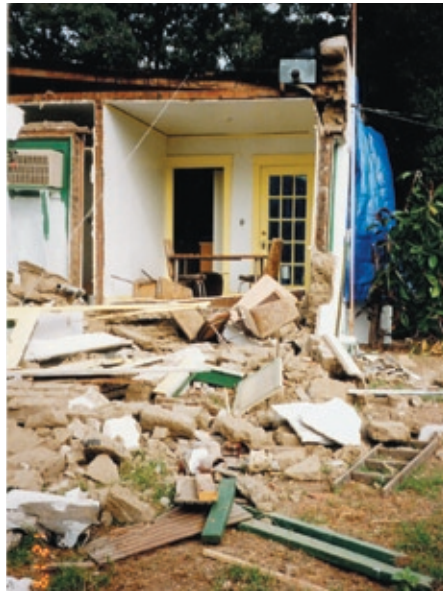
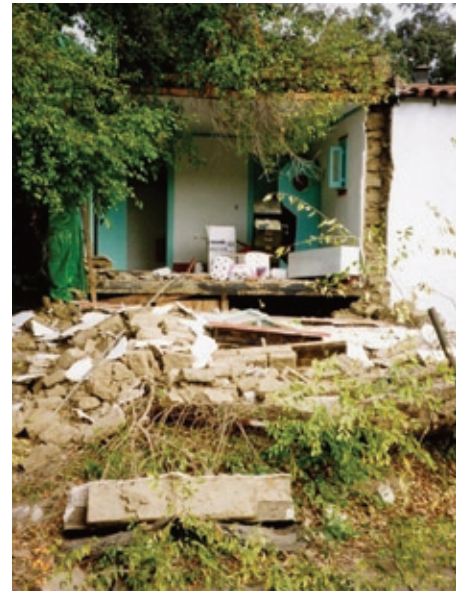
FIGURES 5A AND 5B Small Adobe at Rancho Camulos, which suffered severe damage during the 1994 Northridge earthquake. Shown here are the collapsed walls at the southwest corner (a) and the southeast corner (b) of the building.

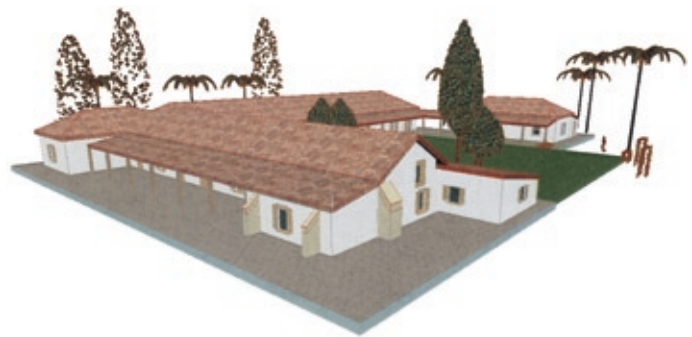
FIGURE 6 The Main Residence at Rancho Camulos seen from the southeast corner.

residence. As in the original construction, the exterior walls of the additions are 24 in. (0.6 m) in thickness, and the interior walls are 12 in. (0.3 m) thick. The walls in the additions are 9.5 ft. (2.9 m) in height. The building is shown in figure 6.

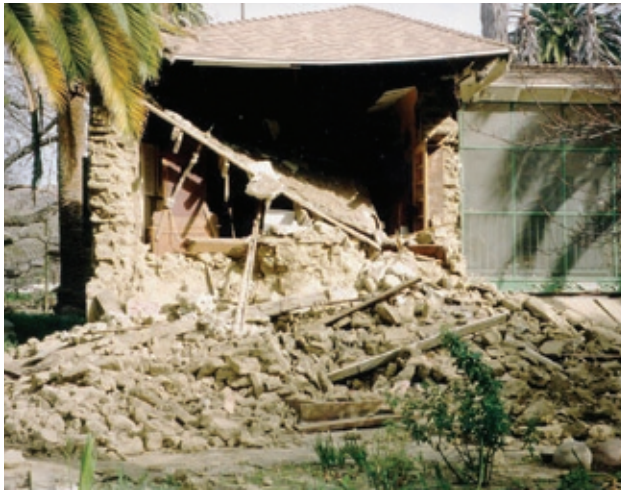
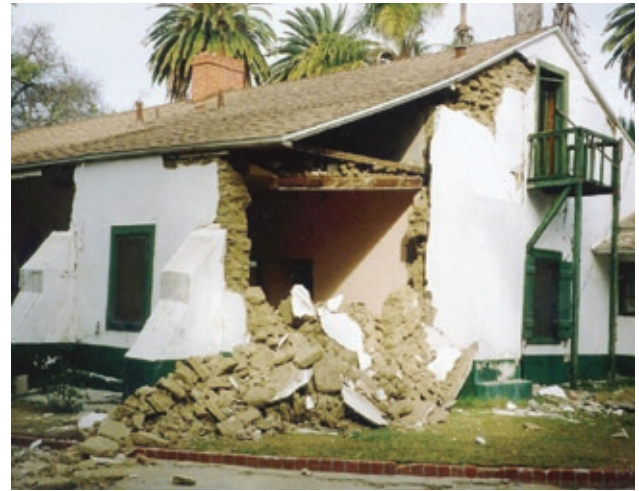
FIGURES 7A AND 7B Severe earthquake damage to the Main Residence at Rancho Camulos. Collapse of the walls occurred in the southwest corner (a) and the southeast corner (b) of the building.

The Main Residence at Rancho Camulos also suffered serious damage during the 1994 Northridge earthquake, as shown in figures 7a and 7b. There was crack damage to many of the walls throughout the building. The walls of the bedrooms in the southeast and southwest corners of the building collapsed and required reconstruction.

The retrofit of the Main Residence used a variety of retrofit techniques. The roof system was tied into the roof diaphragm with top-of-wall anchors attached with epoxy grout. The more severely damaged walls were reinforced with vertical straps on both sides of the walls. A perimeter cabling system was used throughout the building to provide longitudinal continuity to the walls. The second-floor framing was attached to the cabling system through the adobe walls. Finally, the walls that had collapsed were reconstructed with new adobe bricks and were reinforced with horizontal ladder ties in the mortar joint of every fourth course, and with vertical center core rods in 2 in. (0.05 m) diameter holes spaced at approximately 26 in. (0.66 m) on center; they were anchored in epoxy grout.

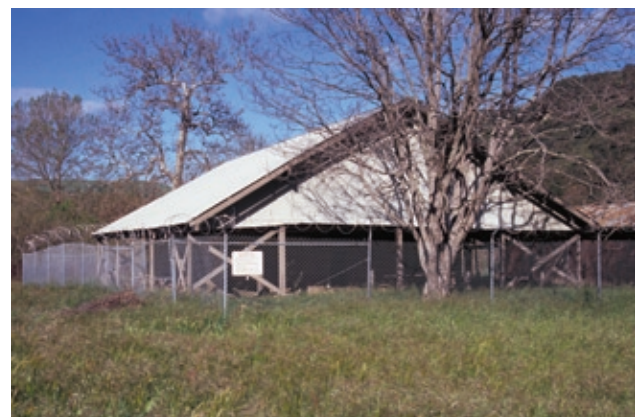
FIGURE 8 Las Cruces Adobe covered by a wood shelter that protects the ruins. Photo: Gail Ostergren.

The Las Cruces Adobe was constructed in the 1840s and has been unoccupied since the early 1900s. A shelter was built over the site in the 1970s to protect the fragile ruins (fig. 8). The walls (fig. 9) and roof framing are both in poor condition. What remains of the building is original and indicative of the type of construction characteristic of that period.

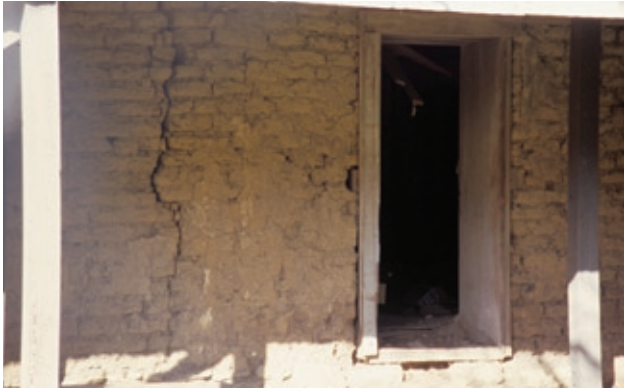
FIGURE 9 An interior wall of Las Cruces Adobe, representative of the general condition of the building. Photo: Gail Ostergren.

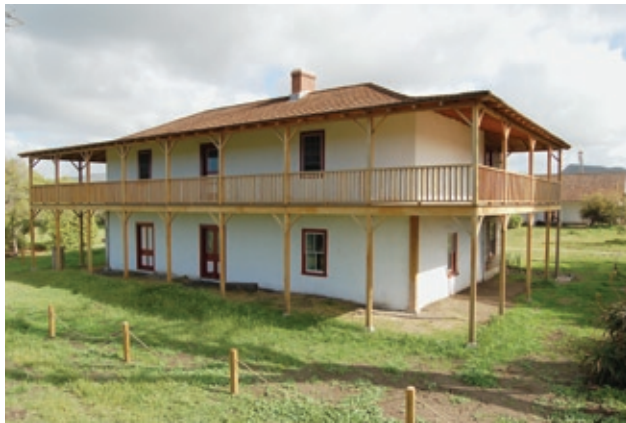
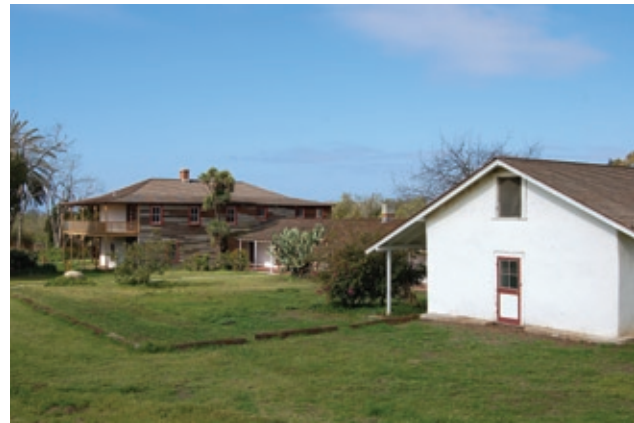
FIGURES 1A AND 1B The Las Flores complex with a ranch house (main house) consisting of the two-story Monterey block (a) and the Hacienda block, which is the long, low section connecting the Monterey block on the left and the carriage house on the right (b).

Built in 1868, the Las Flores complex includes a ranch house, or main house, consisting of a formal two-story Monterey block and a long, low Hacienda block with rooms opening onto a *portal*, or porch (figs. 1a and 1b). There is also an attached carriage house. The Las Flores site is one of a few authentic nineteenth-century adobe ranch houses combining the Hacienda and the Monterey styles, which are unique to California. The United States Marine Corps, the National Park Service (NPS), the Graduate Program in Historic Preservation at the University of Vermont, and private sector architectural and engineering professionals have partnered in the planning, design, and stabilization of the building complex.

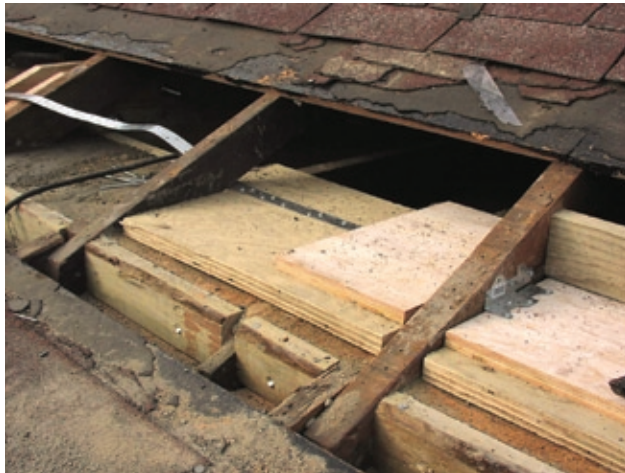
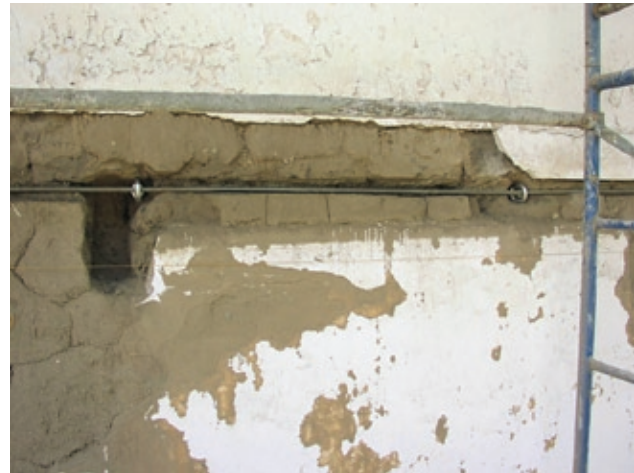
FIGURES 4A AND 4B Seismic retrofits for the main house. The tops of the walls were leveled by the addition of a pisé course. The wooden bond beam incorporated a stainless steel strap and was fastened to the walls with center core pins and to the roof frame with commercially available metal clips (a). At the level of the second-floor frame of the Monterey block, a stainless steel belt was installed below exterior plaster and tied back to floor joists with eyebolts and Simpson anchor brackets (b).

Where the tops of the adobe walls were uneven and out of level, the walls were capped with soil cement (portland cement and local soil mixed at a ratio of approximately 1 part by volume of portland to 5-7 parts

ets were fastened to every other interior joist behind the interior surface of the wall. A threaded eyebolt was fastened into the Simpson tie with the eye set in the channel on the exterior. A 1.27 cm (0.50 in.) threaded rod was inserted into the eye, wrapped around the entire house, and fastened at the four corners to an L flange. On the east and west end walls in line with parallel running joists, stabilization required longer rod connectors drilled through two perpendicular joists, bolted with nuts and washers, and extending through the adobe wall to tie to the belting rod. This type of belted anchorage will improve the ductility of the wall construction. The anchoring capacity no longer depends on the strength of the adobe; rather, it serves to restrain the adobe wall. It is highly unlikely that the rod could be pulled through the wall, and only localized crushing of the adobe is anticipated in a seismic event.

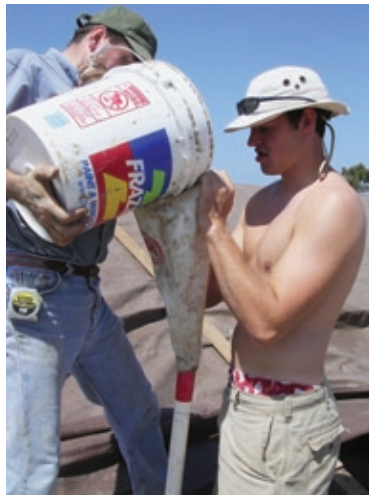
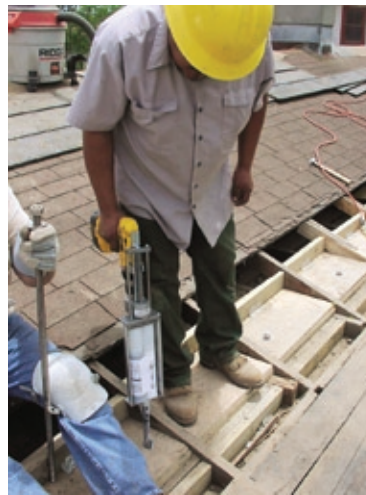
FIGURES 5A AND 5B Grout techniques for the Las Flores Adobe retrofit. For the carriage house, techniques were developed for installing an earthen grout (a). In contrast, the crew had used a resin-based grout for installing center core pins in the main house retrofit (b). The earthen grout is more compatible with the historic wall materials and provides greater possibilities for reversibility of the treatment.

Rods were fixed into place with a soil-cement grout (fig. 5a). This choice marked a major change in design and represents a desire for greater compatibility and reversibility of treatments. In contrast, the main house retrofit system relied on a resin-based grout with strength characteristics in excess of design criteria (fig. 5b). Earthen grouts are compatible with historic adobe materials and offer greater potential for reversibility and thus were chosen for the carriage house. The grout mix selected was similar to one developed by Nels Roselund (1990) and tested for use in the repair of the historic Pio Pico Adobe in Whittier, California; it consisted of adobe soil, sand, a small amount of portland

Initial testing of the grout included qualitative evaluation of material samples with respect to shrinkage, hardness, abrasion resistance, and permeability, and injection of the grout into test panels that then could be visually evaluated to assess crack-filling properties. Subsequent testing by Krakower and Associates included tension and shear tests of anchors installed with the grout, in order to determine bond strength of the grout to anchors and to adobe wall materials. At Las Flores, sample cylinders were made for conducting compression strength tests in the lab. Tests were conducted on a Tinius Olson machine operating in the lowest range (0–272 kg, 0–600 lb.). Results, including load versus deflection and shear angle, were consistent from sample to sample.

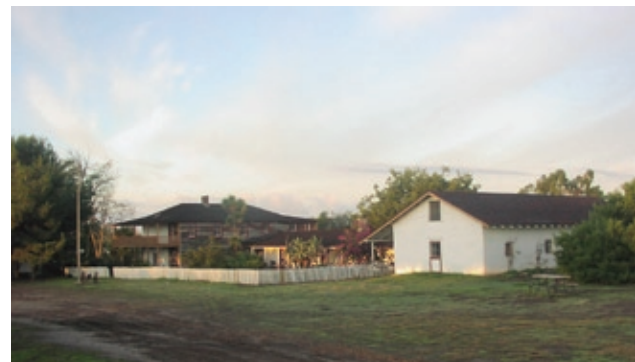
FIGURE 6 The Las Flores Adobe after completion of structural and seismic stabilization of the buildings. By the close of the 2004 construction season, porches on the Monterey block were reinstated, building envelopes were secured against weather, and interior rehabilitation was started.

Key to the success of the Las Flores project—measured by limited alteration to the historic character-defining features of the house—was the multidisciplinary planning and design process, and the flexibility built into the construction phase by the use of architectural and engineering services throughout. This practice prevented the break in linkage among disciplines that often occurs in large construction campaigns. Management participation ensured that project goals and resource allocation stayed viable throughout. Bringing the University of Vermont into the process offered capacity building, training, and research opportunities. The design solutions represent a minimal and efficient treatment approach that achieved the basic goals while simultaneously accomplishing resource preservation agendas (fig. 6).
