Seismic Response of Fiber-Reinforced and Stabilized Adobe Structures

Mohammad Shariful Islam and Kazuyoshi Iwashita

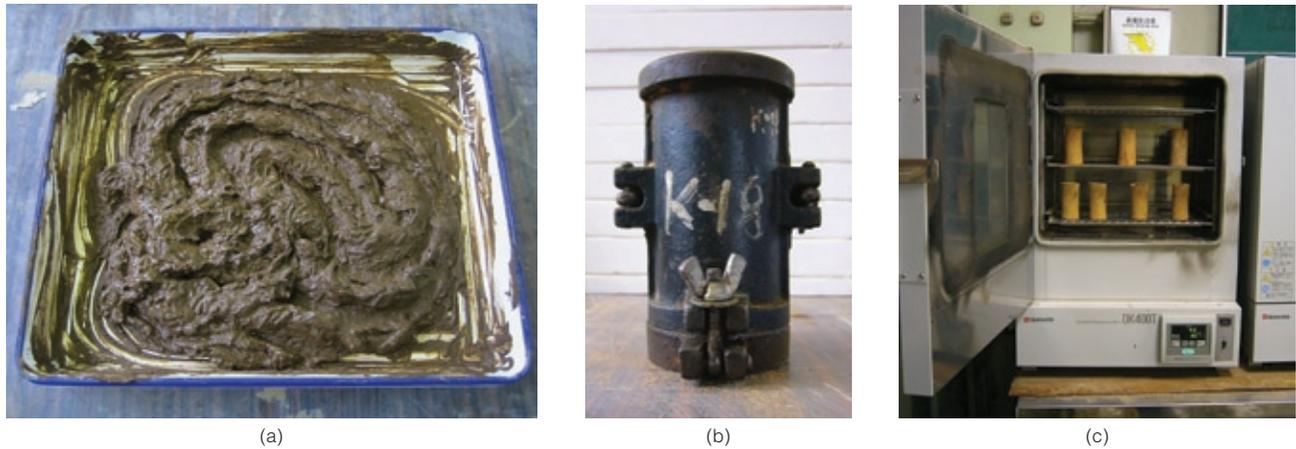
FIGURES 2A-C Preparation of adobe specimens: soil-sand slurry (a); steel mold for specimen preparation (b); and oven used for drying specimens (c).

Specimens were prepared from soil-sand mixture, fiber, and cement. At first, water and soils were mixed vigorously so that a homogeneous mix was formed. The mix was then poured into a steel mold 5 cm (2.0 in.) in diameter and 10 cm (3.9 in.) in height in three layers. Each layer was compacted to remove the entrapped air. After that, the mold with the sample was kept in an oven at 60°C for three days. Finally, specimens were taken out from the mold and returned to the oven at the same temperature for three more days. Figures 2a–c show the details of specimen preparation using an oven.

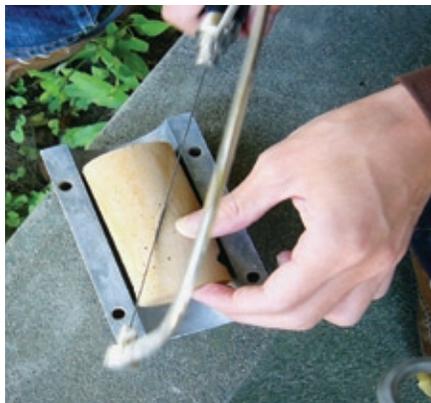
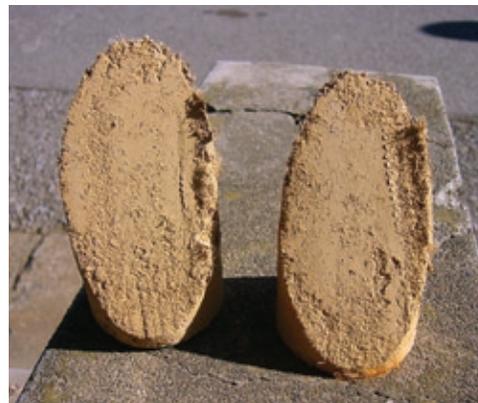
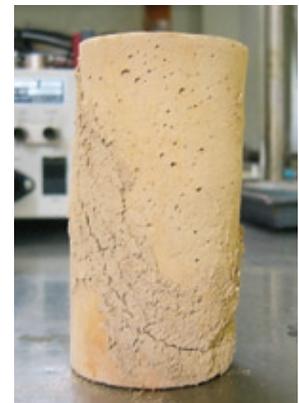
FIGURES 7A–C Making of sandwich specimens: cutting of cylindrical specimens at 60° to horizontal (a); two parts of specimen after cutting (b); and a sandwich specimen (c).

Past earthquakes showed that mortar is the weakest part of adobe structures. Cylindrical sandwich specimens were prepared to investigate the effectiveness of selected reinforcing material in improving mortar characteristics. Sandwich specimens were prepared cutting cylindrical specimens into two pieces at 60° to horizontal, since failure of specimens under uniaxial compression showed that specimens failed at 60°–70° to horizontal. Mortar of about 0.5 cm (0.2 in.) thickness was inserted between the two parts. The sandwich specimens were then kept in an oven at 60°C for three to four days for drying. Figures 7a–c show the details of the sandwich specimen preparation.

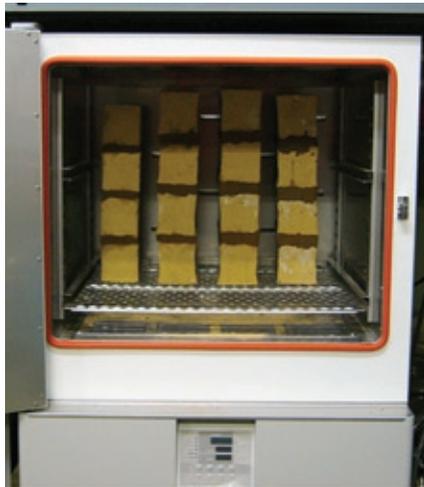
FIGURES 9A AND 9B Procedure for adobe model making. Models are placed in the oven (a), resulting in a finished adobe model (b).

Each model was constructed using four blocks. At first, mortar of about 1–2 cm (0.4–0.8 in.) thickness was inserted between blocks. After that, the model was kept in an oven at 40°C for two days. Then the models were kept in the oven for two more days at 60°C. Details of adobe model making have been presented in figures 9a and 9b.
