New Zealand: Aseismic Performance-Based Standards, Earth Construction, Research, and Opportunities

Hugh Morris

Abstract: *New Zealand has a combination of owner-built earth buildings and high-value earth houses built by contractors. This paper outlines the historical context of earth construction, comments on the status of conservation, gives an overview of the development of the New Zealand earth building standards, and identifies research opportunities.*

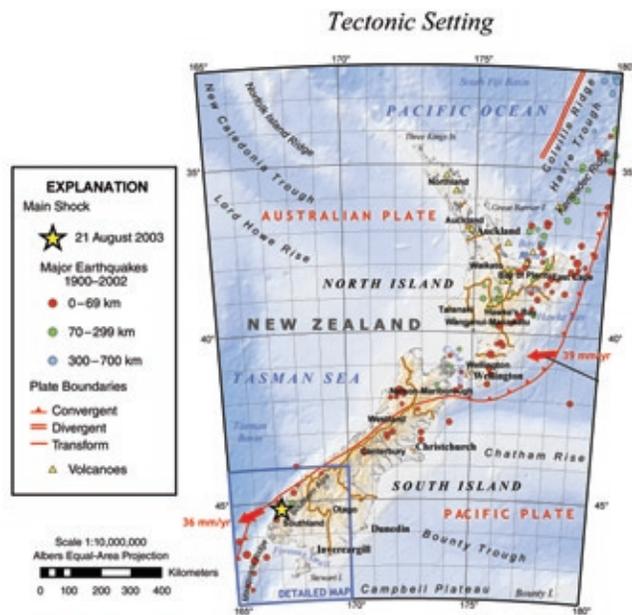
FIGURE 1 New Zealand seismicity, 1900–2002, and major earthquake events and volcanoes. Detail of USGS poster (National Earthquake Information Center 2003). Credit: U.S. Geological Survey, Department of the Interior.

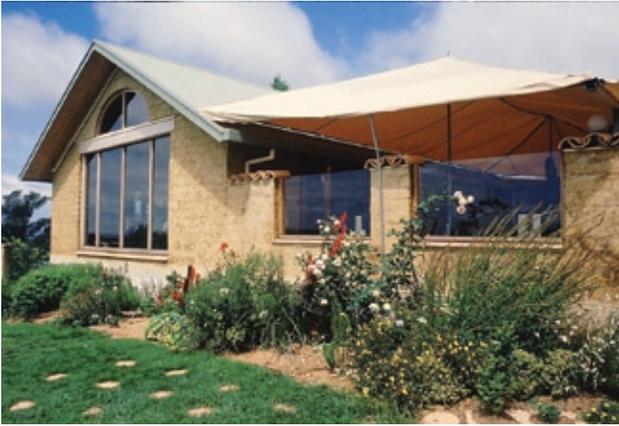
FIGURE 2 Typical midrange adobe home in New Zealand.

Of the extant older earth buildings, those of adobe and cob construction are the most common. The main forms of earth construction at present in New Zealand are adobe, rammed earth, and pressed brick. Adobe bricks usually use straw in the mix, and there is a range of construction, from small owner-built houses up to luxury homes built by specialist contractors. Some mid-range adobe houses are shown in figures 2 and 3.

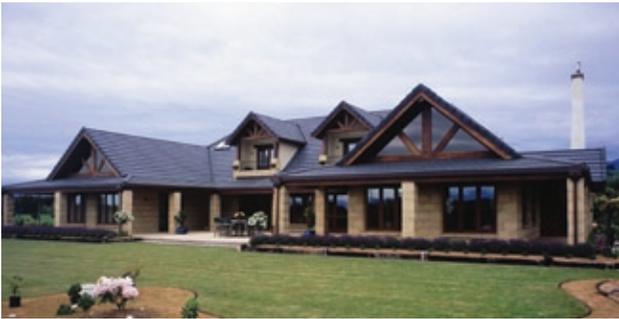
FIGURE 3 Typical midrange adobe home in New Zealand.

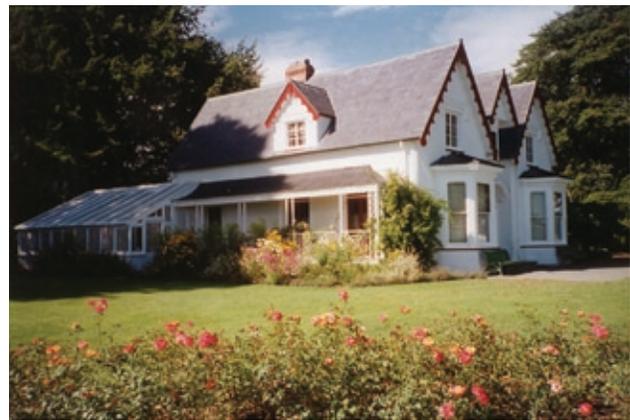
FIGURE 4 Broadgreen House, with lower-story cob walls. Photo: Richard Walker.

Another notable example of an 1850s earth building that has survived three major earthquakes (MMI VII or greater) is Broadgreen House, near Nelson in the upper South Island (fig. 4). The apparent factors that account for the good performance of this large two-story cob building are the low height-to-thickness ratio of the earth walls, the relatively few openings, sufficient earth bracing walls in each direction, the first floor acting as a structural diaphragm, and relatively good-quality earth wall construction. The 50 cm (19.5 in.) thick earth walls of the ground floor reach 2.7 m (8.9 ft.) to the first floor, giving a height-to-thickness ratio of 5.4, which complies with present design criteria for unreinforced earth walls in New Zealand.

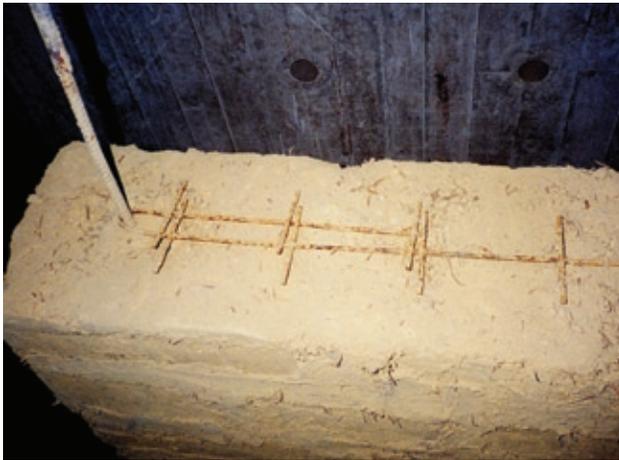
FIGURE 12 Detail of reinforcement, with vertical rods in holes through the adobes and horizontal reinforcement wrapped around the vertical rods. Now geogrid is more typically used for horizontal reinforcement.

wall. This graph shows that slipping in the mortar planes provided effective ductility to the wall system (Morris 1993). Figure 11 illustrates the crack patterns in a wall with both horizontal and vertical reinforcing, as observed by Jacobson. It shows the crack growth progression of the wall as the reversing loads were applied; the load to the right is recorded as positive. Figure 12 shows the reinforcing detail during demolition following the wall tests.

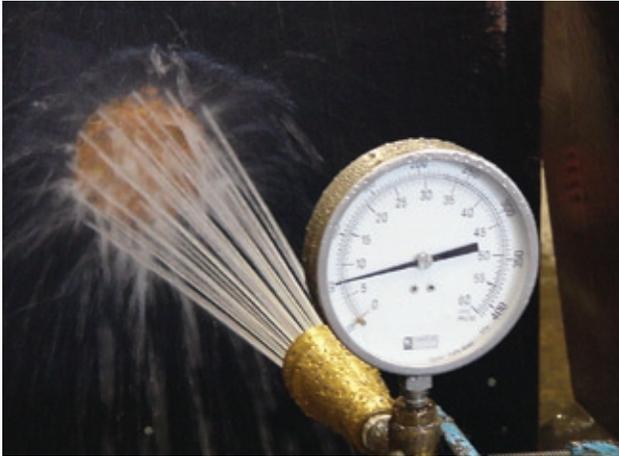
FIGURE 13 Accelerated degradation water spray test.

The durability of earth walls is of concern in both temperate and tropical climates. A need exists for a test approach that is simple and low in cost. The New Zealand standards have two tests modified from those developed in Australia. The accelerated spray test uses an expensive standard nozzle and sprays a very severe jet, as shown in figure 13. This can cause the failure of otherwise satisfactory adobe materials. This severe test is complemented by a very simple drip test, where water drops 40 cm (15.6 in.) onto the surface. This technique was checked by some simple laboratory experiments that considered raindrop energies, but the test needs field verification.

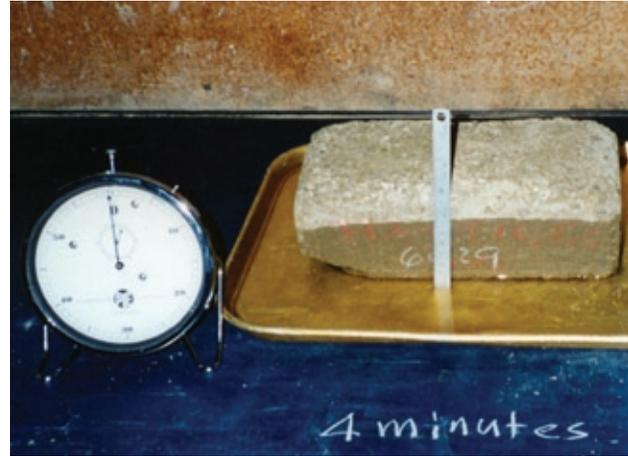
FIGURE 14 Surface soak test. Note that the moisture has nearly penetrated the soil-cement brick after four minutes.

With guidance from members of the New Zealand Earth Building Standards Committee, I also developed a surface wetting and drying test in which moisture penetration and surface effects from a single soaked surface are observed. The brick sits 1.5 mm (0.06 in.) off the bottom of a tray, and the water depth is maintained at 10 mm (0.4 in.) (as shown in fig. 14) for a fixed time, after which the deterioration is evaluated. This test is repeatable because of its ease of setup, and it has a number of empirical visual checks that indicate suitability; but only a limited number of trials were undertaken.

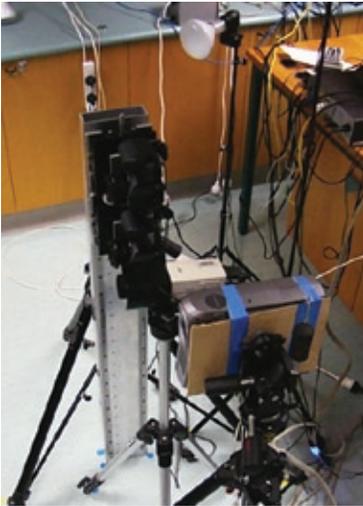
FIGURE 15 Stereo cameras set up with light projector and video for calibration. Photo: John Morris, University of Auckland.

Another approach is to monitor weather conditions precisely and to measure surface degradation on real buildings as a function of time. A number of methods for obtaining a surface mold were attempted, but all damaged the surface of adobe. John Morris of the University of Auckland Department of Computer Science has recently supervised experimental work using stereophotogrammetry to give precise, noninvasive measurements of surface degradation (Lin 2006; Lin, Morris, and Govignon 2007). Figures 15 and 16 show the laboratory test camera arrangement, which has the capability of precise adjustment. The data projector is used to create a Gray code line shift pattern of light for calibration.
