Observing and Applying Ancient Repair Techniques to Pisé and Adobe in Seismic Regions of Central Asia and Trans-Himalaya

John Hurd

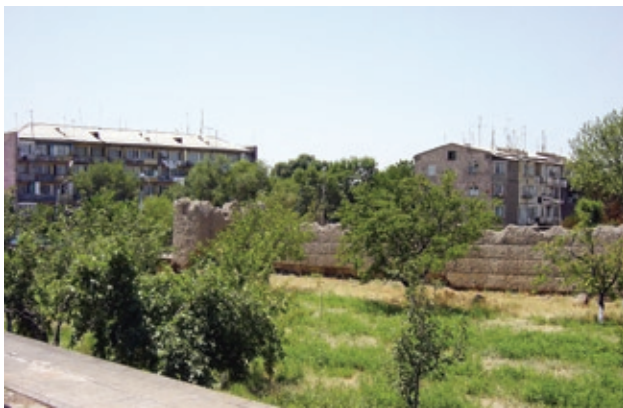
FIGURE 7 Pisé city wall, Yerevan, Armenia. There are regular horizontal lifts, each lift line concealing a turf lift.

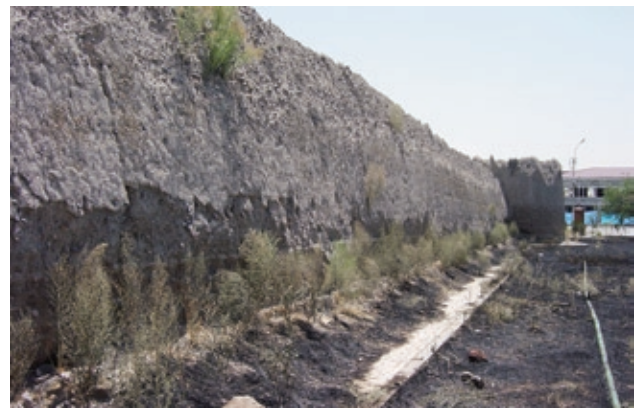
FIGURE 8 City wall with pisé lifts, Armenia. A horizontal turf lift is revealed behind plasters on the lower wall.

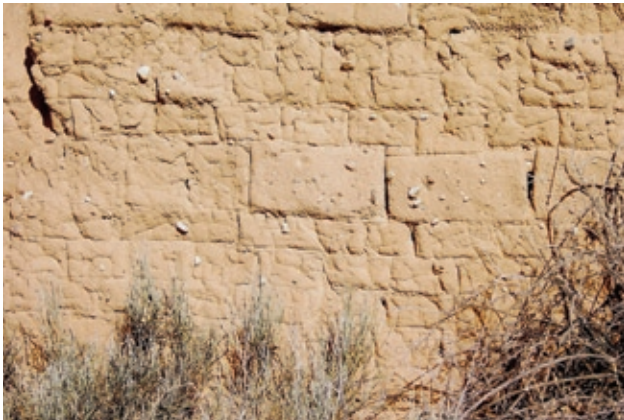
FIGURE 11 Nineteenth-century wall with large-block ring beam, Kyrgyzia. These modern remnants show horizontal changes in block size.

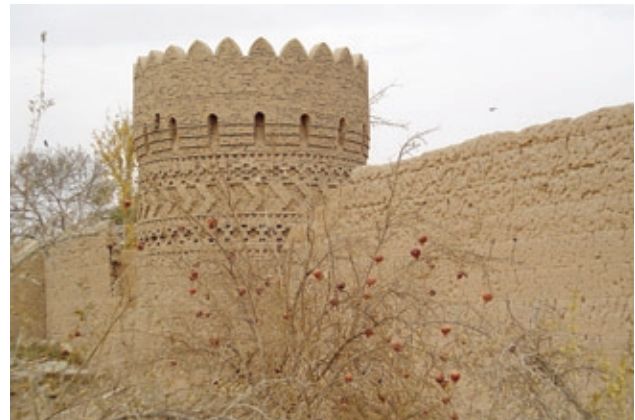
FIGURE 12 Adobe wall with horizontal vegetation mattresses in Yazd, Iran. The tower, which has been rebuilt, has no ring beam.

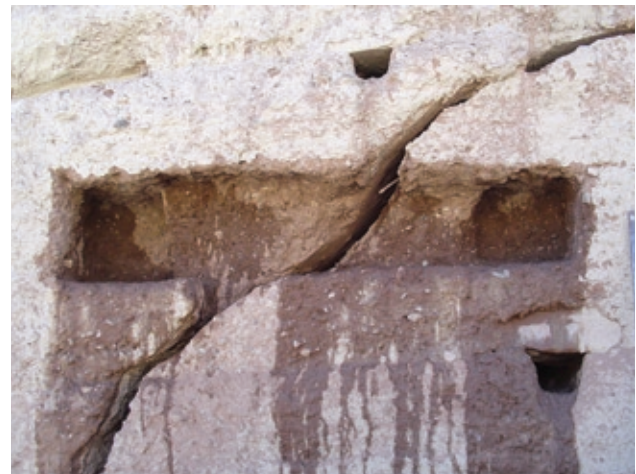
FIGURE 20 Wetting the finished chase.

eliminate suction leading to hairline cracks around the repair (fig. 20). The chase is then filled with alternate lifts of wet vegetation or woven matting with lifts of adobe bricks (figs. 21 and 22). The top course of the stitch some 10–15 cm (about 4–6 in.) deep is then wetted down and strongly but carefully mallet-dry-packed with loose material identical to that of the blocks (fig. 23). The dry packing presses down the whole stitch into a dense and strongly rammed fill (fig. 24). Alternate lifts are achieved at approximately 0.5 m (about 20 in.) intervals, internally and externally. The stitches are of varying length to allow for stitching of subsidiary cracks and to prevent the formation of new cleavage planes that may develop from stitches of regular length (figs. 25 and 26).

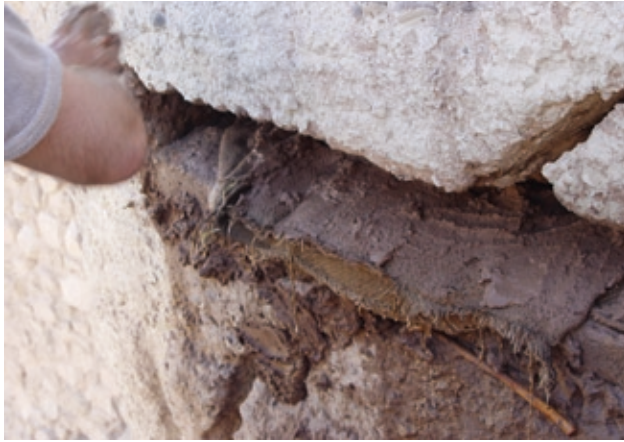
FIGURE 21 Filling the chase with *yagtsa* and hemp matting.

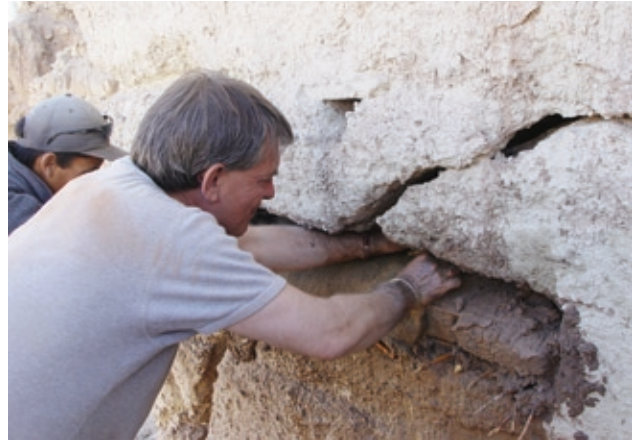
FIGURE 22 Filling the chase.
