# Seismic Vulnerability and Conservation Strategies for Lalitpur Minor Heritage

Dina D'Ayala

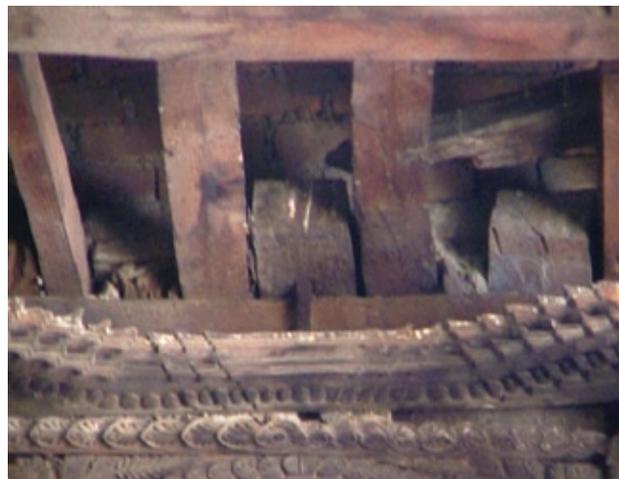
FIGURE 1 Timber pegs, or *chokus*.

A rather common feature of Nepalese traditional construction is the insertion of pegs, called *chokus*, to restrain floor joists from sliding over walls. Two vertical pegs are usually inserted through a joist on each side of the wall. Typically this will occur every two or three joists (fig. 1). From an external visual inspection, the *chokus* are easily identified at roof level, due to the presence of the overhang; however, they are also present at intermediate stories on joists passing over the internal wall. For the intermediate stories, the common practice is for the joists to be anchored with pegs on the internal face of the external wall and in between the two masonry leaves or wythes. This practice is very effective in preventing relative sliding of the floor structure on the walls in the presence of lateral forces and hence creates a box effect, while at the same time, given the flexibility of the pegs and their position, it does not prevent other movements associated with temperature and other environmental effects. The presence of the pegs is also

effective in limiting any substantial out-of-plane movement of the external walls due to uneven settlements.

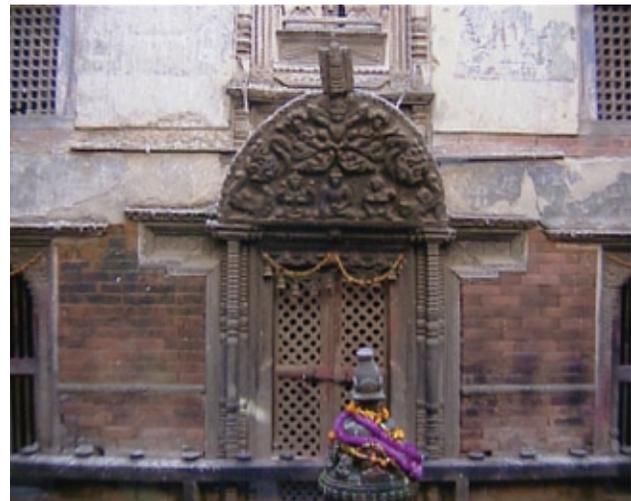
FIGURE 4 Structure with timber bands at mid-height of the wall.

Most commonly, the pegs butt on a timber wall plate running along the width of the facade on which the joists sit. In most cases the timber wall plate is positioned directly above the level of the window frames, spanning the openings, and it runs the entire width of the facade (fig. 4).

A similar function is played by the timber bands included in the masonry at the mid-height of the wall within the masonry piers (fig. 4). Their presence is most effective when they run the entire length of the facade and continue around the corner, so as to form an effective ring beam that ties the orthogonal walls together. They are rather uncommon in the sample studied.

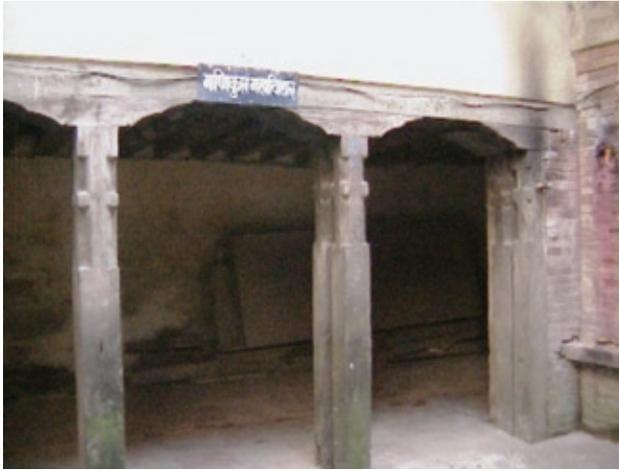
FIGURE 5 *Dalan* structure at the ground floor of a courtyard.

In seismic terms, the *dalan* construction can be compared to a modern, concrete, soft-story structure and its associated failure mechanism, as all connections are simply pinned. The only lateral restraint, when present, is provided by the shear strength of the masonry piers at the edge of the facade. Figure 5 shows a well-preserved

example of *dalan* in the internal courtyard of a *math* house, while figure 6 is an example of *dalan* walled in at a later stage to create more residential accommodation on the ground floor.

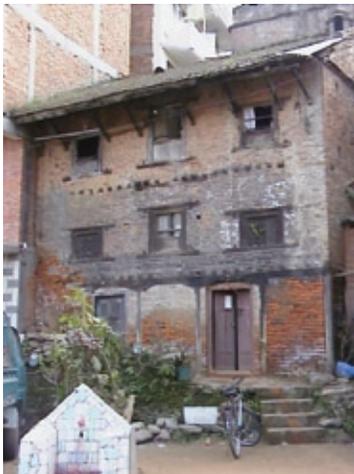
FIGURE 6 Original *dalan* structure walled in at a later time. Note that there is no external masonry pier adjacent to the external *dalan* column.

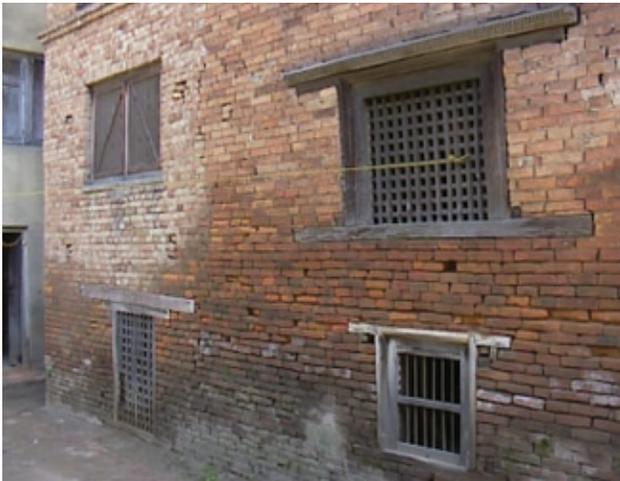
FIGURE 8 Malla period (ca. 1200–1767) window.

frame, one within the external masonry leaf or wythe and a slightly larger one within the internal masonry leaf or wythe. The two frames are connected by timber elements embedded in the masonry (fig. 8). The size of the windows within a story may vary, depending on the use of the room.

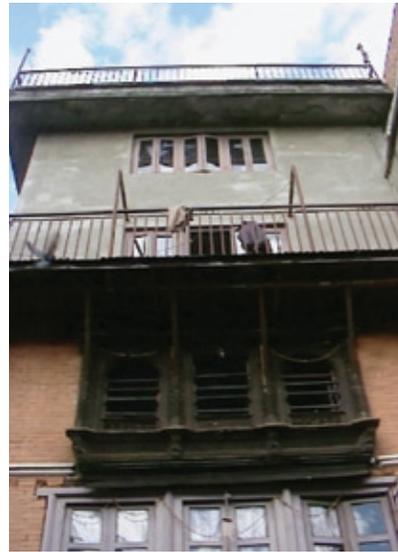
FIGURE 9 *San Jhya* window.

A feature of older buildings is the *San Jhya* window (fig. 9), a richly decorated window that spans most of the facade at the third-story level with seating framed within it. Later buildings have more homogeneous openings;

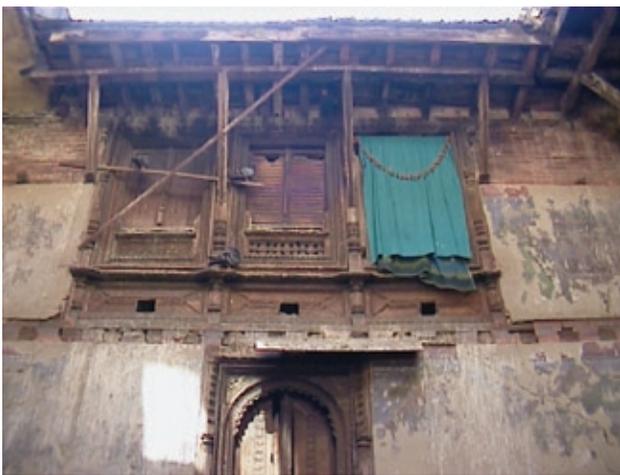
FIGURE 10 Full-height windows based on the *San Jhya* model.

they are usually taller and narrower, of about 800 mm (31.2 in.) in width and extending almost from floor to floor (fig. 10). In this typology, spandrels above windows are very narrow. In more recent construction or alterations, the concept of the *San Jhya* has been extended to each floor, so that there is very little masonry left on the front facade of the house.

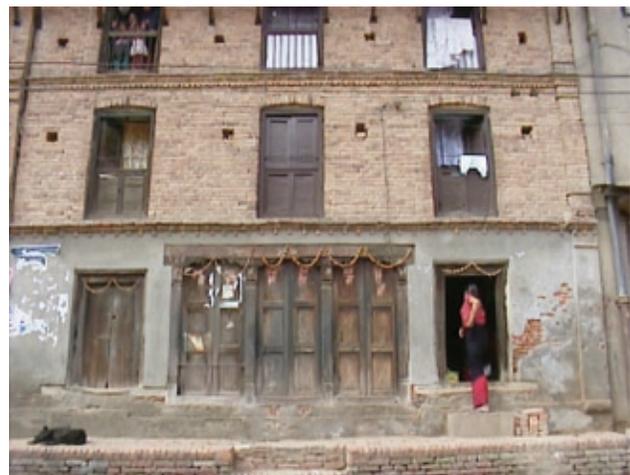
FIGURE 11 Full-height windows with flat brickwork arches.

In more modern construction, window lintels are made of flat brickwork arches and, in a minority of cases, by stone frames (fig. 11). Traditionally the openings are

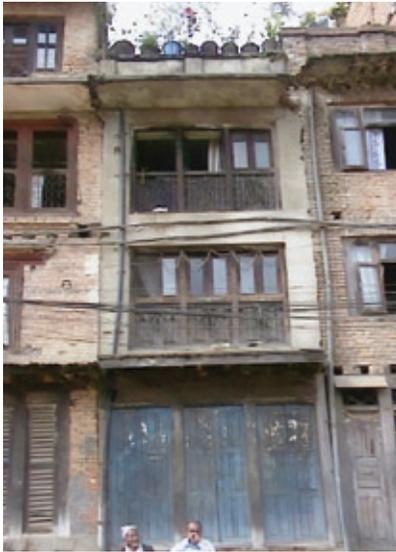
FIGURE 12 Full-width windows that do not leave sufficient width for the lateral pier.

placed at a fair distance from the facade's edges, leaving sufficient width for the lateral pier, constant throughout the full height of the building. This means that the pier can develop good structural behavior with substantial in-plane shear stiffness and, in turn, effective connection with lateral walls.

The increasing alteration of the openings, due to population overcrowding and internal subdivision of units, has led, as mentioned above, to a reduction in the width of lateral piers (fig. 12). The lateral capacity of the facade is hence reduced to the piers' flexural capacity, which is modest because of the poor tensile strength of the masonry.
