BASE RECORDING:
GATHERING INFORMATION

Rapid Assessment

Anthony Crosby

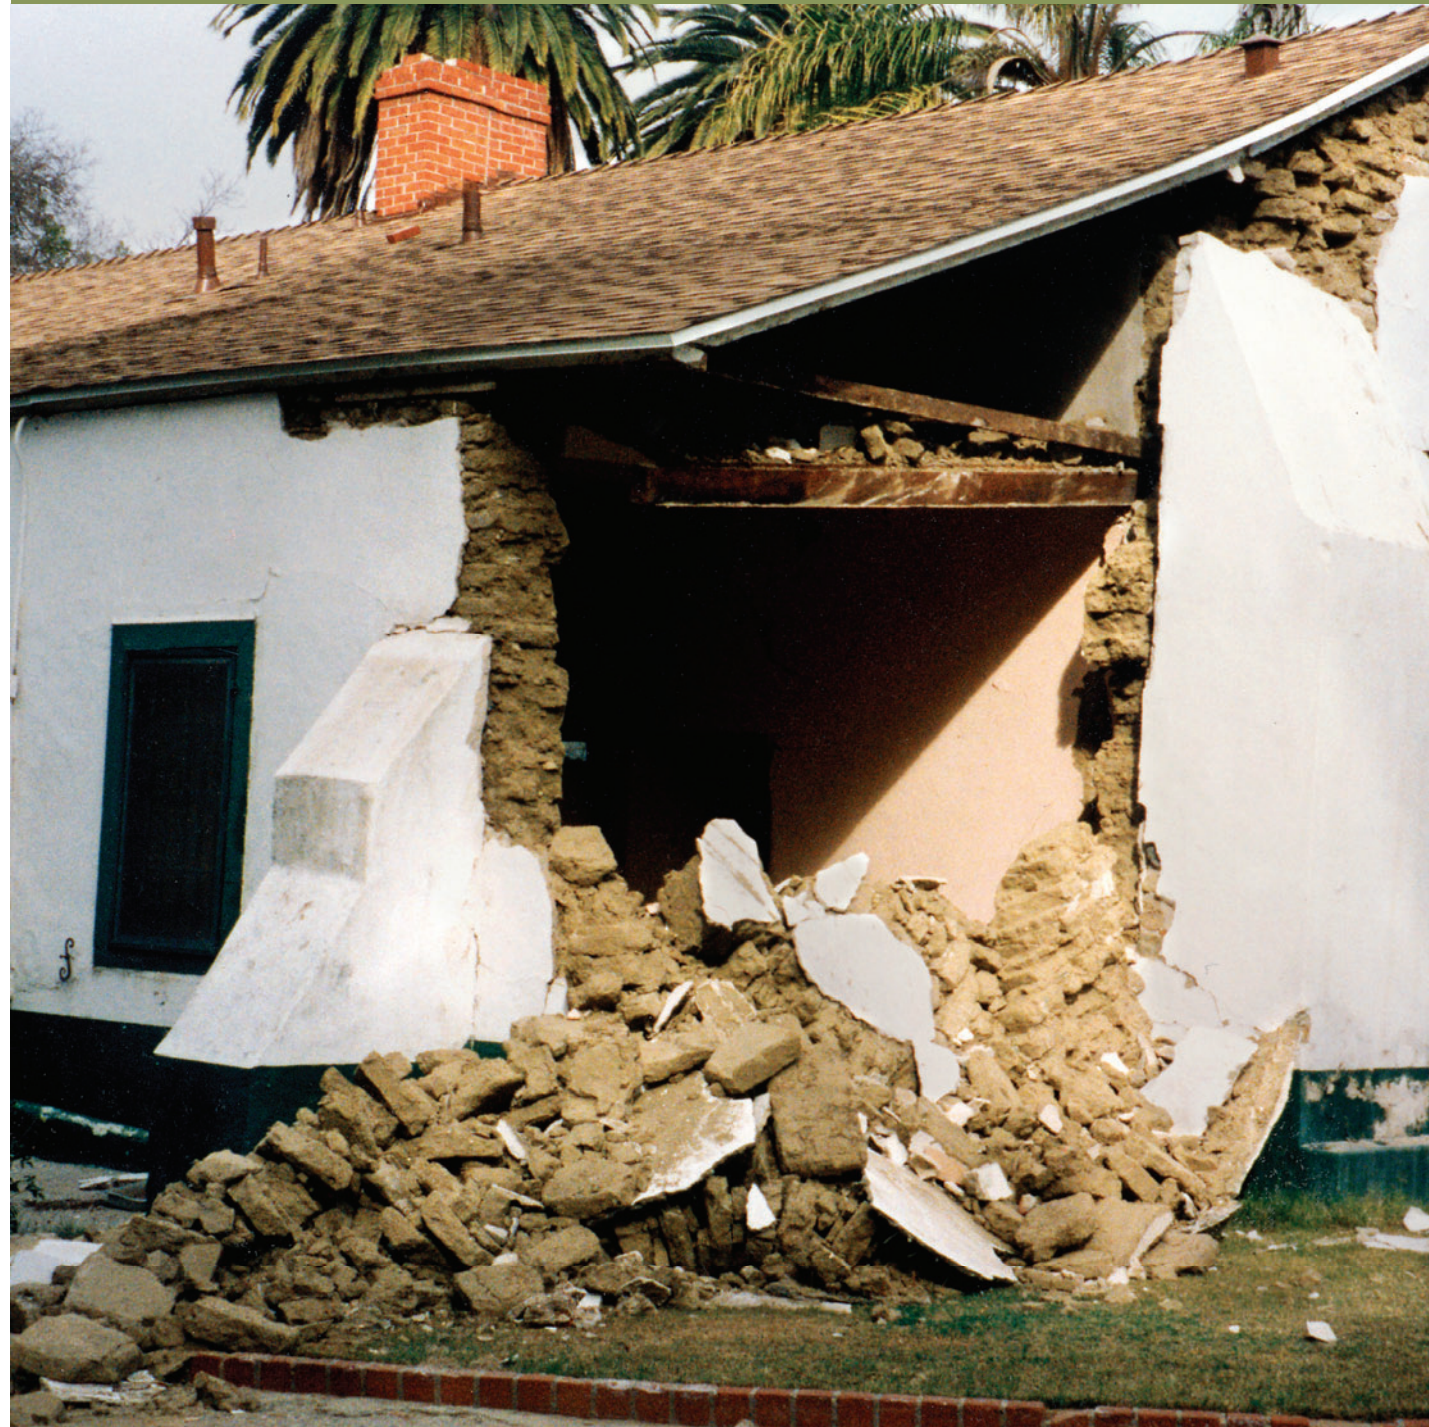
Southwest corner of the Rancho Camulos Adobe after the 1994 Northridge earthquake in the Los Angeles area. Photos of historic structures taken immediately after disasters but before cleanup or stabilization can aid engineers in understanding the causes of structural failure. Photo: © Rancho Camulos Museum, 1994.

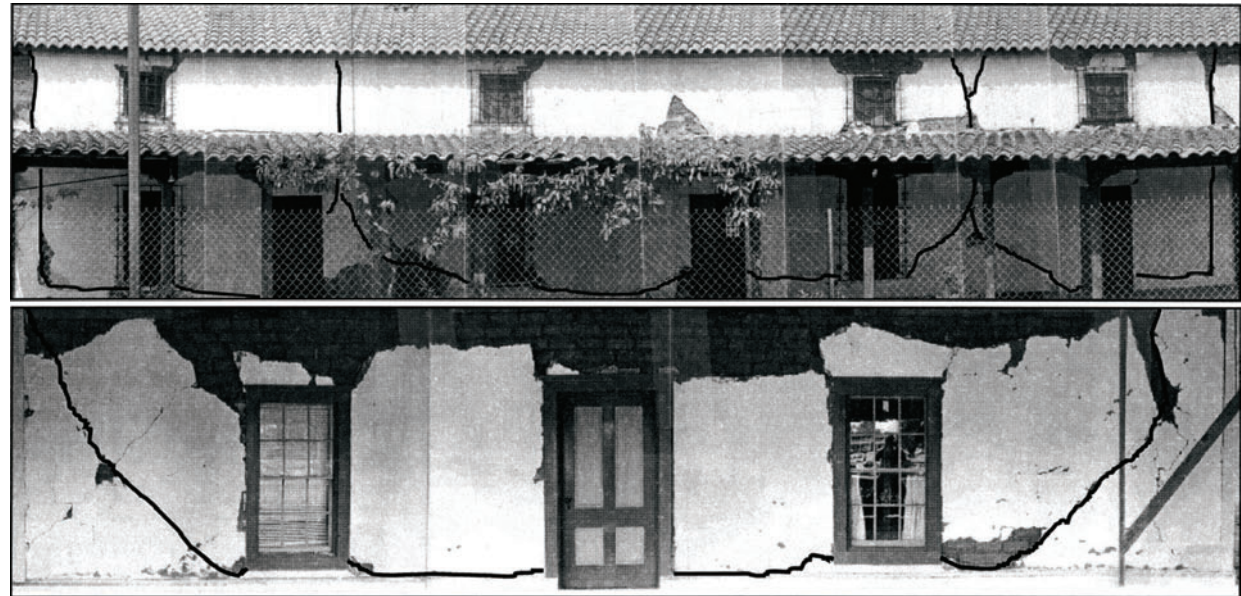
East exterior elevations of the Andres Pico Adobe, after initial structural assessment. Structural failures such as cracks caused by out-of-plane flexure were sketched on top of 35mm film and Polaroid images that were taken perpendicular to the building. This type of on-site assessment allowed engineers and architects to compile the final synthesis analysis and quickly move on to the next building. Photo: E. Leroy Tolles.

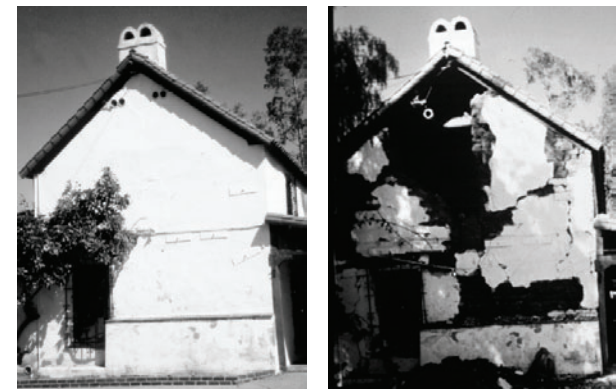
Before and after images of the Andres Pico Adobe. Photo: E. Leroy Tolles.

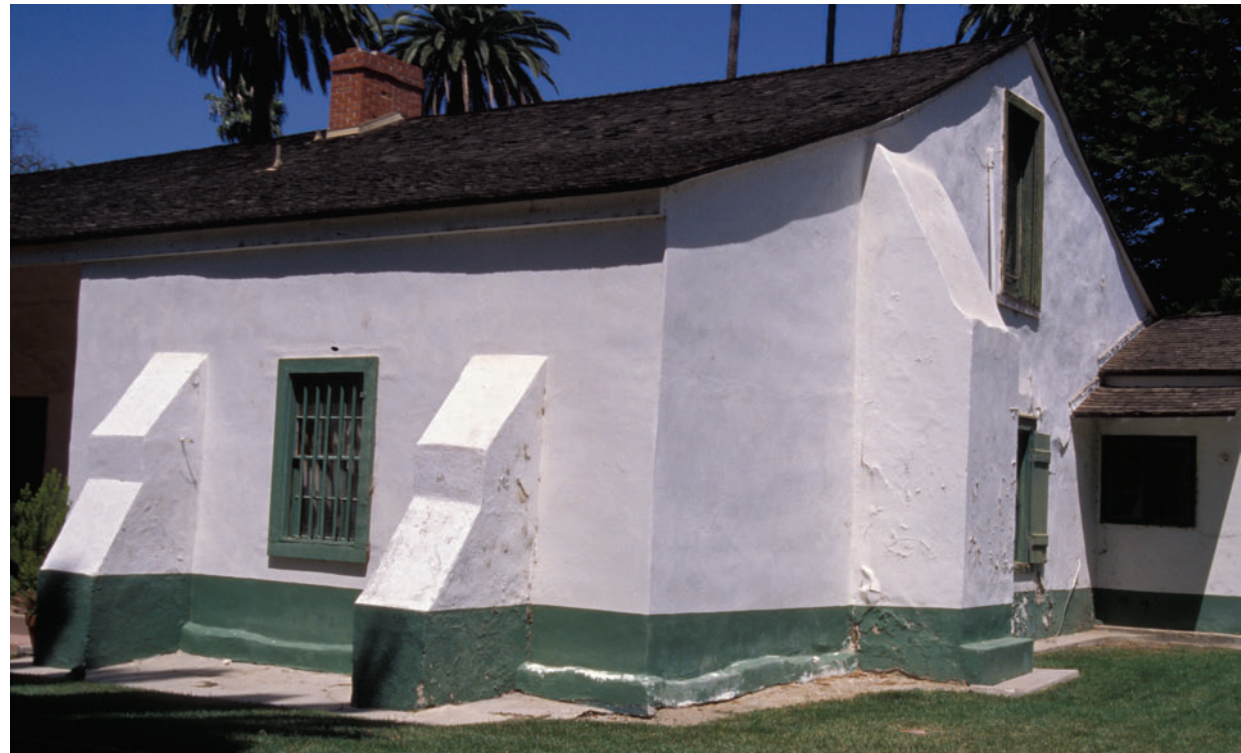
Southwest corner of the Rancho Camulos Adobe, after rehabilitation. Data collected during the rapid assessment were used to design earthquake mitigation techniques and devices that can be used on other historic earthen structures. Photo: Gail Ostergren.

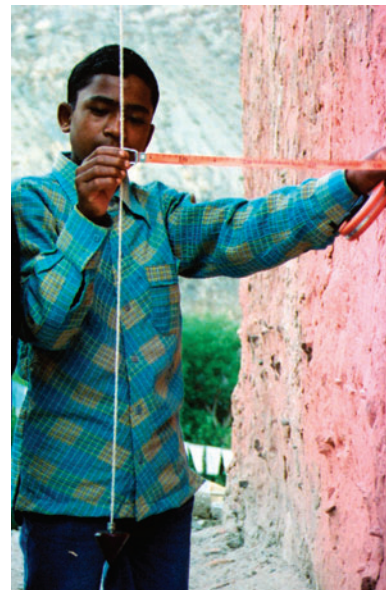
A worker measuring exterior deformation in reference to a vertical plumb line at Chango Temple. Photo: © Sandeep Sikka.

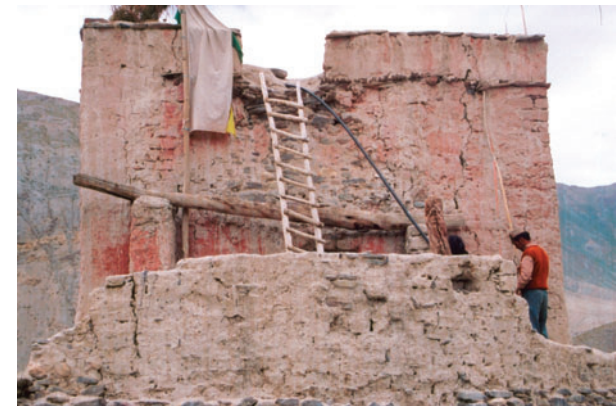
A local worker recording the front elevation of Chango Temple. Manual recording techniques, although labor intensive, are readily available and allow conservators to study buildings in great detail. Photo: © Sandeep Sikka.

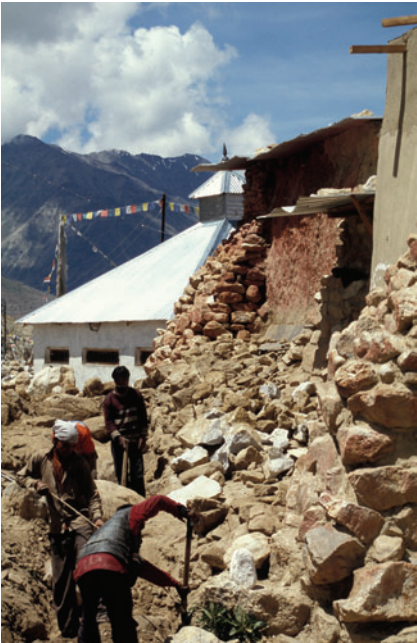
Workers burying perforated drains. Photo: © Sandeep Sikka.

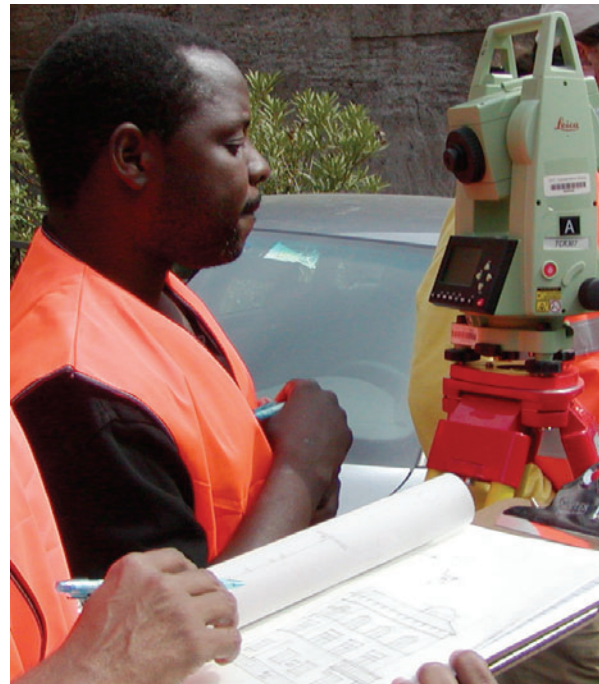
The author using a total station theodolite. The total station and its onboard computer calculate the position of a point through trigonometry by recording the horizontal and vertical angles and distance. Photo: Rand Eppich.

The total station theodolite used in this survey was a Topcon GTS200 series. Placed atop a tripod, it consists of a powerful telescope mounted on a base that rotates both horizontally and vertically. Features such as roads, buildings, and property boundaries are identified by looking through the telescope at a prism or reflector target on a pole held by another surveyor. These features can be as close as 2 meters or up to 5 kilometers away, depending on the telescope. When the surveyor focuses the telescope on the prism, the total station theodolite accurately records the horizontal and vertical angles and distance. Distance is measured with a feature known as electronic distance measurement (EDM). An infrared beam is projected from the total station theodolite, which “bounces” back to its source and, using a timing device, the distance is calculated. Many total station theodolites also have a mode known as reflectorless, meaning that within short distances of 100 meters or less, a prism or reflector is not needed. This allows the instrument to be operated by only one surveyor, which is useful when measuring points difficult to access, such as cliff faces or ridge beams. Trigonometric calculations are then performed by the onboard computer, combining the horizontal and vertical angles with the distance measurement to determine an XYZ coordinate, usually within a centimeter. By recording and then

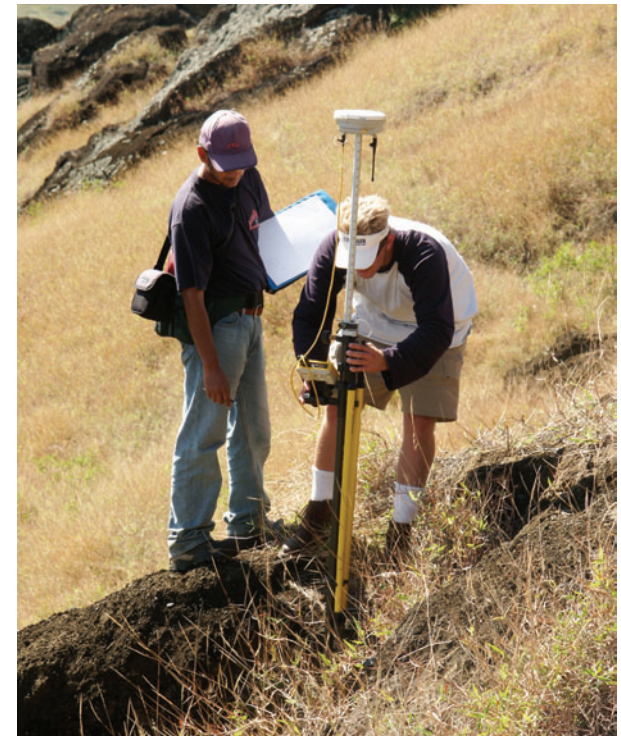
Cristián Arévalo Pakarati (*left*) and surveyor Matt Bates collecting data using a GPS rover unit. Photo: Jo Anne Van Tilburg © Jo Anne Van Tilburg/Easter Island Statue Project.

The receiver used was a single-frequency system that required no cables and operated on standard batteries. This system is expandable, adaptable, light, and mobile and can achieve centimeter-level accuracy. In the Stop/Go surveying procedure that was used, one of two receivers was stationary and the other—the rover—was mounted on a survey pole. When the rover was held in front of the stationary receiver, contact was established via an infrared port and the units were synchronized.

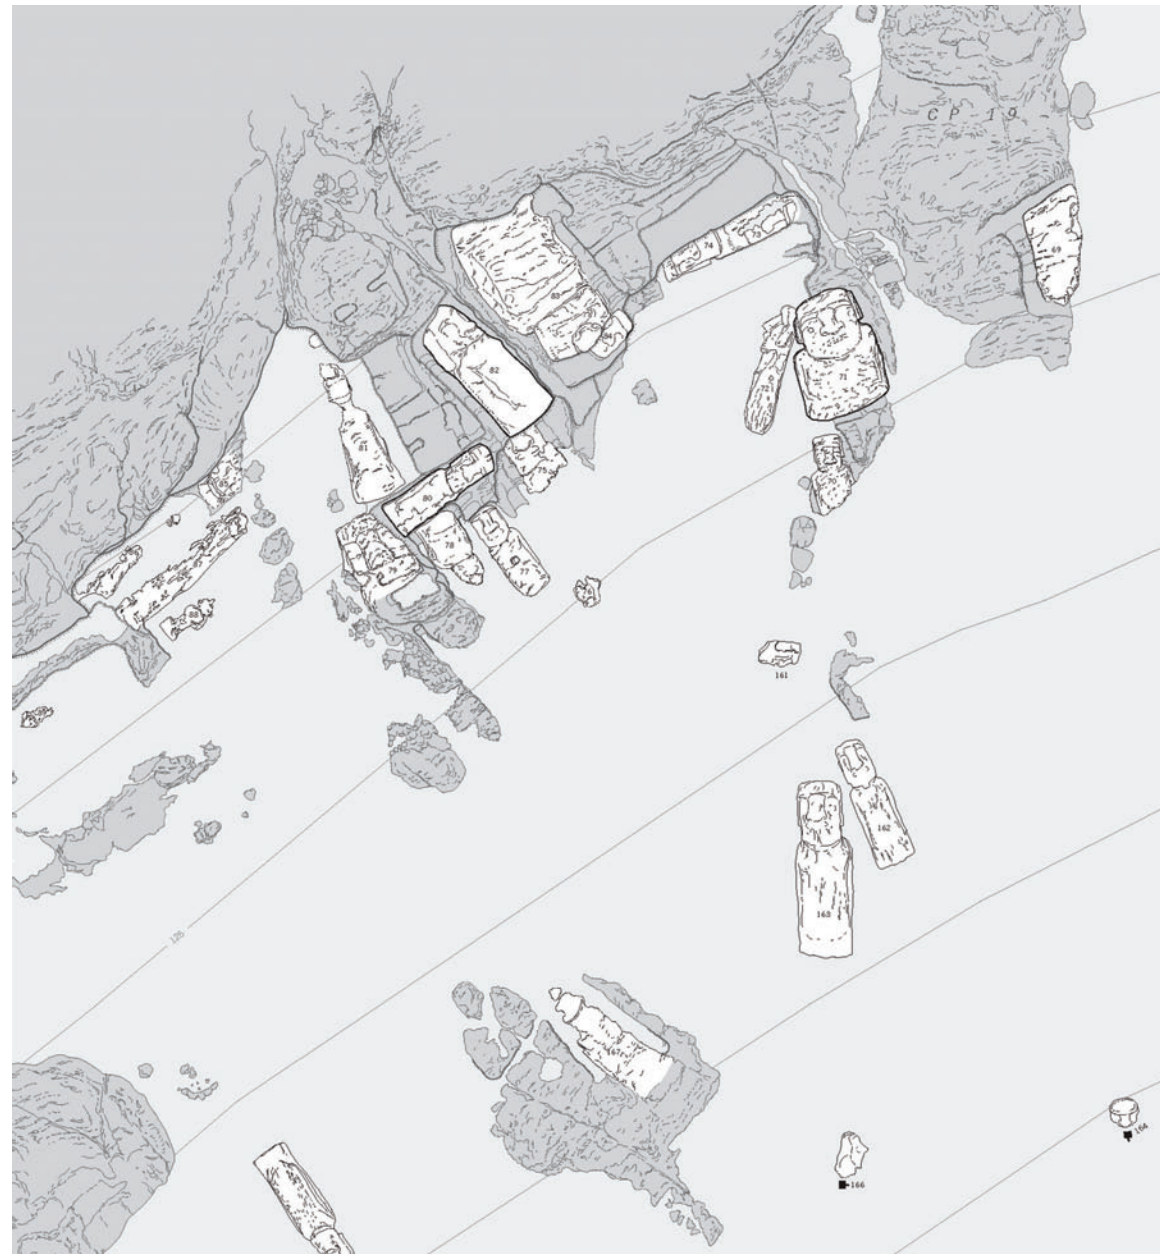
A portion of the finished map, generated from GPS data, showing the location and features of the unfinished moai within the quarry. Diagram: Alice Hom © Jo Anne Van Tilburg/Easter Island Statue Project.

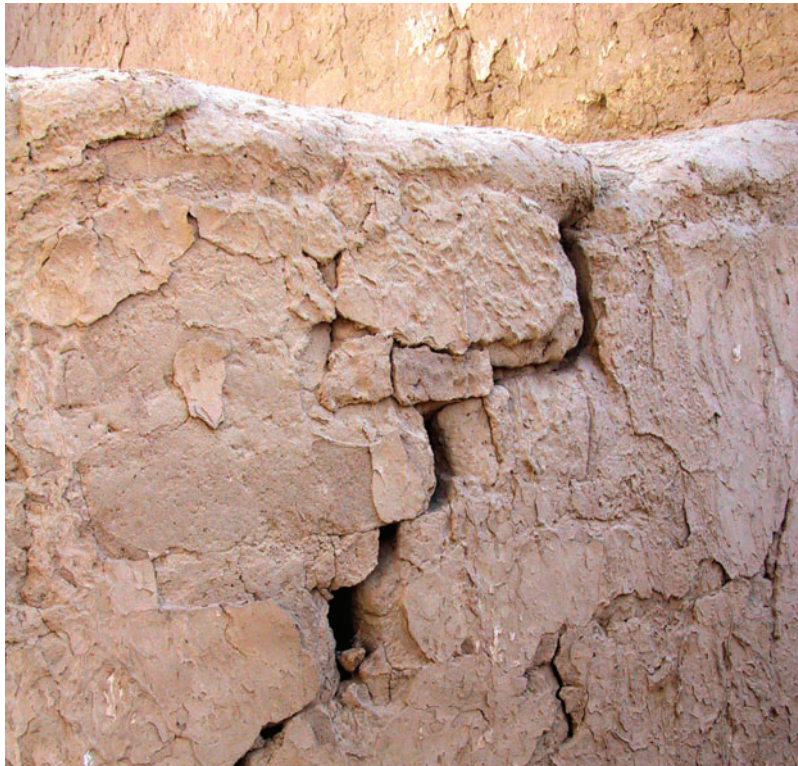
Example of structural damage to the earthen adobe walls of the Tambo complex. Photo: © Alonzo Addison.

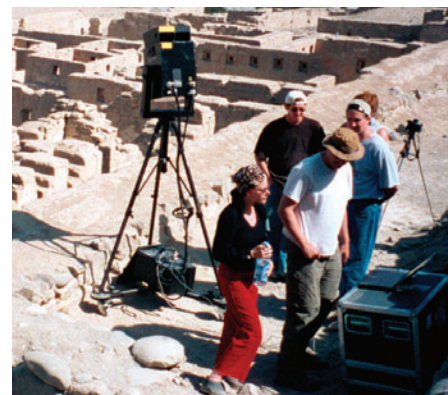
The documentation team at Tambo Colorado preparing to use the Cyrax 2400/2500 (which became the Leica HDS 2500) long-range laser scanner. Photo: © Alonzo Addison.

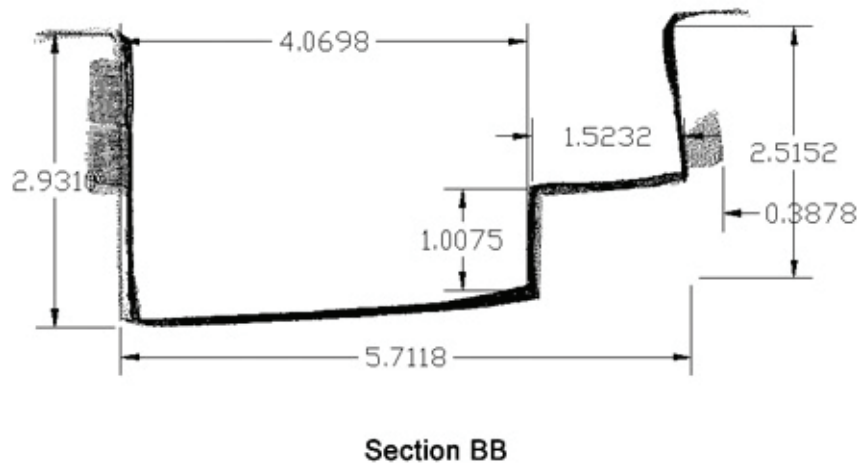
Top: Isolated isometric point cloud of one structure at the site. *Bottom:* A cross section through the isometric point cloud. Images: © Courtesy Center for Design Visualization, UC Berkeley.
