PART FOUR

Managing Sites with Mosaics

Conservation and Preservation of Mosaics in Syria: The Case for a Multidisciplinary Approach— or New Strategies for Old Problems

Amr Nawar Al Muayyad Al-Azm

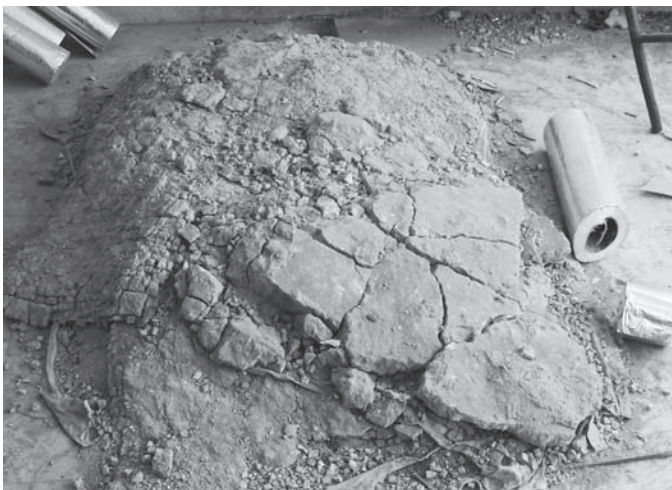
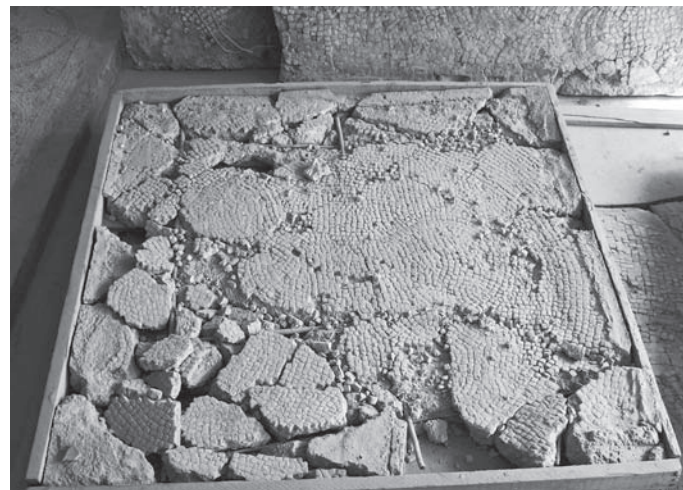
FIGURE 1 Examples of poor storage conditions: (a) stacking of faced fragments with no supports; and (b) loose tesserae and fragments of damaged relaid panel. Courtesy of Department of Antiquities and Museums (DGAM), Syria.

removal rather than preservation in situ, and the majority of these mosaics continue to be stored in very poor conditions similar to those described in 2003 (fig. 1).

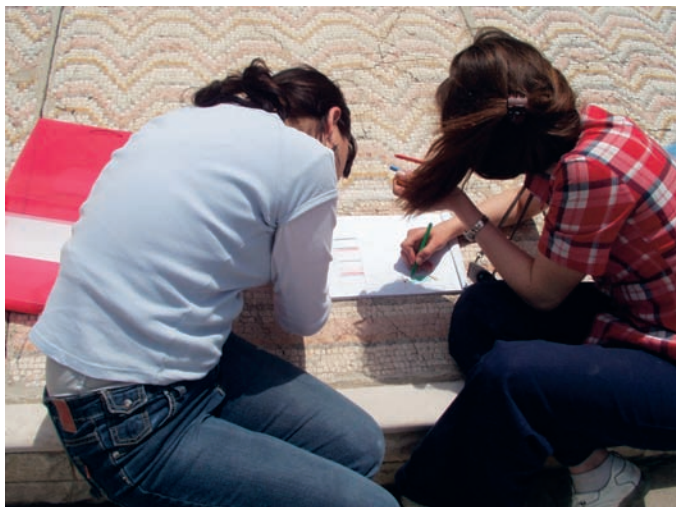
FIGURE 3 Copying surface patterns. Courtesy of Department of Antiquities and Museums (DGAM), Syria.

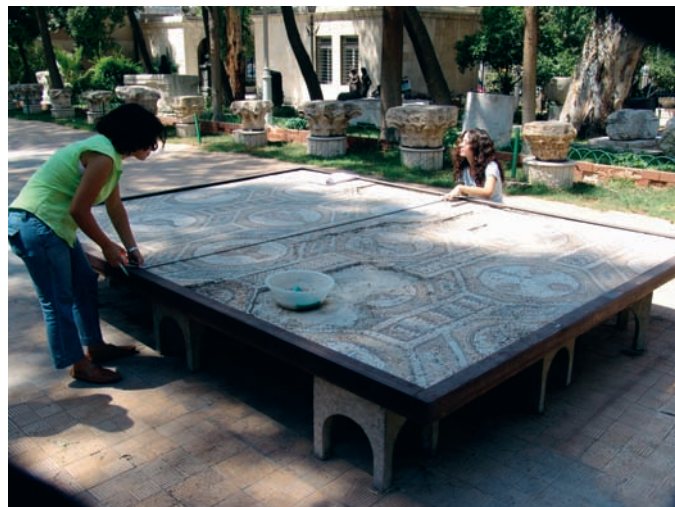
FIGURE 4 Measuring dimensions. Courtesy of Department of Antiquities and Museums (DGAM), Syria.

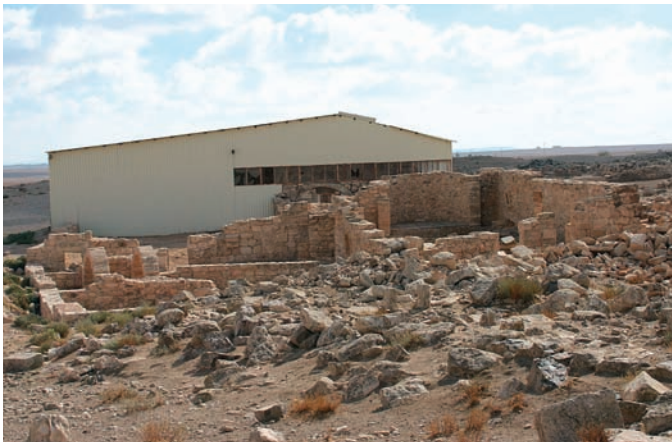
FIGURE 3 The existing shelter structure. Photo by Mervat Ma'moun Ha'obsh.

mately 4 meters apart. The roofing is a saddle roof made of thin steel plates. The supporting columns are founded outside the original walls, within unexcavated zones. The shelter elevations are pierced with large glass openings. Only one access point allows visitors to enter, on footbridges raised about 1.20 meters above the floor. The building is 7.50 meters high, and all the side panels are light yellow-green (figs. 3, 4).

Although the shelter protects the mosaics from bad weather, it does not mitigate other problems, such as water and air infiltration and poor air circulation, lighting, and water drainage. In addition, the visual impact of this huge shelter on the site and the architectural quality of the interior volume need to be adequately addressed. The beams are a conventional lattice truss with iron corners. Parts of the beams were welded on-site. Some of the shelter parts are noticeably old and require replacement in the near future. Finally, the indoor walkways are built too high above the mosaics and constitute another negative characteristic of the shelter.

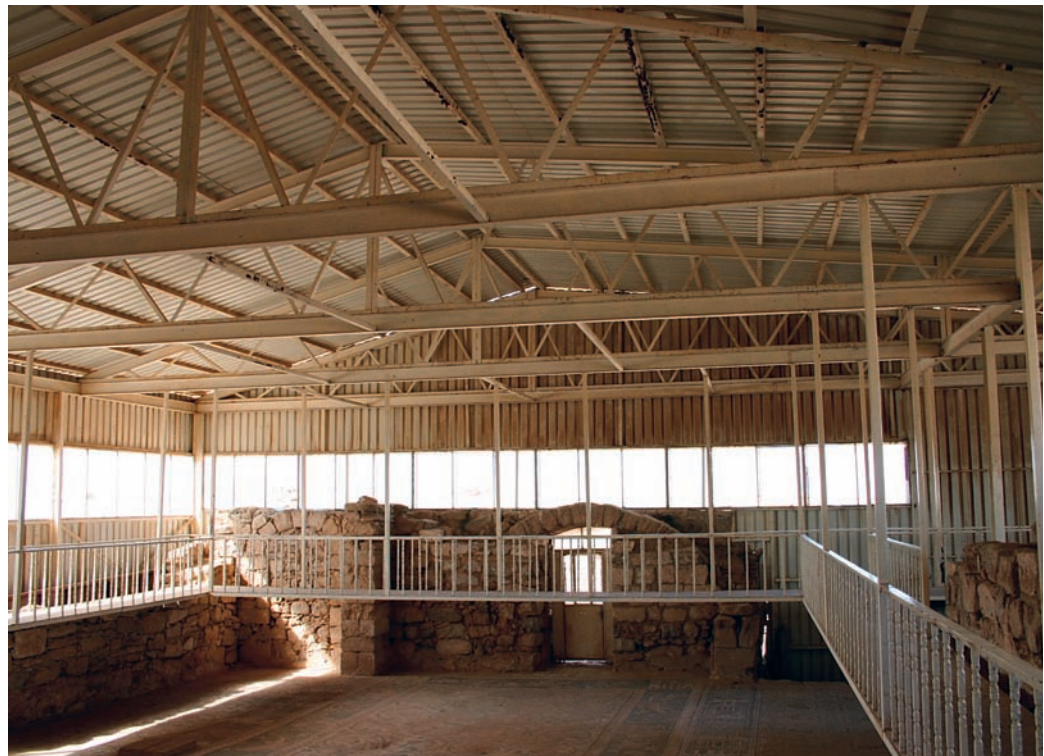
FIGURE 4 The interior of the existing shelter. Photo by Mervat Ma'moun Ha'obsh.

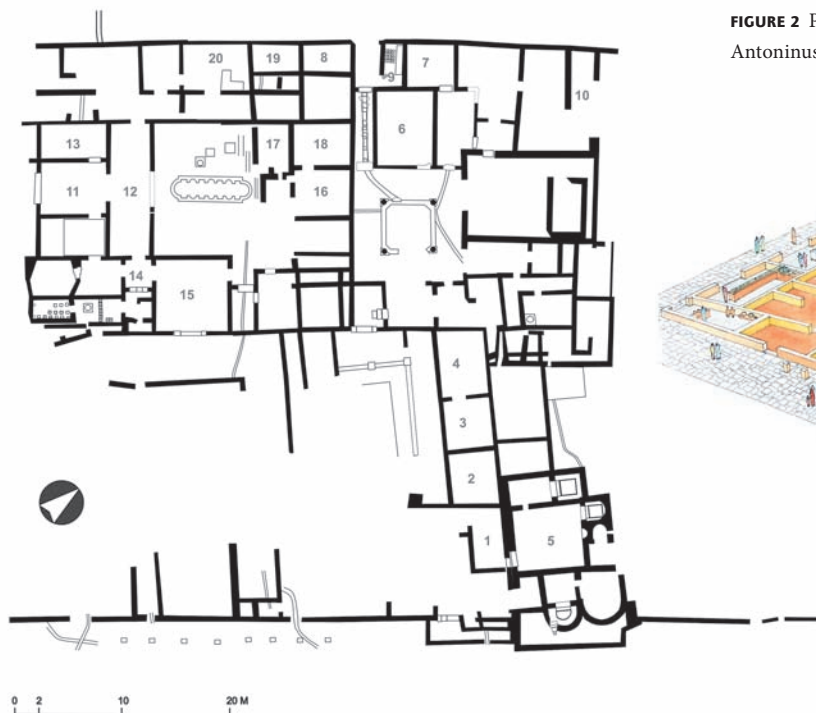
FIGURE 2 Plan and reconstructed view of the House of Manius Antoninus.

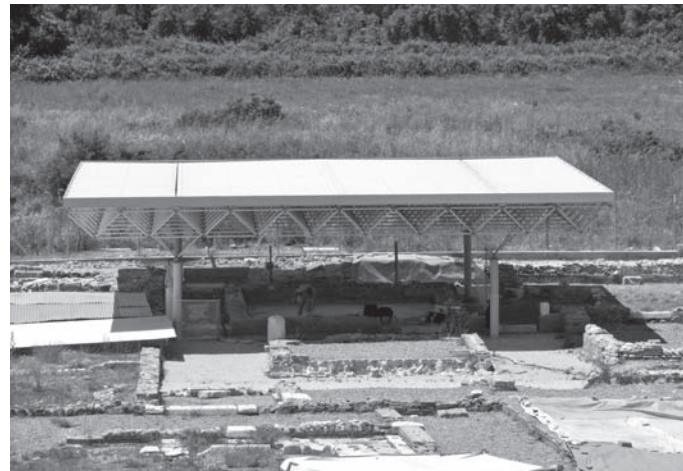
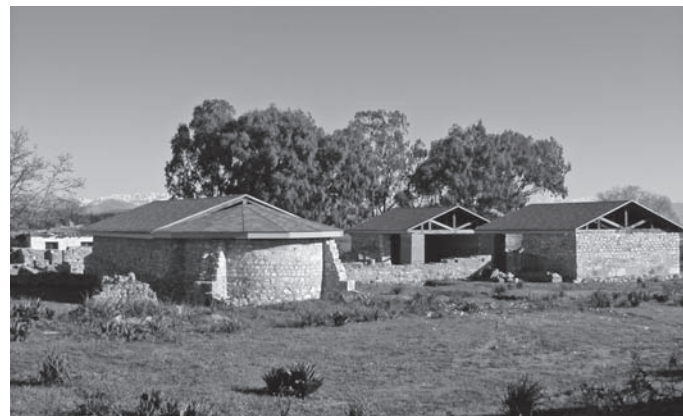
FIGURE 5A, B Mosaic protective shelters: (a) House of Manius Antoninus, completed 2000; (b) Basilica A, completed 2005.

After conservation is completed and when it is determined that a respectable number of mosaics should be visible and accessible to the public (within the framework of the overall restoration of a building), a shelter is placed over the mosaics, as in the case of Room 6, which was covered over by a metal framed shelter that can be extended if needed in the future (fig. 5).

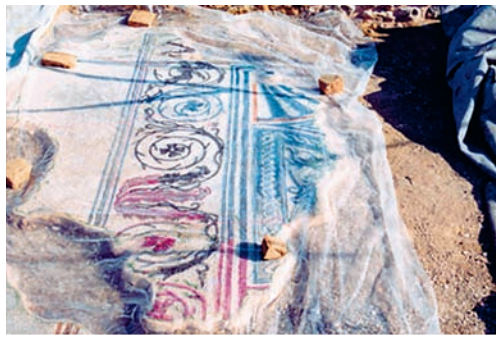
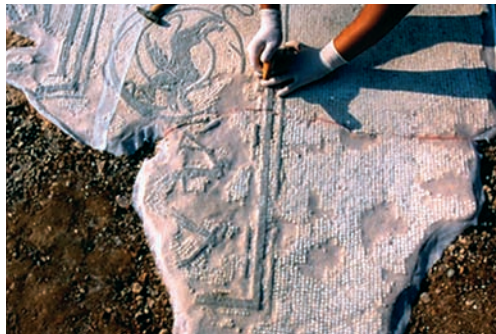
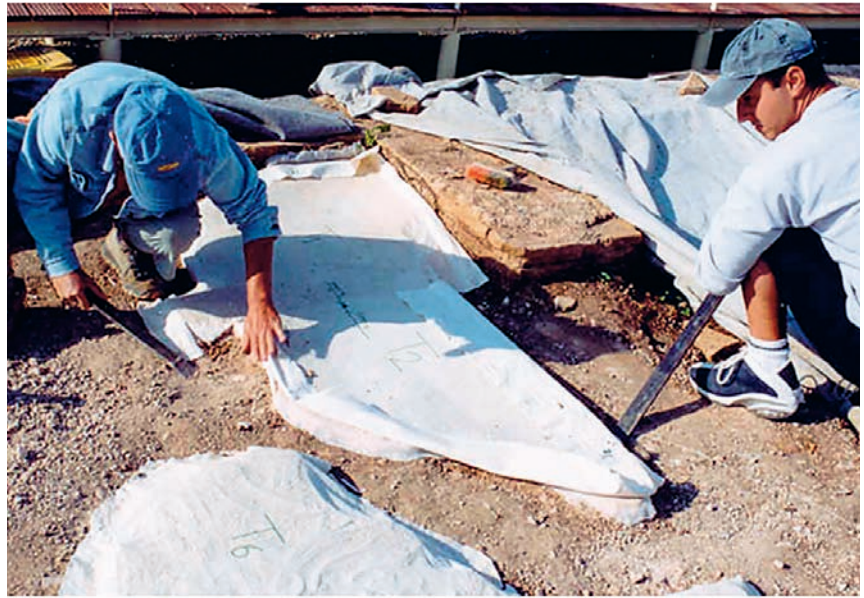
FIGURE 6A-C House of Manius Antoninus. Room 3 mosaic showing (a) stabilization, (b) drawing, and (c) lifting in process.

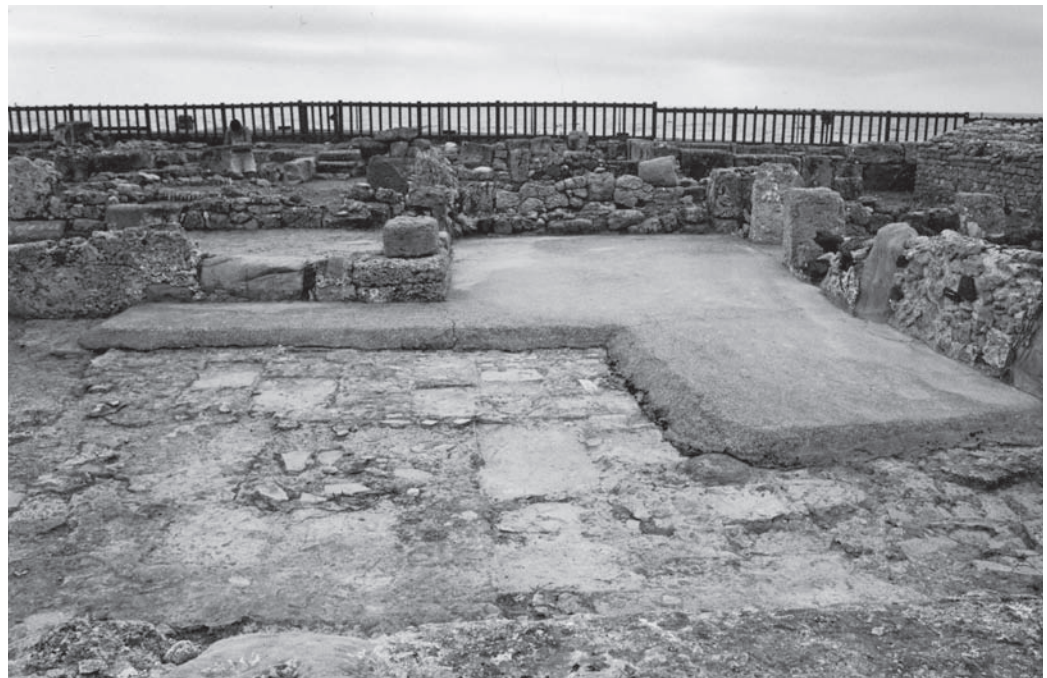
FIGURE 2 The protective contact covering of lime-cement mortar completely isolates the surfaces from contact with the environment. Courtesy Centro di Conservazione Archeologica-Rome (CCA).

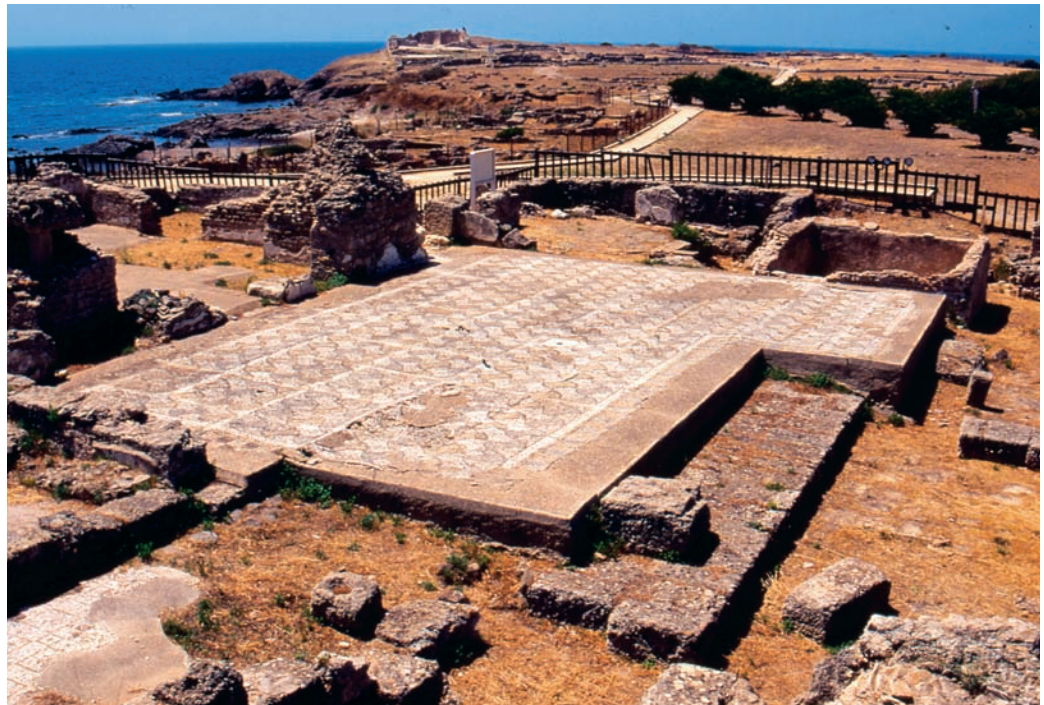
FIGURE 4 Central baths, *frigidarium*.

The pavement is on reinforced concrete with metal rods and suffers from such serious deterioration that the survival of the original material is at great risk. Courtesy Centro di Conservazione Archeologica–Rome (CCA).

concrete with metal rods (fig. 4). For some years now mosaic specialists have known the reasons for this situation: oxidation and consequent expansion of the iron, the excessive hardness and low porosity of cement, and solubilization and crystallization of soluble salts—all these factors take their toll on the ancient materials.

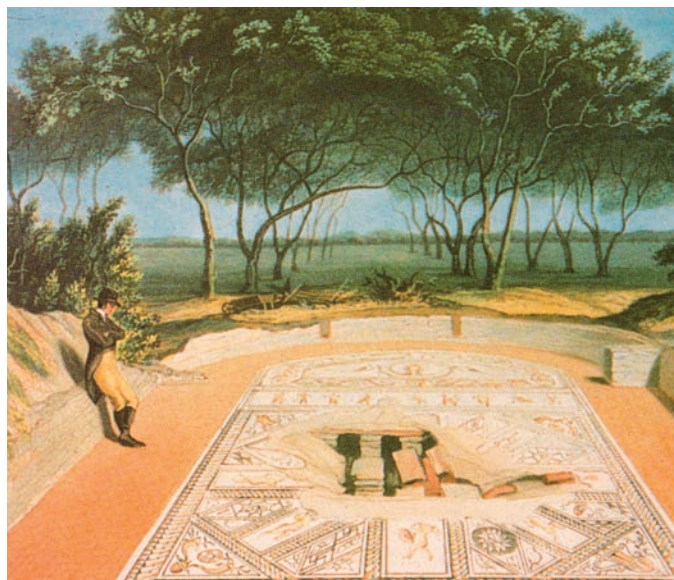
FIGURE 1 Bignor Roman Villa. The Venus Room after its discovery in 1811 (Richard Smirke) and before construction of its shelter. Subsequent loss of the *tessellatum* in the center of the mosaic may have been a result of collapse of the hypocaust. The pavement was relaid in 1926. Reproduced with the kind permission of the Tupper family. Bignor Roman Villa, West Sussex, U.K.

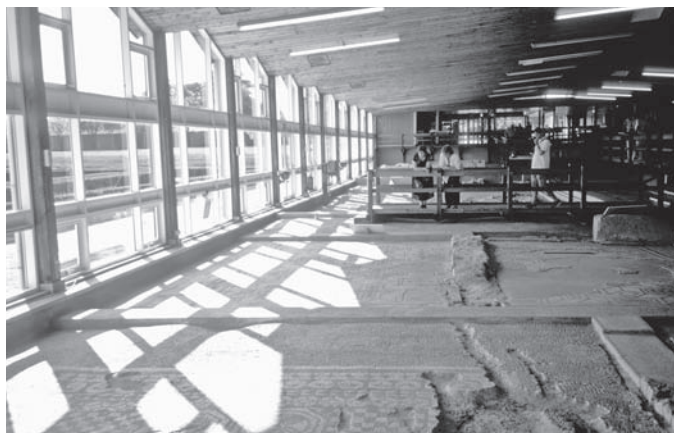
FIGURE 3 Fishbourne Roman Palace. Extensive glazing in the shelter’s original design contributed to major solar gain on adjacent mosaics and high internal temperatures. Photo: John Stewart.

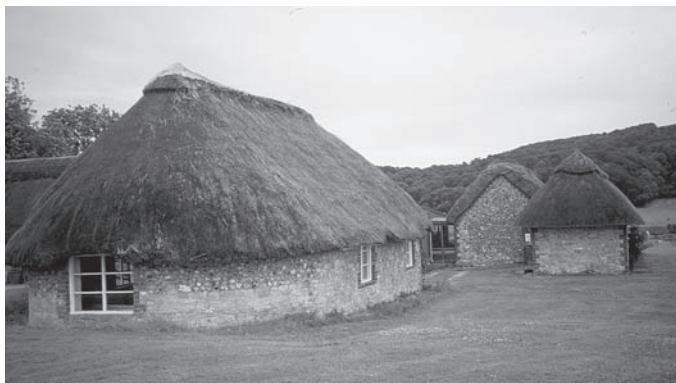
FIGURE 4 Bignor Roman Villa. The earliest surviving site shelters in England (1812–16), built of stone and timber and thatched roofs. Another shelter of brick (1818) is out of view. Photo: John Stewart.

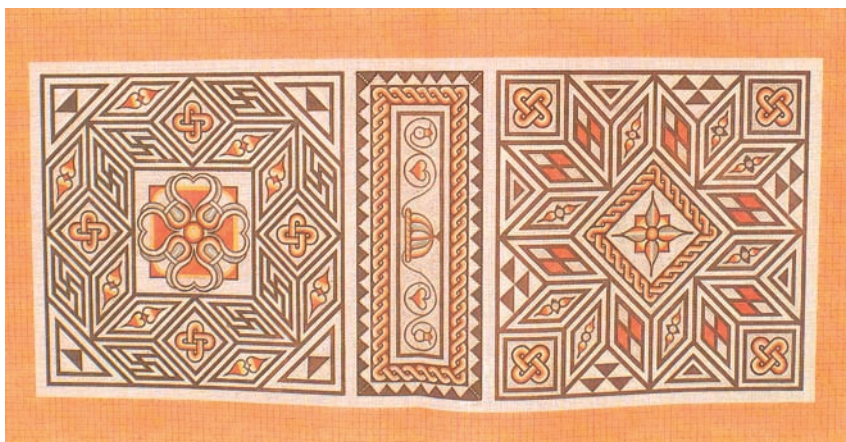
FIGURE 5 Bignor Roman Villa. The *tessellatum* of the Geometric mosaic in 1815 (Samuel Lysons), which survives intact to this day. However, serious deterioration began in the 1990s with a rise in groundwater level. Reproduced with the kind permission of the Tupper family, Bignor Roman Villa, West Sussex, U.K.

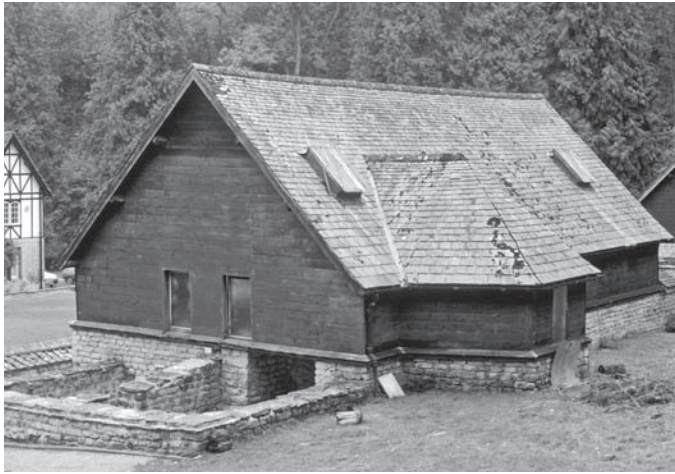
FIGURE 6 Chedworth Roman Villa (ca. 1867). The Western Bath Suite, sheltering five mosaics. Photo: John Stewart.

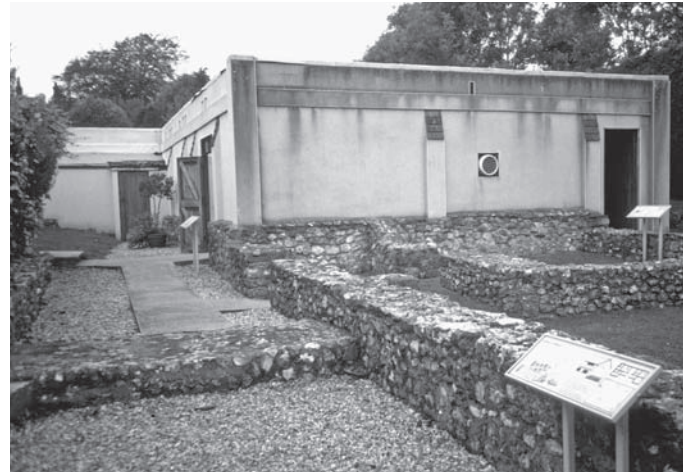
FIGURE 8 Newport Roman Villa (1960s?). Window apertures have been blocked in to help reduce algal growth in the shelter. Photo: John Stewart.

Newport Roman Villa was discovered in 1926. The current shelter is of concrete blocks and may date to the 1960s, but this still needs to be confirmed (fig. 8). In 1982 windows were filled in to improve presentation with new internal lighting. The shelter protects five mosaics, most of which appear to be on their original supports.

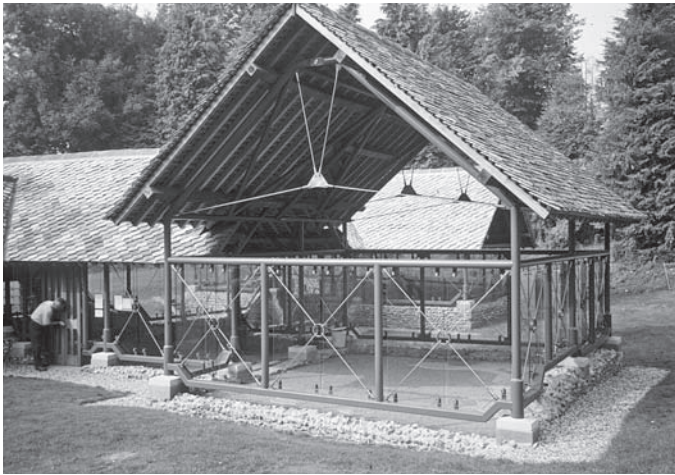
FIGURE 7 Dorchester Roman Town House (1996–99). Steel structural frame with open gables and glass sheets below. Photo: John Stewart.

Dorchester Roman Town House (Colliton Park) was excavated in 1937–38 and subsequently reburied. The mosaic of Room 8 was revealed again and presented under a wooden shed in 1957. Four decades later the rest of the house was fully reexcavated and a shelter constructed over it. The steel-framed structure has open gables above and fragmented glass panels below, creating a high degree of ventilation (fig. 7). The shelter offers negligible thermal insulation and allows direct sunlight to fall on at least one pavement. The roof of stone slate attempts to replicate the Roman design and therefore does not have gutters. Consequently, the roof feeds a large quantity of rainwater directly to the outer perimeter of the building. Site drainage was already poor, as a result of the depression created by the original excavation.

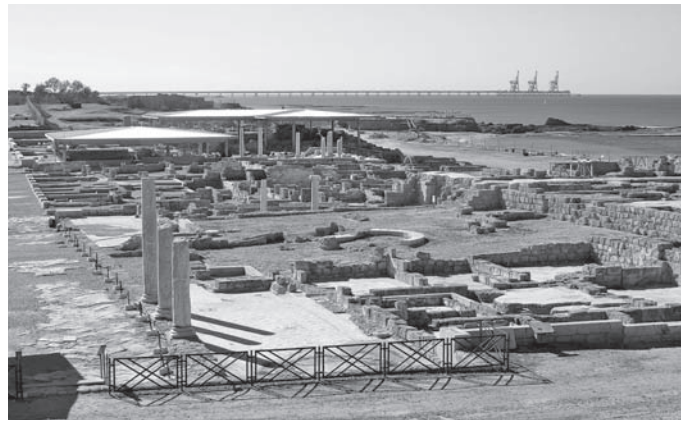
FIGURE 1 In 2001 two large shelters were built over the Domus and Bathhouse in Caesarea. The shelters in the marine environment protect the mosaics from rain but allow aerosol and dust accumulation on the mosaics. Photo by N. Davidov (2005) © IAA.

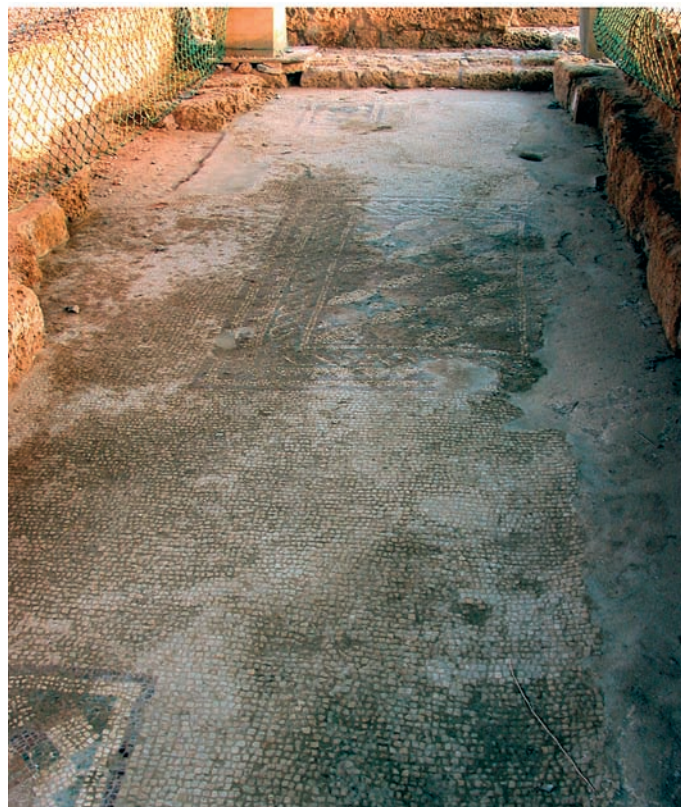
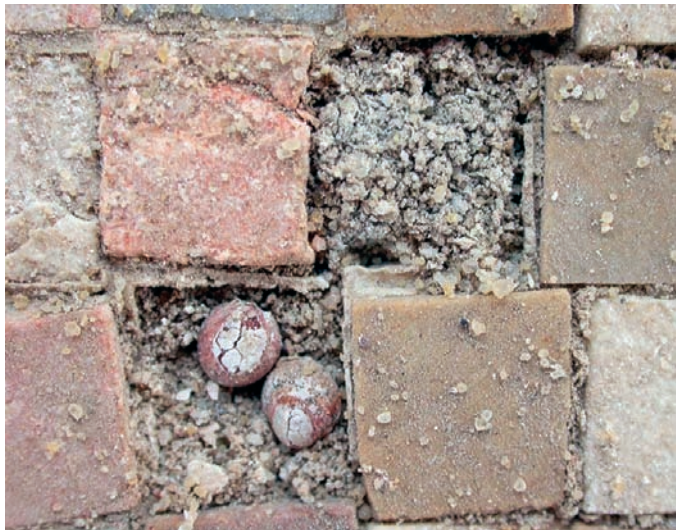
FIGURE 2A, B The experimental shelter (NN4) in Caesarea is a low-pitched roof, built in 1998 (a). The photo of the interior taken in summer shows dampness on the mosaic caused by severe condensation (b). The problem is the outcome of insufficient ventilation in the humid climate. This mosaic also suffers from water runoff and wind-driven rain in winter and from inadequate protection from direct sun, which accelerates wet and dry cycles. Photos by Y. Alef (2006) © IAA.

In a marine environment the consequence of condensation under open shelters is even more severe because of the corrosion of the materials such as stone and metal. The worst case of condensation was indeed observed in the experimental shelter of NN4 in Caesarea. This shelter was built in 1998 over a small mosaic as part of the comparative exposure testing project. The low-pitch roof rests on a wooden structure, with posts set in concrete footings. In the rapid assessment survey undertaken in summer 2006,⁸ the mosaic was found wet. This was not surprising since it is a long-recorded phenomenon at this mosaic. During the comparative exposure testing, mosaic test

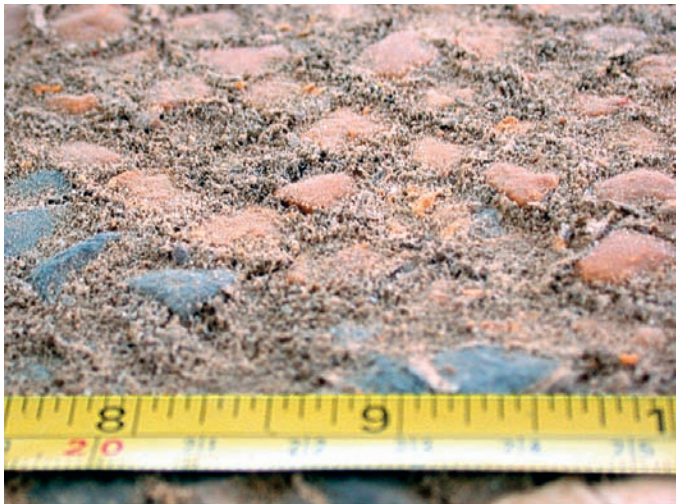
FIGURE 3A, B The test panel (a) shows severe disaggregation caused by the aggressive environmental conditions (high relative humidity, condensation, dust, aerosols) under the experimental shelter (NN4) in Caesarea. These phenomena are also evident on the mosaic (b). Test panel photo by N. Davidov (2003), mosaic photo by Y. Alef (2006) © IAA.

panels under the shelter soon disintegrated into powder. The corrosion factors in these conditions are relative humidity, marine aerosols, surface deposits (very fine dust particles), and additional water from condensation, which activate and accelerate the deterioration processes that relate to multiple cycles of salt crystallization. This process in different variations, as shown so far, is a key to understanding corrosion under shelters.

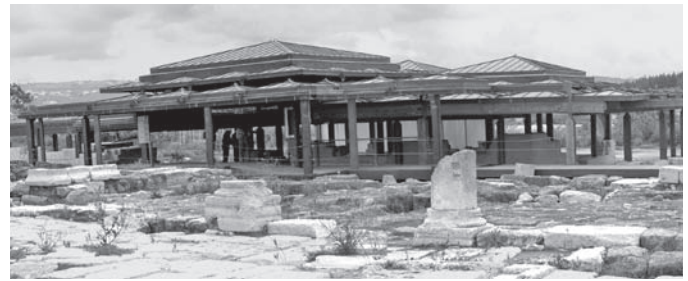
FIGURE 4 The Nile Festival shelter is a complex system of pitched roofs made of fiberboard and copper that rest on a metal-and-timber frame structure. A series of faults in the design and during its construction impaired its protective efficacy. Photo by Y. Alef (2002) © IAA.

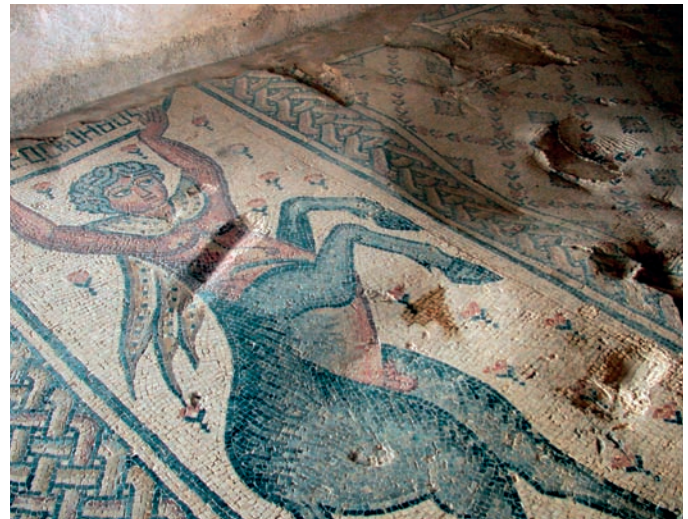
FIGURE 5 During the summer the Centaur panel in the Nile shelter suffers from water accumulating on its surface (under the right front leg of the Centaur). A difference in thermal conductivity of the copper and the wood in addition to lack of insulation in the roof construction causes condensation on the fiberboard, which then drops onto the mosaic. Photo by Y. Alef (2006) © IAA.

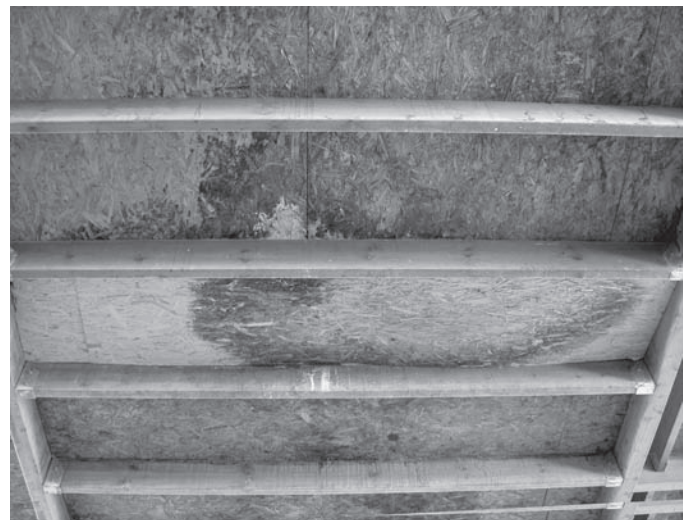
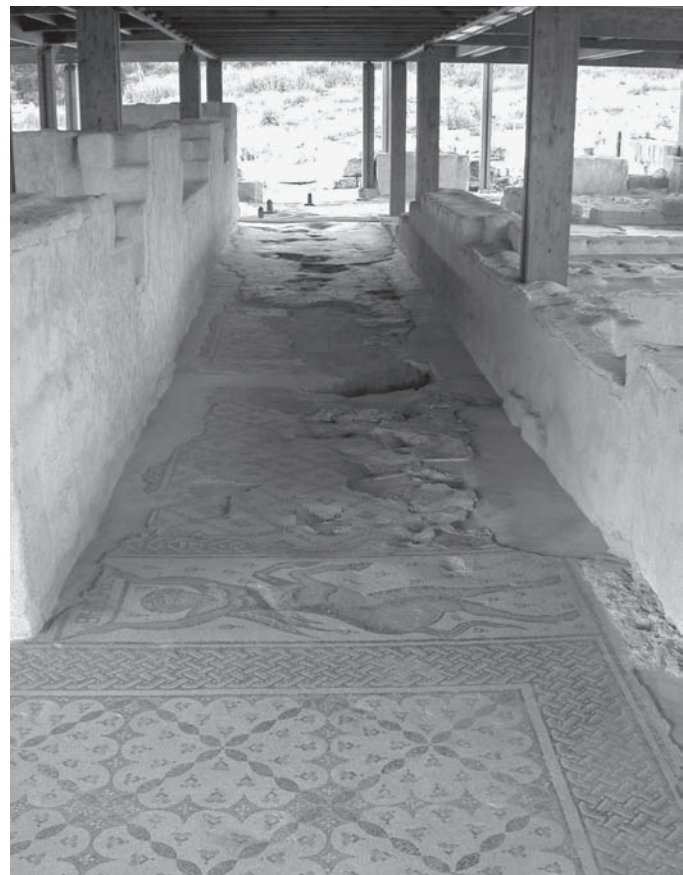
FIGURE 6A, B The fiberboard above the Centaur panel (a) shows signs of rot and needs to be replaced. Whereas in most of the roofed area there is sufficient slope, above the Centaur panel the roof is horizontal and water that condenses on the fiberboard drops onto the mosaic (b). Photo by Y. Alef (2006) © IAA.

During the rapid assessment survey, the Centaur panel was found to be wet from water dropping from the roof (fig. 5).⁷ This phenomenon was already recorded in 2000 during a site inspection. An explanation for the accumulation of water on the mosaic has to do with the condensation of water on the

fiberboard that then falls directly on the mosaic. A difference in thermal conductivity of the copper and the wood, in addition to lack of insulation in the roof construction, is a cause of condensation on the fiberboard. It is not surprising, therefore, that the fiberboard all over the shelter shows signs of rot and needs to be replaced (fig. 6). However, most of the roof area has an angle sufficient to allow the water from condensation to leak along the slope. This is not the case above the Centaur panel, which rests at the end of a corridor, where a horizontal roof links two of the pitched roof modules (see fig. 6). The water that condenses on the fiberboard drops down on the mosaic. As a general note, soluble salts are not a major threat in Zippori, but the constant dry and wet cycles accelerated the damage to the mosaics, resulting in salt crystallization, bulging, and black-colored microorganisms on the mosaics.

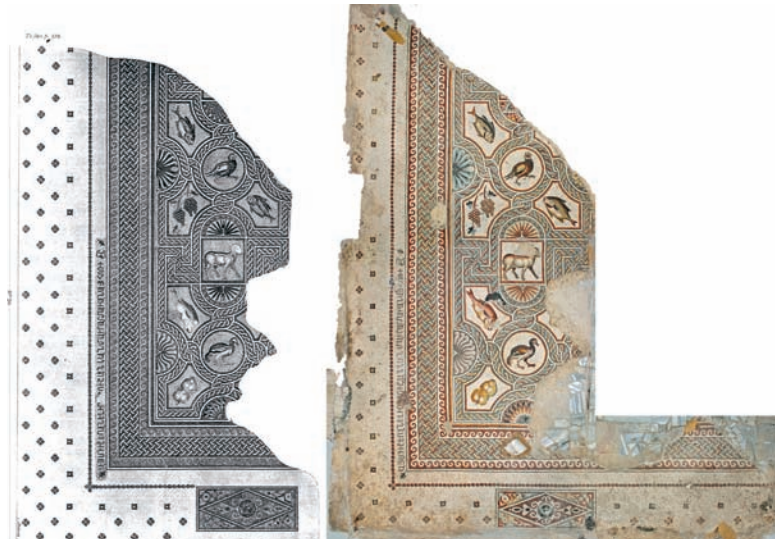
FIGURE 7 The Artaban mosaic from the Mount of Olives was sheltered in 1873. The drawing on the left was made following the excavation (Clermont-Ganneau 1899). The photo on the right was taken in 2006 and shows the mosaic still in good condition. Photo by N. Davidov (2006) © IAA.

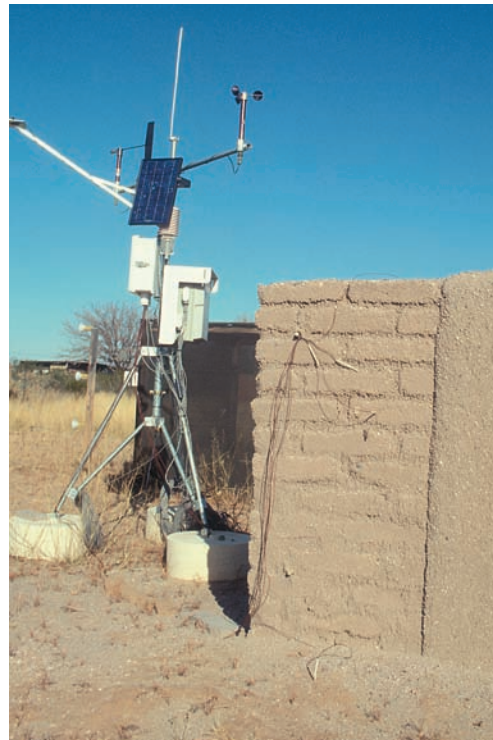
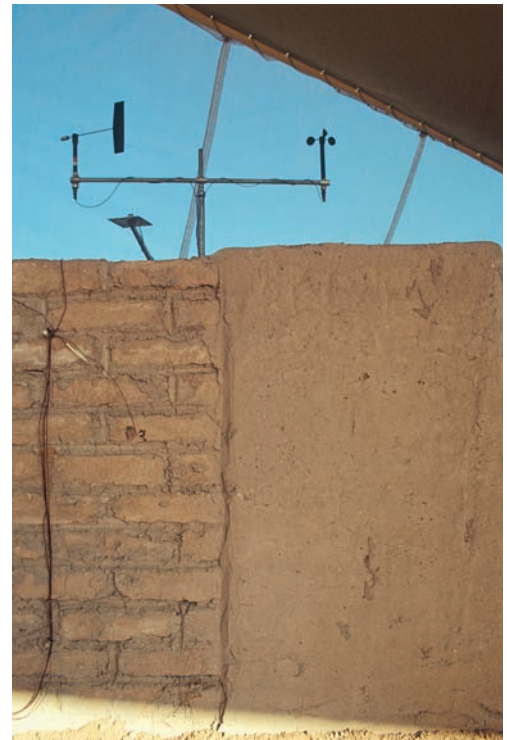
FIGURE 3A, B Fort Selden, New Mexico. Adobe test walls outside the hexashelter (a) and beneath the hexashelter (b) after nine months of exposure. Photos: Neville Agnew. © J. Paul Getty Trust 1991.

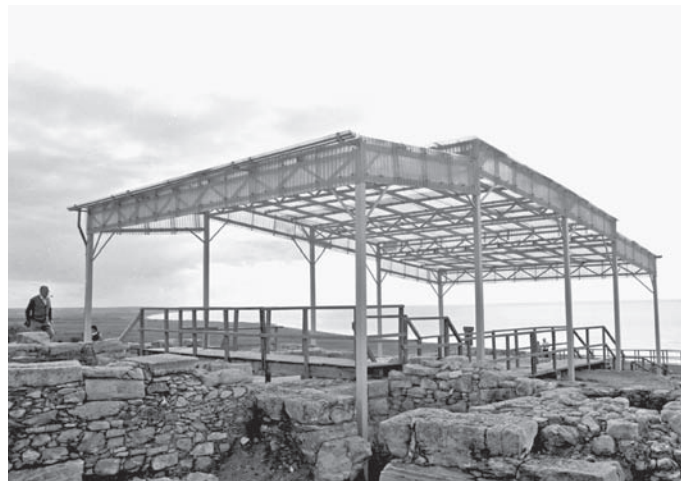
FIGURE 1 The shelter constructed over the Annex of Eustolios in 1985. Courtesy of Department of Antiquities, Nicosia, Cyprus.

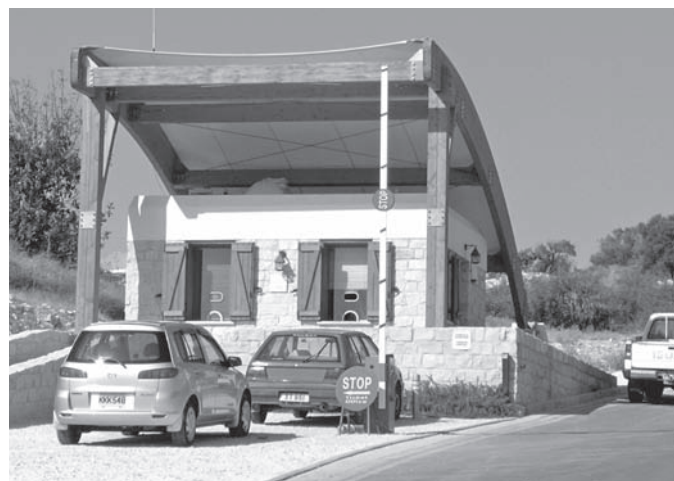
FIGURE 2 The shelter over the ticket office. Photo by Demetrios Michaelides.

Beauty is in the eyes of the beholder, but to the eyes of the present writers, the beauty of some of the current shelters at Kourion is diminished or lost when one considers their visual impact on the site. Kourion was a beautiful site in the romantic sense of the word: well-preserved ruins in a beautiful landscape with the sea as a backdrop. Now, however, the site, both from within and from without, is marred by these shelters, which seem to have grown up like mushrooms. Those responsible seem to have been possessed by shelter mania; there are shelters everywhere, even where they were not needed, as in the case of the modern, stone-built ticket office (fig. 2).

How much thought has gone into the functionality of these structures, rather than their uniformity of appearance, is illustrated by the ticket office, the shelter of which was designed so that it covers only the back of the building. Thus the front, with its Perspex ticket windows, is left totally exposed to the strong sun during the first half of the day, making it an unbearable workplace, especially during the summer. Furthermore, this unnecessary shelter mars the wonderful view from the ancient theater across the site and down to the coast. A lack of similar functional considerations characterizes the shelter over the House of the Gladiators (fig. 3), which faces into the wind coming from the sea with what may be described as gaping jaws and draws wind, rain, and salty airborne water over the mosaics all the way to the back of the structure, from where the water has no easy escape.

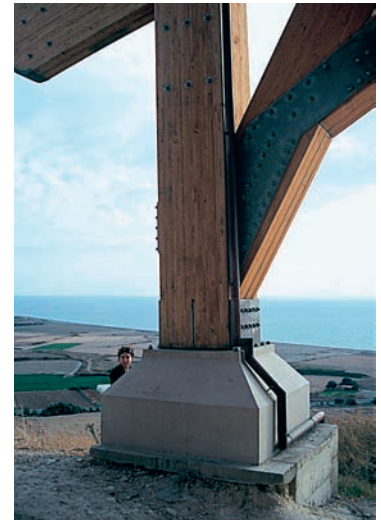
FIGURE 6 The current shelter of the Annex of Eustolios. (Photo by X. Michael 2005)

The biggest part of the project is the protective shelter over the Annex of Eustolios (fig. 6). Its design is composed of a wooden arch-shaped frame consisting of heavy, curved beams topped by a membrane roof that covers an area of 30 to 35 square meters. The wooden beams are reinforced with metal bolts and connecting metal cables. The frame is secured to the ground with sixteen enormous cement blocks, whose foundations are 12 meters deep. Unfortunately, more details on the structure and its materials of construction are not yet available.

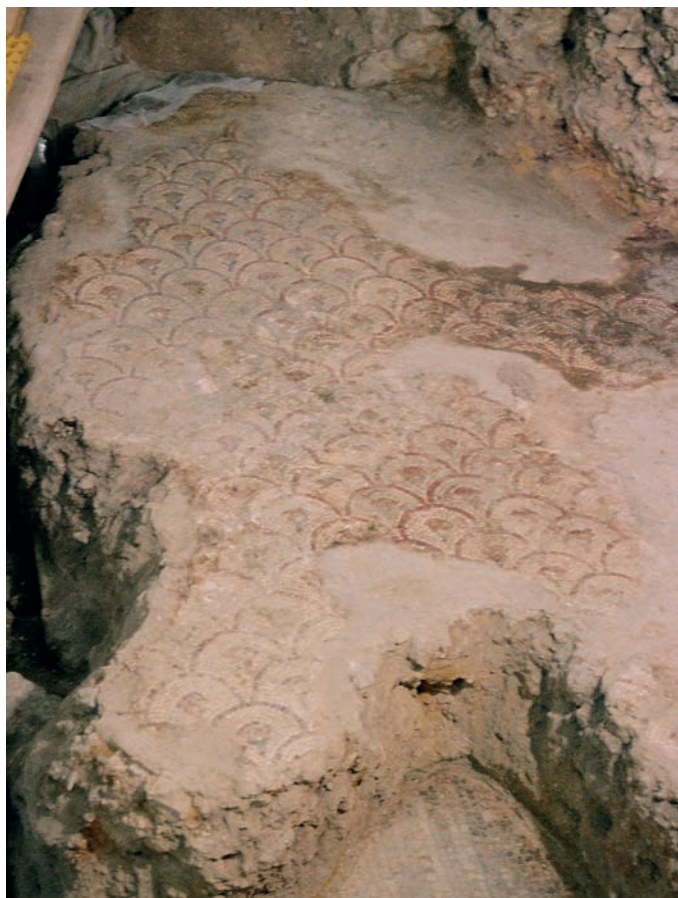
FIGURE 3 Mosaïque à double niveau (Est). Photo I. Skaf.

Deux pavements à motifs géométriques (fig. 3) sont superposés et situés contre le mur Est de la crypte. La mosaïque supérieure d'une surface d'environ 5 m² se compose d'un motif d'écailles oblongues adjacentes monochromes avec apex chargé d'un bouton de rose (Balmelle et al. 2002 : 340). Le second niveau, qui n'est que très partiellement visible, présente un motif linéaire de méandres de svastikas.

Le pavement supérieur présente des problèmes de conservation principalement liés à l'humidité. Le parvis Est à l'extérieur de la crypte n'est pas dallé et un drainage insuffisant favorise les infiltrations d'eau de pluie. Le mur accolé à

la mosaïque en sous-sol absorbe et emmagasine ainsi beaucoup d'humidité, ce qui favorise le développement de micro-organismes, surtout au point de contact entre le mur et les tesselles ainsi que dans les parties lacunaires du pavement. La bordure qui longe la berme archéologique est très fragile et sa consolidation devra se faire en fonction du traitement de la berme. Dans l'ensemble, la cohésion des tesselles est bonne et le mortier est en bon état.

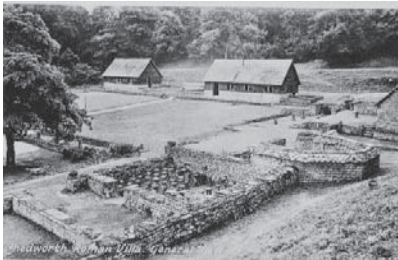
FIGURE 2 Late-nineteenth- or early-twentieth-century postcard showing the original site shelters and the wall capping using Roman roof tiles.

The owner of the site, Lord Eldon, was determined to present his discovery to the world. Shelters were built over some of the surviving mosaics on-site (fig. 2); other fragments were reburied. The room interiors left unsheltered were covered in earth and allowed to grass over, and the surviving walls were leveled and capped using original stone from the building’s collapse. A dedicated site museum was also built, and a house for a resident custodian was added soon after the initial excavation. It is clear that a plan to preserve and display the villa was made from the outset, but what can never be known is the thinking behind the selective reburial of the mosaics. Why were some left exposed and others not? The reasons could vary from the condition of the mosaics (only the least fragile were left uncovered?) to aesthetic considerations (only the most interesting/beautiful were not reburied?) to economic constraints (too costly to shelter and display the whole site?).

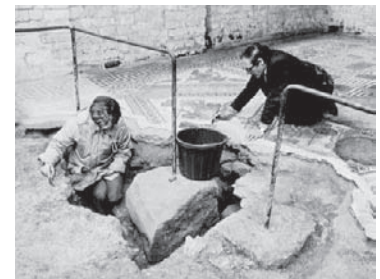
FIGURE 4 Excavation of the major lacuna in the triclinium mosaic, ca. 1980. The metal barriers were removed and visitor access to the triclinium halted from this date.

Further work was carried out in the triclinium, with much discussion on the correct methodology to be used in the re-laying of the pavement fragments that had been lifted for safekeeping around 1980. The debate was a reflection of what was (and is still) going on in the wider world of mosaic conservation regarding the aesthetics of presentation, the need to preserve original bedding material, and so on. Before any re-laying was carried out, a French drain was dug across the back of the building to reduce the flow of water downslope

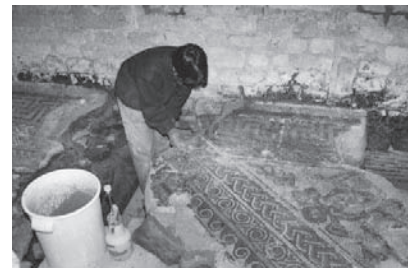
FIGURE 5 Re-laying of part of the triclinium mosaic in the early 1990s. As much of the original mortar as possible was retained, and the new mortars were based on particle-size analysis of the Roman material. Photo by Philip Bethell.

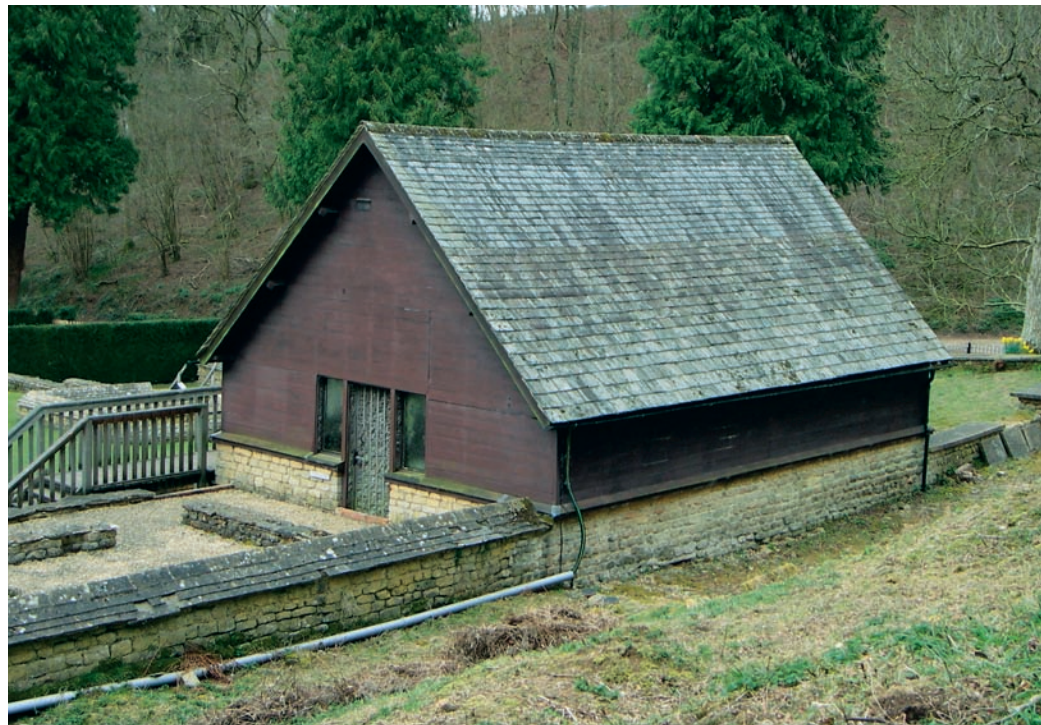
FIGURE 8 The triclinium shelter today. The original roof has been repaired and insulated and the timber cleaned and treated, but otherwise the structure is essentially as it was built in the nineteenth century. Photo by Philip Bethell.

- maintenance of historic shelters (including quinquennial structural survey, roof replacement, timber repairs, painting of exterior with wood preserver) (fig. 8);
- monitoring the internal environment of historic shelters and modifications to improve it;
- regular mechanical cleaning, with a defined protocol (including precleaning salt and algae survey, use of deionized water with separate buckets for salt-containing rinse water, use of foam padding to avoid pressure, supervision by a qualified conservator);
- monitoring of reburied mosaics via selective reexcavation and recording and surface temperature monitoring with buried sensors;
- excavation to understand the full extent of surviving archaeology and the hydrology of the site;
- base record production and regular monitoring of exposed historic fabric; and
- long-term conservation planning based on the best practice to date.
