THE CONSERVATION OF THE ORPHEUS MOSAIC AT PAPHOS, CYPRUS

THE GETTY CONSERVATION INSTITUTE

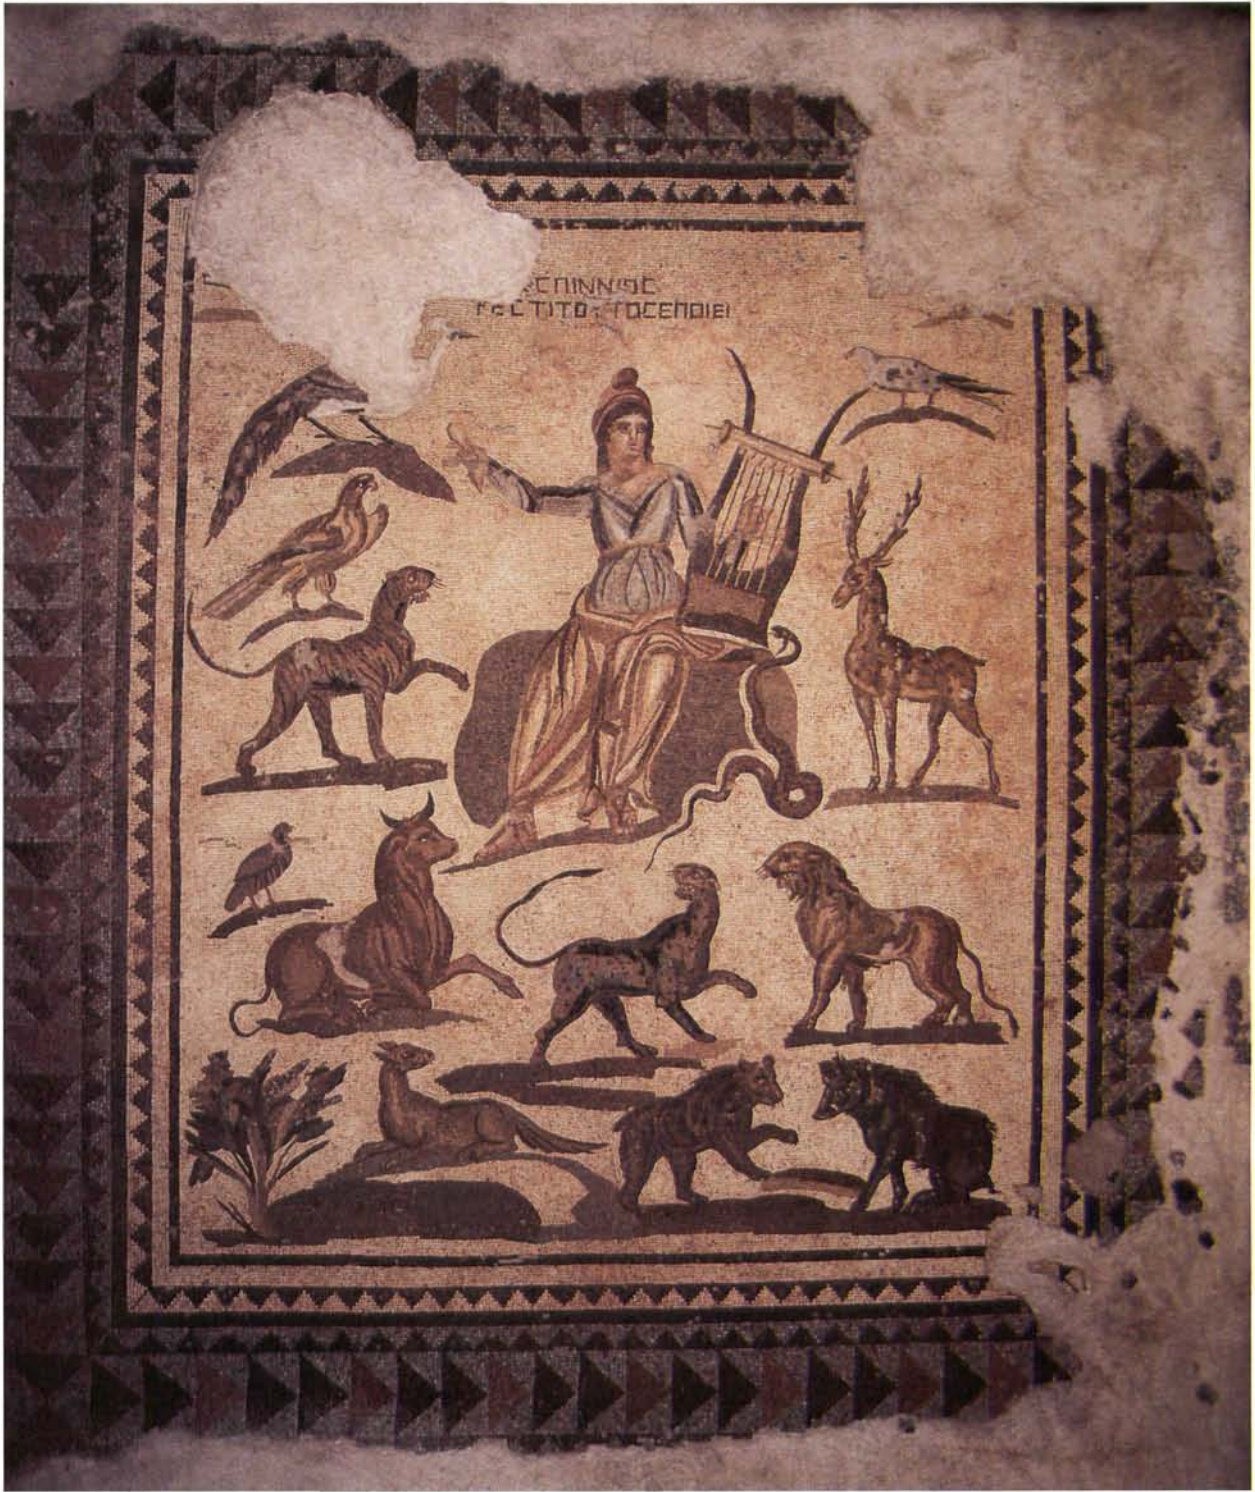
Plate 1. The Orpheus Mosaic after conservation.

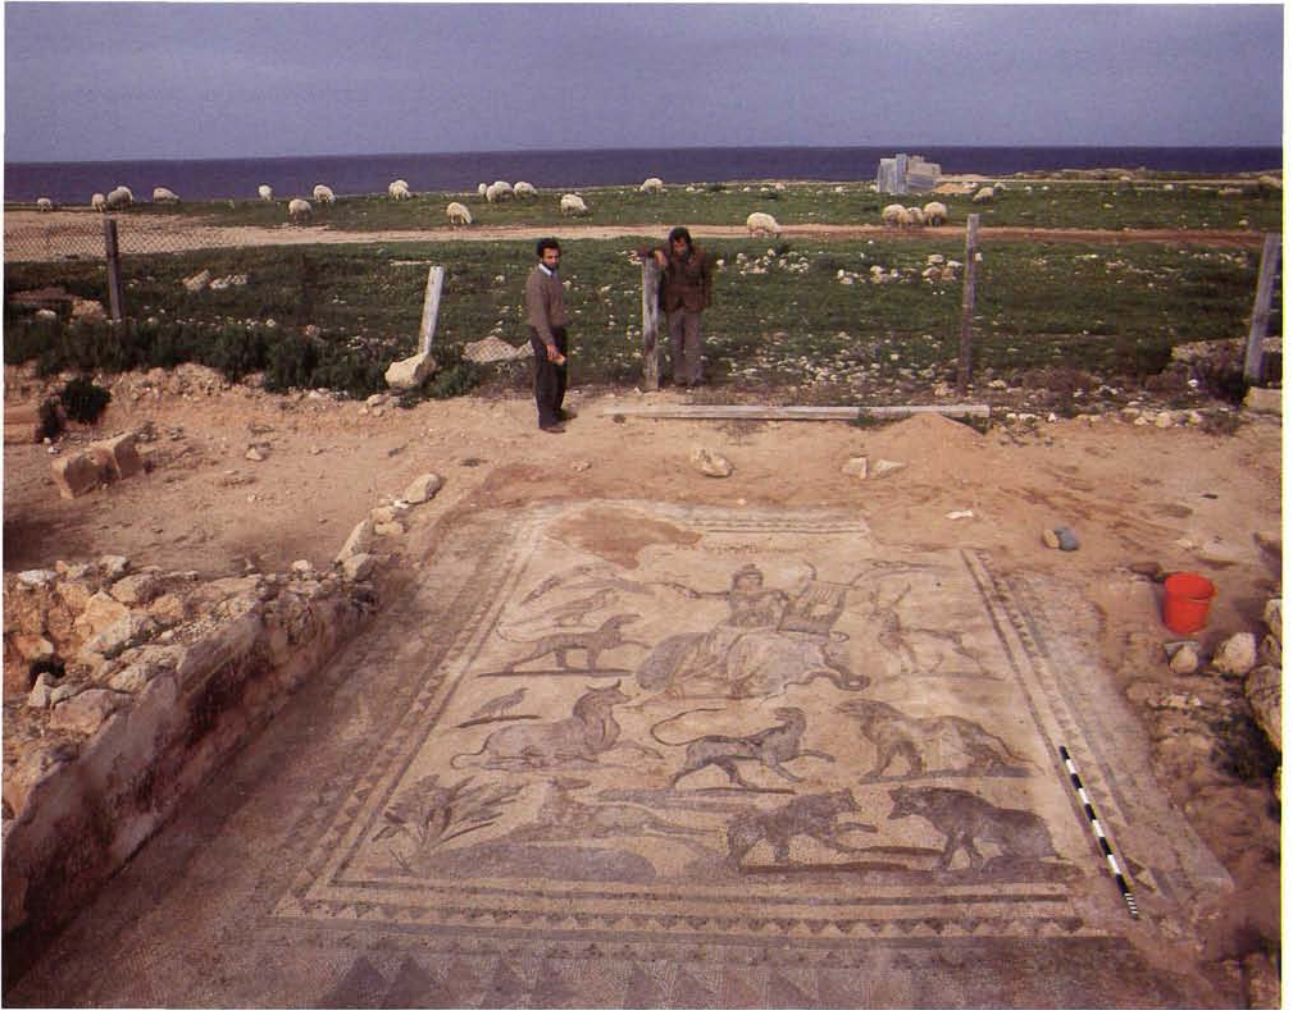
*Plate 2. The Orpheus Mosaic
before conservation.*

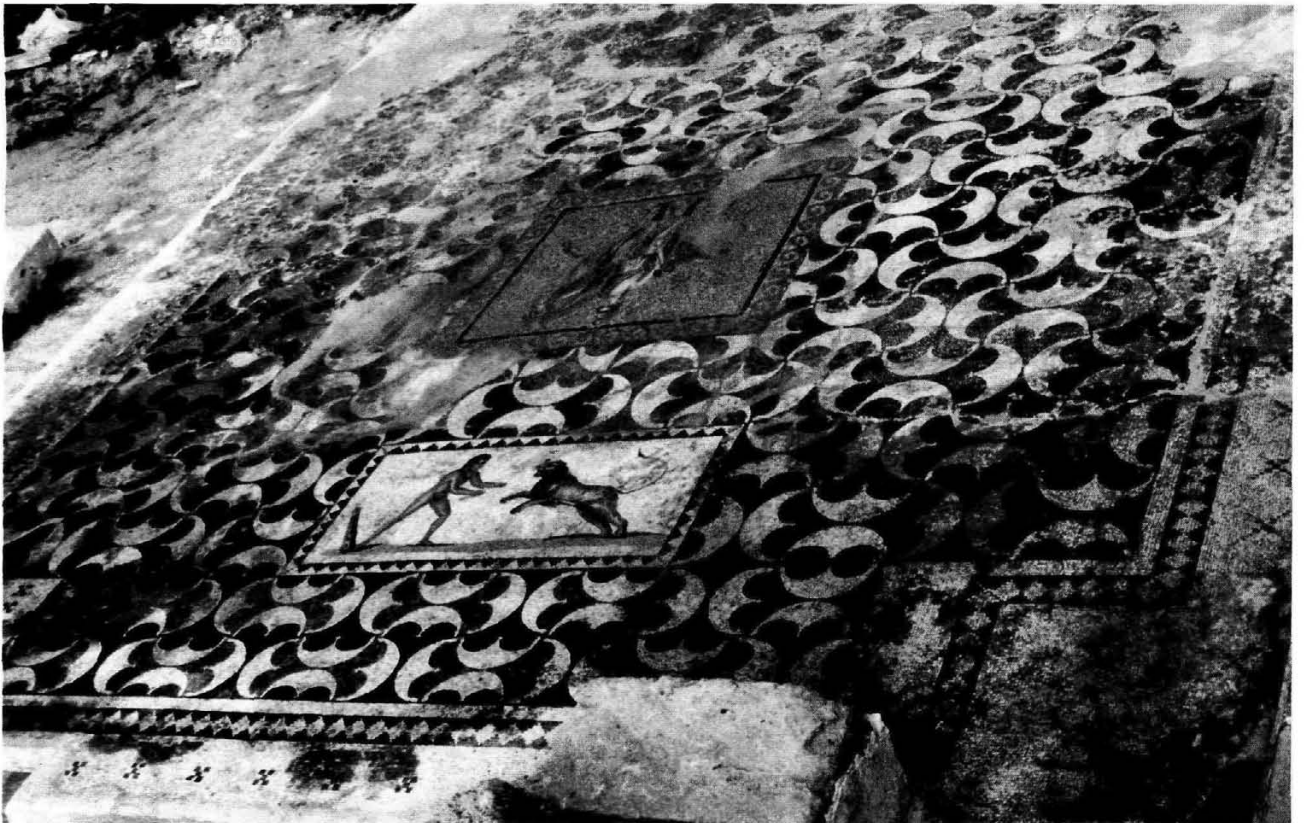
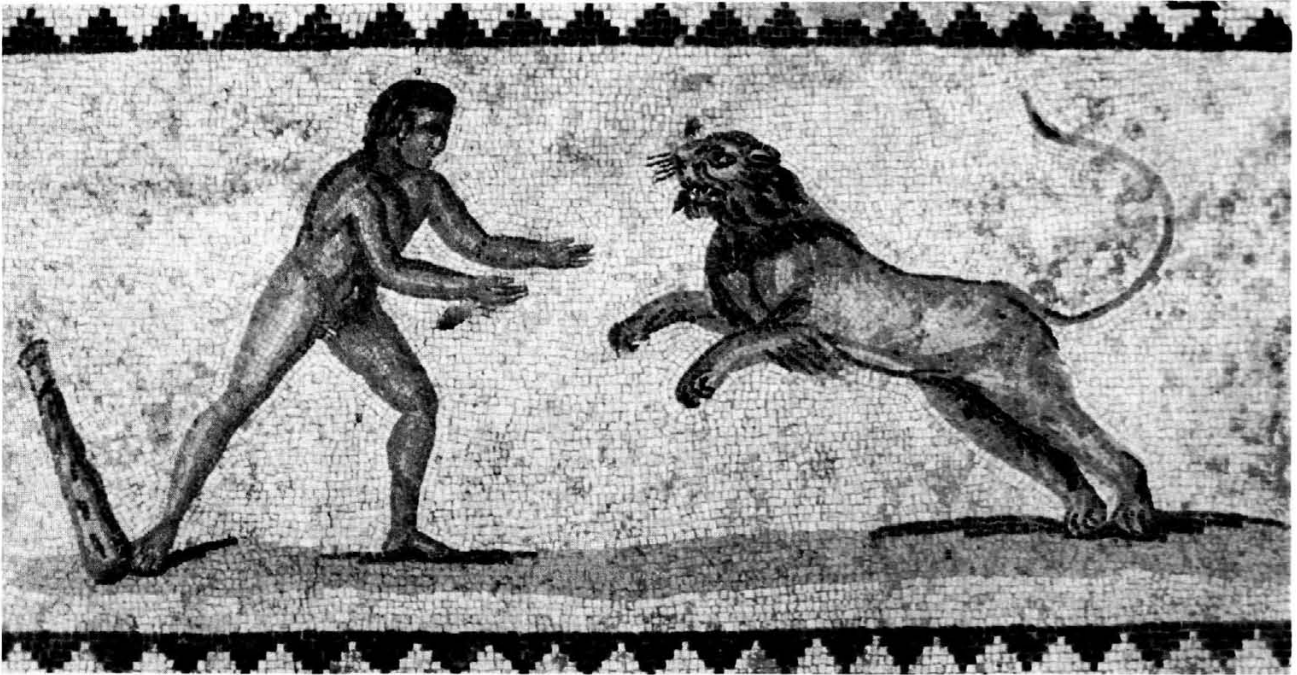
Figure 3. The Hercules and Amazon Mosaic.

Figure 4. *The Hercules panel.*

Of the three surviving mosaic floors, the largest is the one decorated with two panels, one representing Hercules and the lion, the other an Amazon and her horse (Fig. 3). These are set in a geometric field with a polychrome running-pelta pattern, the whole framed by a series of geometric borders and measuring approximately 7 m x 6.5 m. The room is approached from the east through a tripartite opening formed by two rectangular stone pillars. The two figural panels are arranged in this field in a rather asymmetric manner. That of Hercules is opposite the central door on the east, and one would face it on entering the room. It is not, however, situated on the east-west axis. The Amazon panel acts as a more or less central pseudoemblem, and is situated on the east-west axis. It is, however, off-center and closer to the door on the east. It is also upside-down in relation to the Hercules panel and is meant to be viewed from inside the room. This, and the positioning of the panels, would indicate that the room was a

The Hercules panel (Fig. 4) is rectangular, measuring 1.60 m x 0.69 m, and is framed by a band of grey serrated saw-tooth triangles against a white background. It depicts Hercules' First Labor, his combat with the Lion of Nemea. The naked hero, having discarded his club, is about to grab the attacking lion and throttle it with his bare hands. It is this detail that renders the mosaic unique, because although Hercules and the Lion are commonly represented in ancient art, normal iconography shows the two protagonists already engaged in the fight. In this respect, the scene is iconographically closer to the Hunting Mosaics of the nearby House of Dionysus than to other mosaic depictions of Hercules.

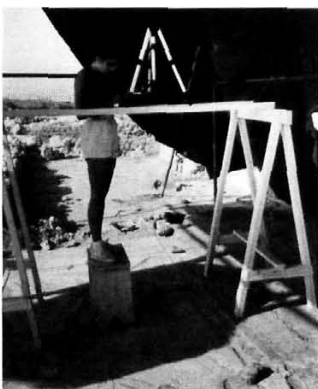
Figure 5. Photographing quadrants of the Orpheus mosaic using a camera mounted on a wooden frame.

To photograph these quadrants, a wooden structure (Fig. 5) was built to hold the camera (35 mm Canon AE1, 35 mm lens, FP4 film). Each quadrant was photographed with the camera always positioned the same distance from the ground, on axis with the center of the quadrant. The images were printed at a scale of 1:10, following the metric reference provided by tapes delimiting each quadrant. The photographs were then joined to obtain a complete image of the mosaic, the general design of which was traced onto transparent paper. This drawing served as the basis for the final condition drawings.

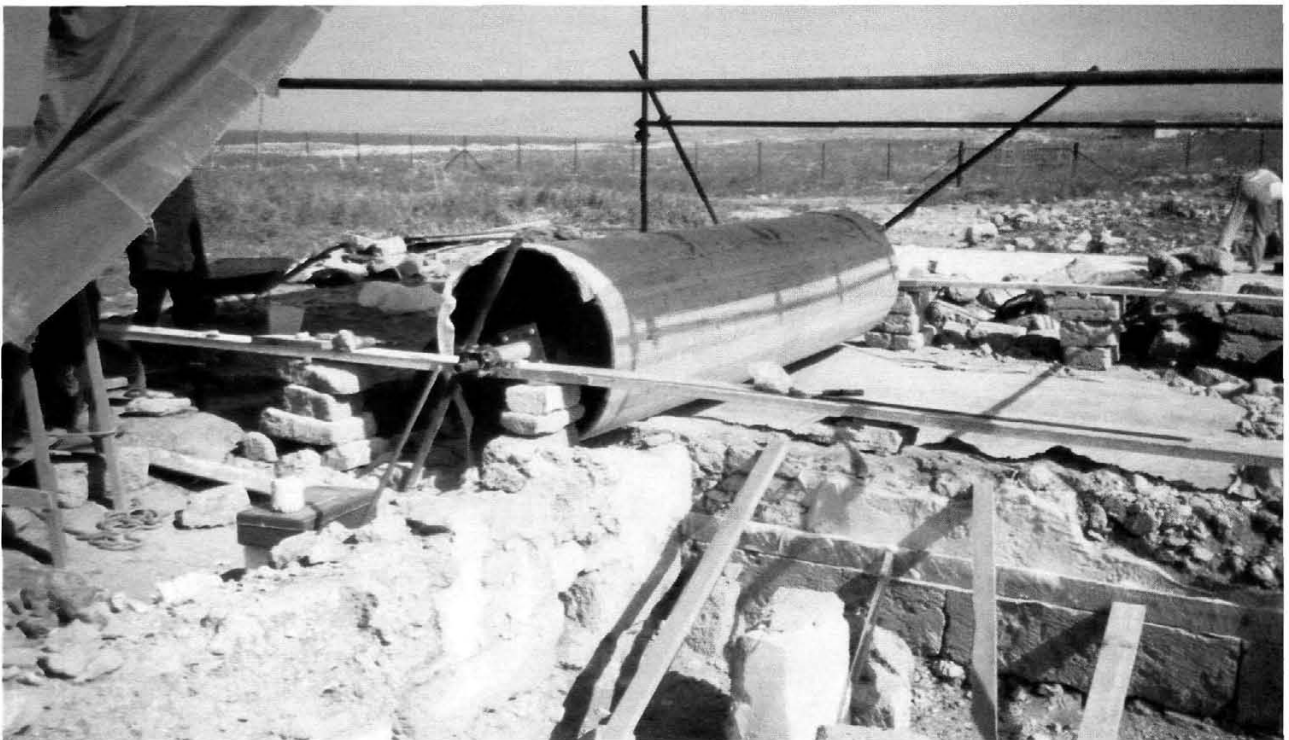
Figure 12 (right). Detachment of the mosaic from the east end. The drum is stabilized with supports exploiting lacunae in the mosaic surface.

operation commenced. Once the area with these lacunae had been rolled onto the drum, it was possible to cut through the facing fabric, the temporary mortar consolidation, and the wooden panels of the drum, in order to insert wooden poles radially into the drum (Fig. 12). These acted as levers and greatly facilitated the turning of the drum. When the detachment and rolling operation reached a point about 1 m from the east end of the mosaic, it was decided to simplify and speed up the process by working simultaneously from both sides of the drum.

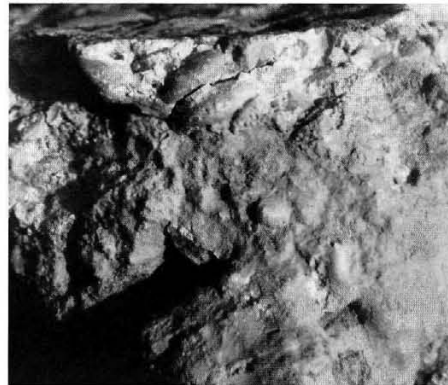
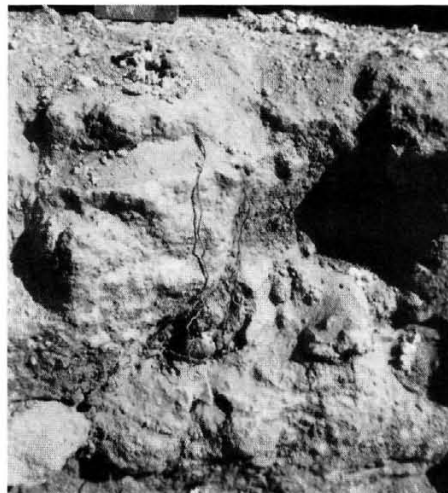
Figure 14. Stratification of the preparatory layers. See Pl. 5 for a schematic diagram of these layers. (a, top) Levels 2 (bedding layer), 3 (nucleus), and 4 (mortar). (b, middle) Levels 5 (rudus) and 6 (statumen). (c, bottom) Levels 6 and 7 (deep statumen).

In the course of the detachment operation, the preparatory layers underlying the Orpheus mosaic were recorded (Fig. 14; Pl. 5).² Of particular note are fragments, approximately 2 cm x 1 cm, found between levels 2 and 3; these show traces of red coloring material and were probably part of the preparatory design drawing (sinopia) to define the spaces of the mosaic floor. Another fragment, found between levels 3 and 4, shows evidence of freshly incised rectilinear lines.

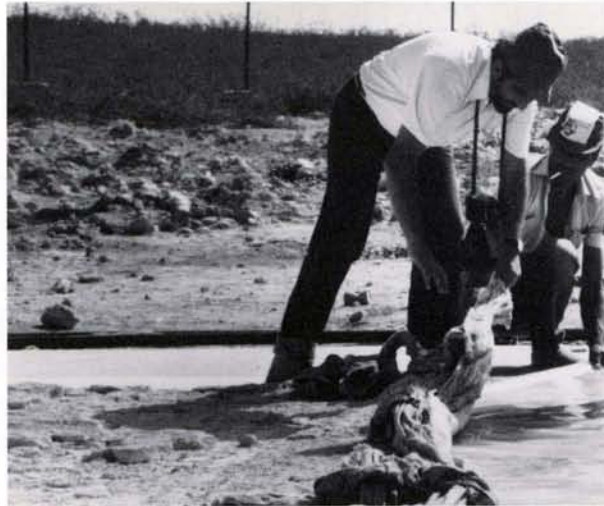
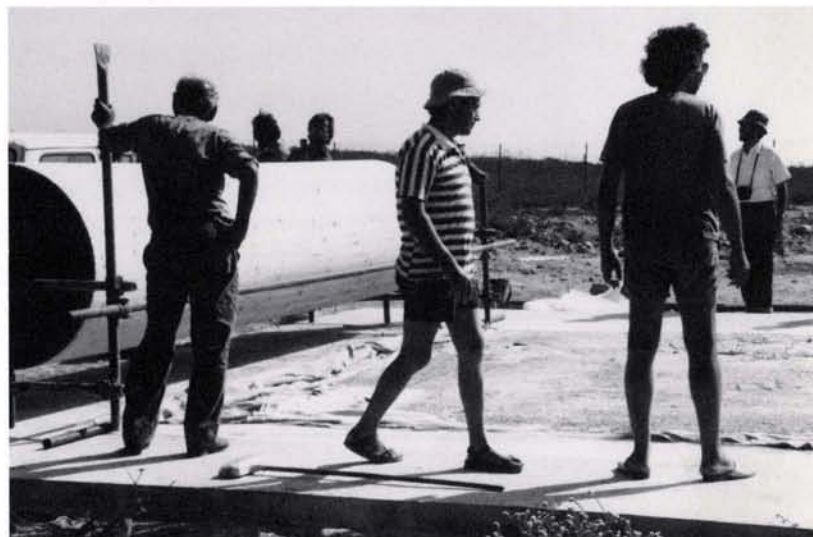
Figures 16 and 17. Unrolling the mosaic on the concrete platform.

The drum and mosaic were transported to a concrete platform that had been constructed by the Department of Antiquities approximately 50 m away. It was placed on a temporary support built of scaffolding tubing (Fig. 15), then unrolled face down with a sheet of polyethylene between the concrete platform and the mosaic (Figs. 16,17). It is very important that the polyethylene sheet be stretched completely flat prior to unrolling the mosaic, as any creases in the sheeting will be permanently impressed in the surface of the tesserae.

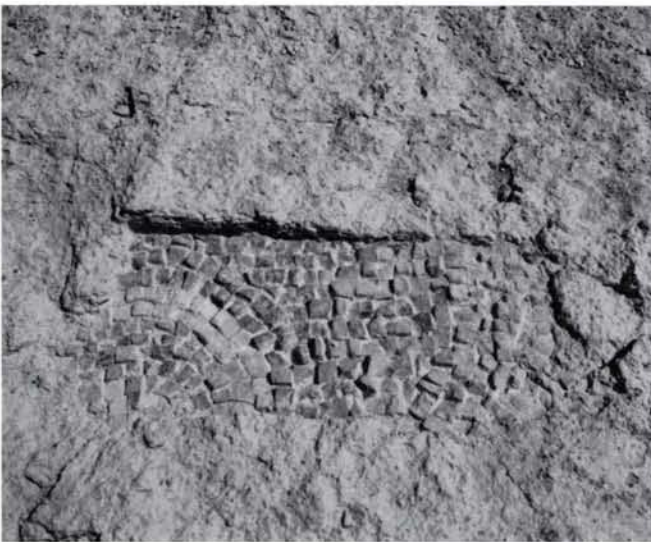
Figure 19 (above). Section of mosaic back after *spillatura*.

After using abrasive and cutting tools to remove the disintegrated mortars of the preparatory layers, cleaning of the back of the mosaic continued using more precise tools. This operation is traditionally called the *spillatura* because it is carried out using *spilli*, small metal awls, although these are now supplemented with precision electrical instruments. The tools used on the Orpheus mosaic included fine stainless steel awls, dental drills with microfraises (rotating cutters), and vibrating cutters with the tip modified to a chisel-shape (Fig. 19).

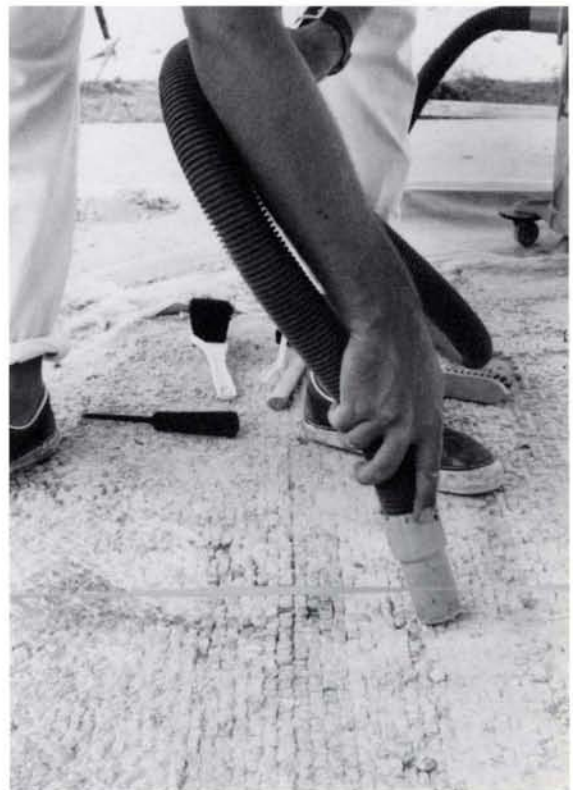
Figure 20 (above right). Vacuuming the back of the mosaic.

The aim of this operation was to free the interstitial spaces of the tesserae of residues from the disintegrated setting-bed and of all traces of organic matter and earth accumulated between the tesserae during burial, which might interfere with adhesion between the mosaic and its new support. The residues from the cleaning operations were removed using a vacuum cleaner (Fig. 20). Finally, the back of the mosaic was disinfected using a biocide (Metatin N 5870/101, see p. 59) applied by brush.

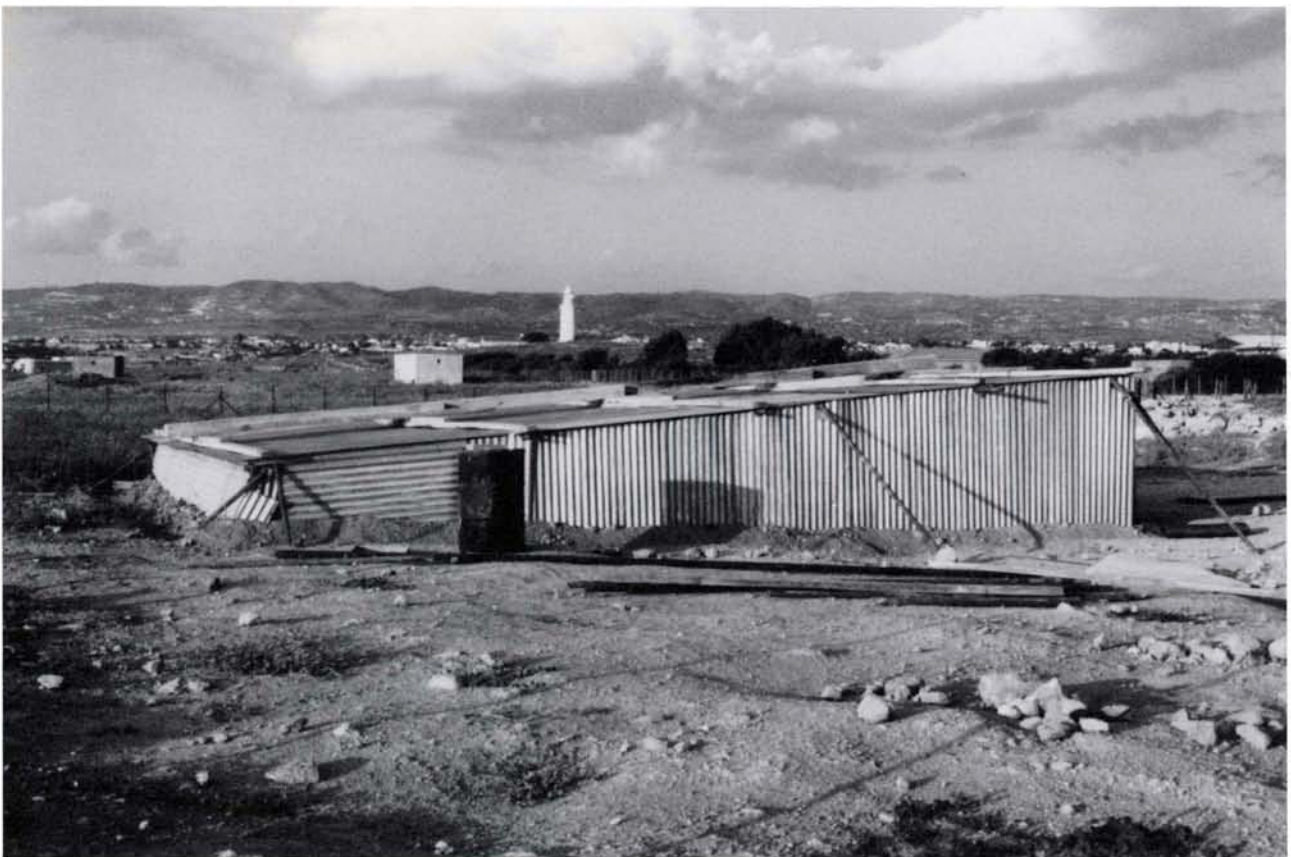
Figure 21. Temporary shelter over the Orpheus mosaic.

The structure of the roof shelter was built of steel tubing of the kind used in scaffolding, assembled by means of coupling clamps and covered with corrugated sheets of galvanized steel (Fig. 21). The shelter roof was built at an angle that would assure efficient run-off of rainwater, but not offer too large a

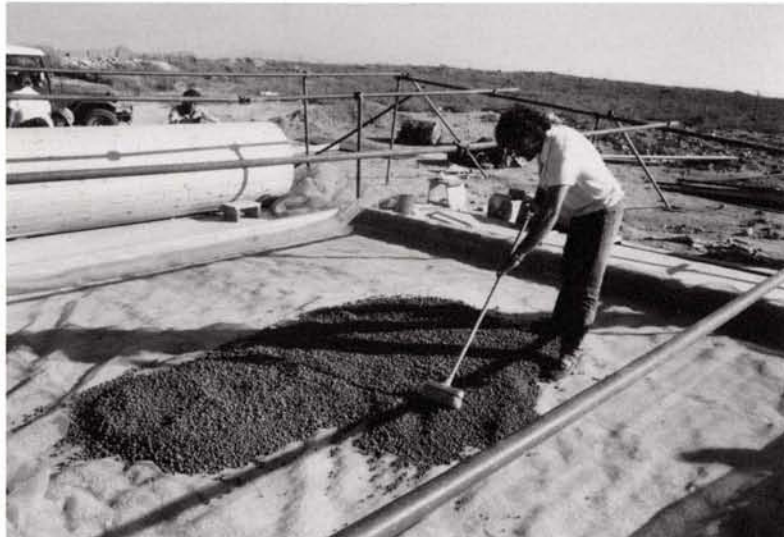
Figure 24 (right). Spreading clay pellets over the nylon net.

A sheet of polyethylene had previously been laid down between the mosaic and the concrete platform, and a broad-spectrum biocide had been applied to the back of the tesserae. A fine-mesh nylon net was then stretched over the mosaic and over the edges of the wooden coffer that surrounded it, to facilitate later removal of the first layer of inert isolating material. This material, a layer (approximately 20 cm) of expanded clay pellets (Fig. 24), has been tested many times in similar situations.

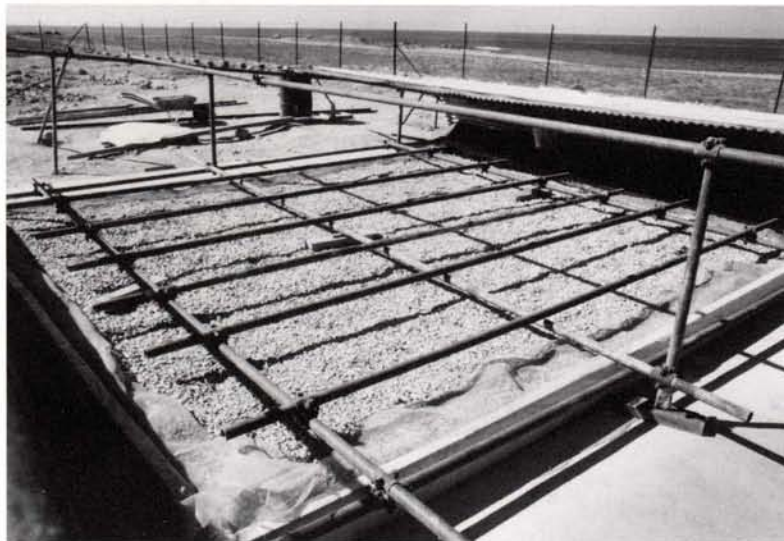
Figure 25 (below right). Structure of scaffolding poles constructed over the mosaic for additional security.

A second nylon net was laid over the expanded clay, followed by a layer of 20 cm of local gravel which, because of its weight, represented a reasonable deterrent to potential theft. A reticular structure, of the same tubular scaffolding elements used for the roof, was then constructed a few centimeters above the second protective layer for added security (Fig. 25).

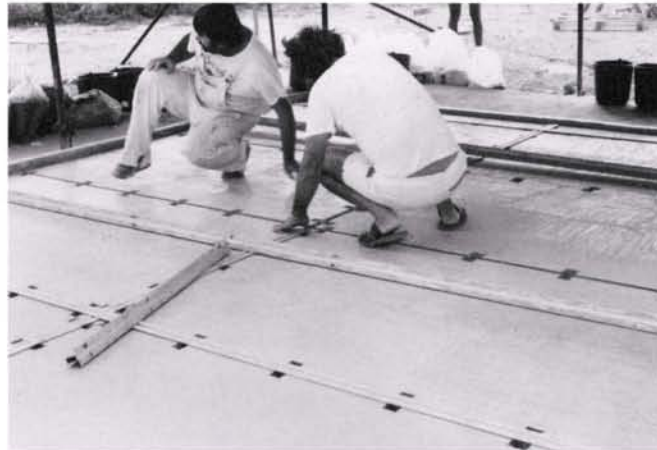
Figure 28 (right). Testing the support “dry” to ensure that all joints and measurements are correct.

The entire structure described above was tested several times “dry” to ensure that all joints and measurements were correct (Fig. 28). The necessary quantity of chopped mat fiberglass (weight: 330 g per m²) was then cut to size, and the appropriate quantity of resin was mixed. Epoxy resin from Ciba-Geigy

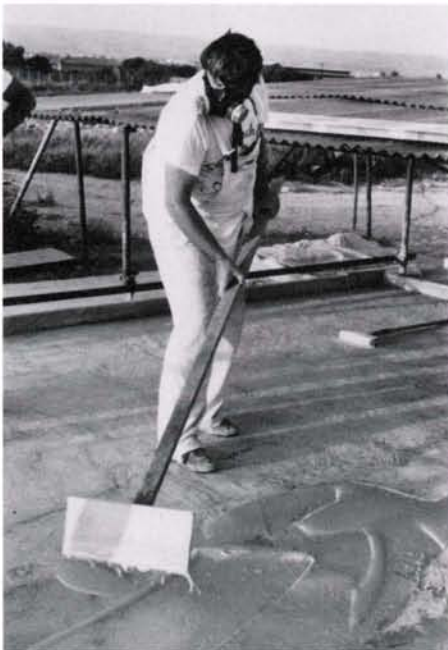
Figure 29 (below). Applying the first layer of epoxy to the back of the mosaic.

The resin was spread on the back of the mosaic in bands no wider than a sheet of fiberglass (Fig. 29). The fiberglass sheets were laid in place and another coat of resin applied. After the epoxy/fiberglass layer had cured, its surface was roughened with a mechanical grinder, as were the surfaces of the panels (Fig. 30) and the aluminum reinforcements. The aluminum was also degreased with acetone.

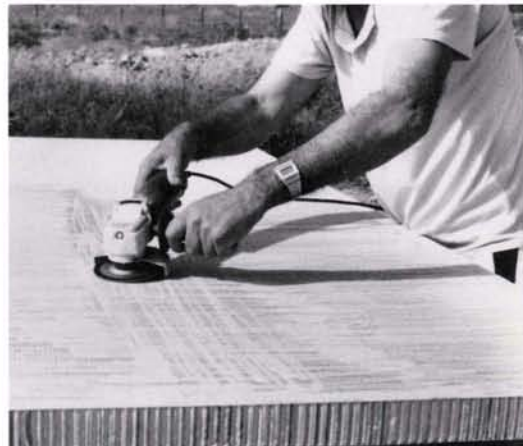
Figure 30 (below right). Roughening the surface of one of the panels.

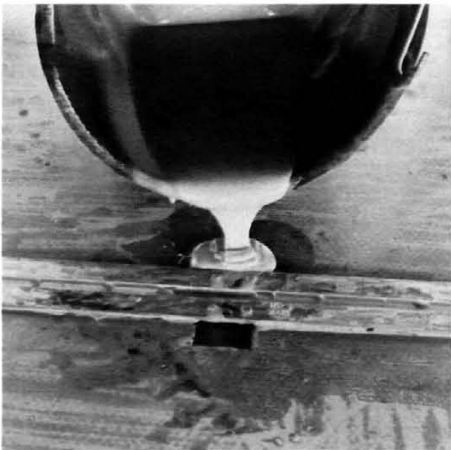
Figure 31 (above). Pouring epoxy into the inserts in the panels.

The panels were positioned on the mosaic, then each was lifted in turn, the epoxy was applied beneath it, and it was replaced in position. The aluminum reinforcements were then put in place. The next day, after the epoxy beneath the panels had cured, the inserts around the reinforcements were filled with more epoxy (Fig. 31).

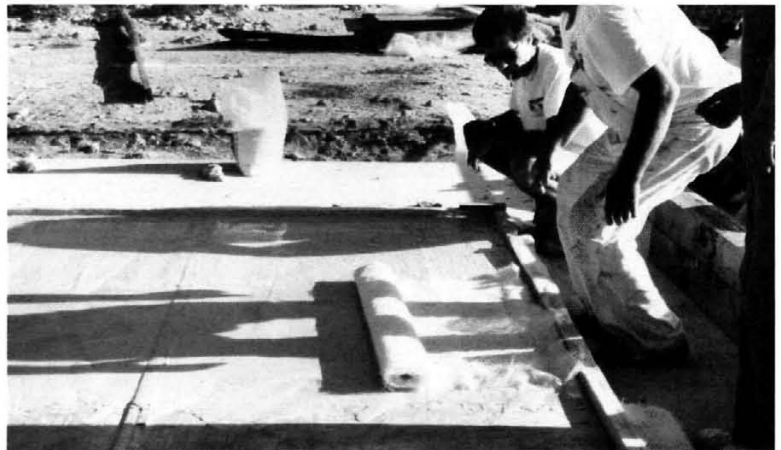
Figure 32 (above right). Applying the final layer of fiberglass and epoxy.

The following day an additional layer of epoxy and fiberglass was applied (Fig. 32). Once that had cured, a second set of inserts was cut to allow attachment of another set of aluminum reinforcements, installed perpendicular to the first and fixed in place with screws and epoxy (Fig. 33). These allowed the mosaic to sit clear of the concrete slab.

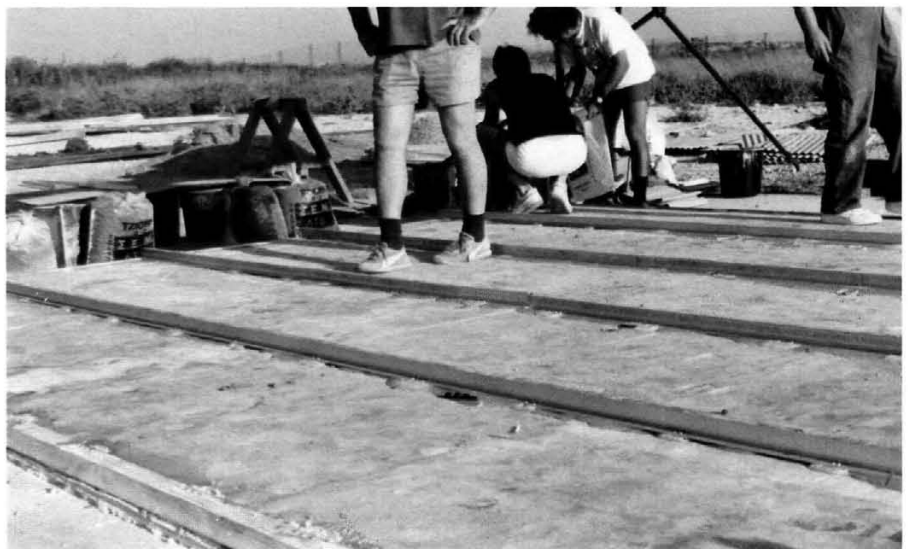
Figure 33 (right). Installing the second set of aluminum reinforcements.

Figure 34. The mosaic, with its new support, being lowered onto its original site.

When the resin had cured, the panel was turned over, first with the assistance of levers and a mechanical hoist, and then with the help of a crane (Fig. 34).¹ The weight of the mosaic pavement without mortar is estimated at 20 kg/m². The combined weight of the whole panel (pavement and support) is a little over 1000 kg (see Table 2 for the weight of the support materials).

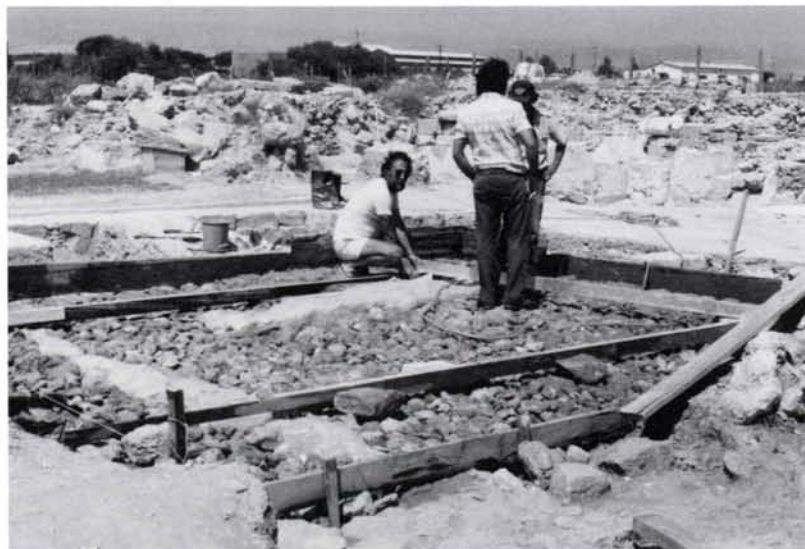
Figure 35. The excavated area backfilled and prepared for the pouring of the concrete slab.

Once the mosaic had been lifted, and the underlying area fully excavated, the excavated remains were protected with a polyethylene sheet and the trench backfilled with excavated stone material (Fig. 35). This provided a strong foundation for the concrete slab, prepared by the Department of Antiquities, on which the mosaic was reinstalled. Wooden boards placed on the slab beneath the mosaic allowed workers to shift the mosaic into its exact original position, after which they were removed.

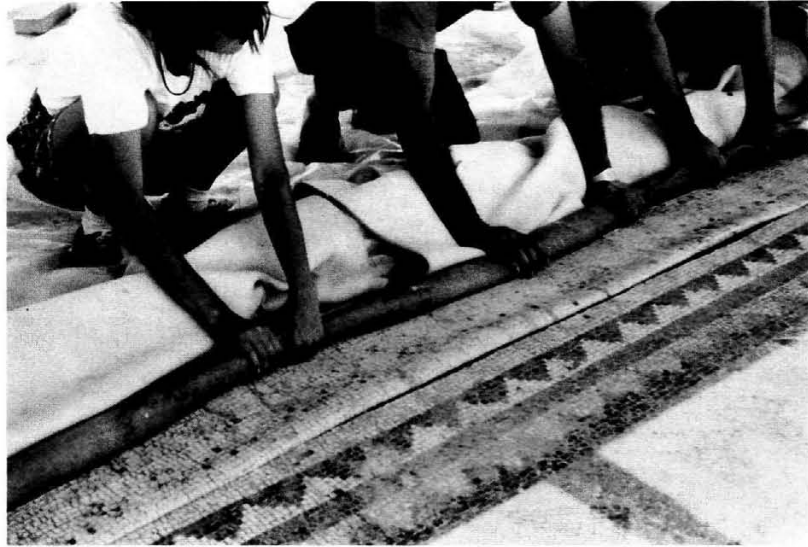
Figure 36. Removal of facings from the mosaic surface.

With the mosaic in place, the facings were removed. To facilitate this, compresses of wetted foam rubber were applied to the mosaic surface. These were left in place for between 48 and 60 hours—sufficient time to reswell the adhesive of the cloth layers and to make them lose their adhesion to the mosaic surface. The cloth was gradually removed using a steady pulling force parallel to the surface (Fig. 36).

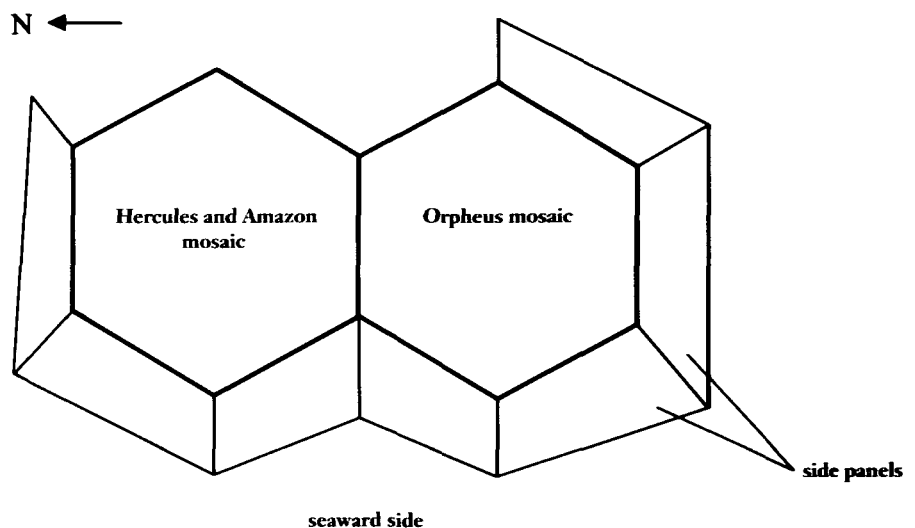
Figure 37. Schematic plan of the two-ring hexashelter.

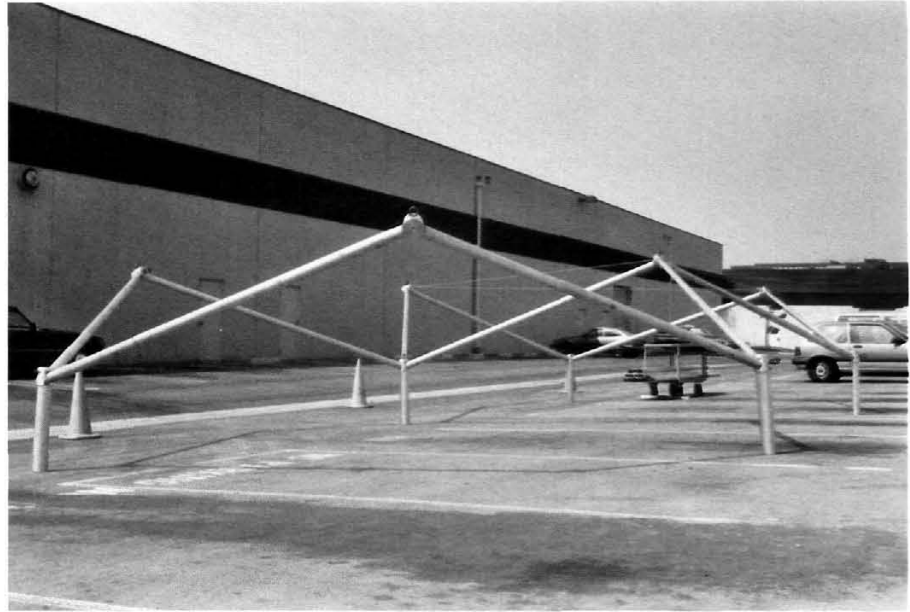
Figure 38 (top). Trial assembly of the hexasbelter, using short support legs for convenience. Note the stabilizing cable linking the three high points of the far ring.

The framework of the structure has a zig-zag profile and six sides; the name "hexashelter," therefore, derives from the hexagonal shape of each module. The framework is aluminum tubing (10 cm diameter for vertical supports; 7.5 cm diameter for roof members) with a fabric roof and side panels. Because it is modular, it can easily be expanded by building laterally from any one of the hexagonal sides. The shelter at Paphos is a dual-ring structure (Figs. 37, 38); one ring is centered over the Orpheus mosaic and the other over the Hercules and

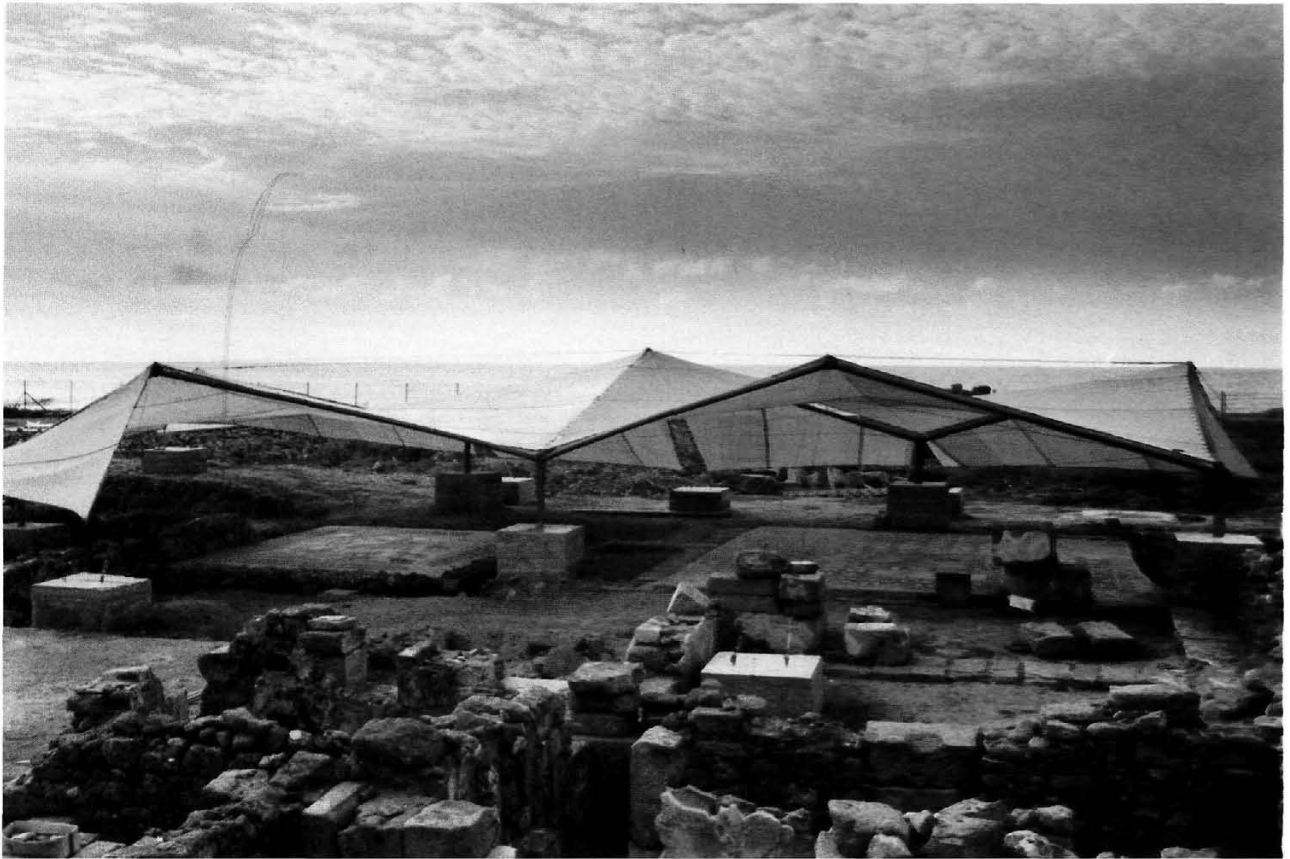
Figure 41. The hexashelter in November 1989, with three sides left open for visitor access.

Because of the open knit, the aerotextile fabric does not provide adequate protection against rain when used as the roof membrane. In planning the project, it was decided to waterproof the fabric in situ; tests and aging experiments were conducted in the laboratory to determine the most durable material for the purpose. Thus, an attempt was made to waterproof or "impermeabilize" the roof membrane over the Orpheus mosaic by applying a GEC silicone gel to the fabric after the structure had been erected. This proved to be time consuming and difficult since the gel could not be coated evenly and was forced through the fabric holes as it was applied. Numerous pinholes developed, allowing rain water to seep through the fabric. Wind-driven rain could also pass through the side

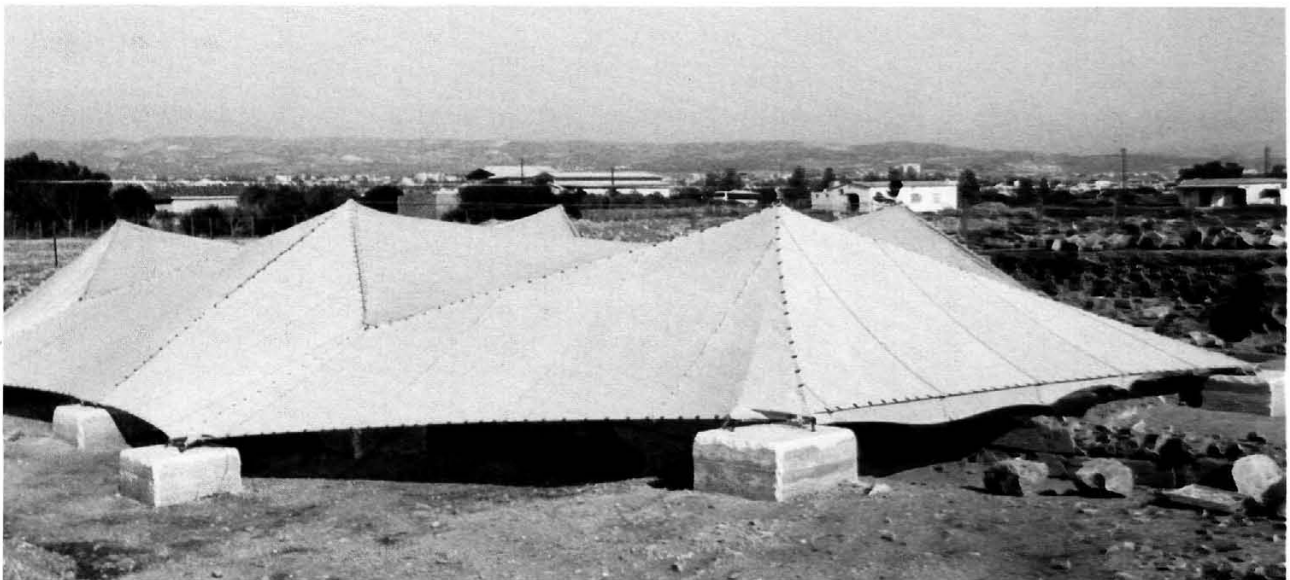
Figure 42. The hexashelter in November 1990 with a new roof membrane and more extensive, overlapping side panels.

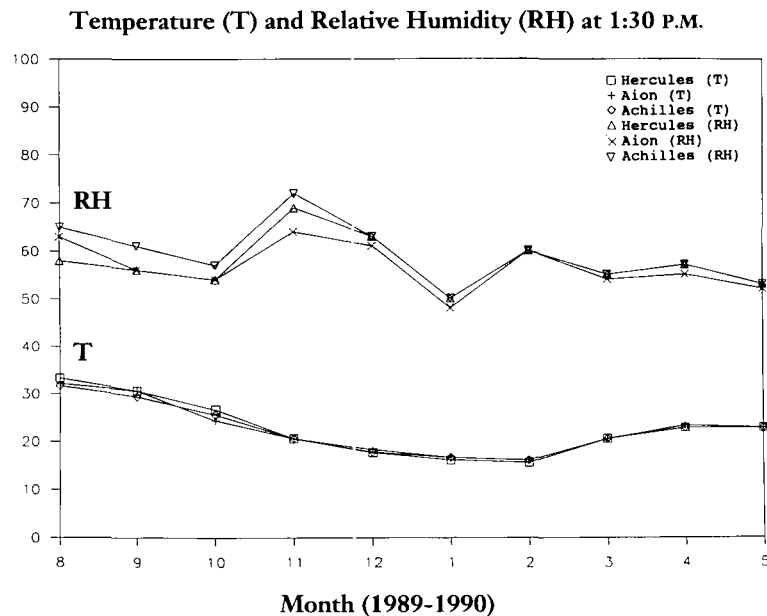
Figure 44 (right). Temperature and RH measured at 1:30 P.M.

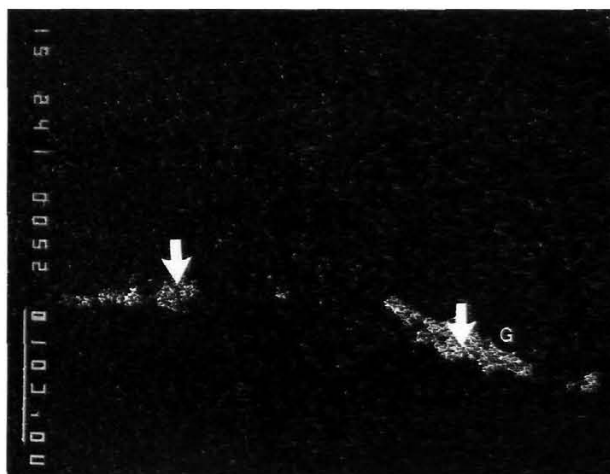
Figure 52 (bottom). X-ray distribution map for sulfur. Sample 21. Note concentration of sulfur (G for gypsum) at surface crust (bottom of micrograph). Same area as Figure 54. Scale bar is 100 μm .
