Valley of the Queens Assessment Report

Volume 1 Conservation and Management Planning

A collaborative project of the Getty Conservation Institute
and the Supreme Council of Antiquities, Egypt

August 2012

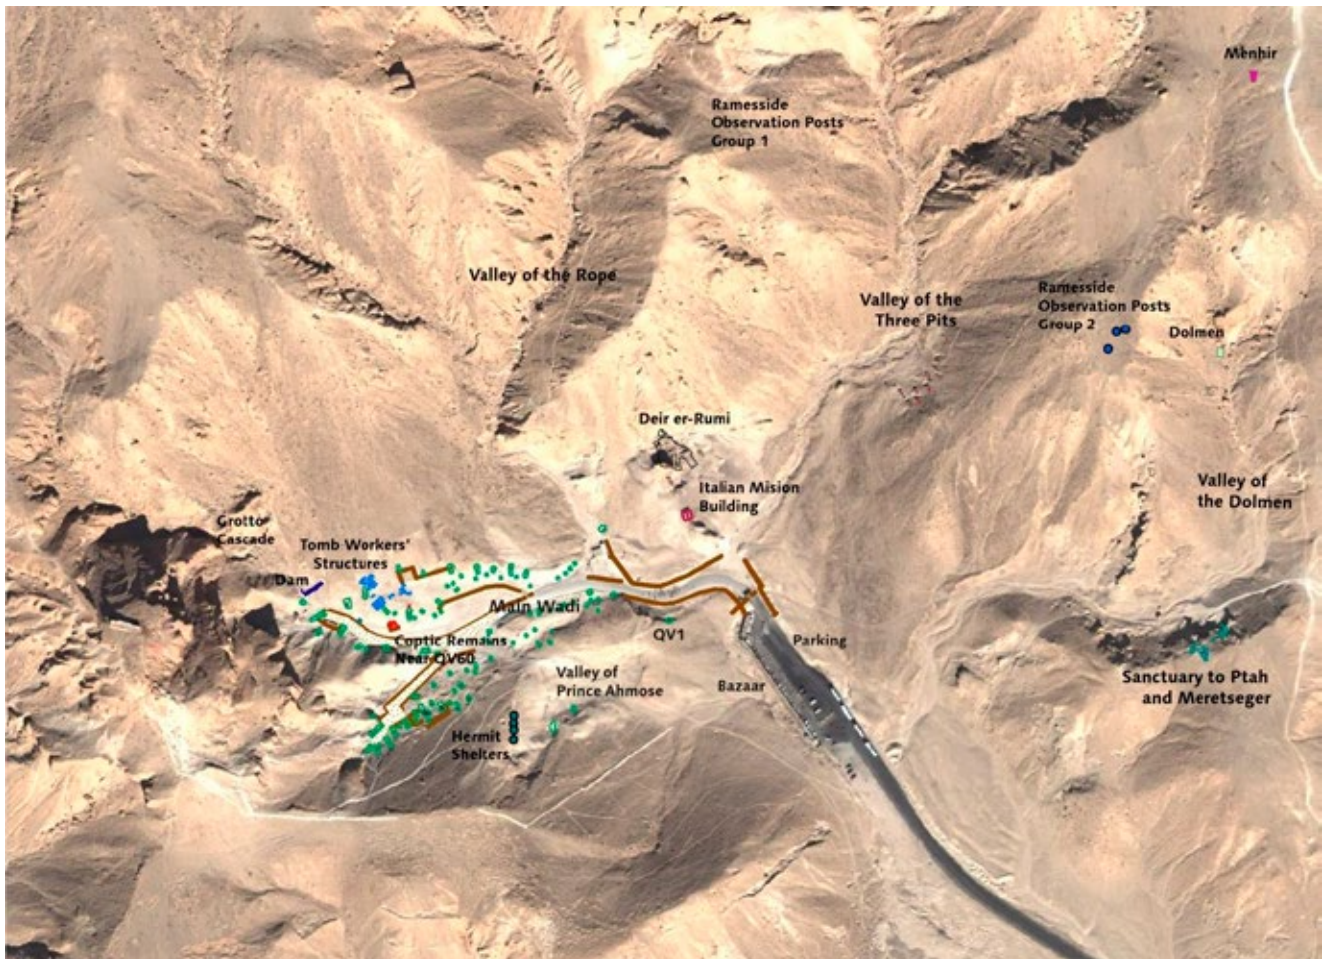
Satellite view of the Queens Valley area indicating the location of tombs clustered in the main Valley (green dots), location of ancillary valleys, historic feature and site elements, and modern infrastructure. (Satellite image: 2006 DigitalGlobe).

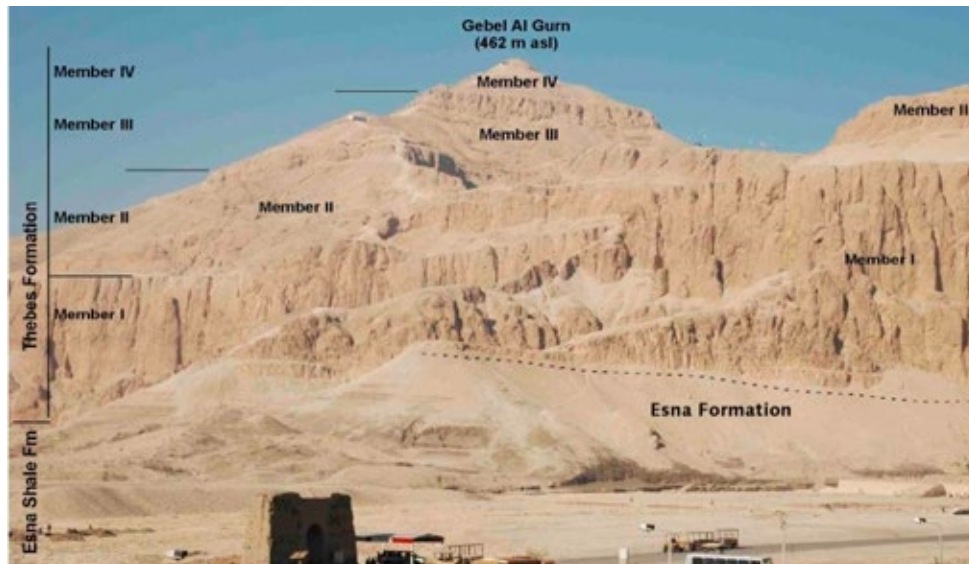
Above: Geological cross-section generated from surface geology (from Wüst 2009) demonstrates the “rotated block” stratigraphy and slumping that occurred in QV due to undercutting (erosion) when the Nile incised the substrate as a result of lowered sea level in the Mediterranean. View to the East.

Though further research may eventually improve understanding of the subsurface geology of the Valley, for the purposes of our assessment, it is sufficient to understand that tombs excavated into the Esna Formation are more prone to deterioration due to the presence of swelling clays in the shale layers. In addition, the tombs were built into a rock formation which contained a fault and joint pattern that predates the pharaonic-era tomb excavations and present weakness points. Likewise, while mapping the precise path and extent of faults in the Valley would require further investigation, it is sufficient to recognize that many tombs are prone to movement and associated damage in the event of regional seismic activity.

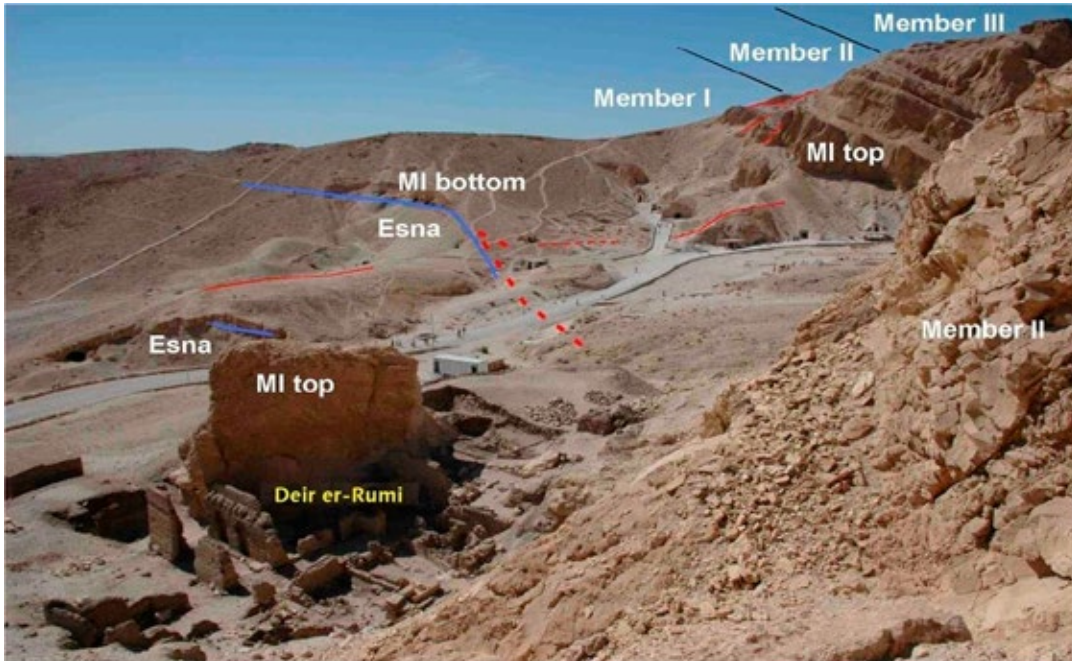
Stratigraphy of the “rotated block,” looking west into the Queens Valley. Faults shown in red. Blue and black lines indicate geological horizons (top of formations), from Wüst 2009.

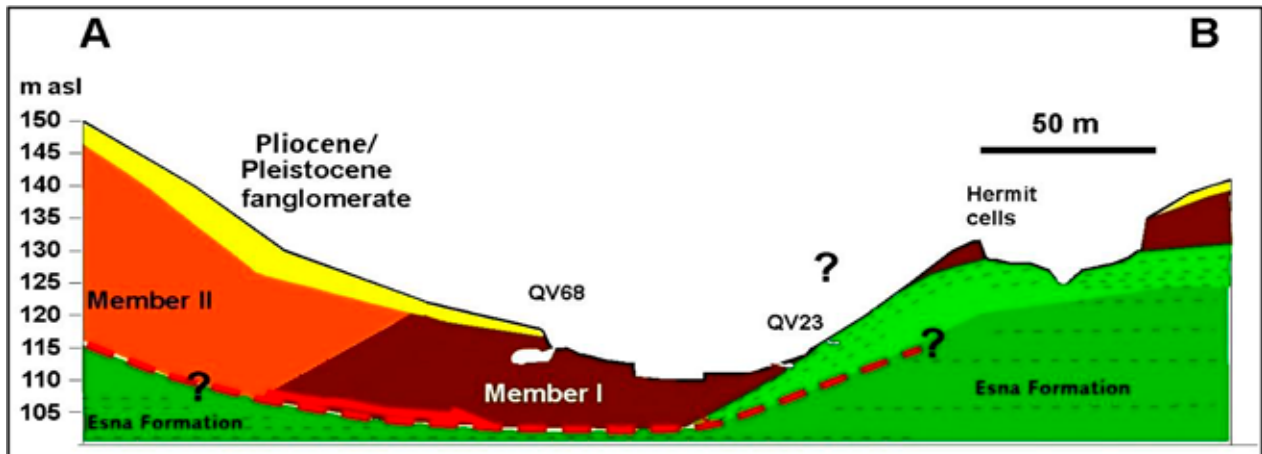
Cross section of the Valley near its midpoint, view to the east. The presence of a large fault facilitating the slumping of the rotated block is denoted by the dashed red line. Dashed black lines denote bedding planes in the Esna Formation, exhibiting plastic deformation, from Wüst 2009.

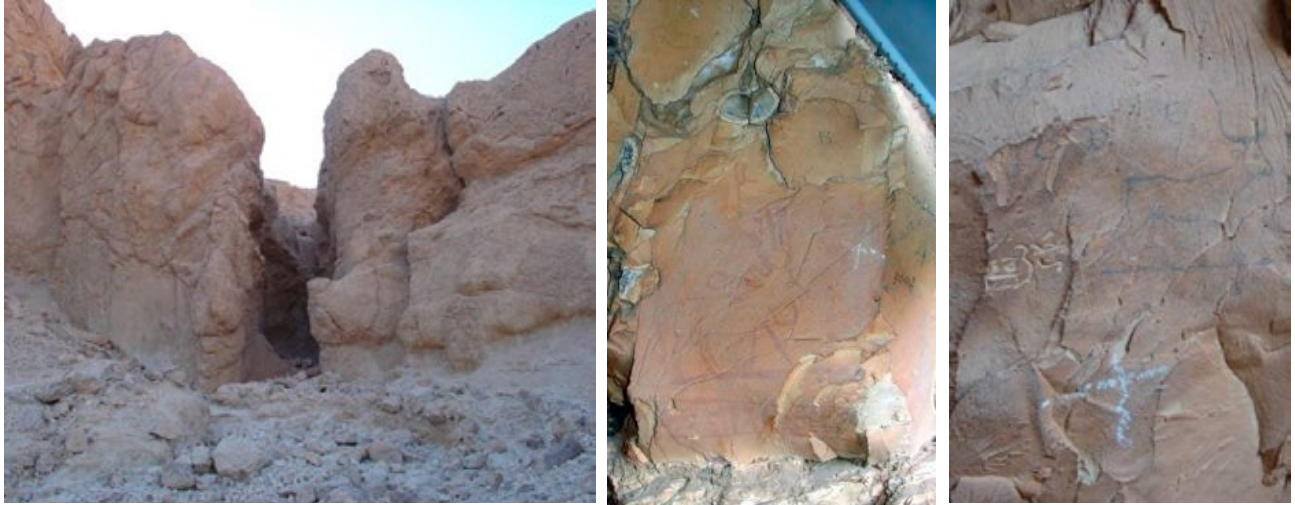
The sacred grotto as viewed from the main Valley (left) and examples of graffiti with depictions of Hathor (middle and right).

Perhaps more importantly, however, was the presence of the sacred grotto located at the end of the main wadi (Leblanc 1989, 12; Desroches Noblecourt 1990). Based on graffiti within the confines of the grotto, it is clear that the Egyptians associated it with the goddess Hathor and likely with the rejuvenation of the deceased in the Valley of the Queens. Several graffiti on a high ledge in the grotto depict cows with the headdress of Hathor and some also show the *menet* necklace, an object typically associated with Hathor and her cult. There is also a figurative graffiti of a goddess and several hieratic inscriptions giving accounts of torrential rain fall washing down the wadi and out of the mouth of the grotto in a cascade. There are several myths associating Hathor with the flood. In the myth of the wandering eye of the sun god Ra, Hathor is the daughter of Ra, the vengeful eye of the god who flees to Nubia and must be summoned to return by Thoth. It is believed that upon her return, she brought with her the inundation. The same is true for the combined deity Hathor-Sothis, the goddess of the star known today as Sirius, whose appearance on the horizon, as that star, heralded the arrival of the inundation and the new year. It makes sense that the cascade created from the rain water pouring out of the grotto should be likened to such an event and thus the cave considered sacred to Hathor.

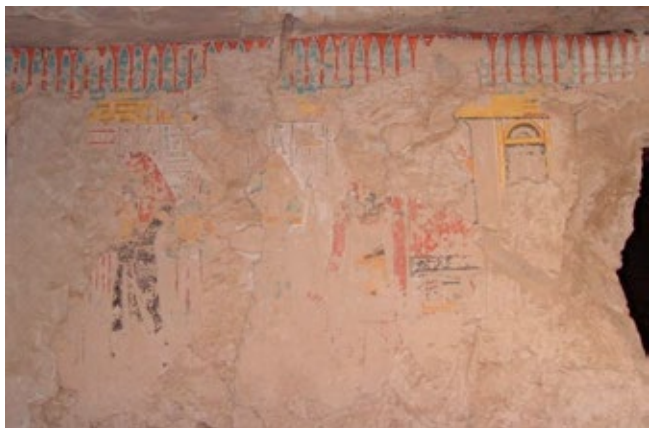
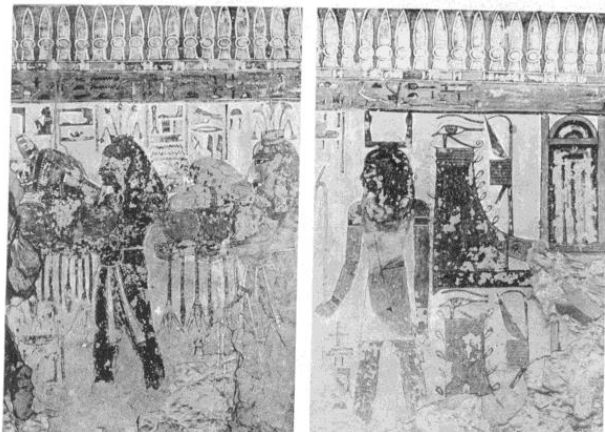
Chamber C, south wall, current condition (left) showing the two fecundity figures, the Ka and the barks of the day and night; and at the time of Schiaparelli’s discovery when iconography is more legible showing detail of fecundity figures (middle) and detail of Ka and the barks (right, Image: Schiaparelli 1923).

Construction on this tomb began in the reign of Seti I or earlier under Rameses I. It may have been halted because of collapse, leaving the relief carved in the rear chamber unfinished. The main chamber (C) has two fecundity gods with offering plates, the spirit Ka and the two barks of Ra (the day and night barks) (Loyrette and Mohammed Sayed 1993, 120-123). Porter and Moss (1964, 751) mistakenly identified scenes from the east wall of Chamber C and an image of a monkey on the right side of Chamber G’s doorway as scenes from the *Book of Caverns*. The east wall was actually decorated with the same deities as shown on the corresponding wall of QV 38; the monkey on the doorway is part of an offering table scene. Both scenes are part of the ‘Satra Repertoire’ defined by McCarthy, which adorns the sarcophagus chamber of every queen’s tomb on the south flank of the Valley (McCarthy 2011, 78-79).

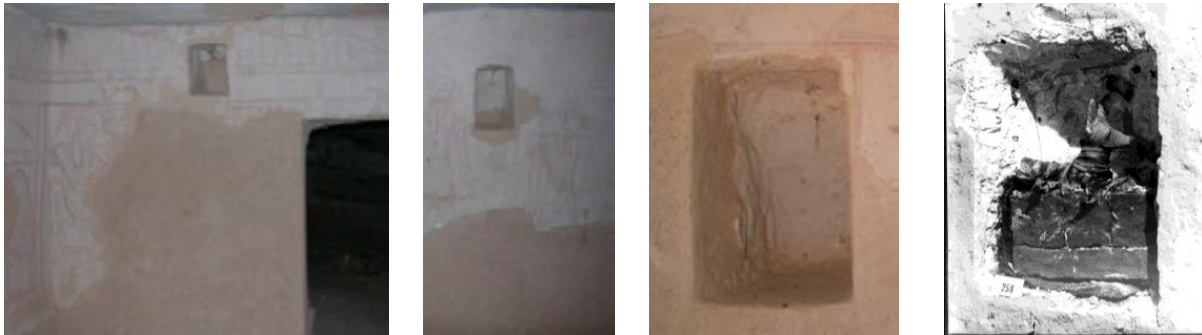
Magical brick niches in Chamber C of QV 38 and intact example with figure of Anubis from Tutankhamen's tomb (far right; Image: Griffith Institute).

Four niches, one on each wall, are found within the burial Chamber C. The niches would have held magical bricks inscribed with images and spells as outlined in the *Book of the Dead*, chapter 151. Intact examples were found in the tomb of Tutankhamen. The four directions can be associated with the four sons of Horus and thus, in turn, with protecting the four parts of the body held within the canopic jars. Likewise, they may be connected to the birthing bricks used in childbirth in Egypt which is natural for a situation where the deceased wishes to be symbolically reborn into the afterlife (Roth and Roehrig 2002, 133).

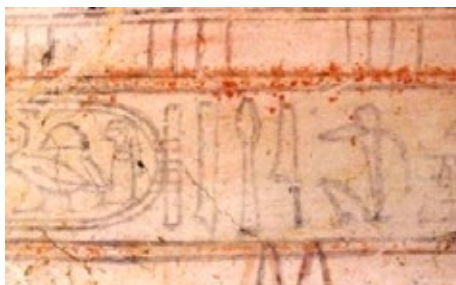
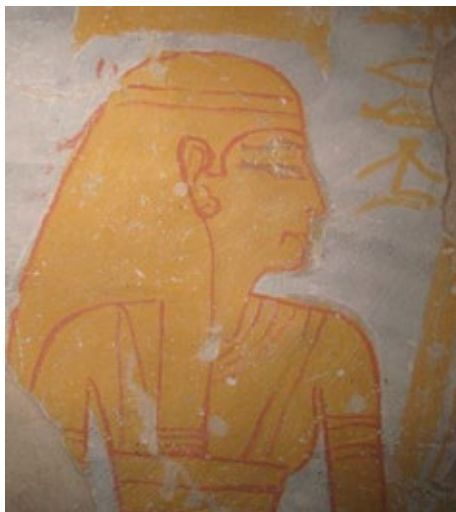
Detail of red snap line, used to lay out decoration, followed by black paint (above left, Image: CNRS); Nut on ceiling (below left); corrected east wall of Chamber C (above; Image: CNRS).

In Chamber C it is possible to see the two step process of decoration with a rough draft sketched in red paint, often showing mistakes and corrections, probably applied by the chief draftsman, and a more detailed drawing later added in black. The only colored figure was on the ceiling where Nut was roughly incised, then painted in yellow and outlined in red. It is unclear why the workmen started by painting the ceiling, but it appears that they then moved to the east wall in the southern corner. There the draftsman made an error in the first draft by drawing the columns of hieroglyphs and the goddess Selkis into the row reserved for the titulary. This was corrected in the second pass over the hieroglyphs, although interestingly, the goddess remained larger than the other deities who follow.

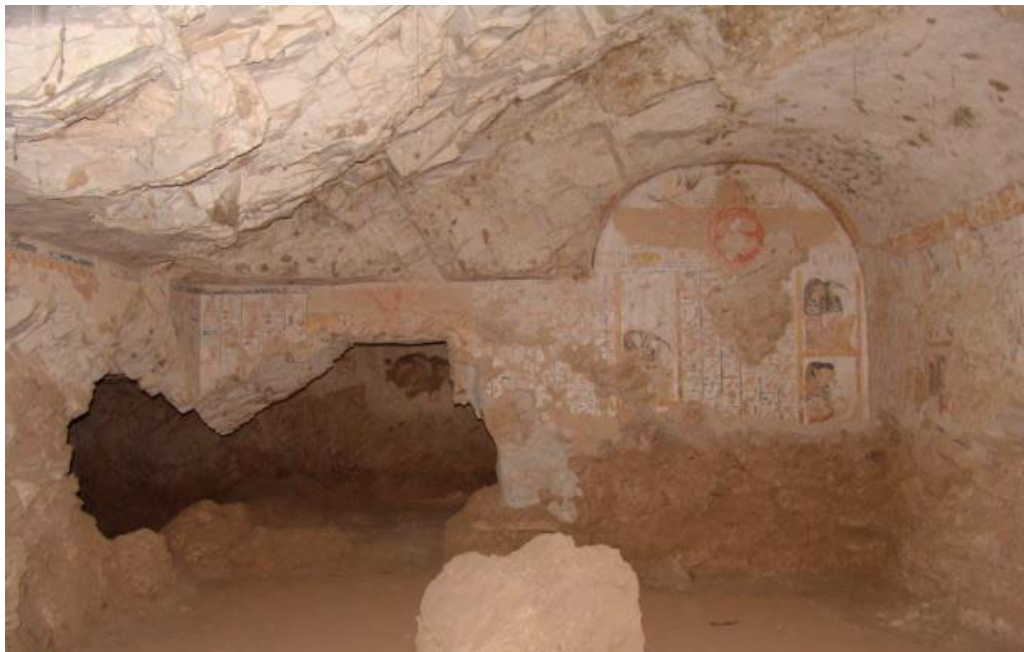
Chamber C with barrel vault (east wall) and structural collapse of ceiling and walls.

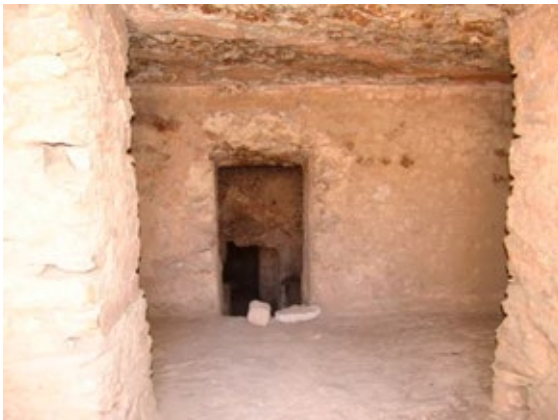
Chamber C.

The tomb has a simple linear plan consisting of a rock-cut stairway (A) descending to a pillared entry chamber (C), followed by a further stairway and smaller chamber (E) leading down to a four-pillared burial chamber (G). Based on the archaeological material recovered by the Franco-Egyptian team, the tomb appears to have been reused during the 22nd Dynasty and again during the Roman period (Leblanc 1988, 146). An undecorated pit (F) was excavated in Chamber E during one of these later periods of reuse.

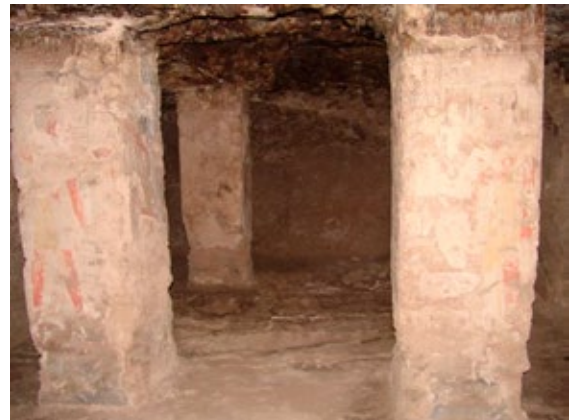
Chamber G.

In the burial chamber (G), some of the decorated surfaces bear enough of their original color and form, allowing them to be recognized more easily. Such is the case with the image of the queen worshipping Ra-Herakty (*Book of the Dead* Chapter 16), taking the form of a falcon with prominent claws holding the hieroglyph *jmntt*. The east half of the south wall depicts funerary goods. The *djed* pillar on the east wall is part of a scene depicting the queen offering to three gods; on the west wall is a unique scene of the queen following a procession of standards.

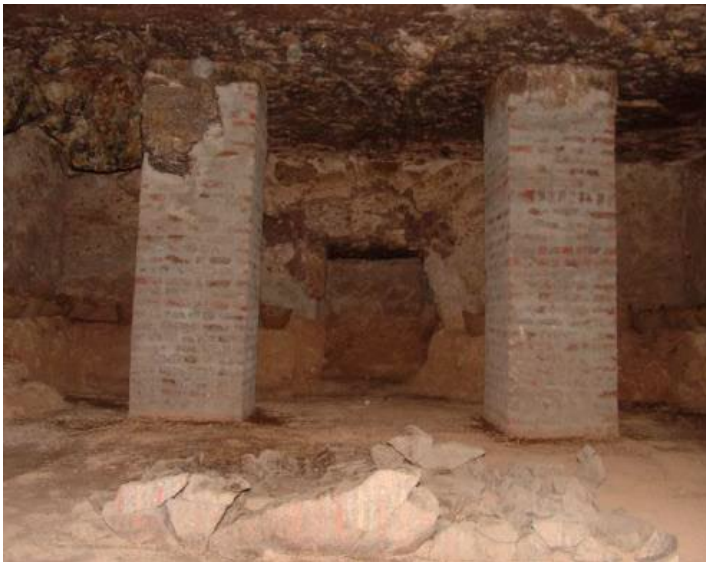
Although the tomb painted reliefs are very poorly preserved due to later re-use in the Third Intermediate and possibly Ptolemaic and Coptic periods, a number of objects were recovered from the tomb by the CNRS-CEDAE team. These include the shattered granite sarcophagus on the floor of the burial chamber (G); lid of a canopic jar in the form of the head of the queen (now in the Luxor Museum); approximately 80 *ushabti* in glass-frit paste showing the queen in her mummified aspect and with text referring to chapter 6 of the *Book of the Dead* (Leblanc 1999); fragments of ceramic receptacles and wine jars, one of which bears an inscription referring to a grape harvest of the year 22 providing a date for the death of the queen; and an alabaster stopper.

Remains of sarcophagus in Chamber G.

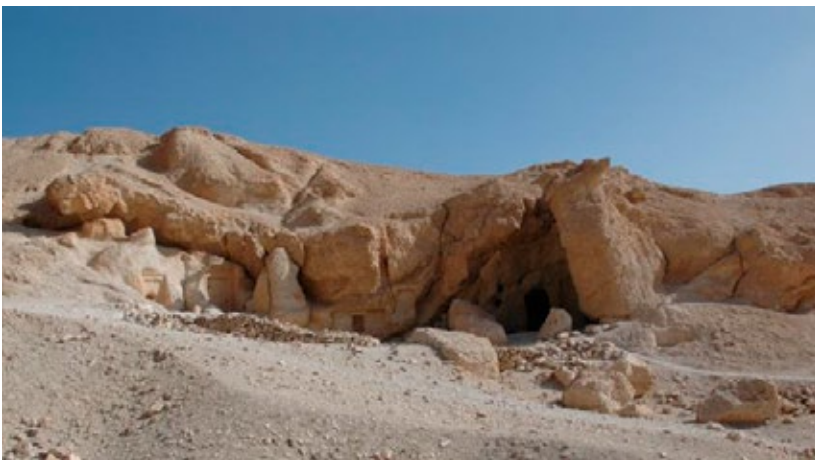
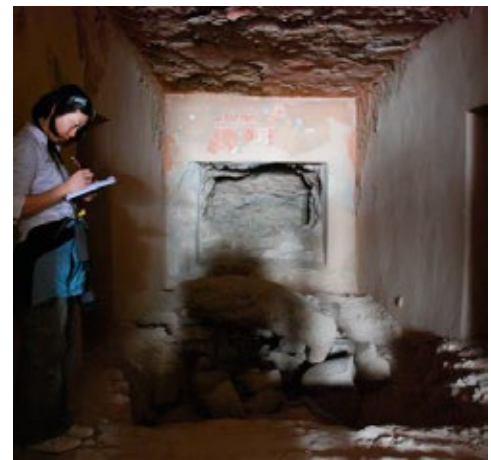
The rock-cut sanctuary dedicated to Ptah and Meretseger (left), located on the ancient path between Queens Valley and the workmen's village at Deir el-Medina, was used by the workmen of the royal tombs at QV during the 20th Dynasty, among which was that of Queen Isis, wife of Rameses III, now largely destroyed, its smashed granite sarcophagus still in situ (right, QV 51).

The Sanctuary to Ptah and Meretseger, located on the path between the workmen's village and the Valley of the Queens, was established towards the end of 19th Dynasty with active religious practice in the early 20th Dynasty. The sanctuary was probably a popular place to worship two local deities: Ptah of Ta Set Neferu, the patron god of the Valley of the Queens, and of craftsmen, and Meretseger, the goddess of the Qurn and the Theban necropoleis. At the shrine, offerings could be made in front of rock-cut stelae. It was later transformed into a place of meditation for Coptic hermits.

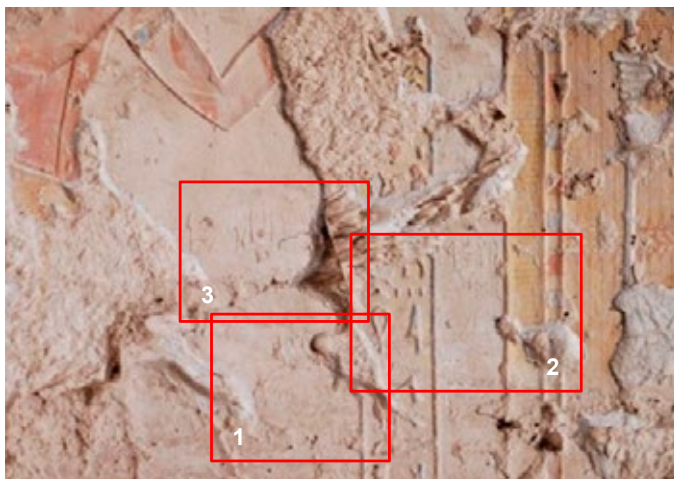
Hieratic graffiti was noted at the Entryway B (not located) as well in Corridor C, attesting to the later use of this tomb (Thomas 1966, 220).

Hieratic graffiti in Corridor C.

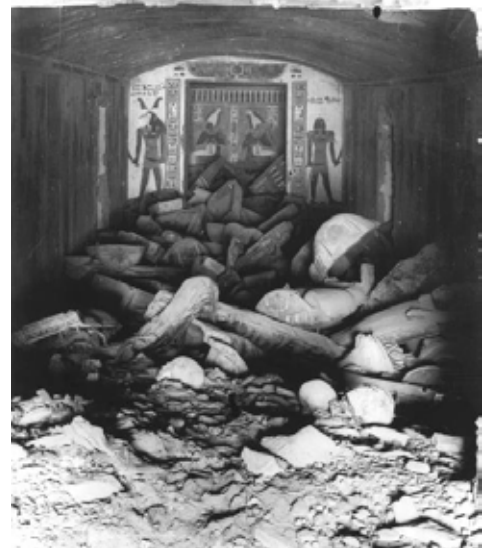
The tomb is located at the end of the side wadi where a number of the sons of Rameses III of the 20th Dynasty were buried. When it was rediscovered by Schiaparelli, it was filled with a huge number of 22nd to 26th Dynasty sarcophagi from later burials.

Contents of tomb on rediscovery by Schiaparelli (Schiaparelli 1923).

The tomb was intensively re-used in the Third Intermediate Period as a family burial of low ranking local elites working as farmers and gardeners in the Temple of Amun. Some 49 wooden sarcophagi dating to the 22nd through the 26th Dynasties were recovered by Schiaparelli.

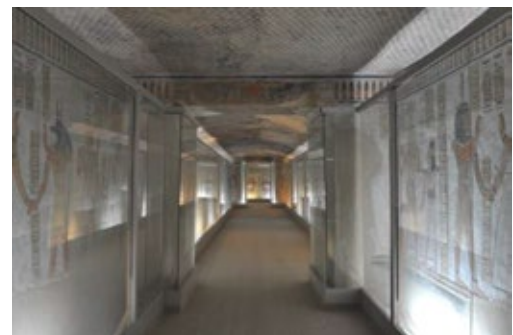
Tomb as it appears today.

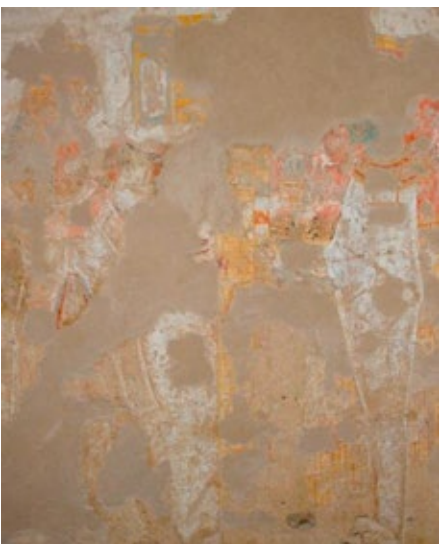
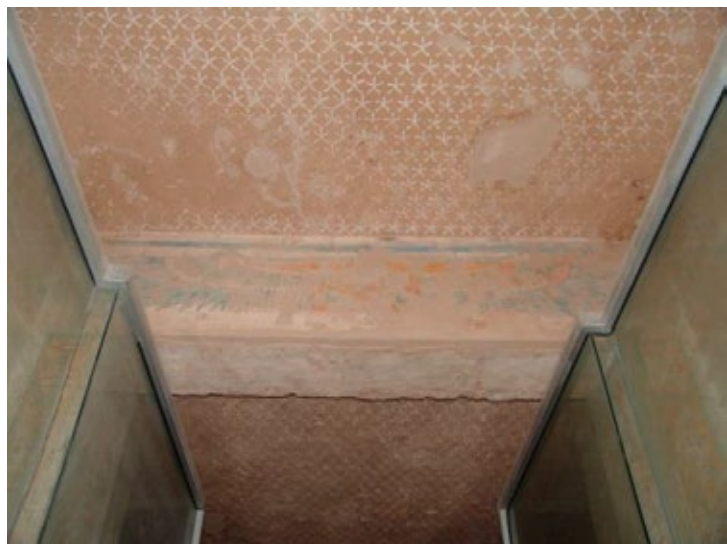
Chamber C, south wall, with typical loss, and ceiling.

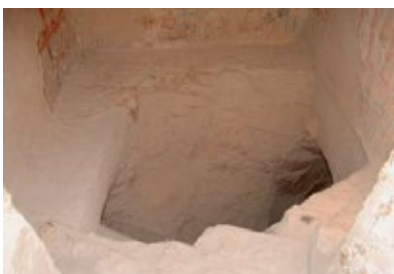
Chamber I had a large pit dug through the floor, which is thought to have been cut during the Third Intermediate Period reuse of this tomb. More than 150 fragments of funerary equipment (sarcophagi, chests, personal items, etc.) were found within this pit as well as a shallower depression which was cut into the floor of the burial chamber (E).

Left: Chamber I with the large pit dug down and under the wall.

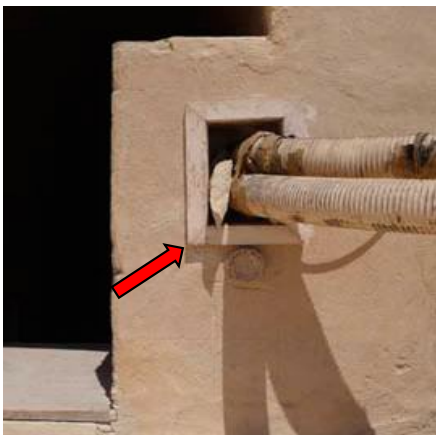
Survey benchmark at entrance to Nefertari tomb (QV 66)

In 1922 the Survey of Egypt, the national mapping authority, published a 1:10,000 scale tourist map of the West Bank, which included the Queens Valley as well as other archaeological monuments. In 1926 the Survey of Egypt mapped and published two topographic map sheets of the Queens Valley area (E-1 and E-2) at 1:1,000 scale in collaboration with the Egyptian Antiquities Department as part of its broader topographic mapping of archaeological areas of the West Bank. This work utilized two permanent benchmarks indicating elevation above mean sea level, one a metal disk embedded in the brick entrance to the tomb of Nefertari and the other a metal post set vertically in the ground approximately 30 meters west of the Sanctuary to Ptah and Meretseger. Both benchmarks remain in place today.

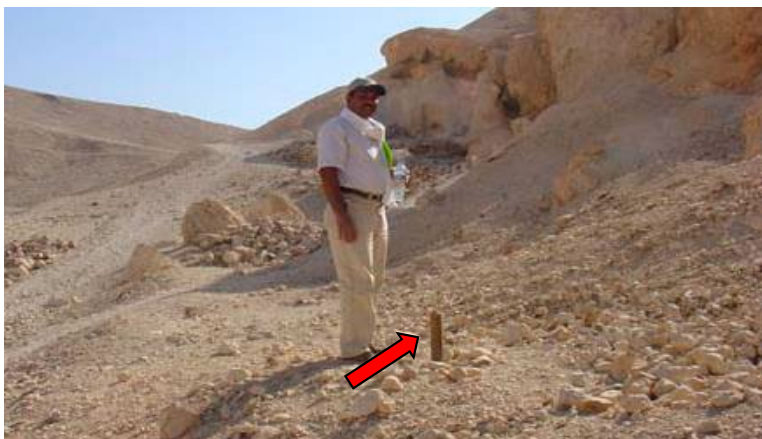
Survey benchmark to west of Sanctuary to Ptah and Meretseger (background)

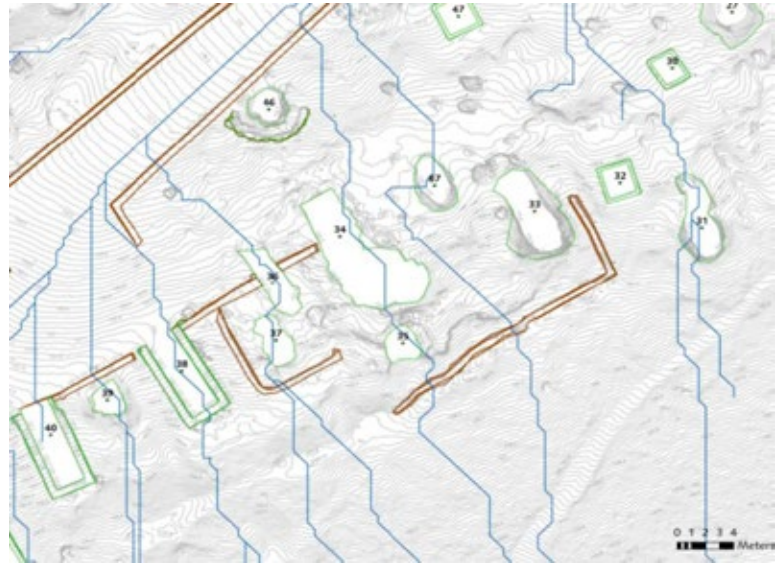
Part of the topographic map produced through laser scanning showing 10cm contour lines (gray), tomb openings (green), and drainage lines (blue) produced through ArcHydro software.

The data produced through this effort resulted in several products. One product is an ESRI ArcMAP™ 9.2 GIS data set that integrates topographic contours of 50cm interval covering the entire rainfall catchment area and of 10cm interval in the area of the main concentration of tombs, digital tomb plans produced by TMP, other digitized CNRS tomb plans, a number of existing maps of QV and the surrounding area that were scanned and geo-referenced, and geo-referenced Digital Globe Quickbird satellite imagery. All data in the QV GIS is georeferenced to the Proximate-ETM system. Topographic data in the GIS, as well as topographic cross sections of five locations along the main QV drainage channel, have been used for assessment of the threat of flash flooding, which is discussed in more detail later in this report.

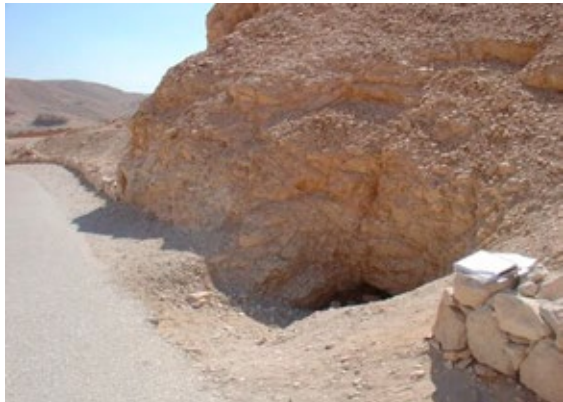
The opening of QV 2 was largely occluded by rubble and scree in 2006.

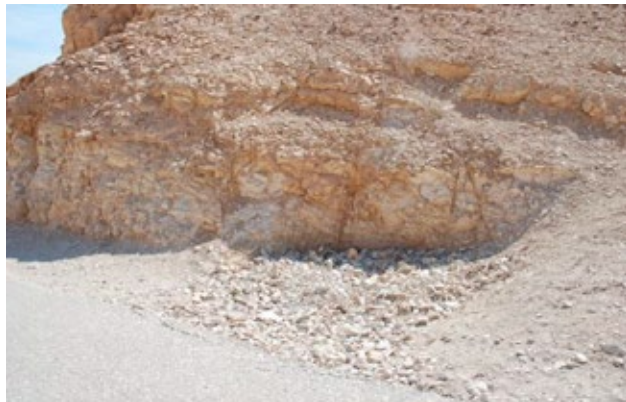
By November 2009, the SCA had filled the entrance entirely with scree.

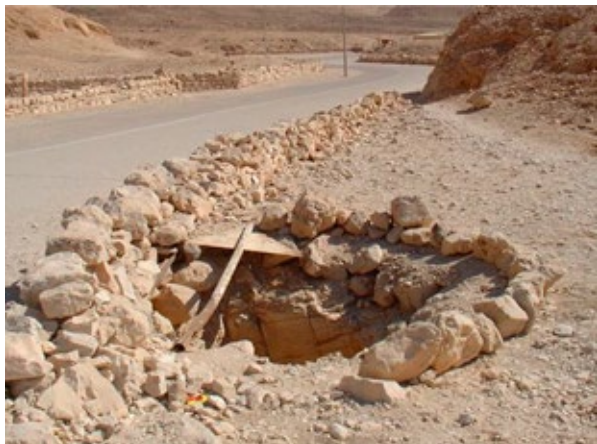
In 2006, a roughly laid circle of boulders and a broken sign surrounded the entrance of QV4.

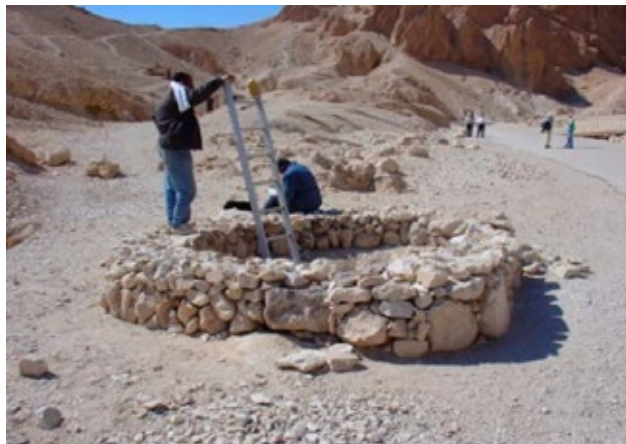
In 2007 a low rubble masonry wall was built around the opening.

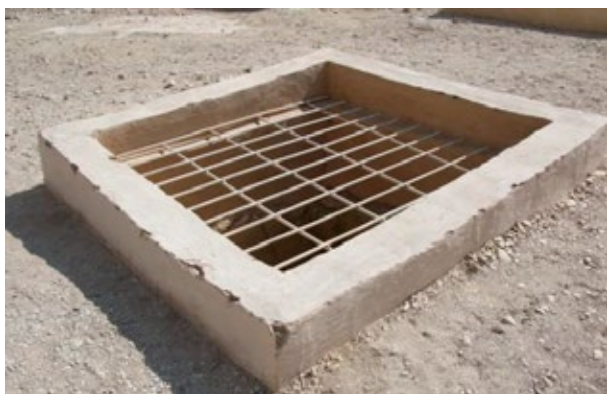
As of Dec. 2009, the SCA had installed a masonry surround with a metal grate over the opening of QV 4.

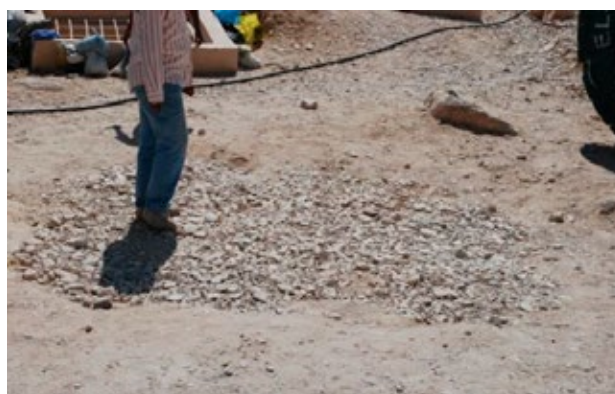
The masonry surround was removed and the shaft of QV 4 was filled with scree as of Feb. 2010.

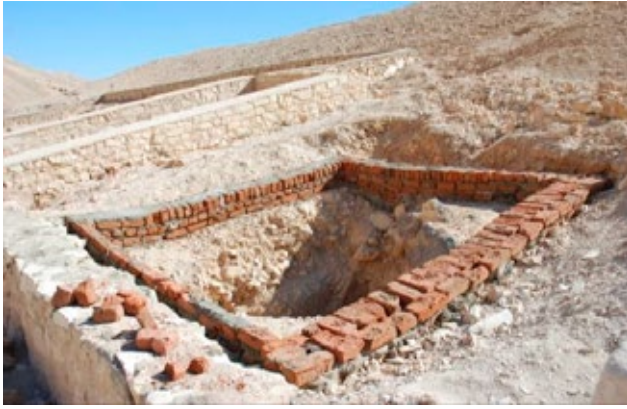
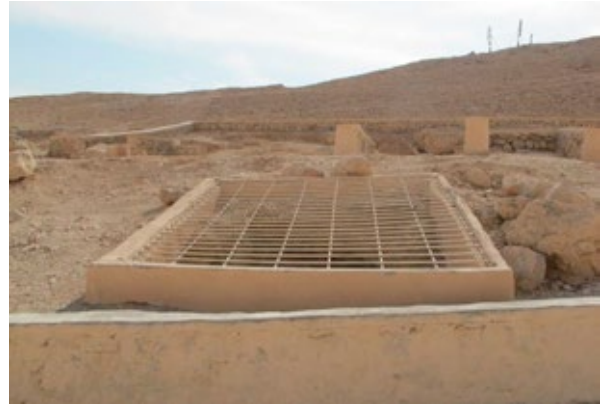
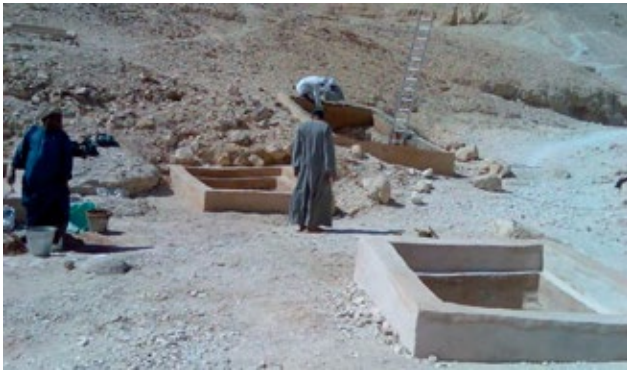
In 2009, new surrounds were constructed on some shaft tombs (QV 39 above) and existing surrounds were re-painted (e.g. left). Bricks for new surrounds were placed directly on loose soil (upper left) and therefore have little structural integrity. They will need to be replaced.

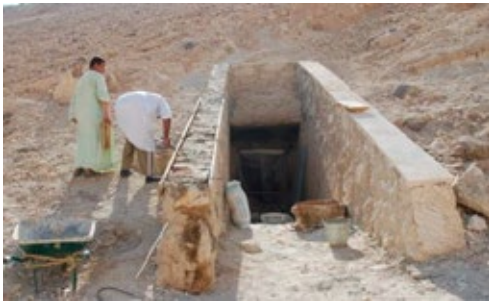
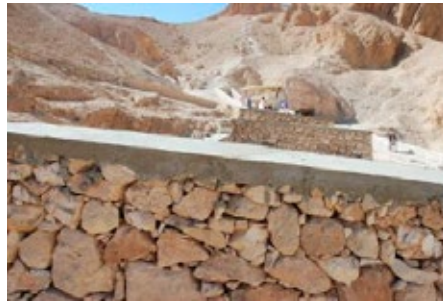
In 2009, existing retaining walls on chamber tombs in the SW wadi were given new cement caps and painted (above, left and middle). A new wall built adjacent to the opening of QV 34 is precariously located above the collapsed chamber of the tomb (above, right).

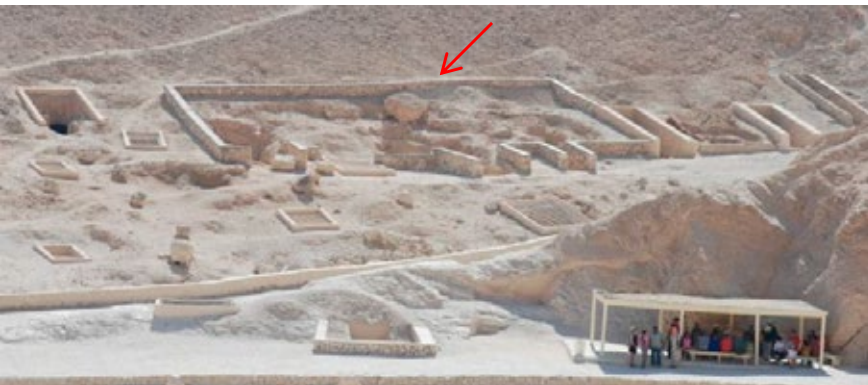
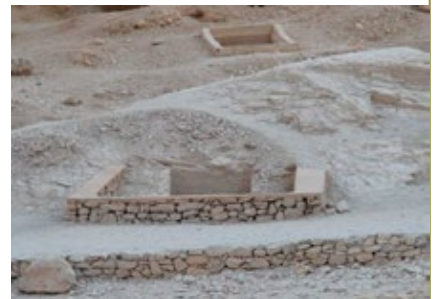
A retaining wall was constructed around the area of instability (above, arrow) in 2009. (Photo also shows new surrounds).

In 2007, along the main wadi, access to tomb ramps was blocked with rubble masonry and new surrounds on QV 50.

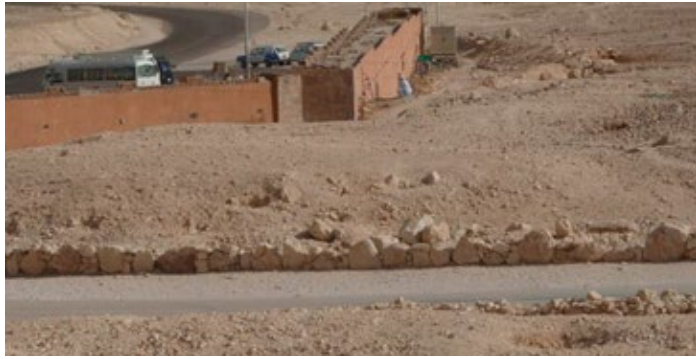
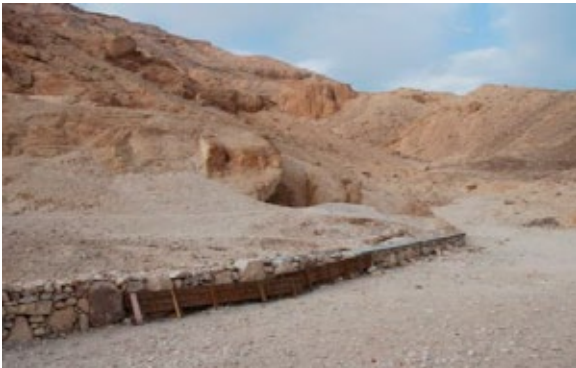
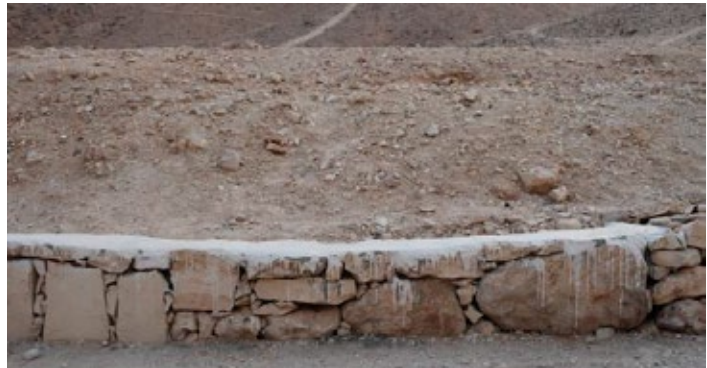
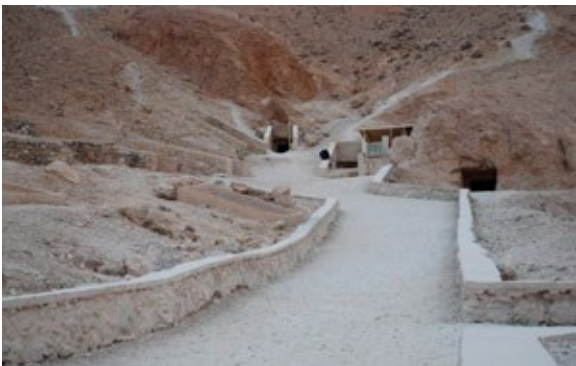
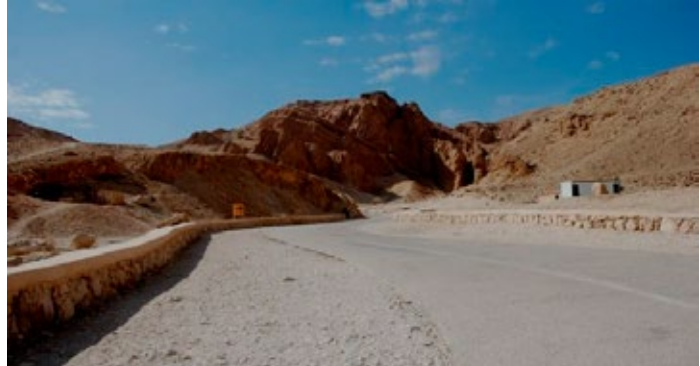
Rubble walls along the south side of main visitor path (left) were dismantled in 2007. New stone masonry walls were built in various stages and versions with painted, cement caps in 2008-2009 (below). Walls edging the SW wadi path were capped with cement (bottom left). The remaining area of tarmac road that constitutes the main path in the valley (seen in photo bottom right) was removed in 2010 (from the security station to the Y-Junction).

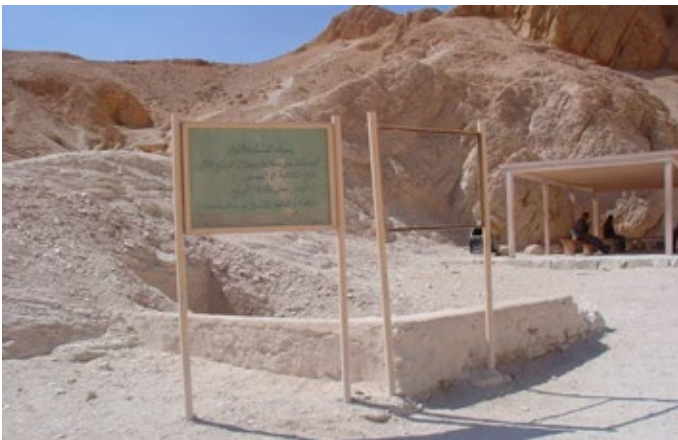
Old signage at the Y-junction was dismantled in 2007.

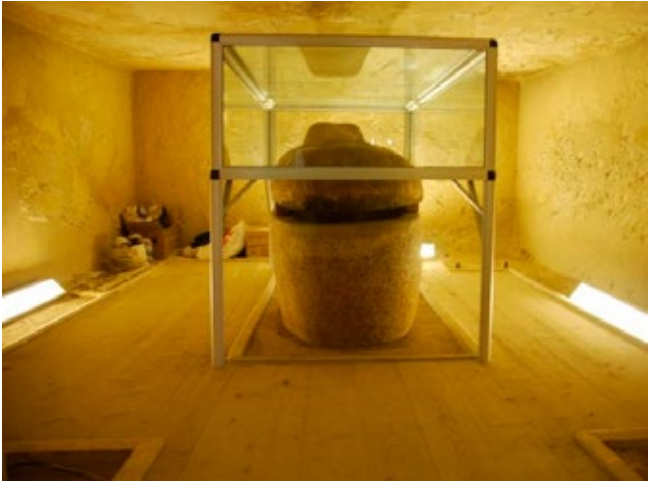
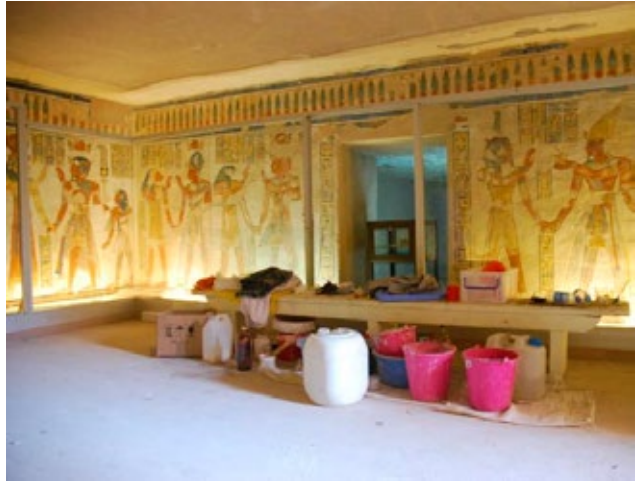
Interior of QV 55

In 2009-2010 SCA technicians undertook work in QV 55, including installation of glass case over sarcophagus, treatment of ceiling cracks, and cleaning of paintings. Glass barriers were removed to undertake the work and replaced when completed. QV 43 was opened to visitors while this work was being carried out.

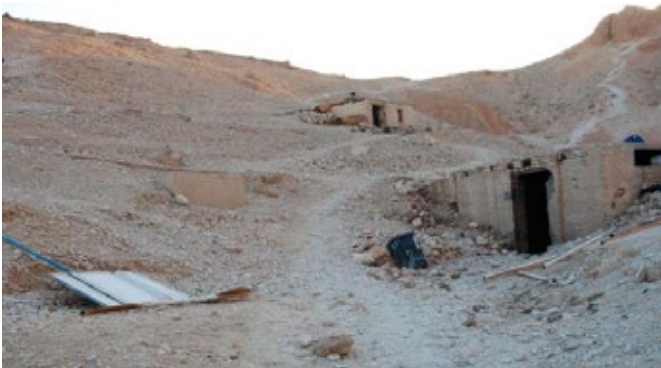
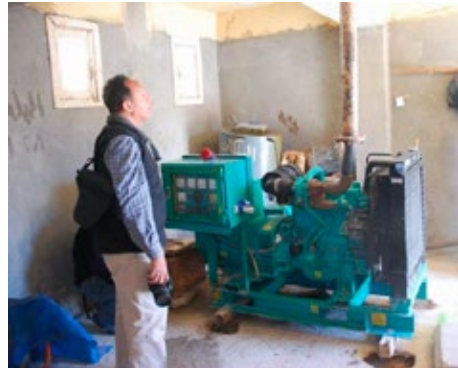
Old generator building and new generator

The 'old generator room' (long since disused and located below the guardian's house, above left) was demolished in 2008. A new generator was installed in 2006 in the generator building (right)

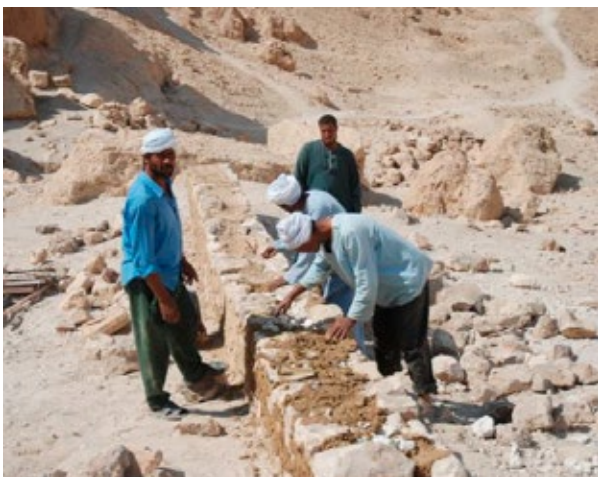
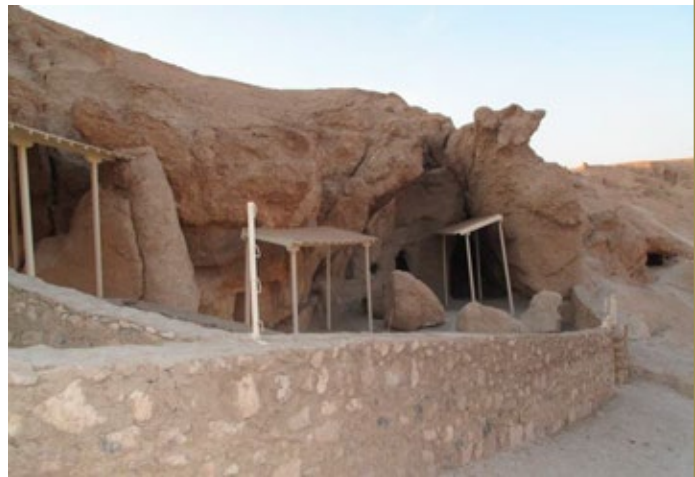
Site Elements – Sanctuary to Ptah and Meretseger

In 2010 a new perimeter wall with fencing was constructed following the line of an existing dry rubble wall along the path adjacent to the Sanctuary to Ptah and Meretseger. Shelters were then constructed to protect engraved stelae. The terrace wall within the sanctuary was also reconstructed.

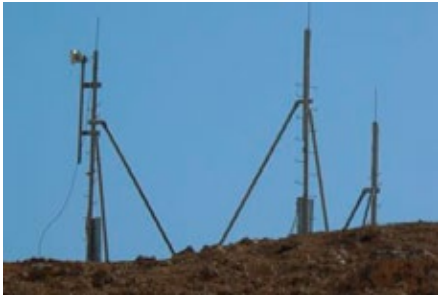
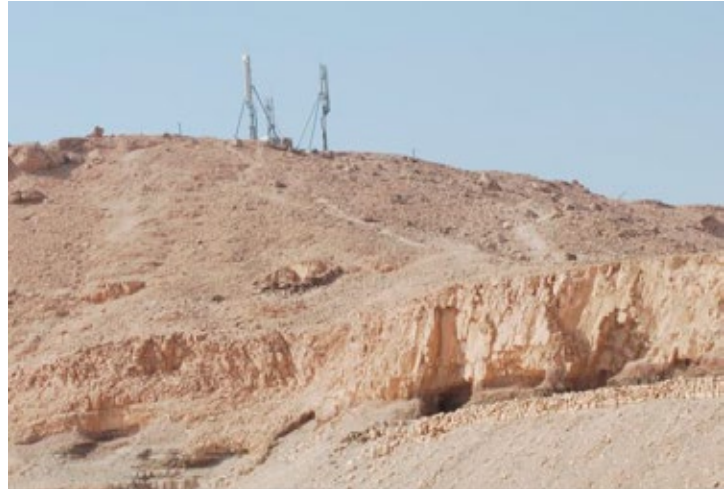
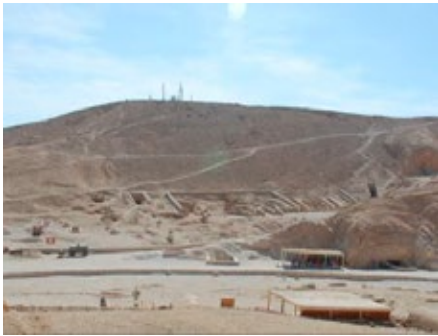
Communications Towers

Cell phone towers were installed on the top of the southern ridge in 2008. The towers are visible from the Valley (lower left).

Wireless communication towers were built on the ridges of the Valley in 2008. They are a visual intrusion on the landscape and are judged to be an inappropriate use of the site.

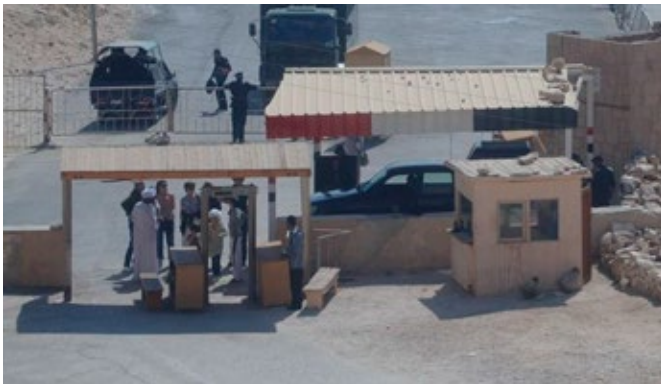
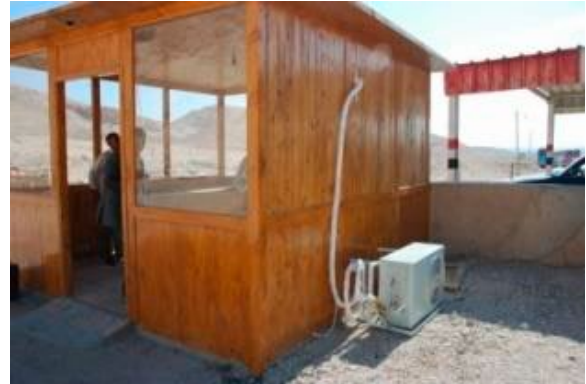
Security station

A new security building with AC (right) was built in 2009 at the entry to the Valley to replace the shed structure (left).

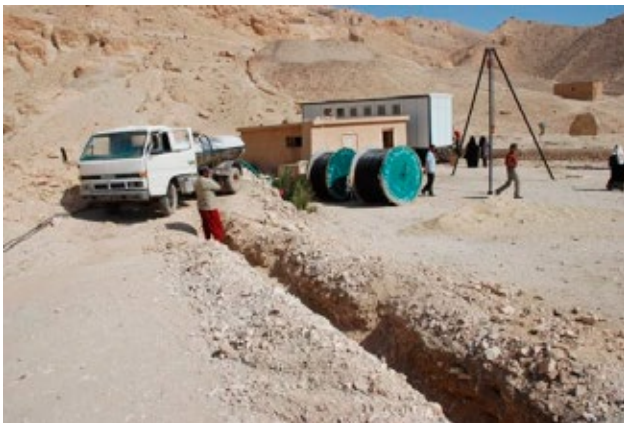
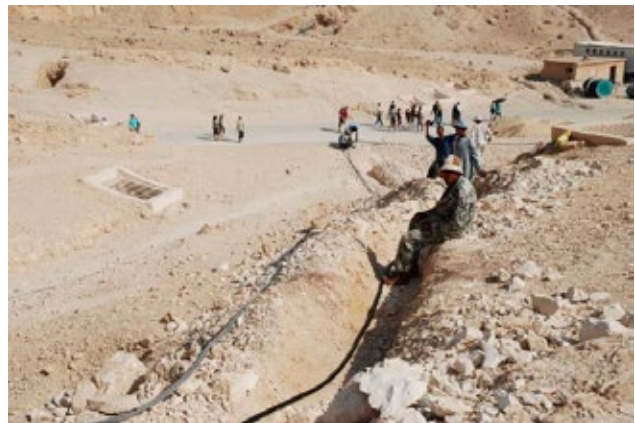
Electrical cabling

In 2010 trenching for installation of electrical cabling for lighting of the mountains was undertaken across the Valley near the generator building and continuing to the mountains.

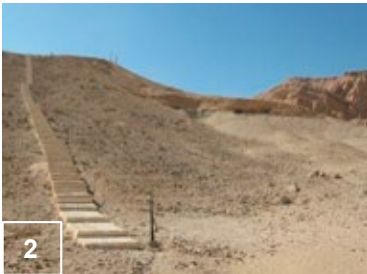
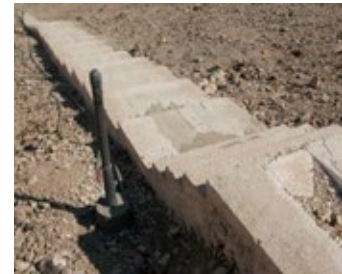
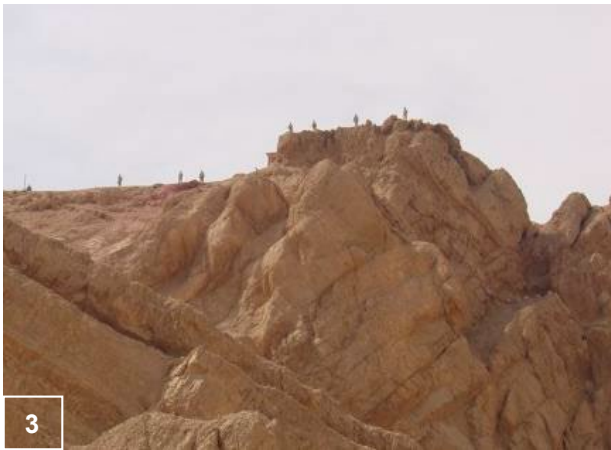
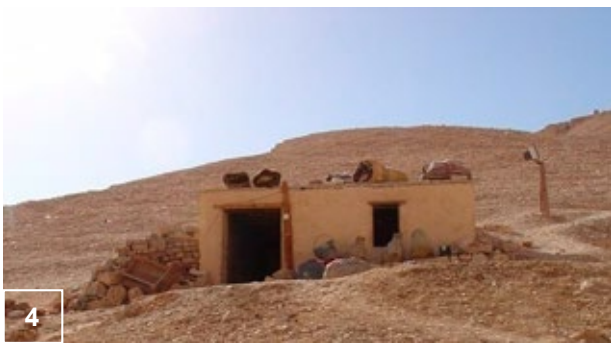
Security buildings and features: There are several structures and features on the site that relate to security operations. These are:

1. In the parking area is a security station with a metal detector (rebuilt in 2008 with air conditioning). Adjacent is the car port for the security vehicle. All of these structures are visually intrusive and only minimally functional.

4. The guard house is a one-room mudbrick structure built on a high point on the south side of the Valley. It is used by the SCA site guardians for making tea and sleeping during night duty. The guard house is believed to have been built on top of QV 28, which cannot be located and is shown in the vicinity on the 1989 CNRS map from *Ta Set Neferou* (Leblanc 1989a). The structure requires repairs and improvements.
