Valley of the Queens Assessment Report

Volume 1 Conservation and Management Planning

A collaborative project of the Getty Conservation Institute
and the Supreme Council of Antiquities, Egypt

August 2012

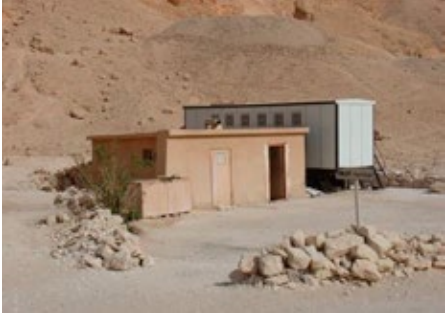
New generator building (left) with generator (right).

New generator building: The new generator building (built in 1960 as the W.C.) is a two-room mudbrick structure that has housed the new emergency generator for the site since 2000. It is located in a clearing towards the eastern end of the main path adjacent to the toilet trailer. It is a serviceable building and can be used for its current function but requires basic repairs and rehabilitation and removal or re-location of the water tank in front of the building.

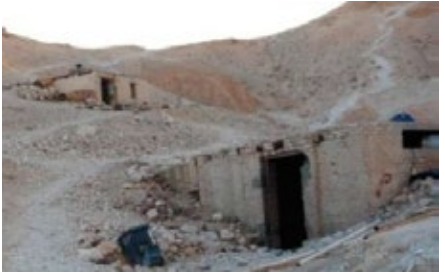
Old generator building (left) and mobile generator (right).

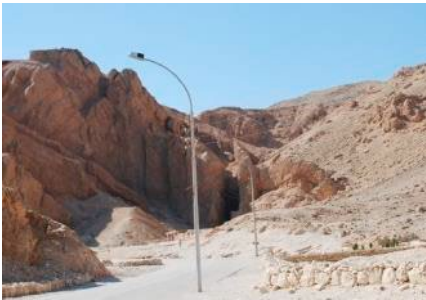
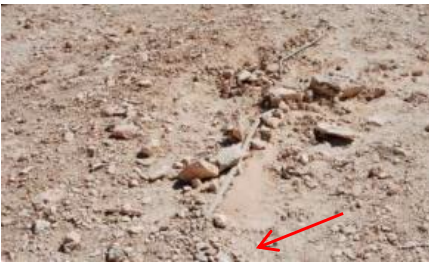
Clockwise: Goose neck lamps on path, spotlight, electrical junction box and exposed cabling.

Electrical supply and lighting: Goose neck security lamps along eastern end of main path were removed by the SCA in 2009. Junction boxes for security night lighting are located (in the ground) at a number of points on site, and shallowly buried cabling runs along the visitor path and crosses the site at various points. Cabling is partly exposed in places and could easily be tampered with or damaged. New cabling for lighting of the mountain is being installed and trenches had been dug for this purpose as of late 2009 (see Part I: Appendix 4).

No map exists showing the cabling and junction boxes. The map (lower left) shows approximate location of existing cabling (green lines) based on knowledge of local staff, areas of exposed cable and visible junction boxes. Some of these cables may have been moved during laying of new cable for mountain lighting in 2009.

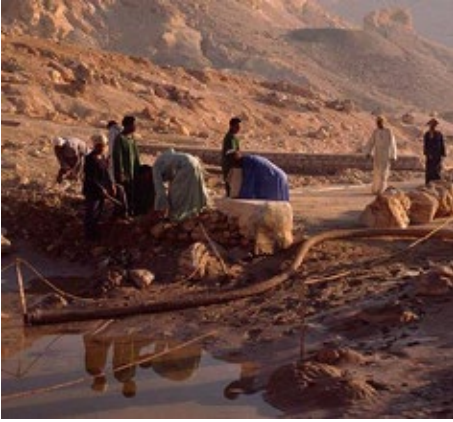
Pumping water from tombs after the 1994 flood (CNRS)

The possibility of a devastating flood at the site is an ever-present danger; the last flood of consequence occurred in 1994 (see Part V:2). There is no emergency response plan for staff in the event of a flood. Nor is the necessary equipment, such as pumps or tools, available on site to cope with a flood event. Personnel have not been trained in responding to a flood, including how to deal with visitors during an emergency.

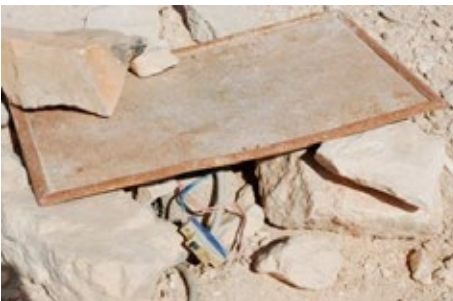
Maintenance of the generator is undertaken by dedicated electricians, but wiring in tombs and junction boxes is faulty, dangerous, and poorly maintained.

Junction box for electrical cables

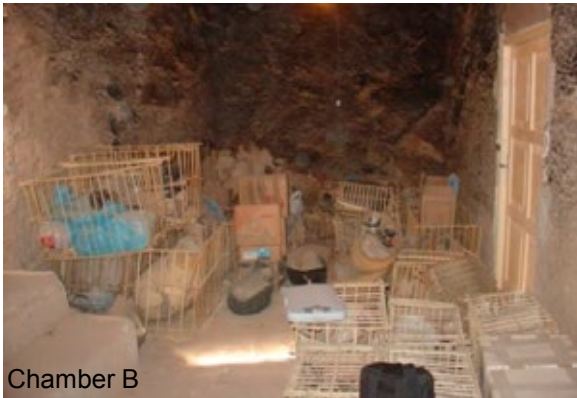
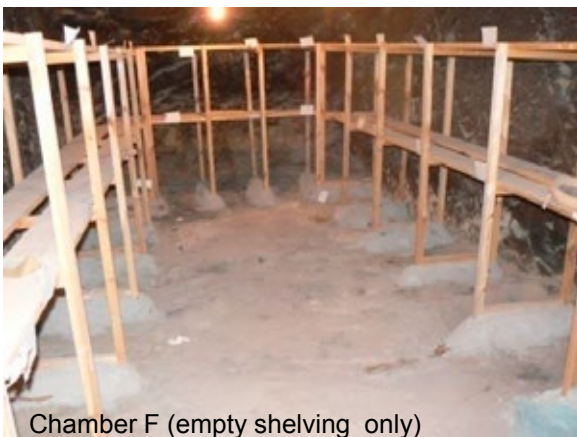
QV storage areas

QV 58 is furnished with shelving (red lines on plan below) in three of its chambers (D, F, H) and has secure doors leading to the tomb and to each chamber.

The QV materials stored in QV 58 (mainly Chambers B and D with small quantities in H) prior to October 2008 will remain there. Materials in Chamber B were, however, transferred to the shelves in Chamber F.

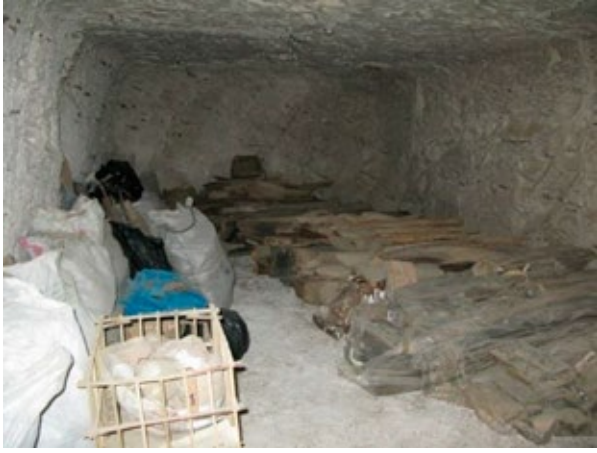
QV 69 is a stable shaft tomb with large chambers. At the time of the assessment it contained well-ordered crates of human and animal bones within one of its chambers.

All of the materials collected from the tombs (human remains and mummies, ceramics, wood and stone fragments, etc.) and the potsherds lying east of Nefertari's tomb were relocated to the remaining chambers of QV 69 in Oct. 2008 and Dec. 2010 (left and below). A metal grill in a masonry surround at the top of the tomb shaft provides security.

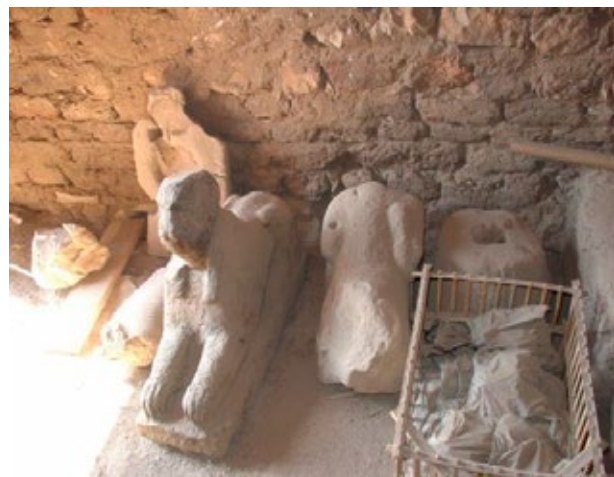
QV 95 is an unfinished 20th Dynasty chamber tomb located within the Deir er- Rumi complex. It contains miscellaneous materials excavated from Deir er- Rumi. Security is provided by a metal bar and mesh door with lock at the tomb entry.

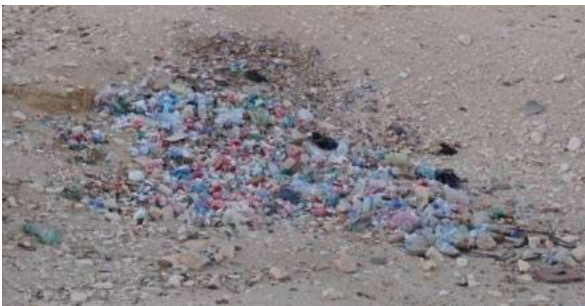
The trash in the Valley of Prince Ahmose was widespread but more shallowly deposited. It consisted mainly of soda cans, water bottles, large quantities of size 'D' batteries, QV tickets, and human waste. It is believed to come primarily from the vendors and the site. The batteries are from guardian and guard use of flashlights; these pose an environmental hazard from heavy metals leaching into the soil. The trash west of the toilets is concentrated in a large pit (tomb 94) and consists of waste from the toilets. Other smaller pockets of trash were noted throughout the Valley. Trash was also assessed in the 92 tombs in the main Valley. Most of the tombs without proper doors or closures contained concentrations of trash and excrement.

Top left: Trash, including dozens of D-size batteries, in the Valley of Prince Ahmose

A site-wide cleaning of trash was undertaken in February 2007, focusing on the Cascade valley and the Valley of Ahmose. Since then, additional trash from the National Security guard house accumulated in the Cascade valley and in the Valley of Ahmose from the site and vendors, and was cleaned again in February 2008.

The cause of this situation can be attributed to the absence of adequate trash receptacles and a functional mechanism for trash disposal, as well as lack of clear responsibility and accountability, including insufficient inspection of the site by archaeological inspectors. The situation has improved since late 2008. It should be noted that there are no places for safe disposal of batteries in the Luxor area and their disposal presents a long-term problem for the West Bank.

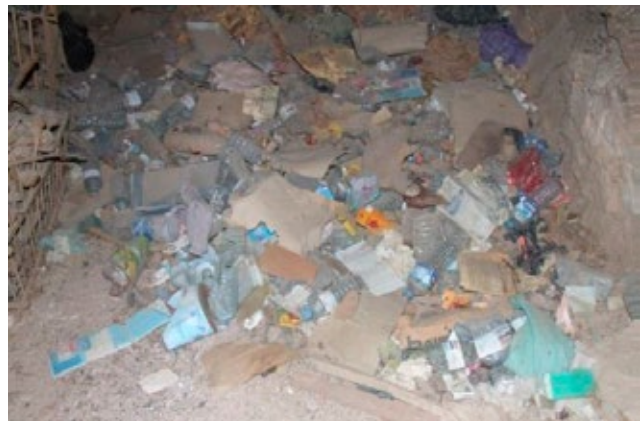
Bottom left: Trash accumulation in the Cascade valley

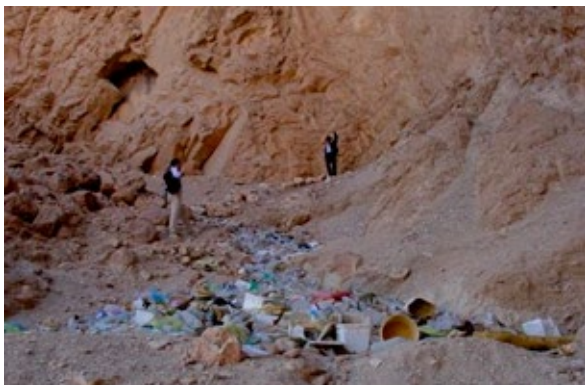
Above: Example of trash accumulation in a tomb (QV 16)

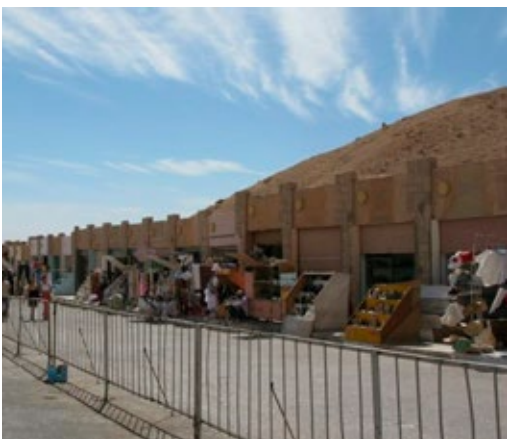
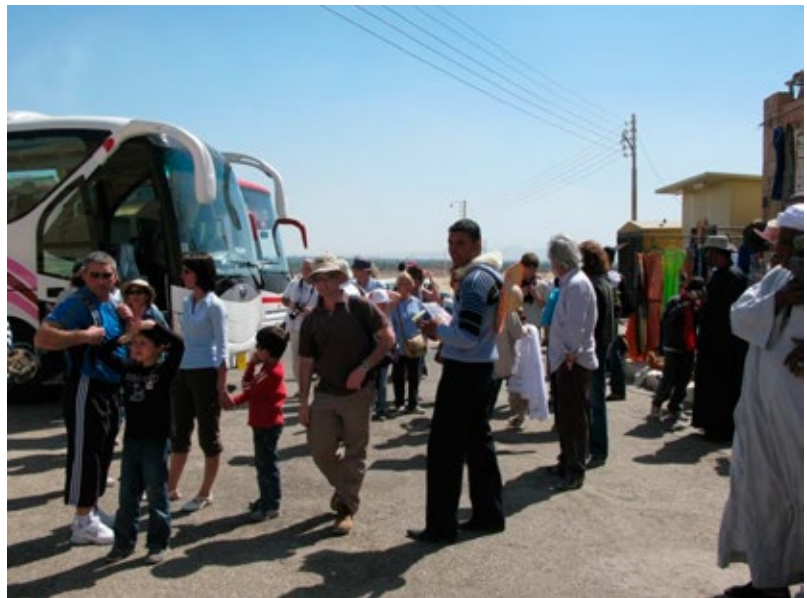
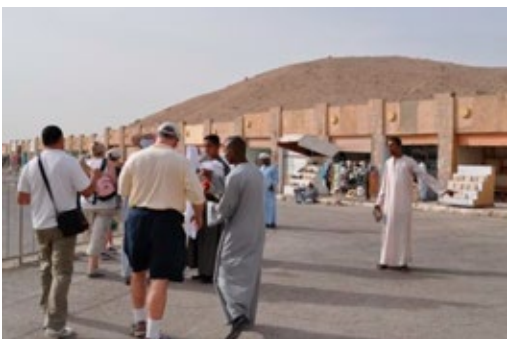
Currently, visitors to Queens Valley must pass through the bazaar area twice, once as they enter the site and again as they leave. Most of the vendors stand in the middle of this passage with products in hand, trying to convince visitors to buy. In this way, visitors feel like they are running a gauntlet and vendors must jostle with each other to try to secure a sale; all parties involved are often left dissatisfied by this interaction. Nevertheless, the prevailing concern expressed by the vendors was that any change to their current business model would fatally cripple their ability to earn an income. According to the vendors, if the QV parking area was changed to be like that of KV and Deir el-Bahari so that visitors passed by the bazaar only once, income would drop precipitously. Furthermore, they claimed that after renovation of the bazaar area at these two sites, stall rental fees at both of these sites increased considerably. In any case, it is clear that rental fees have also increased at QV since the time of the focus group discussion conducted by SCA inspectors in June 2007, at which time rent was L.E. 110/month (it has since climbed to L.E. 250/month).

General view of bazaars on a quiet day (upper left); visitors emerging from buses are led directly into the bazaar area (upper right), and must pass through the bazaars again on their return (lower left).

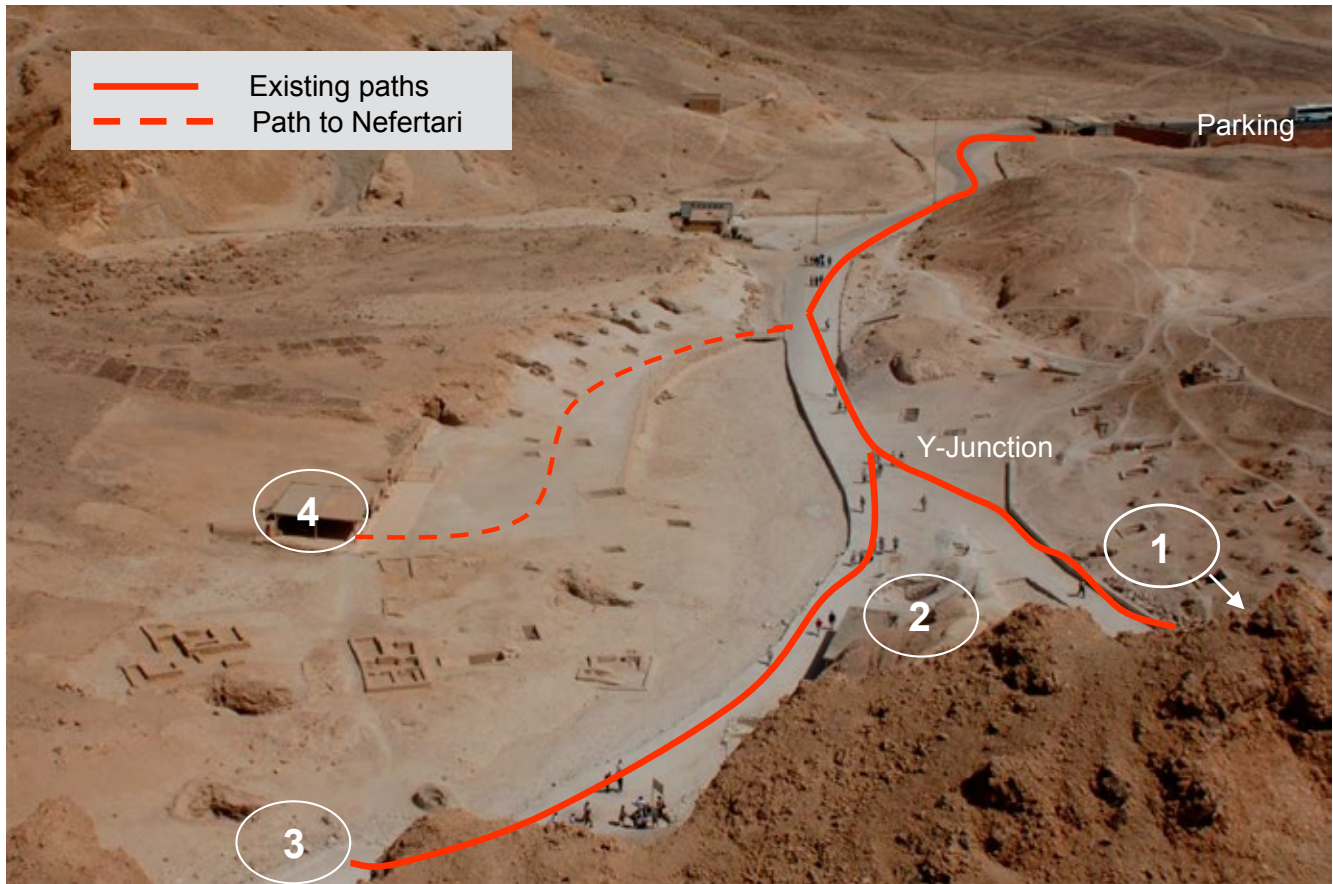
Main wadi with current routing and shelters

Currently, visitors enter the Valley on the tarmac road from the parking area and make their way to the Y-shaped junction where they can continue along the main wadi to tombs 52 and 55 or take the side wadi to tomb 44. There is an unpaved pathway from the main path to the tomb of Nefertari that is normally roped off to prevent access to general visitors. Thus, the routing is one way in and out.

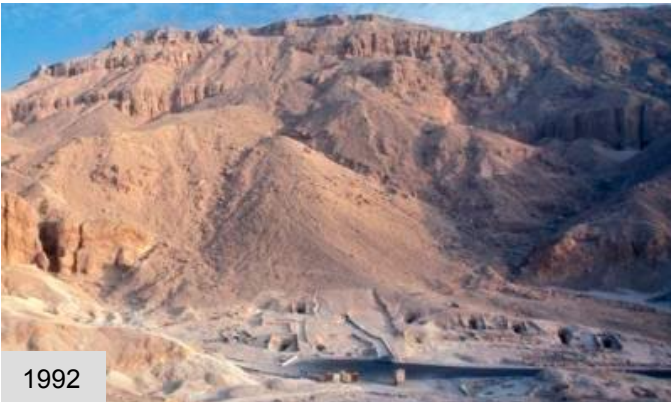
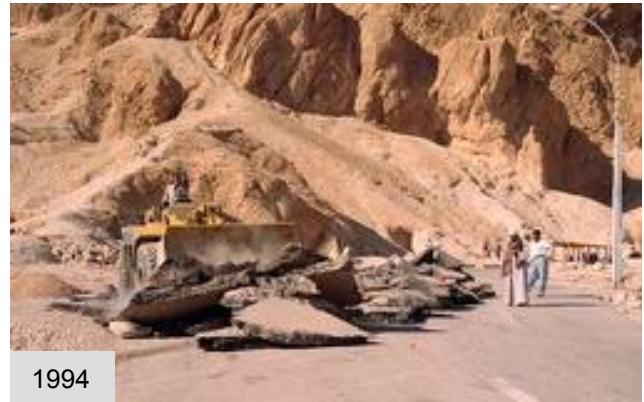
Tarmac in Y-junction within the Valley (left, foreground) was used for parking and bazaars until the early 1990s. The tarmac was removed from the Y-junction area (right; Image: CNRS) after the 1994 flood.

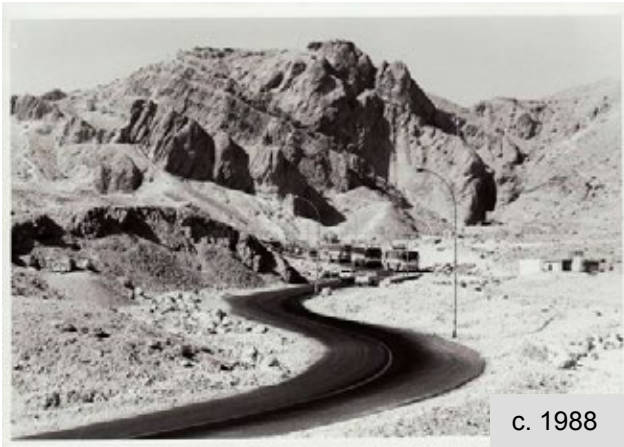
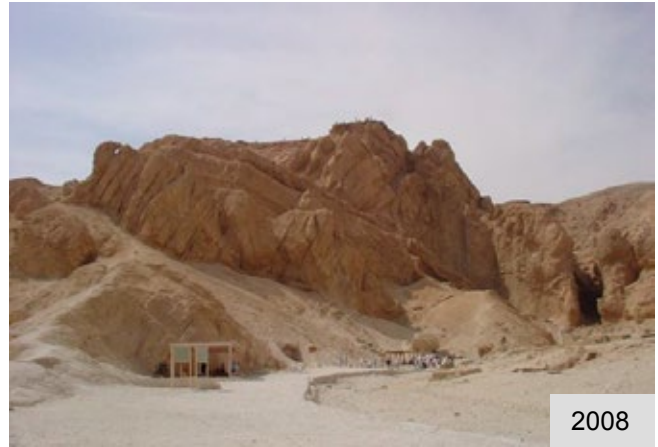
c. 1988

General view of vehicle road into QV c.1988 (left; Image: CNRS) and as it looks today (right). The tarmac road has been removed in 2 stages: around the Y-junction after the 1994 flood and the remainder in July 2010.

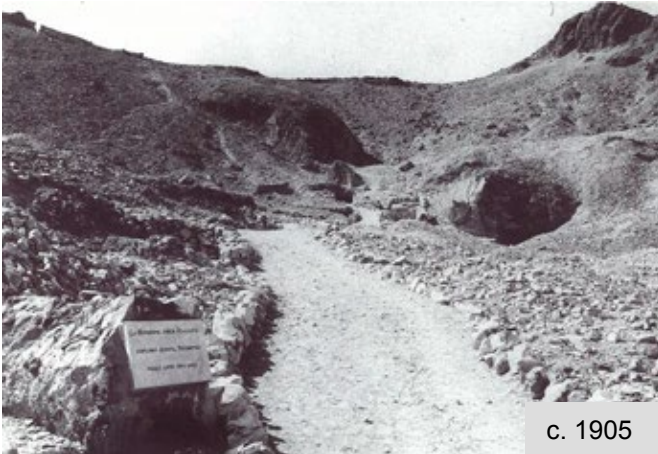
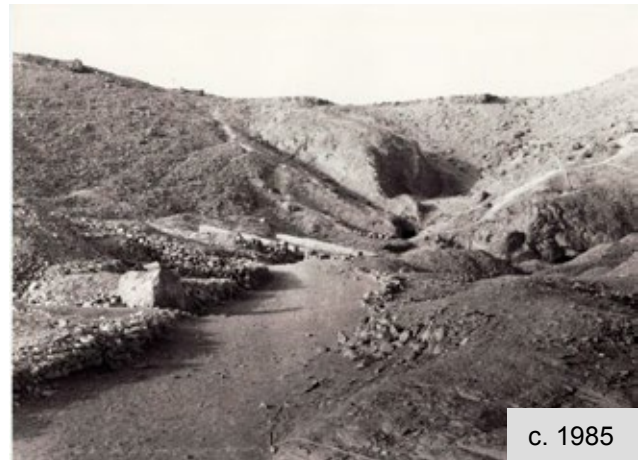
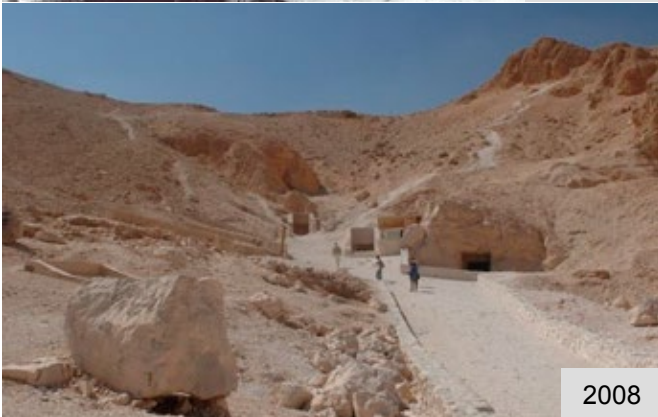
c. 1905

Path to the SW wadi with marble plaque set up by Schiaparelli (upper left; Image: Museo Egizio) recording the Italian Archaeological Mission's work at QV (The sign reads: *La Missione Arch. Italiana Esploro Questa Necropoli Negli Anni 1903-1905*).

The same path and rock is visible in the photo from c.1985 (upper right; Image: CNRS) during the CNRS mission (plaque no longer in situ) and as seen today (left), after renewal of the paths with edging walls in the late 1980s and again in 1994.

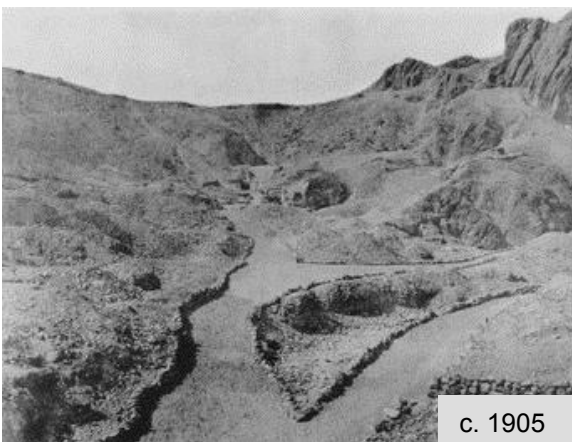
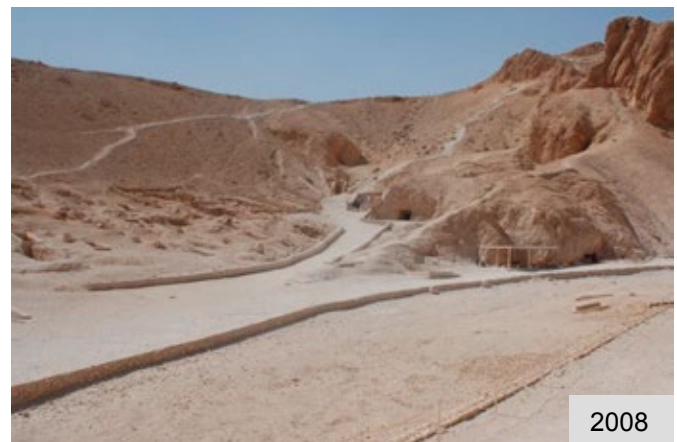
c. 1905

The paths at the Y-junction of the main wadi and SW wadi as laid out by Schiaparelli (left; Image: Museo Egizio) and current view (right).

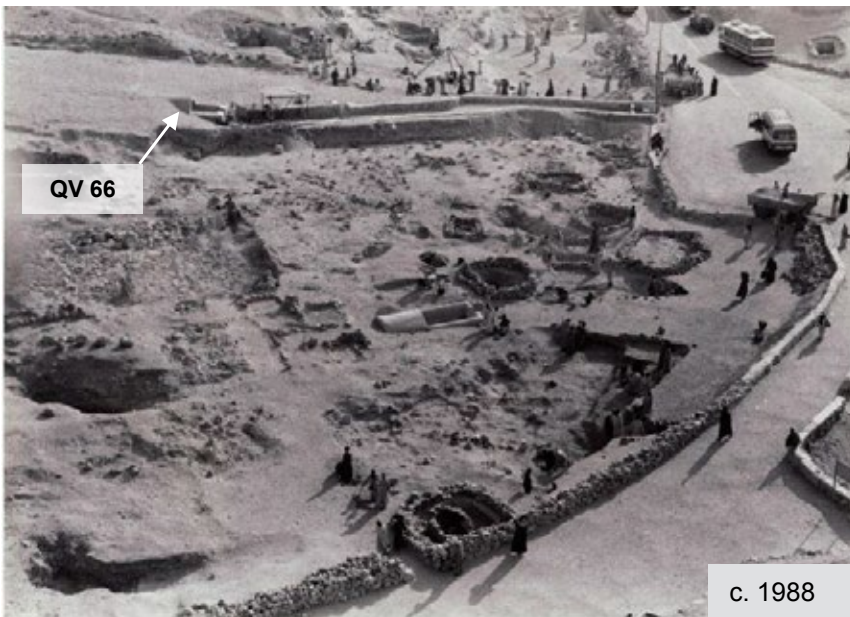
The middle photo shows the same area during the CNRS excavations in c. 1988. The path from QV 66 to the end of the wadi has been removed to allow for excavation (Image: CNRS).

After the 1994 flood, the wadi was lowered and expanded, the parking removed permanently to its current location, and the path to Nefertari (QV 66) established farther to the east, closer to where it was during Schiaparelli's time. The tarmac in the parking area was also removed at this time. New retaining walls and paths were built along the wadi and additional shade shelters were constructed (near QV 44 and 55). These developments characterize the site as seen today (left), with the exception of changes made in 2008-2010 by the SCA (see Part II, Appendix 4, for these changes).

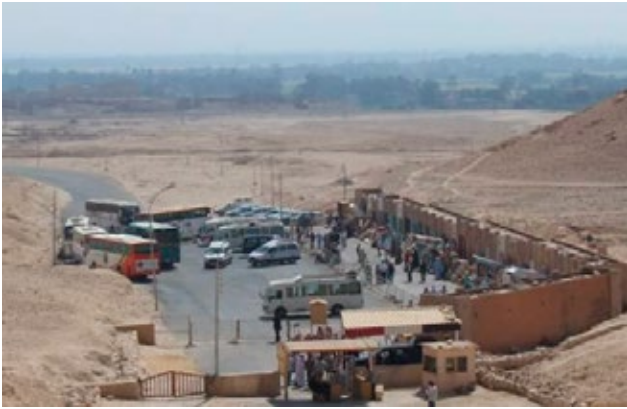
1. Paved parking area

Date of construction: c. 1988-89

Description/function: Intended for coaches and vans

Condition/operability: Too small and constricted for size and number of coaches, causing congestion and chaos during peak periods

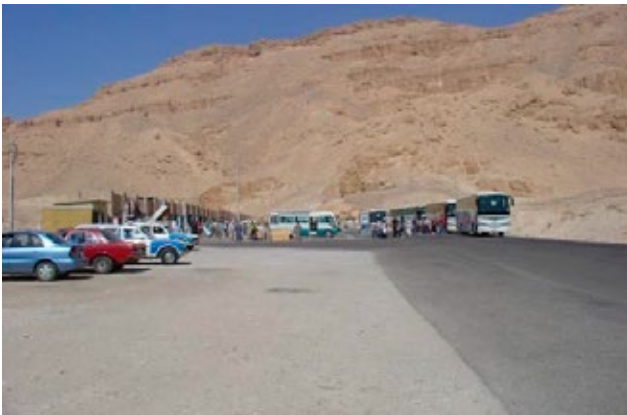
2. Unpaved parking area

Date of construction: Ad hoc addition to paved parking

Description/function: For private vehicles and taxis

Condition/operability: Provides adequate space for private vehicles, which are relatively few in number

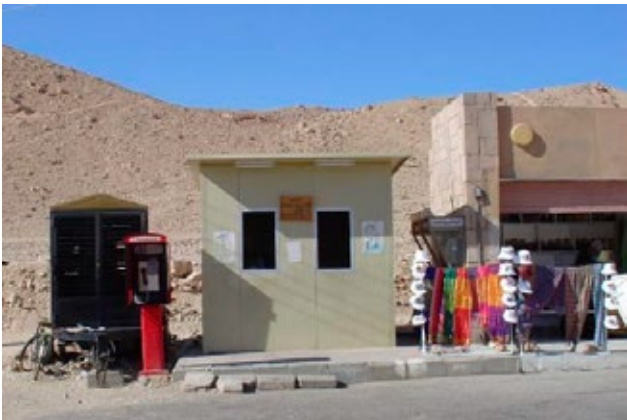
3. Ticket office

Date of construction: 2004

Description/function: Located at the beginning of the bazaar, tickets are purchased here, mainly by guides. Money from late afternoon sales is left in the office, thus requiring some level of security.

Condition/operability: Inadequate in terms of location, function and security

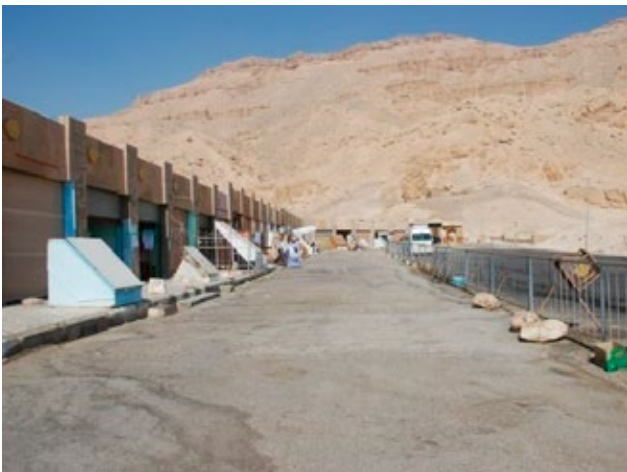
4. Shops/bazaar

Date of construction: 1993

Description/function: There are 32 shops, which carry similar, low quality goods. The area in front of the shops functions as entrance to and exit from site, thus requiring visitors to run the gauntlet of persistent vendors twice during their brief visit.

Condition/operability: The shops are poorly constructed and present a shabby appearance

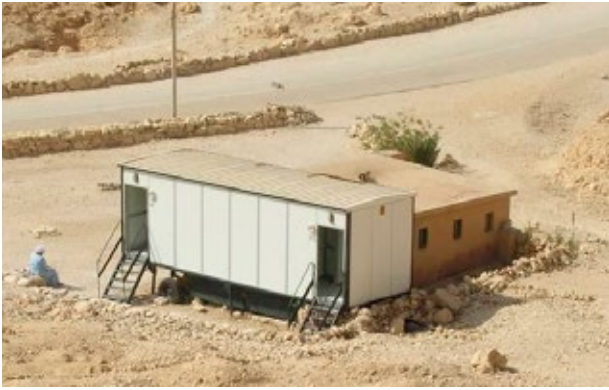
5. Toilets

Date of construction: Installed c.1990

Description/function: Trailer with 3 toilets for men and 3 for women; this is the only toilet facility on the site.

Condition/operability: Reasonably adequate in terms of number of stalls; queues are rare. Constitutes a visual intrusion.

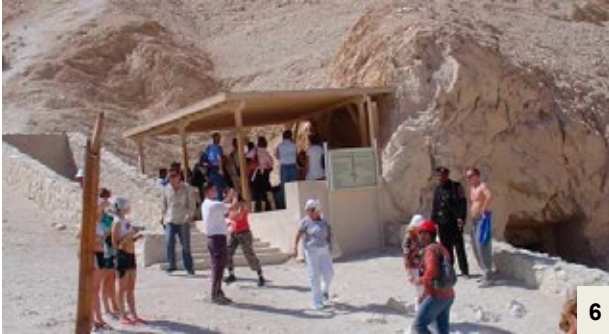
6

6. Shelter for Tomb 44

Constructed by: SCA

Condition/operability: Serviceable but space is severely constrained. Used more by guardian and tourist police than visitors.

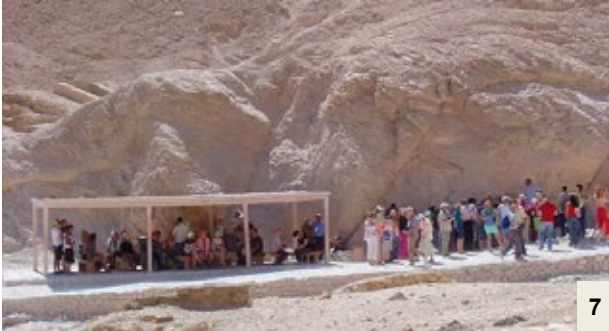
7

7. Shelter for Tomb 52

Constructed by: SCA

Condition/operability: Serviceable but too small and distant from tomb 52; however, there is no available space closer to the tomb.

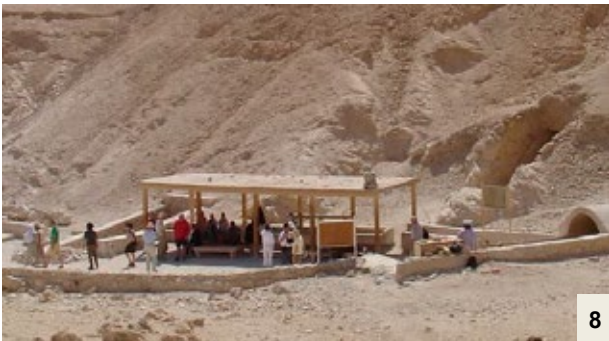
8

8. Shelter for Tomb 55

Condition/operability: Serviceable but too small and provides inadequate shade.

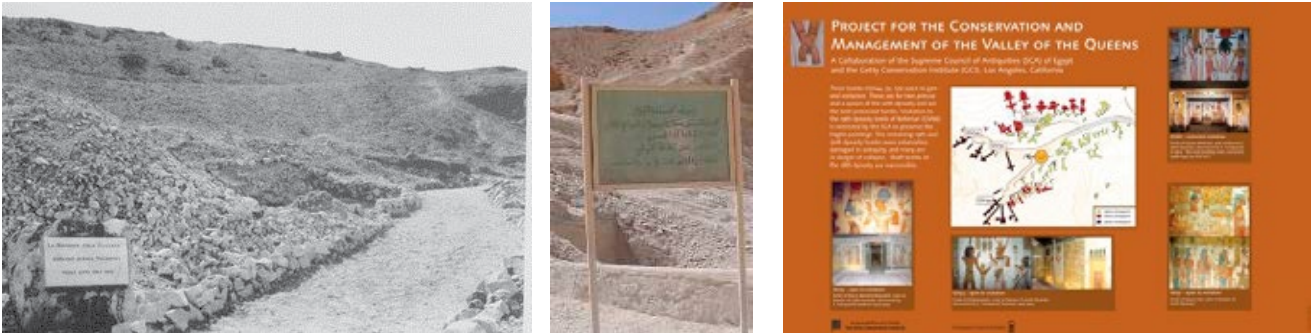
The path of the SW wadi with marble plaque (left) set up by Schiaparelli recording the Italian Archaeological Mission's work at QV ('La Missione Arch. Italiana Esploro Questa Necropoli Negli Anni 1903-1905') (Image: Schiaparelli 1923). The rock remains in situ today but the sign has long been removed. Sign at Y-junction installed in 1990s (since removed in 2007 by SCA). One of three temporary panels installed near Y-junction in 2009 for GCI-SCA project (right).

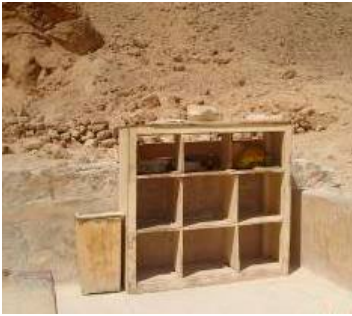
QV 55 entry

Bag check: Furnishings for checking bags exist at shelters or tomb entries for QV 55, 44 and 66. They are inadequate, untidy and their location is intrusive. Only the bag check at Nefertari is fairly consistently used. Their location is problematic since those located within the entry areas of tombs (QV 55) are an obstacle to traffic flow, while those located under shelters (QV 44) are lacking security such that visitors feel comfortable leaving their belongings. These issues will not be easy to address due to lack of space, but need to be framed within a coherent and consistently applied policy on bringing bags and cameras into the tombs.

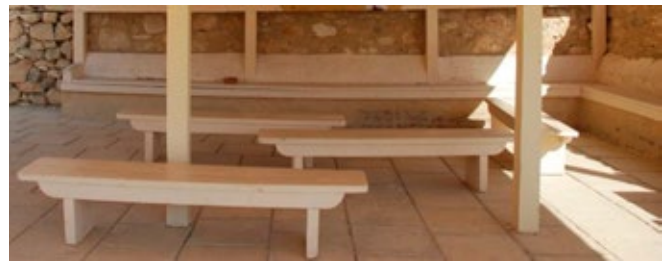
QV 66 under shelter

Benches/seats: Moveable wooden benches and built-in plastered masonry seats provide seating under shelters. These are used as much by tourist police as visitors. Seating is important since visitors must often wait in fierce heat to enter tombs and listen to guides give their narration. While the moveable benches are useful for guides to consolidate their groups and can be moved into the shade, they are also an obstacle within the shelters.

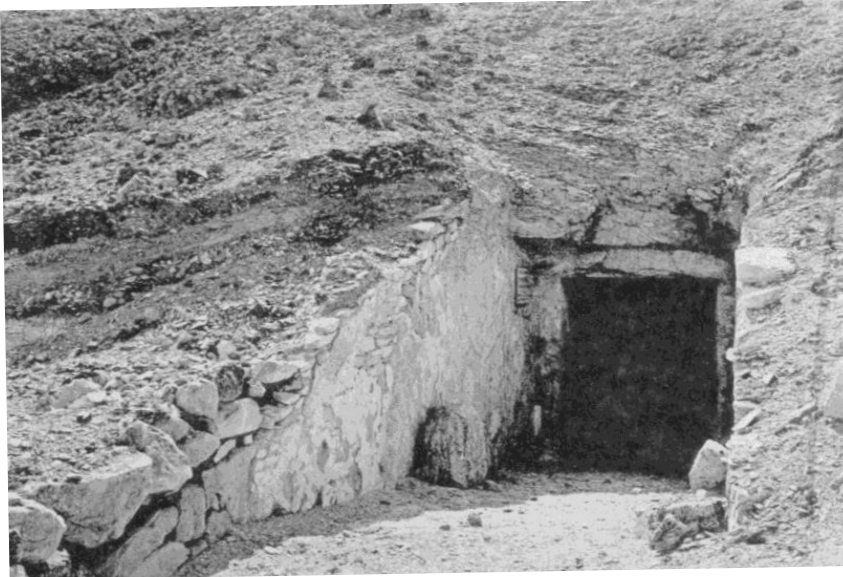
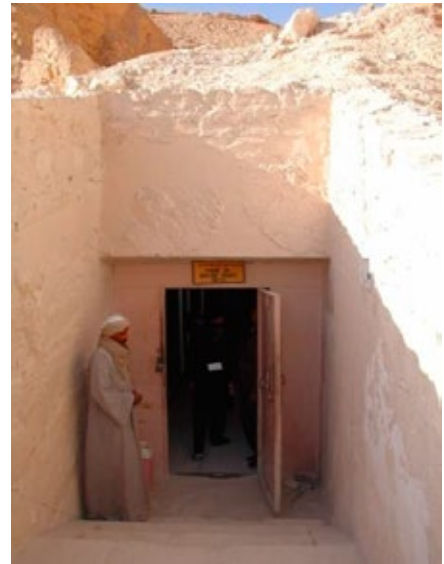
QV 44. The entrance to the tomb during the time of its discovery by Schiaparelli (left) (Image: Schiaparelli 1923) before installation of door (1903-4). At right, the entry as it looks today (2005) with door installed by Schiaparelli and masonry retaining walls built on the ramp cutting and above the door lintel in 1991. There is no arched cover to protect the tomb from flood debris flow from the slope above the door.

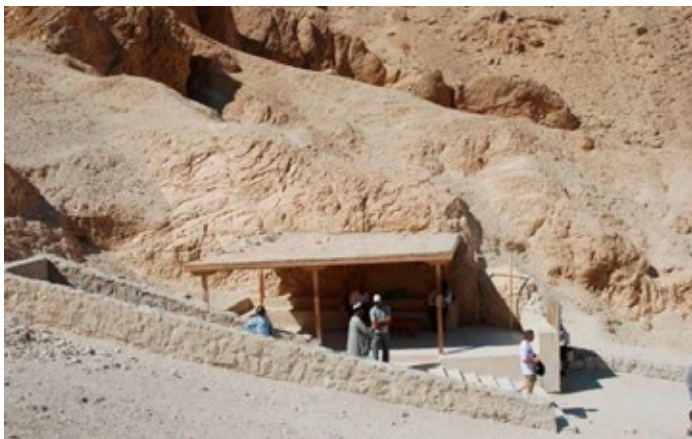
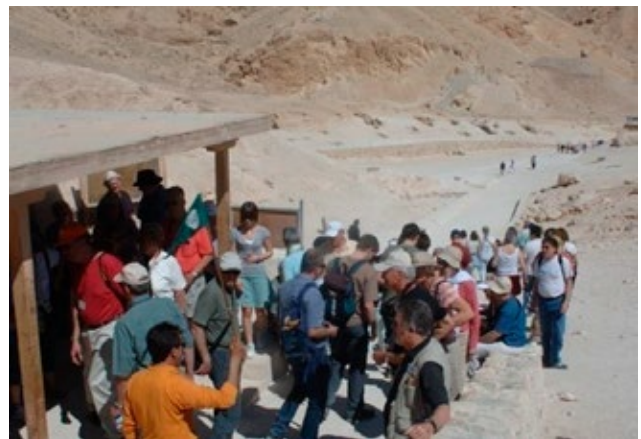
QV 44. Retaining walls and steps in the ramp were built in the 1990s to protect the tomb and provide easier access to visitors. The entry area and adjacent shelter become highly congested as groups jostle to exit and enter the tomb. The space available for extension of the shelter is, however, highly restricted. Upslope flood debris flow through the shelter must be retained so as to prevent flow into the down slope of the ramp toward the tomb.

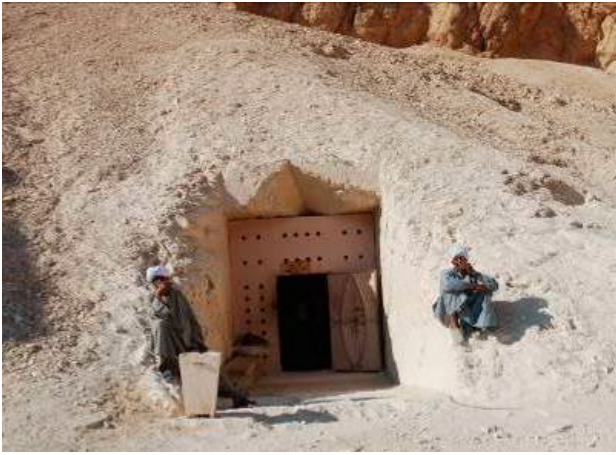
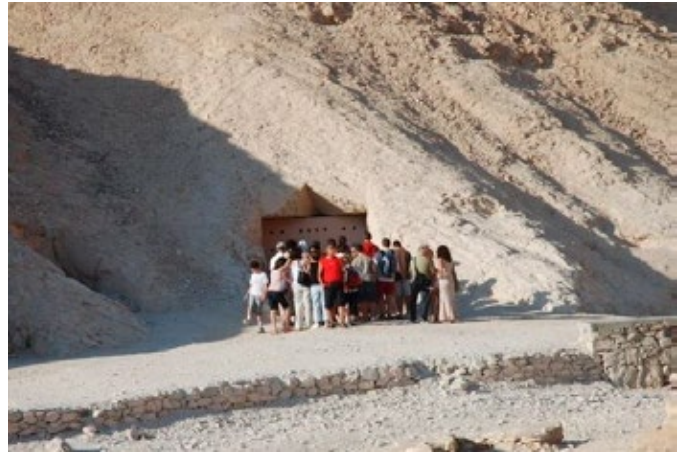
QV 52. Schiaparelli era door protects the tomb (left). There are no retaining walls or arched cover to protect the tomb from debris flow from slope above entrance; nor is there protection from flooding from the adjacent wadi. Visitors congregating in front of the tomb awaiting access put undue pressure on the entry as they attempt to gain access and seek shade.

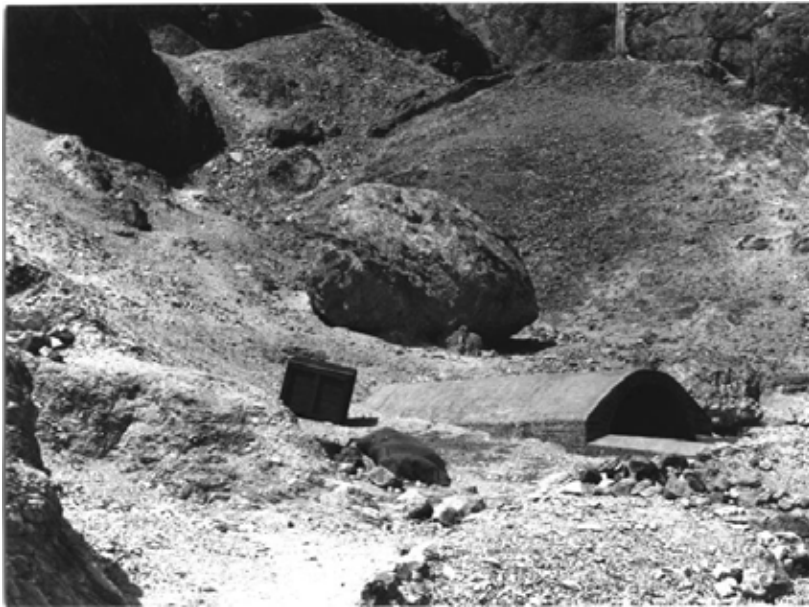
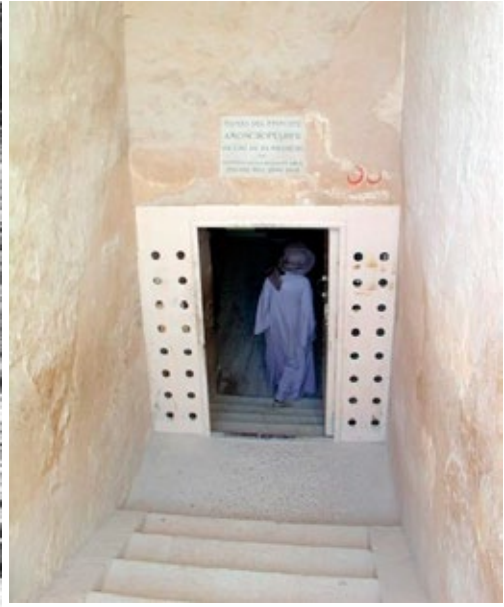
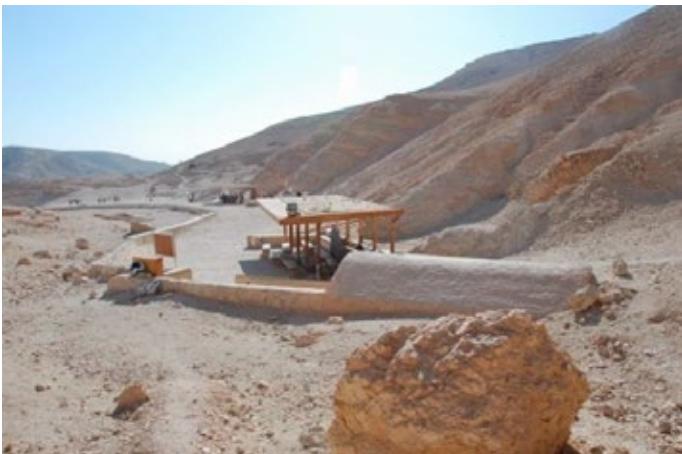
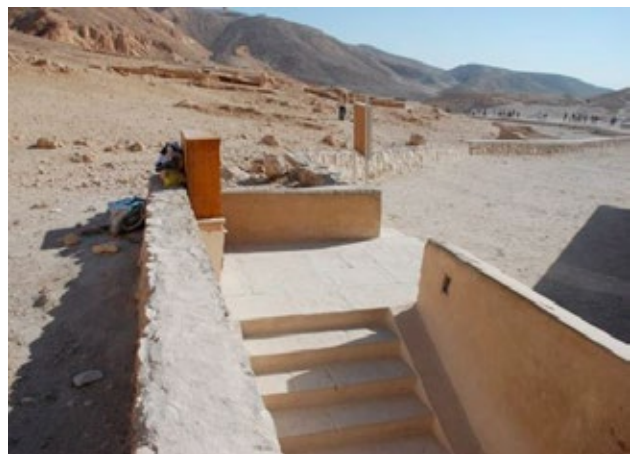
QV 55. Retaining walls and brick arched cover as built by Schiaparelli c.1905 (top left) (Image: Museo Egizio); entry with door and plaque installed by Schiaparelli as it looks today (2005) (top right). The retaining walls and brick arched cover built by Schiaparelli (the walls extended and entry created at a later date) provide some, though insufficient, protection against flooding from the wadi, as seen bottom left). The platform at the top of the steps (bottom right) becomes easily congested as groups attempt to enter and exit the ramp.

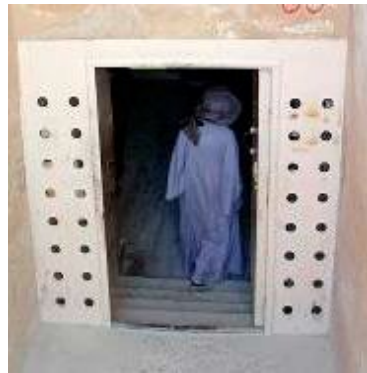
QV55. Exterior

Doors: Heavy metal doors with elaborate locking mechanisms protect the three visited tombs and date to Schiaparelli's time (apparently designed by H. Carter, Director of Upper Egypt in the *Service des Antiquities* at the time; Carter 1905, 120). QV 44 has a solid door and frame; QV 52 and 55 have ventilation holes in the side and transom panels. These are inadequately screened to prevent entry of small animals. (QV 43, not currently open to visitors, also has a Schiaparelli period solid door with ventilation holes). Entry of dust is also problematic and filters should be considered.

The existing metal doors can and should be retained but require refurbishing (new paint and fittings). Doors that have ventilation holes need to be provided with a method of preventing entry of bats and rodents. Since 2009 the GCI has been undertaking environmental monitoring of these tombs, which will provide information about the impact and utility of the ventilation holes.

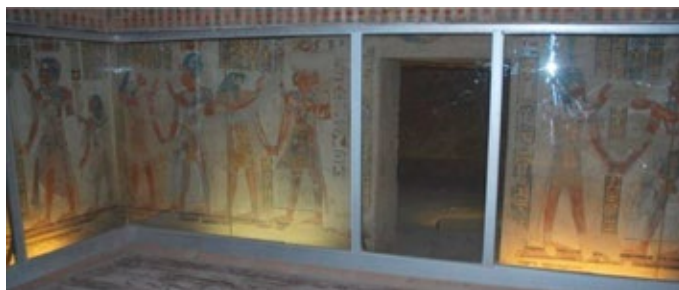
Lighting of wall paintings, QV 55

Lighting: Fluorescent lights are placed on the floor behind the glass barriers and used to illuminate the wall paintings and tomb features. They are long-lasting, but focus the light at base of walls, are difficult to access behind the barriers for maintenance, and have poor quality housing.

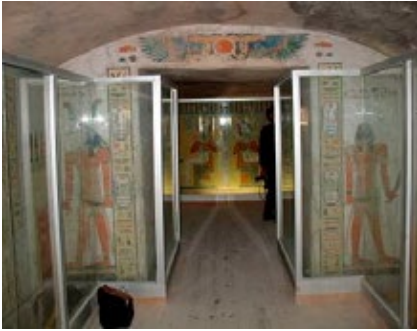
QV 44: general view of glass barriers and missing large glass panel in the corridor (right)

Protective barriers: Existing glass barriers set in aluminum frames are intrusive, difficult to clean and see through due to reflection and adherent dust.

The heavy glass panel above the low entry to Chamber K of QV 55, was dislodged and removed in 2008 after being impacted one too many times by the heads of visitors. One of the large glass panes in QV 44 has been missing for several years, offering better viewing but endangering the wall painting (this was replaced in 2009). A large panel in QV 52 was shattered when removed for SCA photo-documentation in November 2008.

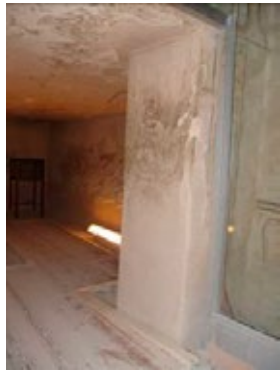
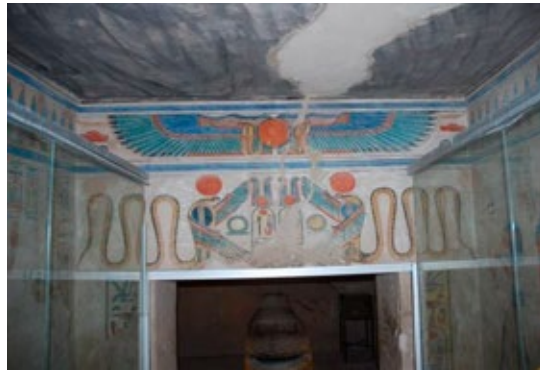
Some form of barrier is necessary to protect paintings from visitors, especially in the confined spaces of the axial corridors and small side chambers. This is illustrated where barriers are missing in the entrance to the rear chamber of QV 55.

QV 55: wall painting soiled by touching (left); lost glass panel above doorway (right)

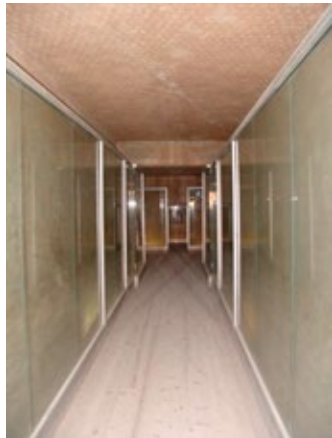
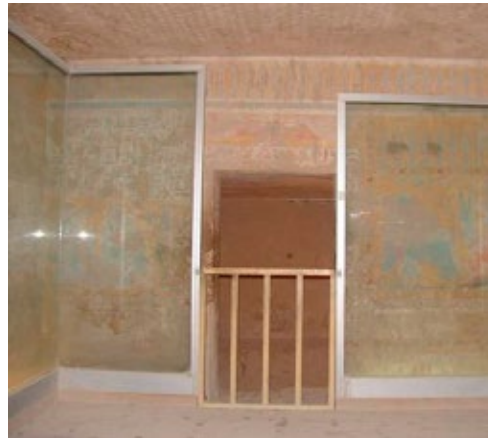
QV 52: narrow corridors of tomb (left); make-shift barrier and glass panels of unequal height and different construction (right)

In QV 52 a make-shift barrier to the side chamber and shaft between glass panels of unequal height and different construction further degrades the presentation of the tomb architecture and paintings.

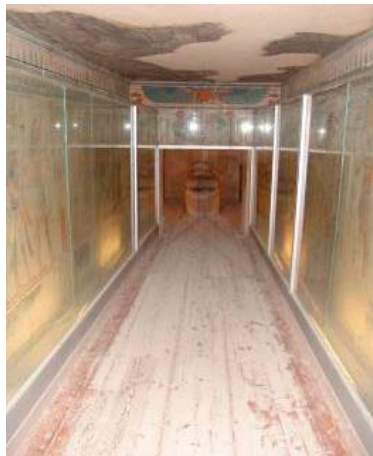
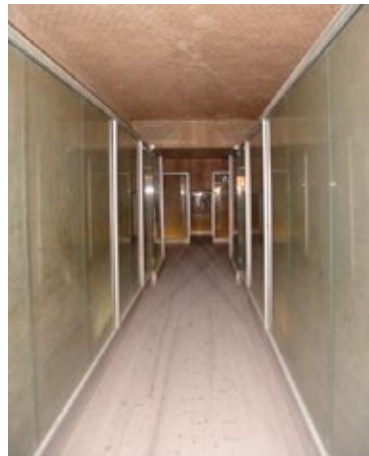
Floors: Wooden walkways in the open tombs are sound, but in need of refinishing, if they are retained. The walkways will need to be replaced, however, if sub-floor ventilation systems are introduced or new barrier systems installed. Accumulation of dust behind the barriers intrudes below flooring and is impossible to remove.

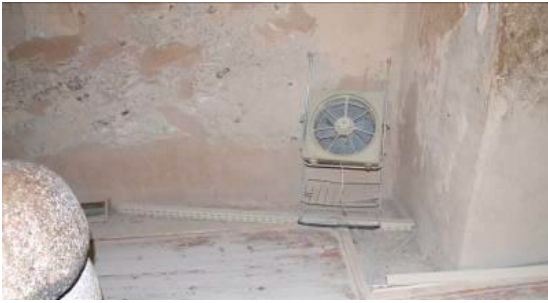
Ventilation: As indicated in visitor surveys, the air quality in the tombs can be quite poor, especially in the summer when CO₂ levels, and heat and body odors create a toxic mix. A fan in QV 55 attempts to ameliorate these conditions to little avail. GCI began monitoring humidity, temperature and air quality in the tombs in February 2009.

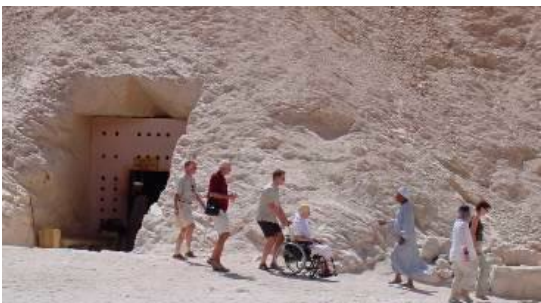
Wheelchair accessibility: None of the tombs are wheelchair accessible. QV 52 does not have stairs and might be adapted for wheelchair accessibility (and for other mobility challenged visitors), although the stone threshold poses difficulties.

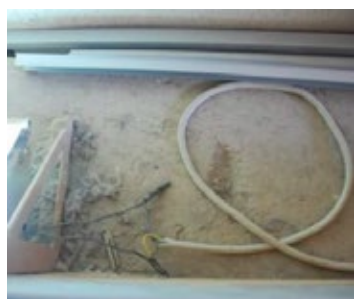
Electrical wiring: All the visited tombs are wired. Electrical connections are not up to safety code and constitute a fire hazard. Wires are not enclosed in conduits. The junction box outside QV 44 is dilapidated and missing its cover.

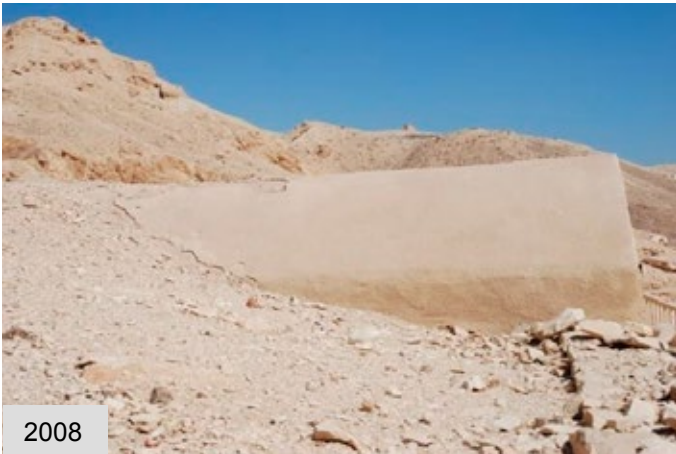
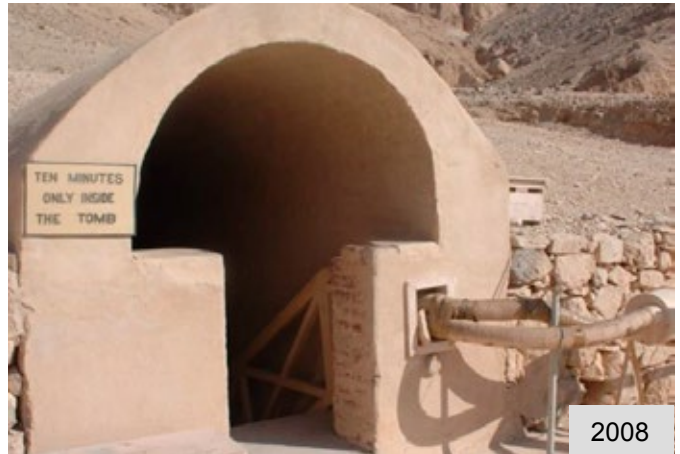
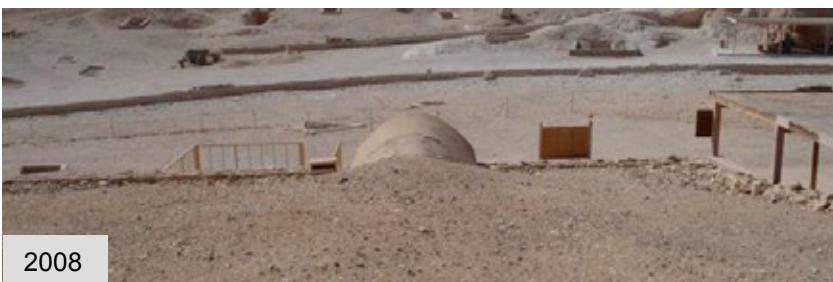
Plaster coating on arched cover is now deteriorating. Tops of the lateral retaining walls on either side of entrance lack a stable capping and there is no drainage to prevent rain or flood water infiltration behind these walls.

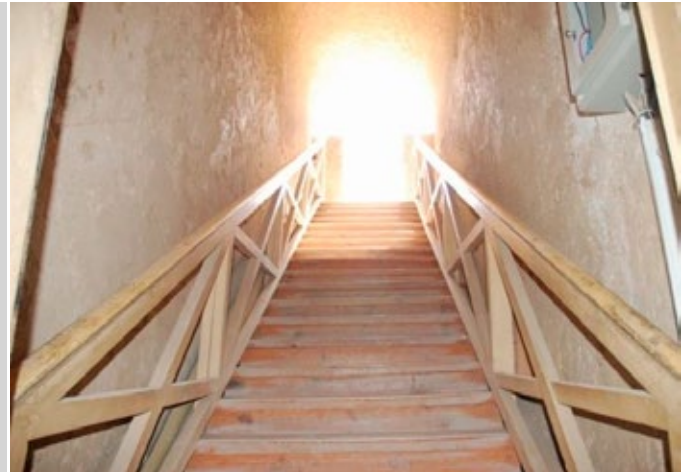
Wooden staircase and handrail constructed on the original stepped ramp (A)

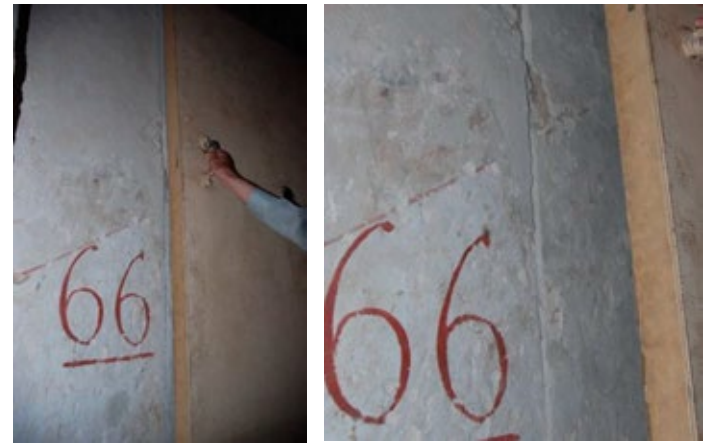
Impact of heavy metal door opening onto the wall of the stepped ramp (left and detail right). A method of preventing the door from hitting the wall is required.

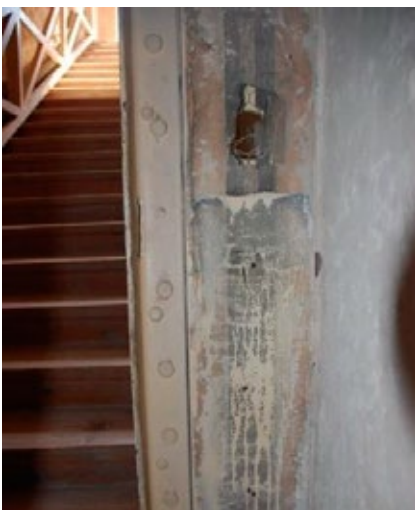
Screen over vent holes is torn and sand-clogged. Door is left open during visitation allowing air-borne particulates to enter tomb.
