Valley of the Queens Assessment Report

Volume 1 Conservation and Management Planning

A collaborative project of the Getty Conservation Institute
and the Supreme Council of Antiquities, Egypt

August 2012

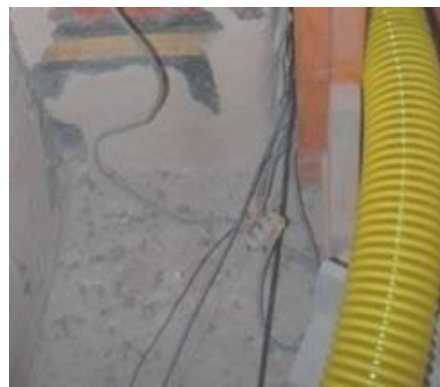
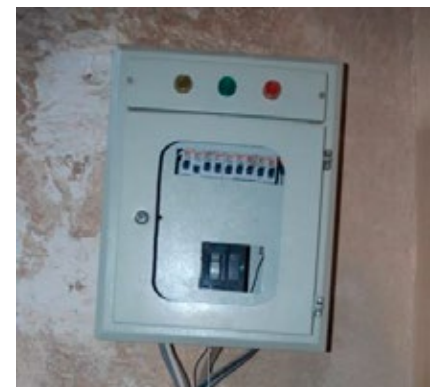
Electrical wiring is untidy and unsafe. As recommended by GCI in 1996, all electrical wires should be enclosed in metal conduits and electrical connections in metal enclosures to prevent fire and shock and prevent mice from eating wires. These recommendations have not been implemented, but provisional measures were put in place during the assessment. Voltage requirements for any new lighting system need to be considered in relation to potential fire hazard.

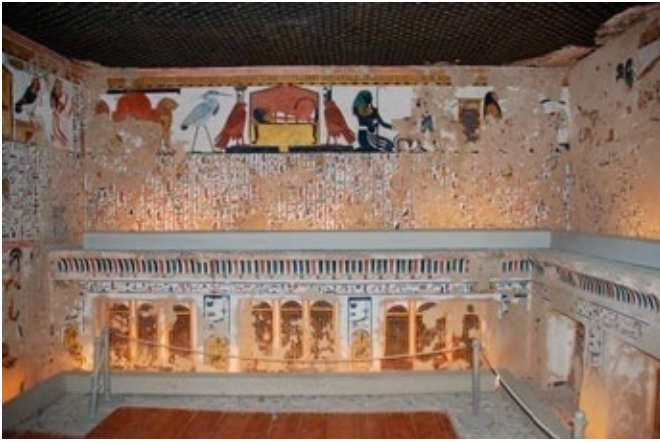
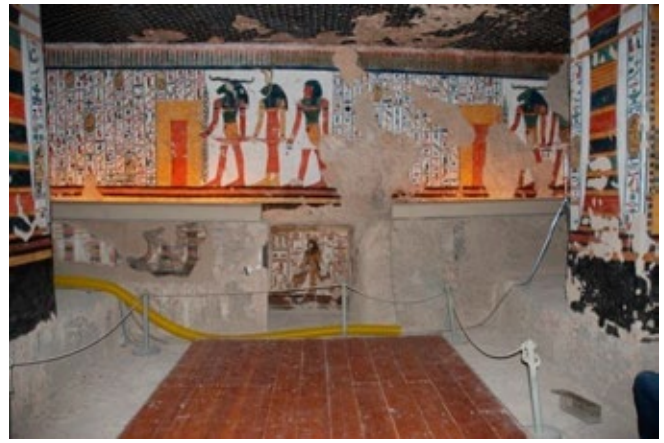
Lighting, stanchions and wooden platform in Chamber K. Note platform ends approx. 30cm from wall. Stanchions and platform function more as psychological than physical barriers. This system is viable because of the restricted number of visitors allowed at any one time in the tomb, but stanchions are unstable and potentially dangerous. Recommendations were made in the past to anchor the stanchions, which are at risk of being knocked over, to the walkways.

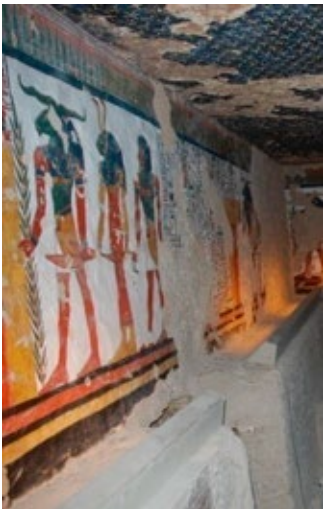
Housing for fluorescent lights on ledge in Chamber K (left), and on floor and ledge in Chamber C (right). Illumination is strong at source and falls off on upper parts of walls.

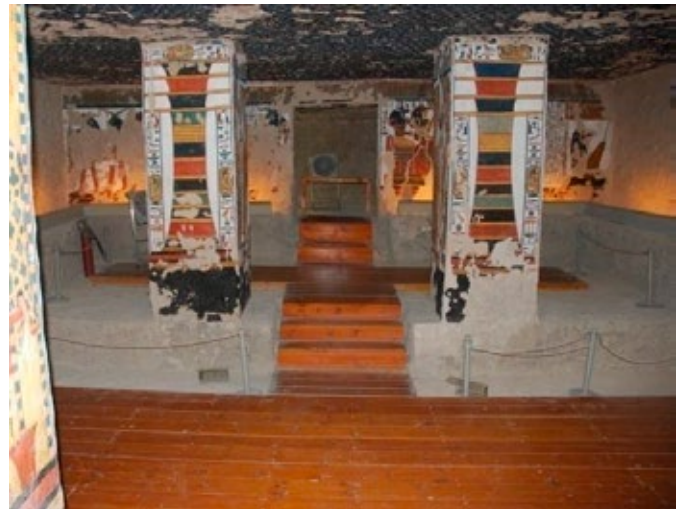
Wooden walkways and platform in Chamber K (foreground) leading to rear Chamber Q. The wooden walkways are in generally good condition, but are not of modular construction making it impossible to remove them to clean dust and lint below them.

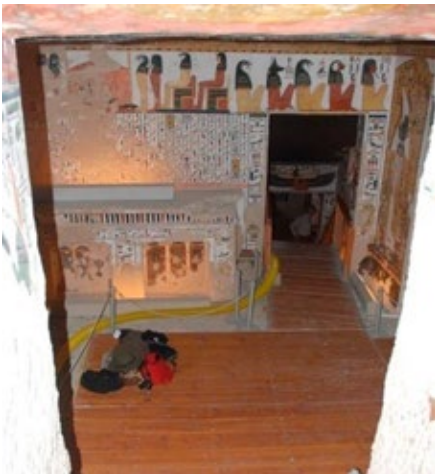
Wooden platform and stanchions in Chamber C, viewed from stepped entry ramp.

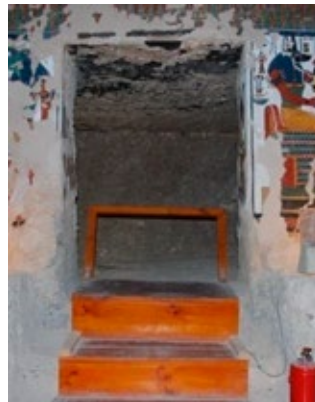
Walkway barriers are low and too close to wall paintings at doorways. Barrier to Chamber Q (above) is not stable.

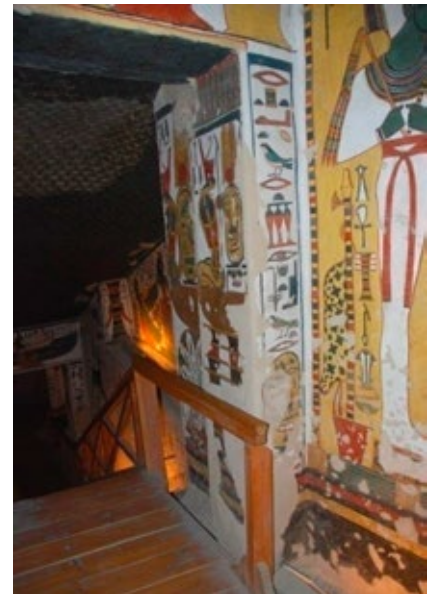
An air extraction system was installed in the tomb of Nefertari in 1995 (see Part V:1, Environmental Monitoring). The extraction pipes have been in disrepair for several years (see next page for provisional measures to rectify system). The fans only function to circulate the air in the tomb and do not assist with air exchange with the outside.

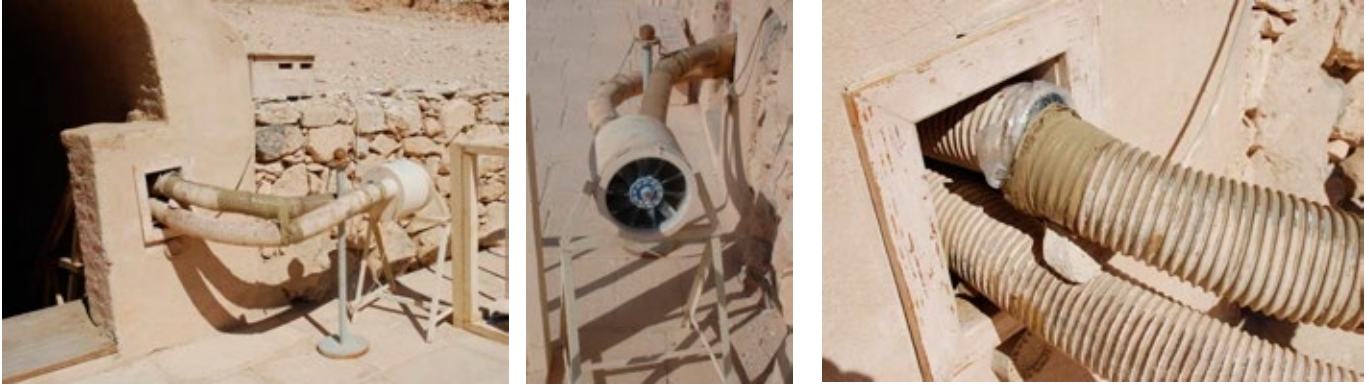
Air extraction pump outside entry to tomb. The pipe exits at the front of the tomb and is a significant visual intrusion. Extraction pipe was broken in several places, occasionally repaired with tape.

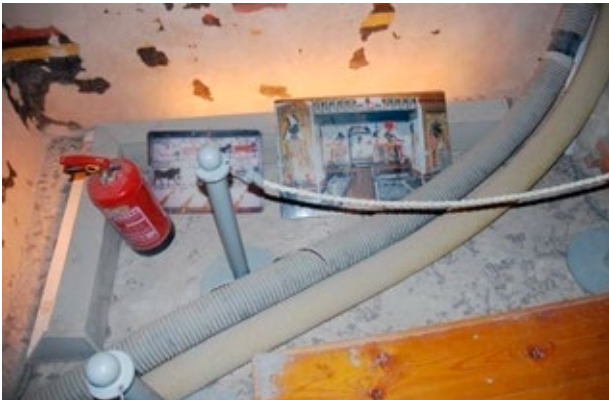
Fire extinguisher and air extraction pipes in upper chamber. Contact of pipes with wall causes abrasion.

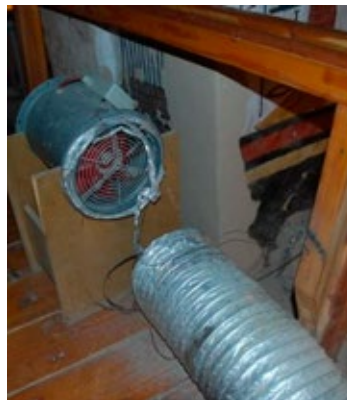
Broken extraction pipe at top of stairs.

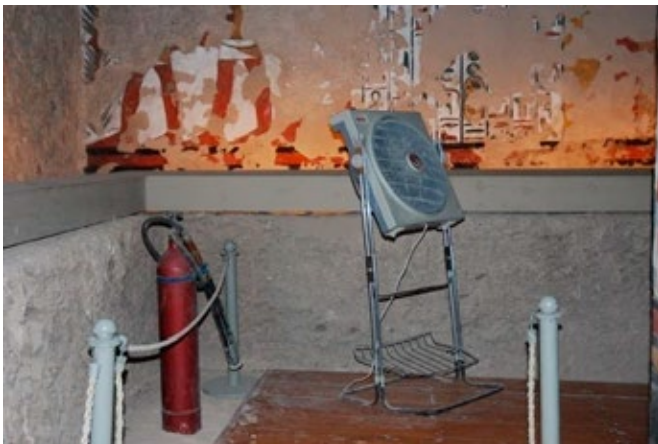
Fire extinguisher and fan for air circulation in lower chambers.

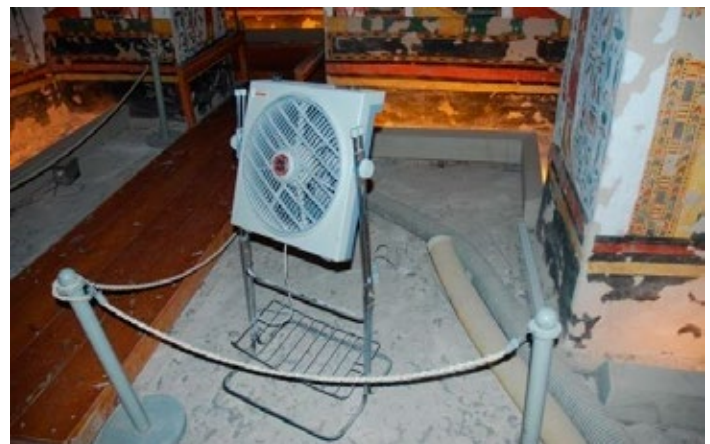
Fan in upper Chamber C.

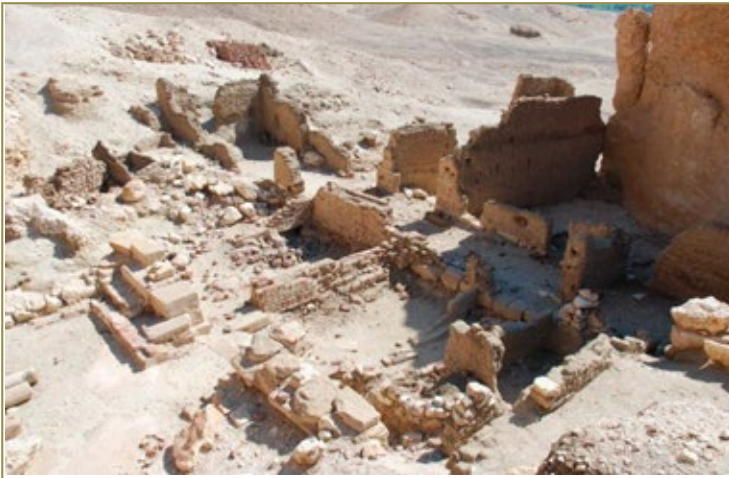
View of Deir er-Rumi from above looking east, with remains of Coptic monastery and Roman sanctuary.

Safety concerns: Site is quite fragile and easily damaged by large groups. There are severe problems of structural instability of the rock slope behind ruins.

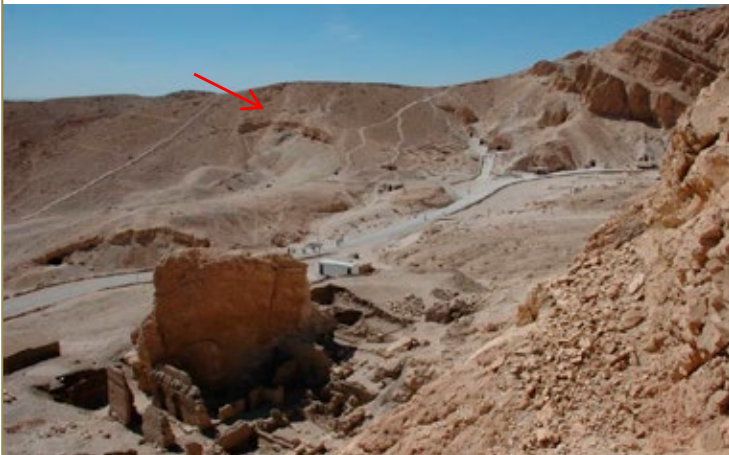
View of Deir er-Rumi from above looking southwest, with remains of Hermit Shelters on hillside (arrow).

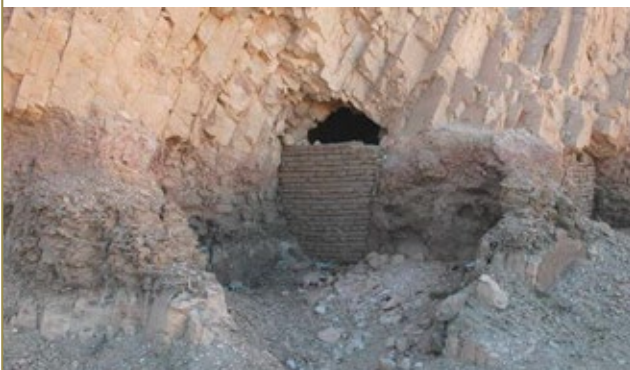
Hermit shelters on hillside

Two smaller site elements contribute to an understanding of the Coptic use of the site. QV 1, originally thought to be a tomb and numbered as such, is now thought to be a hermit shelter associated with the use of Deir er-Rumi. On the ridge of the hill above QV 1 are the Hermit Shelters, a series of 3 cavities with architectural features on the terraced hillside. Both elements are visible to the south of the visitor path, as one rounds the bend from the parking area, and in visual range of Deir er-Rumi to the north. Their remains are too fragile to allow visitation.

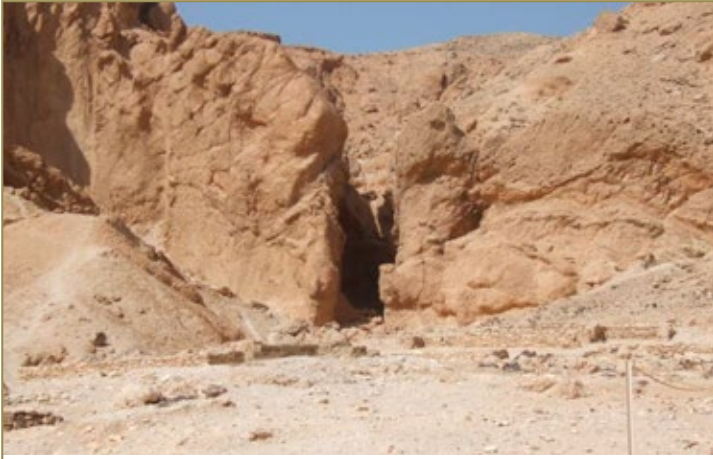
View of the Grotto Cascade from the Valley.

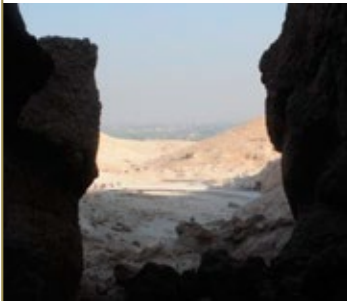
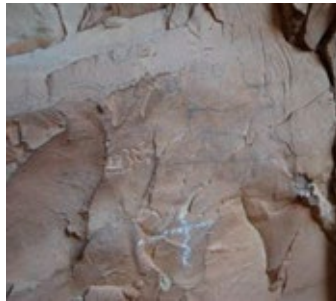
View of the Valley from within the Grotto Cascade (left) and detail of graffiti on rock walls.

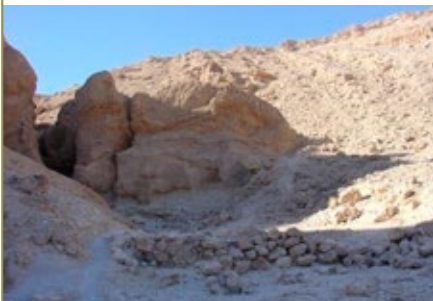
Flood protection dam (left, foreground) in front of the Cascade and detail of painted image of Hathor (right)

At the outfall of the Grotto Cascade is a Ramesside period dam built to protect the tombs from floodwaters or collect rain water. Although not associated with the sacred aspects of the Cascade, the dam is in visual range and relates to the Cascade as a major source of flood water to the main valley.

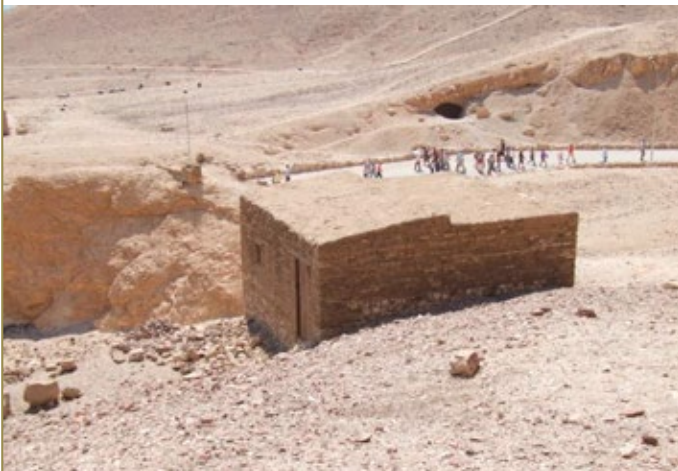
View of the Italian Mission Building from the hillside above, looking down on the visitor path below.

Noteworthy: The building was used as a kitchen by the Italian mission led by Schiaparelli.

Visitation potential: Visitation is not possible, nor necessary. The building can be viewed from the visitor path below and interpreted in the context of the modern history of excavation at the site in site panels.

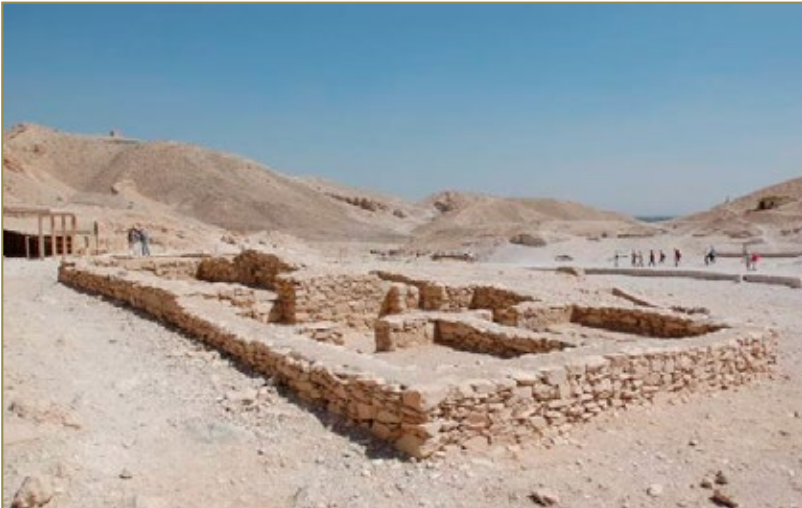
View of workmens' huts looking east down the Valley

Noteworthy: Remains of the huts where tomb workers lived.

Visitation potential: No direct access should be allowed, but remains of structures are easily viewed from visitor paths. Finds from the site such as ostraca, and the relationship to the worker's village at Deir el-Medina can be interpreted.

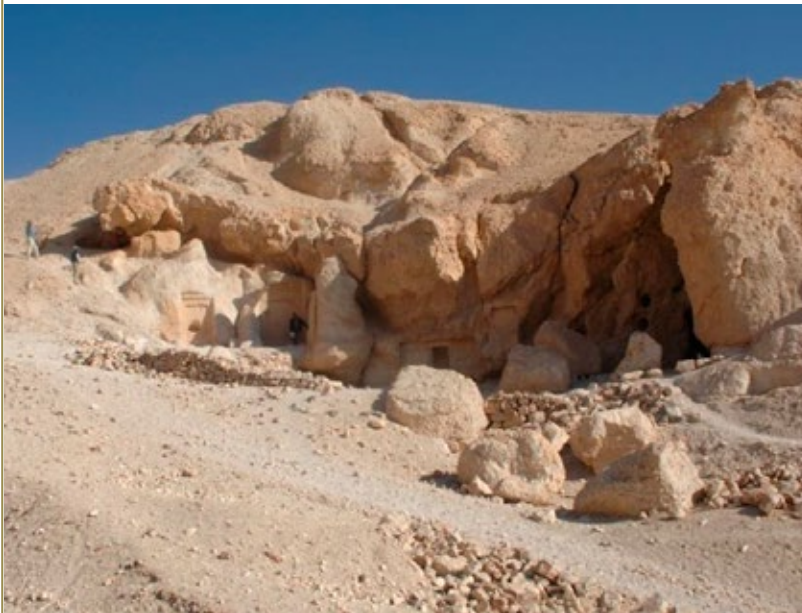
View of Sanctuary of Ptah from the path between QV and Deir el-Medina.

Visitation potential: The potential for visitation is high but direct access to chapels needs to be restricted or monitored to prevent vandalism.

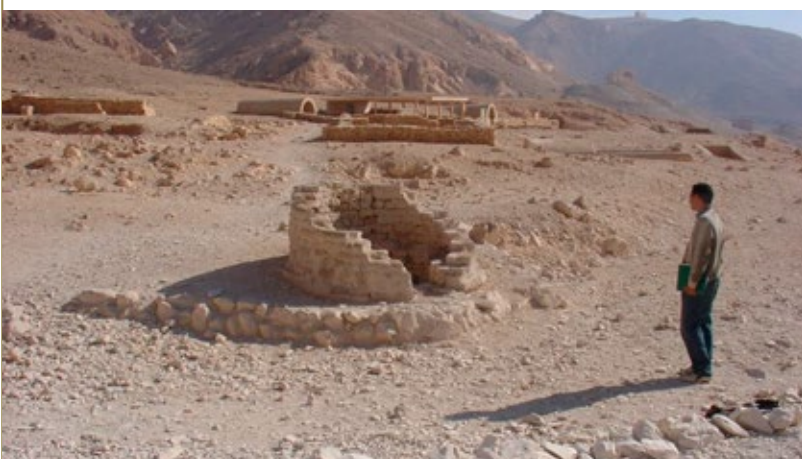
Ancient kiln in the wadi looking northeast toward the workmens' huts and tomb of Nefertari.

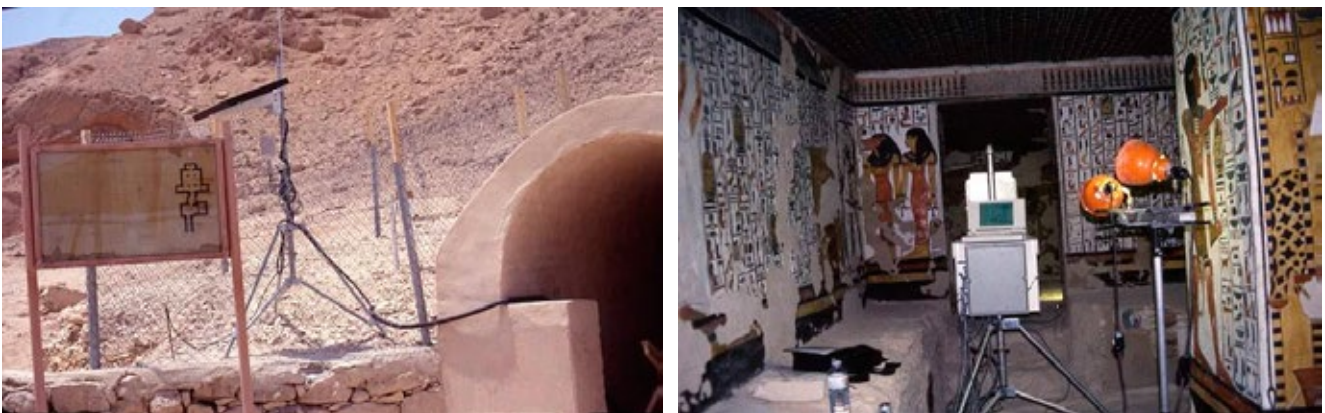
The environmental monitoring station installed at the tomb of Nefertari (QV 66) in August 1991. Left image shows a solar panel and sensors installed on a tripod just outside the entrance arch. Right image shows station's datalogger in the burial chamber.

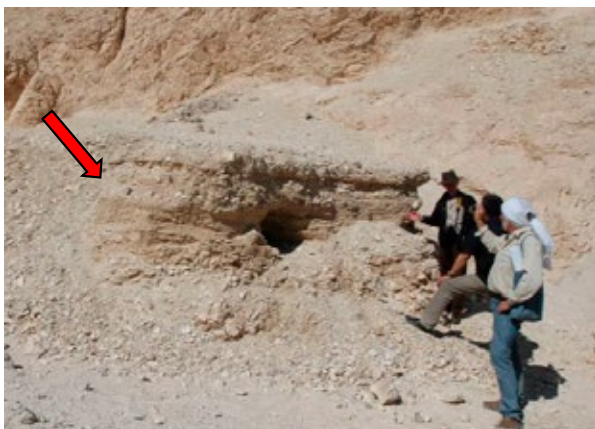
Section of alluvial stratigraphy left intact by the Franco-Egyptian mission.

The Franco-Egyptian mission left intact a section of historic alluvial stratigraphy in the wadi's southwest branch to provide a tangible record of historic deposition. Leblanc has noted that this stratigraphic section indicates the occurrence of twelve major depositional events (C. Leblanc, 2007, pers. comm.). C. Leblanc's brief published descriptions of the November 1994 flash flood and another storm in May 1995 are given in the following pages.

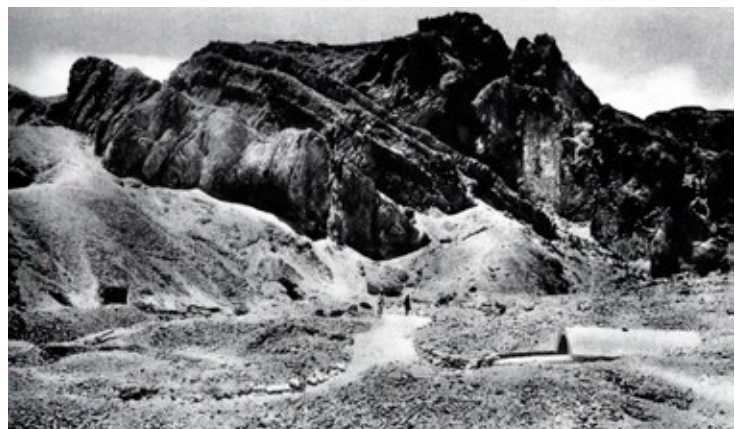
View of Valley at the time of Schiaparelli's mission, looking west from near QV 66 (Nefertari), showing build-up of flood debris. (Image: Schiaparelli 1923)

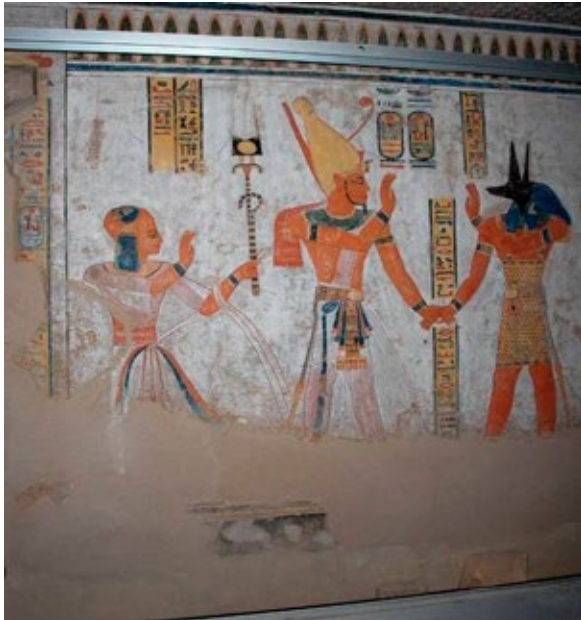
Loss of painted plaster at the wall base of tomb QV 44 (Khaemwaset), presumably due to historic flooding. The tomb is open to general visitation.

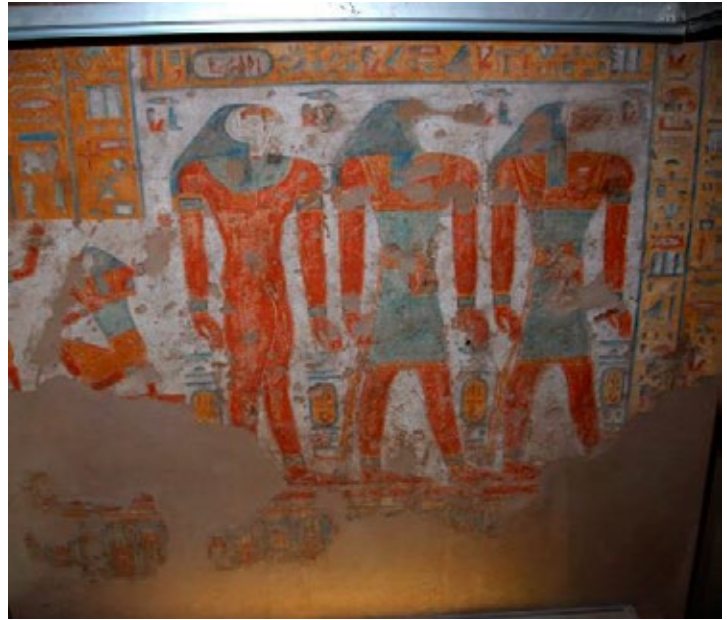
Loss of painted plaster at the wall base of tomb QV 52 (Tyti) presumably due to historic flooding. The tomb, open to general visitation, is in a vulnerable position near the main drainage channel.

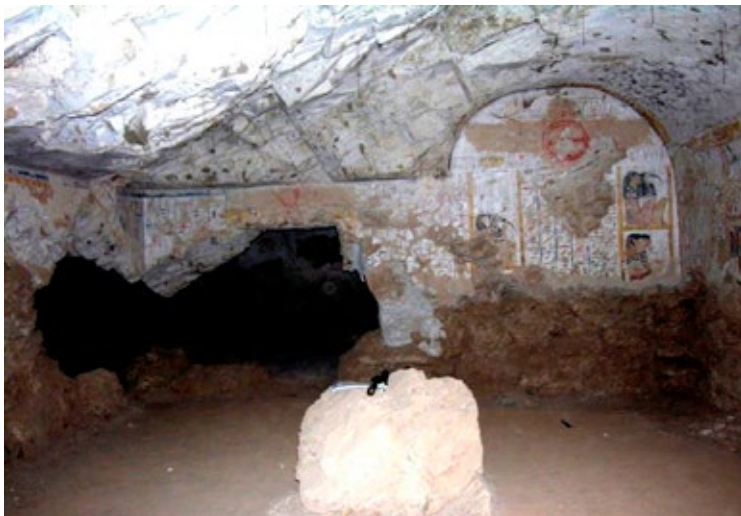
Rock collapse, deterioration, and loss of painted plaster in the lower walls of tomb QV 60 (Nebettau) due to repeated flooding, including in 1994.

Looking again specifically at the Queens Valley, records of early explorers and, later, archaeologists mention sediment in several QV tombs before they were cleared, presumably coming from flash flooding. For example, more than one meter of sediment was found in tomb QV 60, including stratigraphic evidence of at least six to seven major flood events (Messein et al., 1994, 480-481). A number of tombs show significant damage from past flooding or moisture infiltration. These range from damage to wall paintings by the moisture-activated growth of salt crystals, to the loss of painted plasters at the base of walls from flooding and ingress of moisture-saturated debris, to severe structural damage and collapse, particularly within tombs cut into high-clay content shale, and to a lesser extent marl.

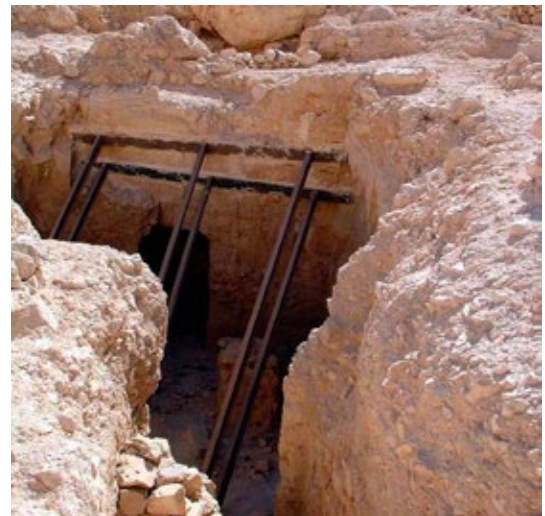
View of roof collapse of tomb QV 34, which is in an area where most tombs contain shale susceptible to water damage.

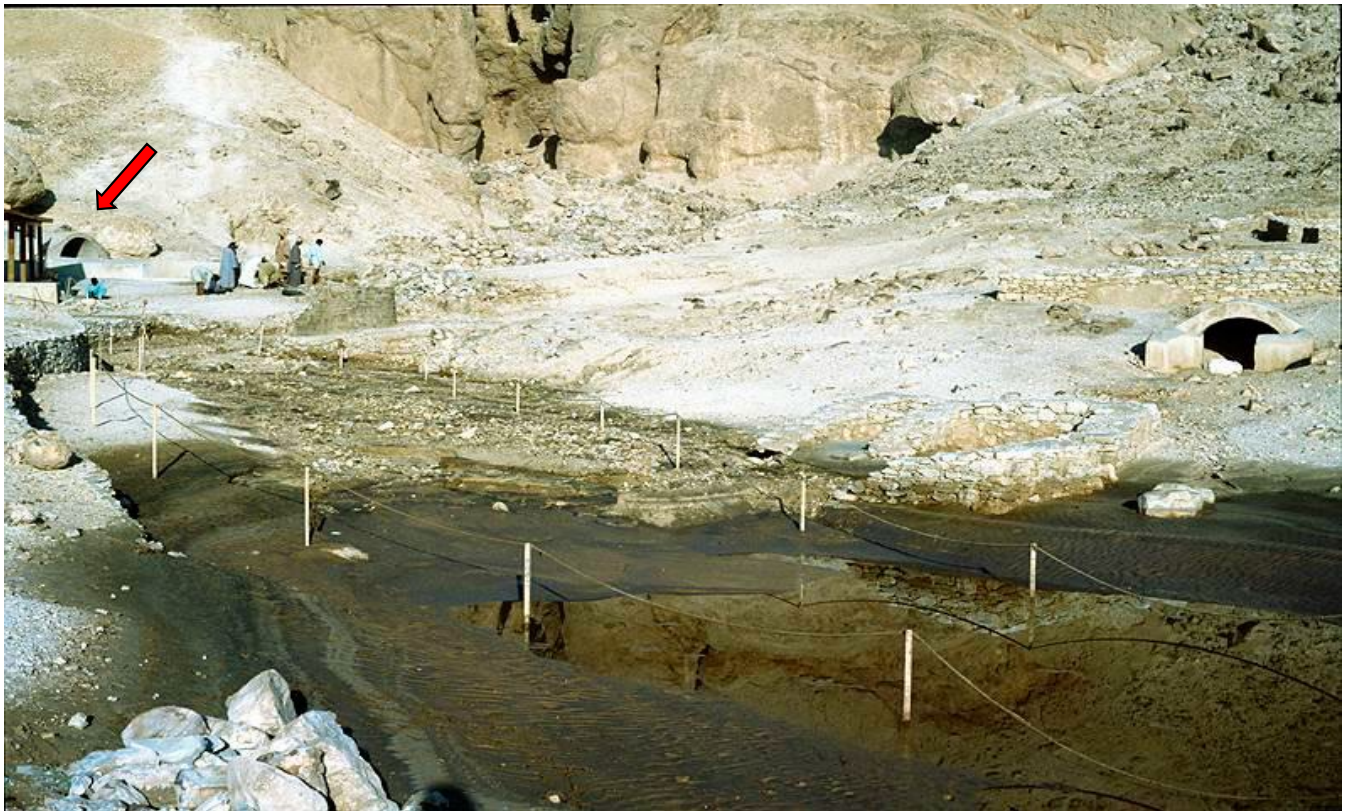
Water standing in the wadi after the 1994 flood. QV 55, one of the three tombs open to general visitation, is indicated by arrow. In the foreground are the foundations of Rameside-era and Coptic-era structures and tomb QV 58, now a magazine, on the right. (Image: CNRS)

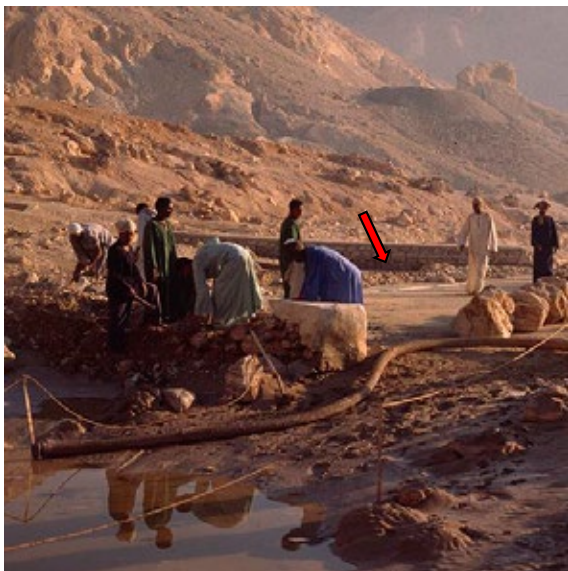
The former parking area was removed after the flood (Image: CNRS).

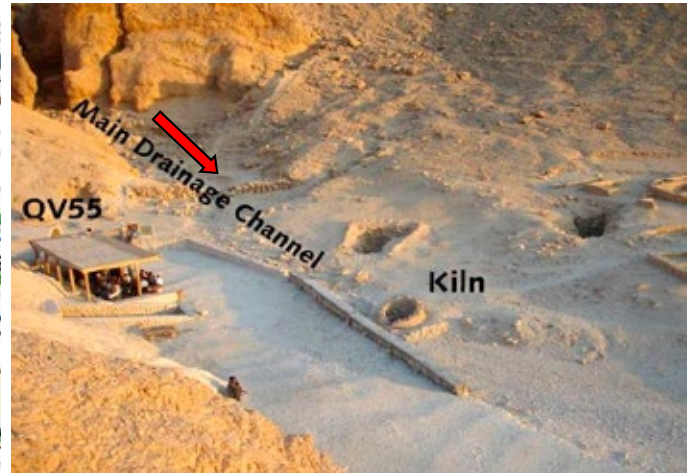
The ancient Roman or Coptic kiln is in the path of the main drainage flow near tombs QV 55 and 53. The direction of flow is indicated on the map and image by arrows. A wall was constructed in 2007 along the north side of the visitor path next to the kiln, which almost completely constricts the channel on the kiln's south side.

Location where the kiln obstructs the main drainage channel.

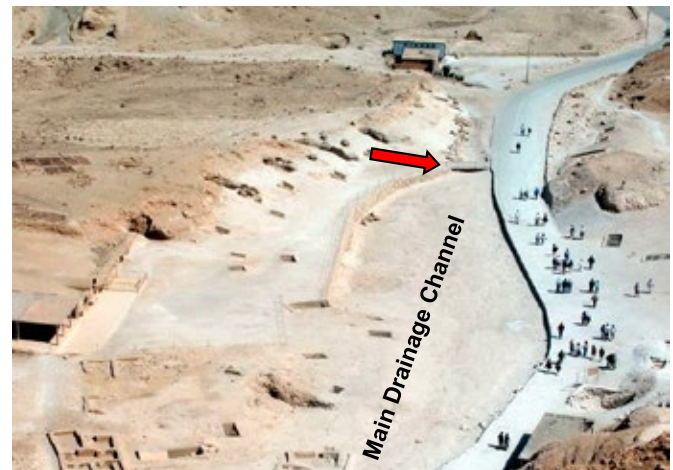
View of main drainage channel looking downstream showing channel narrowing and point of constriction at bridge (arrow).

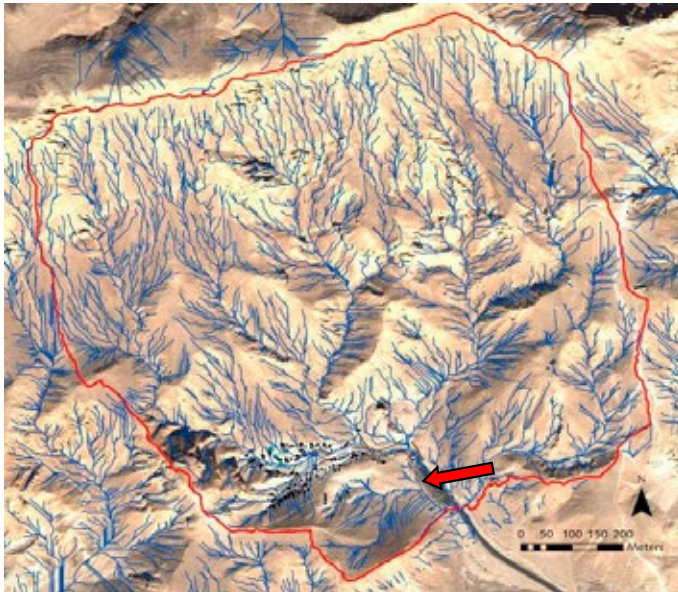
The convergence of flows from the six main sub-catchments threatens infrastructure at the site entrance. Blockage at this point would result in back-up of water, mud and rock and affect the entire site.

Above: View of the convergence of drainage subcatchments at the site entrance.

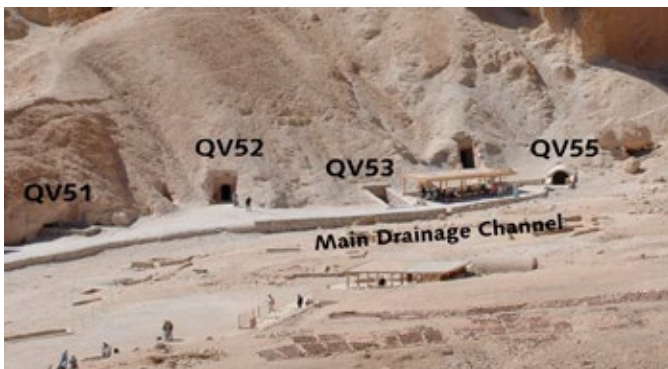
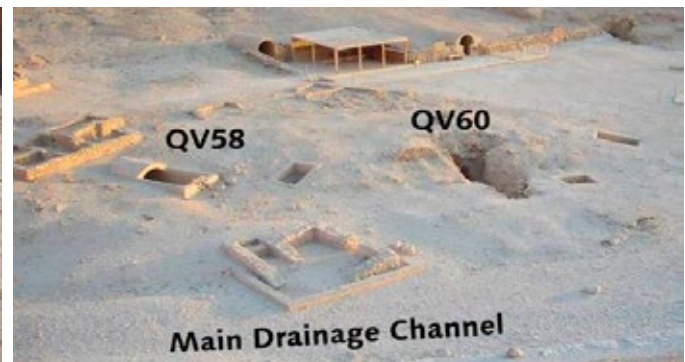
Below: View of Area 1 (left) and Area 2 (right). Note location of QV 53, which flooded in 1994.

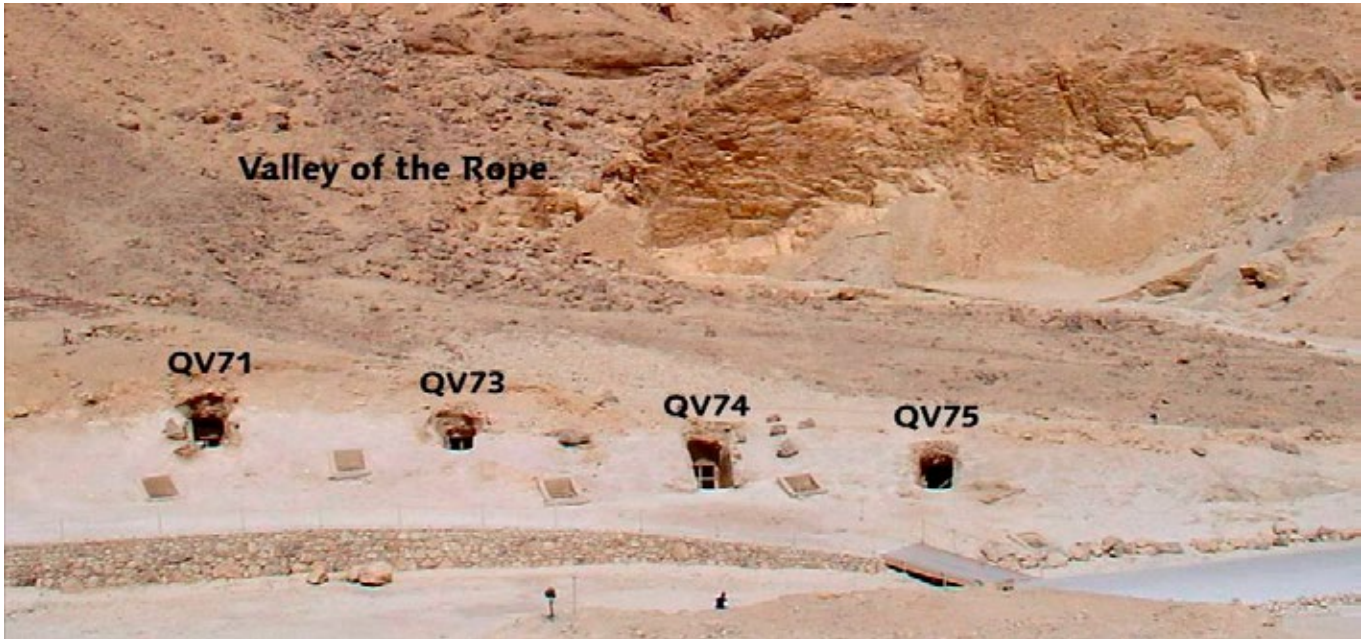
If a substantial flood event occurs, tombs QV 71 – 75 are vulnerable from upslope overflow from the Valley of the Rope drainage path to the north. The chief of the SCA site guardians indicated that QV 71 and 73 flooded in 1994 (2009 pers. comm.).

General view of Area 4 showing the Valley of the Rope outflow in the background.

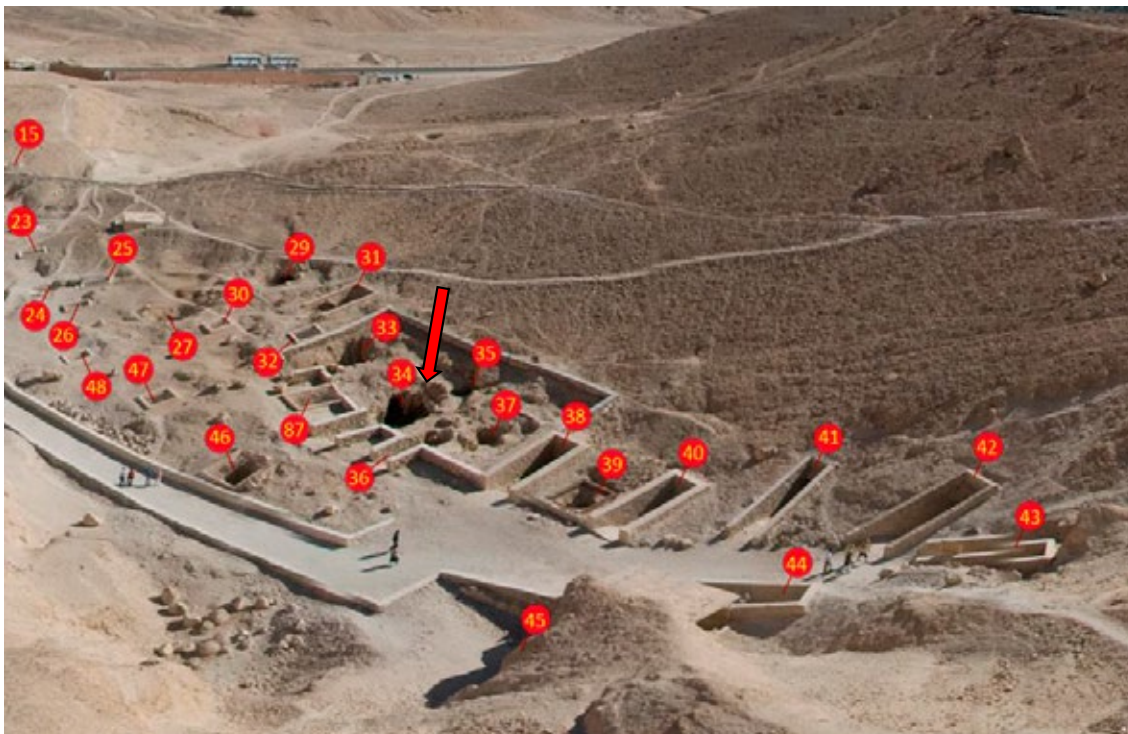
General view of Area 5, with arrow indicating QV 34 with collapsed roof.

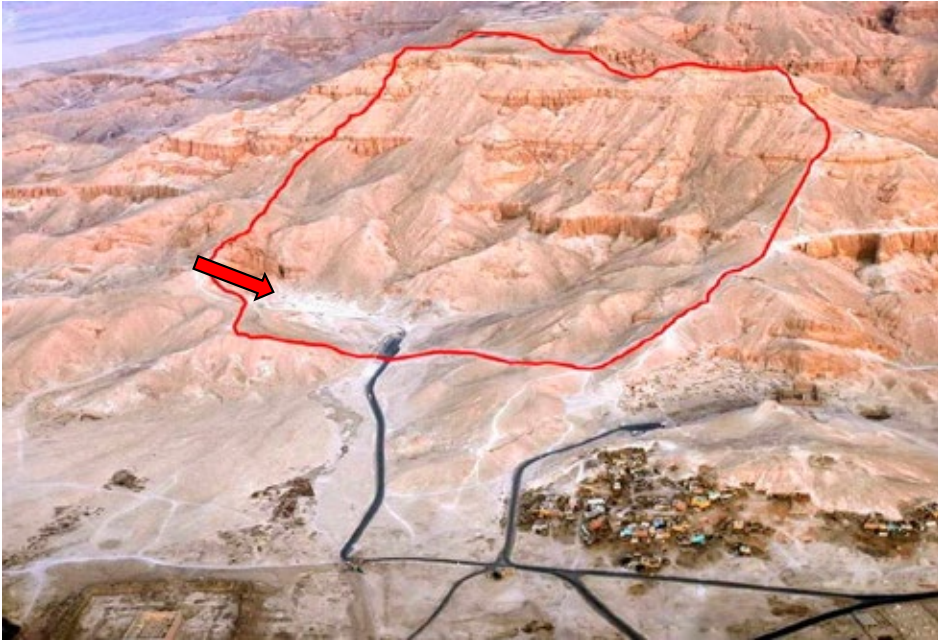
The QV rainfall catchment area, which extends to the top of the Theban Mountain, covers 104 hectares (more than 1 km square). The concentration of tombs at the base of the mountain is indicated by the arrow.

The Watershed Modeling System (WMS), a leading software package for graphical watershed computer simulations, was used for hydrologic modeling to delineate the rainfall catchment area and to analyze rainfall runoff. The new topographic mapping data was imported into the WMS package to develop a Digital Elevation Model (DEM) of the QV catchment area. Within WMS, the DEM was used to automatically delineate the overall catchment and sub-catchment boundaries, identify flow lines, as well as calculate flood hydrographs and water volumes for different sub-catchments. This analysis concluded by estimating sediment yields for peak rainfall events.

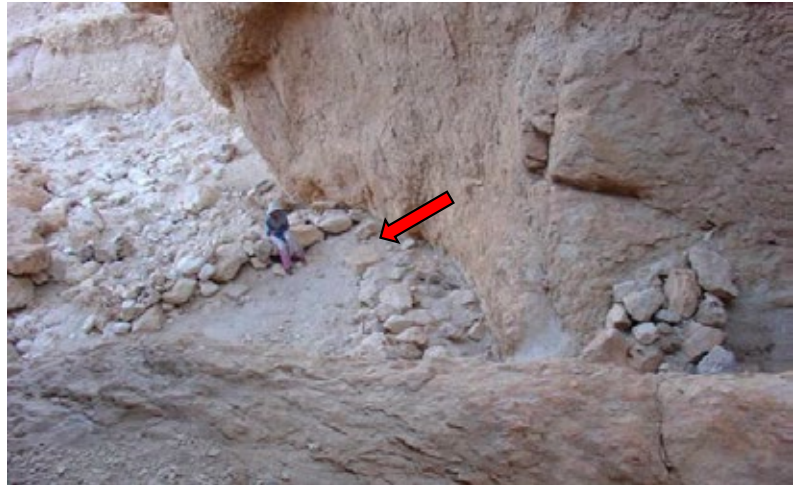
View looking down from the Grotto to the Cascade, with arrow indicating what CNRS has identified as the first barrage (2 on plan).

The ancient Egyptians created two basins at the foot of the Cascade with constructed rubble barrages (2 and 4 on plan) that apparently dammed or collected rain water in conjunction with the Dam further downstream (Desrouches Noblecourt 1990, 10). Within the upper basin (6 on plan), investigations have revealed traces of pharaonic-era broken ceramic pots and scattered red ochre pigment. Desroches Noblecourt has interpreted these remains as evidence of ancient ceremonial activities at the site.

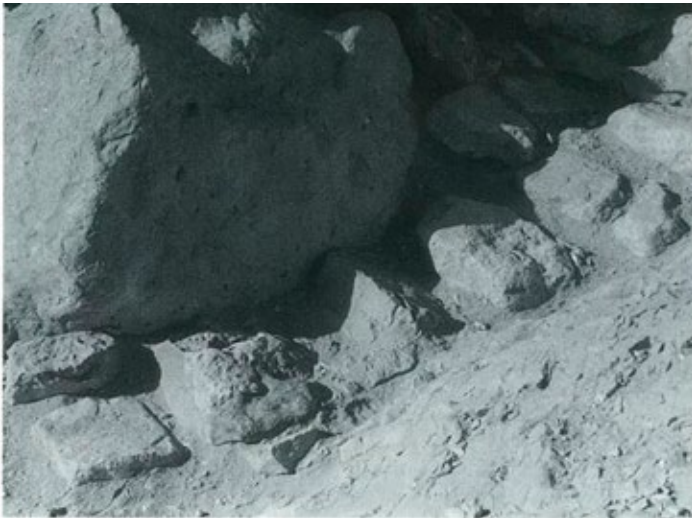
Rock paving steps (5 on plan), as excavated, on the path leading from the lower to the upper basin (Image: CNRS).

At the bottom of the Grotto Cascade complex has been found a foot path (1 on plan) that was apparently used to aid access to the Grotto. What may be rock paving stones that served as steps (5 on plan) have been found as well on the path leading from the lower to the upper basin.

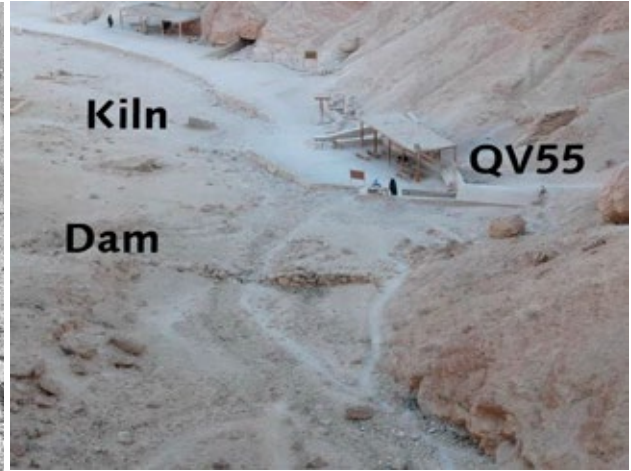
View from upstream side of Dam within context of drainage channel and in relation to QV 55, the adjacent visitor path, and the kiln.

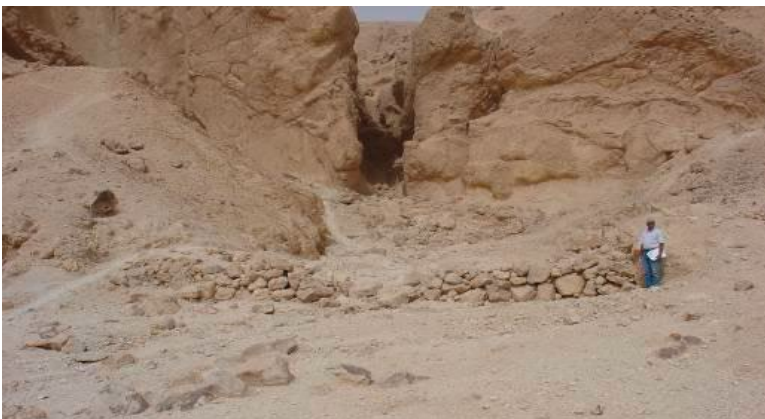
Dam looking from the downstream side, with the opening to the Grotto Cascade in the background.

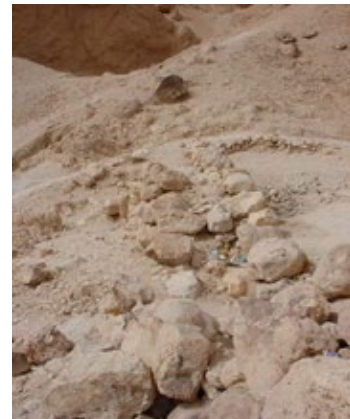
Dam from a lateral view.

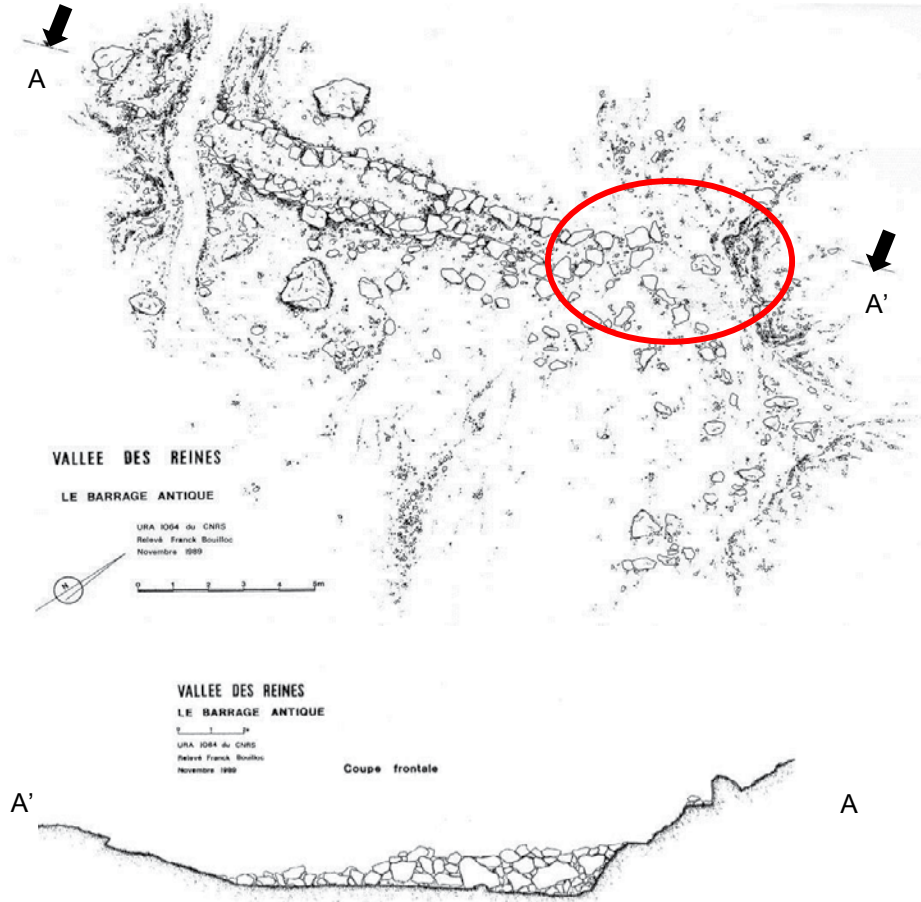
Plan (left) and section (below) of the Dam from 1989, showing the area of missing stones (circled) near eastern end. (Plan and section: CNRS)

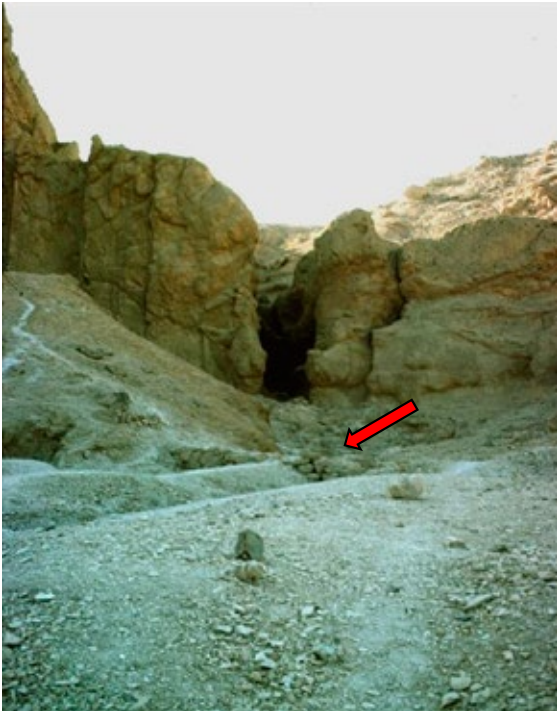
1987 view of Dam (indicated by arrow) before clearance of debris on its downstream side (Image: CNRS).

Comparison of CNRS photographs from the late 1980s with current conditions shows that extensive debris was removed from around the Dam in the late 1980s, particularly from its east (downstream) side. Although removal of the debris exposed the entire structure to investigation and made it more visible from the visitor trail, these changes have also made the Dam more susceptible to disturbance by flood. Leblanc has stated (2007 pers. comm.) that the Dam was largely disrupted during the November 1994 flood and that the CNRS-SCA mission afterward reassembled affected parts of it to its prior state.

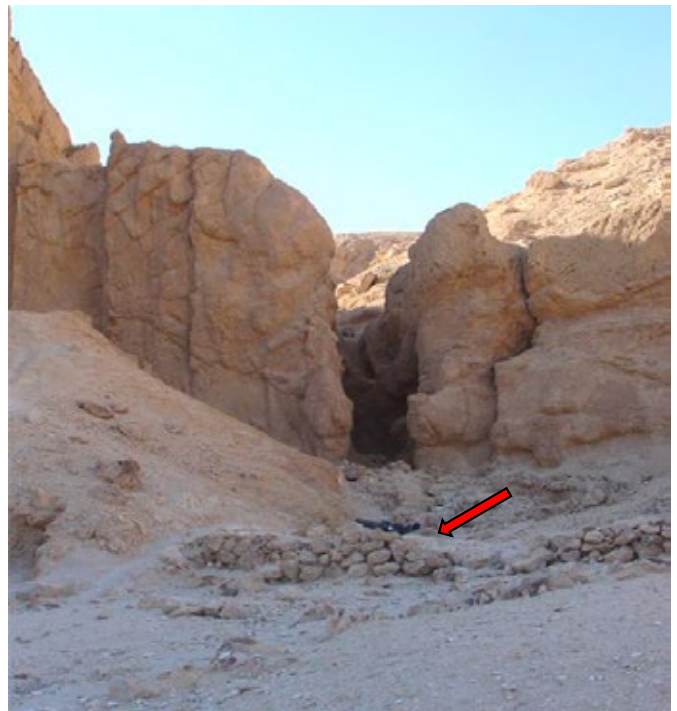
2008 view showing Dam (indicated by arrow) after debris clearance.

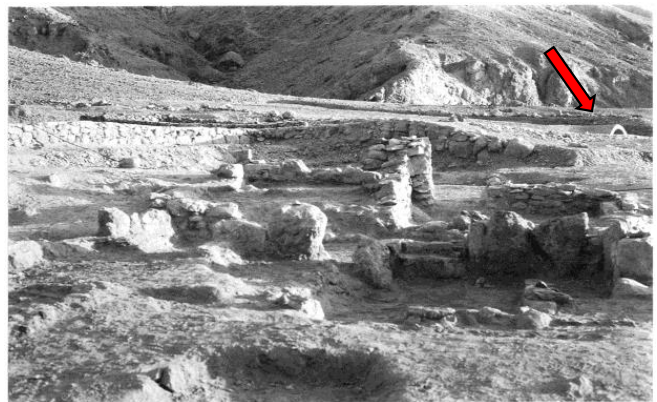
Two views from the late 1980s of the site of the Tomb Workers' Structures following excavation by the Franco-Egyptian mission (Images: CNRS). The photo to the left is a view of the area of Houses 1 and 2 from the southwest, behind QV 58 at the bottom right. The photo to the right from 1985 is of the remains of House 1 from the west, with QV 66 in the background indicated by the arrow.

The structures' appearance immediately after excavation is recorded in the CNRS photographs and plans that follow. Their remnants as excavated consisted of little more than rubble foundations and partially intact wall bases built of dry-laid limestone, with some extant earthen plaster on both interior and exterior sides. CNRS has identified two of the structures as House 1 and House 2 (Kalos 1990, 32). House 1 is located between the entrances to QV 57 and QV 58, and just south of what has been identified as an ancient path through QV. House 2 is located just upslope (north) from the entrance to QV 57. The complex included other similar structures, particularly to the east of House 1, designated by CNRS as the East Sector.

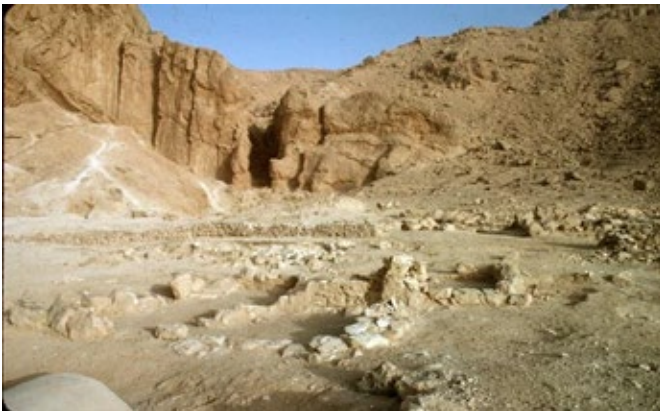
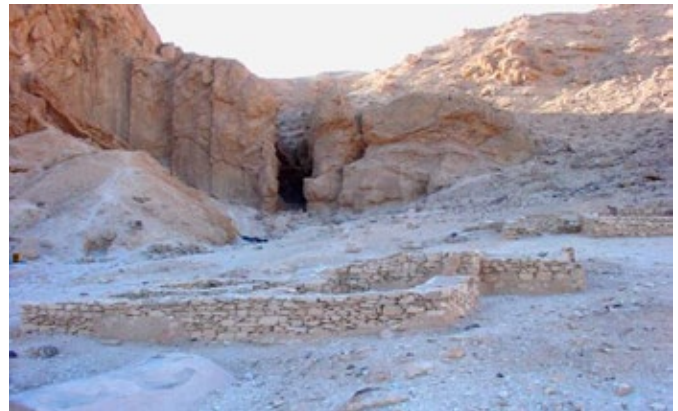
Comparison of House 1, from the southeast, following excavation in 1987 (left, Image: CNRS) and in 2008, after restoration by CNRS (right). The barrel arch over the entrance to QV 58 is at the bottom left of both images.

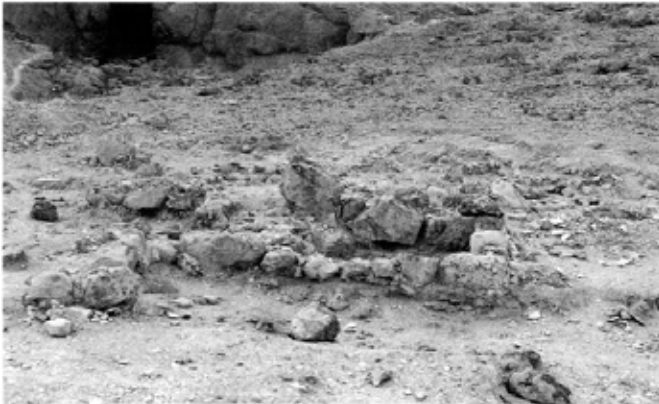
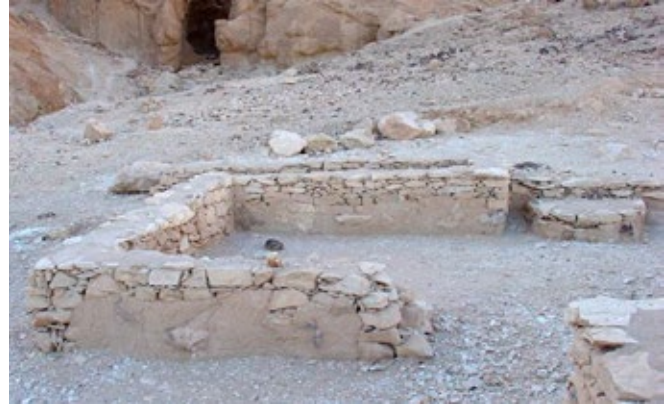
Comparison of northwestern part of House 2, from the southeast, in 1985 following excavation (left, Image: CNRS) and in 2008 (right).
