Valley of the Queens Assessment Report

Volume 1 Conservation and Management Planning

A collaborative project of the Getty Conservation Institute
and the Supreme Council of Antiquities, Egypt

August 2012

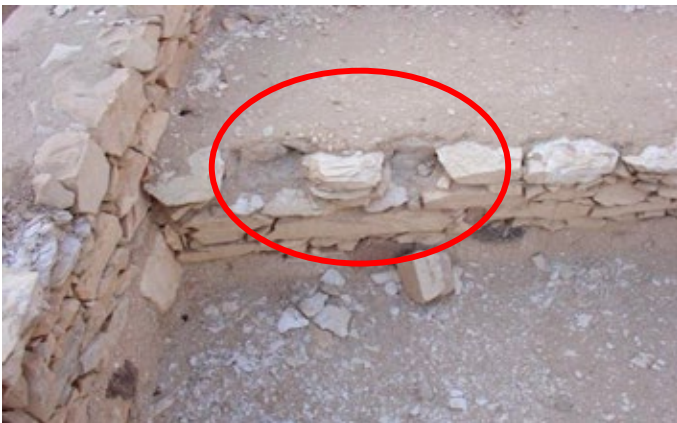
Damage to House 2 where limestone blocks have been displaced from the mortar in which they had been imbedded through CNRS restoration work in the late 1980s.

- **Stabilize walls:** Some of the reconstructed walls have loose stones, which should be stabilized with mortar.
- **Protect from visitor impacts:** If visitor circulation is routed nearby, create unobtrusive barriers to prevent visitors from being able to stand or sit on the structures. SCA inspectors and guardians should prevent visitors or other individuals from standing or sitting on the structures.
- **Protect from flood:** The primary means for protecting the structures from flood will be through constructing a flood diversion wall on the upslope side of the structures to divert water runoff to the main drainage channel.

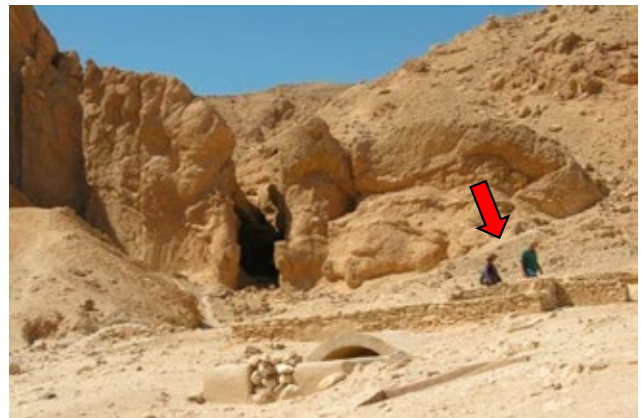
Tourists (arrow) who have left the authorized visitor path and are walking through the area of the Tomb Workers' Structures.

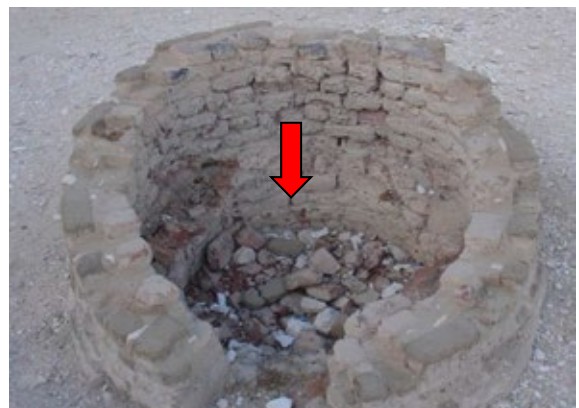
Kiln in 2008. Note bricks that have fallen within the Kiln's interior (arrow).

The Kiln is generally stable. However, several bricks that once formed part of it have fallen within the structure, and two additional bricks were found just outside it; a few loose bricks also rest on top of its wall, and many loose fragments of brick are present in the interior face (some of these loose or fallen bricks may be from the restoration). A few of the lowest course of bricks on the southern, lower side of the structure are undercut. Cracks are present, presumably due to shrinkage, between the mudbricks and the re-pointing mortar. The low masonry wall just below the Kiln also appears stable.

- **Protect from flood:** To protect the Kiln from flood, it is recommended to relocate it further away from the base of the wadi on higher ground nearby. If the Kiln is moved as a structure then it should be stabilized with mortar repairs beforehand. If it is moved brick by brick then prior stabilization is not required, and fallen bricks and fragments can be replaced after the structure is moved.
- **Monitoring and maintenance:** The condition of the Kiln should be monitored regularly and loose bricks should be stabilized and fallen bricks re-instated in their original location.

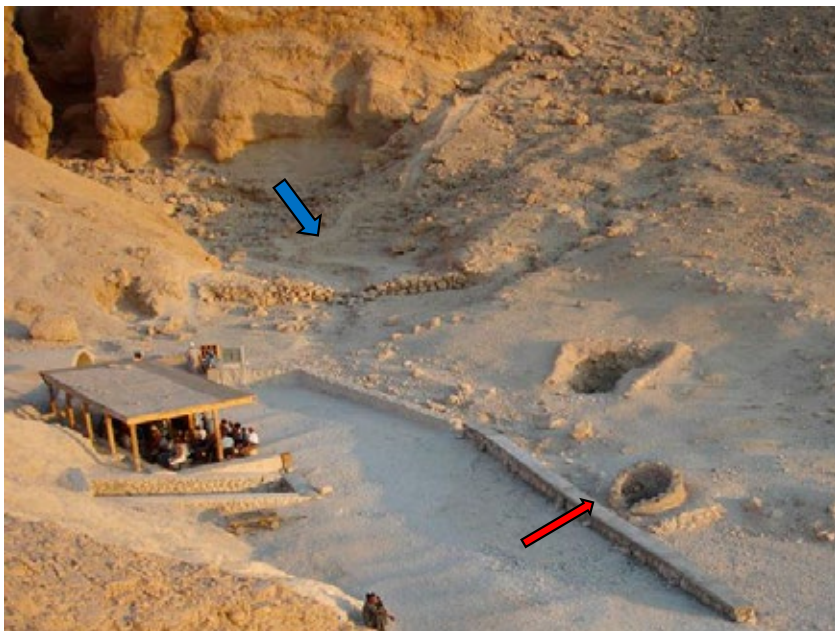
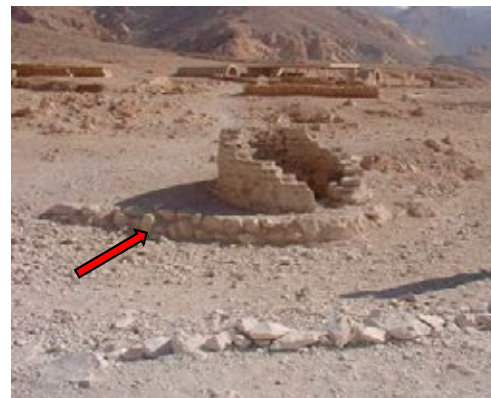
Kiln and stabilized ancient masonry wall (arrow) below it as seen from the visitor trail.

The location of the Kiln (red arrow) within the main QV drainage channel, with the direction of flow coming from the Valley of the Grand Cascade indicated by the blue arrow.

- An potential threat to the survival of the Kiln is flash flooding. It is located in the direct path of drainage from a rainfall catchment area exceeding 19 hectares. It impedes floodwater flow in the main wadi and would likely be destroyed or else severely damaged by a large-scale flood event. This threat is compounded by the construction in 2007 by the SCA of a low wall along the visitor trail next to the Kiln, which will further constrict the flow of drainage around the Kiln.

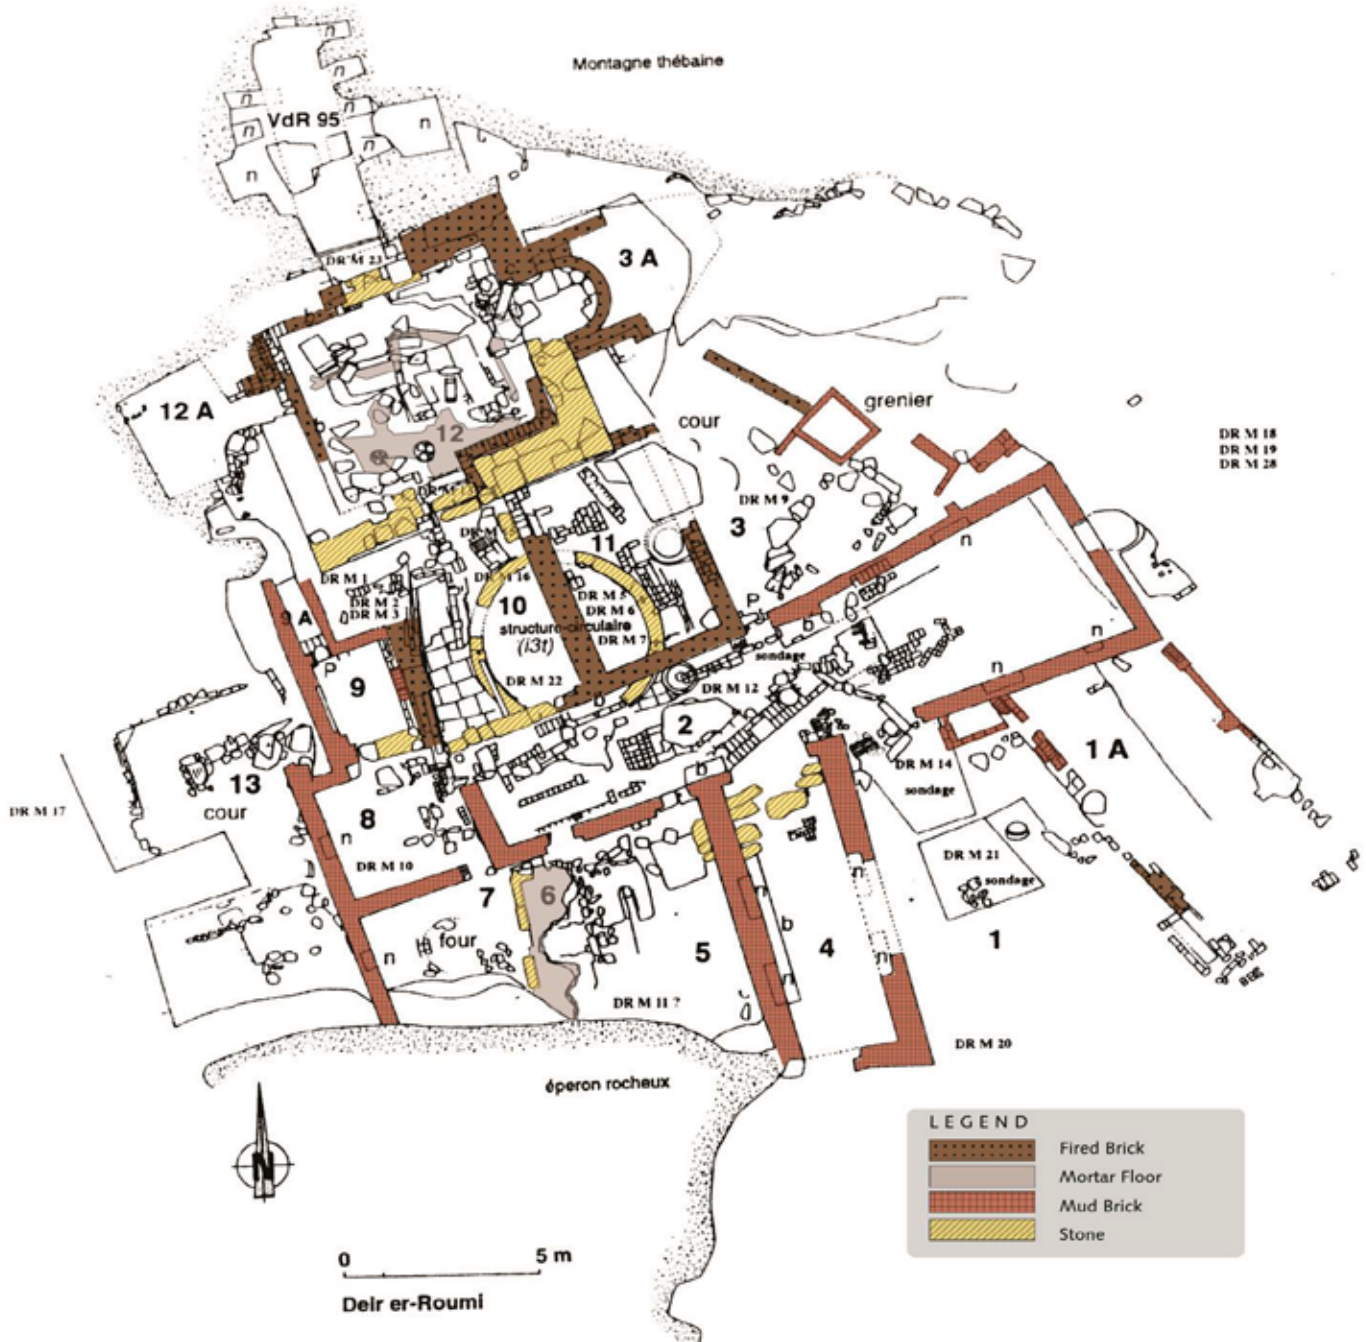
Indication of primary building materials of walls and other architectural features [plan from Augé and Lecuyot 1998, 108, adapted by GCI for condition assessment]. (Base plan: CNRS)

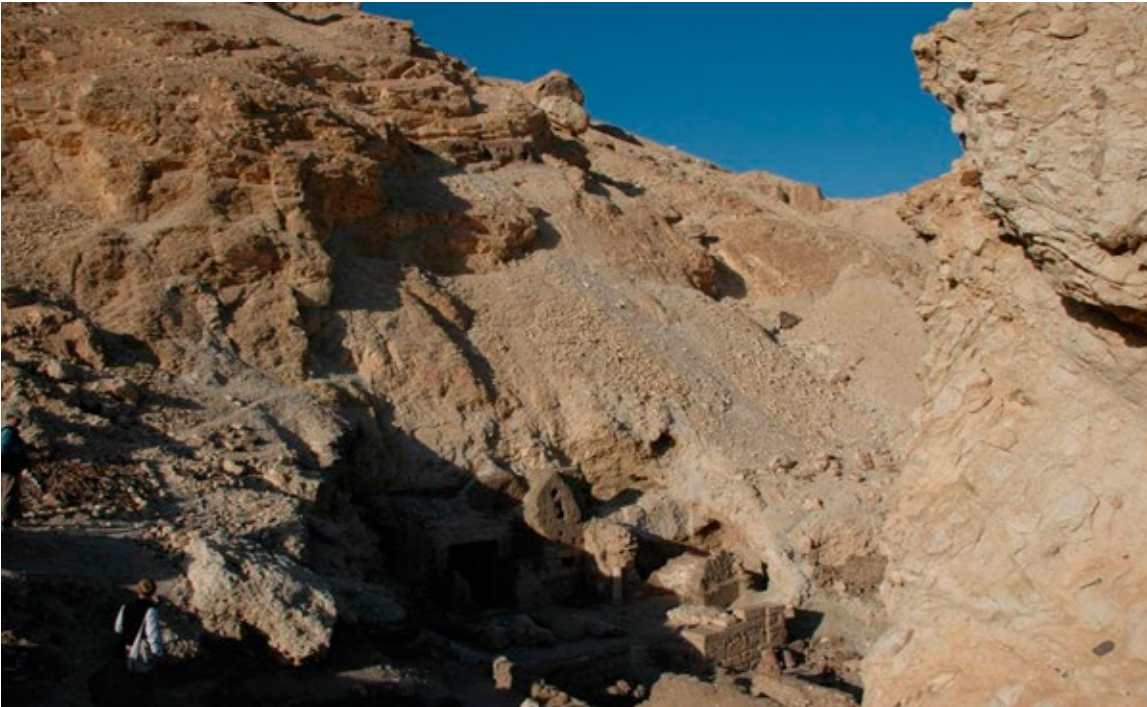
Hill slope to the north of Deir er-Rumi, which puts the site at risk of further deterioration from water runoff and rock fall.

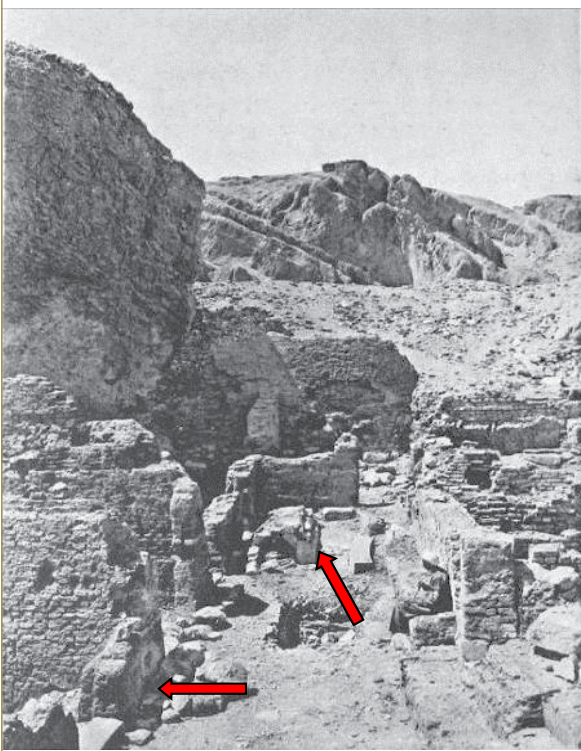
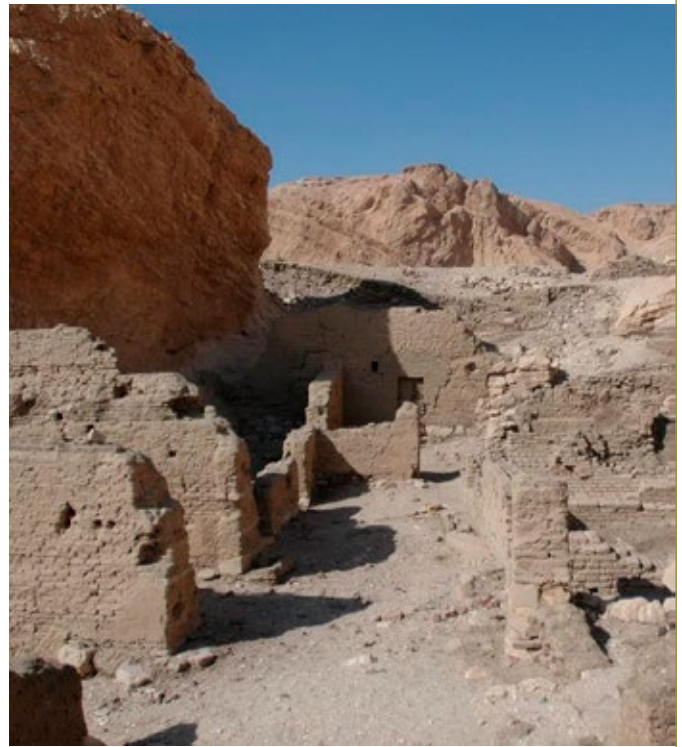
Comparison of conditions between the time of the Schiaparelli mission work (ca. 1906) (Image: Schiaparelli 1923) and 2007, view from the east end of the vestibule toward the west, generally shows standing structures remaining intact and localized significant areas of loss (arrows).

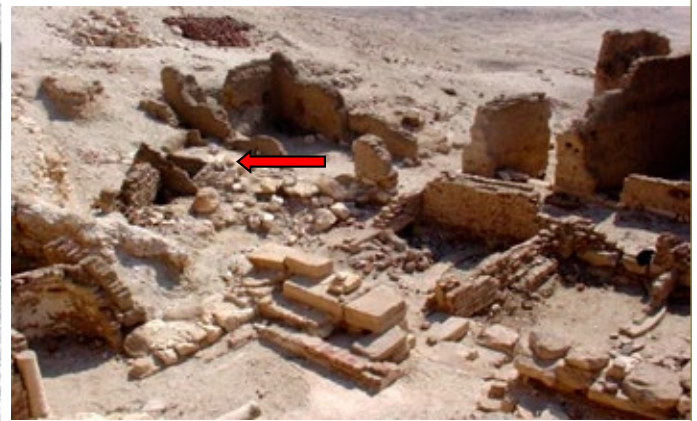
Granary (3): Remains of the granary storage receptacle are in fragile condition due to the decay of their earthen materials, and susceptible to damage from rock fall and water runoff from the hill slope to the north; most of the upper south side has been lost since 1988 (based on comparison with photo by Lecuyot that follows); a section of the fired brick top of the wall protruding to the northwest from the granary has been lost since February 2005; this loss appears to have been caused by rock fall, as a few large rocks are lying immediately to either side of the loss.

Comparison of conditions between 1988 (left, Image: CNRS) and 2008 showing the extent to which CNRS cleared the site of loose materials, and significant loss to the mudbrick granary (arrows).

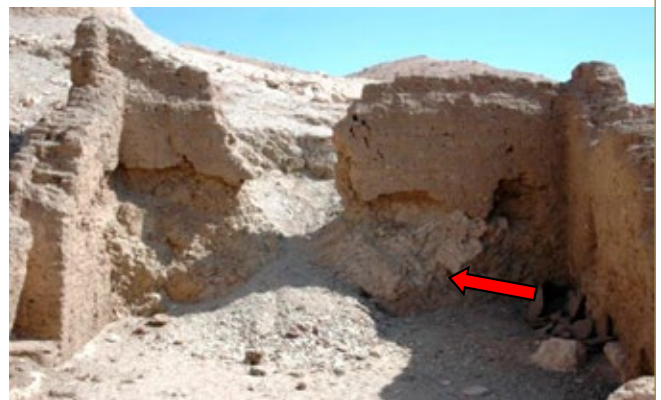
Vestibule (2): A large gap in the east wall appears to be at a location where water runoff may enter from the hill slope to north. Shale bedrock under this east wall has eroded significantly since 1995, leading to loss of support and causing structural cracks to appear in the remaining mudbrick wall to both sides of this gap. One mudbrick section of the north wall (directly south of room 3) is leaning inward, apparently due to the lateral pressure caused by the soil present at a higher level against the outside of the wall. One section of the south wall has been incised with Arabic graffiti (north of room 5). This space's far western wall has lost original material at its base. This area of loss has been filled with dry-laid fired bricks.

Comparison of 1995 view of east wall of vestibule (left, Image: CEDAE 95) and 2007 view demonstrating loss of sediment supporting mudbrick walls, which exhibit cracking.

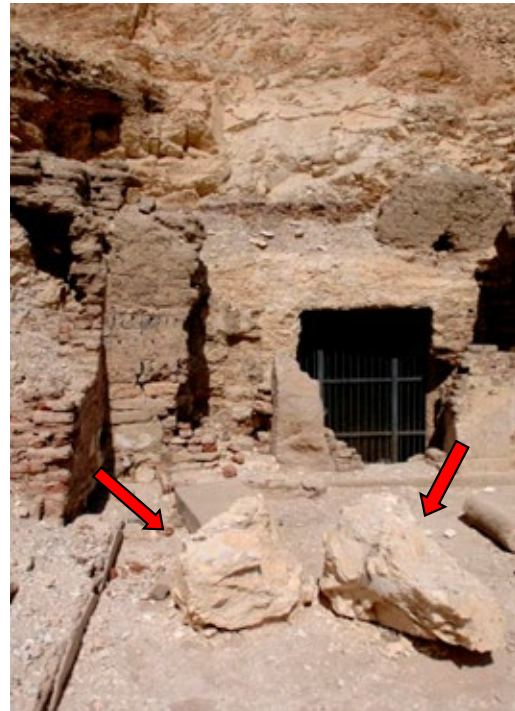
- **Rock fall:** Since 1995 CEDAE photography, two rock boulders (present today) have fallen onto the church floor (west side) from the hill slope to north, likely causing damage. A section of the fired brick top of the wall protruding from the granary to the northwest has been lost since February 2005; this loss also appears to have been caused by rock fall, as a few large rocks lie immediately to either side of the loss. The slope above is extensively covered with rock debris, including a large boulder on the slope to the northeast above the site, which continues to put the site at risk of further damage.

Boulders (right) that have fallen on the church floor since June 1995 (left, Image: CEDAE 95).

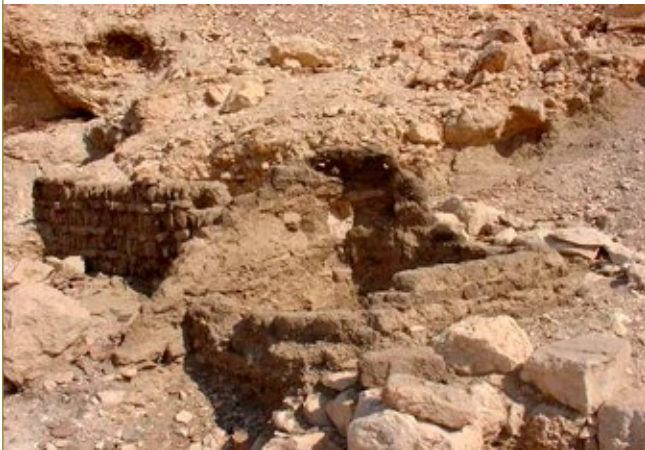
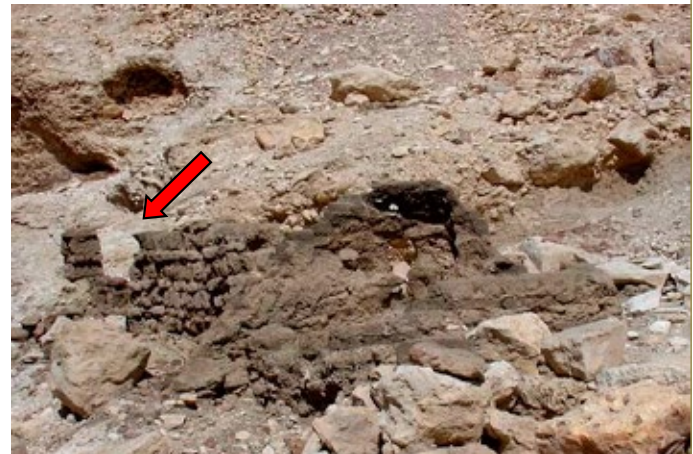
Comparison of March 2006 (left) and February 2008 (right) views of the granary showing loss of section of fired brick wall projecting to northwest, apparently due to rock fall.

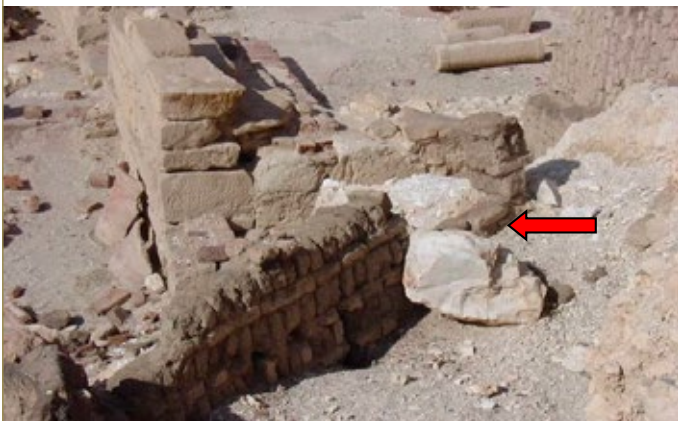
February 2008 image showing large rock leaning against lost wall section of granary.

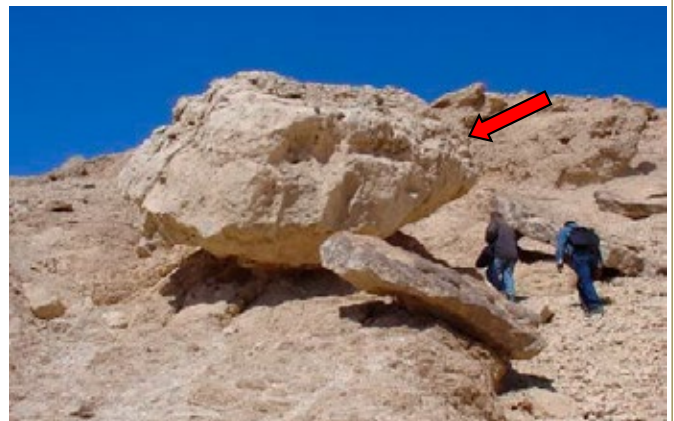
Massive boulder on slope above Deir er-Rumi that threatens the fragile ruins.

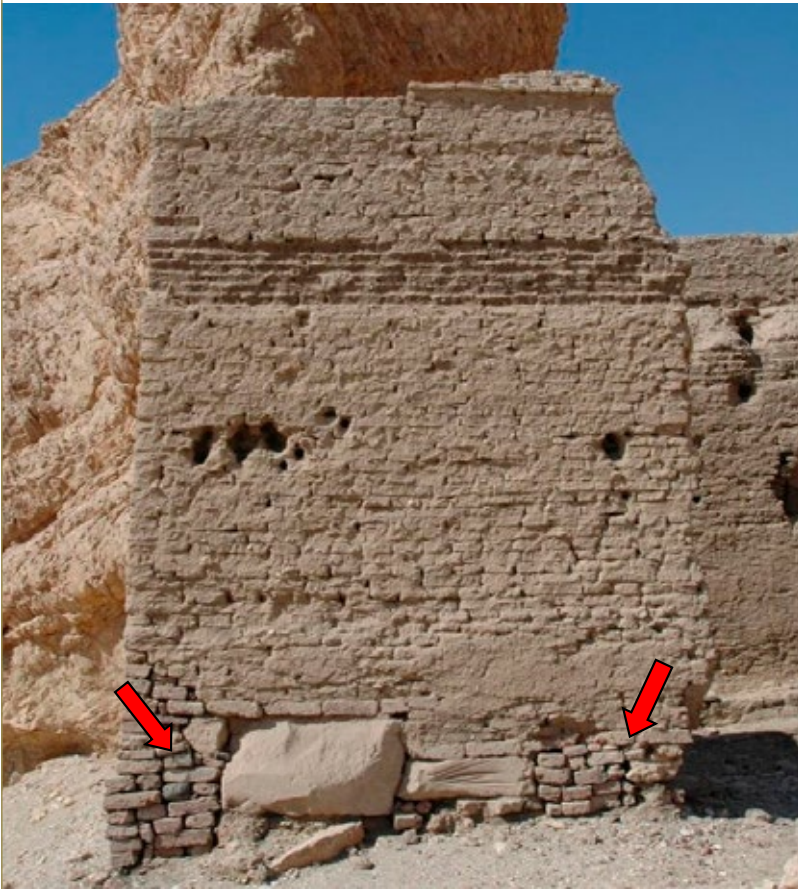
Example of infill of lost foundation stones at wall base with loose fired bricks.

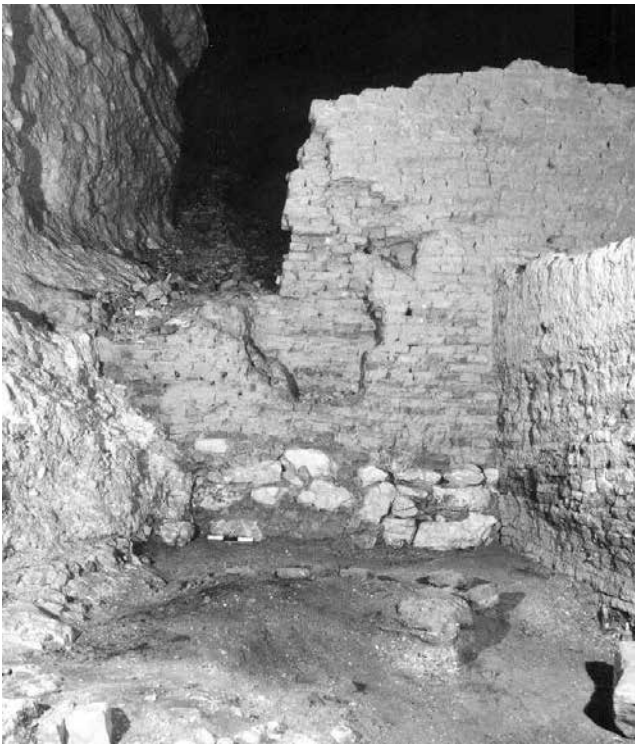
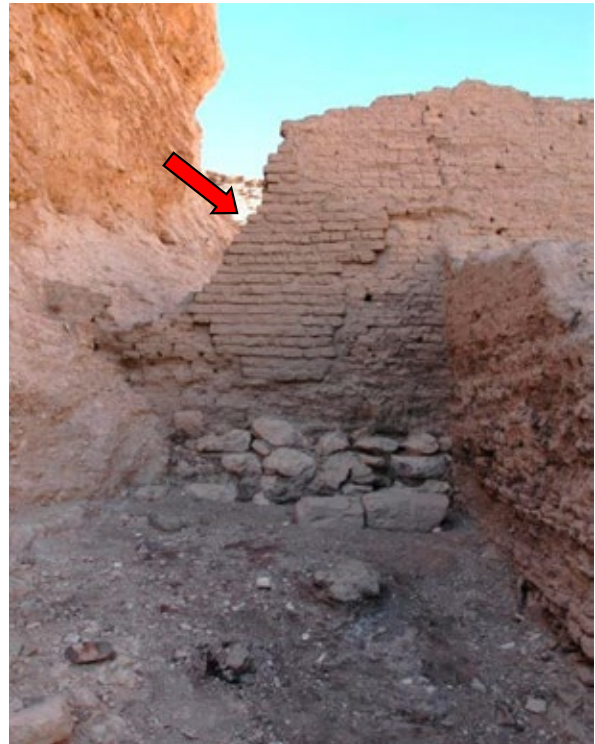
Area of modern mudbrick infill (right) since June 1995 (left, Image: CEDAE 95) on the west wall of room 7. The repair material (arrow) is harder than the original material.

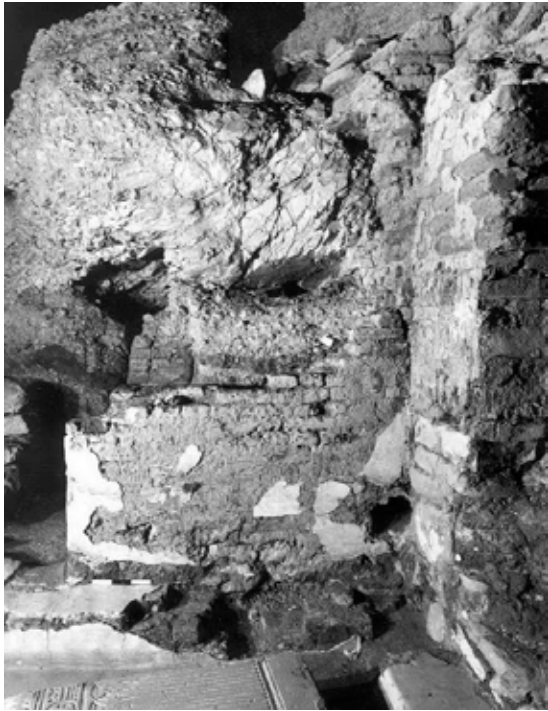
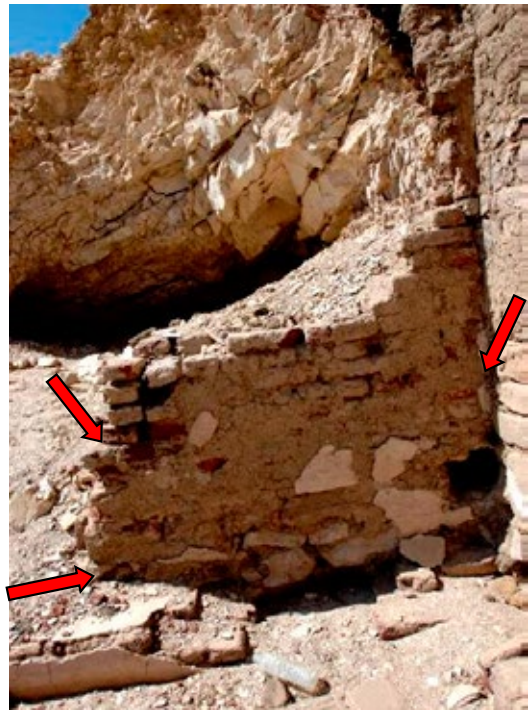
Church (12): Fragments of undecorated white plaster remain on the church walls. They are generally in a fragile condition. On the west wall, a few large areas have been lost since 1995 (note CEDAE photo 32320), and one area of plaster is now partially detached and at high risk of loss. A small area of plaster loss on the east wall adjacent to the apse has occurred since 1995 (see CEDAE photo 32325), as has substantial areas of loss inside the apse (see CEDAE photo 32326), with remaining plaster in areas cracked and partially detached from the wall. Areas of the north wall west of the entrance to QV 95 contain red, and to a lesser extent yellow, pigments.

Comparison of 1995 (left, Image: CEDAE 95) to 2007 (right) of west wall of church, showing loss of large fragments of wall plaster in two areas. Some of the remaining fragments are partially detached and at risk of loss. The stratigraphic material in the annex above and to the rear of the wall apparently eroded due to rainfall drainage.

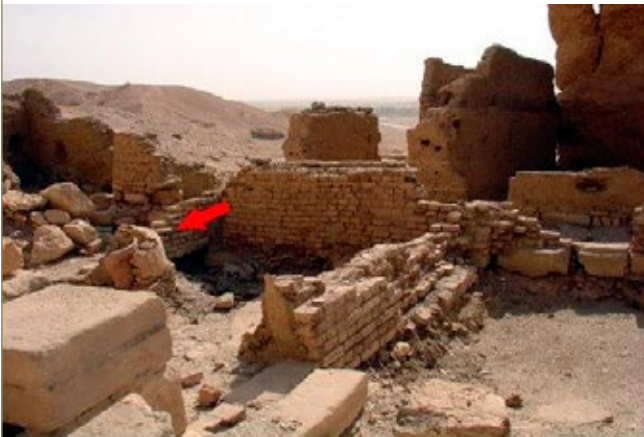
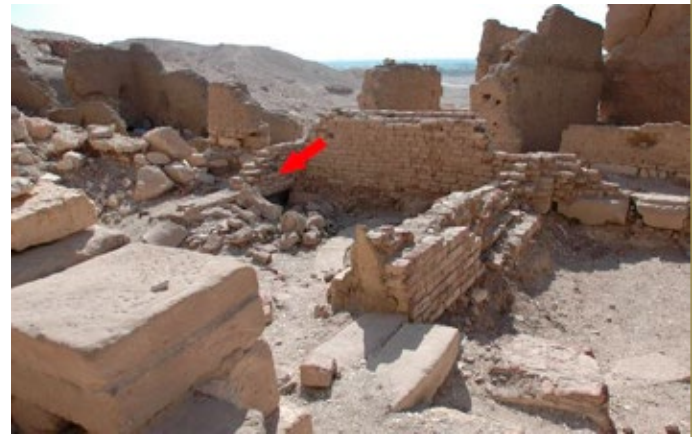
Comparison of February 2005 view of baptismal font partially intact (left) and in February 2007 destroyed, presumably by vandalism.

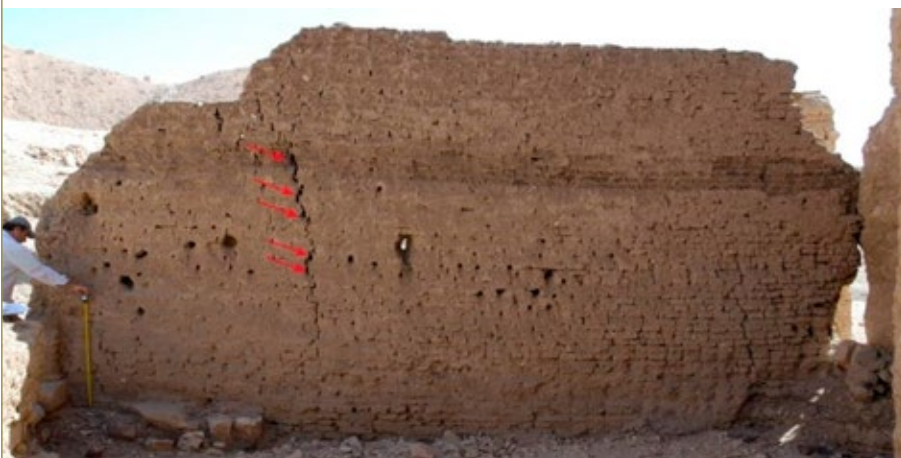
The vertical crack (indicated by arrows) running through the westerly wall of the arcaded hall (4).

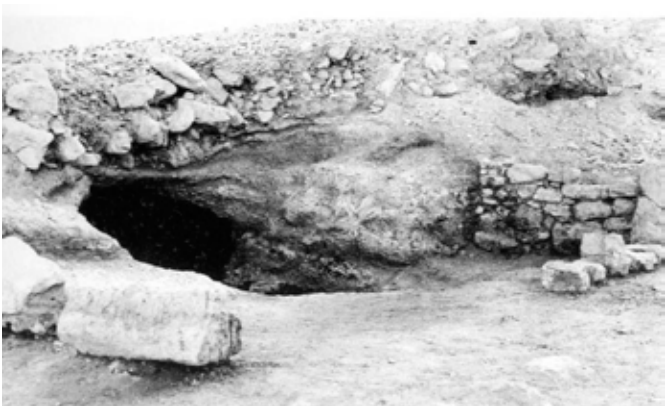
QV 1 viewed from the northwest after its excavation in 1985 showing a low masonry wall at the west side of its entrance. (Image: CNRS)

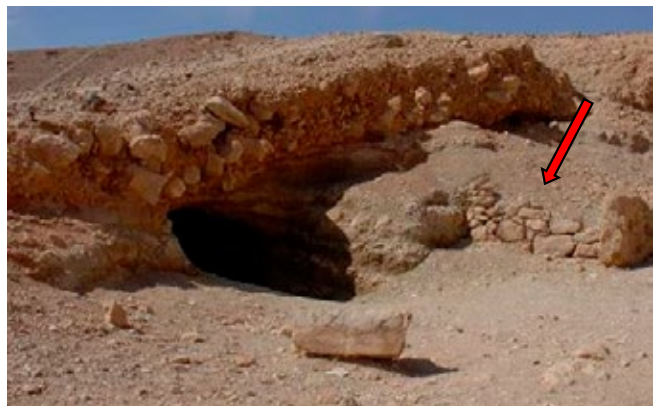
A similar view of QV 1 in 2006 showing loss of stones in the upper part of the masonry wall (indicated by arrow) and around the shelter's opening.

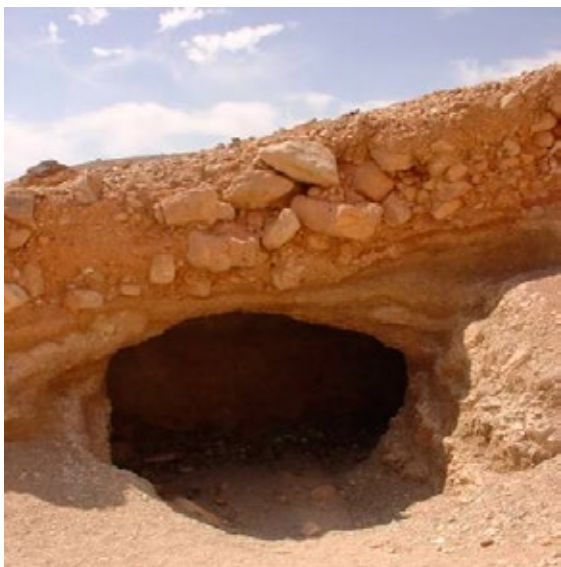
QV 1 entrance in 2006, with stone steps evident in 1985 image no longer visible.

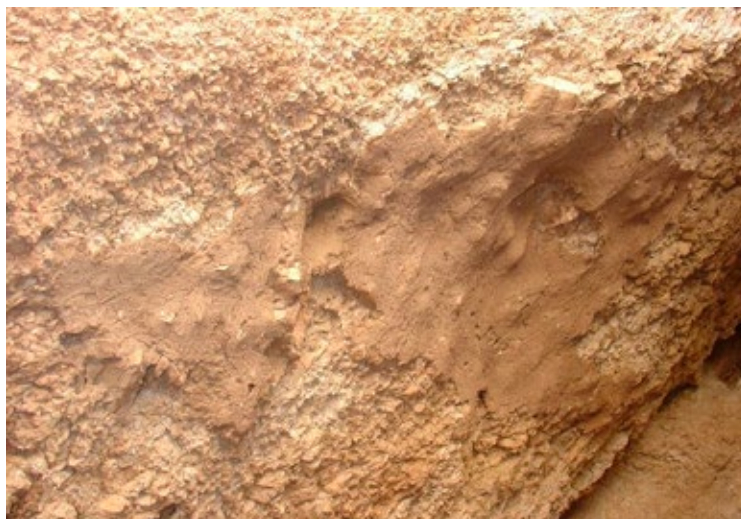
Earthen plaster within QV 1.

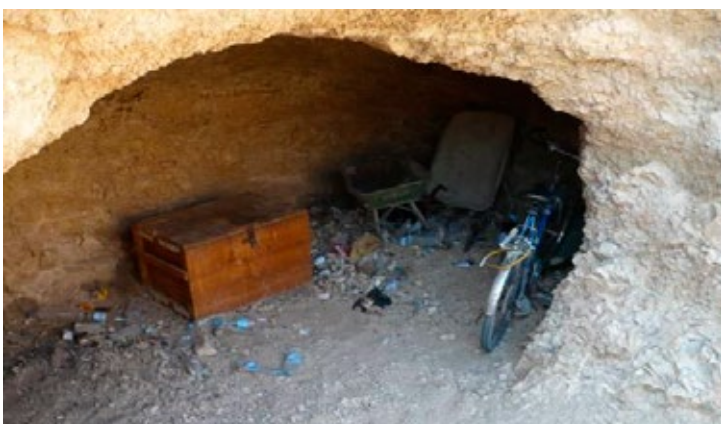
- QV 1 has been observed to be occasionally used by site personnel for the temporary storage of bicycles and work materials, including wheel barrows, and also to be where trash is dumped. These activities put the site, and particularly its fragile plaster, at risk of damage and loss.
- Overhanging boulders are susceptible to collapse due to rainwater erosion.

Use of QV 1 in 2007 by site personnel for the temporary storage of bicycles and work materials.

- QV 1 should not be visited by tourists. It should also not be used by site personnel for storage or for dumping trash.
- Convey the significance of QV 1 to site personnel and stress the importance of not using it.

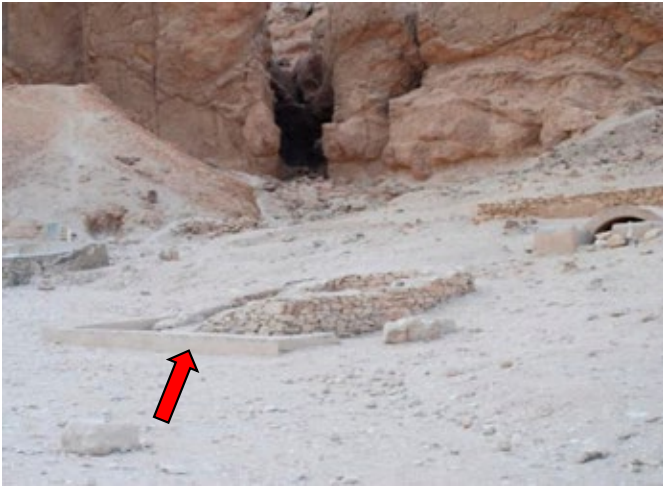
2009 view of Structure II from the southwest, with low masonry wall (arrow) constructed by CNRS to protect it from flood waters flowing through the main drainage channel.

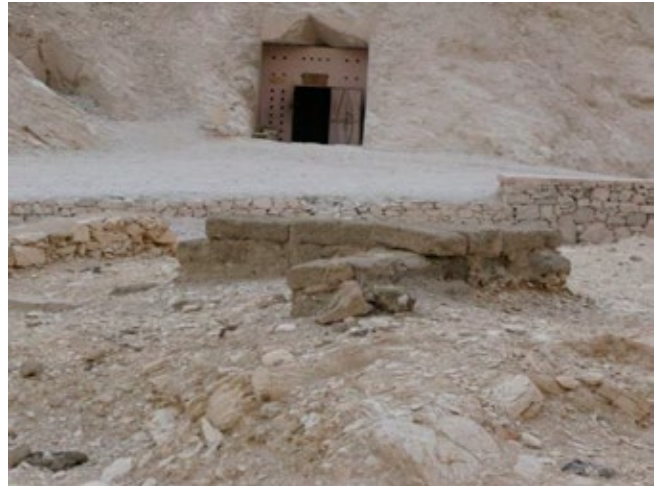
2009 view of Structure III viewed from the northeast.

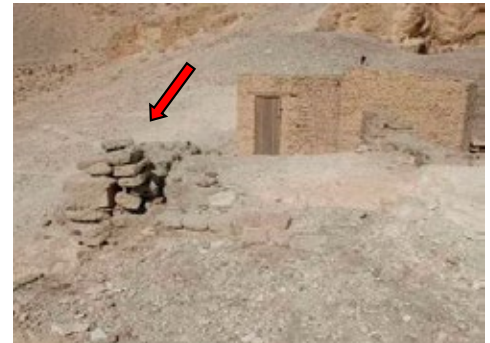
Remnants of a mudbrick structure shown in the early 20th century photo, located on the rocky spur to the south of the building.

- fill hole in roof;
- replace cracked beam supporting roof over southeast room;
- replace missing wooden lintels above interior doorways;
- the granite, Ramesside-period archaeological materials located to the east of the building should be properly stored elsewhere; and
- the remains of the structure to the south of the Italian mission building should be stabilized or reburied.

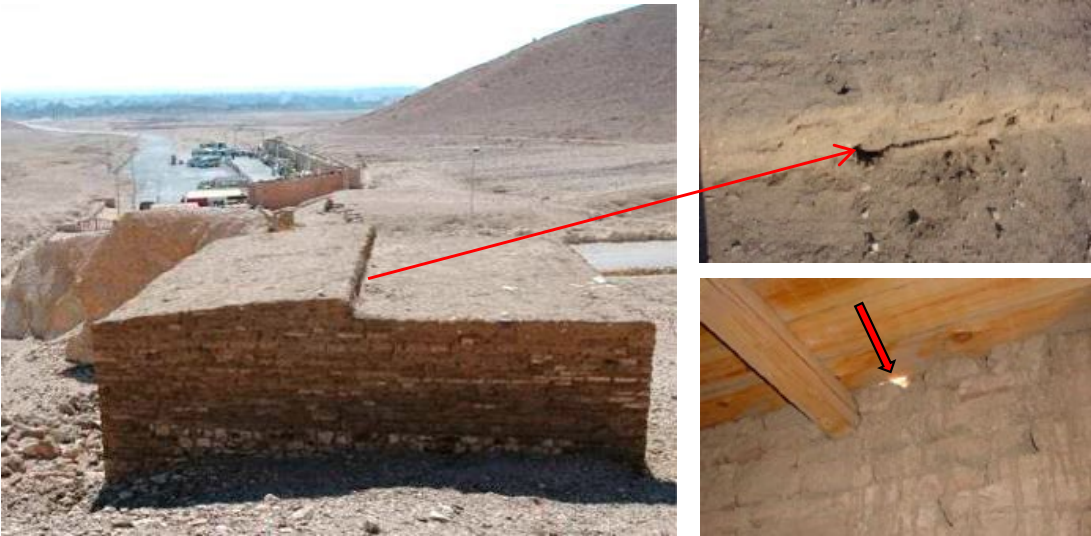
Left: North elevation with site entrance and parking area in background. Upper right: Detail of the hole in the building's roof at the juncture between the two levels. Lower right: Interior view of the hole in roof (arrow), with mud drip lines below providing evidence of water infiltration.

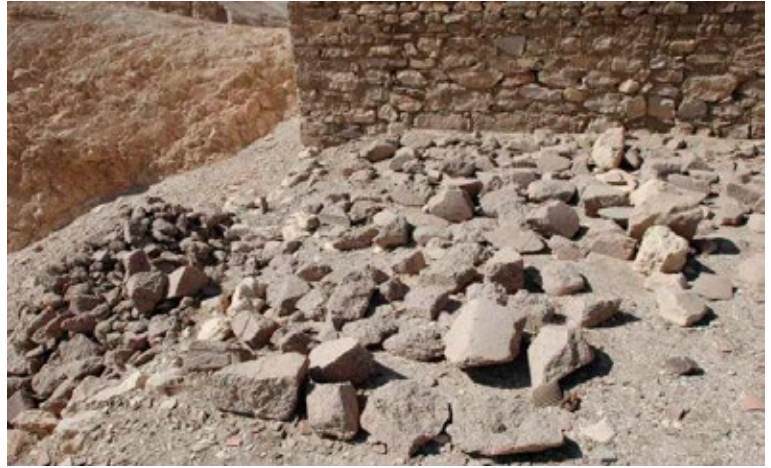
Granite fragments from the Ramesside period scattered on ground on the east side of the building.

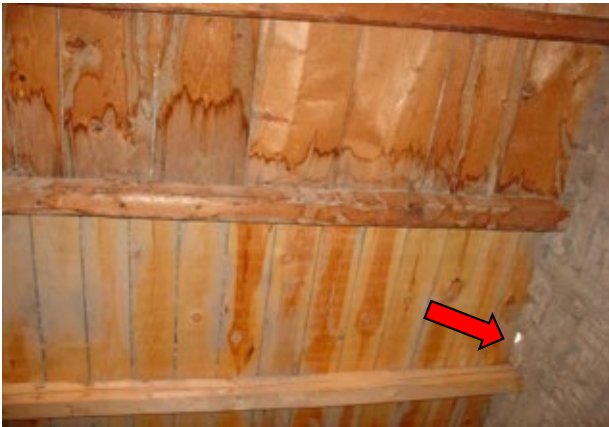
Interior view of water stains on the wooden ceiling adjacent to the hole in the roof (arrow).

- a relatively small hole in the roof at the juncture of its split level, with evidence of water infiltration in the form of drip marks down the wall below the hole and water staining of adjacent wooden ceiling planks;
- the roof sags over the southeast room due to the beam supporting the roof in this area being cracked in its middle;
- missing wooden lintels above interior doorways, which were apparently removed, causing some loss of bricks above;
- parts of the west wall of the remains of the structure on the rocky spur to the south of the kitchen consist of stacked mud bricks that appear unstable.

- The leaking roof has so far caused only minor damage but this problem will worsen if not repaired, as rainwater infiltration will eventually endanger the building's structural integrity as well as the archaeological materials contained in it;
- Cracked beam in southeast room could threaten the roof's stability;
- Loss of interior doorway lintels threatens collapse of bricks above;
- The granite, Ramesside-period archaeological materials located to the east of the building are at risk of theft.

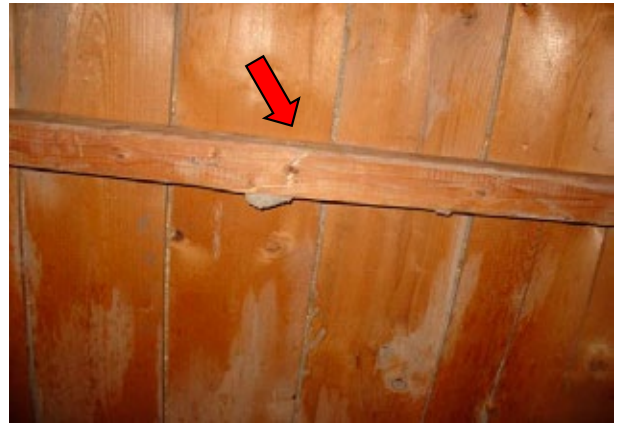
Crack in the middle of the beam supporting the roof in the southeast room. The roof sags in this area.

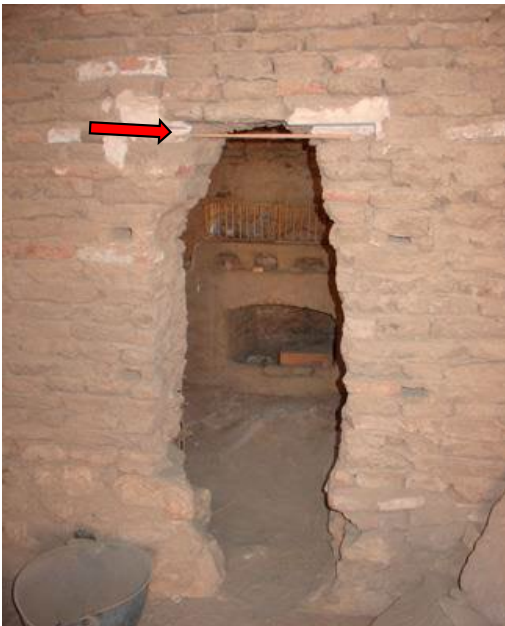
View of missing lintel (arrow) in doorway between the northeast room and the west room.

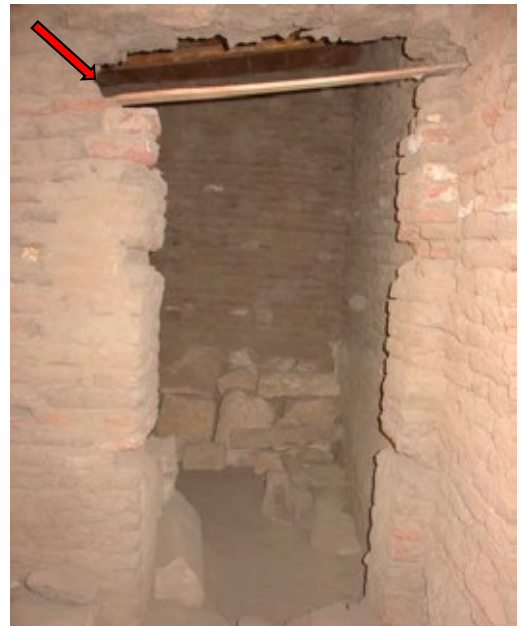
View of missing lintel (arrow) and bricks above it in doorway between the northwest and northeast rooms.

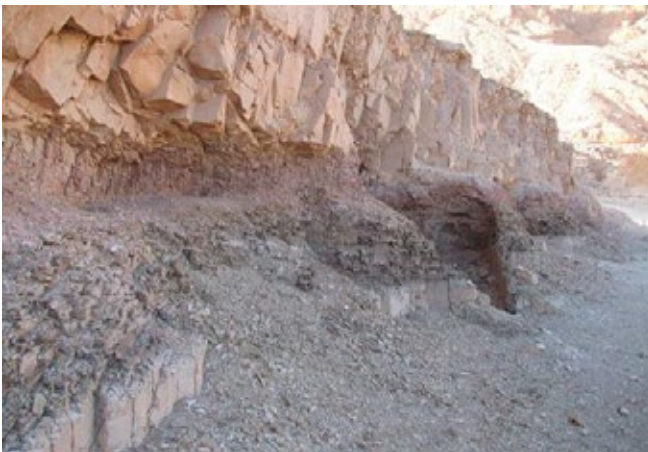
North-facing view of geologic context showing dark, friable shale overlain by fractured marl.

Most of the shelter cavities are in poor condition due to extensive loss of surrounding structural rock, as the shelters were dug into a hill slope that is in an ongoing state of erosion. The shelters were cut into a weak and friable shale layer, which is overlain by a highly fractured marl layer. The aggressive erosion of the hill slope is evidenced by extensive shale and marl talus strewn on the terrace and down the slope below, much of which was not visible in the 1980s CNRS photos.

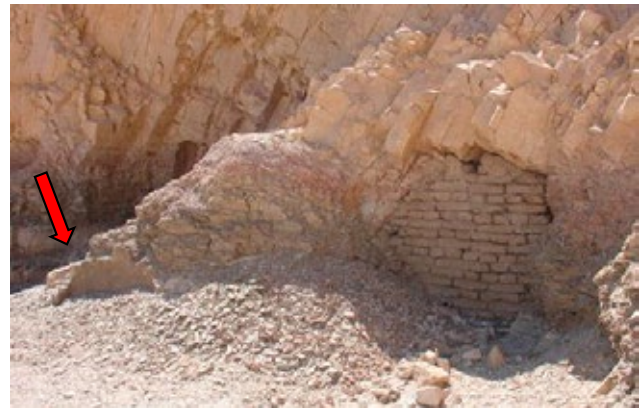
Hermit Shelter 2. View of the blocked, north entrance at the time of the assessment (2006), with mud plaster remains (arrow) largely covered by talus debris.

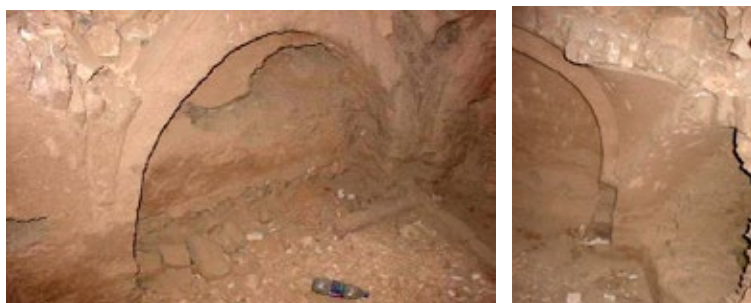
Hermit Shelter 2. Interior view (2007) showing parts of three of four remaining mudbrick arches that supported a dome.

The shelter containing the mudbrick arches (2) is in the best condition of all due to it having been dug deepest into the hillslope, and therefore being both more protected from the elements and away from the eroding edge of the slope located along the terrace. Although this cavity could not be entered for inspection due to the modern walls blocking both entrances, it appears from viewing over the top of the wall that the remaining mudbrick arches and mud plaster around them are in stable condition. This cavity has a hole in its roof, which exposes the arches to the elements.

- **Protect arches and plaster in Hermit Shelter 2:** To protect the shelter containing mudbrick arches from the elements, dry-laid stones should be stacked on the hilltop over the hole in its roof. Mortar should be applied locally to the fractured rock ceiling to stabilize it and prevent fragments from falling on the mudbrick arches and plaster.
- **Stabilize and protect ancient plasters:** Mud plaster should generally be stabilized with localized mortar repairs, and exterior mud plaster protected through reburial due to the extremely fragile nature of the shale substrate.
- **No visitation but interpretation:** The site should not be actively visited by tourists. A non-intrusive barrier should be considered for placement at the north end of the terrace to let wandering visitors know that the site is off limits. The significance of the site should be interpreted off site.

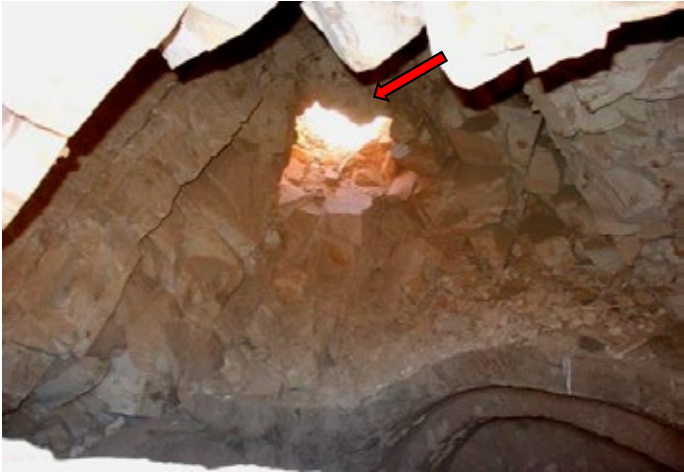
Hermit Shelter 2. Interior view (2006) of hole in the marl rock ceiling (arrow) of shelter 2, with part of mudbrick arch to lower right.

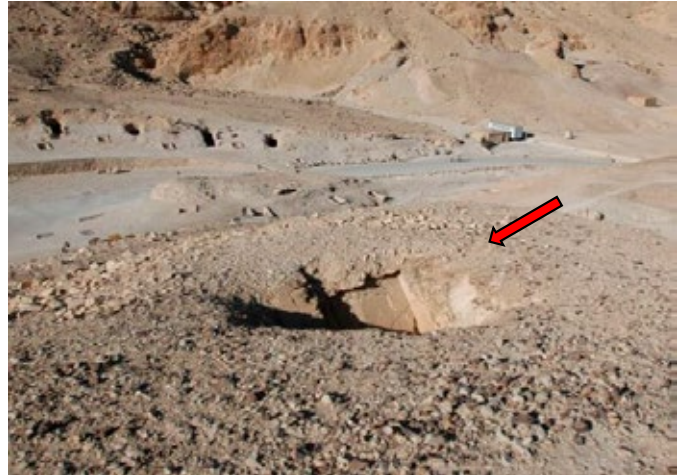
Hermit Shelter 2. Exterior view (2006) of hole in the ceiling (arrow).

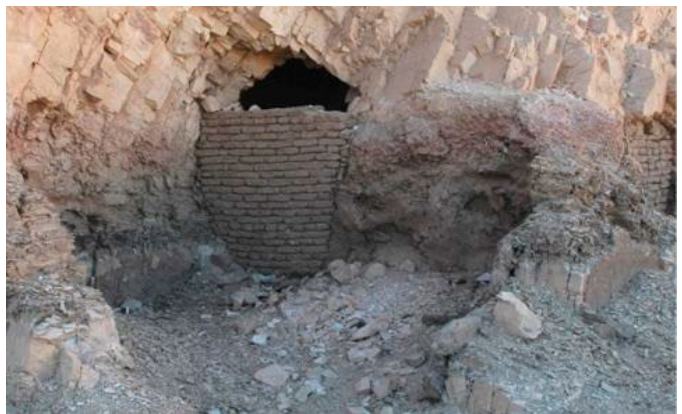
Hermit Shelter 3. View (2007) of shelter at the time of this assessment showing the mudbrick bench and shelter floor covered, and hence protected, by talus debris, and the south entrance to the northerly middle shelter blocked by a modern mudbrick wall.

In the southerly of the middle cavities (3), the mudbrick bench on the north wall is largely buried under shale talus, which helps protect it from erosion. Mud plaster on the wall above the bench is in a fragile condition with areas of severe detachment, and the shale substrate to which it is attached is highly fractured and disaggregating. On the lower east wall next to the bench, the mud plaster attached to the low wall is more intact and in a more stable condition, but on the western wall the shale is very friable and the mud plaster is severely detached and fragments have fallen off. Large pieces of marl have fallen into the shelter from above and some are located on the top of the modern mudbrick wall. On the exterior wall of the cavity, a small area of mud plaster attached to the lower wall appears stable.

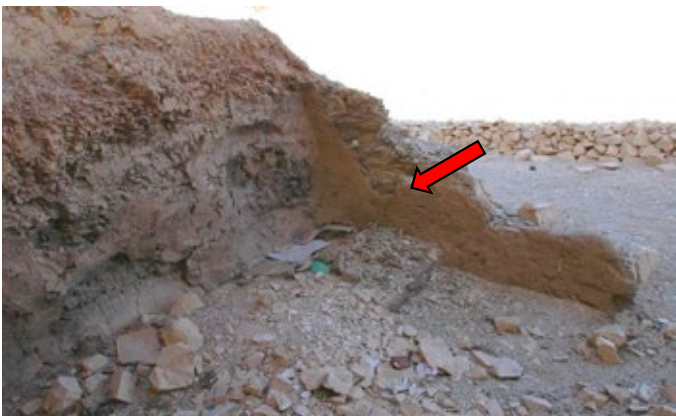
Hermit Shelter 3. View (2007) of shelter showing extant mud plaster attached to vertical surfaces and remnants of a low mudbrick bench, or *mastaba* (arrow).

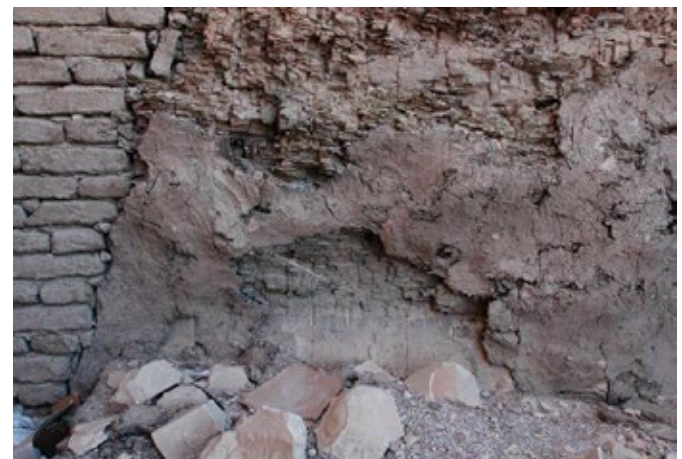
Hermit Shelter 3. Detail view (2007) of exposed mud plaster on the wall of shelter.

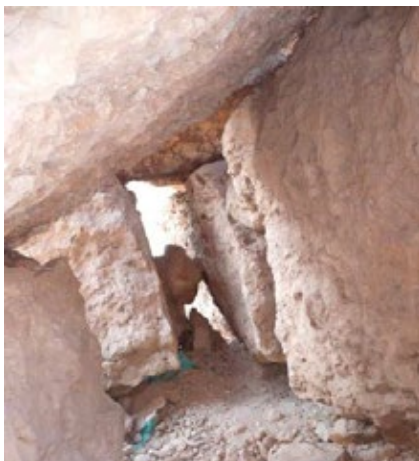
Interior view of the Dolmen, with trash present.

- The only threat noted was the presence of modern trash, which indicates that the Dolmen may have been used as a shelter by local workers or inhabitants.

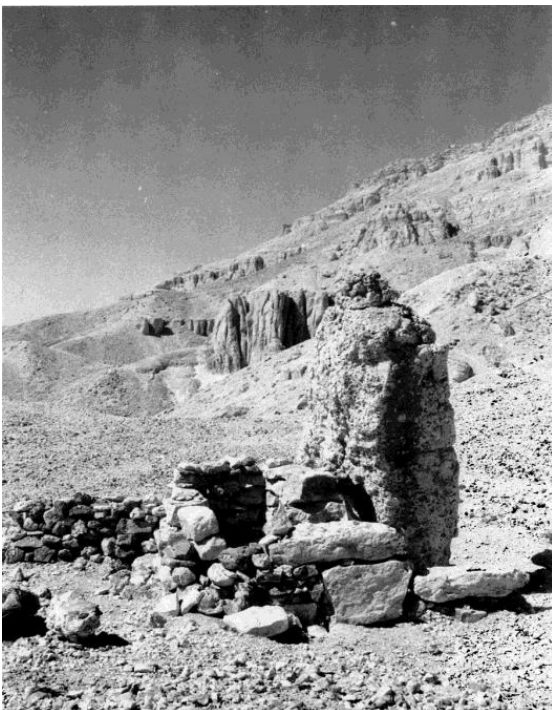
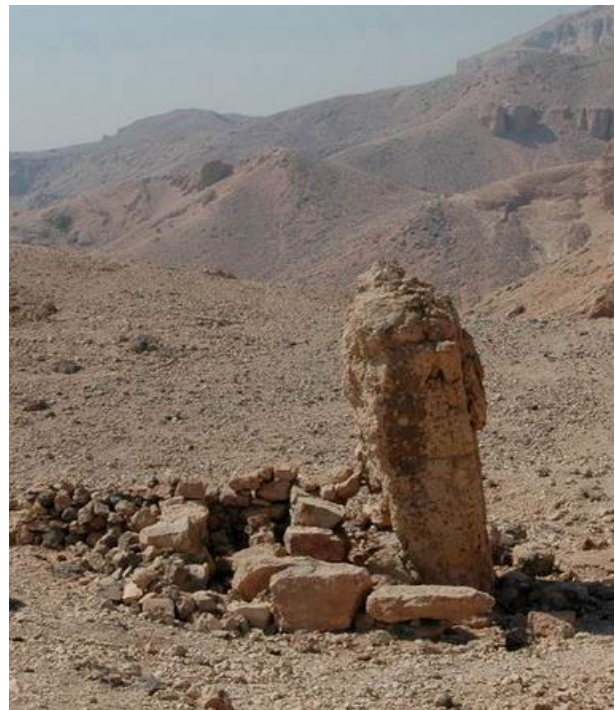
Views of the Menhir from the east in the 1960s (left, Černý, Desroches Noblecourt and Kurz 1969-1970, GMT I/1, pl. LXXXI, CNRS) and in 2007 (right).
