Valley of the Queens Assessment Report

Volume 1 Conservation and Management Planning

A collaborative project of the Getty Conservation Institute
and the Supreme Council of Antiquities, Egypt

August 2012

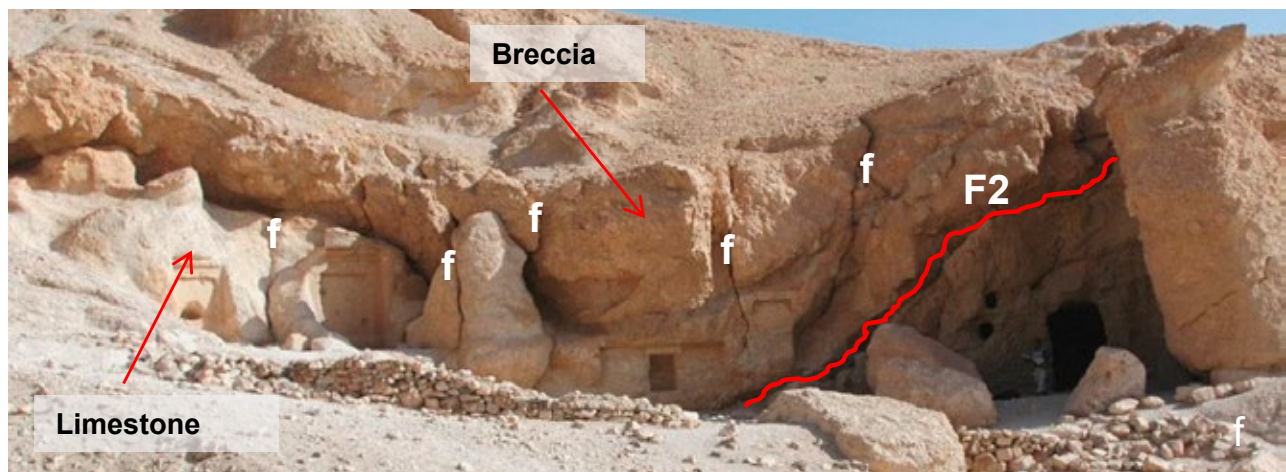
The location of faults (F) and fractures (f) identified by Aubry et al.

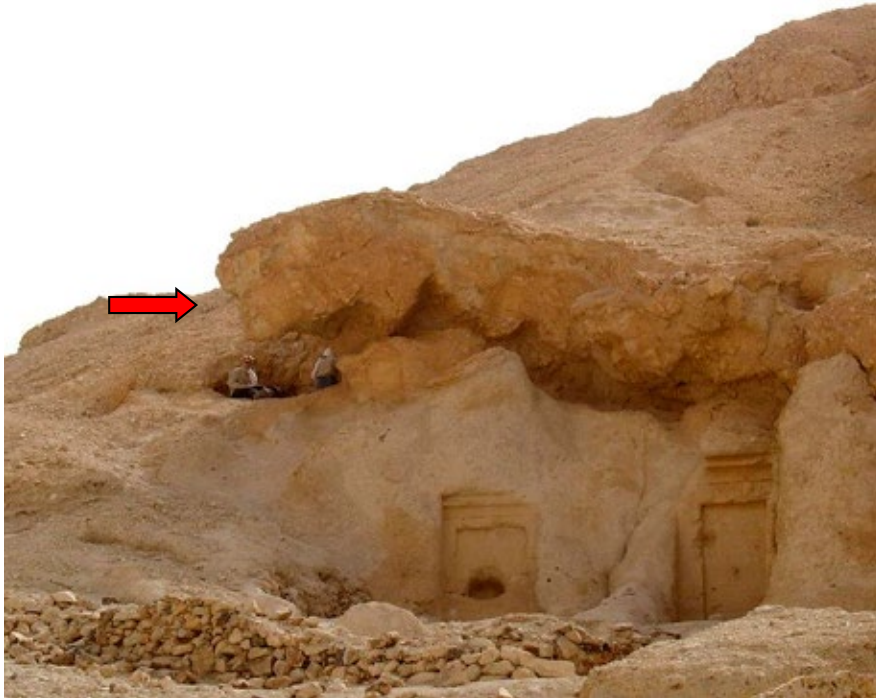
Breccia rock outcrop above chapels A and B undercut by preferential erosion of the shaley marl layer underlying it. The breccia outcrop's lack of structural support, particularly in the area of Chapel A (indicated by arrow), puts it at risk of collapse.

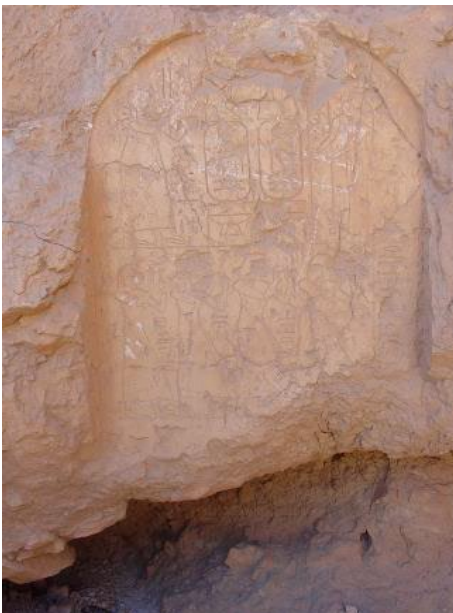
Chapel A: Chapel A was constructed into both the breccia rock that overlays a shaley marl layer, and into limestone below. Two embedded stelae were removed and only the cavities where they were situated remain. Of the two remaining stelae, the one to the upper right has been severely affected by vandalism, exhibiting extensive white scratch marks that appear to be relatively recent given their lack of patina. The lower left stele has the name "Hassan" scratched onto it in Arabic script. The bottom of this stele has been partially lost through rock deterioration as it is located directly above the heavily eroded shaley marl layer which has undercut the breccia above.

Lower left stele showing rock erosion at its bottom.

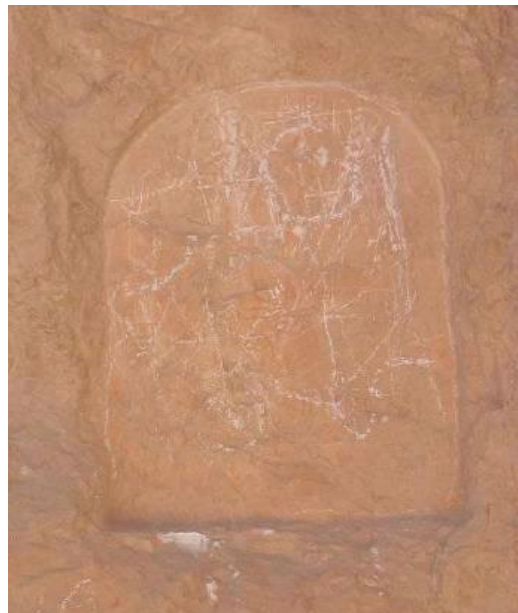
Upper right stele exhibiting extensive damage by scratching.

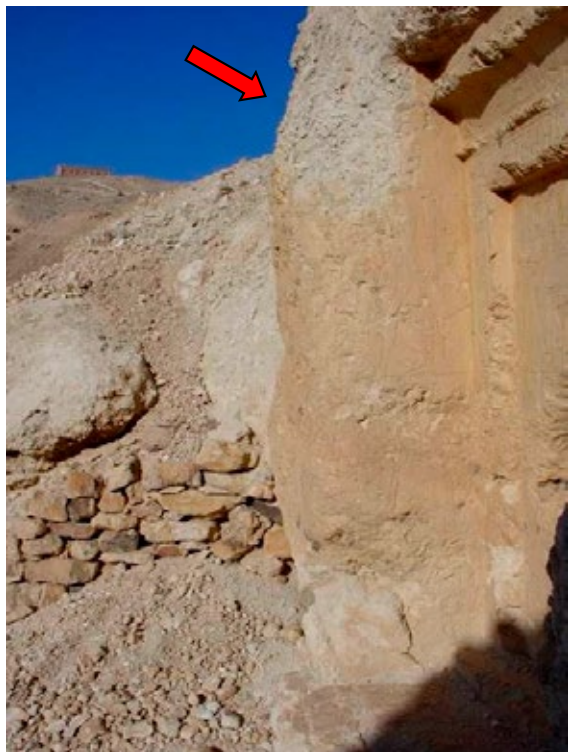
Left jamb of stele, with area of active rock deterioration indicated by arrow.

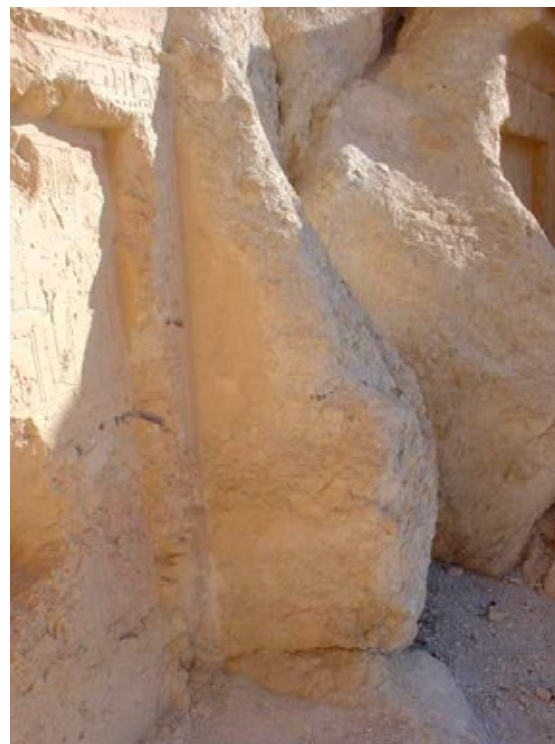
Chapel B: The large hole in the middle of the stele was present at the time of the first known photograph of the site by the Schiaparelli mission (ca. 1906). Bruyère interprets it to be an ancient niche rather than damage. The degraded and whitish appearance and lack of patina of the remnants of the side walls of the stele appear to indicate active rock deterioration, presumably due to surface moisture and wet-dry cycles. The chapel has been damaged by modern graffiti in scattered areas, but to a lesser extent than other chapels at the site. The carved threshold at the base of the stele shows signs of cracking and crumbling.

Right jamb of stele.

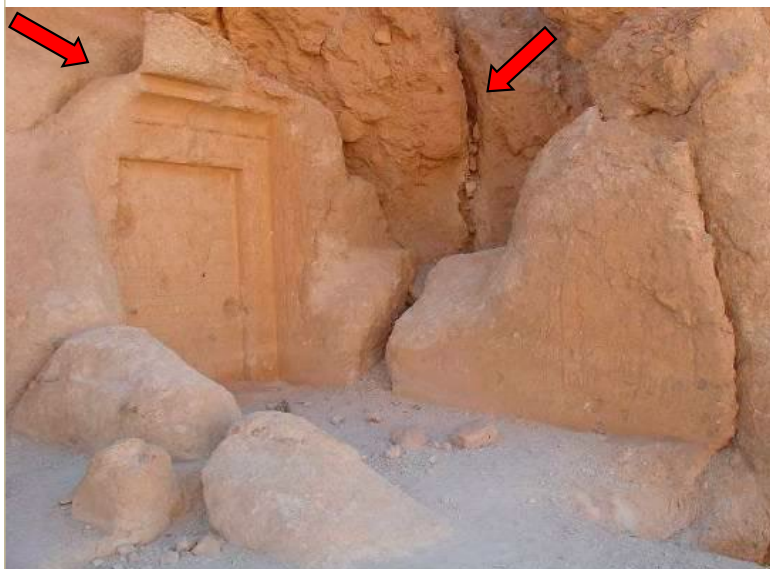
Erosion and surface flaking at the top and behind the stele (left arrow) and fracture running through the middle of the chapel (right arrow).

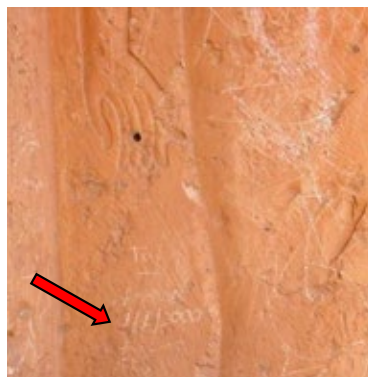
Chapel C: The extant decoration of Chapel C is less exposed to the elements than Chapel B, with the southern part of the chapel more sheltered than the northern. Given the apparent continuing rock erosion and flaking behind the upper part of the stele, the top of the stele may eventually collapse if it is not protected and stabilized. The southwest and northeast walls of the chapel are intersected by substantial geologic fracture. These walls appear to have experienced significant losses. A fragment of the far right part of the molding at the upper right of the stele was lost between February 2007 and February 2008. The cause is not known. The decorated surfaces of Chapel C have also been extensively damaged by modern graffiti.

Left: Graffiti scratched onto the south (right) jamb. Below: graffiti on stele iconography.

- Limiting the visual prominence of existing graffiti damage has been shown to reduce occurrences of new graffiti. Where possible, deep graffiti incisions should be visually reintegrated with surrounding decoration to lessen the visual prominence of this type of graffiti damage.

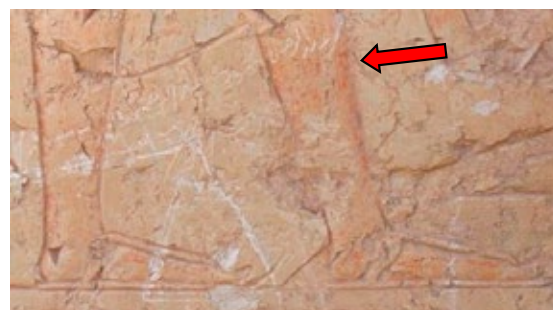
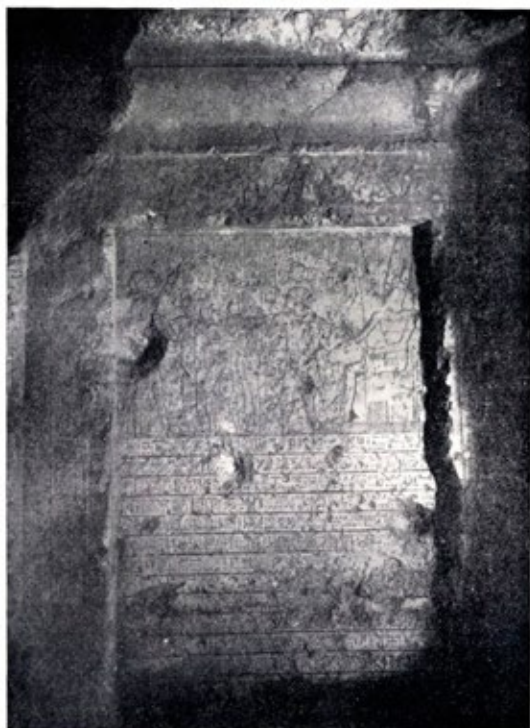
Comparison of Chapel C in 1926 (left, Image: Bruyère 1929-1930, 32) and 2008 (right). Arrow to right indicates location of loss of a fragment of the stele molding between February 2007 and February 2008.

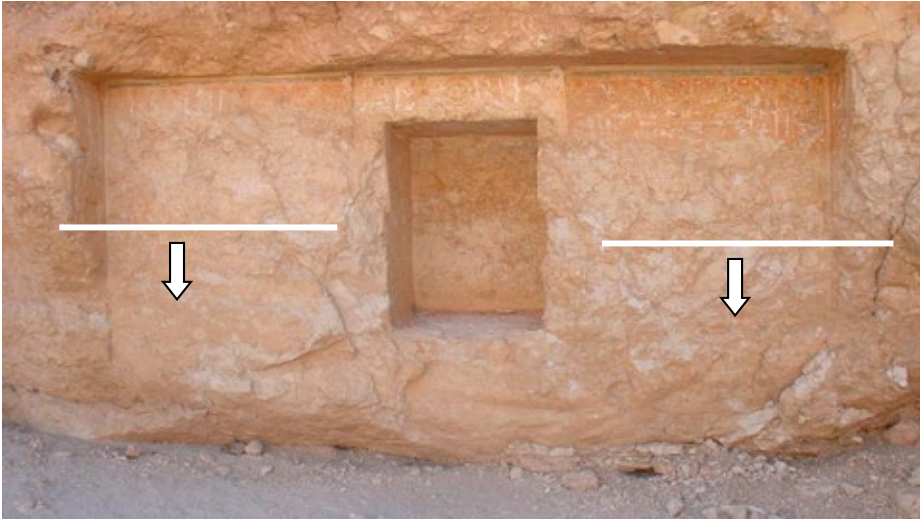
Decorated surfaces of the stele of Chapel D below the white line have been lost, apparently due to rock deterioration.

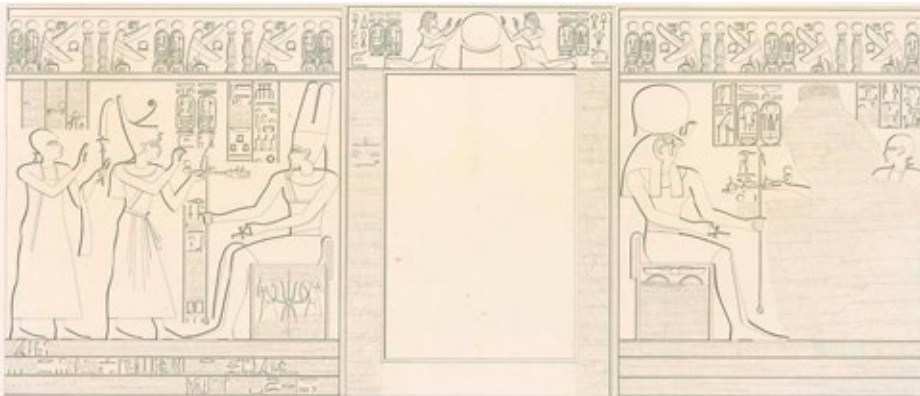
Chapel D: The lower part of the stele has suffered surface loss from erosion, flaking and delamination along limestone bedding planes more than in the upper part. The relatively higher degree of preservation of painted decoration on the stele under the projecting rock cornice is likely due in part to its better protection from rain water and greater distance from the ground, where water may collect. Abrasion from contact with donkeys which are brought to the site to rest may also be contributing to rock loss. There is fairly widespread damage to extant decoration from modern, incised graffiti. In the stele's niche, the plaster on the top has been severely damaged by modern, inscribed graffiti.

Lepsius's 1844 drawing shows that much more of the lower part of the stele's decorated surfaces were apparently intact at that time. (Drawing: Lepsius).

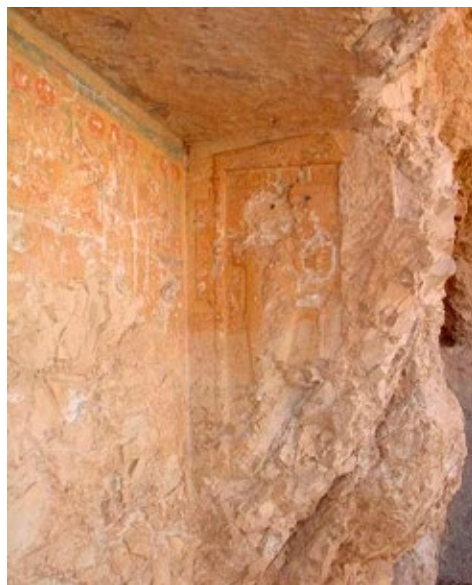
Right jamb of the stele of Chapel D, showing modern graffiti damage.

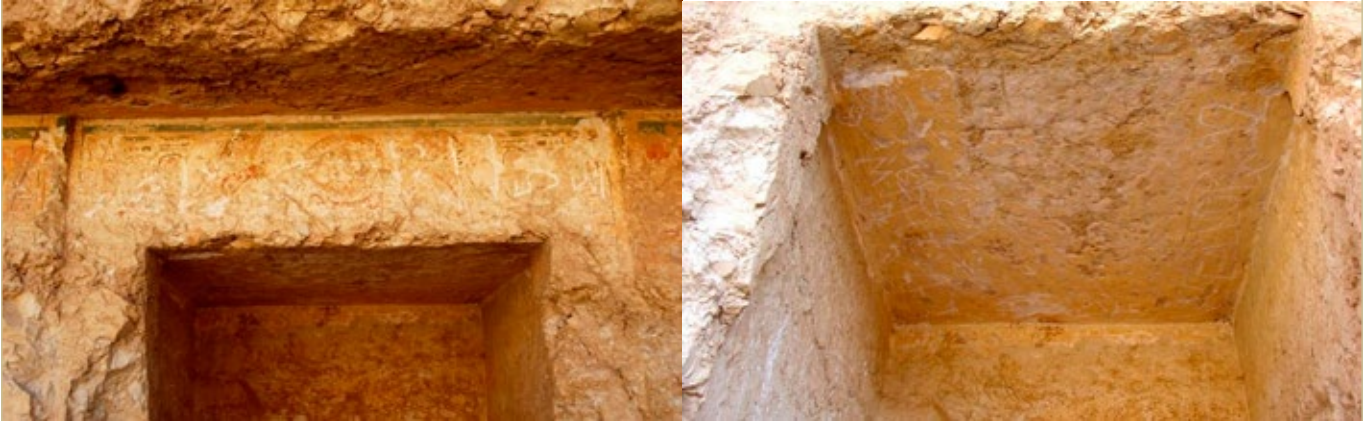
Graffiti damage to the decorated surfaces of the stele of Chapel D.

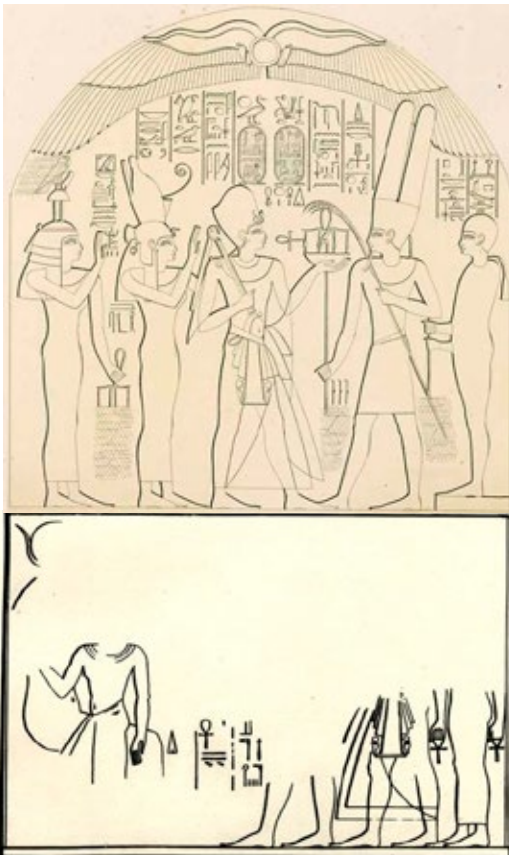
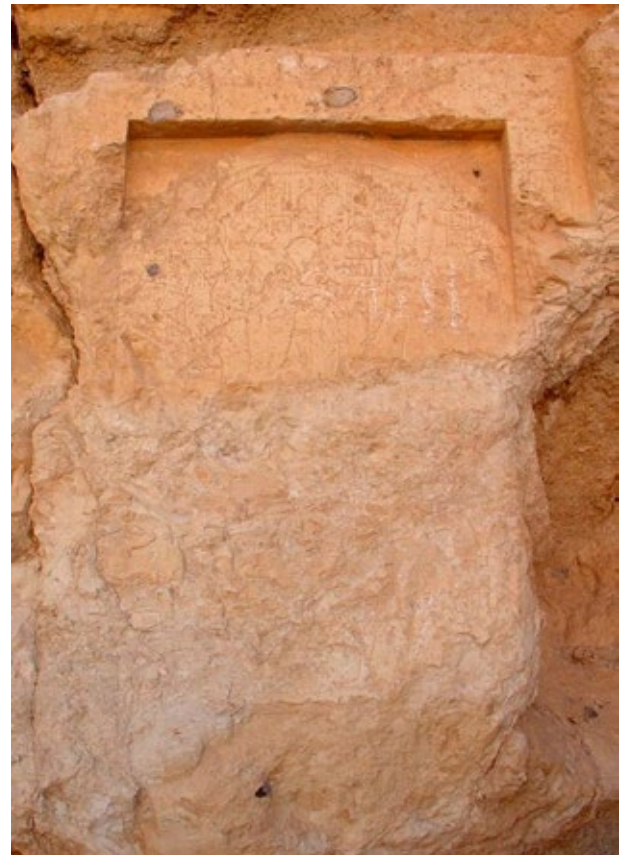
Comparison of areas with decorated surfaces of Chapel E recorded (left) by Lepsius (top register 1844) and Bruyère (bottom register 1926) and areas intact in 2005 (right). (Drawings: Lepsius; Bruyère 1929-1930, PI VI).

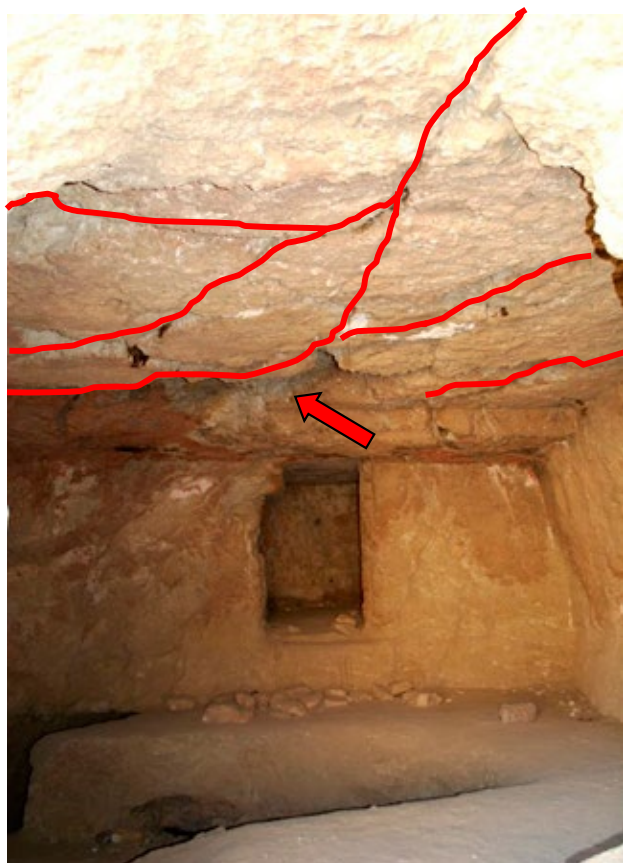
Outer chamber of Chapel F, with red lines indicating locations of structural cracks in the ceiling, and arrow indicating area of substantial rock loss.

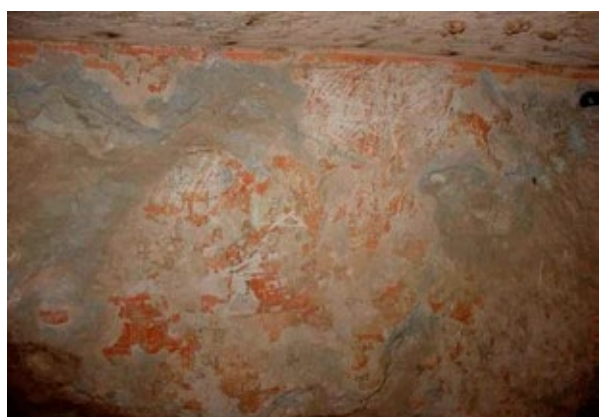
In the *naos*, or rear chamber, the west wall has lost extensive areas of rock. Decorated earthen plasters in the *naos* have been damaged extensively by apparently modern incised graffiti. The south wall also exhibits signs of charcoal graffiti. There are also extensive remains of wasp nests on the walls and ceiling, although no recent wasp activity was observed.

Area of red painted plaster on the west wall of the *naos* that is substantially degraded, in areas by scratching.

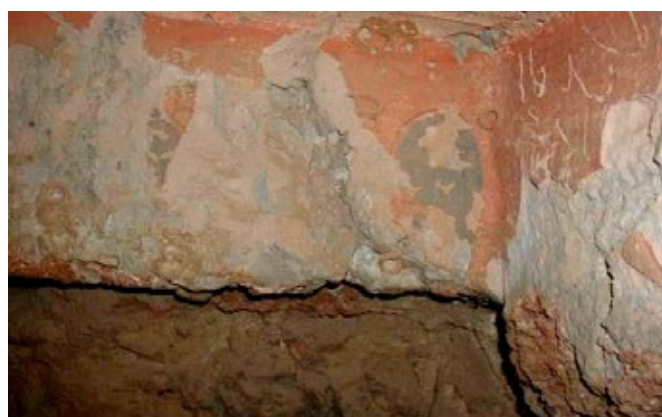
Red painted plaster on the northwest wall of the *naos*, which has been lost in its lower part.

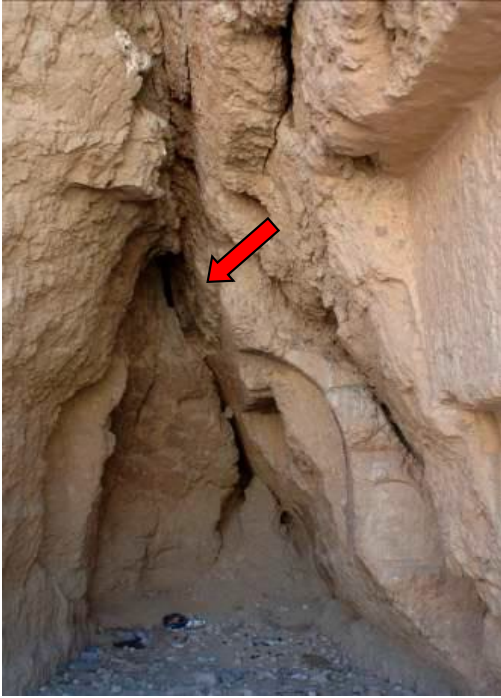
Chapel G: A substantial vertical opening runs directly through the southwest room of the chapel, which coincides with a geologic fault (F1) and marks the interface of the breccia rock to the west and the shale rock to the east. On the western wall, the lower register of the stele has been severely damaged by graffiti, which has been incised deeply into the plaster. The better preserved decoration on the western wall is on the upper half of the upper register, out of reach from graffiti damage and better sheltered from the elements. The remaining plaster and paint on the western wall generally appears stable, and the entire chapel is well sheltered from the elements. The eastern wall and rock cut arch leading to the rear chamber is no longer preserved as it is cut out of the weaker shale rock.

Fault (F1) running vertically through the southwest room of Chapel G.

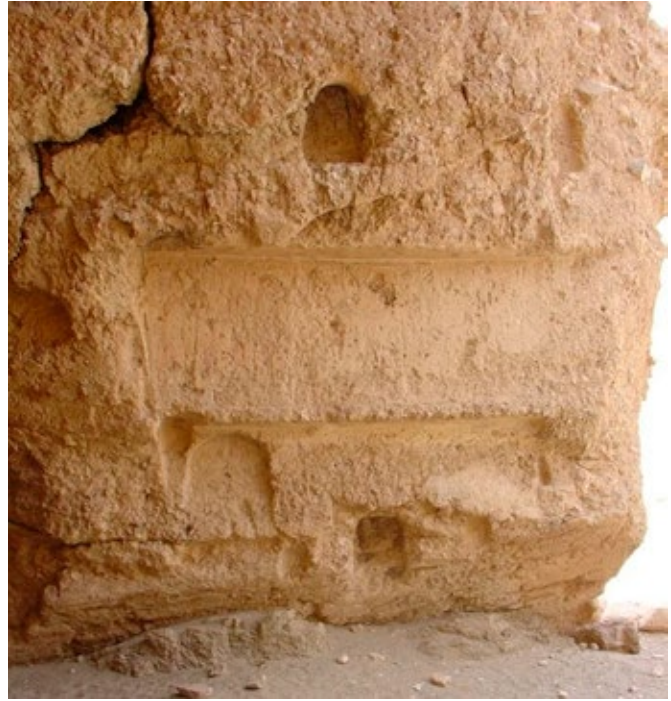
Western wall of Chapel G, which has been extensively damaged by graffiti.

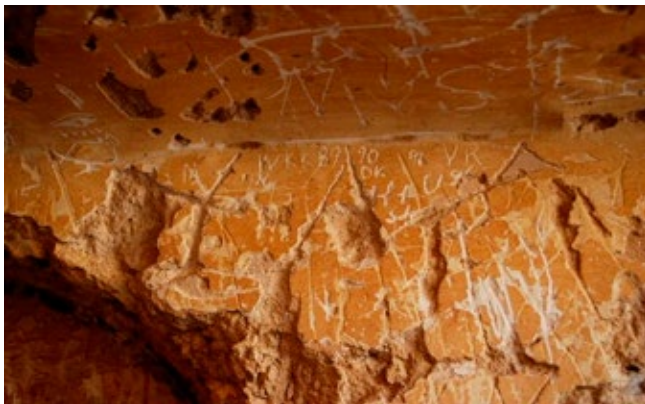
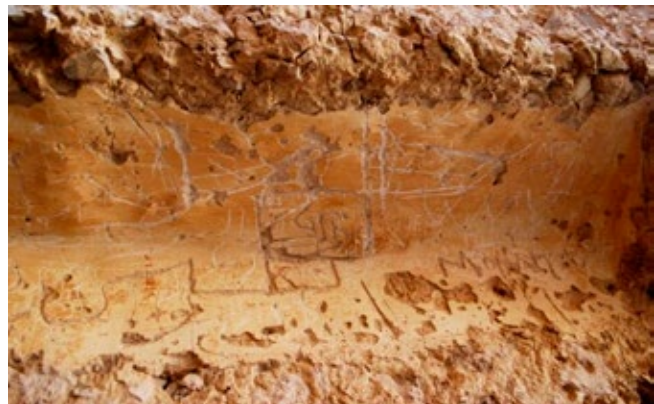
Examples of incised graffiti damage to the western wall of Chapel G.

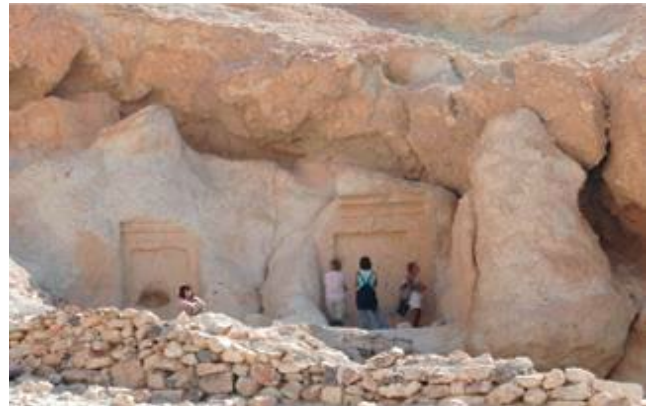
• **Graffiti, vandalism, and tourism-related impacts:** The most aggressive cause of recent damage to the decorated surfaces of the site has been modern graffiti and vandalism. The sanctuary is located along a regularly traversed tourist trail between Queens Valley, Deir el-Medina, as well as Kings Valley and Deir el-Bahari, and the site is not guarded, nor are there barriers or signs preventing entry. Tourists have been observed touching the stele surfaces. Donkeys allowed by tour guides to rest there may contribute to the abrasion of rock surfaces. (See Part II, Appendix 5 for recent interventions by SCA to address this problem)

Unsupervised tourists visiting the sanctuary.

- The site should not be open to visitors, unless a guard is permanently stationed there, due to its vulnerability to damage, particularly from graffiti. Visitors with special permission should only visit the site with an SCA inspector or guardian.

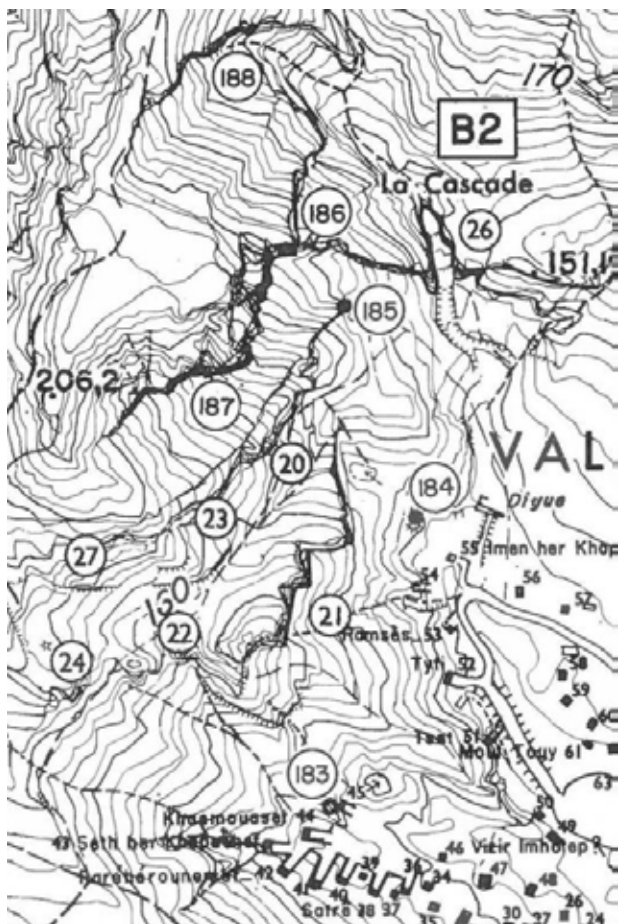
Locations of QV graffiti clusters recorded as CEDAE sections in *Graffiti de la Montagne Thébaine* (Note: map excerpts not to scale) (Maps: CNRS)

Sections 20-24, 27, and 184-188 up the slopes west of the main wadi of QV and section 26 in the Grotto Cascade.

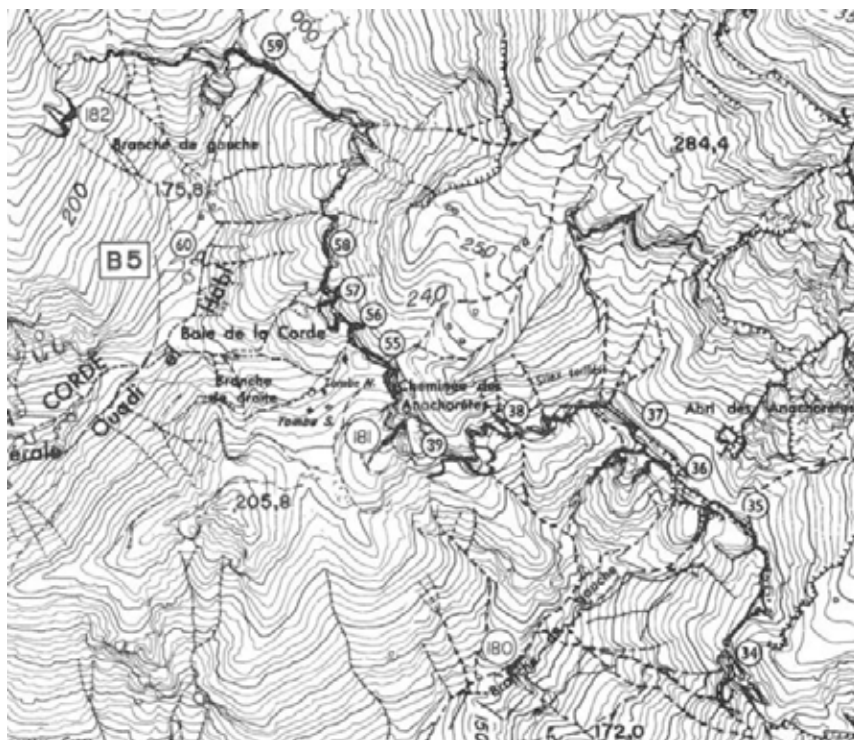
Locations of QV graffiti clusters recorded as CEDAE sections in *Graffiti de la Montagne Thébaine* (Note: map excerpts not to scale) (Maps: CNRS)

Sections 29 - 33 in the Valley of the Dolmen near tombs QV 90 and QV 91.

Sections 34 – 39 at the top of the first escarpment in the Valley of the Three Pits, and Sections 55 – 60 in the Valley of the Rope, also mostly at the top of the lowest escarpment and in the vicinity of tombs QV 92, QV 93, and QV 97, as well as sections 180-182.
