# 殊像寺简述

## Description of Shuxiang Temple

### DESCRIPTION OF SHUXIANG TEMPLE

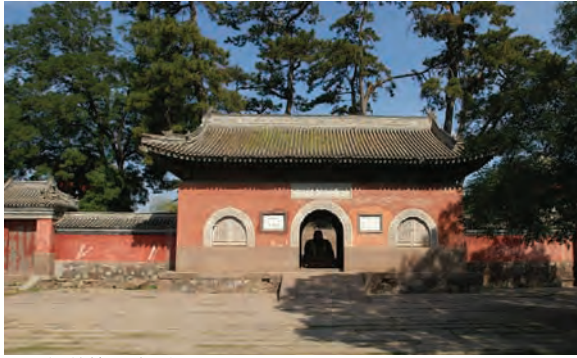
3.山门前檐（南面）  
South facade of Shanmen

山门面宽三间，进深一间，单檐歇山灰色布瓦顶。1975年对屋顶进行维修时修补了斗拱、椽飞望板、连檐及瓦口等。山门的台基有典型的虎皮毛石砌筑的台帮及红砂岩压面石，殿身的内、外墙体下碱均为红砂岩。山墙外表的红色抹灰共有两层：估计第一道为清代的抹灰，第二道大约为1959年或1975年修缮时所加。山门明间前檐（朝南）、后檐（朝北）均设带有装饰花纹的鸚鵡岩石卷门（图案名称为汉纹）（照片3-5）；石卷门东、西两侧为鸚鵡岩半圆盲窗，盲窗棂格为六角菱花。檐下外部的额枋、檩、斗拱仍保存小部分残损的彩画（见卷二《油饰彩画、塑像、陈设物及器物状况评估报告》）。

Shanmen is three bays long and one bay deep with a single-eave Chinese hip and gable roof with unglazed grey tiles. In 1975 the roof was repaired, which included replacement of brackets, flying rafters, eave edging (*lianyan*) and tile edging (*wakou*). The building is composed of a typical platform ('tiger-skin' rubble masonry with ashlar-corners), on which is constructed a sill wall of red sandstone (interior and exterior). The exterior wall above the sill wall is covered with red-colored stucco, composed of 2 distinct layers that may relate to different campaigns: the first assumed to be historic, the second may date to repairs carried out in 1959 or 1975. There are central arched doors at the front (south) and rear (north) facades of the gatehouse with carved tuff stone surrounds (Photos 3-5). On the east and west sides of the doorways are arched, false windows of carved tuff stone with a patterned surround (the pattern of the surround is called *hanwen*, and the lattice pattern on the windows is known as *liujiao linghua*, or 'six-horned caltrop') (Photo 5). On the external architraves, purlins, and brackets below the eaves are remains of deteriorated decorative painting (*caihua*) (see Vol. 2, *Assessment of Painted Architectural Surfaces* for details).

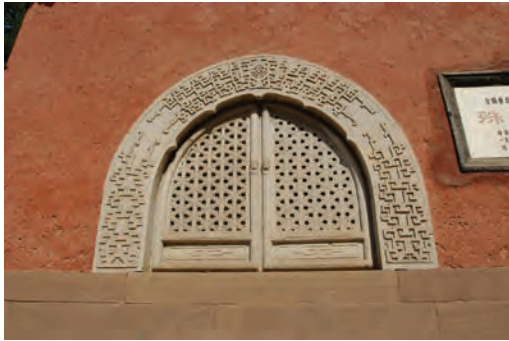
5.石半圆盲窗（上边），石卷门（下边）  
Details of stone window (above) and door surround (below)

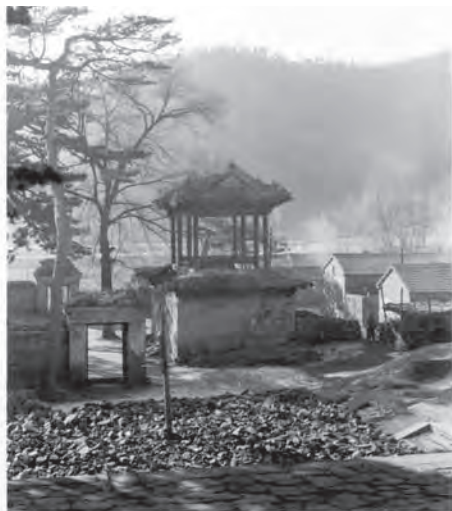
12. 第一进院落西北角腰墙不存之处（1979年）  
Enclosure wall missing in NW corner of Courtyard 1 (1979, L. von Faulkenhausen)

山门出口有石砌的礅擦，由此即进入一个封闭大院落。院落的东、西两侧设腰墙，北边是天王殿（照片9、10）。在1979年拍摄的照片上看不到鼓楼以北的腰墙和腰门以西的腰墙（照片12），因而这两段腰墙当为1979年以后重建。院落内有几条冰纹海墁，分别处在南北轴线上的天王殿与山门间（2002年用水泥重新铺面，照片13），东西轴线上的钟鼓楼间，以及院外腰门与院内腰门间。院落西南处和东南处有两幢用红砂岩制成的方形旗杆石座和座基（照片11）。在山门旁边的东便门内有一栋铺有现代屋顶的建筑，现为寺庙工作人员的储藏室与辅助性办公室。

After passing through Shanmen one enters, by way of a stone paved ramp, a large enclosed courtyard delimited by enclosure walls on the east and west and by Tianwang Hall on the north (Photos 9, 10). The segment of the enclosure wall north of the Drum Tower and west of the side gate (*yaomen*) is missing in a 1979 photo (Photo 12) and was thus rebuilt after that date. Within the courtyard are paths of crazy-paving (*hai man bing wen*, literally 'cracked-ice') on a N-S axis connecting the gatehouse with Tianwang Hall (re-laid with cement in 2002, Photo 13), and two connecting the external side gates with internal side gates in the courtyard perimeter wall; and on an E-W axis connecting the Drum and Bell Towers. The platforms and red sandstone bases for two square banner (*dhvaja*) poles survive in the SW and SE part of the courtyard (Photo 11). There is a modern roofed structure on the inside of the eastern side gate, next to Shanmen, used as a storage and auxiliary office for the temple custodial staff.

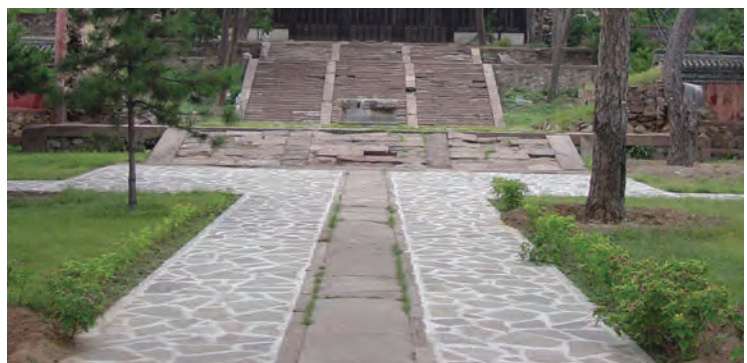
13. 第一进院落内用水泥重新铺的冰纹甬路  
Crazy-paving re-laid with cement in Courtyard 1

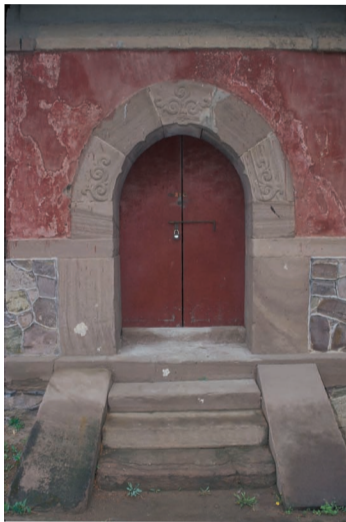
17. 钟楼券门的细部  
Detail of entrance to Bell Tower

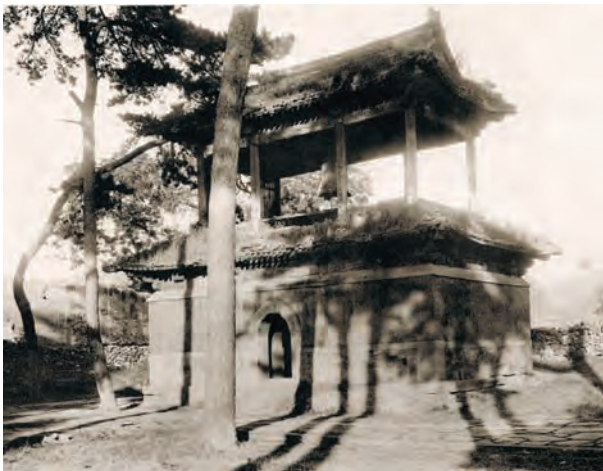
20. 1933年的钟楼  
Bell Tower in 1933

坐落在第一进院落的钟楼（东侧）和鼓楼（西侧）形制相同，位置对称。上、下层均面宽三间，进深一间；（照片14、15、17）。这两座楼曾在1959年进行维修，在1982年至1983年大修。台基及下层，其中包括毛石砌筑的墙体以及钟楼部分彩画的均为原件；上层墙体的木栈板（照片16）及屋顶基本是新补换的。1933年、1979年的照片表明当时上层仅有木柱，木栈板不存在（照片20、21）。

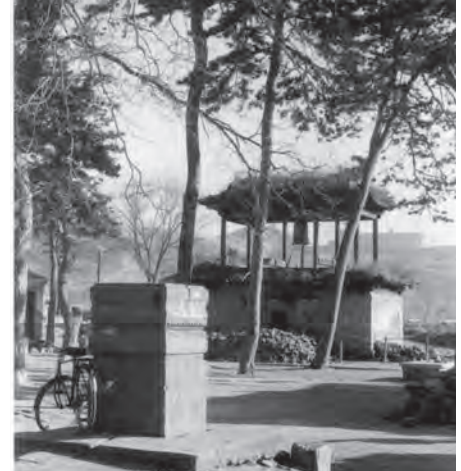
21. 1979年的钟楼  
Bell Tower in 1979, L. von Faulkenhausen

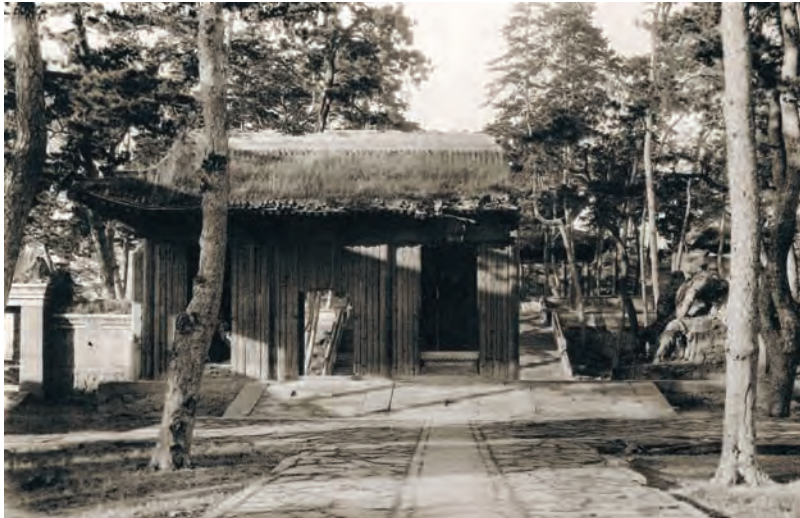
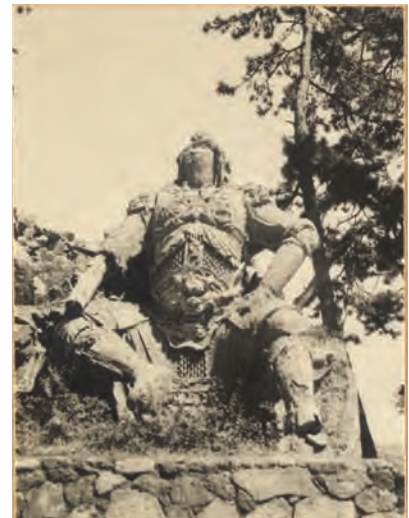
22. 1933年拍摄的天王殿、天王供像遗迹  
Remains of Tianwang and Heavenly King statues (right) in 1933, and detail of statue in 1934

1933年的照片表明当时天王殿只存西侧的三间殿屋，东侧的两间已被拆除（照片22）。从照片上还可以清楚地看到殿内东侧置于石座上的天王像残躯，但无法看清其它塑像是否存在。普乐寺有经过修复的类似的木栈板大殿，寺内有弥勒佛像、手持金刚杵的韦陀立像以及天王像。

In a 1933 photo, only the western three bays of the Hall are standing; the two eastern bays have been removed (Photo 22). One can discern the deteriorated remains of the two Heavenly King statues at the eastern side of the Hall still seated on their platforms. It is not possible to determine whether the other statues are inside the building. A similar restored Hall exists at Pule temple, with wood facade and housing the statues of Maitreya (*Milefo*), *Weituo* holding ‘the diamond mace,’ and the Heavenly Kings.

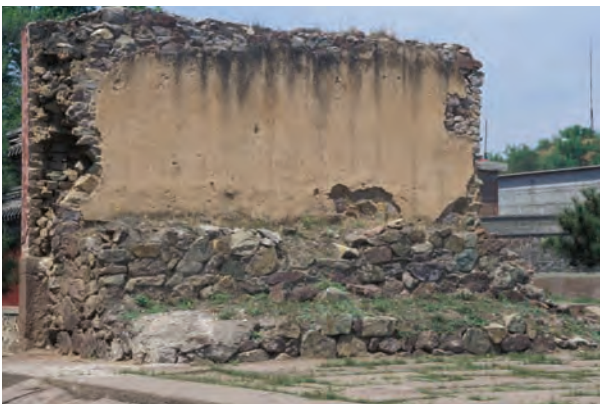
23. 西墙和须弥座的遗迹  
Remains of west wall and statue platform

天王殿正中朝南供奉坐姿弥勒佛像一尊，佛像置于鸚鵡岩须弥座上。弥勒佛以北原供韦陀立像一尊，此像亦置于石质须弥座上。这两尊塑像像表均为金漆（照片26）。现今在原址上只存鸚鵡岩须弥座。1933年前弥勒佛像迁至会乘殿（照片66），以后又迁至山门；韦陀立像目前藏于钟楼。天王殿东、西侧原设四大天王（已不存），四大天王原置殿内东、西墙两侧的阶式平台上，现今只存平台芯的碎石（照片23、24）。

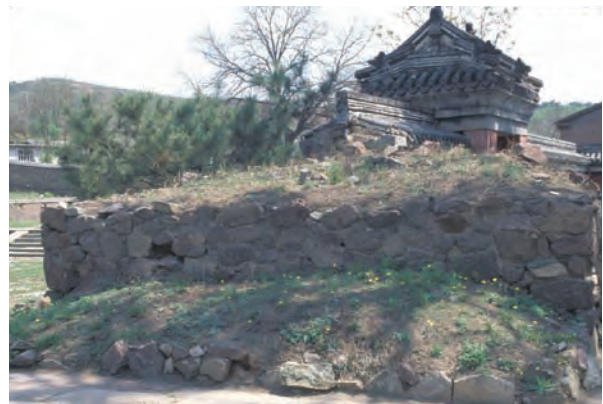
24. 东墙和须弥座的遗迹  
Remains of east wall and statue platform

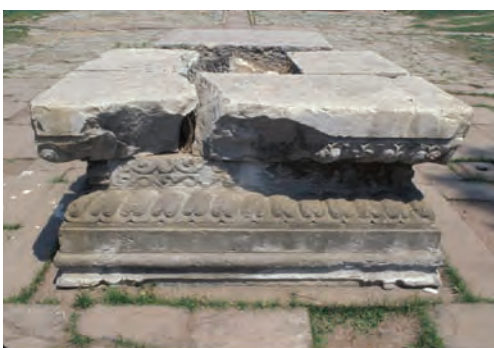
25. 弥勒佛像、韦陀像的底座，朝西（上边）、北（下边）  
Statue base for Maitreya and Weituo, looking west (upper) and north (lower)

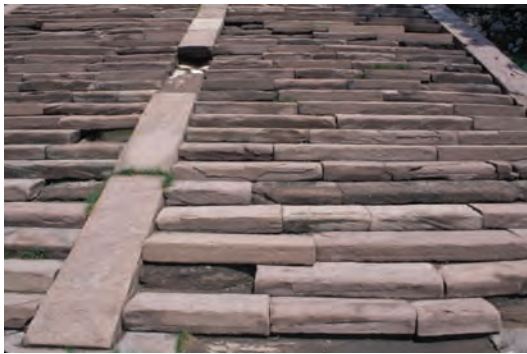
34. 台阶和垂带的近景  
Close-up of stairway and splay

从第二进院落上到第一层月台（月台在下面予以描述）有26级台阶，沿台阶坡度方向的四条砂岩垂带将台阶一分为三（照片33、34），据1933年的照片，台阶东、西侧的垂带上设女墙（照片43）。如今仅存置于西侧垂带南端的抱鼓石部分构件（抱鼓石用鸚鵡岩雕刻而成）（照片35）。台阶砂岩垂带的表面凿有凹形小沟和榫眼以固定女墙（小沟和榫眼可在东南角无栏板的垂带上见到）。靠近大台阶的东侧有一块半露的鸚鵡岩石块，可能是原来西南角的一块女墙角柱。目前有数件女墙构件散放在靠近下层月台的地面上（照片36）。在其他垂带（地袱）上都可以看到用于固定女墙的榫眼（照片37）。

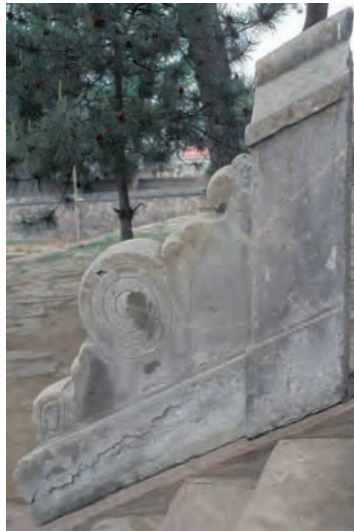
35. 在原址的女墙抱鼓石（西南角）  
In situ balustrade element (SW corner)

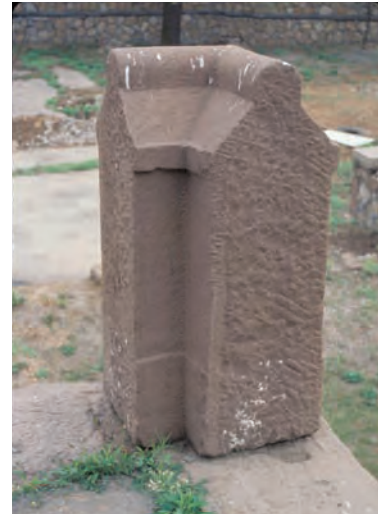
40. 下层月台东南角女墙角柱石  
SE corner stone, Lower Terrace

通向下层月台的大台阶和下层月台的地面均为红砂岩条石，大台阶的两侧为冰纹青石。月台边缘原设女墙，如今仅存东南角红砂岩女墙角柱石（照片40）。在1933年的照片上月台女墙依然清晰可见（照片43）。在南边阶条石上另存八件排水挑头（每侧四件）（见照片44、45）。在下层月台和上层月台之间，设九级台阶，台阶西部垂带（地袱）上还保存原女墙角柱石。

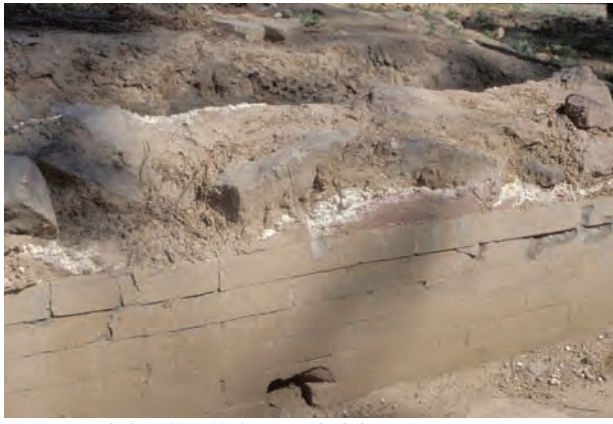
41. 上层月台东面的护坡墙，2003年发掘  
East wall of Upper Terrace, excavated Nov. 2003

上层月台为两层大台阶的终点，上面建有会乘殿和两座配殿（面月和指峰）。上层月台在临陡坡的南、东、西三侧为毛石砌筑的护坡墙，护坡墙的压顶石为红砂岩条石，压顶石上原来是否还有其它构筑物，现在不清楚。2003年11月在月台东侧护坡墙北端的发掘中发现了女儿墙基址。女儿墙墙基的下层为六层砖，上层为毛石；毛石表面仍保存部分红色抹灰（照片41）。月台西侧护坡墙仅存条石压面。在靠近西侧护坡墙北端的女儿墙中有一个开口，开口和一处由假山石块铺成的台阶相连，台阶通往4号区的下层。另外在开口两侧发现的压面石上均有浅槽，与现在落到护坡墙西侧不远之处的角柱石上的榫头似乎相吻合（照片42）。

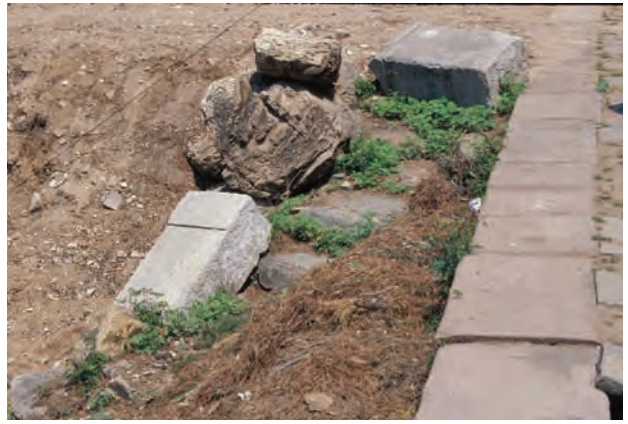
42. 从上层月台落下来的女墙角柱  
Carved blocks fallen from west entrance of Upper Terrace

The Upper Terrace is the culmination of the Grand Staircase, and constitutes the platform on which was constructed Huicheng Hall and two side halls (Mianyue and Zhifeng). The upper terrace is supported by a rubble masonry retaining wall on its steep south, east, and west sides; the finishing course of the retaining wall is horizontally laid red sandstone ashlar blocks. The original construction above these ashlar blocks is not certain. At the northern end of the east terrace wall, excavation in November 2003 revealed the remains of a narrow parapet (or enclosure) wall. The excavated remains show a foundation of 6 courses of brick followed by rubble masonry construction; remnants of red-colored stucco survive on the rubble masonry (Photo 41). The western terrace wall preserves only its ashlar blocks; however toward the northern end of the wall there was an opening in the presumed parapet/enclosure wall that leads to stairs of rough-hewn stones, which descend to the lower level of Area 4. On either side of the opening the ashlar blocks have been slightly recessed, probably to receive the carved, tuff blocks that have fallen just west of the terrace wall (Photo 42).

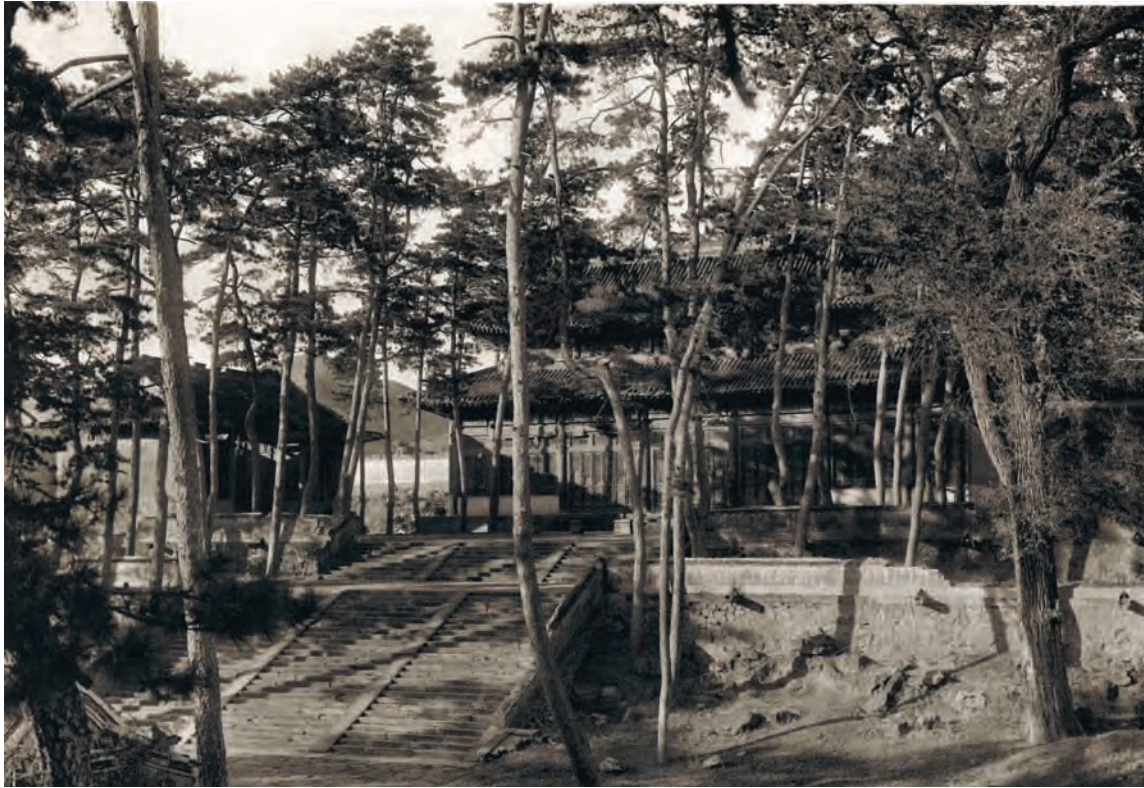
43. 1933年设有女墙的月台  
Terraces with balustrades in 1933

上层月台南端原有女儿墙，女儿墙在1933年的照片上依然清晰可见（照片43）。与下层月台一样，上层月台的南侧也建有八个排水挑头（照片44、45）。上层月台铺有两种石面：大台阶上端与会乘殿入口处之间为大红砂岩条石或方石（照片46）；月台的东、西两侧为粗制青色冰纹海墁（碎纹石面）。在院落内的对称位置上植有松树（现仍存十棵），树干周围有红砂岩树池（照片47、48）。会乘殿门口前有五个雕刻精美的鸚鵡岩须弥座用来盛放五供（照片49），1933年的照片显示这五个须弥座是与会乘殿前檐平行放置的（照片50）。

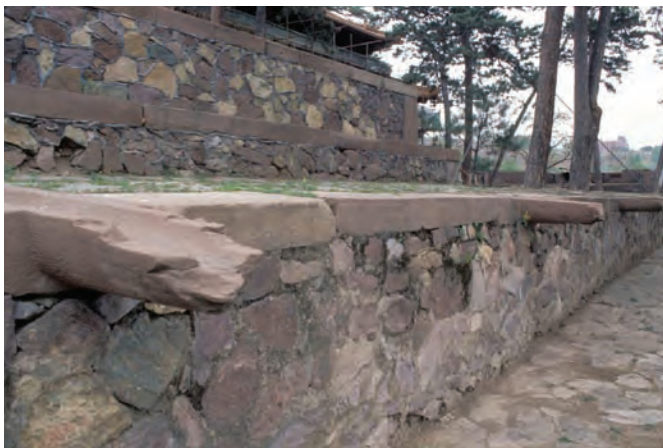
44. 上层月台的排水挑头 Scuppers of Upper Terrace

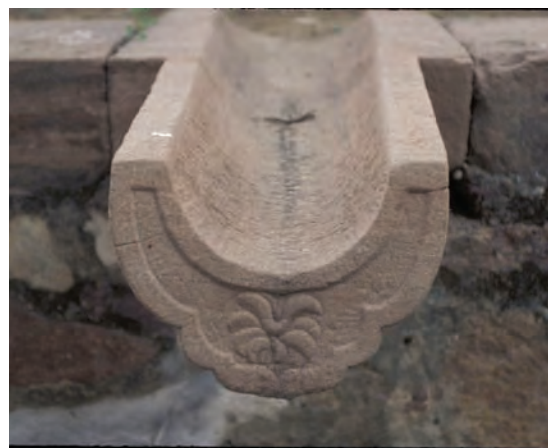
45. 排水挑头的细部 Detail of scupper

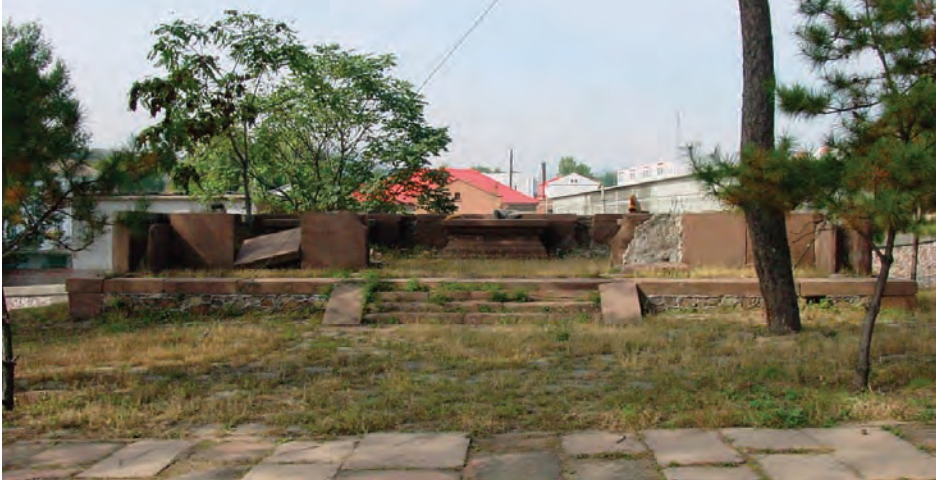
51. 面月殿（朝西）  
Mianyue Hall, looking from the west

在上层月台的东南角和西南角各有三间配殿，东为指峰殿，西为面月殿，如今二殿仅存遗址。面月殿仍保存台基和墙体下碱，建筑石材主要为红砂岩和大约是后期修补用的零散的青砂岩条石（照片51）。槛墙下碱内外均用陡板石制成（照片52），其他墙体下碱内包金用陡板石，外包金用毛石砌筑。后檐墙下有三个红砂岩的须弥座。现在殿址内储存有屋面瓦（照片52）。从

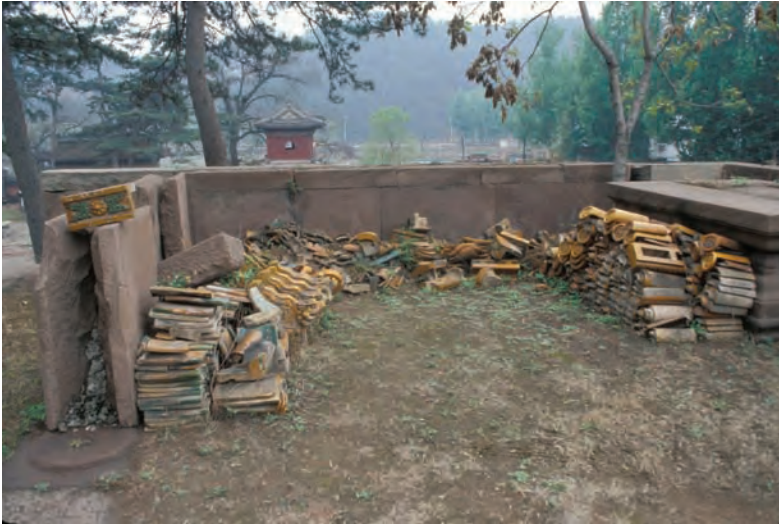
52. 面月殿址内储存的屋面瓦  
Interior of Mianyue Hall, with store of roof tiles

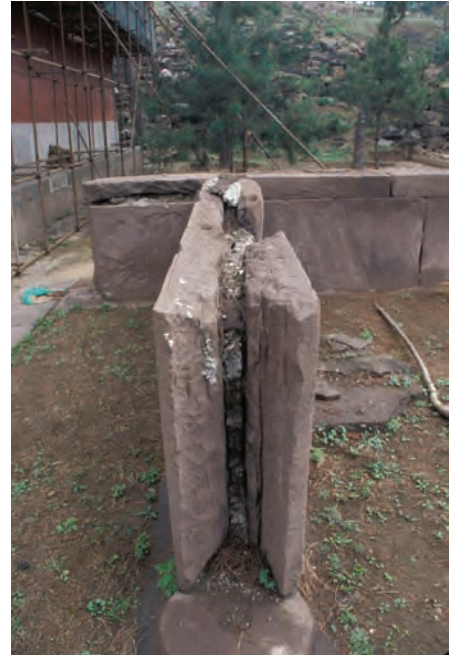
53. 指峰殿槛墙  
Detail of sill wall, Zhifeng Hall

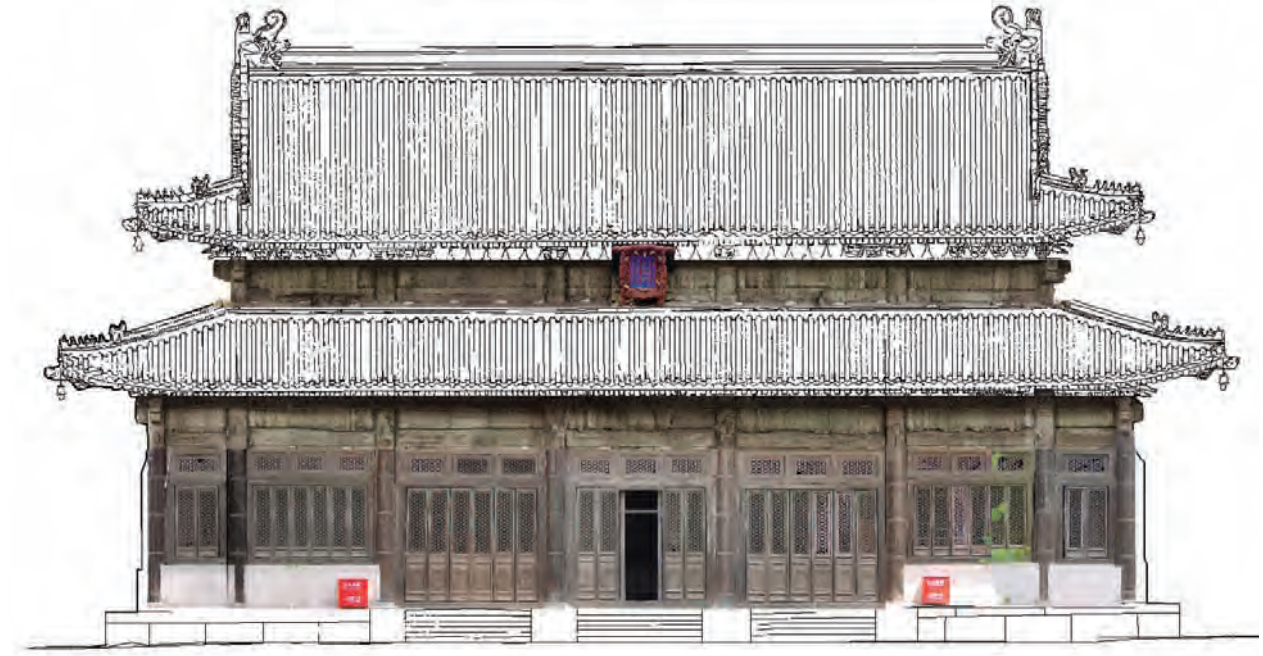
58. 与照片重叠的会乘殿正立面图（南立面）  
Elevation of Huicheng Hall with partial photographic overlay, South facade

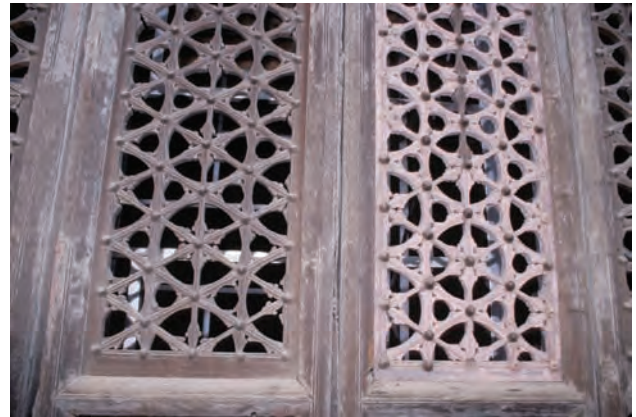
62. 隔扇棂心  
Detail of lattice on doors

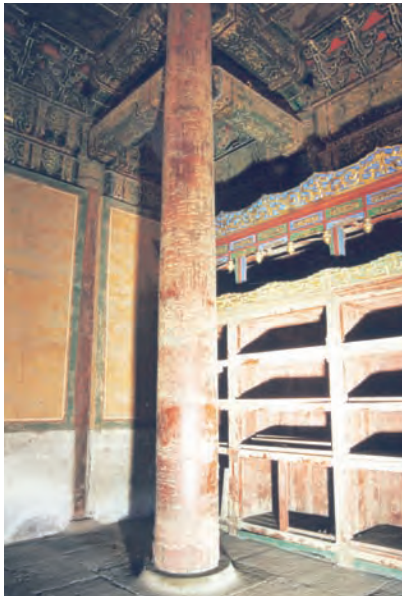
76. 经格、柜 Sutra shelves

东、西两侧山墙内各置杉木经格（照片76、77），每侧有经格33个（共三层格，每层11格）。经格下面另有一层11格的碗碟厨；两类相加，全殿共有经格和碗碟厨格88个。经格木雕门已多次补换过，1933年照片上所见的经格门就已经不存在（照片66、67）。其中个别的经格门曾用于修补该殿南侧门门扇的枋心，其余的也可能储存在经格内（见1933年的照片）。经格至少上过两道漆，其中包括近期上的一道。目前所见门上的木雕款式并不统一，进一步证明了经格至少修缮过一次，甚或两次（见卷二《油饰彩画、塑像、陈设物及器物状况评估报告》）。

On the eastern and western walls (the gable walls) of the interior of the hall are sutra shelves and cupboards made from fir wood (Photos 76-77). On each side there are 33 shelves (11 sets of 3 shelves) above a row of 11 cupboards for a total of 88 in the entire hall. Many of the carved doors of the shelves have been replaced and/or repaired on more than one occasion; in the 1933 photos there are no doors in place (Photos 66, 67), but some were used to board up broken lattice in south facade doors of the hall (visible on close inspection of the 1933 photos) and others may be stored inside the shelves. At least 2 layers of paint, one very recent, and different styles of carving can be detected on the doors today, further suggesting that at least one, and probably two, recent campaigns of interventions took place on the sutra shelves (see Vol 2, *Assessment of Painted Architectural Surfaces* for more detail).

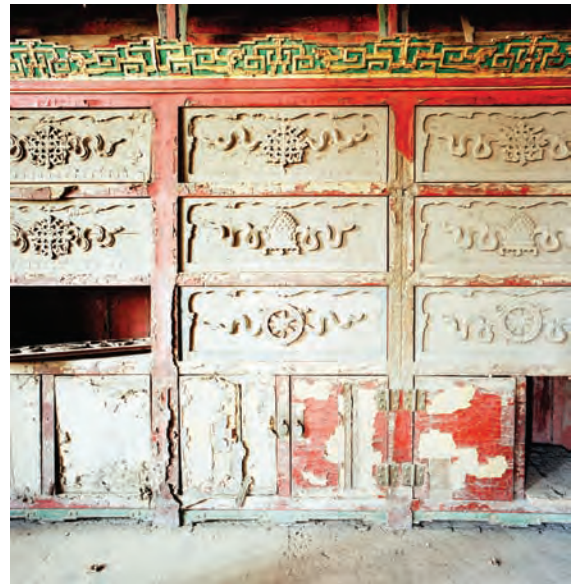
77. 经格、柜（包括门）Sutra shelves with doors

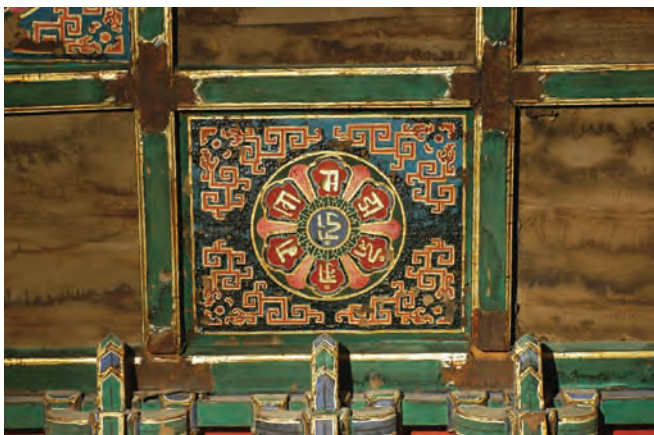
78. 天花板 Ceiling panel

这些经格当年曾存放过佛经和其他经典：满文《大藏经》、《大藏全咒经》十套、满文《西番丹书克经》、《药师琉璃光如来本愿功德经》四部及《千手千眼观世音菩萨大悲心陀罗尼经》四部。殿内经格上边露明的大木构架绘有彩画。天花板原有井口天花（照片71、74、78），可是大部分彩画都已脱落，很多连天花板也不复存在。殿内原有掩盖大木构架的天花板，但是后期修缮屋顶时，为修理内檐大木构架，天花板被拆除，后来并以成本低廉的纸来代替原板（照片66、71）。原板在1933年的照片中就不复存在，如果将照片64与69加以比较，就会发现现存的天花用纸和当年不同，因此，天花可能进行过两次修缮。
