# Conservation and Rehabilitation Plan for Tighermt (Kasbah) Taourirt, Southern Morocco

## Research Report

Claudia Cancino, Benjamin Marcus and  
Mohamed Boussalh

# Conservation and Rehabilitation Plan for Tighermt (Kasbah) Taourirt

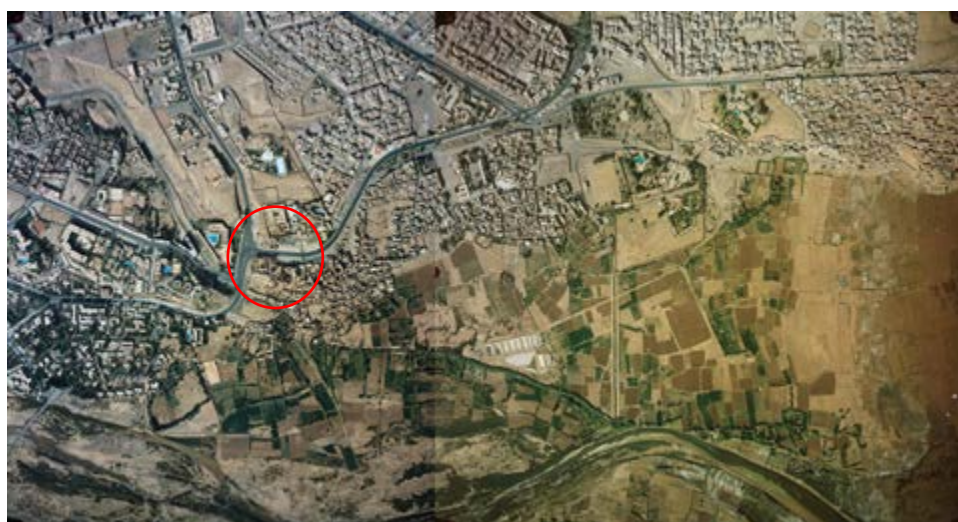
**FIGURE 1.9**

Aerial view of Kasbah Taourirt (in red) within the city of Ouarzazate. Photo: ANCF, 2009.

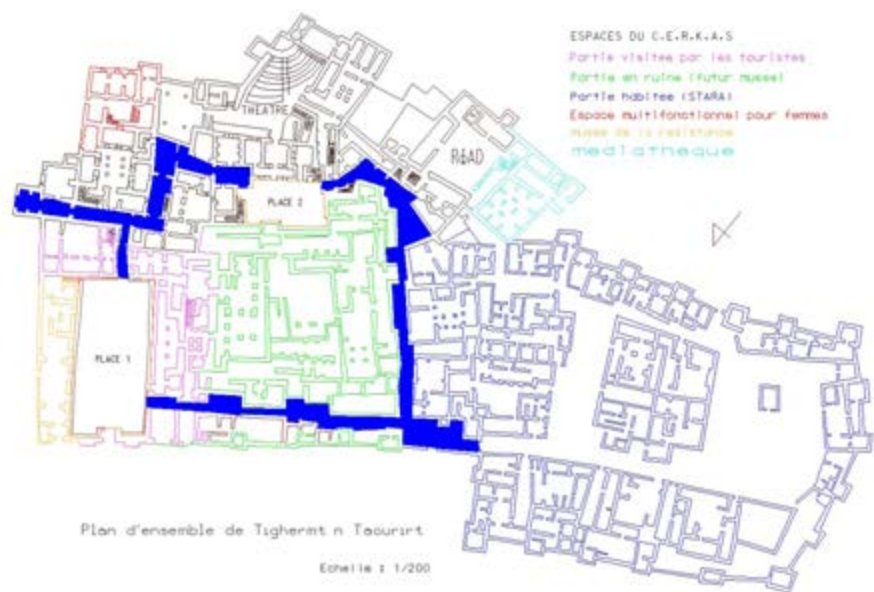
**FIGURE 2.4**

Architectural plan in MicroStation developed by CERKAS from an aerial photo.

1. Architectural drawings of Kasbah Taourirt: The existing architectural drawings are limited to a roof plan, site border, open spaces, and some interiors based on an aerial photograph of 2004 (fig. 2.4). These architectural plans were made in MS. Despite the fact that the plans can be transferred and opened in other software, they are not accurate regarding dimensions and configurations of space, which is quite normal when using an aerial photograph (usually distorted) to create a base map. Thus, an accurate and detailed survey needed to be developed using the base map created in MS but correcting any errors.

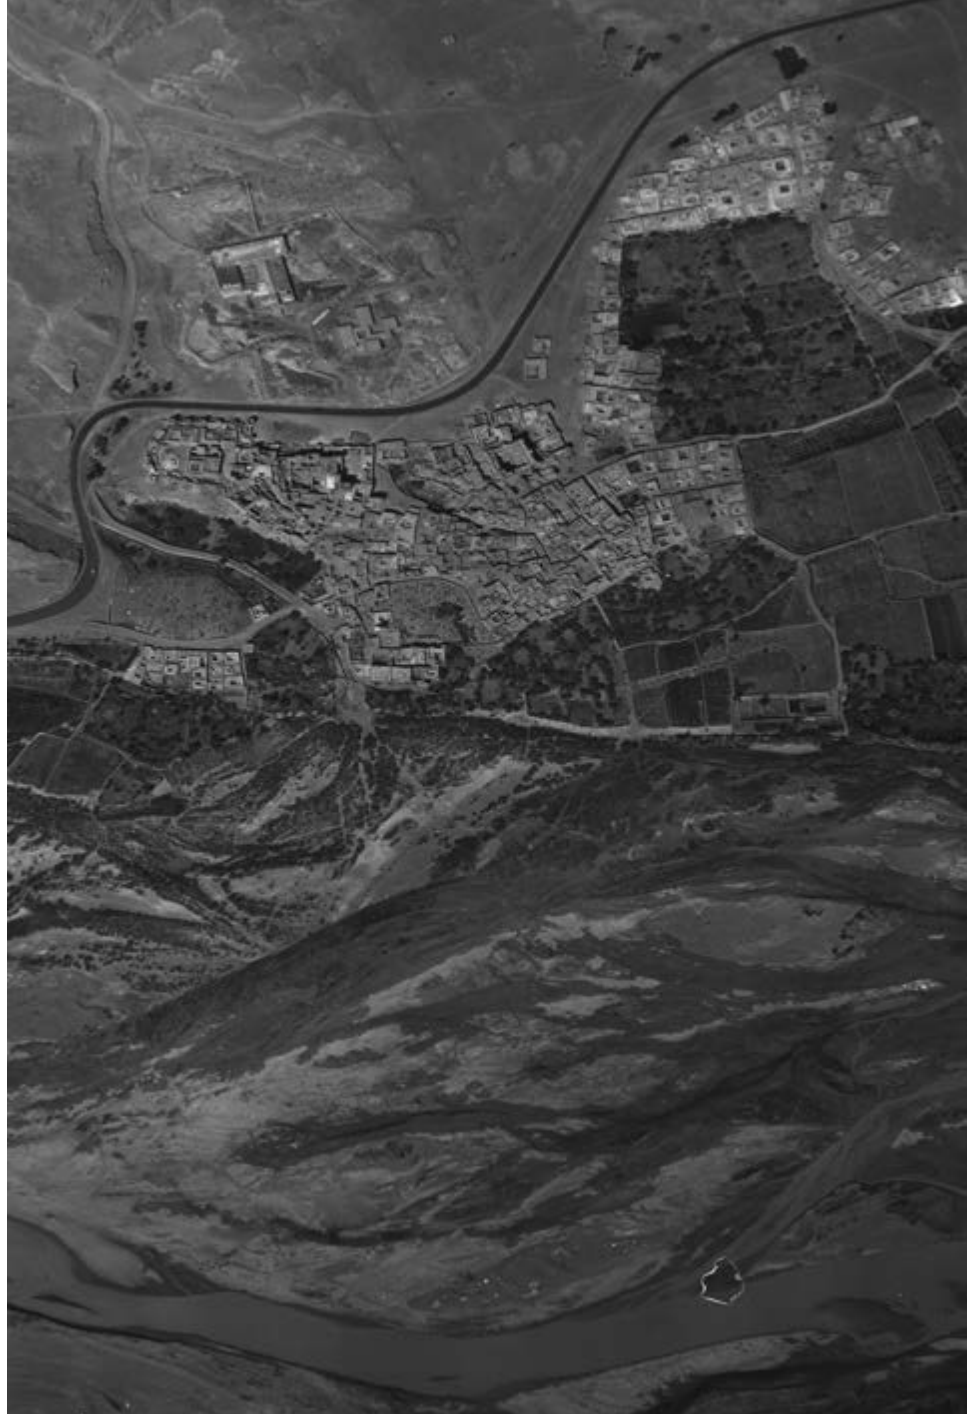
**FIGURE 2.7**

Aerial photograph of the kasbah and ksar of Taourirt, 1960–70.  
Photo: CERKAS archives.

5. Historical images: As detailed in appendix D, the project collected a good series of images of Taourirt and its surroundings over time (fig. 2.7). The photos were further investigated, properly dated, and organized in a way that can provide information regarding the development and evolution of the site.

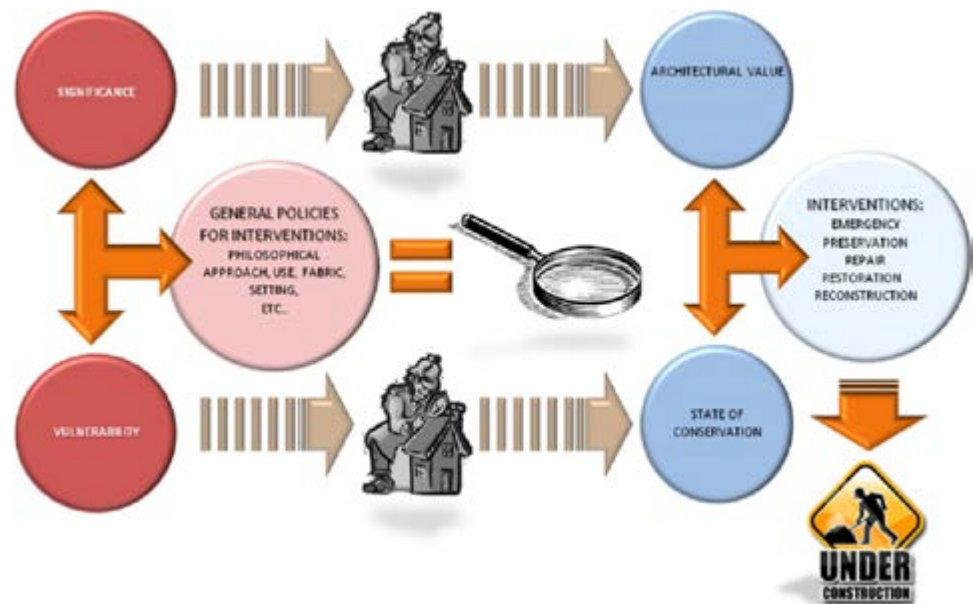
**FIGURE 2.14**  
General site documentation methodology scheme.  
Diagram: Claudia Cancino, 2011.

The ultimate objective of the site survey process was to become a tool for CERKAS in making decisions about general policies as well as specific actions for interventions (long and immediate term) for the site of Taourirt. General policies were based on the site level of significance and vulnerability. Specific interventions will be under the umbrella of the general policies and will be based on the site's architectural values and current conditions. This scheme was used to better define the information to be collected (fig. 2.14).

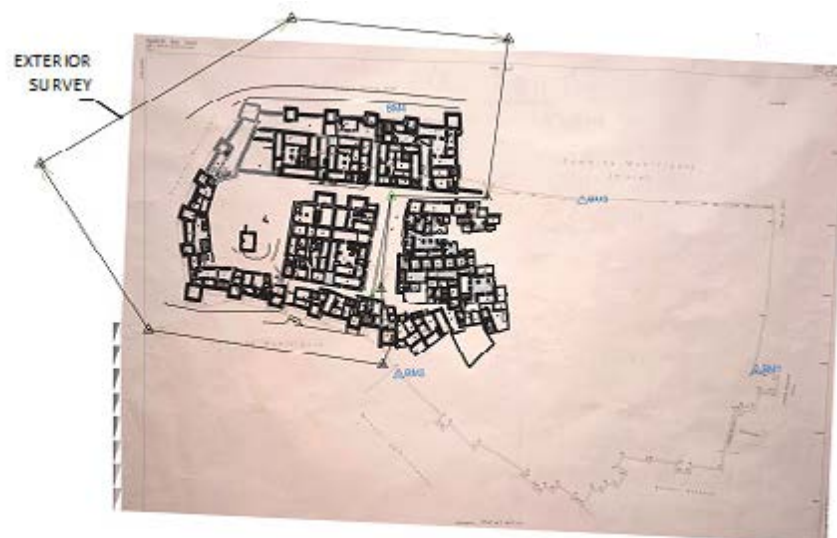
**FIGURE 2.22**

CIMS survey markers (BMs in blue) and topographic exterior points.

The support team, prior to the start of the documentation of the Stara portion of Kasbah Taourirt, established a survey network to allow both production teams to measure heritage records in a common coordinate system (fig. 2.22). Once this system was established in the first days of the campaign, the two teams started their work by dividing the kasbah into two areas of survey to ensure that there would be no duplication.

At the end of the campaign, survey markers were established at four strategic locations to help ensure that any future survey work could be tied to the captured information from the 2012 recording campaign. Although these are in a local coordinate system established by the 2012 documentation team, these points will allow the matching/transformation of any future work to the existing measured drawings.

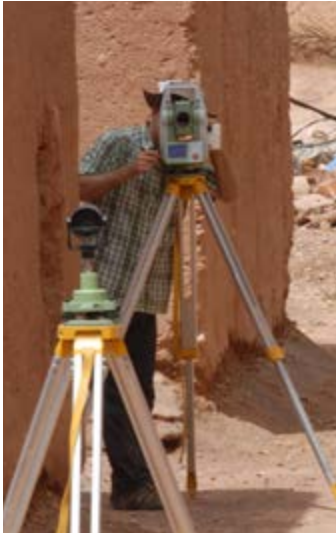
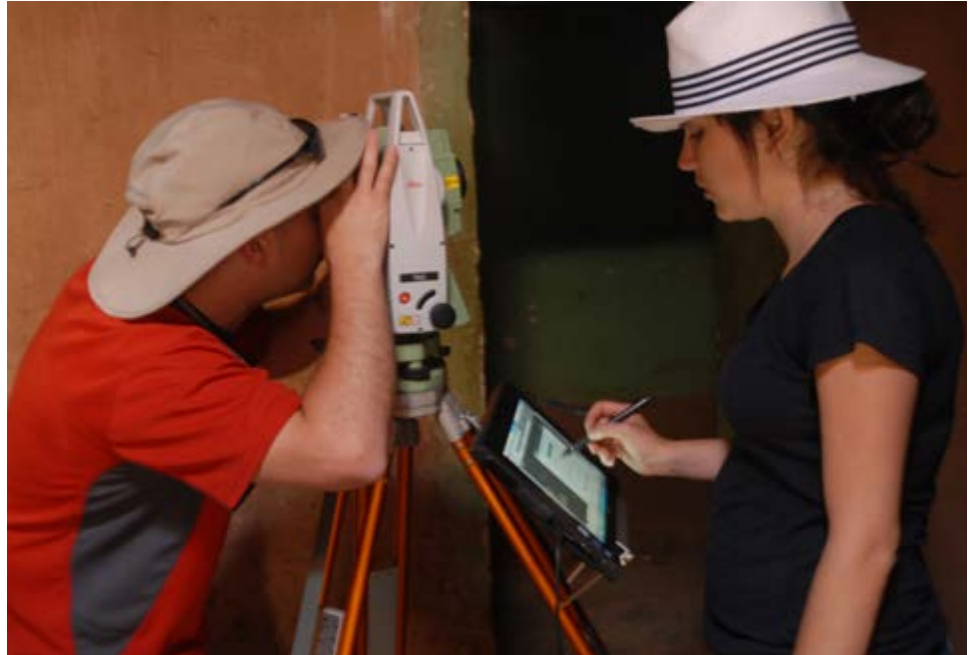
**FIGURES 2.23 AND 2.24**  
CIMS team members recording points using the total station.  
Photos: Claudia Cancino, 2012.

The documentation of the kasbah was primarily achieved using two methodologies. The first was done using a direct survey technique. This involved surveying the exterior and interior spaces with a total station, which was connected to a tablet PC, thus allowing the data to be directly transferred to CAD on site. Any obstructions were hand measured and input directly into CAD (figs. 2.23 and 2.24).

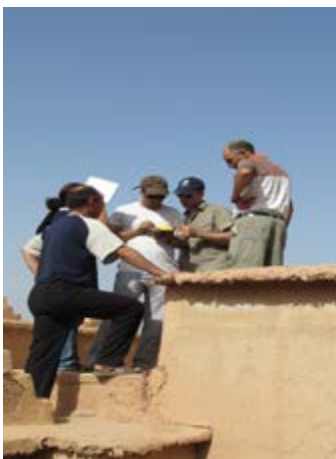
**FIGURE 2.30**

CERKAS team members using a GPS to link the local coordinate system with the national grid. Photo: Mario Santana, 2012.

To link the architectural survey with the provided ground plan of the kasbah, four coordinates were selected in both the local system and Moroccan Lambert system. Originally a GPS unit equipped with European real-time EGNOS correction was selected to link the local coordinate system with the national grid; however, given the better accuracy of points provided by the “Moroccan Topographic Institute,” this device was mainly used for training CERKAS staff (fig. 2.30).

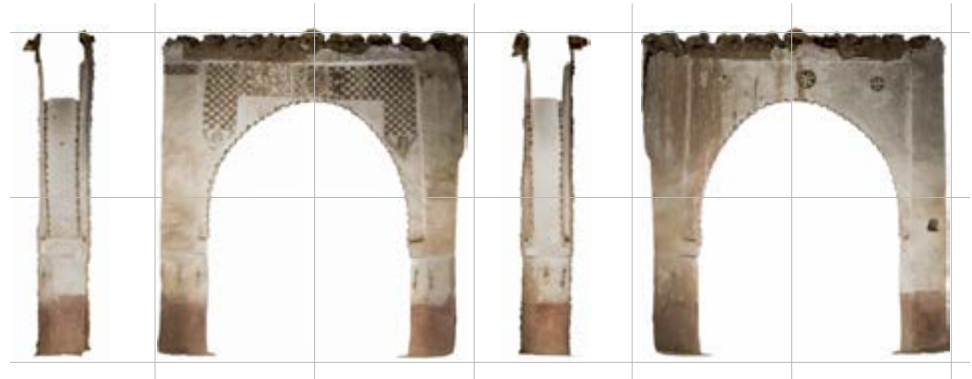
**FIGURE 2.31**

Scheme showing the process used to create panoramic photos. Photos: CIMS, 2012.

Due to the complex geometry and highly decorated wall surfaces in a collection of rooms at the Caïd Residence, digital photogrammetry was used as an accurate documentation technique. Photogrammetry was chosen to produce high-resolution orthographic photo elevations, scaled and laid out to allow condition assessment of the wall paintings to be accurately recorded in situ (fig. 2.31).

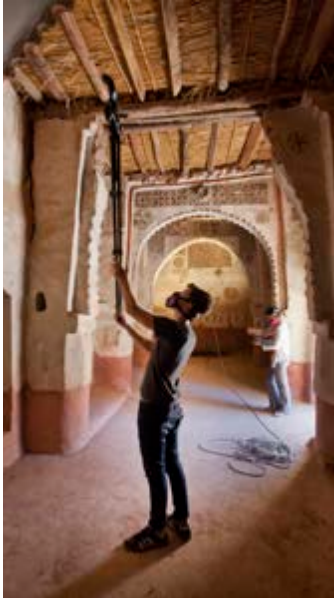
**FIGURES 2.32 AND 2.33**

Top: GCI team member taking photographs of the wall paintings. Photo: Scott Warren, 2014.  
Right: Orthographic photography of the northwest interior wall paintings of the Caïd Residence. Photo: CIMS, 2014.

Photographs were captured using a hand-held digital camera mounted on a tripod, a low-cost lighting kit consisting of four speedlights/flashes equipped with diffusers, and wireless transmitters mounted on light stands or placed on the floor (fig. 2.32). Even lighting was required for consistent and evenly exposed photographs.

A sequence of overlapping images was captured, making sure all the required surfaces are recorded in at least two images. The photographs were batch processed for white balance using one adjustment as only the speedlight/flashes were used as a light source (fig. 2.33).

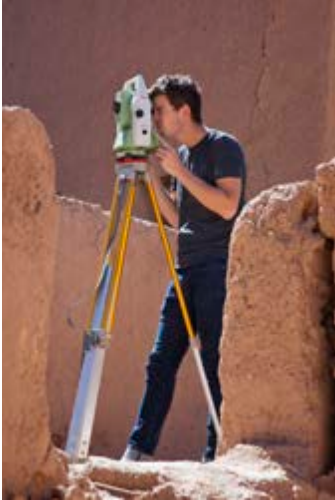
**FIGURES 2.34**

GCI team member using the total station at the Caïd Residence to collect control points.

In order to orient and scale the resulting point clouds, a total station was used to collect control points with 3D coordinates (x,y,z) that link these models to the overall kasbah survey, allowing surface and volume measurement as well as the correct geospatial orientation of the model (fig. 2.34).

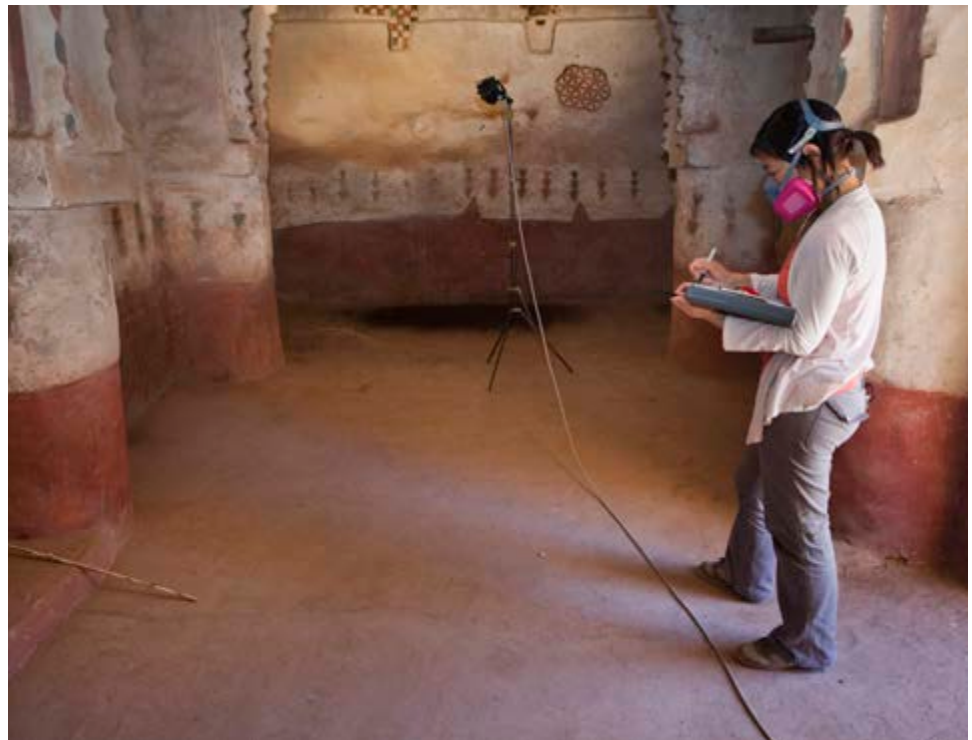
**FIGURE 2.35**

GCI staff performing condition assessment of the wall paintings using orthographic photography.

This registration of the model also facilitates breaking the model down into zones wall by wall. Because all the separate zones are registered in the same coordinate system, they can be loaded, viewed, edited, and exported separately or collectively. Models were exported in OBJ format, allowing the open-source software Meshlab to create orthographic photo elevations. These images were then scaled and arranged in AutoCAD, printed, and used for the condition assessment of the wall paintings (fig. 2.35).

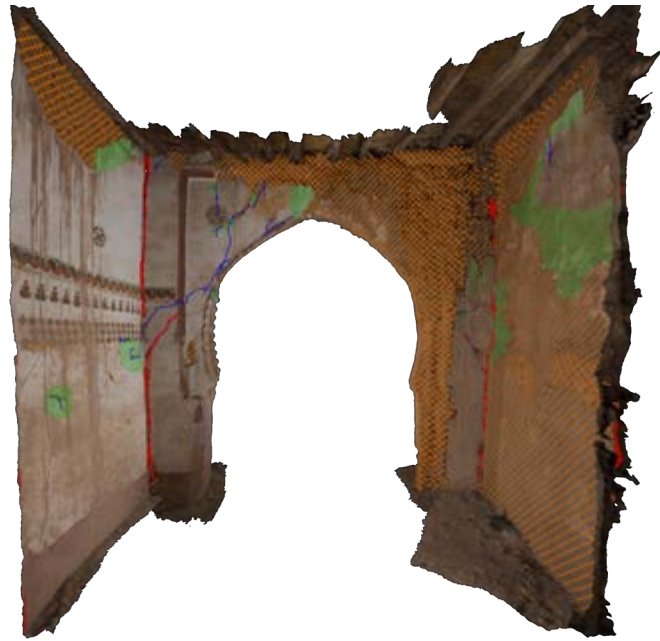
**FIGURE 2.36**

Rendering of the 3D photogrammetric model (OBJ format) with the condition assessment created using Adobe Photoshop.

Once the condition of the wall paintings had been recorded and digitized in AutoCAD, these images could then be used to re-render the photogrammetric model with the output of the condition assessment, creating a 3D model including the condition assessment of the wall paintings (fig. 2.36).

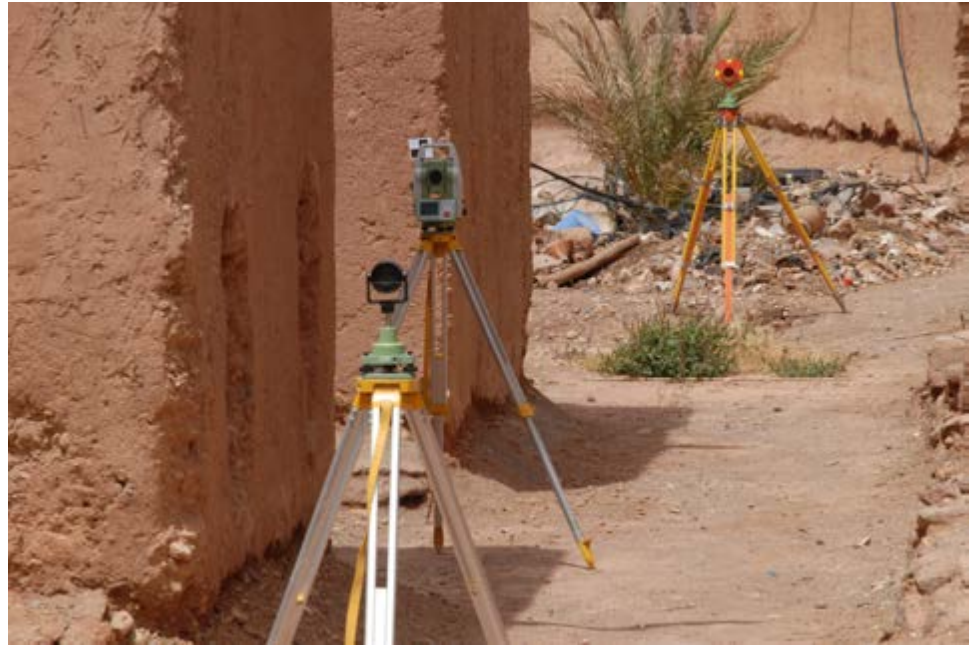
**FIGURE 2.38**

Total station equipment used for the development of the architectural survey.

- Leica Geosystems Total Station TS11, with a distance accuracy of 2 mm and angular 2 ppm (fig. 2.38)
- Leica Geosystems Total Station TS06, with a distance accuracy of 1.5 mm and angular 2 ppm
- Leica Geosystems TCR405 Power, with a distance accuracy of 2 to 4 mm and angular 2 ppm
- Leica Geosystems TCR304 (provided by the GCI to CERKAS), with a distance accuracy of 2 to 4 mm and angular 2 ppm

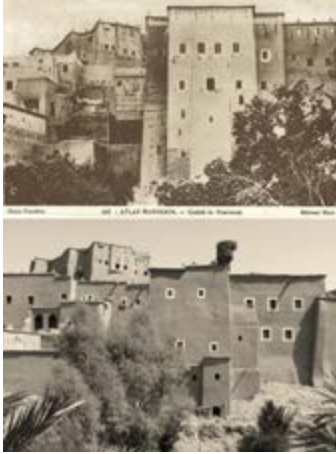
**FIGURE 3.3**

Views of south facade of the kasbah in the 1920s (top) and in 2011 (bottom). The morphological changes over the years help to establish the chronology of the kasbah.

Due to the fact that photographs were rarely accurately dated, the GCI has created a database of photographs that includes information regarding the subject, author, approximate date, source, and copyright (appendix D). Photographs have been dated through comparison between written documentation and features shown in the images. Comparisons between historical and modern views (figs. 3.3, 3.4, and 3.6), taken from the same vantage points, help to clarify transformations over time.

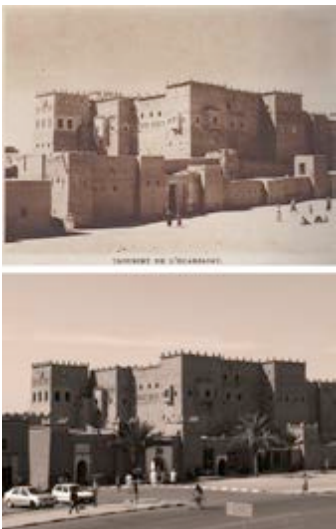
**FIGURE 3.4**

Views of north facade of the kasbah in the 1930s–40s (top) and in 2011 (bottom).

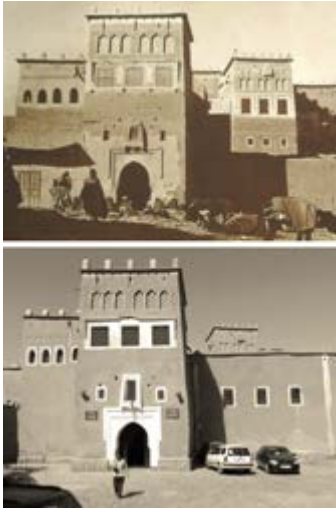
**FIGURE 3.6**

Views of former entrance to the kasbah in 1950 (top) and in 2011 (bottom).

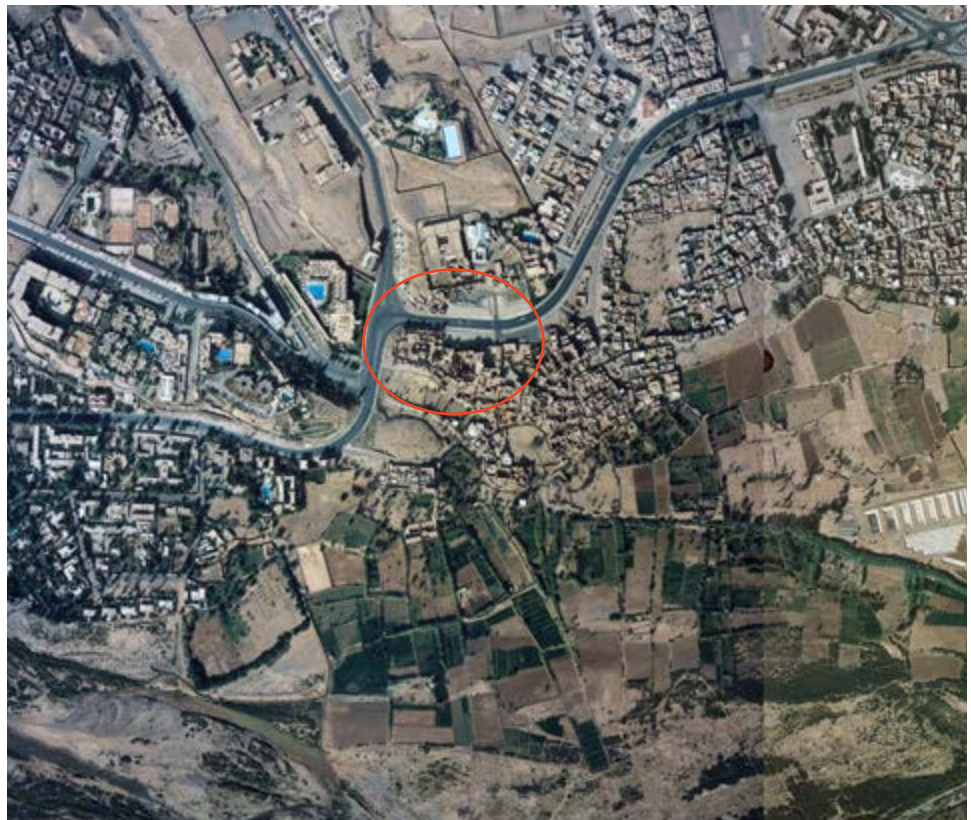
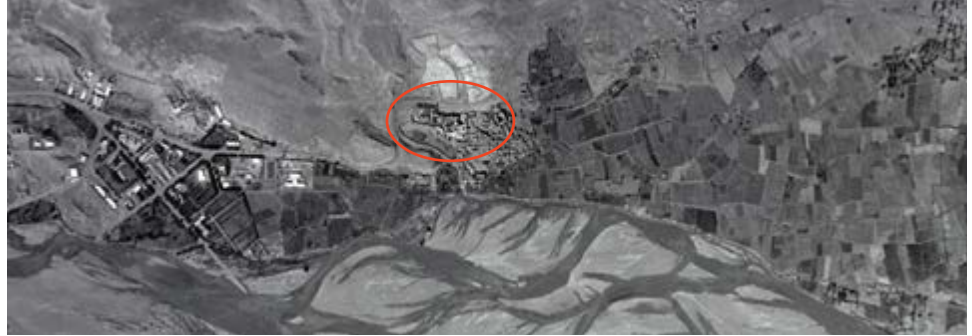
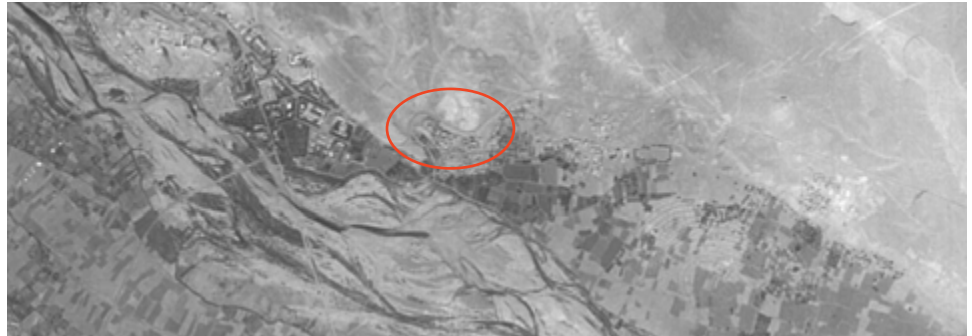
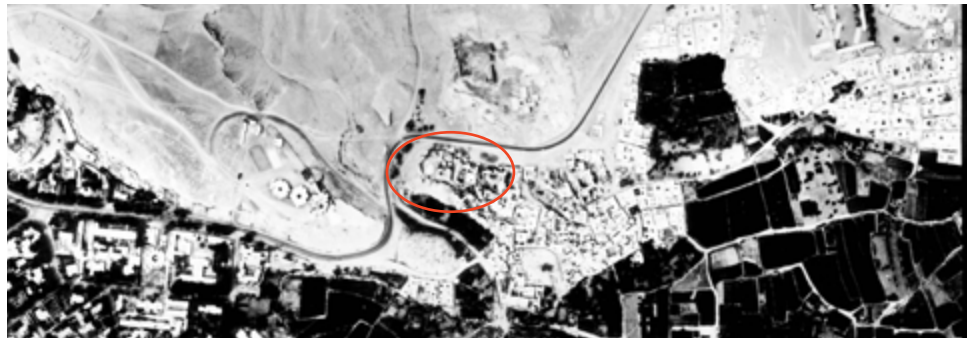
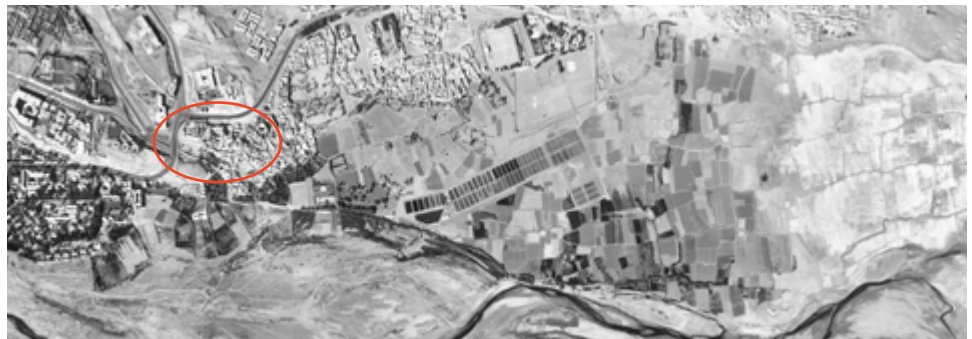
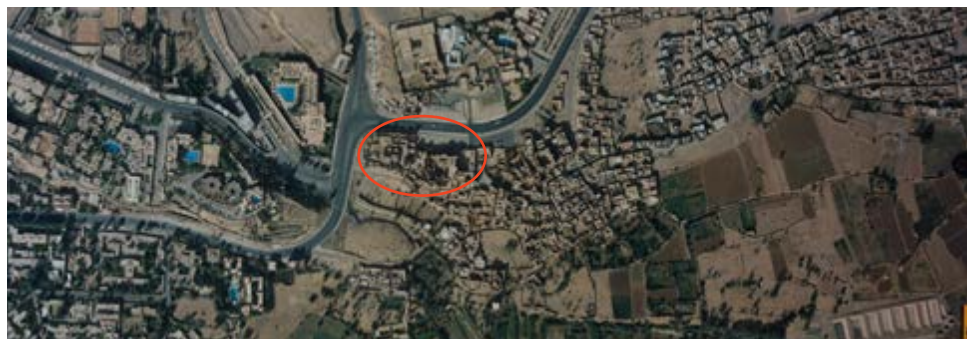
**FIGURES 3.15-3.19**

Photos showing urban evolution around Kasbah Taourirt (in red) from 1920 to 2009.

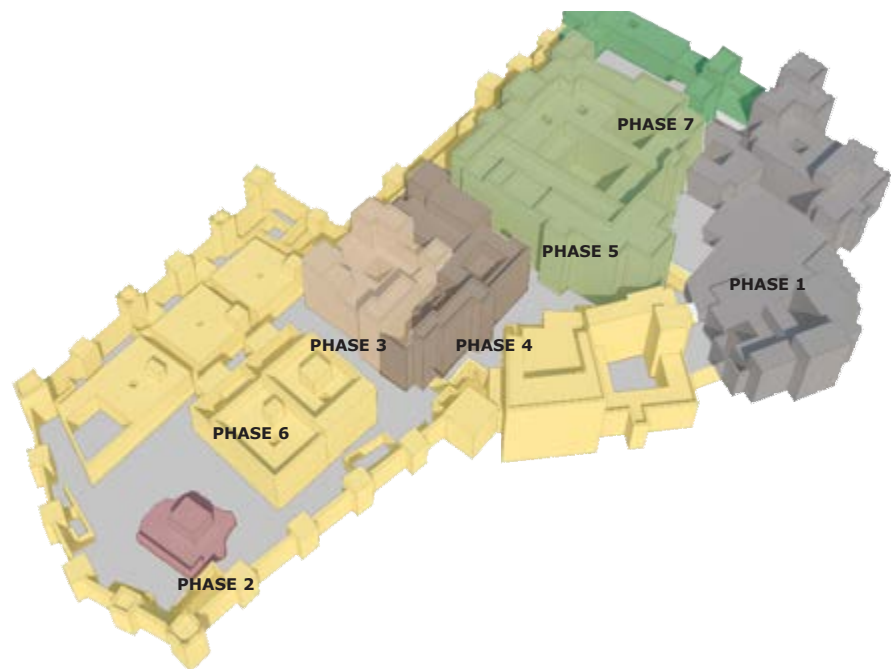
**FIGURES 3.20–3.30**  
Chronology of construction at Kasbah Taourirt, showing the different historical phases.  
Drawings: Elena Macchioni, 2013.

Through the combination of oral and written history with on-site investigation, the models link historical events and changes in power or ownership to alterations in the physical fabric of the site. However, establishing exact construction phases in earthen architecture is a challenge. The nature of earthen construction—in which the same material is used for masonry units, mortars, and plasters, and much of the masonry is rendered (most of the time, the construction details of the walls cannot be seen)—together with the continuous evolution of the complex, makes exact mapping of alterations difficult. Hence, the models highlight major campaigns of construction or alteration, while historical events associated with each phase are explained in the accompanying text.

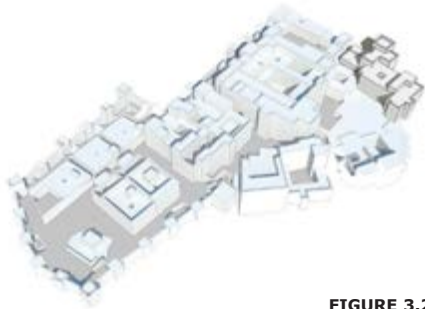
FIGURE 3.21

**17th Century** (Phase 1)

The earliest part of the kasbah, the area occupied today by the offices of CERKAS (fig. 3.21), is said to have been built in the seventeenth century. This structure is built on the edge of the palm grove and close to the historical ksar, which fits with traditional patterns of residential construction around the periphery of oases in the region. It was completely reconstructed in the nineteenth century.

These documents were used to develop schematic 3D models of the site. The models explain visually the chronology of construction over time and highlight different historical phases (fig. 3.20). In the models shown in figures 3.21 to 3.30, the areas in red represent new construction or additions to existing buildings, which are represented in white. Yellow areas represent demolition or deterioration, which occurred mostly in the late twentieth century.

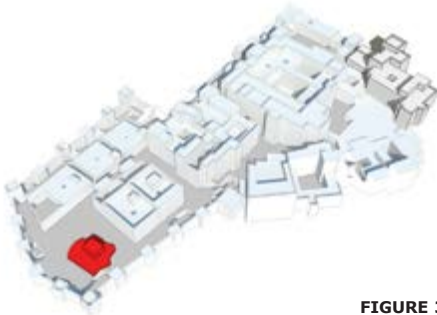
FIGURE 3.22

**18th-19th Century** (Phase 2)

The second oldest part of the kasbah, according to oral tradition, is the Marabout, dedicated to Saint Sidi Boussaid (fig. 3.22, in red). This structure is thought to have been built in the late eighteenth to early nineteenth century. During this period, the Caïd Si Mohamed ou Abdellah, named representative of Sultan Moulay Abderrahman ben Hicham (1822–59), is said to have lived in the kasbah.

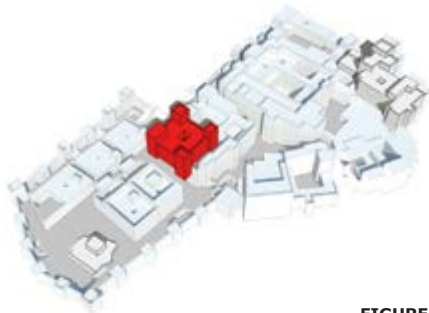
FIGURE 3.23

**Ca. 1860** (Phase 3)

The core of the Stara East is a traditional kasbah structure, with a central courtyard and four towers, now partially obscured by later additions (fig. 3.23, in red). According to oral history, this kasbah is said to have been occupied and possibly built by the successor to Caïd Si Mohamed ou Abdellah, another *amghar* (tribal leader) by the name of Mohamed ou Hmad ou Abou, who came to power in 1860. He was the leader of the Tamnougalt caïds, though his power is said to have been limited compared to that of his Glaoui successors.

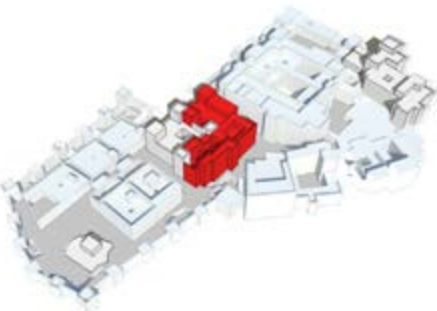
FIGURE 3.24

**1870s** (Phase 4)

The Stara East expands with the addition of new structures, specifically on the south and east sides (fig. 3.24, in red). One of these new structures will become the house of Mohamed (a son of the Caïd) and his children. This building has the traditional spatial configuration typical in the kasbah and of the region, with a two-story central courtyard surrounded by pillars and residential rooms.

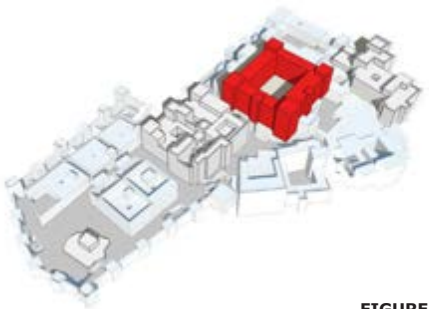
FIGURE 3.25

**Ca. 1882** (Phase 5)

Hammadi, son of Mohamed Ibibt el Mezouari and brother of Madani el Glaoui, established himself at the death of Mohamed ou Hmad ou Abou in the structure known as the Caïd Residence, built in the early 1880s. The structure was originally based on a square plan with a central courtyard and a defense system known as *gri igidar* (fig. 3.25, in red). This Amazigh word refers to a construction system of double walls with a 60 to 80 cm space between them. This space was used to prevent entry if one of the walls was breached and to allow for surveillance and attack from anywhere within the walls.

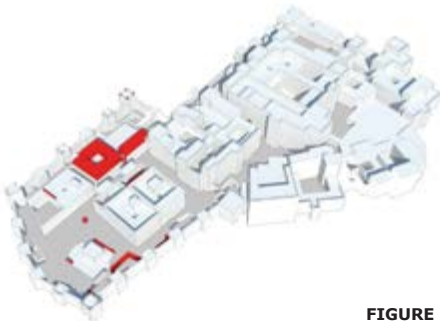
FIGURE 3.27

**1900s-1930s (Phase 7)**

The last major building activity at the kasbah occurred in the early twentieth century and included the construction of portions of the northeastern part of the Caïd Residence, where the most decorated towers can be found (fig. 3.27, in red). In this period, the Cannon Square and its associated structures were also built.

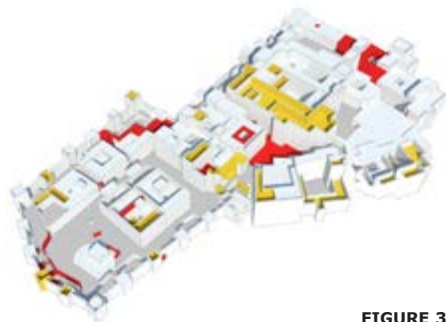
FIGURE 3.28

**1930s-1950s**

During this period, several additions were made in the Stara area, particularly the construction of second-story rooms above the one-story Atelier buildings (fig. 3.28, in red).

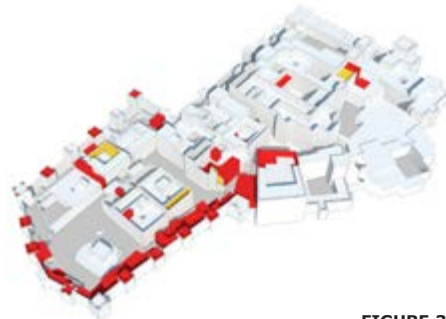
FIGURE 3.29

**1950s-1980s**

Kasbah Taourirt was occupied by the Glaoui family until the end of the French Protectorate. In 1954, the kasbah was added to the Moroccan National Heritage List, and in 1956 control of the property passed to the Moroccan state. In the early 1960s, the state returned ownership to the Glaoui, and in 1972 the kasbah was sold by the Glaoui heirs to the Municipality of Ouarzazate. With no inhabitants or maintenance in this period, the kasbah rapidly fell into ruin and was largely abandoned until the late 1980s (fig. 3.29, collapses in yellow; alterations in red).

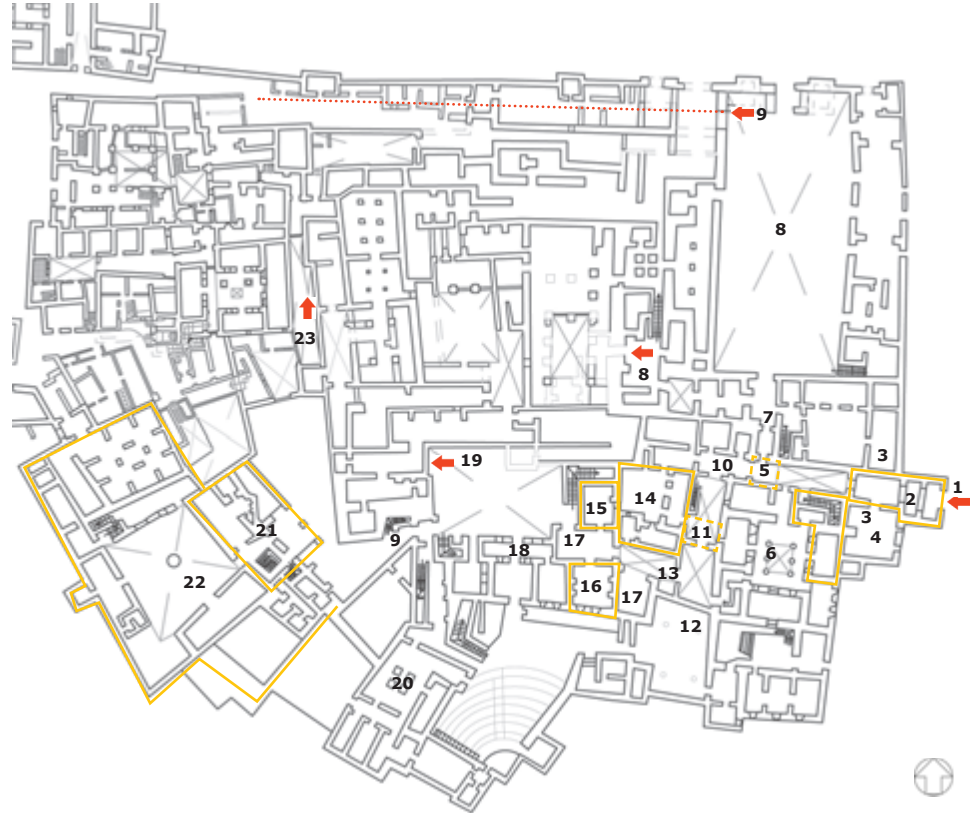
**FIGURE 3.41**

Schematic plan of east sector of Kasbah Taourirt.

This section includes references to the schematic plan in figure 3.41. An element of the kasbah or ksar is followed by a number in parentheses, corresponding to its location on the schematic.

From Tigmi lajdid, it was possible to get through a gateway to one of the numerous Caïd's *Menzeh* (apartments). One of these apartments, called El Menzeh N'imi N'indaf (7), was located next to the gateway of the same name. This Menzeh had an official function as the courthouse where the Caïd issued his rulings. Next to the courthouse was a room where the Caïd prayed, especially on the Lailat Al Kadr, or "night of ordainment," the twenty-sixth day of Ramadan, during which the Prophet received his first revelation.

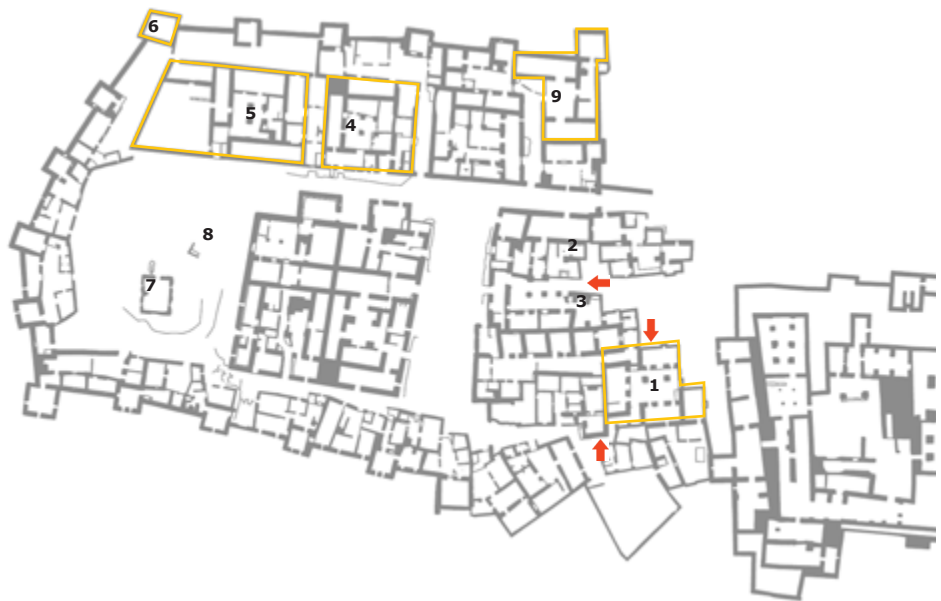
**FIGURE 3.46**

Schematic plan of the west sector of Kasbah Taourirt. Doors used at the time of the Caïd are marked with red arrows.

*The following section includes references to the schematic plan in figure 3.46. An element of the kasbah or ksar is followed by a number in parentheses, corresponding to its location on the schematic.*

There is one Marabout inside the kasbah called Sidi Bouzid (7)(fig. 3.47), where Moulay Abdellah Outhar, who, according to tradition, is a descendant of the Prophet, is buried. Inside are seven or eight graves and two more outside. On the northern side of the Marabout was a well, later on a fountain (8). The surrounding open space was used to slaughter animals for both religious ceremonies and food preparation. In this place, an oven could also be found. It is important to mention that there was another Marabout outside the kasbah that had a strong relation to the one inside (some religious ceremonies involved the use of both at the same time).

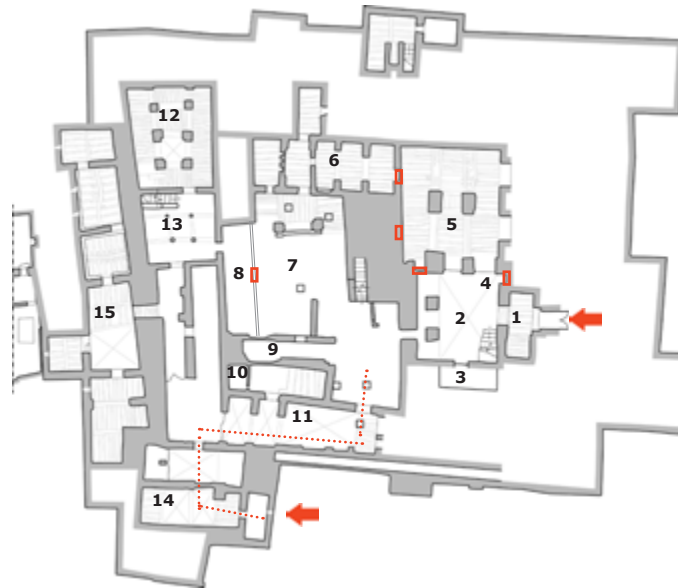
Legend:

1. First gate
2. Small courtyard
3. Room with a well
4. Access to the staircase
5. Kitchen
6. Kitchen
7. Main courtyard
8. Room, now collapsed
9. Granary
10. Small hammam
11. Corridor to the second door
12. Residence
13. Main granary
14. Room where carpets were made
15. Original street, later a deposit

The following section includes references to the schematic plan in figure 3.54. An element of the kasbah or ksar is followed by a number in parentheses, corresponding to its location on the schematic.

There were two gates into the Caïd Residence, both leading to the inner courtyard, to which only the family of the Caïd, slaves, and laborers were allowed to enter. The first gate (1), still existing, leads to an open courtyard on the eastern side of the building. The second gate, Imi n'Iflwane, was on the ground floor of the tower called Borj Lalla Ftoum and today opens onto the CERKAS courtyard.

Entering the inner part of the Caïd Residence from the entrance, one sees a small courtyard (2) surrounded by service spaces. On the south side, a room (3) with a well was used for washing. Above it on the second floor was a room for the storage of meat. On the east side, one door (now walled) gave access to a staircase leading to the upper floor (4). The space on the north side of the courtyard was used as a kitchen (5) and was connected by two doors to the main courtyard and to a second space also used as a kitchen (6).

The main courtyard (7), called *tarhabit*, was used as a service area with animals, grinding mills, and ovens, and had an underground cistern. Originally, it probably was partially covered, with an open courtyard in the center. On the west side, there was a room (8), now collapsed, with a central door. The south side room was used as a granary (9); south of it was a small hammam (10). No remains can be found of a building on the southeast side of the courtyard that appears in aerial photographs. A corridor (11) led to the second door of the Caïd Residence, on the east side of Borj Lalla Ftoum. On the ground floor of the tower was a room where carpets were made (14). The space around a central light well had a residential use (12). The

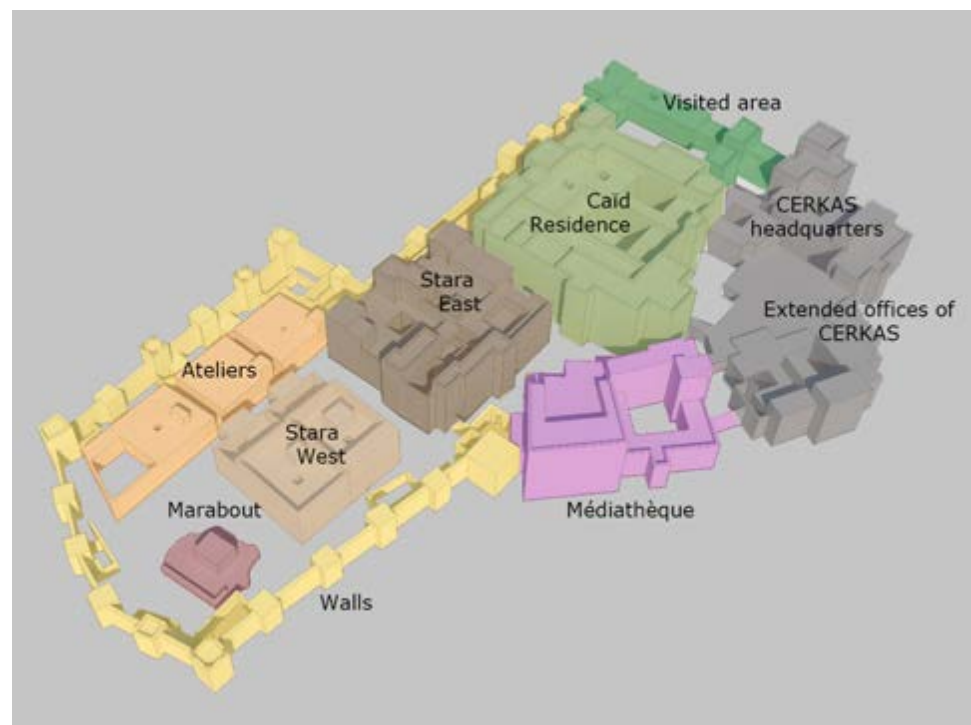
**FIGURE 4.1**  
Schematic model of Kasbah Taourirt, showing the various structures that compose the kasbah.  
Diagram: Elena Macchioni, 2013.

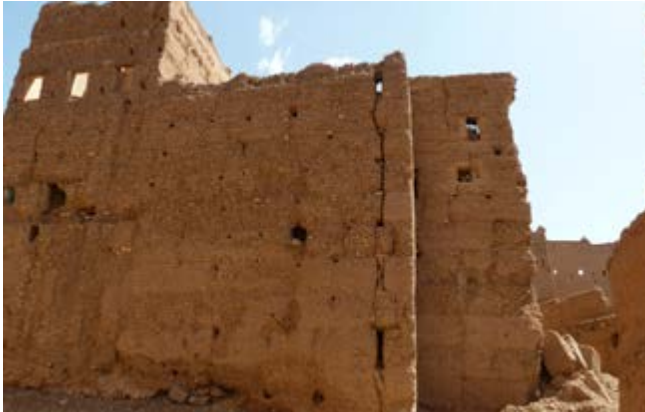
Stara East, west facade.

#### Structural crack

Crack through a load-bearing wall. Characterized by crack thickness in the order of centimeters. Also applies to diagonal or shear cracks and through-wall cracks of variable thickness.

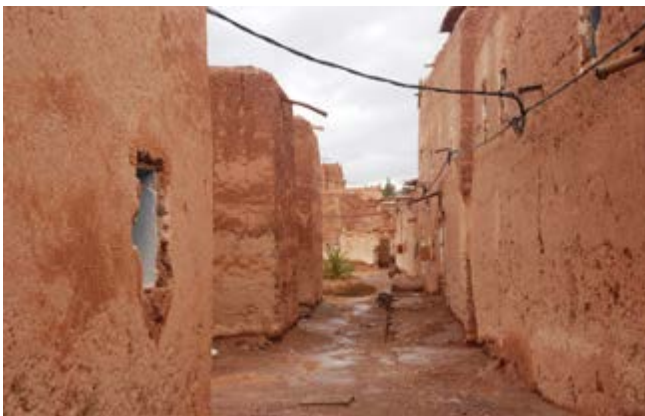
Stara, eastern Atelier.

#### Basal erosion (coving)

Erosion/loss of material at the base of walls resulting in loss of wall section thickness. Typically due to rising moisture, salts, or use of an impermeable coating such as cement.

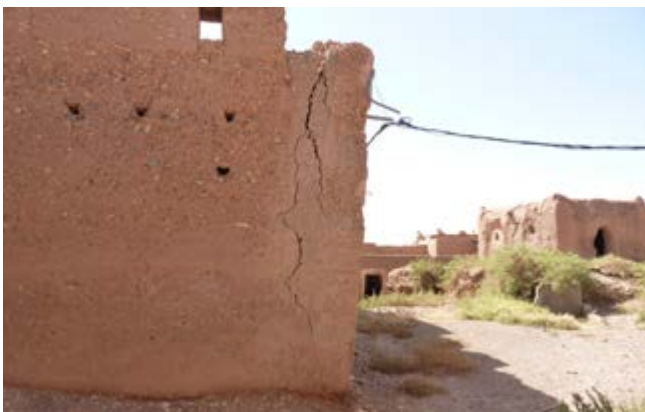
Stara West, northwest corner.

#### Leaning wall

Out-of-plane wall. Planar wall movement is generally due to failed connections with other walls or beams, shallow foundations, or basal erosion/saturation from lack of drainage.

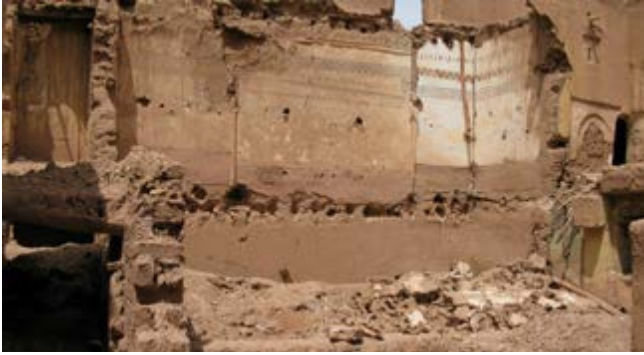
**FIGURE 4.7**

### Unstable free wall

Unstable or partially collapsed wall section that lacks wall-floor connection and/or connection with adjacent walls.

Caïd Residence, interior courtyard wall.  
Photo: Elena Macchioni, 2014.

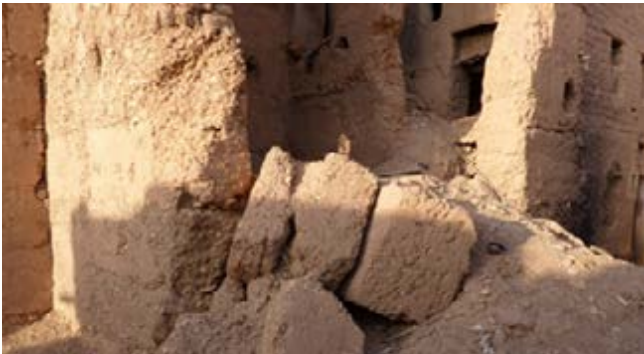
**FIGURE 4.8**

### Collapsed wall

Missing wall section showing debris and remains of recently collapsed wall.

Stara East, southwest corner.  
Photo: Sebastien Moriset, 2011.

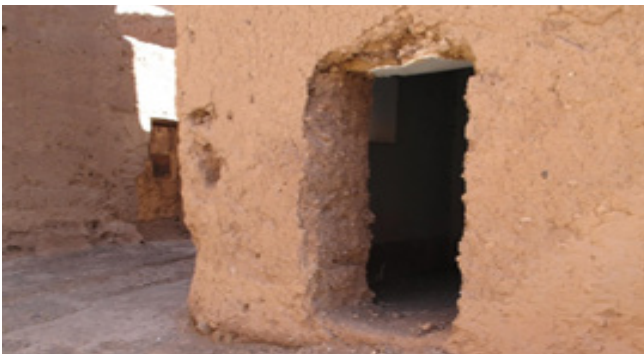
### Loss due to alteration (structure)

Loss of historic fabric due to recent alterations such as the introduction of new doors, windows, and conduits.

Introduced doorway, Stara East, northwest corner.  
Photo: Benjamin Marcus, 2013.

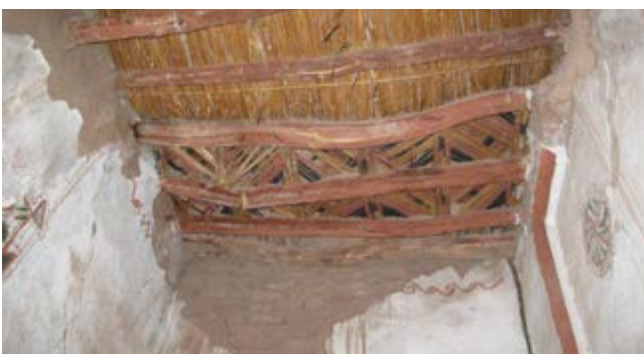
**FIGURE 4.10**

### Beam failure

Failure or collapse of individual roof beams, generally due to localized water pooling combined with an overloaded roof.

Caïd Residence, rear decorated room ceiling.  
Photo: Benjamin Marcus, 2013.

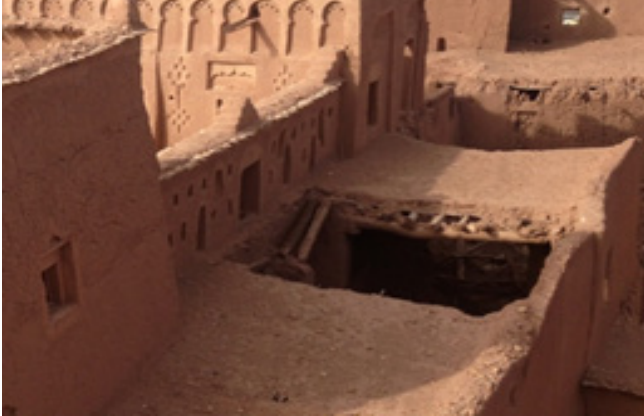
**FIGURE 4.11**

### Collapsed roof

Partial or total loss of a roof or roof section including roof surface and supporting structure.

Collapsed roof at Caid Residence.  
Photo: Benjamin Marcus, 2013.

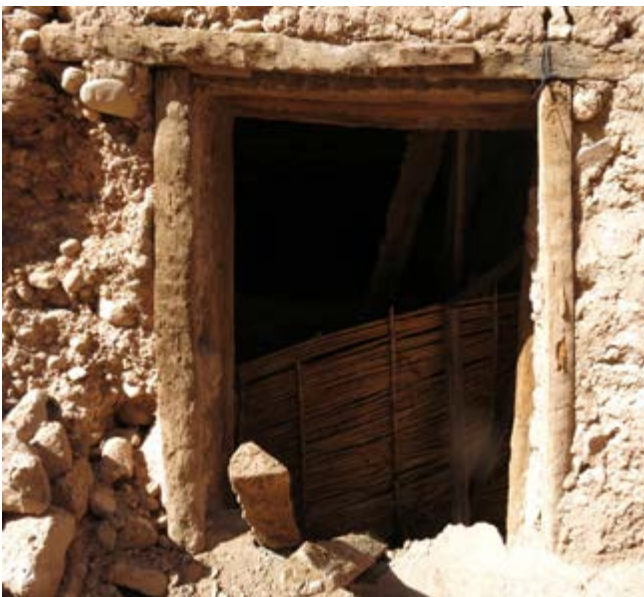
**FIGURE 4.12**

### Deteriorated lintel

Damaged or weakened lintel that typically causes structural deformation of supported masonry, resulting in areas of settling, cracking, or collapse above the doorway.

Doorway, Stara West.  
Photo: Claudia Cancino, 2013.

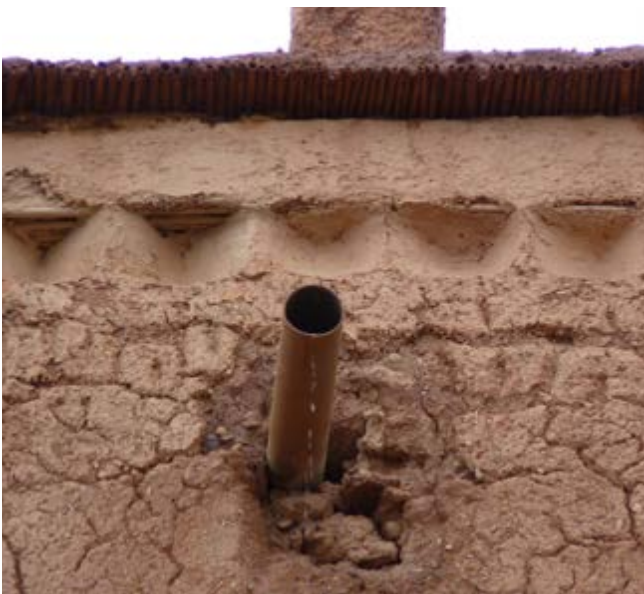
### Failed drainage

Failed or blocked drainage that causes damage to the adjacent fabric. May also be related to roof failure or improper slope of the roof surface.

Failed drainage at the visited area.  
Photo: Sebastien Moriset, 2011.

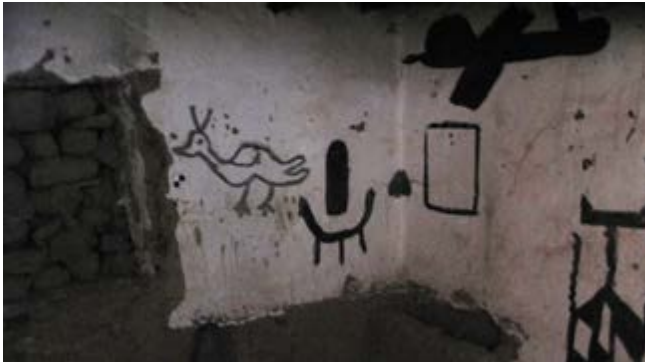
**FIGURE 4.14**

### Loss due to alteration (surface)

Loss of historic surface finish due to alterations or additions to the building fabric.

Loss of surface finish at Caïd Residence.  
Photo: Benjamin Marcus, 2013.
