# Conservation and Rehabilitation Plan for Tighermt (Kasbah) Taourirt, Southern Morocco

## Research Report

Claudia Cancino, Benjamin Marcus and  
Mohamed Boussalh

# Conservation and Rehabilitation Plan for Tighermt (Kasbah) Taourirt

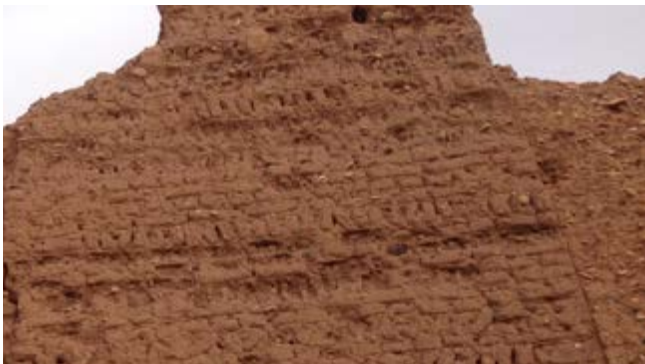
**FIGURE 4.15**

### Erosion

Heavy weathering that results in complete loss of wall surface, deep pitting, and/or loss of masonry unit integrity.

Erosion in the Caïd Residence, outer wall of western rooms.  
Photo: Benjamin Marcus, 2013.

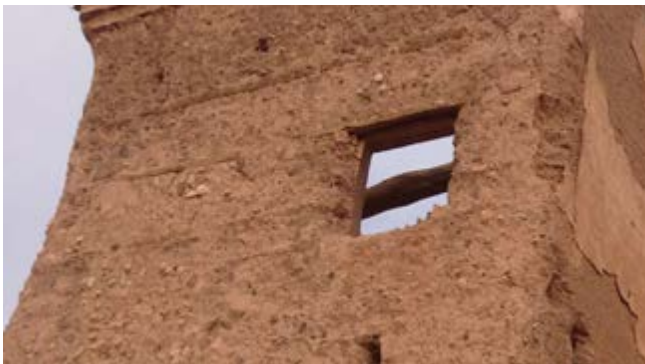
**FIGURE 4.16**

### Surface erosion

Shallow erosion limited to the masonry surface that does not affect the masonry unit or structural integrity of the wall.

Surface erosion in the Caïd Residence, outer wall of western rooms.  
Photo: Benjamin Marcus, 2013.

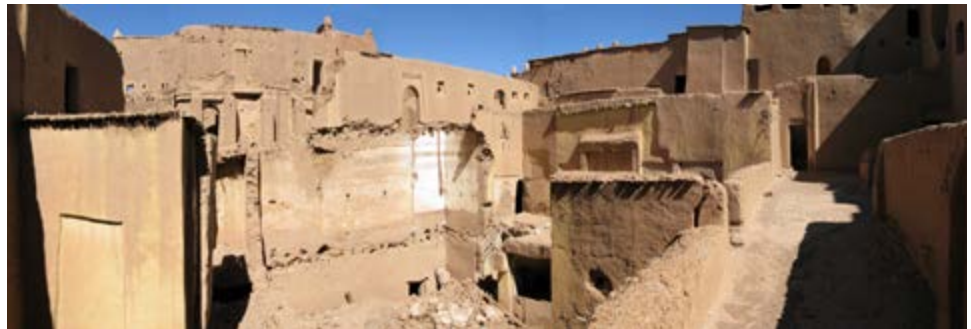
**FIGURE 4.19**

Example of the use of mud brick on upper walls at Stara West.

Adobe, or mud brick, is generally used for the upper floors of towers and parapets of structures where decorative surfaces and window openings are common (fig. 4.19). Decorative features such as arches, recessed niches, and traditional Amazigh designs are all executed in brick and then covered in earthen plaster. Mud brick is also used for the construction of smaller partition walls, staircases, and columns on the interiors of buildings.

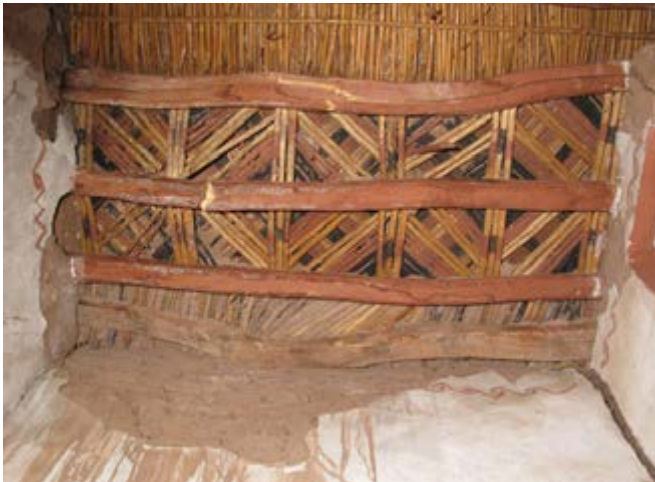
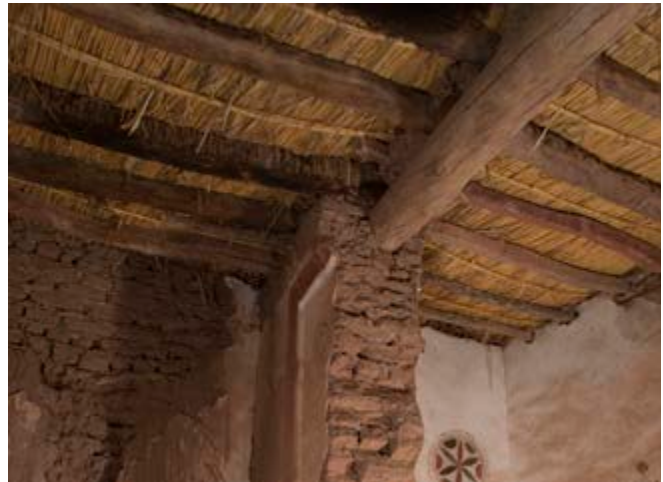
**FIGURES 4.20 AND 4.21**

- **Tataoui:** Spaces used for entertaining guests or for other high-level ceremonial functions were often constructed with tataoui ceilings. Tataoui employs layers of laurel wood and natural colors to create decorative patterns (fig. 4.20).
- **Reed:** In lesser spaces, simple reed matting is used with either poplar wood or palm wood beams (fig. 4.21).
- **False ceilings:** False ceilings employ a double layer of reed matting covered in plaster to create a smooth plaster finish, often in the form of a dome or incised with geometric shapes.
- **Painted wood:** Located primarily in the Caïd Residence, richly painted ceilings employ designs from Marrakech and convey the space's importance (fig. 4.22).

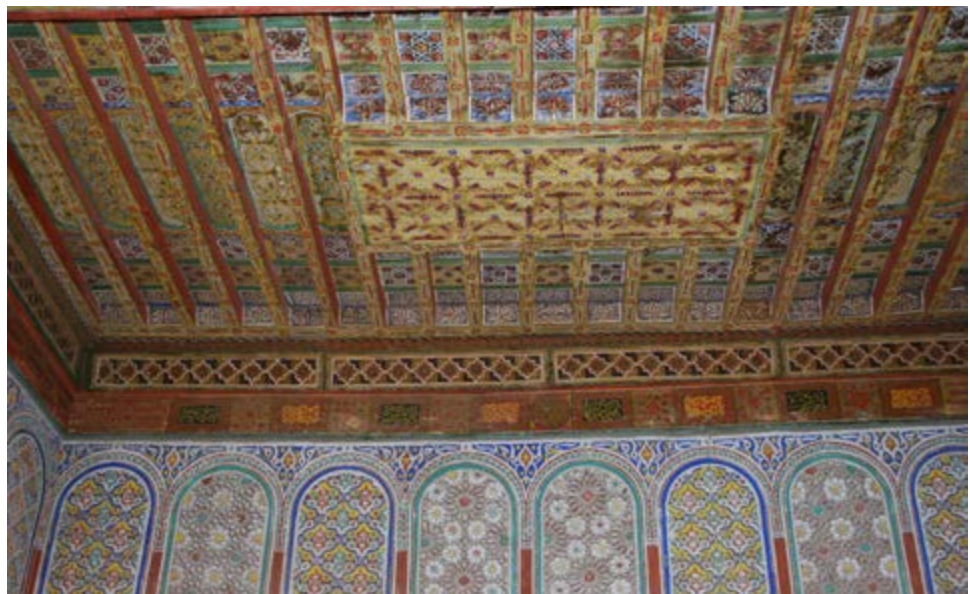
**FIGURE 4.22**

Painted wood ceiling with carved plaster frieze in the visited area of the Caïd Residence.

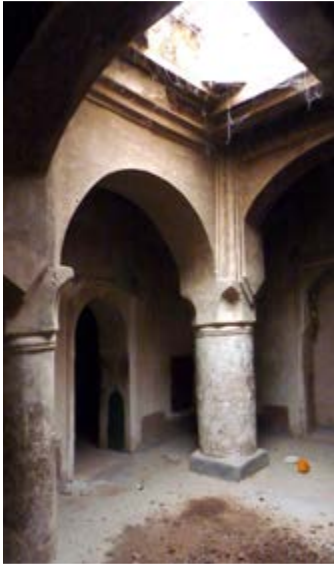
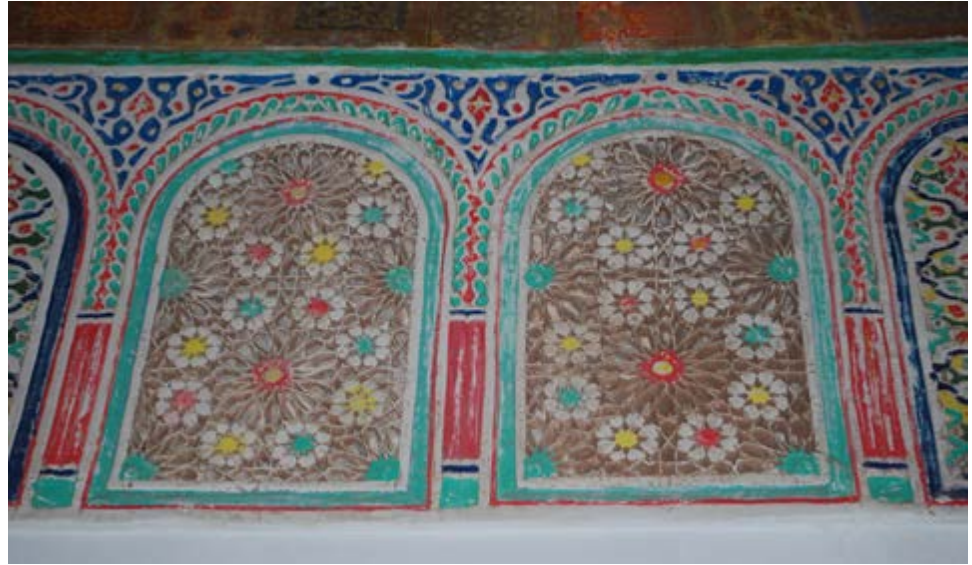
**FIGURES 4.23 AND 4.24**

Left: Tadalakht and gypsum room in the Stara East. Photo: Sebastien Moriset, 2011.

Right: Detail of carved and painted plaster panels in the Caïd Residence.

Gypsum plaster is used in many residential spaces as an interior finish. In particularly important spaces, it is formed into decorative shapes such as recessed arches and column capitals. In the Caïd's private residence, carved plaster panels were applied to the wall and painted in bright colors (fig. 4.23).

In some important spaces, particularly those that required water usage such as bathrooms or kitchens, a lime-based interior finish was used called *tadalakht*. Tadalakht is made from lime, sand, and egg white and rubbed with smooth stones and cloth to achieve a shiny, water-resistant finish. Such decorative gypsum and tadalakht work can be found in the Stara East (fig. 4.24).

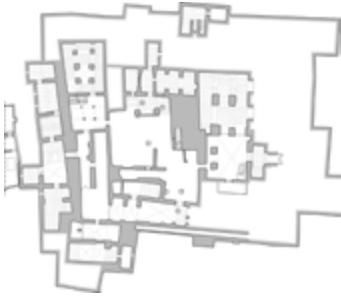
**FIGURE 4.26**  
Caïd Residence, ground floor.  
Drawing: CIMS, 2013.

A “reception” courtyard articulates the Caïd’s residence with the plaza situated north of the kasbah through a door (not original) that today is the tourist entrance. Old photos show this area as an open space with animal pens. Adjacent to the “new” entrance door are other recent constructions used by souvenir vendors.

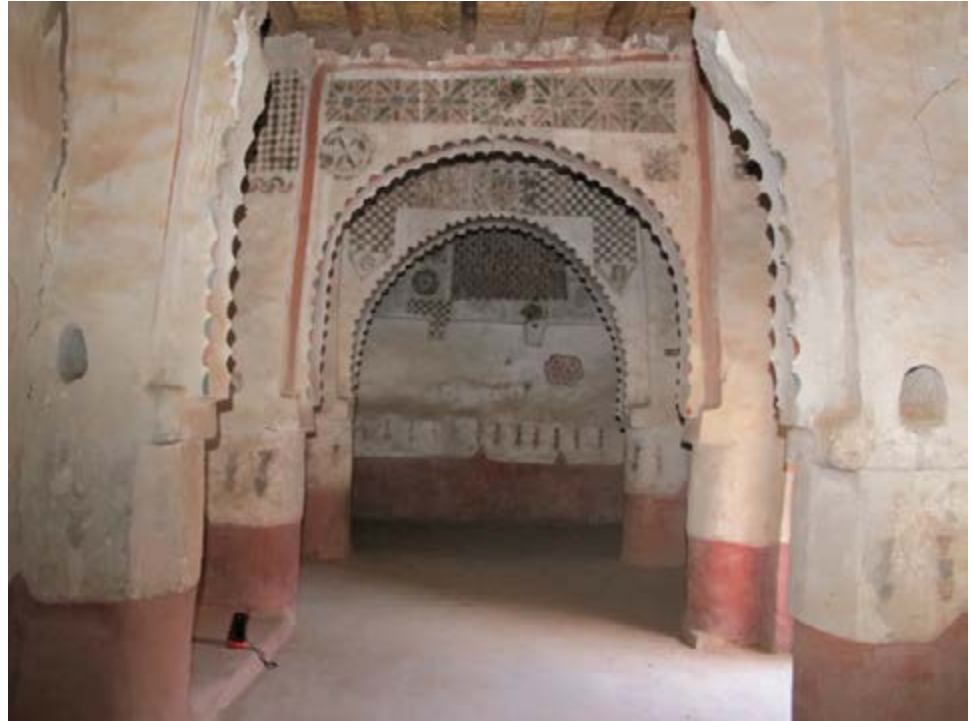
**FIGURE 4.27**  
North front room at the Caïd Residence.  
Photo: Lorinda Wong, 2013.

The northeastern rooms contain painted ceilings, ornate friezes on the upper parts of the walls, and fine carvings around the doorways. The decoration is largely inspired by the Marrakech style and uses its techniques and materials such as painted wood and carved and painted plaster. Adjacent to this area and directly connected to it are the buildings built around the central patio or courtyard, now partially in ruins.

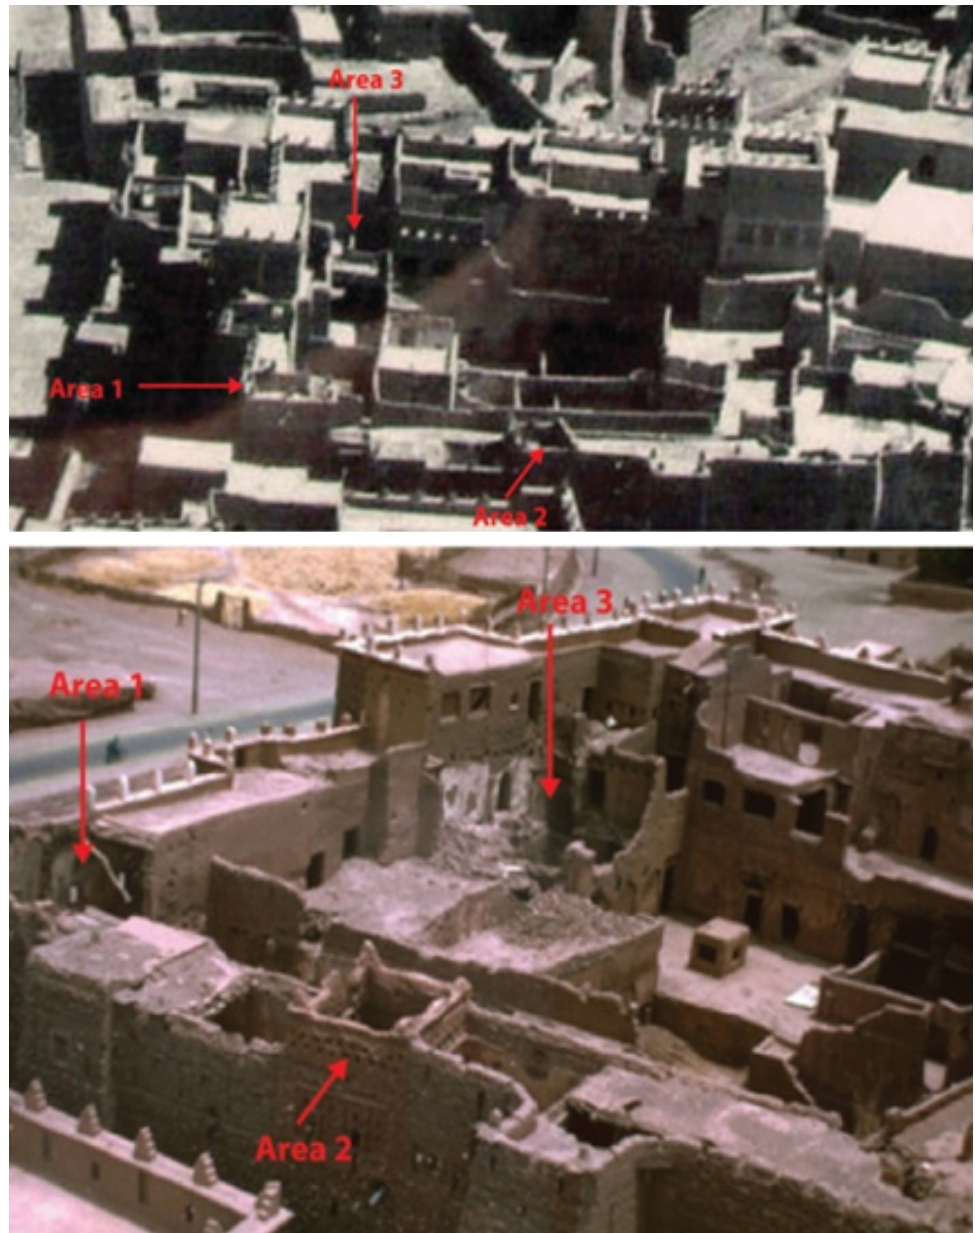
**FIGURES 4.30 AND 4.31**  
 Aerial photos taken in 1951 (top) and ca. 1970 (bottom), indicating areas of significant collapse.  
 Photos: CERKAS collection.

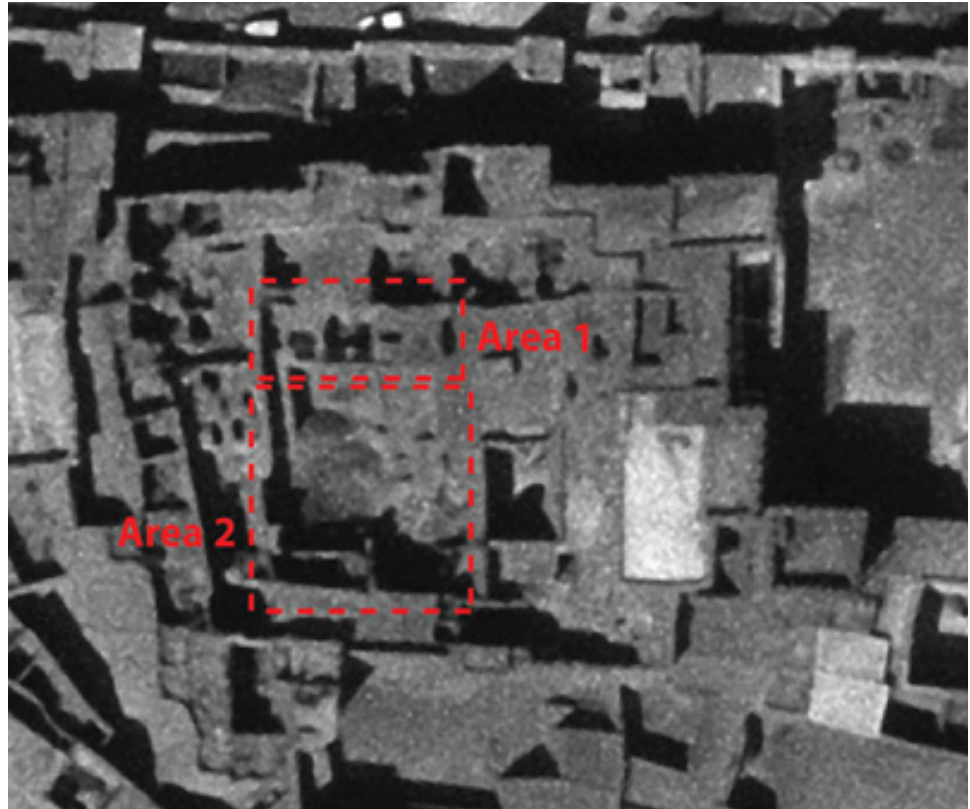
**FIGURE 4.32**  
Aerial photo (c. 1977) of the Caïd Residence, showing areas of change (in red).  
Photo: CERKAS collection.

The extent of change in this period of neglect can be seen in the aerial photograph estimated to date from 1977 (fig. 4.32). Area 1 appears to show further collapse or change to the roofs; this is the north front room where the most extensive painting is now found, meaning the painting may have been exposed in this period. Area 2 reveals what may be the collapse of the central courtyard and

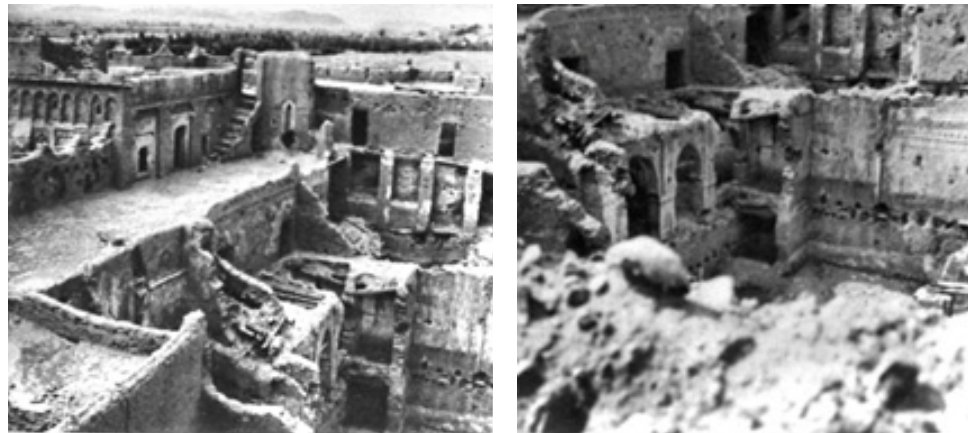
**FIGURES 4.33 AND 4.34**  
The area of collapse to the south and southwest is revealed by photographs taken ca. 1970.  
Photos: CERKAS collection.

Photographs estimated to have been taken in the 1970s of the southwest corner (figs. 4.33 and 4.34) show the extent of the collapse and deterioration in this area. West 1 room has collapsed, and the rooms to the south of the central courtyard are in a state of ruin.

The three images (figs. 4.33, 4.34, and 4.35) looking to the west of the building, taken in the 1970s, are the earliest available images of the wall paintings in the Caïd Residence, meaning the painting predates this period of neglect and may be linked to the time of occupation by the Caïd family.

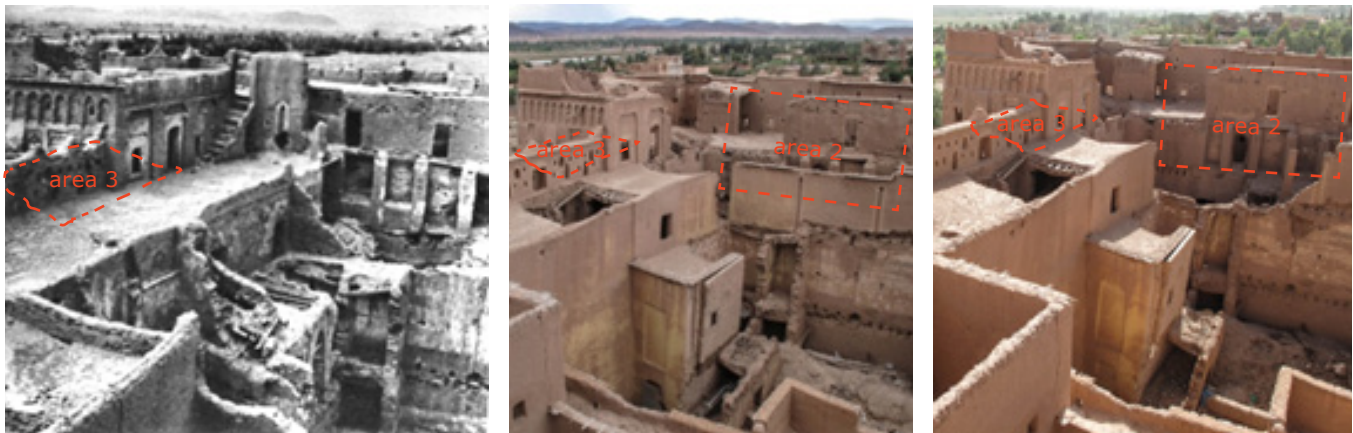
**FIGURES 4.39, 4.40, AND 4.41**

Comparisons between photographs taken around 1970 (fig. 4.39) and the present condition show significant collapse in the southwest tower. A roof has collapsed to the south of the building between 2004 (fig. 4.38, area 3) and 2010 (fig. 4.40, area 3).

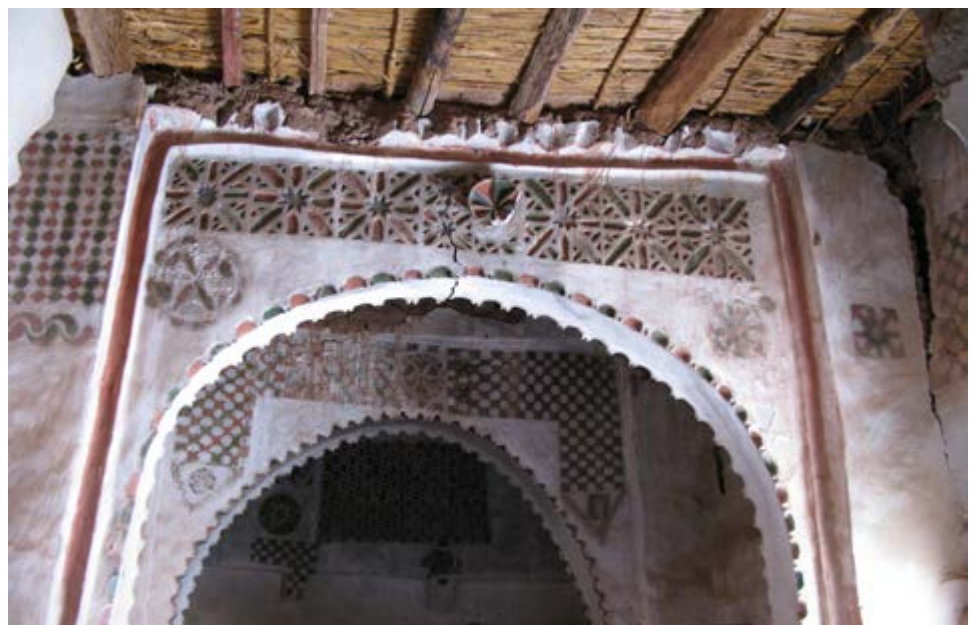
**FIGURE 4.43**  
Detail of sagging arches leading to structural cracks separating the painted arches from the walls.  
Photo: Lorinda Wong, 2013.

Based on evidence from historic aerial photographs, the painted rooms have suffered repeated loss, repair, and reconstruction of the roofing. The current roofs are said to be constructed in the 1980s and employ a mixture of recycled beams, palm matting, and plastic bags and other rubbish as an intermediate layer. They are of poor quality and condition, with several holes that allow water to enter the rooms, particularly on the western side, causing extensive damage to the paintings below.

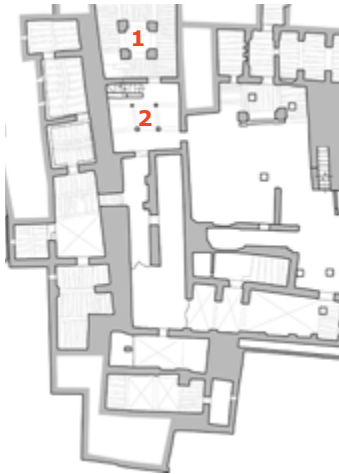
**FIGURES 4.45, 4.46, AND 4.47**

Above: Schematic plan of Caïd Residence with granaries (1) and (2). Diagram: CIMS, 2013.

Two rooms west of the painted rooms were also assessed. The northernmost room is a two-story columned space with a central *puit de lumière*, or light well (1) (fig. 4.45). The first floor is a utilitarian space with earthen plaster walls and square columns. A mostly collapsed staircase leads to the second floor. On the second floor, pointed arches with sculpted moldings surround the two-story square light well; the walls are whitewashed, featuring minimal painted decorations in white and red of unknown age (fig. 4.46).

The southern room, perhaps the original granary of the Caïd Residence (2) (fig. 4.45), is a two-story structure with thin wooden columns on both levels supporting roofs of hewn logs and reed matting (fig. 4.47). A staircase of mud-bricks and wooden treads leads to the upper floor. The upper floor features low walls of single wythe mud-brick, perhaps dividers for storing different grains or other goods.

On both floors, the wooden columns support carved wooden capitals in traditional Amazigh design. This granary is in excellent condition, with almost no damage except for the deterioration of one of its wooden capitals, which has caused the roof in this area to sag 10 to 15 cm. Several existing holes in the roof allow water into the space and threaten to grow larger if left open.

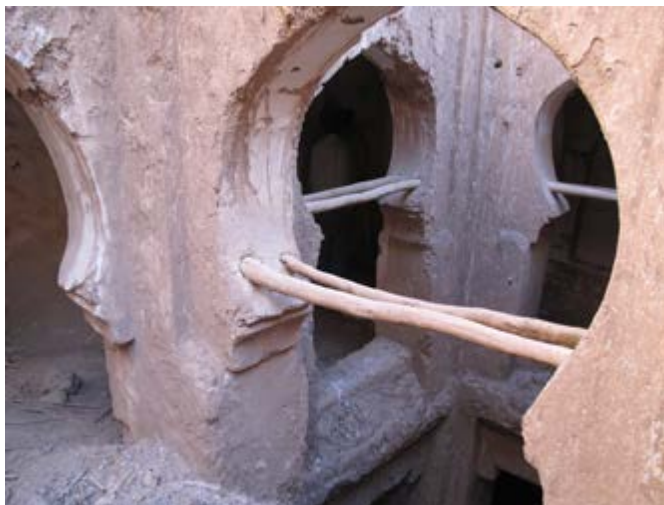
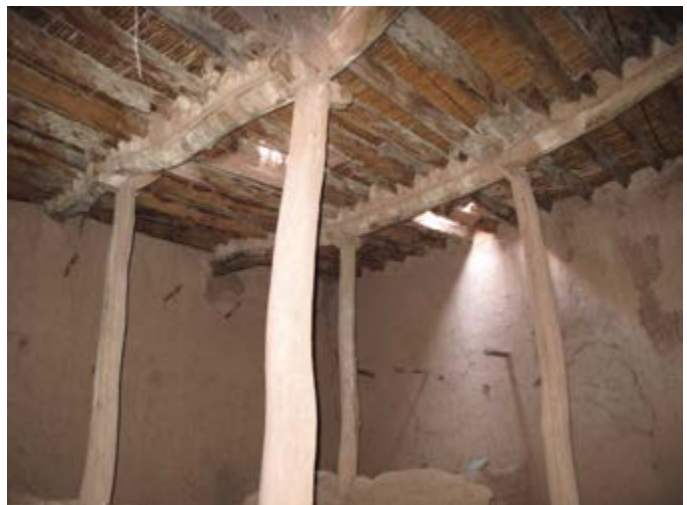
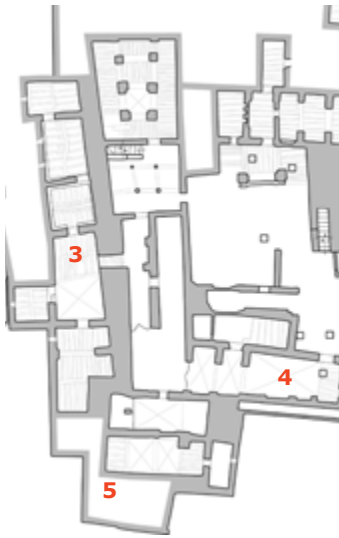
**FIGURES 4.48, 4.49, AND 4.50**

Above left: Schematic plan of Caïd Residence, showing western rooms/alleys (3), southern rooms (4), and Borj Lalla Ftoum (5). Drawing: CIMS, 2013.

Right: Southern rooms looking west.

A series of rooms along the western side of the residence may have originally served as an alley outside the main residence, according to oral history, and was later covered over and divided (3) (fig. 4.48). Evidence for this can be seen in the remaining exterior drainage channels, now blocked by later roofing, and eroded condition of parts of the wall, indicating that it may have been exposed to the elements at one time.

These rooms vary in height but are generally three stories high and feature walls finished with earthen plaster and basic ceilings of poplar wood and reed matting. All walls are constructed in rammed earth and remain in good condition (4) (figs. 4.48–4.50).

The main deterioration factor in this area is the collapse of one roof section, which has led to the loss of intermediate floors. The rooms are also dark for the most part and bat infestation is found in the northernmost rooms.

South of this area lies a four-story tower built in rammed earth known as Borj Lalla Ftoum, or Lalla Ftoum's tower, a former residence of one of the Caïd's wives (5) (fig. 4.48). This tower has a staircase on the west side that provided access to the upper floors. The intermediate floors, now collapsed, were originally supported by mud-brick walls on the first floor, pointed arches on the second floor, and square pilasters on the third floor. The fourth floor contains several small interconnected residential spaces that are richly decorated with gypsum plaster (fig. 4.51).

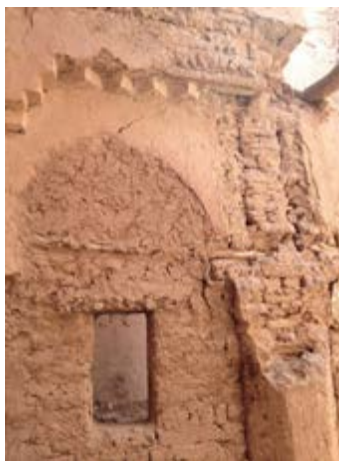
**FIGURE 4.51**

Interior of Borj Lalla Ftoum, showing pointed arches (now filled in), columns, and decorative brickwork.

The roofs of Borj Lalla Ftoum have collapsed, destroying the intermediate floors and creating a large debris pile at the base. The stairway has also filled with debris and partially collapsed. The decorated rooms and their roofs are partially intact but have several holes and areas of water penetration that are rapidly causing the deterioration and collapse of the faux ceiling, as well as the roof above.

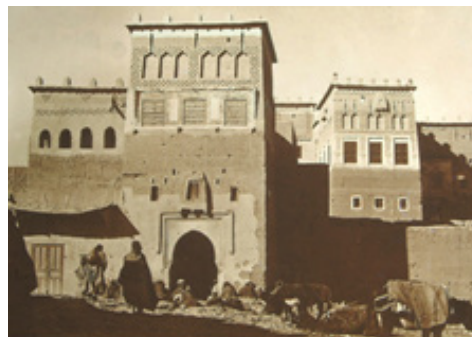
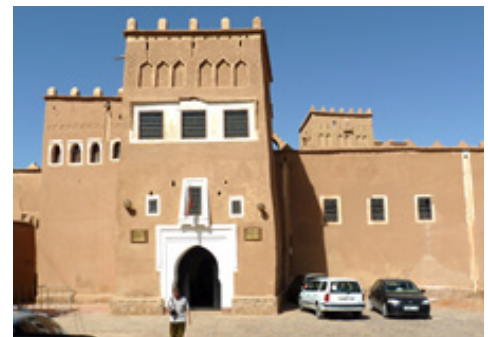
**FIGURES 4.55 AND 4.56**

Views toward east entrance of the CERKAS offices ca. 1950 (right) and in 2011 (far right), showing the second-story addition north of the central tower.

In the mid-twentieth century, the open passageway between the museum courtyard and area of the CERKAS offices was covered, and a second story was added to the entire area, including the wing north of the CERKAS door (figs. 4.55 and 4.56). Doors to a shop or residence located to the left of the main CERKAS door were removed.

The main door to the museum area has been altered several times. According to oral tradition, historically there was no door on the north facade; instead, the eastern entrance was the main access point to the entire kasbah (see fig. 4.55). In the mid-twentieth century, the doorway was altered to create the current whitewashed arch with green tiles (fig. 4.59). Before 1930, a plain square opening with wooden lintels existed or was introduced (fig. 4.60). After 1955, additional arched and whitewashed doors were added to create the current shops, two to the right and one to the left of the main door (fig. 4.61).

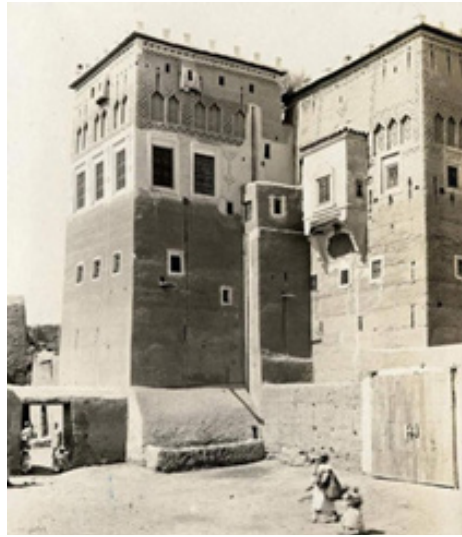
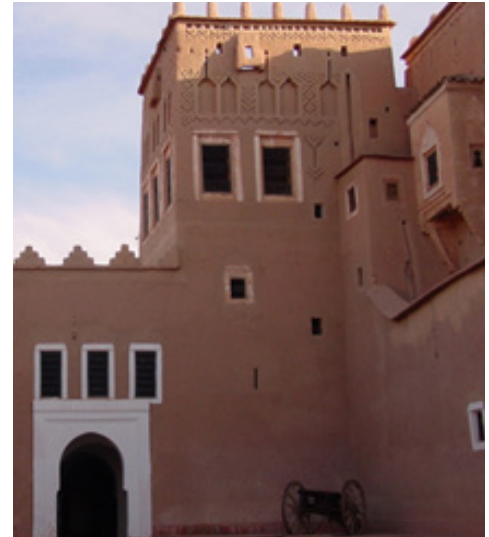
**FIGURES 4.57 AND 4.58**

Views toward the southwestern corner of the museum courtyard, showing additions that included covering over the passageway between the museum courtyard and CERKAS offices (right) as well as construction of the present arched doorway (far right).

As part of the second-story addition between the museum courtyard and CERKAS headquarters, the current arched opening was constructed, replacing an earlier square doorway. The western wall of the museum courtyard was also built higher, and minor changes were made to the configuration of elements, including doors, windows, and earthen buttresses (figs. 4.57 and 4.58).

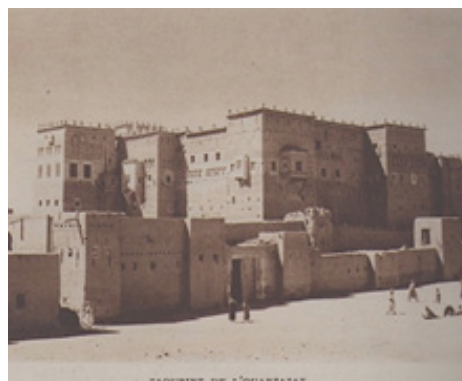
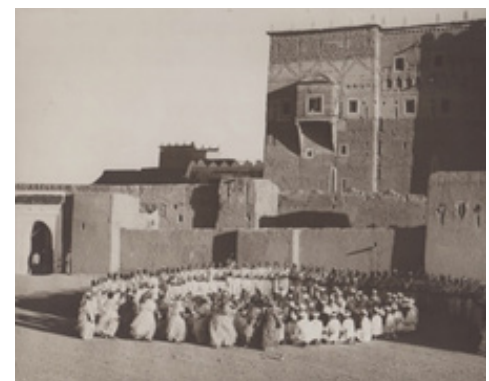
**FIGURES 4.60 AND 4.61**

Views of the main entrance in the north facade, showing changes in the main door from a square opening before 1930 (right) to an arch in 1955 (far right).

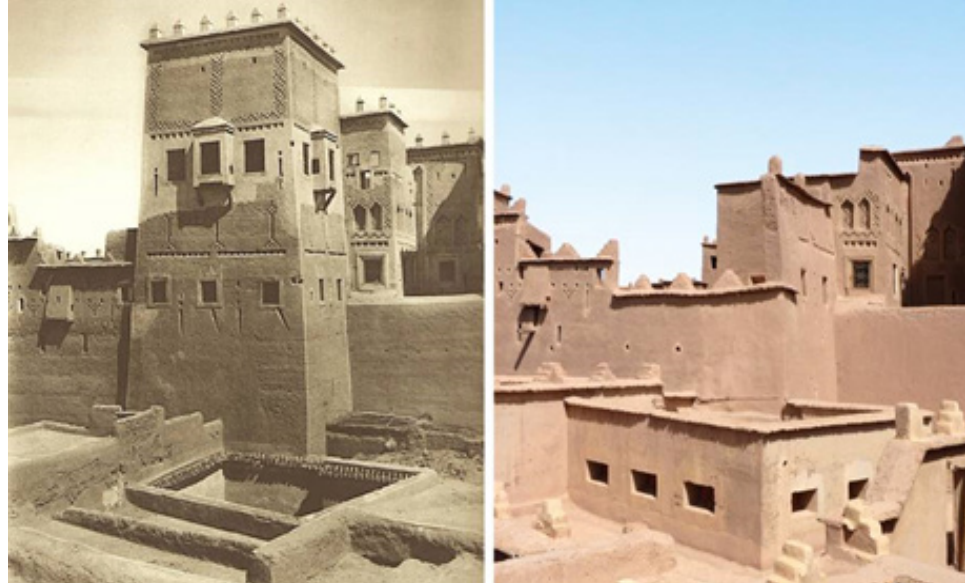
**FIGURES 4.62 AND 4.63**

Views facing north toward the Caïd Residence, showing two towers that were present ca. 1930 (right) but subsequently collapsed (far right).

Collapses significantly altered the configuration of the museum area, including the partial loss of two towers at the western side of CERKAS headquarters (figs. 4.62 and 4.63). In 1989, the structures south of the Caïd Residence were restored for use by CERKAS. Later, in the mid-1990s, the suite of rooms that forms the eastern side of the Residence was also restored and opened for visitation as an architectural exhibition. While retaining the majority of historic spaces intact, these restorations involved many changes:

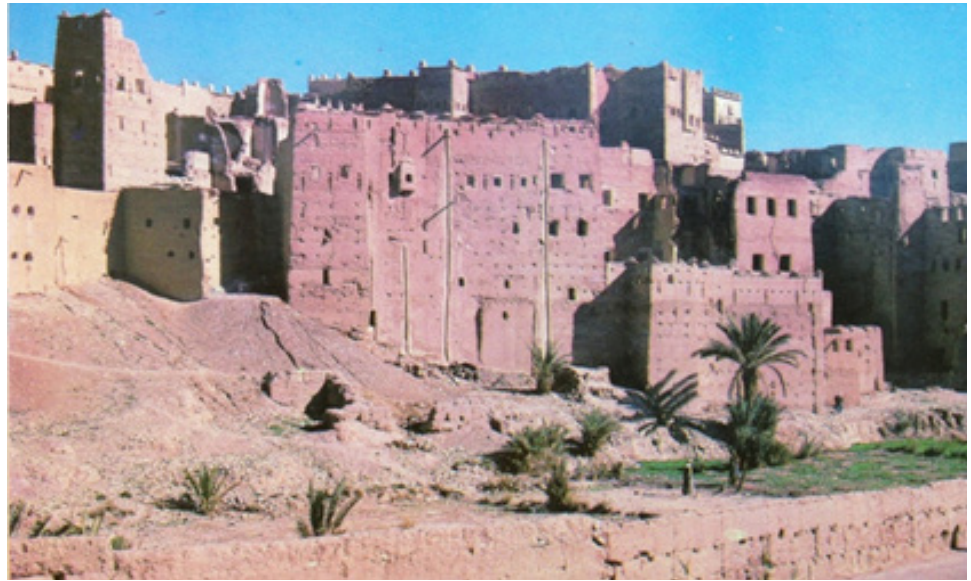
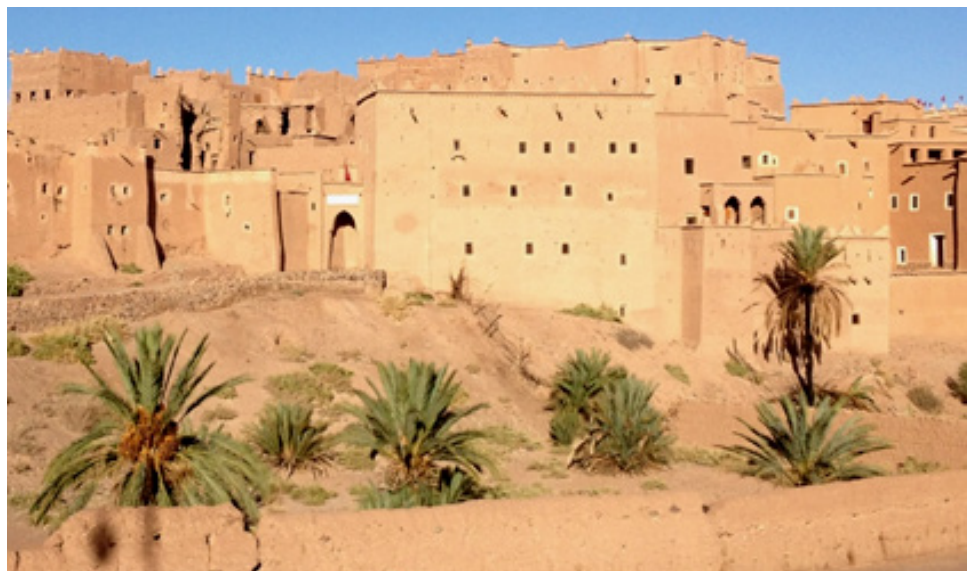
Views of the southern facade of the kasbah, facing northeast. Photos from ca. 1930 (top), ca. 1980 (middle), and 2013 (bottom) show the evolution of this part of the building, including the addition of a new gateway to the Médiathèque, the alteration of windows and drainage systems, and the reconfiguration of collapsed buildings east of the Médiathèque.

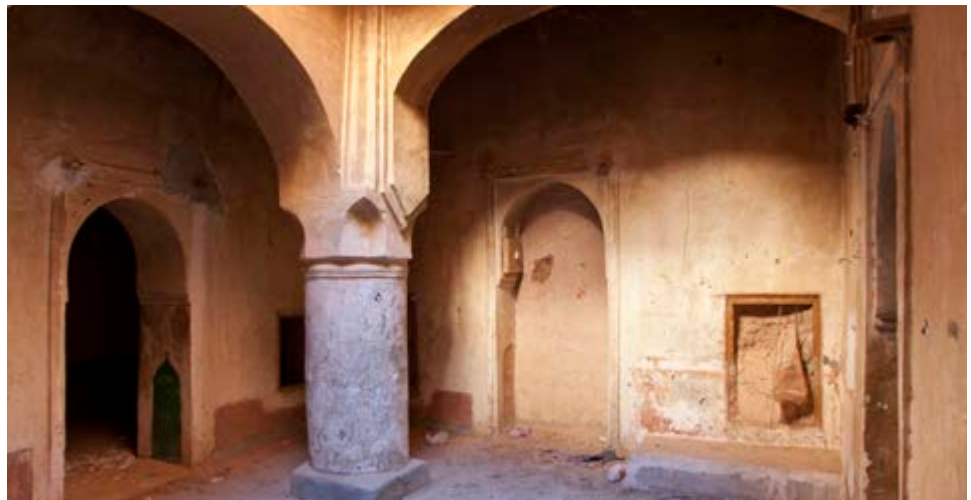
**FIGURE 4.68**

Second courtyard at Stara East with *tadlakht* walls.

The southern sector of the Stara East contains two open courtyards surrounded by rooms. The western courtyard is a long unroofed space surrounded by small rooms. A passageway at the eastern side of the courtyard leads to a second courtyard space. This two-story space is arranged around a square central light well. On the ground floor, the space is highly decorated with white *tadlakht* walls. Four rooms surround two round columns with decorative capitals (fig. 4.68). The columns support arches and a wooden ceiling. The second floor of this space is also oriented around a square central courtyard.

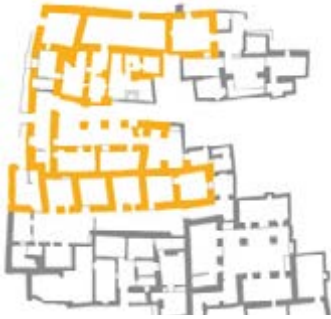
**FIGURE 4.69**

Plan of the Stara East, showing traditional square plan core and possible additions to the south side of the building.

In the Stara East, a series of historic additions or alterations to a potentially historic core can be seen that also predate 1930. While it is not confirmed which are the older parts of the building, it appears that the northern half of the Stara East features a traditional square plan with a colonnade and well at the center, while the southern half of the building is separated by an open courtyard and may be a later addition or a separate construction that was adjoined to another structure on the site (fig. 4.69).

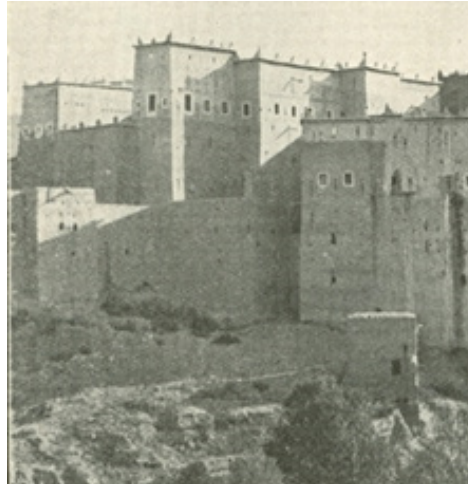
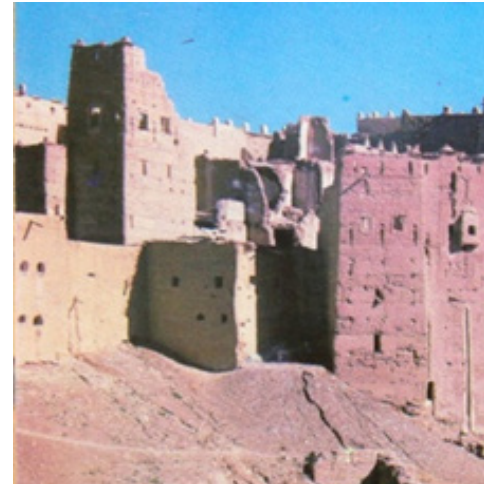
Details of historic photographs, showing southern area of the Stara East before collapse (1931, right) and after collapse (ca. 1980, far right). This part of the building was subsequently filled in with squatter dwellings and the tower, also pictured, eventually collapsed.

A large area of the southern facade of the Stara East collapsed sometime before the 1980s, completely altering the configuration and plan of this area (figs. 4.70 and 4.71). The remaining southwest tower was in a state of decay, with its roof gone and upper floor partially missing.

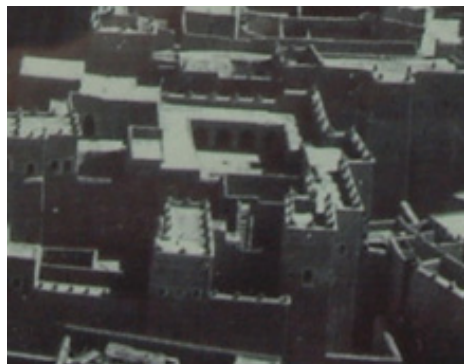
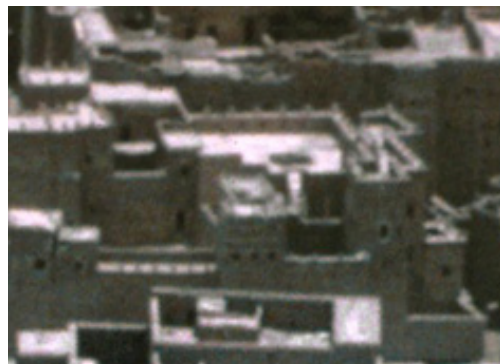
**FIGURES 4.72 AND 4.73**

Details of historic photographs, showing the second-floor courtyard, originally constructed as an open space (1951, right) and subsequently enclosed with an overhanging roof (ca. 1975, far right). Photos: Archives J. Gandini, 1951 (right); CERKAS collection, 1975 (far right).

Another alteration to the Stara East occurred on the roof of the southern half of the building, located above the decorative gypsum room. The second floor was originally a square plan open courtyard with no roof, allowing maximum light into a series of rooms around the courtyard. Sometime between 1951 and the 1970s, an overhanging roof of wood and earth was added, which further enclosed the space, creating a polygonal opening (figs. 4.72 and 4.73).

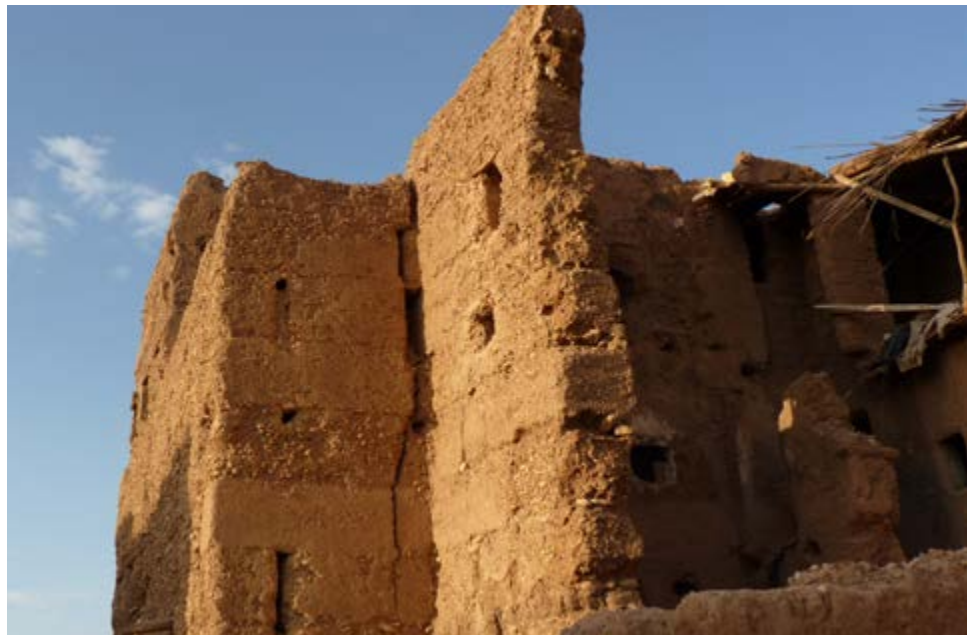
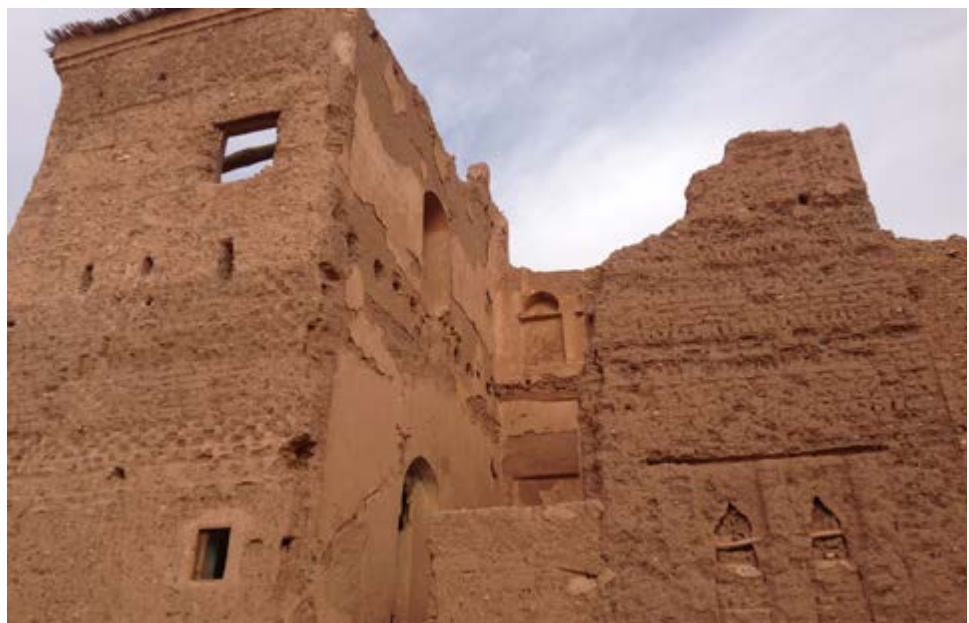
**FIGURE 4.76**

Details of Stara East, showing structural damage (top) and roof loss in decorated spaces (bottom). Photos: Benjamin Marcus, 2013.

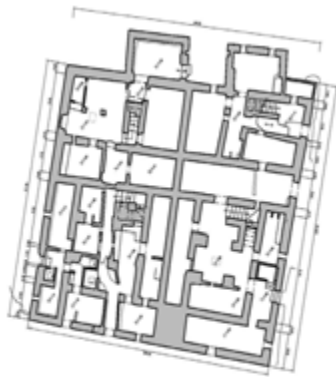
**FIGURE 4.77**

Ground-floor plan of the Stara West.

The Stara West is a two-story square plan structure built primarily of rammed earth (fig. 4.76). The plan of the building is divided into two identically designed halves, each oriented around a central light well with four columns. Rectangular rooms surround the light wells on both upper and lower floors (fig. 4.77). Rooms are lit with small windows on the eastern, southern, and western sides, while interior rooms receive no natural light except from the two central light wells. Each half of the building has a set of stairs from the ground floor to the roof. The northern side of the building features large open rooms that may have originally been used as utilitarian spaces. According to oral history, the building is said to have been used as a residence and workshop for the Caïd's cavalry.

The Stara West was also heavily subdivided during occupation by squatters. This especially affected the western half of the building, where exterior doors were added, structural columns removed, and numerous small rooms built to create separate living quarters for a number of families. The April 2014 conservation work by CERKAS involved the demolition of these partition walls, reconstruction of all floors and ceilings, and rebuilding of several lost columns.

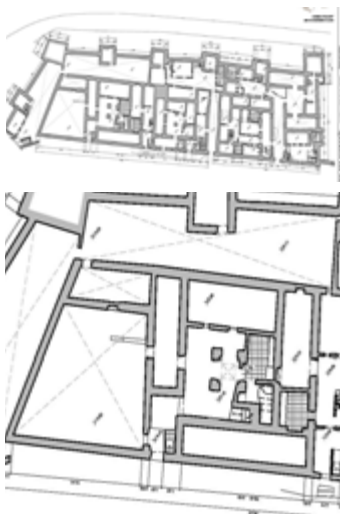
**FIGURE 4.79**

Plan of Ateliers, accompanied by a detail of the western Atelier.

Three structures, known as the Ateliers, are located on the northern side of the Stara and are two stories in height except for the western Atelier, which is only one story (fig. 4.78). All three structures have similar plans based on typical kasbah design, with a central light well framed by four columns and rectangular surrounding rooms (fig. 4.79). Narrow alleys separate each structure, and the principal doors to the buildings open onto these alleys, providing access to the building interiors. The first floor of each structure is constructed of rammed earth while the second floors and parapets are made of mud-bricks. Recent conservation work by CERKAS has involved the reconstruction of the second floor on two of the houses, while the southernmost Atelier remains a one-story structure. Staircases in the southeastern corner of each building provide access to the second level.

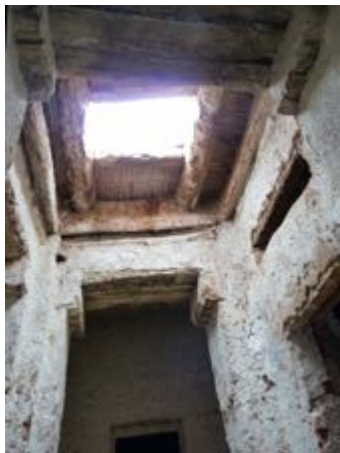
**FIGURE 4.80**

*Puit de lumière*, or light well, in the interior of one of the Ateliers in the Stara.

While their original construction date has not been established, the Ateliers date from before 1930. The Ateliers were originally built as one-story buildings separated by narrow alleys. Each building features a square plan based around a central light well, supported by four columns (fig. 4.80). The westernmost building has a walled courtyard on its western side that may have been used as a garden or animal pen. According to oral tradition, the Ateliers were used as quarters for slaves and servants during the period of the Caïd. All three buildings have been altered substantially over time, though the western building is well preserved and retains its original plan and height, as well as some historic finishes on the interior.

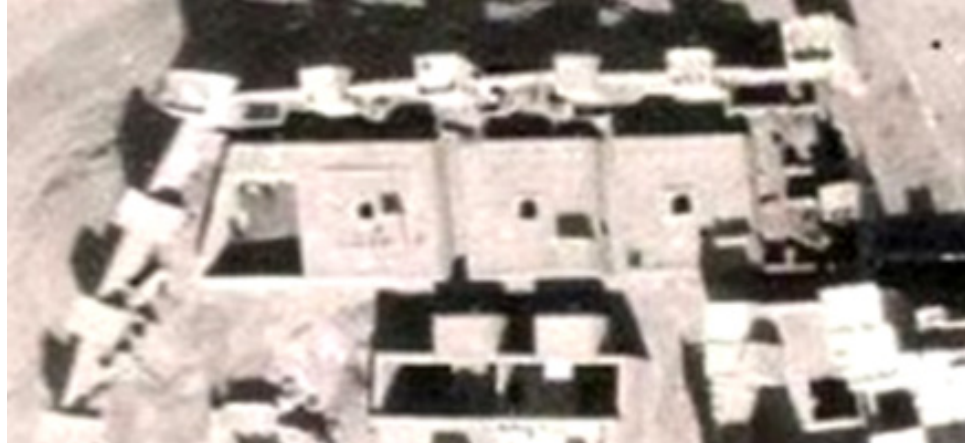
Details of historical photographs, showing the transformation of the middle and eastern Ateliers from one-story structures (top) to two-story structures through additions (bottom). Note also the small well in the foreground of the bottom photo.

The middle and eastern Ateliers have been altered heavily through the addition of second-story rooms and the construction of partition walls on the interiors and within the alleys. Between 1930 and 1951, a full second story was added to the middle Atelier and to the southern side of the eastern Atelier, and later to the eastern side (figs. 4.81 and 4.82). After 1956, the buildings deteriorated substantially with the rapid loss of their palm wood roofs. By 1970, the roofs of the additions had partially collapsed and subsequently caused the collapse of parts of the original structure.

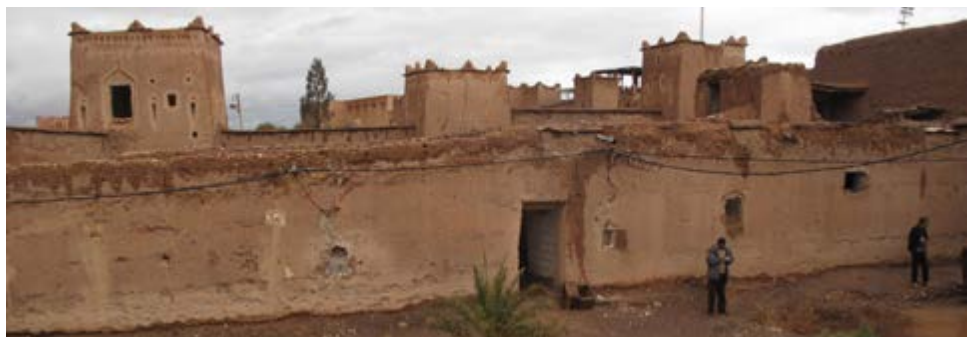
**FIGURE 4.83**

South facade of the Ateliers, showing the state of deterioration of the buildings.

At the beginning of the GCI's involvement in the project, the Ateliers were unoccupied but had been extensively subdivided during the occupation by squatters. The upper floors of both the eastern and middle atelier were in extremely poor condition, with walls remaining from the collapse of past rooms. However, the ground-floor spaces were habitable due to their recent occupation (fig. 4.83).

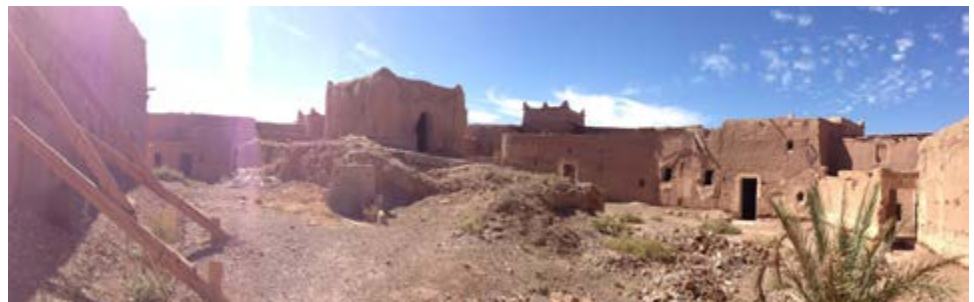
**FIGURE 4.85**

The interior is in good condition, with the original roof intact. On the exterior, erosion in the form of long channels on the east and south walls was observed, most likely caused by blocked drainage. The roof is also covered in debris, which may account for the interruption of drainage.

View of the Marabout within the open space of the Stara area.

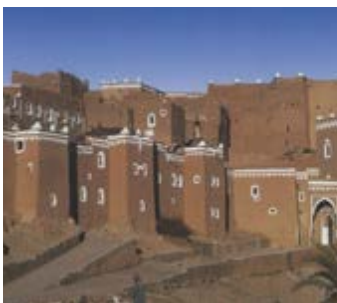
**FIGURE 4.87**

Freshly painted decorations on south portion of the Stara walls. Photo: CERKAS collection, ca. 2000.

White (now faint) painted decorations were added to the crenellations on the exterior walls (fig. 4.87), most likely as part of a film shoot or public event that took place around the year 2000.

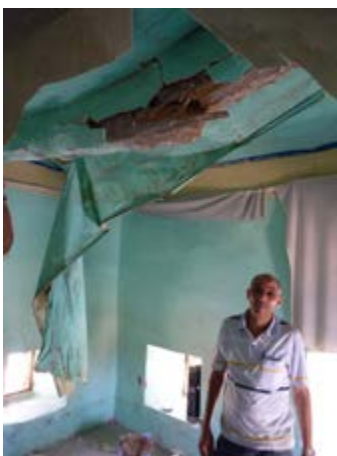
**FIGURE 4.88**

Interior view of one of the towers, showing collapse of the upper floor. Photo: Sebastien Moriset, 2012.

Several towers of the walls had structural issues that were repaired during the CERKAS conservation work in 2014–15. These issues included replacing collapsed roof beams and rebuilding a large area of collapse on the upper floor of one of the northern towers (fig. 4.88).

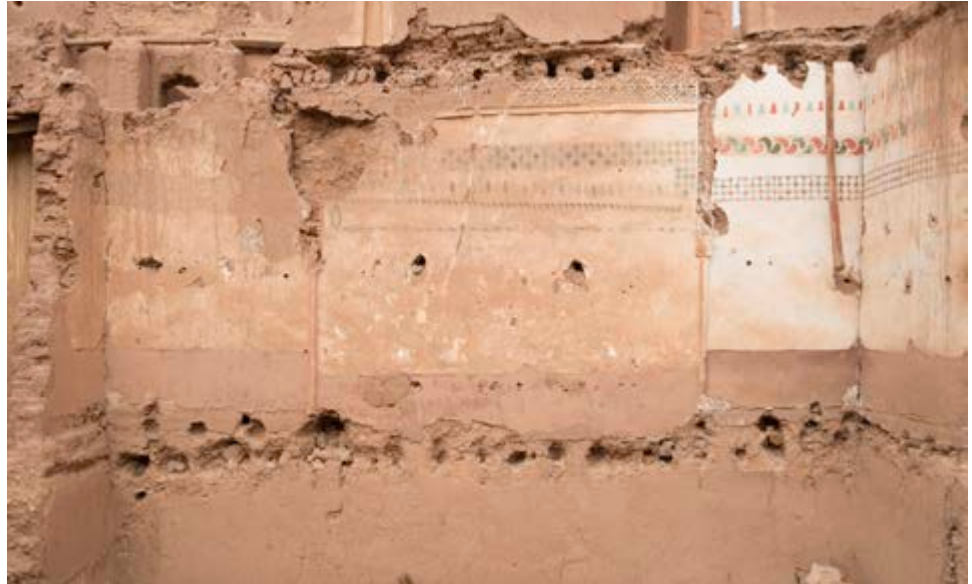
**FIGURE 5.34**

West 1 room (fig. 5.33) is now half collapsed: the floor and ceiling have collapsed as well as the eastern and southern walls and two arches. Wall painting remains on the western and northern walls (fig. 5.34). Remains of decorative painted plasterwork exist at the top of the central section of the eastern wall. Horizontal bands of repeating geometric patterns run along these walls at a lower height. The northern wall is highly unstable, having become separated from the northern and southern walls.

The western wall of West 1 room, showing remains of wall painting.  
Photo: Samuel Whittaker, 2014.

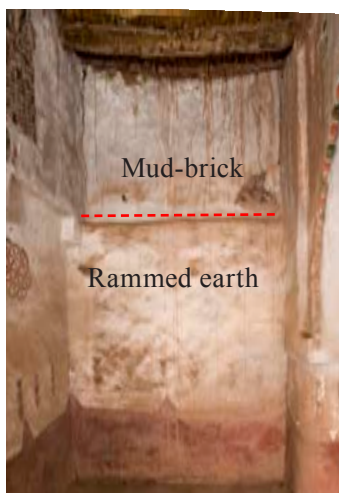
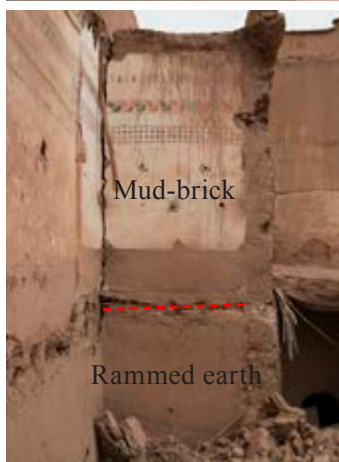
**FIGURES 5.37 AND 5.38**

Both sides of the south wall of the North-front room, showing the joint between the mud brick and rammed earth, creating a clear bulge in the wall.
