# Conservation and Rehabilitation Plan for Tighermt (Kasbah) Taourirt, Southern Morocco

## Research Report

Claudia Cancino, Benjamin Marcus and  
Mohamed Boussalh

# Conservation and Rehabilitation Plan for Tighermt (Kasbah) Taourirt

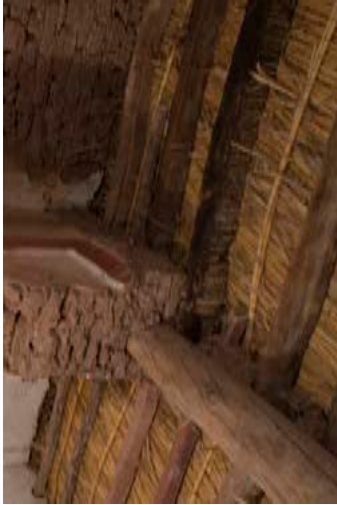
**FIGURE 5.40**

The collapse of this arch reveals the method of construction: mud bricks supported by a wooden beam.

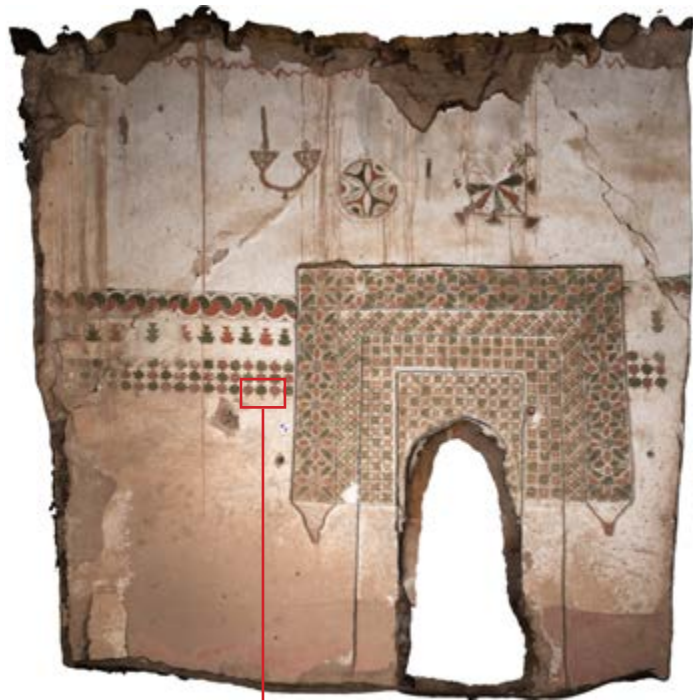
**FIGURE 5.41**

The red box shows the location of Area 1 on the east wall of the North-rear room.

Technical imaging, including visible-reflected (VIS), visible-reflected raking (VIS-R), IR-reflected (IRR), UV-reflected (UVR), and UV-induced visible luminescence (UVL), was used on an area of paintings in the North-rear room (figs. 5.41–5.49). By recording how the materials responded to different forms of radiation, questions about the different periods of painting and paint stratigraphy could be answered.

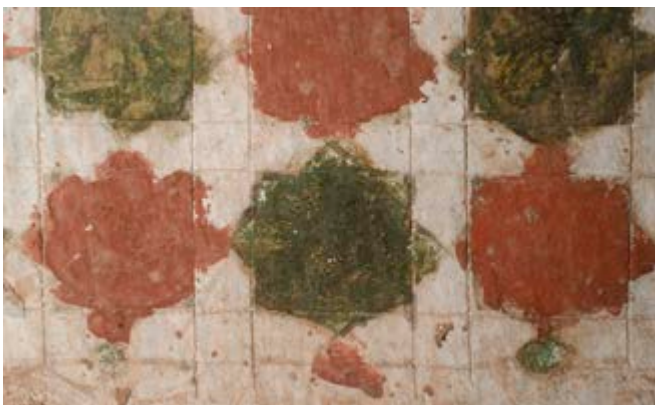
**FIGURES 5.42 AND 5.43**

Left: An area of painted surface targeted for UVL imaging. Right: In the UVL image, a red that luminesces a strong orange/yellow is seen in the lower right. A non-luminescing red is seen in the lower left (outlined in red) and upper center of the image. This appears to be the result of two periods of painting where the luminescent red was applied first and later painted over with the non-luminescent pigment.

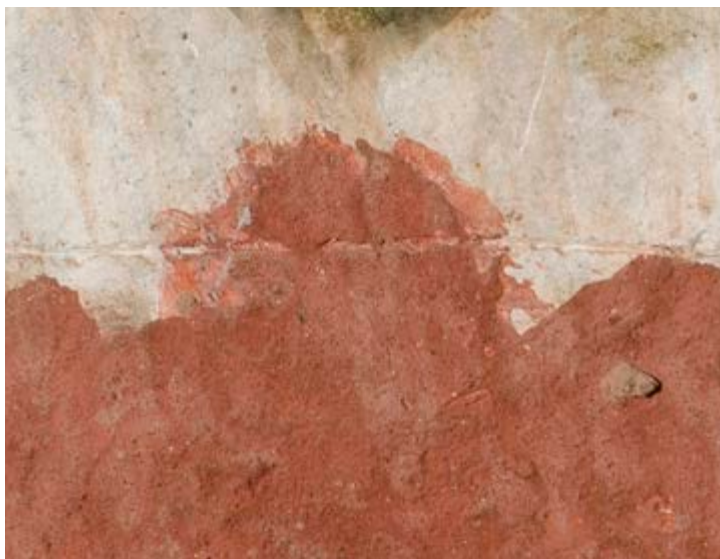
**FIGURE 5.45**

The luminescent red in this UVL image can be observed underneath the non-luminescent red on the star to the right. Both periods of painting appear to have been hastily and poorly executed.

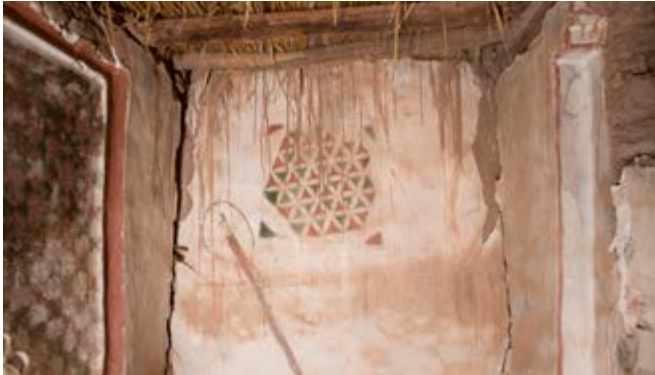
**FIGURE 5.50**

Crack through both the support and plaster layers of the painting. Characterized by crack thickness in the order of centimeters. The crack may also cause cracks in the plaster and paint layers of the surface.

Structural crack in the North-front room.  
Photo: Samuel Whittaker, 2014.

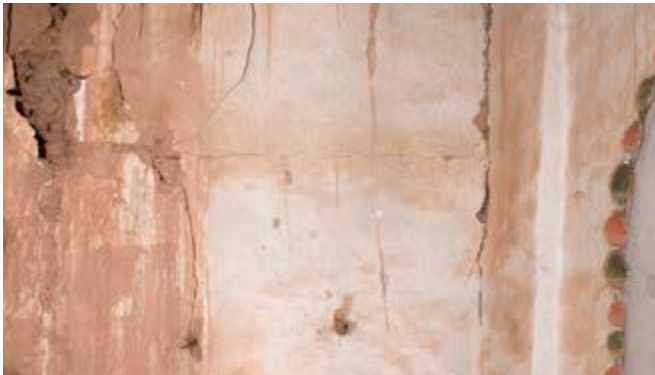
Crack through any or all of the plaster and paint layers. Characterized by crack thickness in the order of millimeters. Often occurring in relation to structural cracks, delamination, and loss of the plaster layer.

Crack in the plaster in the North-front room.  
Photo: Samuel Whittaker, 2014.

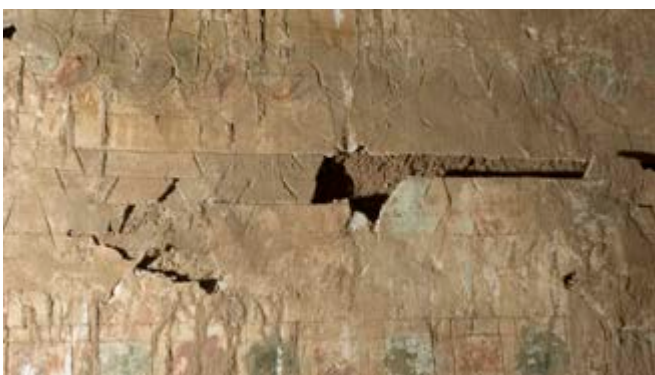
**FIGURE 5.52**

Lack of adhesion between separate plaster layers or between plaster layer and primary support that creates a void. Often characterized by bulging or displacement of the plaster layer.

Detached area of painted plaster.  
Photo: Samuel Whittaker, 2014.

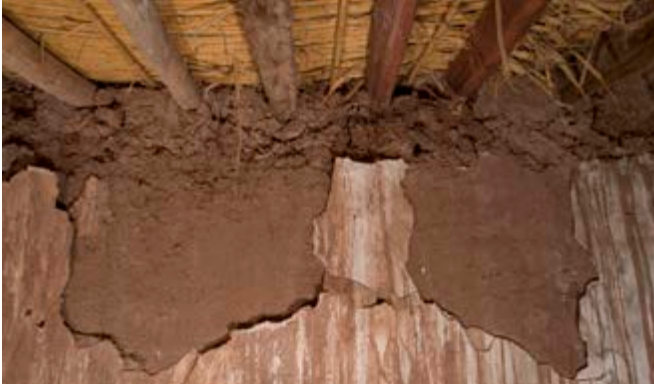
**FIGURE 5.53**

Loss of the paint and partial loss of the plaster layers. The loss to the secondary support is either partial loss within one layer or loss of an entire plaster layer, revealing an earlier plaster layer beneath.

Loss of painted plaster in West 2 room.  
Photo: Samuel Whittaker, 2014.

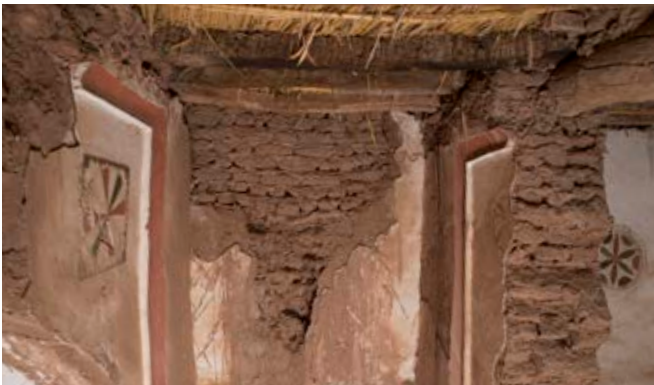
**FIGURE 5.54**

Loss of the entire painting stratigraphy (paint and plaster layers), leaving the mud bricks and rammed earth exposed.

Deep loss in the Northwest room.  
Photo: Samuel Whittaker, 2014.

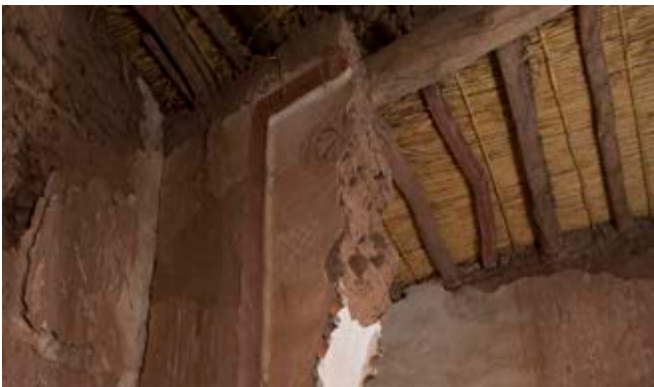
**FIGURE 5.55**

Loss of the entire painting stratigraphy and supporting structure due to structural collapse.

Complete loss of part of arch in the Northwest room.  
Photo: Samuel Whittaker, 2014.

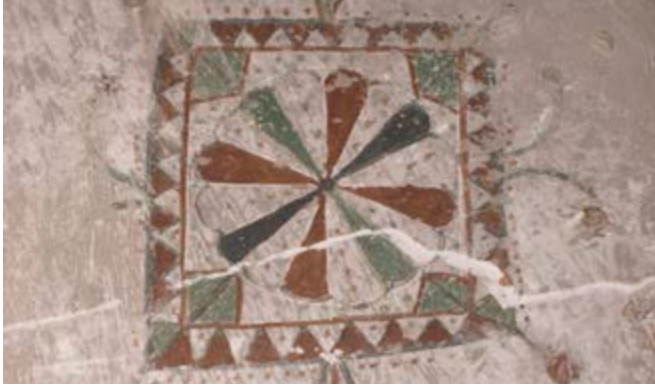
**FIGURE 5.56**

Loss of upper painted plaster, revealing lower painting scheme.  
Photo: Samuel Whittaker, 2014.

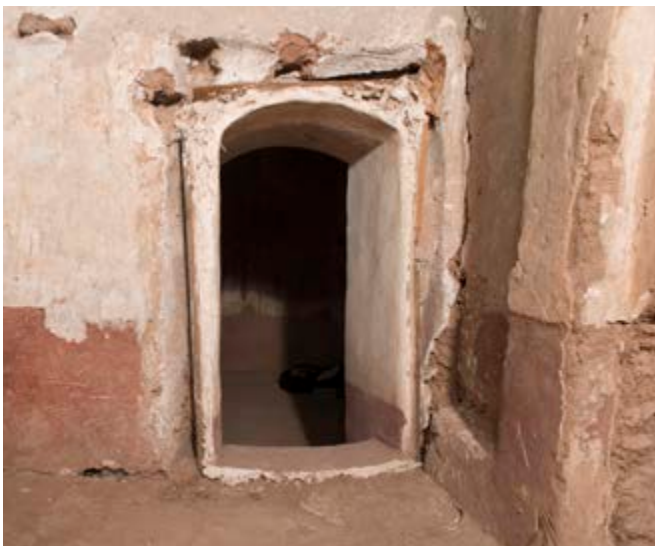
**FIGURE 5.59**

### Damage due to structural alterations and additions

Change to the building structure such as replacement, repair of the ceilings, or alterations to doorways. This has often caused damage and/or loss to the wall paintings.

Recent doorway between the North-rear and North-front rooms.  
Photo: Samuel Whittaker, 2014.

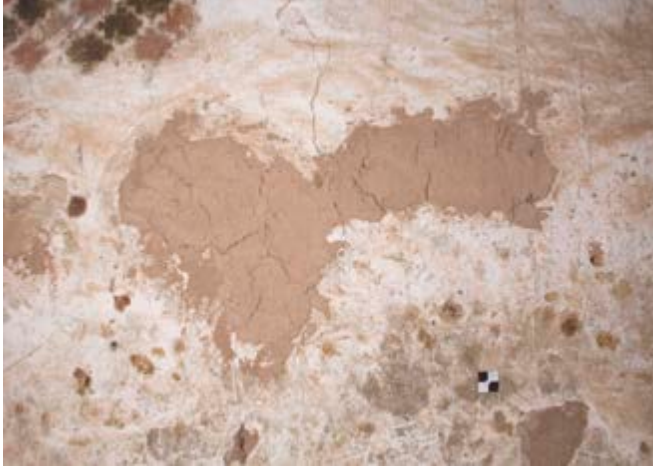
**FIGURE 5.60**

### Earthen plaster

Areas of loss in the plaster that have been repaired using an earthen plaster.

Area of loss filled with an earthen plaster in West 2 room.  
Photo: Samuel Whittaker, 2014.

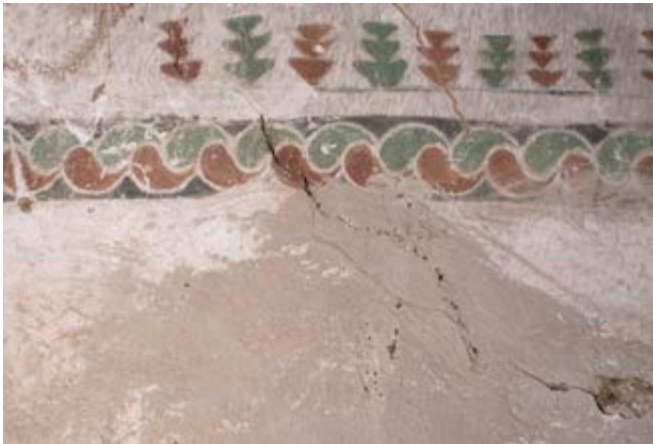
### Gray plaster

Areas of loss in the plaster that have been repaired using a coarse gray plaster. This plaster has also been smeared over the surface of the painted decoration in a rough, haphazard manner.

Gray repair plaster in the North-rear room.  
Photo: Samuel Whittaker, 2014.

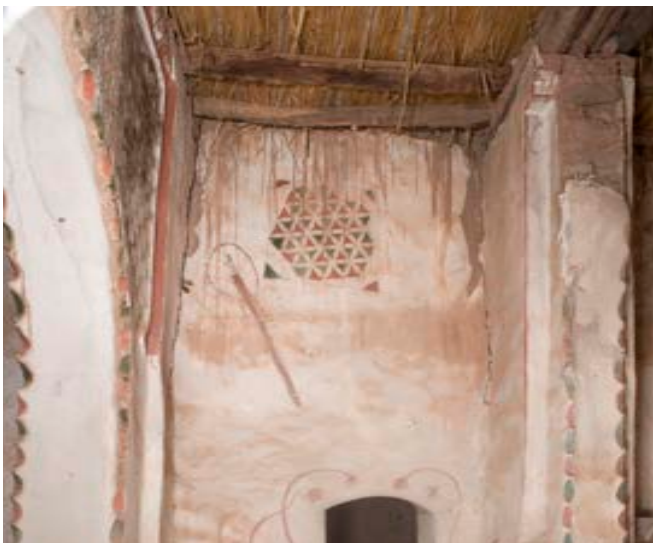
**FIGURE 5.62**

### Dust

Widespread deposition of dust, often relating to the uneven topography of the wall painting, that obscures the wall paintings.

Protruding area of painting above the door in the North-front room, covered with a thick layer of dust.  
Photo: Samuel Whittaker, 2014.

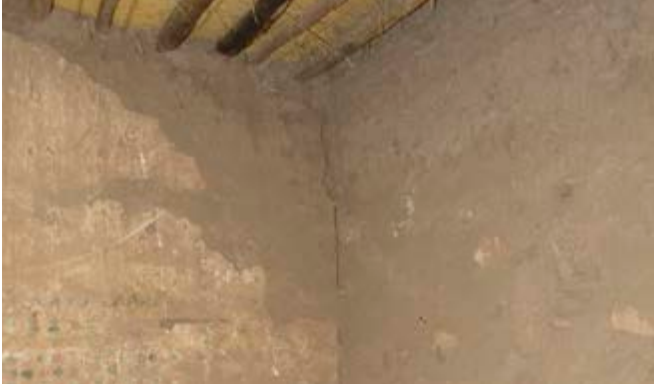
**FIGURE 5.63**

### Dirt

Thick layer of earth-colored material covering the painting in localized areas. Often occurring in areas of exposed earthen plaster and walls or where collapse has exposed the paintings to the macro environment.

Paintings in the Northwest room covered with a thick layer of mud.  
Photo: Samuel Whittaker, 2014.

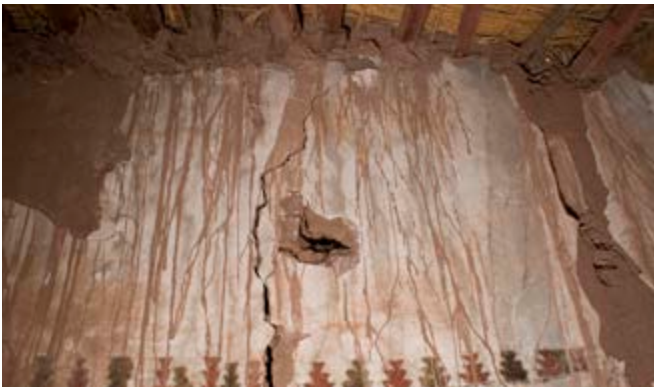
**FIGURE 5.64**

### Drips

Vertical drips of earthen material originating from the apex of the wall that obscure the wall paintings.

Earthen plaster drips on the painted plaster.  
Photo: Samuel Whittaker, 2014.

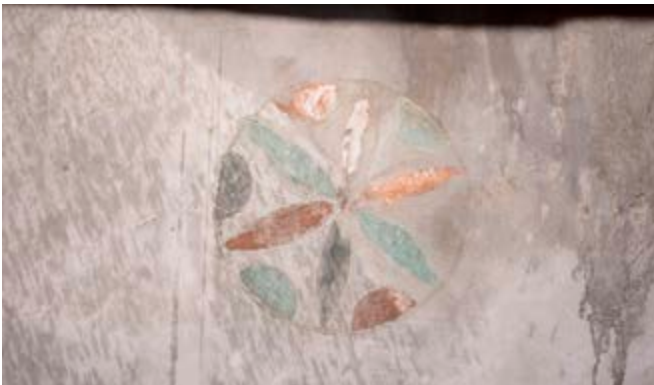
**FIGURE 5.65**

### Bat excreta (urine)

Gray directional splashes of bat urine that discolor the paint and plaster layers.

Bat excreta in the North-rear room.  
Photo: Samuel Whittaker, 2014.

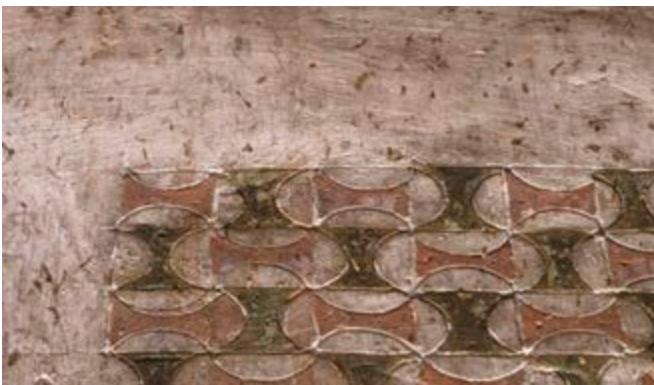
### Bat excreta (guano)

Small round dark pellets of bat excreta adhered to the wall.

Bat excreta in the North-front room.  
Photo: Samuel Whittaker, 2014.

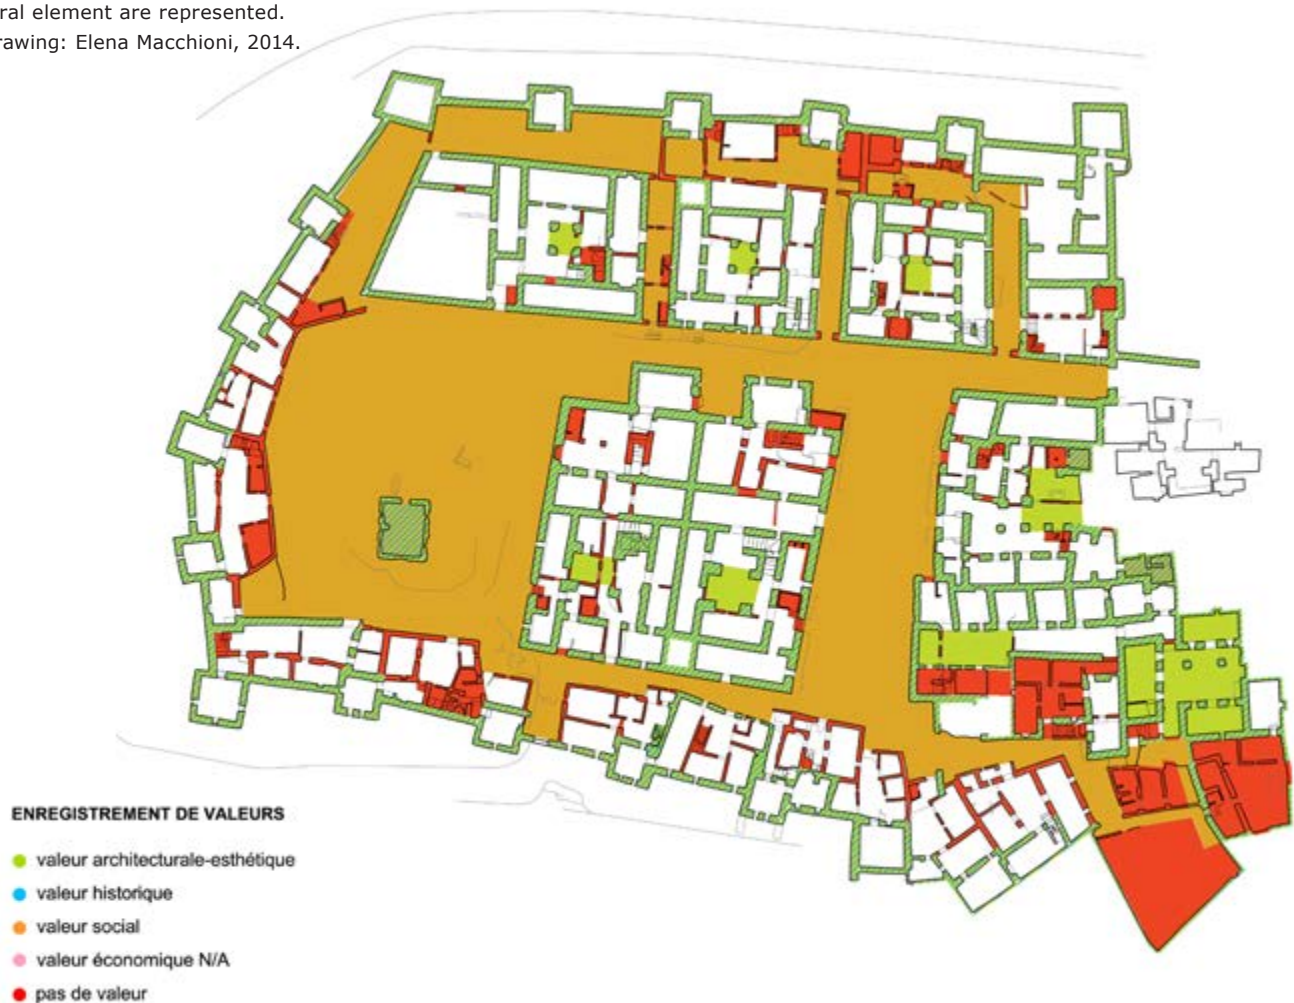
Significance map of the Stara. The different values of each architectural element are represented.

The participants, including representatives of the Municipality of Ouarzazate, were then asked to identify the attributes of the site values in the complex of the Stara East (figs. 6.25 and 6.26). They were asked to indicate through different colors the type of values that an element would represent (architectural and aesthetic, historical, social and anthropological, and economic). Participants were able to locate those elements that represent more than one value, including some of the modern wall paintings probably made by children who lived in the area in the last decade, as being representative of social and anthropological values, in addition to the walls of the Caïd Residence, where carved and painted decorations represent architectural and aesthetic value. A similar case was the Marabout, located in the Stara, which combines social value with historical and architectural values.

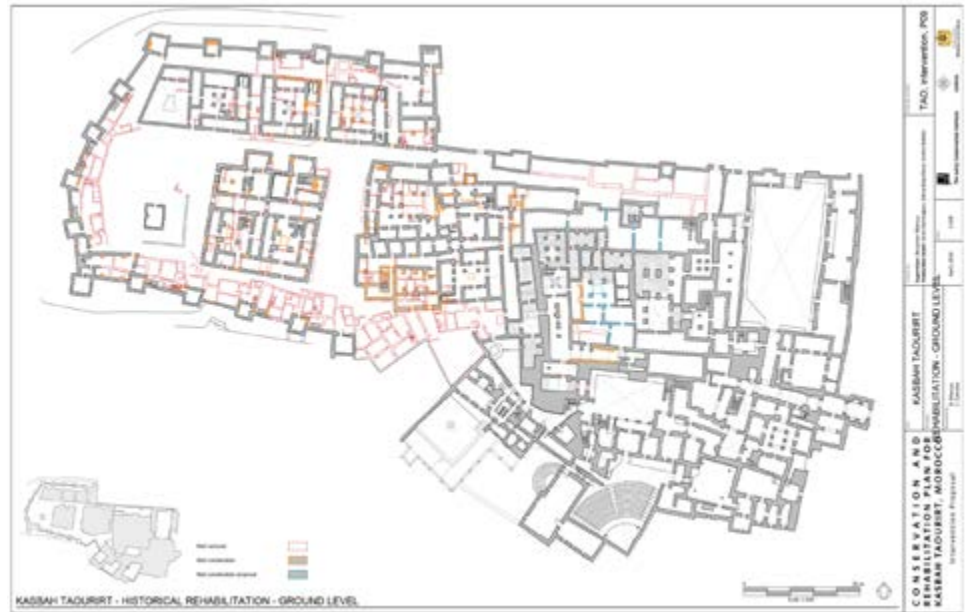
**FIGURE 8.3**

Architectural drawing showing structures that were removed along the Stara walls as well as internal spaces, revealing the historical configuration of the site.

The work was planned in conjunction with CERKAS and the Municipality of Ouarzazate. As described in chapters 3 and 4, it began with the study of the existing architectural form, including assessing conditions; studying the building materials; distinguishing historic walls from those added after 1956, the year the kasbah was listed as a national monument; and identifying additions made by squatters (fig. 8.3; see appendices F and I).

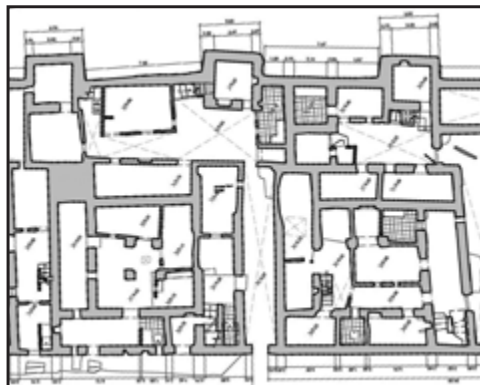
**FIGURES 8.9 AND 8.10**

Two Atelier buildings before intervention (right) and after removal of partition walls (far right). Cross-hatched areas indicate reconstructed elements.

This work was done according to drawings prepared by the GCI and CERKAS, the result of years of intensive study and survey of the site. The work was carried out in two phases, beginning first with the walls, Ateliers, and Stara West. Demolitions removed structures that had encapsulated the walls, revealing the original form and rhythm of the walls and towers. On the interiors, the traditional four-columned courtyard spaces within the Ateliers and Stara West were revealed and restored (figs. 8.9 and 8.10).

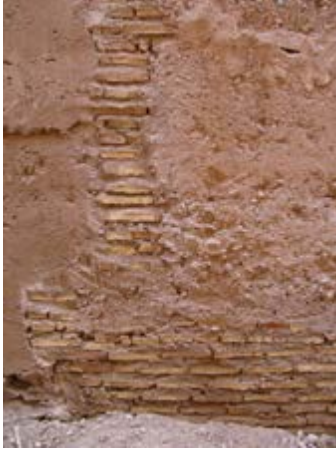
**FIGURE 8.11**

An area of basal erosion and a large crack repaired with lime and fired brick.

Structural repairs carried out as part of the work in the Stara included stabilization of deteriorated wall bases, stitching of cracks, and selective reconstruction of lost wall sections. Repair of basal erosion was carried out using fired-clay brick/tiles and a hydraulic lime mortar to fill lost areas, as this repair is durable in the long term against future water incursion and is compatible with the rammed earth walls. The bricks used for repair are a low-fire, 0.24 x 0.12 x 0.03 m thin brick used commonly in historical construction in Marrakech and surrounding areas (fig. 8.11). Hydraulic lime is also sourced from outside of Marrakech where it is produced and purchased in bulk quantity (not bagged). Currently there is no lime production in Ouarzazate.

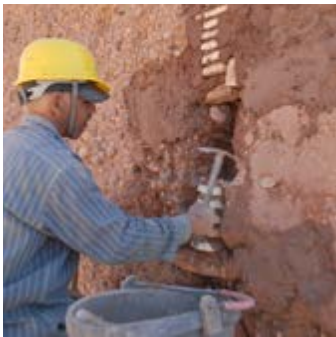
**FIGURE 8.12**

Repair of a large structural crack with wooden stitches (already installed) and fired brick.

The bricks are laid horizontally and keyed into the rammed earth and used in this way to fill large cracks and gaps in walls (fig. 8.12). Major structural cracks are also reinforced with wooden stitches. The stitches are large pieces of laurel or palm wood fashioned into an “I” shape and inserted into a channel cut into the wall that bridges the gap. The stitches are fixed in place with gypsum plaster or lime mortar and are placed approximately every meter, though this spacing depends on the length and severity of the crack.

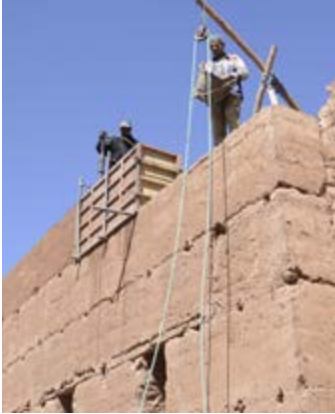
**FIGURE 8.16**

Construction of rammed earth walls with metal form and pneumatic hammer.

The soil obtained for construction is slightly moistened, placed in a metal formwork, and compacted with the aid of a pneumatic hammer (fig. 8.16). This method has often replaced the laborious use of the wooden manual rammer in southern Morocco, though the rammer is used in more remote communities and in those without access to an air compressor. The rammed-earth form is approximately 85 x 250 x 60 cm in dimension, producing a similar wall section. These are unified by inserting wooden stitches that bridge each section of rammed earth.

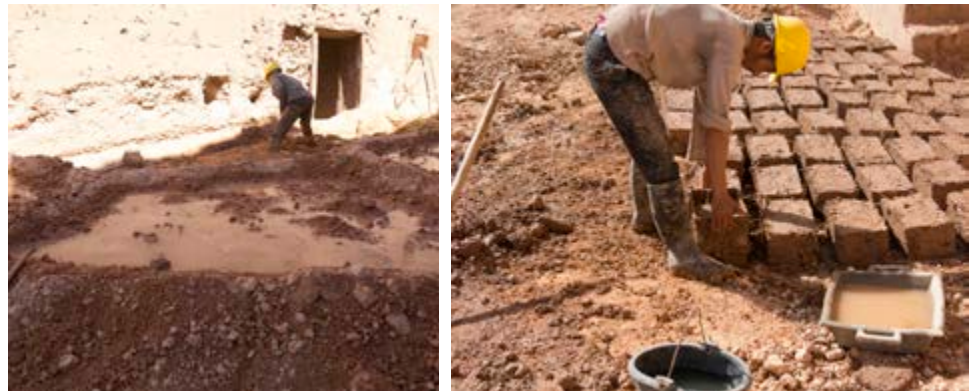
**FIGURE 8.20**

Example of smaller-size bricks used in decoration.

The bricks are left to dry for three to five days, depending on humidity, before they can be used for construction. A ma'alem and his assistants can make between 150 and 200 bricks per day. The smaller-size bricks are traditionally used for decorative elements at the top of walls (fig. 8.20) or around roofing beams, while larger bricks are used in constructing pillars and walls that are not built with rammed earth. Three people work in the construction of a mud brick wall: the mason, who places the bricks; an assistant who prepares and serves the mortar; and a carrier who transports bricks to the wall.

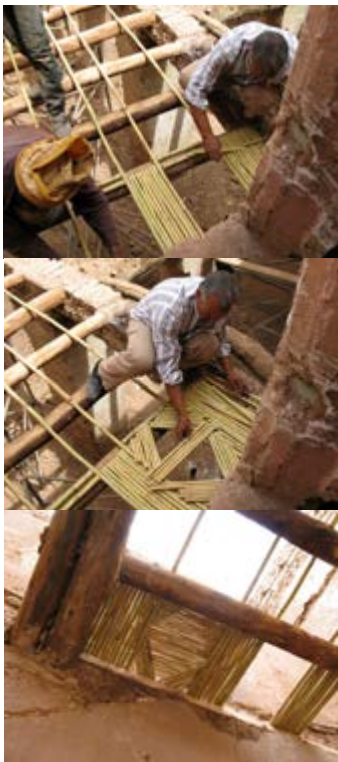
**FIGURES 8.25, 8.26, AND 8.27**

Craftsman making a decorative *tataoui* ceiling of three layers from cut reed.

Next, a bed of reeds is laid, either in simple configuration (fig. 8.24) or arranged in complex geometric *tataoui* (figs. 8.25–8.27). *Tataoui* ceilings are made primarily with laurel wood harvested in the mountain valleys near Ouarzazate, or with reed made from groves near the river. The standard reed matt ceiling is prepared by drying the stalk and stripping the exterior of any leafy growths. It is then cut to size with a saw and woven together to form a roofing matt.

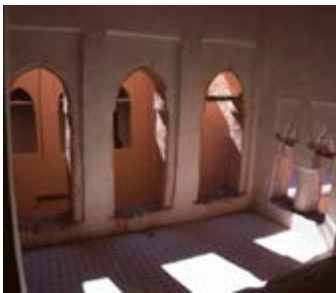
**FIGURES 8.31 AND 8.32**

Above: Interior view of upper floor of the Stara East, where windows have been opened following rehabilitation work.

Right: South facade of the Stara East, where exterior windows have been reestablished.

Original wooden doors and windows were largely lost during the occupation by squatters, though the openings remained and could in most cases be reused for new windows and doors. The few remaining historic doors have been preserved where possible. An example of this can be seen at the entrance to the Stara East, where the original heavy wooden door, constructed with wrought-iron nails and hinges, is kept in place. However, the majority of doors and windows were fabricated new, using traditional styles and techniques. They are made of pine wood, often with chamfered edges. Window screens are produced locally and are made of wrought iron following a traditional design used widely in the pre-Saharan valleys (figs. 8.31 and 8.32).

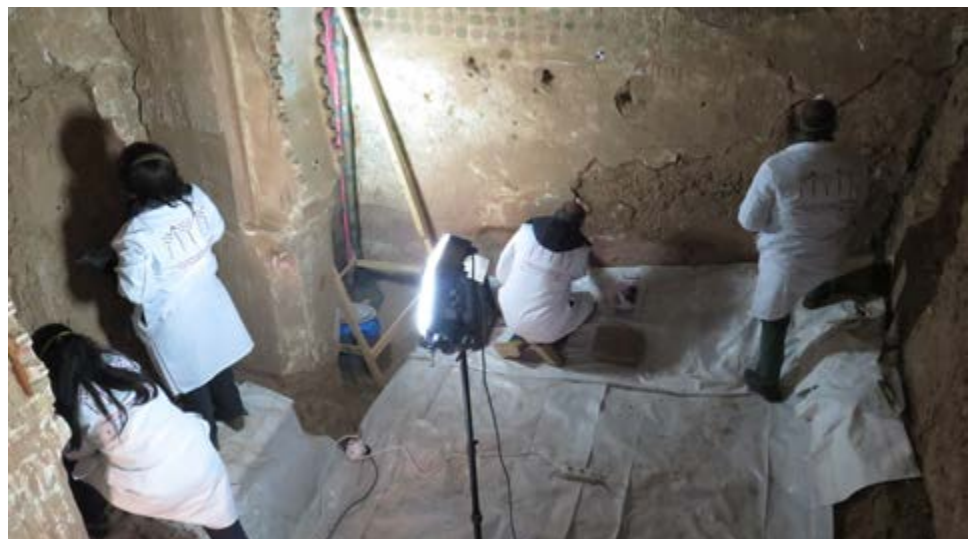
**FIGURES 8.36 AND 8.37**

The wall painting demonstration area in the Northwest room, with protection measures in place, including plastic sheeting and mesh and frame to protect the paintings during structural interventions on the building.

The painting in this area was entirely stabilized by the wall painting team (figs. 8.34 and 8.35). Following treatment, protective materials, including plastic sheeting, mesh, and a wooden frame, were installed in the demonstration area using locally available materials (figs. 8.36 and 8.37). Another extensive area of exterior exposed wall paintings in the collapsed West 2 room was also covered with plastic sheeting for protection (fig. 8.38).

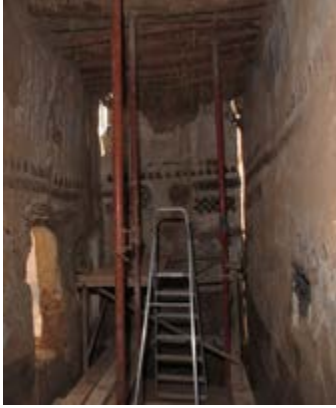
**FIGURES 8.39 AND 8.40**

Above: Many of the painted rooms have severe structural issues. Large structural cracks are visible in West 1 room.

Right: Detailed view of loss and detached painted surfaces in the Caïd Residence.

The structural stability of the Caïd Residence in Kasbah Taourirt was extremely compromised and led to substantial loss and deterioration of wall paintings. For many years, the buildings have been neglected, leading to leaking roofs that allowed significant water (and mud) infiltration into the buildings, causing large portions of the painted rooms to collapse and leaving many of the paintings exposed to and unprotected from the elements. These structural instabilities have also led to complete separation of the walls in some areas and serious cracking throughout the buildings. In addition, a large bat colony inhabited the rooms for many years, covering the painted walls and floors with excreta. All of this has taken a substantial toll on the painted decoration. Large areas of the wall paintings were unstable at the start of the project (including detached plaster layers, structural cracks, and exposed and poorly adhered plaster edges) and were at extreme risk of collapse (figs. 8.39 and 8.40).

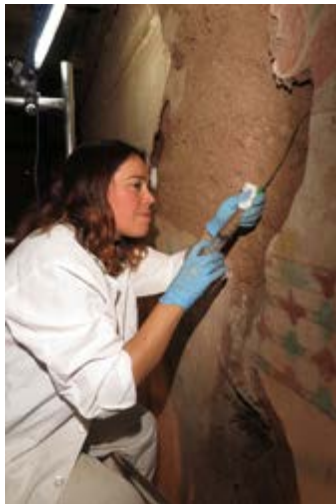
**FIGURES 8.47 AND 8.48**

Grouting tests were undertaken in situ, which allows for future retreatments.

A grout with minimal water was desired with suitable bulk to create anchor points rather than to fill all of the voids. The rationale behind this decision was that grout failure was likely to occur in some areas during structural work. Localized grouting allows for retreatment in the future (figs. 8.47 and 8.48). All component materials, including the earth, sand, and water (both tap and locally available deionized water), were tested with Merck ion test strips to establish their anion content. Fifteen grout mixtures were tested (table 1).

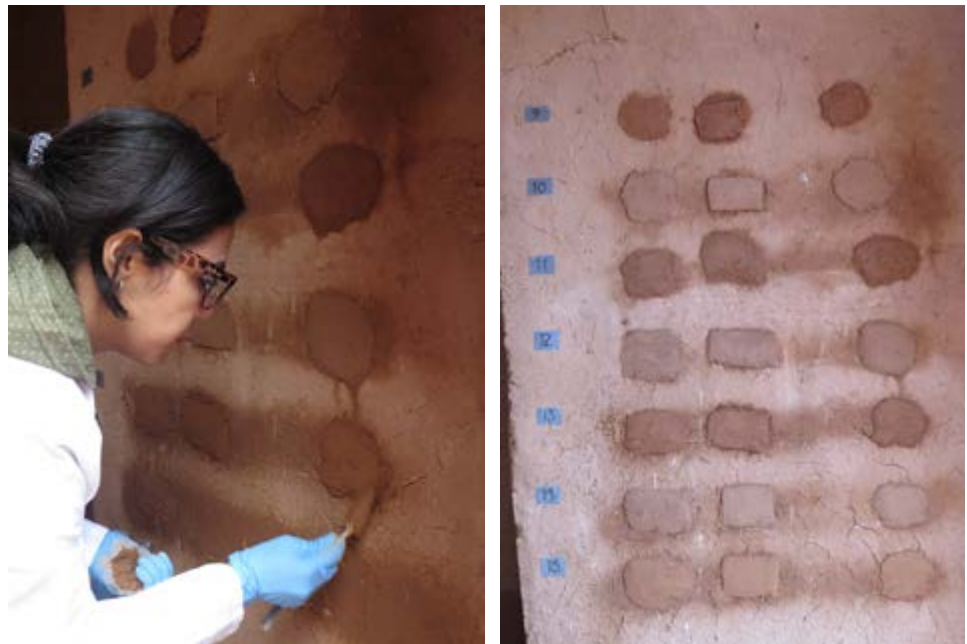
**FIGURES 8.50 AND 8.51**

Tests were done on the 15 plaster edging repair mixtures to assess workability, shrinkage, cracking, and color.

Initial testing aimed to compare the following properties and performance (figs. 8.50 and 8.51):

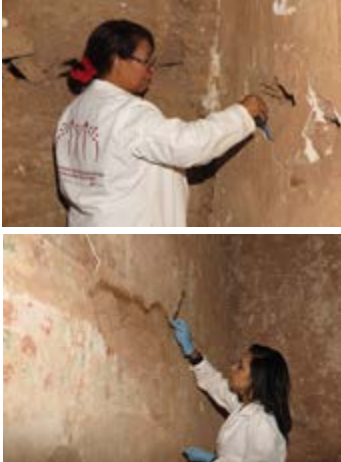
**FIGURES 8.52 AND 8.53**

Wall painting team implementing edging repairs to secure edges of a wall painting in the Caïd Residence demo area.

Edging repair mixtures 14 and 15 were selected for use in the demo area because they did not show shrinkage or cracking, had good workability, and were a good color match to the original painted plaster (figs. 8.52, 8.53, and 8.54). Two mixtures were selected in order to have the option of two different colored plasters for use depending on the area (table 4):

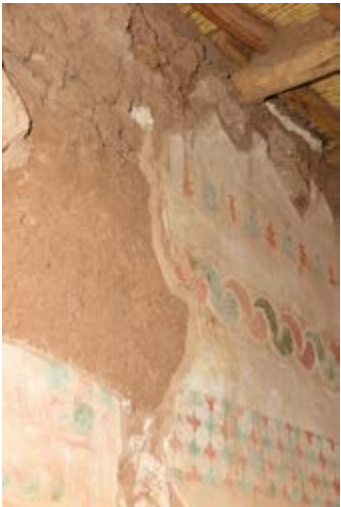
**FIGURE 8.54**

Detail of edging of a section of a wall painting in the Caïd Residence.

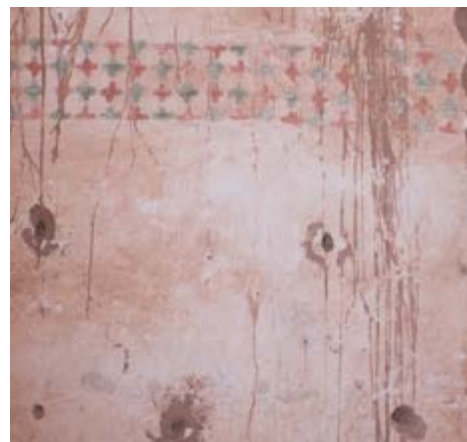
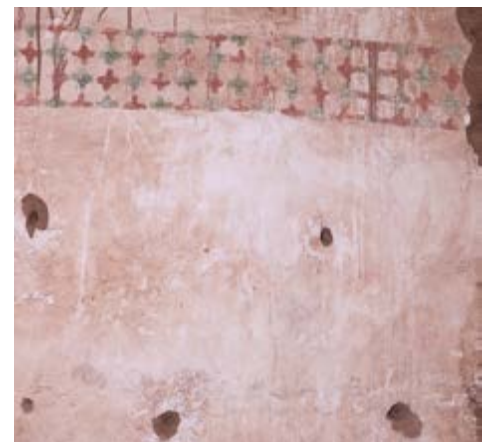
**FIGURES 8.57 AND 8.58**

Cleaning trials undertaken on the north wall of West 1 room, showing before cleaning (right) and after cleaning (far right). Mud drips were removed with soft brushes and mechanical action. Photos: Charlotte Martin de Fonjaudran, 2015.

Given the water sensitivity of the painted plaster, rapid and easily achievable water-based cleaning is difficult. The cleaning tests were therefore restricted to mechanical methods that used soft brushes to remove surface dust and mud drips (figs. 8.57 and 8.58). Because of time limitations, only small cleaning tests were undertaken.

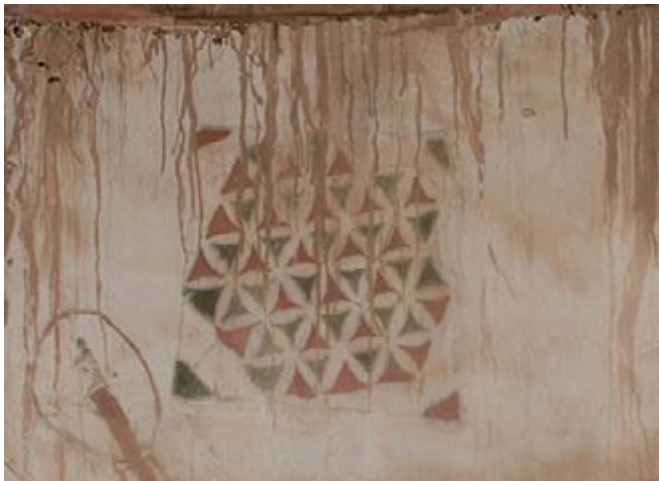
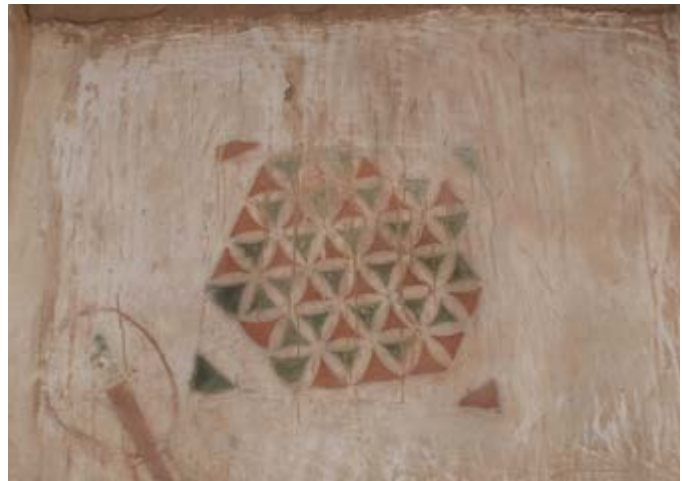
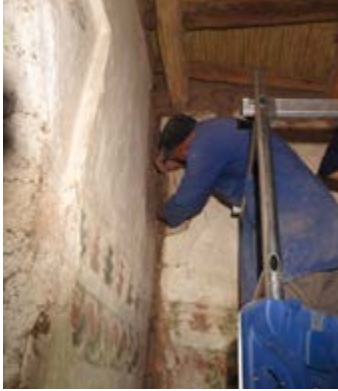
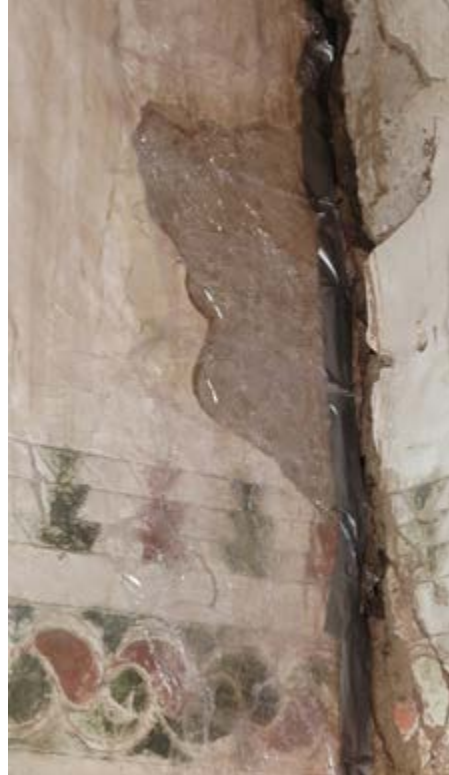
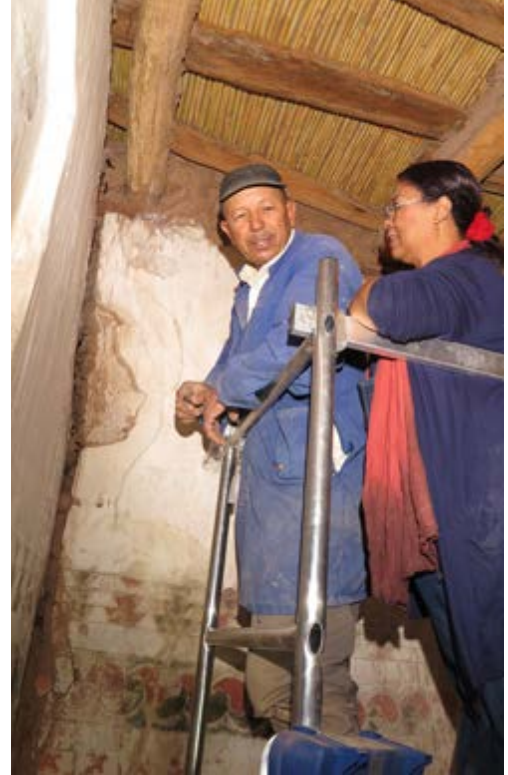
**FIGURES 8.63, 8.64, AND 8.65**

Before filling a structural crack, wall paintings in the Caïd Residence were stabilized and protected (top, right) by ma'alem under the supervision of CERKAS staff member Noufissa Ouberchkik (far right). Photos: Lorinda Wong, 2015.

A significant amount of structural interventions was undertaken in the Caïd Residence on the rooms with decoration. As part of this work, a large structural crack was filled as a demonstration of how to treat cracks in the vicinity of areas of painting. The paintings were first stabilized, areas grouted and edges secured, and were then protected with plastic wrap (figs. 8.63 and 8.64). Conservators worked with the ma'alem to fill the crack and plaster it (fig. 8.65).

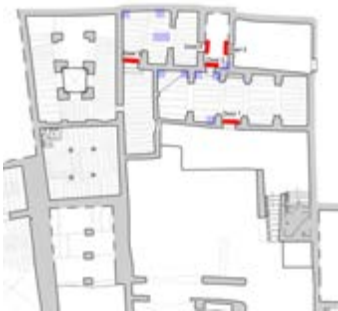
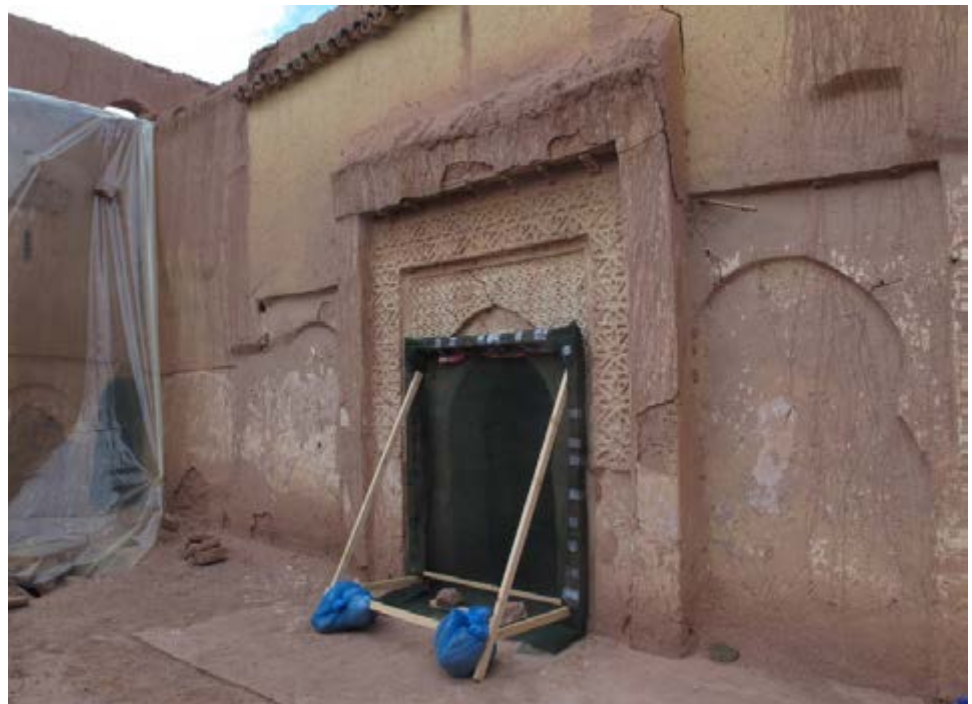
**FIGURES 8.66 AND 8.67**

Above: Floor plan showing the location of temporary doors (in red) and openings that were sealed (in blue) to prevent bat entry to the Caïd Residence.

Right: Temporary door placed in front of the north terrace door. Drawing: CIMS, 2013. Photo: Lorinda Wong, 2015.

Significant time was dedicated to the design and installation of temporary doors and to the filling of entry points to prevent bats from entering the painted rooms in the Caïd Residence. The bat exclusion measures proved successful as no bats have yet returned, but a permanent door closure system has still been determined necessary (figs. 8.66 and 8.67).

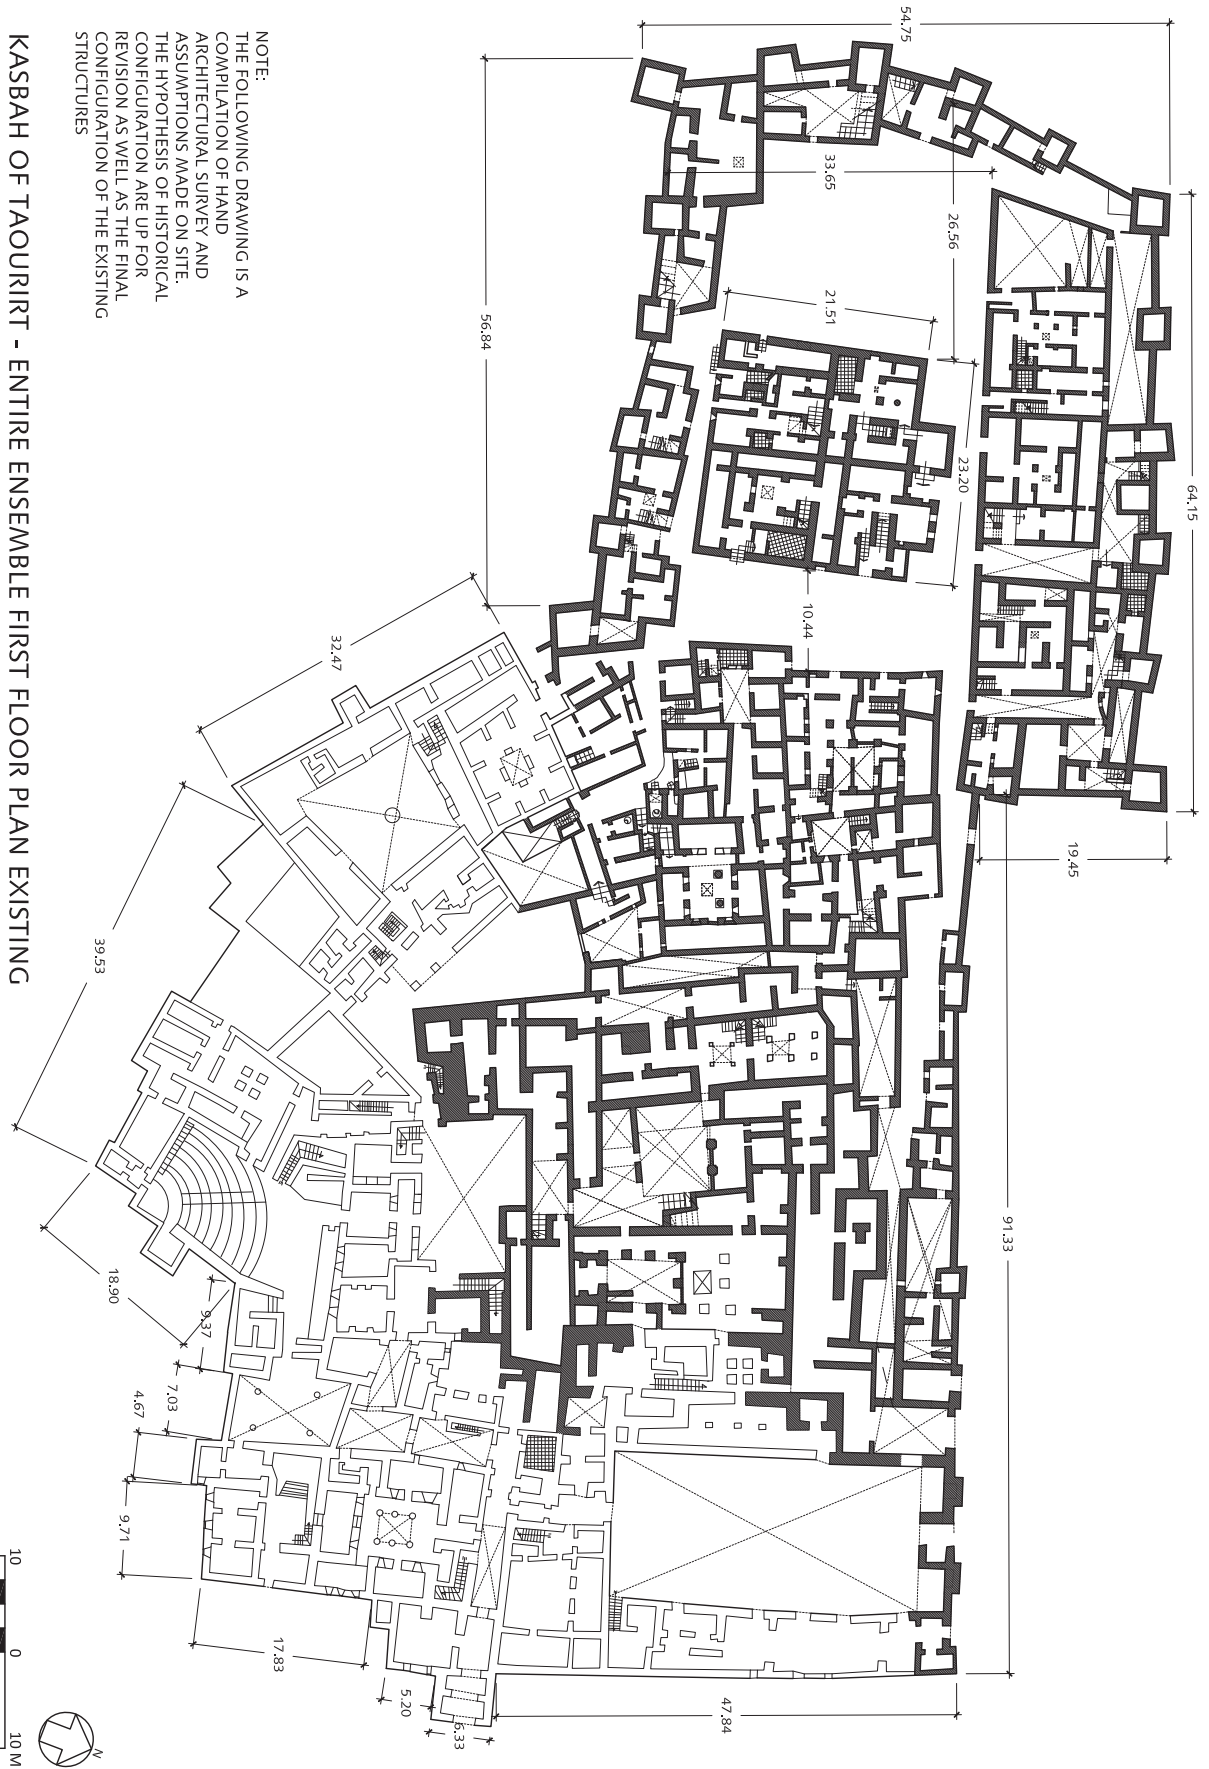
**KASBAH OF TAOURIRT - ENTIRE ENSEMBLE FIRST FLOOR PLAN EXISTING**

NOTE:  
 THE FOLLOWING DRAWING IS A  
 COMPILATION OF HAND  
 ARCHITECTURAL SURVEY AND  
 ASSUMPTIONS MADE ON SITE.  
 THE HYPOTHESES OF HISTORICAL  
 CONFIGURATION ARE UP FOR  
 REVISION AS WELL AS THE FINAL  
 CONFIGURATION OF THE EXISTING  
 STRUCTURES

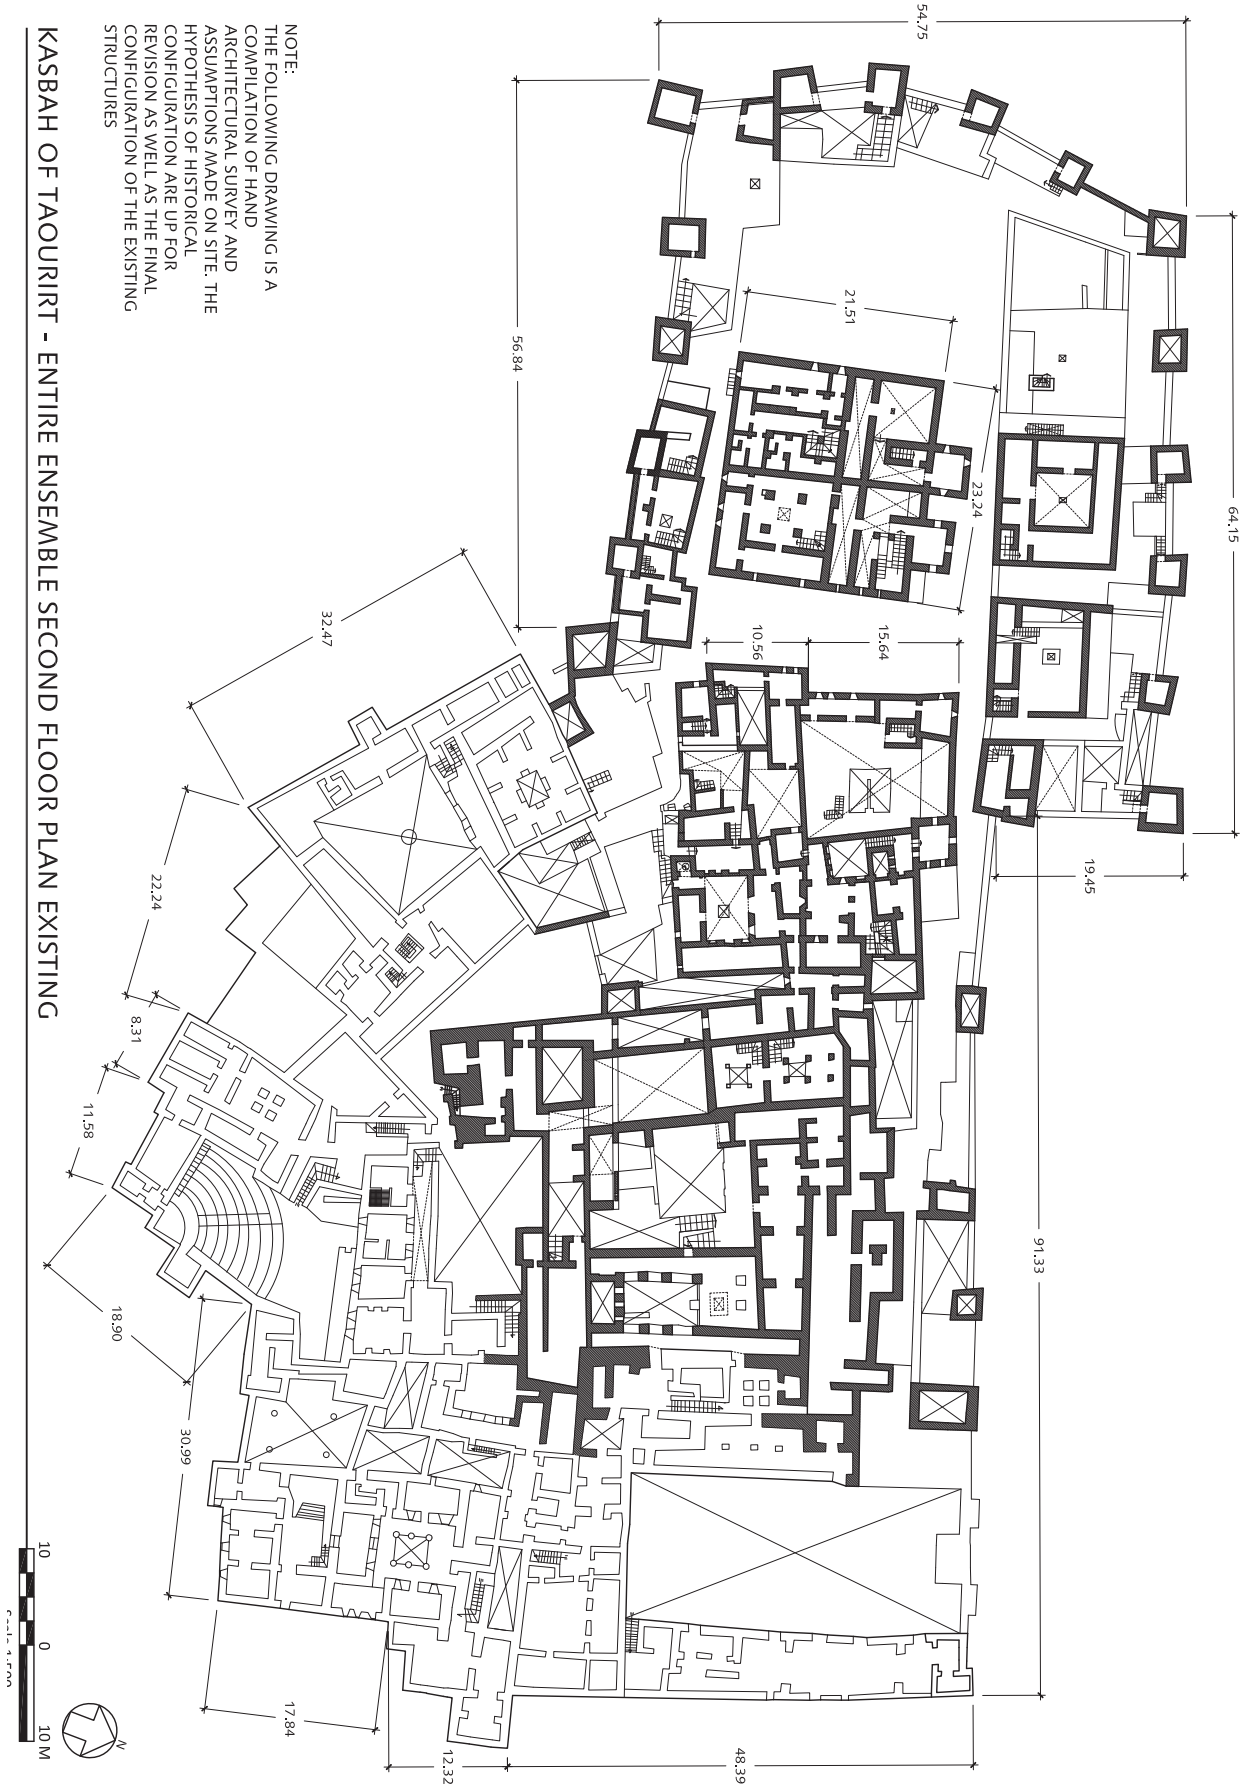
**KASBAH OF TAOURIRT - ENTIRE ENSEMBLE SECOND FLOOR PLAN EXISTING**

NOTE:  
 THE FOLLOWING DRAWING IS A  
 COMPILATION OF HAND  
 ARCHITECTURAL SURVEY AND  
 ASSUMPTIONS MADE ON SITE. THE  
 HYPOTHESIS OF HISTORICAL  
 CONFIGURATION ARE UP FOR  
 REVISION AS WELL AS THE FINAL  
 CONFIGURATION OF THE EXISTING  
 STRUCTURES
