# Conservation and Rehabilitation Plan for Tighermt (Kasbah) Taourirt, Southern Morocco

## Research Report

Claudia Cancino, Benjamin Marcus and  
Mohamed Boussalh

# Conservation and Rehabilitation Plan for Tighermt (Kasbah) Taourirt

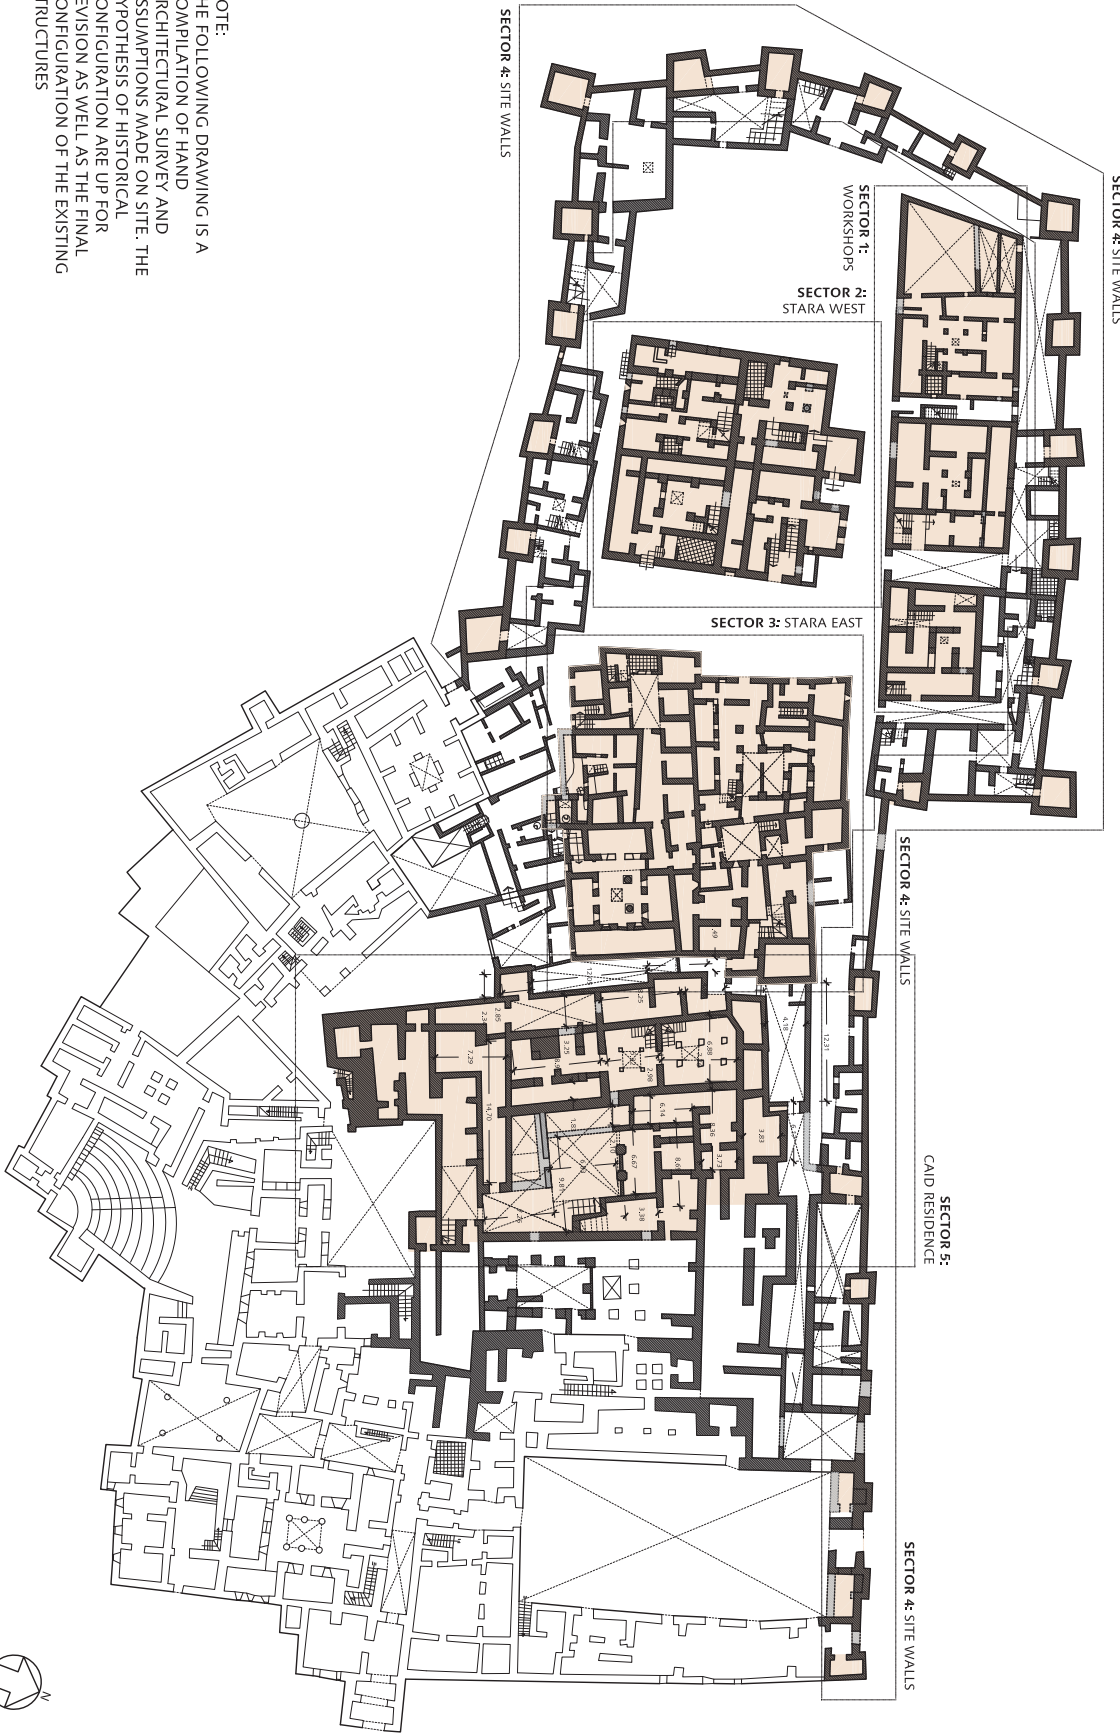
KASBAH OF TAOURIRT - ENTIRE ENSEMBLE FIRST FLOOR PLAN SECTORS

NOTE:  
 THE FOLLOWING DRAWING IS A  
 COMPILATION OF HAND  
 ARCHITECTURAL SURVEY AND  
 ASSUMPTIONS MADE ON SITE. THE  
 HYPOTHESIS OF HISTORICAL  
 CONFIGURATION ARE UP FOR  
 REVISION AS WELL AS THE FINAL  
 CONFIGURATION OF THE EXISTING  
 STRUCTURES

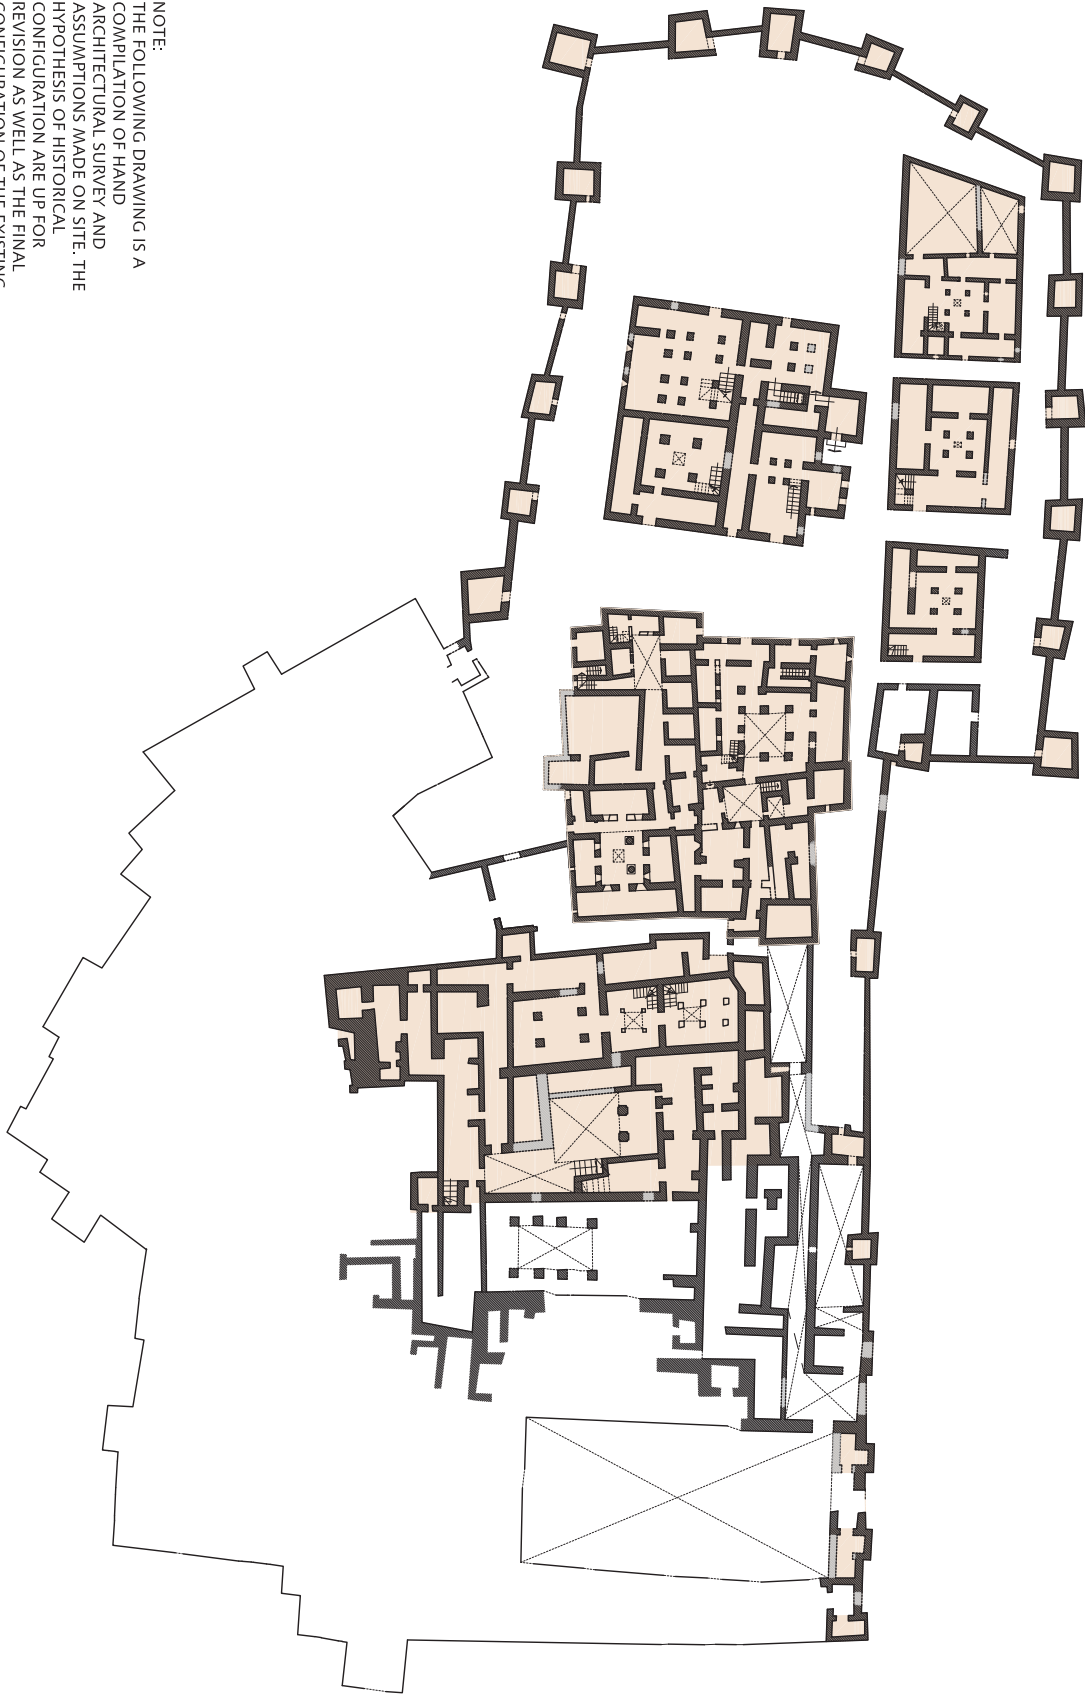
**KASBAH OF TAOURIRT - ENTIRE ENSEMBLE FIRST FLOOR HISTORIC**

NOTE:  
 THE FOLLOWING DRAWING IS A  
 COMPILATION OF HAND  
 ARCHITECTURAL SURVEY AND  
 ASSUMPTIONS MADE ON SITE. THE  
 HYPOTHESIS OF HISTORICAL  
 CONFIGURATION ARE UP FOR  
 REVISION AS WELL AS THE FINAL  
 CONFIGURATION OF THE EXISTING  
 STRUCTURES

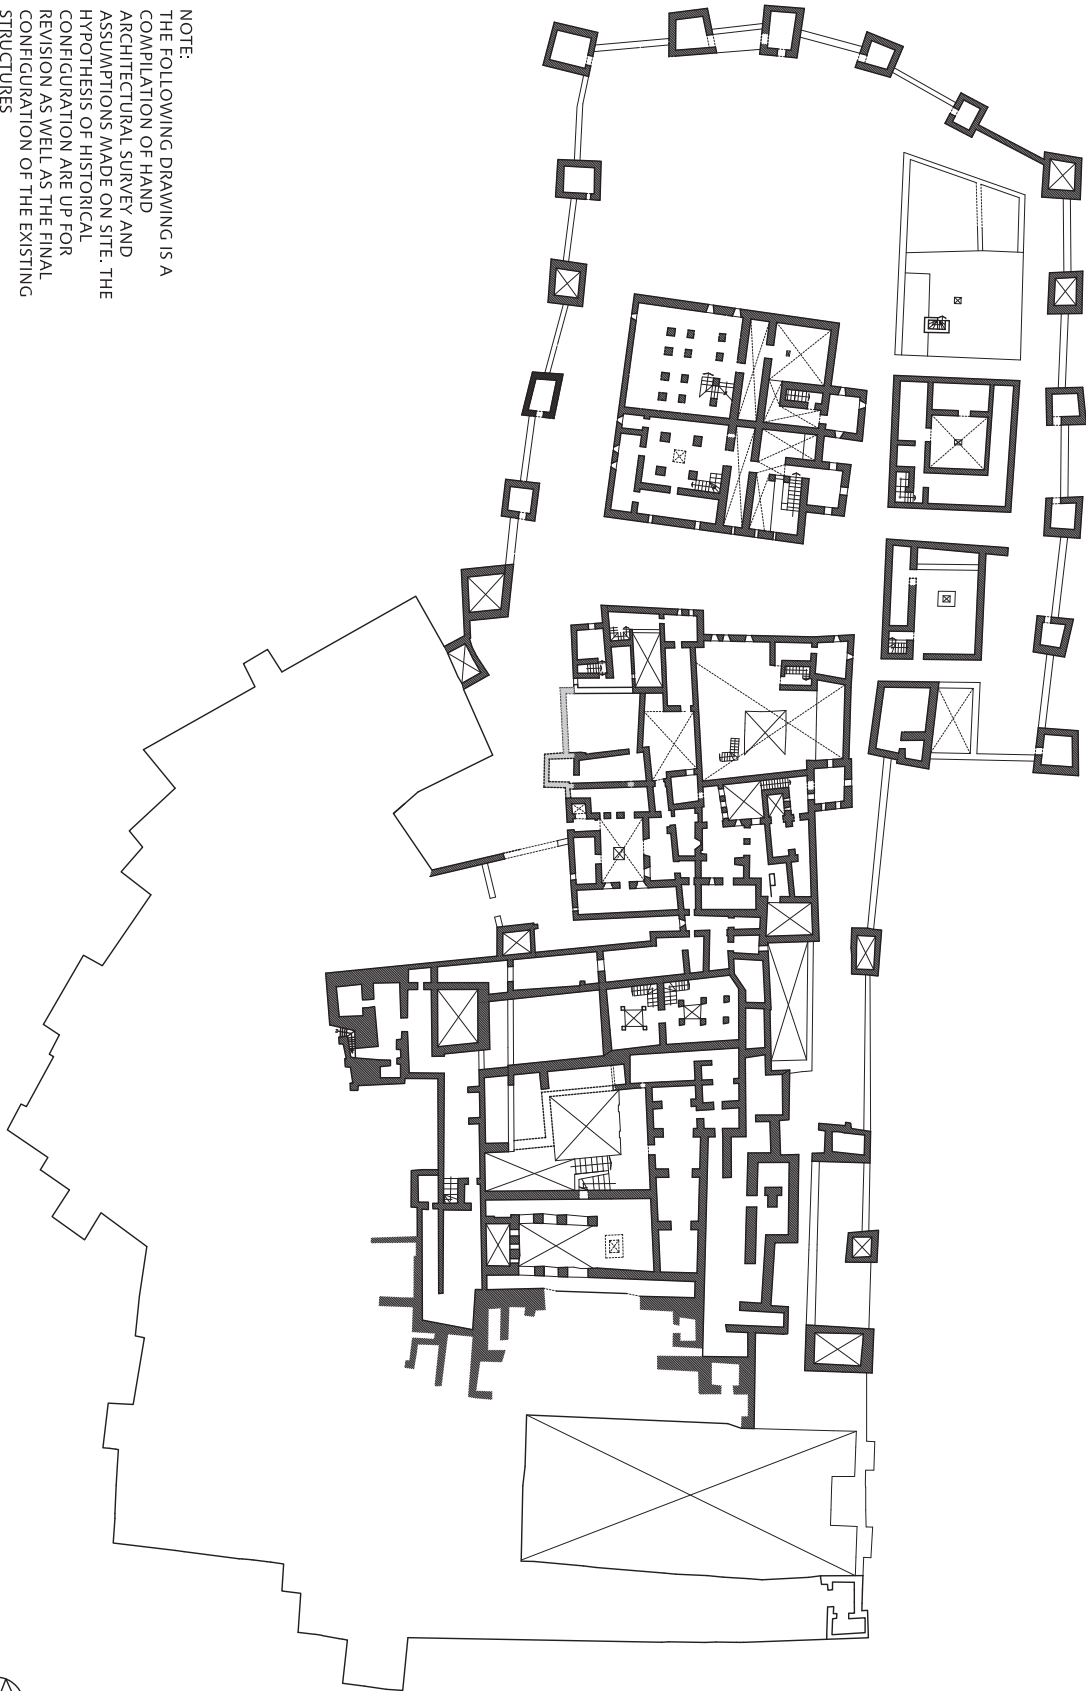
KASBAH OF TAOURIRT - ENTIRE ENSEMBLE SECOND FLOOR HISTORIC

NOTE:  
 THE FOLLOWING DRAWING IS A  
 COMPILATION OF HAND  
 ARCHITECTURAL SURVEY AND  
 ASSUMPTIONS MADE ON SITE. THE  
 HYPOTHESIS OF HISTORICAL  
 CONFIGURATION ARE UP FOR  
 REVISION AS WELL AS THE FINAL  
 CONFIGURATION OF THE EXISTING  
 STRUCTURES

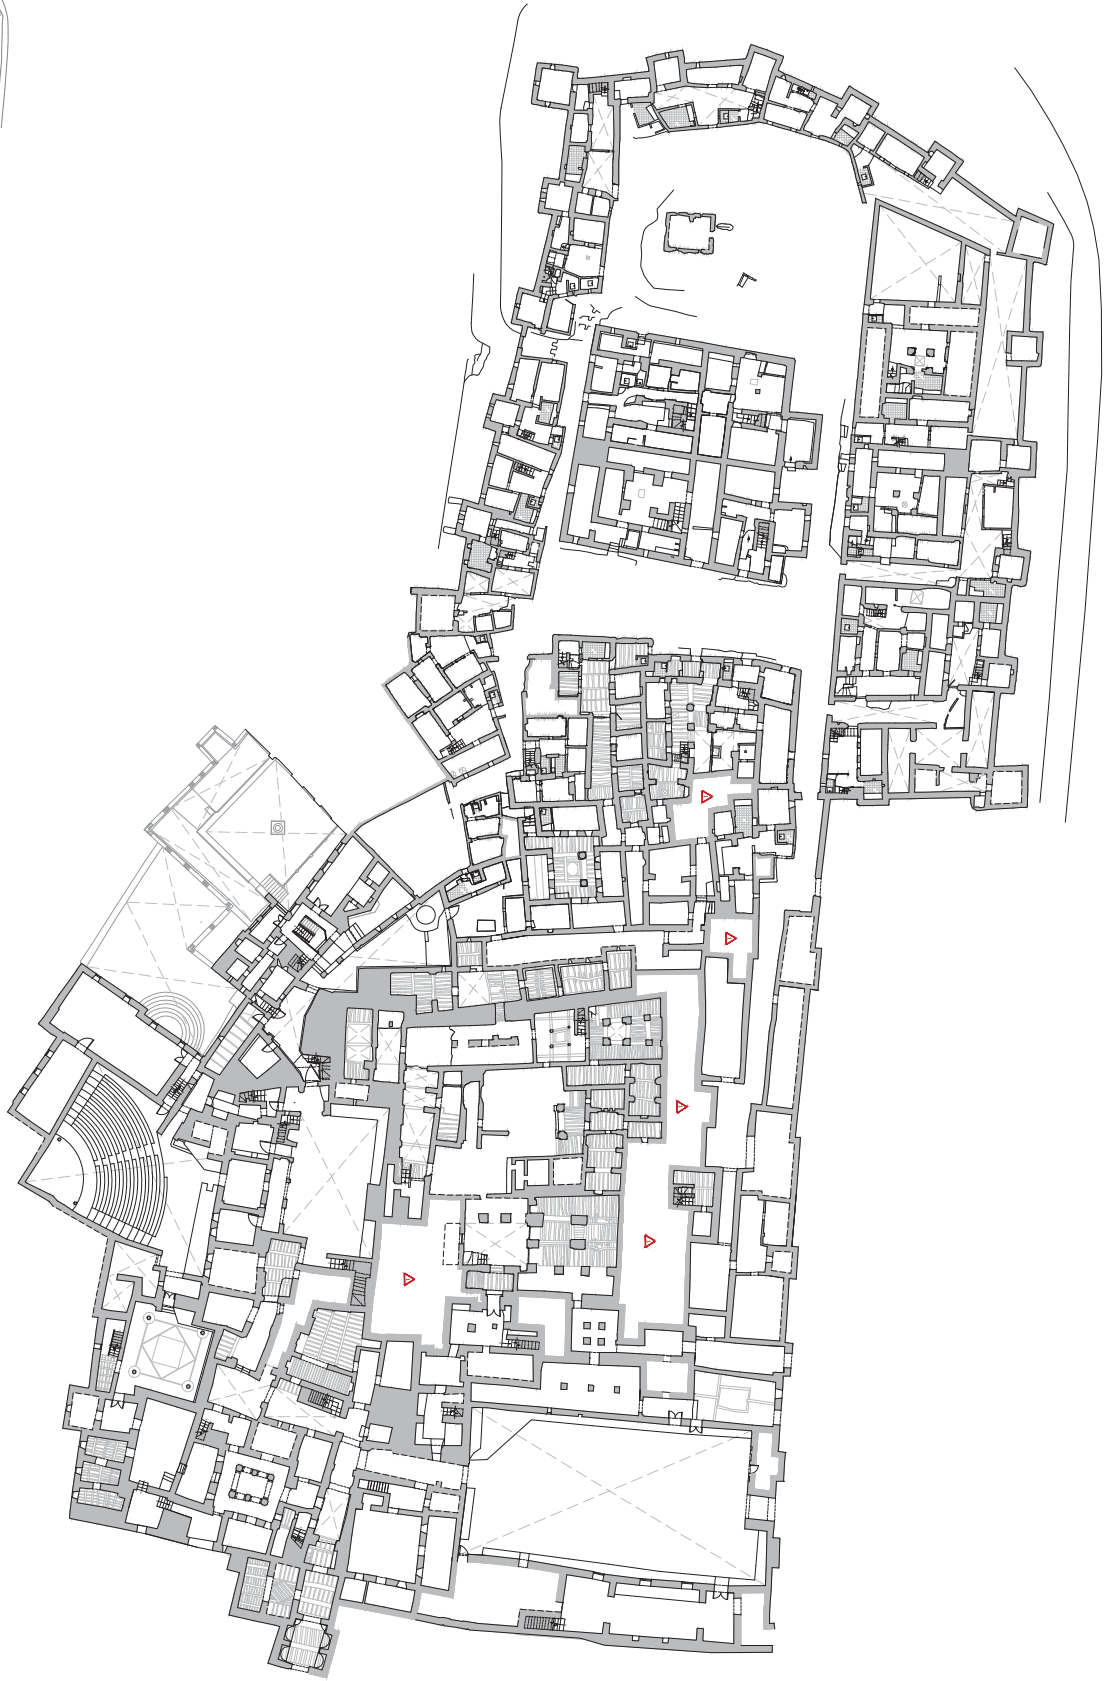
Drawing number: **TAO, arch. survey, P04**

Site: **KASBAH TAOURIRT**  
 Drawing: **GROUND LEVEL**  
 Reviewed by: B. Marcus, C. Cancino  
 Created by: Carleton University, CIMS

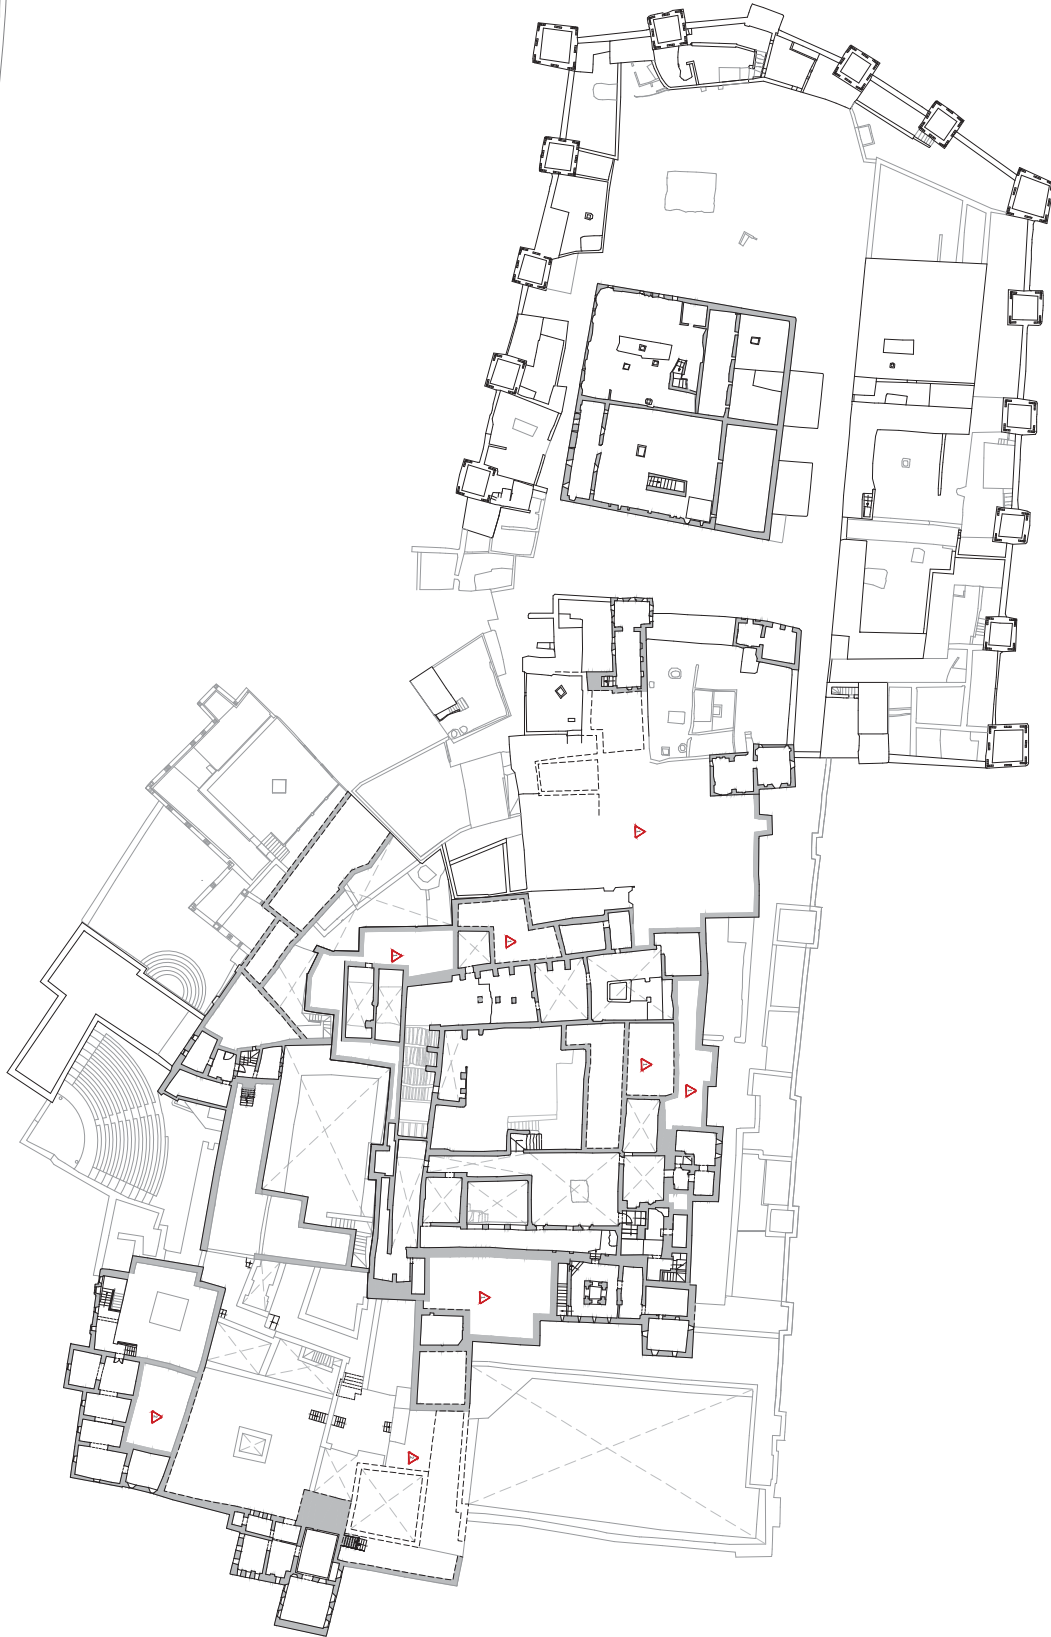
Drawing number: **TAO, arch. survey, P06**

Site: **KASBAH TAOURIRT**  
Drawing: **LEVEL 2**  
Reviewed by: B. Marcus  
C. Cancino  
Created by: Carleton UNIVERSITY CIMS

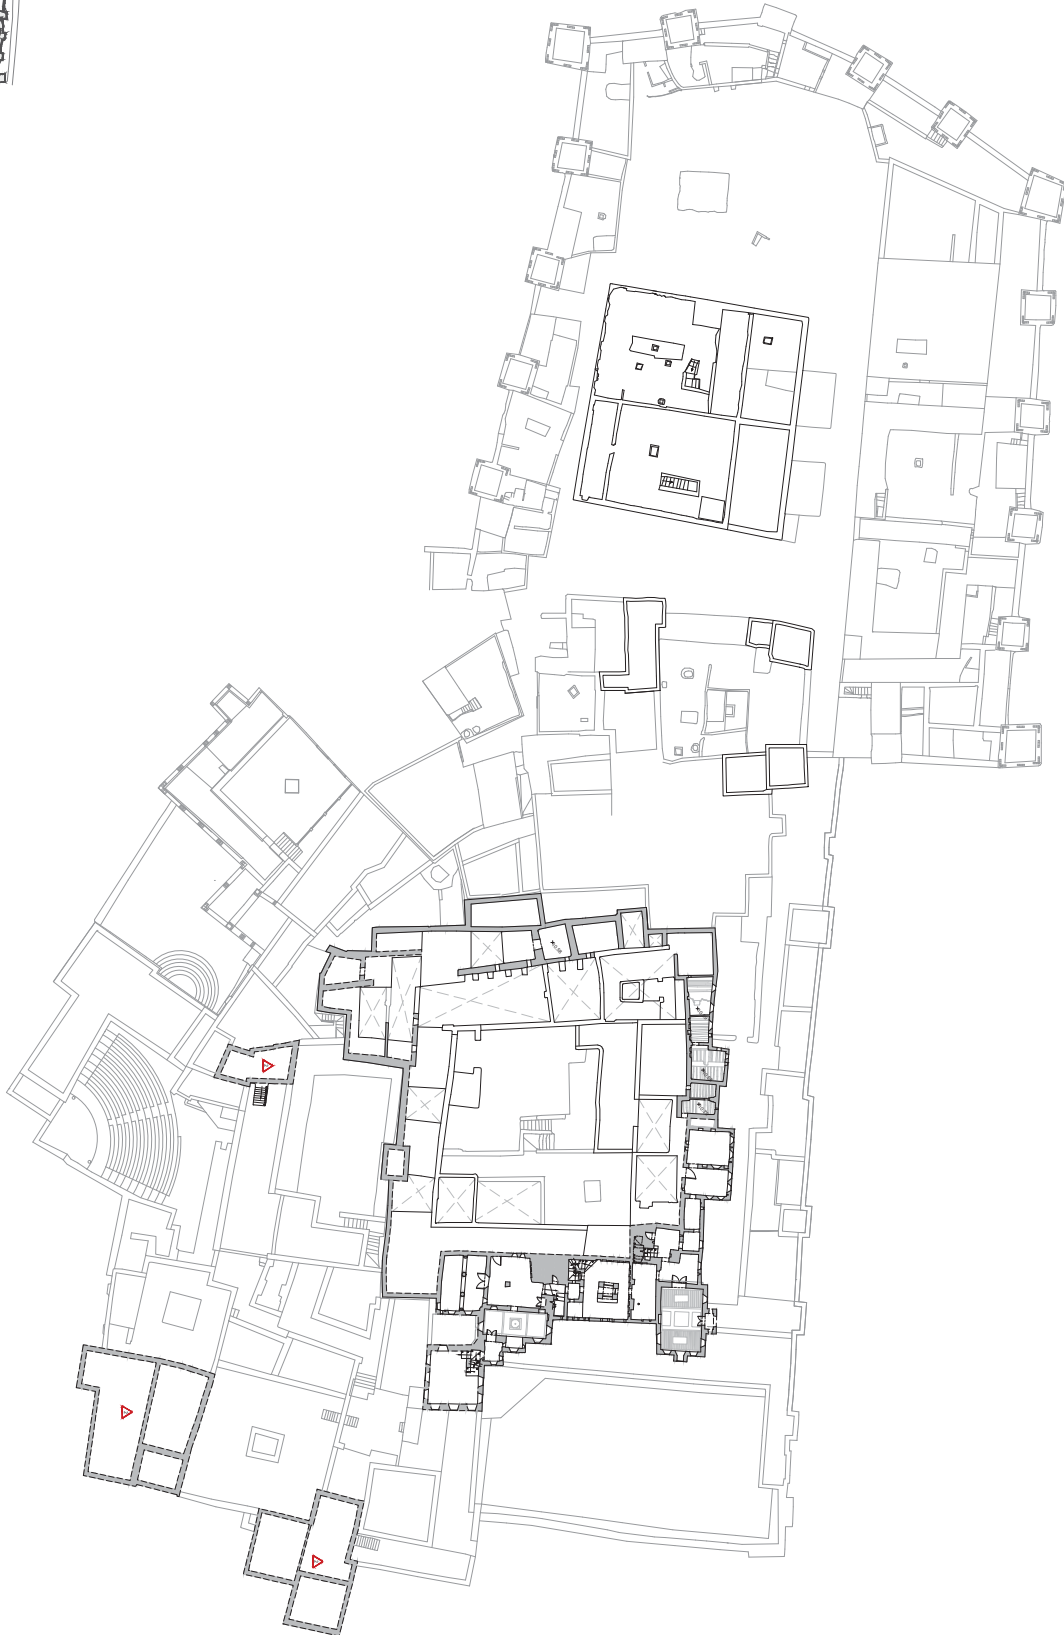
Drawing number: **TAO, arch. survey, P07**  
The Getty Conservation Institute  
CERKAS  
Ministerio de Cultura

Site: **KASBAH TAOURIRT**  
Drawing: **LEVEL 3**  
Reviewed by: B. Marcus, C. Cancino  
Created by: Carleton UNIVERSITY CIMS

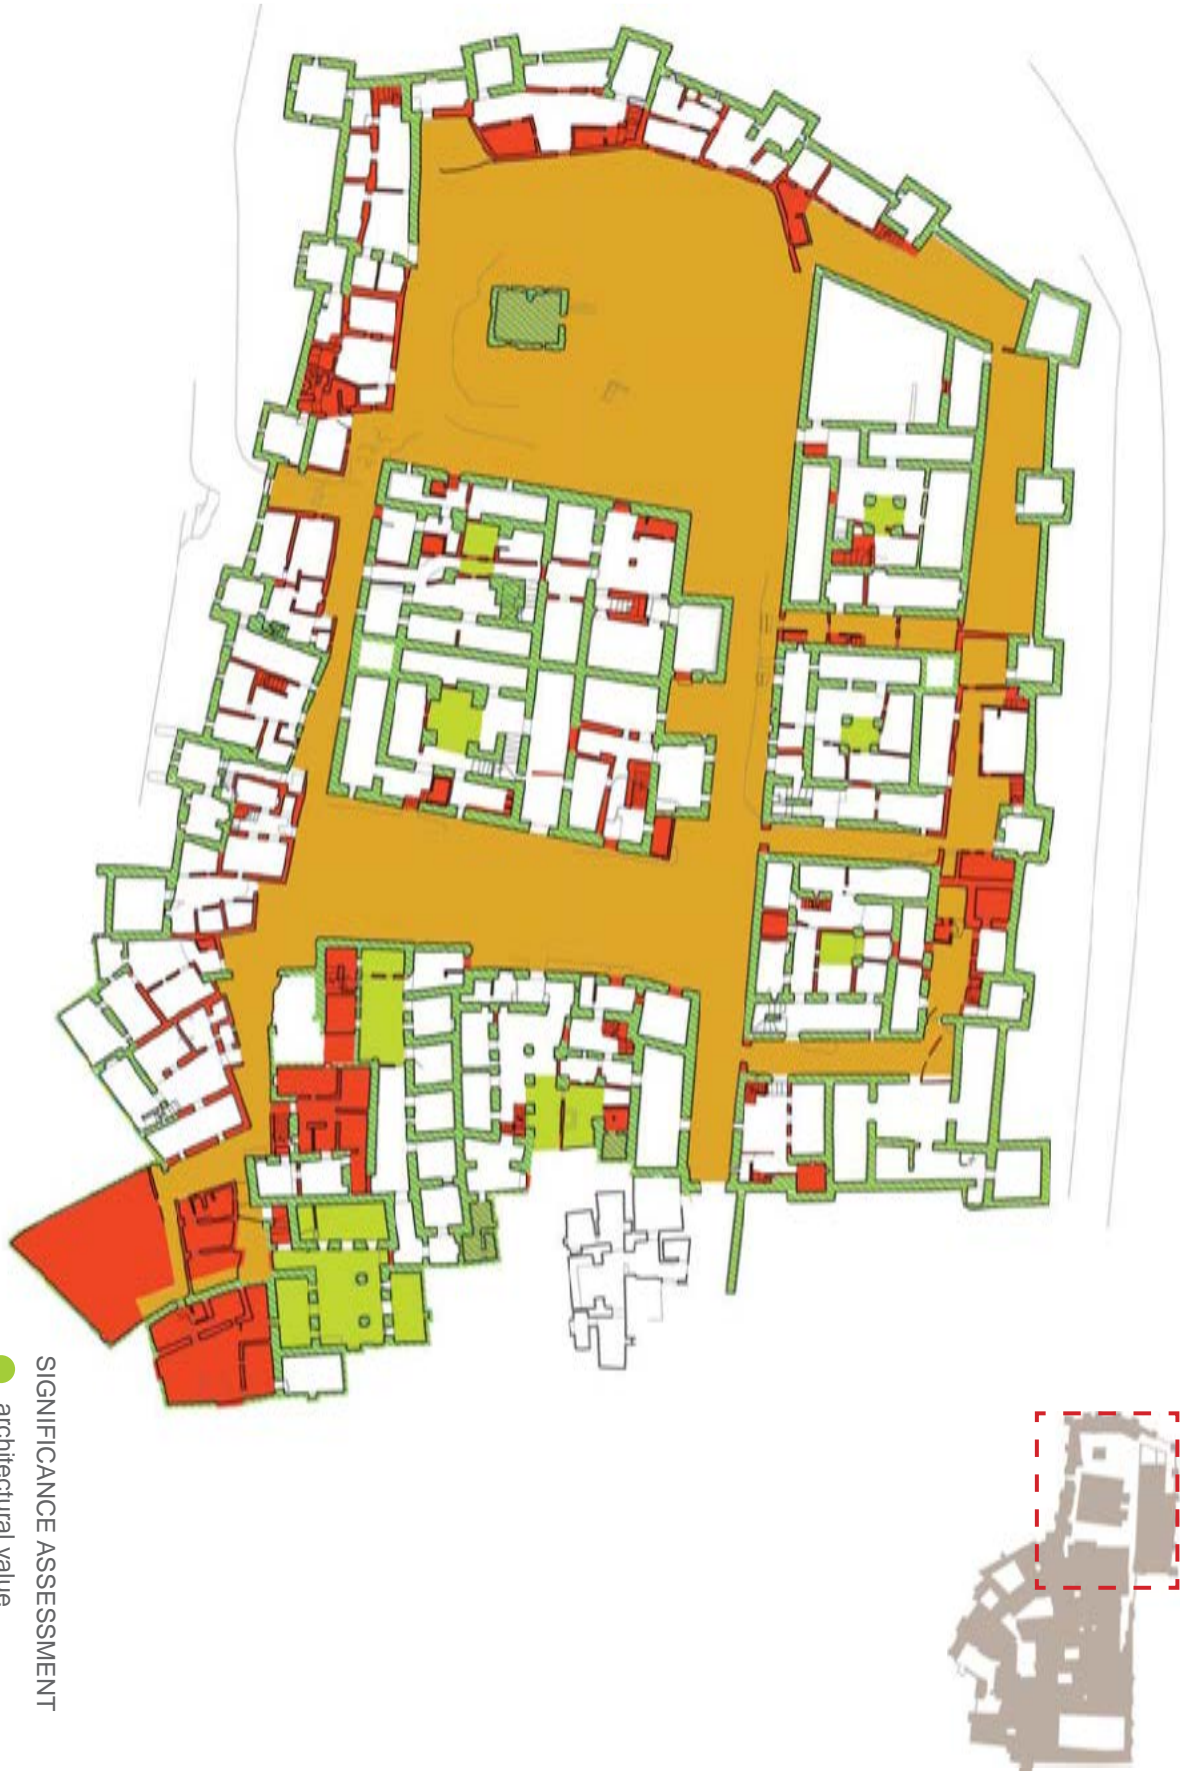
Drawing number: TAO\_VAL\_CR\_03  
 Scale: 1:300  
 Date: April 2014

STARA AREA - GROUND LEVEL

- SIGNIFICANCE ASSESSMENT
- architectural value
  - historical value
  - social value
  - economic value
  - no value

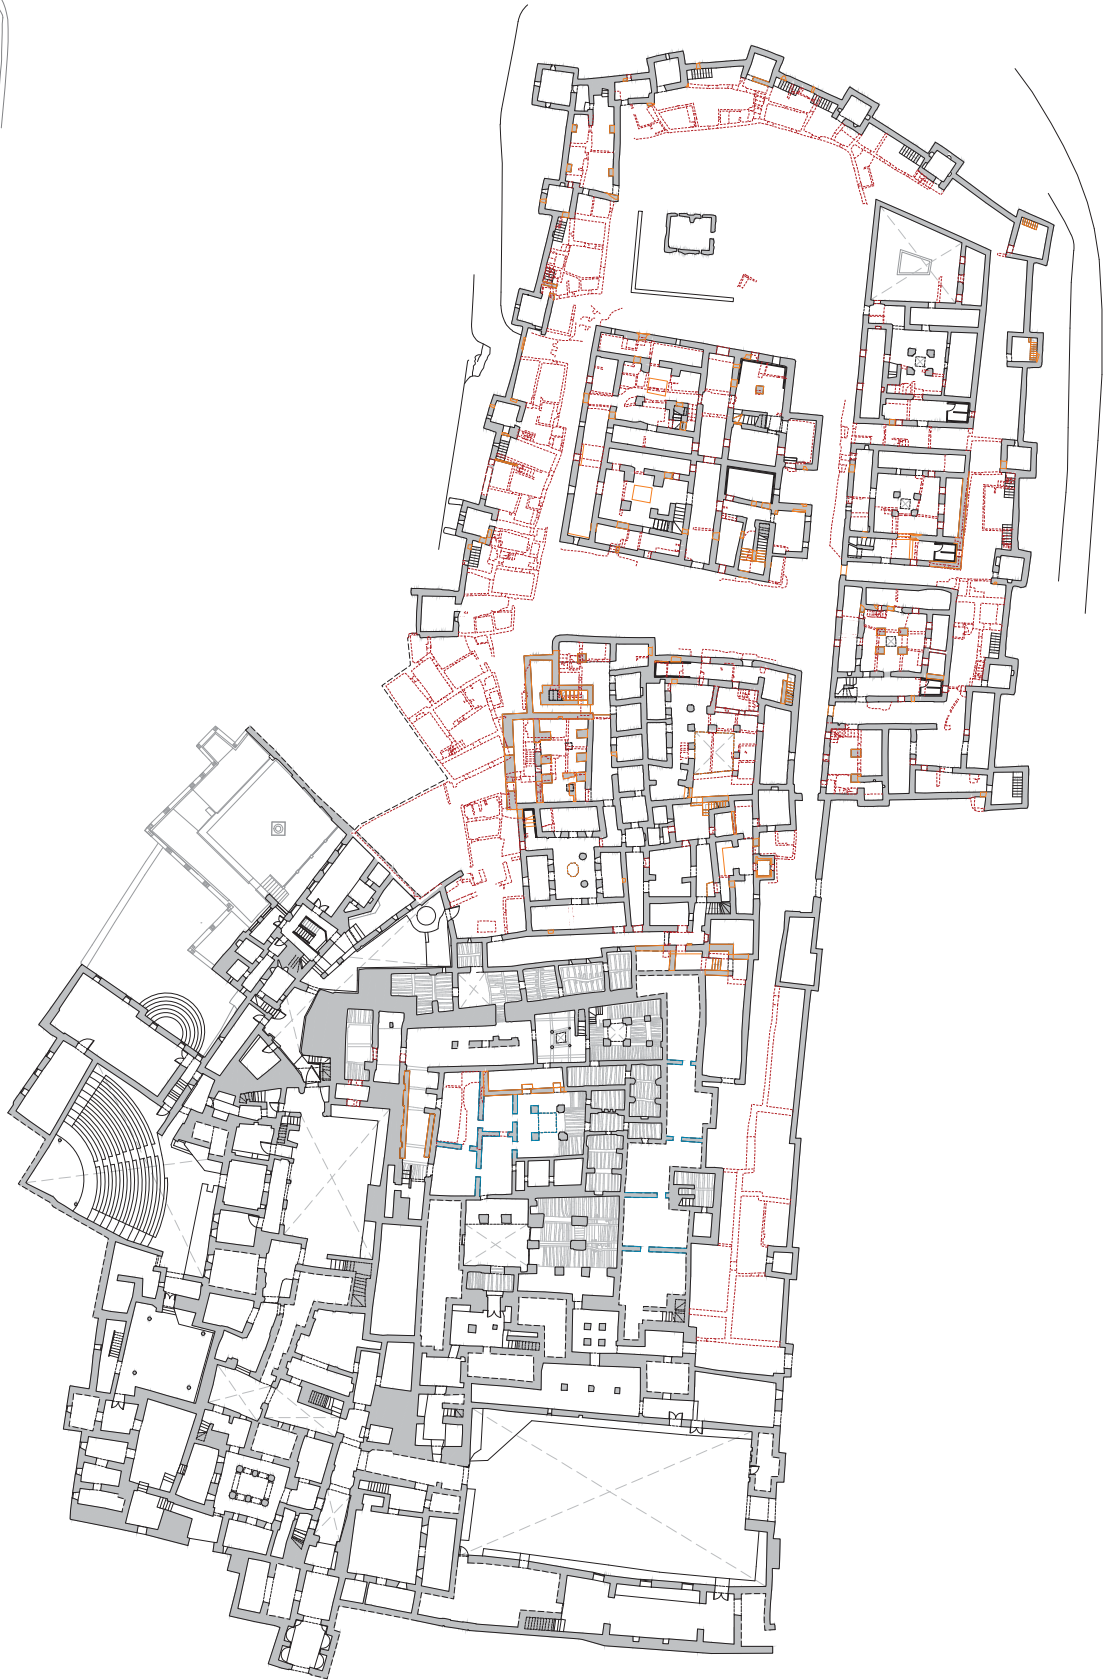
Site: **KASBAH TAOURIRT**  
Drawing: **REHABILITATION - GR. LEVEL**  
Reviewed by: B. Marcus  
C. Cancino

- Wall removal
- Wall construction
- Wall construction proposal

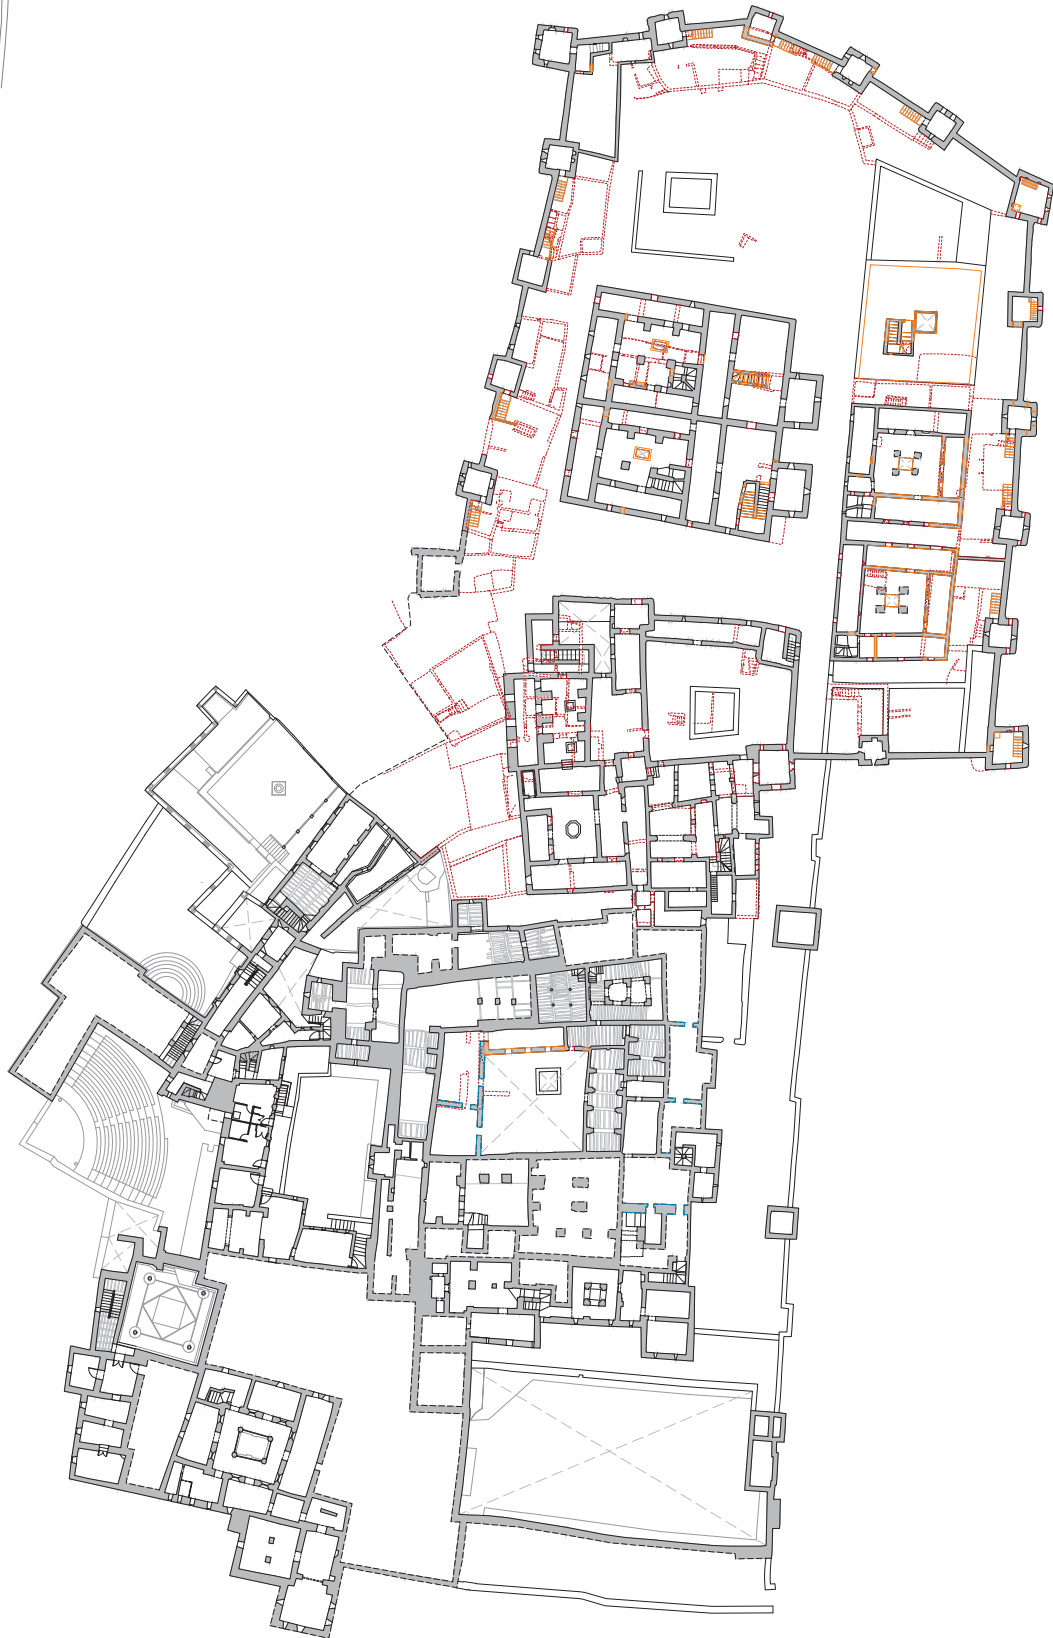
Site: **KASBAH TAOURIRT**  
Drawing: **REHABILITATION - LEVEL 1**  
Reviewed by: B. Marcus  
C. Cancino

- Wall removal
- Wall construction
- Wall construction proposal

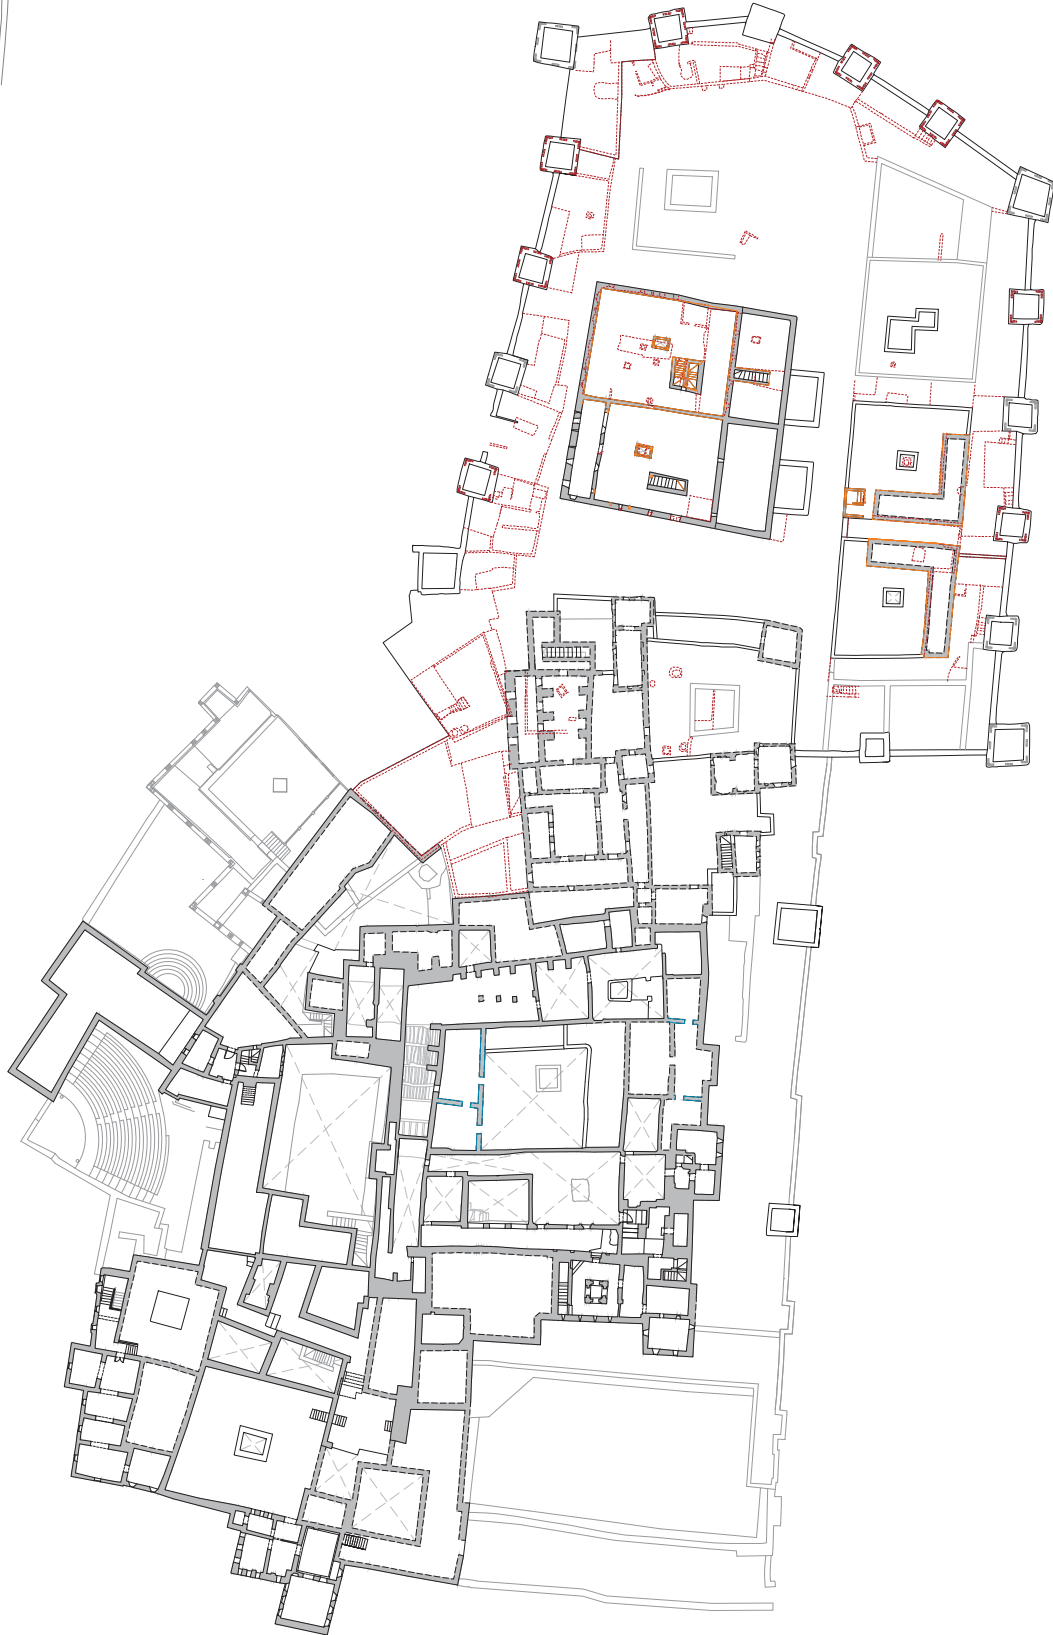
Site: **KASBAH TAOURIRT**  
Drawing: **REHABILITATION - LEVEL 2**  
Reviewed by: B. Marcus  
C. Cancino

- Wall removal
- Wall construction
- Wall construction proposal

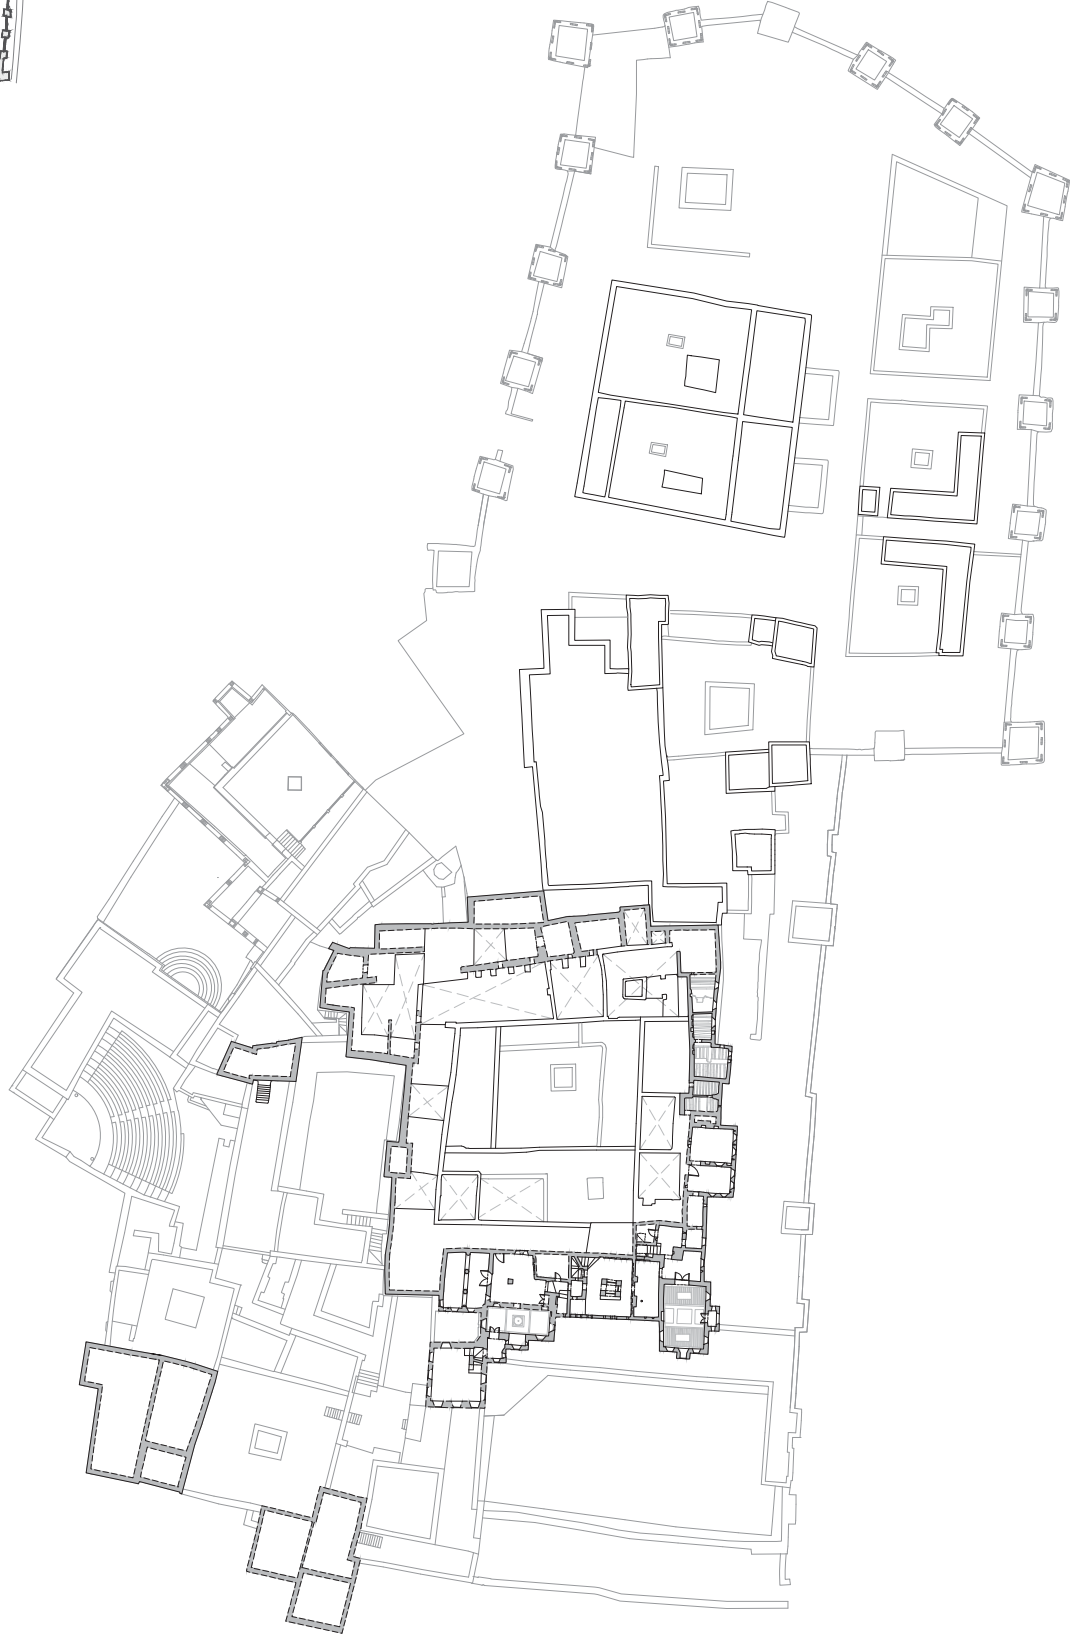
Site: **KASBAH TAOURIRT**  
Drawing: **REHABILITATION - LEVEL 3**  
Reviewed by: B. Marcus  
C. Cancino

- Wall removal
- Wall construction
- Wall construction proposal

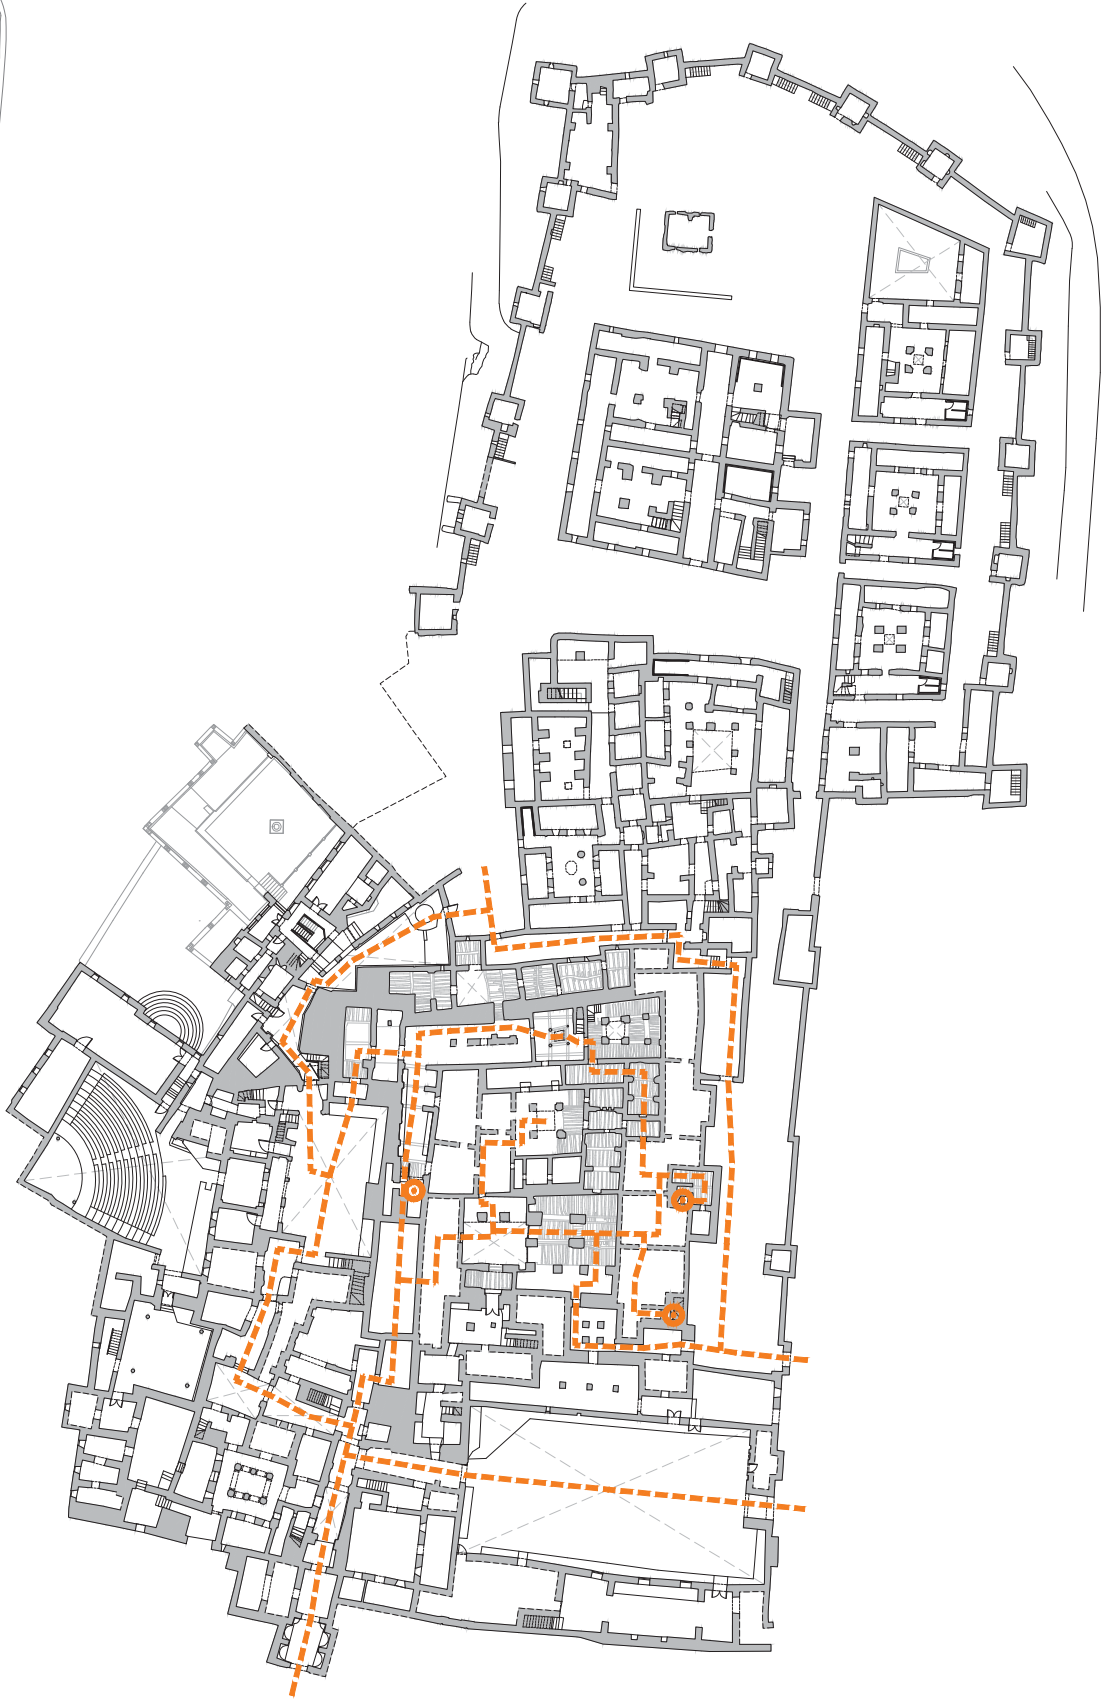
Vertical connection downstairs  
 Vertical connection upstairs  
 Proposed circulation

<b>CONSERVATION AND REHABILITATION PLAN FOR KASBAH TAOURIRT, MOROCCO</b> Intervention Proposal	Site: <b>KASBAH TAOURIRT</b>	Created by: Supervisor: Benjamin Marcus Production team: Oriol Dominguez, Elena Macchioni, Emilio Roldán	Drawing number: <b>TAO, intervention, P14</b>
	Drawing: <b>CIRCULATION - GR. LEVEL</b>	Reviewed by: B. Marcus C. Cancino	Scale: April, 2016 Date: 1:500
