# Conservation and Rehabilitation Plan for Tighermt (Kasbah) Taourirt, Southern Morocco

## Research Report

Claudia Cancino, Benjamin Marcus and  
Mohamed Boussalh

# Conservation and Rehabilitation Plan for Tighermt (Kasbah) Taourirt

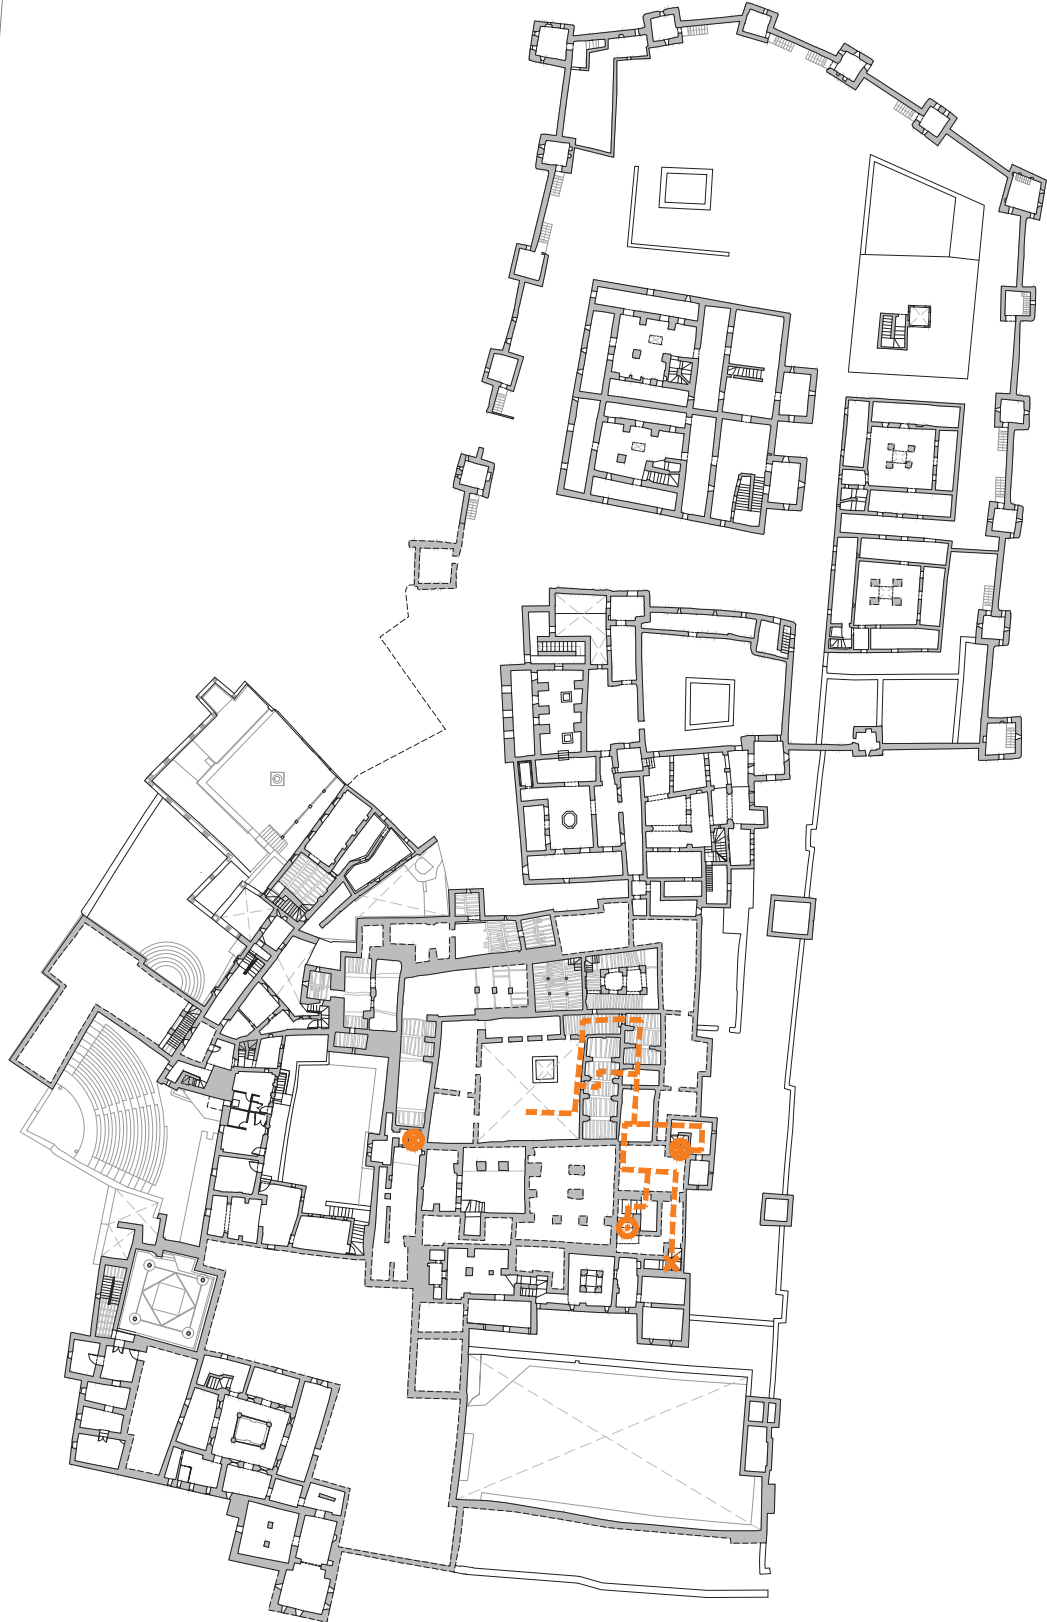
Vertical connection downstairs  
 Vertical connection upstairs  
 Proposed circulation

Site: **KASBAH TAOURIRT**  
 Drawing: **CIRCULATION - LEVEL 1**  
 Reviewed by: B. Marcus  
 C. Cancino

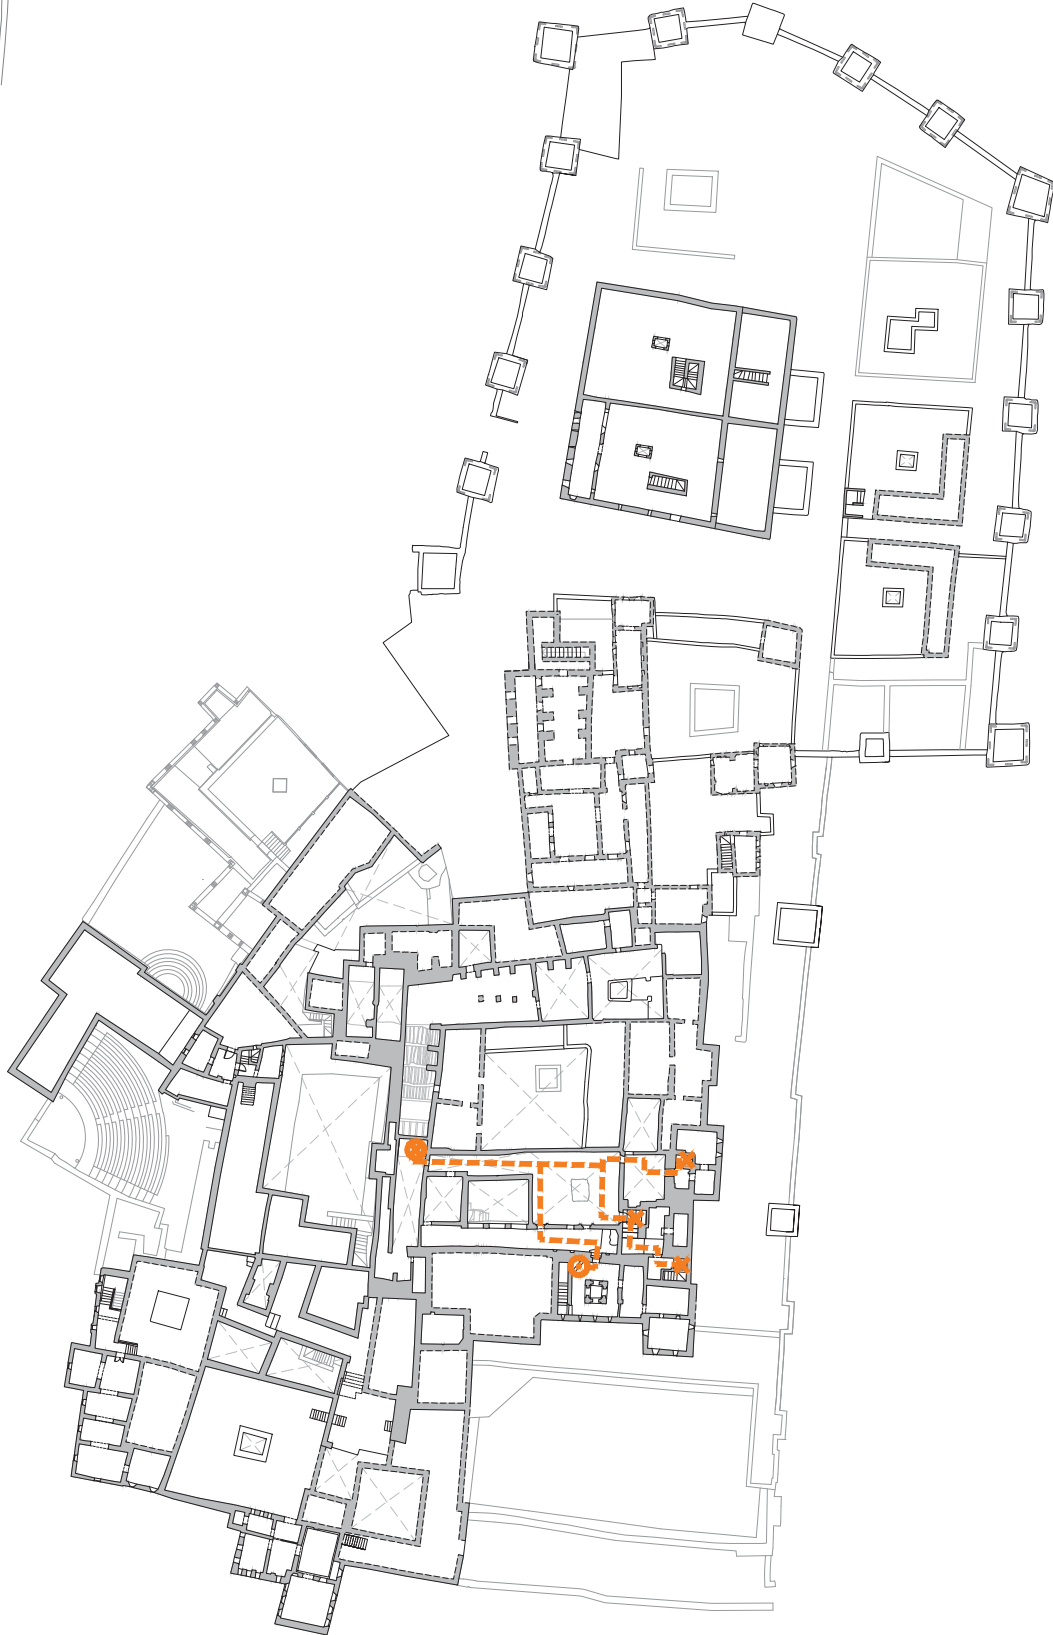
Vertical connection downstairs  
 Vertical connection upstairs  
 Proposed circulation

Site: **KASBAH TAOURIRT**  
 Drawing: **CIRCULATION - LEVEL 2**

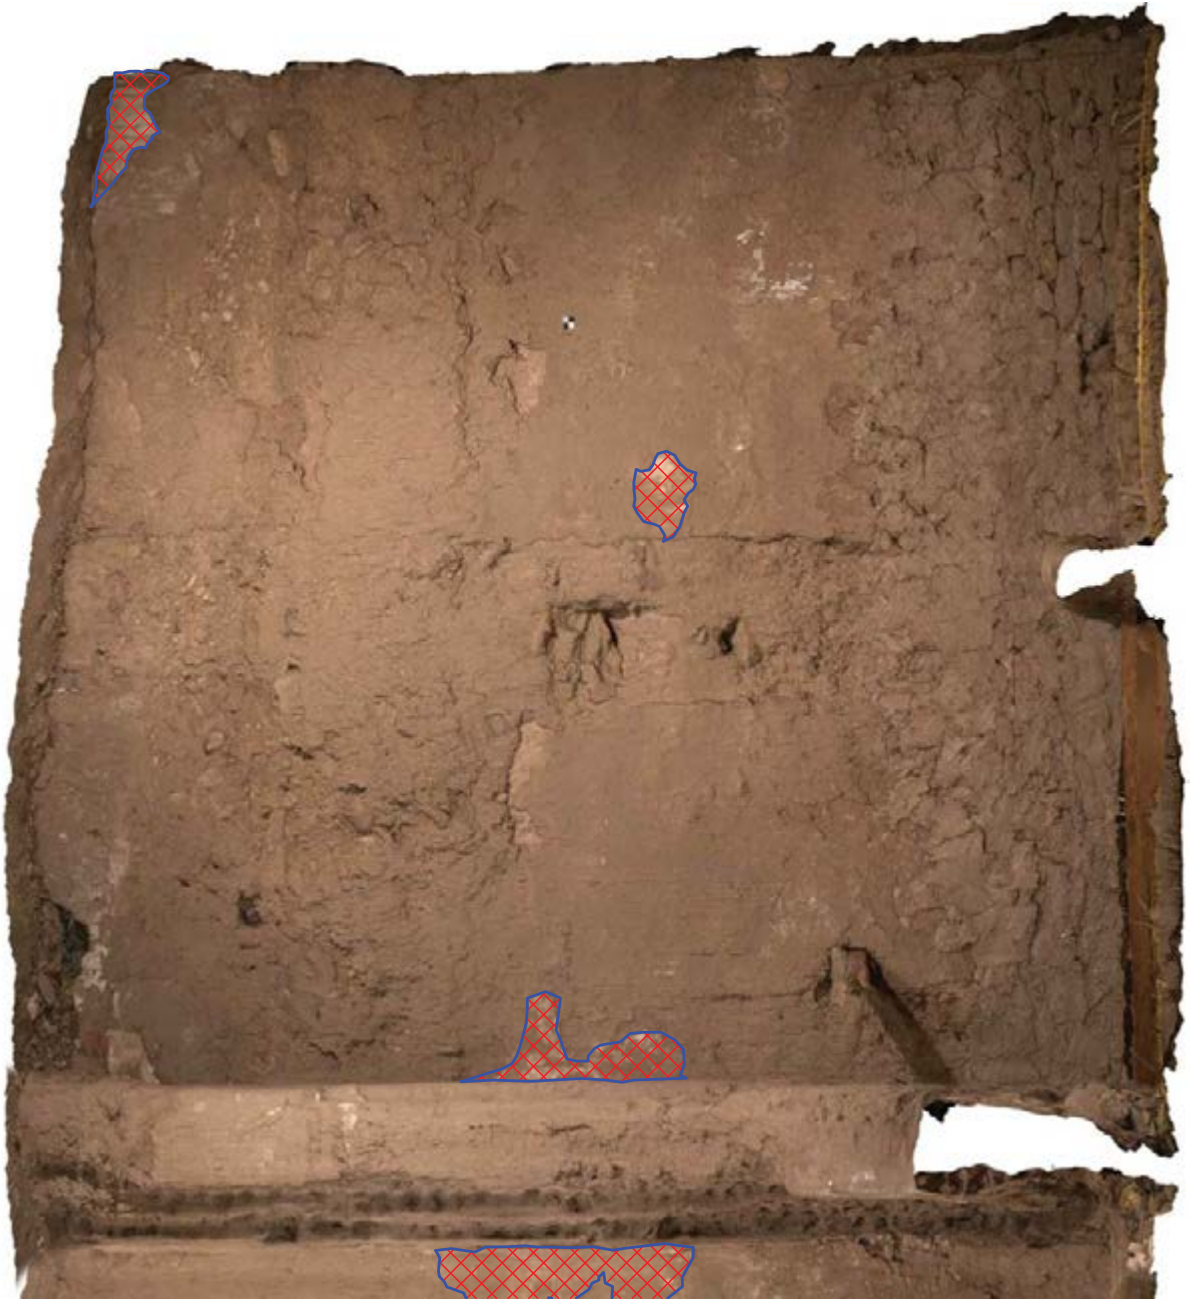
CAID RESIDENCE - NORTH-WESTERN ROOM - NORTHERN WALL (NW\_N\_S1/S2/B\_N\_S)

RISK ASSESSMENT: EMERGENCY STABILIZATION

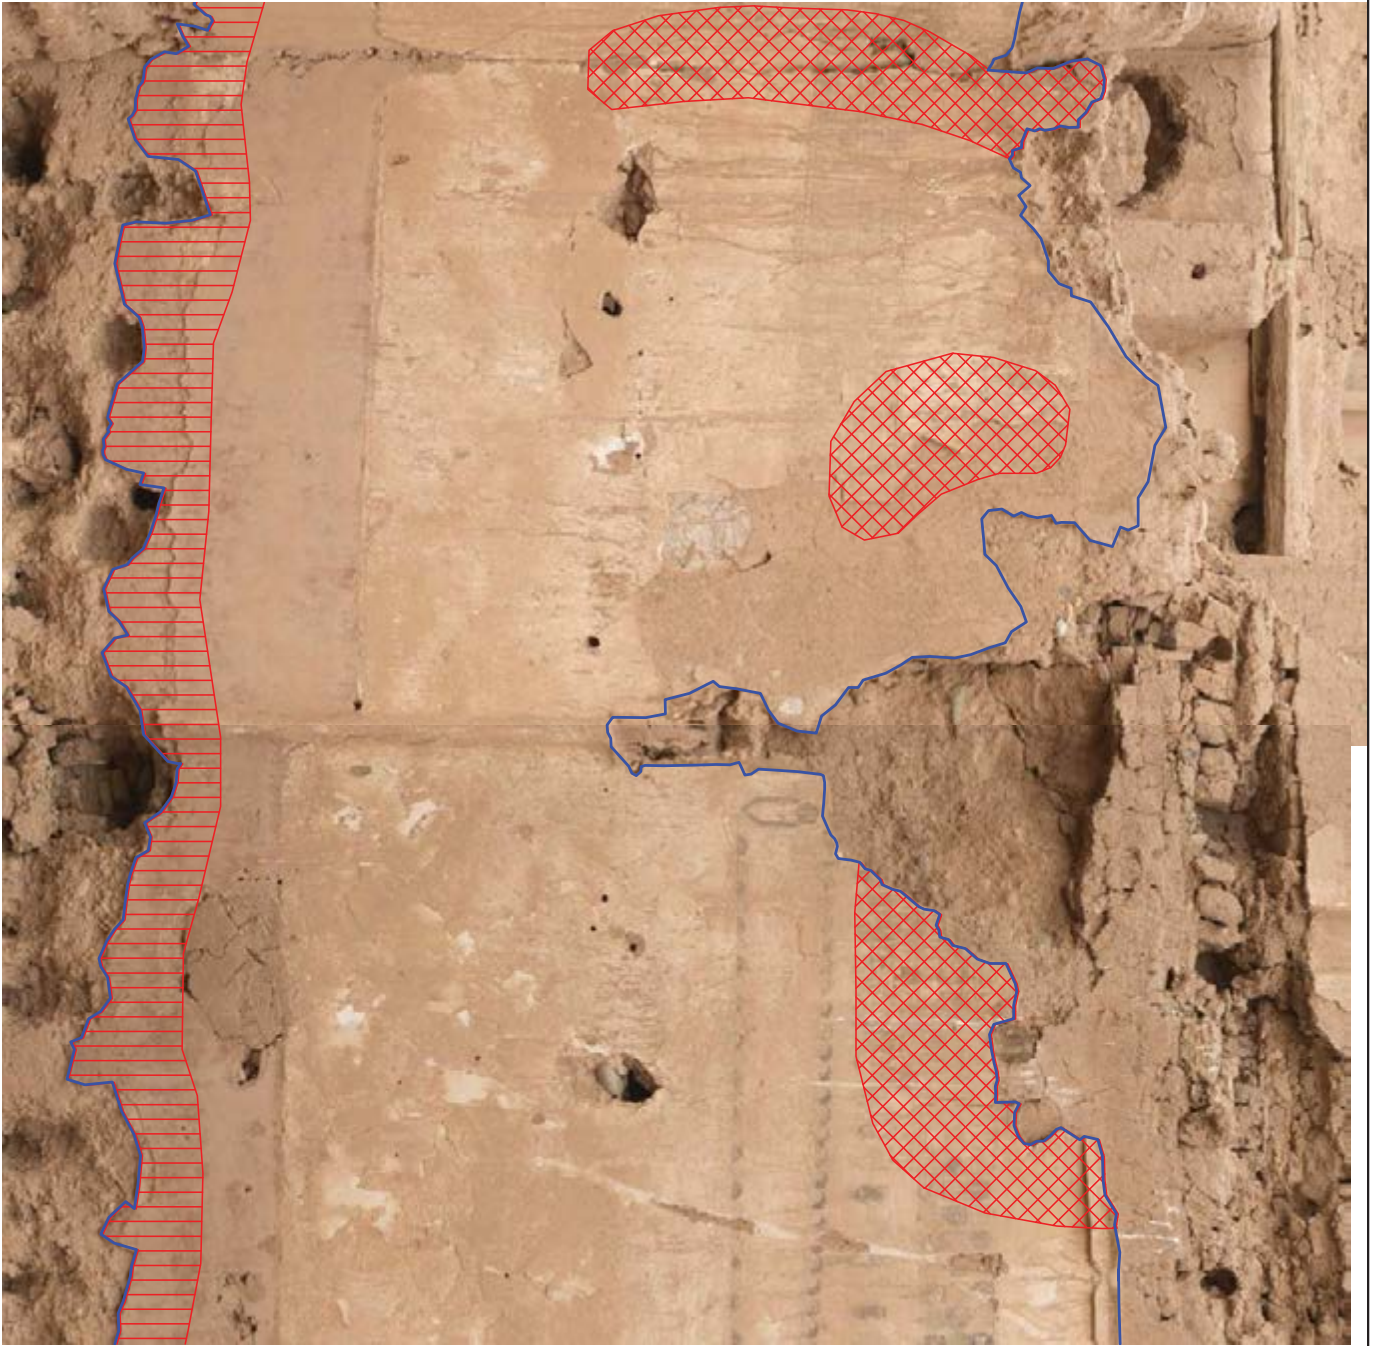
Drawing number: TAO\_CR\_RAPM\_36  
 Scale: Not to scale  
 Date: Oct 2014

**HIGH RISK**  
Detached and very unstable plaster requiring selective grouting and facing.

**HIGH RISK**  
Cracked and unstable plaster requiring selective edge repairs.

**HIGHLY SIGNIFICANCE**  
Risk due to position near area of structural interventions requiring facing.

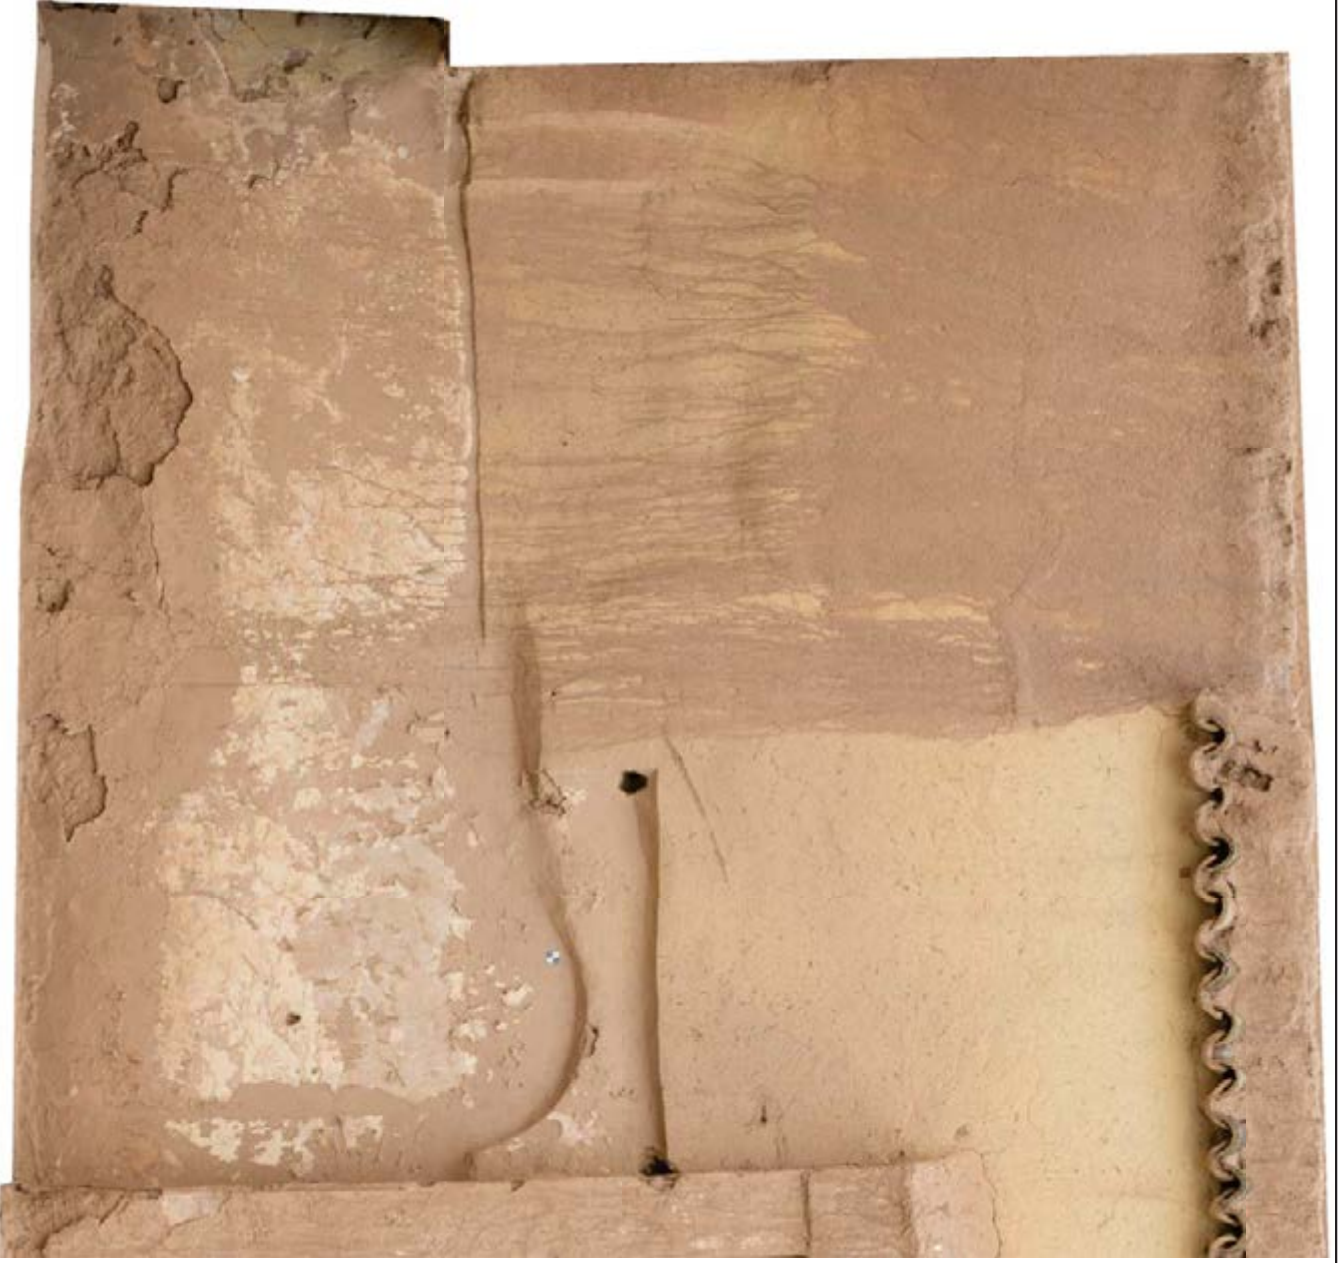
CAID RESIDENCE - NORTHERN FAÇADE - NORTHERN WALL (NFa\_N)

**HIGH RISK**  
Cracked and unstable plaster requiring selective edge repairs.

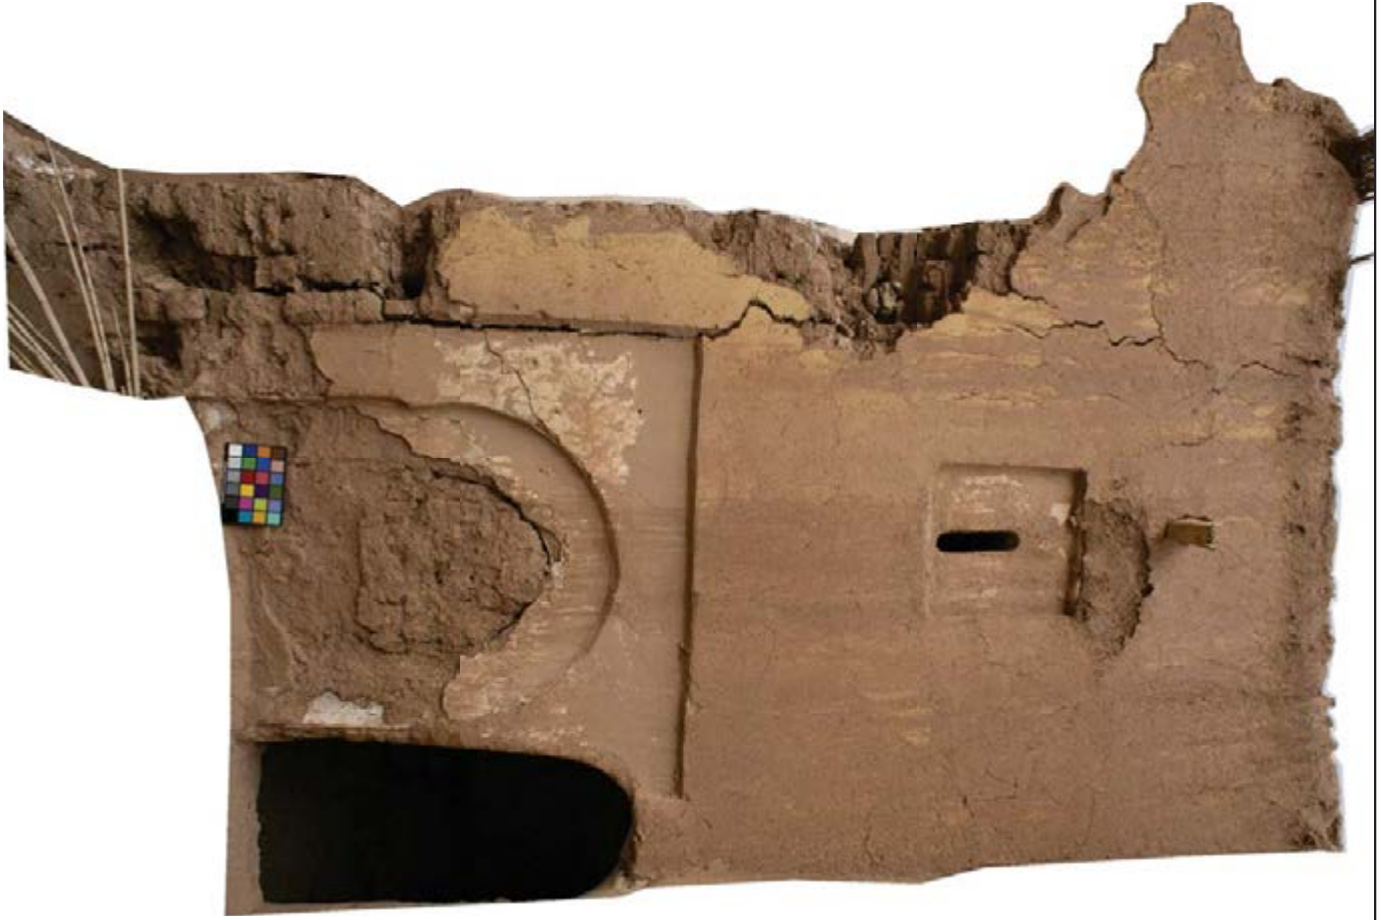
CAID RESIDENCE - NORTHERN FAÇADE - WESTERN WALL (Nfa\_W)

**HIGH RISK**  
Cracked and unstable plaster requiring selective edge repairs.
