## CONDITION ASSESSMENT – MATERIAL AND BUILDING PATHOLOGY

*This session was created by Tony Crosby and modified by Claudia Cancino.*

### ABSTRACT

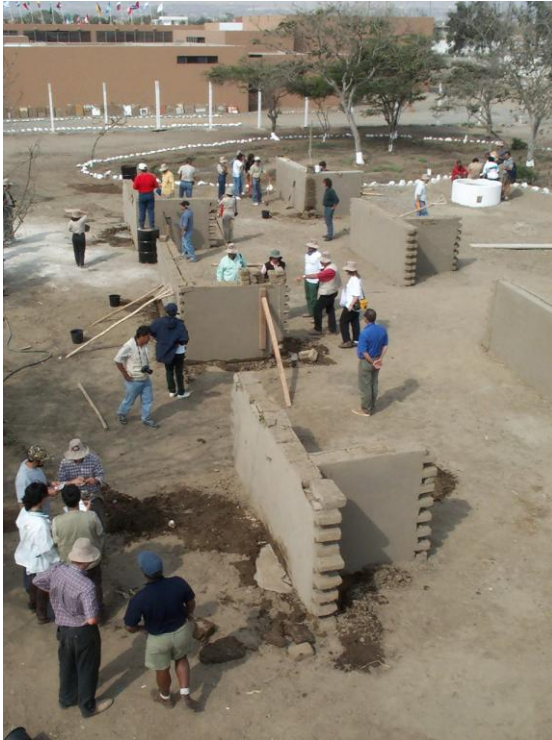
Figure 4.2.3  
Large scale simulation exercise area  
PAT course, 1999 © J. Paul Getty Trust

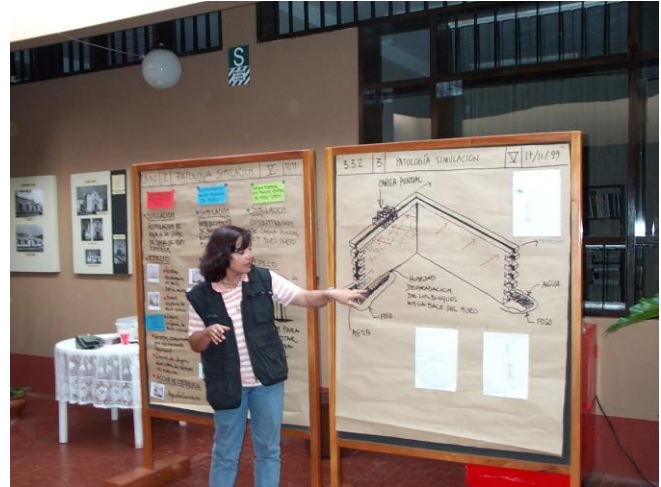
Figure 4.2.6  
PAT students presenting in class the decay  
mechanism on the large-scale sample after simulating  
pathology  
PAT course, 1999 © J. Paul Getty Trust

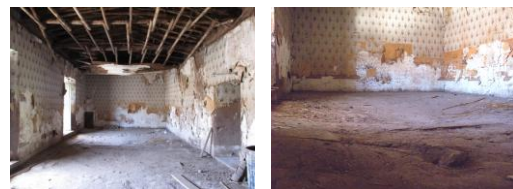
**Moisture decay at residential unite in Lima, Photographer: Claudia Cancino, ©J.Paul Getty Trust**

The image shows loss, detachment and erosion of material at this earthen house in the district of Miraflores in Lima, Peru. Most of the drainage in the historic center of Miraflores is from 1960 and in need of repair?, resulting in water being absorbed? into the soil and transferred to the base of the adobe walls.
