PHYSICAL STRATEGIES – NON STRUCTURAL INTERVENTIONS NON FABRIC INTERVENTIONS

This session was created by Mike Taylor and modified by Claudia Cancino.

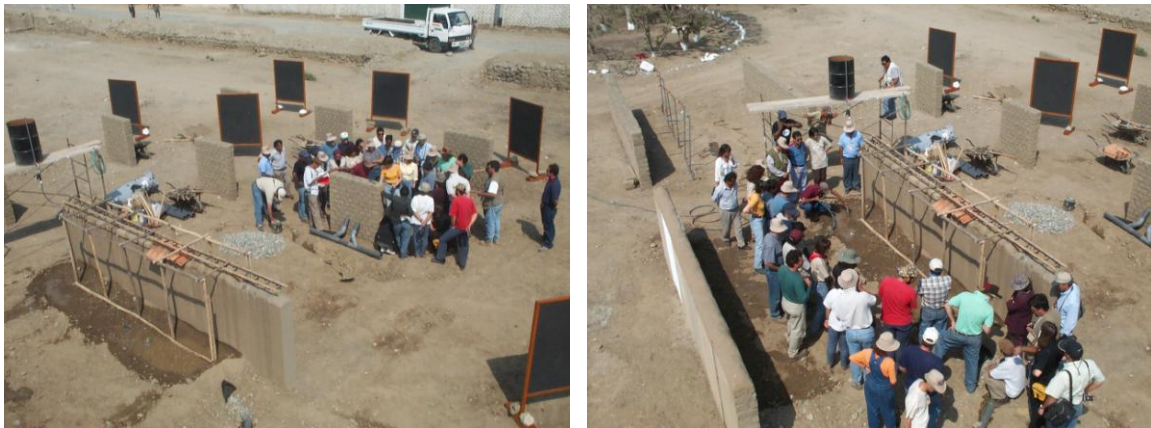
Figure 5.1.1 (left) and 5.1.2 (right)
View of exercise walls with instructor discussing the field exercise to PAT students
PAT course, 1999 © J. Paul Getty Trust

The field exercise will be undertaken at either ten new test walls (one meter high by one meter long) built for this exercise, or at historic earthen walls at an archaeological site.

The construction of ten test walls (5 for the drainage exercise and 5 for the reburial exercise) could serve earlier exercises on building techniques and traditions if needed to expose participants to hands-on construction techniques. If a test wall plot is used as the venue for the exercises, such a plot should have dimensions large enough to accommodate five teams of participants with at least ten small walls.

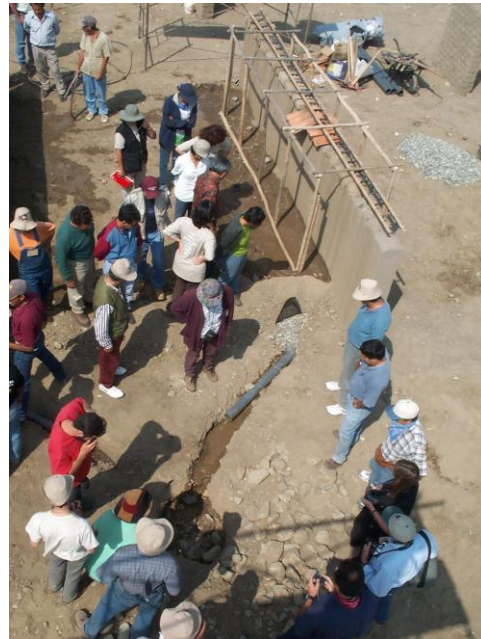
Figure 5.1.3
View of French drain installation
PAT course, 1999 © J. Paul Getty Trust

- French drain: system consisting of a trench excavated at least one meter from walls to a depth even with the bottom of the wall's foundation. In the trench is placed a perforated pipe sloping to an open drain, field or to a dry well. The pipe is surrounded by gravel and the trench filled with gravel to almost grade. The trench sides and top can be covered with a soil filter fabric that will inhibit the passage of soil particles and miscellaneous debris that may clog the system.

Each team will work on installing drainage systems on five walls. Each team will install a French drain on one side of the wall and a geodrain on the other side of the wall. Before the exercise assistants will have already excavated trenches for these installations.

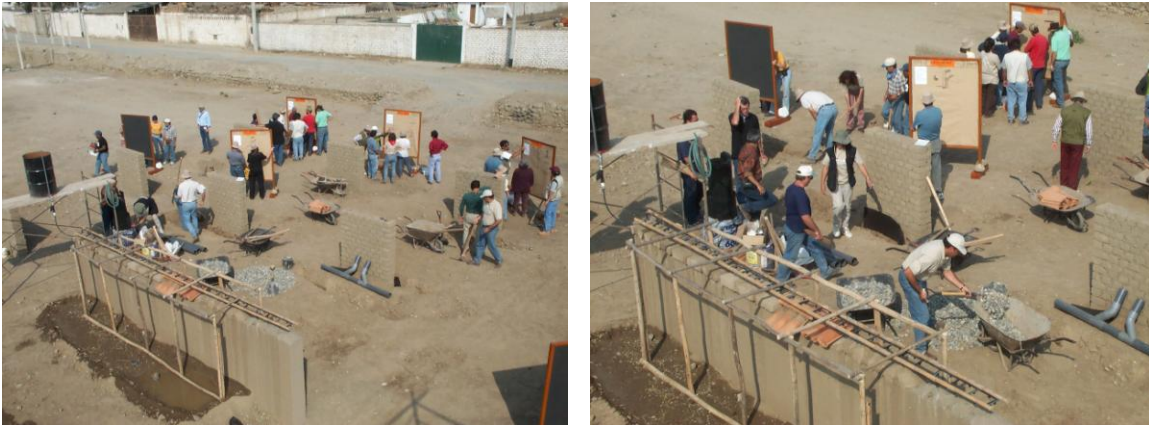
Figure 5.1.4 (left) and 5.1.5 (right)
PAT students working on different drainage installation systems at test walls
PAT course, 1999 © J. Paul Getty Trust

Once the systems are installed, water will be introduced to the base of the walls to demonstrate the efficacy of the drainage systems. Each team will record any observations.

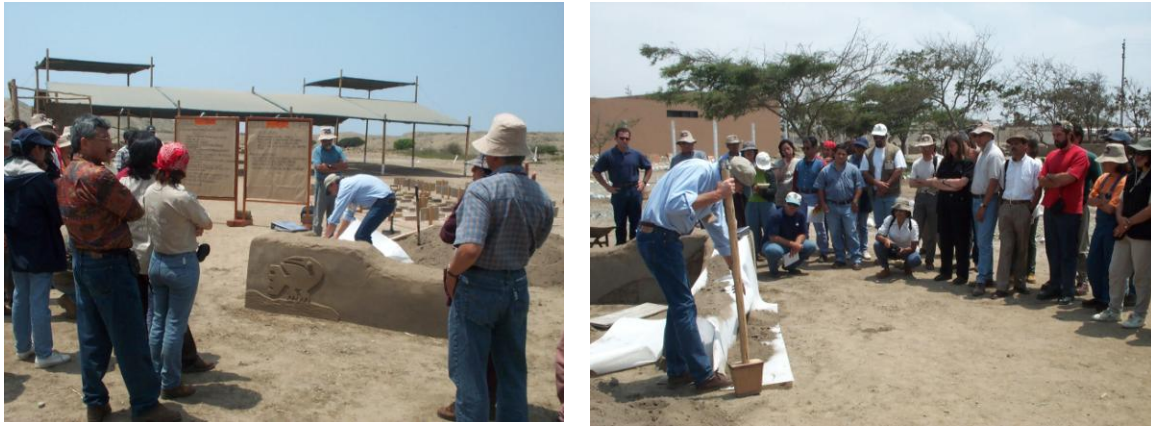
Figure 5.1.6 (left) and 5.1.7 (right)
PAT instructor, Mike Taylor, demonstrating reburial of a test wall with high relieves.
PAT course, 1999 © J. Paul Getty Trust

- Total reburial of a wall using hand equipment
- Partial reburial of a wall using hand equipment
- Total reburial of a wall using heavy equipment (i.e. bobcat)
- Total reburial of a wall using a conveyor belt system fed by bobcat in the hopper

- Estimate amount of fill needed
- Discuss selection of soil type to be used for backfilling
- Install geo fabric material, with discussion of various types available
- Place fill material in levels, with tamping or rolling at each level
- Place of final level of fill, with proper grade requirements
